**ENVIRONMENTAL CONDITION OF
PROPERTY REPORT**

**LYCOMING MEMORIAL
U.S. ARMY RESERVE CENTER (PA148)
1605 Four Mile Drive
Williamsport, PA 17707-1989**

MARCH 2007

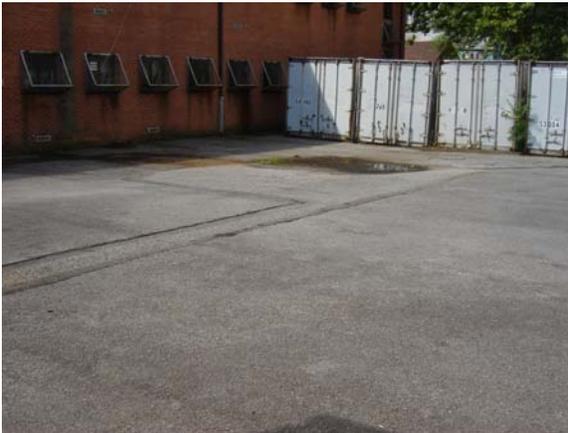
A 1998 facility assessment indicates that in approximately 1988, a contractor removed one 10,000-gallon UST that was used to store fuel oil on the Property. The former UST was located in the MEP area north of the boiler room in the administration building. Based on interviews with site personnel, in 1998, petroleum contamination was encountered during the removal of the UST and contaminated soils were excavated and transported off-site. At the time of the 1998 facility assessment, no UST closure/site assessment report was available for review to document site conditions (soil/groundwater) during the UST removal. It was recommended that the records be researched to determine if the UST was properly removed and if contamination is present beneath the Property. It was also unknown if soil/groundwater samples were collected for analysis during the removal of the tank. It was also recommended that if no closure documentation was identified for review, then a limited subsurface investigation be performed to document the UST removal (U.S. Army, 1998).

3. View to west/southwest of the location of the former 10,000-gallon fuel oil UST (see cutout area of asphalt in front of CONEX containers).

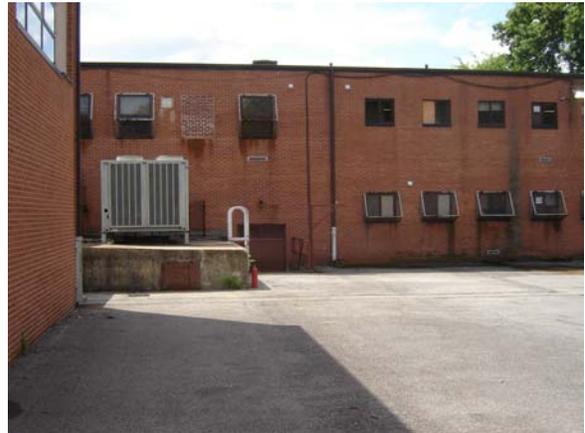
4. View to the south of the former coal storage room (identified by elevated concrete pad) located on the north side of the administration building (the former fuel oil UST area is visible on the right side of the photograph).

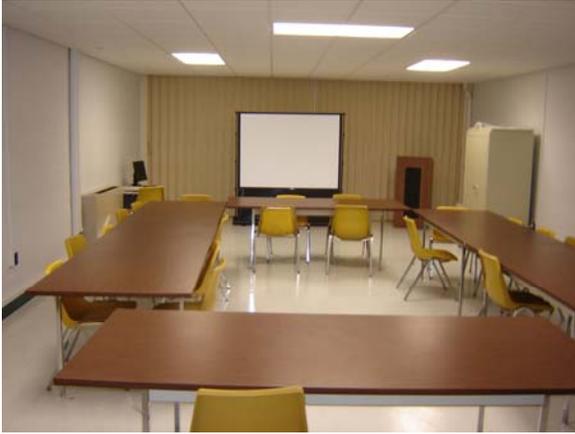
5. Classroom (Room 114) identified as part of the former indoor firing range.

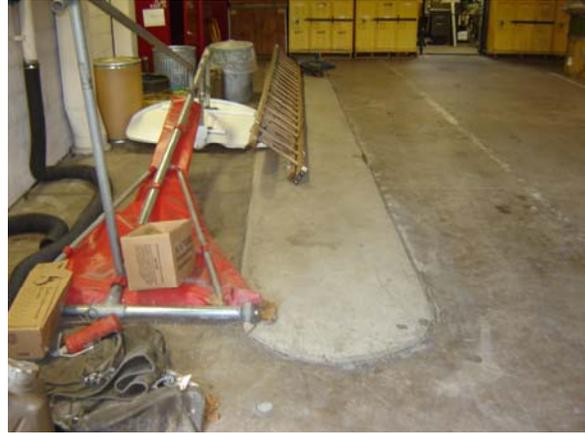
The multi-story OMS building provides unobstructed, open space to perform limited maintenance activities on military equipment. The building contains one service bay and the present main purpose of the building is for storage purposes. At the time of the site reconnaissance, materials/supplies such as tents, pumps, ladders, and water containers were observed in the OMS building. Numerous storage lockers for reservists were also present in the OMS building and were locked and inaccessible. No vehicles were parked in the OMS building and no evidence of recent vehicle maintenance was observed. The former vehicle maintenance pit located in the vehicle bay portion of the OMS building was filled with concrete (Photograph 6, Appendix B). No floor drains were visible in the OMS building.

The OMS building contains three service bays and is currently used for storage purposes. No vehicles were parked in the OMS and no evidence of recent vehicle maintenance was observed. A former vehicle maintenance pit is located in the southernmost vehicle bay of the OMS building. The vehicle maintenance pit was observed as filled with concrete. No floor drains were visible in the OMS building.

6. Former vehicle maintenance pit (closed and filled with concrete) located in the southern bay of the OMS building.

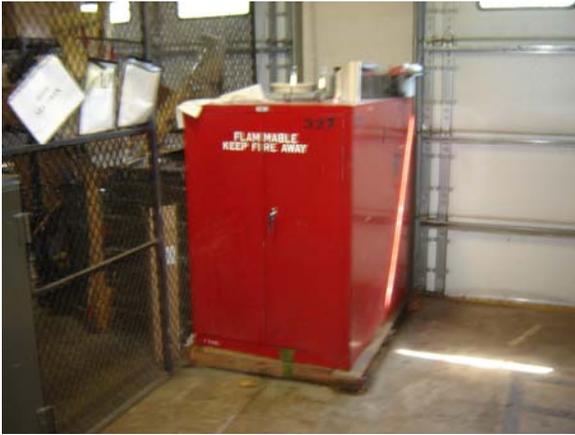
Three flammable storage cabinets were observed in the OMS building. One flammable storage cabinet was empty and the other two flammable storage cabinets were locked. No evidence of staining or chemical-type odors was observed in the vicinities of the flammable storage cabinets. In addition, the petroleum, oil, and lubricant (POL) storage room located in the southwest corner of the OMS building was also locked and could not be opened. According to site personnel, no POLs or antifreeze are presently stored on the Property. POLs or antifreeze that is needed to "top off" military vehicles are purchased at the store.

7. Flammable storage locker in the OMS building (locked and inaccessible at time of site reconnaissance).

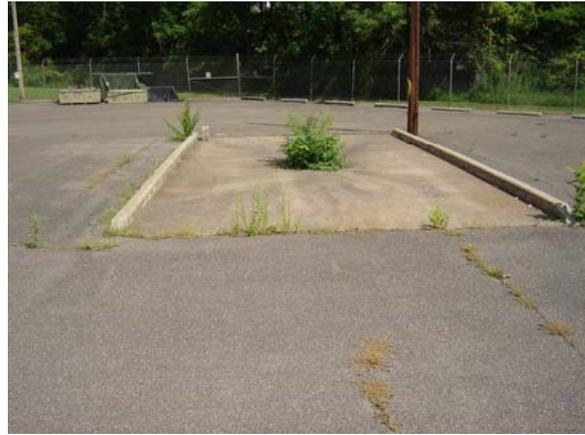
8. View to north of the vehicle wash area located in the MEP area (vegetation growing in sand trap drain in center of concrete pad).

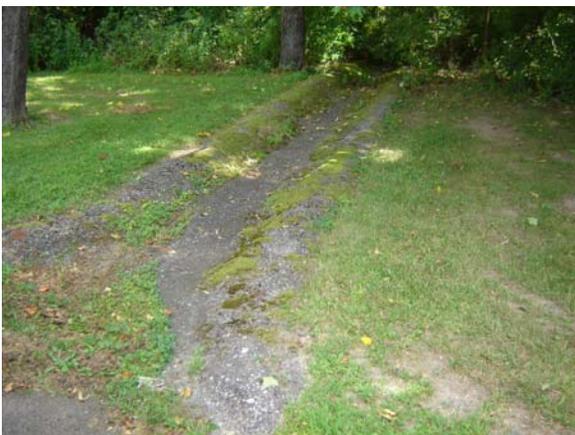
9. Storm water outfall located at northeast corner of POV area that flows into Miller's Run Creek.

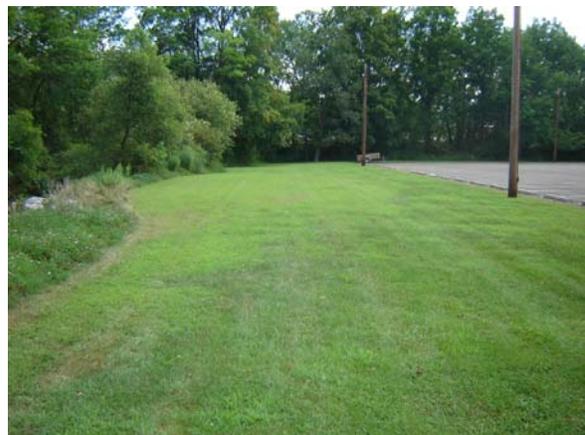
10. View to the east of the northern and eastern property boundaries identified by Miller's Run Creek.
