**Appendix B**  
**Site Reconnaissance Photographs**

**Rufus N. Garrett Jr. USAR Center  
815 West 8<sup>th</sup> Street  
El Dorado, AR**

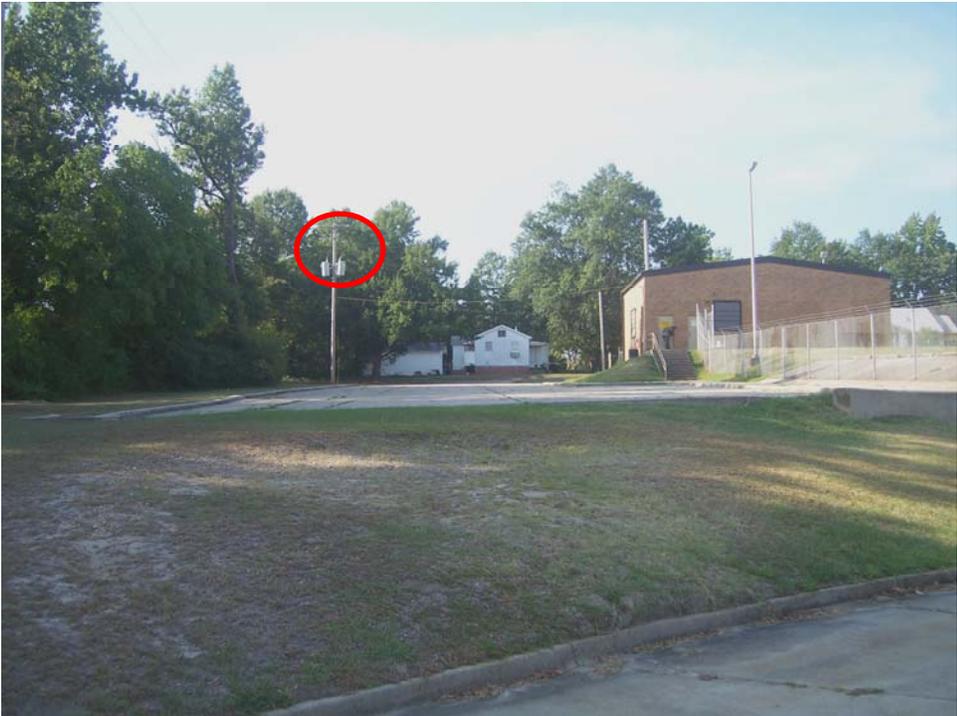
**Photo 4:** View to the south of subject property. The southern boundary adjoining properties are residential and also zoned residential. Note, pole-mounted transformers circled in left background. Right background shows Storage Building.

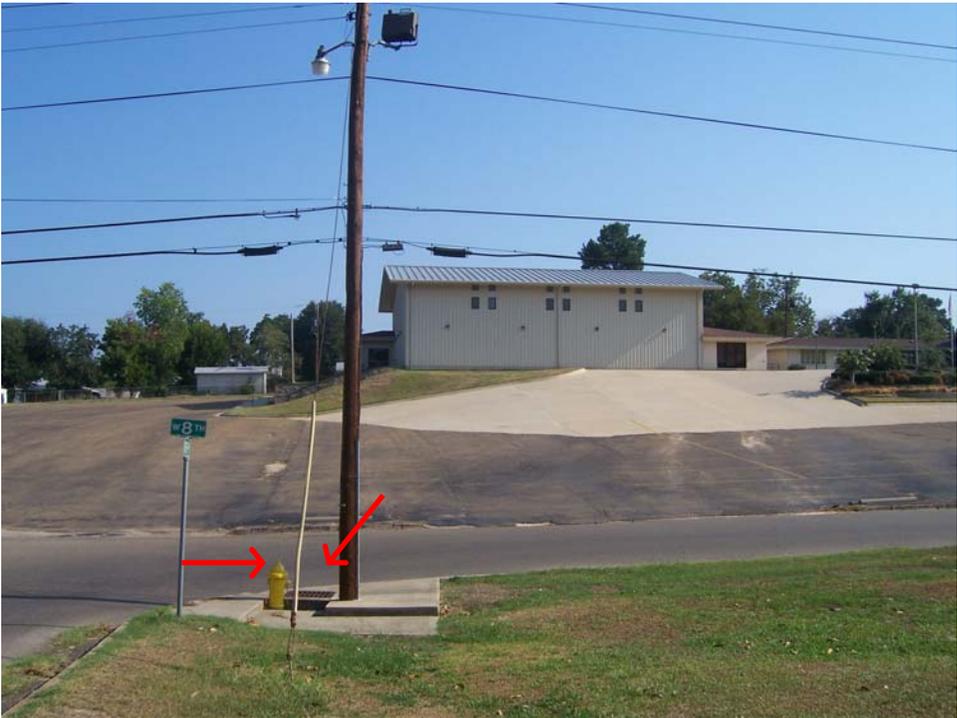
Photo 8: Looking north of subject property at church parking lot. Note, fire hydrant and storm water drain occupying northwest corner of property.

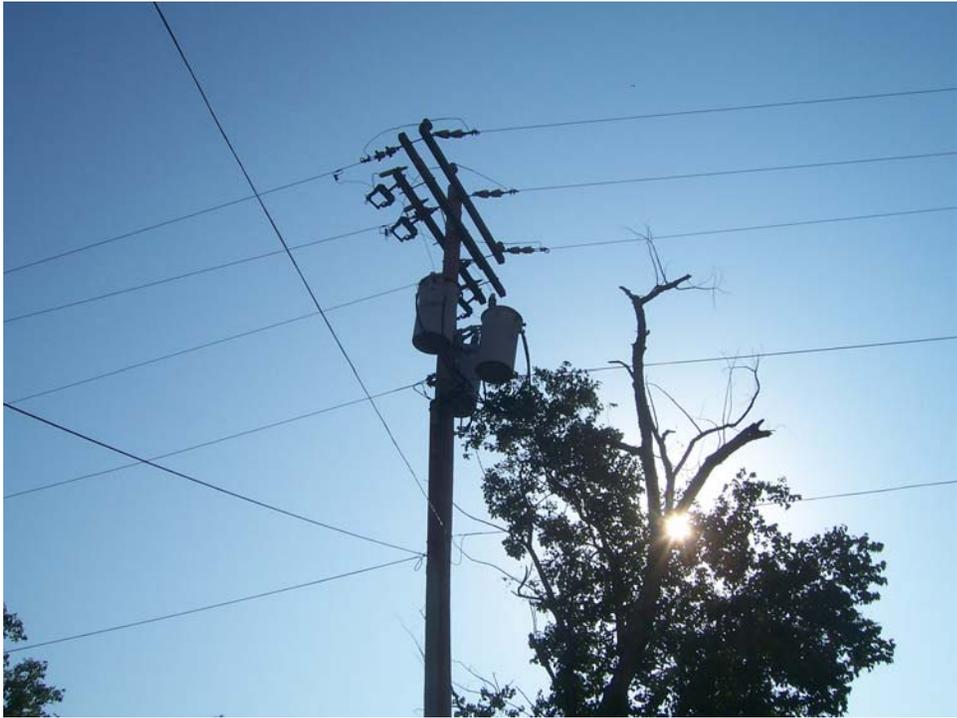
**Photo 9:** View of pole mounted transformers located in northeast corner of property.

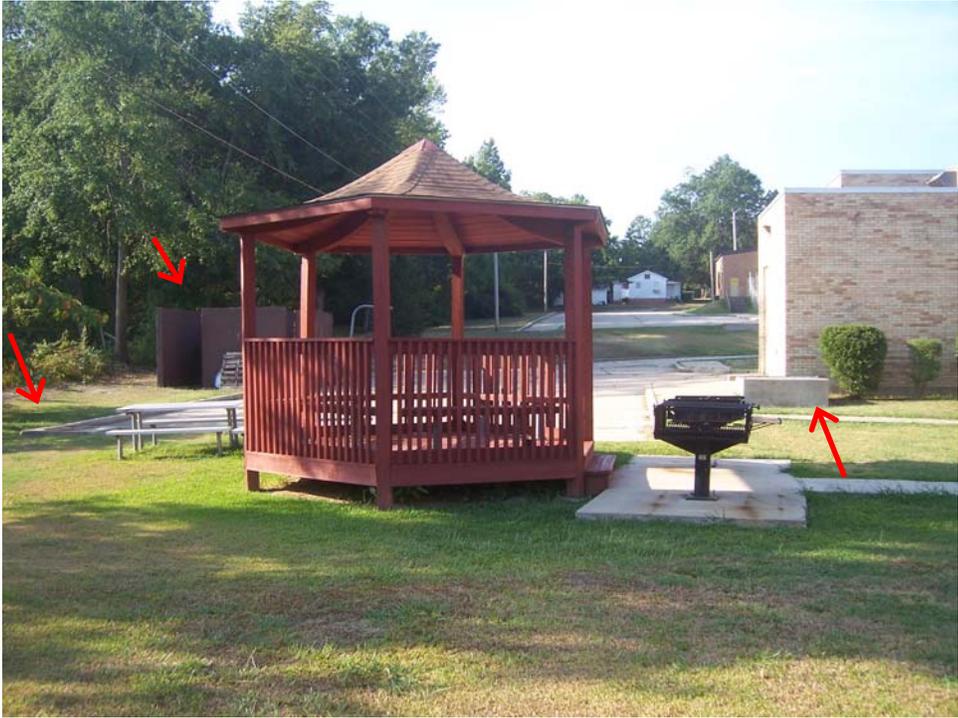
**Photo 11:** Looking south, at gazebo, from northeast corner of property. Note, Dumpster and storm water drain on left and kitchen grease trap in the right background.

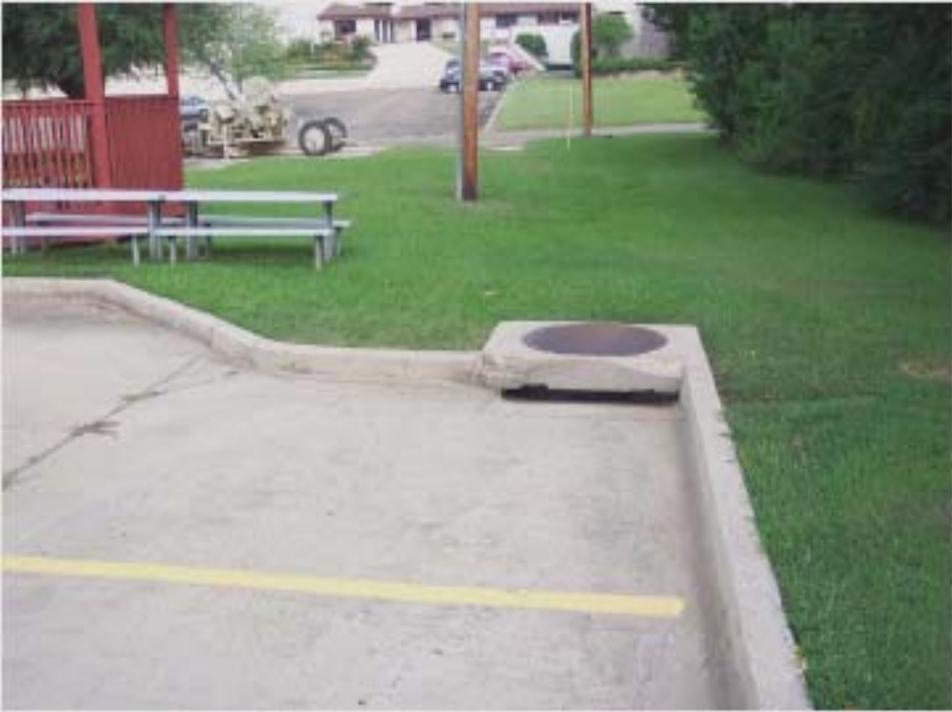
Photo 13: Looking north from Dumpster at storm water drain.

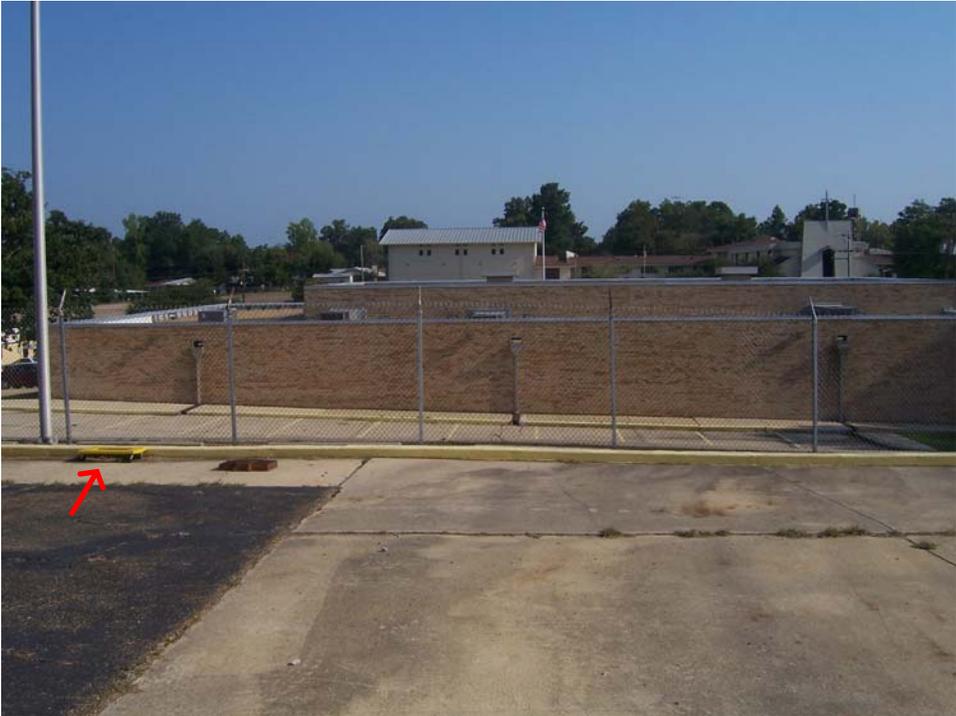
Photo 14: Looking north at the south side of the Training Building. The arrow points to a storm drain on the Site.

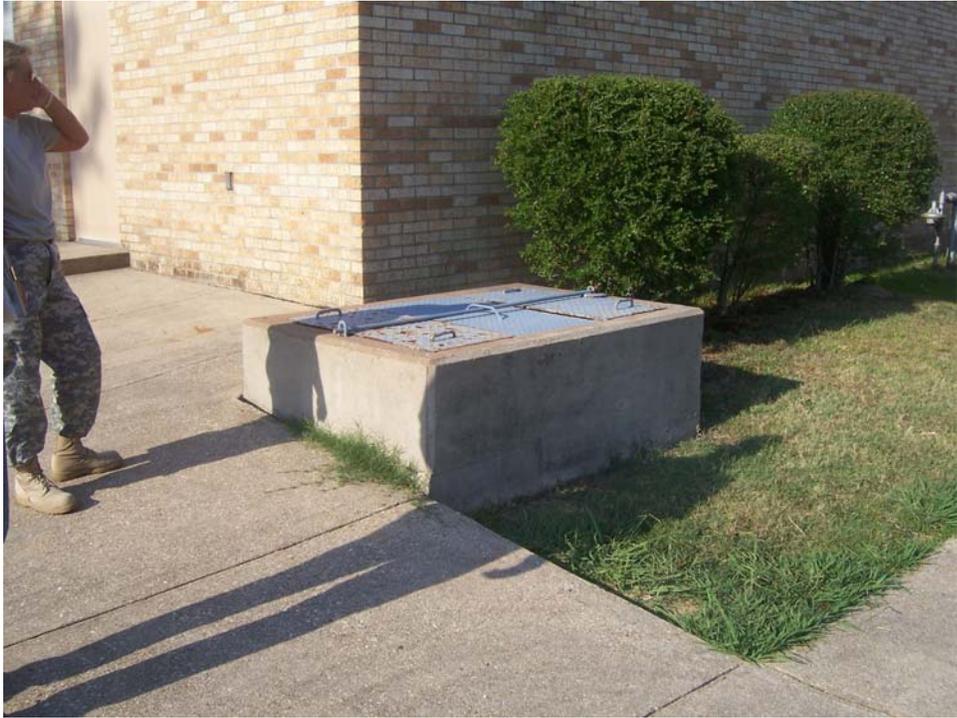
**Photo 17:** Looking southwest at grease trap on east side of Training Building. The kitchen and this associated grease trap are not in use.

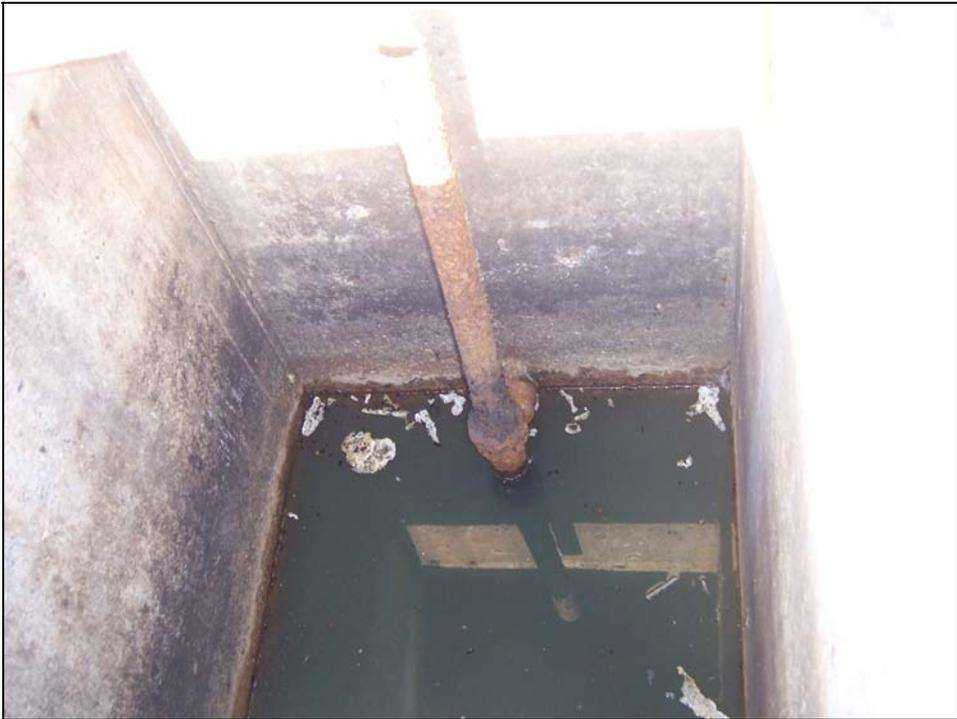
**Photo 18:** View of water inside the grease trap.

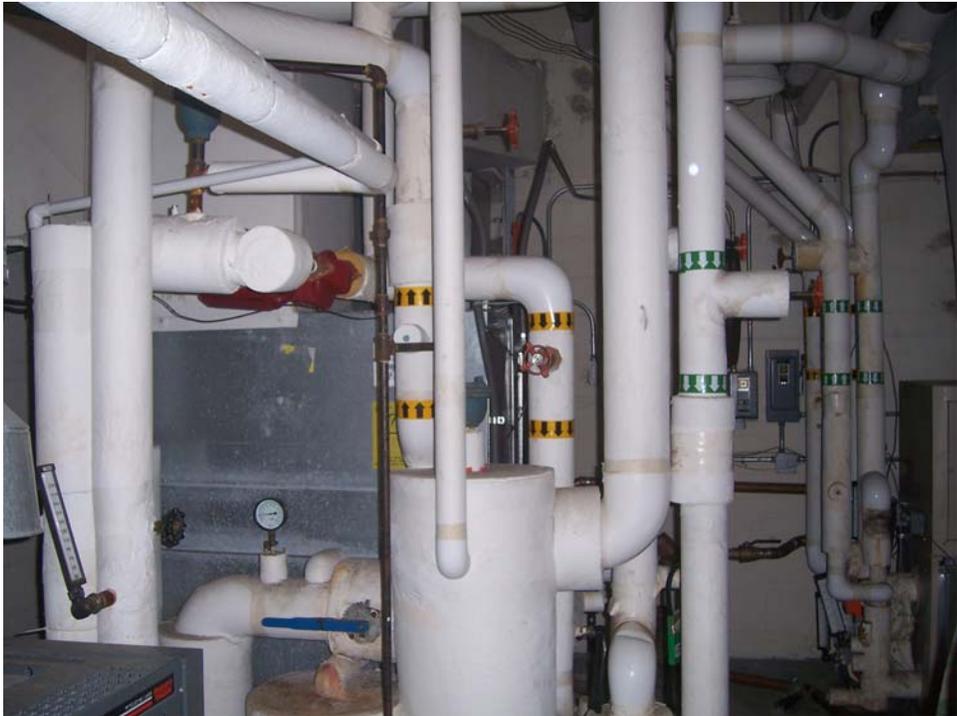
Photo 20: Looking north, inside Training Building boiler room. The piping insulation appeared new.

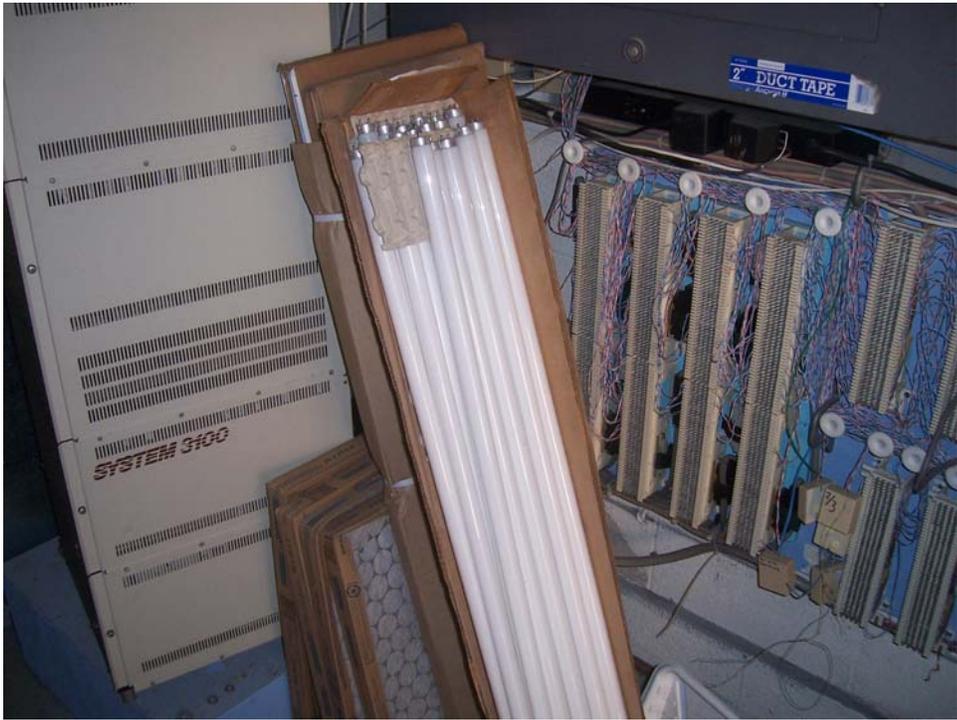
Photo 21: View inside boiler room in Training Building. Fluorescent tubes are stored here pending offsite recycling.

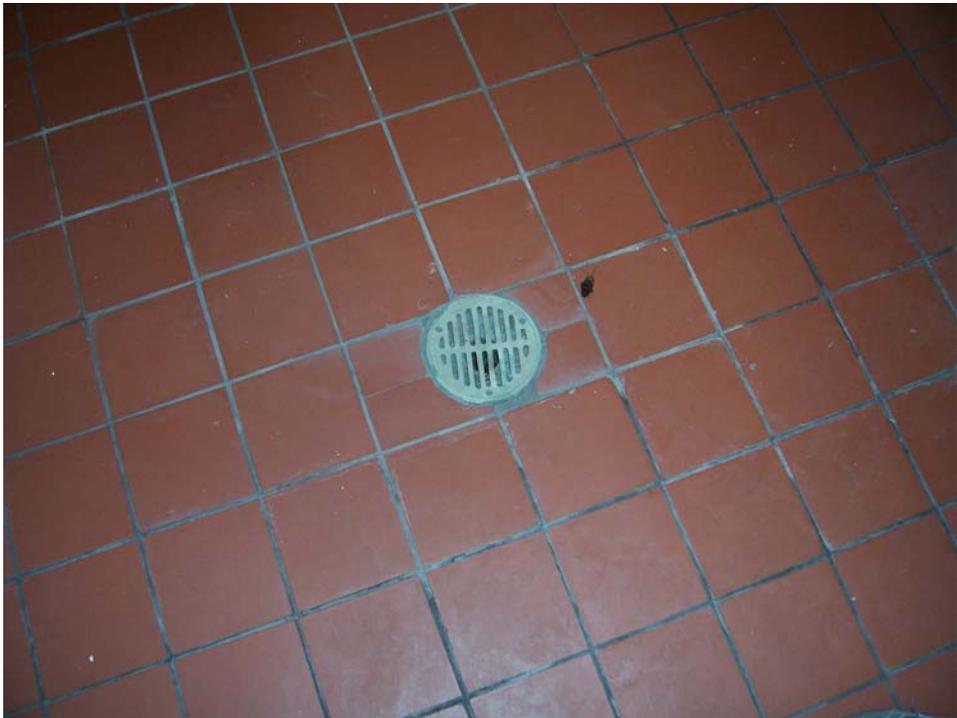
Photo 26: Floor drain in center of kitchen in Training Building.

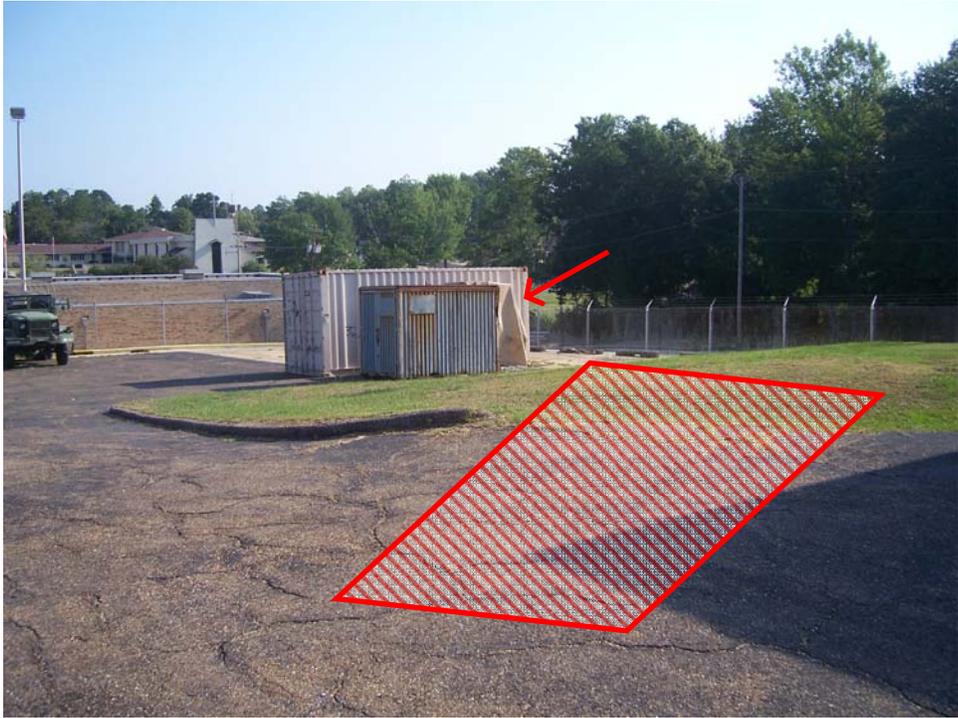
**Photo 27:** Looking north from the west side of the Storage Building, note storage containers in the center, surplus motor pool vehicle on the left, and a tarp covering a forklift on the right side (see arrow) of the small container. Also, the shaded area is the former vehicle wash rack (VWR) location as indicated by the 1998 Historic Architectural Resources report.

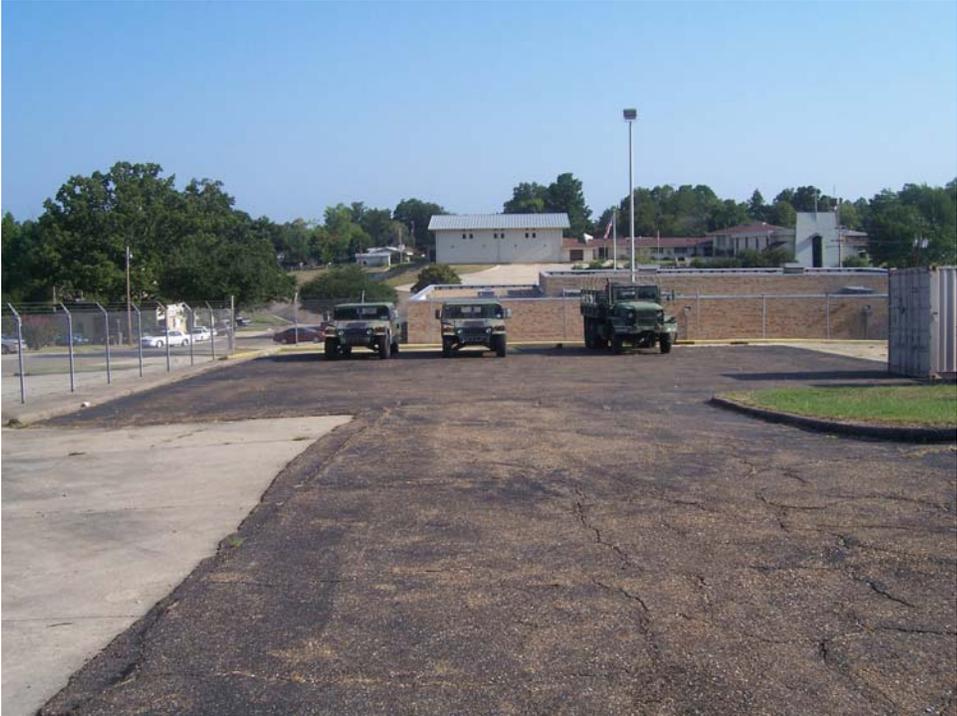
Photo 30: Looking north from Storage Building at motor pool vehicles. Adequately sized, empty, oil catch pans to prevent engine oil from leaking onto the ground surface were under each vehicle. No stains were observed on the asphalt MEP area.

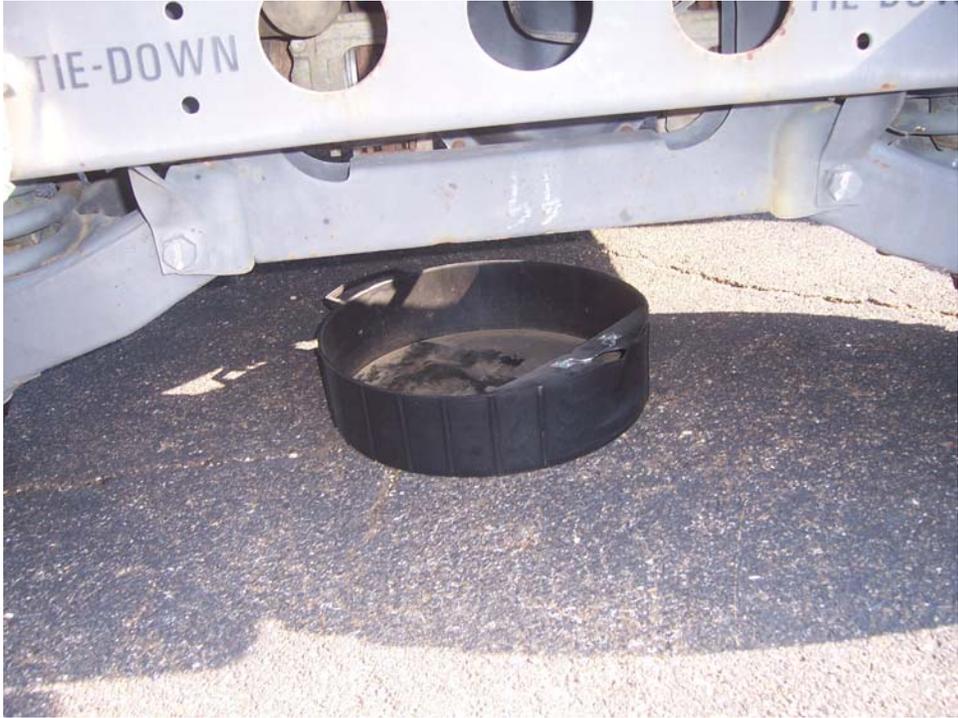
Photo 31: View of oil catch pan under a motor pool vehicle.

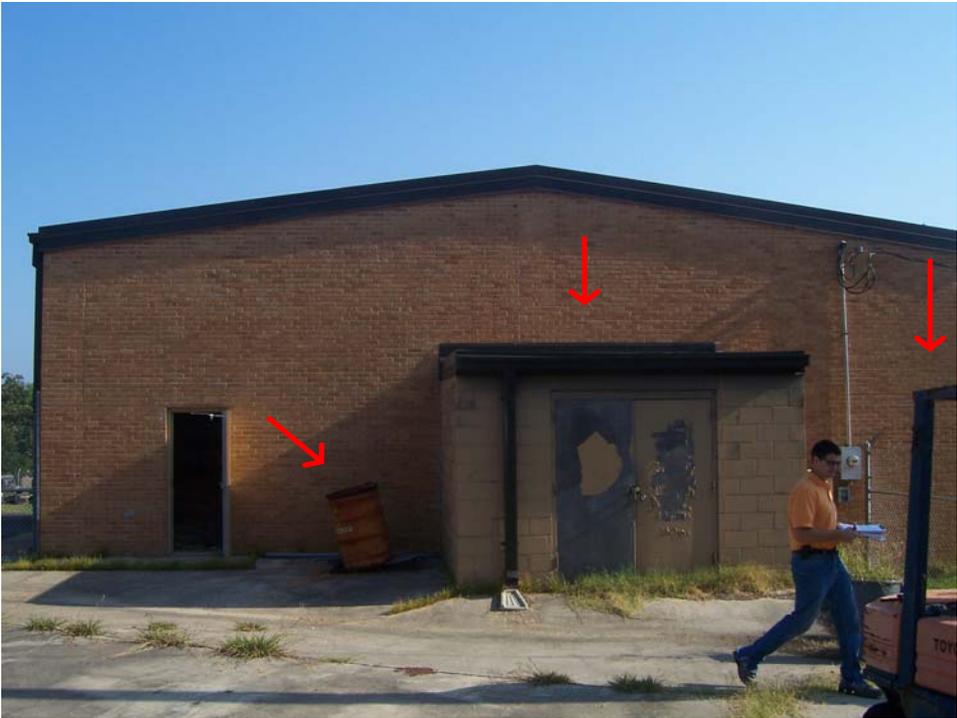
Photo 34: Looking north at rear of Storage Building. Note lighter colored room off back of building formerly used for petroleum, oil, and lubricants (POL) storage. Also note forklift in right foreground and salvage drum to left of former POL storage.

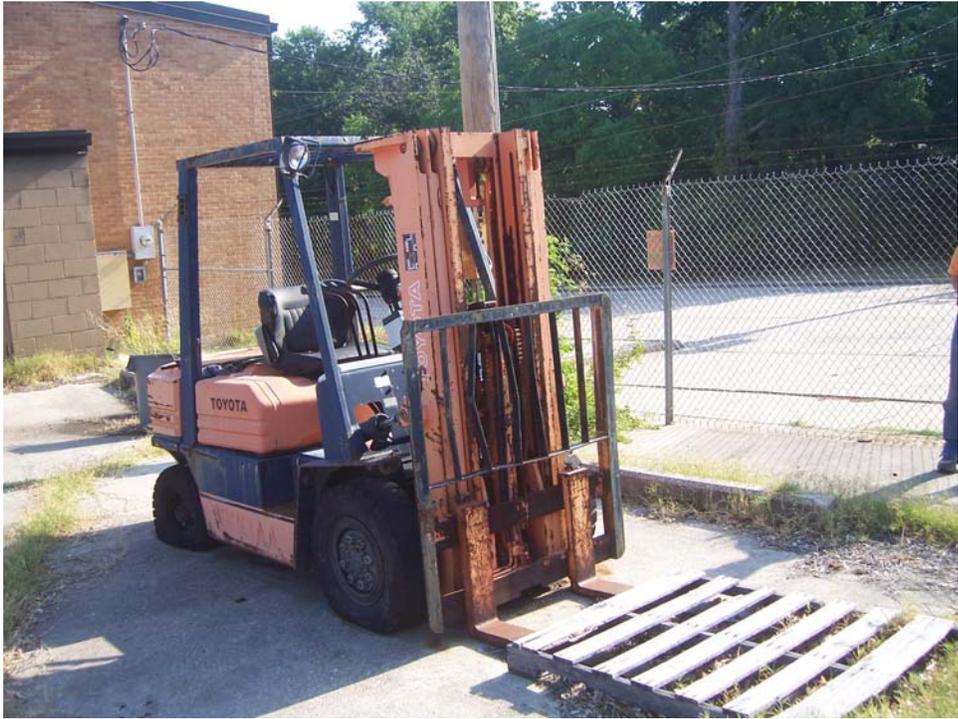
**Photo 35:** View of forklift behind Storage Building. This forklift is not operational.

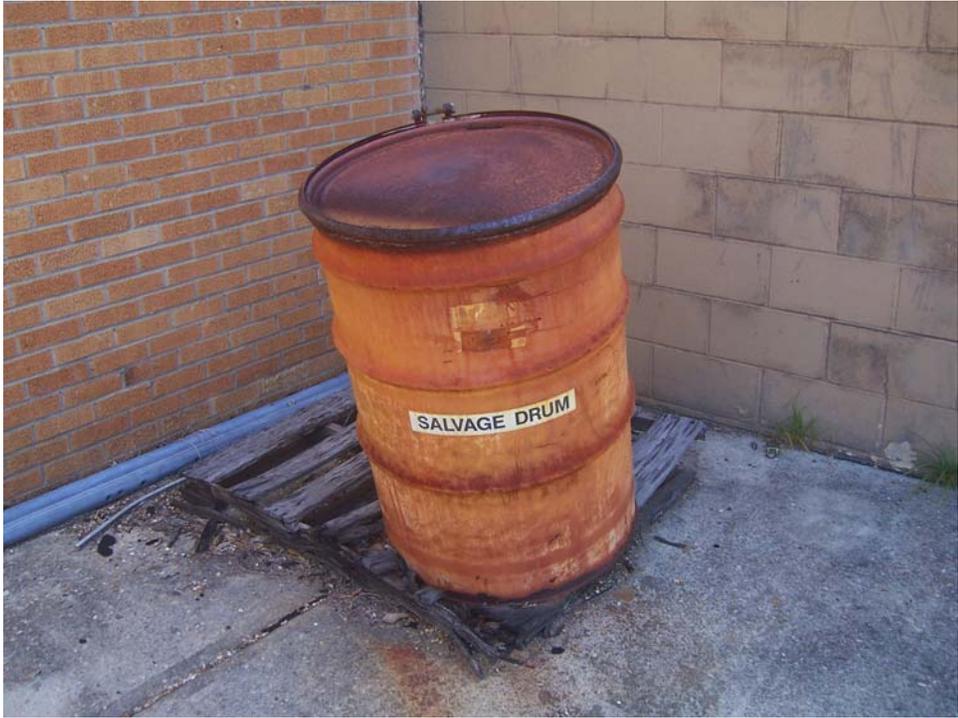
**Photo 36:** Salvage drum full of sand behind Storage Building, next to former POL storage room.

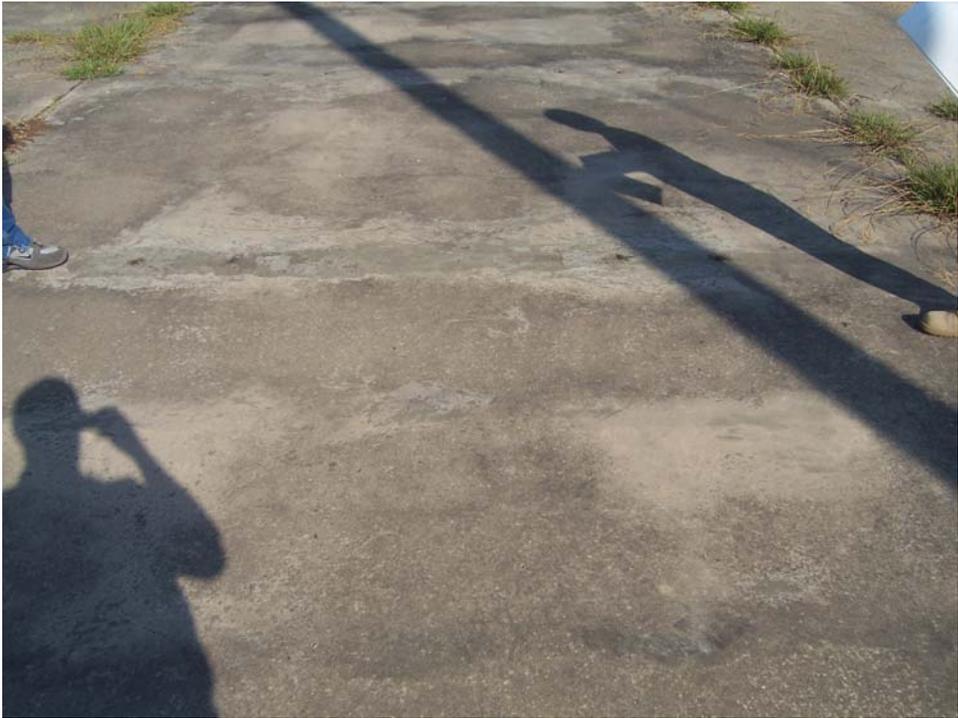
**Photo 37:** Looking northwest from the south side of the Storage Building at what appeared to be a removed grease rack.

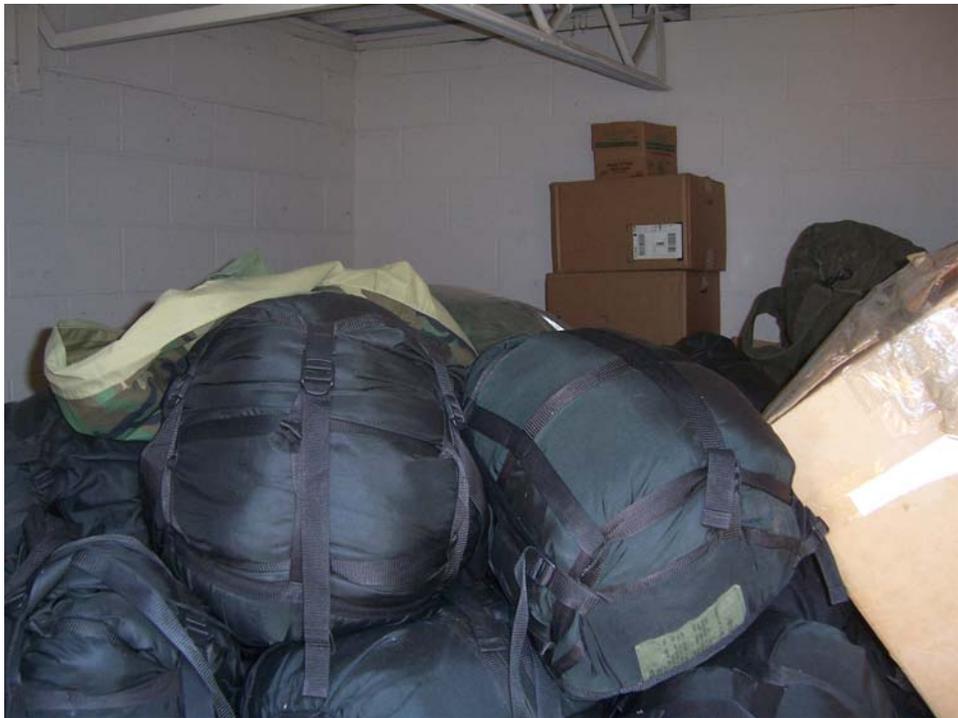
**Photo 38:** View inside of former POL storage room. Room now houses field equipment.

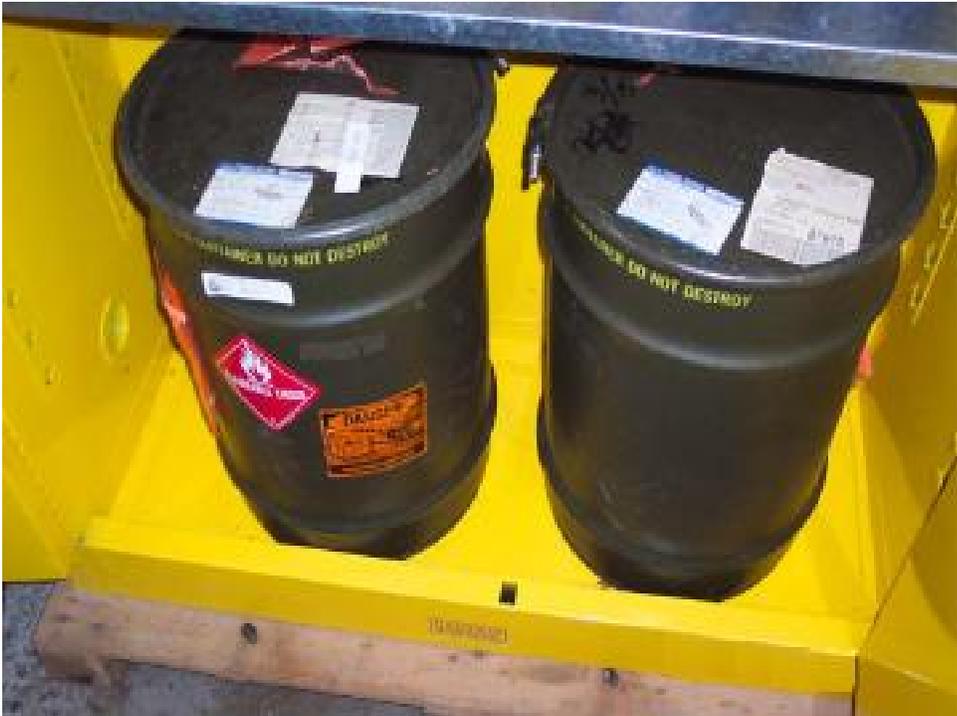
Photo 42: Typical storage in cabinets in flammable storage room.
