Appendix B
Site Reconnaissance Photos

**William Herzog Memorial USAR Center
4900 South Lancaster Road
Dallas, Texas**

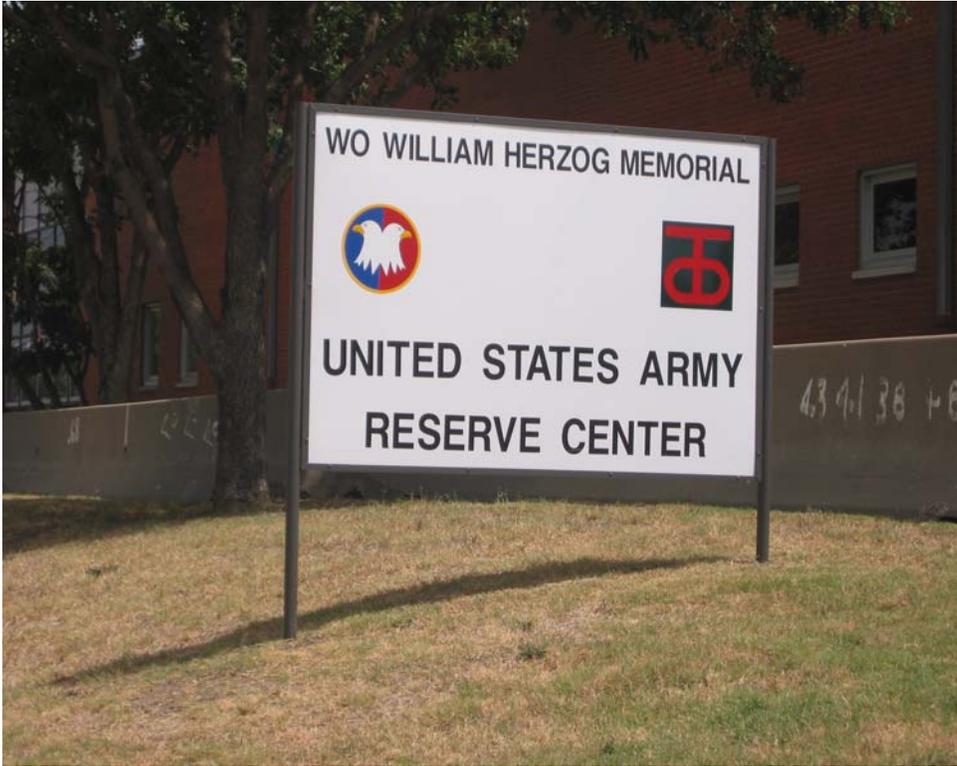
Photo 1: Sign on west side of the USAR Center Administrative Building.

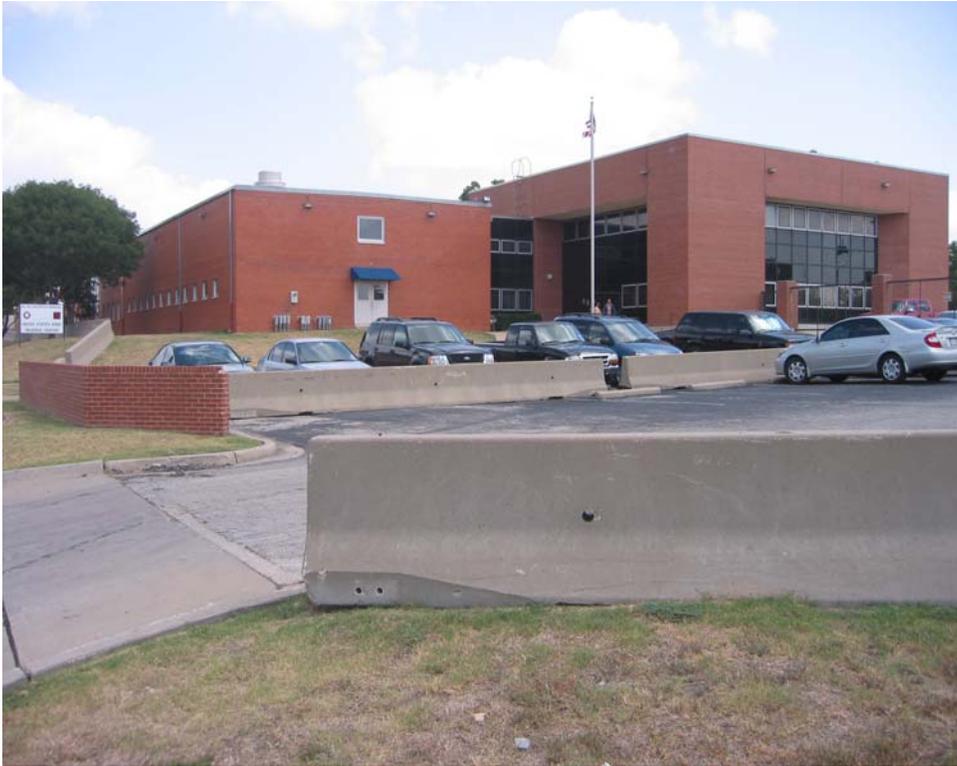
Photo 2: Looking northeast, site view of the Administrative Building from the southwest corner of the Site.

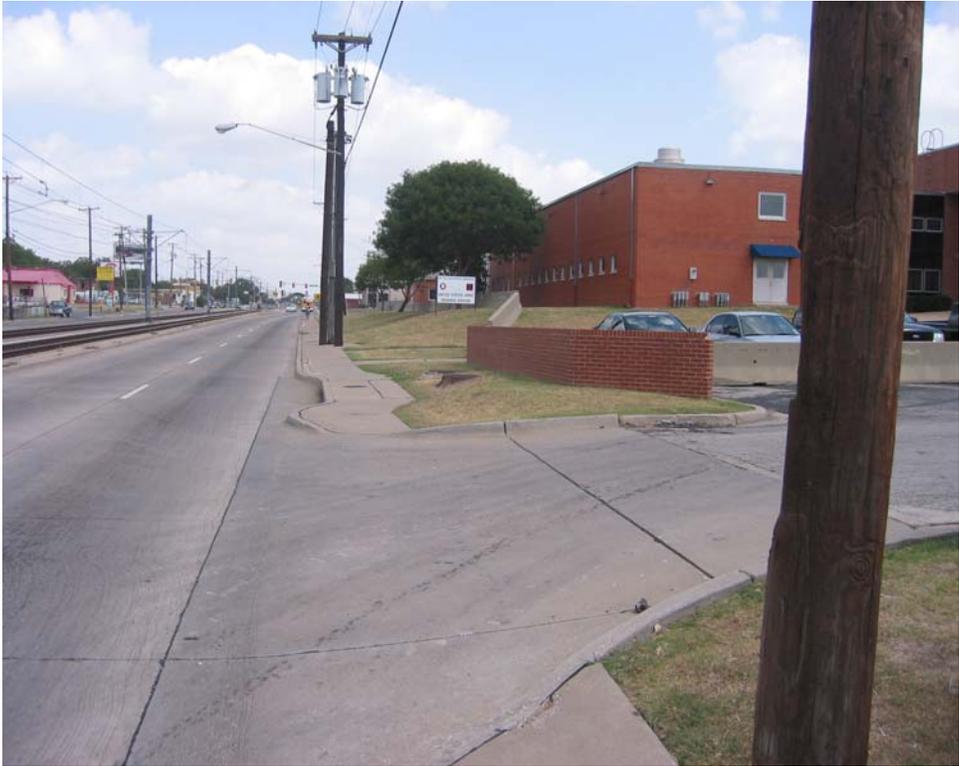
Photo 3: Looking north along South Lancaster Road, site view from the southwest corner of the property. Dallas Area Rapid Transit light rail line shown to the left.

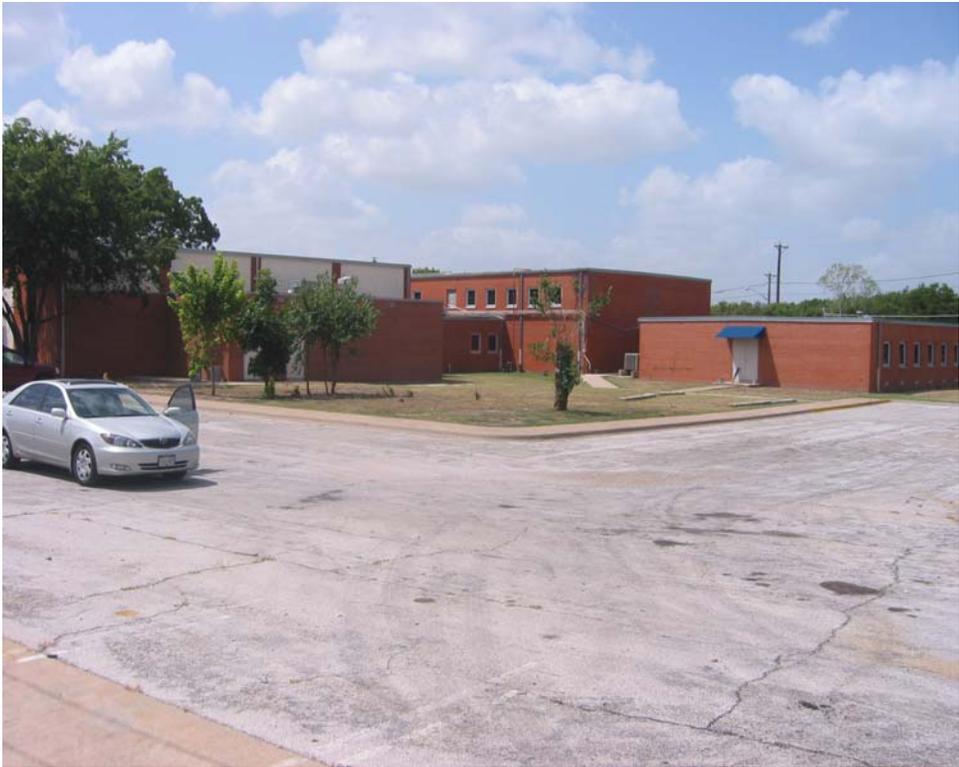
Photo 4: Looking southwest, site view from the northwest corner of the MEP lot.

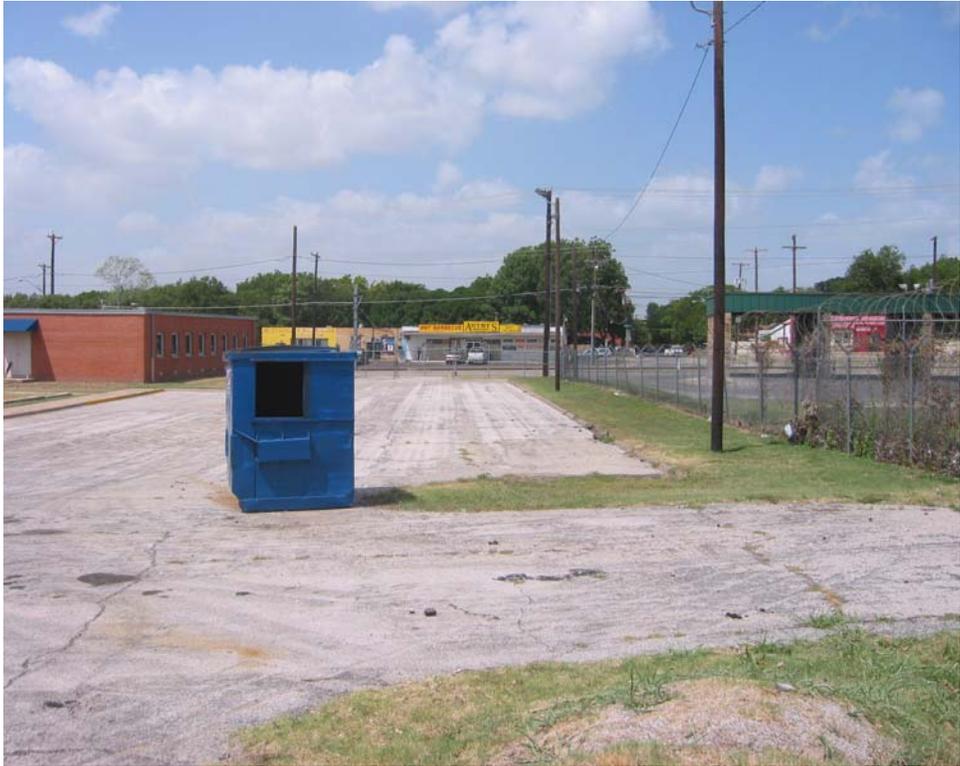
Photo 5: Looking west from the northwest corner of the MEP lot. The facility Dumpster is in center of view, north end of Administration Building is in the left background, South Lancaster Road is in the background, and a car wash on adjoining property is to the right.

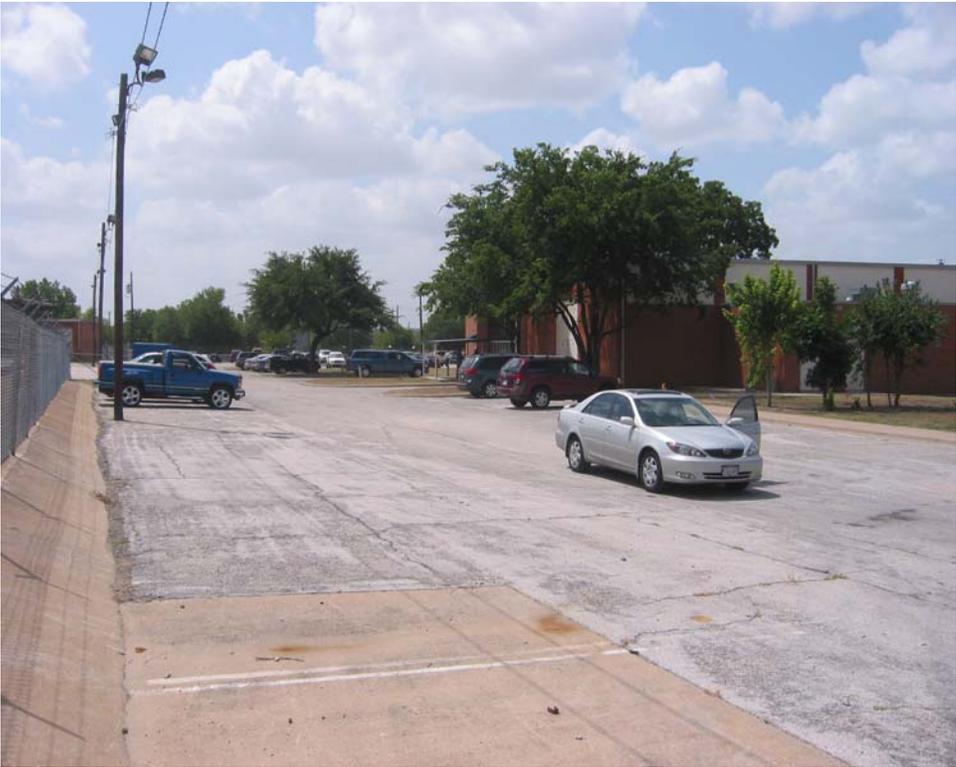
Photo 6: Looking south from the northwest corner of the MEP lot. Administrative Building is in the right background.

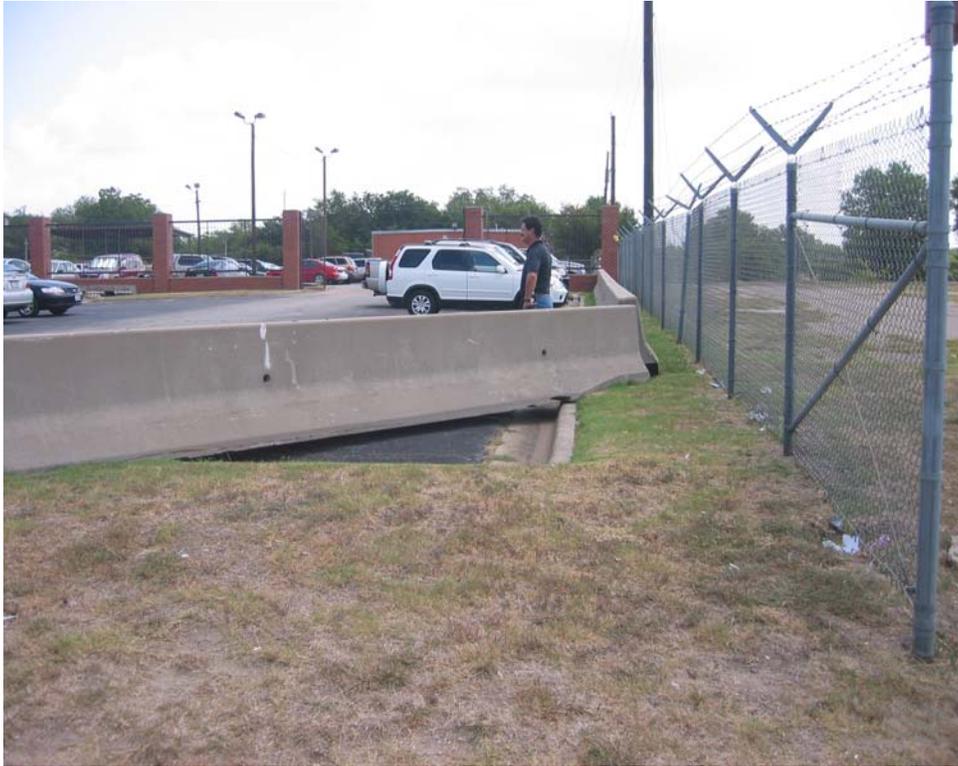
Photo 7: Looking east from the southwest corner of the site. The adjoining property to the right is the apartment complex that was destroyed by a tornado.

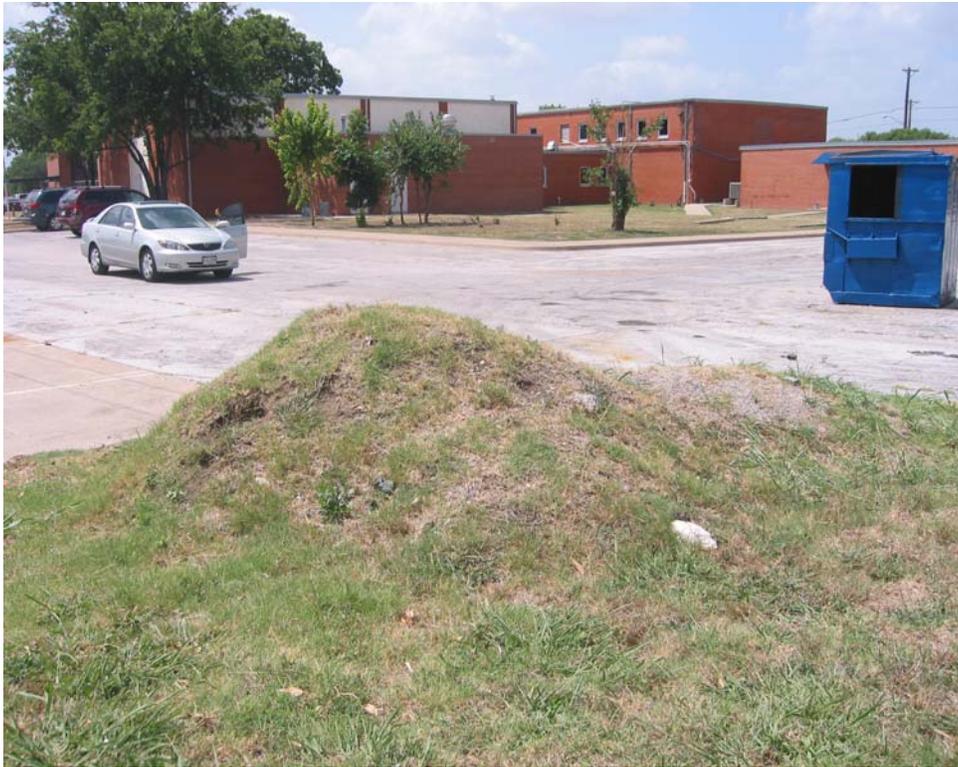
Photo 8: Looking southwest toward Administrative Building from northwest corner of MEP lot. Note dirt pile in foreground and dumpster to the right.

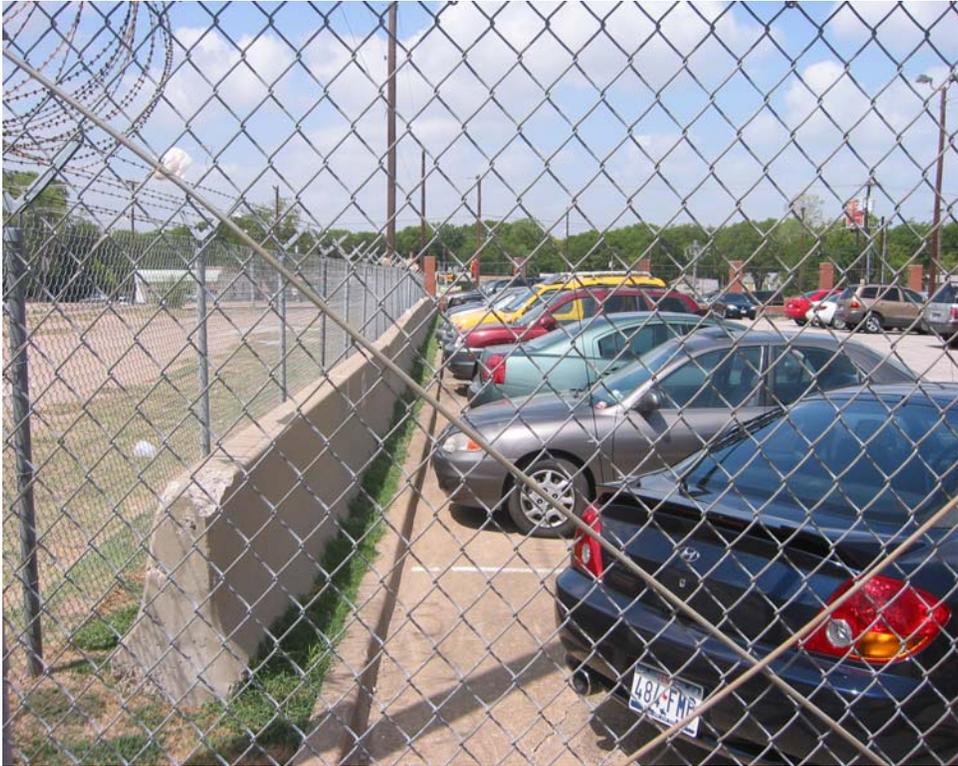
Photo 9: Looking west from the southwest corner of the OMS Building. The adjoining property to the left is the apartment complex that was destroyed by a tornado.

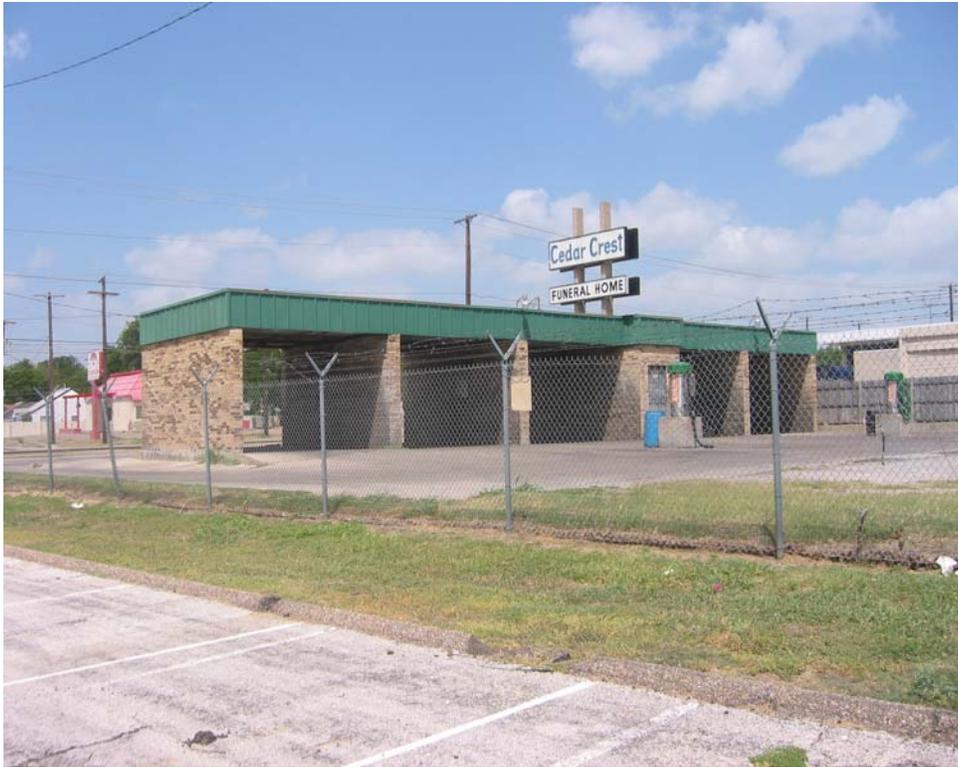
Photo 10: View of adjoining property to the north; a self-serve car wash.

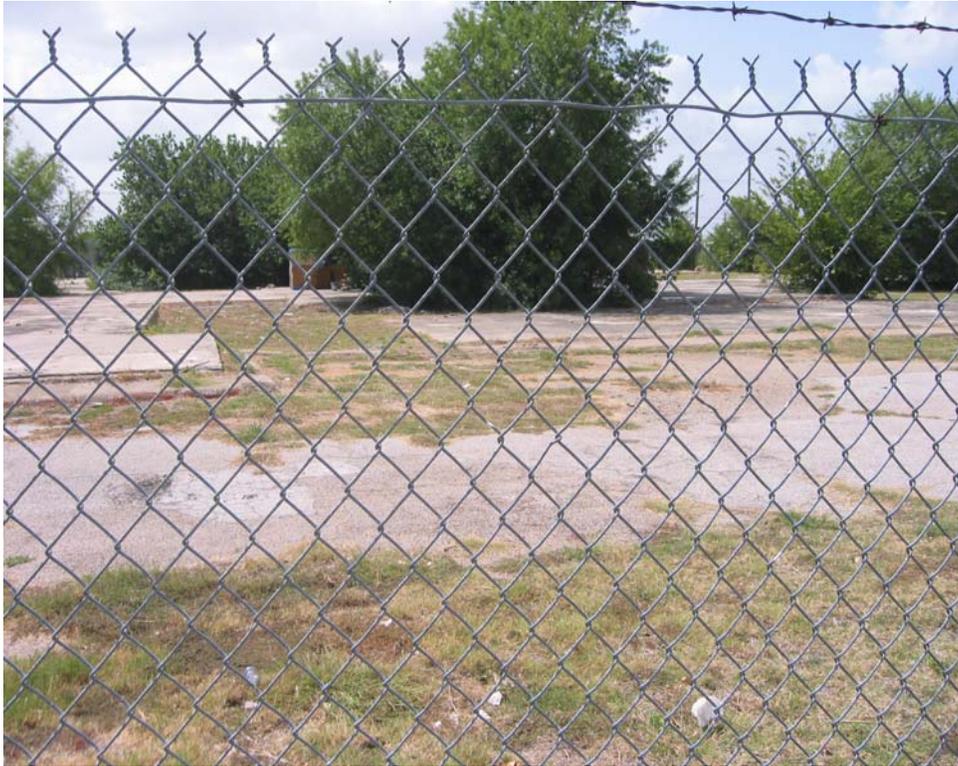
Photo 11: View of adjoining property to the south. A tornado destroyed an apartment complex at this location, and the remnants have been removed, with the exception of the foundations.

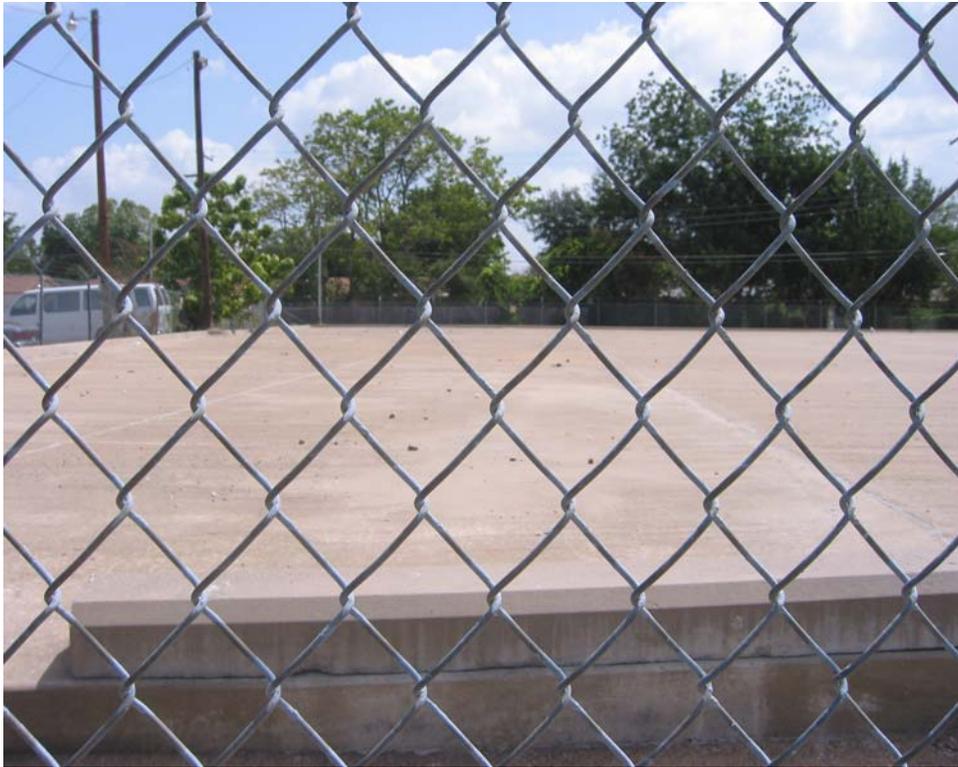
Photo 12: View of MEP lot to east from northwest corner of MEP lot.

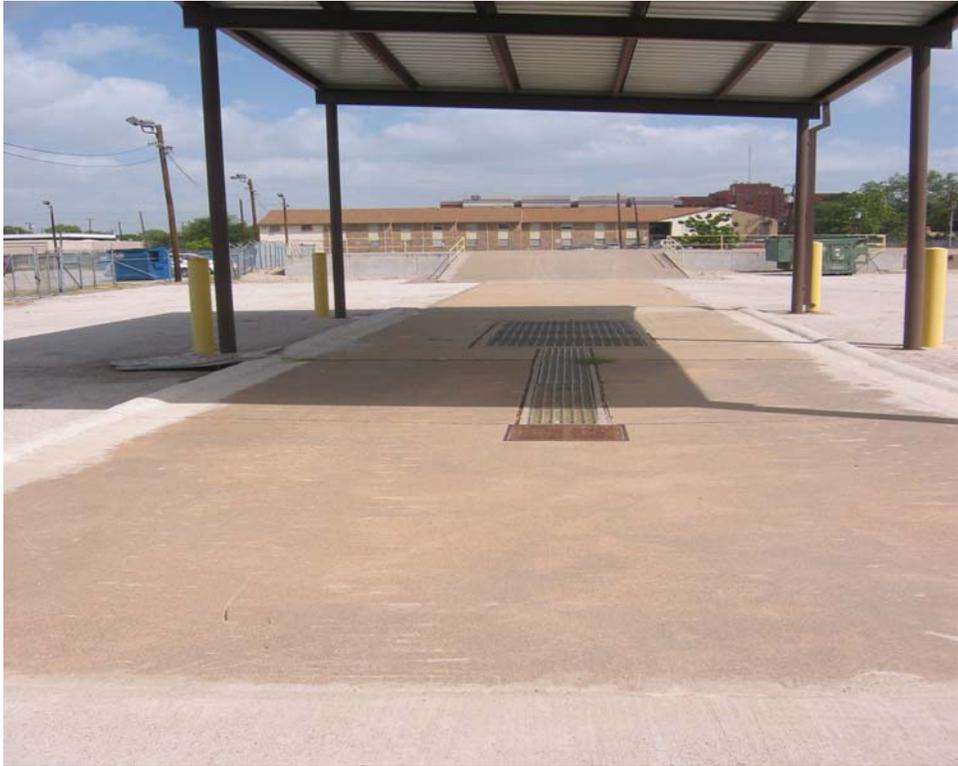
Photo 13: Looking north, view of vehicle wash pad. Note grates that drain spent wash water and direct it to the facility OWS.

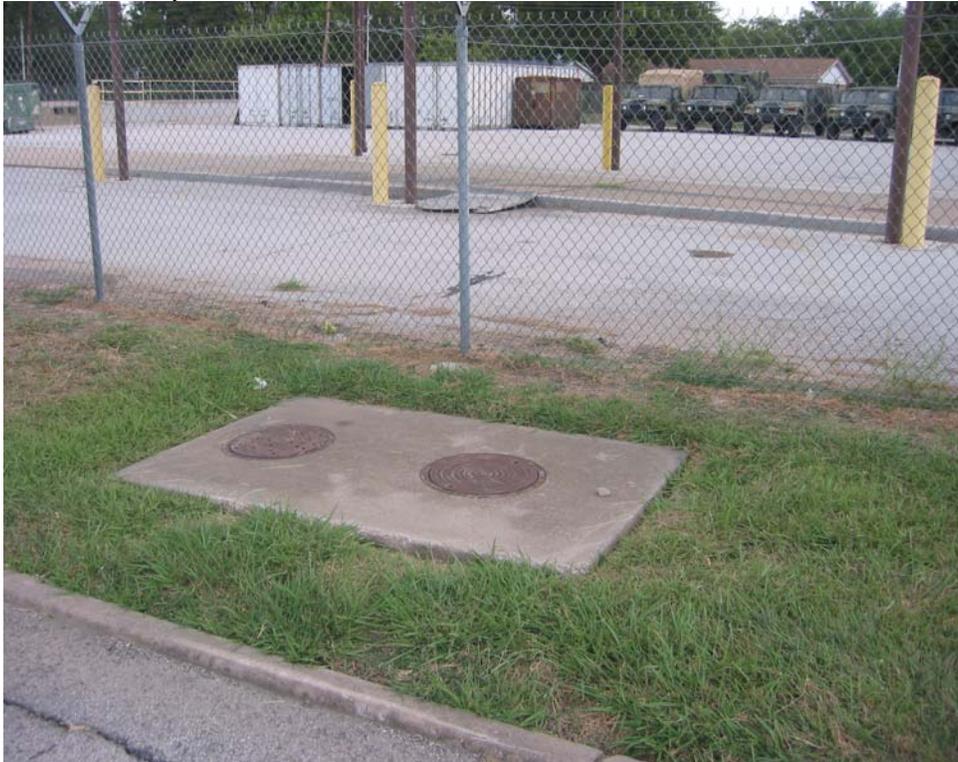
Photo 14: Looking east across the MEP lot. Twin manhole covers are the OWS that service the vehicle wash pad in the background.

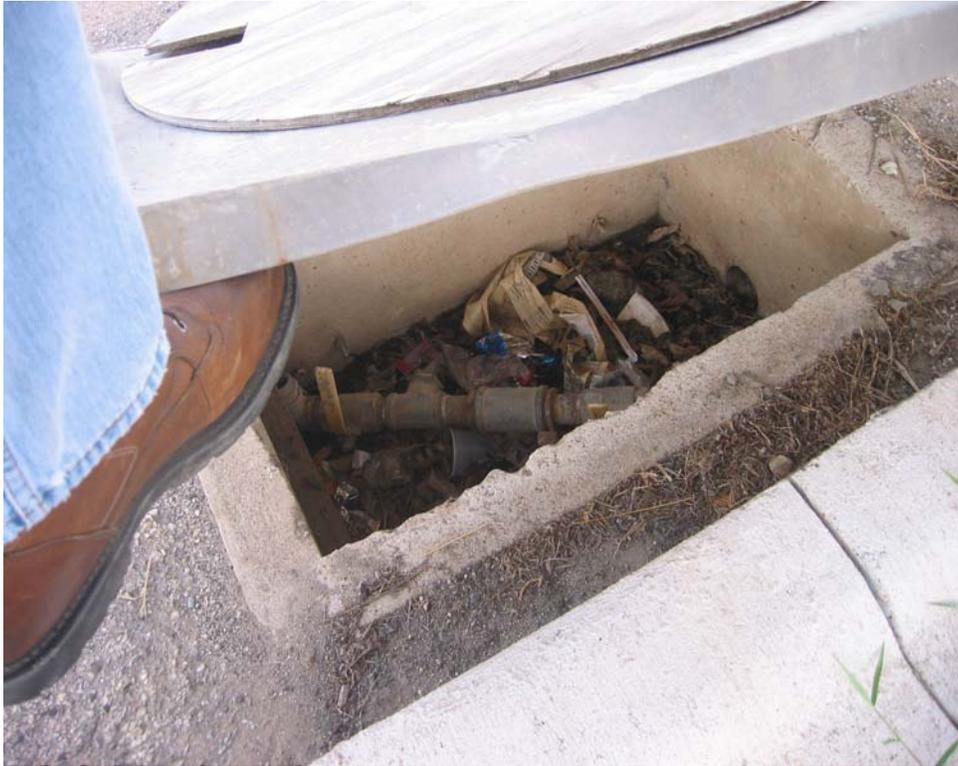
Photo 15: View of manhole for vehicle wash pad water supply.

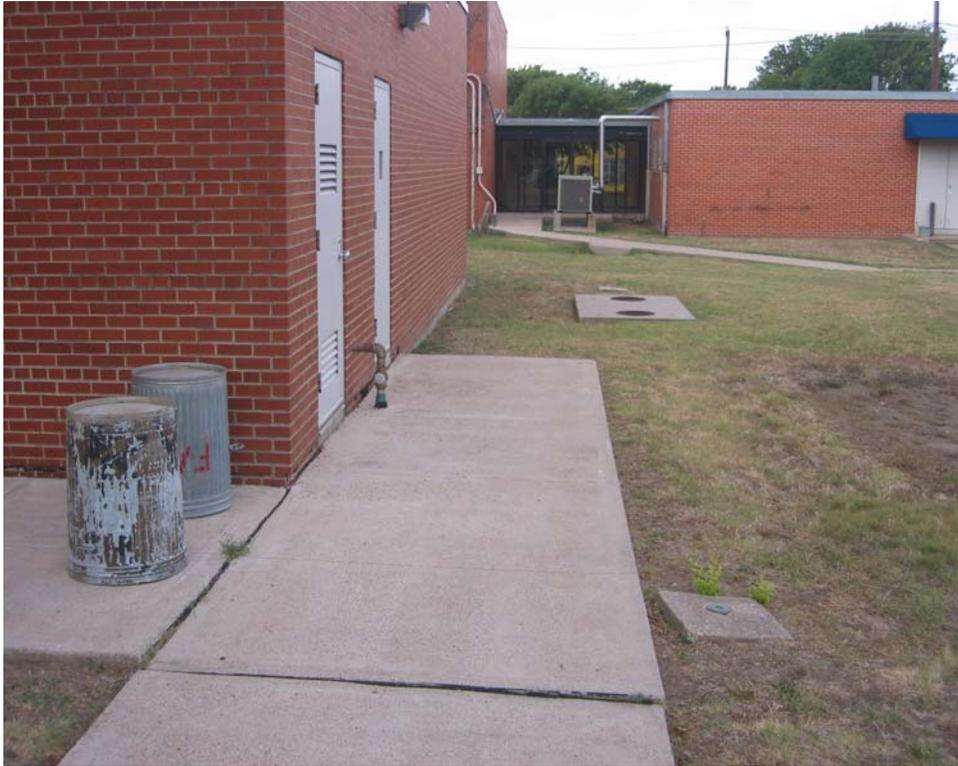
Photo 16: Looking west. Pot washing area of kitchen to left. Twin manhole covers are for kitchen grease trap. Note HVAC equipment in background. Smaller concrete squares in foreground and behind grease trap are for grease trap discharge line.

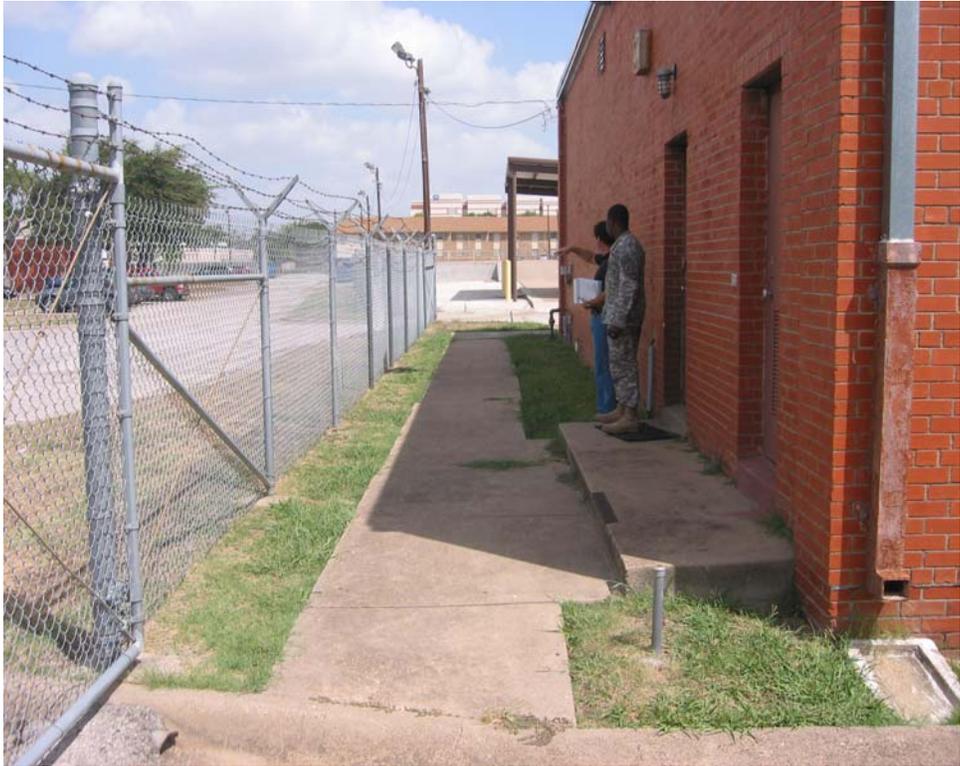
Photo 17: Looking north down the west side of the OMS Building. Vehicle wash pad is in the background.

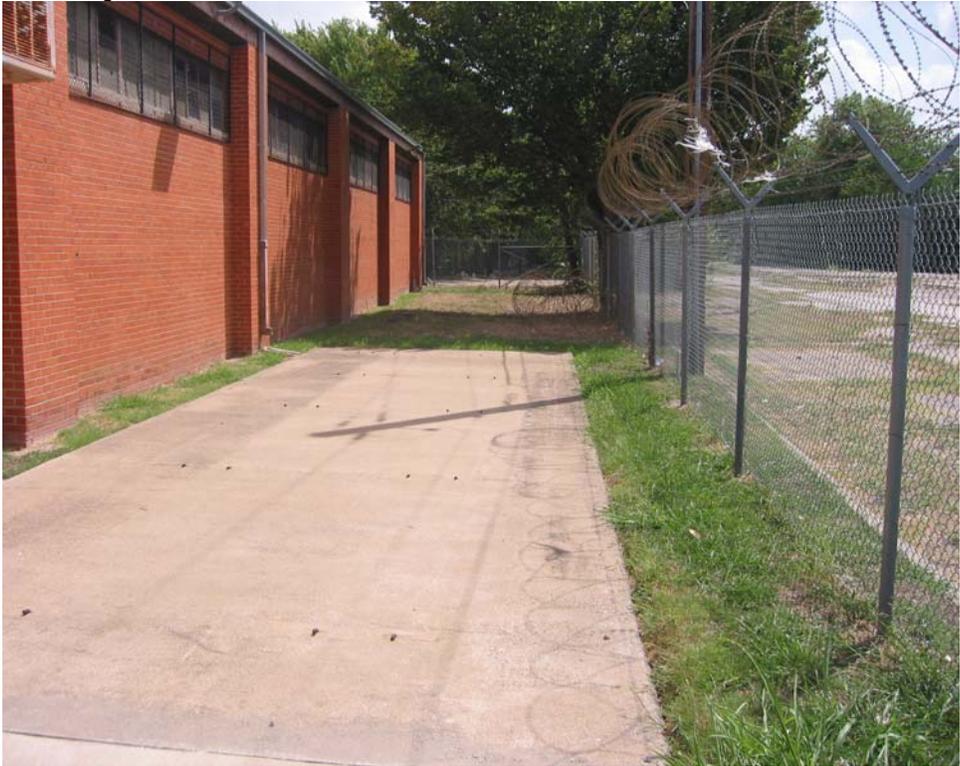
Photo 18: Looking east along south side of OMS Building. The adjoining property to right was an apartment complex destroyed by a tornado.

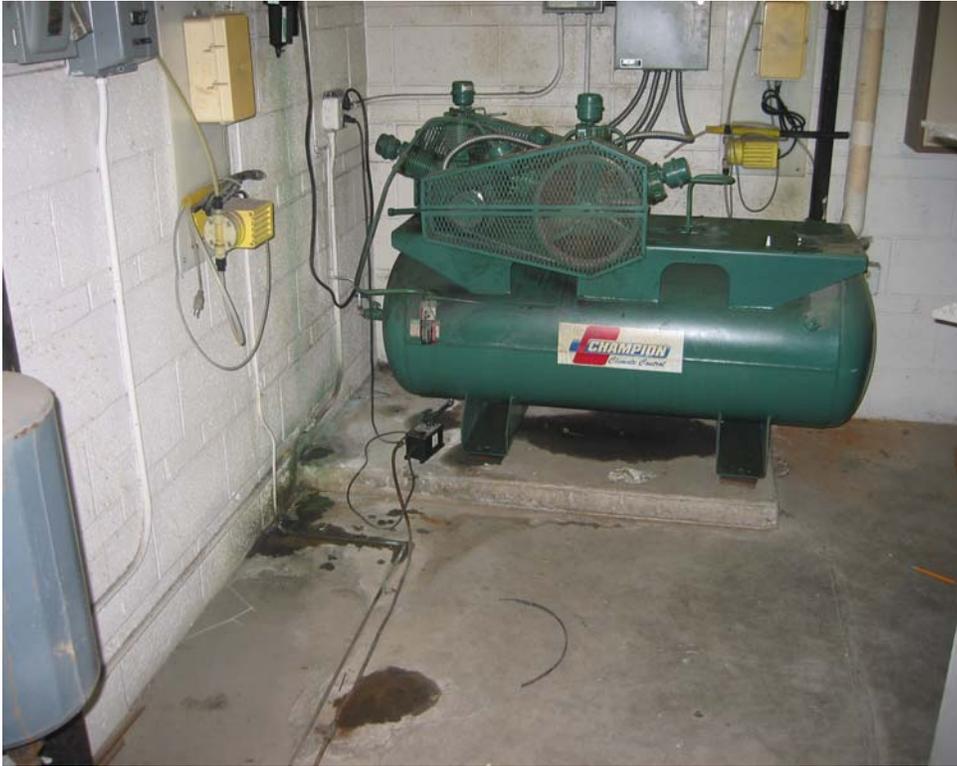
Photo 19: View of compressor in mechanical room of Administrative Building.

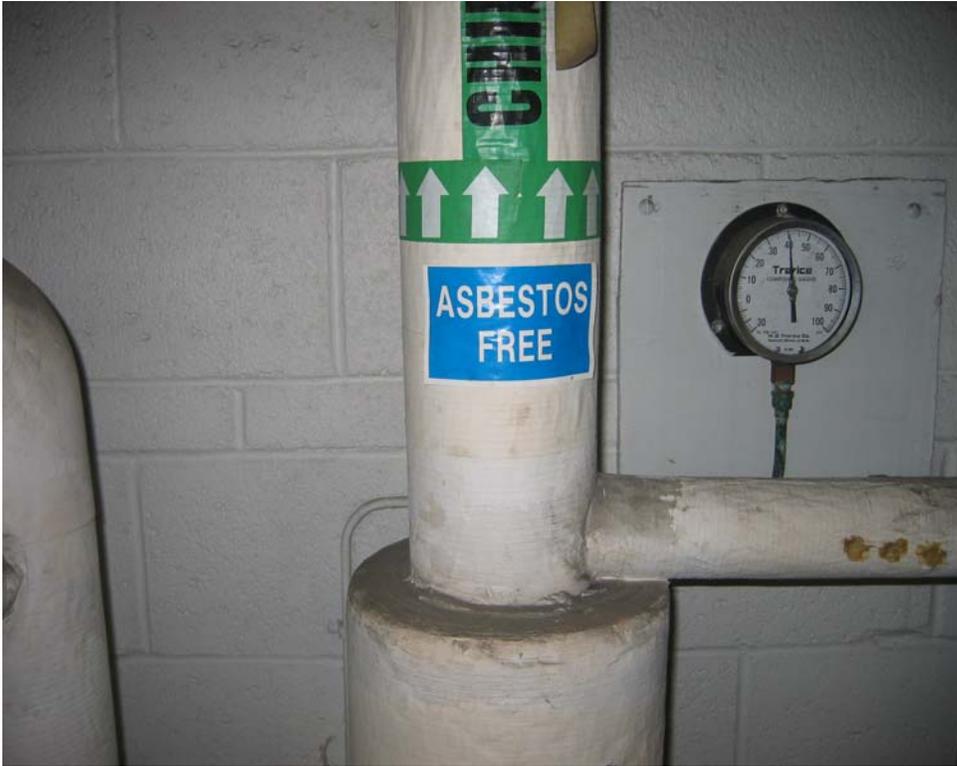
Photo 20: View showing asbestos-free pipe insulation in mechanical room of Administrative Building.

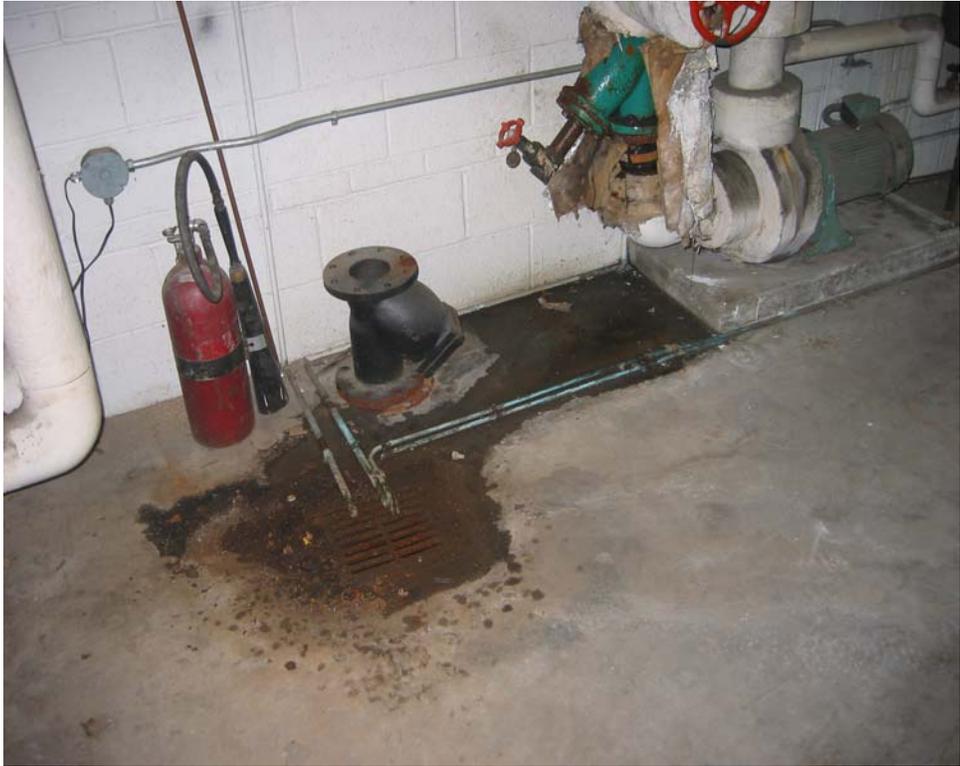
Photo 21: View showing floor drain in mechanical room of Administrative Building.

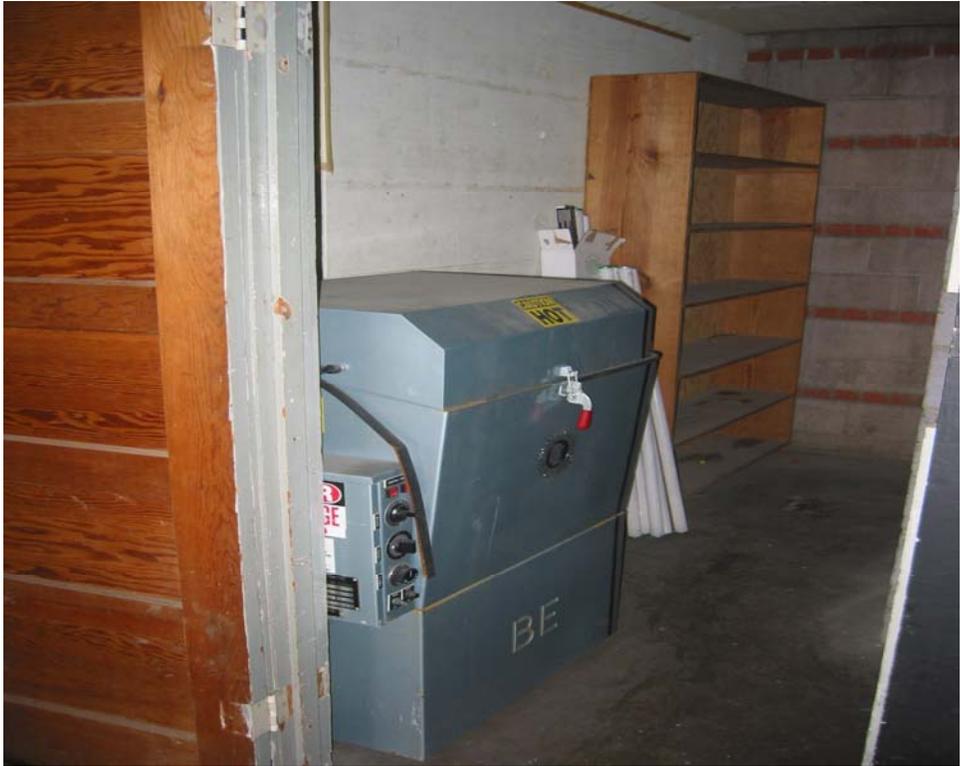
Photo 22: Parts washer inside OMS Building.

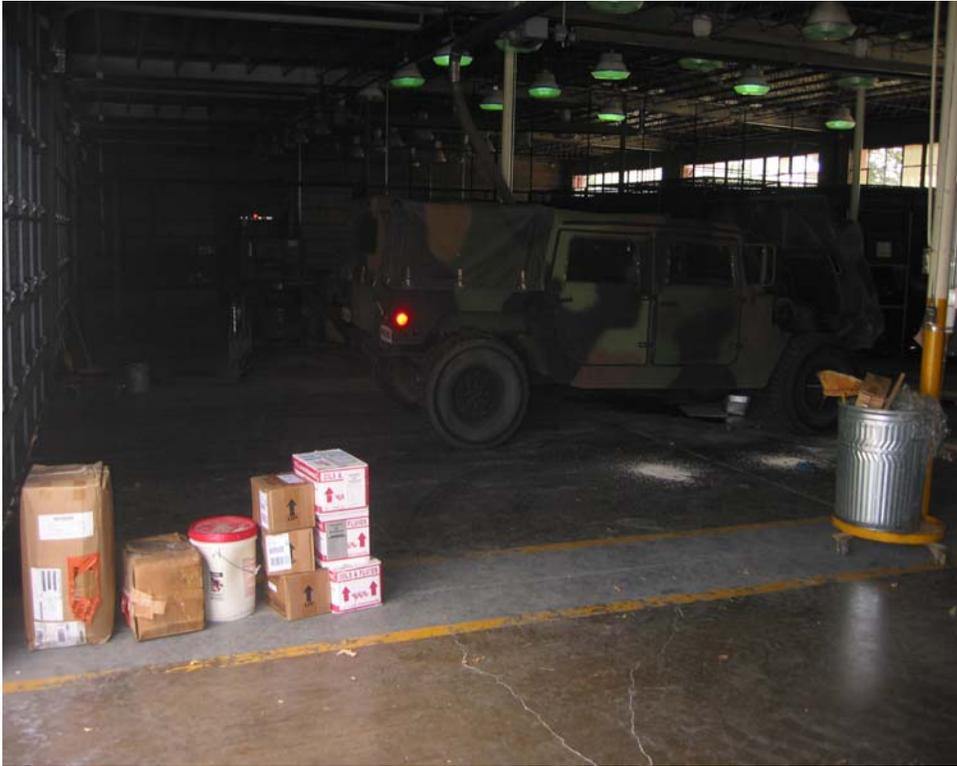
Photo 23: Inside view of OMS Building.

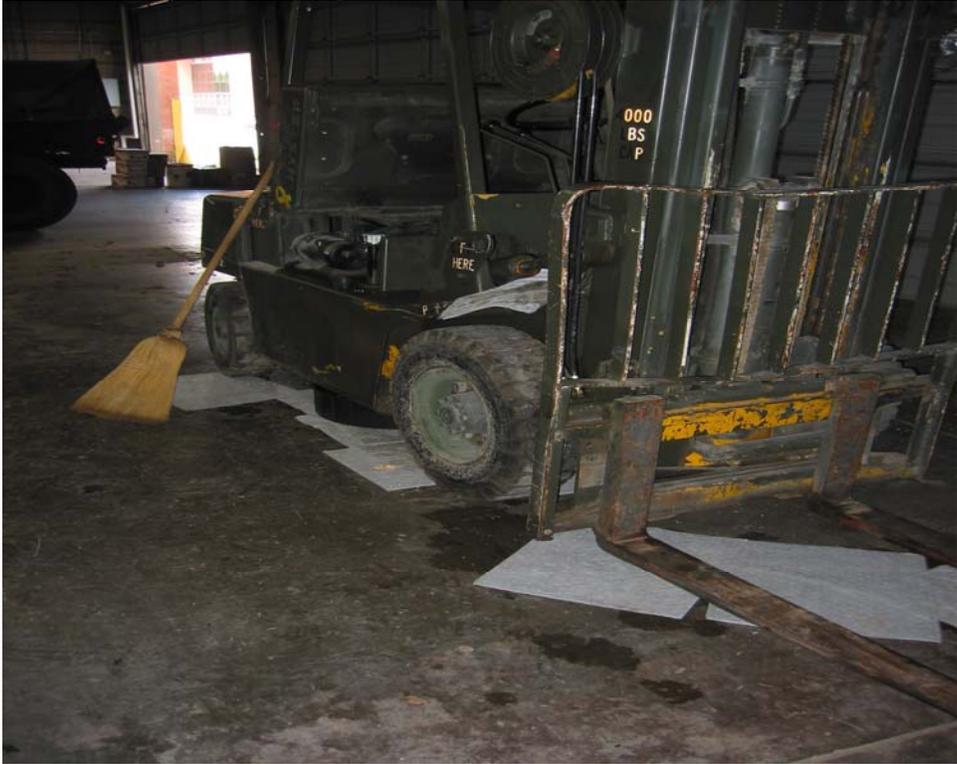
Photo 24: Inside view of OMS Building showing leaking fork lift.

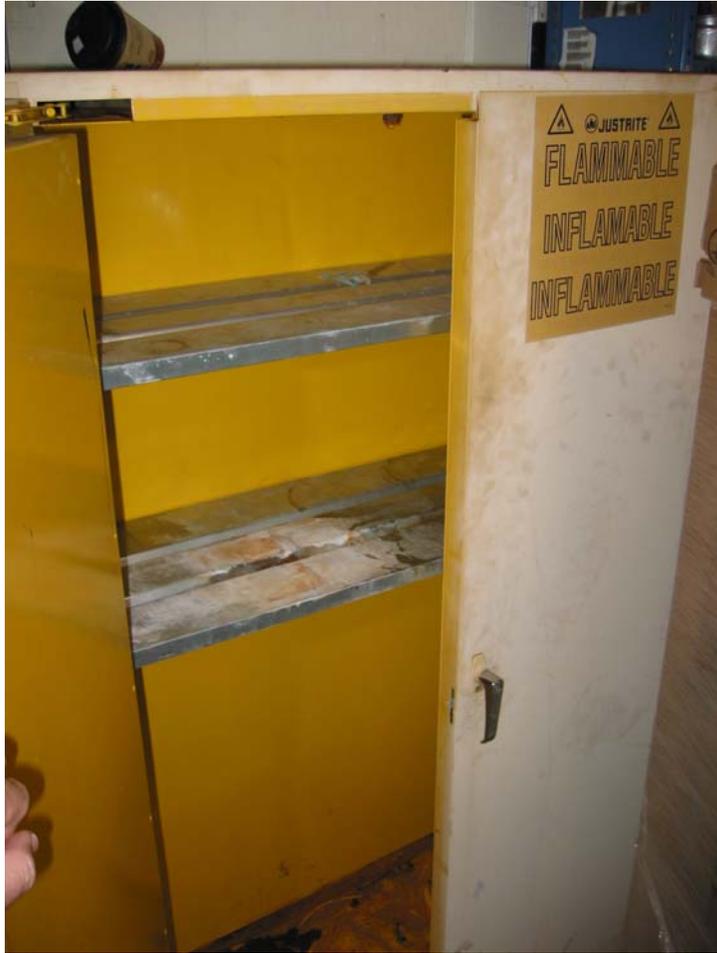
Photo 25: View of empty flammable storage materials cabinet inside OMS Building.

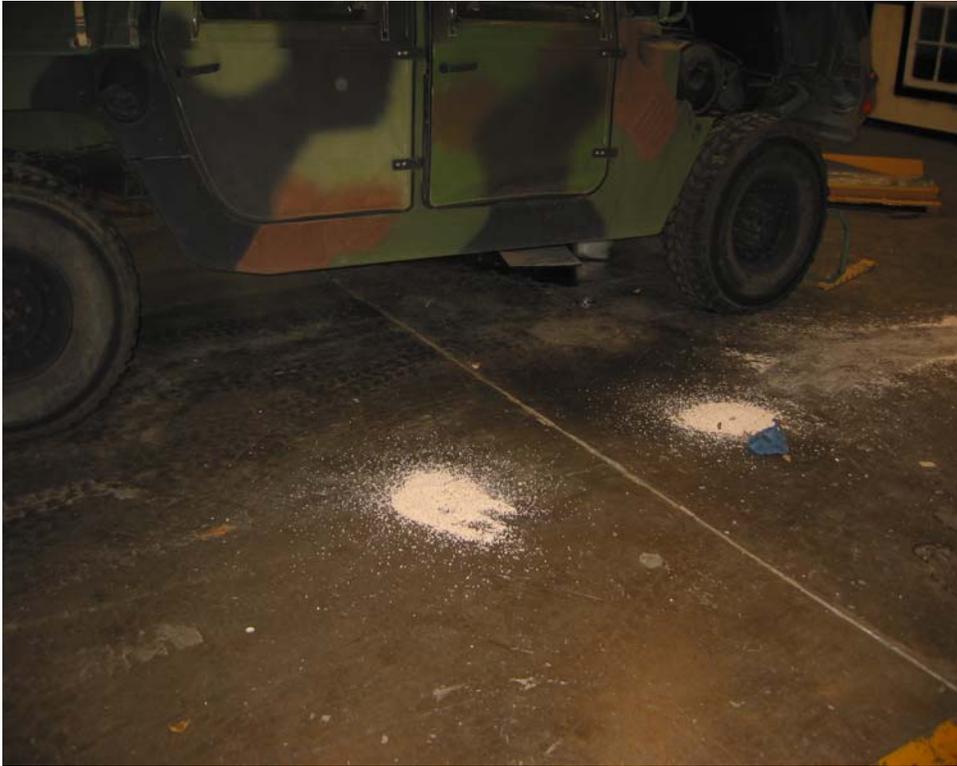
Photo 26: View of sorbents placed over fluid drippage from vehicles in OMS Building.

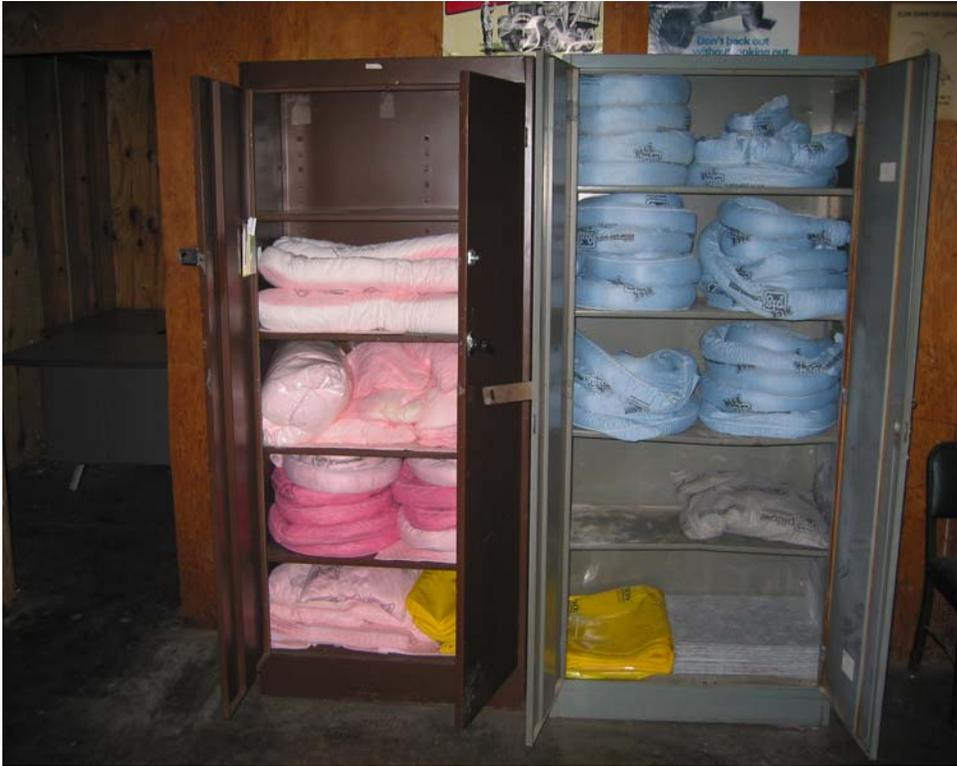
Photo 27: View of spill containment equipment in a locker inside the OMS Building.

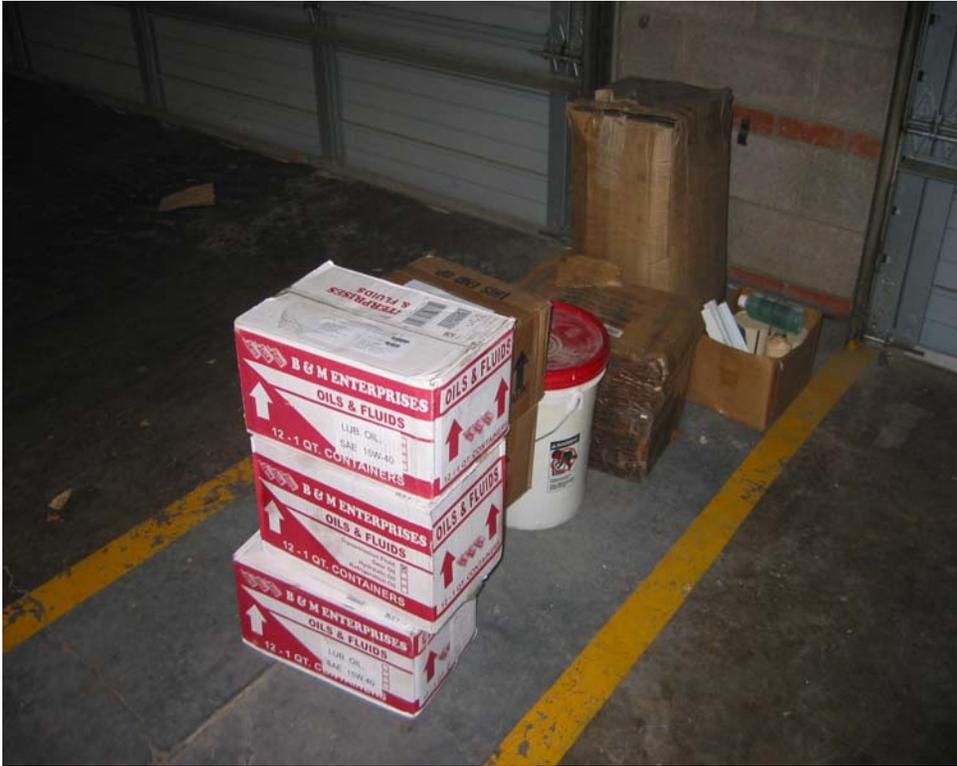
Photo 28: View of chemicals stored inside OMS Building.

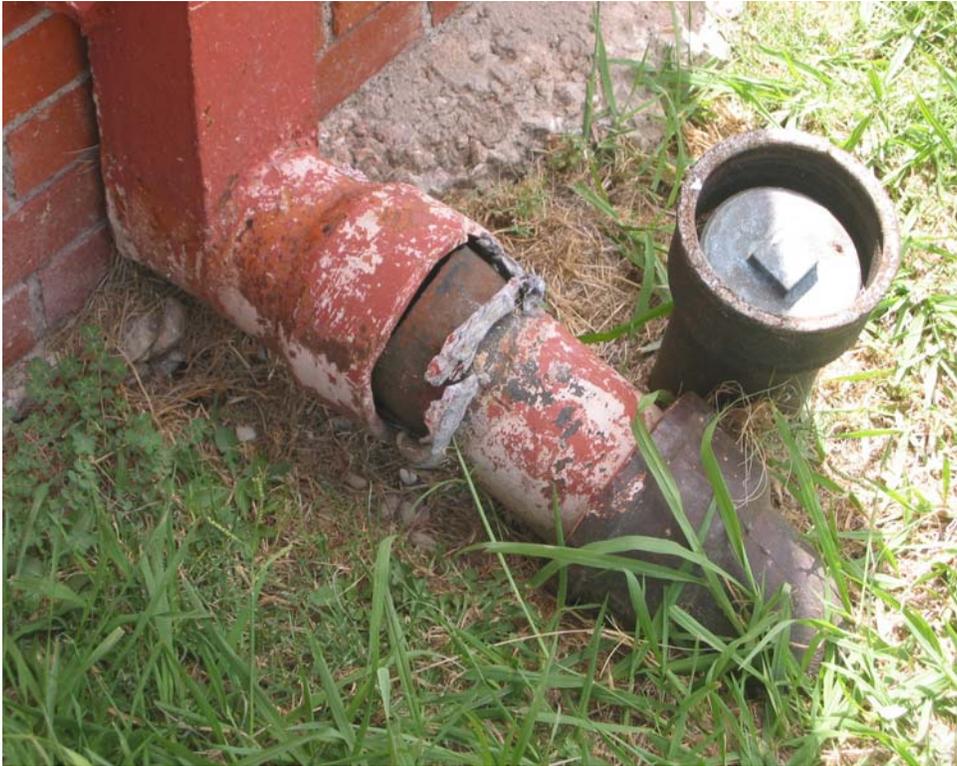
Photo 29: View of potential lead seal on wastewater discharge pipe at the southwest corner of the Administrative Building.

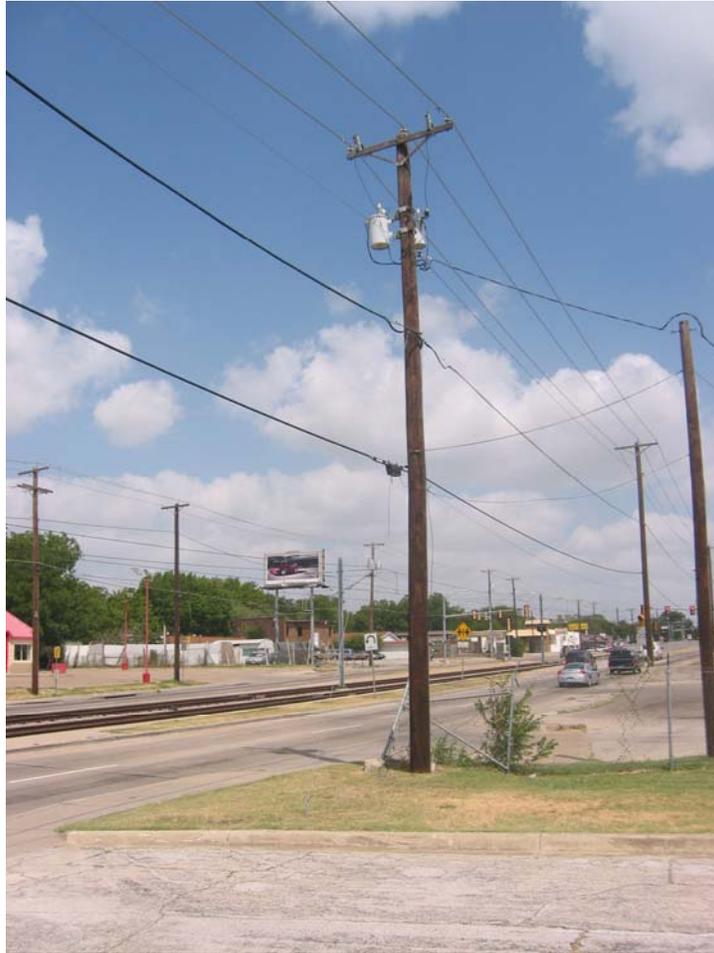
Photo 30: View of pole-mounted transformers at the northwest corner of the property. This transformer services the car wash on the adjoining property to the north.
