Appendix B
Site Reconnaissance Photos

**William Herzog Memorial USAR Center
4900 South Lancaster Road
Dallas, Texas**

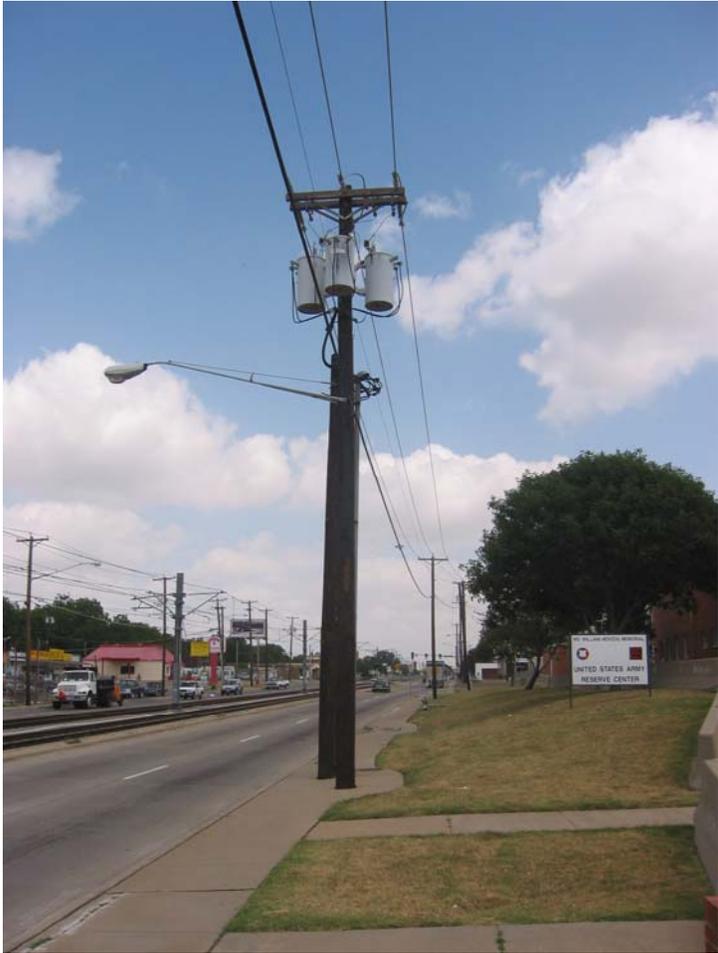
Photo 31: View of pole-mounted transformers at southwest corner of Administrative Building. This transformer services the USAR Center.
