Appendix B
Site Reconnaissance Photos

Houston #2 USAR Center
7077 Perimeter Park Drive
Houston, Texas

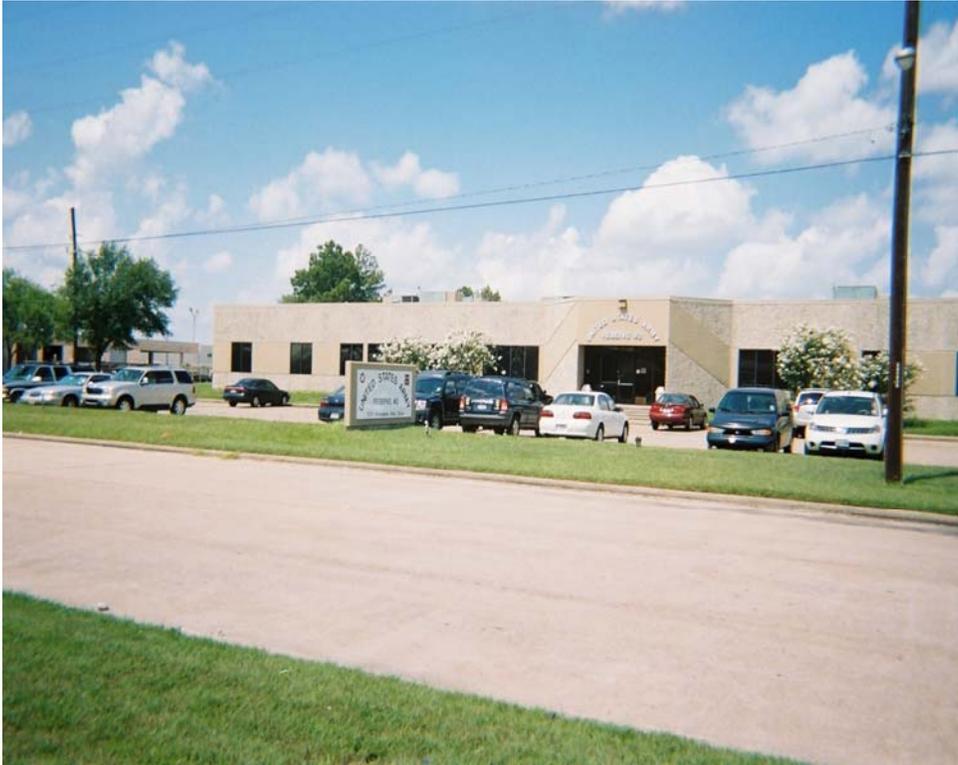
Photo 1: View of Houston #2 USAR Center, looking west across Perimeter Park Drive.

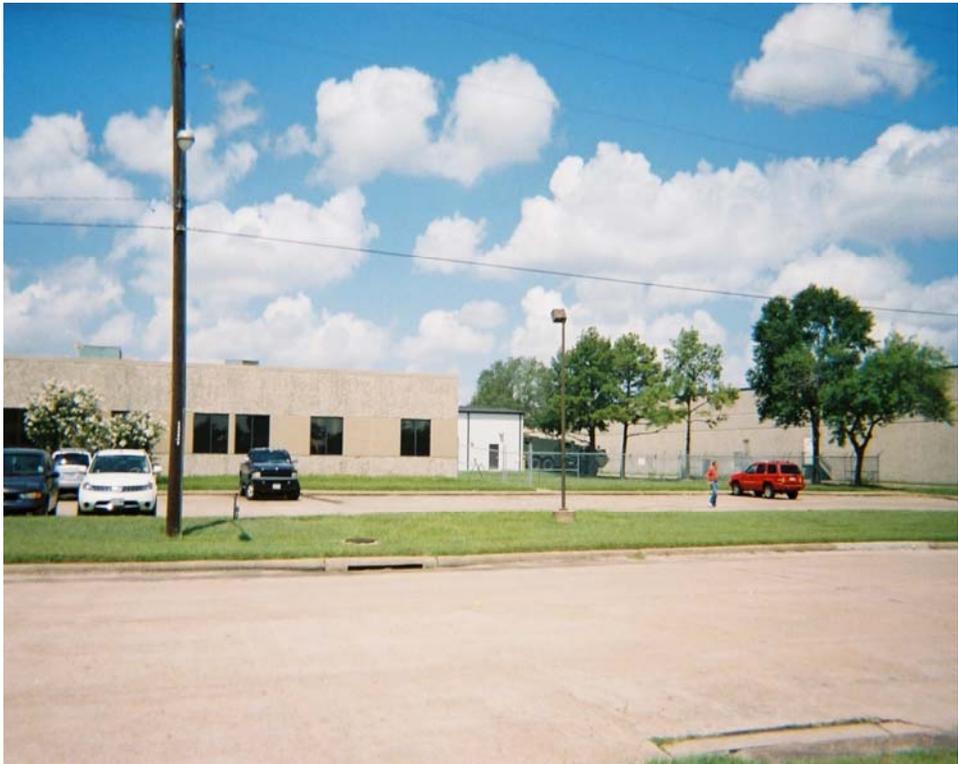
Photo 2: View of Houston #2 USAR Center, looking west across Perimeter Park Drive. Note newly constructed white, corrugated metal building in center of photograph.

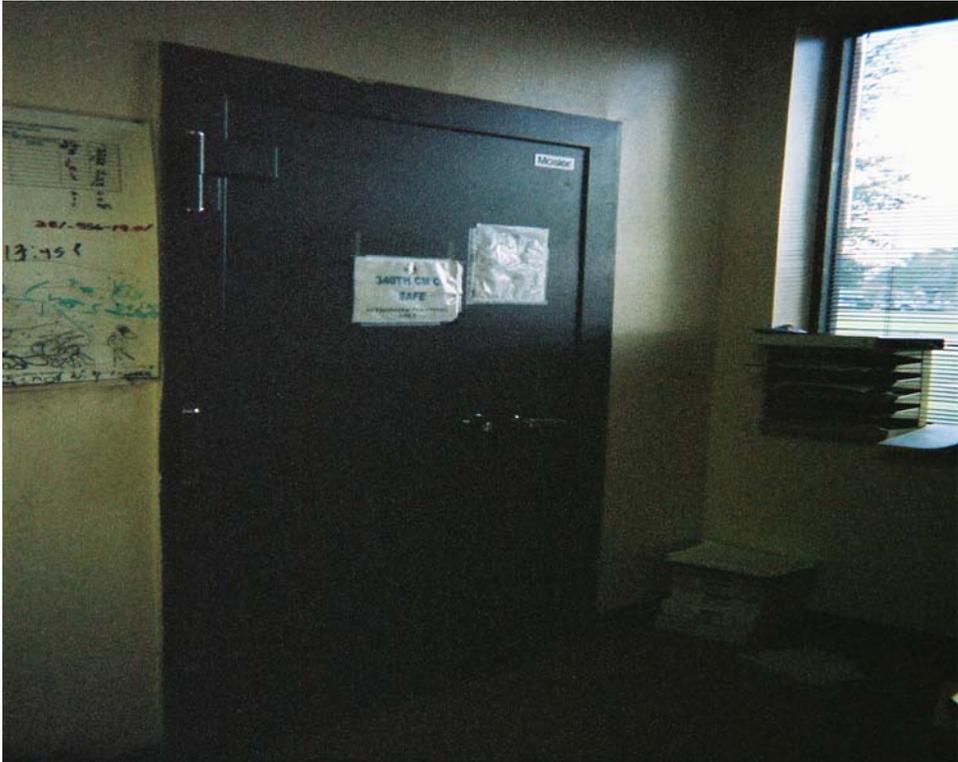
Photo 3: View of former vault located within an office in the main facility building.

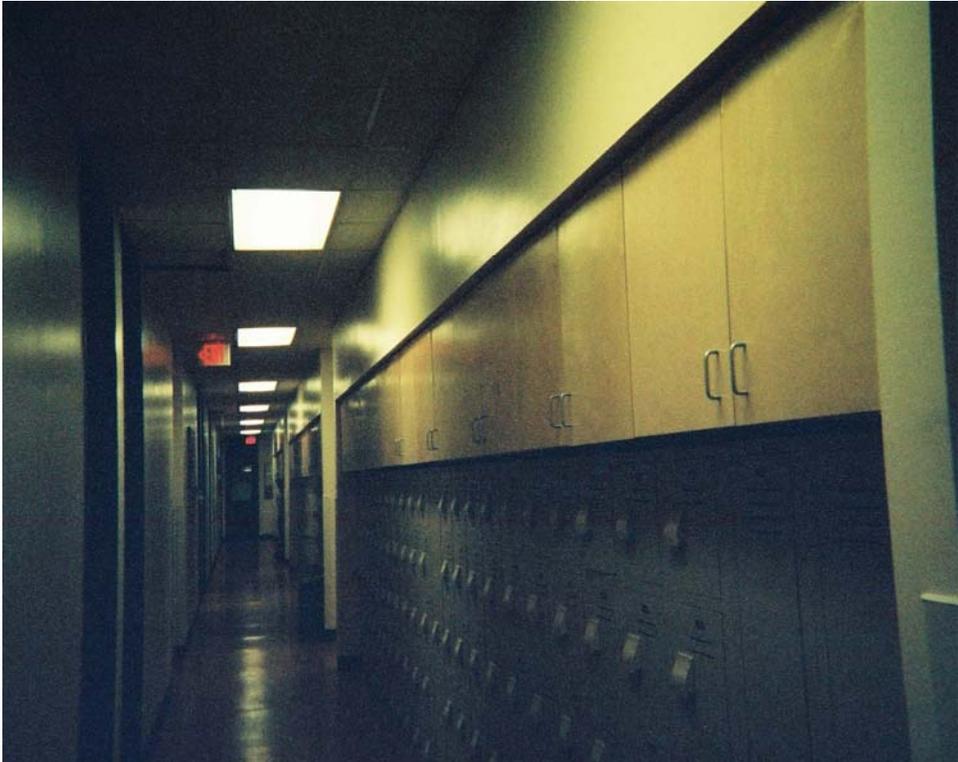
Photo 4: View of newly installed wall lockers and cabinetry within the main facility building.

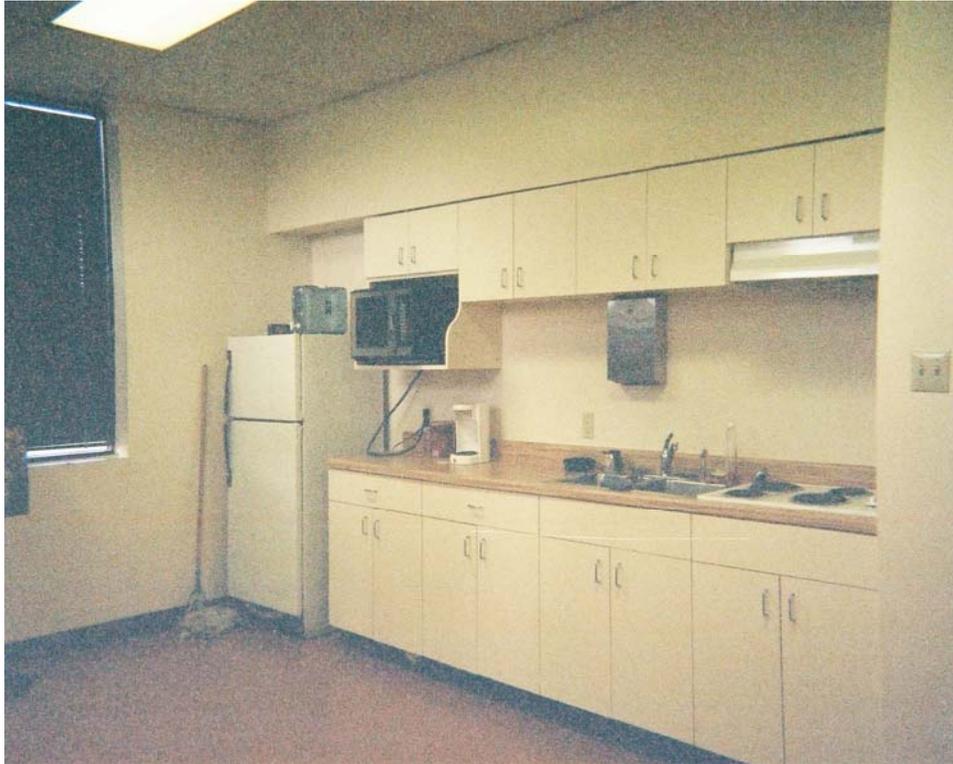
Photo 5: View of kitchen located within the main facility building.

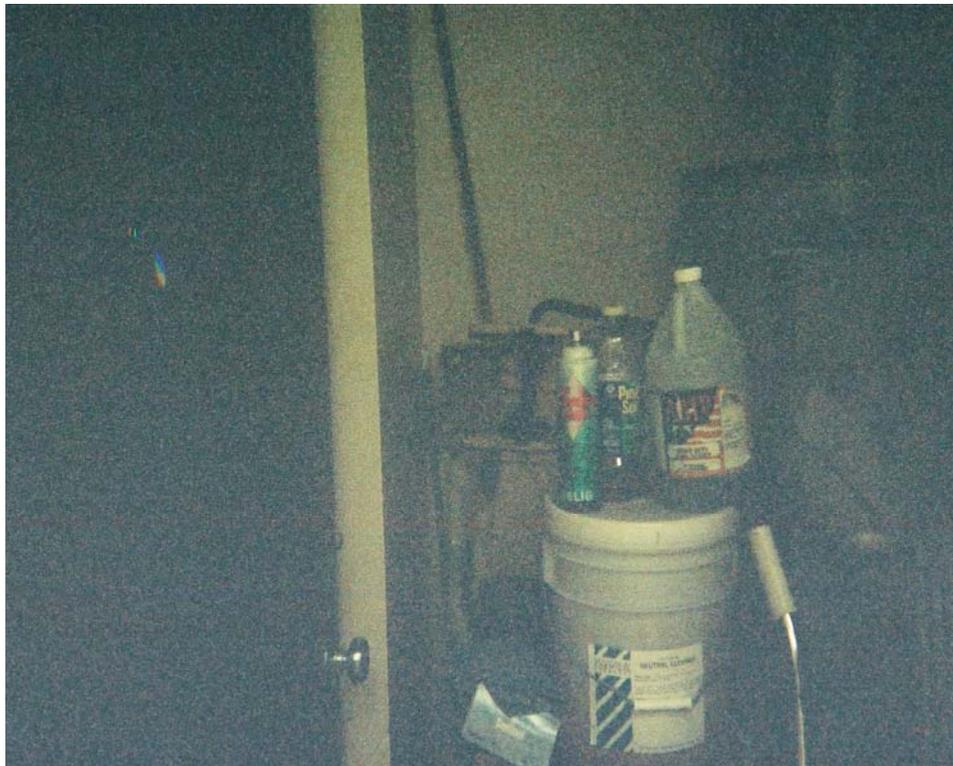
Photo 6: View of janitor's closet located in the women's restroom and a water heater in the background. An overhead access ladder is located on the wall to the right.

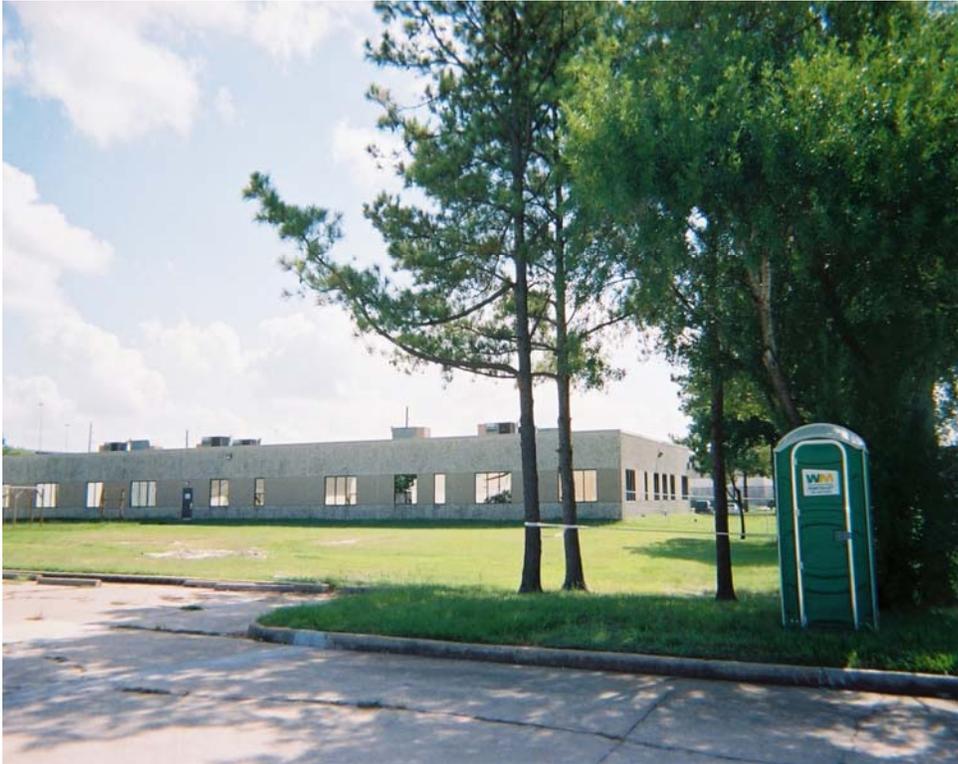
Photo 7: View of grassy area located behind the main facility building, looking east.

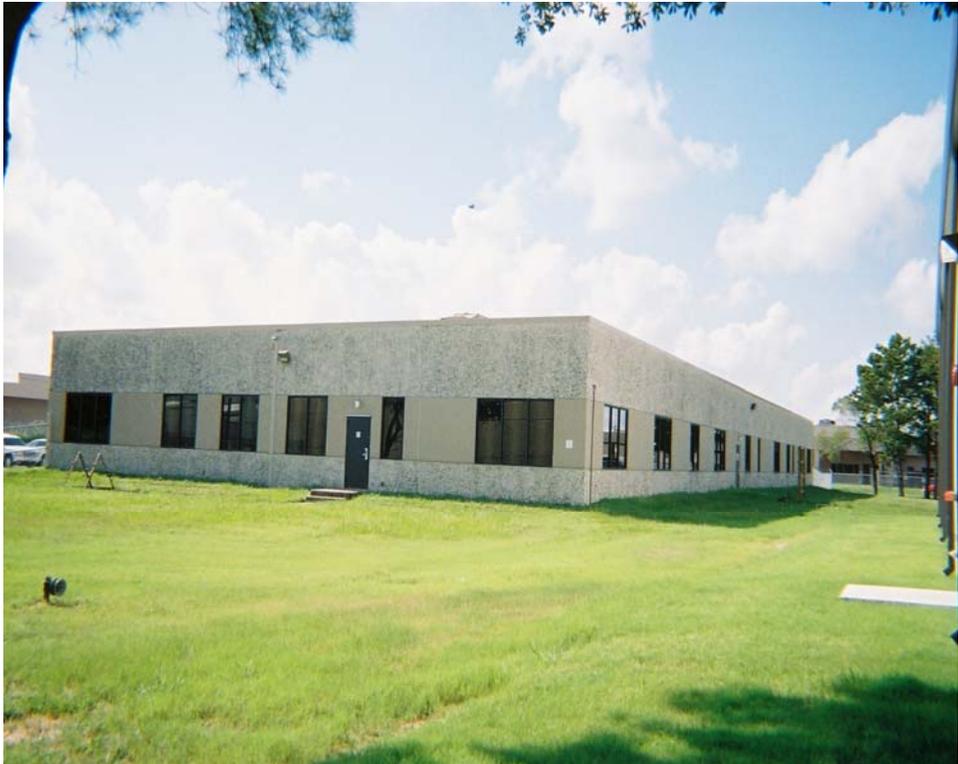
Photo 8: View of north end of the main facility building. Note storm water catch basin located in the grass.

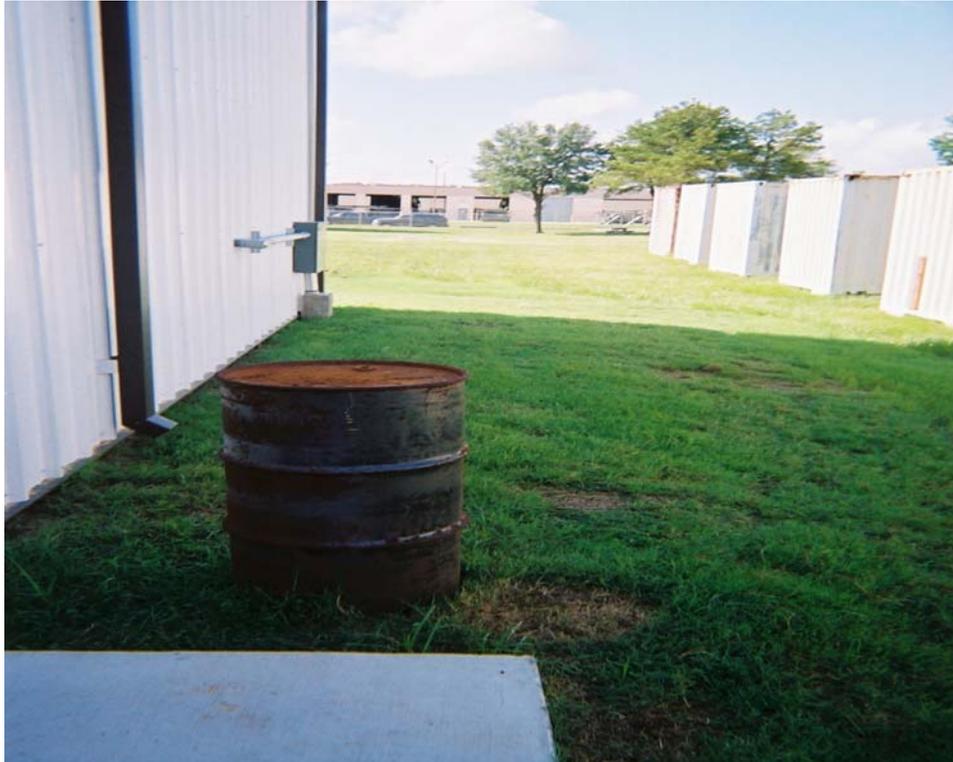
Photo 9: View of unlabeled 55-gallon drum located along the western side of the corrugated metal building. It appeared to have been used as a door prop.

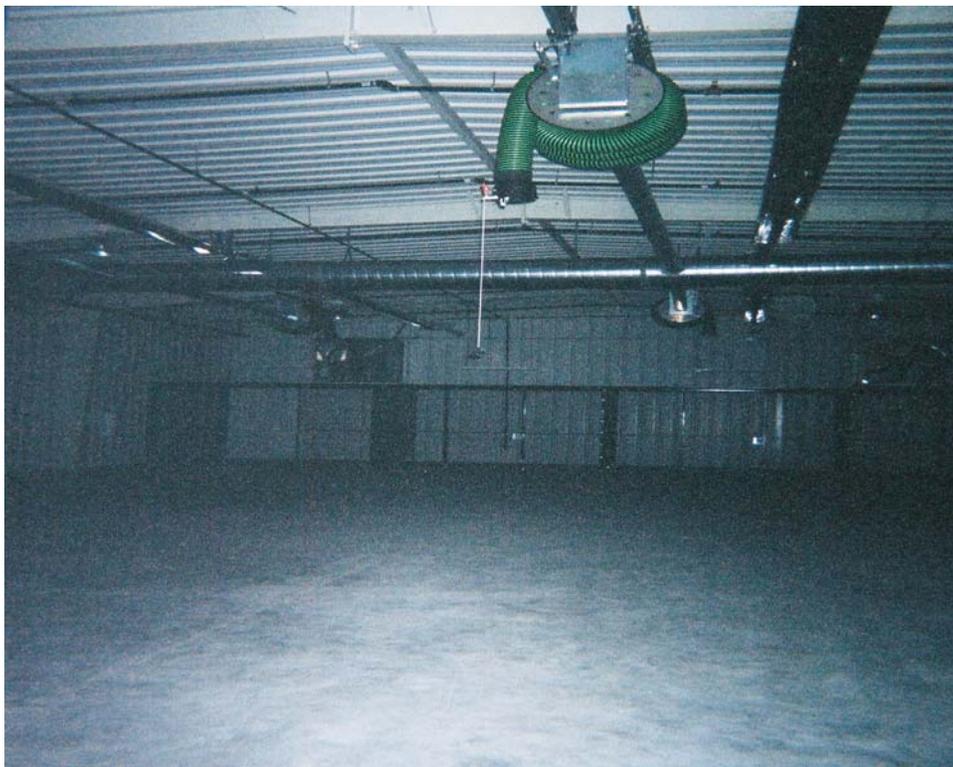
Photo 10: View of the inside of the corrugated metal building. Note caged storage in the background and overhead ventilation system.

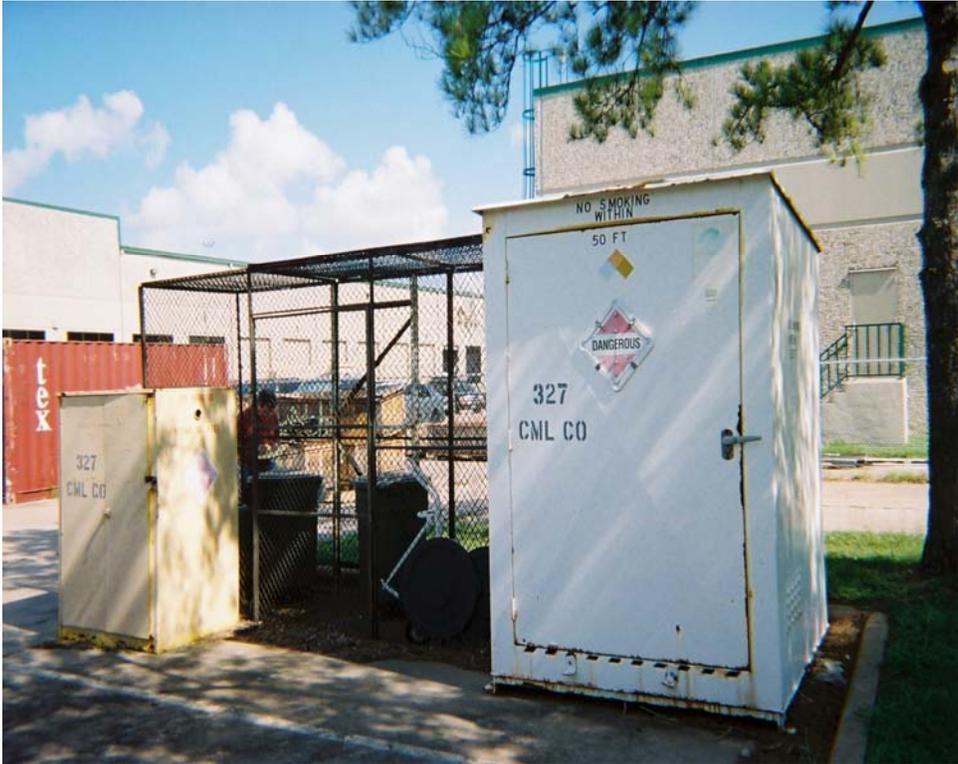
Photo 11: View of hazardous/flammable storage lockers and caged storage located along the northern MEP area.

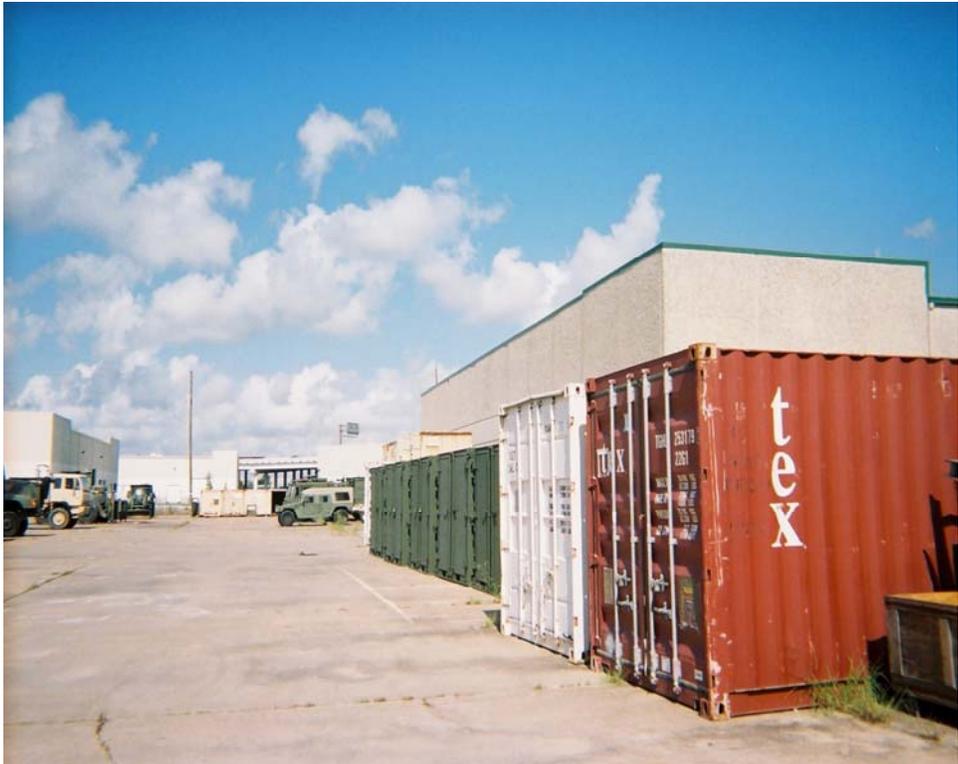
Photo 12: View of northern MEP area, looking west. Container boxes were used for storage and deployment.

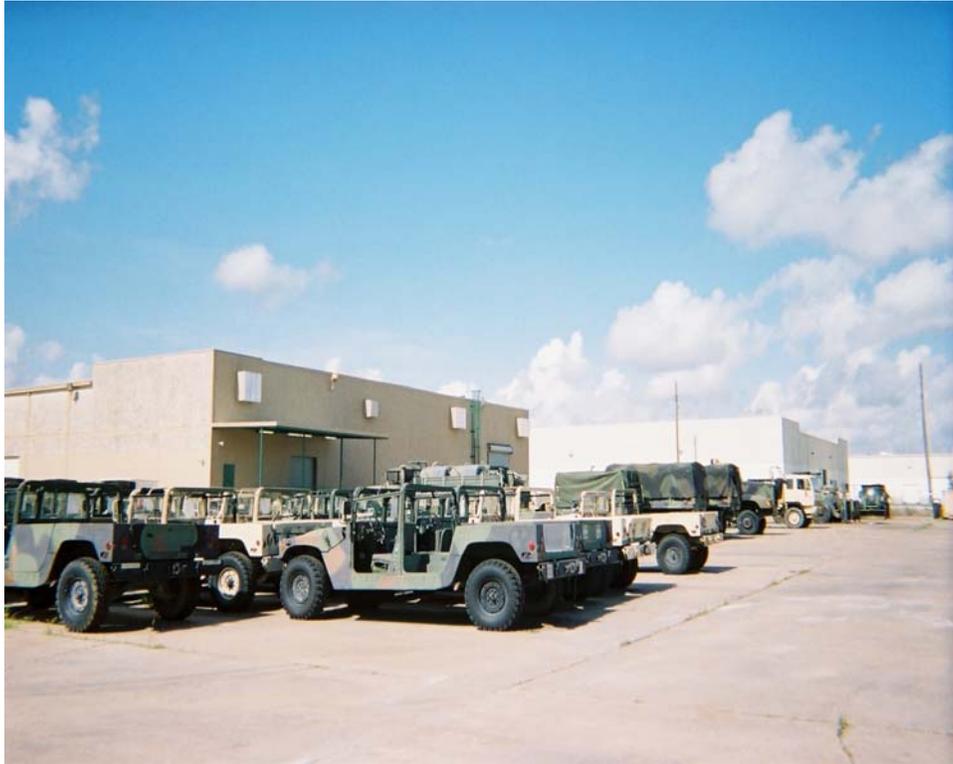
Photo 13: View of MEP area, looking west. Note military vehicles and trailers parked.

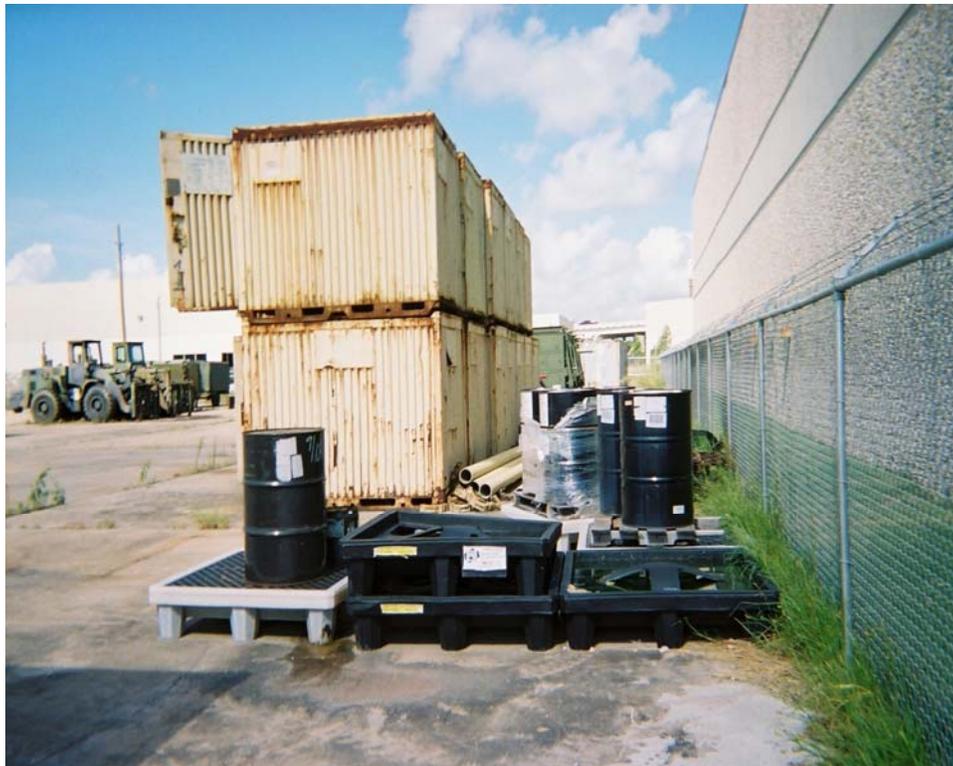
Photo 14: View of 55-gallon drums located on spill pallets located along the northern MEP area. The northern property line is on the right of the photograph. The rusty cream colored container boxes are no longer used and are waiting for removal/disposal.

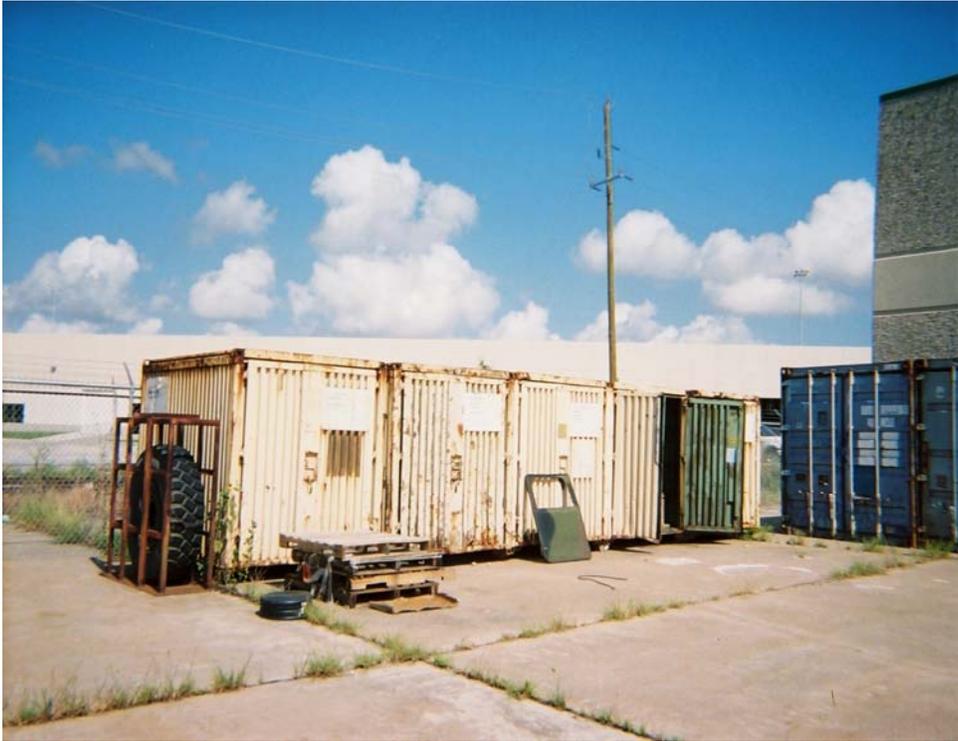
Photo 15: View of container boxes located in the northwest corner of the MEP area. The rusty cream colored container boxes are no longer used and are waiting for removal/disposal. Note railroad line in the background in the left of the photograph.

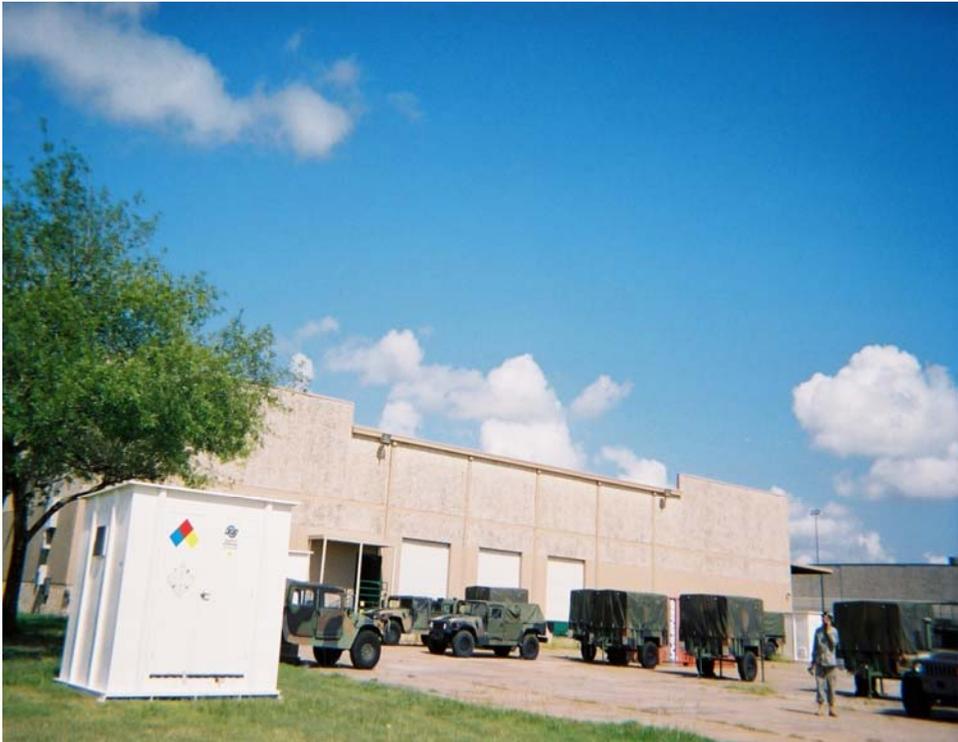
Photo 16: View of the warehouse, looking west. Note the new storage locker (located in the left of the photograph), recently delivered to the Site and not permanently placed.

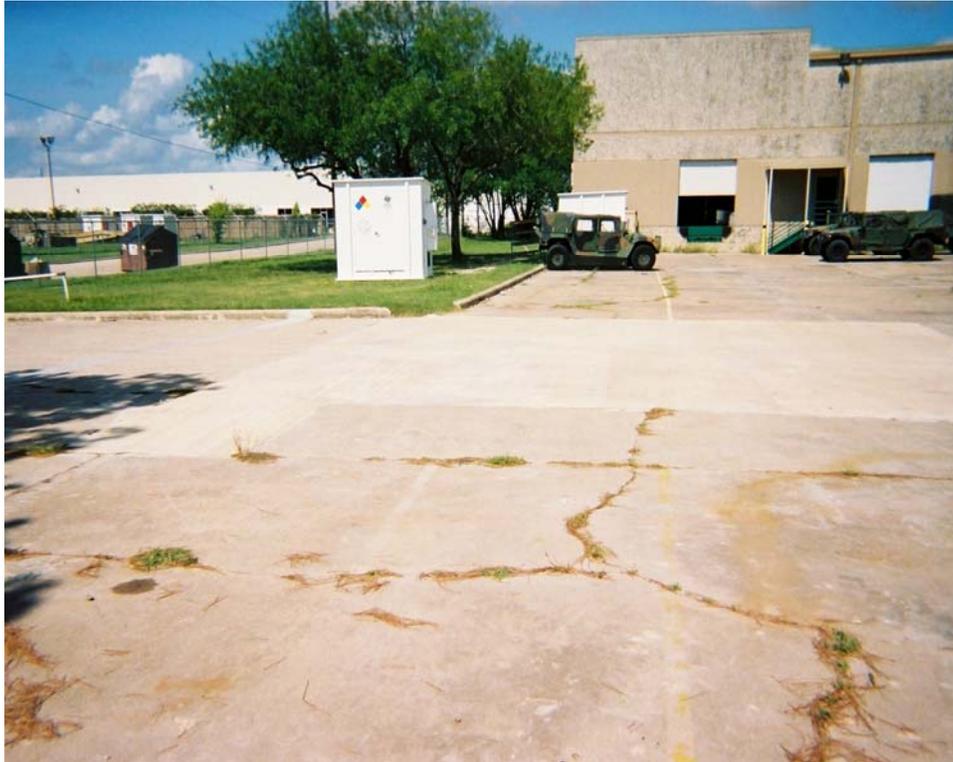
Photo 17: View of recently replaced concrete due to buried electrical line problems. Note cracking in older concrete (grass/weed growth).

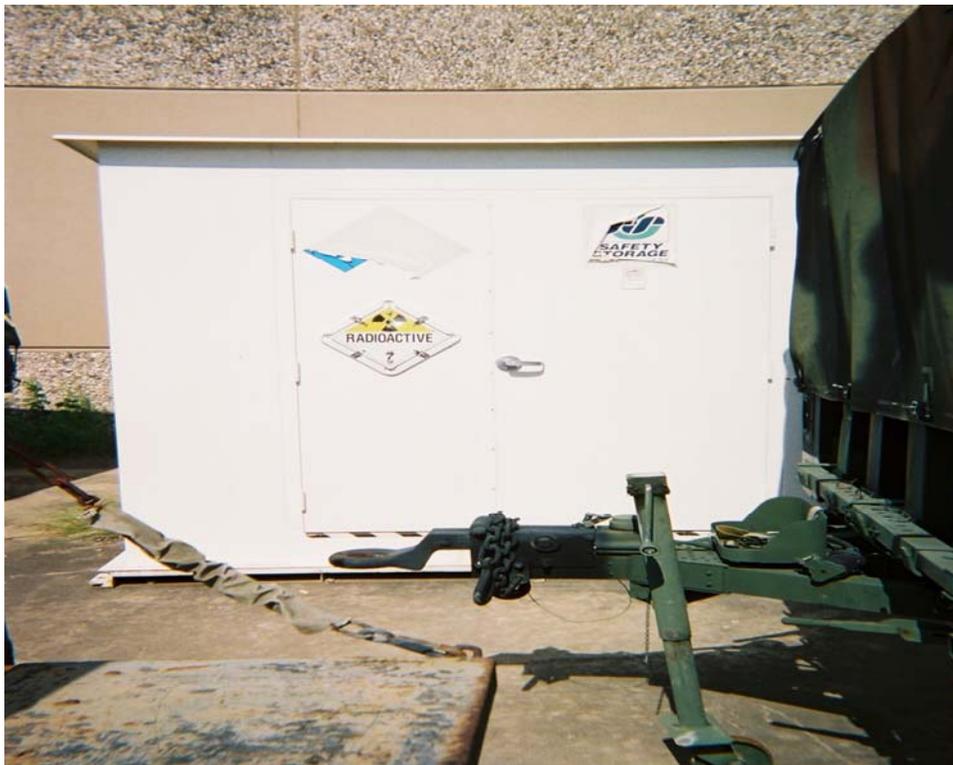
Photo 18: View of hazardous/flammable storage locker located along the eastern wall of the warehouse, looking west. This locker was empty during the August 2006 Site visit.

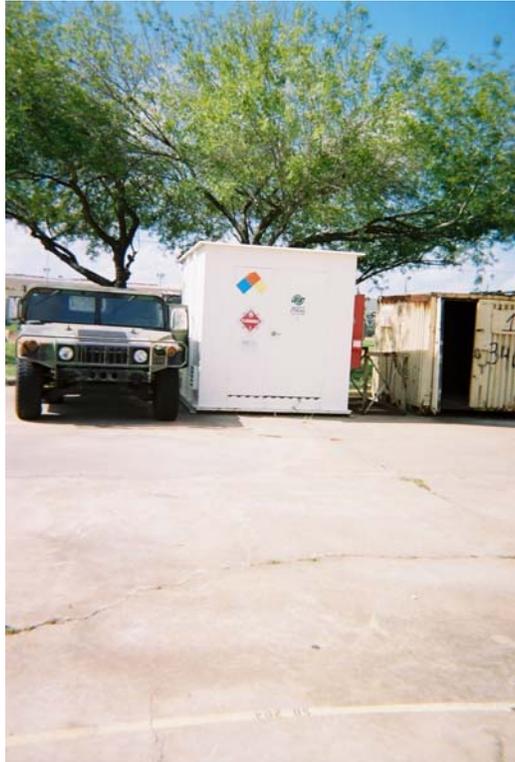
Photo 19: View of hazardous/flammable storage locker located in front of the warehouse, looking south.

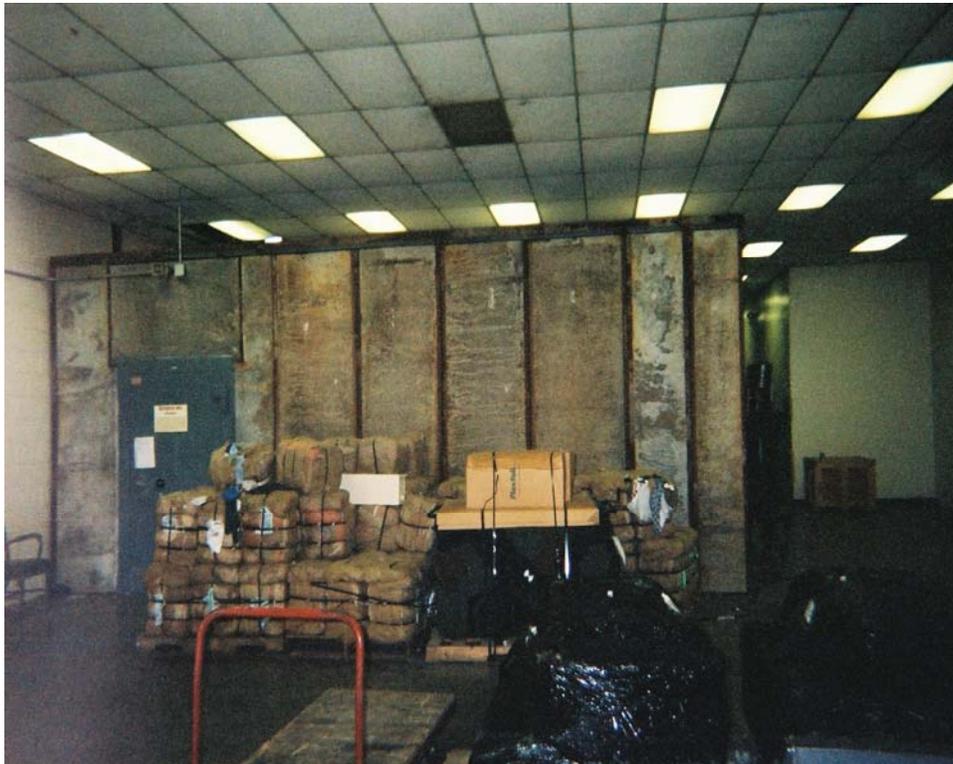
Photo 20: View of arms vault located within the warehouse.

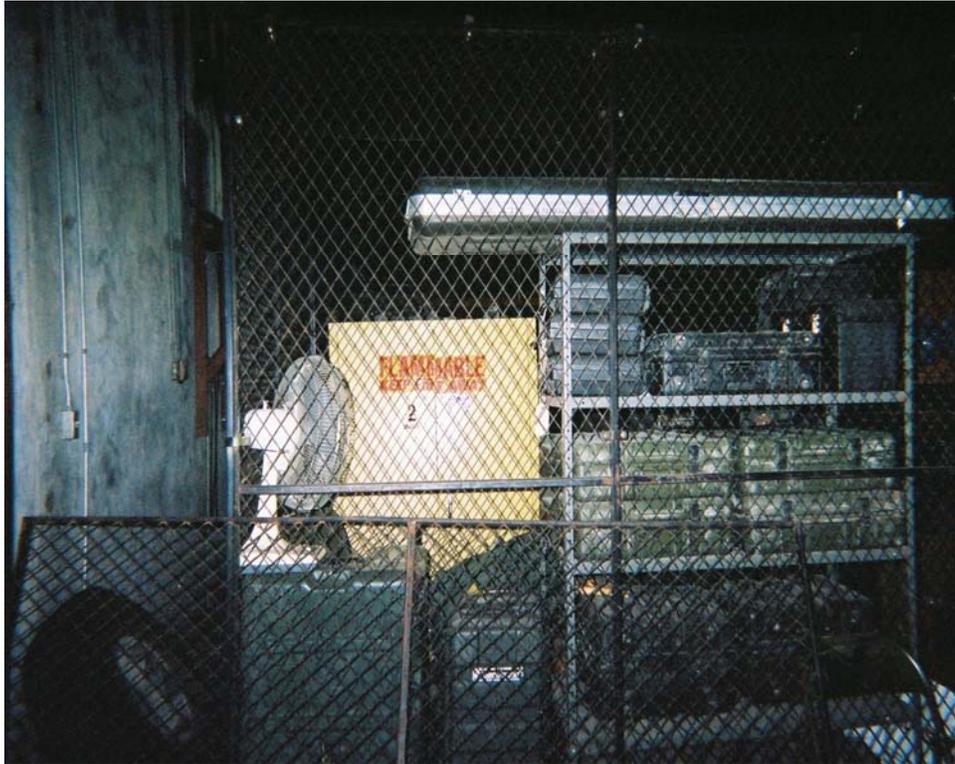
Photo 21: View of flammable materials locker located inside a caged storage area within the warehouse.

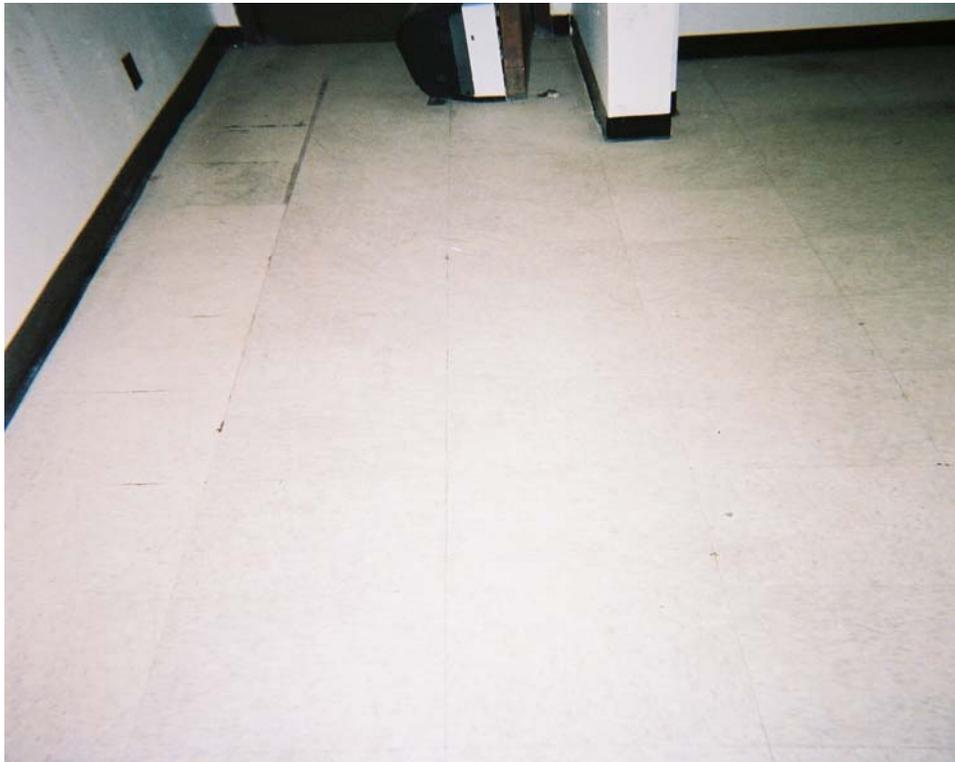
Photo 22: View of white floor tiles located in the women's restroom within the warehouse.

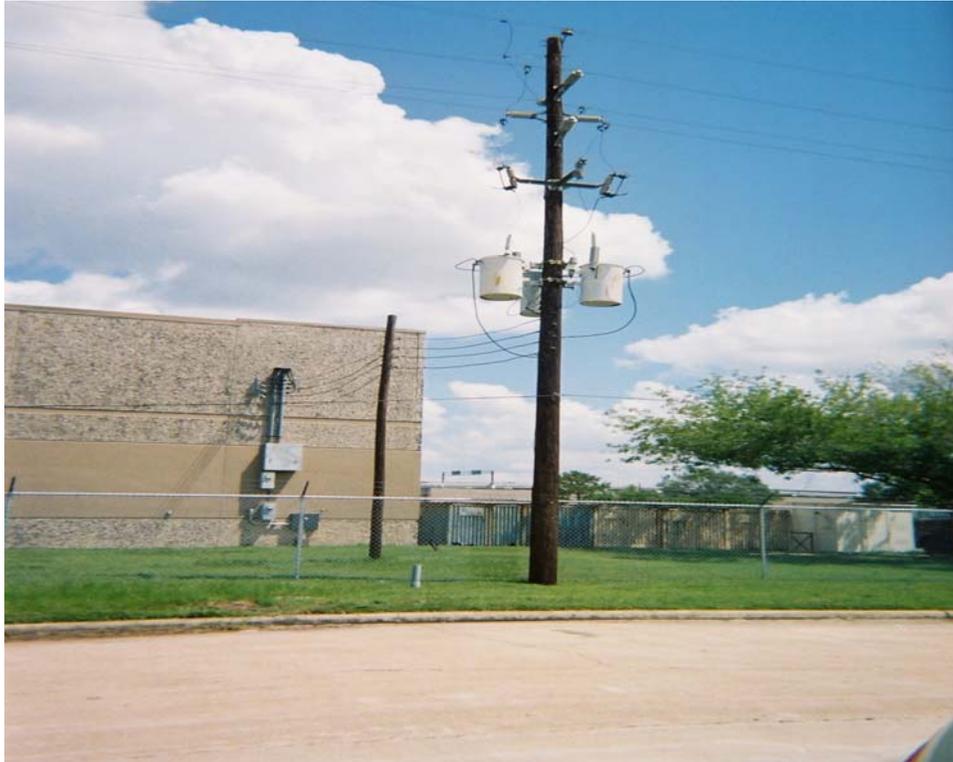
Photo 23: View of the pole-mounted transformers just south of the warehouse along Perimeter West Drive, outside of the fenced area. Note the electric power box on the south wall of the warehouse.

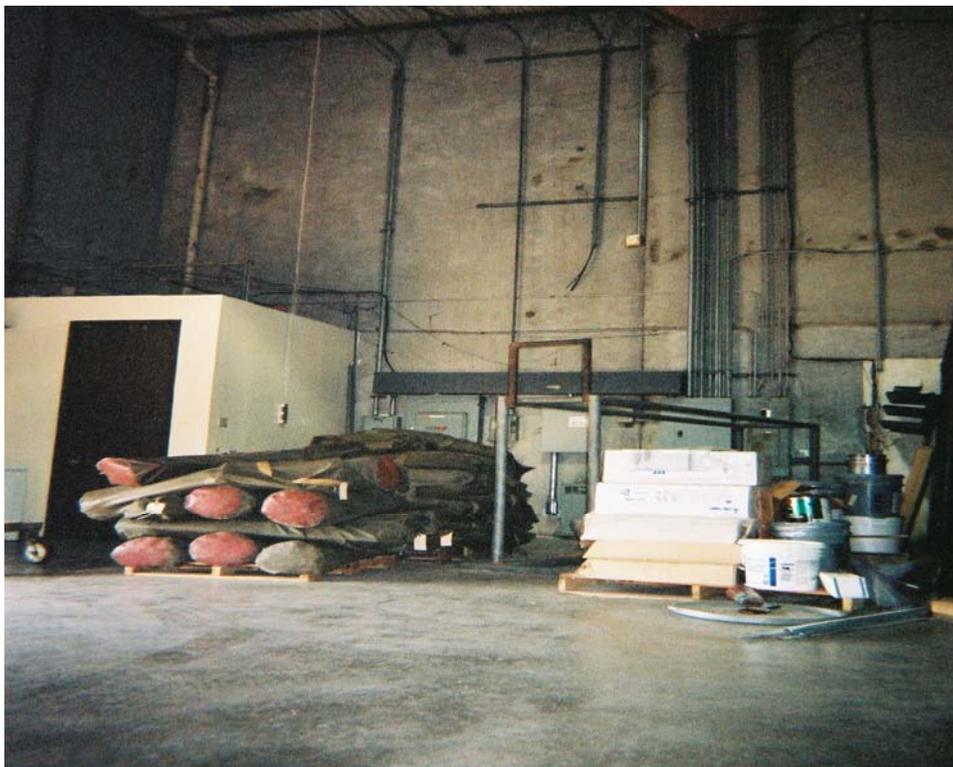
Photo 24: View of the main electric boxes located within the warehouse on the south wall. A restroom is located in the left of the photograph.

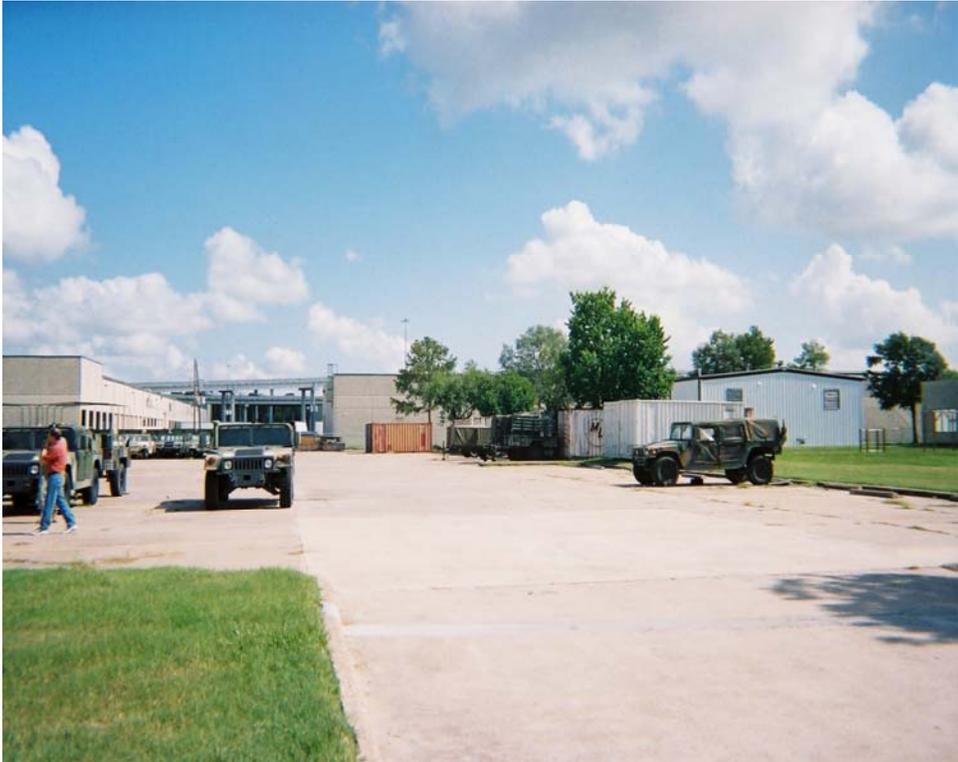
Photo 25: View of the MEP area looking north. Note the corrugated metal building in the background of the photograph on the right.

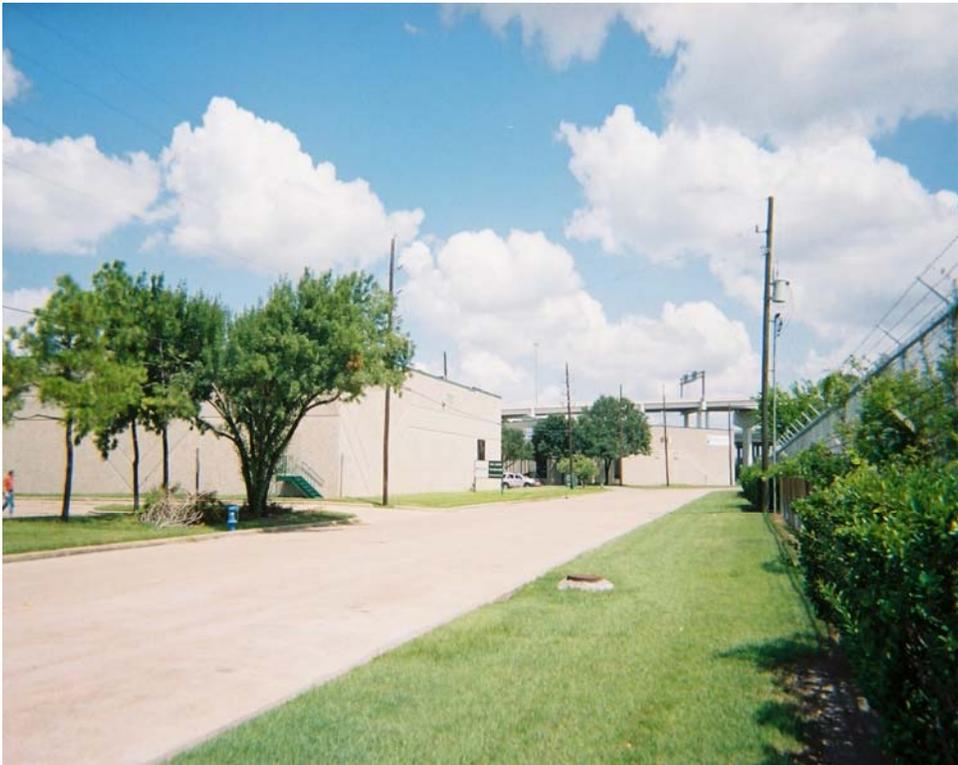
Photo 26: View of adjoining commercial office space/warehouses to the north of the Site.

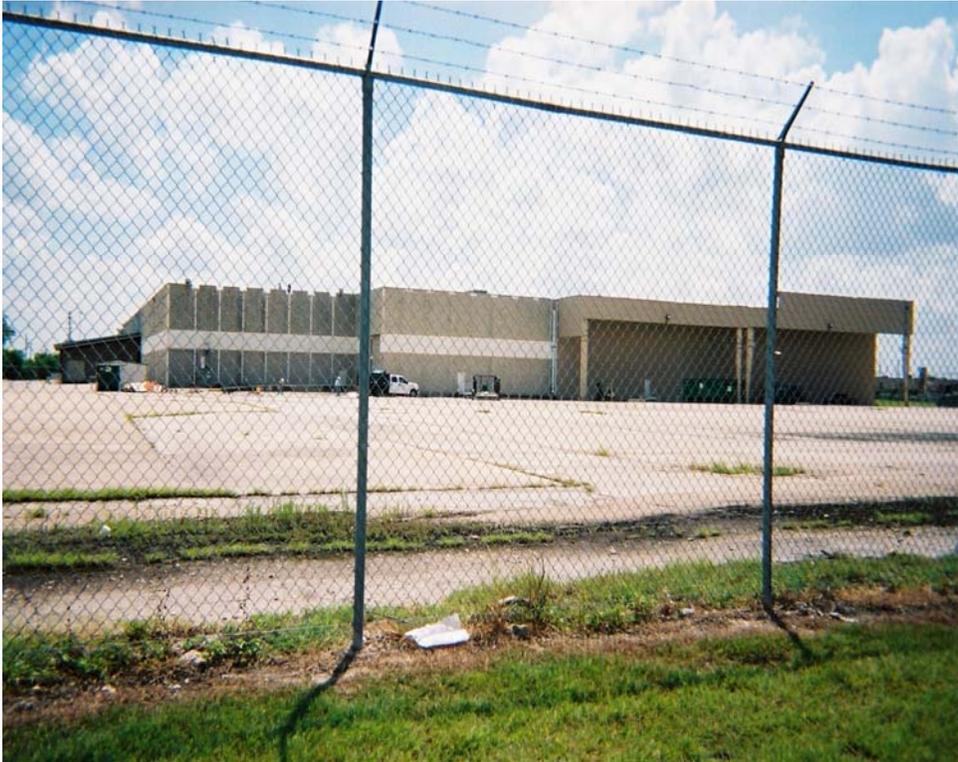
Photo 27: View of adjoining property to the east of the Site (Iron Mountain-Records Management). Vegetation along the fence line, which does not adjoin the Site, appeared to have been sprayed with herbicide.

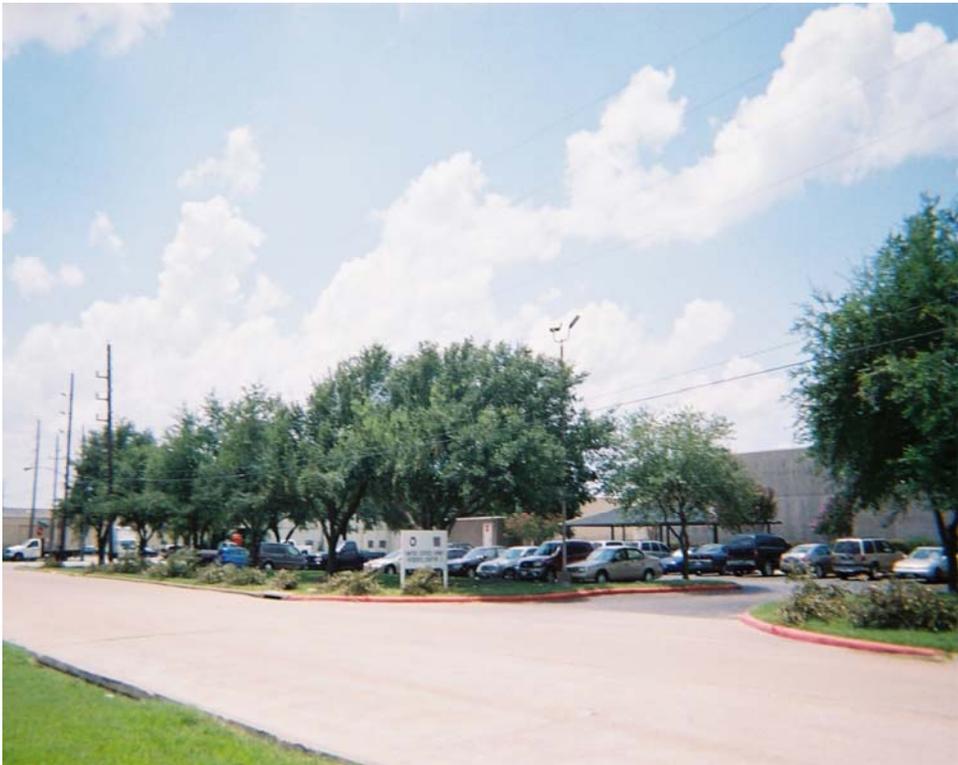
Photo 28: View of Houston #3 USAR Center, adjoining the Site to the south.

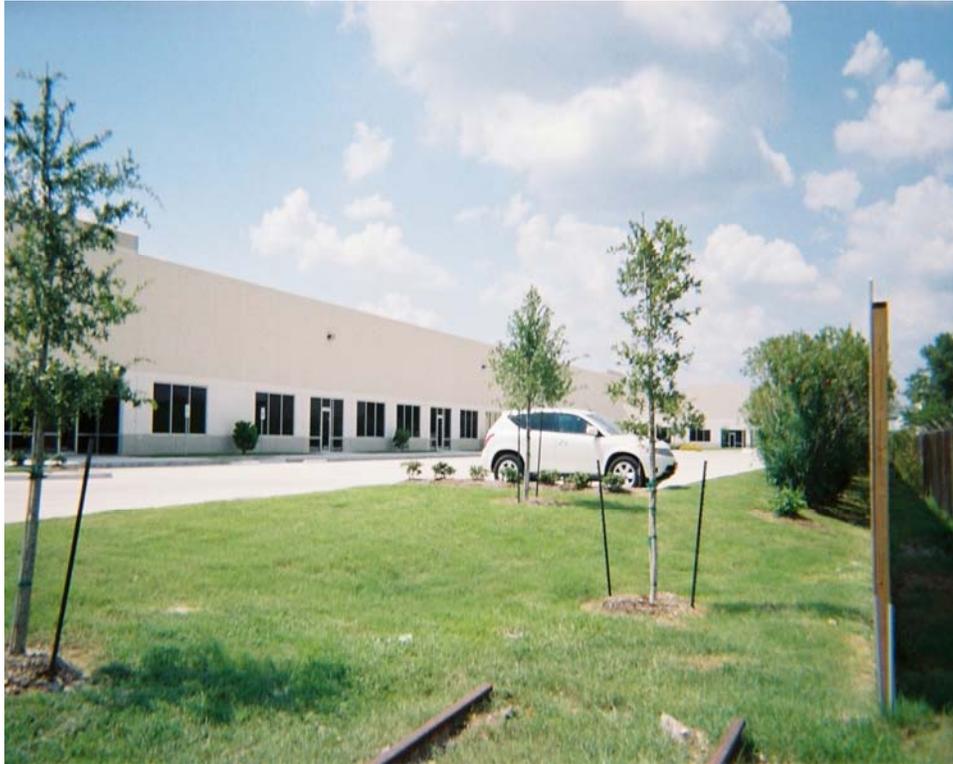
Photo 29: View of warehouses constructed in 2005 adjoining the Site to the west.
