Photograph 1. East exterior of the Oswald USARC Administration Building

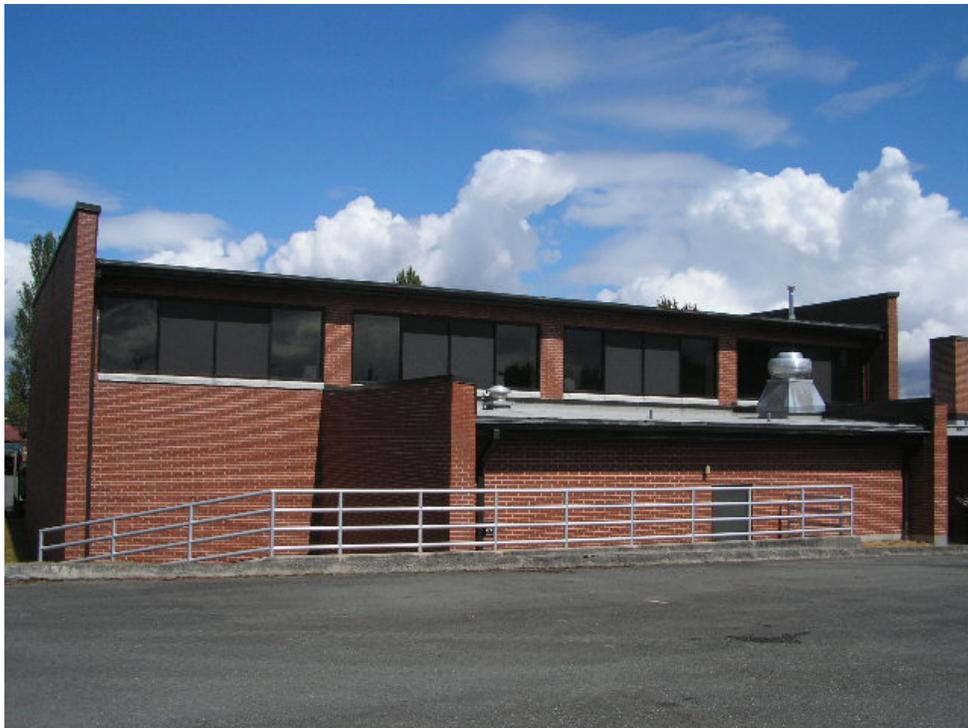
Photograph 2. South exterior of the Oswald USARC Administration Building

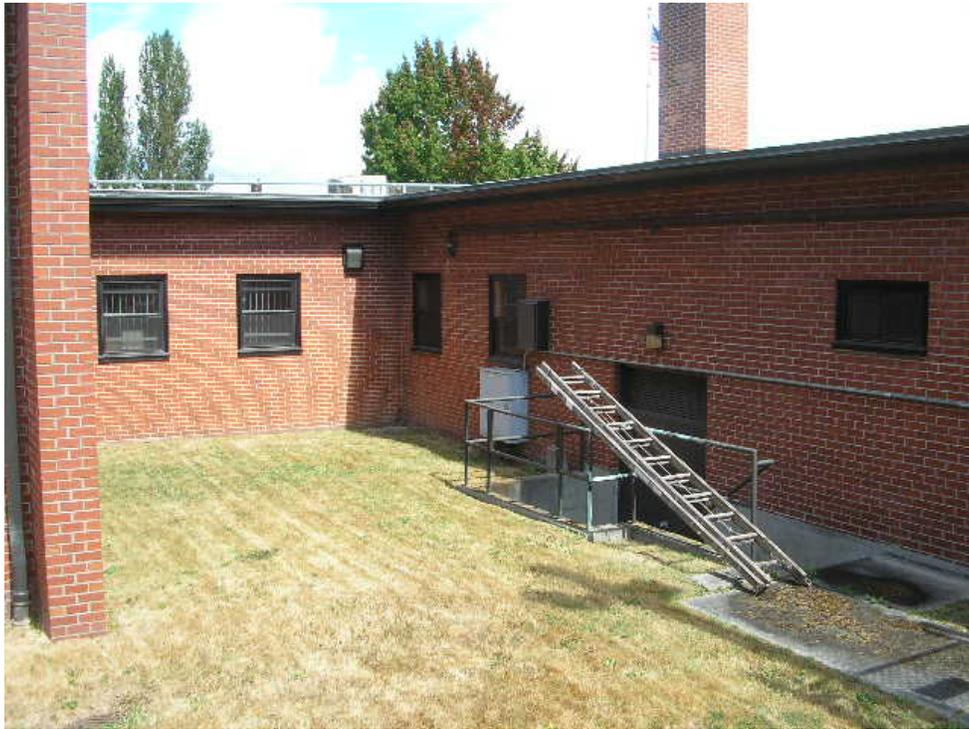
Photograph 3. Approximate location of Former 2,000-Gallon UST Adjacent to Former Boiler Room

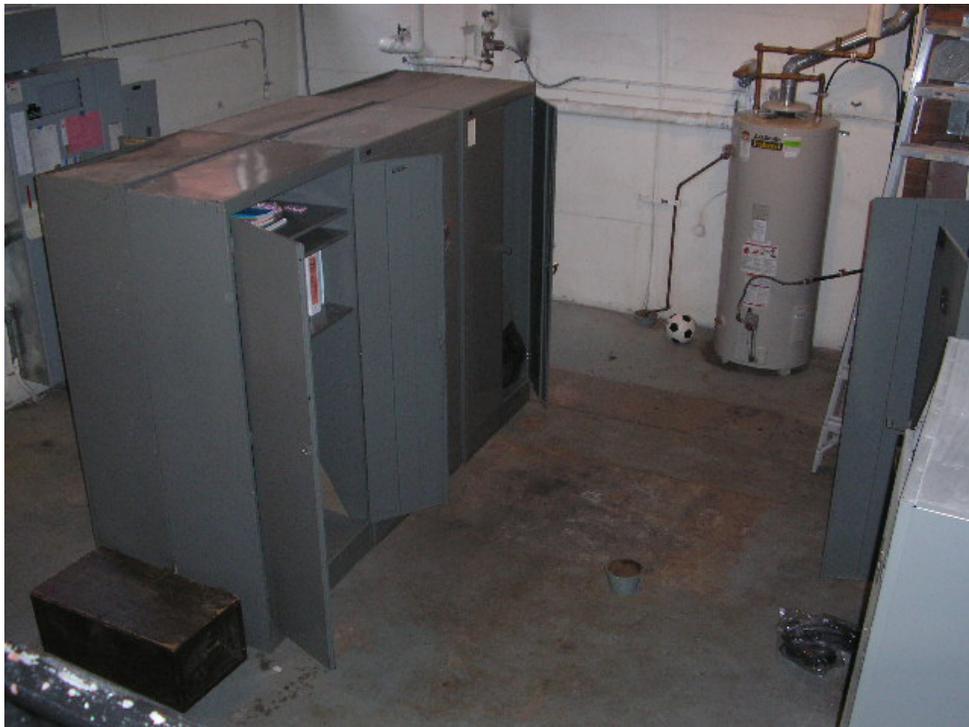
Photograph 4. Boiler room

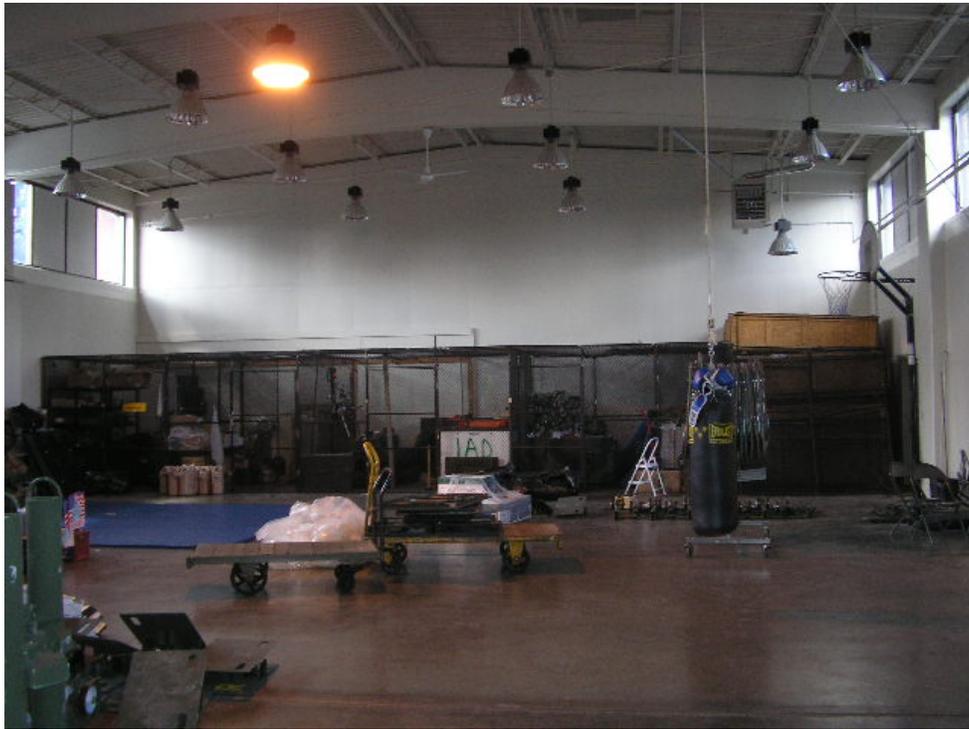
Photograph 5. View of the drill hall located in the Oswald USARC Administration Building

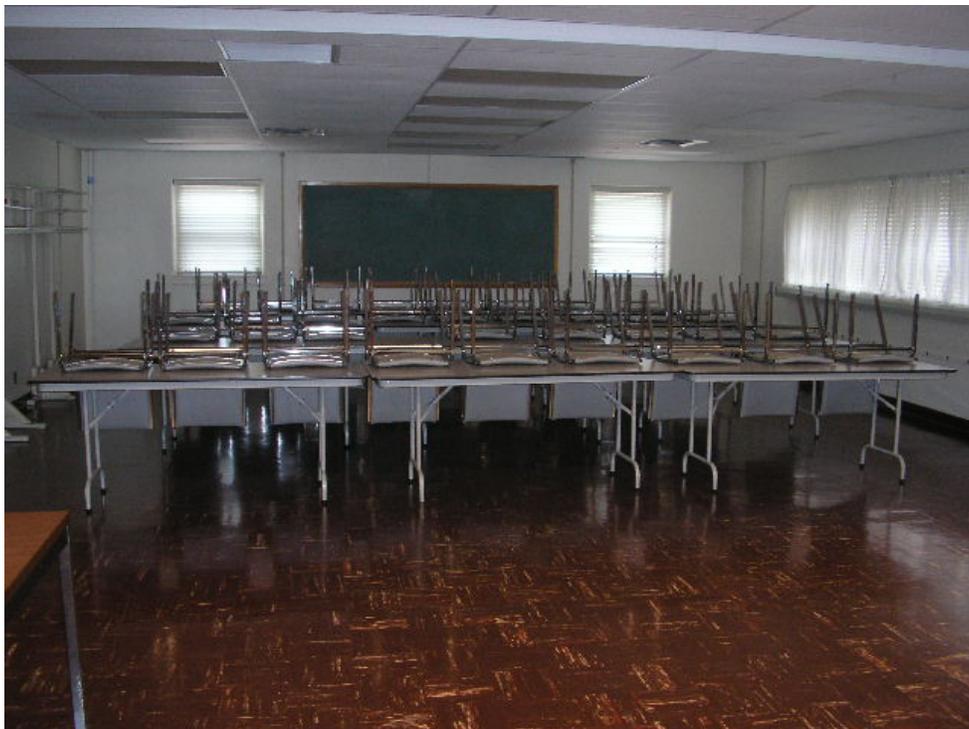
Photograph 6. View of a typical classroom room in the Oswald USARC Administration Building

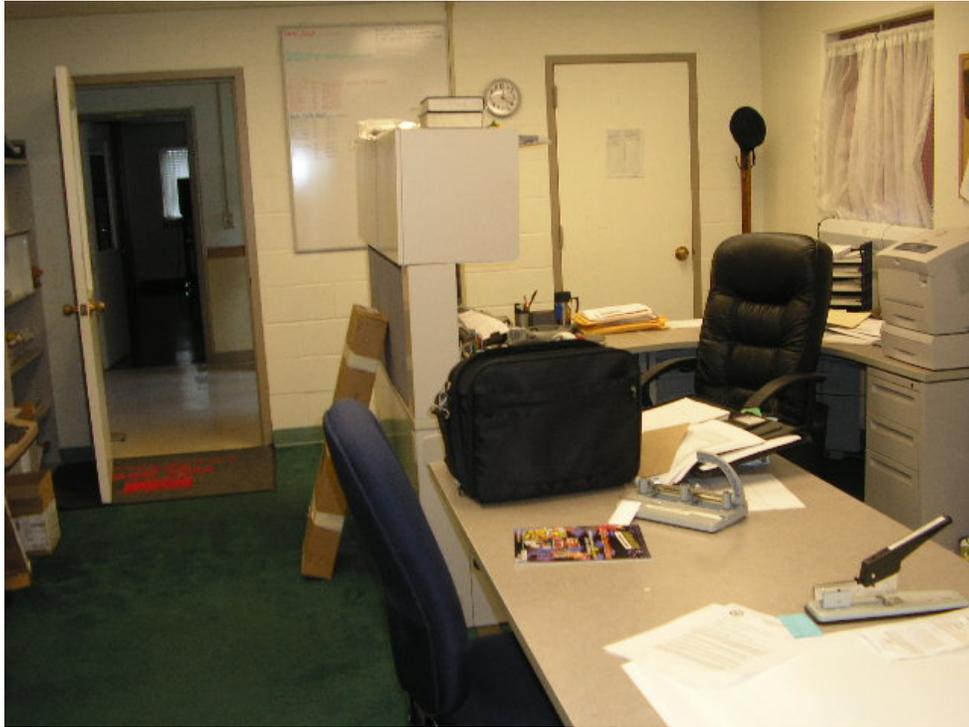
Photograph 7. View of a typical office in the Oswald USARC Administration Building

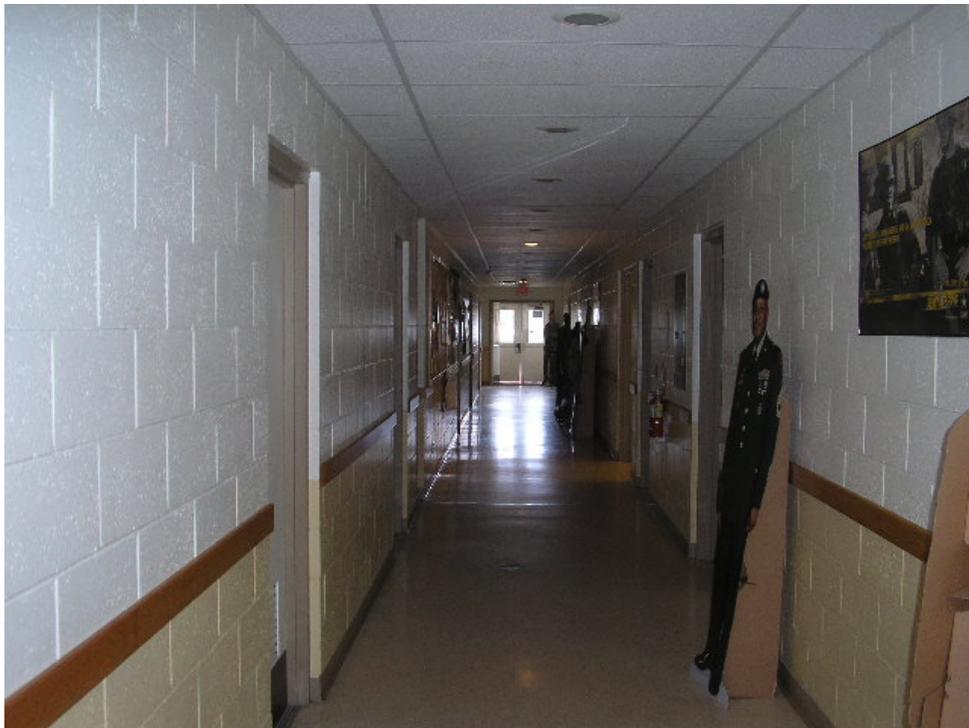
Photograph 8. View of a typical hallway in the Oswald USARC Administration Building

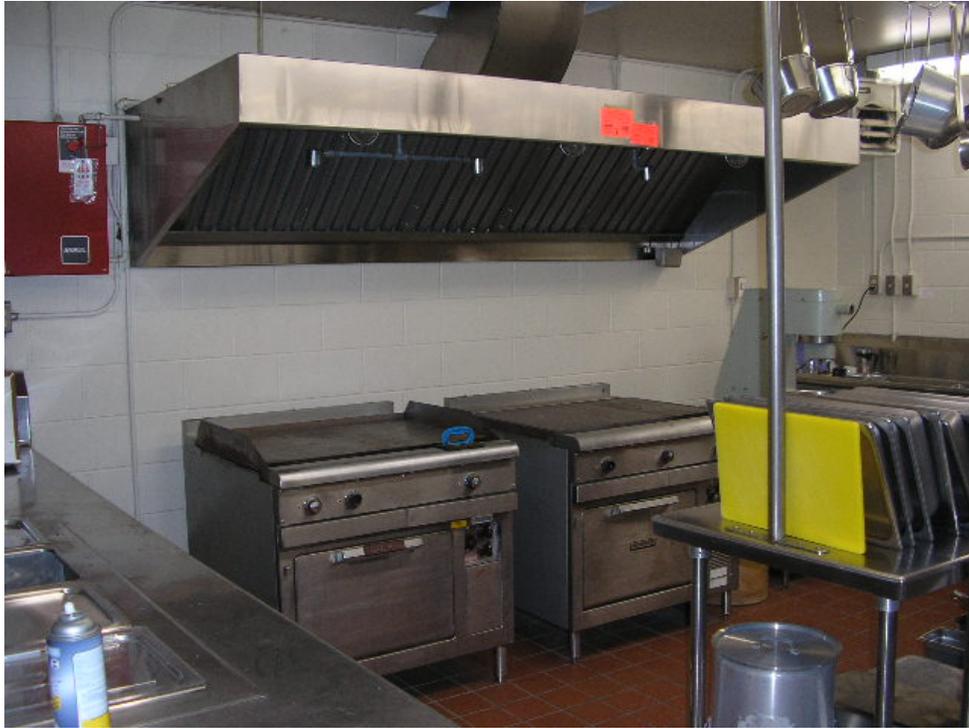
Photograph 9. View of the kitchen in the Oswald USARC Administration Building

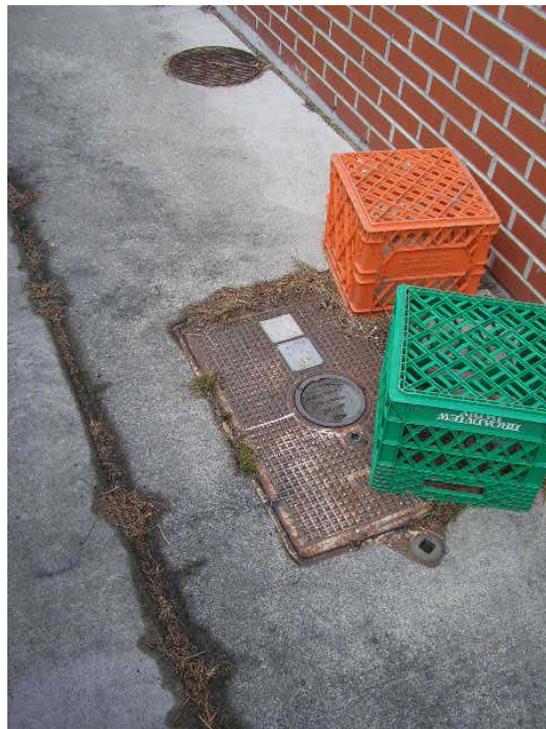
Photograph 10. Grease trap access situated on the southwest exterior of the Oswald USARC Administration Building

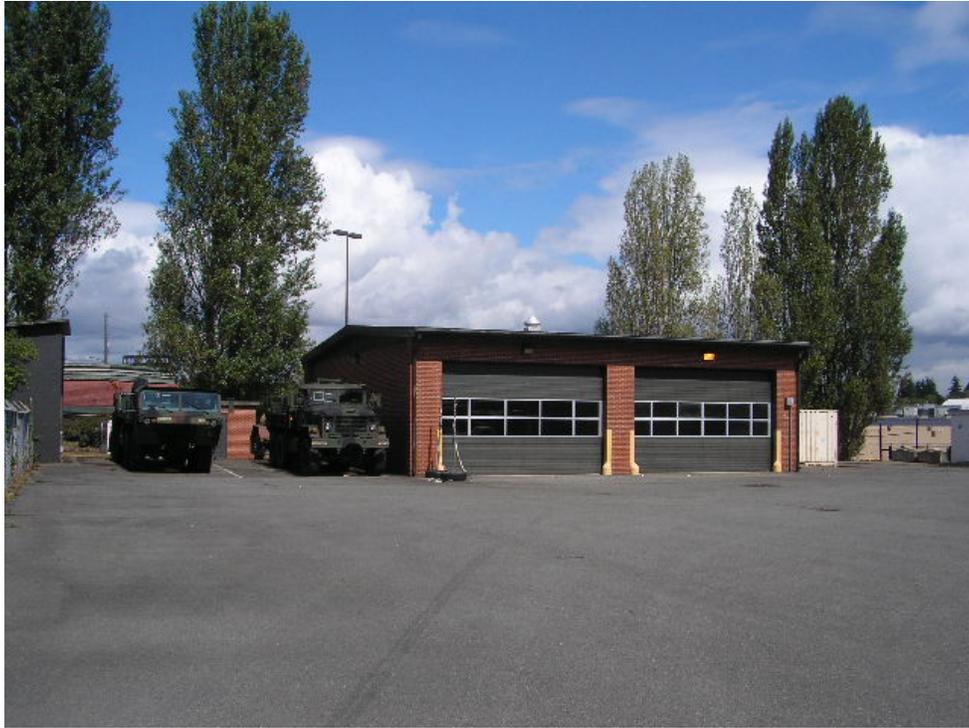
Photograph 11. View of the bay doors situated on the south exterior of the OMS Building

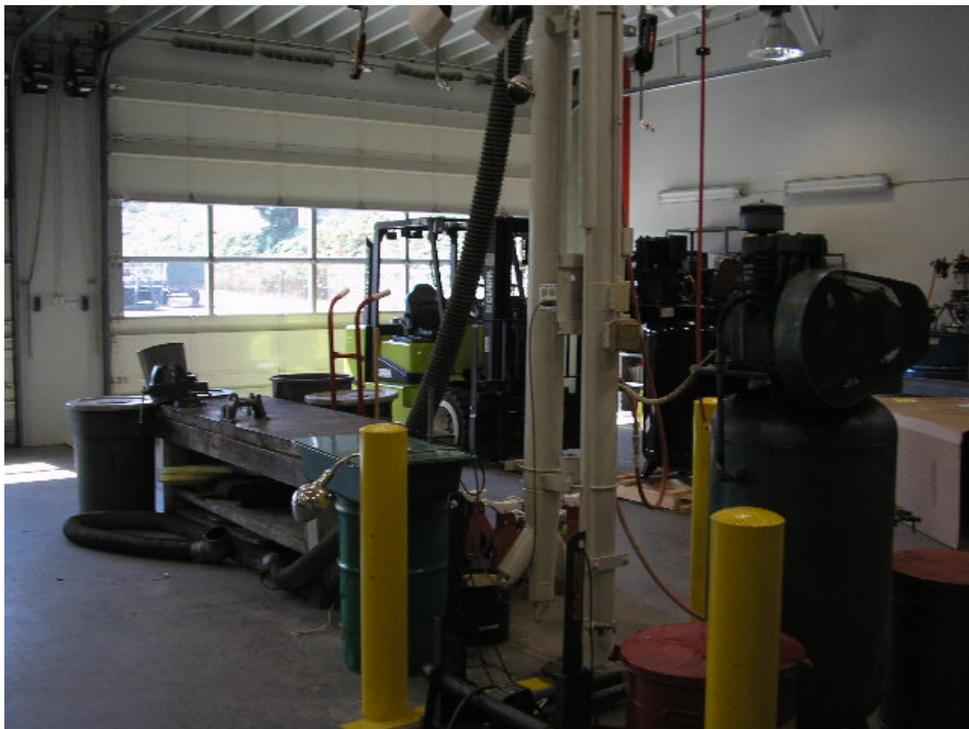
Photograph 12. Interior of the OMS Building vehicle maintenance area

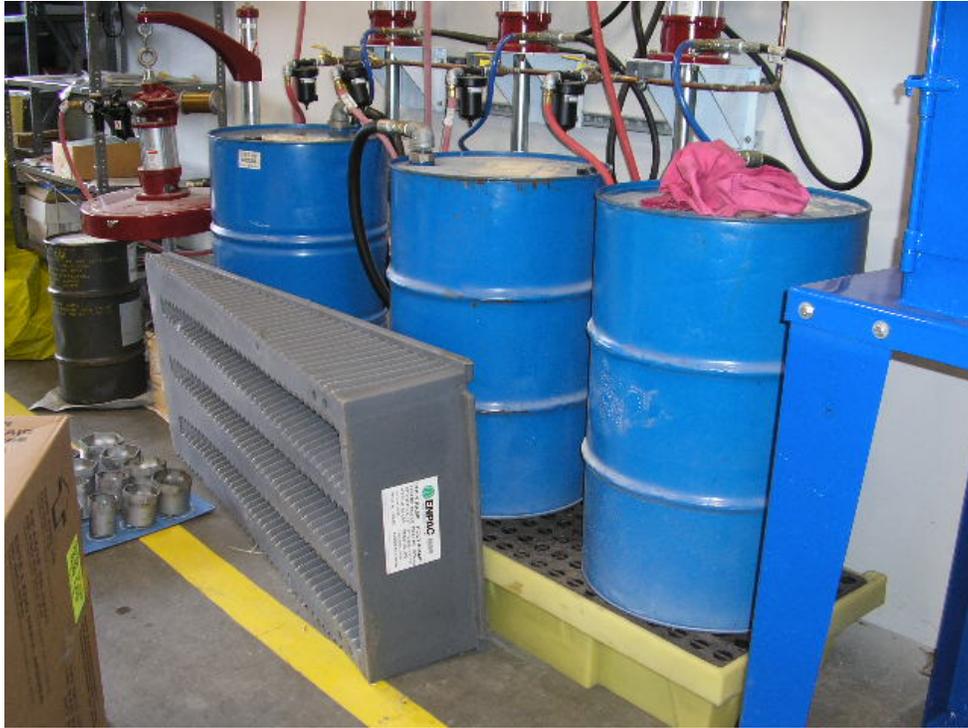
Photograph 13. View of oil and grease storage in the OMS Building

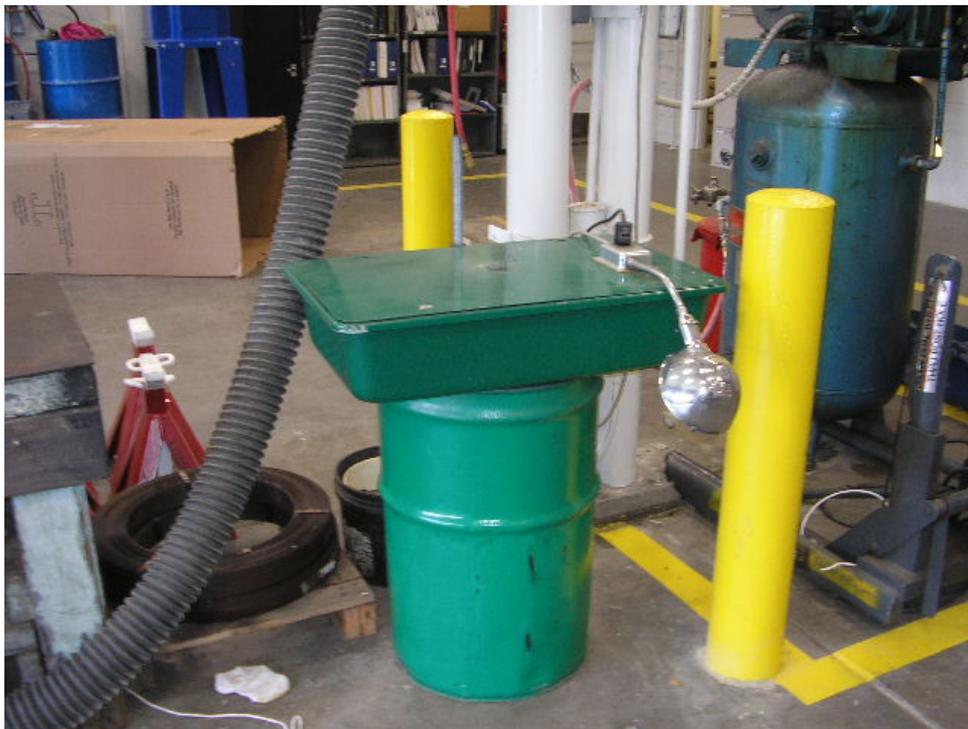
Photograph 14. Solvent sink located in the OMS Building vehicle maintenance area

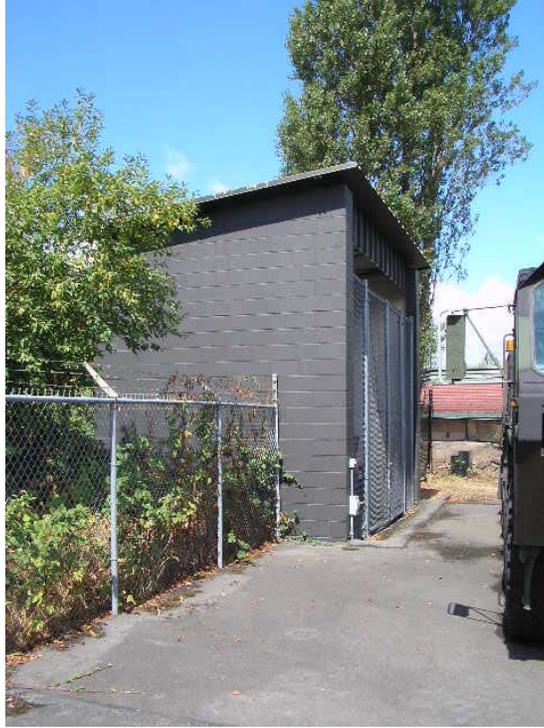
Photograph 15. View of Hazmat Storage Structure situated west of the OMS Building

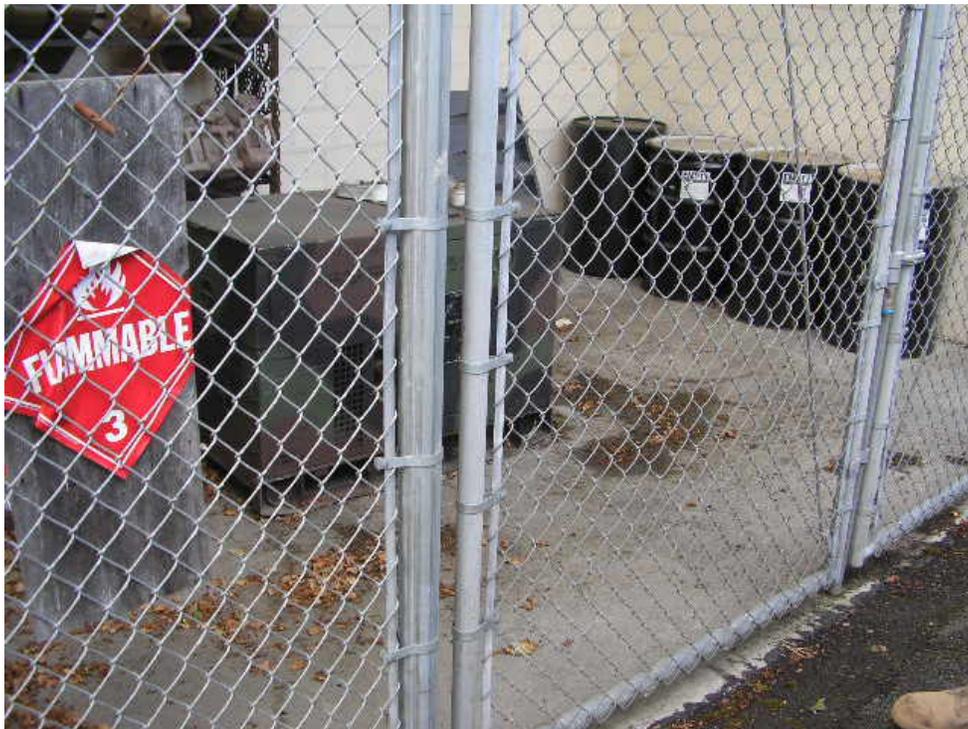
Photograph 16. View of the interior area of the Hazmat Storage Structure

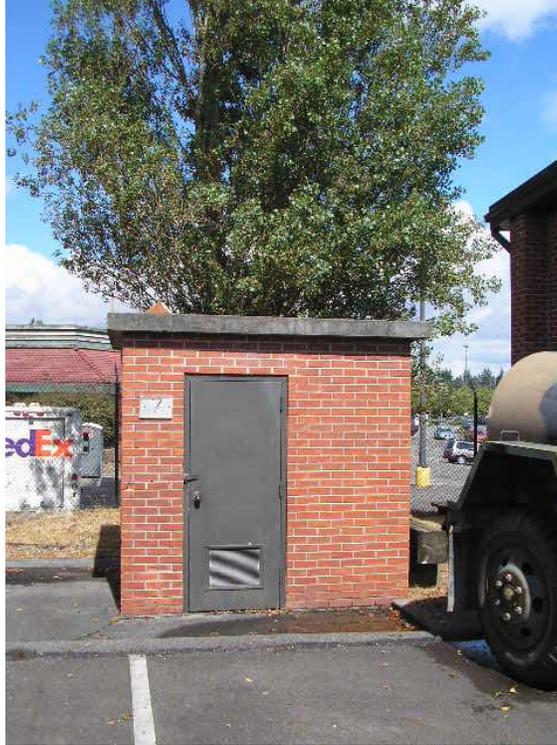
Photograph 17. View of the former Hazmat Storage Shed situated immediately west of the OMS Building

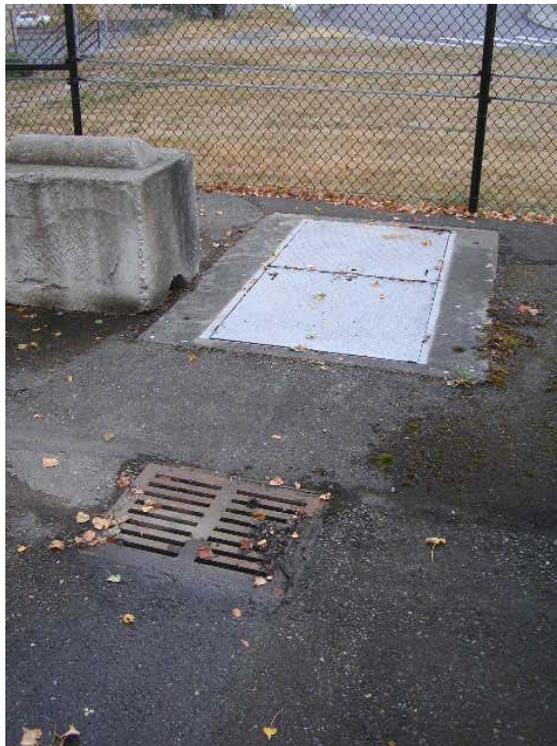
Photograph 18. OWS separator situated on the northeast portion of the Site

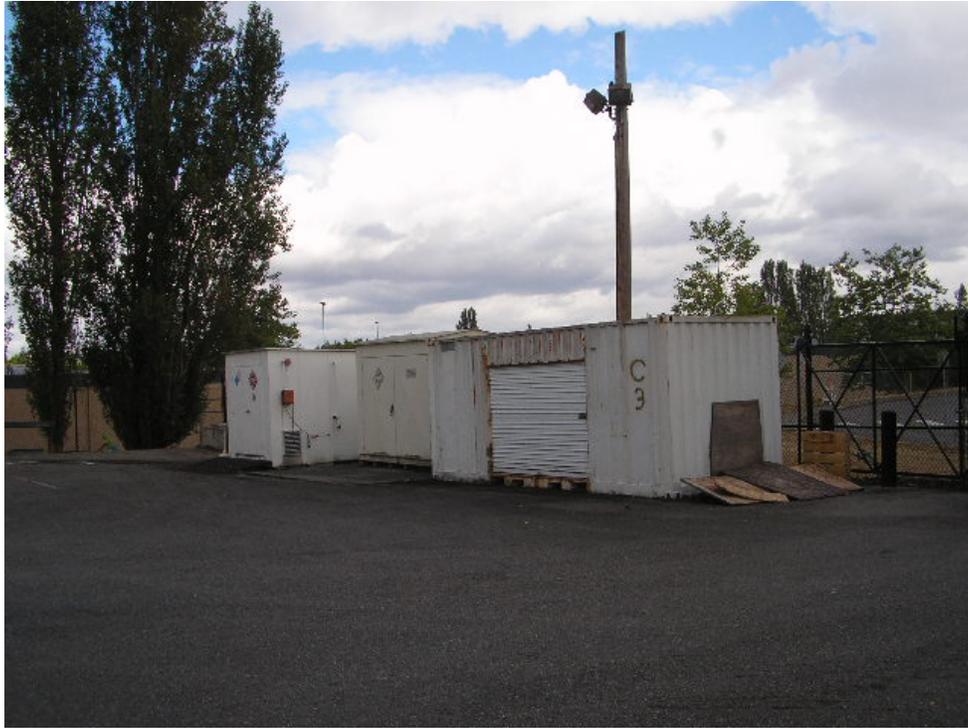
Photograph 19. View of the portable Hazmat Storage Sheds #1 and #2 (pictured left) and a CONEX trailer (pictured right), looking northeast

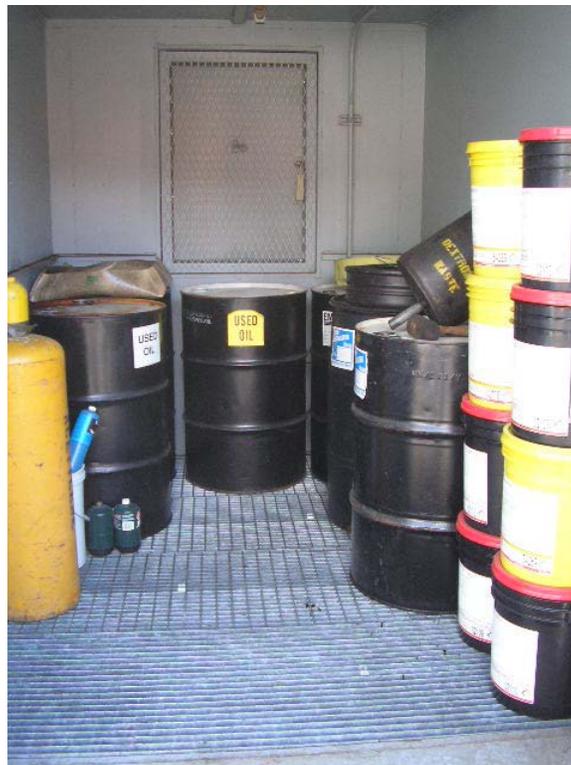
Photograph 20. Interior view of Hazmat Storage Shed #1

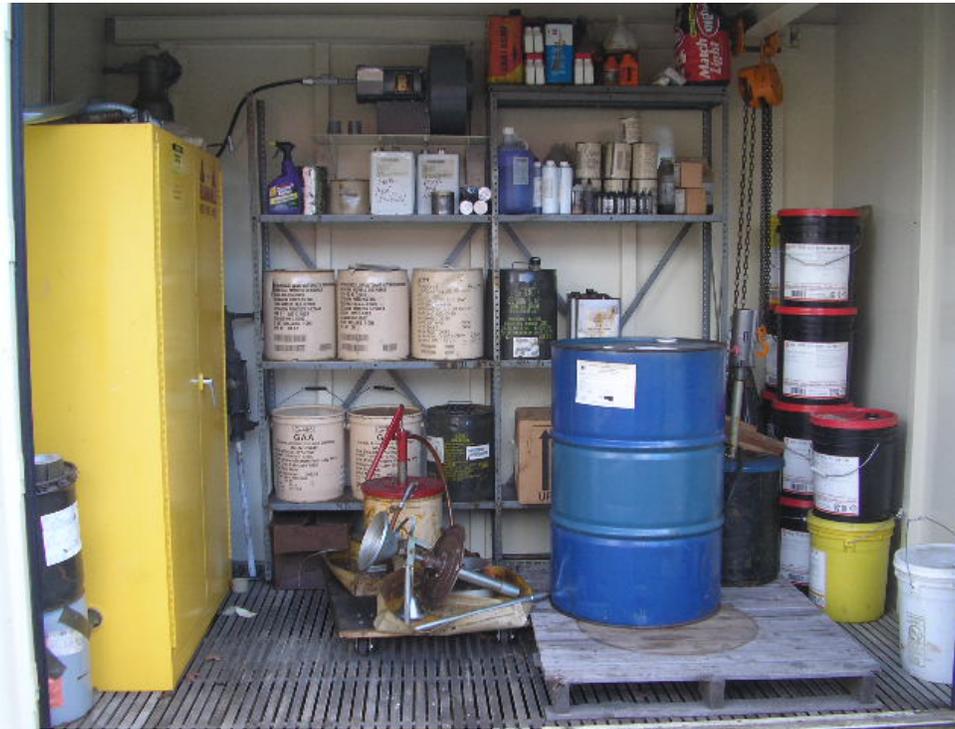
Photograph 21. Interior view of Hazmat Storage Shed #2

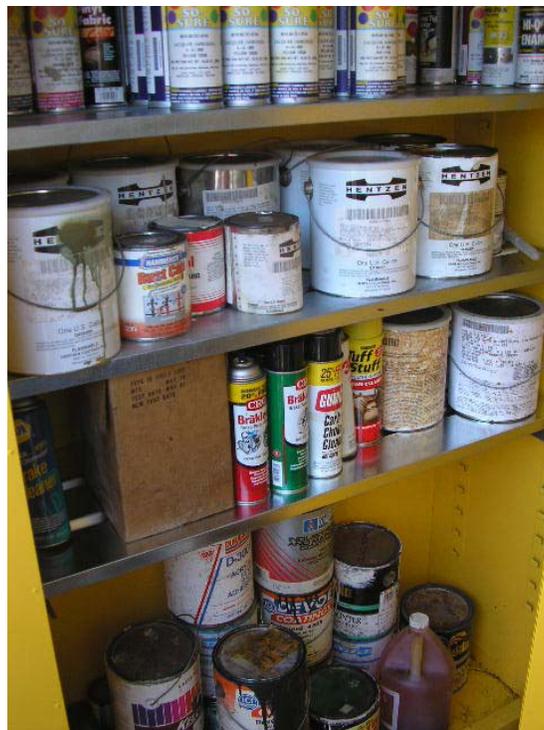
Photograph 22. Interior view of the flammable storage cabinet situated in Hazmat Storage Shed #2

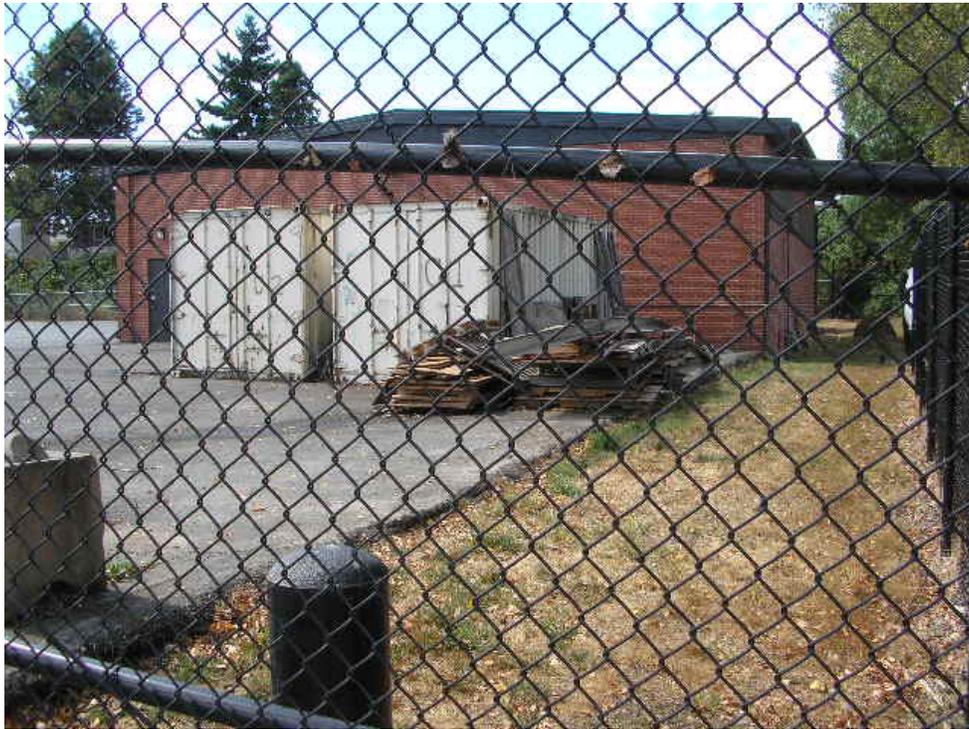
Photograph 23. View of the northeastern portion of the Site in the approximate location of a suspected former UST

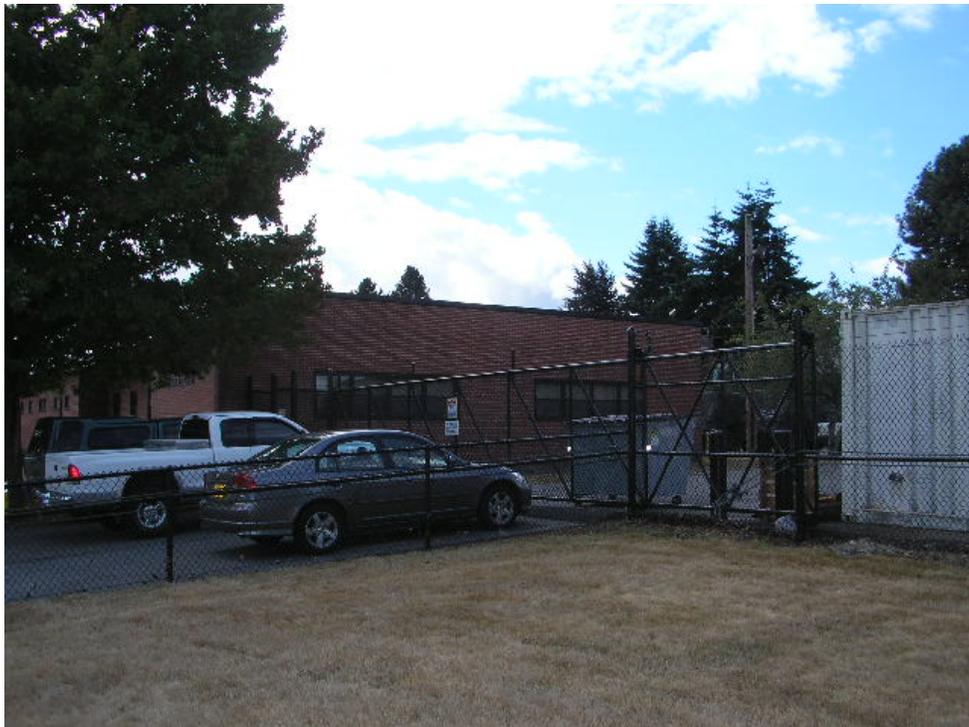
Photograph 24. Gated entrance to the northern portion of the Site, looking southwest from Rainier Avenue

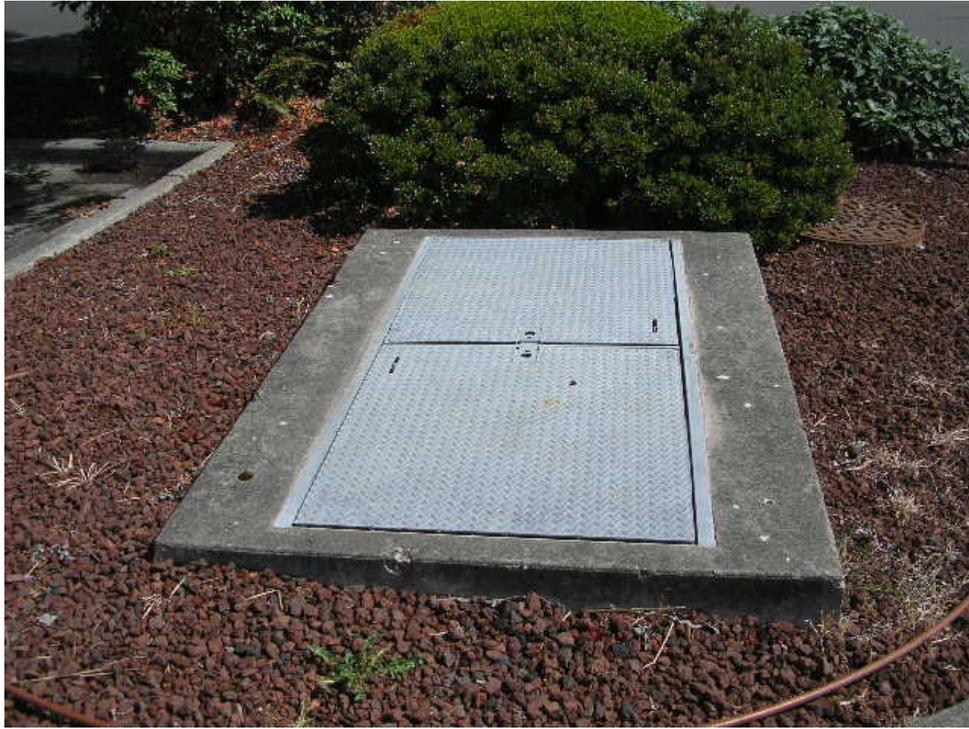
Photograph 25. OWS situated in a planter area adjacent to the POV parking lot on the eastern portion of the Site

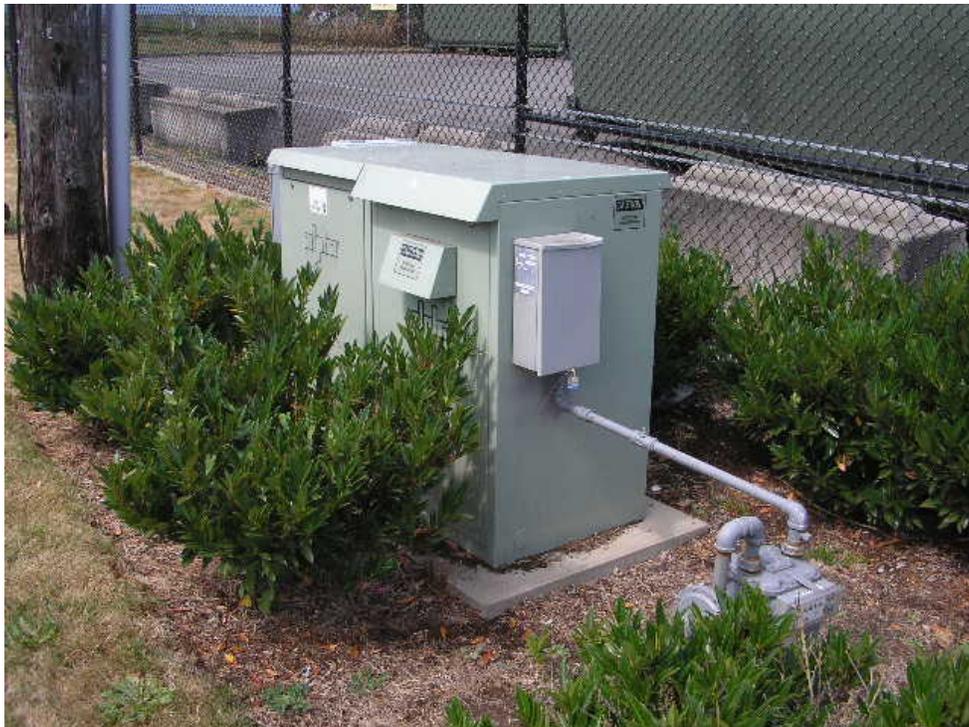
Photograph 26. Pad-mounted transformer situated on the southern perimeter of the Site

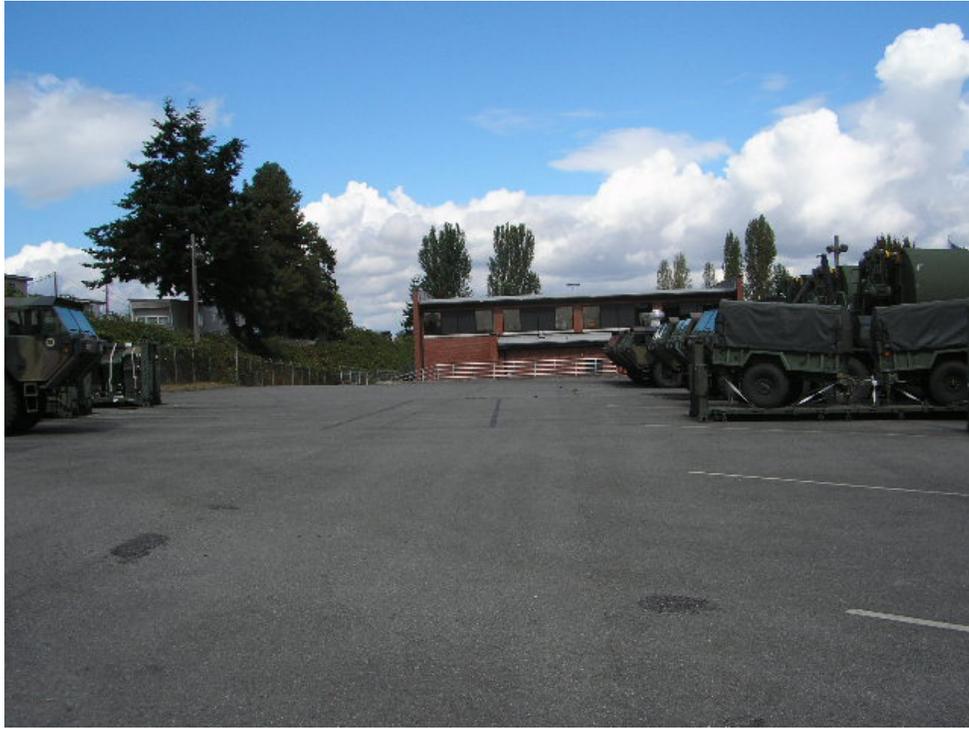
Photograph 27. MEP area on the southwestern portion of the Site, looking north

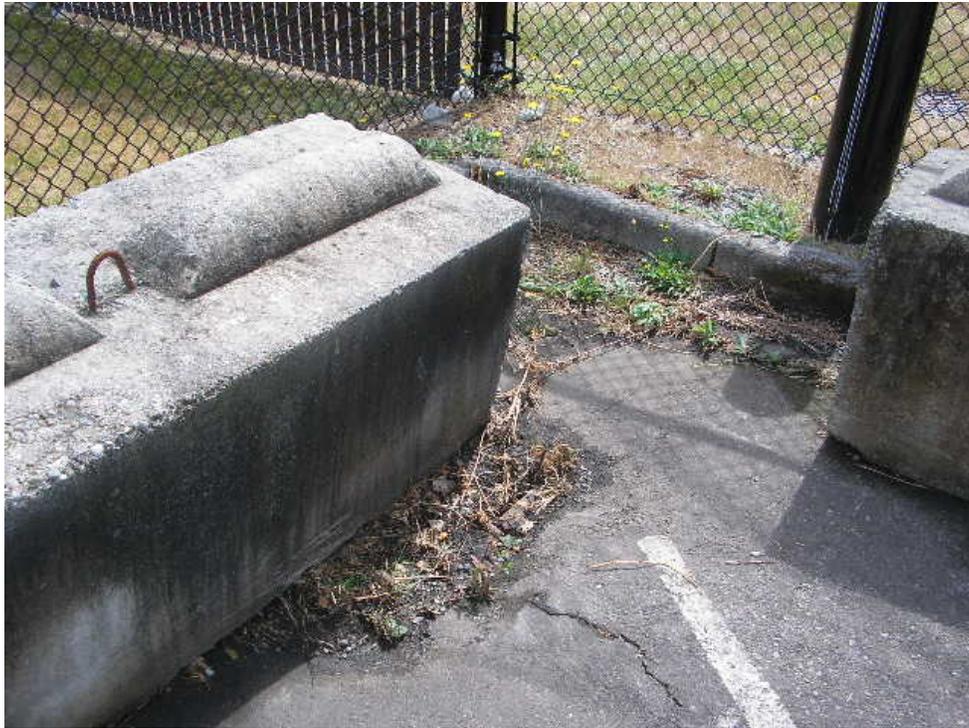
Photograph 28. Storm drain situated on the southeast portion of the MEP area

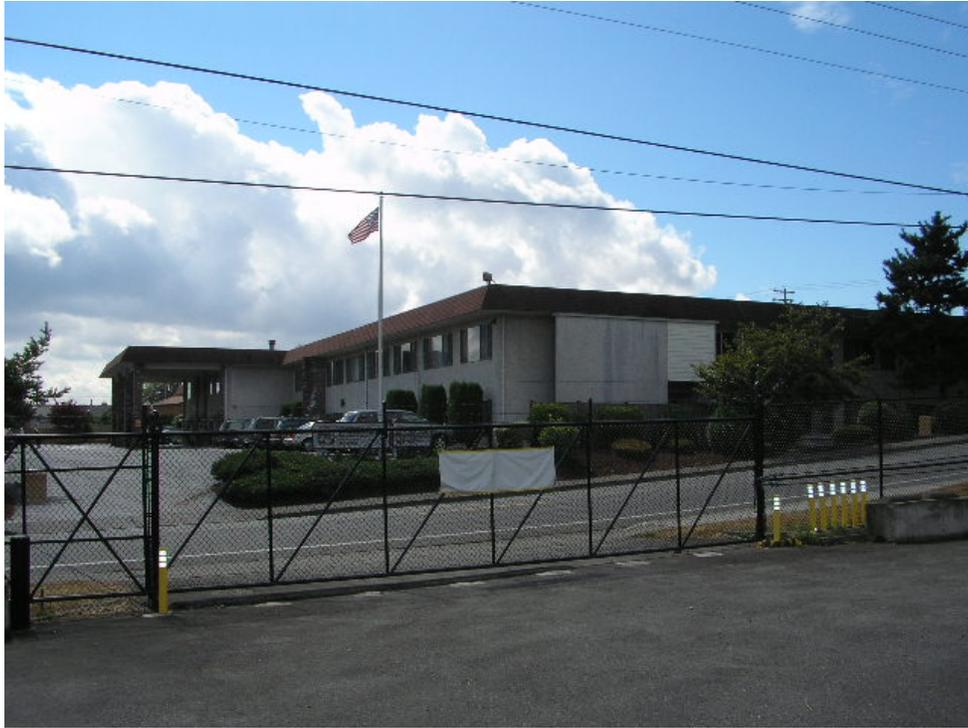
Photograph 29. Gated entrance accessible via 12th Street, looking south from the Site towards the adjoining property (across 12th Street) occupied by an apartment complex

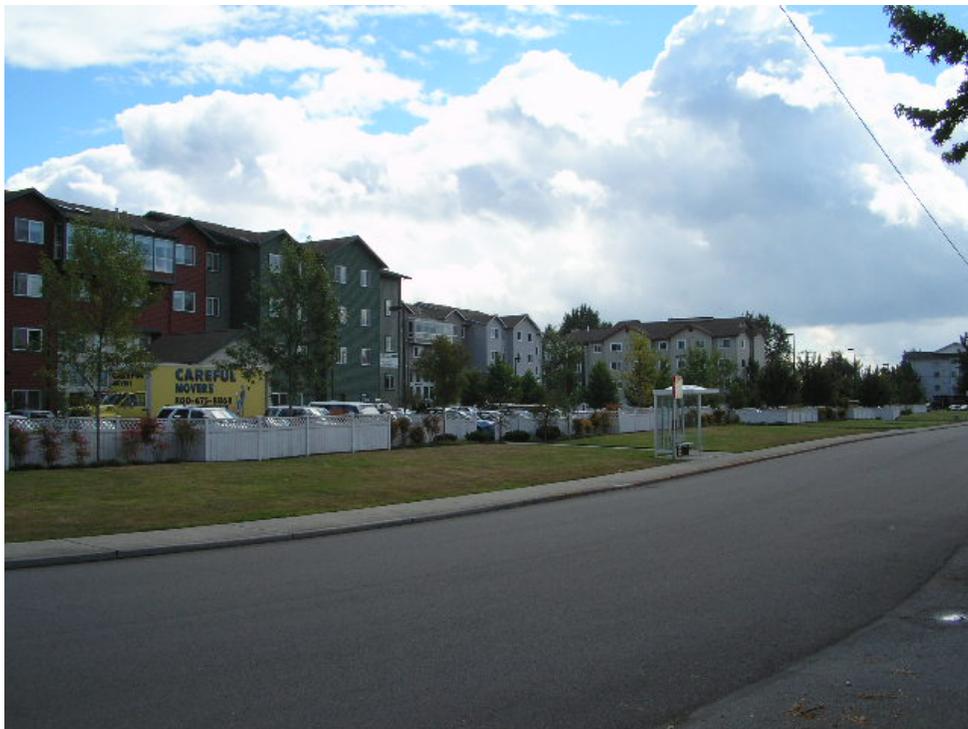
Photograph 30. Meadows Apartments situated east of the Site across Rainier Avenue, looking southeast

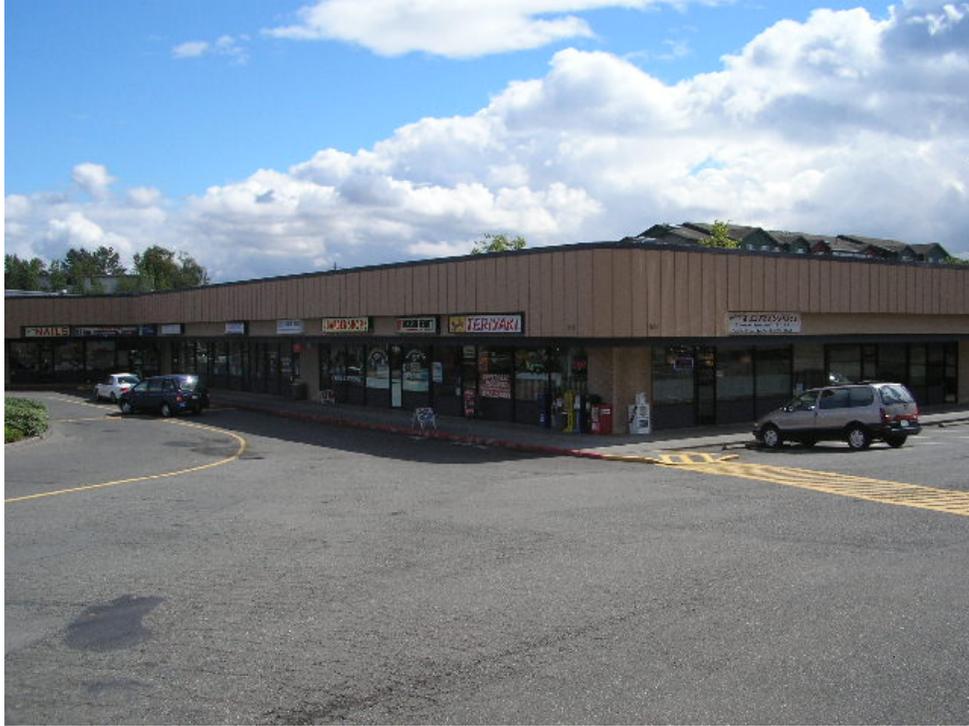
Photograph 31. View of the adjoining shopping plaza situated north of the Site

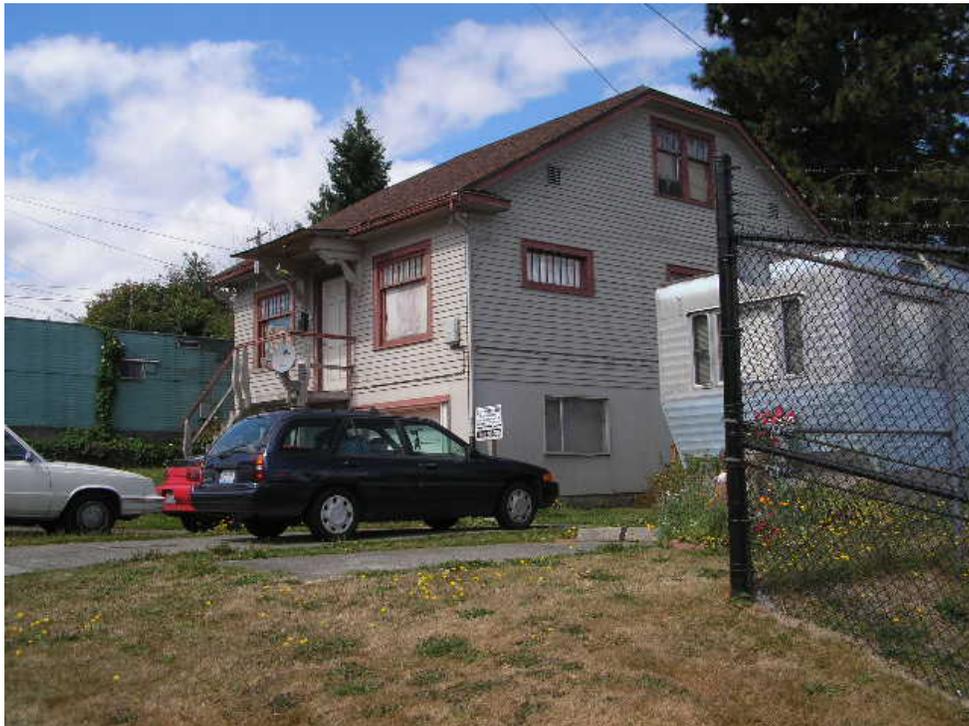
Photograph 32. View of the adjacent residential property west of the Site
