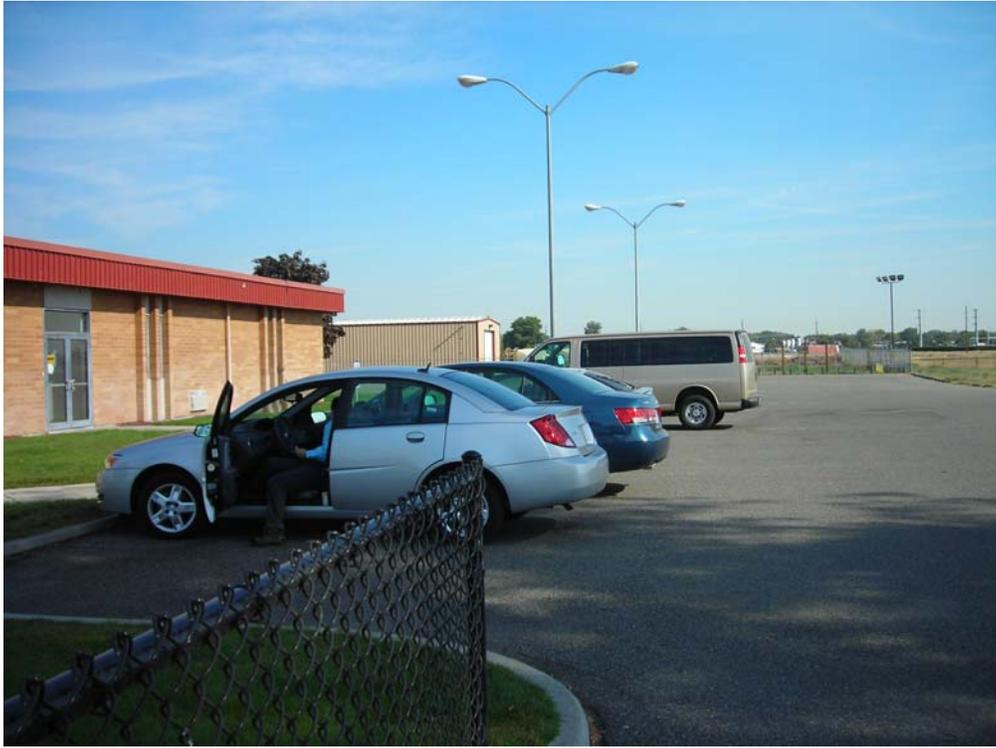
Photograph 1. POV area on east side of USARC administration building

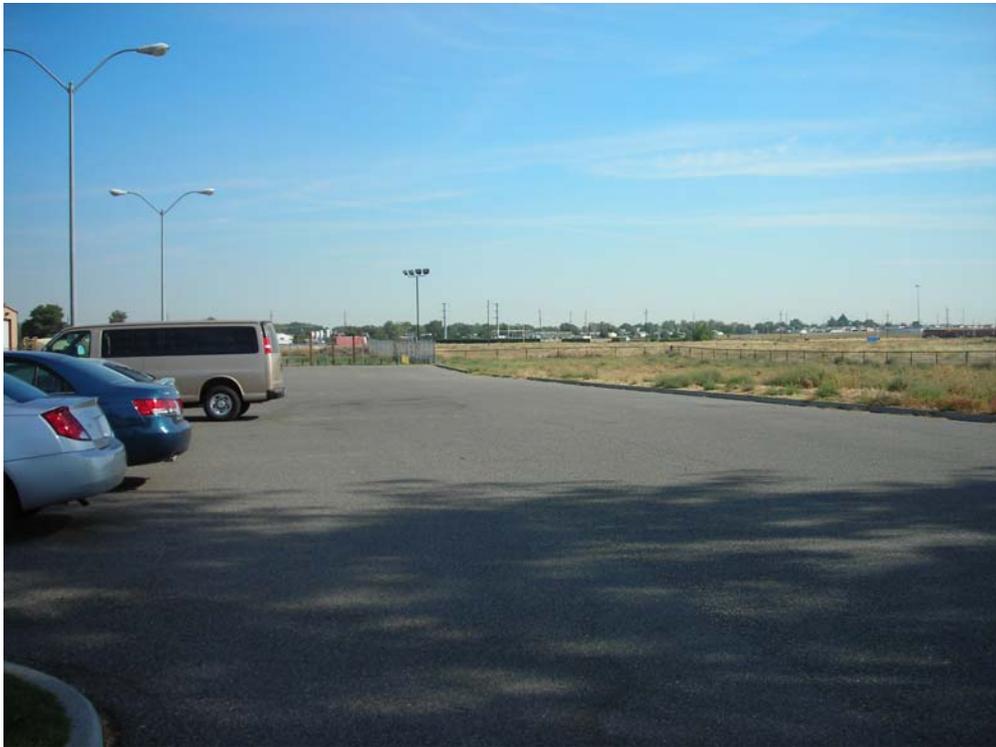
Photograph 2. POV area on east side of administration building

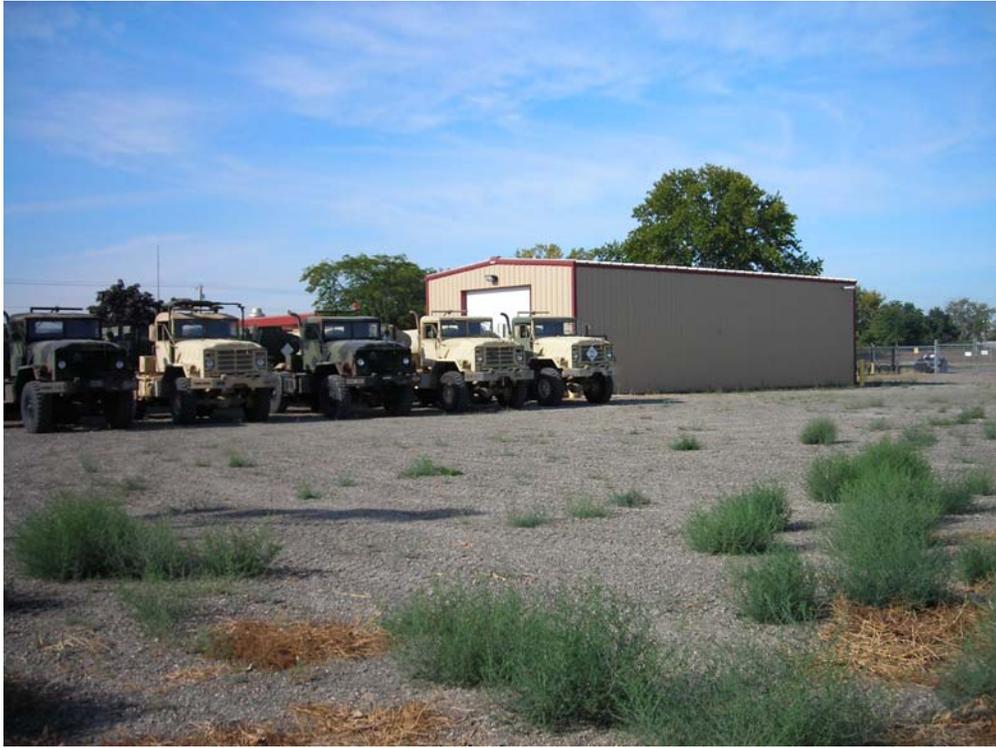
Photograph 3. Gravel MEP area with vehicles and OMS

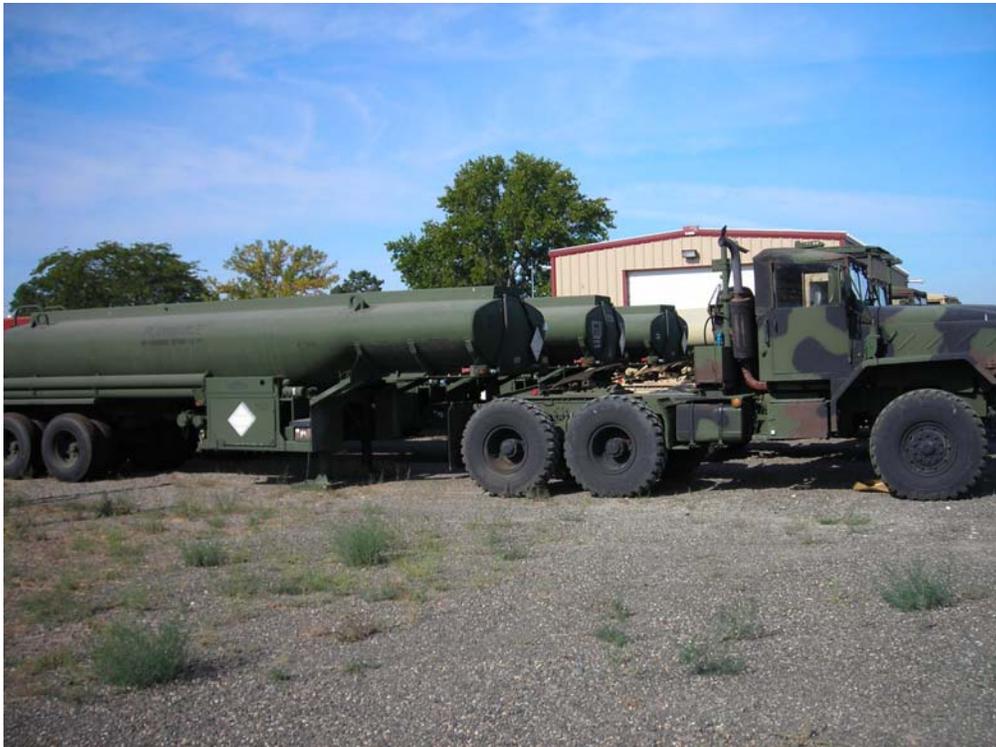
Photograph 4. Gravel MEP area

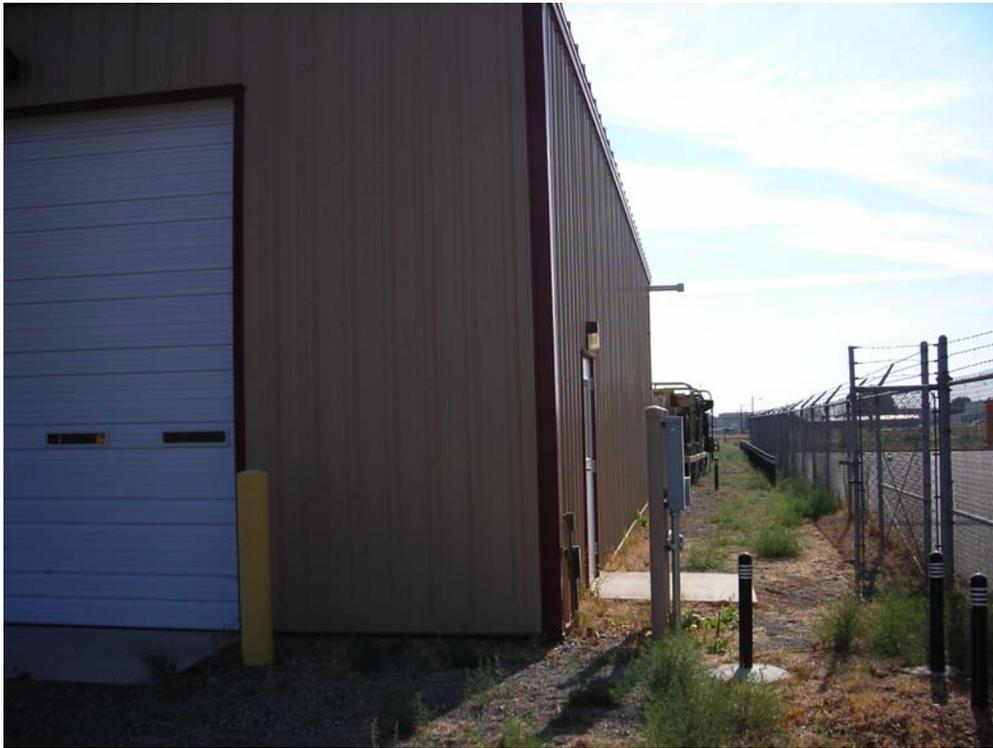
Photograph 5. Security fence between OMS (left) and administration building

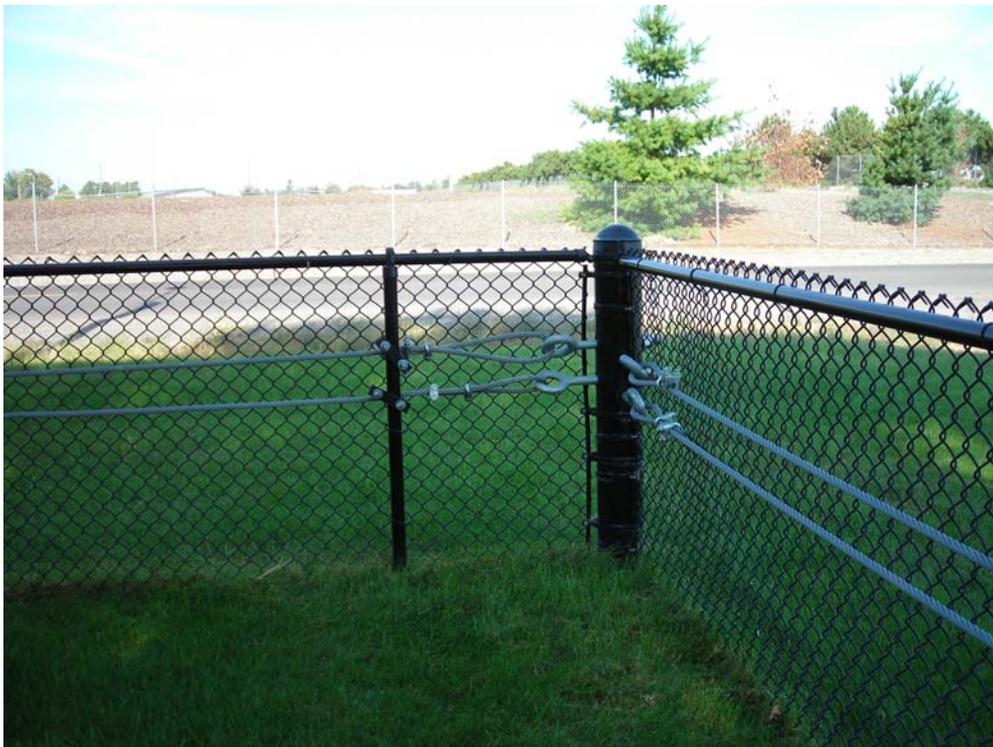
Photograph 6. Chain link and wire reinforced fence around administration building

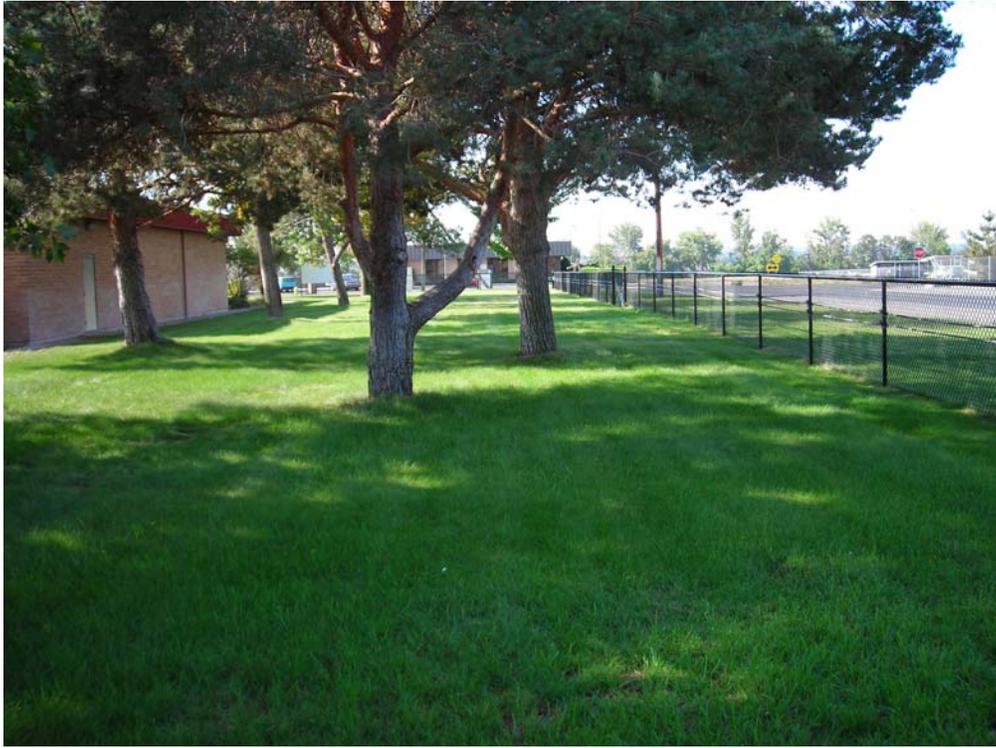
Photograph 7. Landscaping on west side of administration building

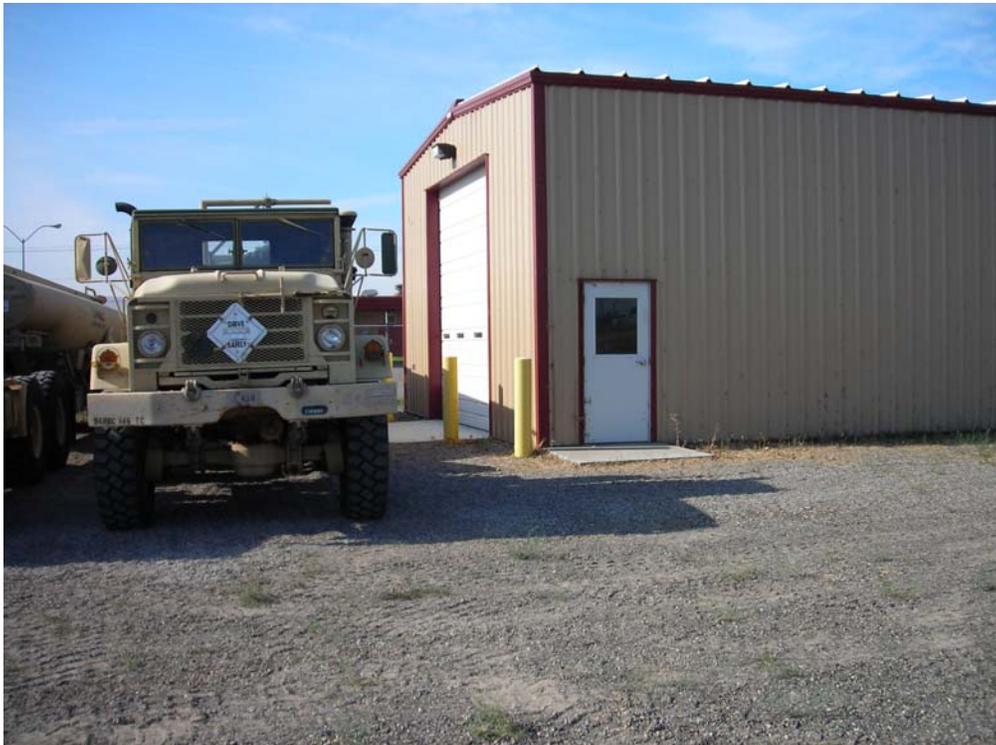
Photograph 8. Gravel area by OMS

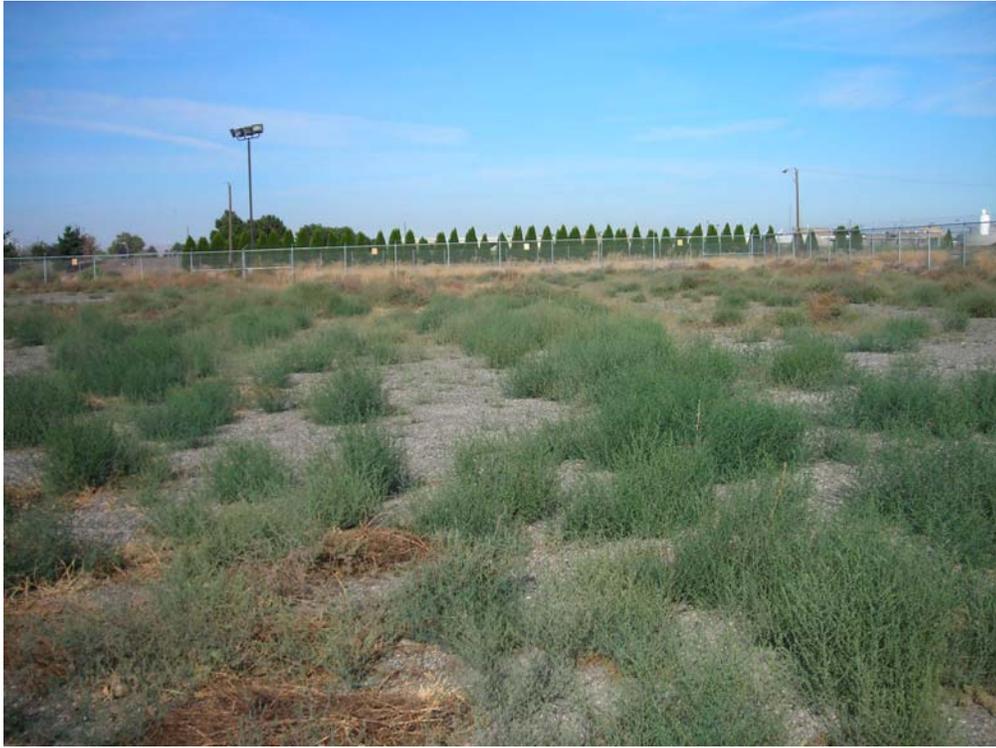
Photograph 9. Open space with scrub grasses and low growing vegetation

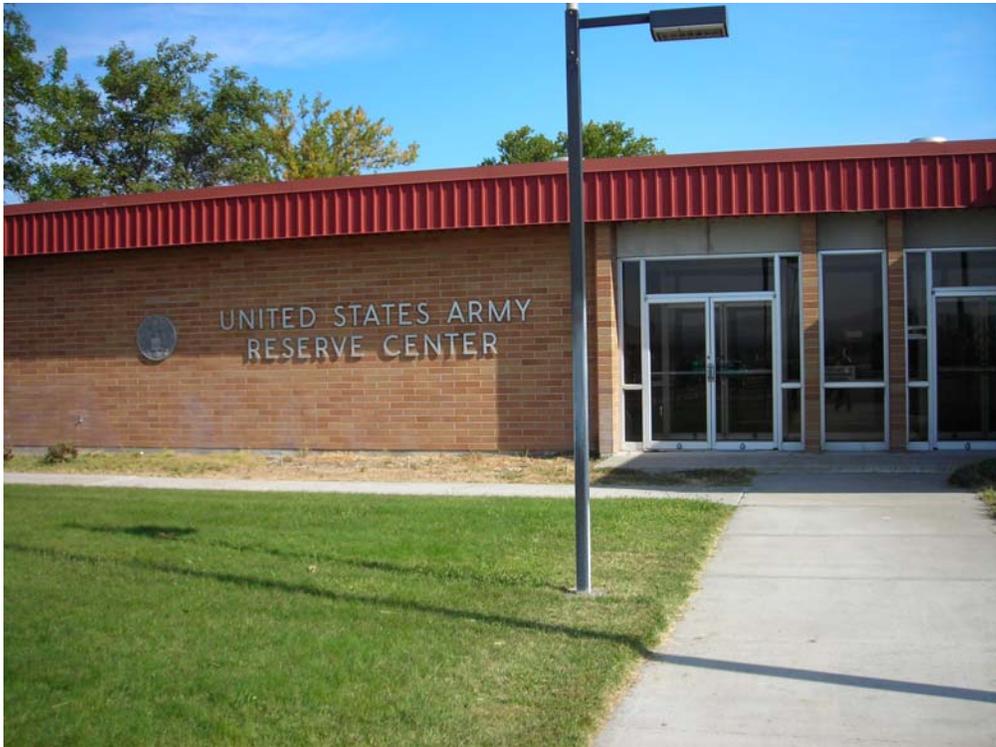
Photograph 10. South entrance of administration building

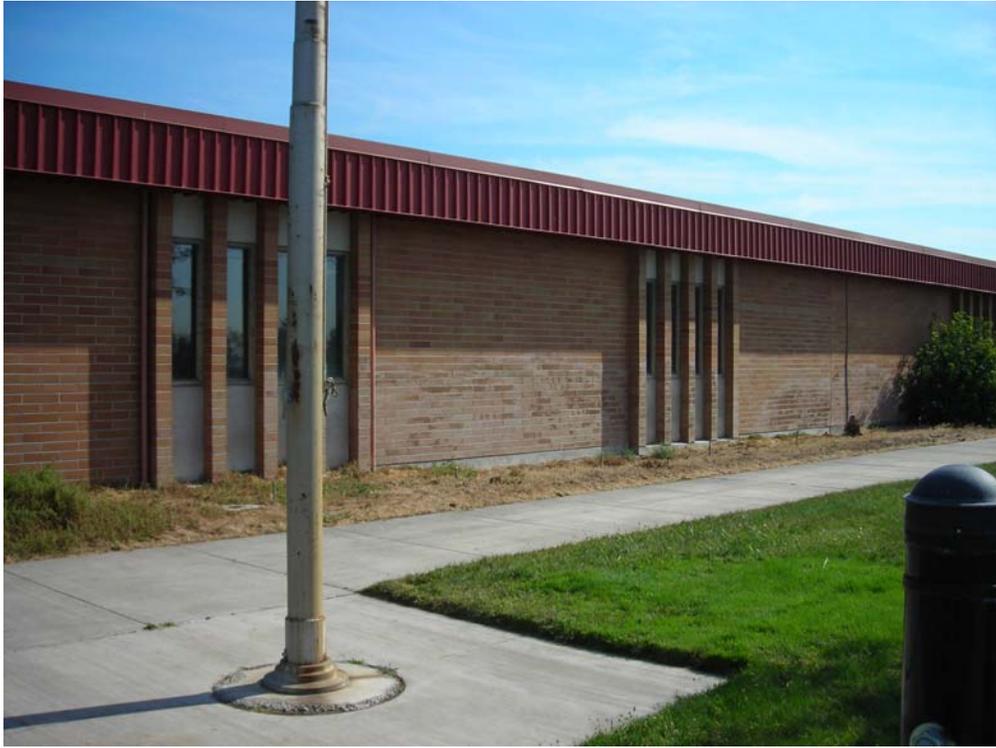
Photograph 11. South side of administration building

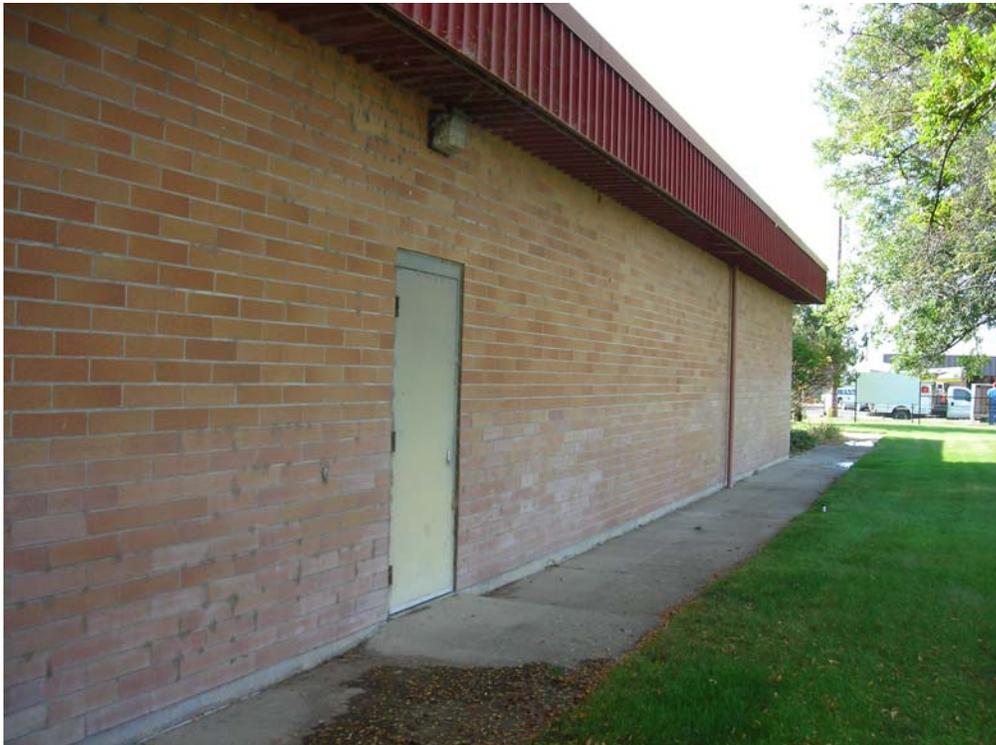
Photograph 12. West side of administration building

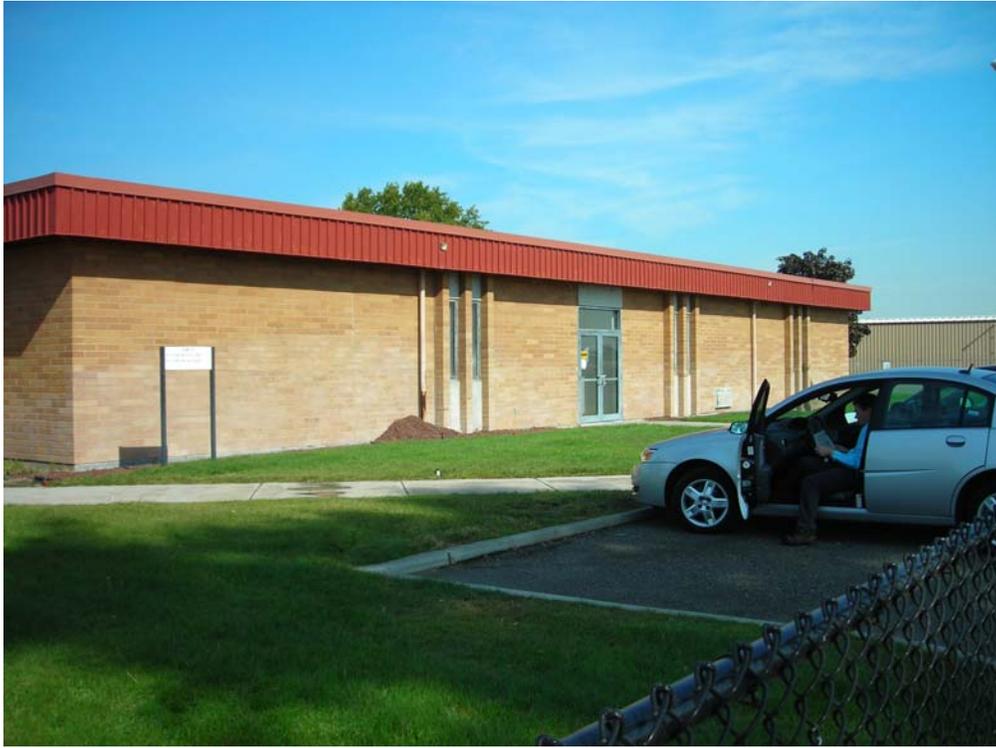
Photograph 13. East side of administration building

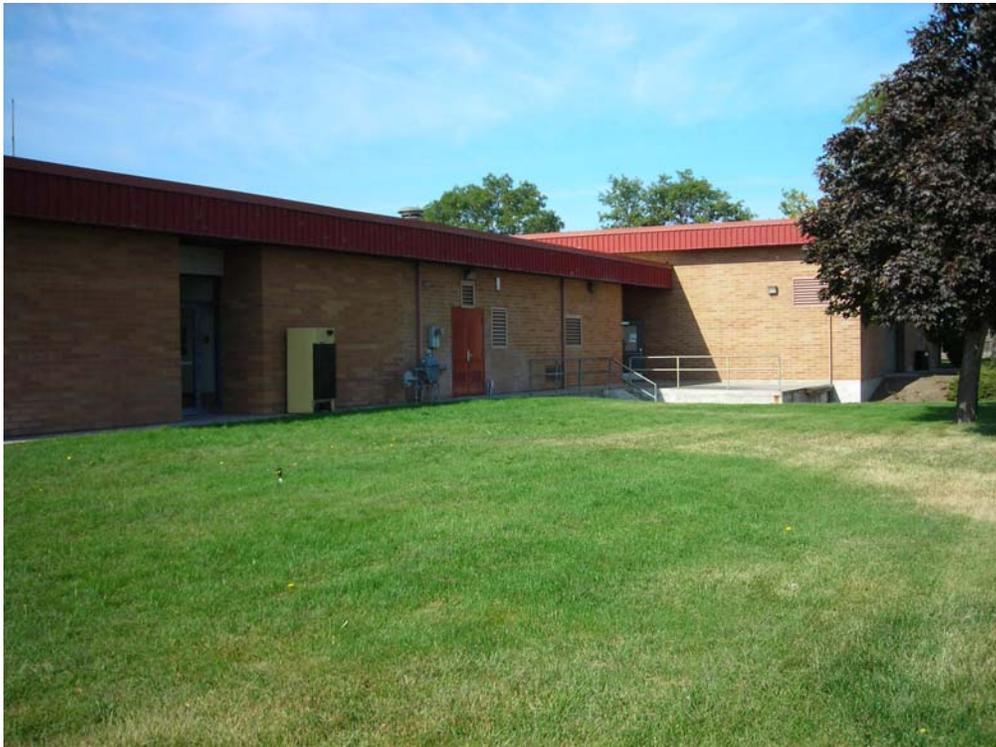
Photograph 14. North exterior of administration building

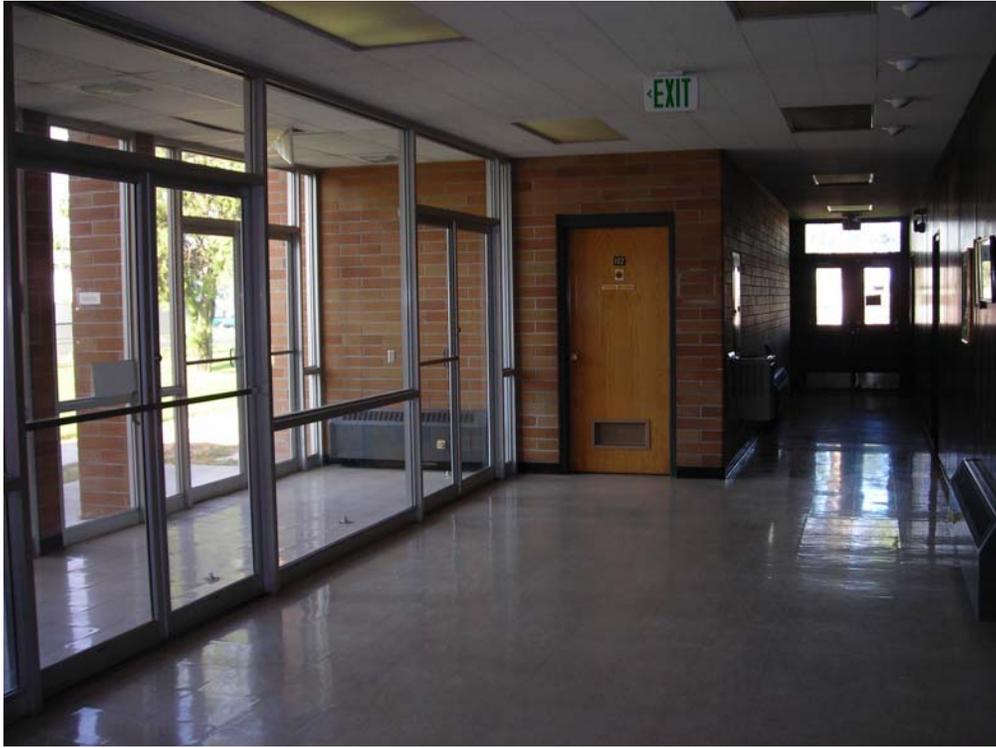
Photograph 15. Front entry area of administration building

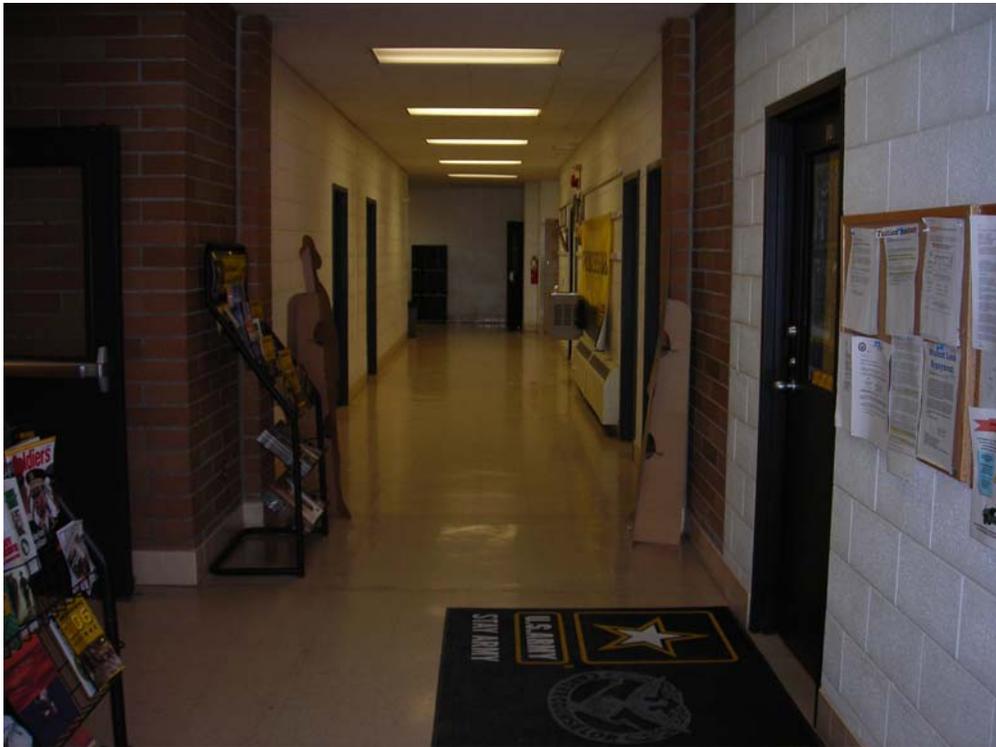
Photograph 16. Main hallway in administration building

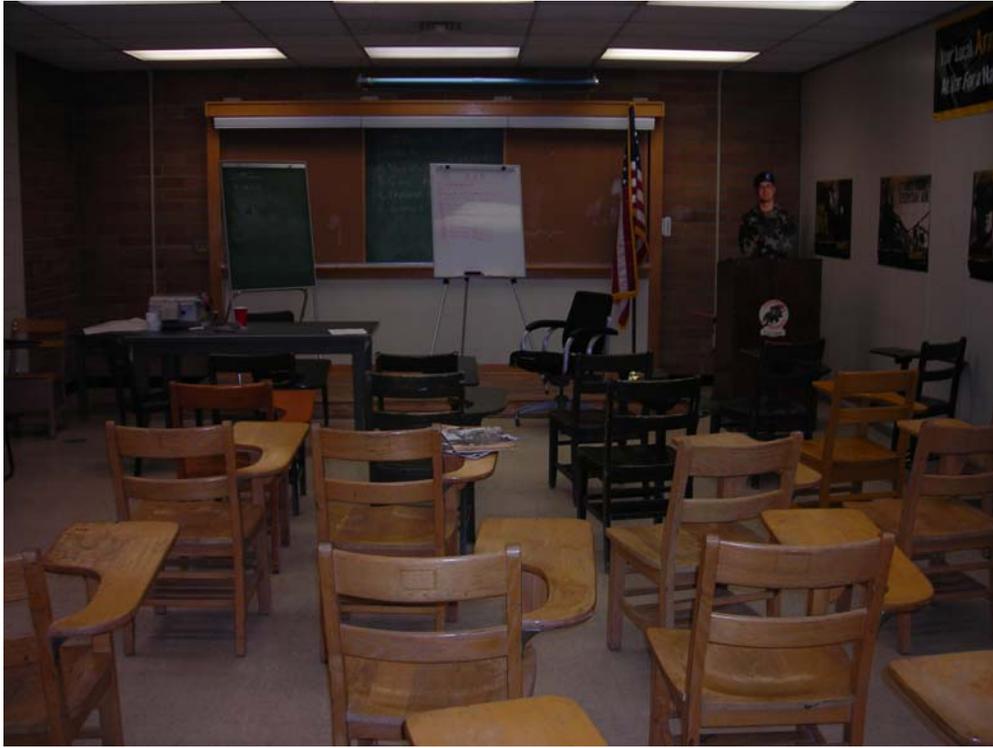
Photograph 17. Typical classroom setup in administration building

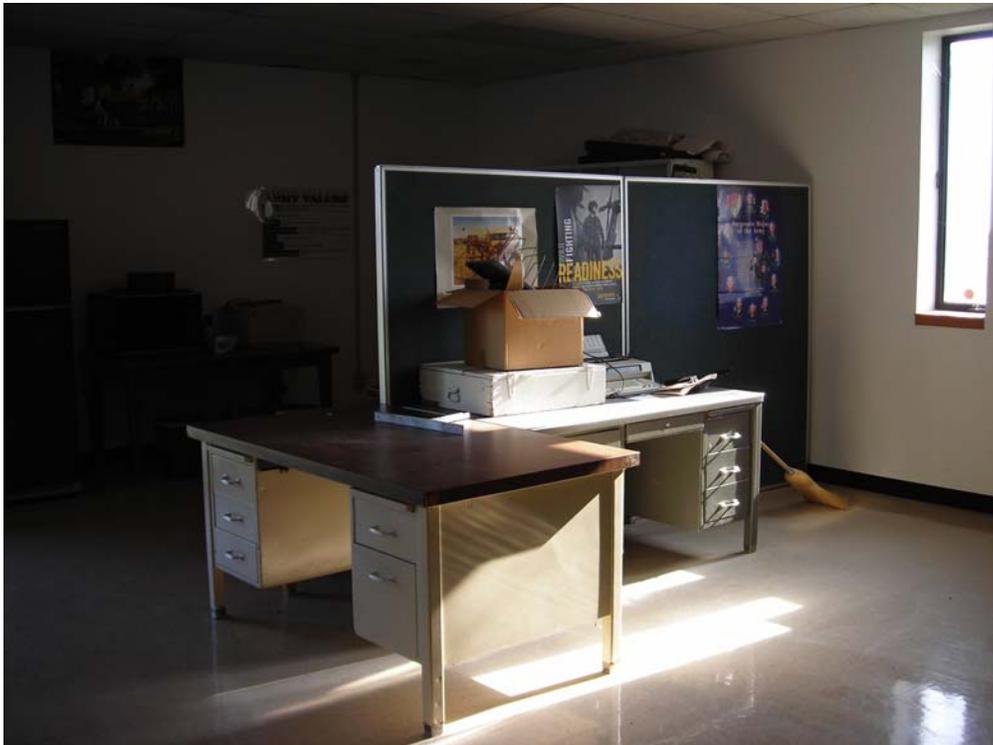
Photograph 18. Typical office setup in administration building

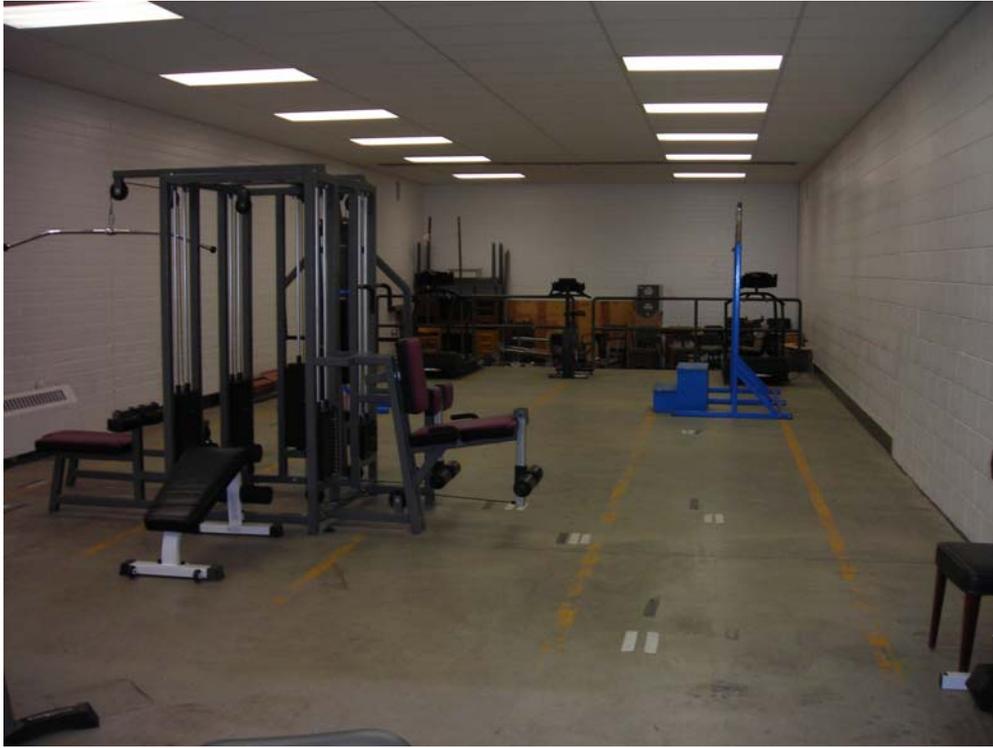
Photograph 19. Former indoor firing range, now weight and physical training room

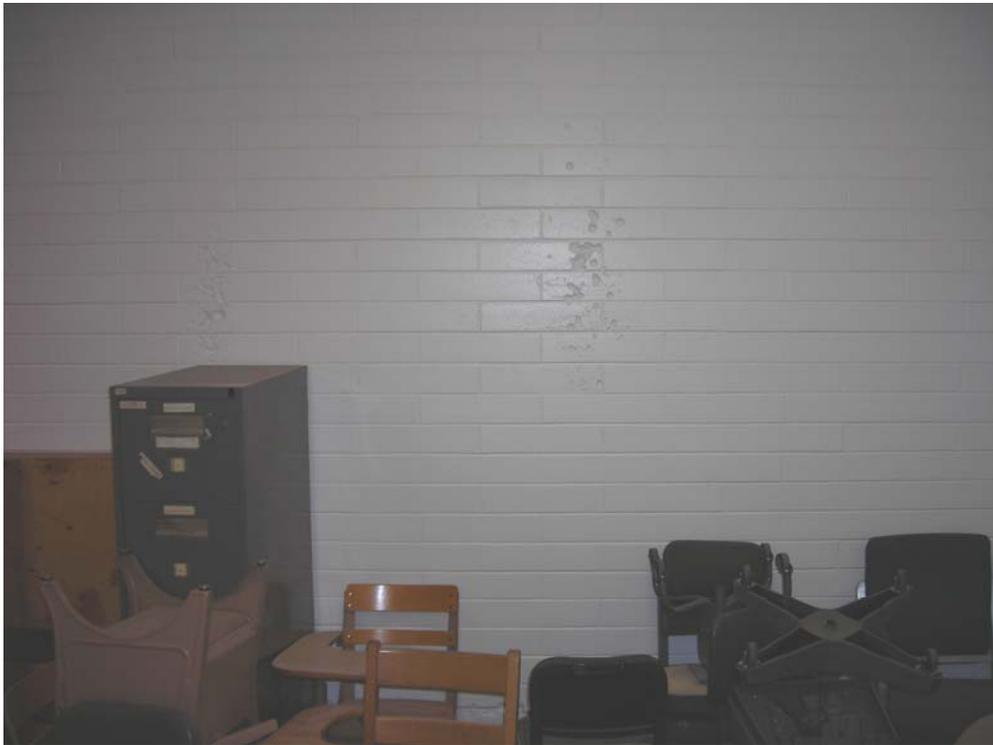
Photograph 20. Pitting in block walls from former indoor firing range use

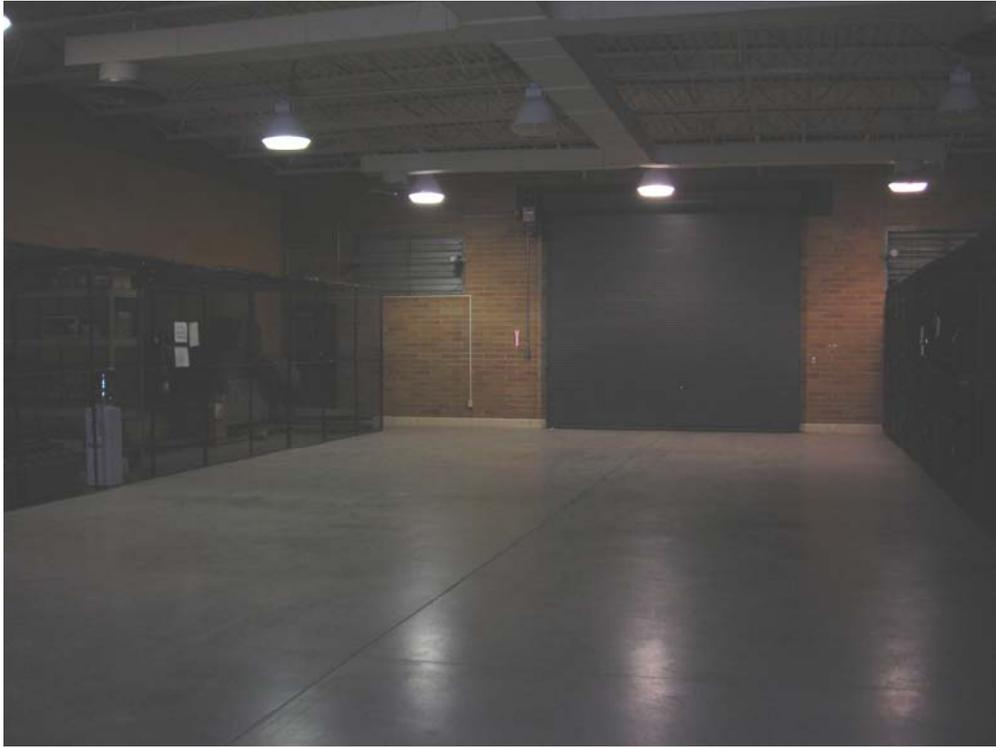
Photograph 21. Drill hall

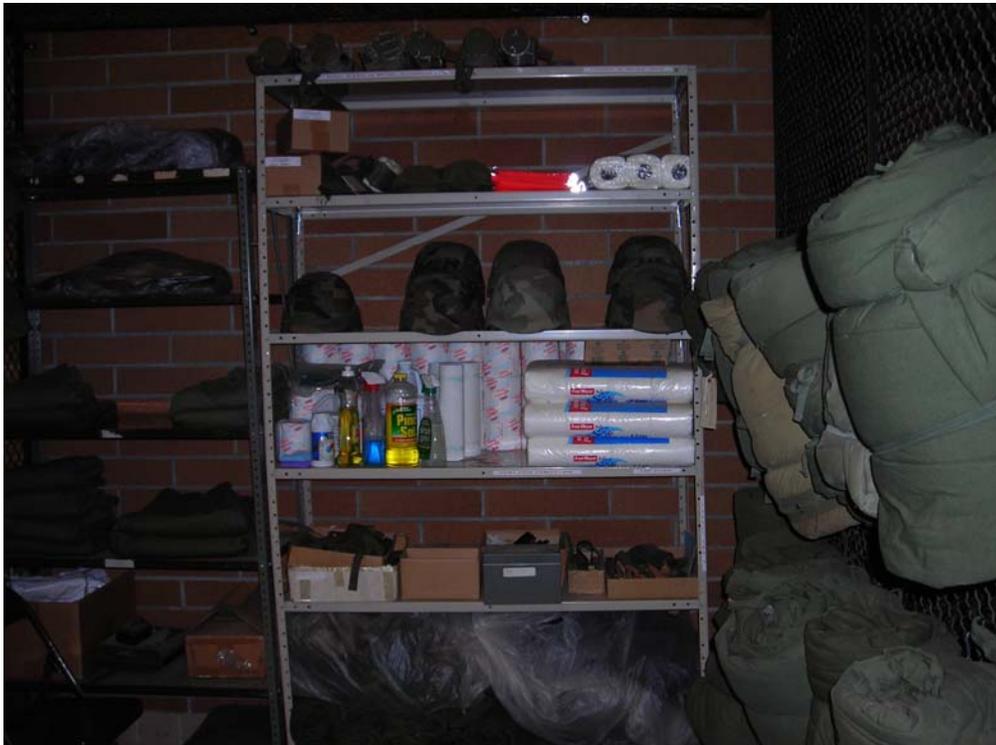
Photograph 22. Interior of unit storage cage in drill hall area

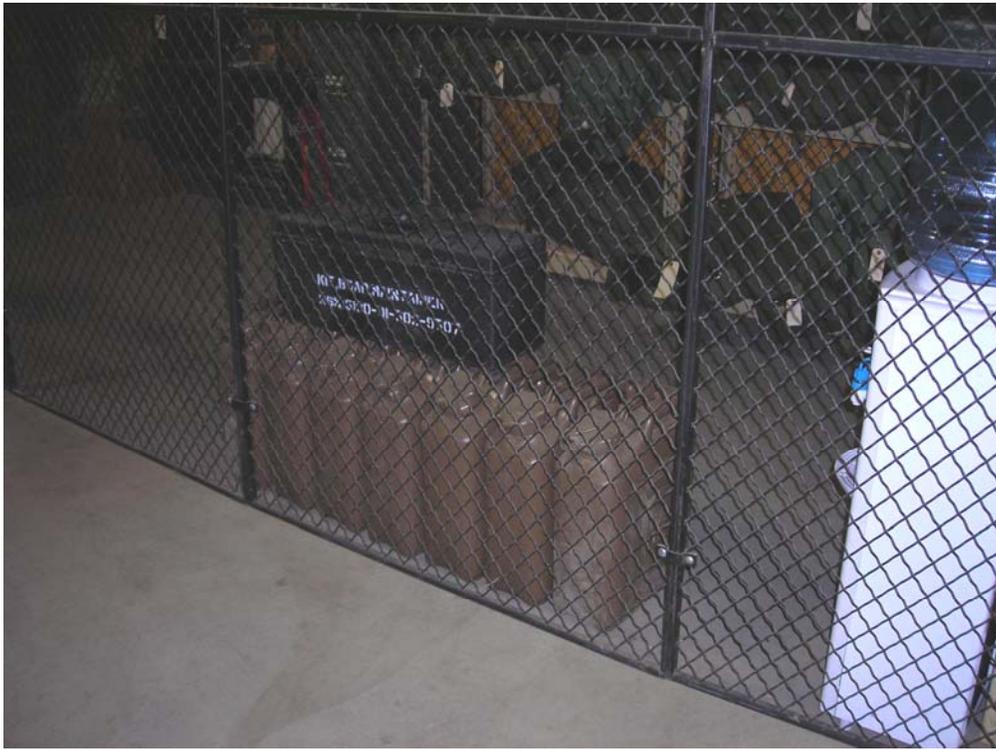
Photograph 23. Interior of unit storage cage in drill hall area (water cans are empty)

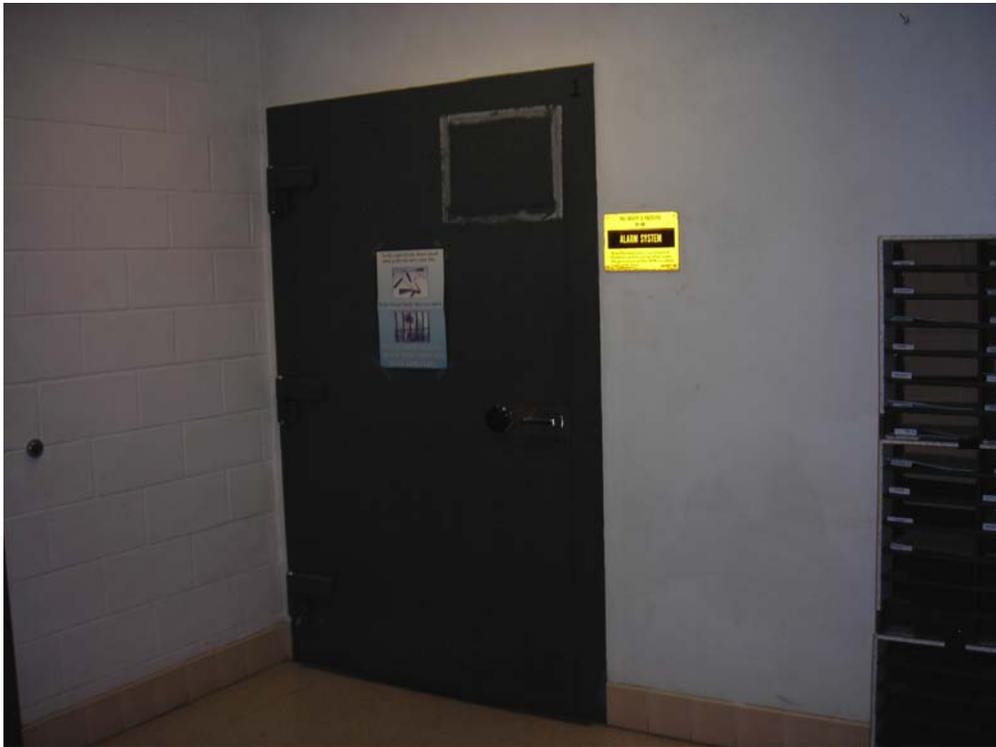
Photograph 24. Weapons vault door

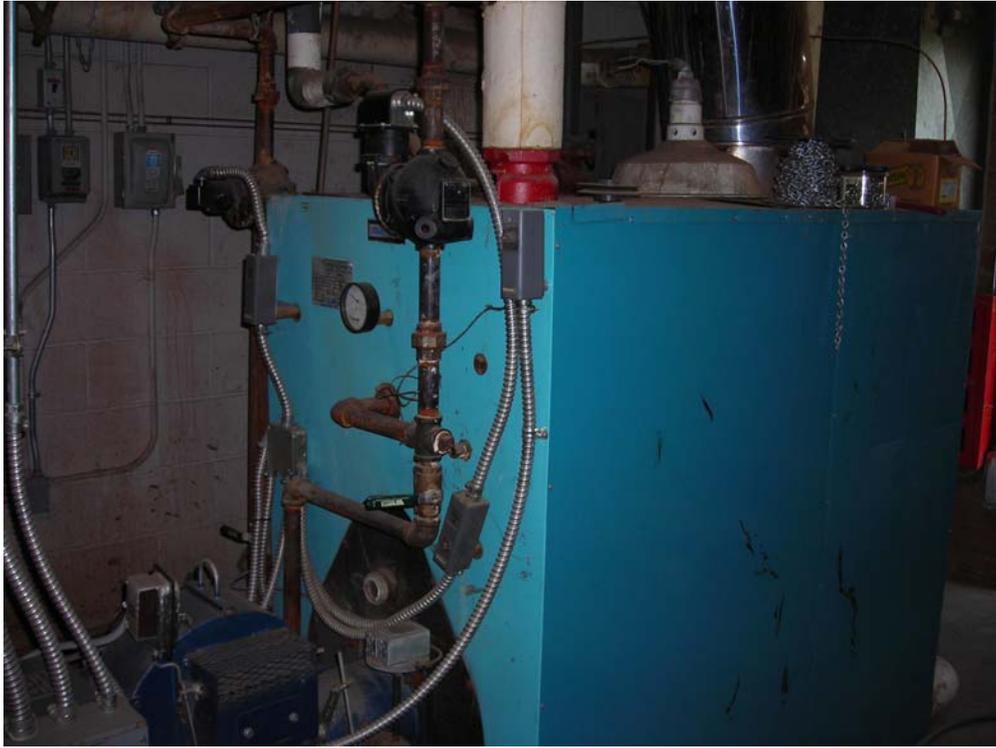
Photograph 25. Boiler in administration mechanical room

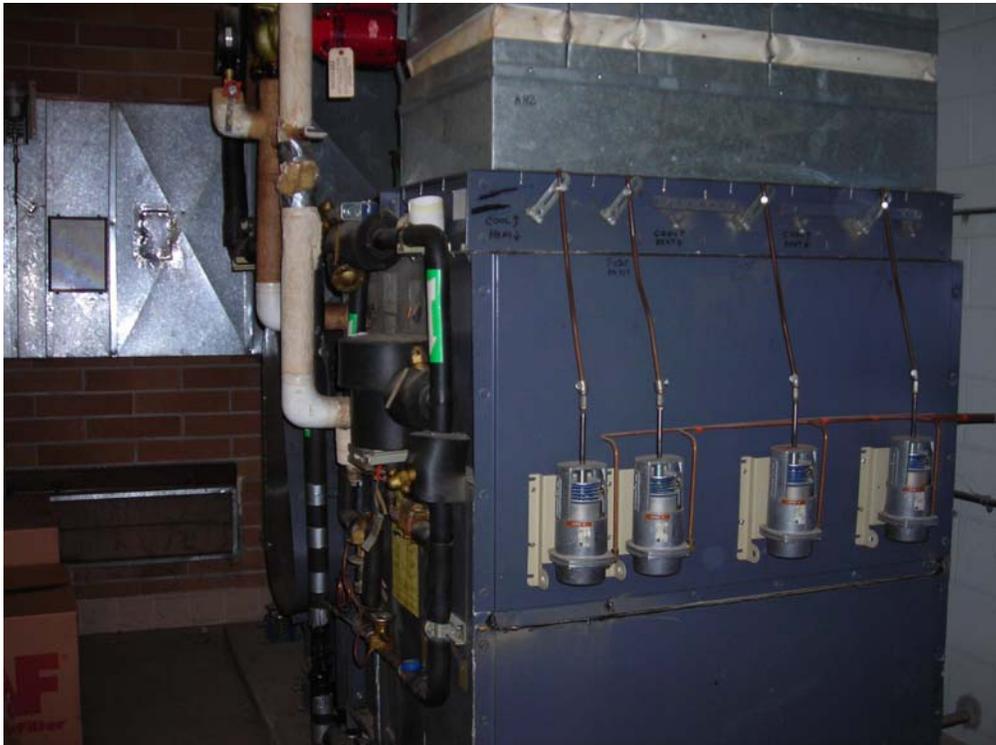
Photograph 26. Administration building air conditioning unit

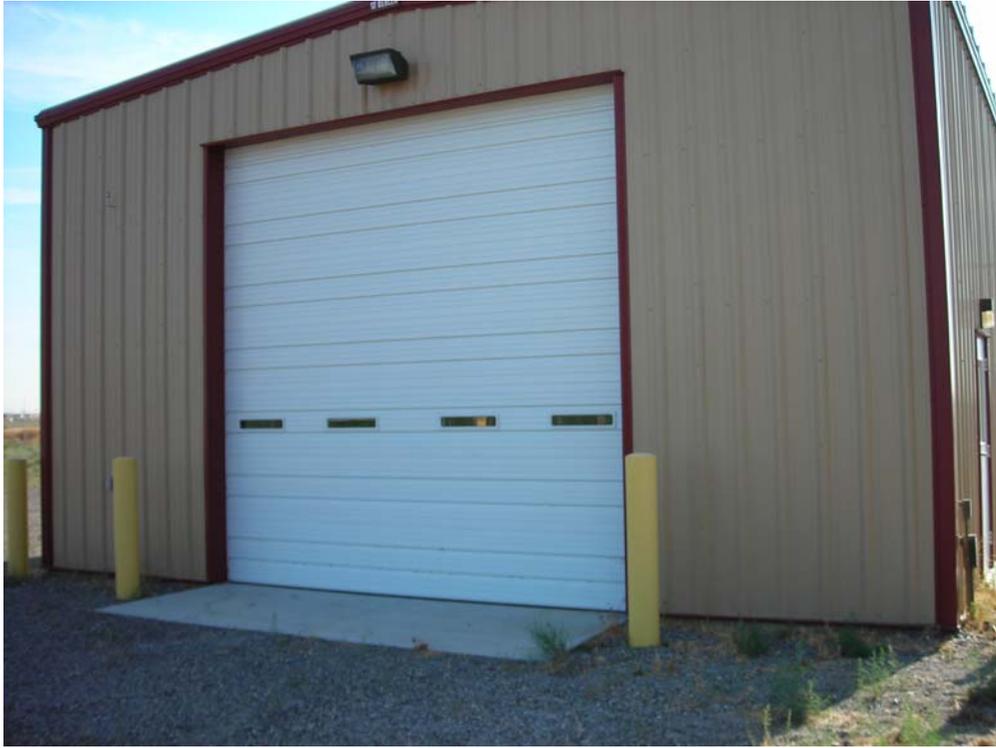
Photograph 27. OMS exterior looking east

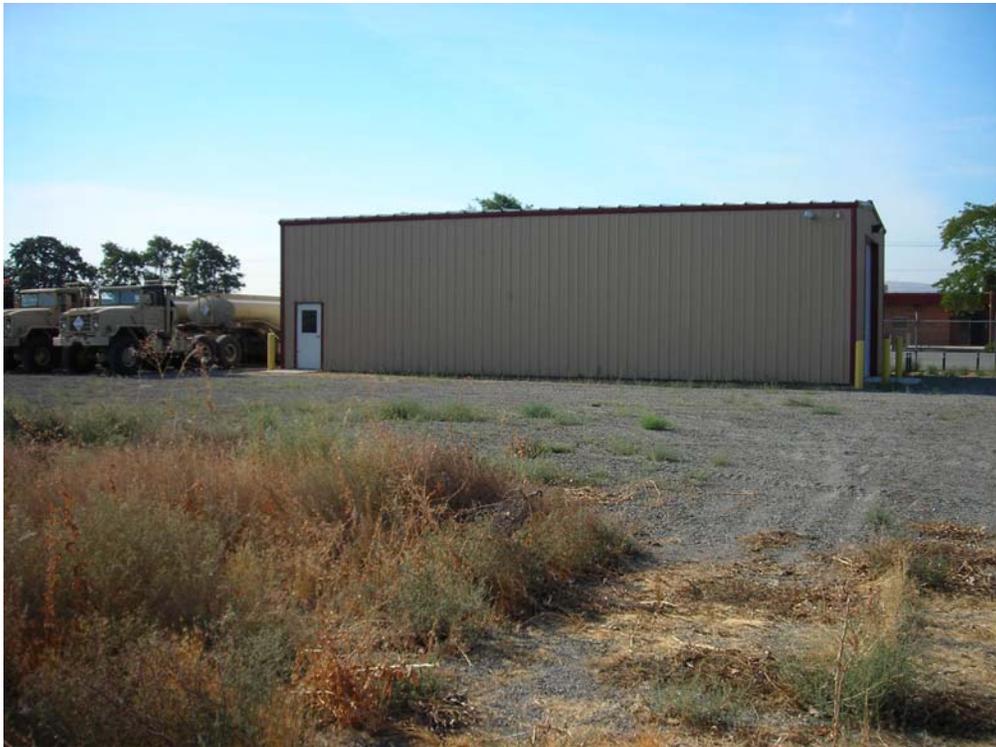
Photograph 28. OMS exterior looking south

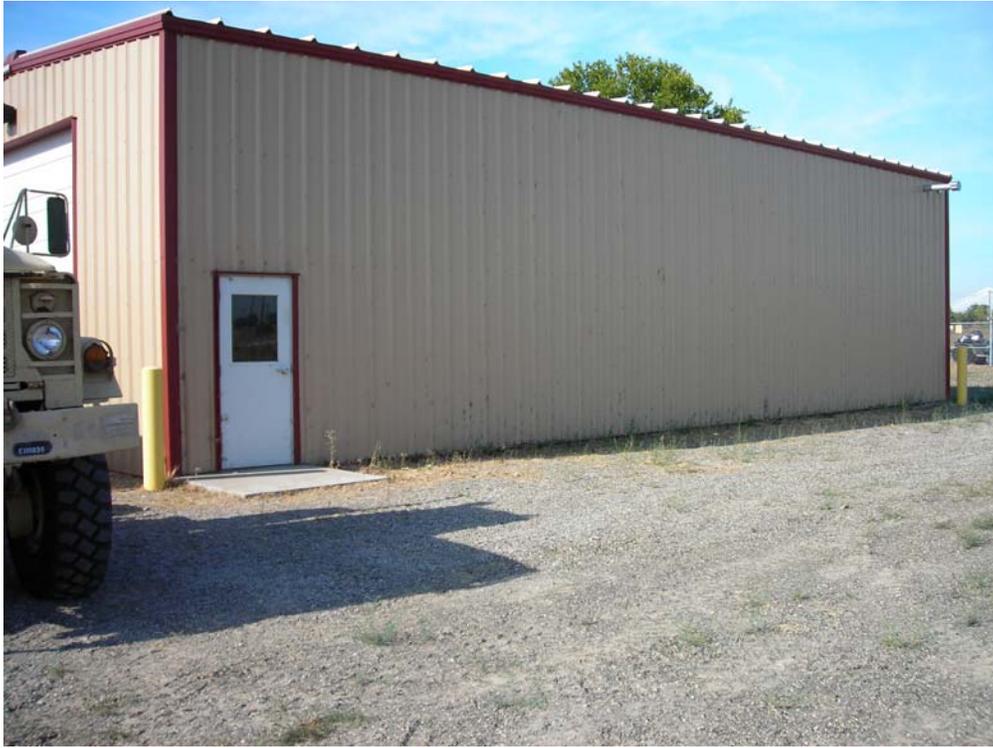
Photograph 29. OMS exterior

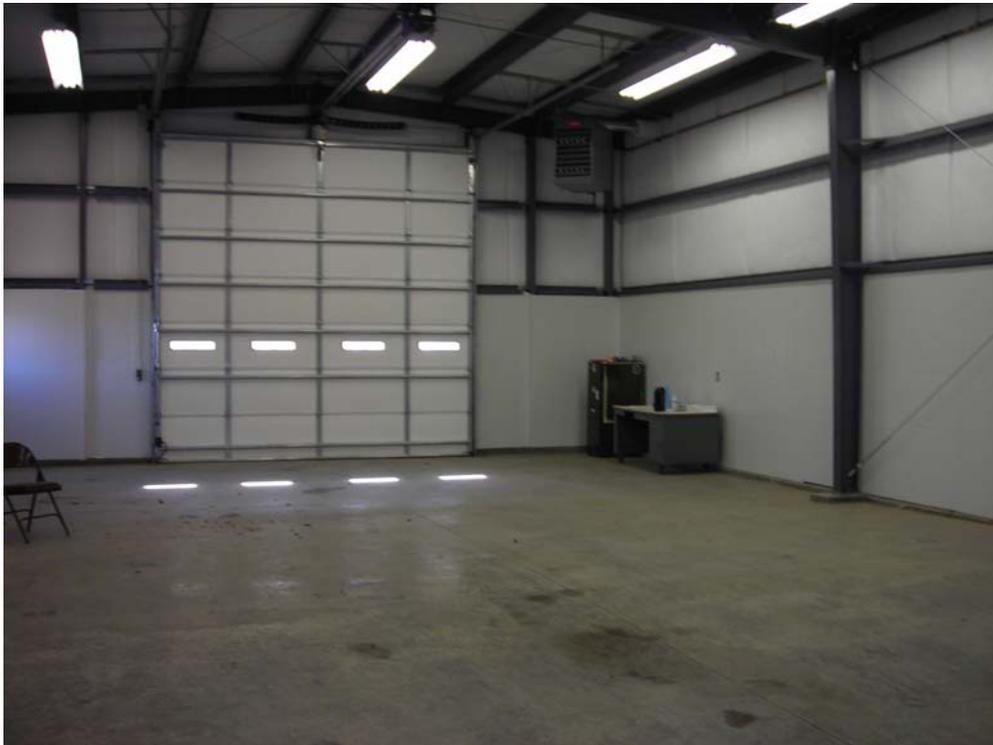
Photograph 30. Relatively empty OMS interior
