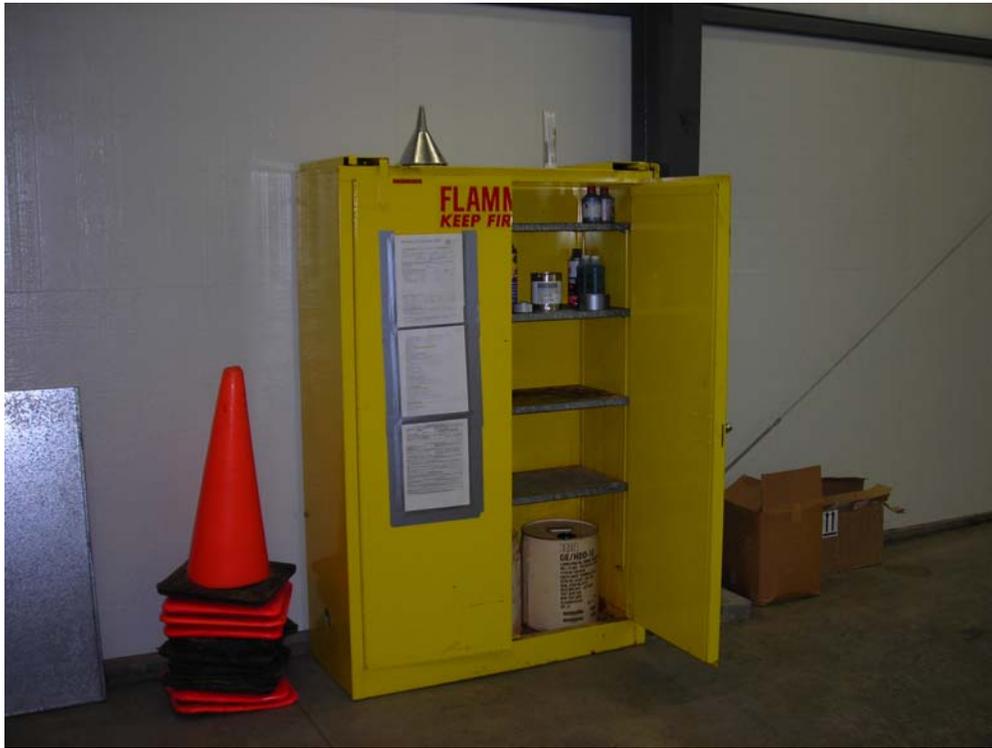
Photograph 31. Fire proof cabinet in OMS

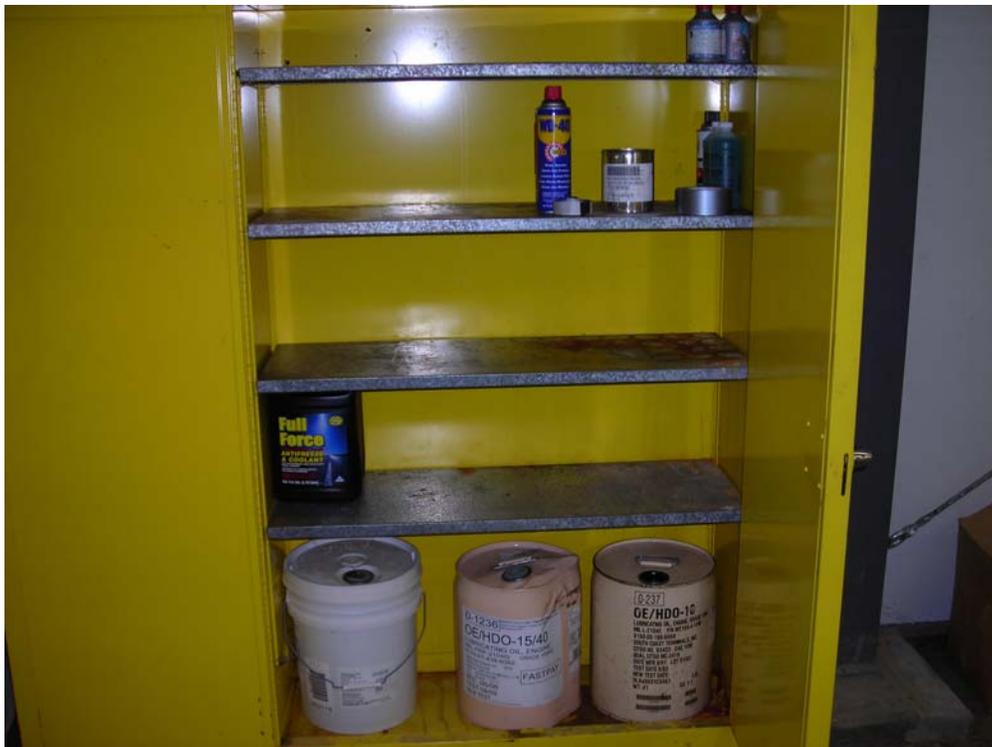
Photograph 32. Fire proof cabinet in OMS showing contents

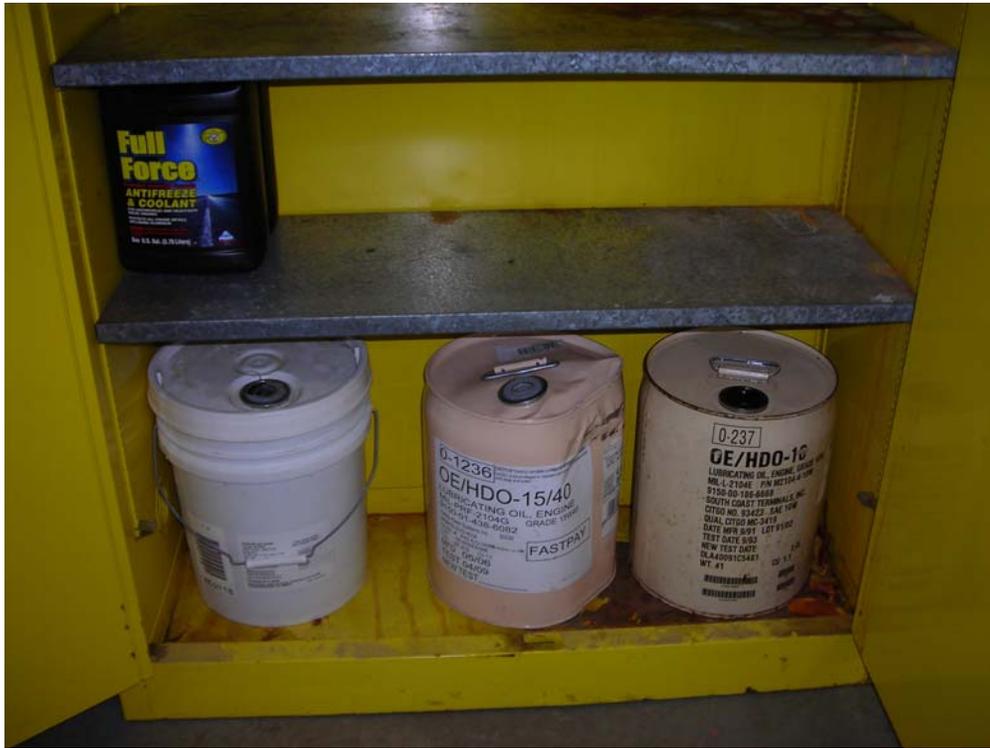
Photograph 33. Fire proof cabinet in OMS with partially empty lubricating oil and antifreeze

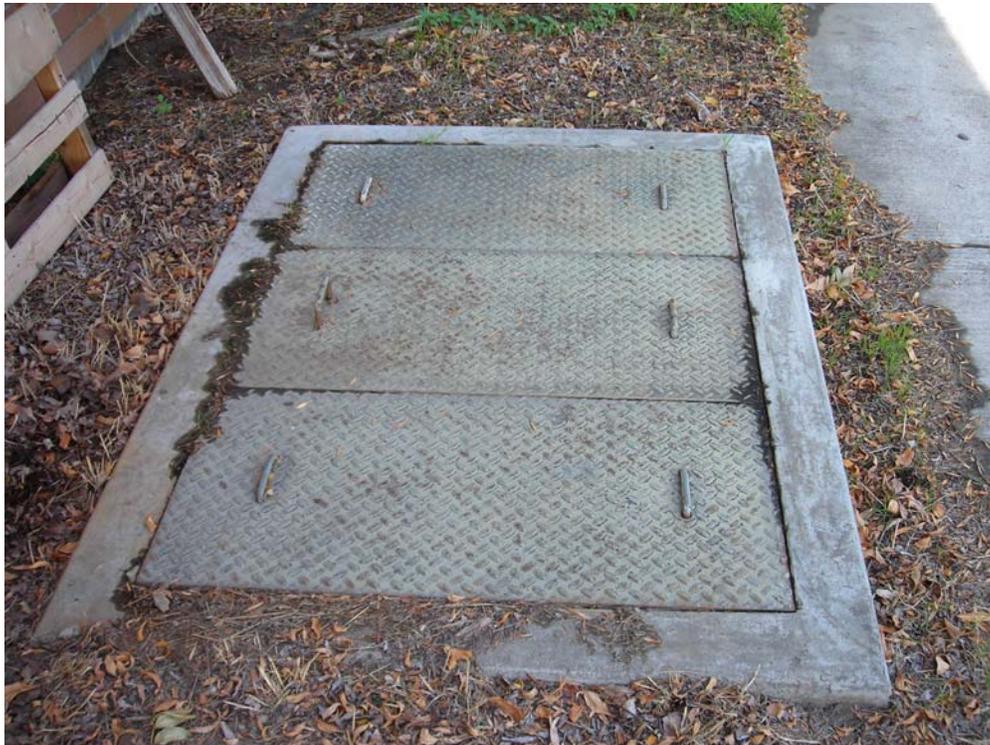
Photograph 34. Grease trap at rear of administration building

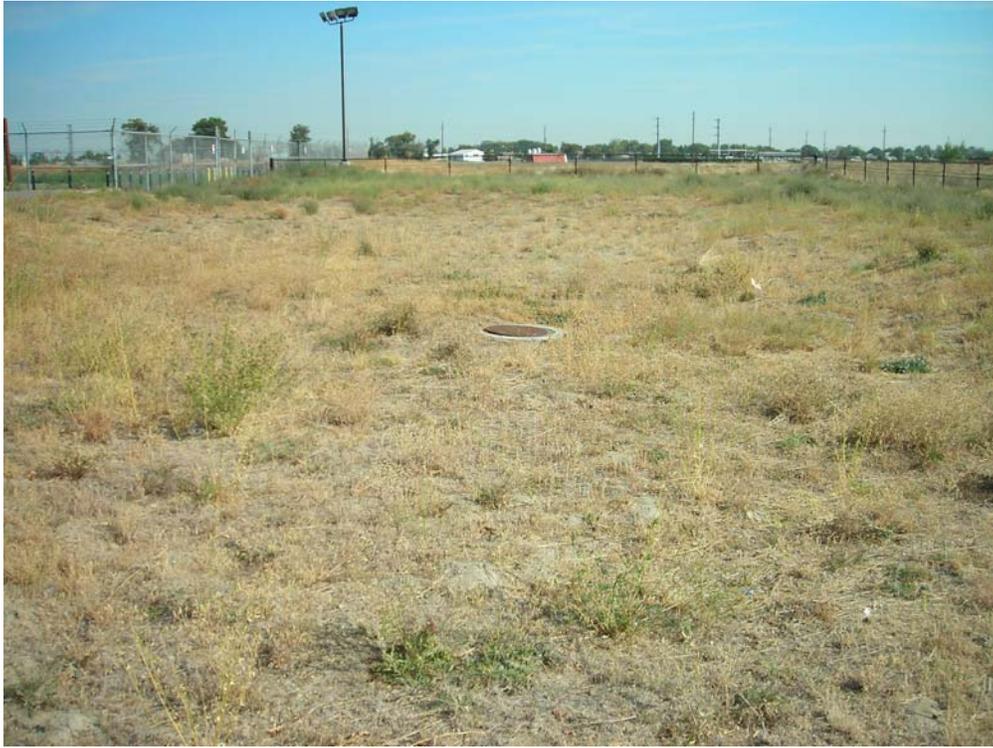
Photograph 35. Grass infiltration pond and overflow drywell (center)

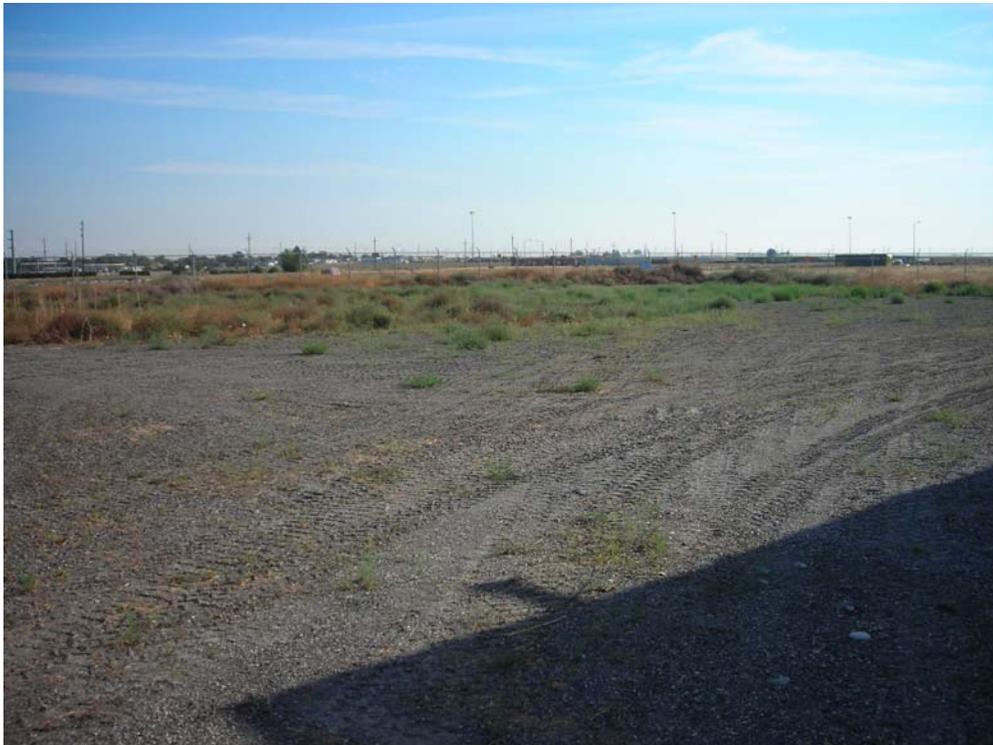
Photograph 36. View of adjacent open space north of USAR Center

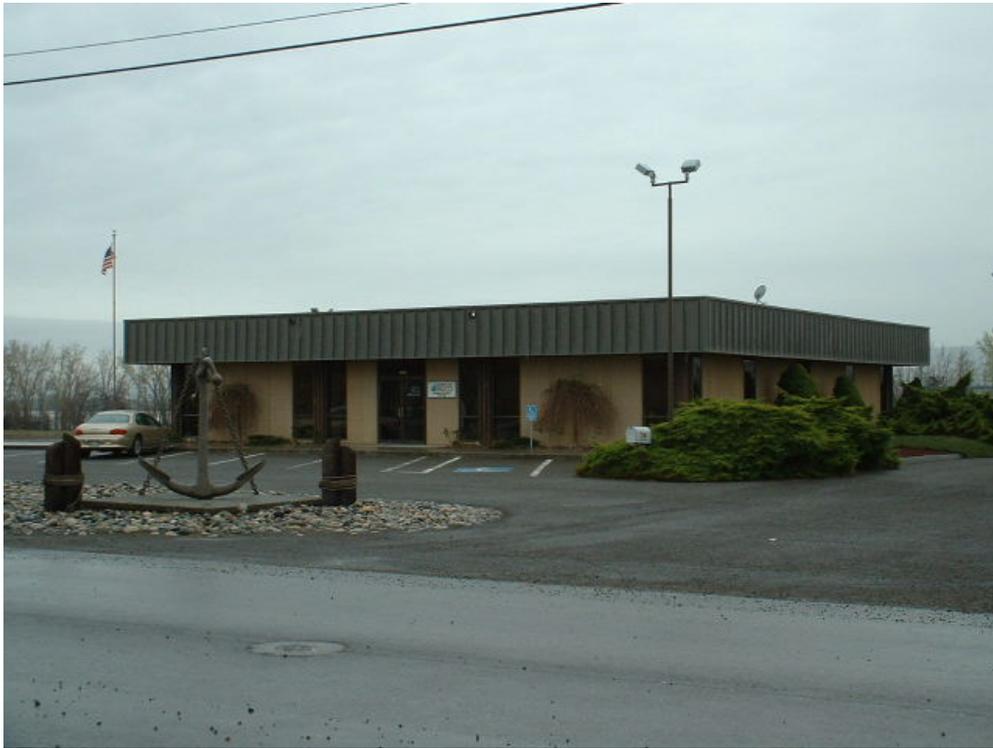
Photograph 37. Port of Pasco administration office south of USAR Center

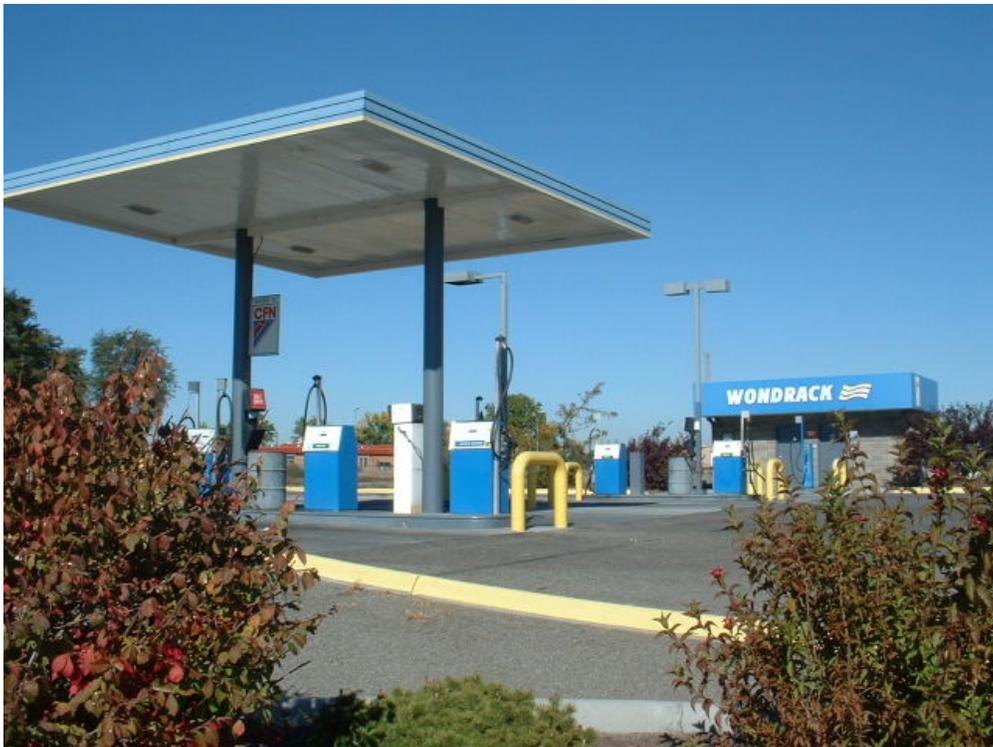
Photograph 38. Wondrack Distributing gasoline station east of USAR Center

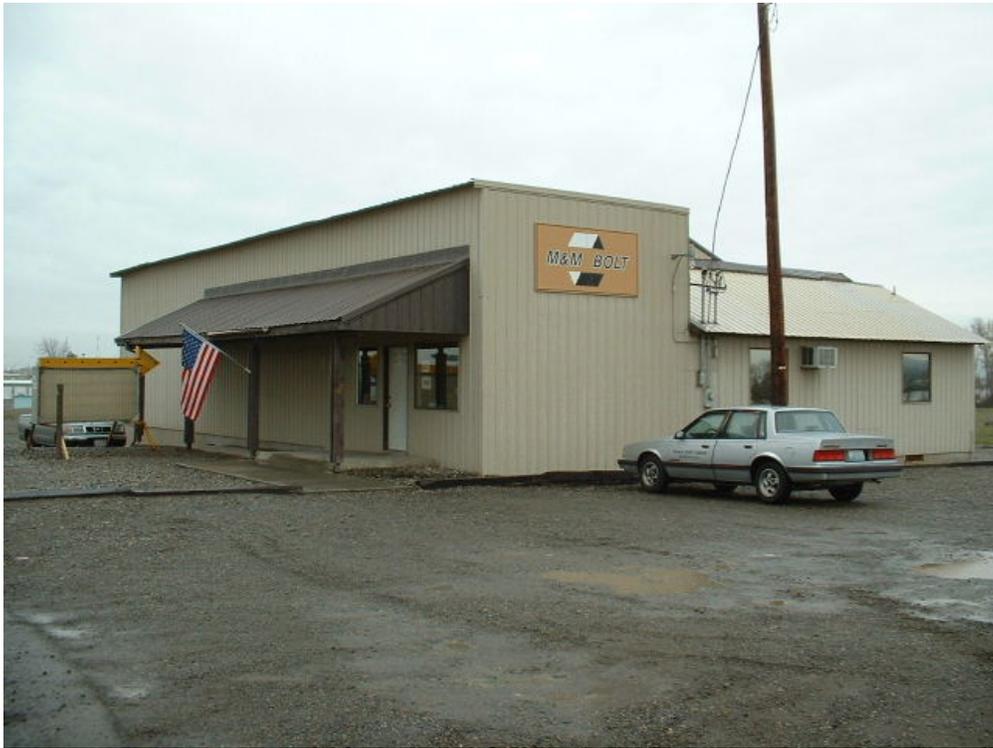
Photograph 39. M&M Bolt south east of USAR Center

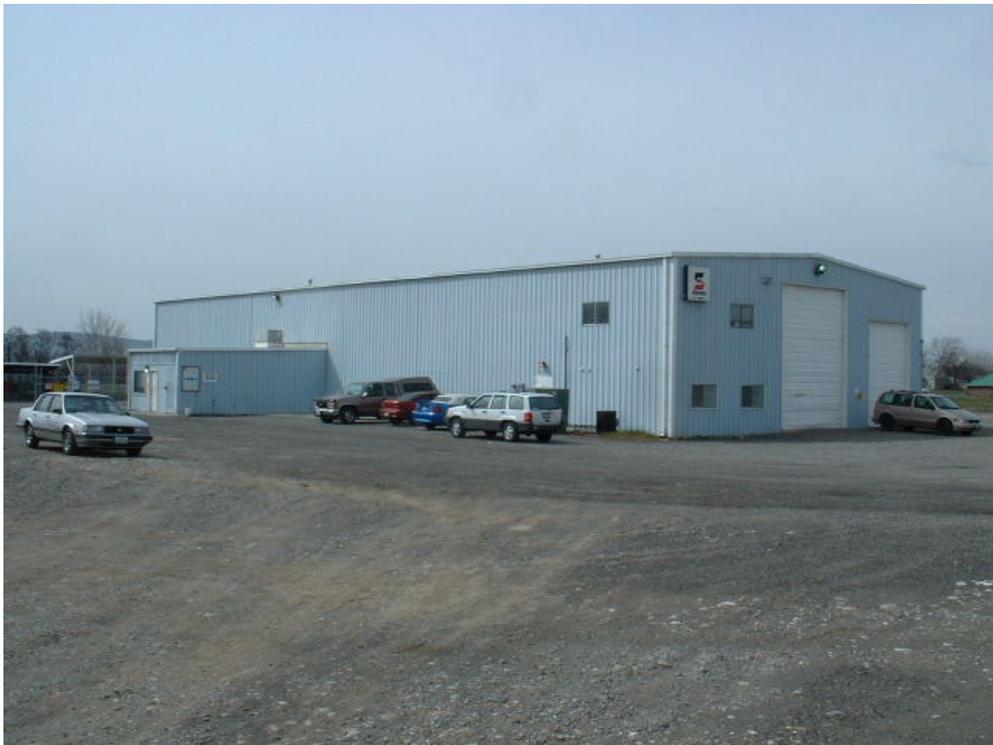
Photograph 40. Safety Kleen southwest of USAR Center

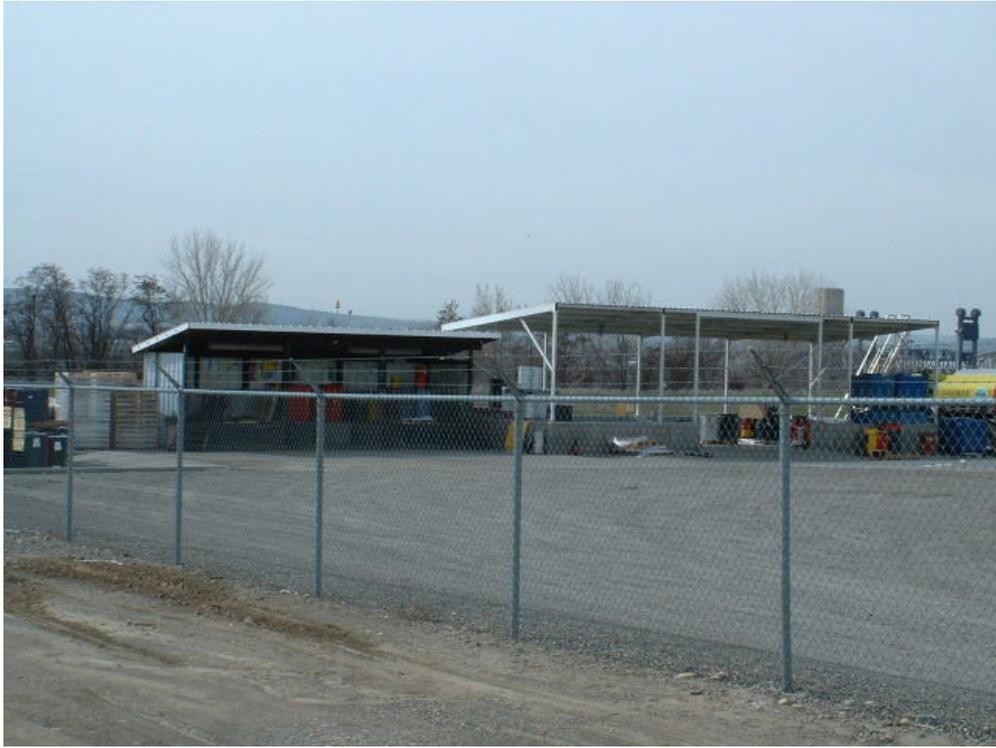
Photograph 41. Rear of Safety Kleen southwest of USAR Center

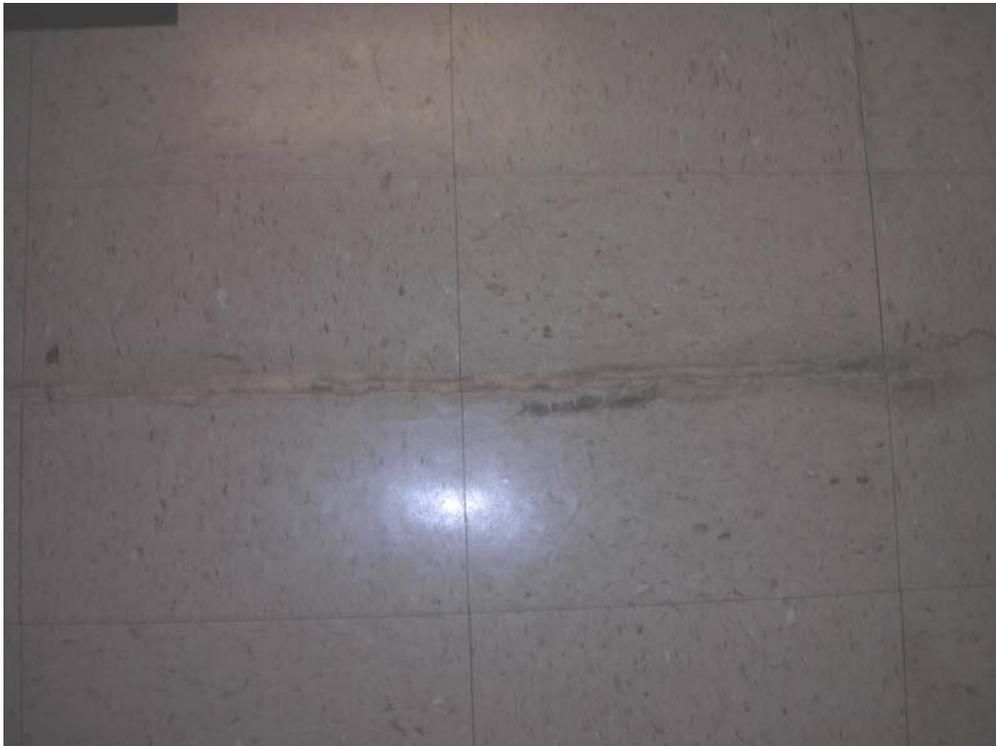
Photograph 42. Cracked floor tile in administration building

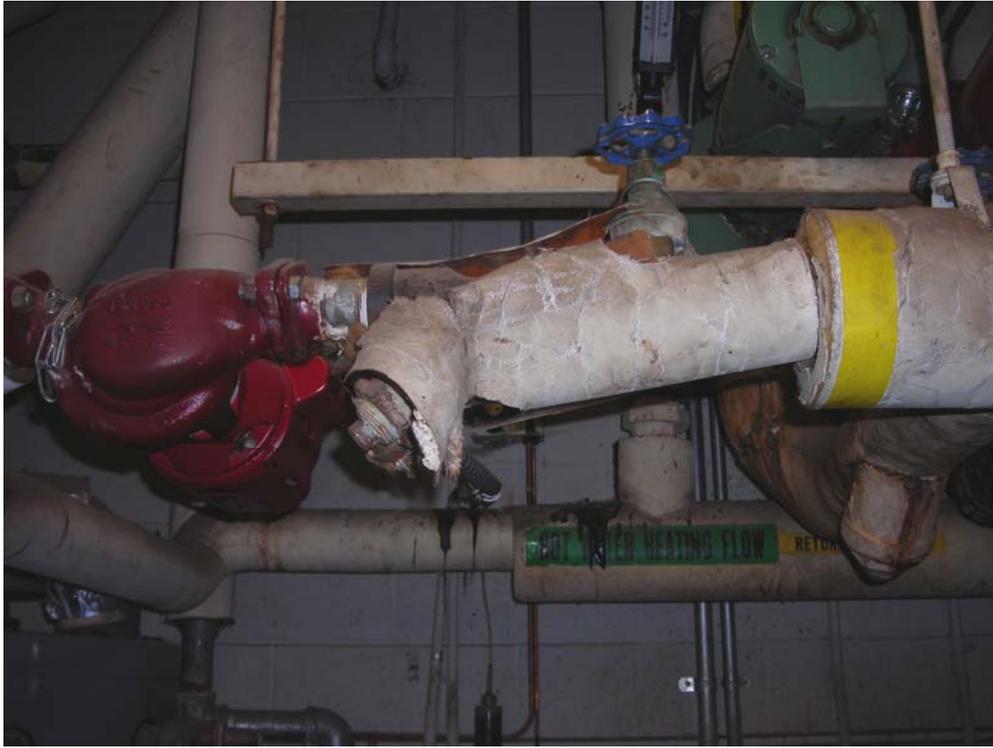
Photograph 43. Torn insulation wrap on boiler piping

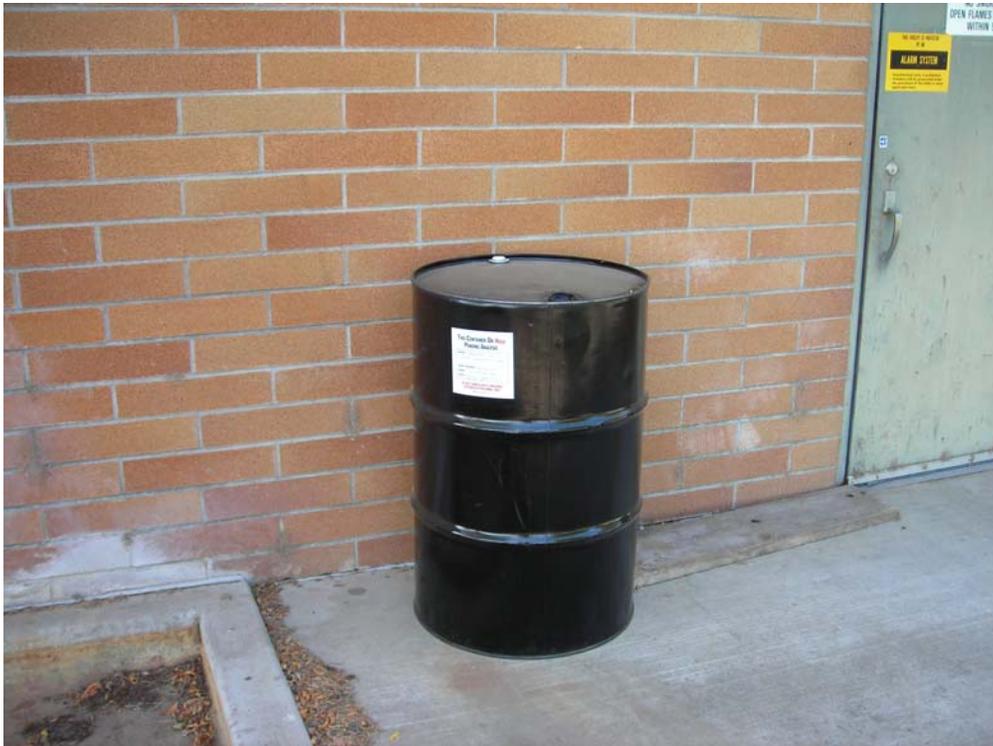
Photograph 44. Drum of waste groundwater from monitoring wells

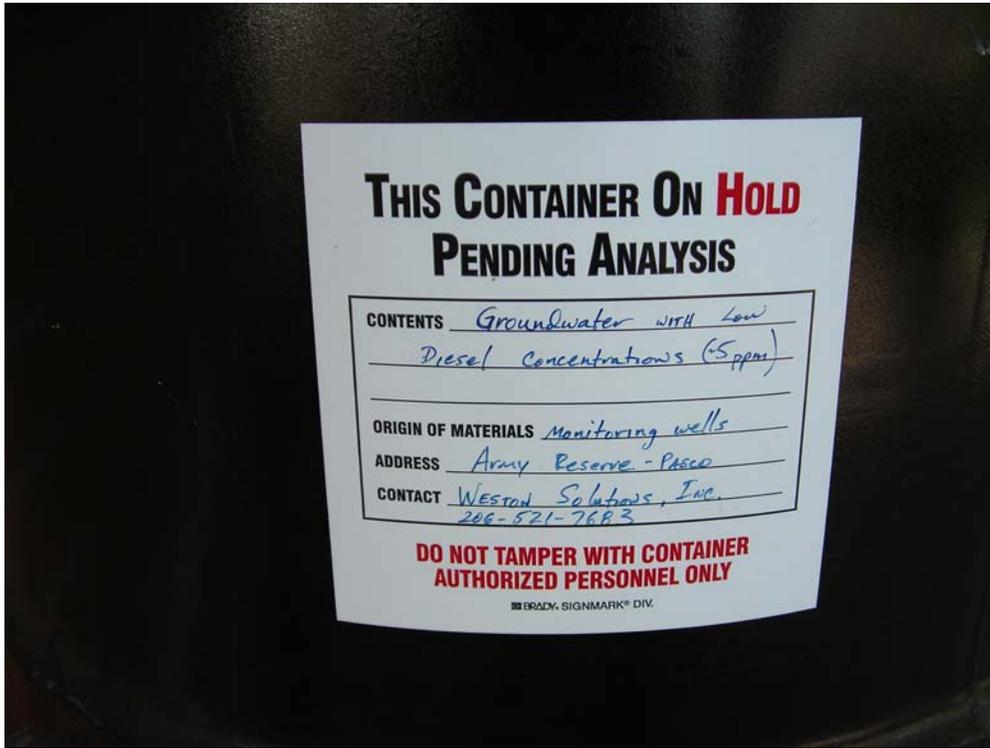
Photograph 45. Label on 55 gallon drum of wastewater from monitoring wells
