APPENDIX B
SITE RECONNAISSANCE PHOTOGRAPHS

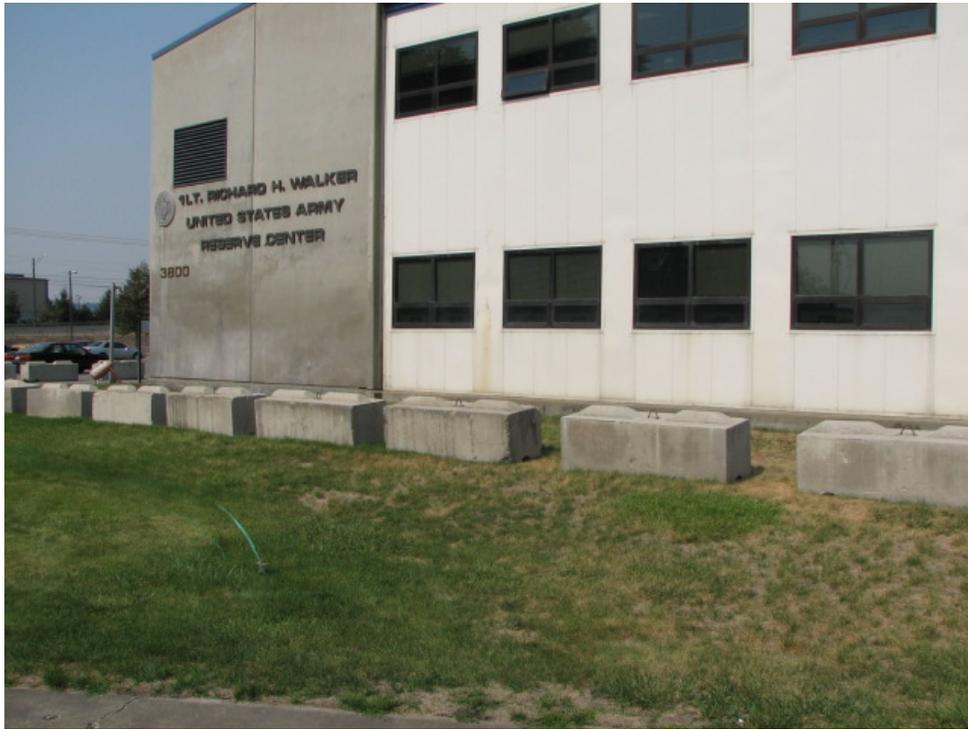
Photograph 1. Administration Building facing north

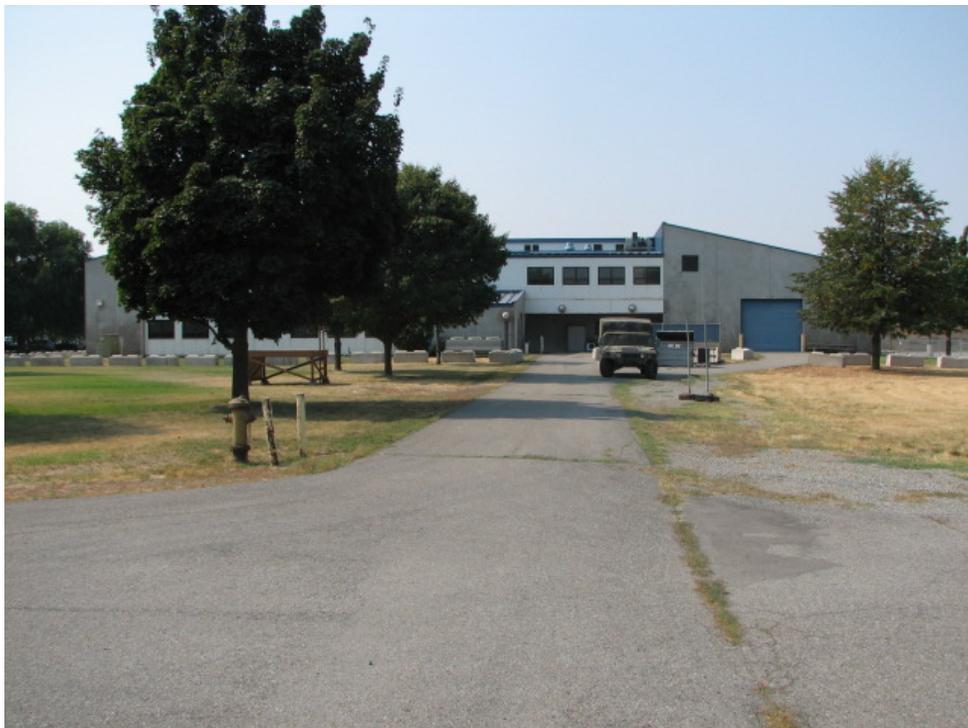
Photograph 2. Administration Building facing west

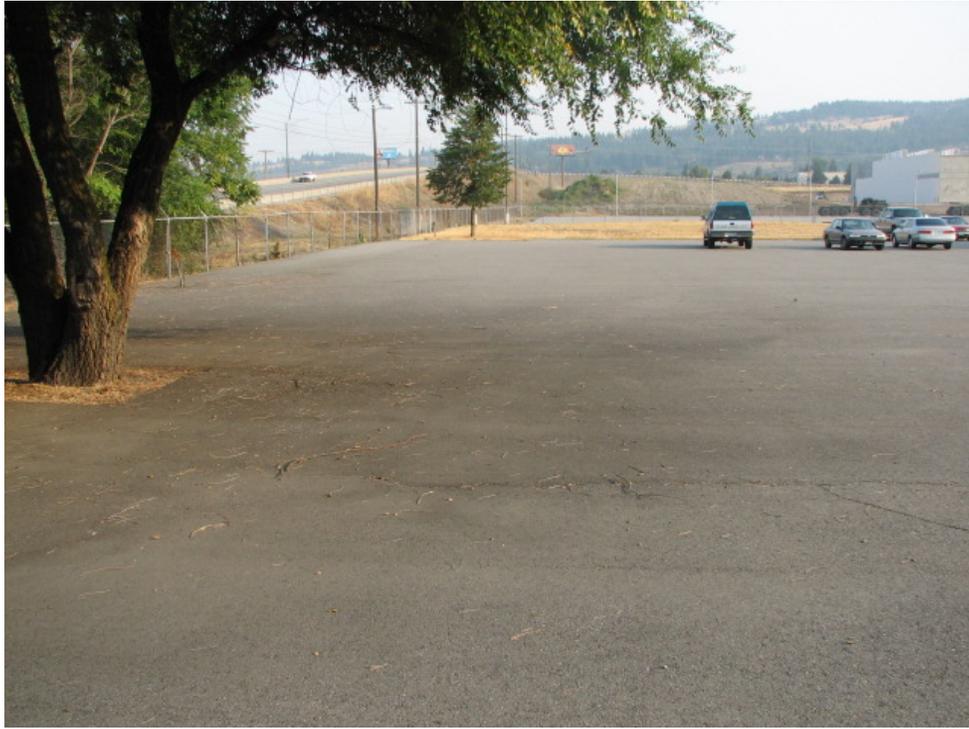
Photograph 3. POV facing north

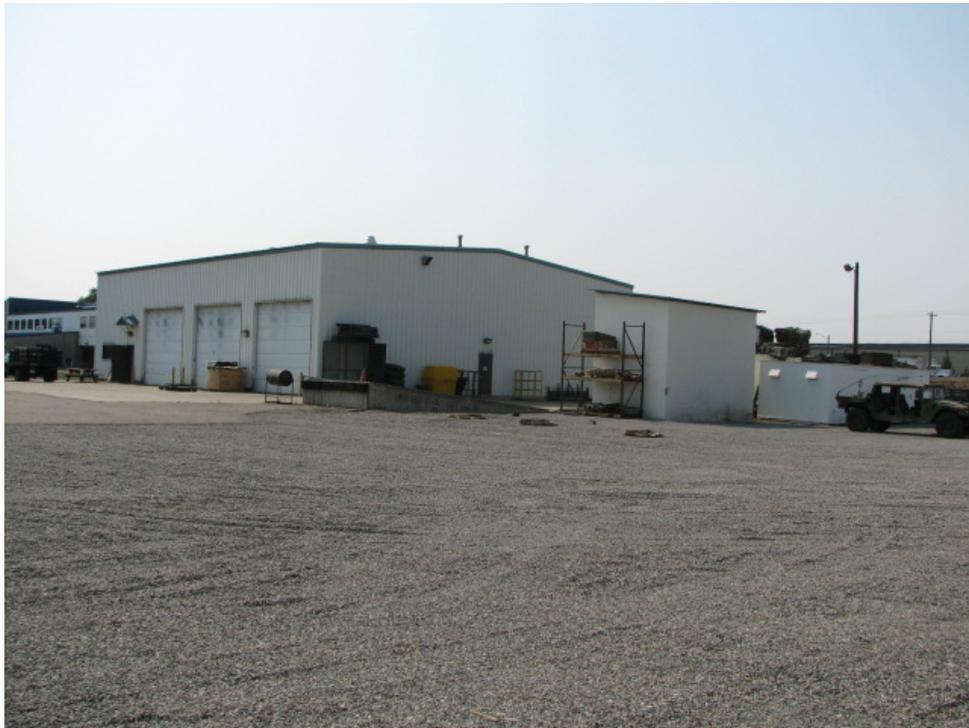
Photograph 4. OMS facing southwest

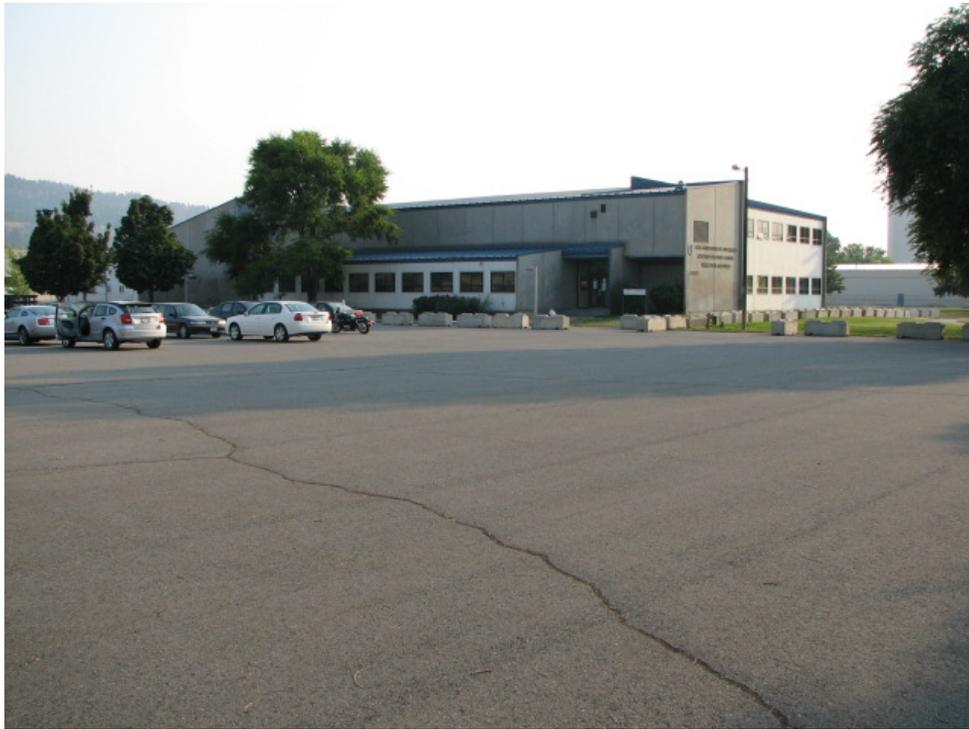
Photograph 5. Administration Building and OMS

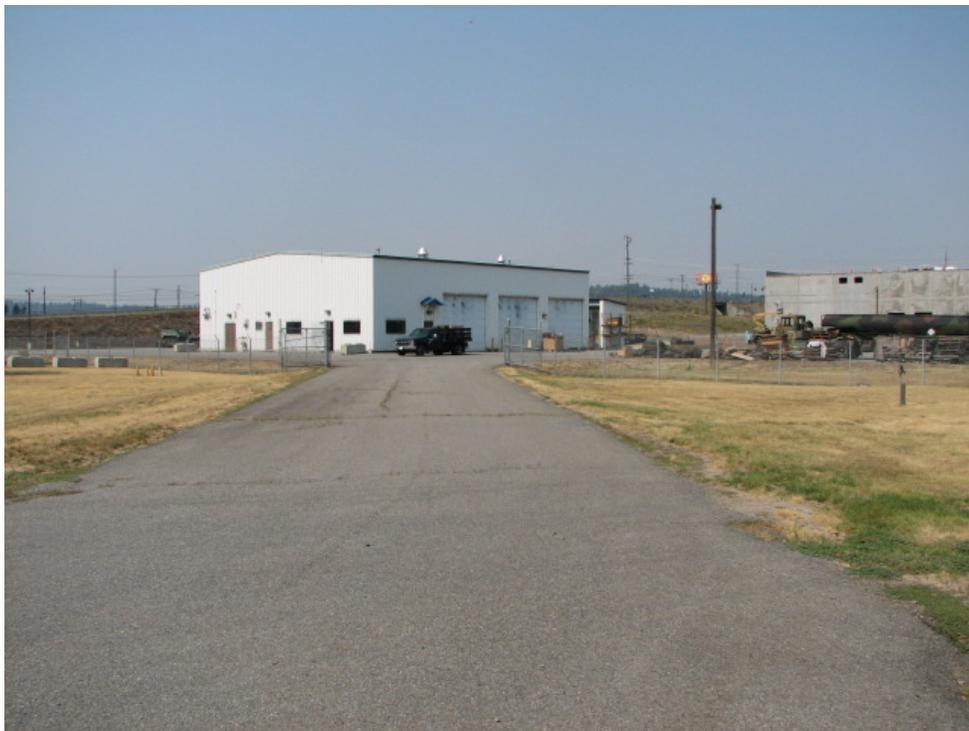
Photograph 6. OMS facing northwest

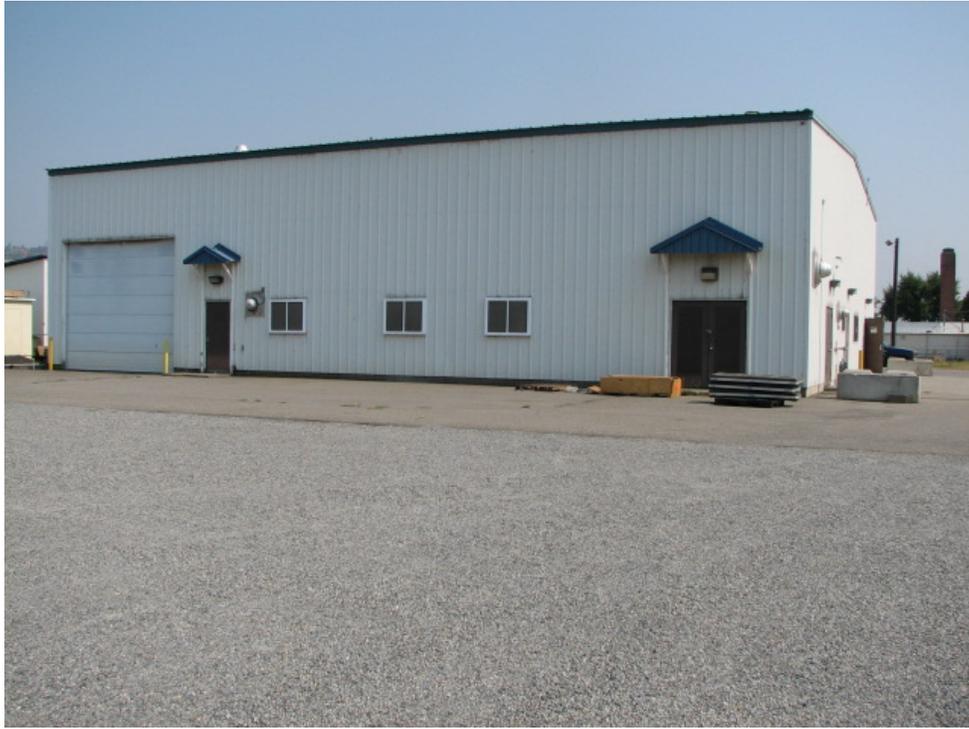
Photograph 7. OMS facing west

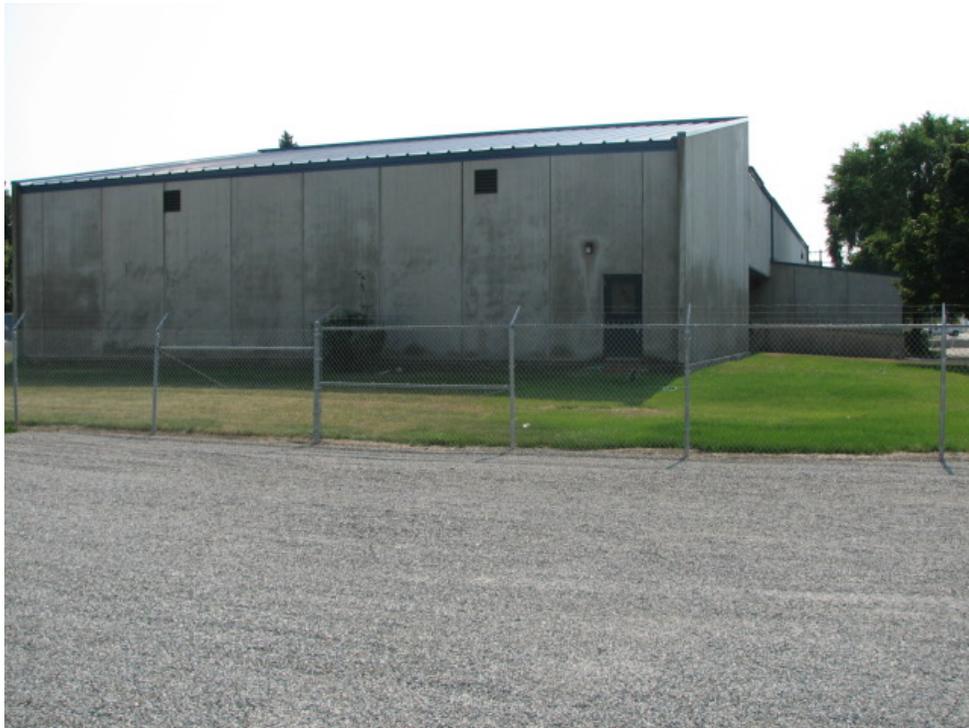
Photograph 8. Administration Building facing west

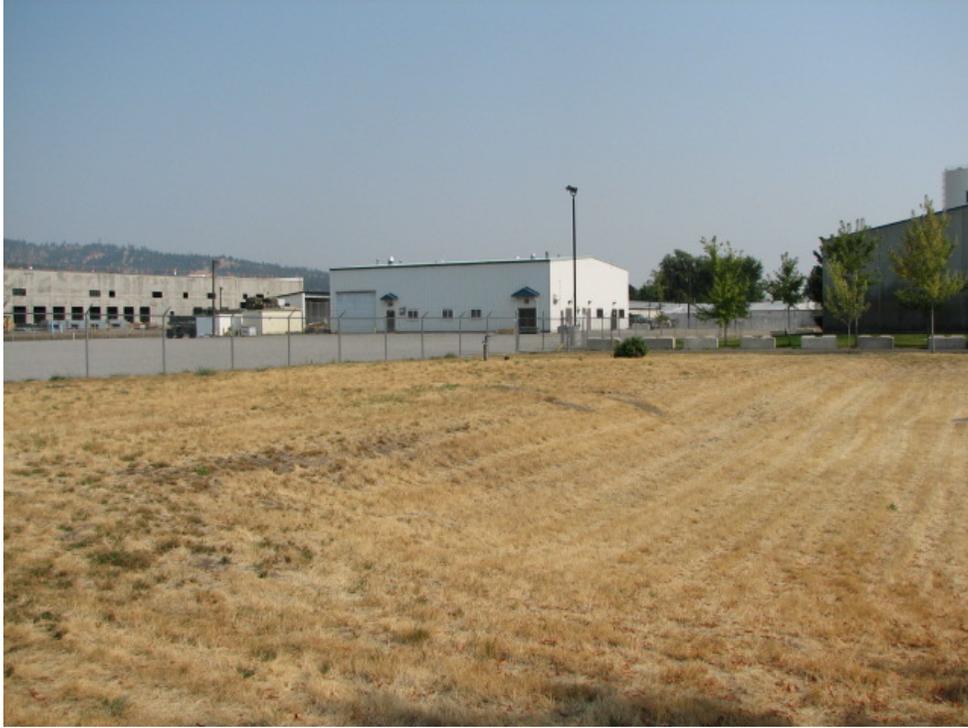
Photograph 9. OMS facing northwest

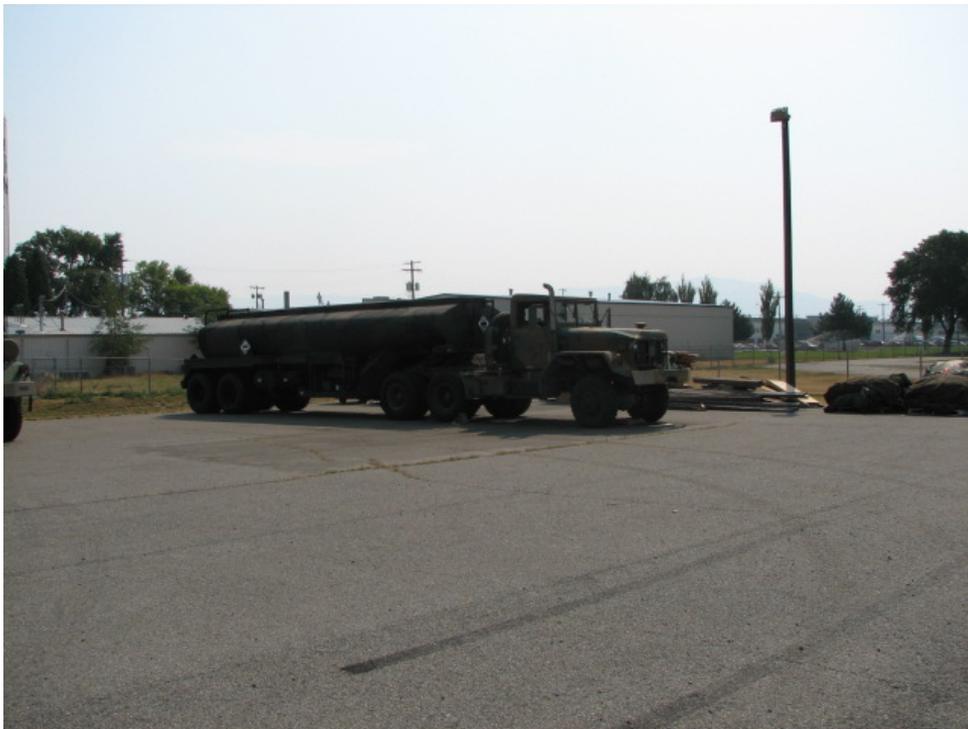
Photograph 10. 5000-gallon Diesel Tanker

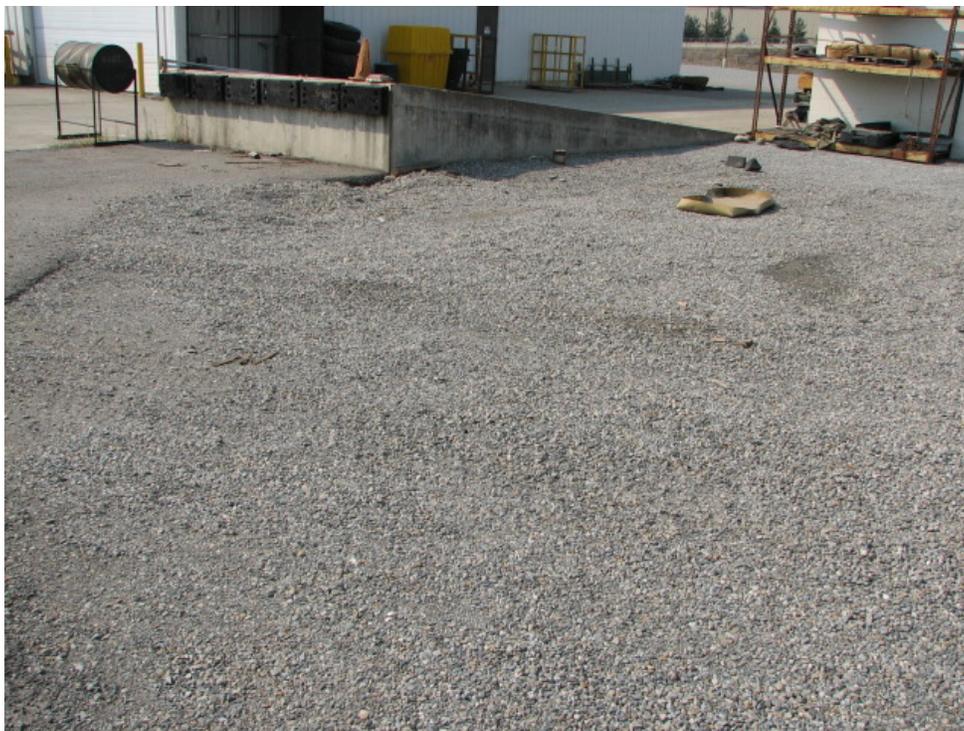
Photograph 11. 100-gallon Diesel Spill Location (southwest of OMS)

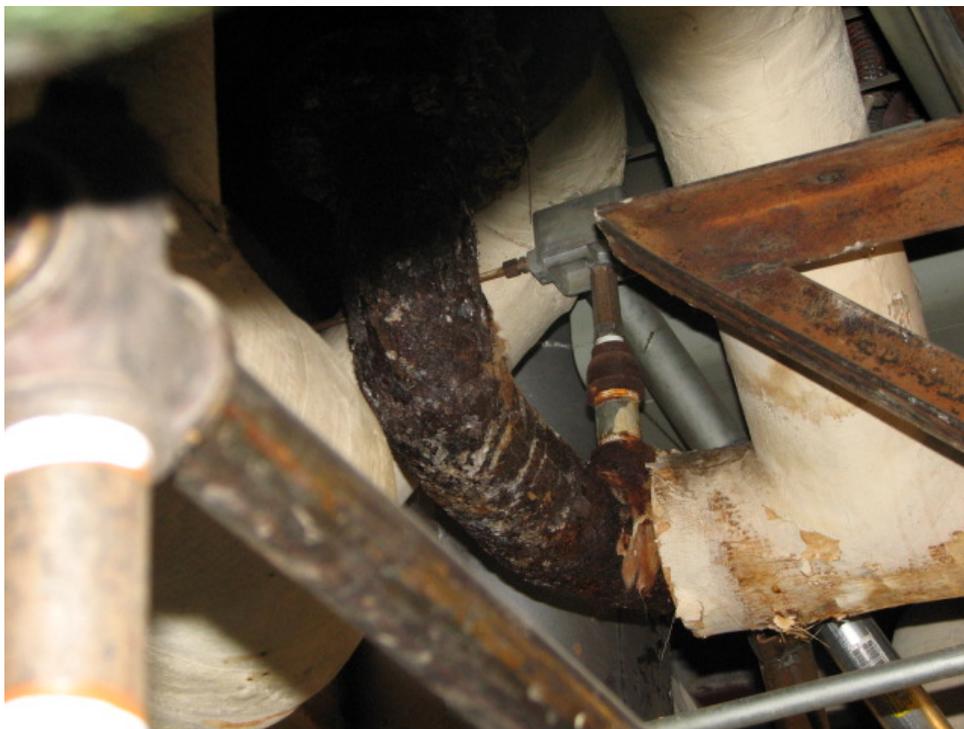
Photograph 12. Insulation in Boiler Room

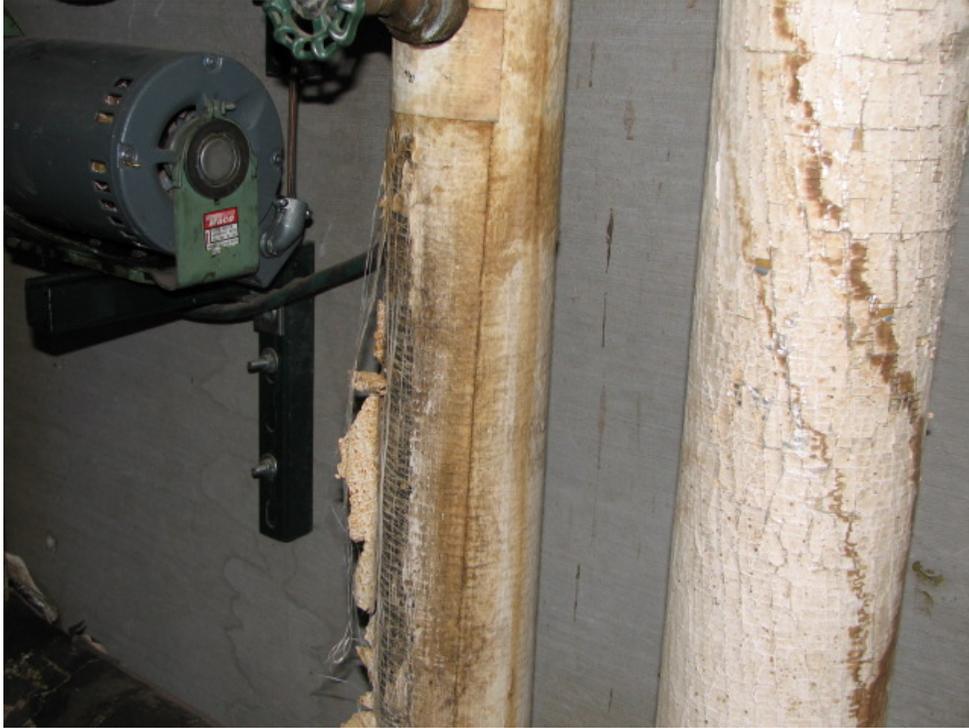
Photograph 13. Insulation in Boiler Room

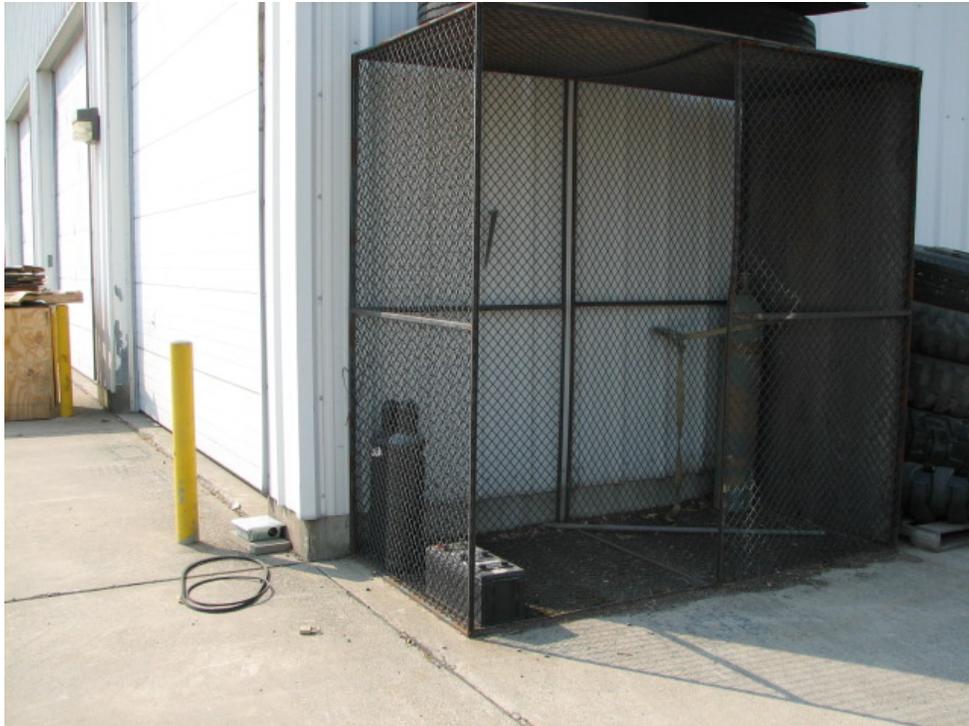
Photograph 14. Used auto battery storage

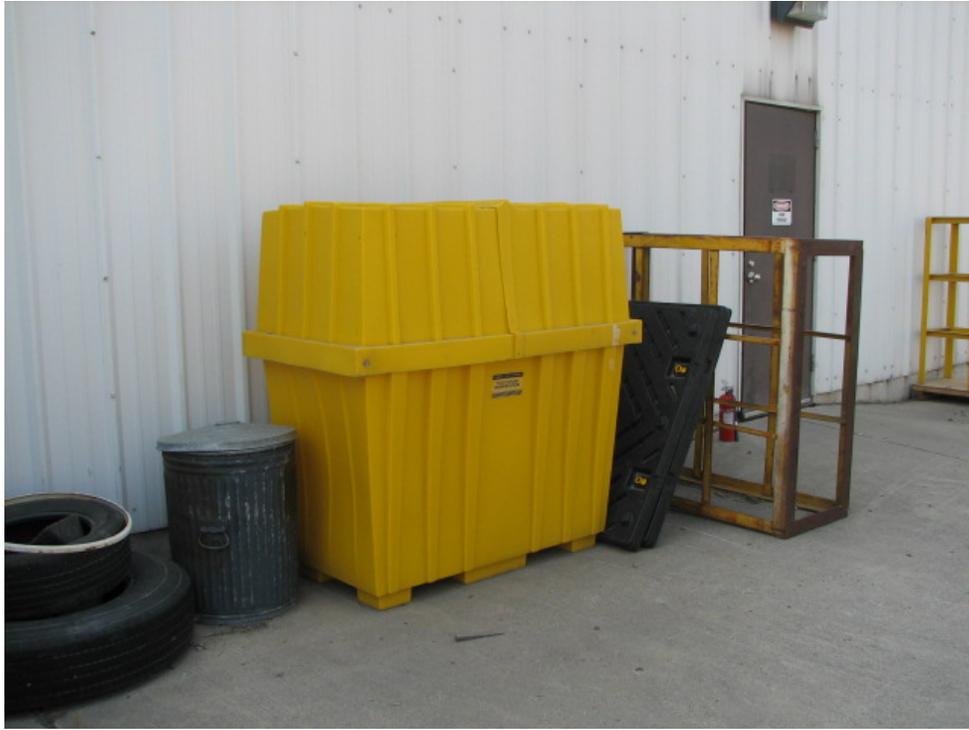
Photograph 15. Waste Containers

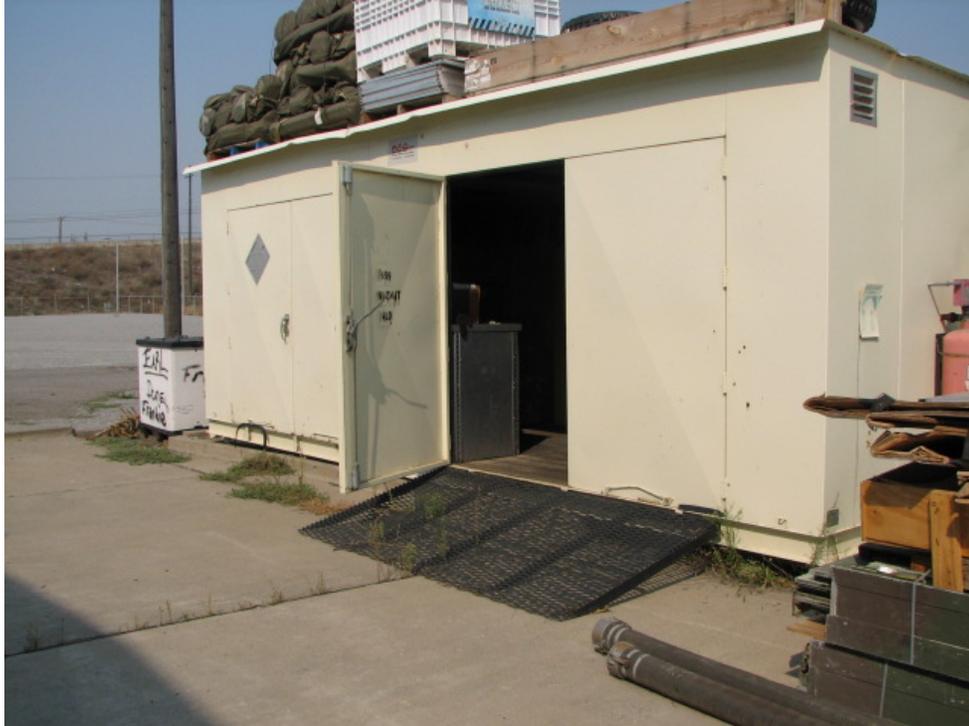
Photograph 16. Hazmat Shed

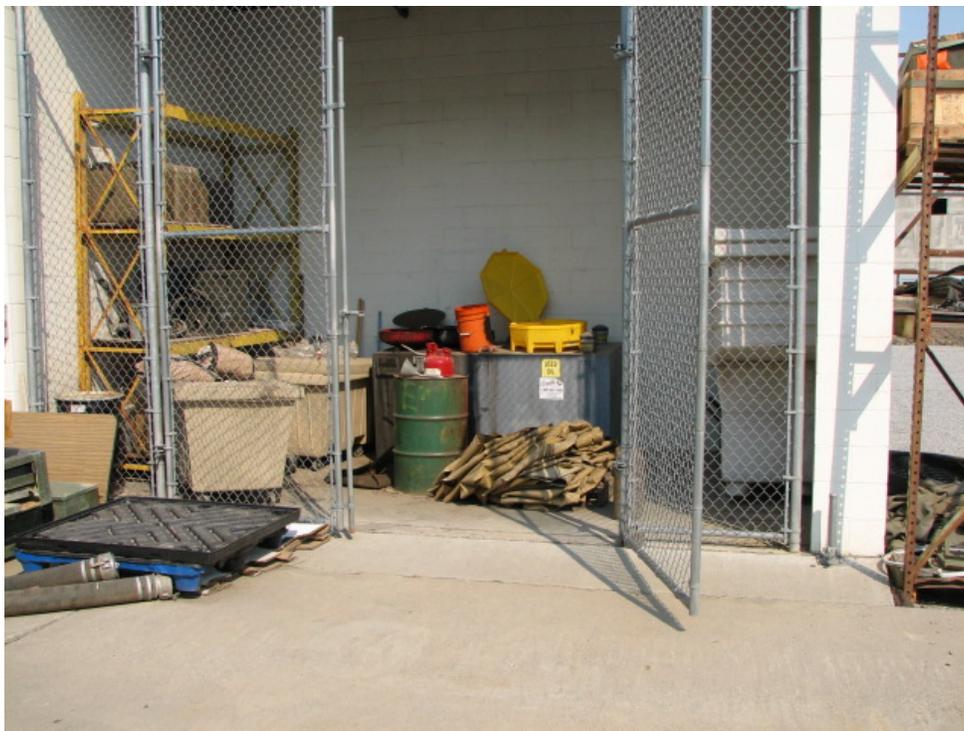
Photograph 17. Caged Hazmat Storage Area. Used oil AST is grey structure in center of shed.

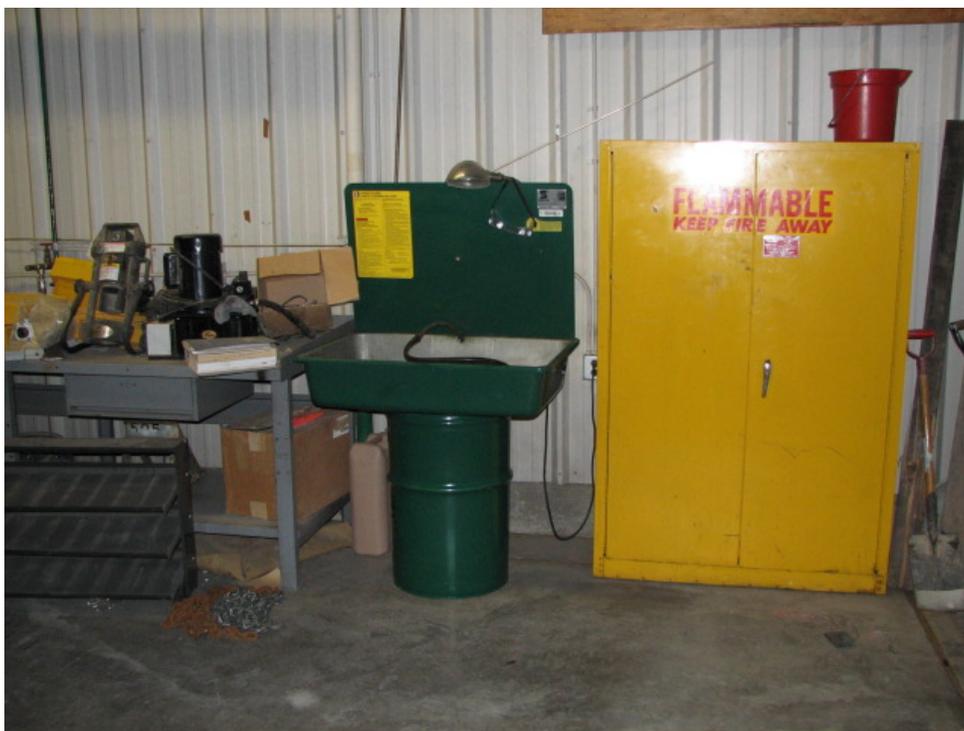
Photograph 18. Hazmat Cabinet and Solvent Wash Station

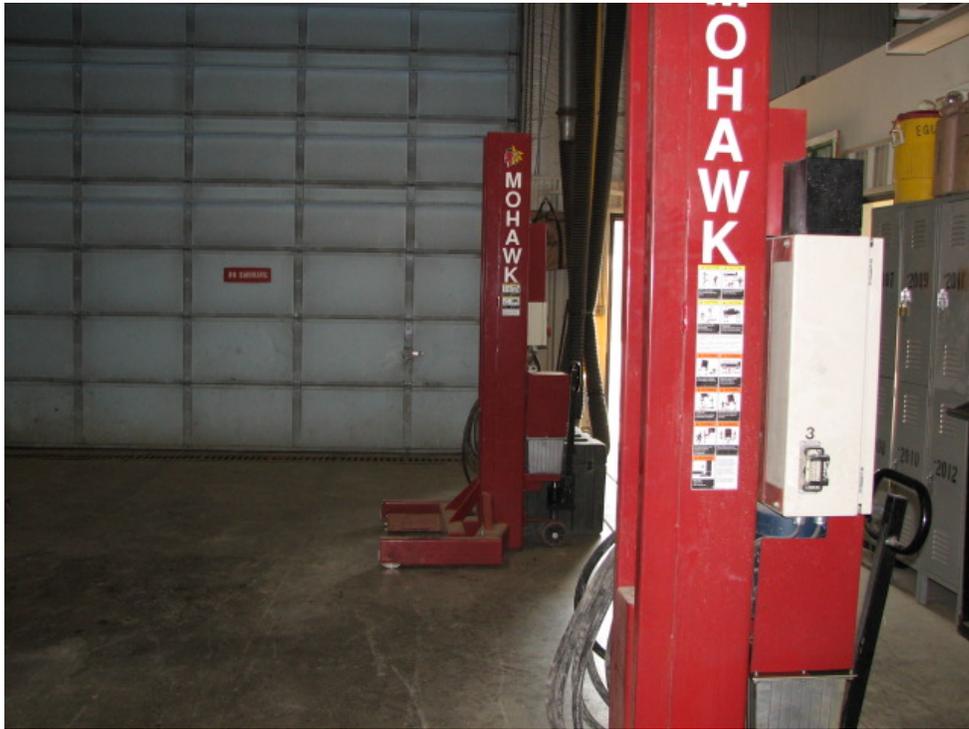
Photograph 19. Mobile Hydraulic Lifts

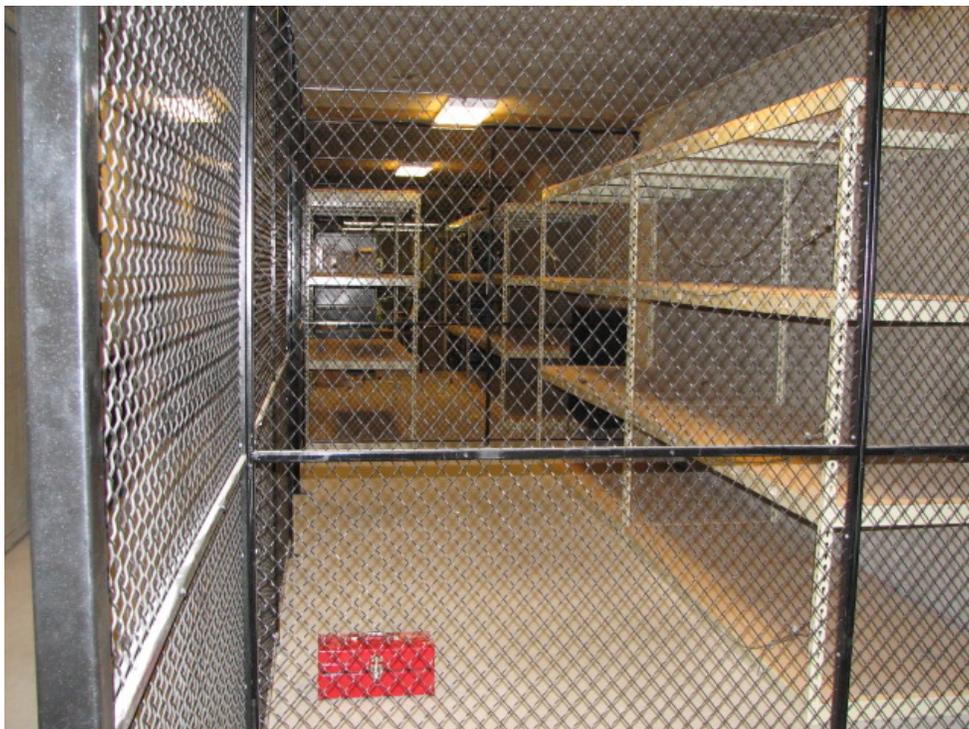
Photograph 20. Former Indoor Firing Range

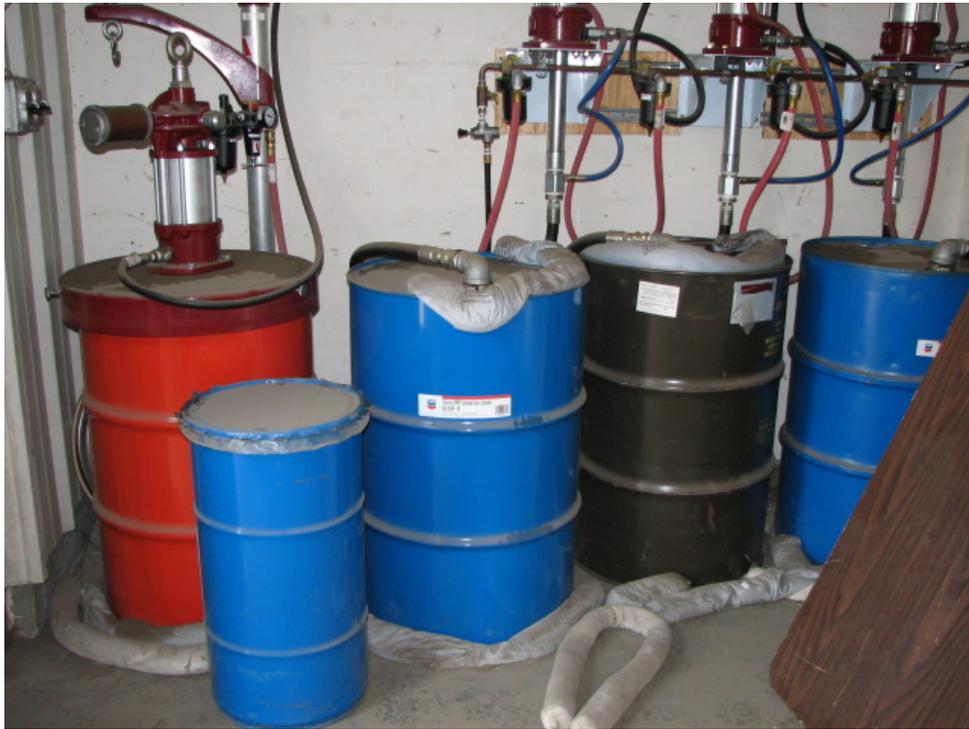
Photograph 21. New oil lines and drums in OMS

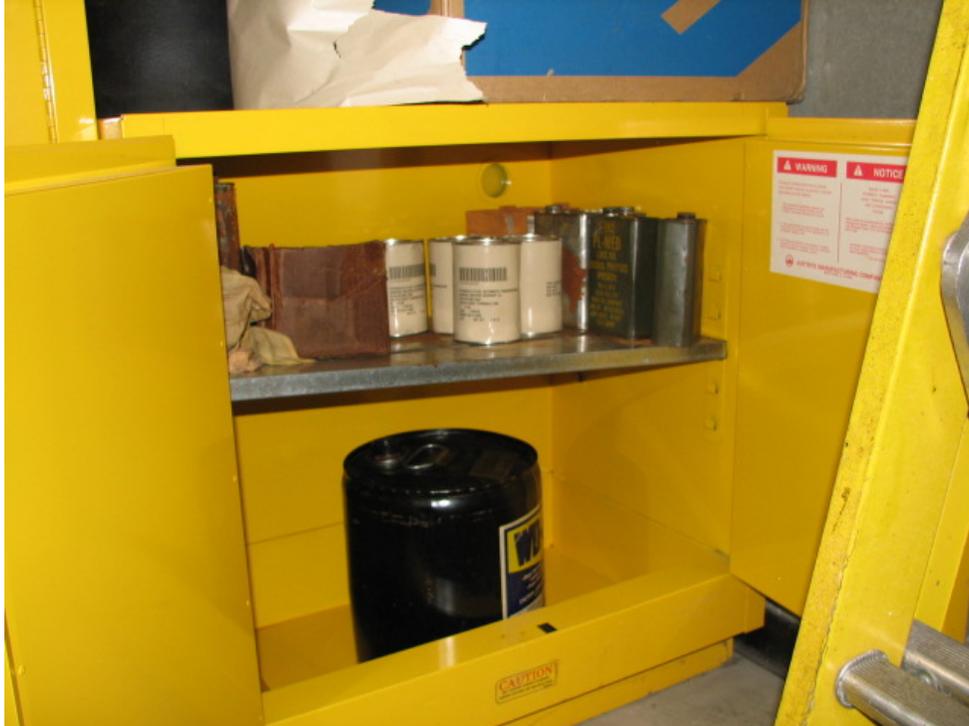
Photograph 22. Hazmat cabinet #1

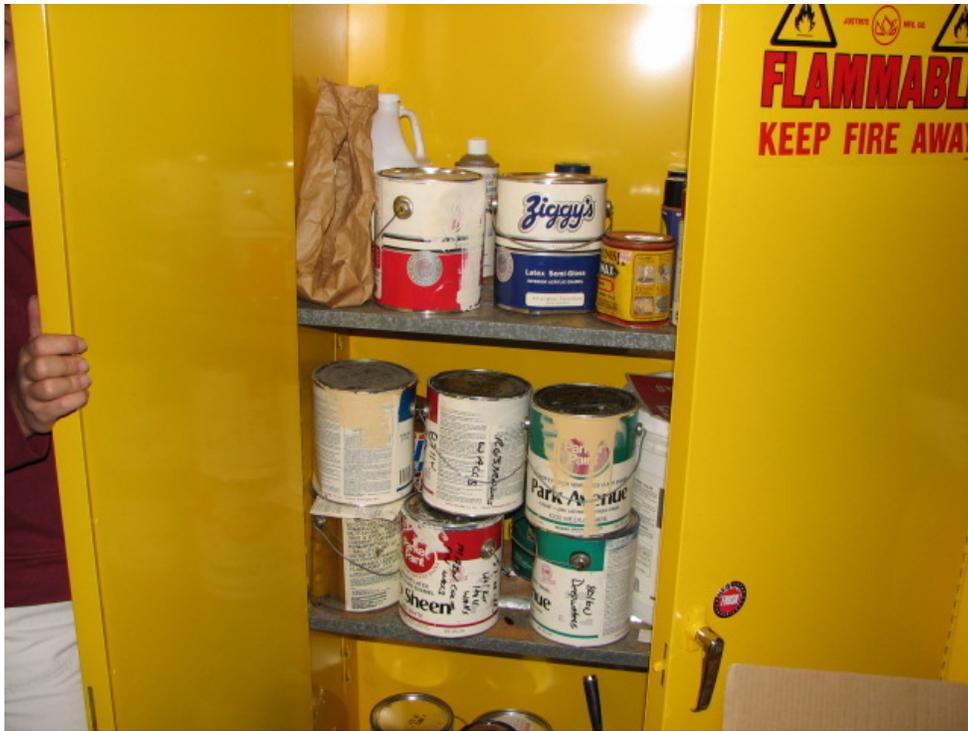
Photograph 23. Hazmat cabinet #2

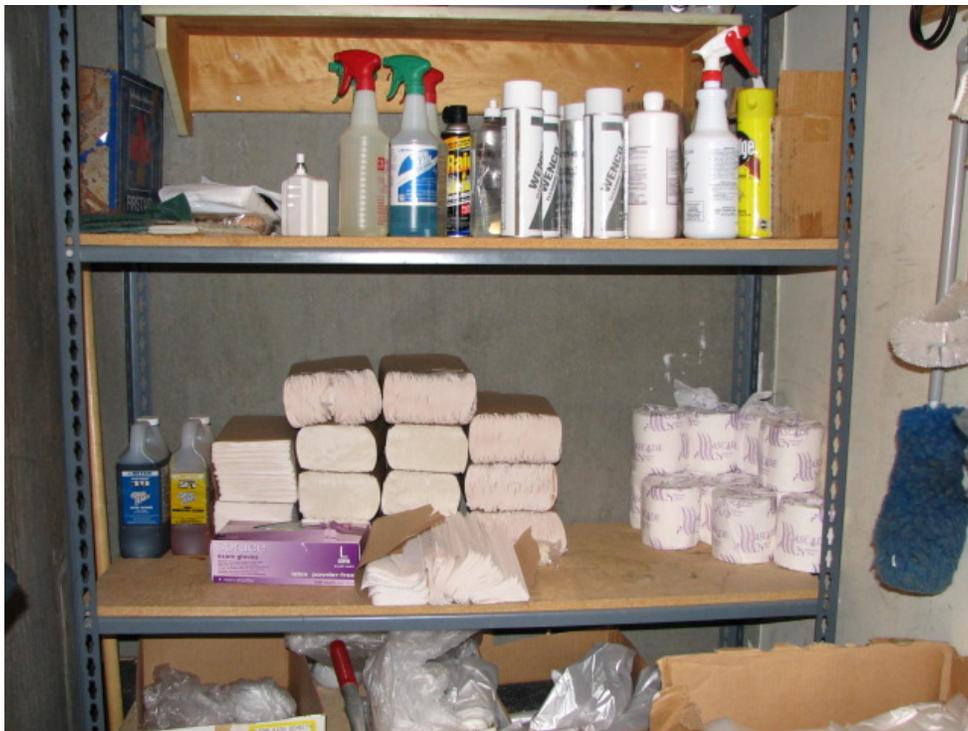
Photograph 24. Janitorial Supply Room

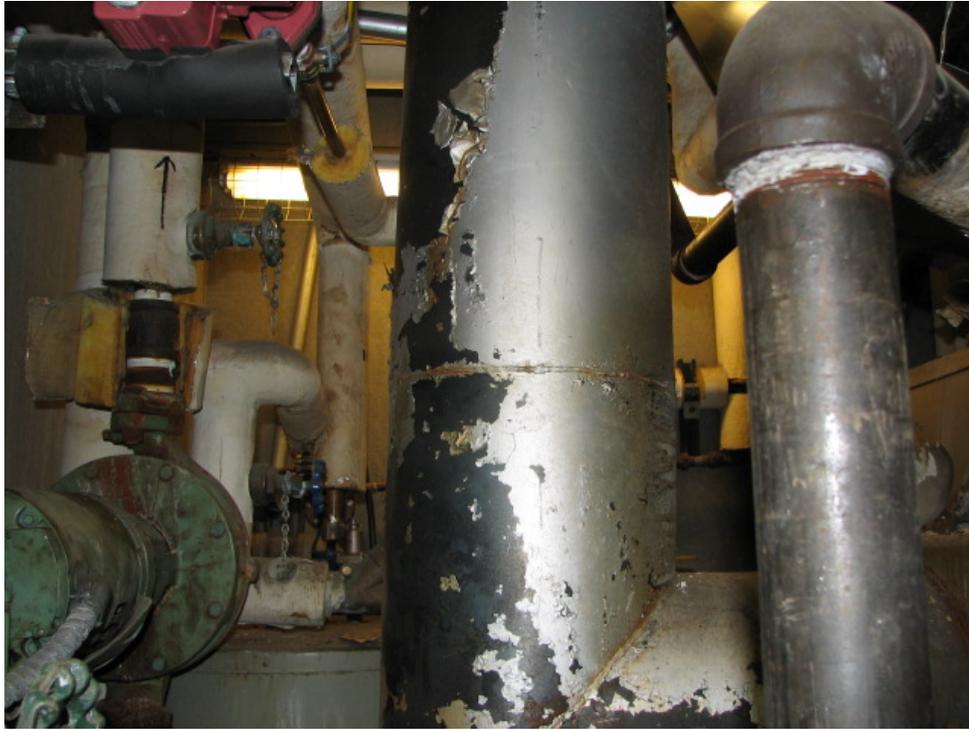
Photograph 25. Peeling paint in Boiler Room

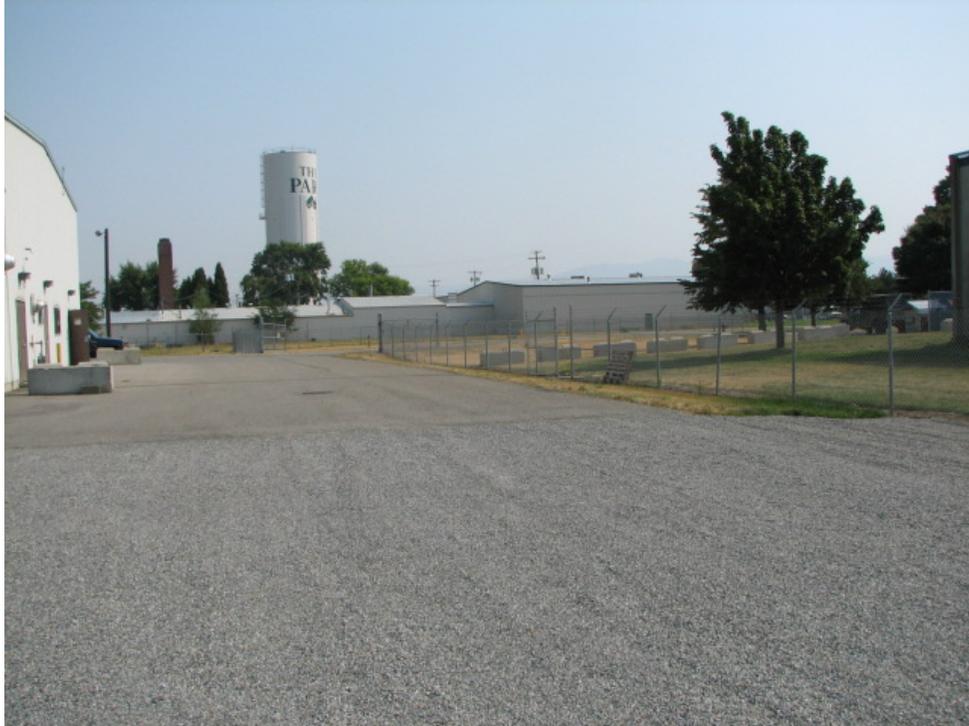
Photograph 26. Off-site (Cintas) facing east

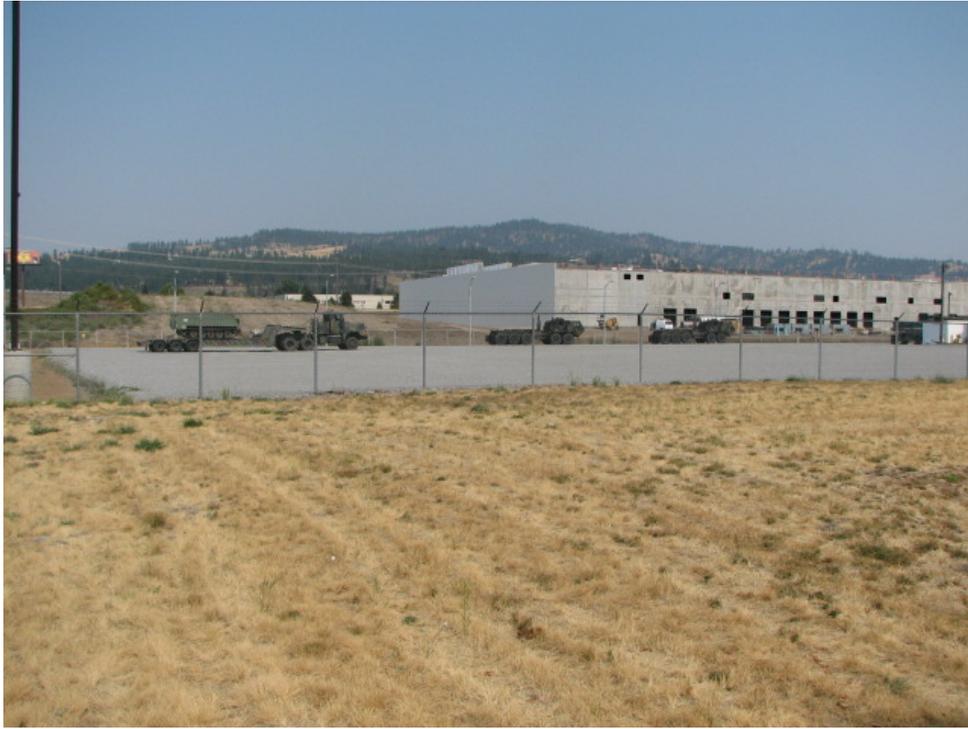
Photograph 27. Off-site in background facing north

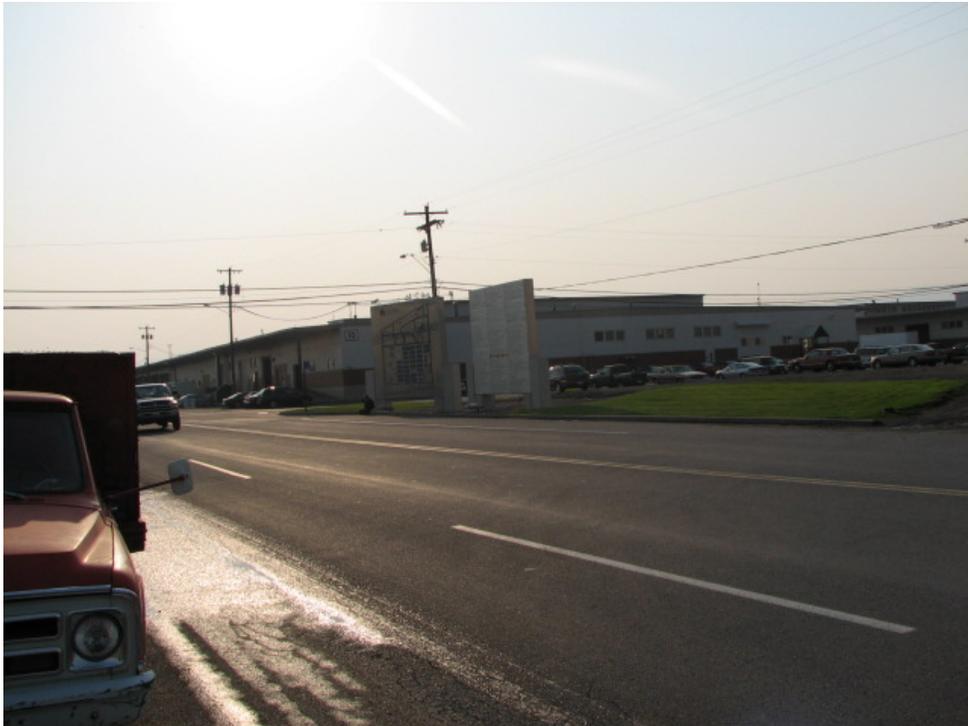
Photograph 28. Industrial Park southeast of Site

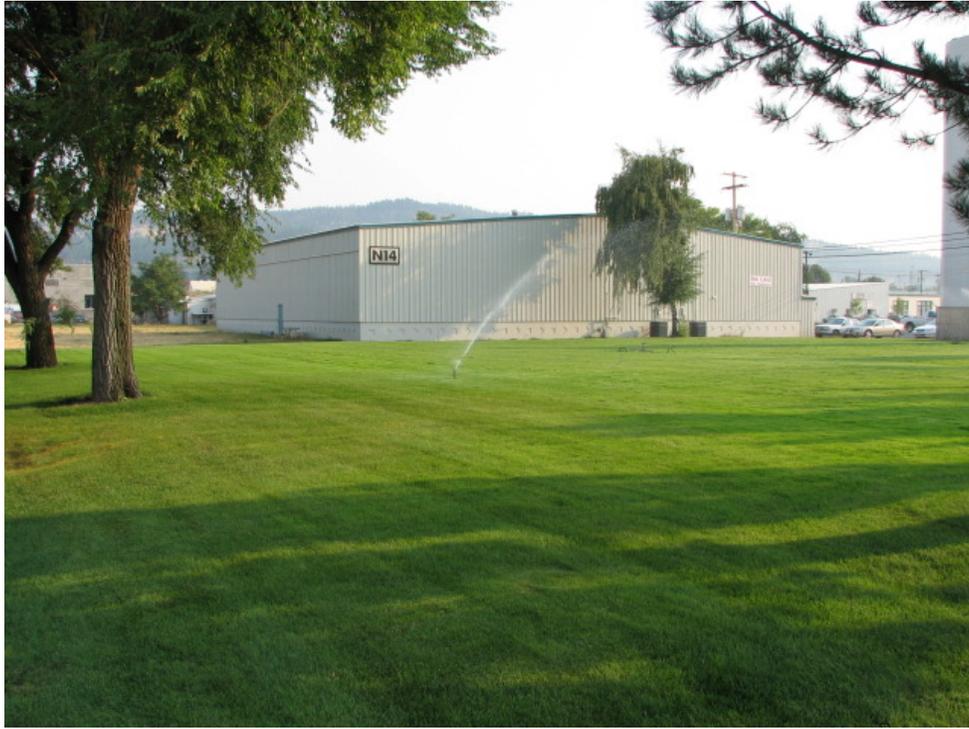
Photograph 29. Industrial Park Building east of Site

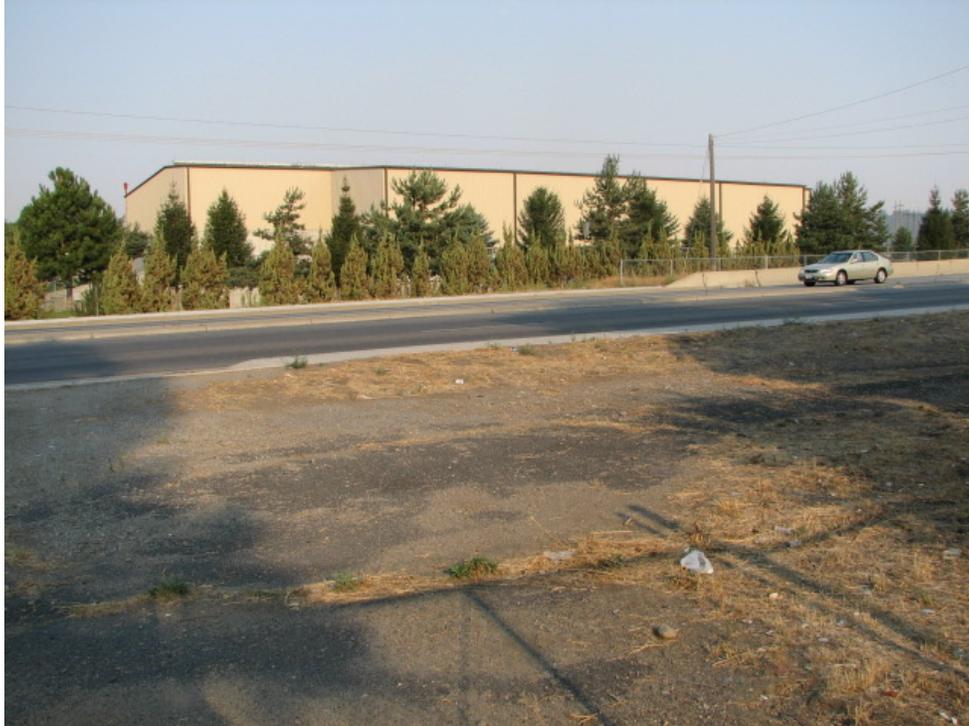
Photograph 30. Spokane Valley Recycling/Treatment Center Facing West

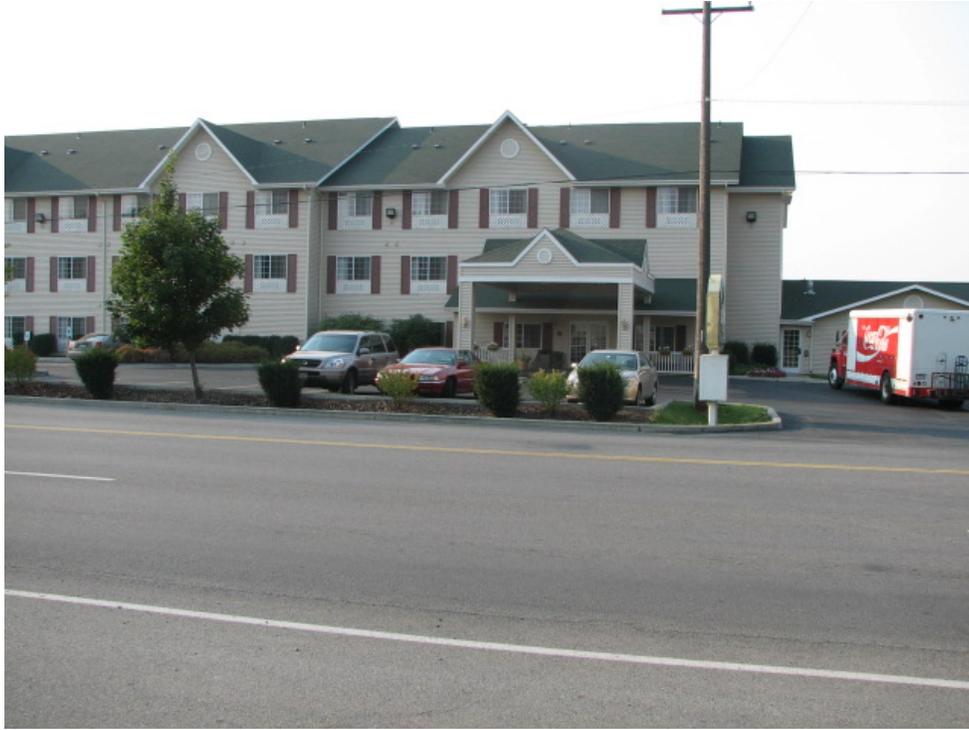
Photograph 31. LaQuinta Hotel south of Site

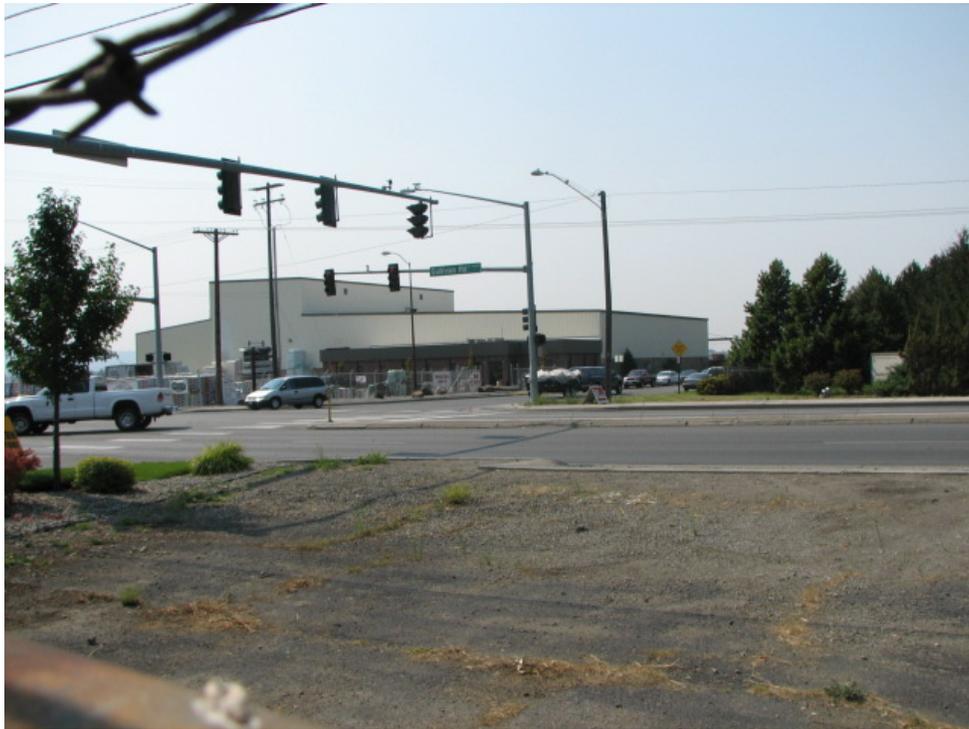
Photograph 32. Construction Supply Center southwest of Site
