APPENDIX B
SITE RECONNAISSANCE PHOTOGRAPHS

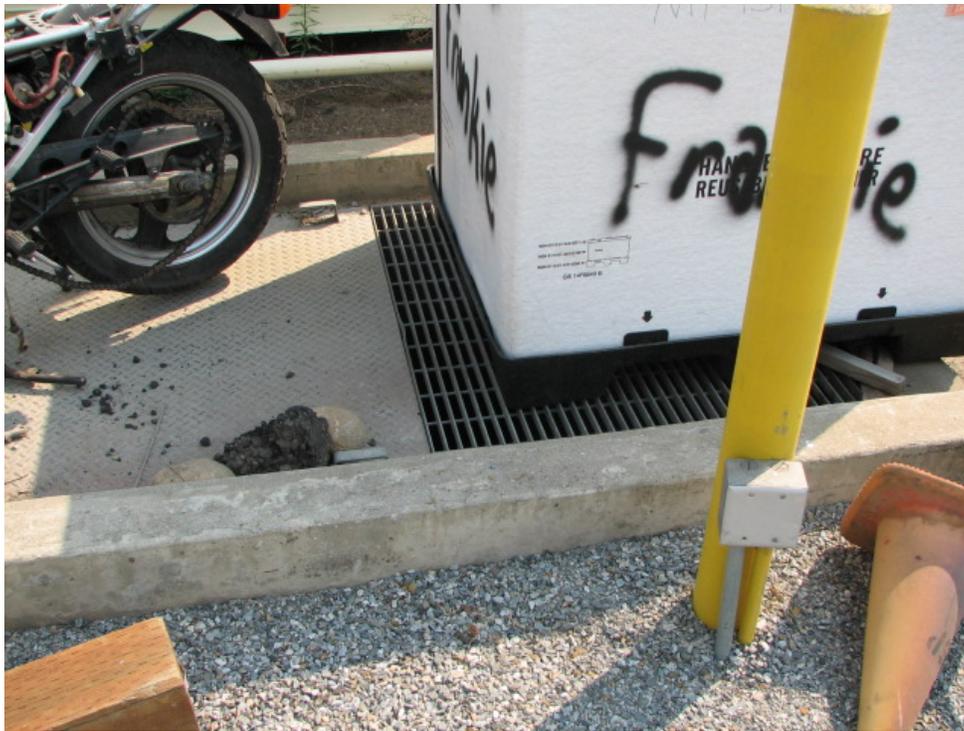
Photograph 33. OWS next to former Vehicle Wash Rack

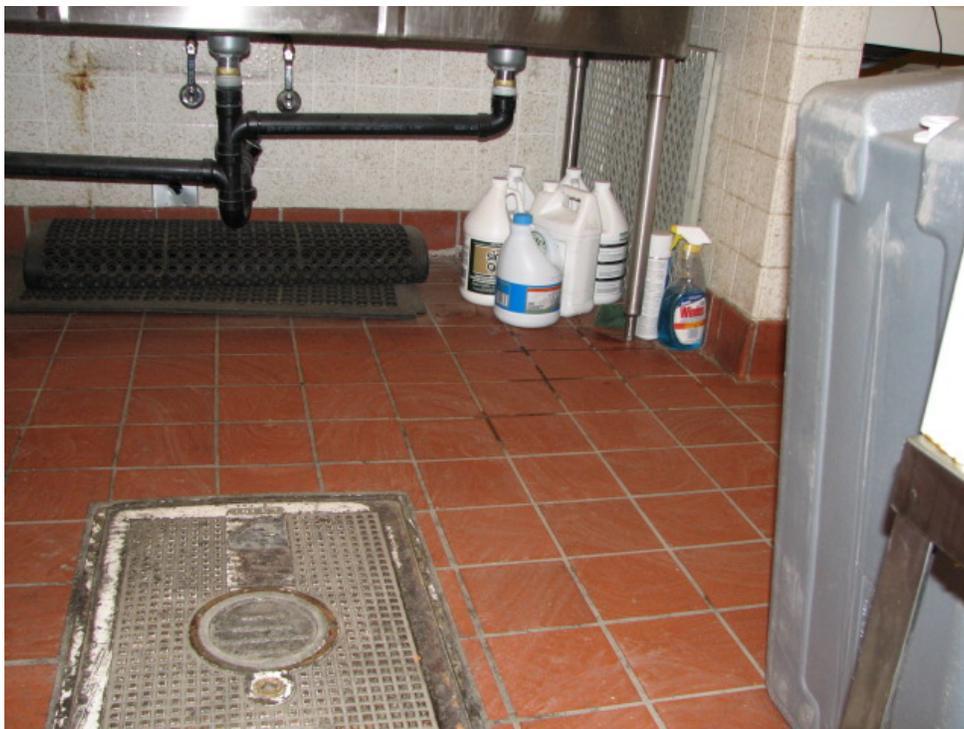
Photograph 34. Grease trap in kitchen and cleaning chemicals

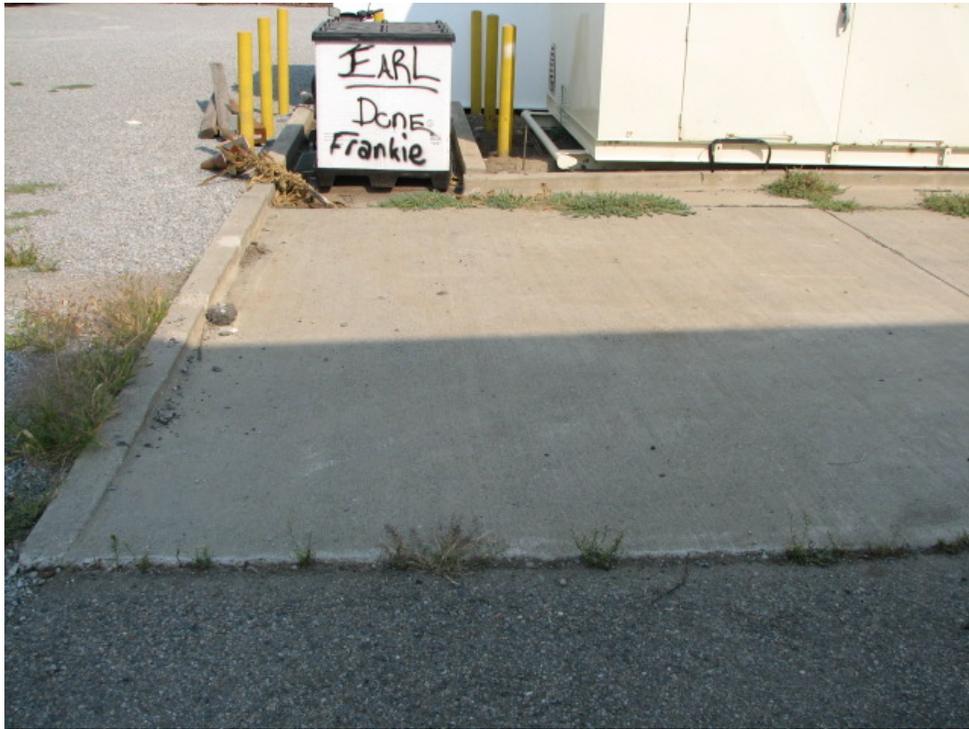
Photograph 35. Former vehicle wash rack

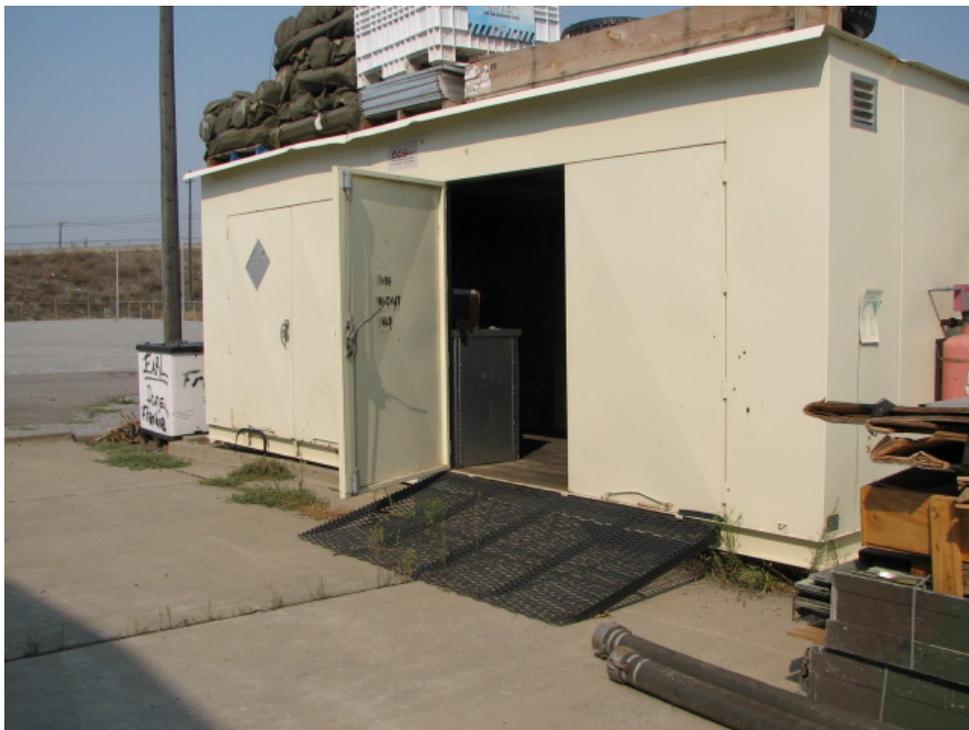
Photograph 36. Hazmat storage shed #1 includes anti-freeze, lube oil, and grease

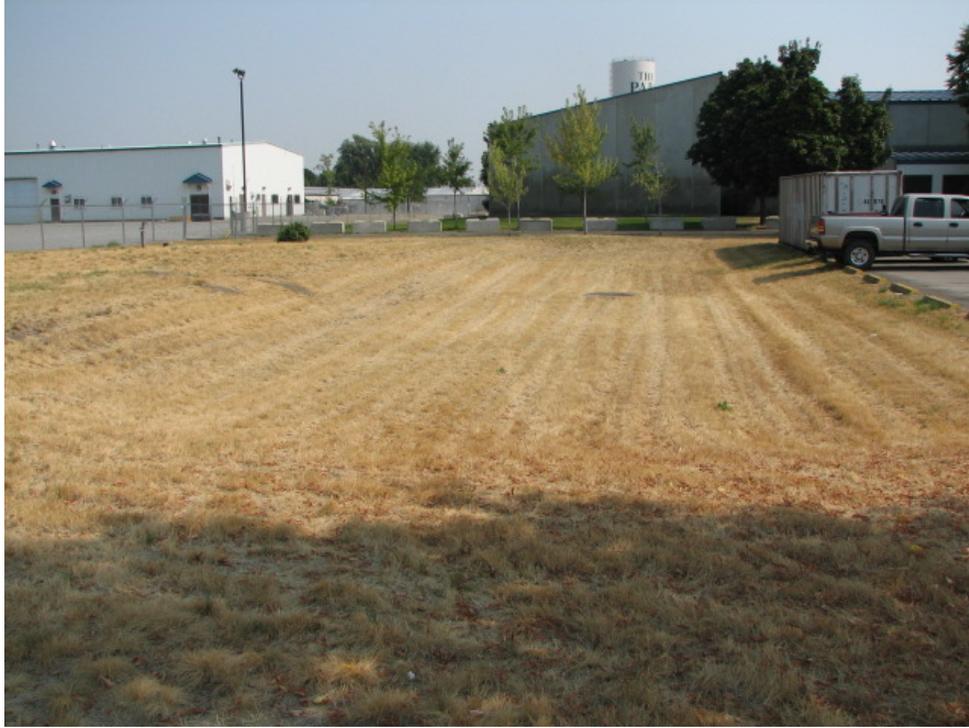
Photograph 37. Grassy area on west side of administration building showing Drywell #1
