**Appendix B**  
**Site Reconnaissance Photographs**

**Equipment Concentration Site #15  
Fort Smith, Arkansas**

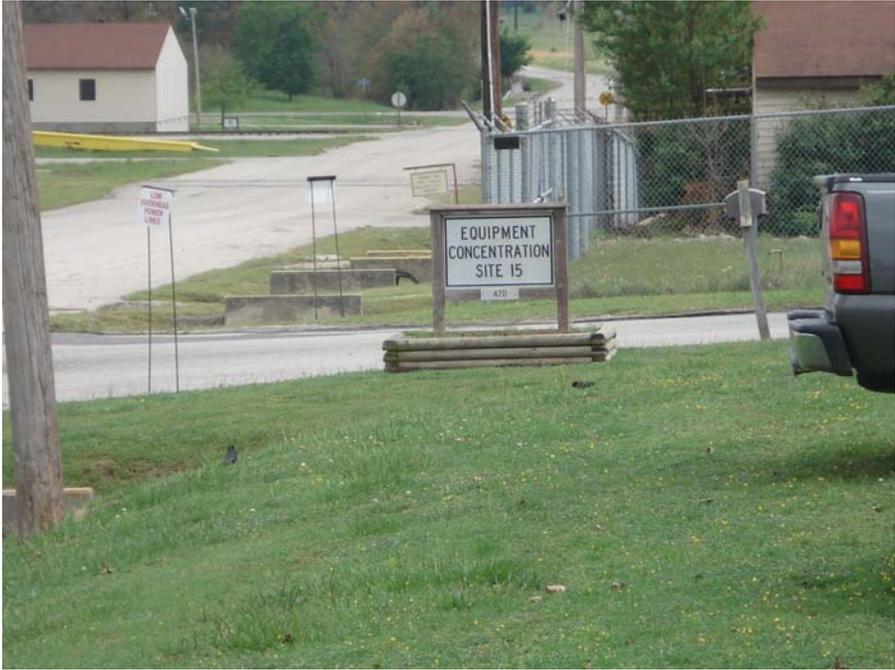
**Photo 1:** View from the northeast border of the Site looking to the southeast. Roberts Boulevard continues to the southeast past the railroad tracks.

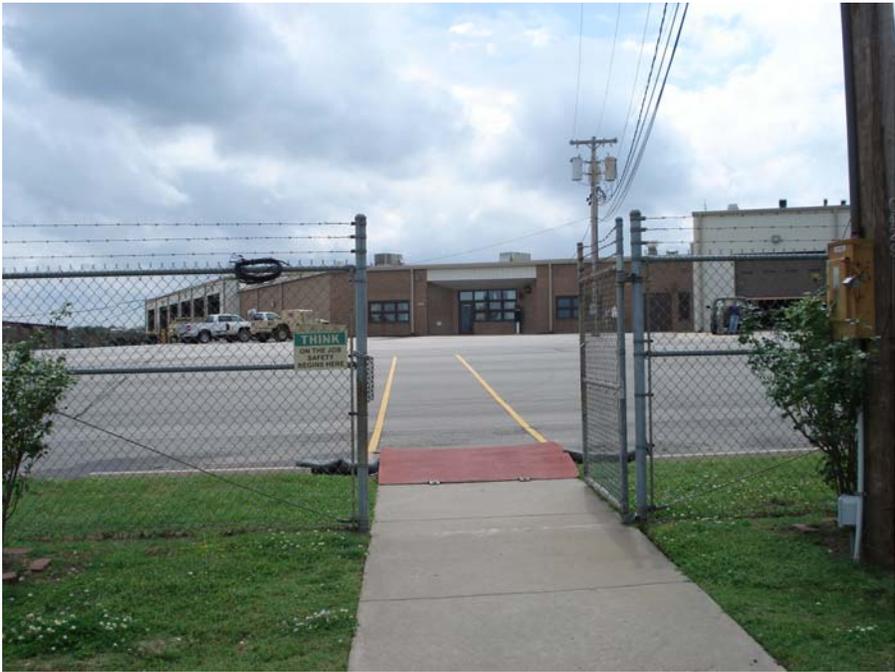
**Photo 2:** Building 470 entrance to office areas, as viewed looking to the southwest. Maintenance shops are visible on the north and south sides of the building.

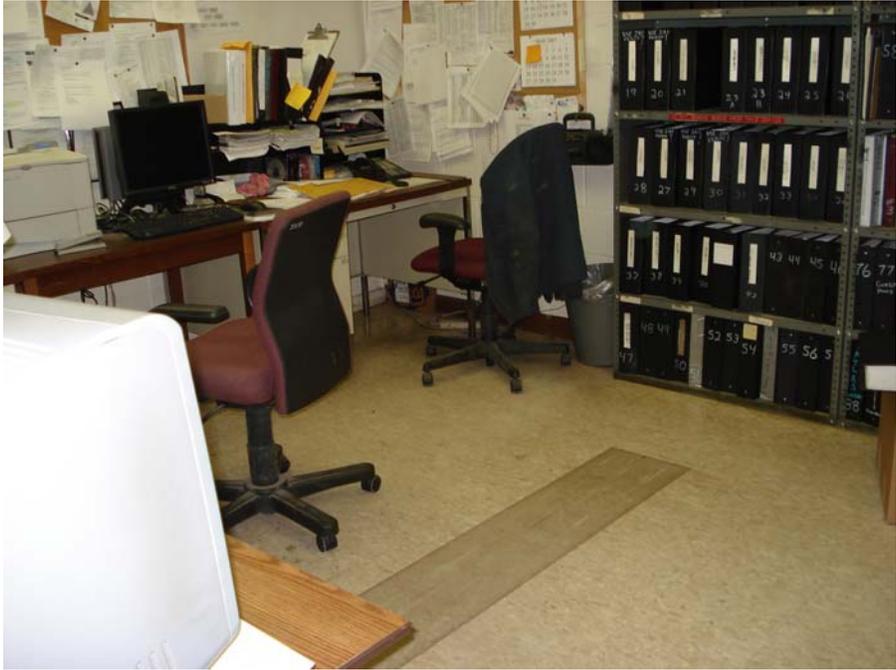
**Photo 3:** Typical interior office space. Portions of the floor tile have been replaced throughout the building.

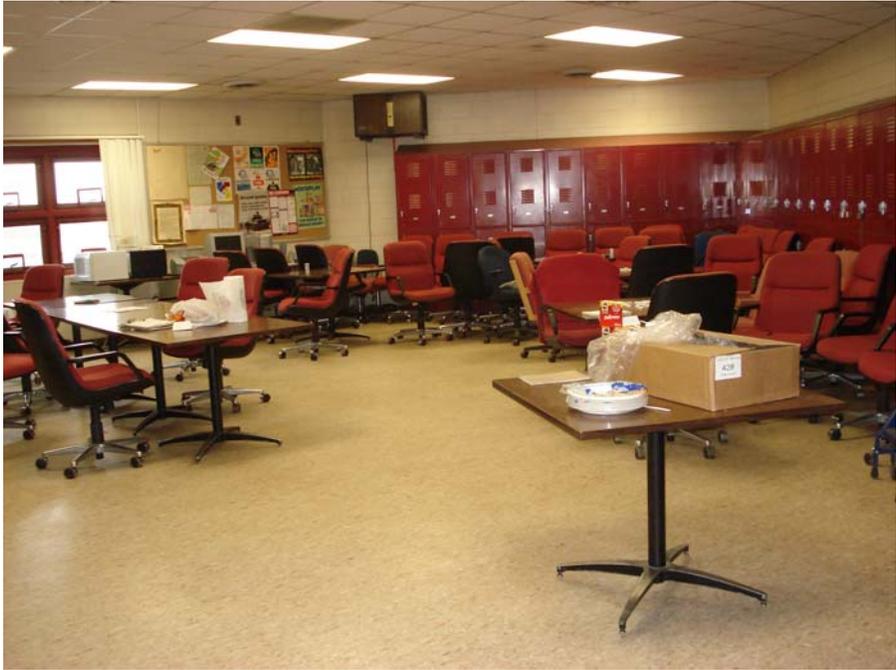
**Photo 4:** Break room in Building 470.

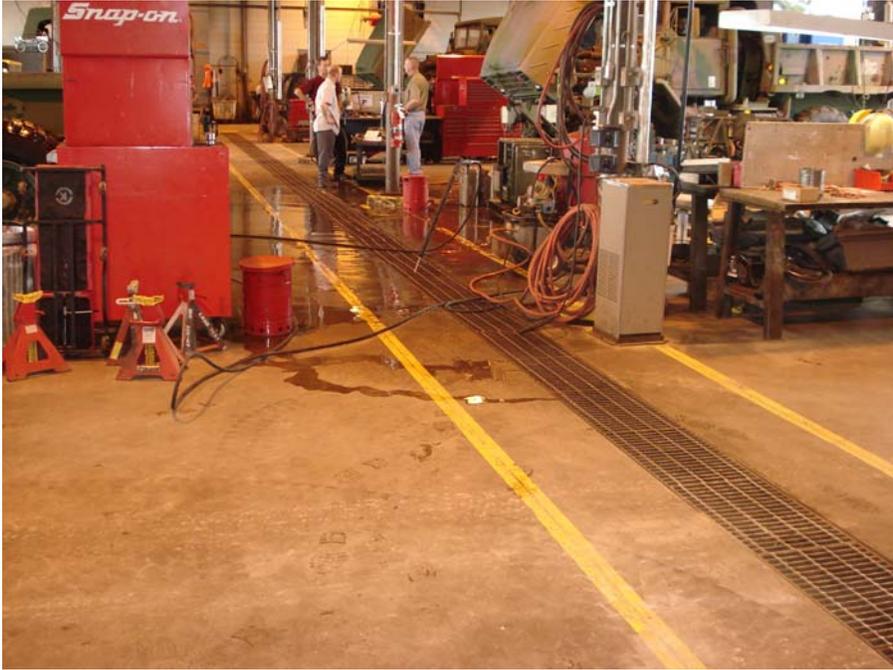
**Photo 11:** The southern shop has a floor drain that discharges to the oil-water separator.

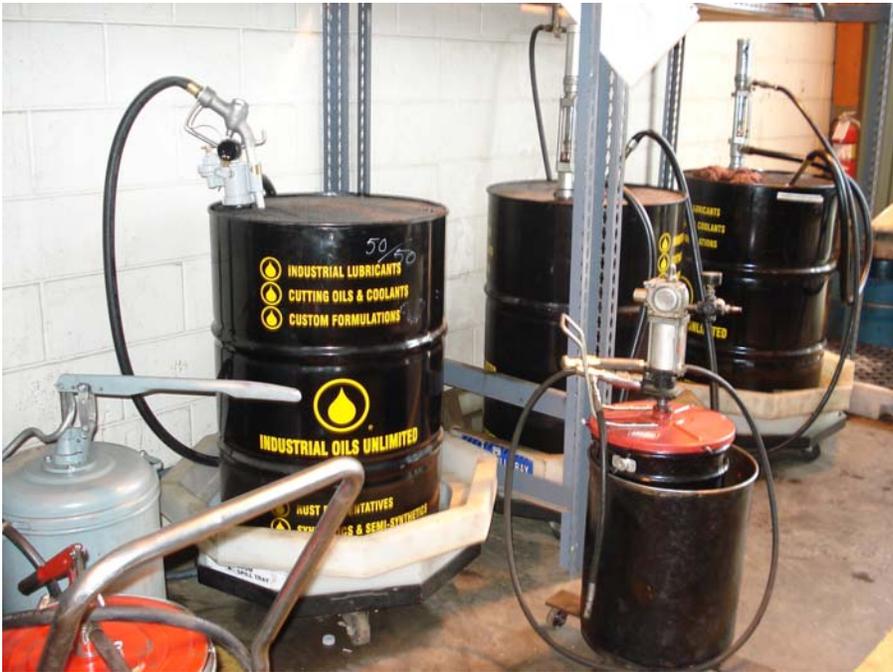
**Photo 12:** Oil is stored in secondary containment within the shop.

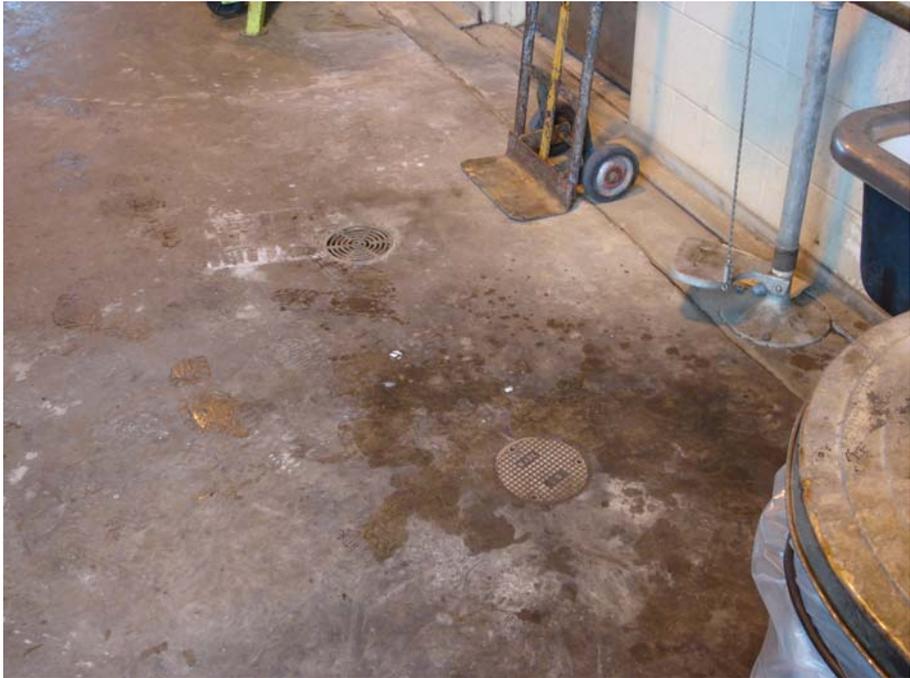
**Photo 15:** A floor drain in the southern maintenance shop is connected to the oil-water separator piping.

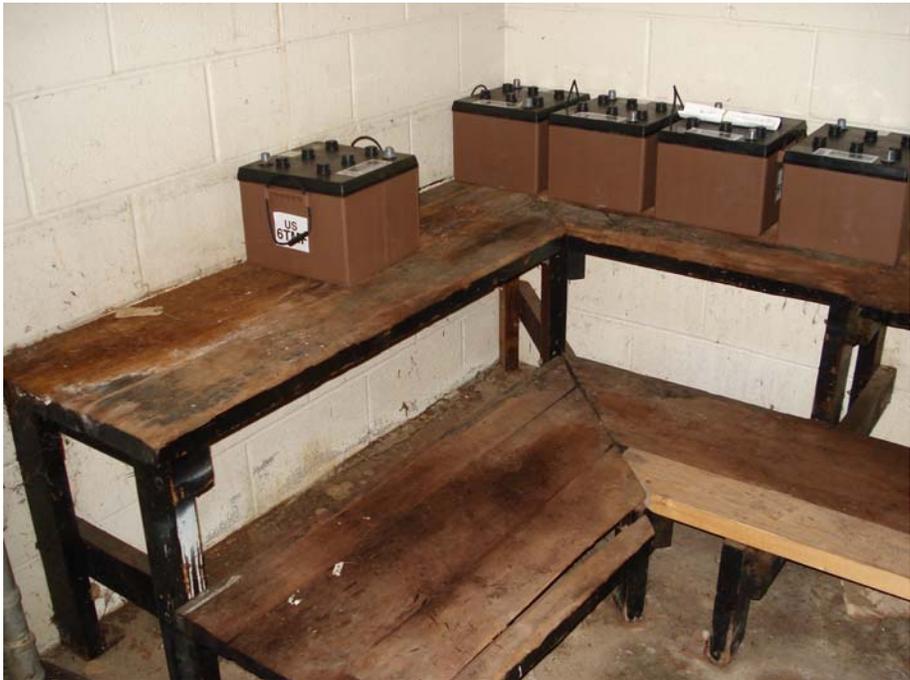
**Photo 16:** Batteries are stored on wood shelves in the battery storage room. The shelves are stained with battery acid.

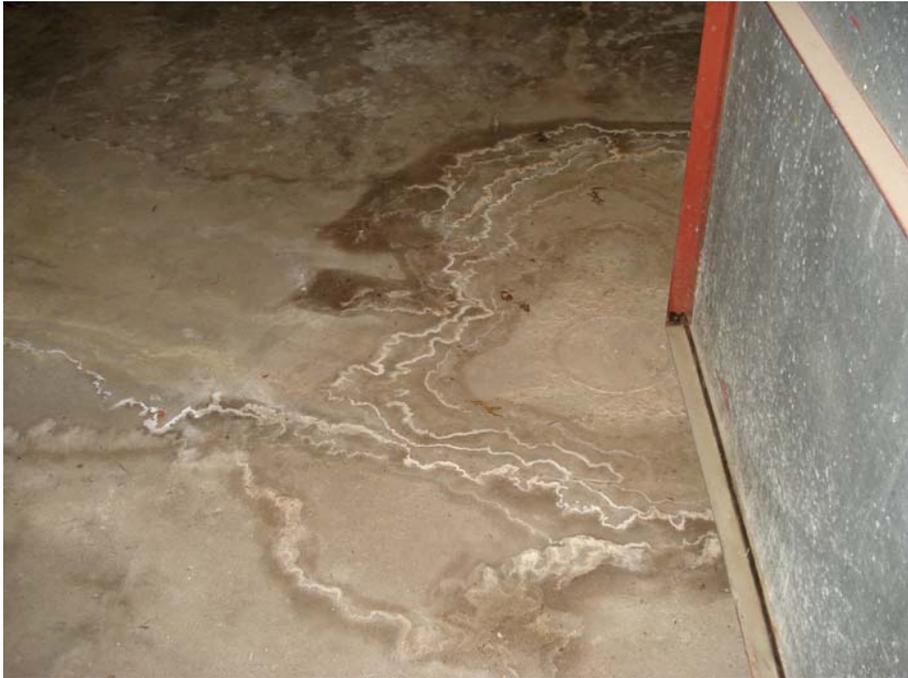
**Photo 17:** The battery room floor drains are closed and the floor shows signs of battery acid stains.

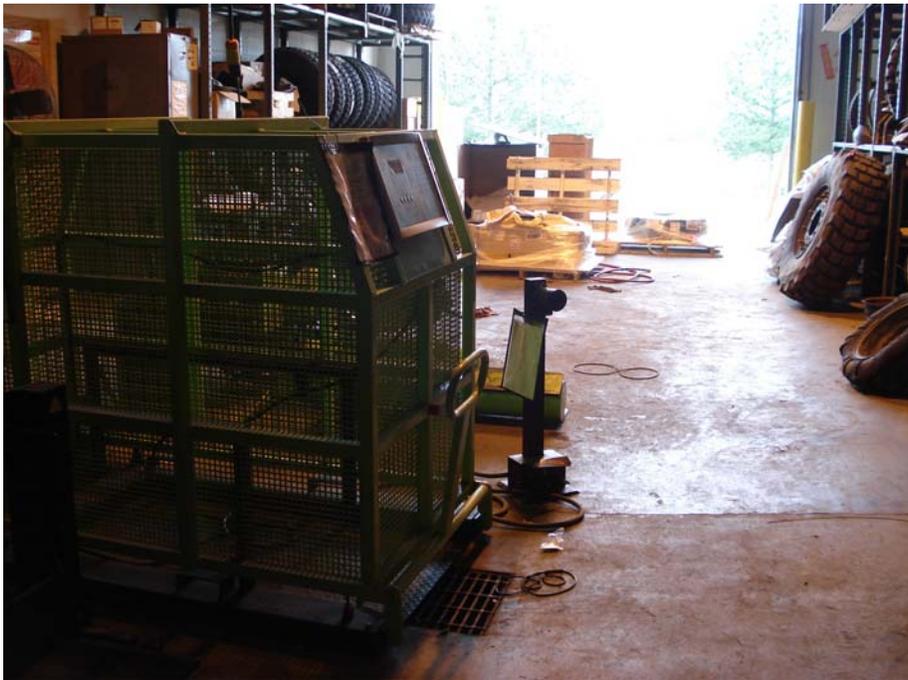
**Photo 18:** The tire bay is on the southern end of Building 470.

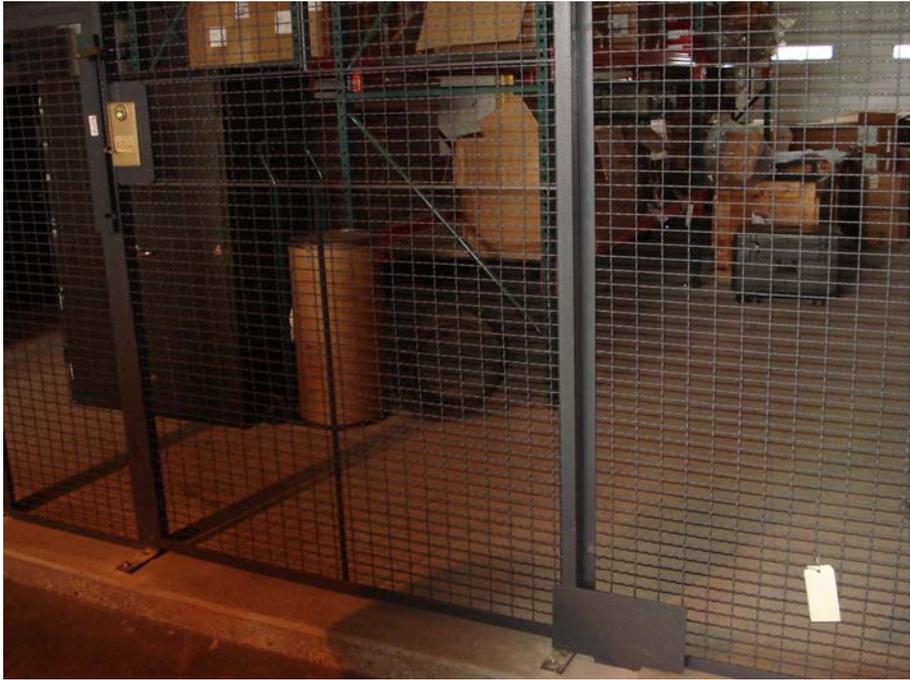
**Photo 19:** This storage area is on the southern end of Building 470 and was previously used for painting. A new floor was installed when the area was converted to storage.

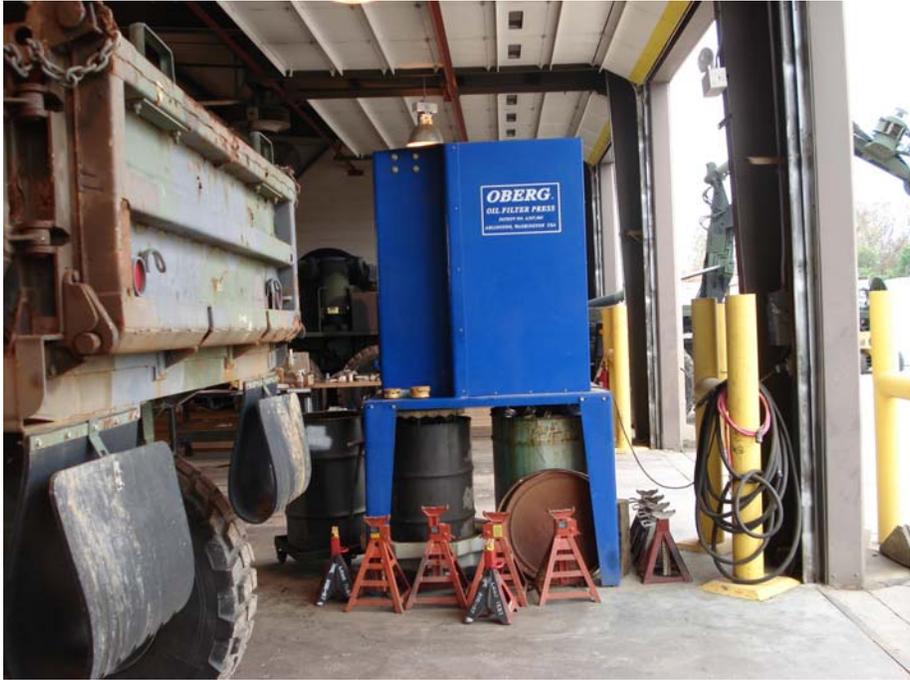
**Photo 20:** An oil filter crusher is in the southern maintenance shop.

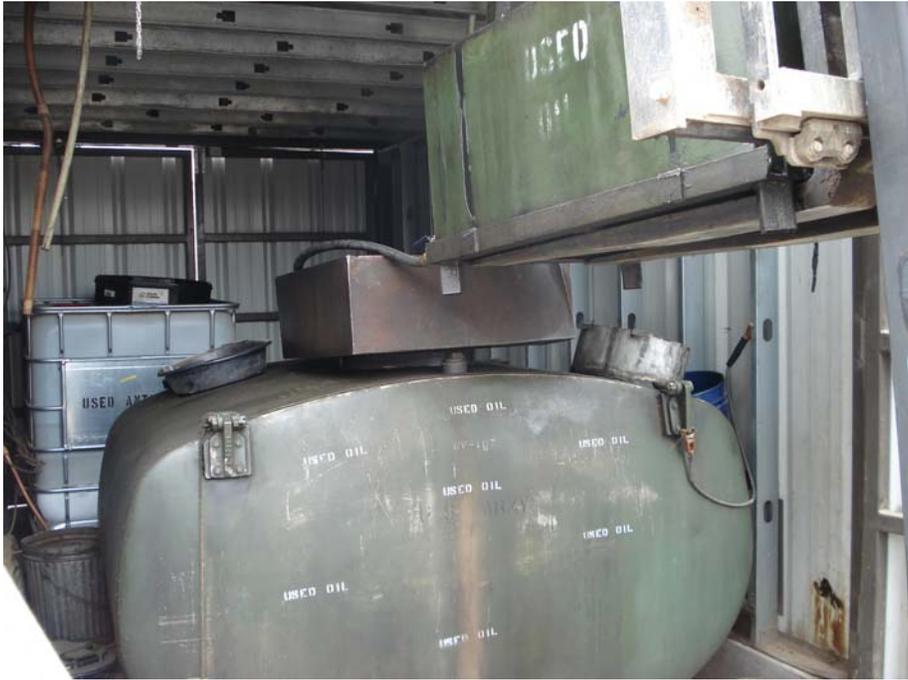
**Photo 23:** Oil transfer to the 300-gallon aboveground storage tank in the permanent POL building.

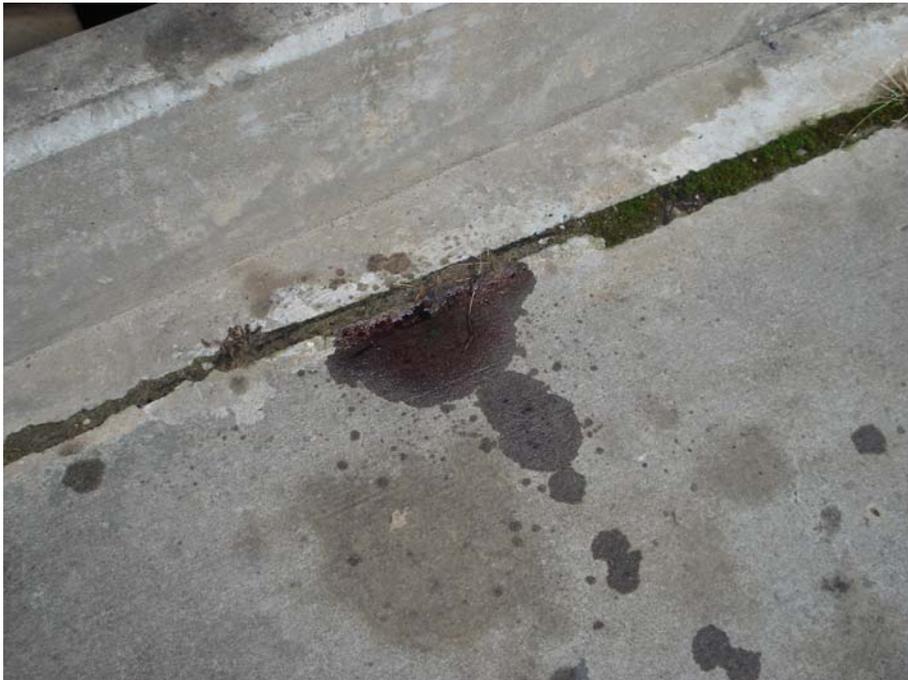
**Photo 24:** An oil stain on the concrete, near a pavement joint, under the oil container being drained into the 300-gallon AST.

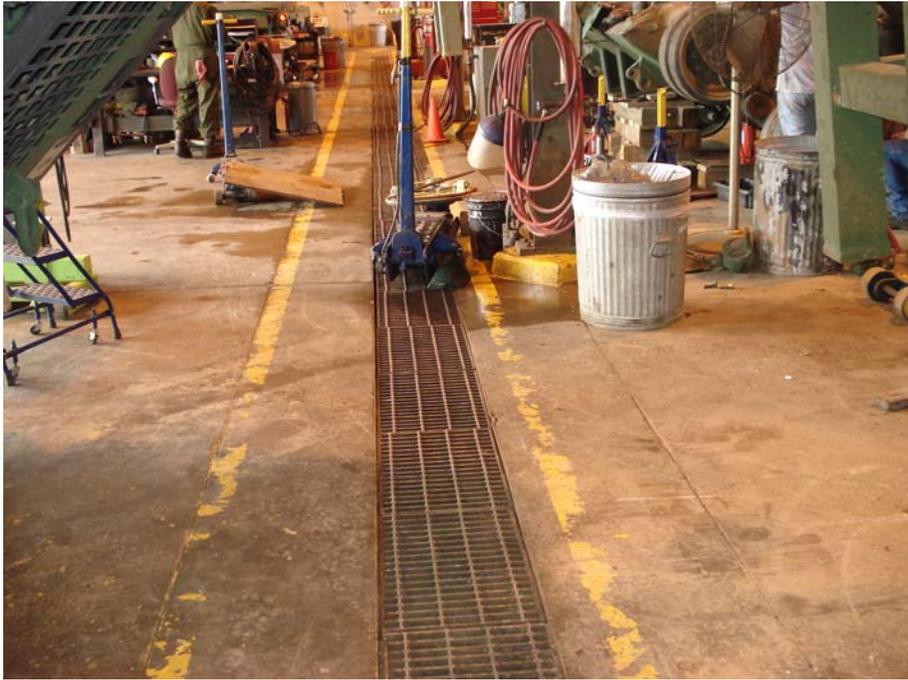
**Photo 29:** The northernmost maintenance shop has a grated floor drain trench.

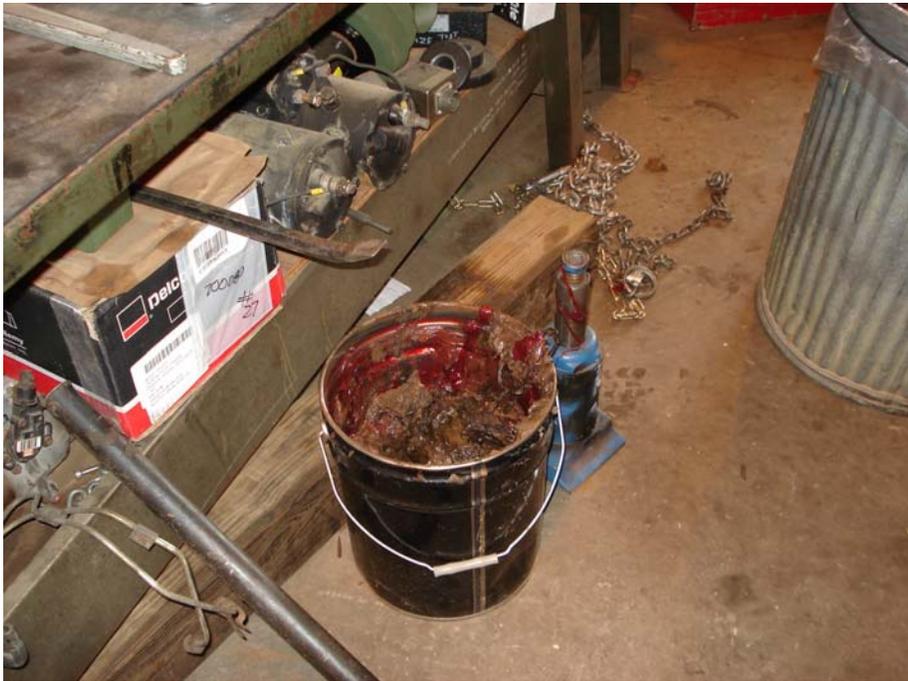
**Photo 30:** Grease was stored in an open container in the northern maintenance shop.

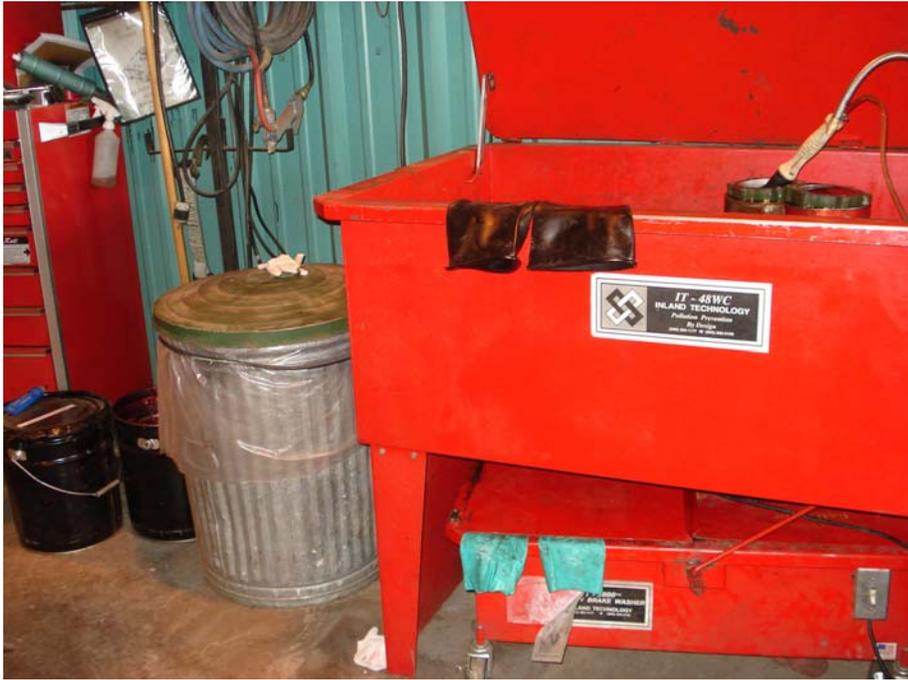
**Photo 31:** A parts washer in the northern maintenance shop was open.

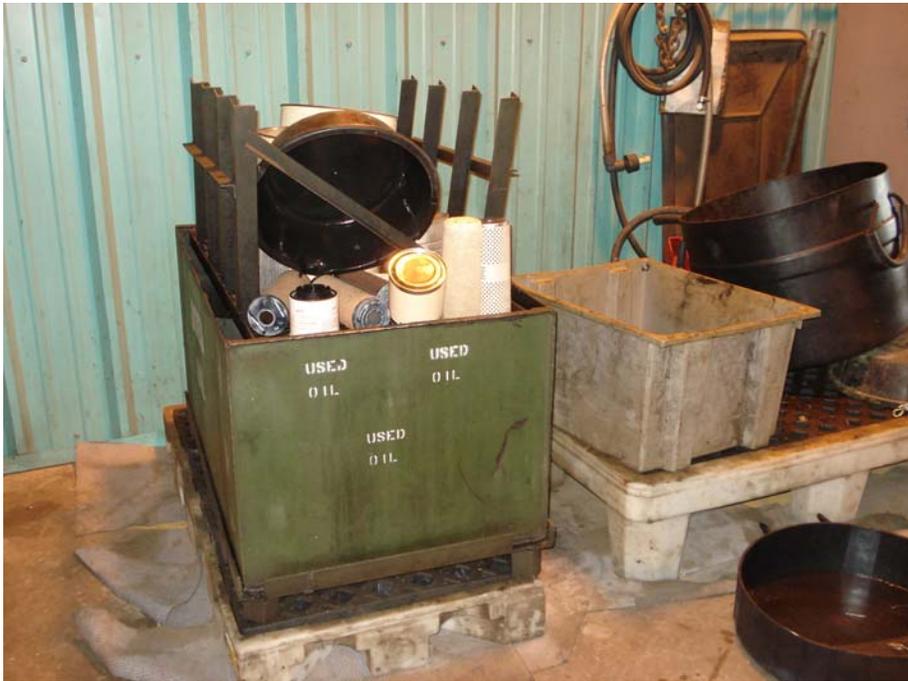
**Photo 32:** Oil containers are stored over secondary containment.

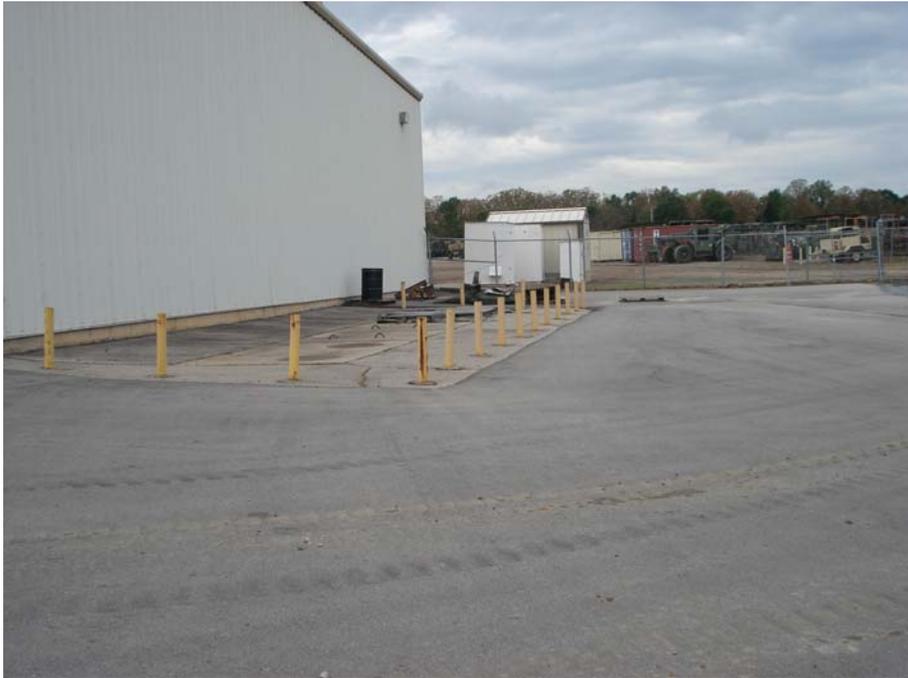
**Photo 39:** An oil-water separator for both maintenance shops is north of the northern maintenance shop. The oil-water separator has an open grate that is covered with tarps to reduce rainwater infiltration.

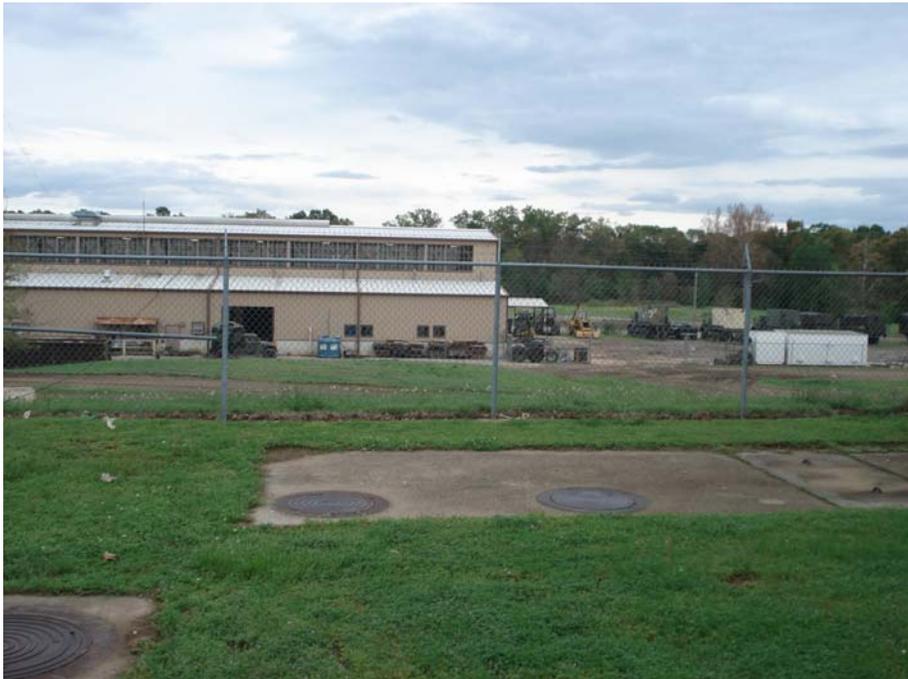
**Photo 40:** The oil-water separator for the vehicle wash rack (VWR) is currently not in use.

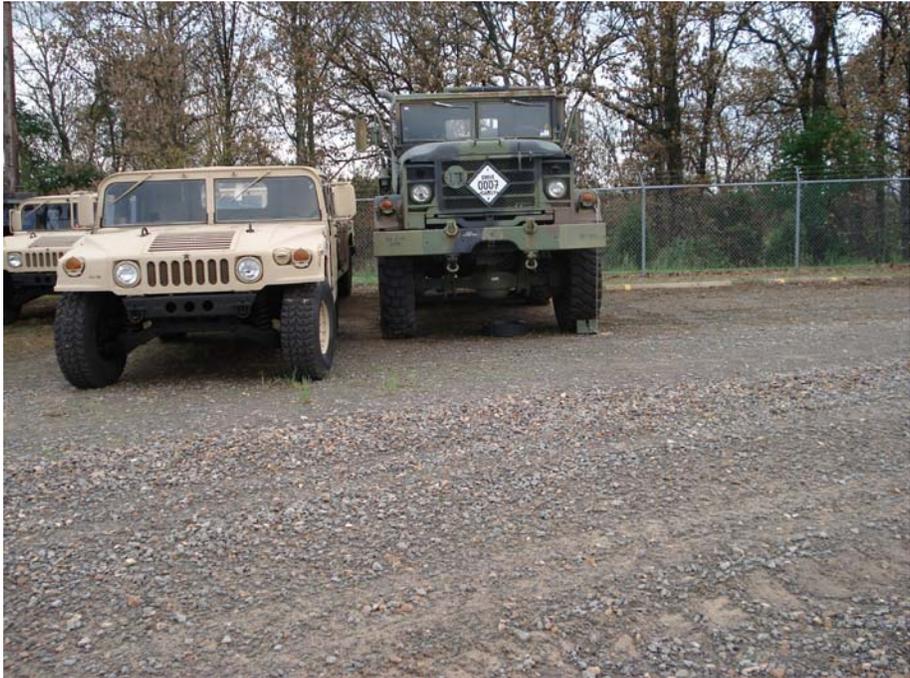
**Photo 43:** Many vehicles in the MEP area have pans under them to collect oil drips.

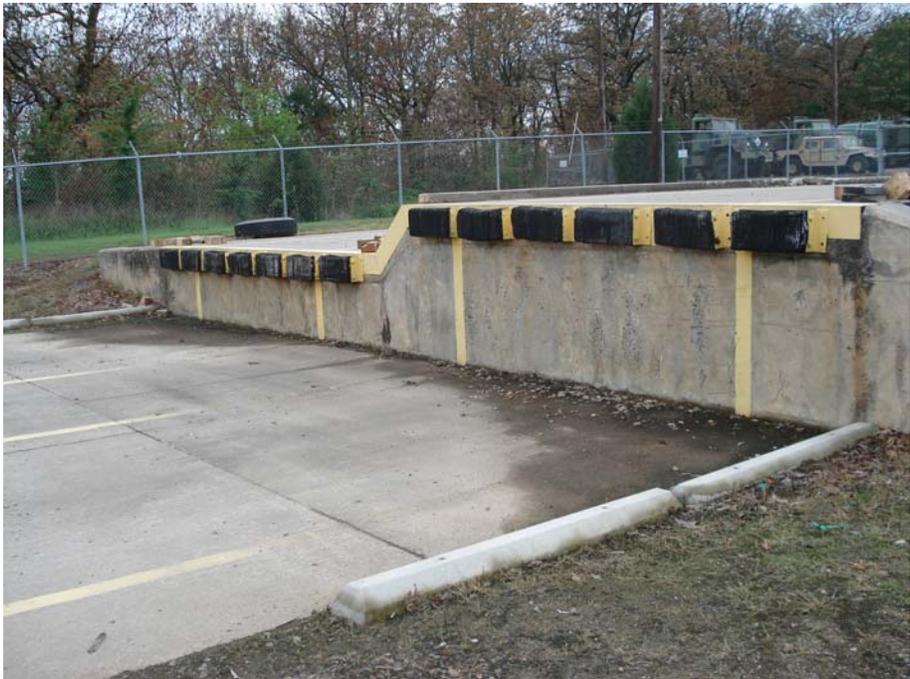
**Photo 44:** The MEP area has a multi-level loading dock.

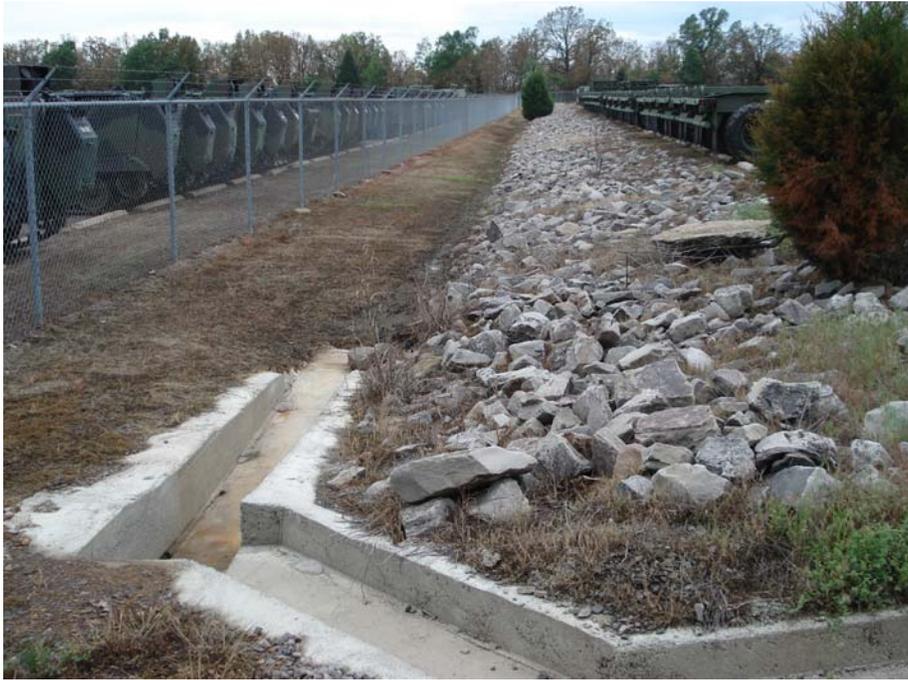
**Photo 45:** A ditch crosses the MEP area to collect storm water runoff.

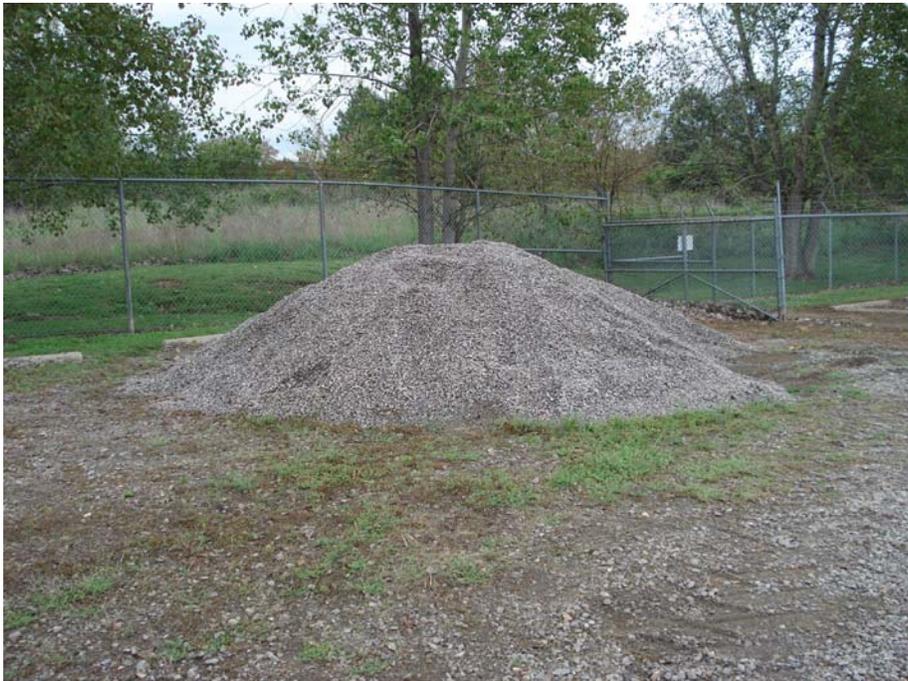
**Photo 46:** A gravel pile on the northwest side of the MEP area is used to replenish gravel in the area.

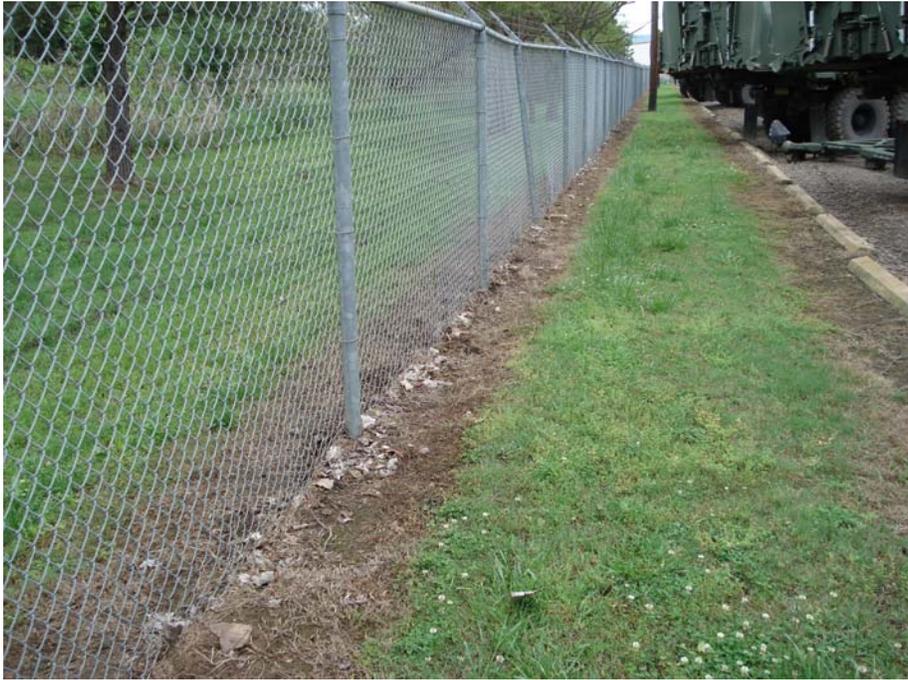
**Photo 47:** The fence line is sprayed with herbicides to reduce the amount of lawn care.

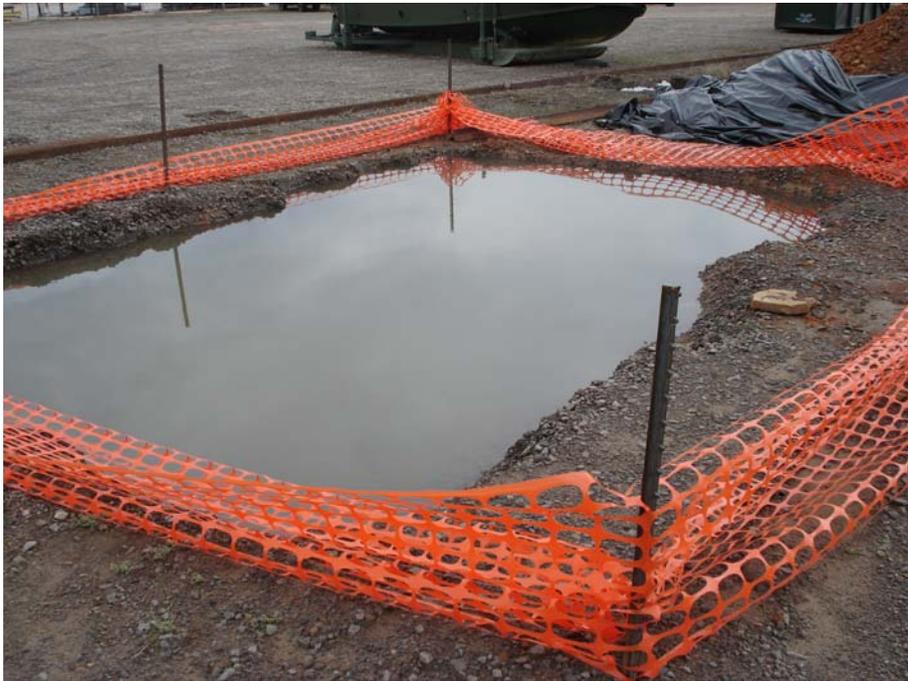
**Photo 48:** A diesel release in the MEP area was remediated by removing the impacted soil. Confirmation samples were collected and the excavation was still open during the Site reconnaissance pending the receipt of sample results.

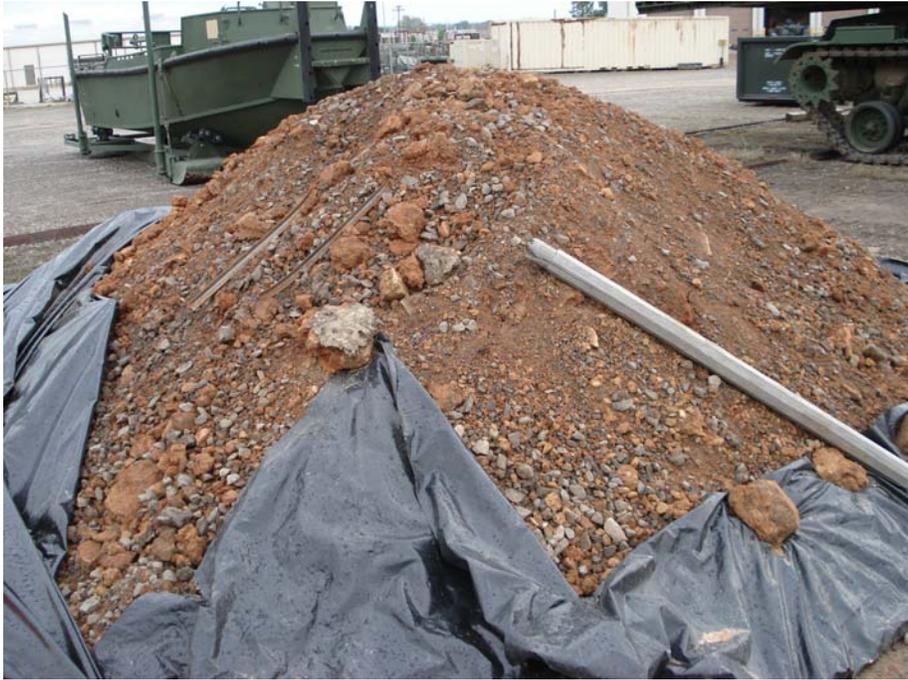
**Photo 49:** The soil removed from the diesel release area in the MEP area is staged for offsite disposal.

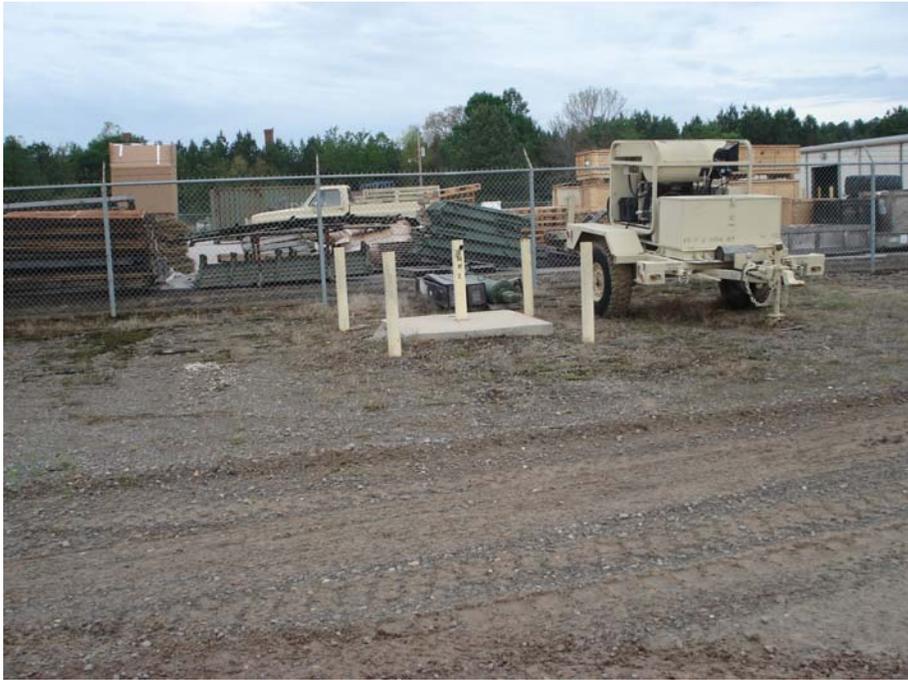
**Photo 50:** One of three monitoring wells on the Site was installed as part of the landfill investigation activities. The fence behind the well encloses an outdoor equipment storage area for the warehouse.

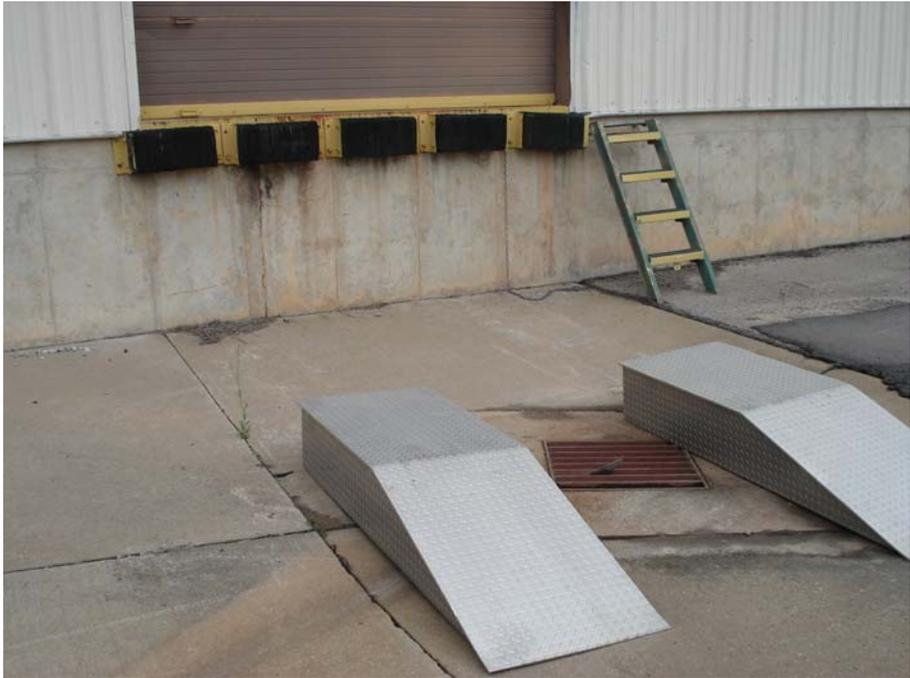
**Photo 59:** The loading dock for the warehouse has a grated storm water drain between the ramps.

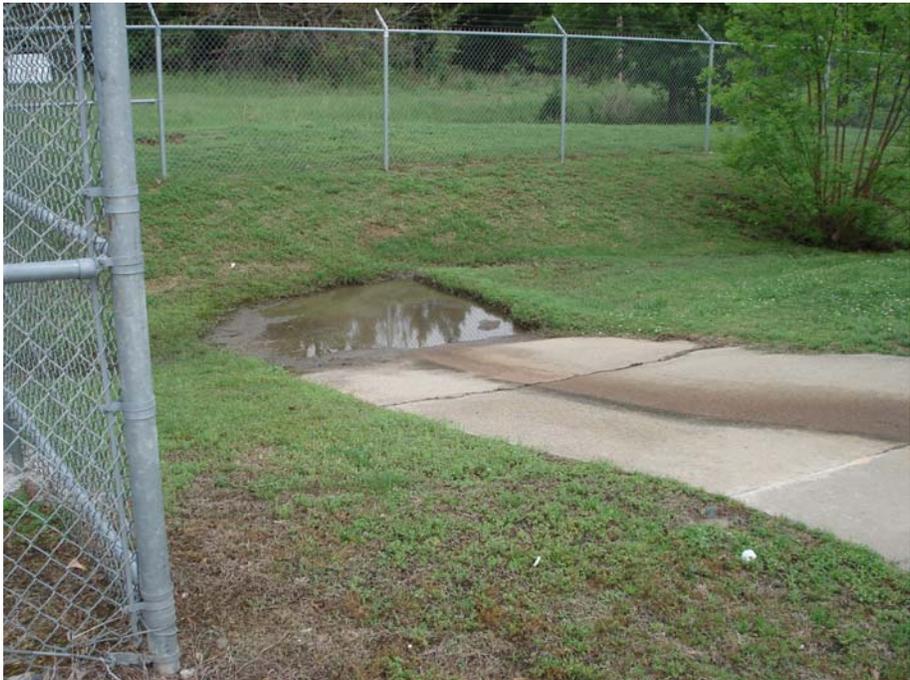
**Photo 60:** A concrete swale southwest of the warehouse directs storm water from the asphalt paved area to a ditch on the northwest side of the warehouse.

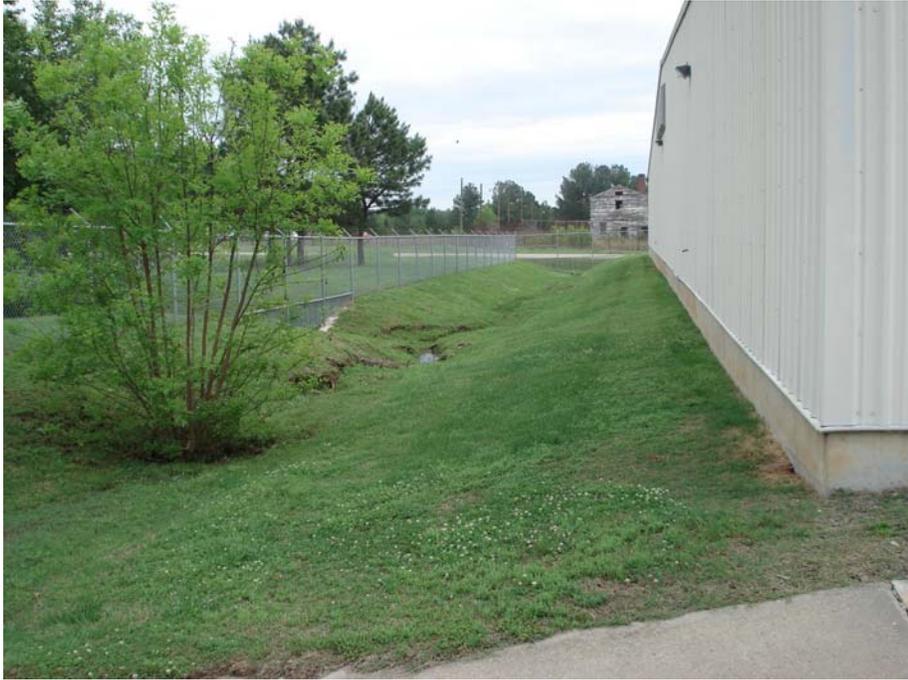
**Photo 61:** The ditch on the northwest side of the warehouse conveys storm water into ditches along Roberts Boulevard.

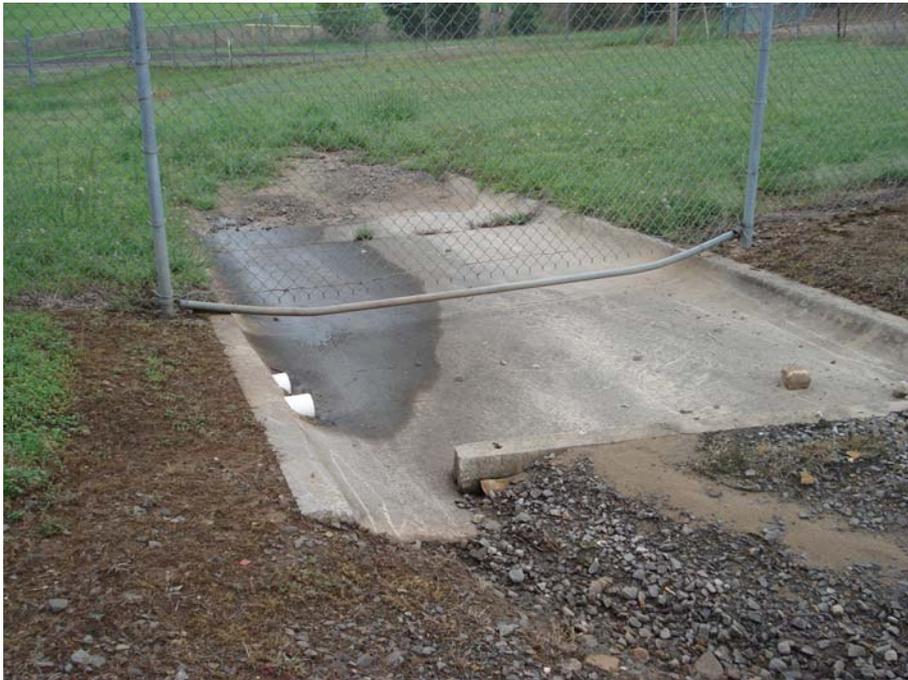
**Photo 62:** A concrete-paved storm water outfall on the south side of the Site discharges to the adjacent property to the southeast.

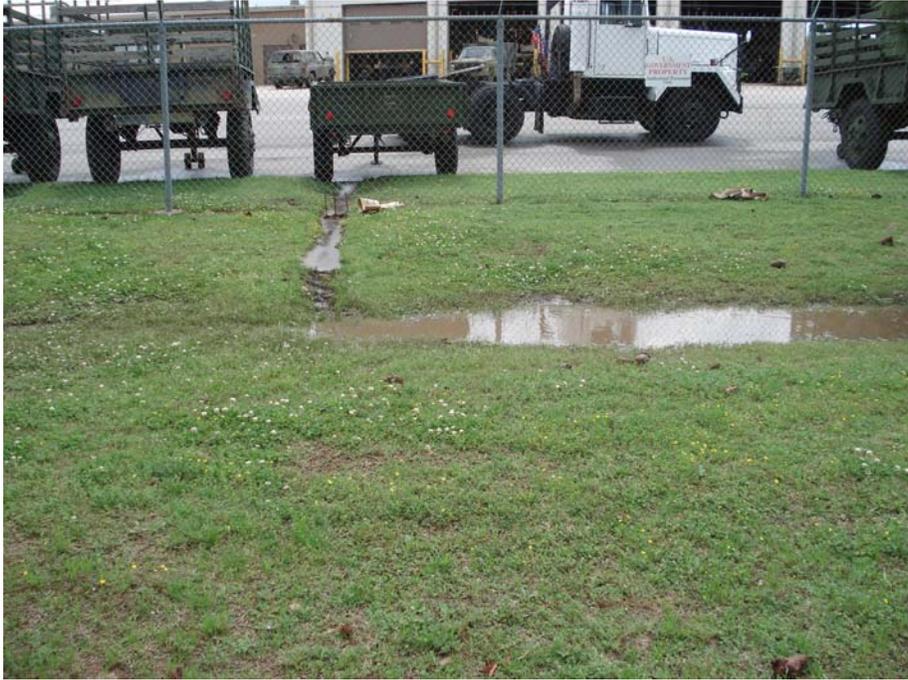
**Photo 63:** Storm water from the asphalt paved area north of Building 470 discharges storm water to the north, and eventually into a ditch along Roberts Boulevard.

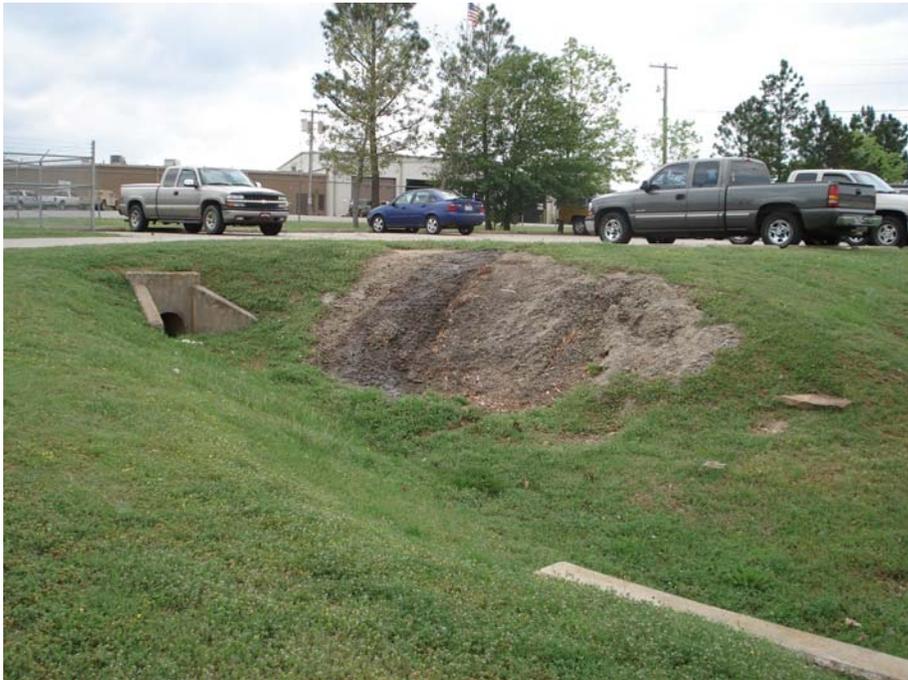
**Photo 64:** A storm water outfall on the north side of the Site conveys water into the ditch along Roberts Boulevard. Some erosion of soil near the POV parking area is visible.

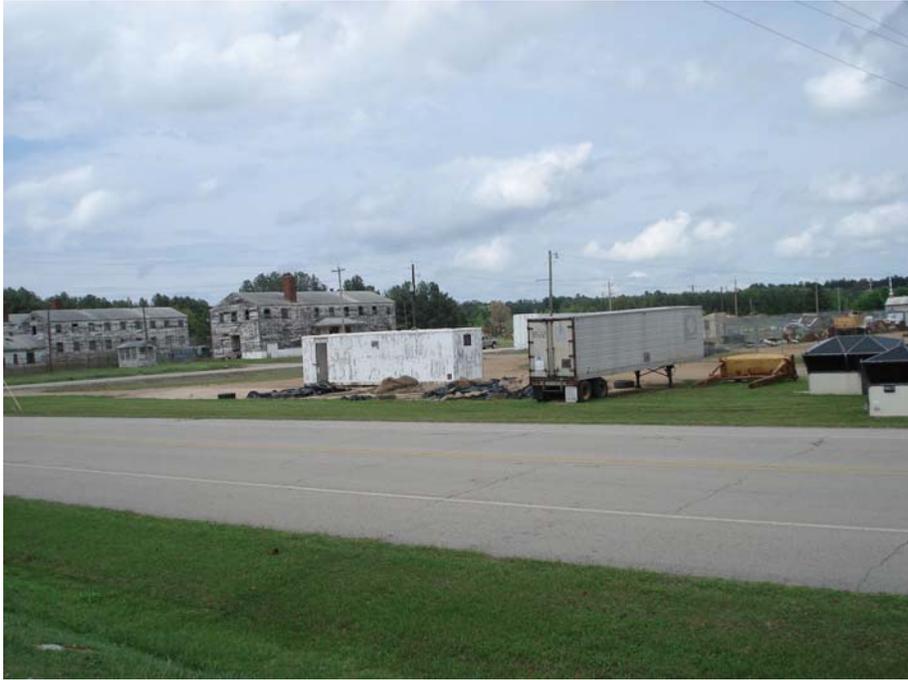
**Photo 65:** View to the north from the north property boundary. To the northeast of the Site are Roberts Boulevard and then structures formerly used by Fort Chaffee.

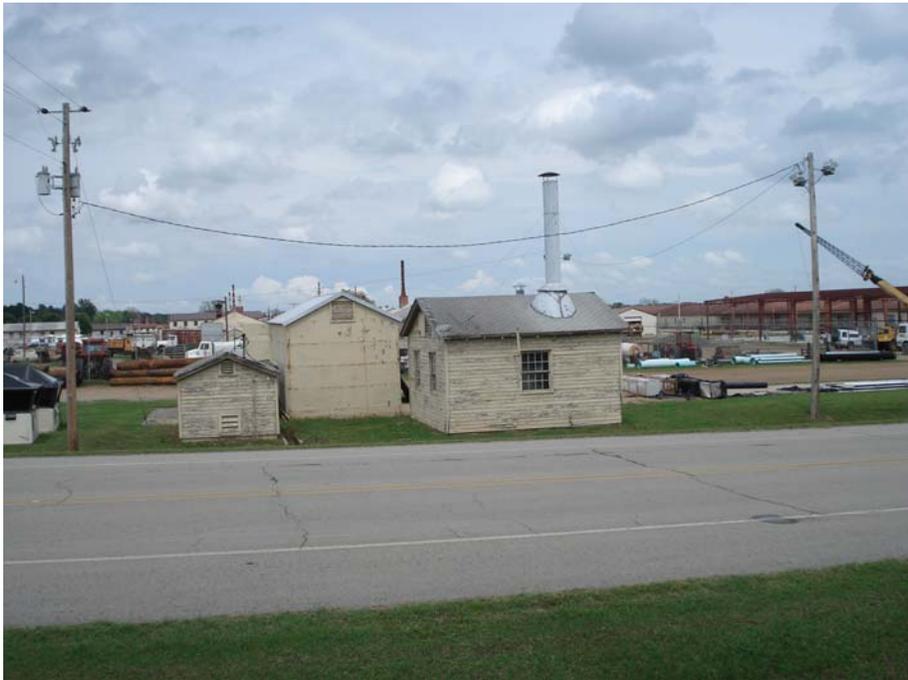
**Photo 66:** View to the northeast from the north property boundary. Across Roberts Boulevard are more Fort Chaffee structures.
