**Appendix B**  
**Site Reconnaissance Photographs**

**Equipment Concentration Site #15  
Fort Smith, Arkansas**

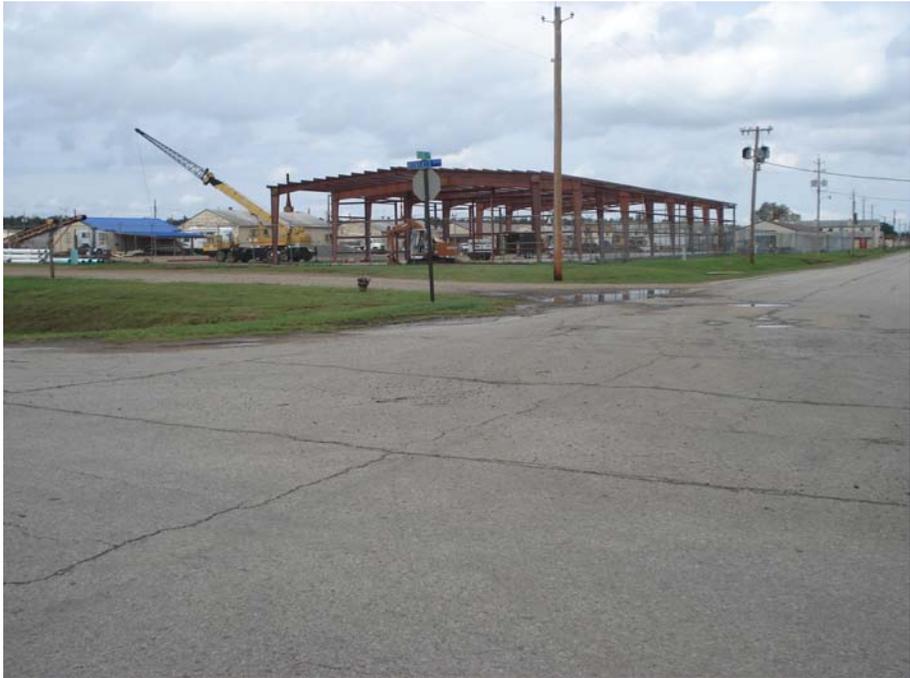
**Photo 67:** View to the east from the north property boundary. Some Fort Chaffee structures have been demolished and are being replaced by new construction.

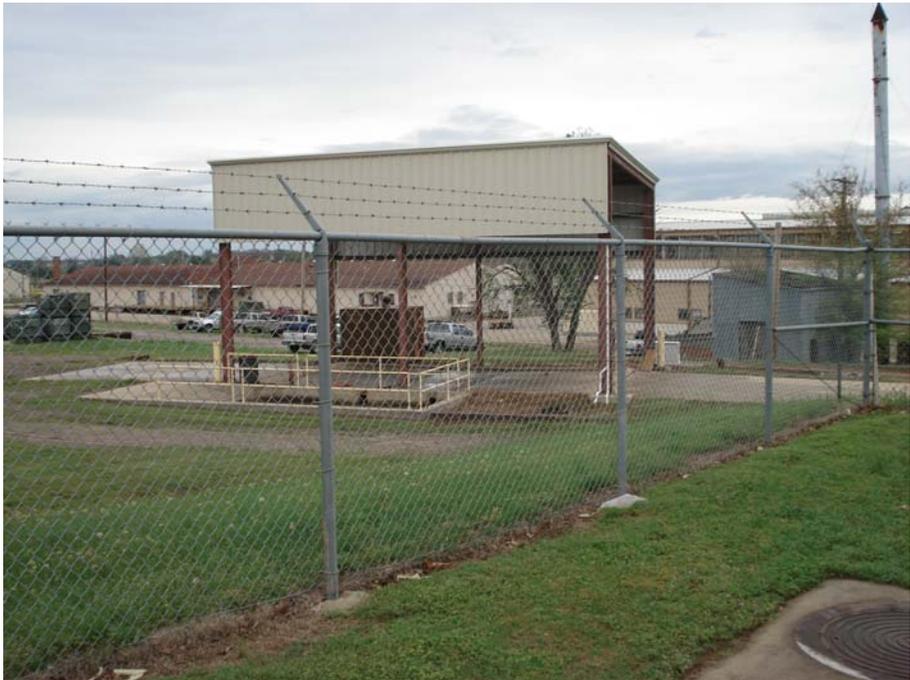
**Photo 68:** To the southeast of the Site is another wash rack, used by the Army National Guard.

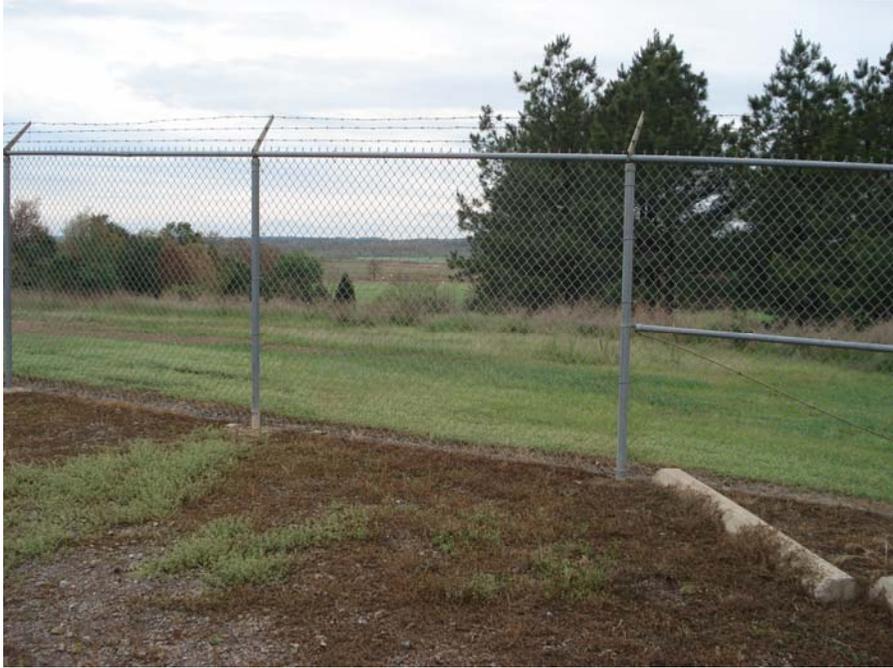
**Photo 69:** View to the south from the MEP area southern boundary. Woods and fields are south of the Site.

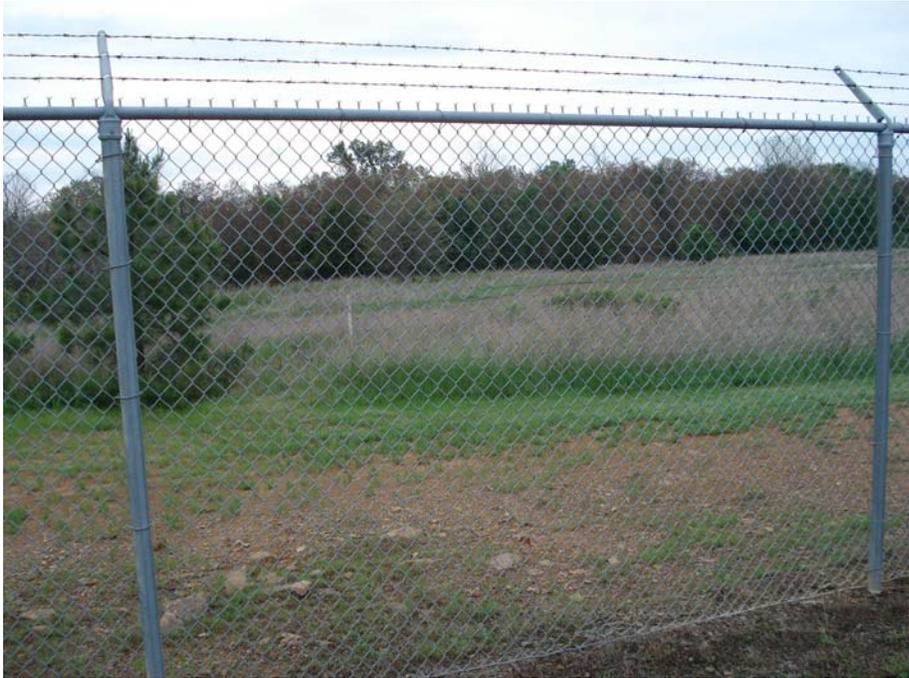
**Photo 70:** View to the west from the west side of the MEP area. The land is not developed, but it may have been part of the former sanitary landfill.

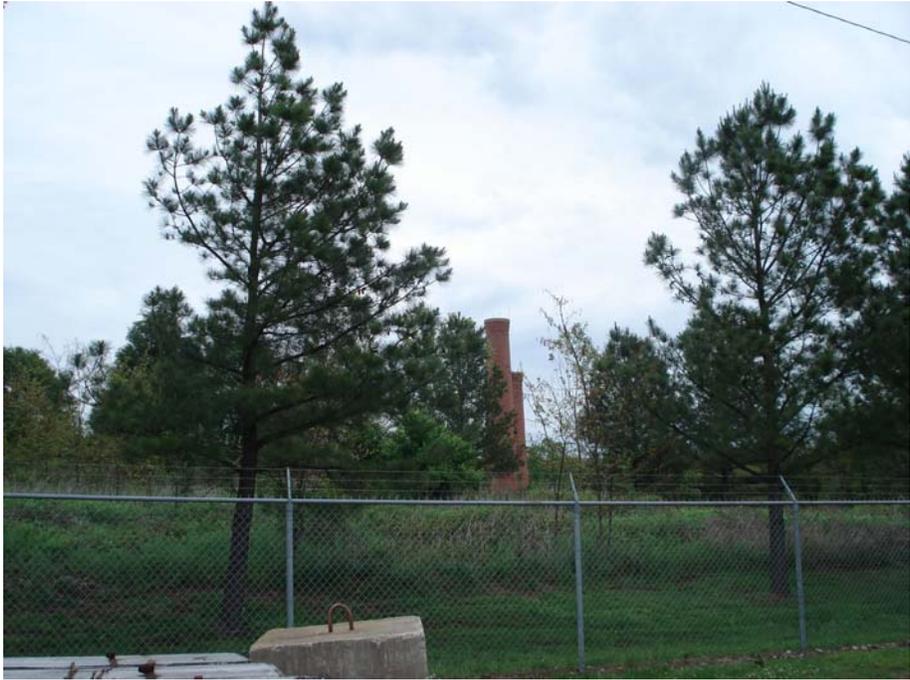
**Photo 71:** View to the north from the north boundary of the MEP area. The incinerator stacks are remnants of incinerators formerly used by Fort Chaffee.
