Appendix B
Site Reconnaissance Photos

**Grimes Memorial USAR Center
4300 S. Treadaway Boulevard
Abilene, Texas**

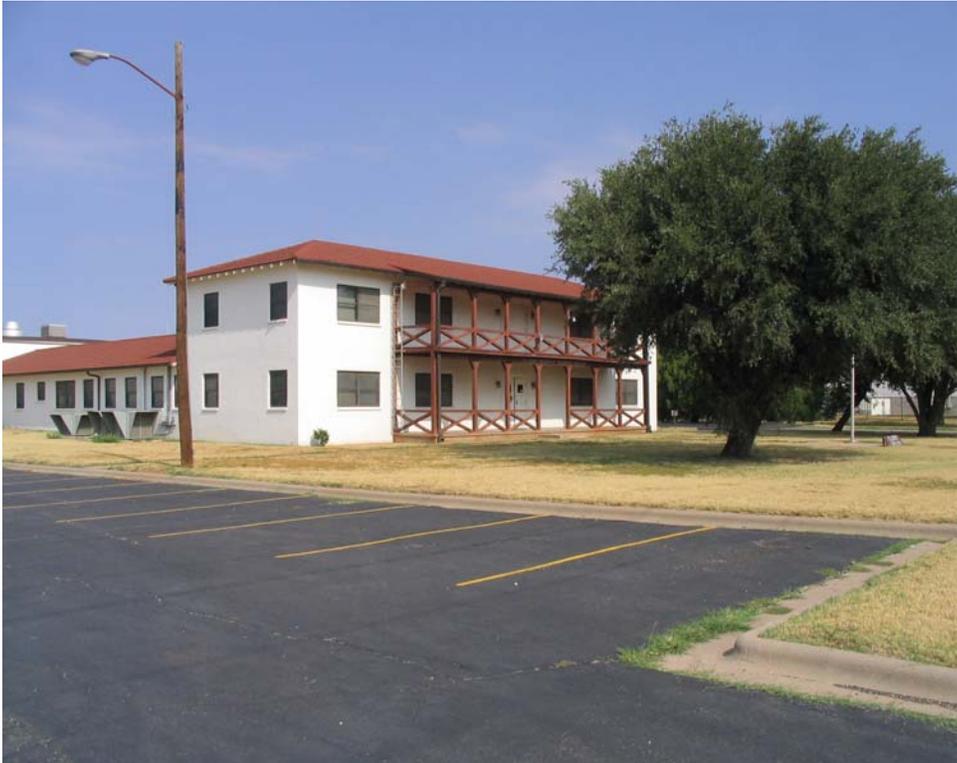
Photo 1: The Grimes Memorial USAR Center as viewed from South Treadaway Boulevard. The red tile roof is on the portion of the building that was built in 1951.

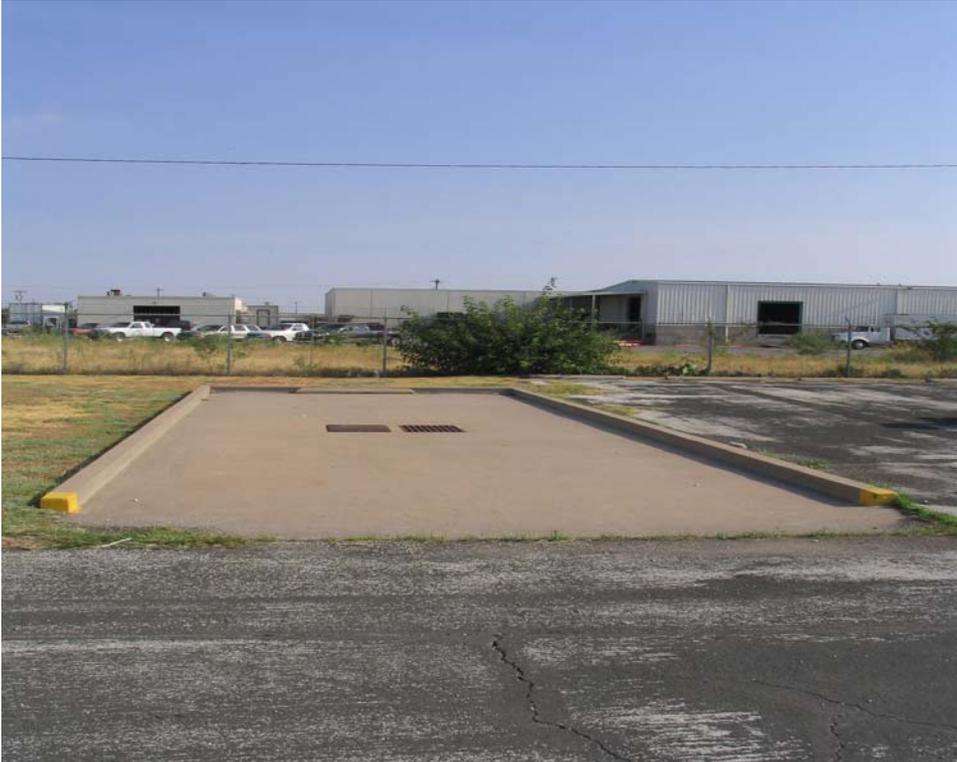
Photo 2: View of the VWR located on the east side of the OMS. Grates in the center are the OWS. Bill Reed Distributing, to the north, is in the background.

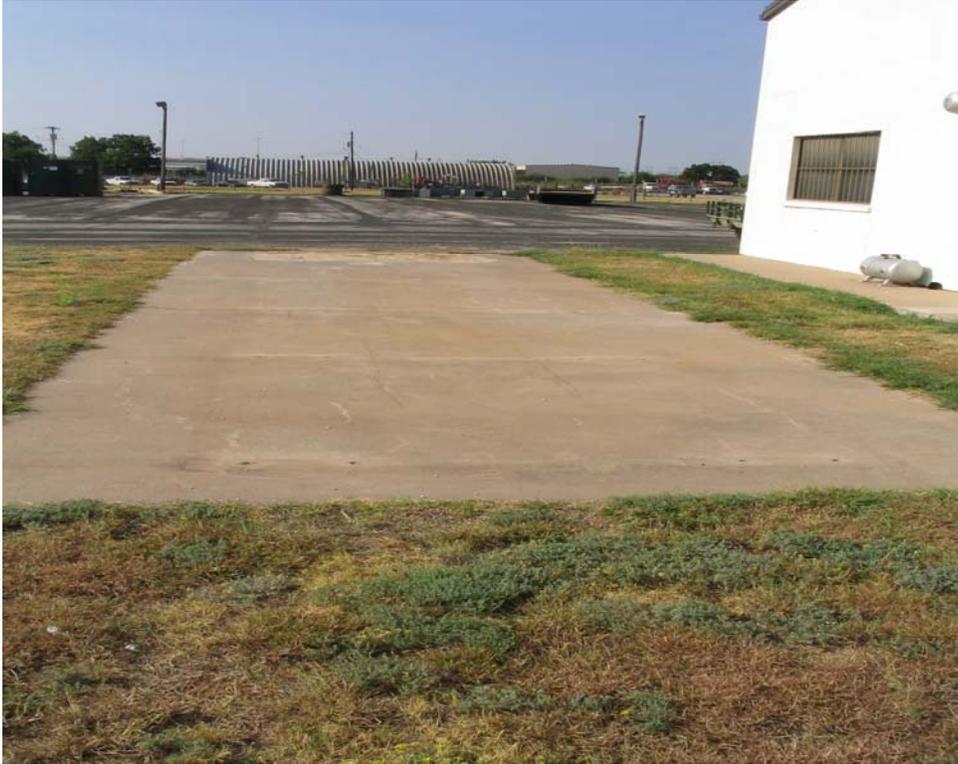
Photo 3: View of foundation of former grease rack on east side of OMS. The VWR is adjacent east of the grease rack, just out of view to the left. View is toward the south with the MEP area in the background.

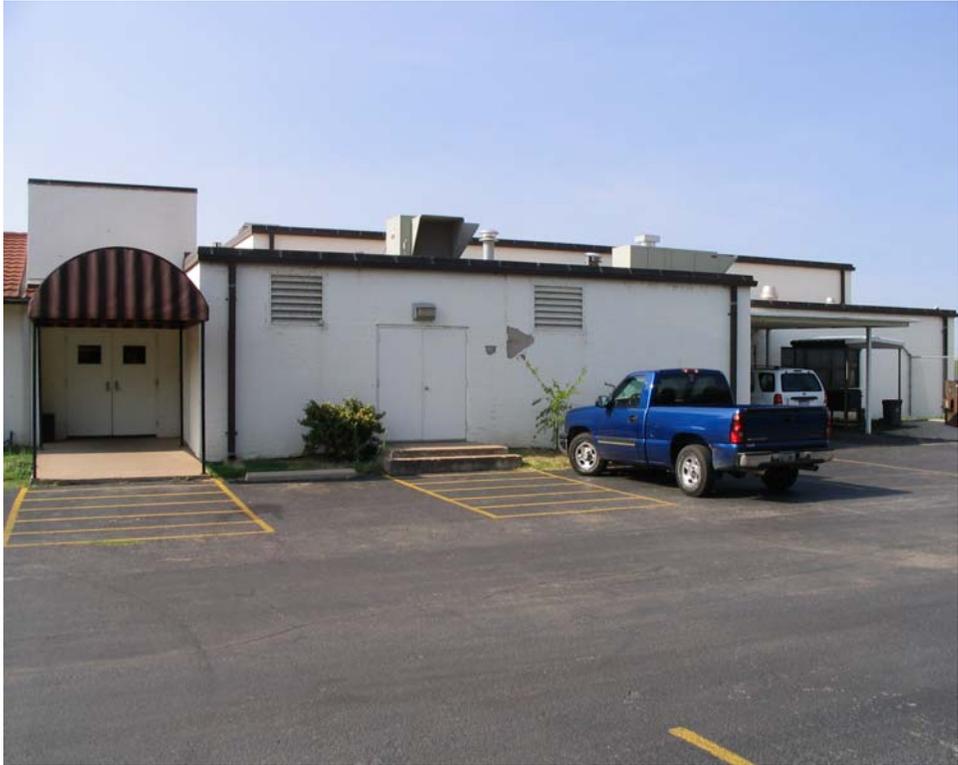
Photo 4: Building addition to USAR Center constructed in 1979. Note the flat tar roof on the addition as opposed to the red tile roof on the original building (Photograph 1).

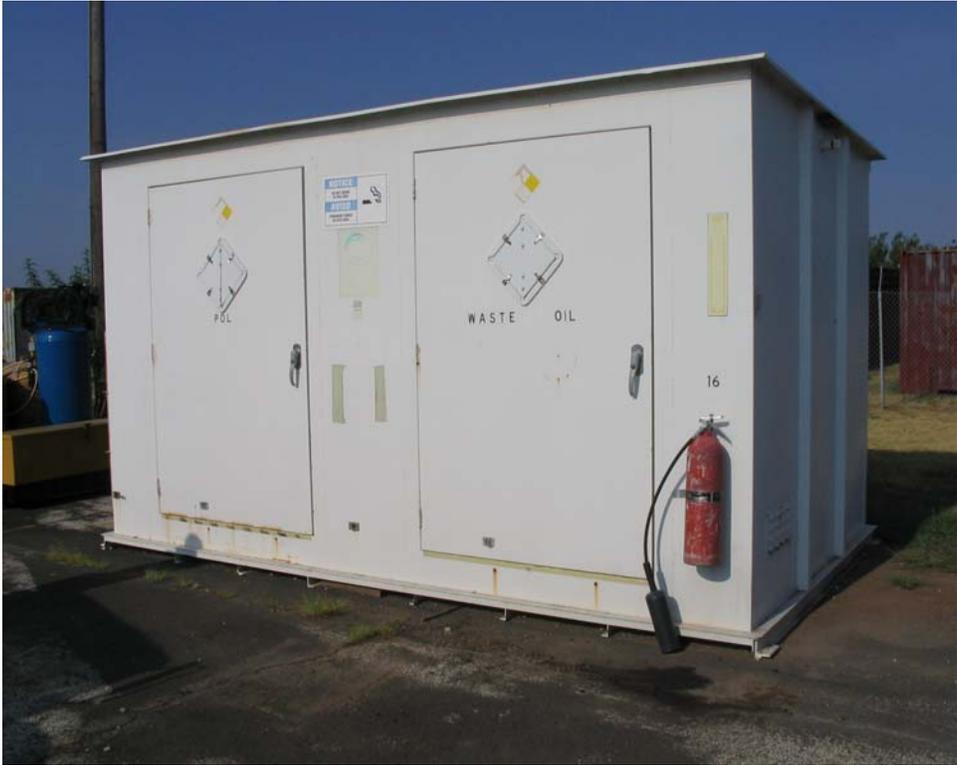
Photo 5: Hazardous materials storage shed located south of the OMS in the MEP area.

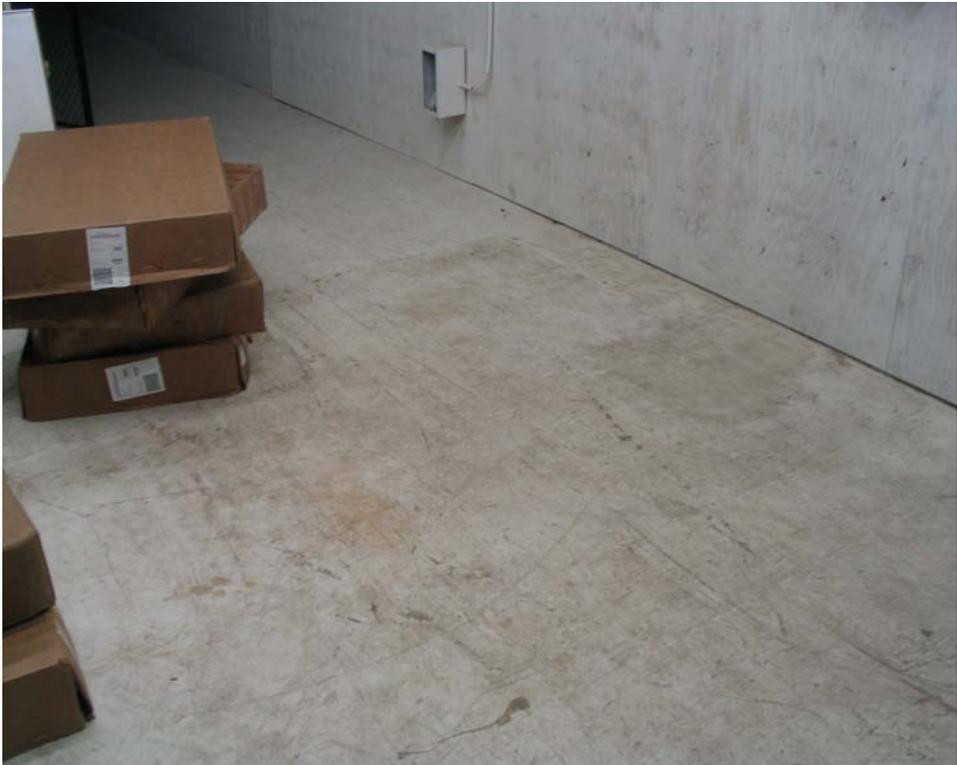
Photo 6: Indoor firing range with concrete floor and plywood walls.

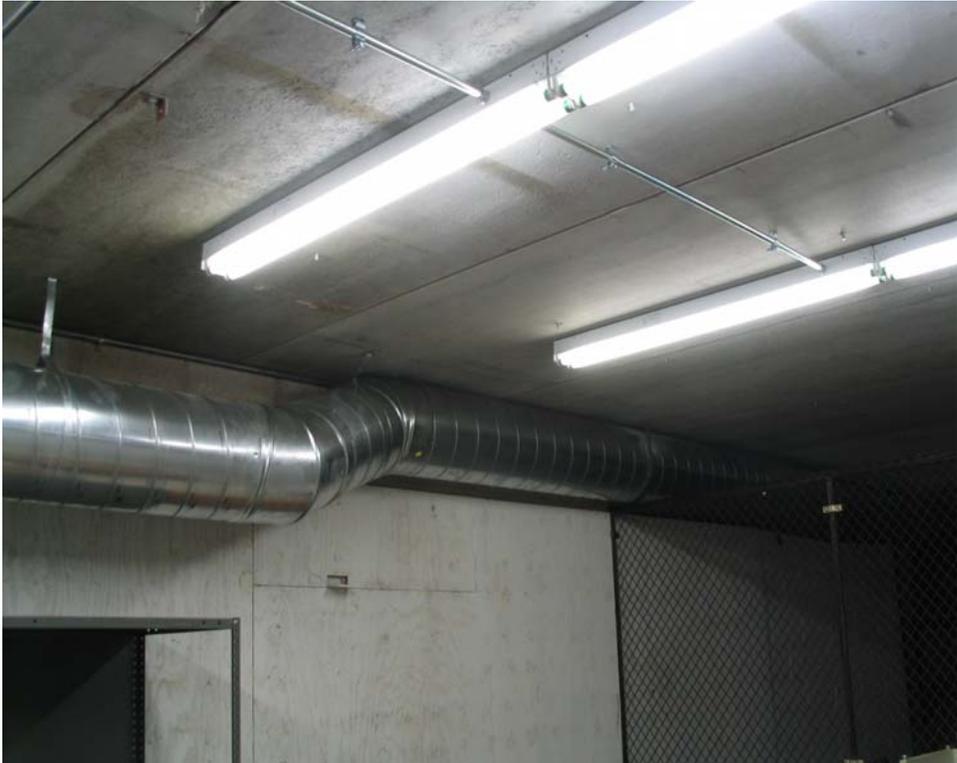
Photo 7: Indoor firing range showing the concrete roof and plywood covered walls.

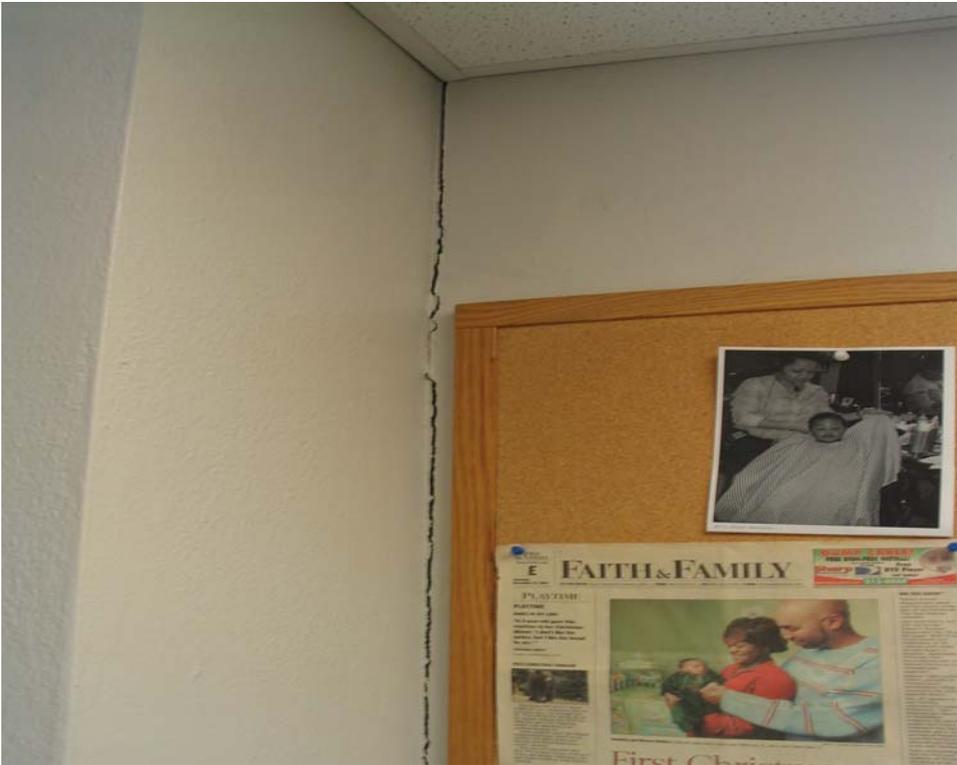
Photo 8: Cracked wall in office area of building constructed in 1951. This crack is present down the full length of the wall, across the floor and up the opposing wall.

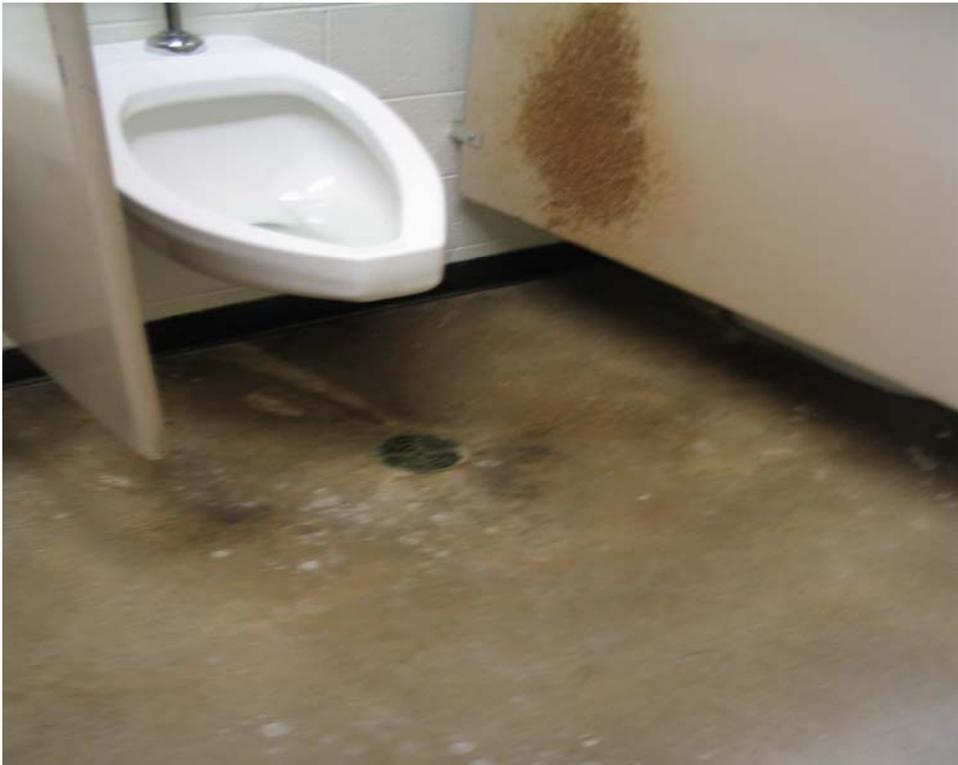
Photo 9: Floor drain in OMS restroom. This floor drain is typical of other floor drains at the USAR Center.

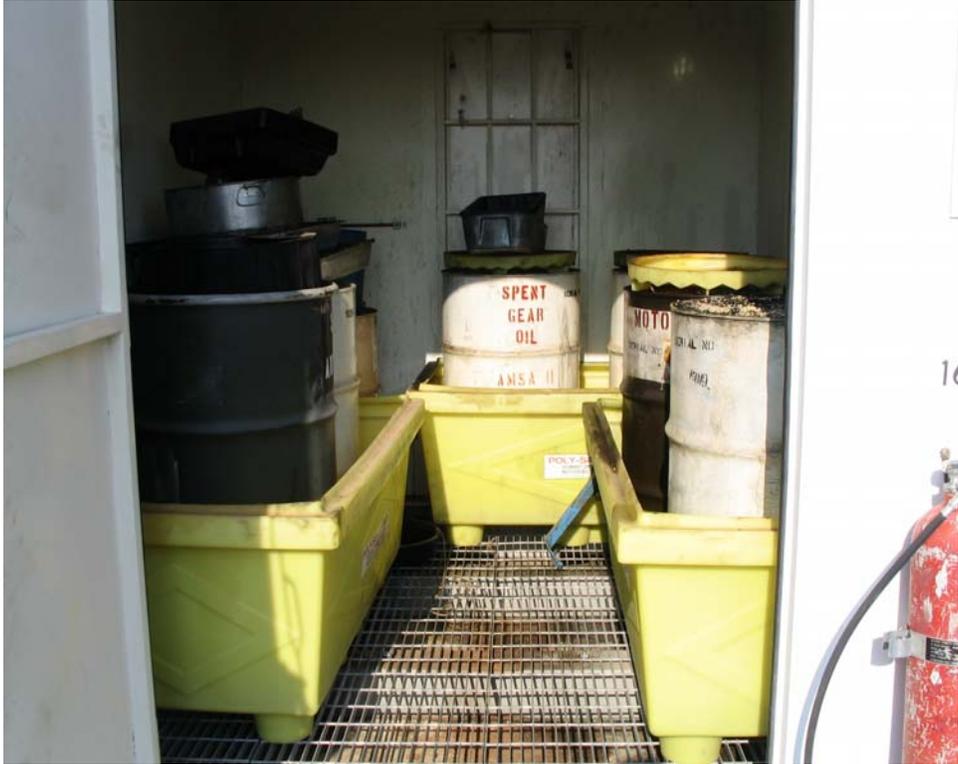
Photo 10: North room of hazardous materials shed showing empty and partially full used oil and antifreeze drums.

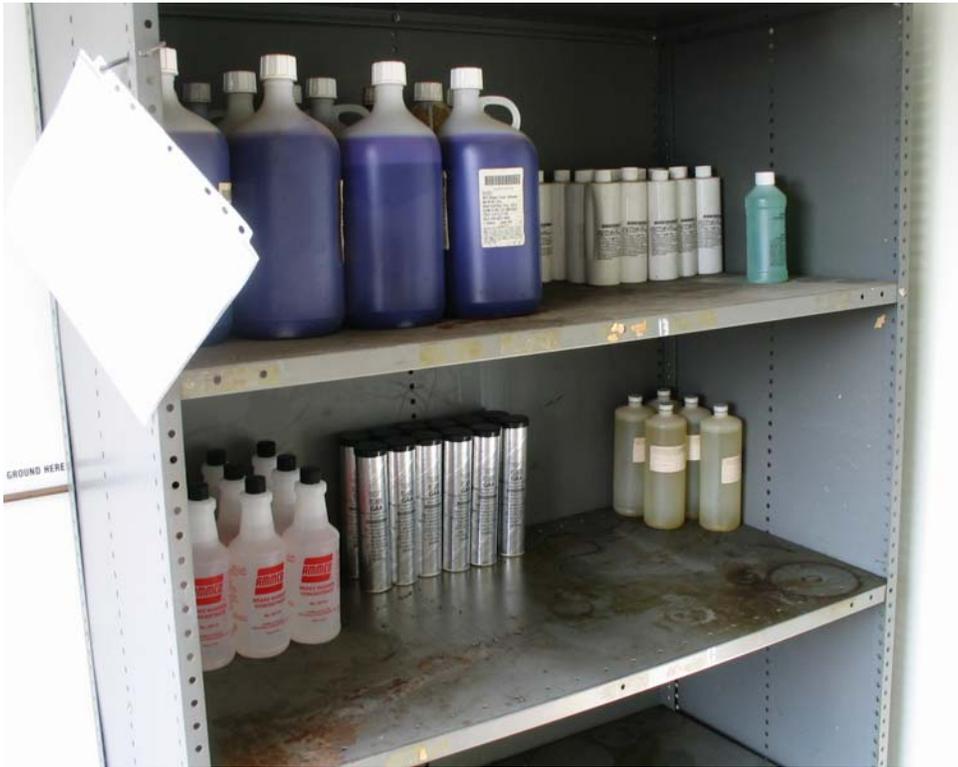
Photo 11: Shelves in south room of hazardous materials shed showing consumer-sized POLs.

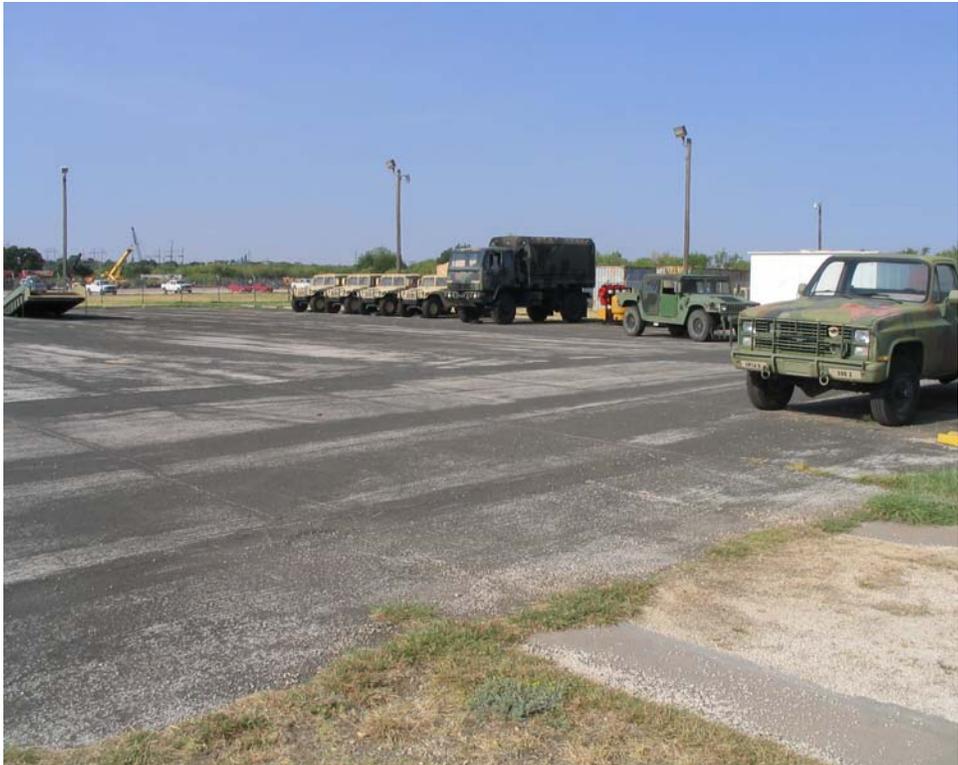
Photo 12: MEP area south of the OMS. The hazardous materials storage shed is visible behind the pick up truck.

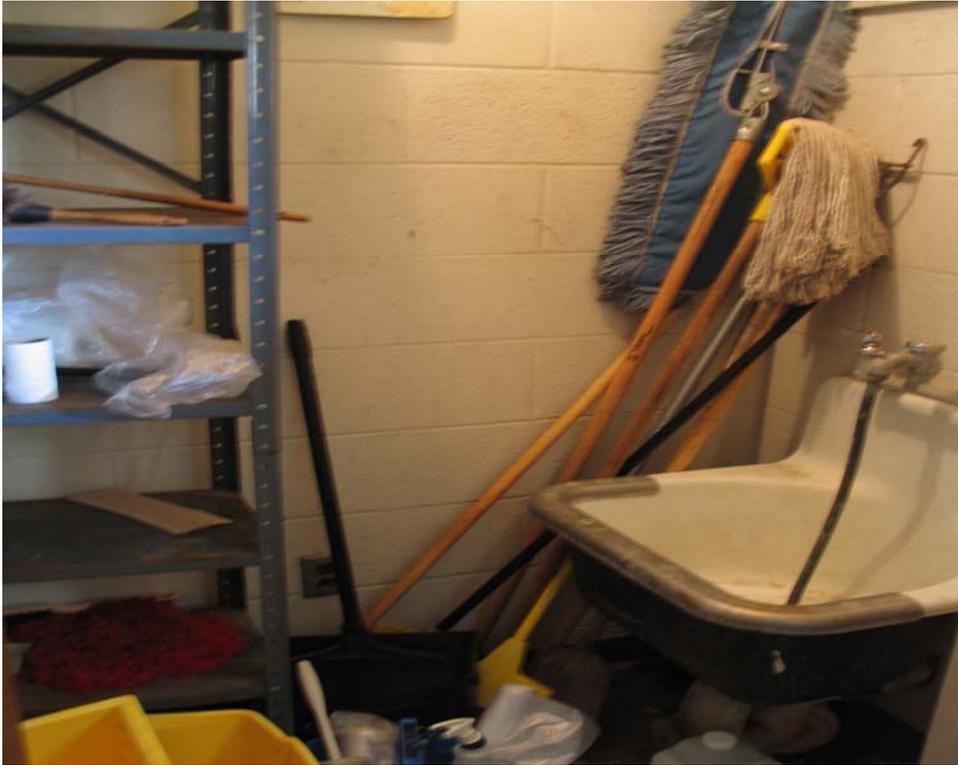
Photo 13: Janitor's closet located in the USAR Center Training Building.

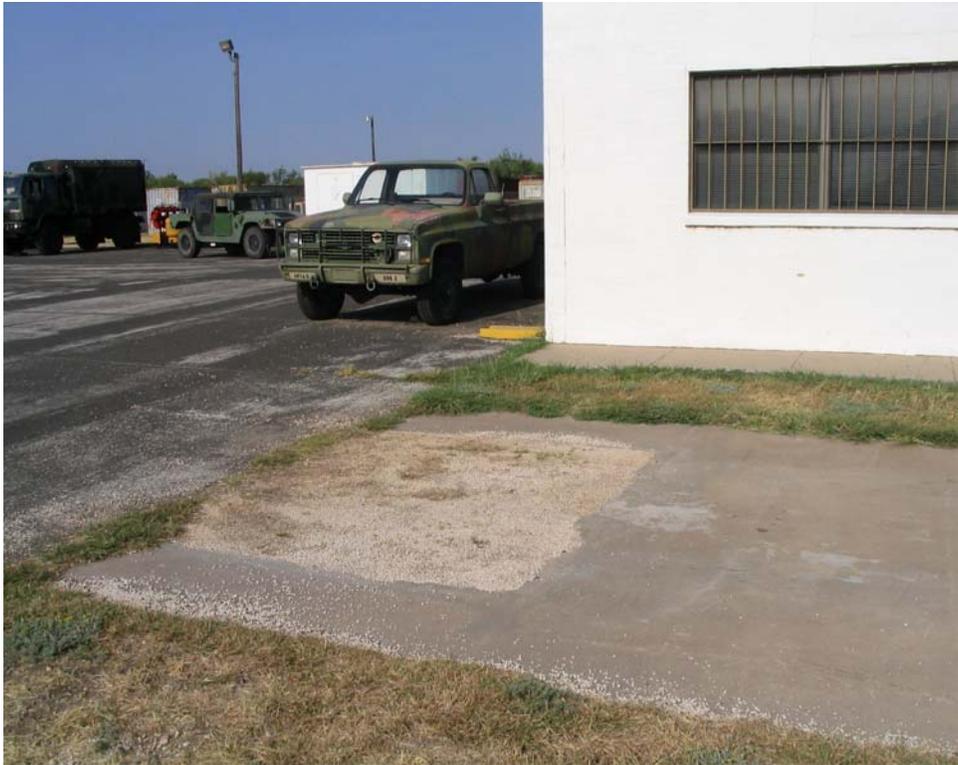
Photo 14: South end of the former grease rack. The tan area in the concrete is fill material. USAR Center personnel were not familiar with why this area had been filled in. The OMS is the building in the background.

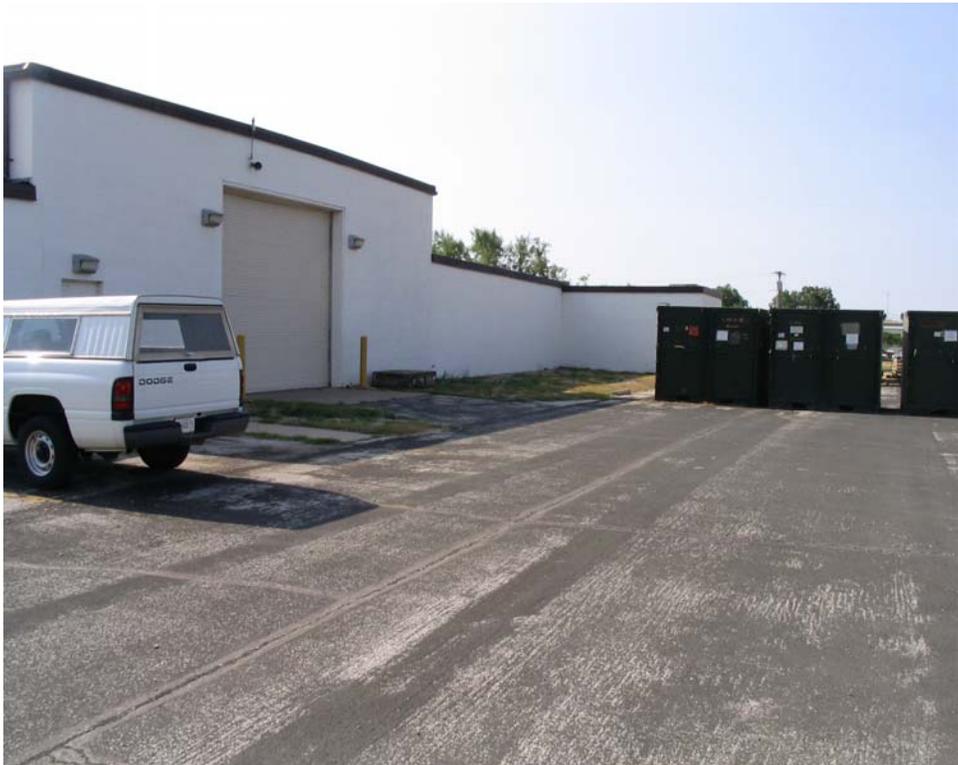
Photo 15: Area west of the Assembly Hall that is depicted on a map in the Parsons 1998 Architectural Assessment report as having two USTs.

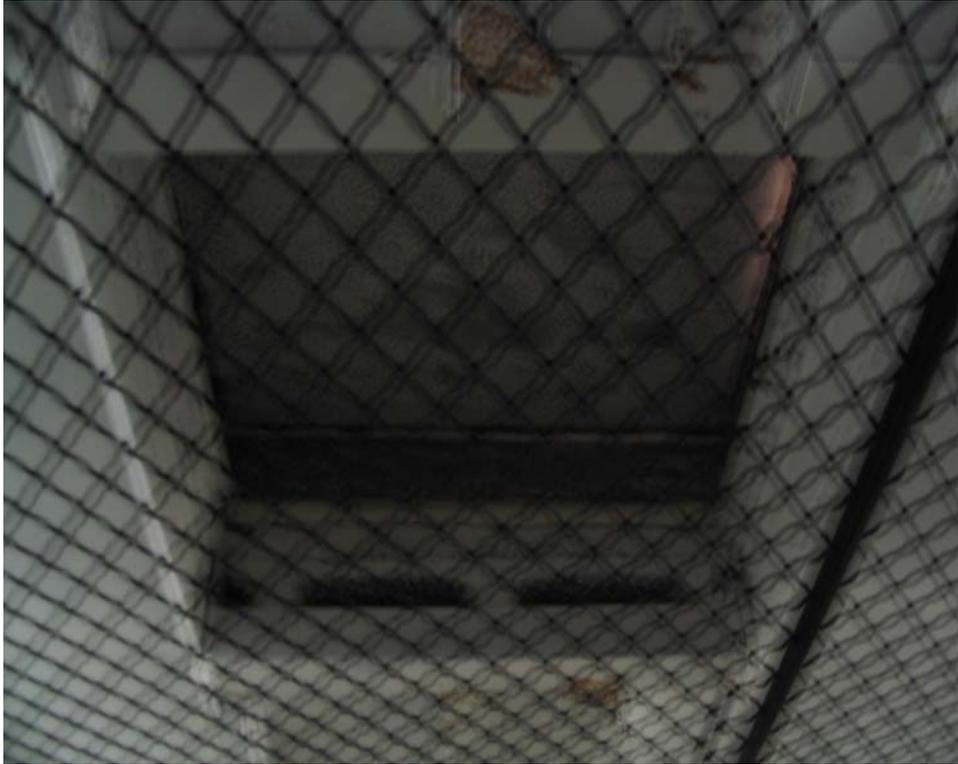
Photo 16: Indoor firing range. The range was decommissioned and the exhaust vent was covered with a metal plate.

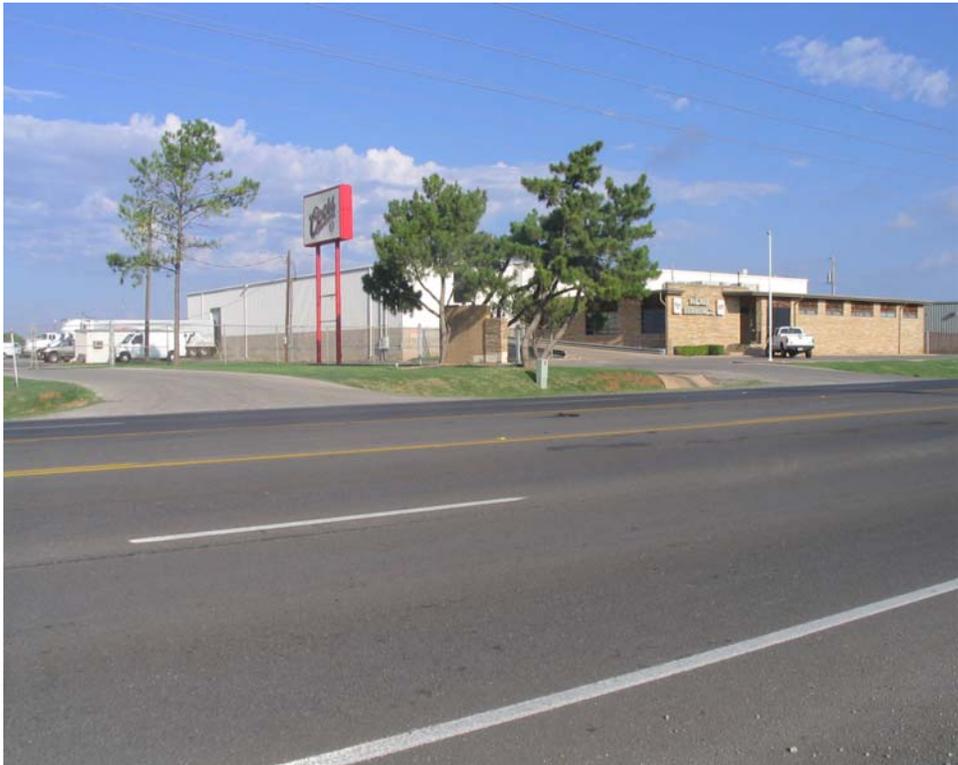
Photo 17: Bill Reed Distributing, located adjacent to the north of the Site.

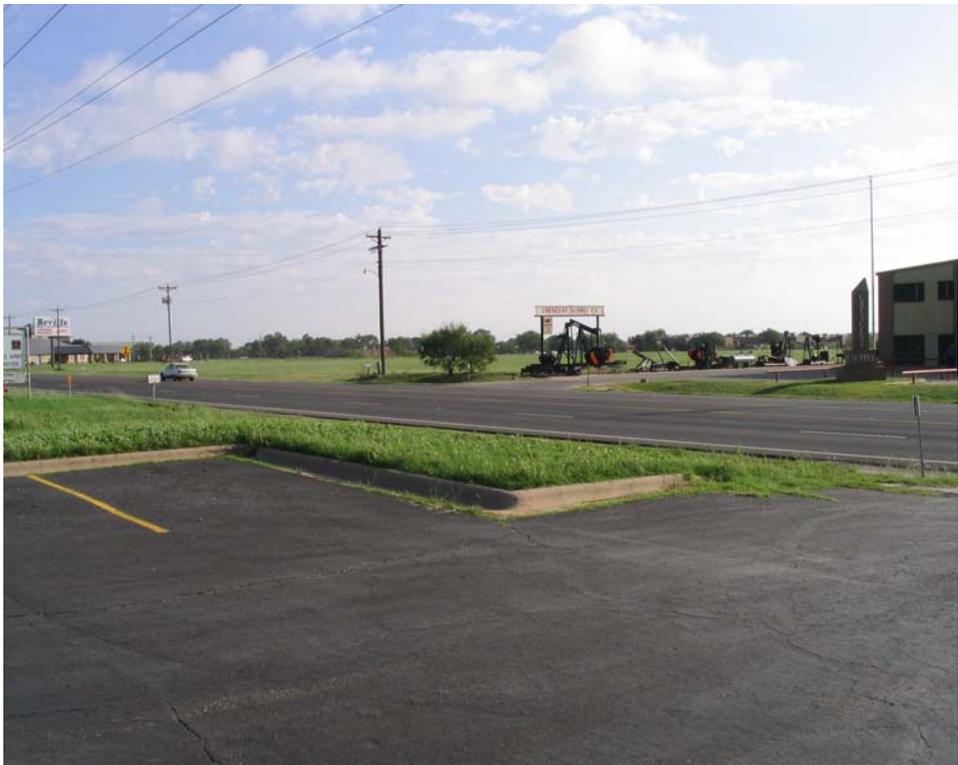
Photo 18: View of the former drive-in theater (vacant lot) across Treadaway from the Site. The southern POV parking area is in the foreground.

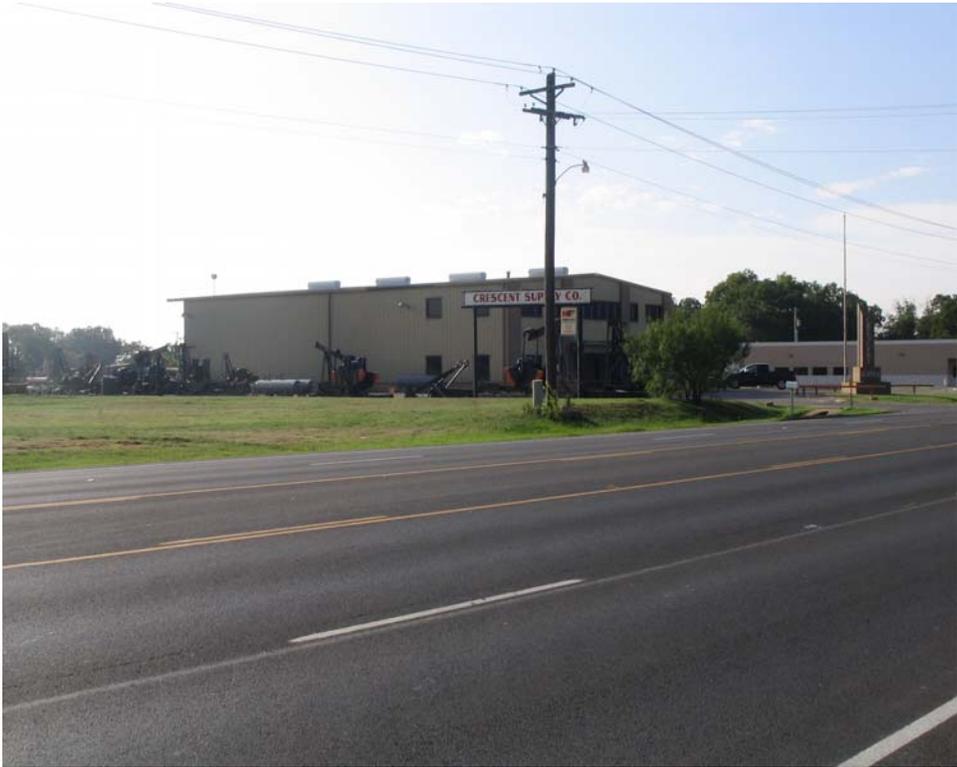
Photo 19: Crescent Supply Company is directly across Treadaway from the Site. Crescent is an oil field equipment supply company. A vacant drive-in is at left of photograph.

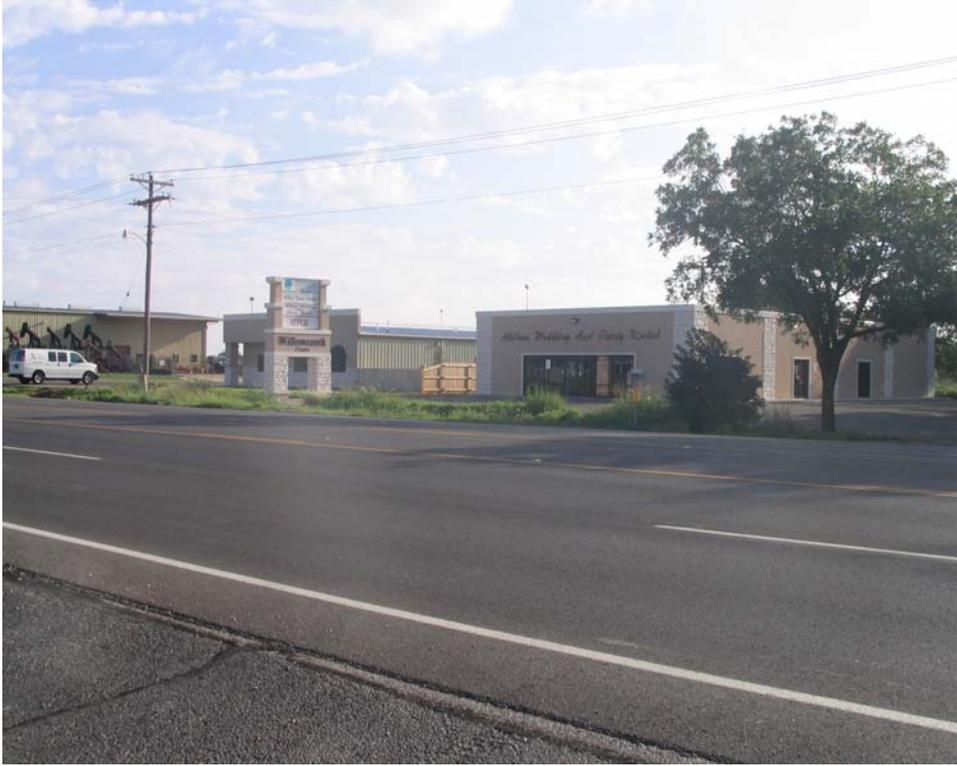
Photo 20: Willow Creek Center is located southwest of the Site across Treadaway. Crescent Supply Company can be seen at the left of the photograph.

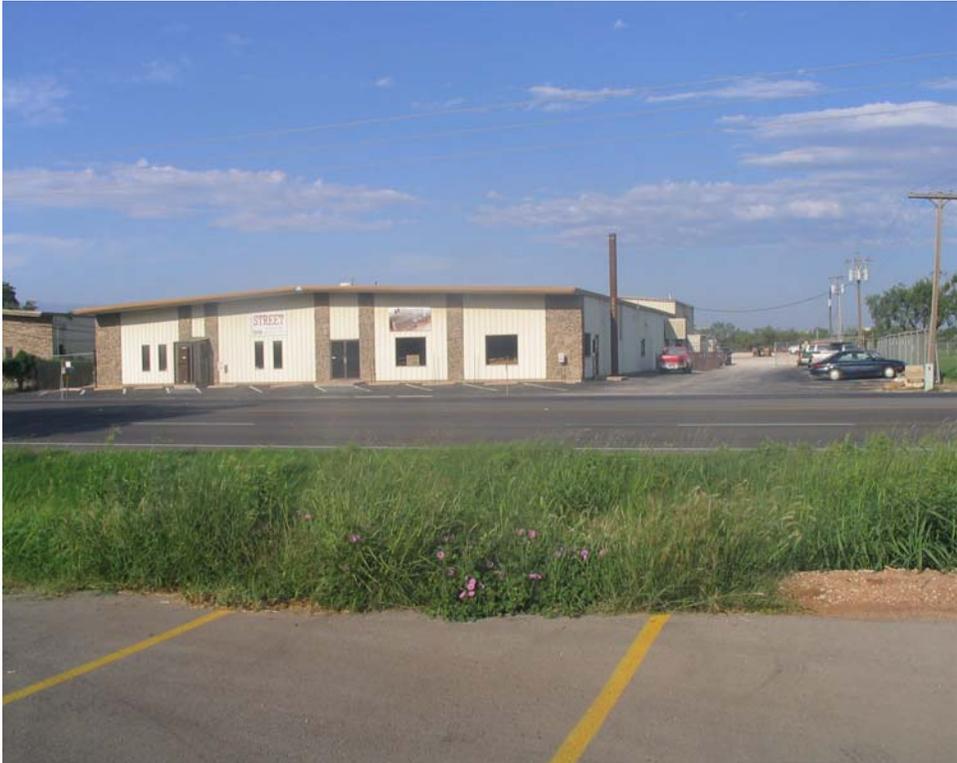
Photo 21: Street Foundation Drilling located adjacent to the south of the Site. The fence on the right side of the photograph is the USAR Center boundary.

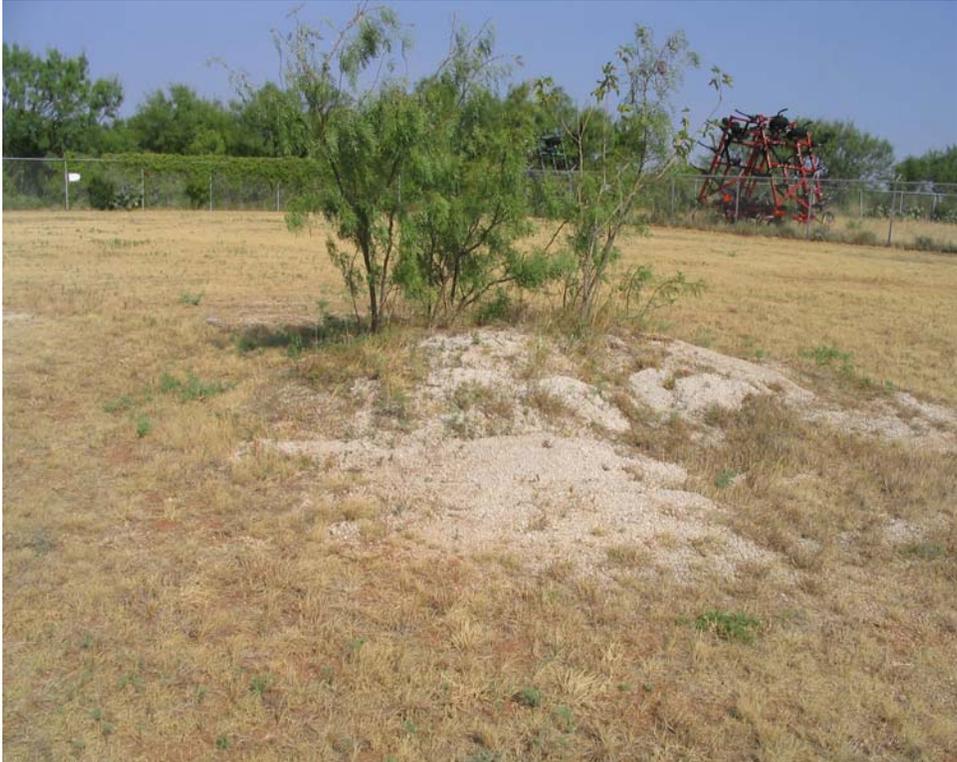
Photo 22: Soil pile west of the MEP area. The soil pile composition is similar to the fill material at the former grease rack. View is to the northwest.

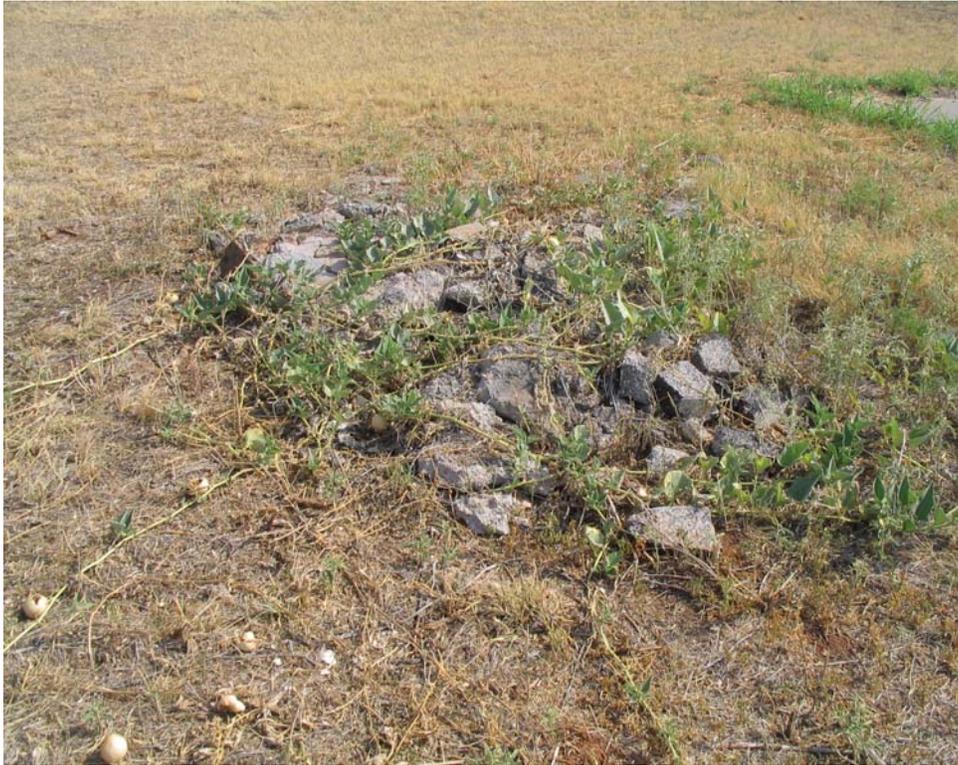
Photo 23: Area of broken concrete near the southeast corner of the fenced area of the Site.

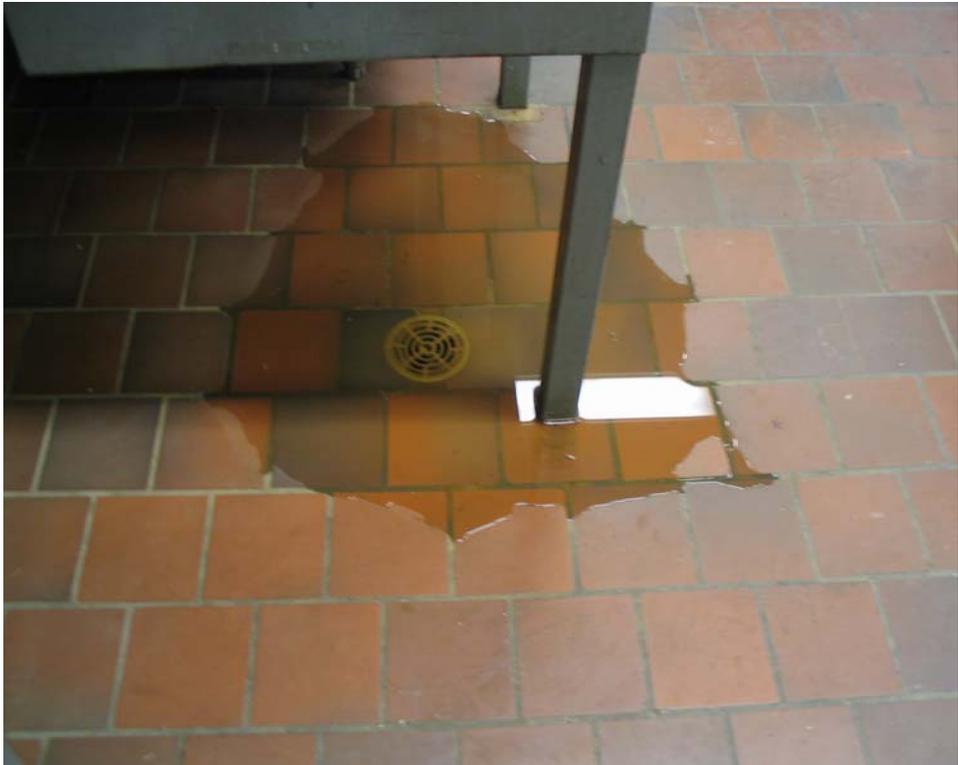
Photo 24: Clogged drain in the kitchen of the USAR Center Training Building. Several other drains in the kitchen were also clogged and backing up onto the floor.

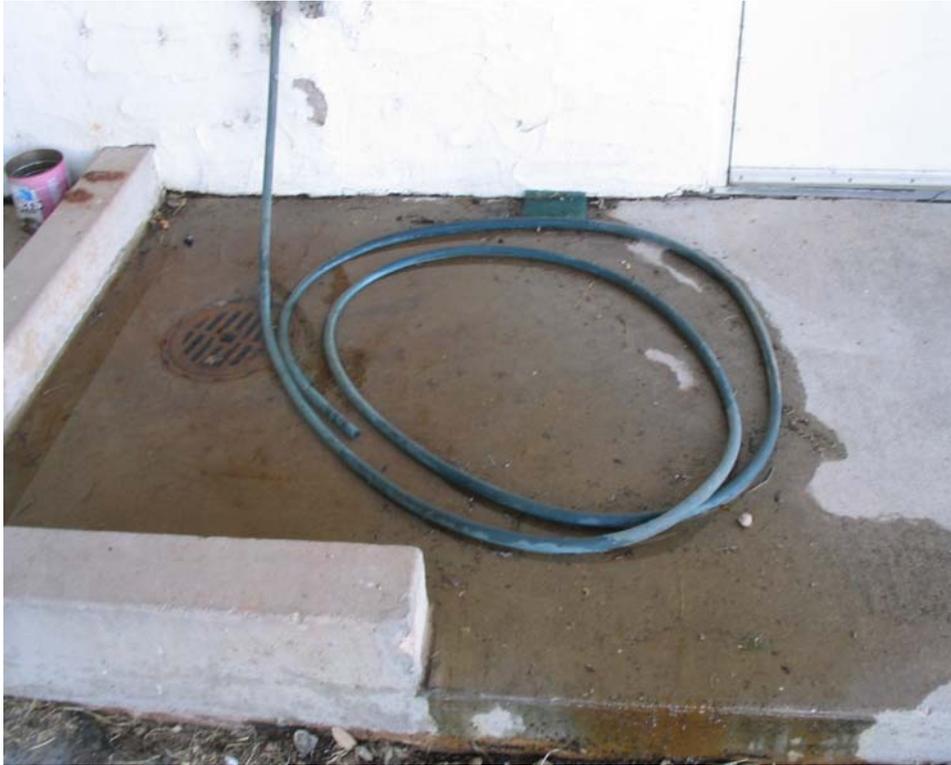
Photo 25: Clogged drain outside the north kitchen wall. This drain services the outside wash area near the north exterior door of the kitchen.

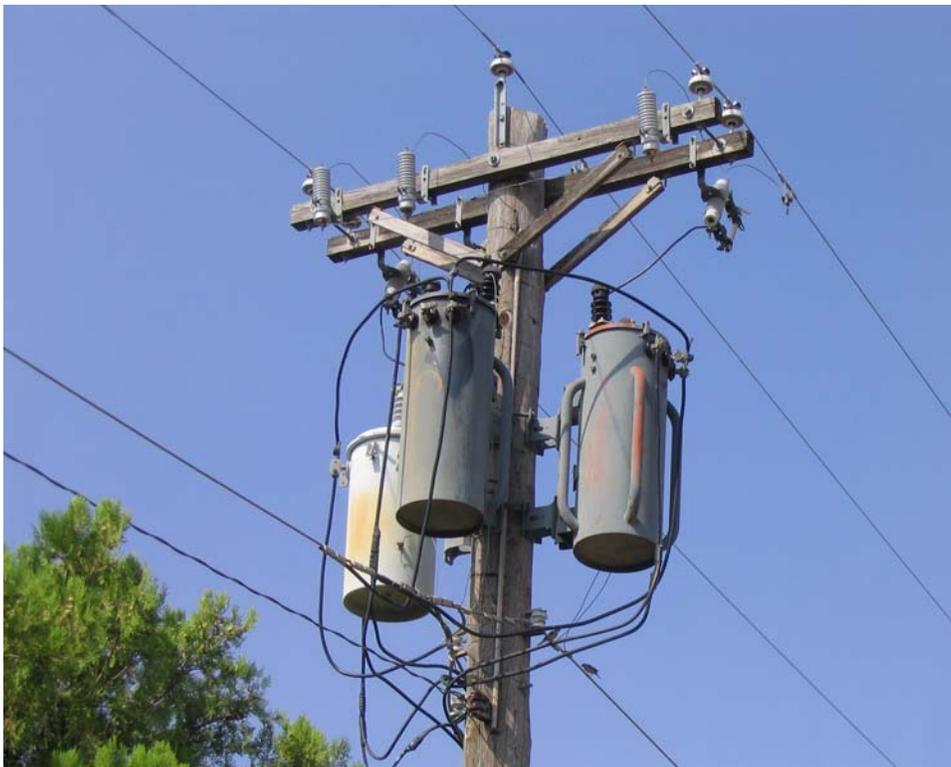
Photo 26: Three pole-mounted transformers located north of the northern POV parking area (west pole). All three PMTs are listed as "not tested" in the 1997 PCB Assessment Report.

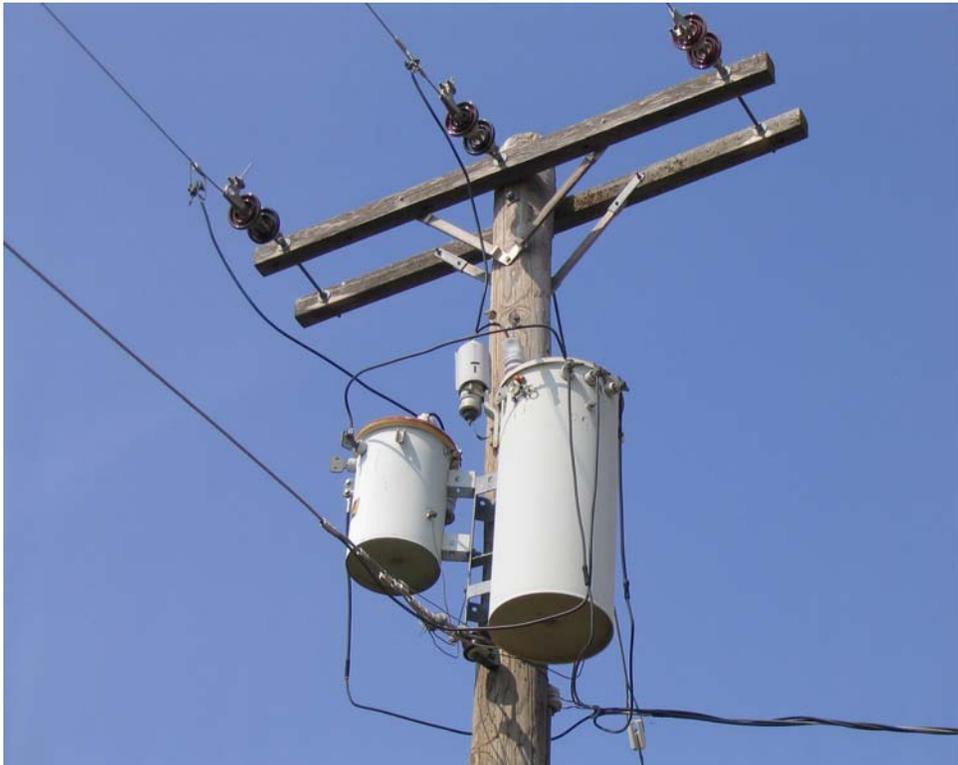
Photo 27: Two pole-mounted transformers located north of the northern POV parking area. One transformer is listed as “non-PCB” and one is listed as “not tested” in the 1997 PCB Assessment Report.

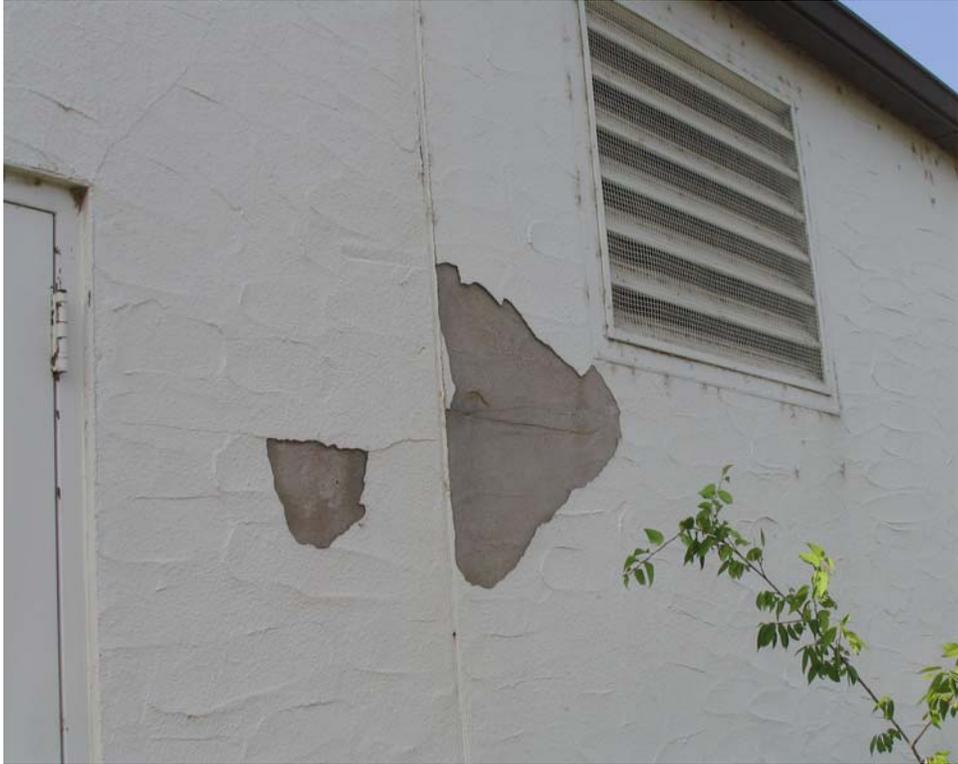
Photo 28: Peeling paint and toweled on texture on the north exterior wall of the Assembly Hall.

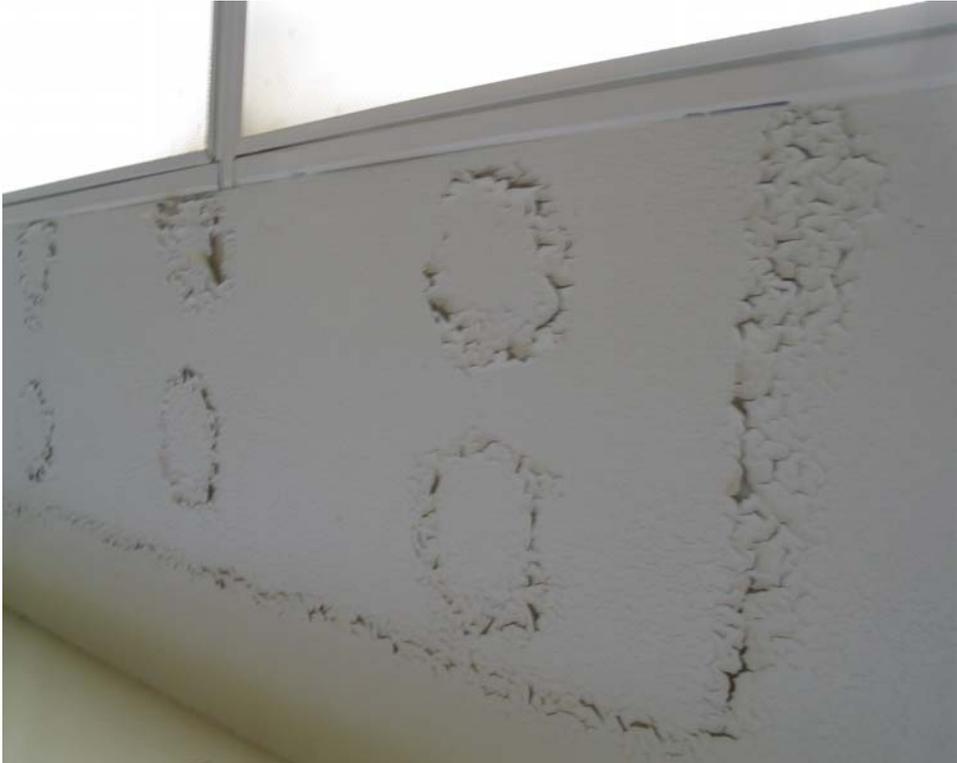
Photo 29: Peeling ceiling paint in Office 102 at the northeast corner of the USAR Center Training Building.

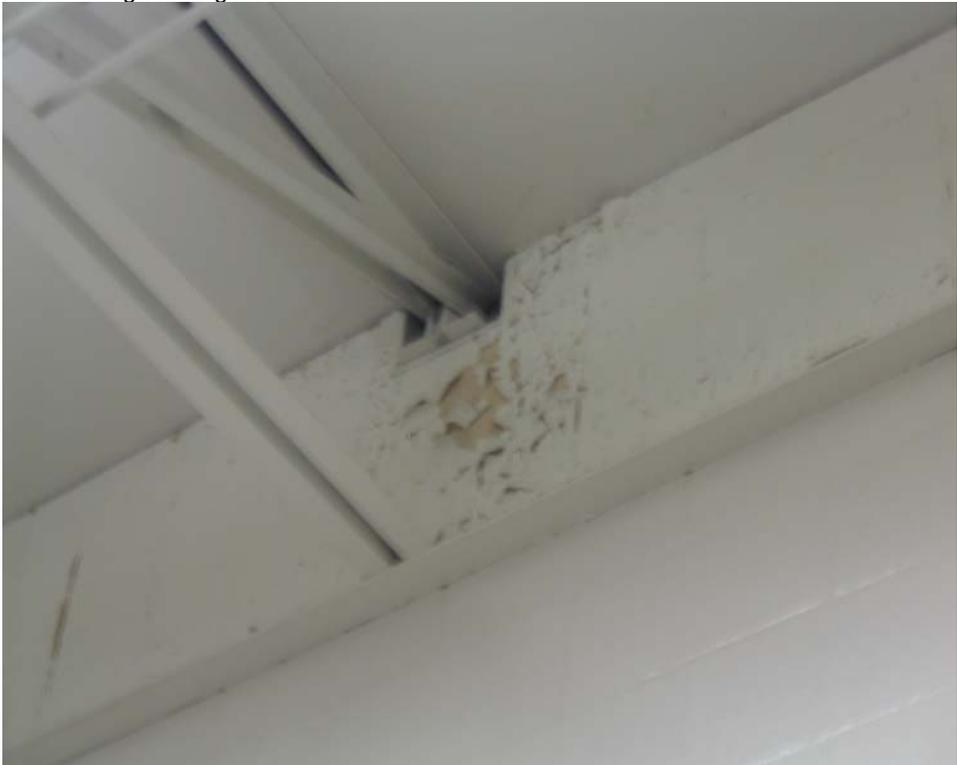
Photo 30: Peeling paint on an I-beam on the north side of the Assembly Hall.
