Appendix B
Site Reconnaissance Photographs

**Alice USAR Center
100 South Stadium Road
Alice, TX**

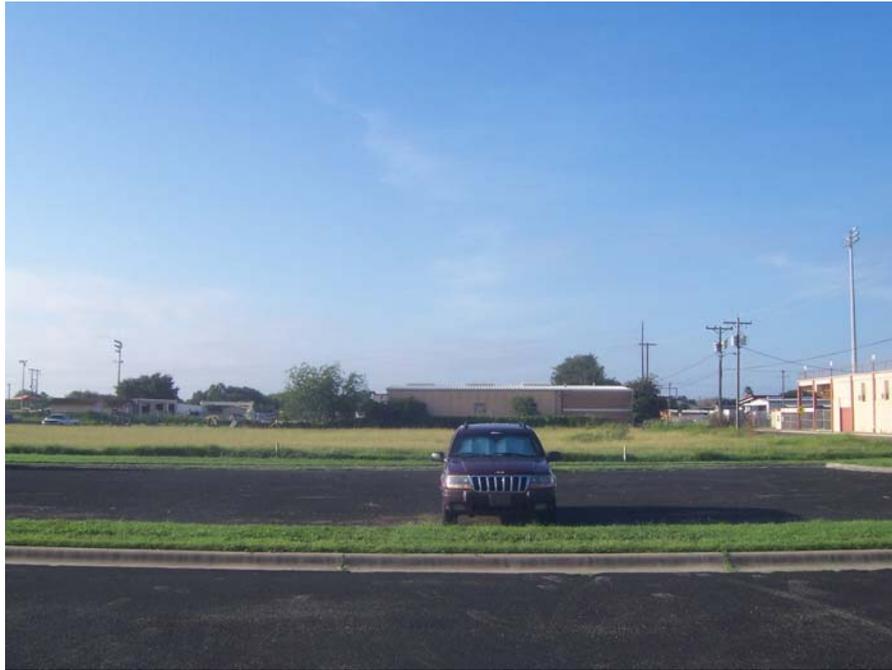
Photo 1: Looking south from the POV parking area, across a field adjacent to the USAR Center, to the Alice Independent School District Maintenance Department complex.

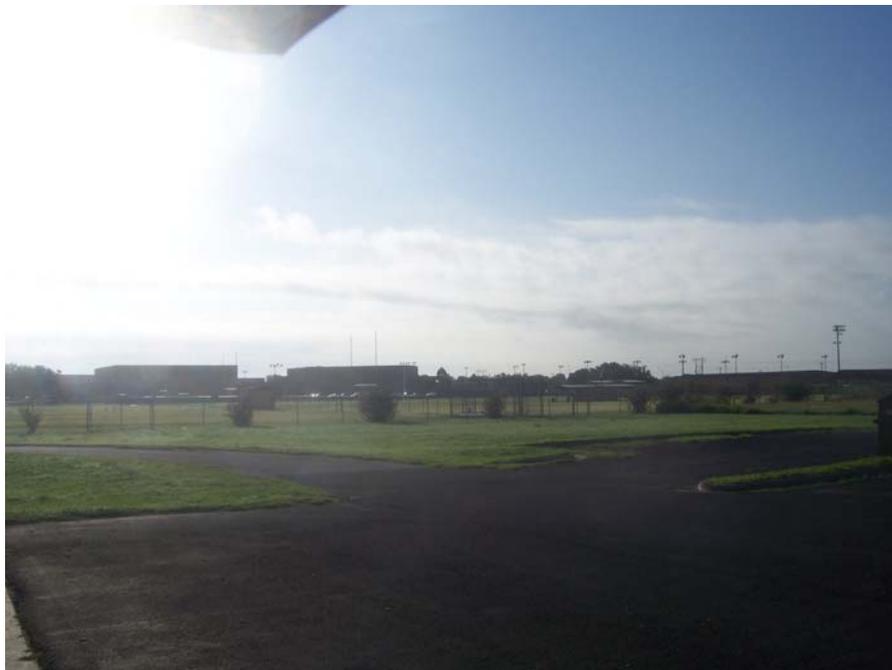
Photo 2: Looking southeast from the POV parking area at the southeast corner of the Site and across the adjacent Alice High School Athletic Field.

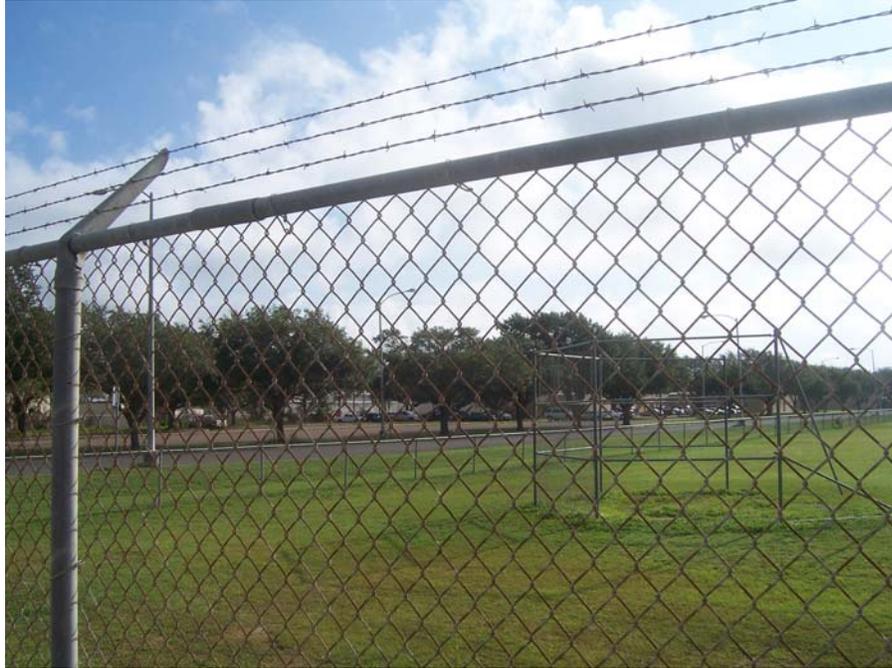
Photo 3: Looking northeast through the OMS fence at the adjacent Alice High School Athletic Field.

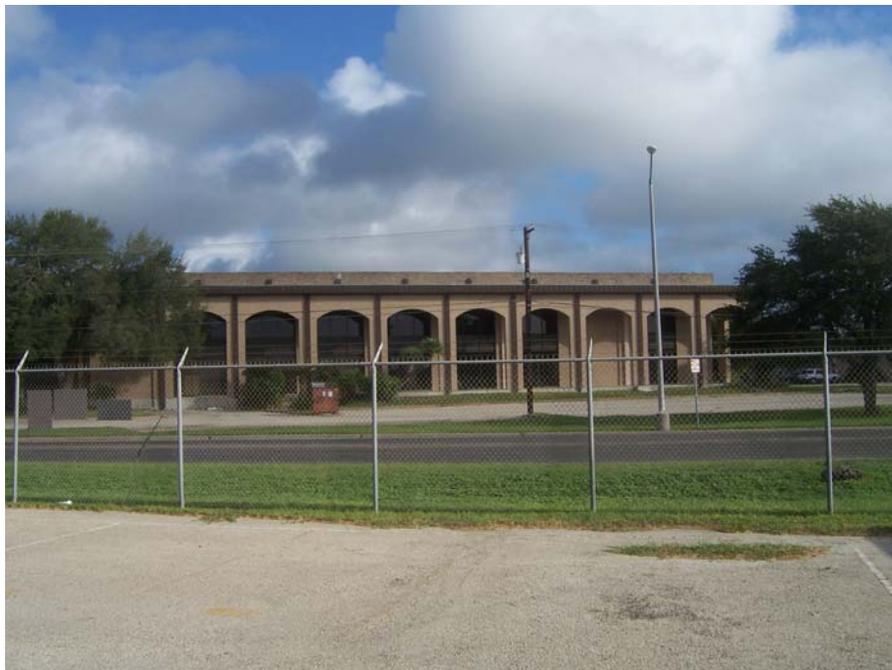
Photo 4: Looking north through the OMS fence, across Houston Street, at the First Community Bank building.

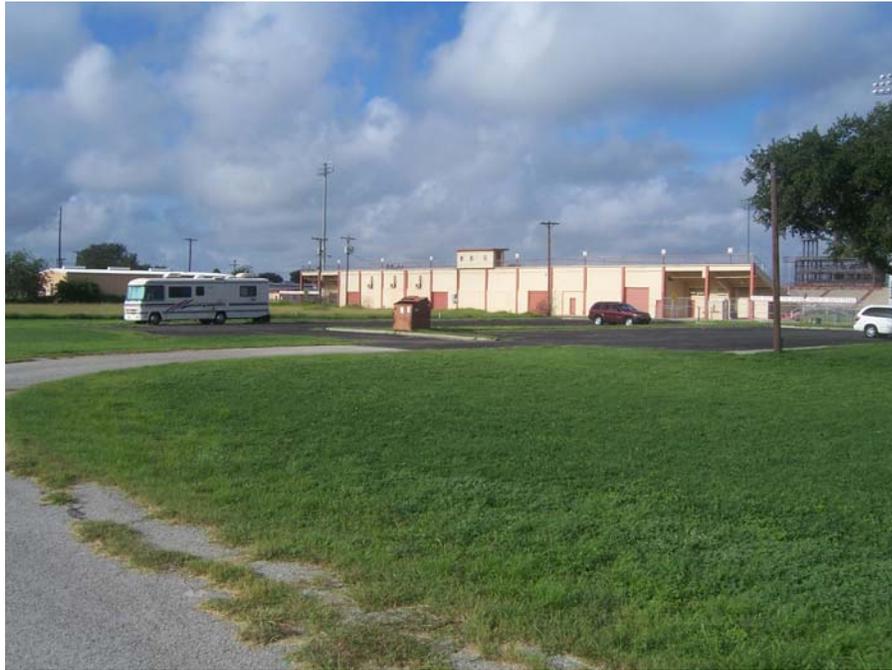
Photo 5: Looking west-southwest from the center of the Site, across Stadium Road, at the Alice High School Stadium.

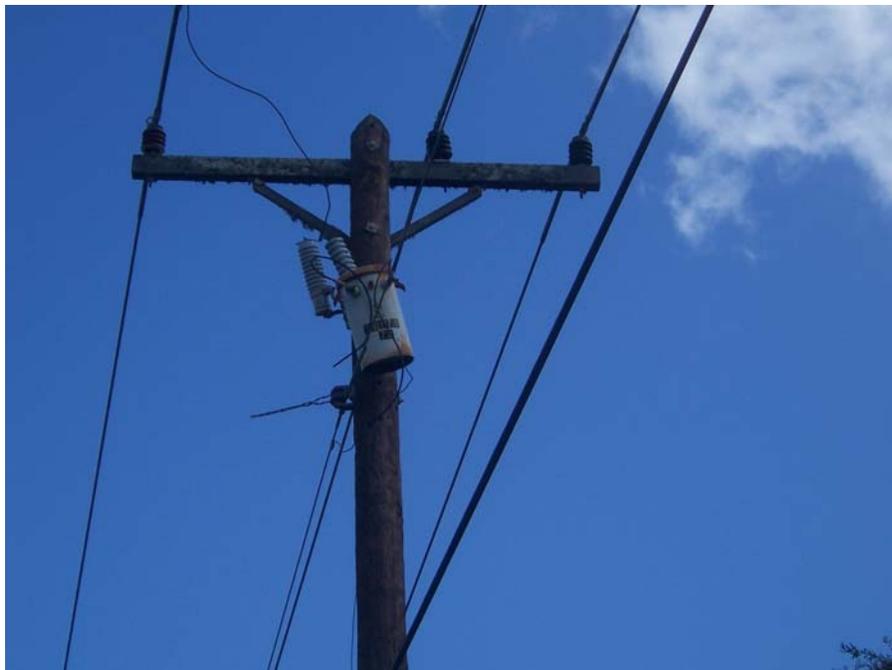
Photo 6: Pole with one transformer located on the west-central Site property boundary.

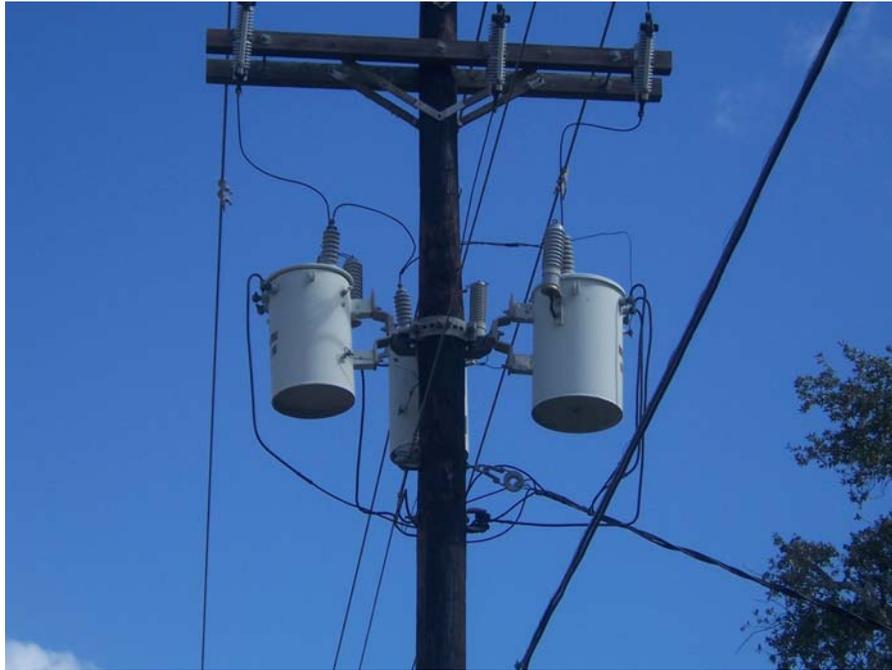
Photo 7: Pole with three transformers located on the northwest Site property boundary.

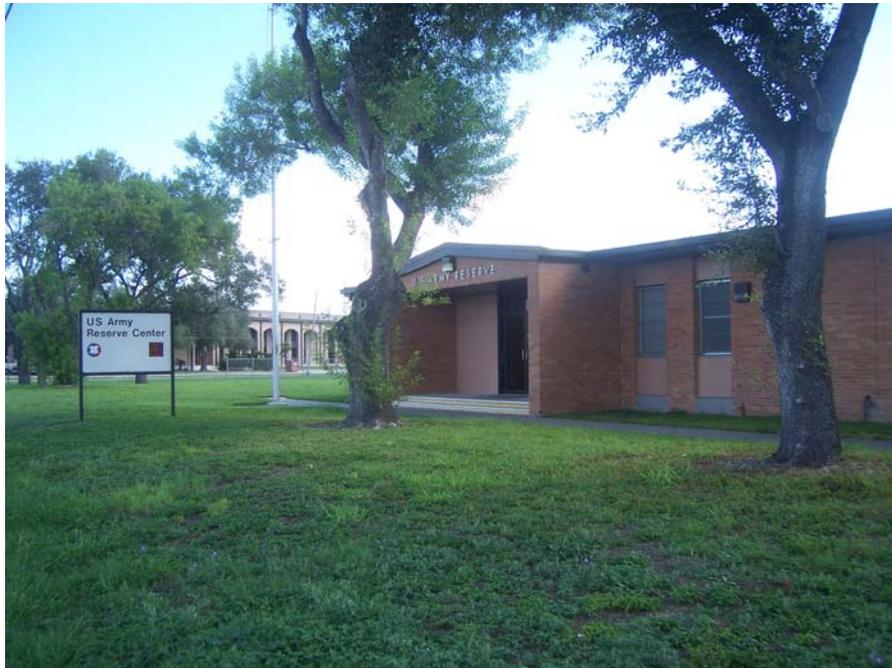
Photo 8: View of the front (west side) of the Administration Building. Photo was taken looking northeast from the POV parking area entrance. The bank adjacent to the property (north) can be seen in the background left.

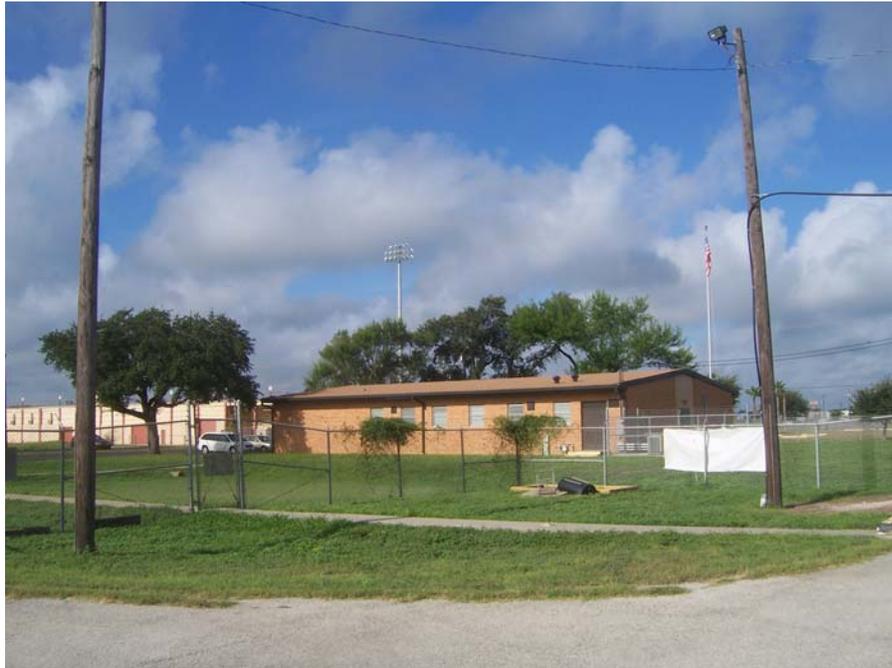
Photo 9: View of the back (east side) of the Administration Building, looking southwest from the fenced OMS Building area. The fence in the foreground surrounds the OMS building, container boxes, flammable materials storage sheds, vehicle washing station, and MEP area. The Alice High School Stadium adjacent to the property (west) can be seen in the background left.

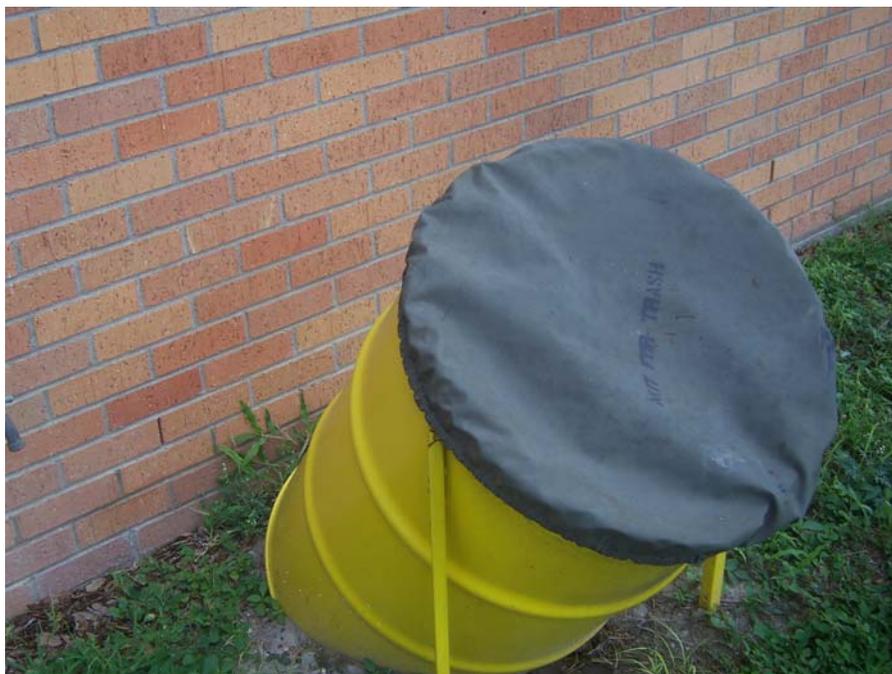
Photo 10: This sand filled drum outside the side door to the Administration Building is designed to be used by soldiers returning from the rifle range. Before a soldier enters the building with a rifle, the muzzle is pointed at the sand in the drum and the trigger pulled to ensure there are no weapons with live rounds in the building. According to USAR personnel, the drum has not been used.

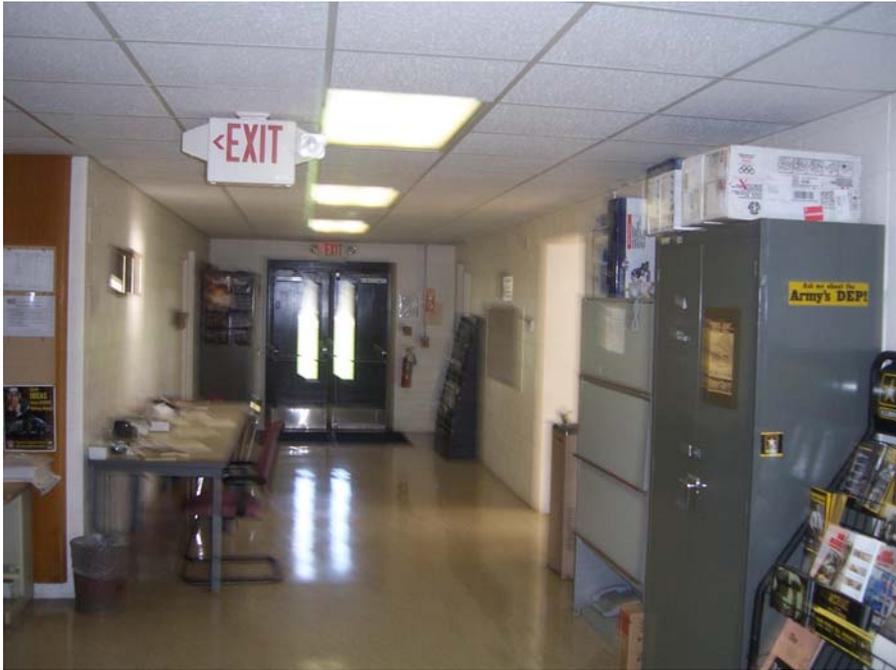
Photo 11: View looking down the Administration Building hallway.

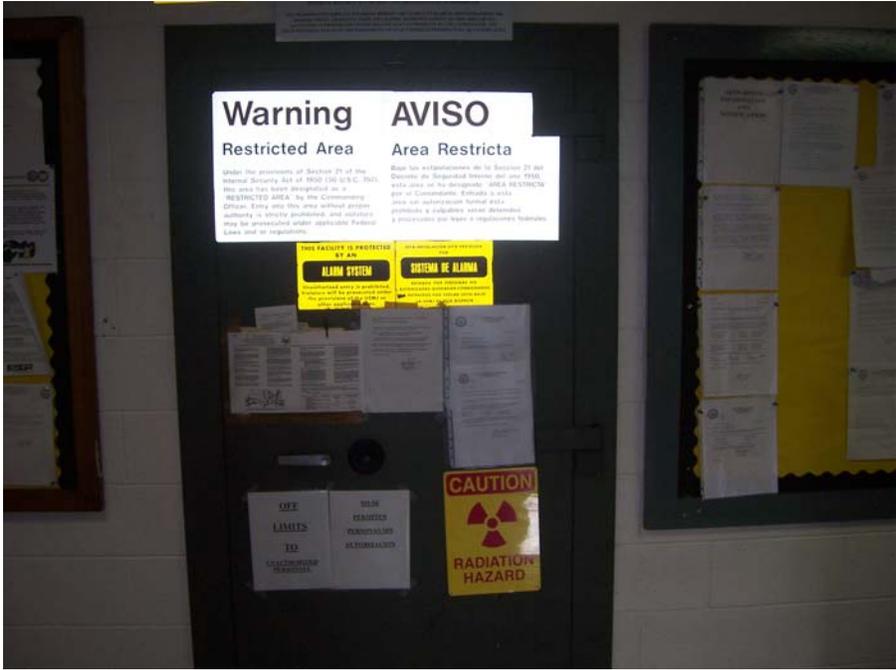
Photo 12: This is a photograph of the weapons vault door. USAR personnel on the Site did not know why there is a radiation hazard placard on the door.

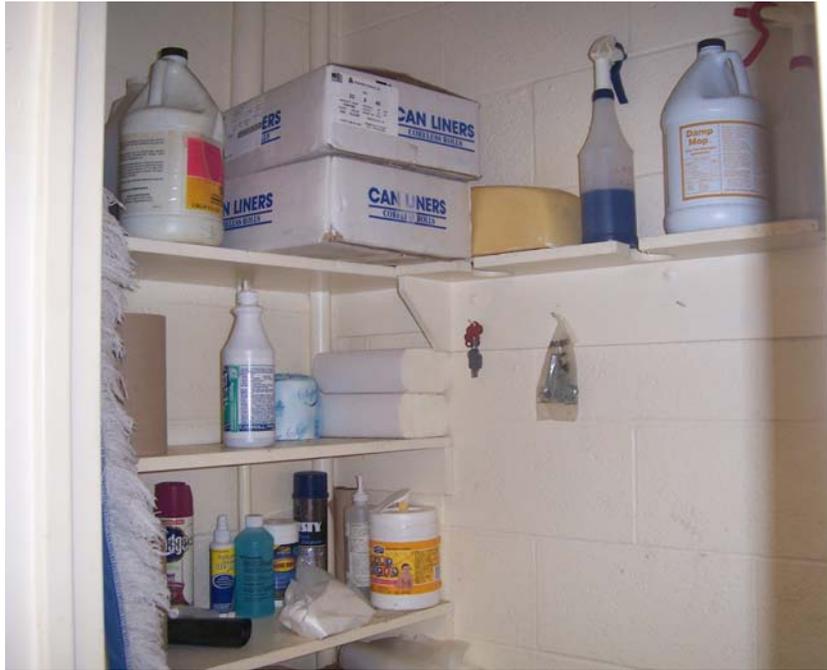
Photo 13: View inside the Administration Building's janitor's closet. Household cleaning supplies were observed.

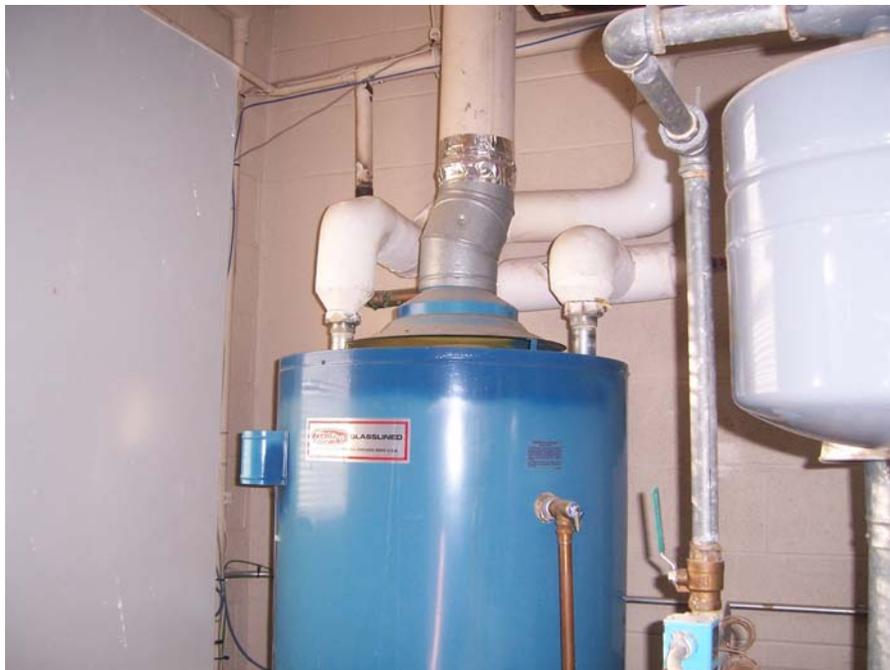
Photo 14: View inside the mechanical room. Most pipe insulation appeared new.

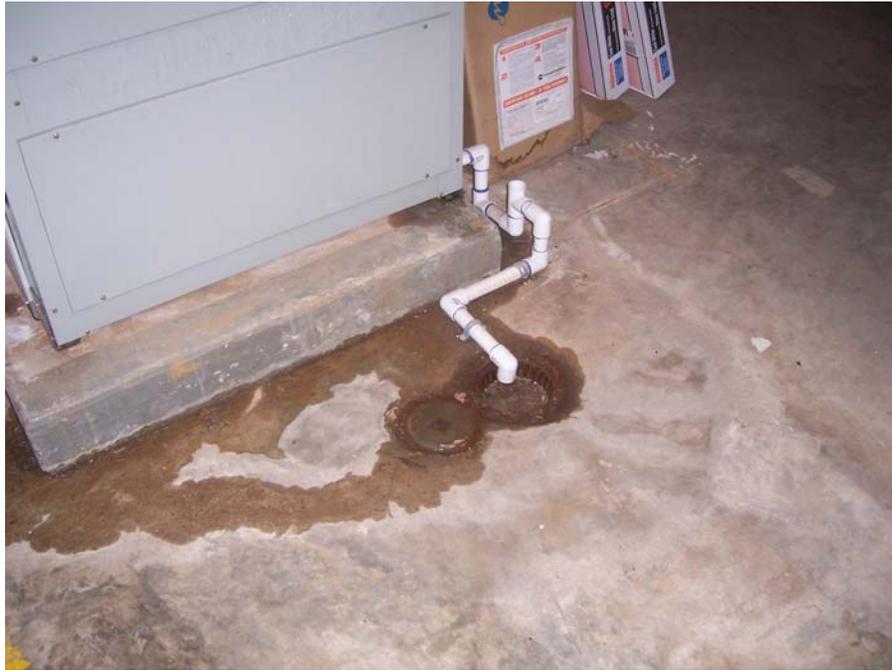
Photo 15: Photograph of the air conditioning condensate discharge pipe. The pipe discharges to the floor drain seen in the center of the photograph. The drain leads to the sanitary sewer.

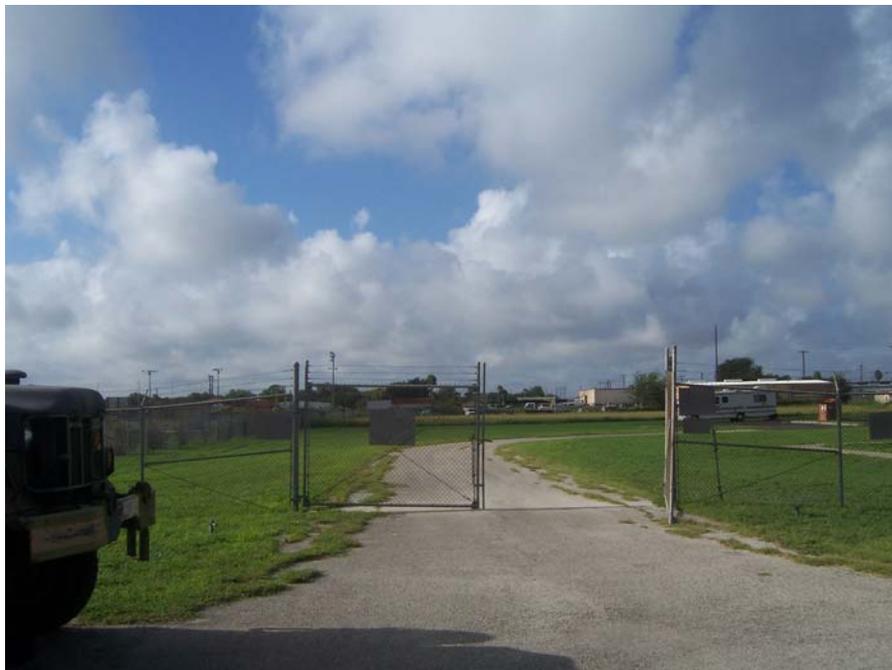
Photo 16: Looking south from the OMS area to the open areas within the southeast portion of the USAR property.

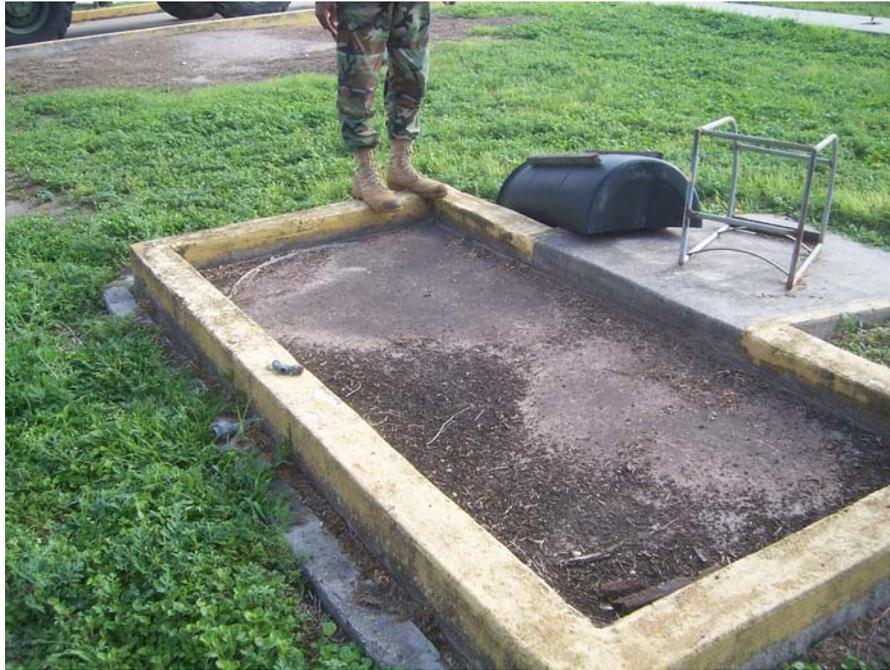
Photo 17: A concrete pad in the southwest corner of the OMS fenced area has a concrete ramp leading over the curb and a bottom drain.

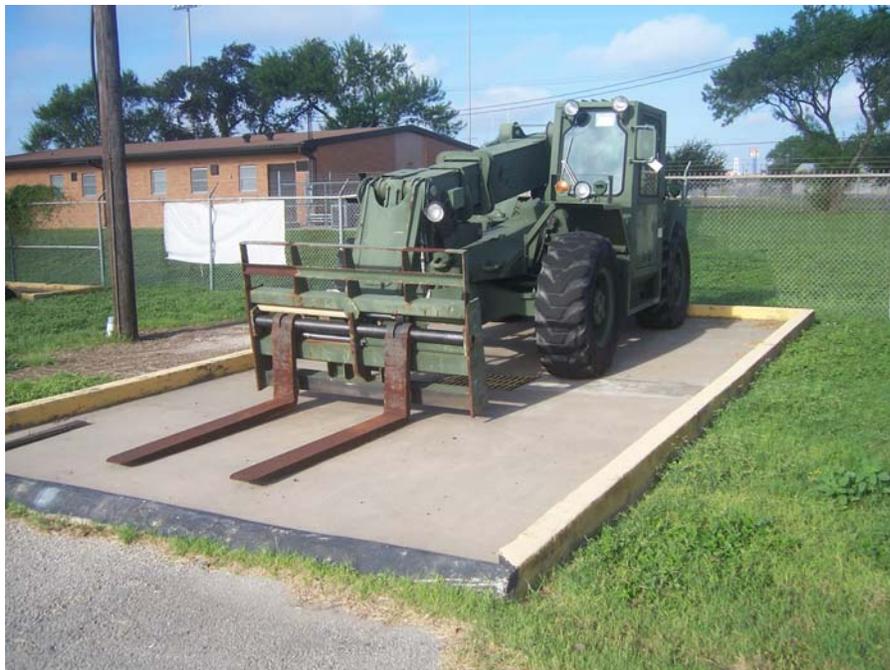
Photo 18: Vehicle wash rack (VWR) with a forklift on it. This is located north of the pad in Photograph 17, and within the OMS fenced area. According to USAR personnel, the pad is not used as a VWR. During the Site visit, the pad appeared in good condition and no signs of a release were observed.

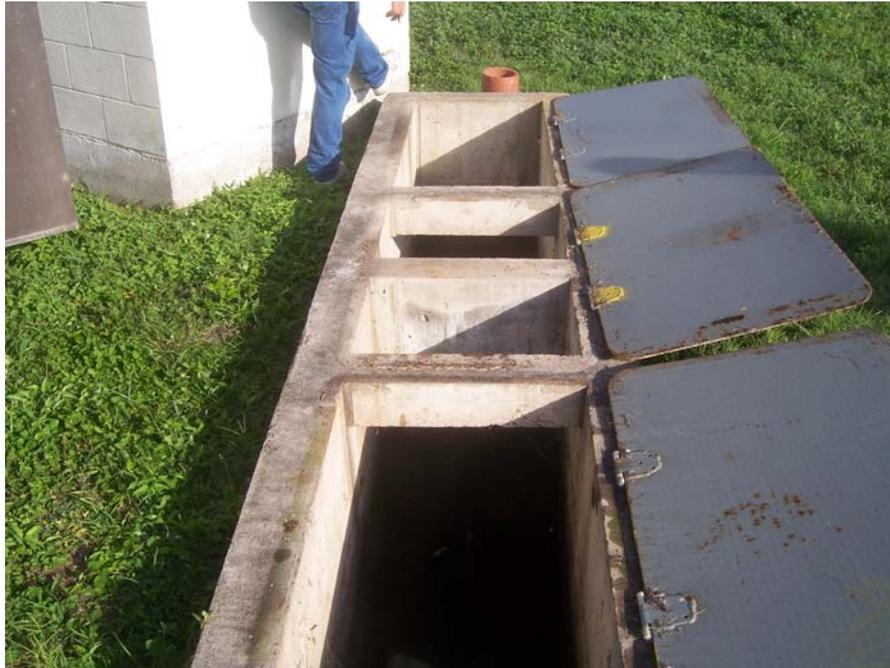
Photo 19: This is the oil-water separator (OWS) associated with the VWR. It is located north of the VWR and immediately east of the two flammable materials storage sheds (background). During the Site visit, the OWS was empty and no liquid, oily residue, or sludge was observed in it. Also, no signs of a release were observed.

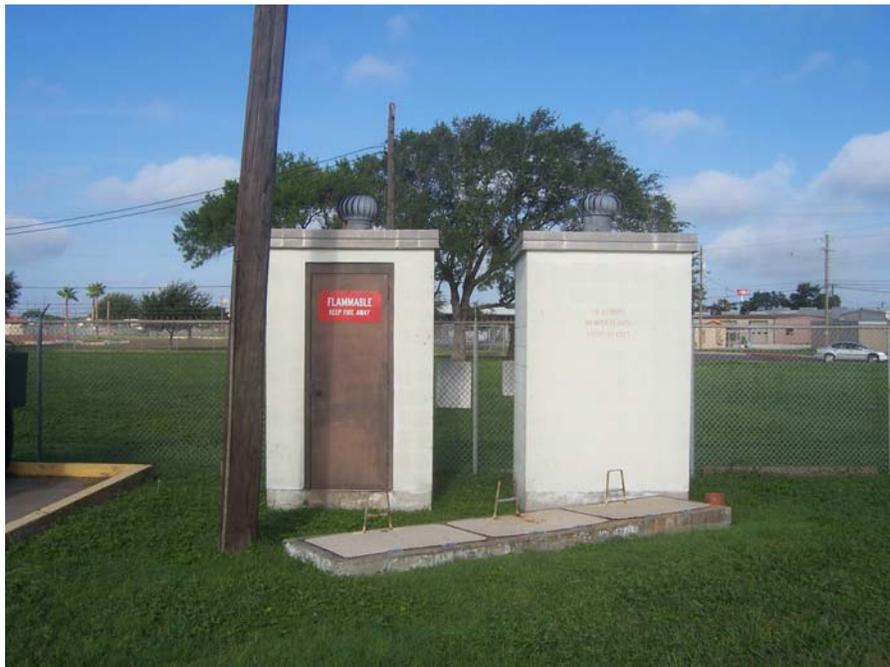
Photo 20: Looking west at the two flammable materials storage sheds located within the OMS fenced area. The OWS can be seen in front of the sheds. There were no signs of a release from these two sheds. Photograph 21 provides an inventory of the contents.

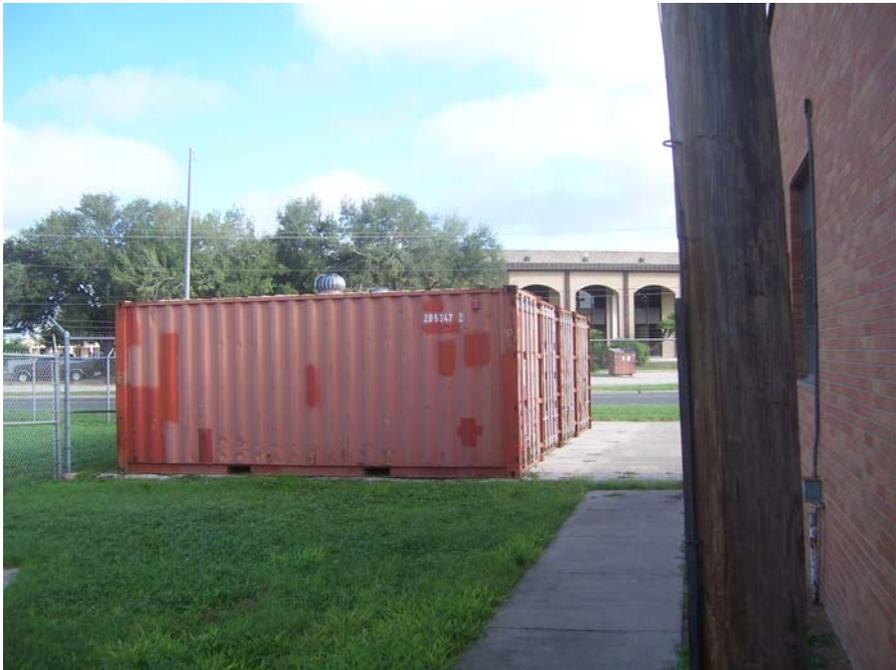
Photo 22: Looking north at four container boxes stored within the OMS fenced area. The boxes were being used for inert storage such as furniture, electronic equipment, field equipment, etc.

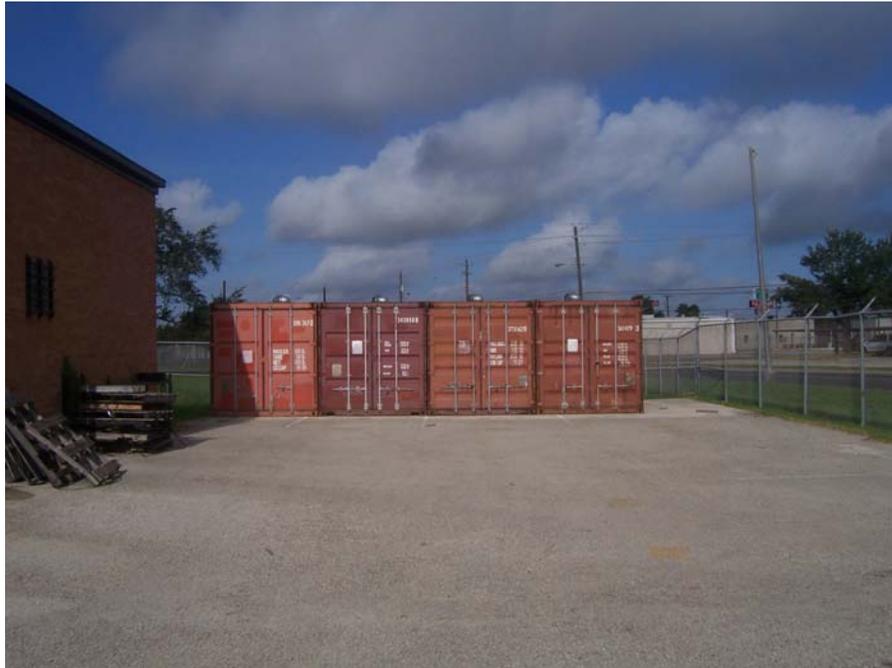
Photo 23: Looking west at the same container boxes shown in Photo 22.

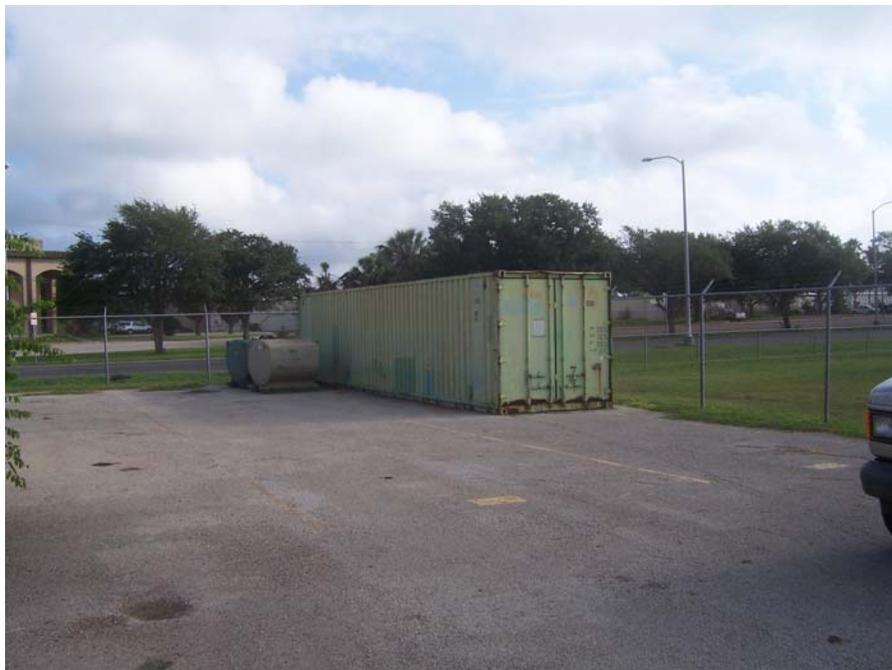
Photo 24: This is a fifth container box located in the northeast corner of the fenced OMS area. This container box is also used for inert storage. There are two empty mobile storage tanks on the asphalt pavement next to the container box. Details of the tanks are given in the next photograph (Photograph 25) caption.

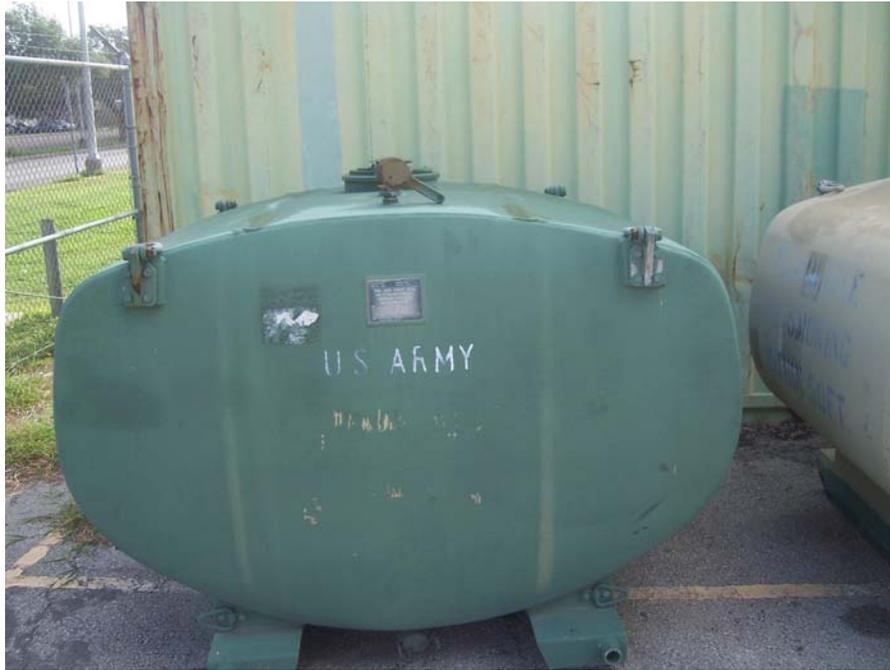
Photo 25: One of two empty 600-gallon, single-walled, steel, mobile diesel tanks. Part of the second tank can be seen to the right. These tanks are set on a flatbed trailer when in use. According to USAR personnel, the tanks have not been used since 2003 when the unit mobilized to Kuwait. Fuel for military vehicles is purchased at a local gas station and is not stored on the Site.

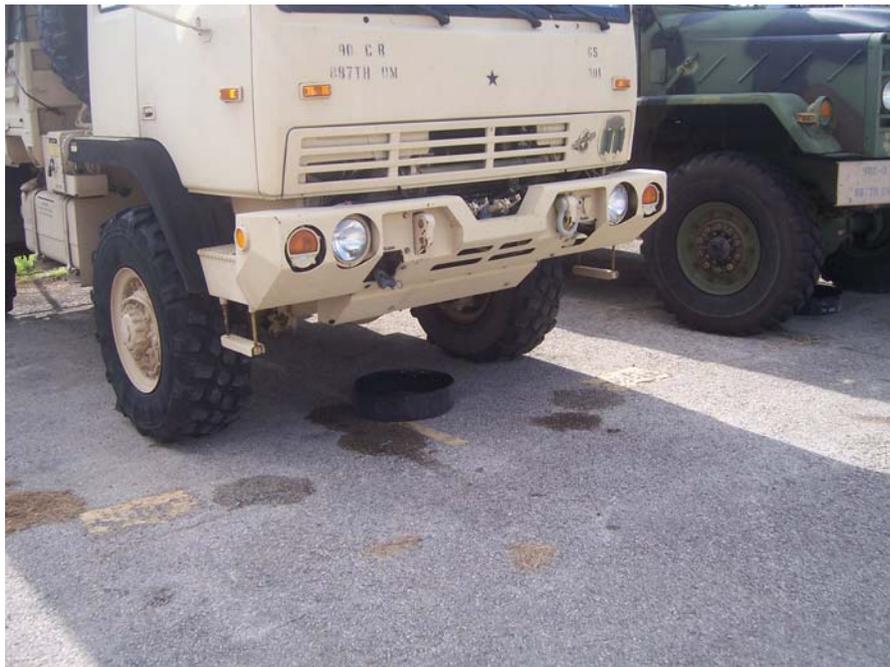
Photo 26: In addition to the forklift on the VWR, there were five military vehicles parked along the eastern fence line. All vehicles had oil drip pans positioned beneath them. Minor staining was observed on the asphalt pavement as shown in this photograph.

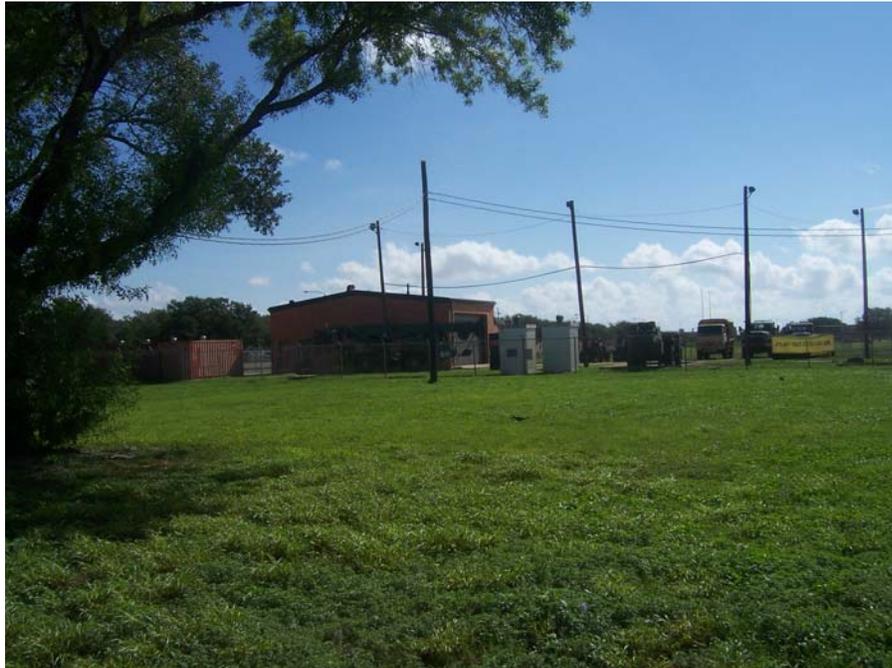
Photo 27: View of the fenced-in OMS area looking east-northeast from the western property line. The OMS is the largest building and can be seen in the upper center of the photograph. A concrete pad from a former grease rack has a vehicle parked on it in front of the OMS.

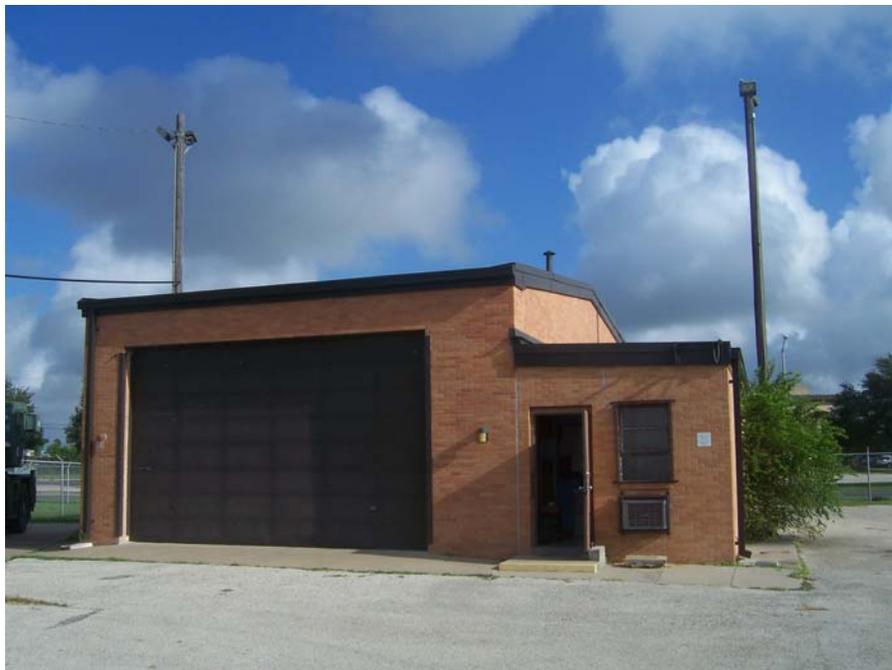
Photo 28: View of the front (south side) of the OMS. The OMS has not been used for vehicle maintenance since 2002 according to USAR personnel. During the Site visit, no evidence of ongoing maintenance activities was observed and the main room inside the OMS was a weight room for physical training. Part of the concrete pad remaining from the former grease rack can be seen in the extreme left of the photograph.

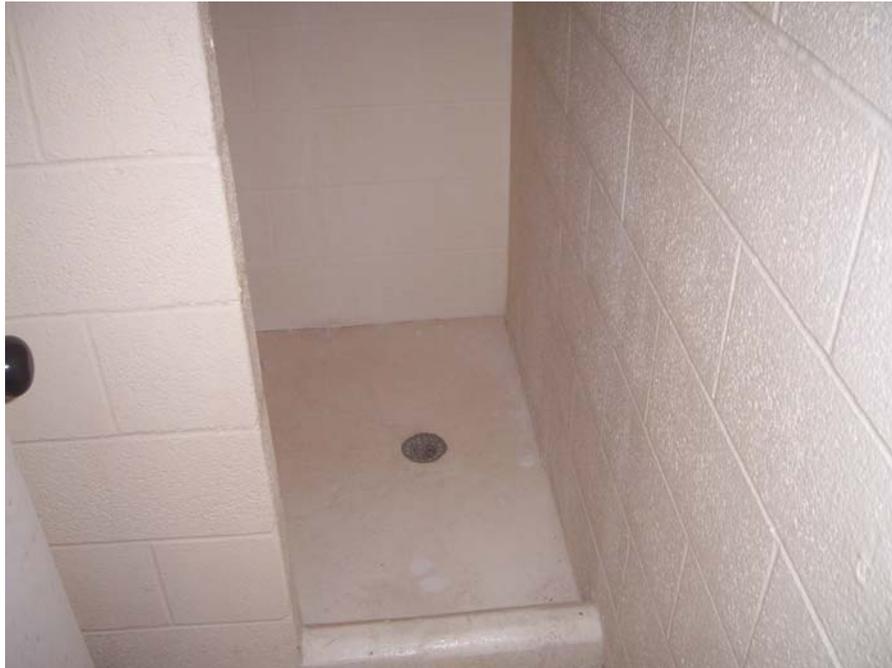
Photo 29: Shower located in the OMS.

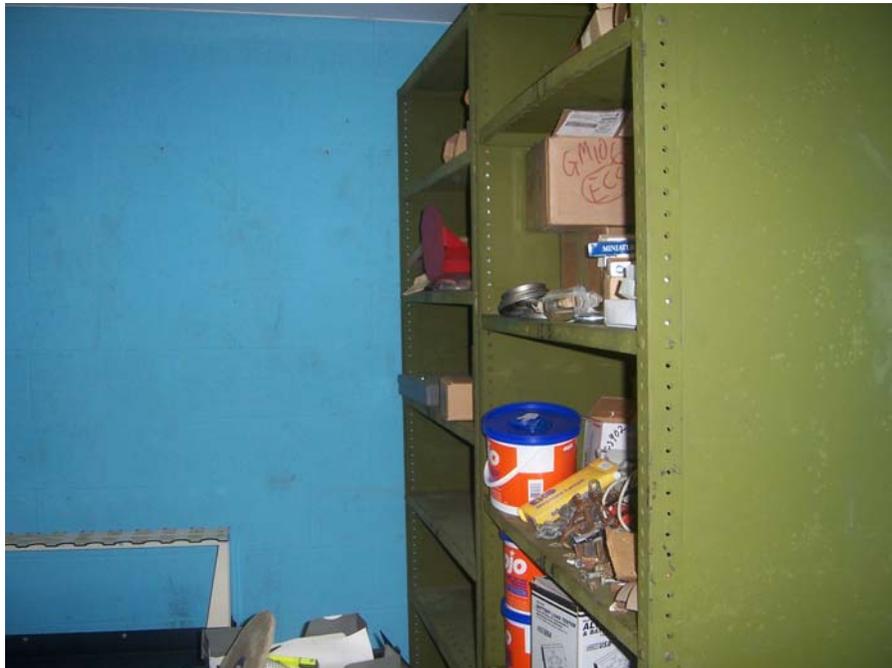
Photo 30: Storage area in the OMS. This set of shelving is used for parts and tools; no chemicals were stored here.

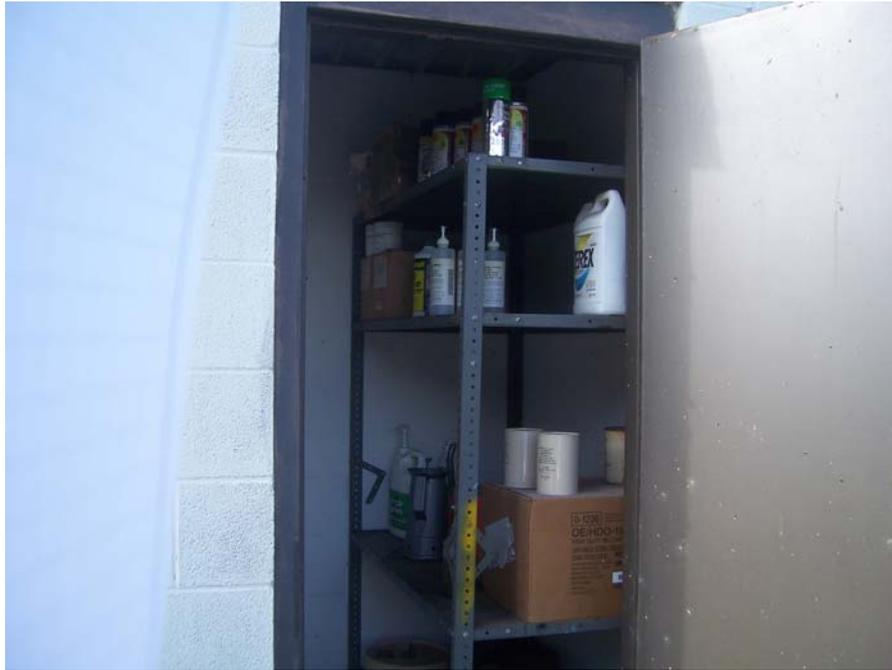
Photo 31: This storage room inside the OMS was used to store small quantities of chemicals and parts such as cleaning fluid, antifreeze, and oil filters.
