Appendix B
Site Reconnaissance Photographs

**Blucher S. Tharp Memorial USAR Center
2801 Duniven Circle
Amarillo, Texas**

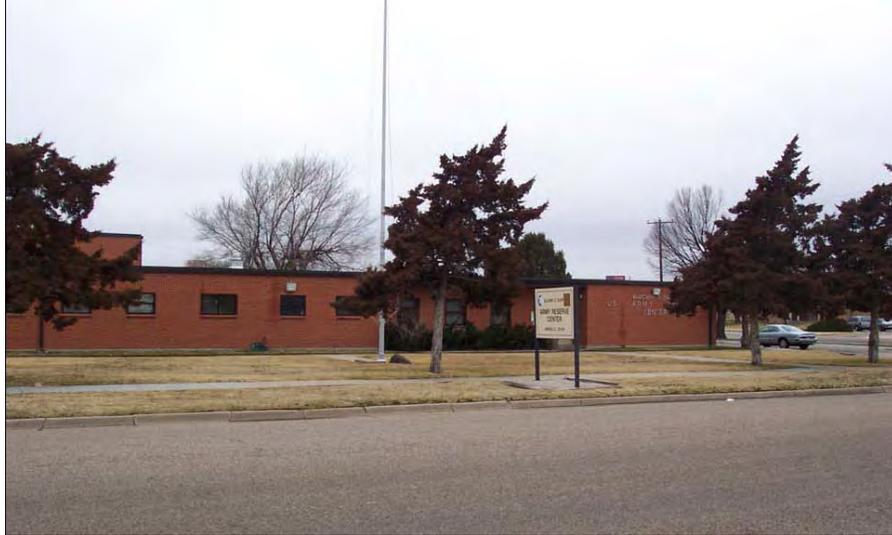
Photo 1: Looking southwest at the front of the Training Building.

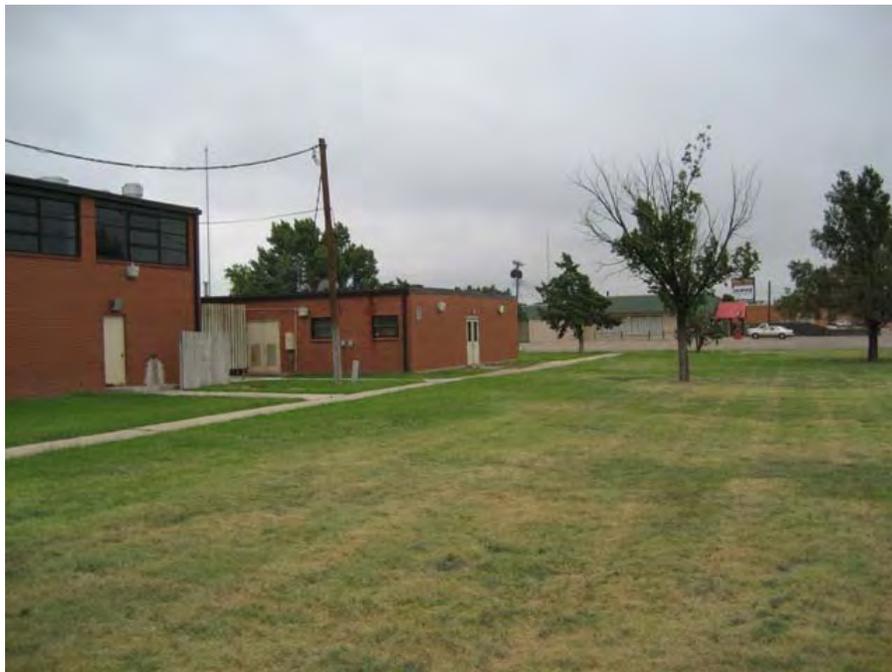
Photo 2: Looking northeast toward the east side of the Training Building and Drill Hall.

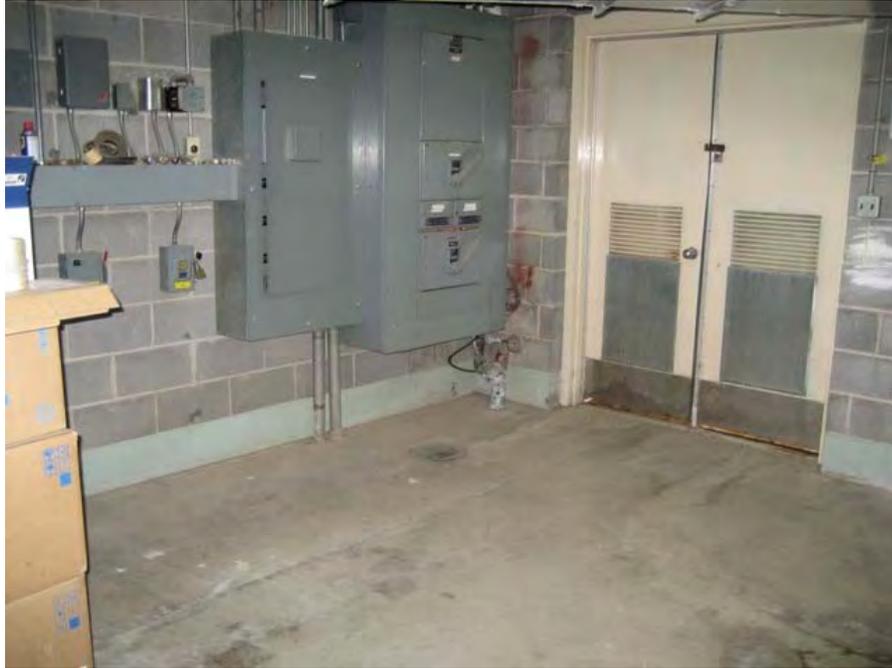
Photo 3: View inside a mechanical room within the Training Building.

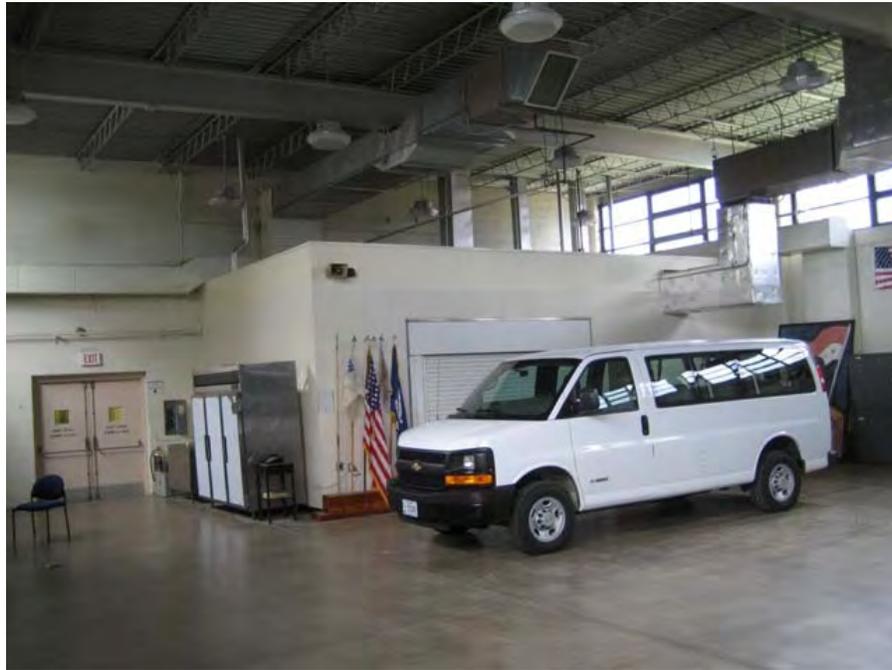
Photo 4: View inside of the Drill Hall of the Training Building. The kitchen area is behind the van in the photograph.

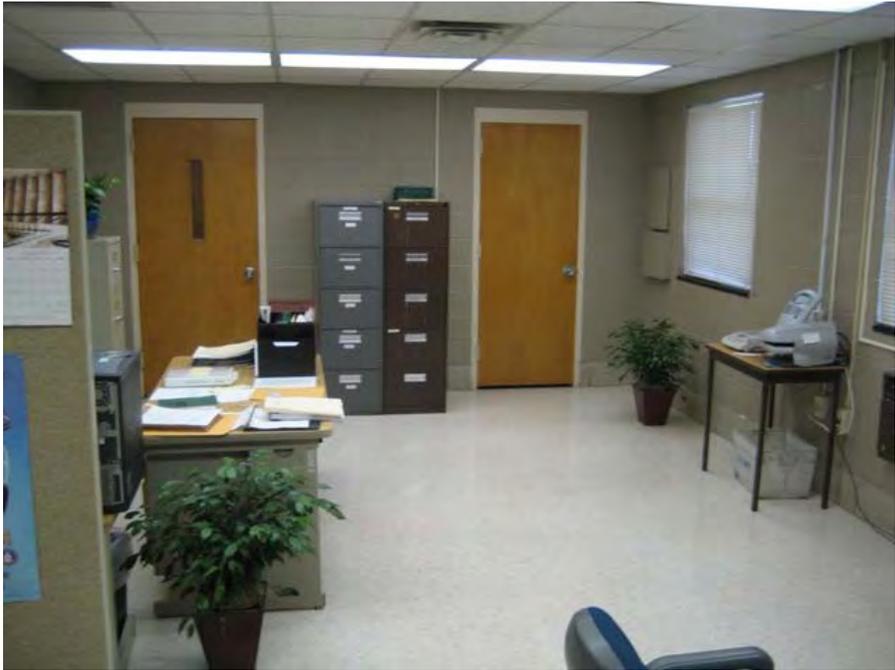
Photo 5: Typical view of an office in the Training Building.

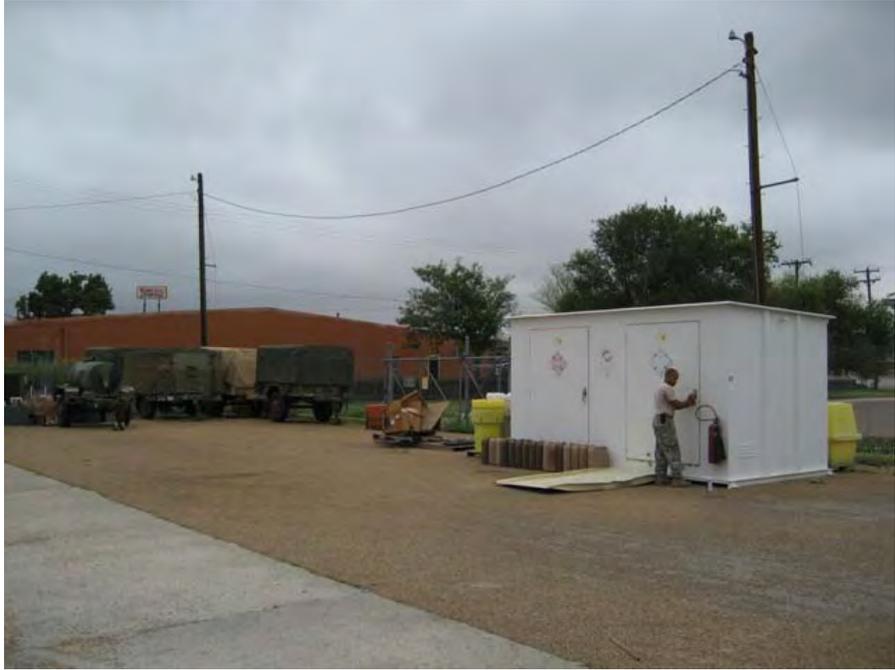
Photo 6: View of the hazardous materials storage building in the MEP area.

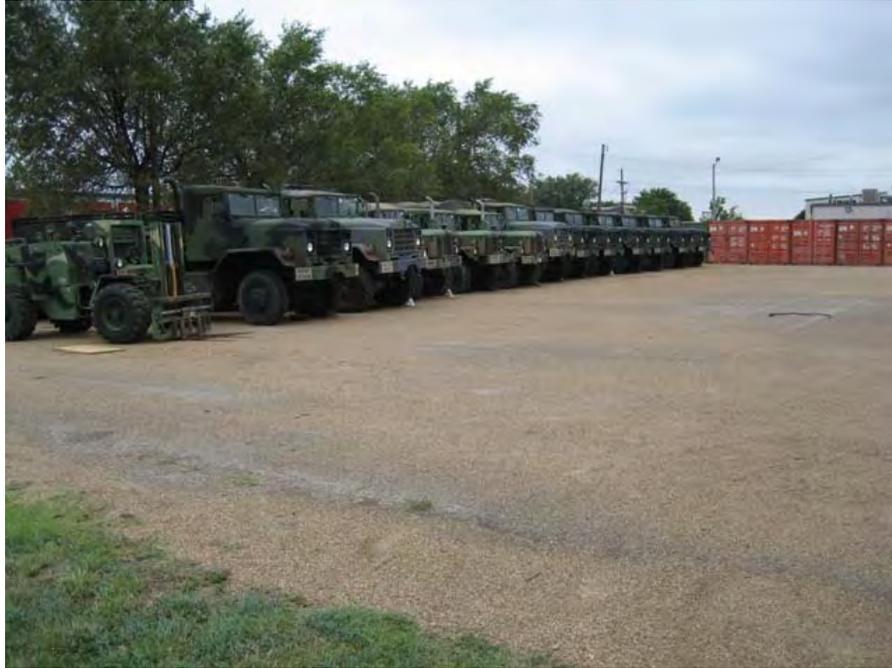
Photo 7: View of northeast side of the MEP area showing military vehicles along the southeast boundary and 20-foot steel transport containers along the southwest boundary.

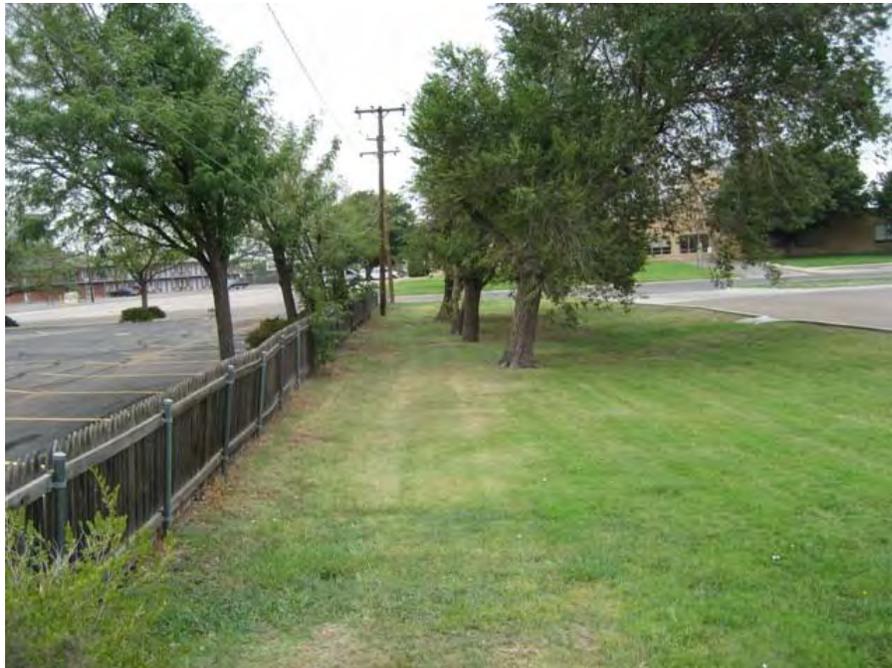
Photo 8: Looking northwest along the southwest boundary of the USAR Center, Church Street is visible along with the entrance to the POV parking area in the right background.

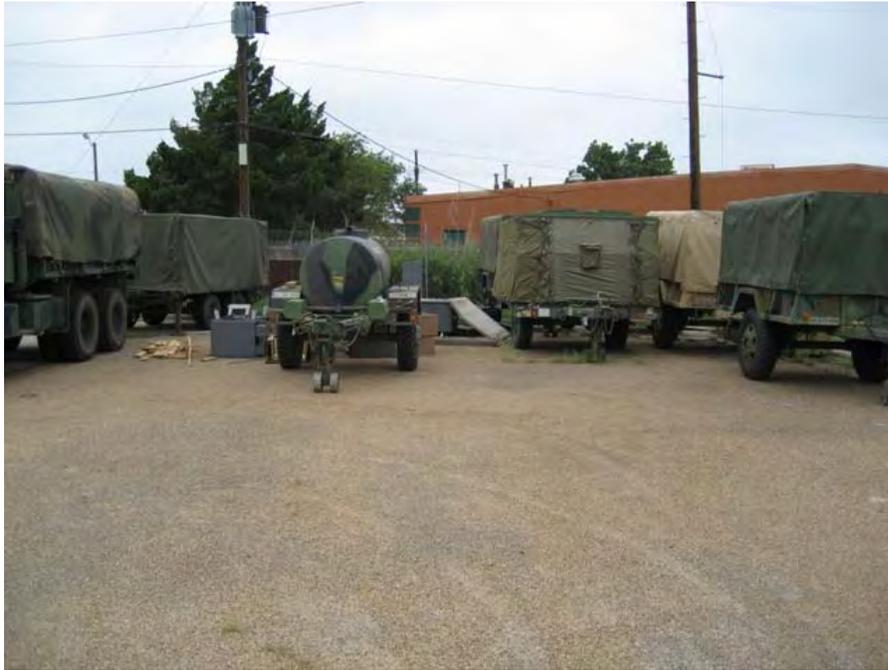
Photo 9: Looking southwest from the northwest end of the MEP area are military vehicles and two pole mounted electrical transformers at the southwest boundary of the Site.

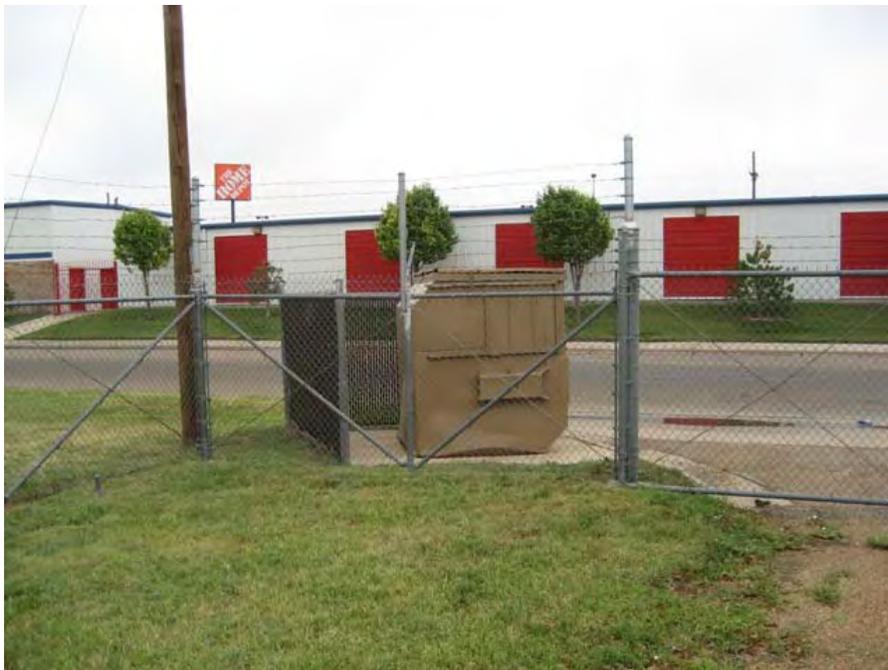
Photo 10: Looking east from the northeast corner of the MEP area, one of two dumpsters on the Site is shown along with Blackburn Street in the background.

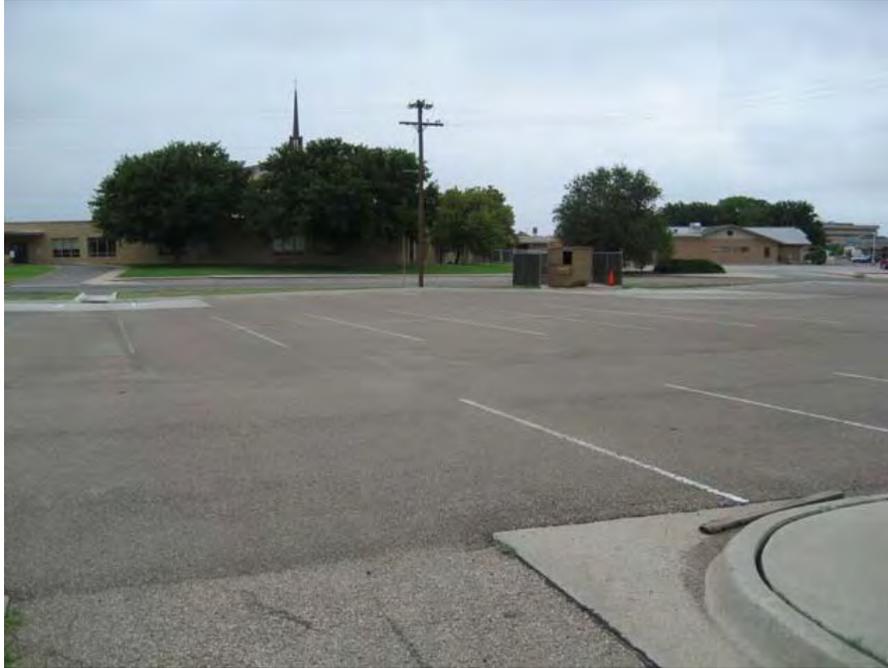
Photo 11: Looking northwest across the POV parking lot, the second of two dumpsters on the Site is visible.

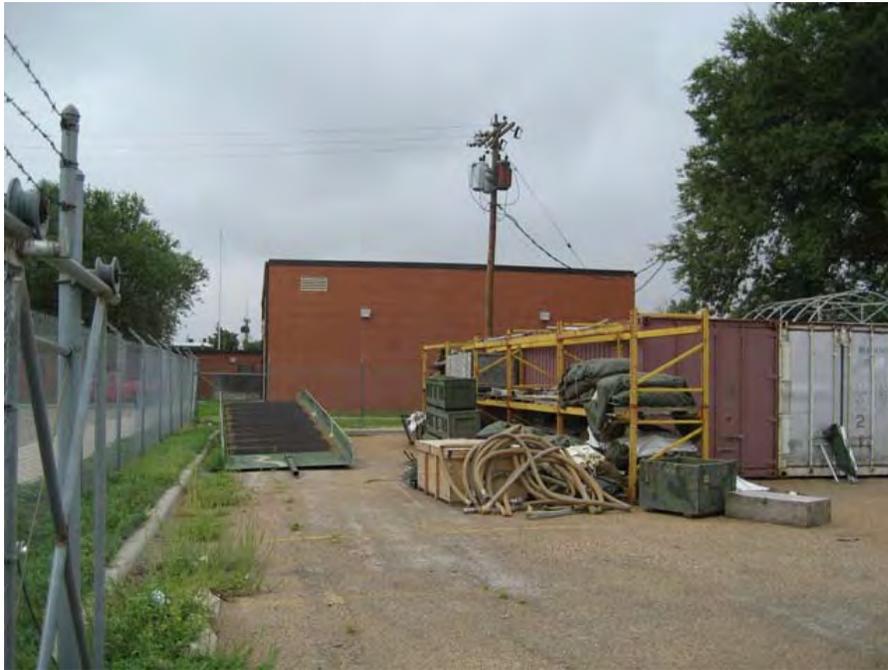
Photo 12: Looking northeast from the northwest corner of the MEP area, the Drill Hall in the Training Building and pole mounted transformers are visible in the background along with 40-foot storage containers to the right.

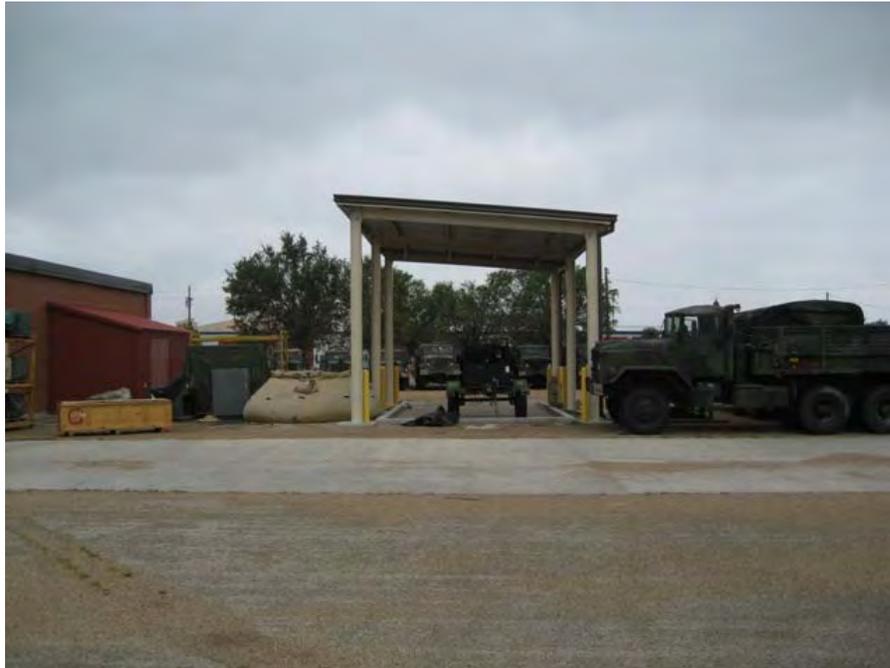
Photo 13: Looking southeast at the vehicle wash rack. The red building extension to the left houses the wash water recirculating system.

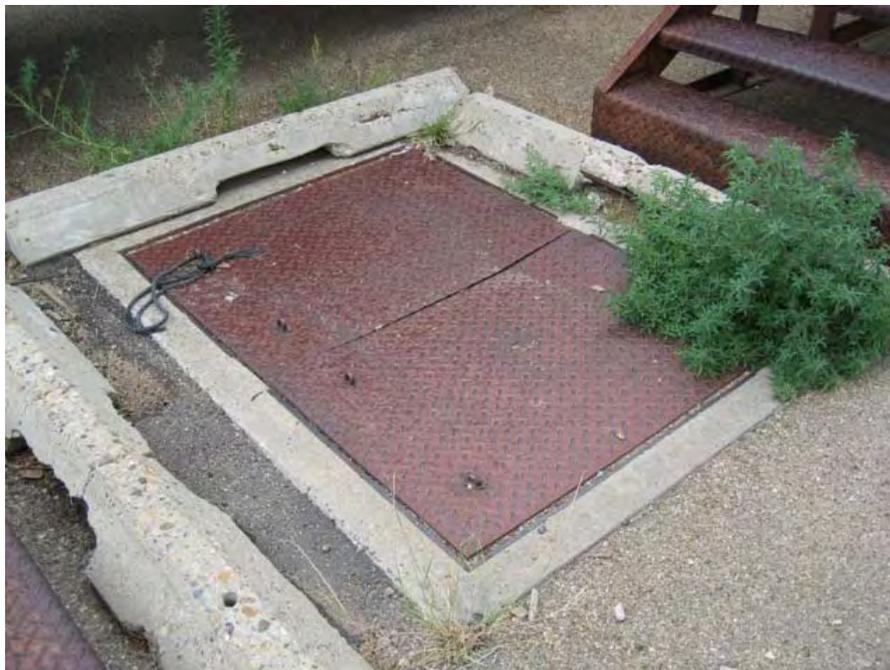
Photo 14: An old OWS on the Site now is used as a sediment trap.

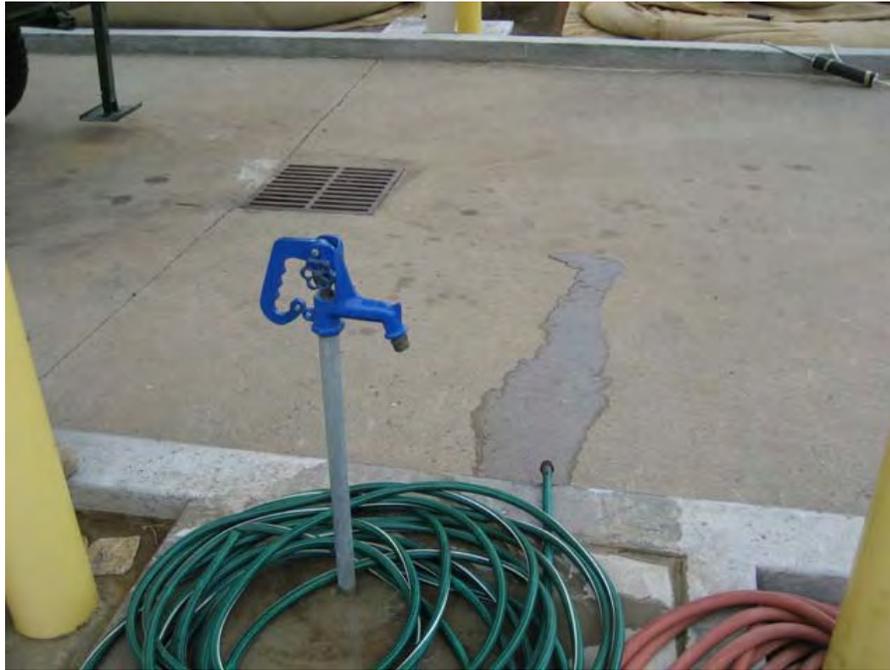
Photo 15: Looking at the vehicle wash rack from the southwest, the slotted floor drain that drains wash water is visible.

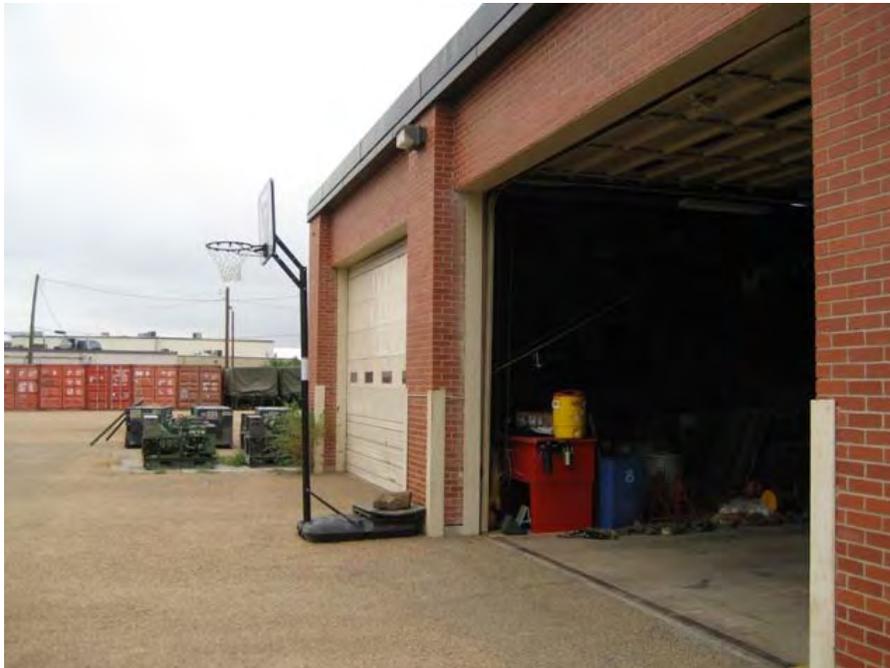
Photo 16: Looking southeast along the southwest side of the OMS, the parts washer is visible inside the bay door.

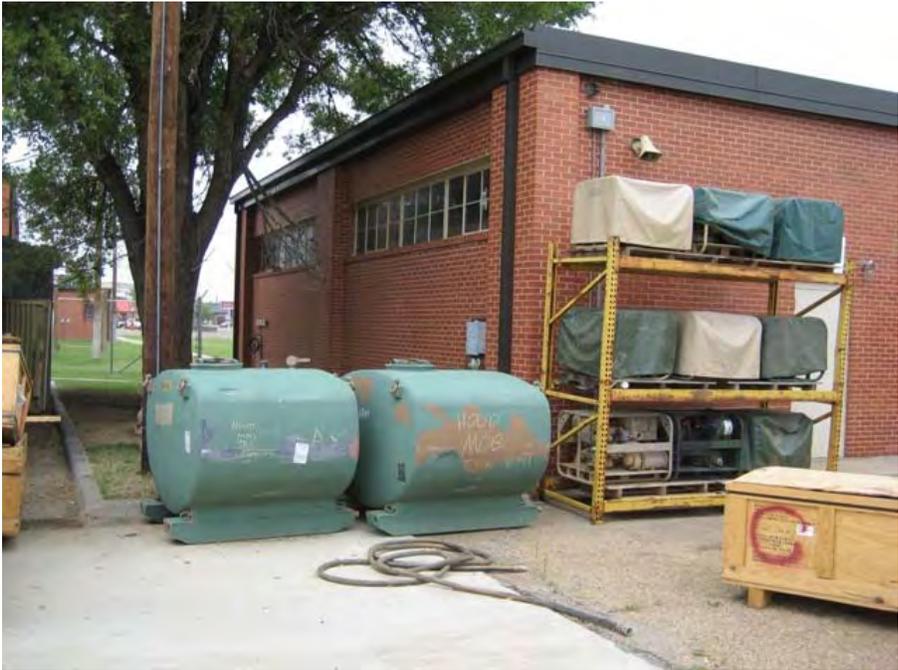
Photo 17: Looking northeast along the northwest side of the OMS are two empty fuel pods.

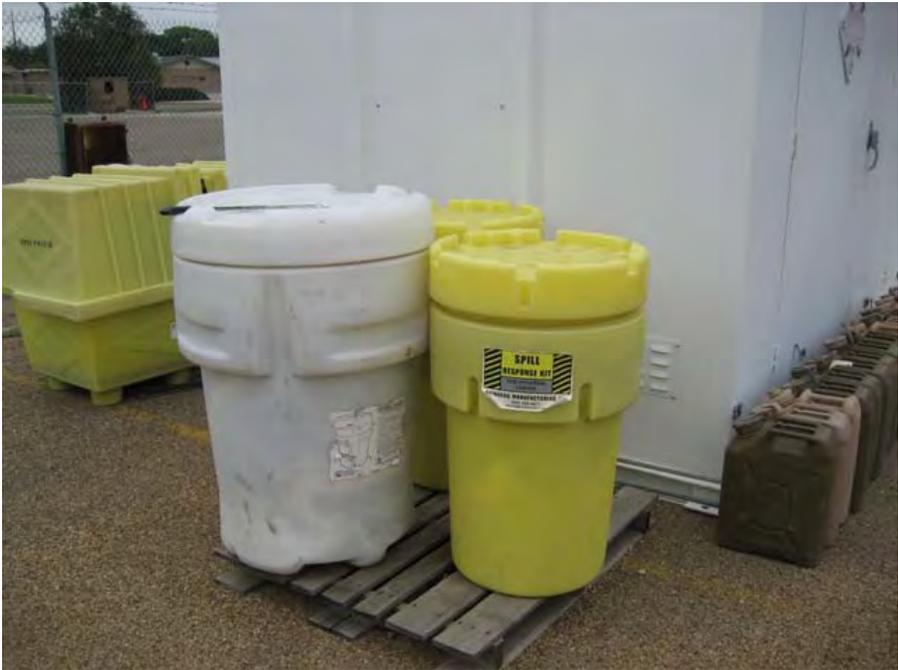
Photo 18: Overpack drums are stored on a pallet on the southwest side of the hazardous materials storage building.

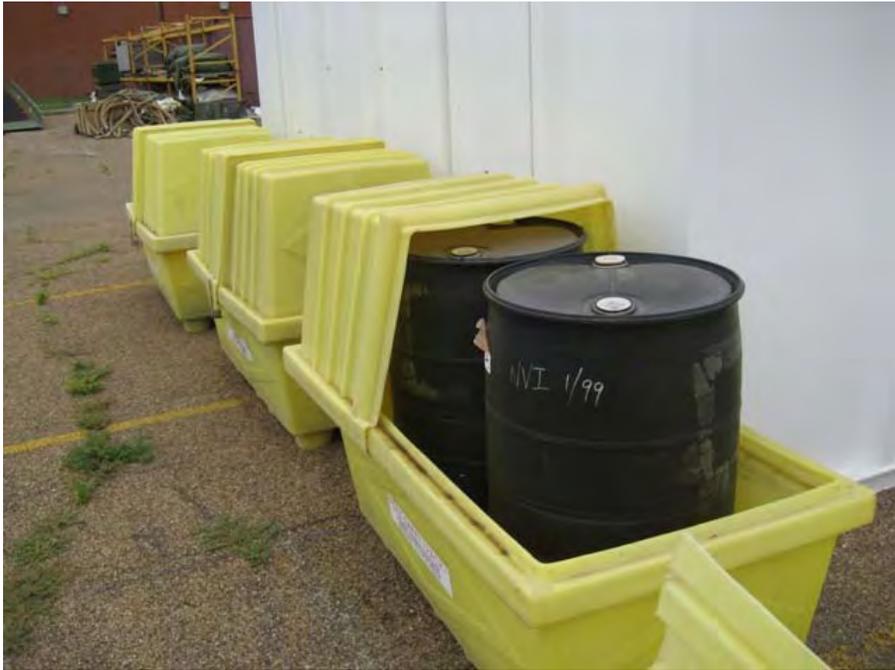
Photo 19: Spill containment for drums is located on the northwest side of the hazardous materials storage building.

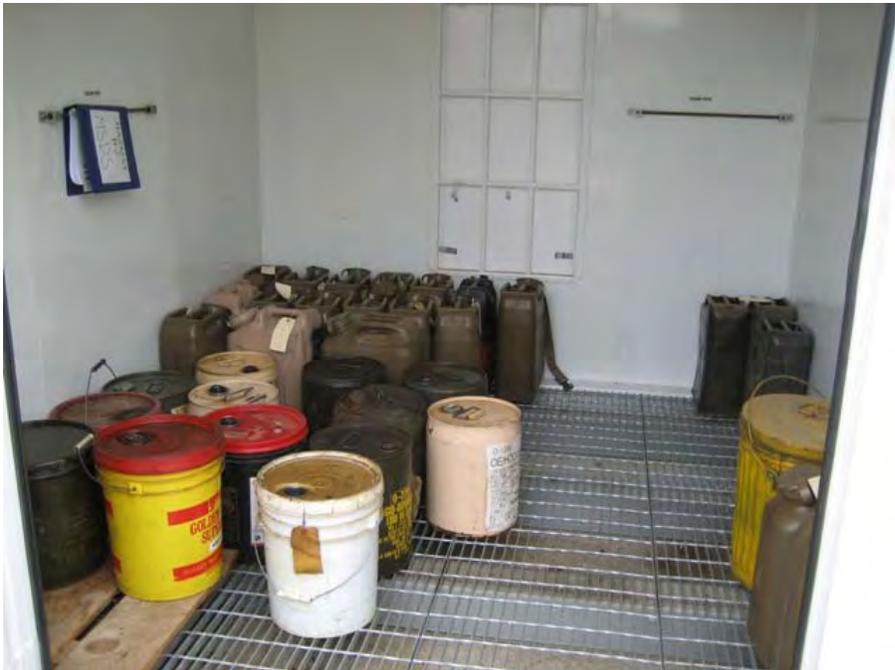
Photo 20: View inside of the hazardous materials storage building which has a catchment basin below the floor.

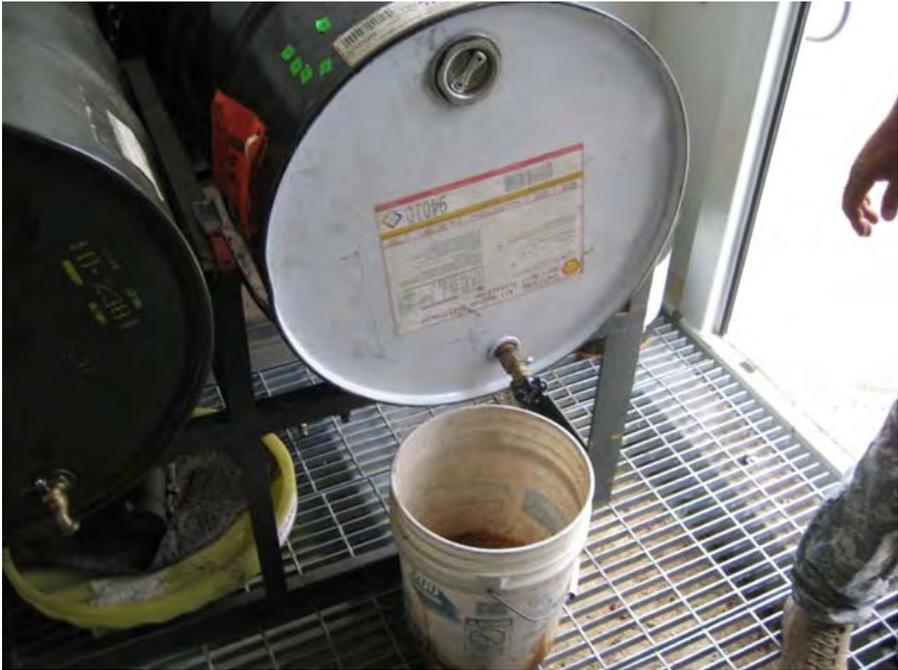
Photo 21: Another view of storage inside the hazardous materials storage building.

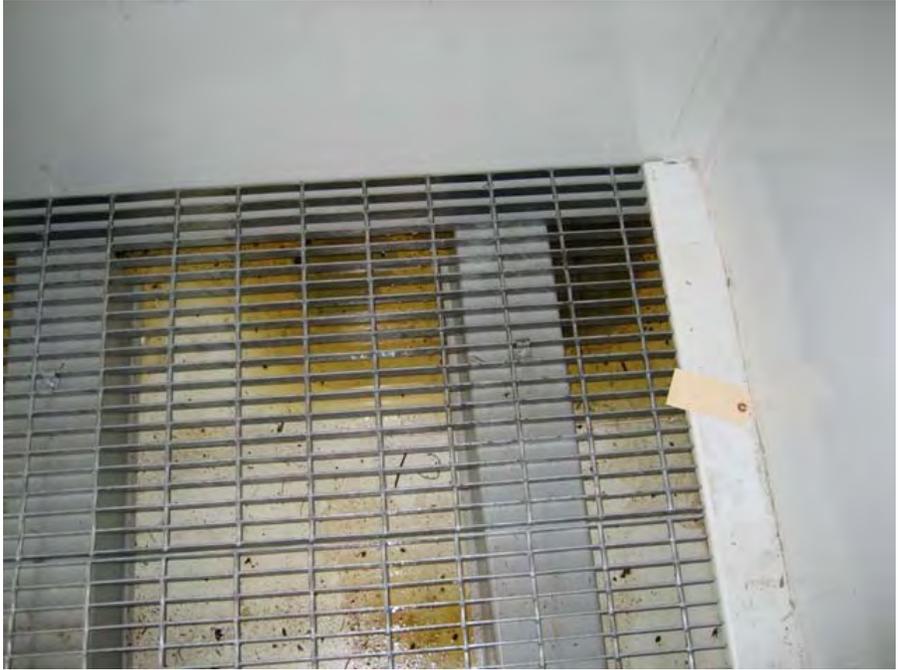
Photo 22: View of minor spillage inside the hazardous materials storage building.

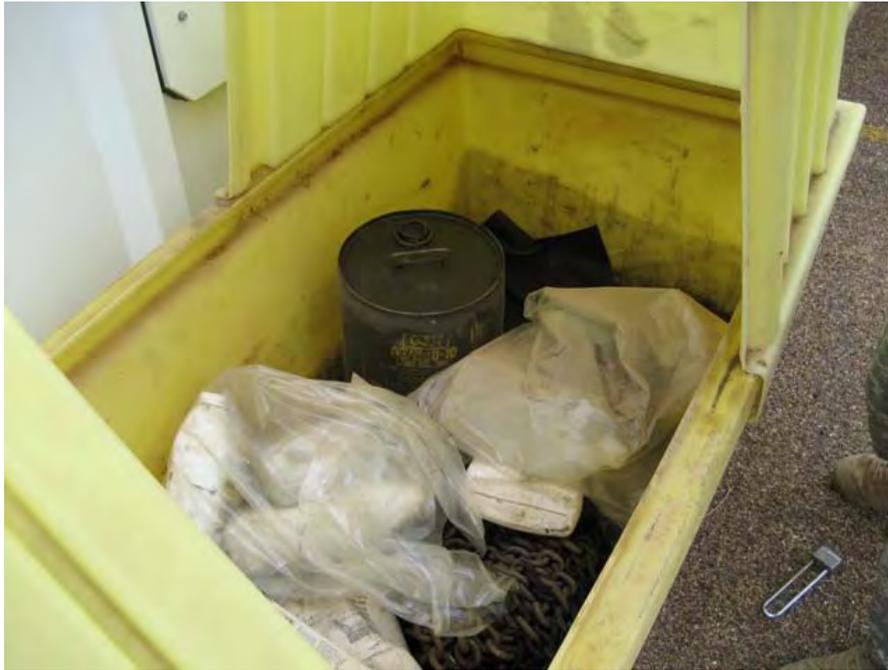
Photo 23: Waste materials waiting transfer to a disposal facility.

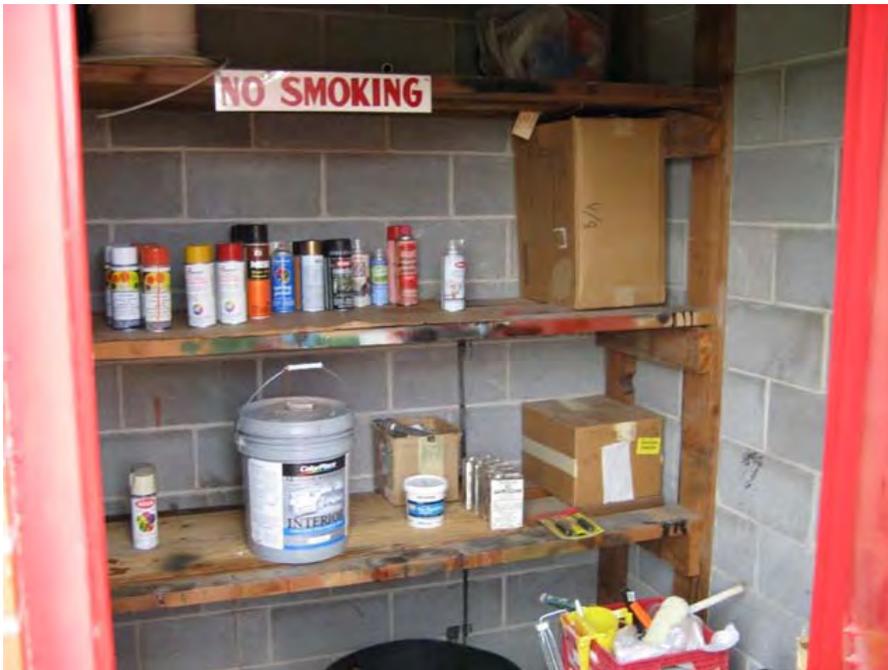
Photo 24: Inside view of a paint locker in the OMS.

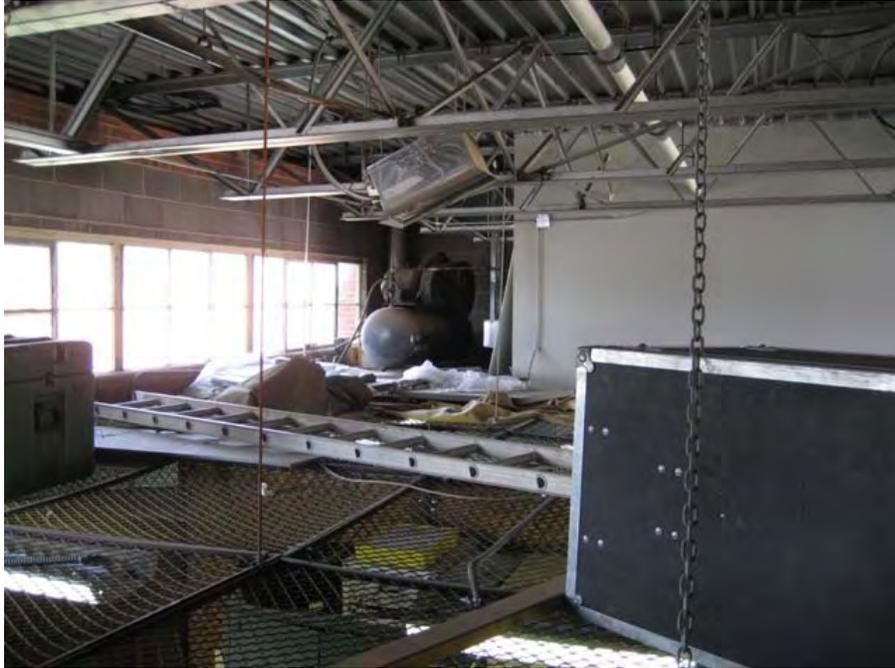
Photo 25: Inside view of the OMS across the top of equipment storage rooms toward air compressor mounted above the paint storage closet.

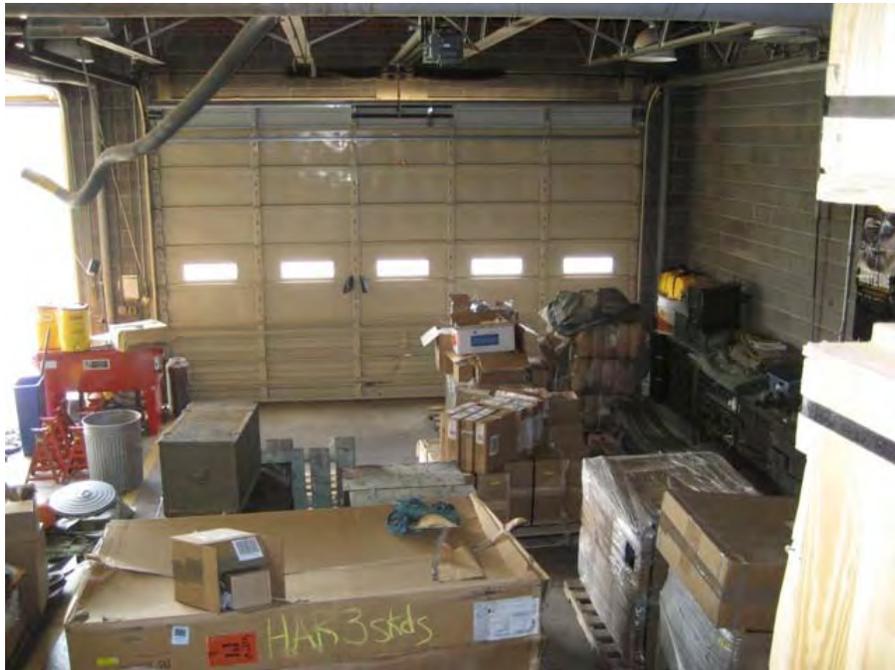
Photo 26: Another inside view of the OMS.

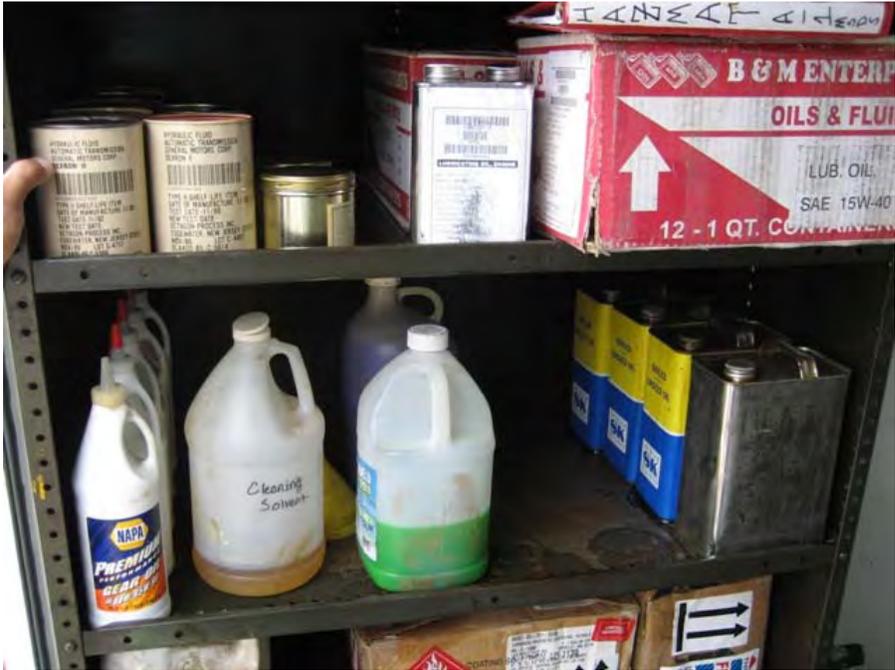
Photo 27: Materials used for vehicle maintenance are stored in the hazardous materials storage building.

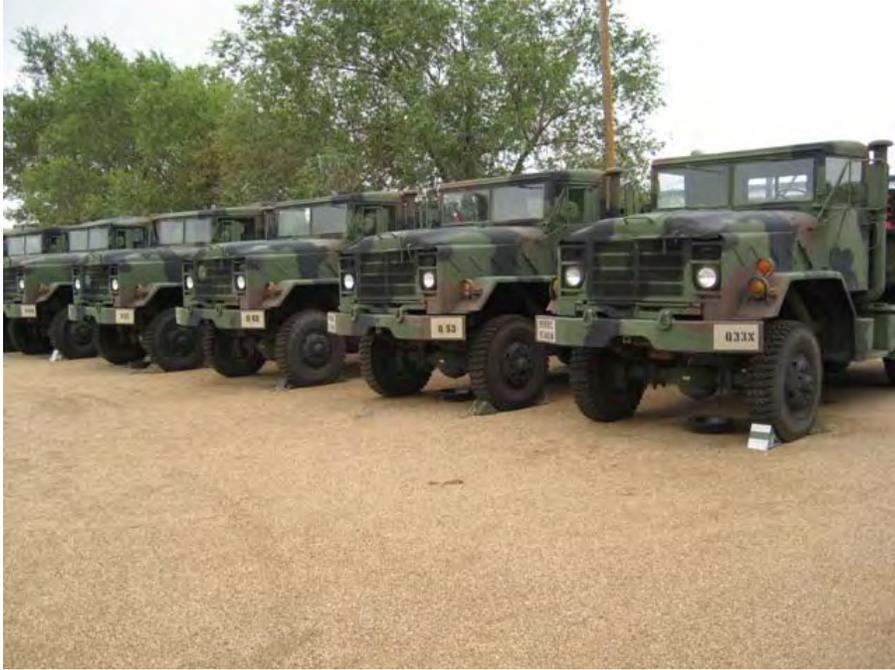
Photo 28: Military trucks are parked in the MEP area with drip pans under the engines of the parked vehicles.

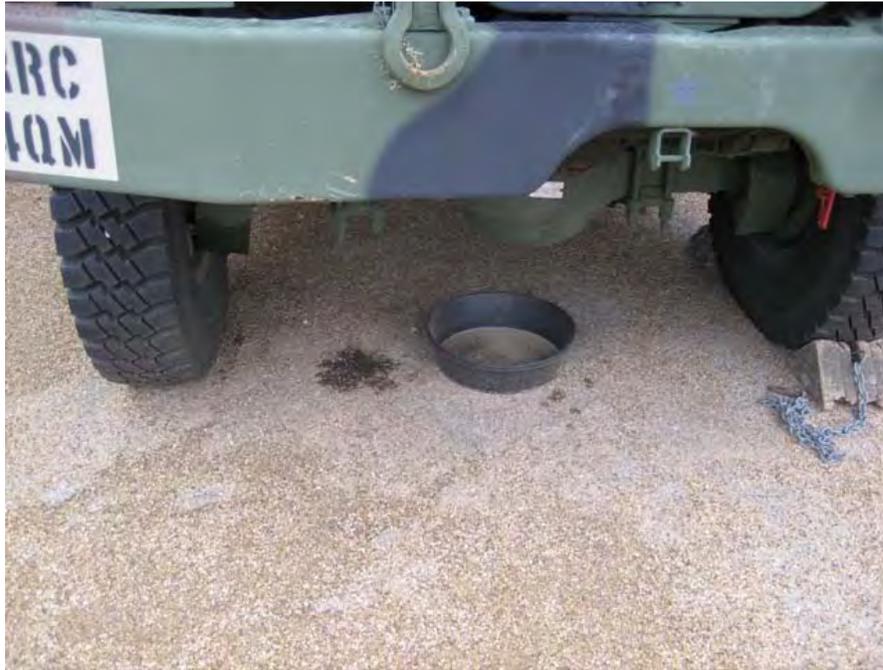
Photo 29: Drip pan beneath engine of parked truck. Note staining on gravel around drip pan.

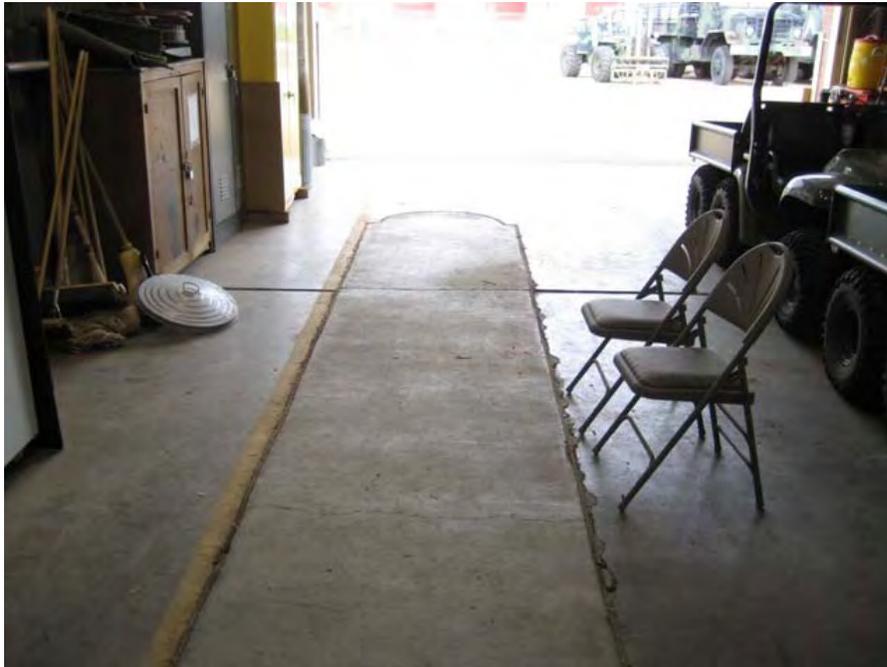
Photo 30: Former mechanics pit located in the north bay of the OMS. The former pit is capped with concrete at the level of the surrounding OMS shop floor.

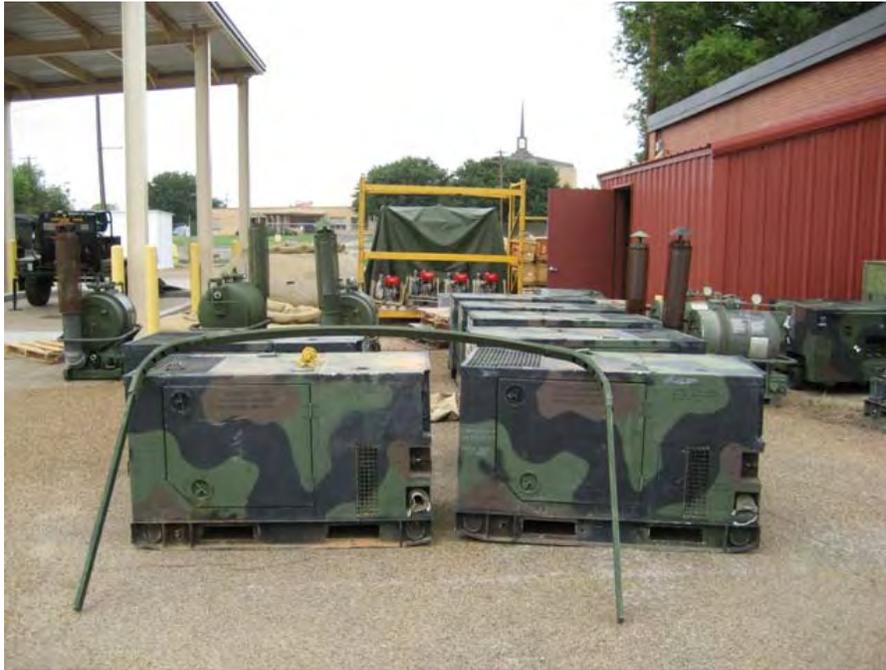
Photo 31: Miscellaneous equipment is stored between the vehicle wash rack and the OMS.

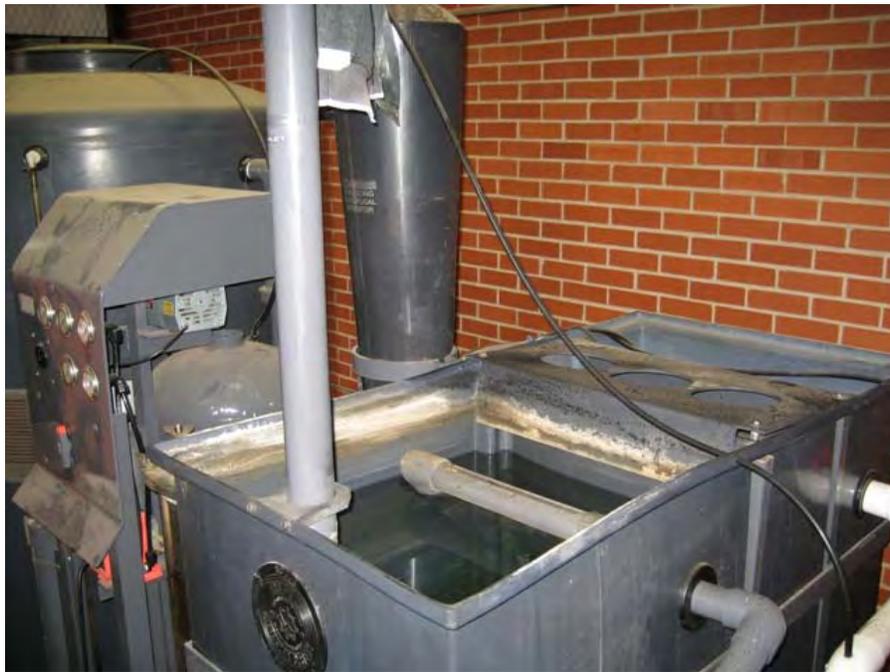
Photo 32: The OWS and water recirculating system for the vehicle wash rack.

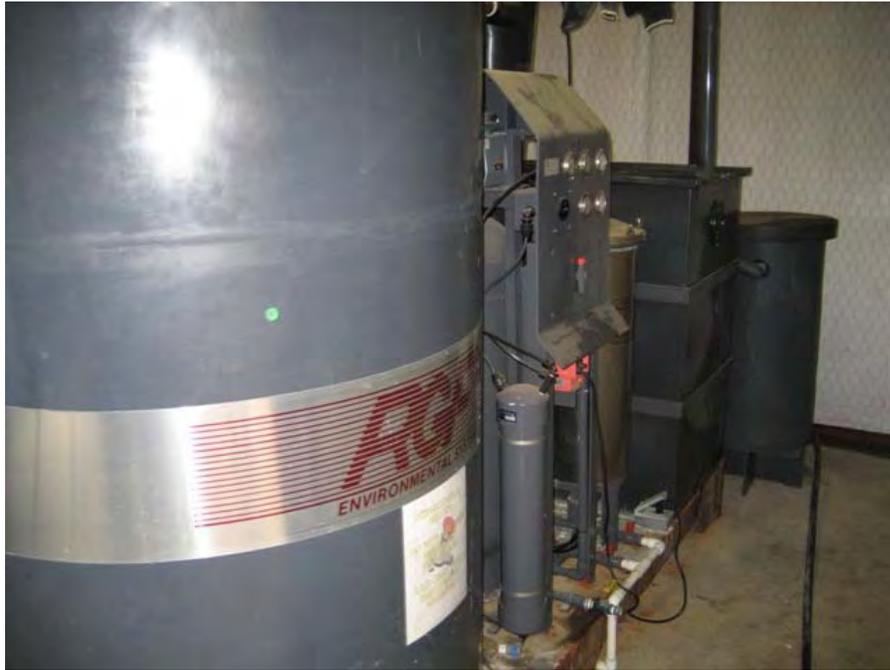
Photo 33: A 500-gallon water storage tank is part of the OWS.

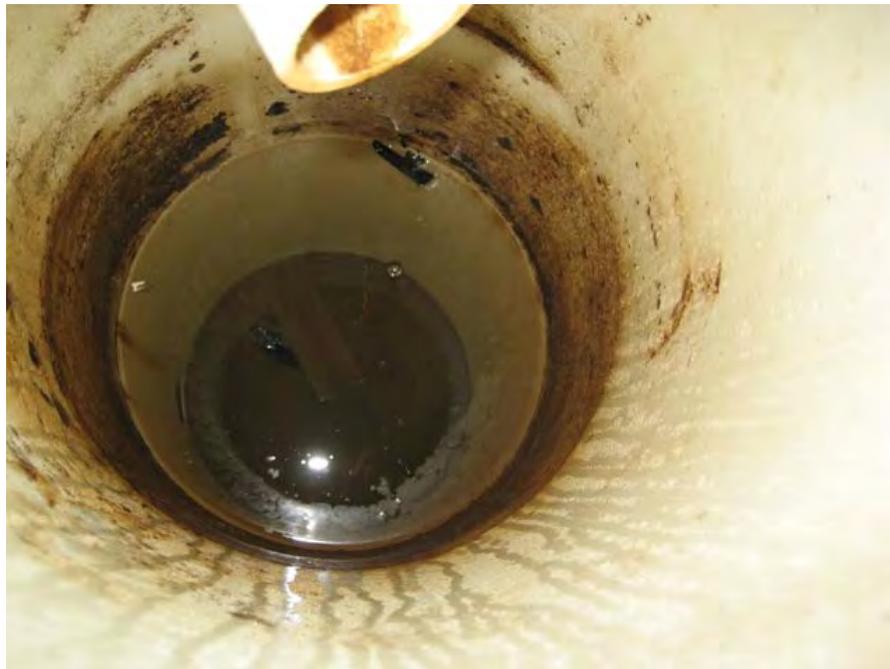
Photo 34: Oil staining was visible in the oil skimmer of the OWS.

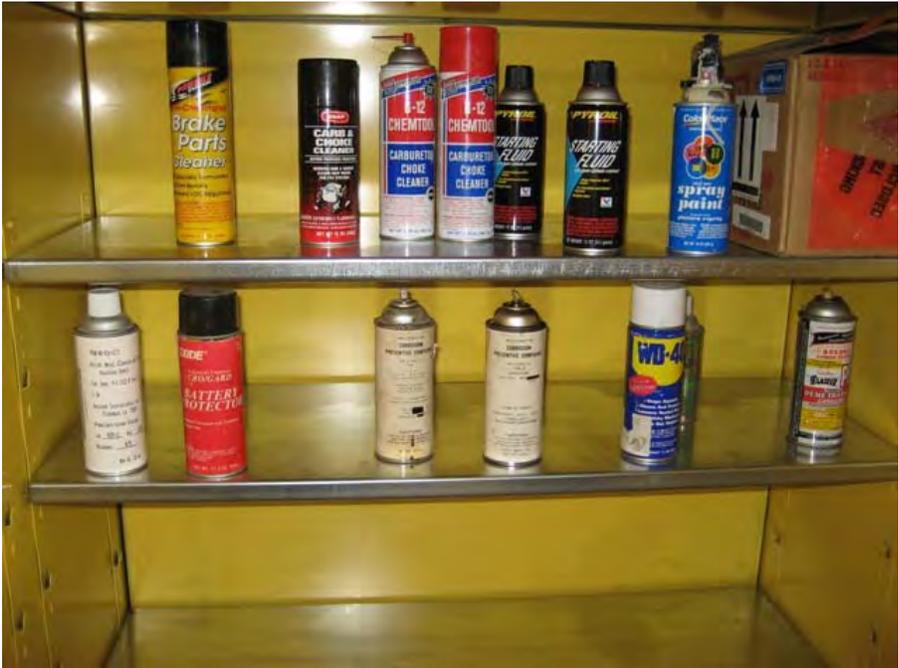
Photo 35: View of flammable materials storage cabinet inside the OMS.

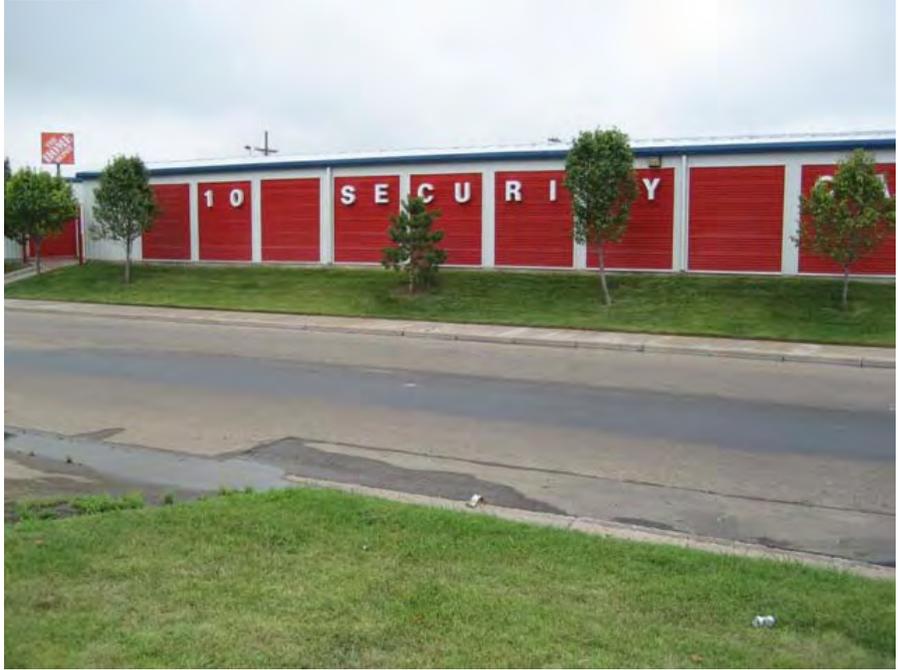
Photo 36: Looking east across Blackburn Street toward the adjoining storage unit property.

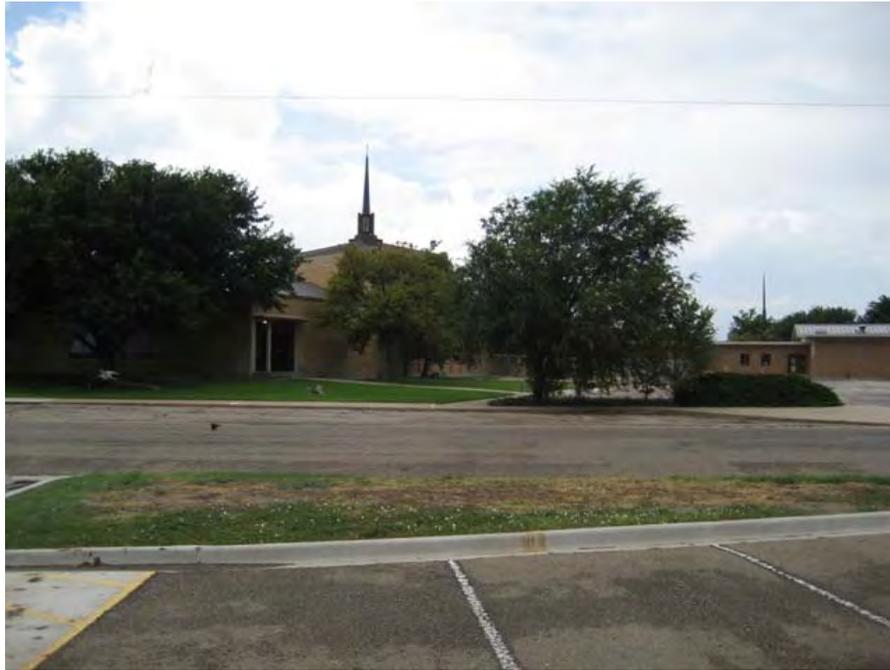
Photo 37: Looking northwest across Church Avenue from the USAR Center toward First Christian Church.
