Appendix B
Site Reconnaissance Photographs

**Blucher S. Tharp Memorial USAR Center
2801 Duniven Circle
Amarillo, Texas**

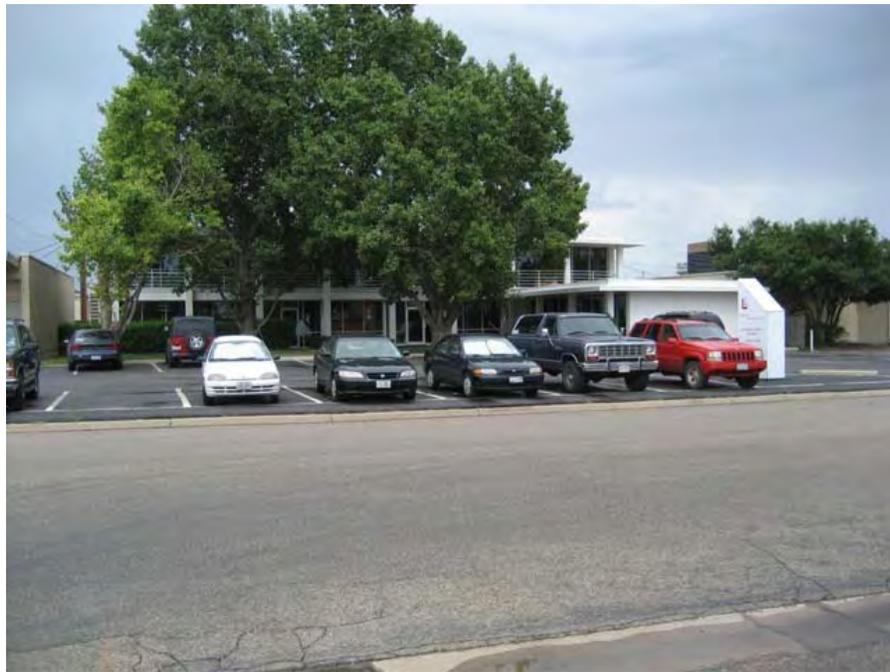
Photo 38: Looking northeast across Duniven Circle toward the adjoining office building property.

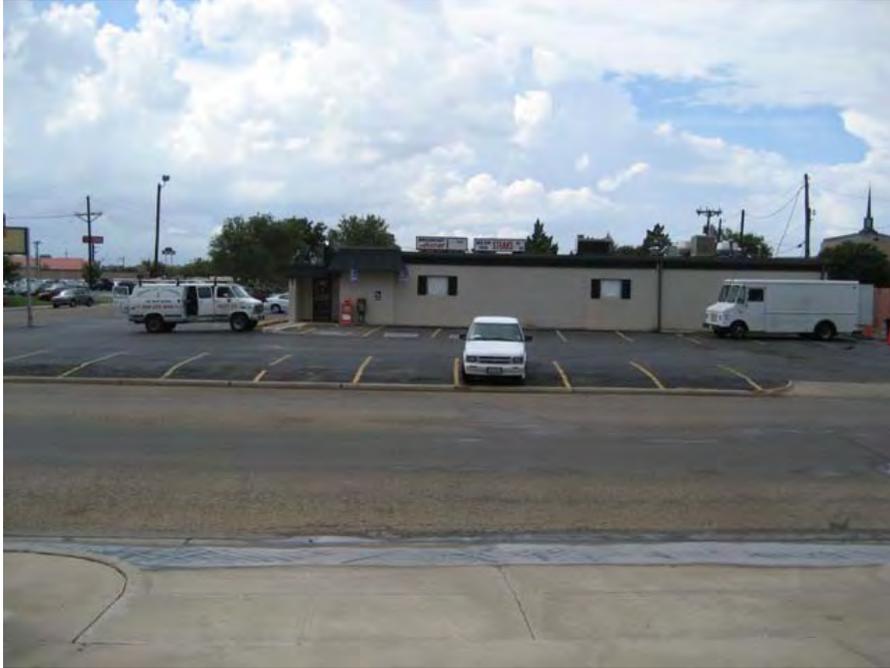
Photo 39: Looking northwest across Blackburn Street toward Pancake Station restaurant (USAR Center is to the right in the photograph).
