Appendix B
Site Reconnaissance Photos

**Jules E. Muchert USAR Center
10031 E. Northwest Highway
Dallas, Texas**

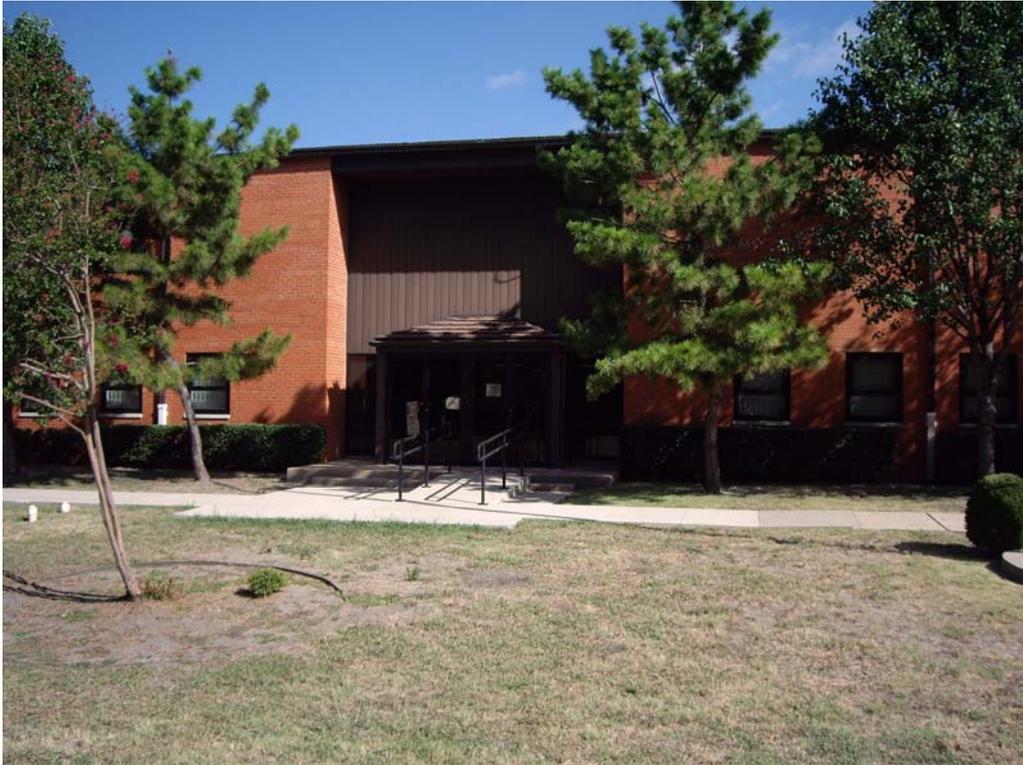
Photo 1: View of front of Jules E. Muchert USAR Center from East Northwest Highway.

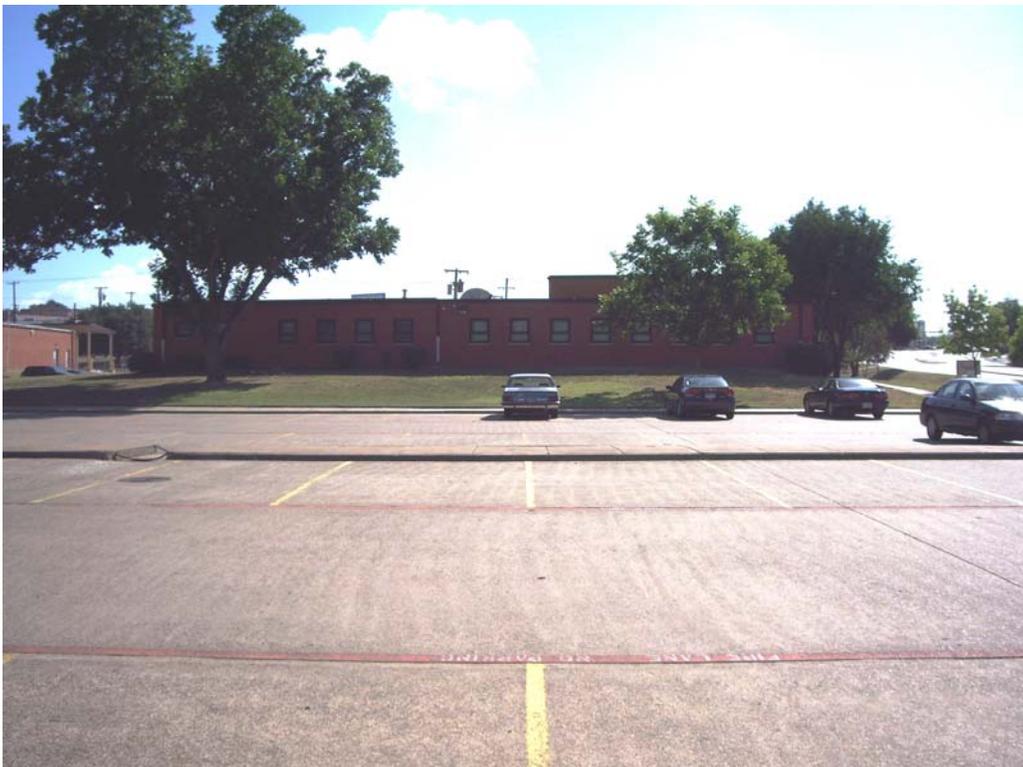
Photo 2: View of west side of USAR Center and west POV.

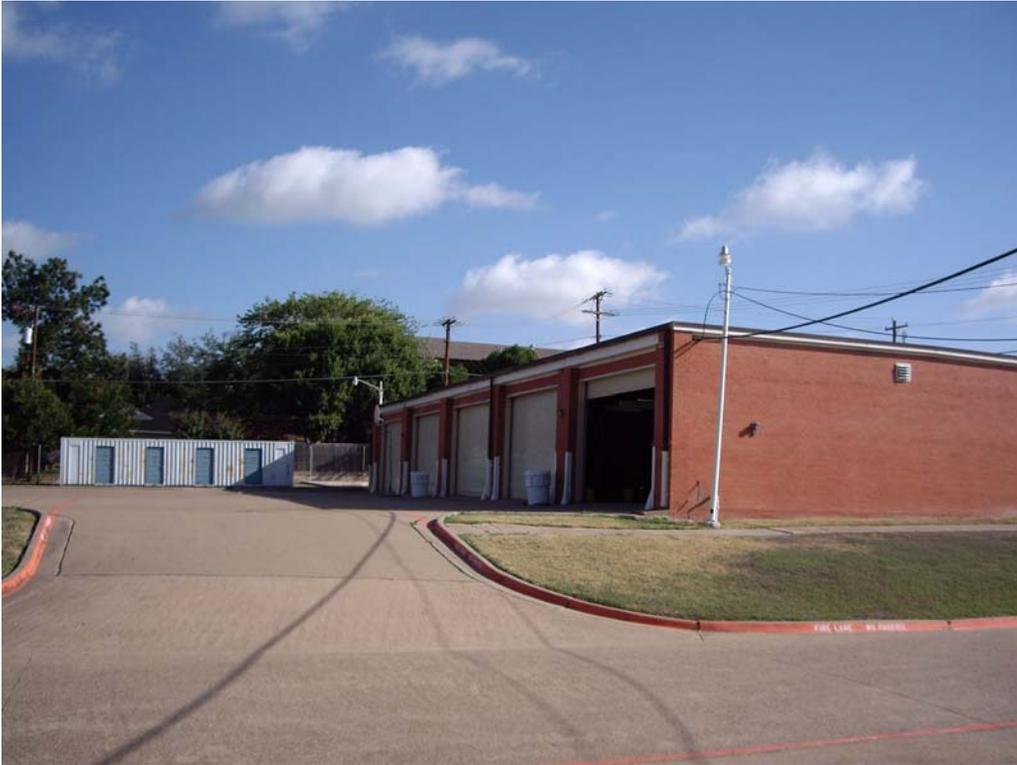
Photo 3: View of west side of OMS and vehicle staging area. A residential area abuts the Site to the north in the background.

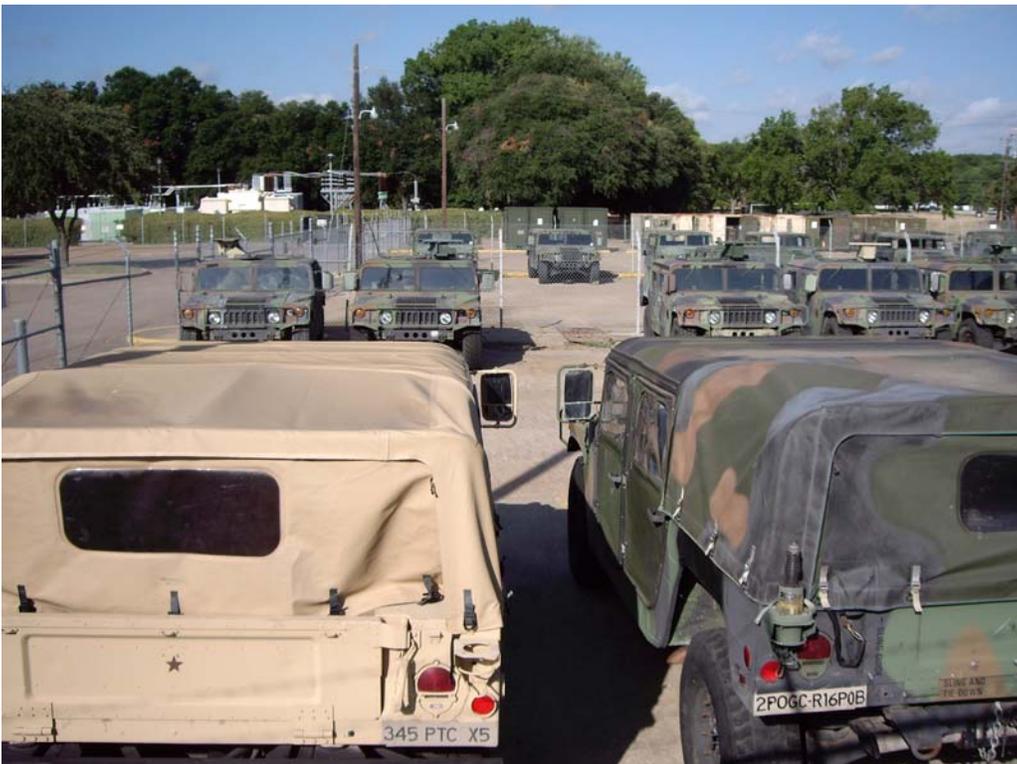
Photo 4: MEP area west of OMS. TU Electric substation in background abuts the west side of the Site.

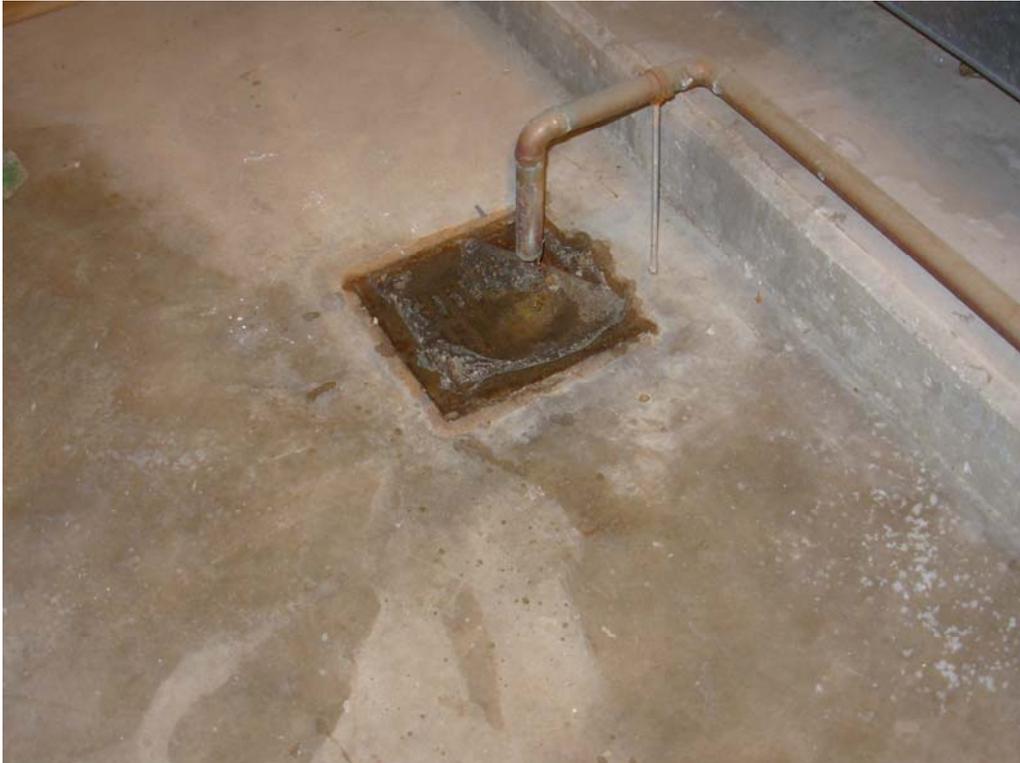
Photo 5: Floor drain for air conditioning condensate. This drain is typical of other condensate floor drains at the facility.

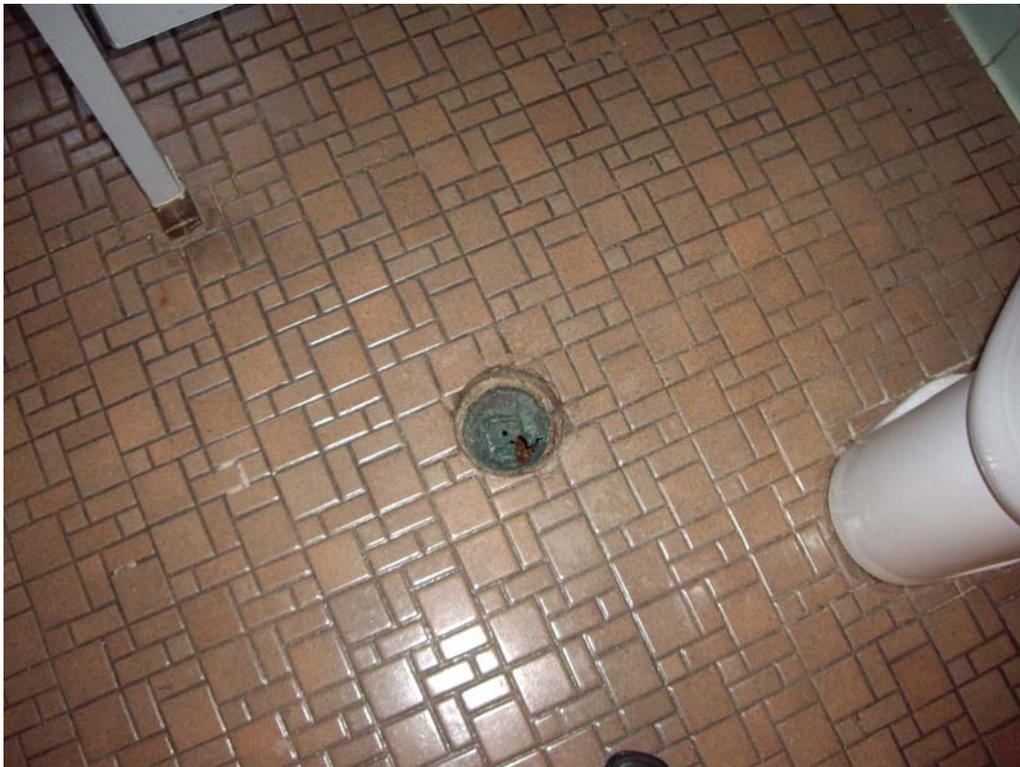
Photo 6: Floor drain in first floor female restroom. This floor drain is typical of other drains in restrooms at the facility.

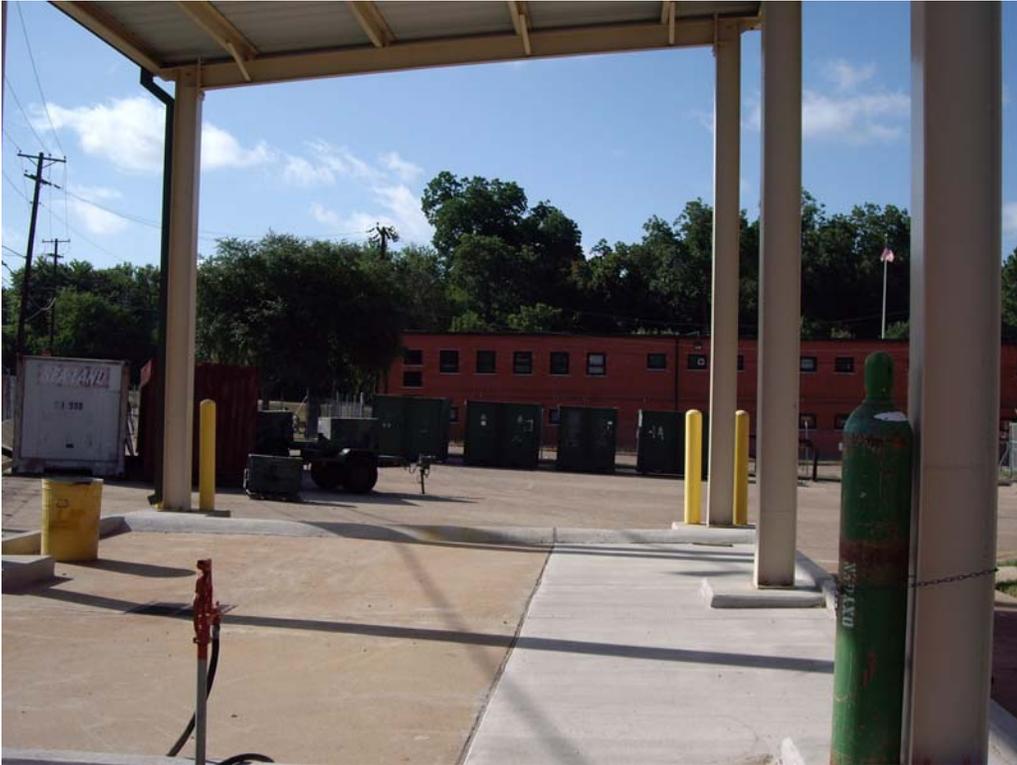
Photo 7: Vehicle wash rack. Hose bib in foreground and new concrete associated with post 1997 awning. View to facing south.

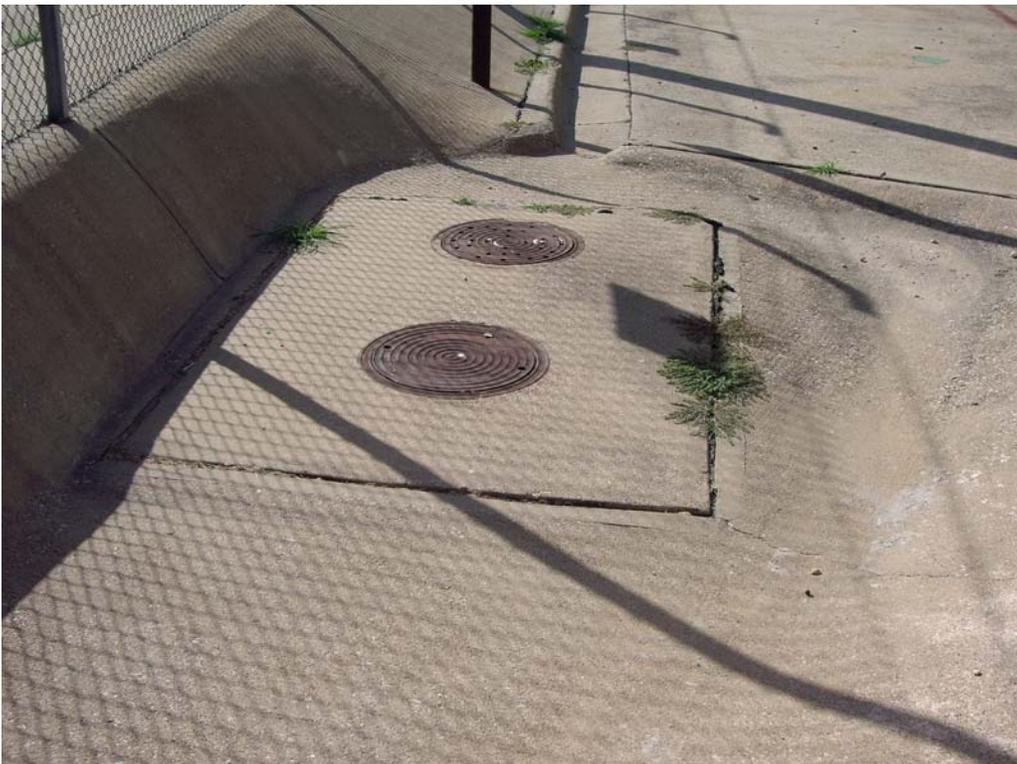
Photo 8: Oil-water separator that processes wash rack water. Separator is located east of the wash rack, next to the Site boundary fence.

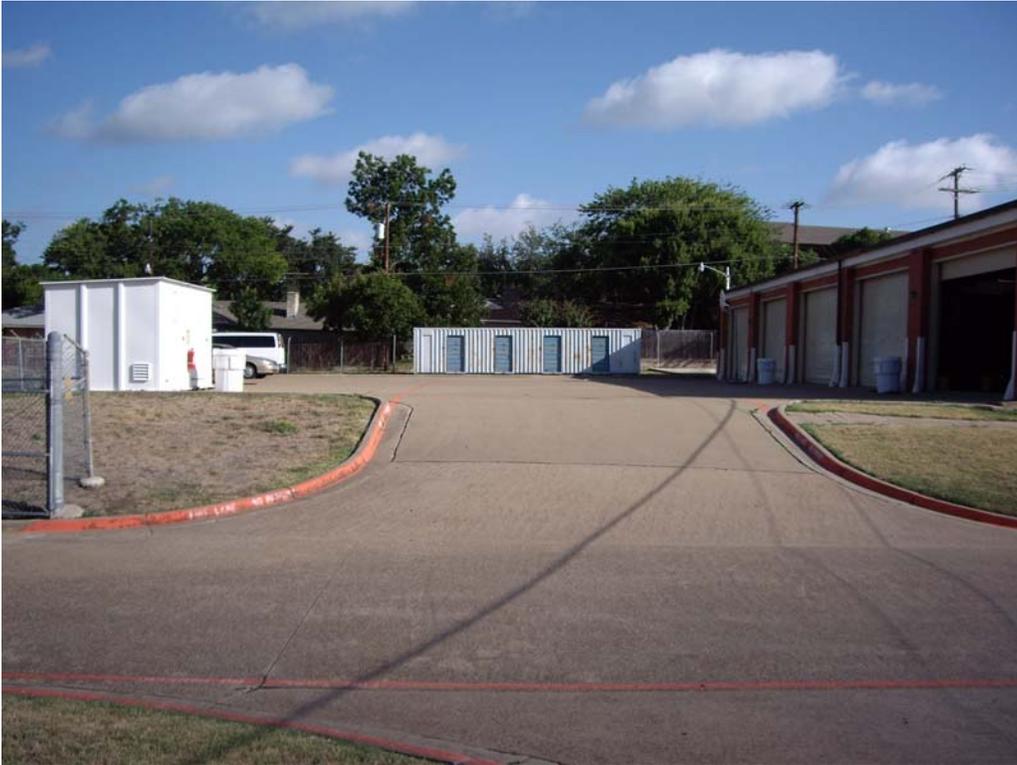
Photo 9: OMS with hazmat shed (far left) and general storage shed (background). A spill kit can be seen in front of the hazmat shed.

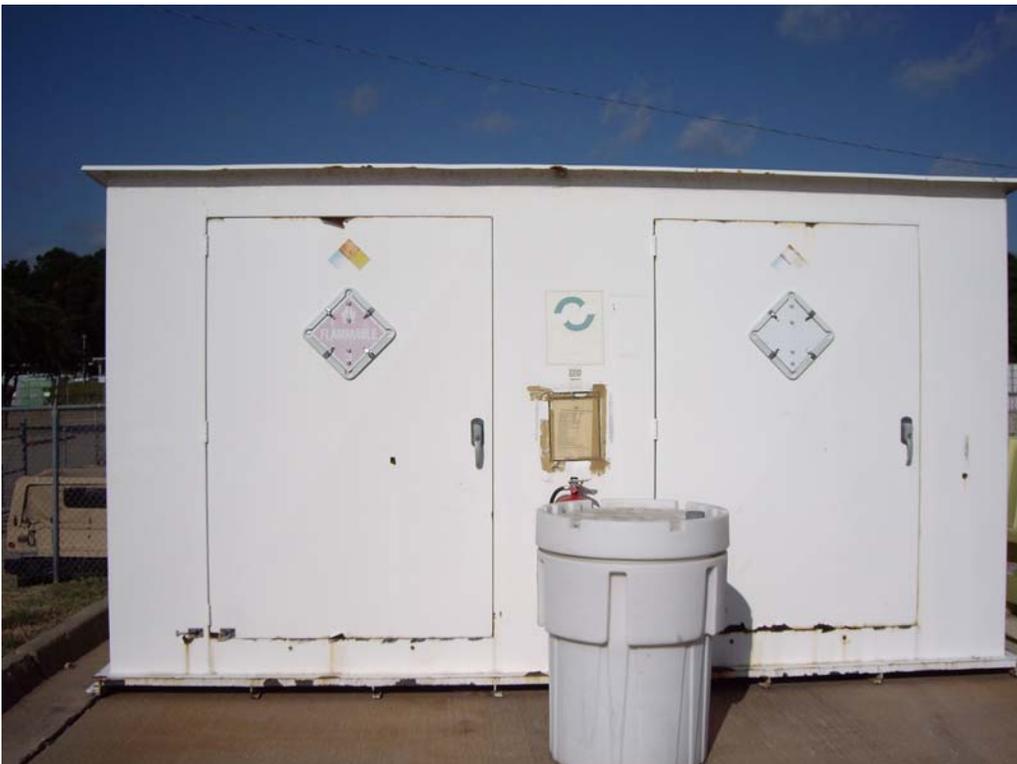
Photo 10: Front view of the hazmat shed.

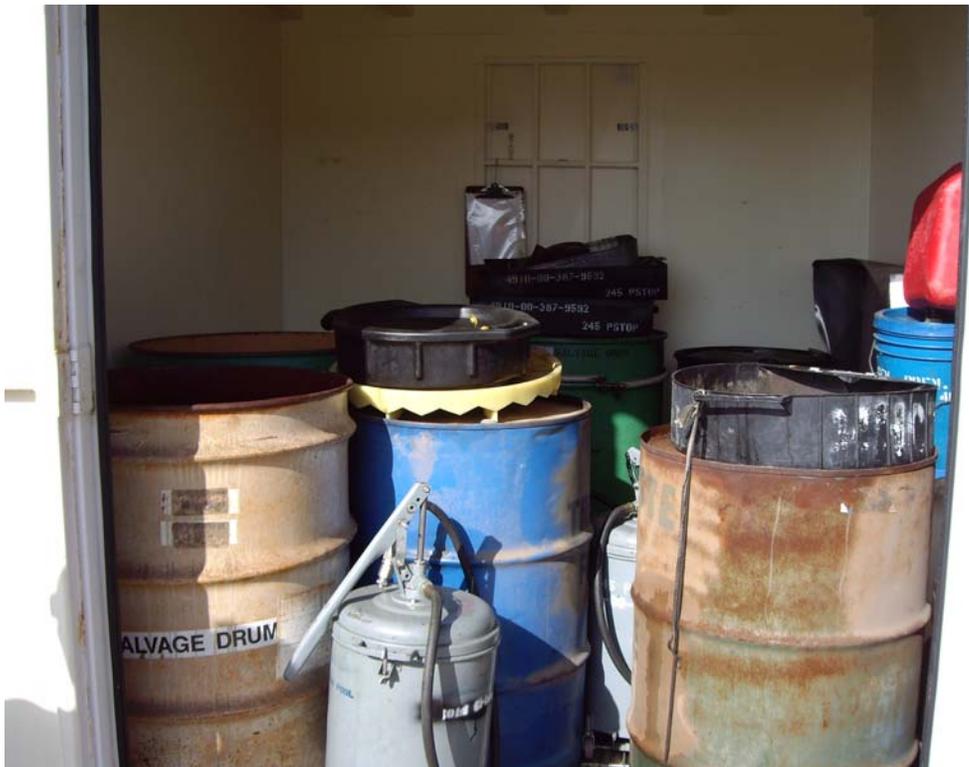
Photo 11: Interior view of the hazmat shed showing empty drums.

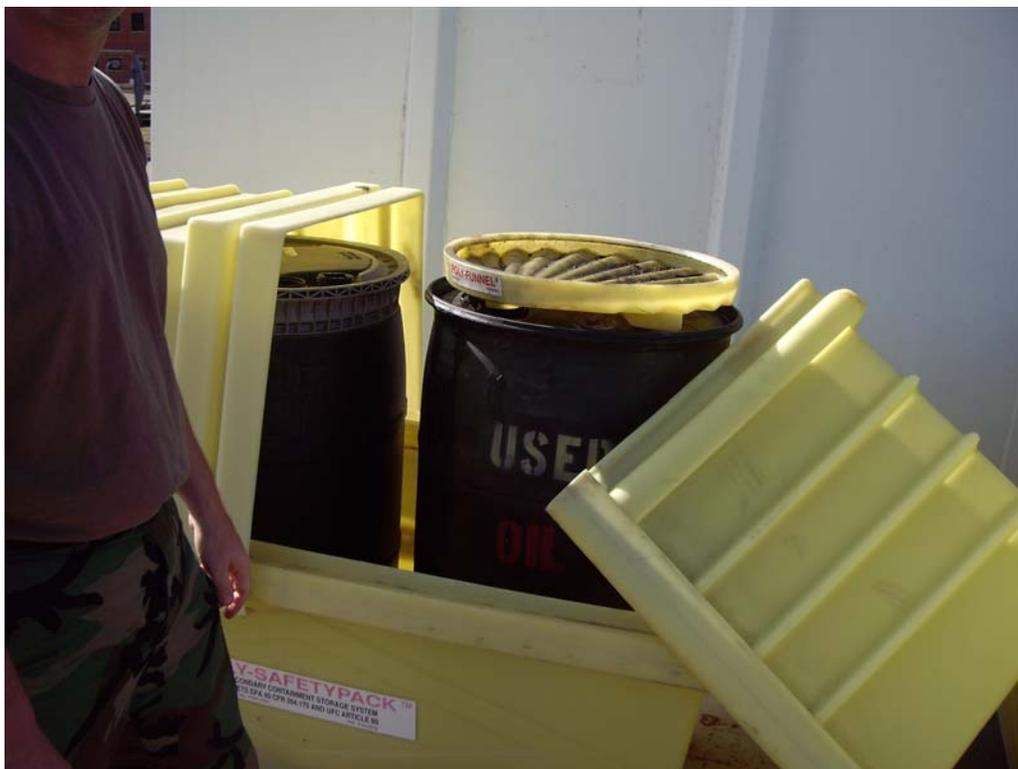
Photo 12: Used oil and antifreeze stored in a safety pack on the north side of the hazmat shed.

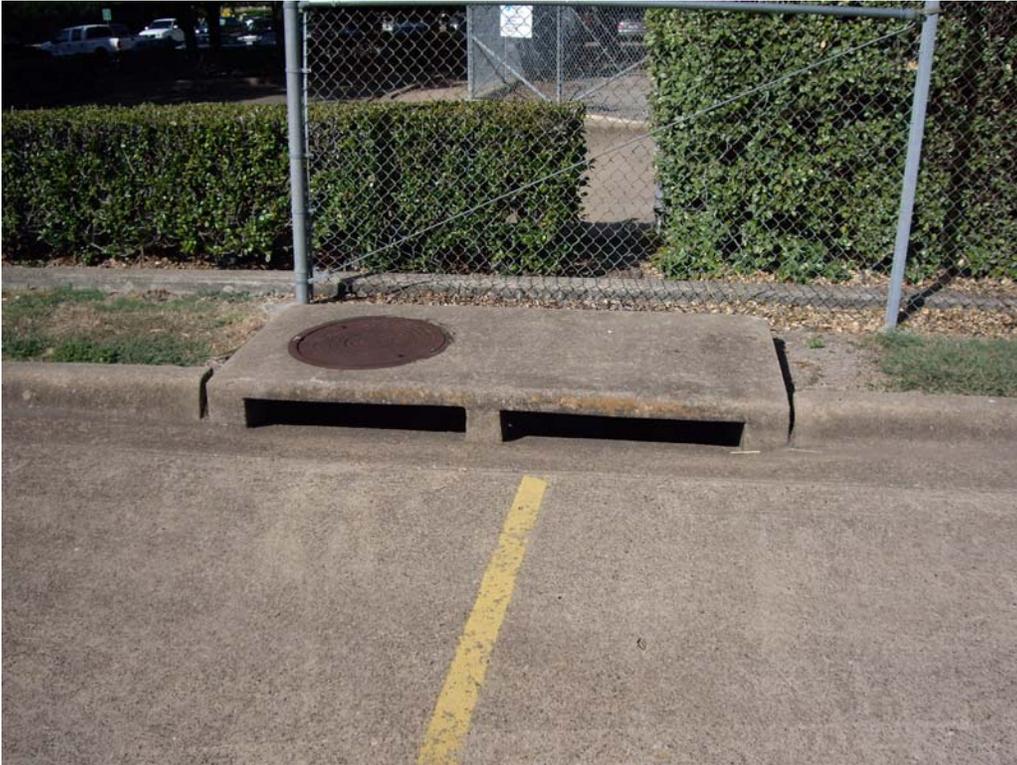
Photo 13: Storm drain located on the west edge of the POV parking lot. Two such drains divert storm water from the western portion of the Site.

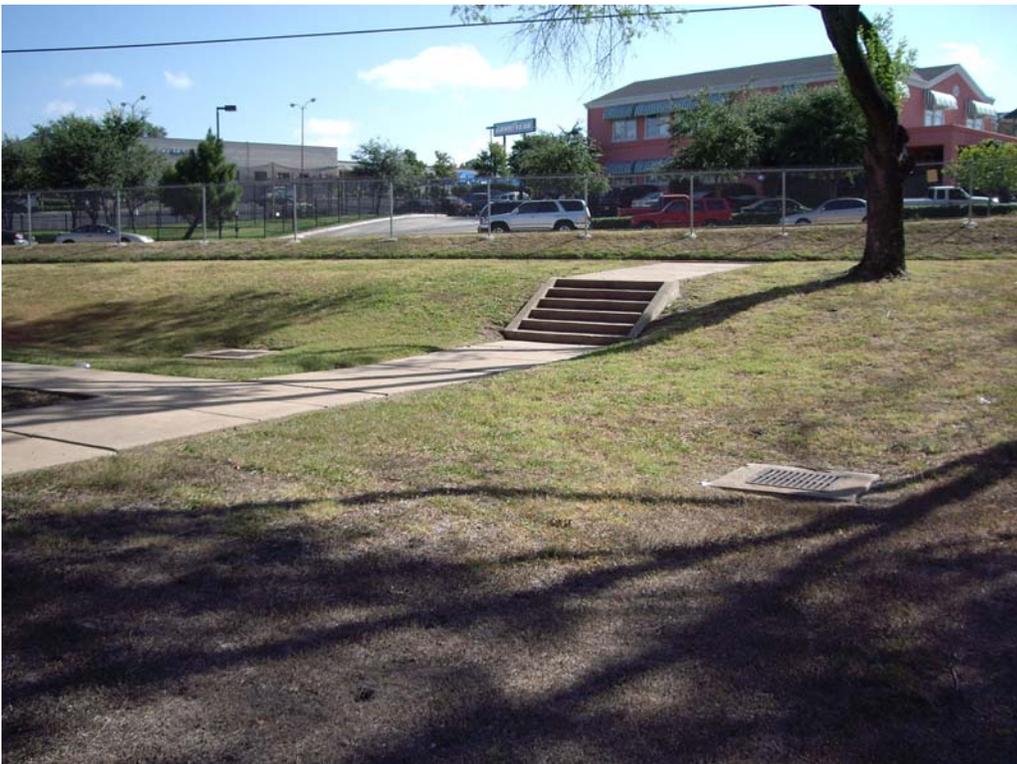
Photo 14: Two storm drains are located in the grassy area near the southeast corner of the property. The pink building in the background is the East Lake Veterinary Hospital.

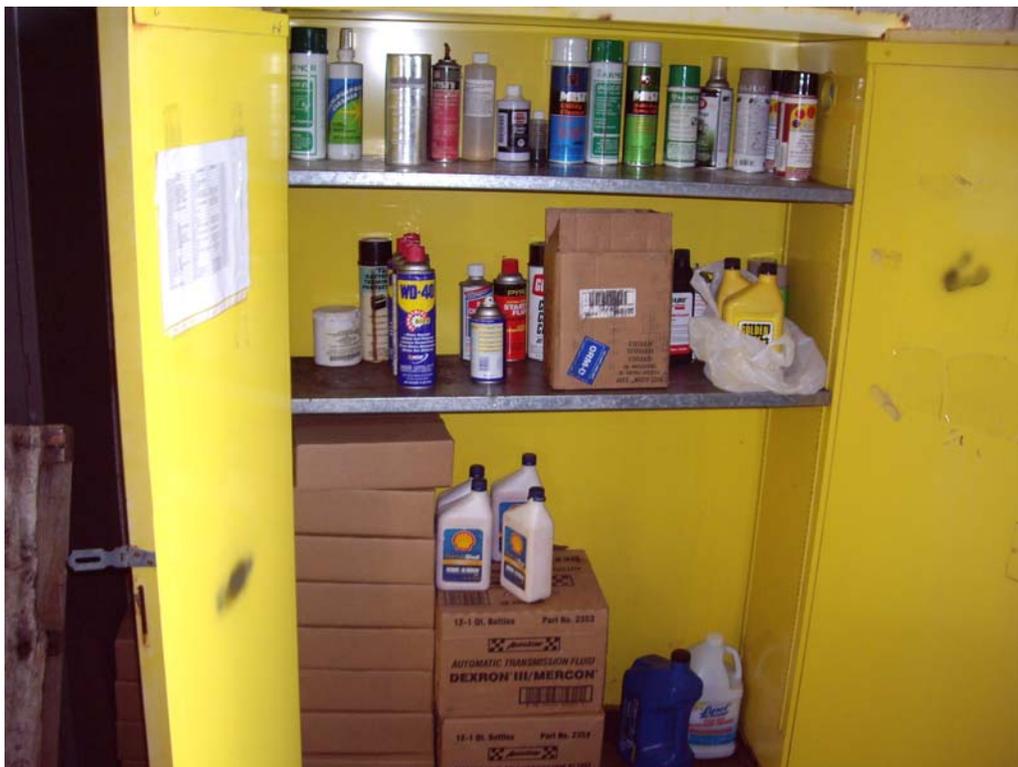
Photo 15: Hazmat locker in the OMS. The locker contained consumer quantities of various vehicle POLs and spray paint.

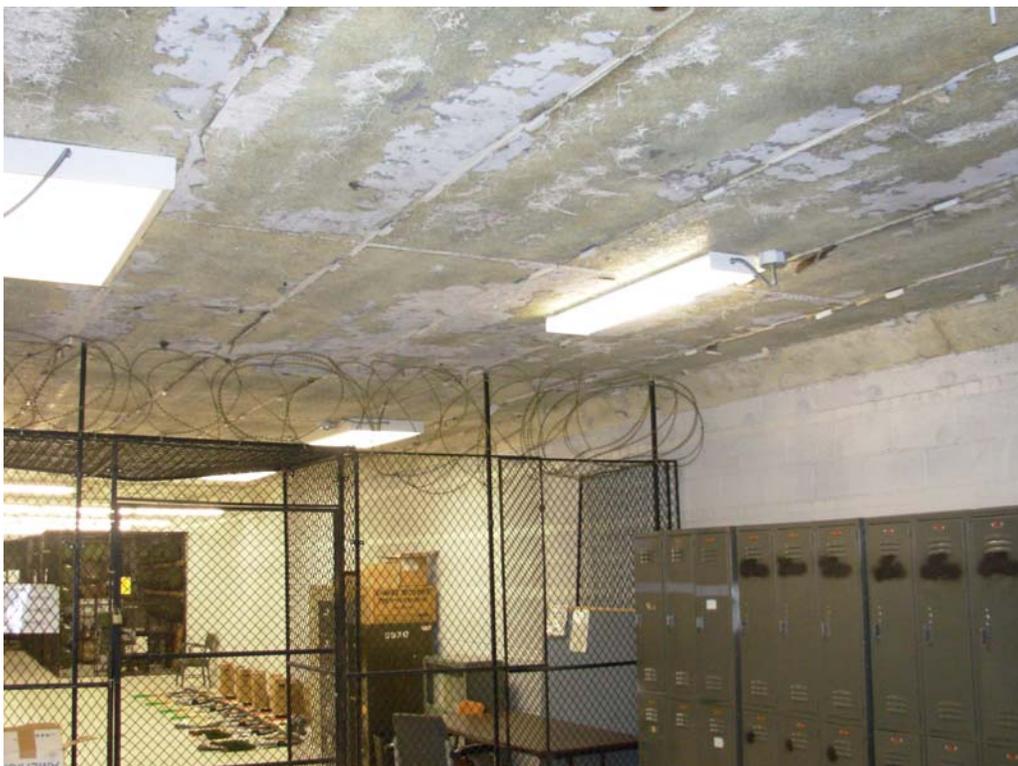
Photo 16: Indoor firing range. The range was decommissioned in 1997 and the metal bullet stops were removed.

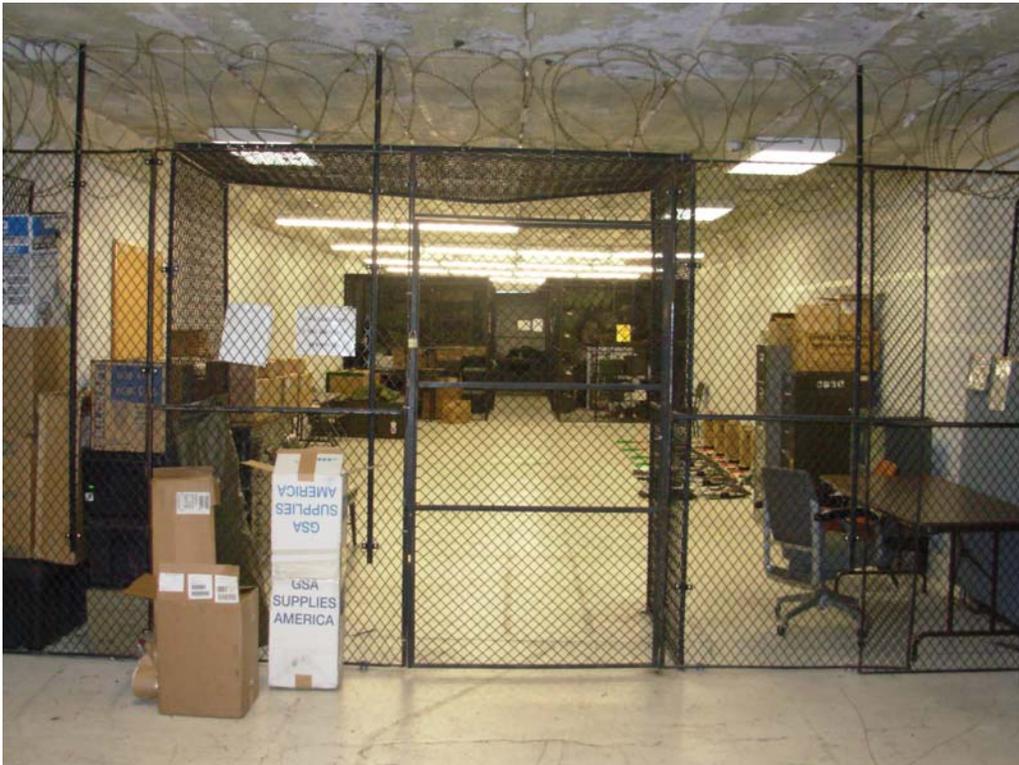
Photo 17: Indoor firing range. The firing range is now used exclusively for storage.

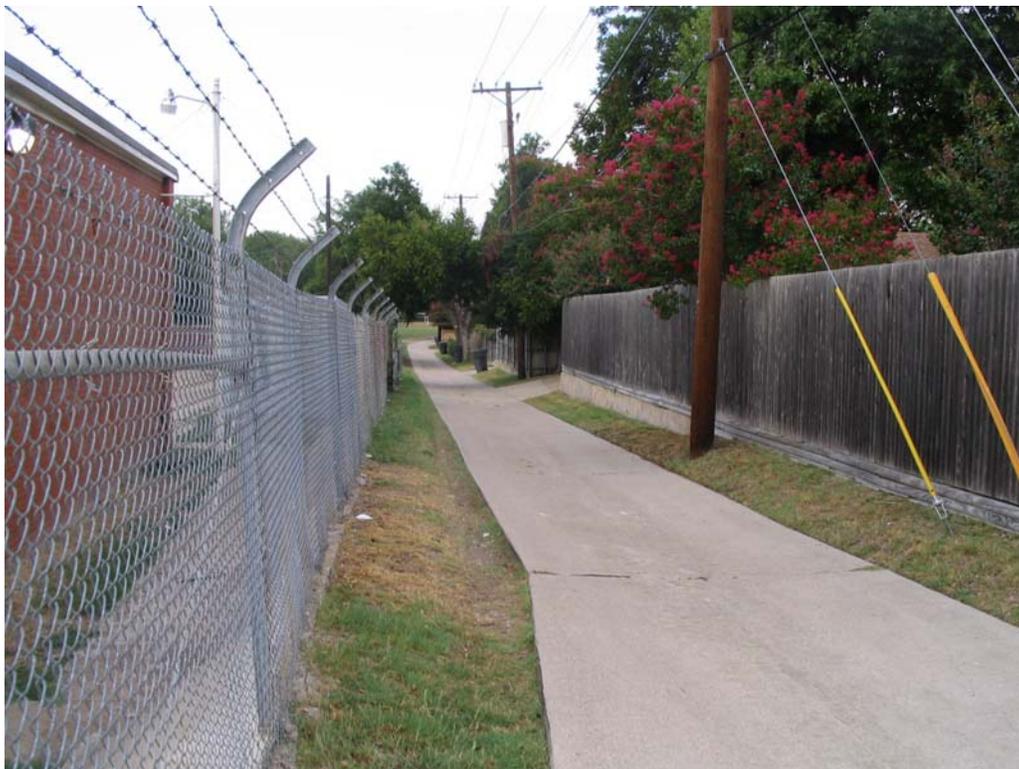
Photo 18: View of northern boundary of the Site. Fences on the right side of photo (north) are the rear of single family residences.

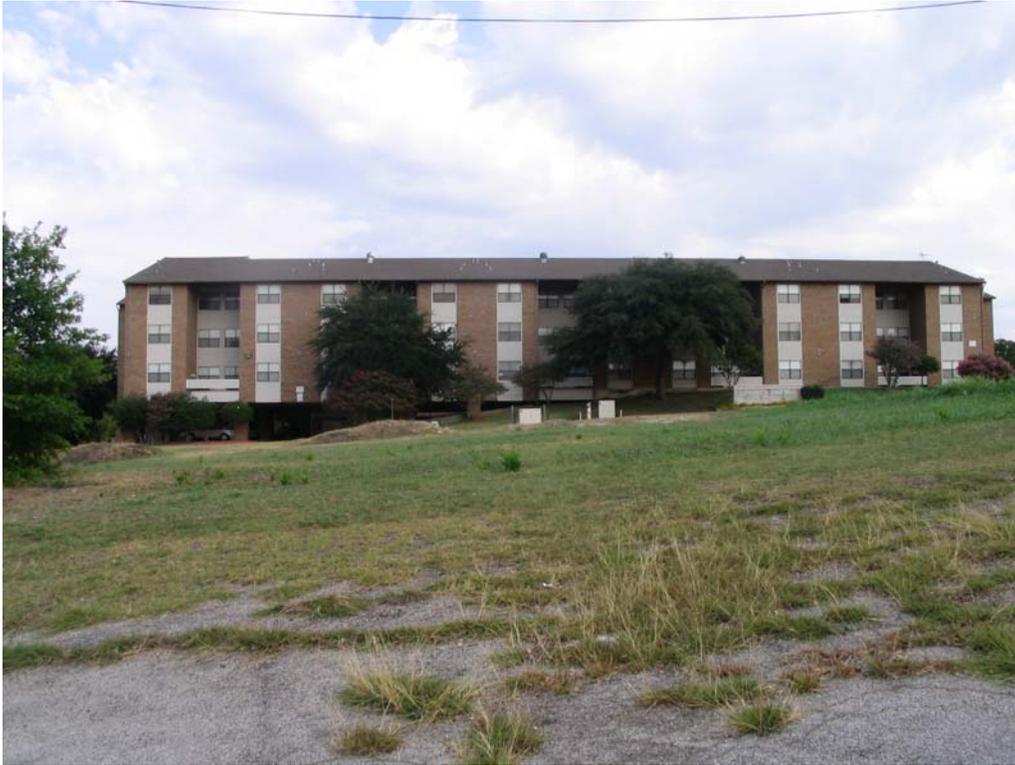
Photo 19: An apartment complex abuts the northeast corner of the USAR Center. The vacant lot in the foreground is directly across Thurgood Lane from the OMS.

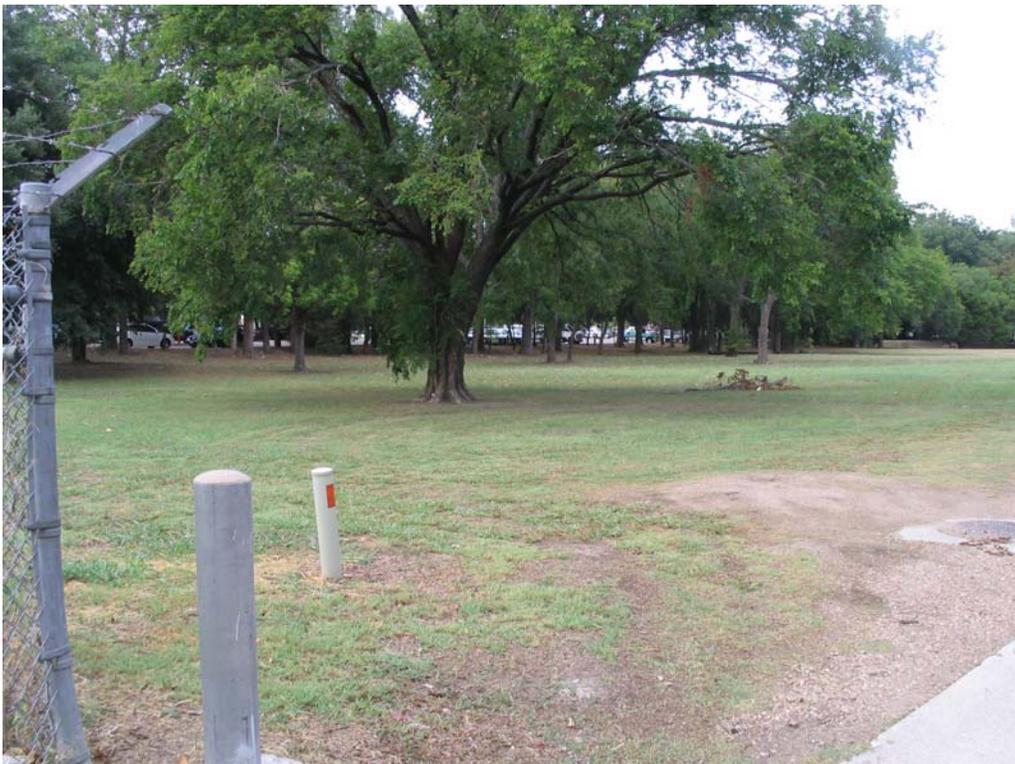
Photo 20: White Rock Park abuts the northwest one-fourth of the USAR Center. The fence post in the foreground is the northwest corner of the Site.

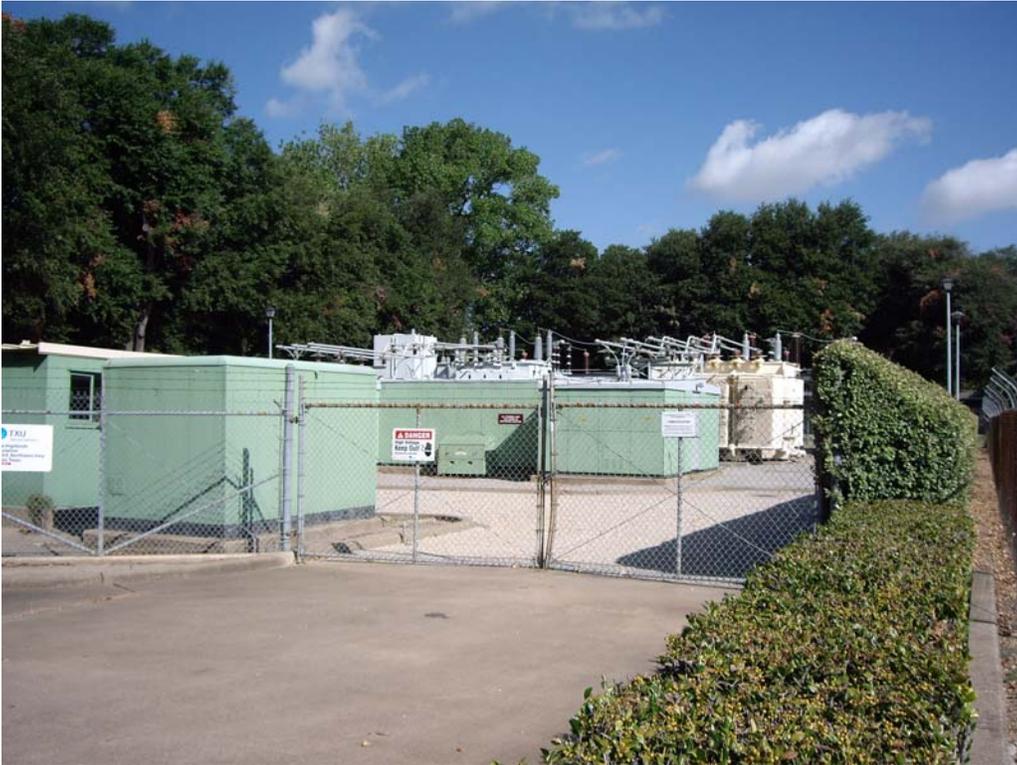
Photo 21: TU Electric's Lake Highland Substation abuts the southern three-fourths of the west boundary of the Site. The fence on the far right of the photo is the USAR Center.

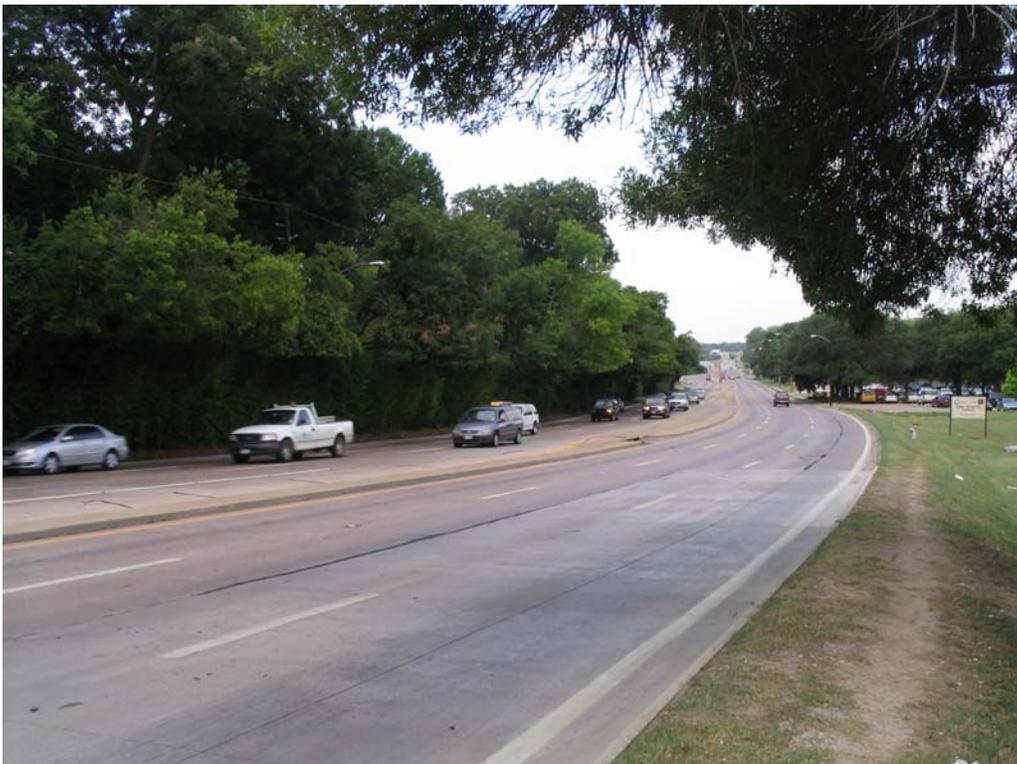
Photo 22: East Northwest Highway viewed from the southeast corner of the Site. Trees on the left side of the photograph are in the yards of single family residences.

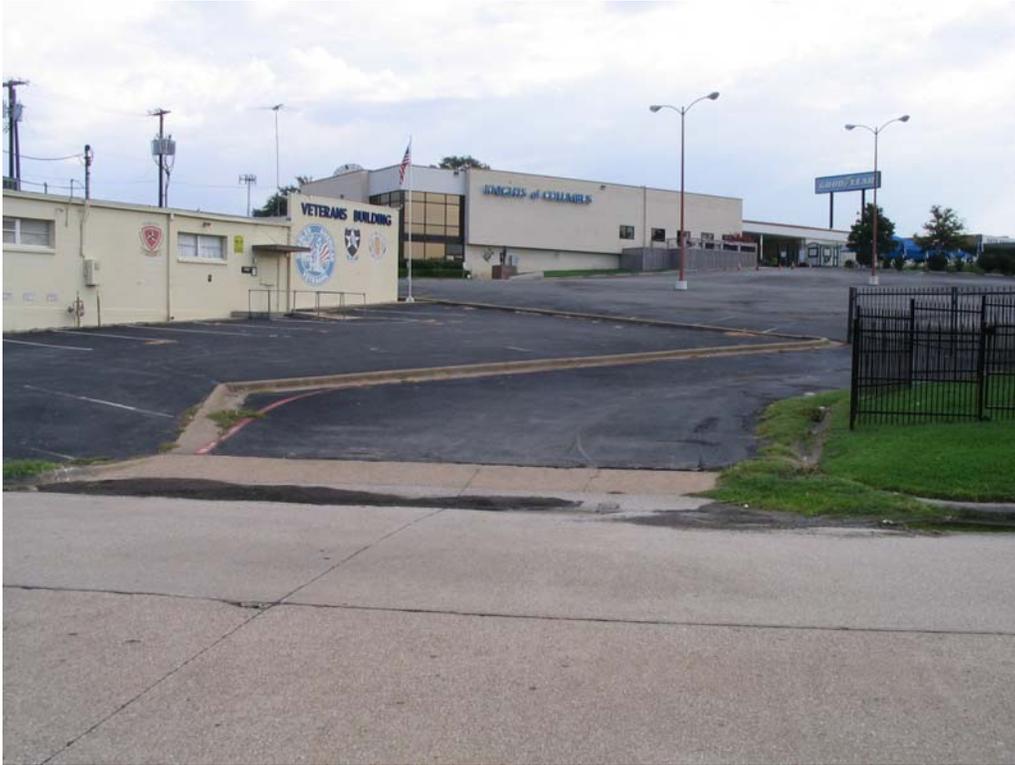
Photo 23: A shopping center is across Thurgood Lane to the east with the Disabled Veterans and Knights of Columbus buildings. Goodyear (UST Database – Table 4) is in the background.

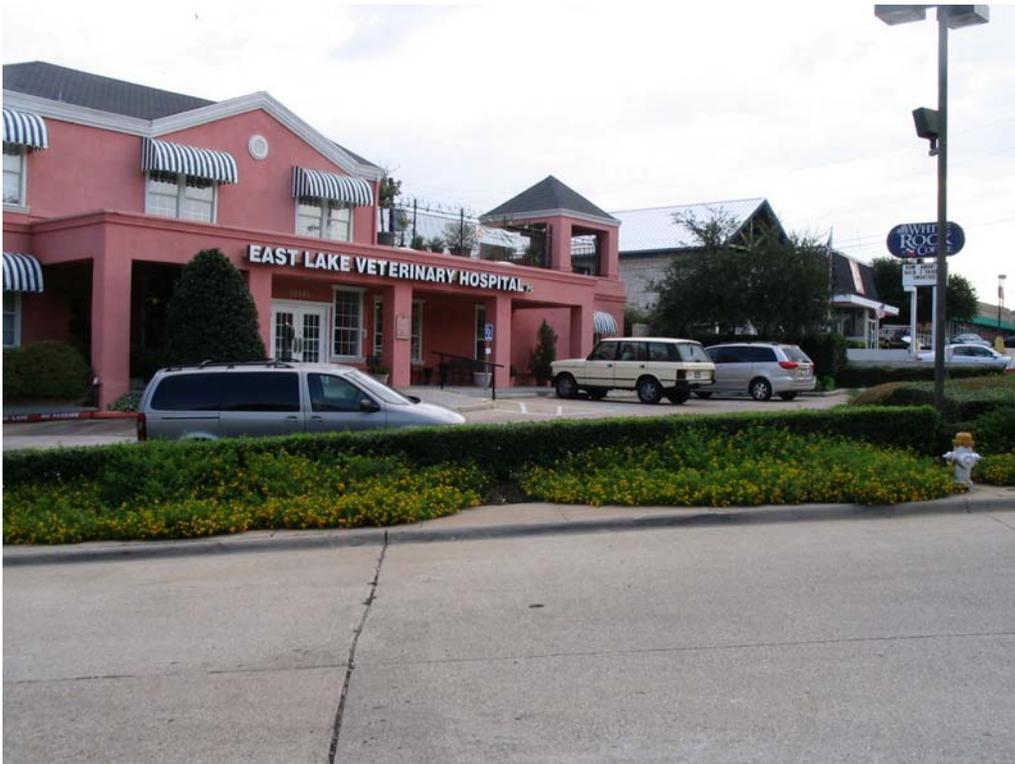
Photo 24: East Lake Veterinary Hospital located across Thurgood Lane from the southeast corner of the Site.

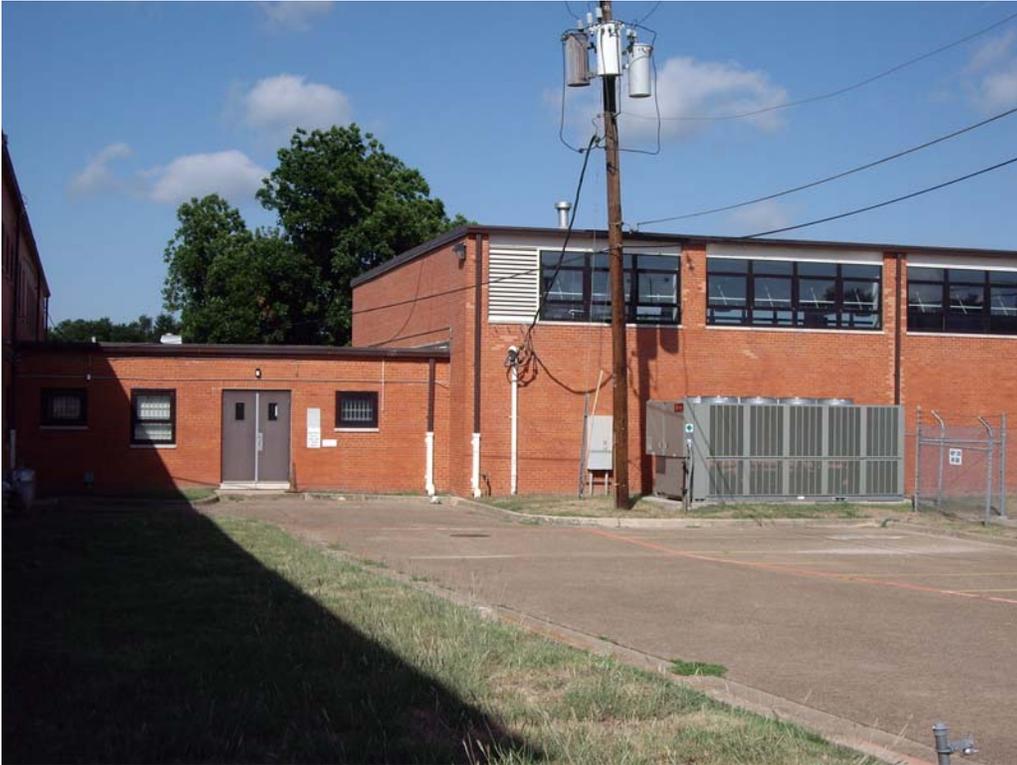
Photo 25: Three pole-mounted transformers located east of the Training Building. The lighter colored transformer is believed to have replaced the leaking transformer discussed in Section 6.6.

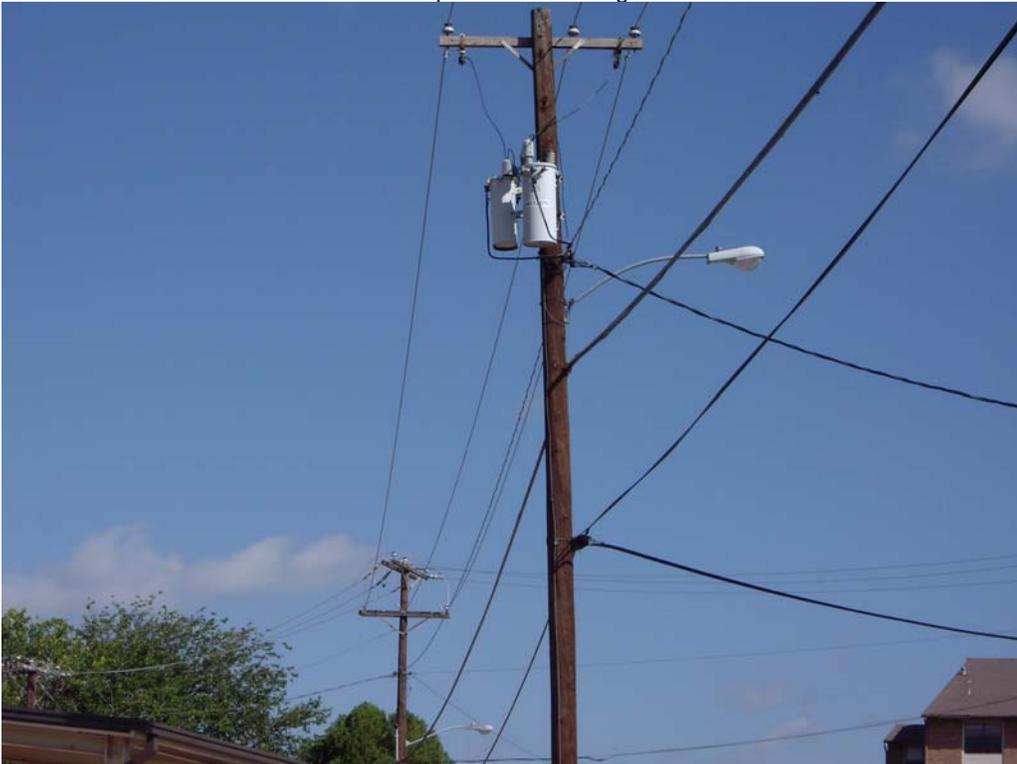
Photo 26: Two pole-mounted transformers located east of the OMS and just outside the Site boundary fence.

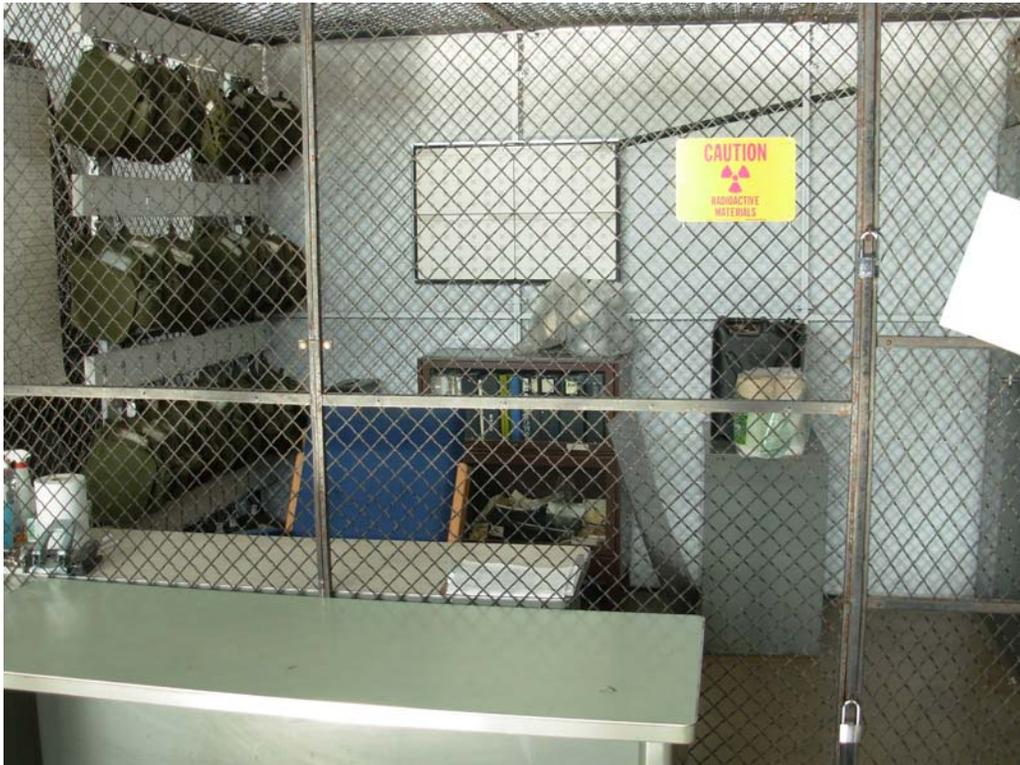
Photo 27: A sign on the storage cage in the assembly hall indicates a radioactive source.
