Appendix B
Site Reconnaissance Photos

Houston #3 USAR Center
6903 Perimeter Park Drive
Houston, Texas

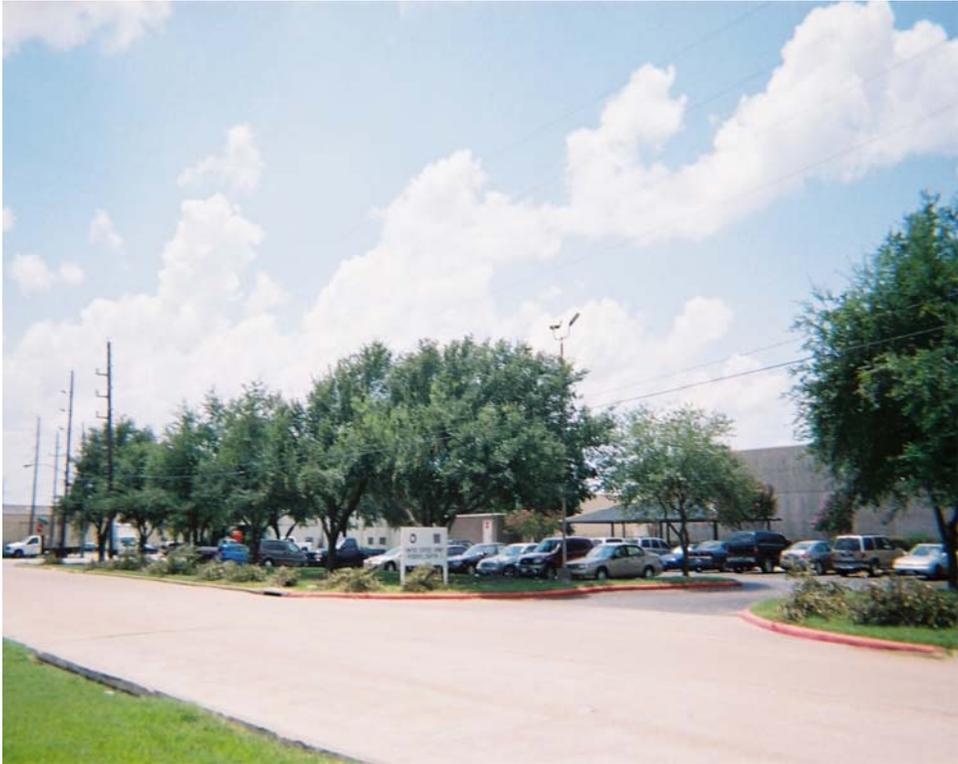
Photo 1: View of Houston #3 USAR Center looking to the southwest.

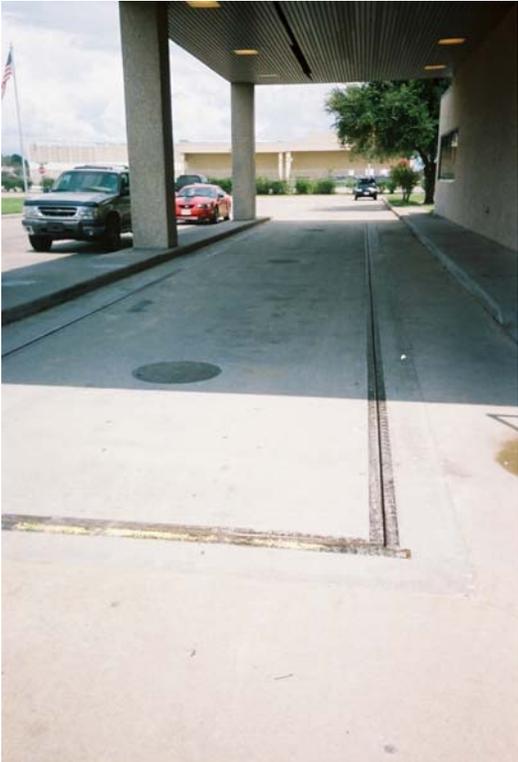
Photo 2: A weight scale is along the north side of the facility building, looking to the east.

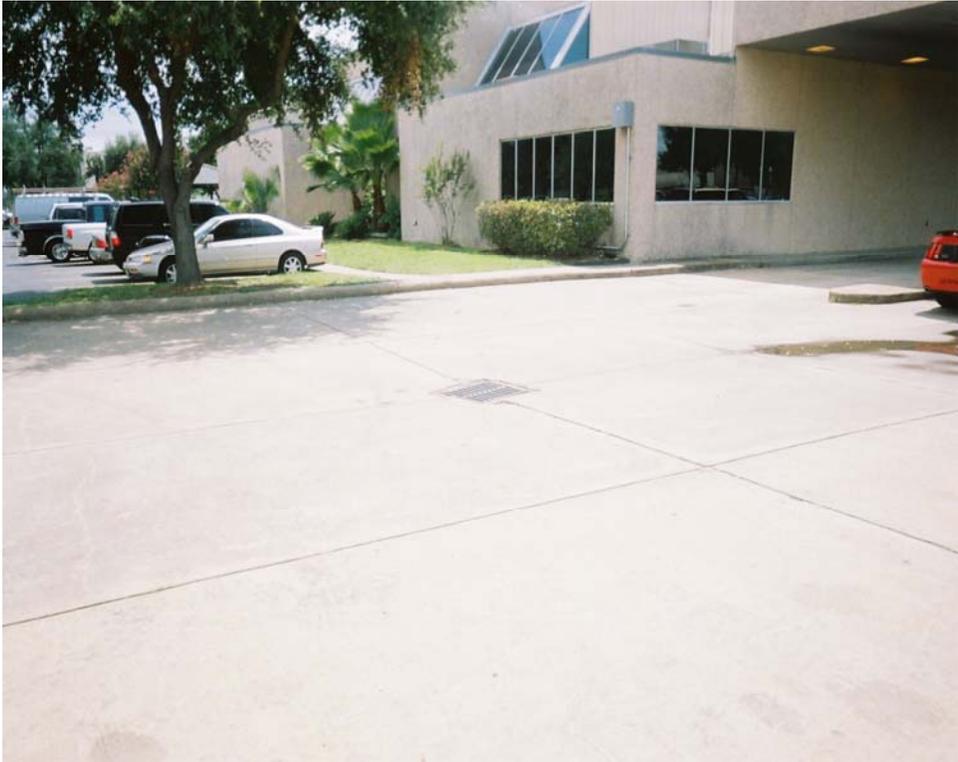
Photo 3: View of a storm water catch basin in the driveway along the north side of the property.

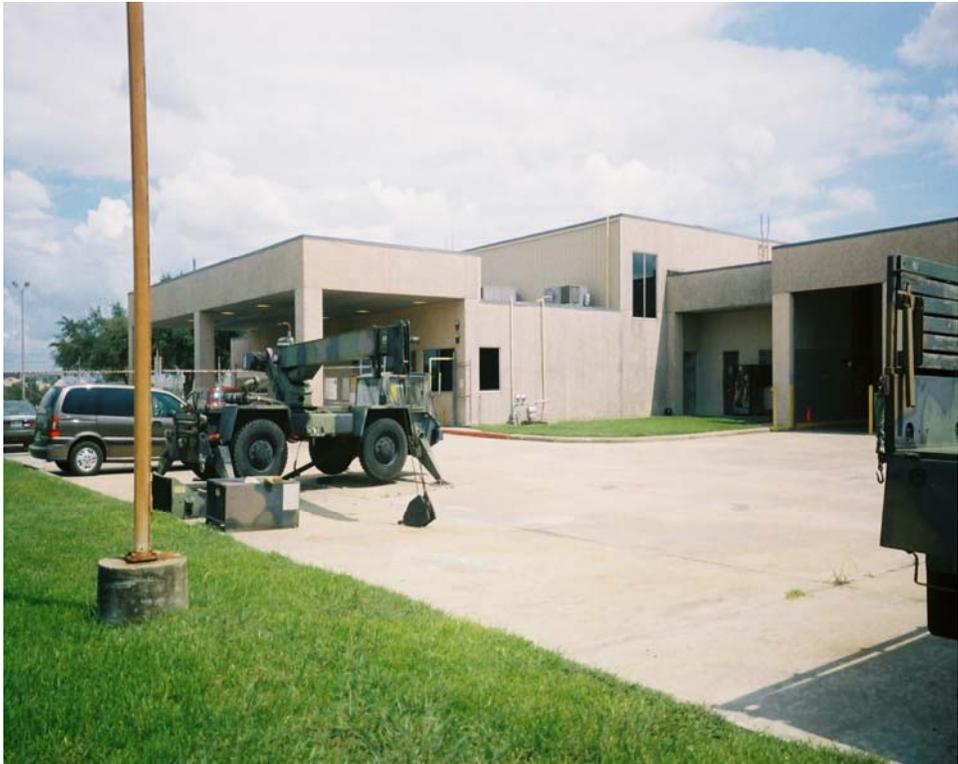
Photo 4: View of north MEP area, looking to the southeast.

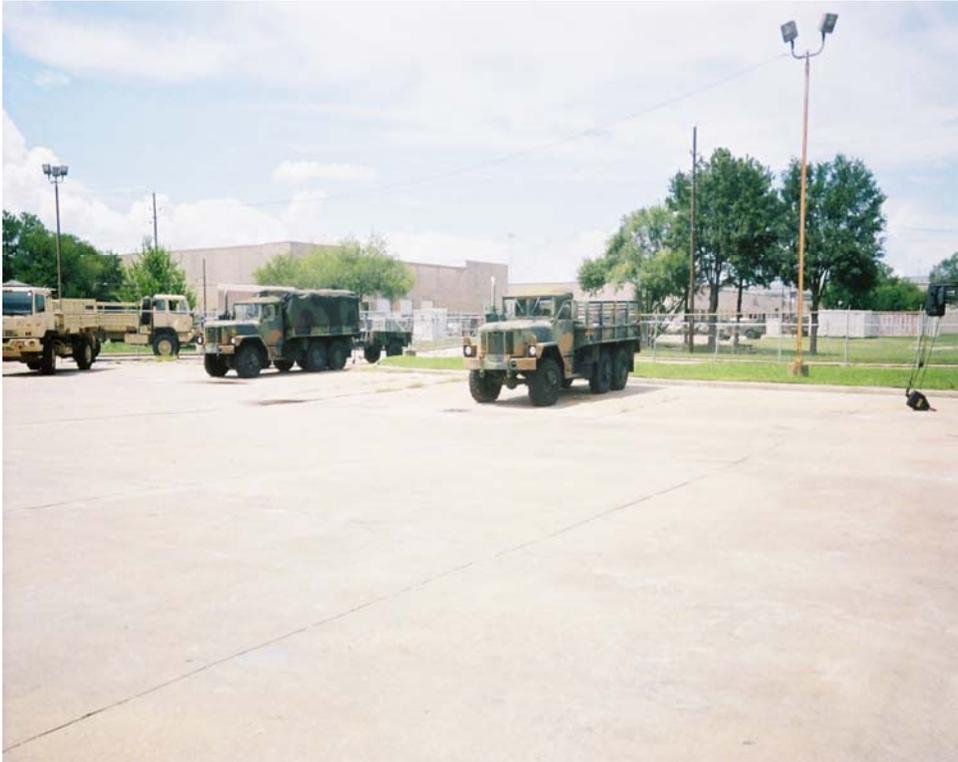
Photo 5: Vehicles parked in the north MEP area have had all maintenance or repair work completed.

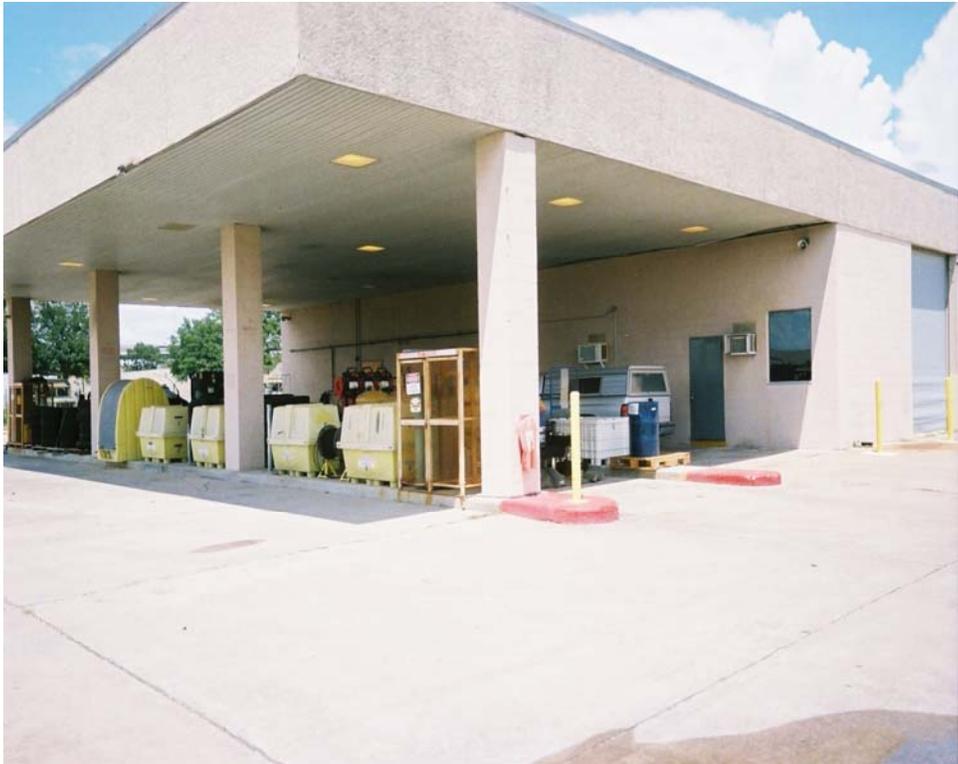
Photo 6: View of the storage cages, covered secondary containment pallets, and tire pallets along the wash rack.

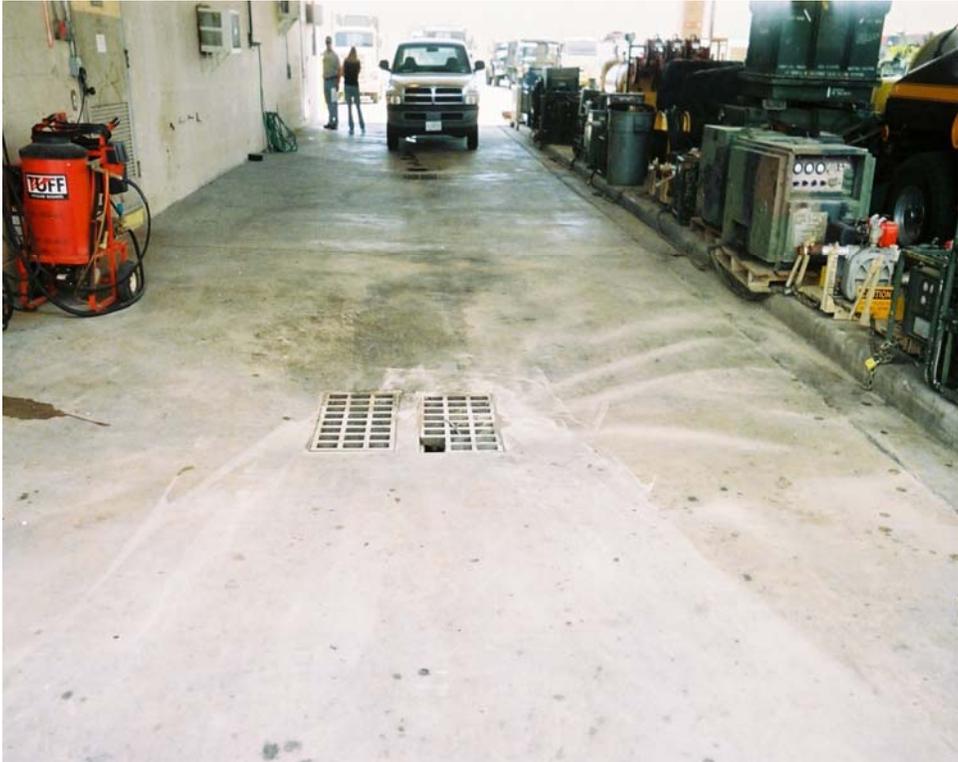
Photo 7: View of drains in the wash rack area, connected to the OWS (looking to the south).

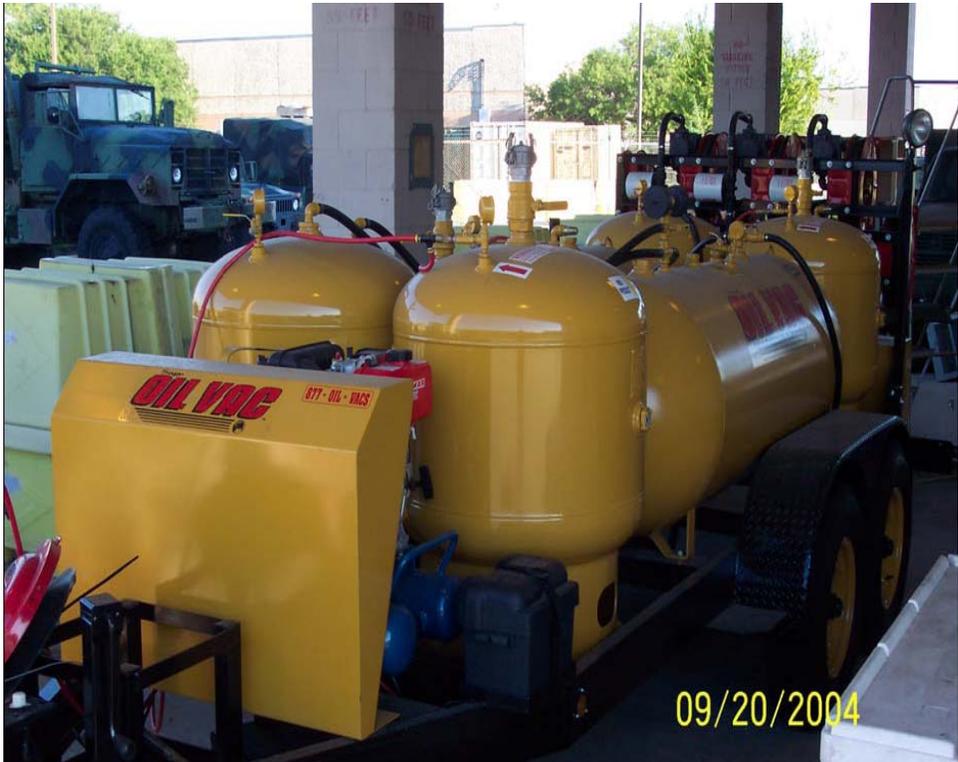
Photo 8: View of SAGE oil-vacuum system, located under the wash rack roof. Secondary containment surrounds the system. (Picture from EBS [ECCL, 2005])

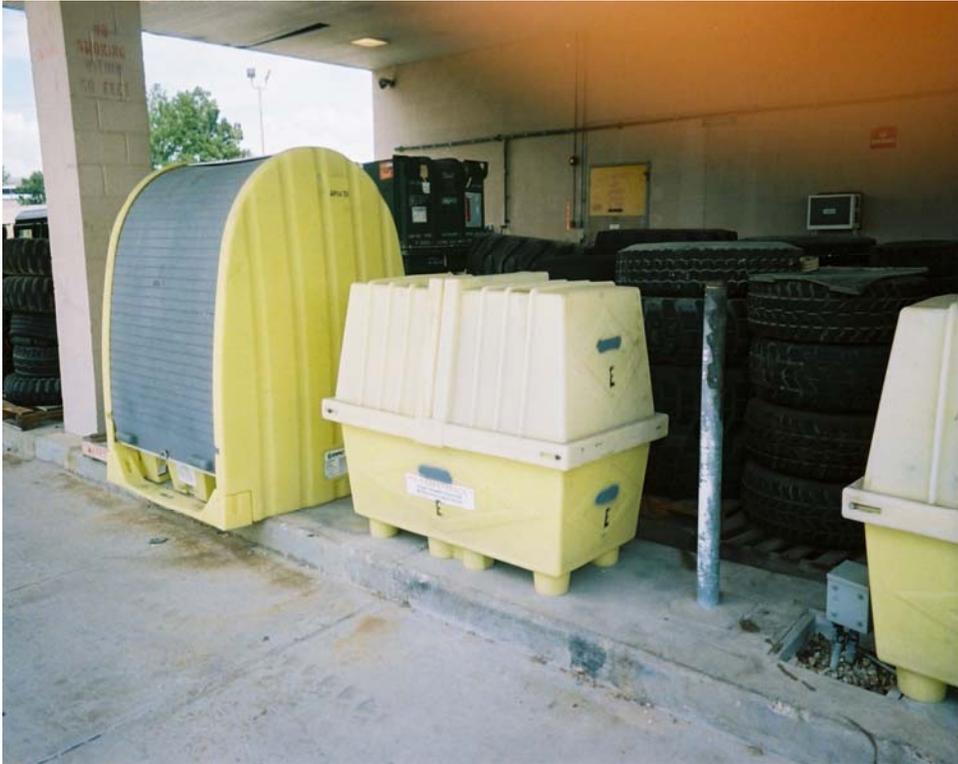
Photo 9: View of the covered secondary containment pallets located along the wash rack.

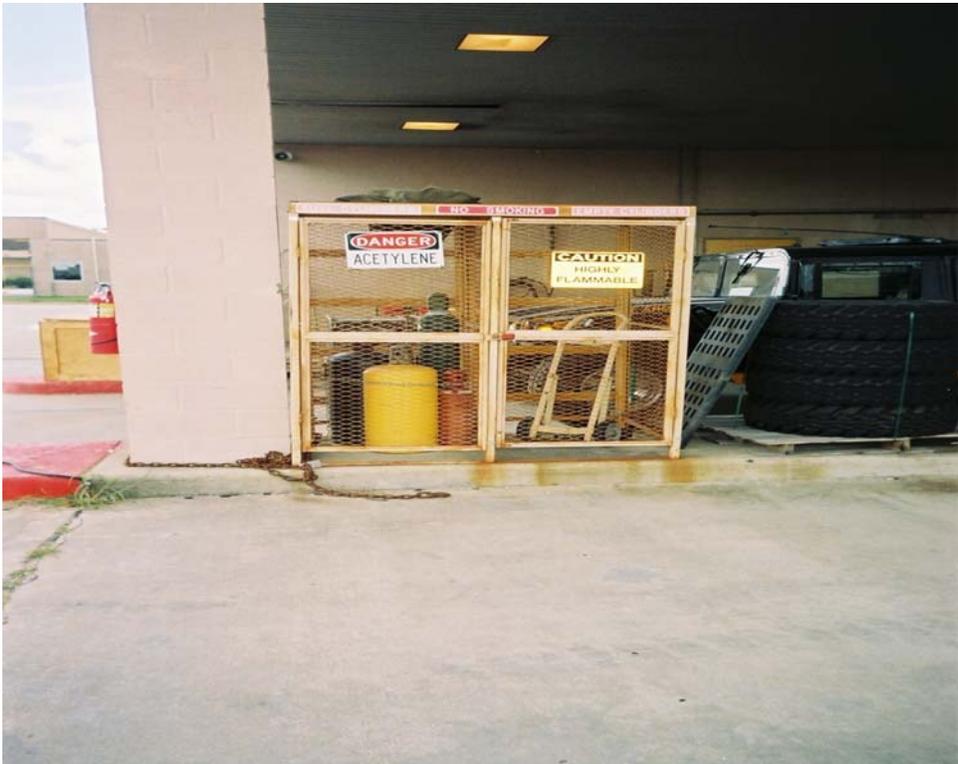
Photo 10: View of storage cages along the wash rack, used for cylinder storage.

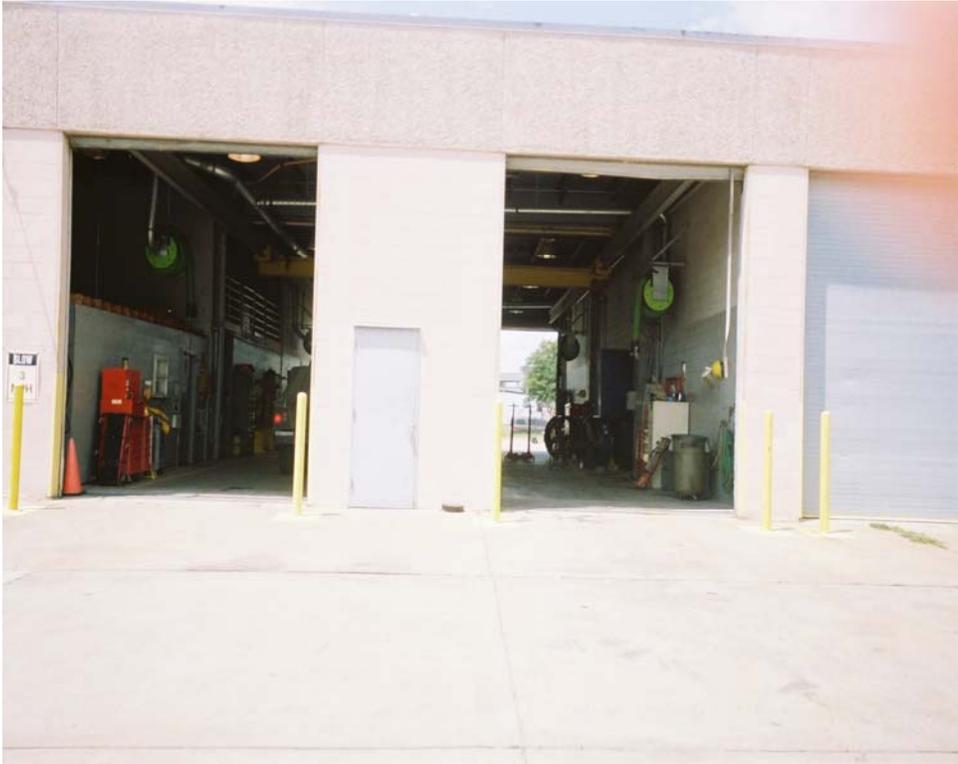
Photo 11: View of two work bays in the AMSA shop area, looking to the south.

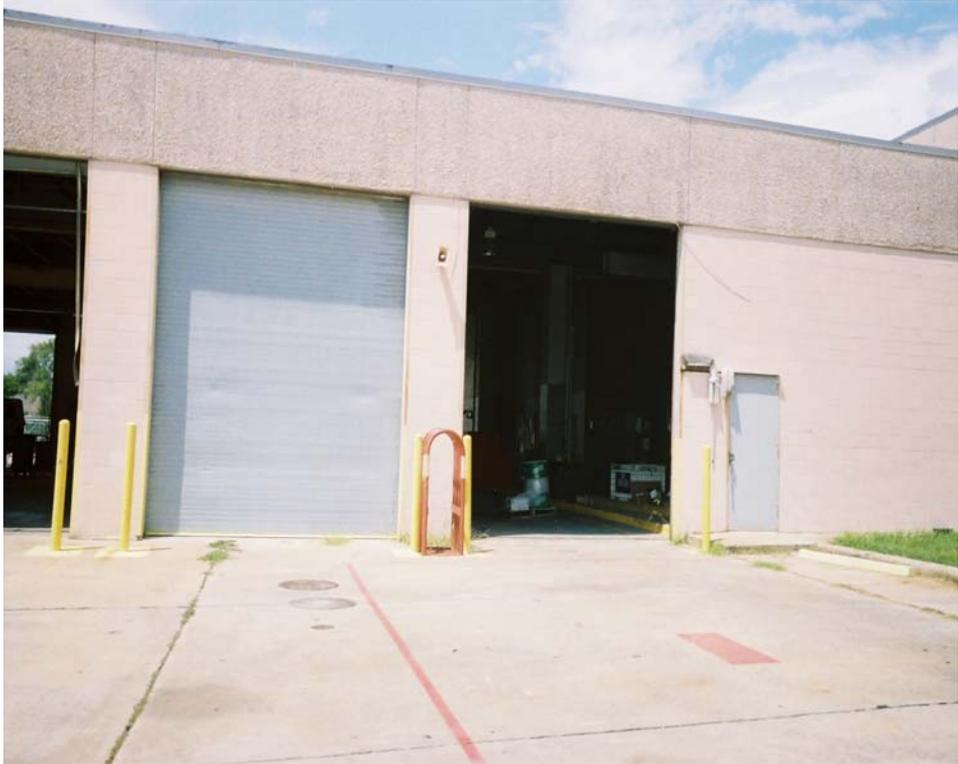
Photo 12: View of OWS manhole covers, and work bays in the AMSA shop area, looking to the north.

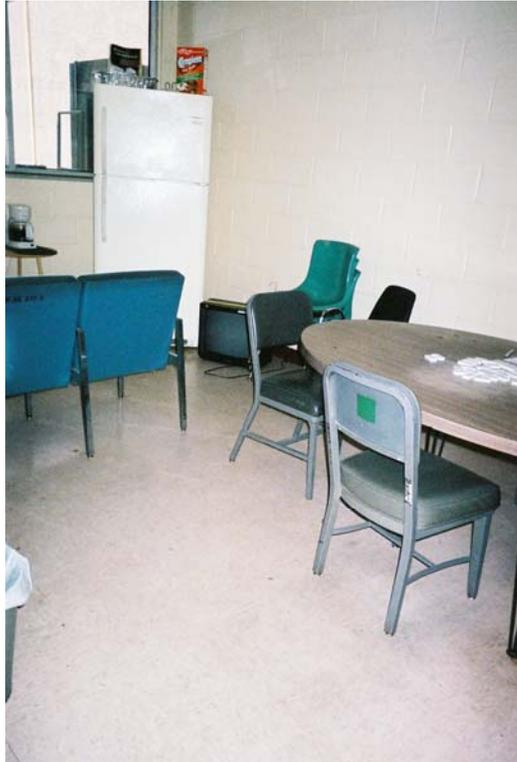
Photo 13: View of break room in the AMSA shop. Note floor tiles, which replaced the previous floor tile that tested positive for asbestos.

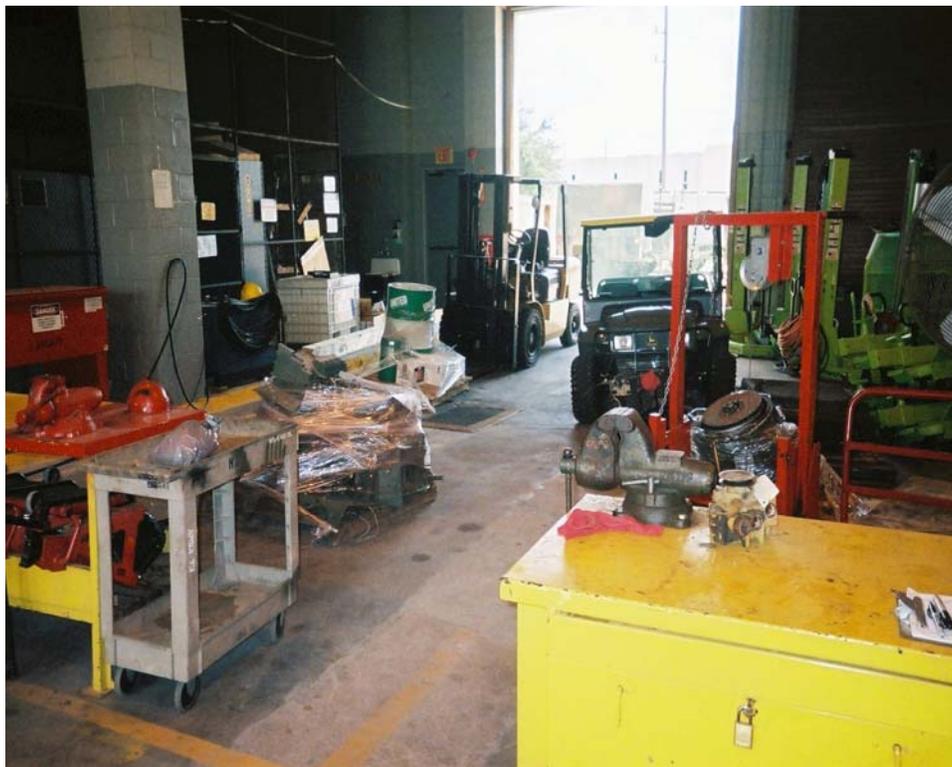
Photo 14: View inside a work bay of the AMSA shop. Note floor drain reportedly connected to the OWS, storage cage, and parts washer shown on the left side.

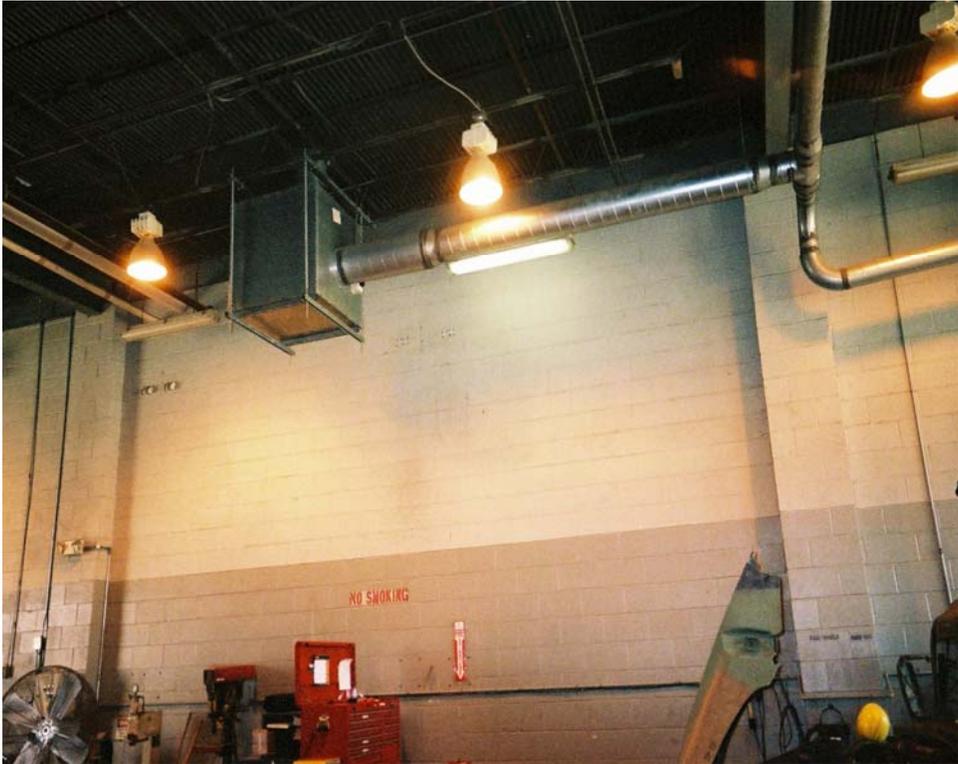
Photo 15: View of gas heater located in a work bay within the AMSA shop.

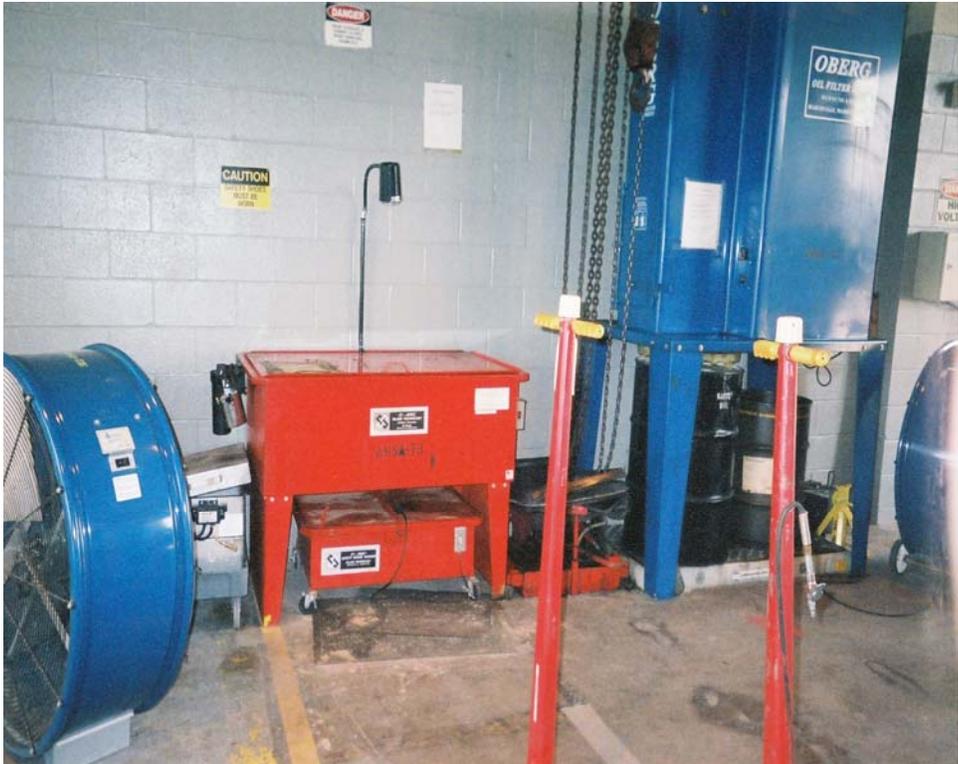
Photo 16: View of a parts washer and Oberg oil filter crusher located in a work bay of the AMSA shop.

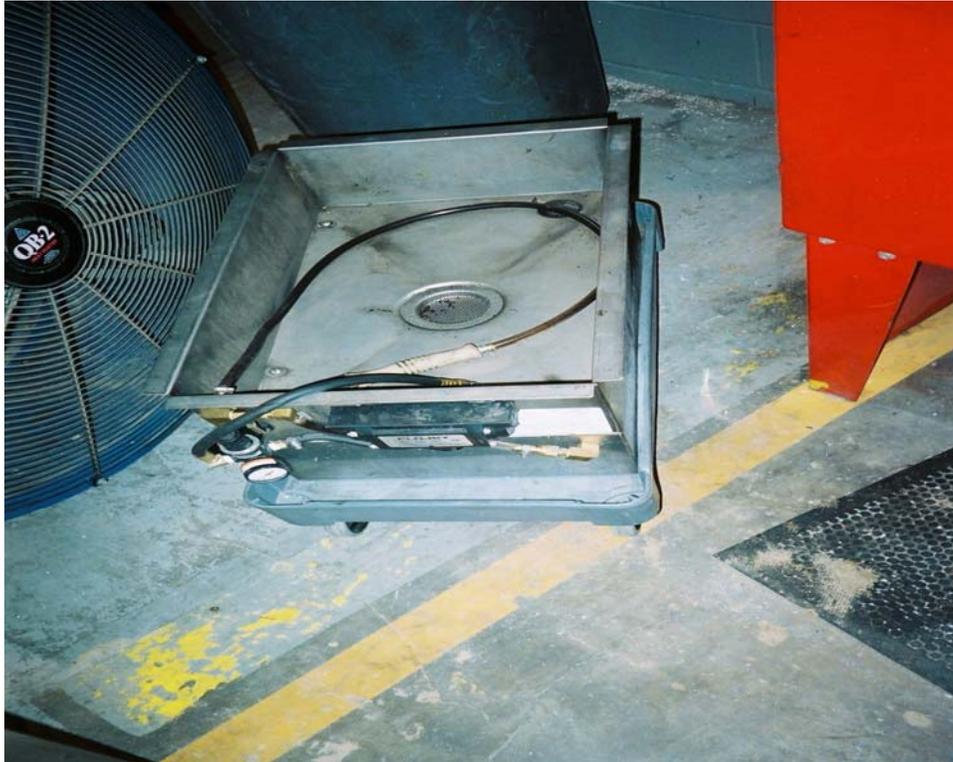
Photo 17: A FloJet mobile washer was stored on the floor within the AMSA shop.

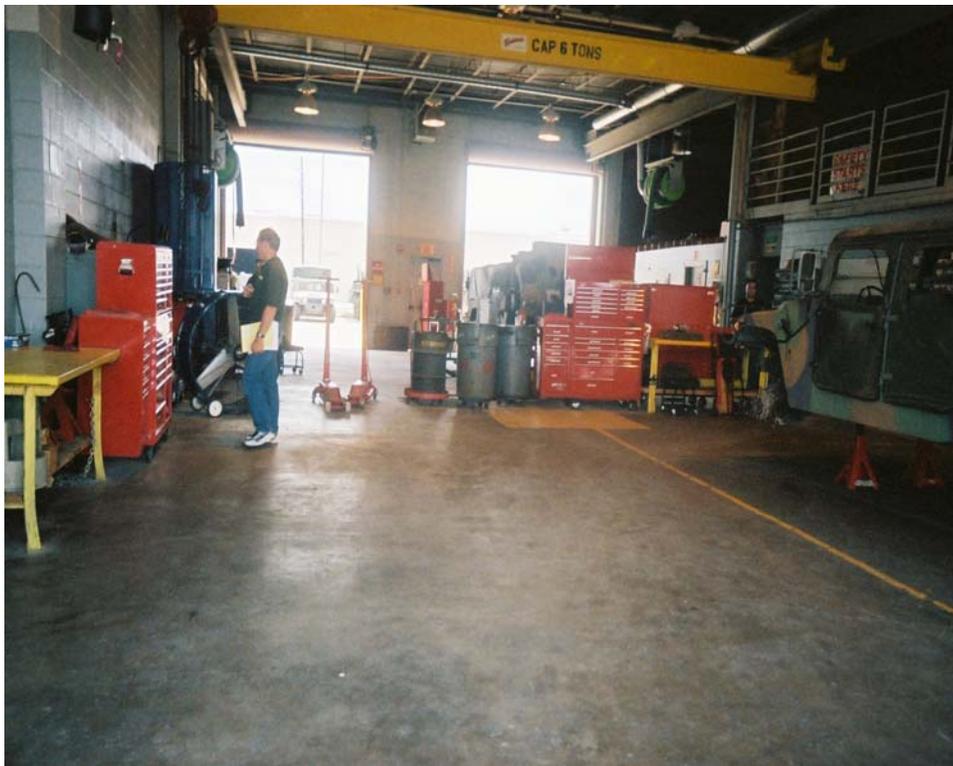
Photo 18: View inside a work bay of the AMSA shop, looking to the south. Note second floor storage shown in the upper right of the photograph.

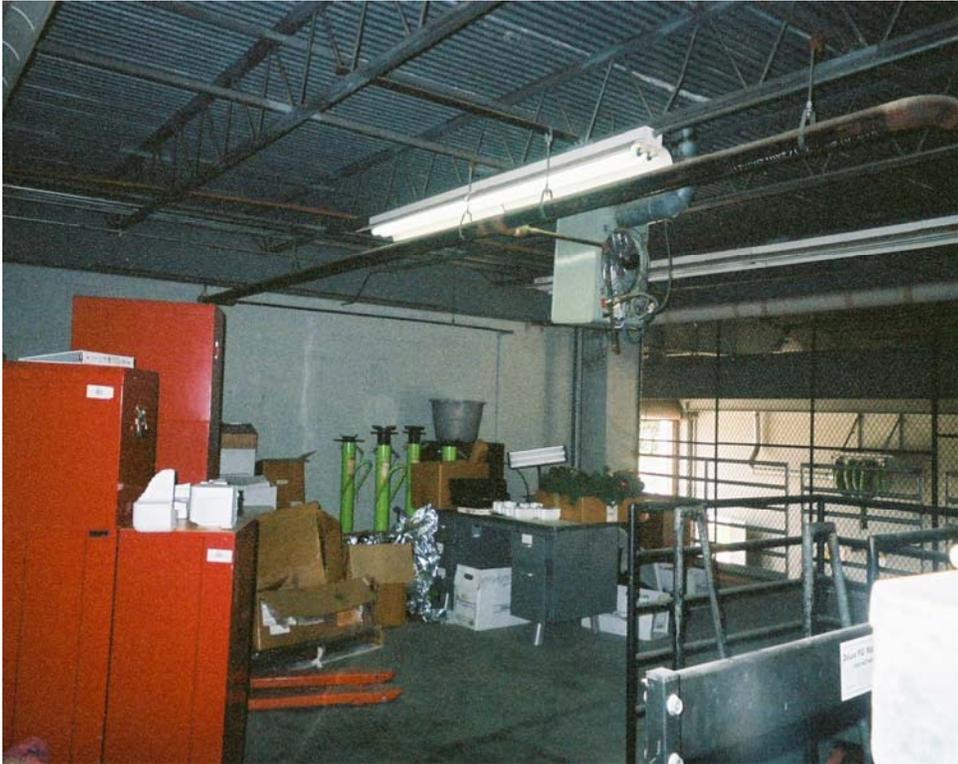
Photo 19: View of second floor storage in the AMSA shop.

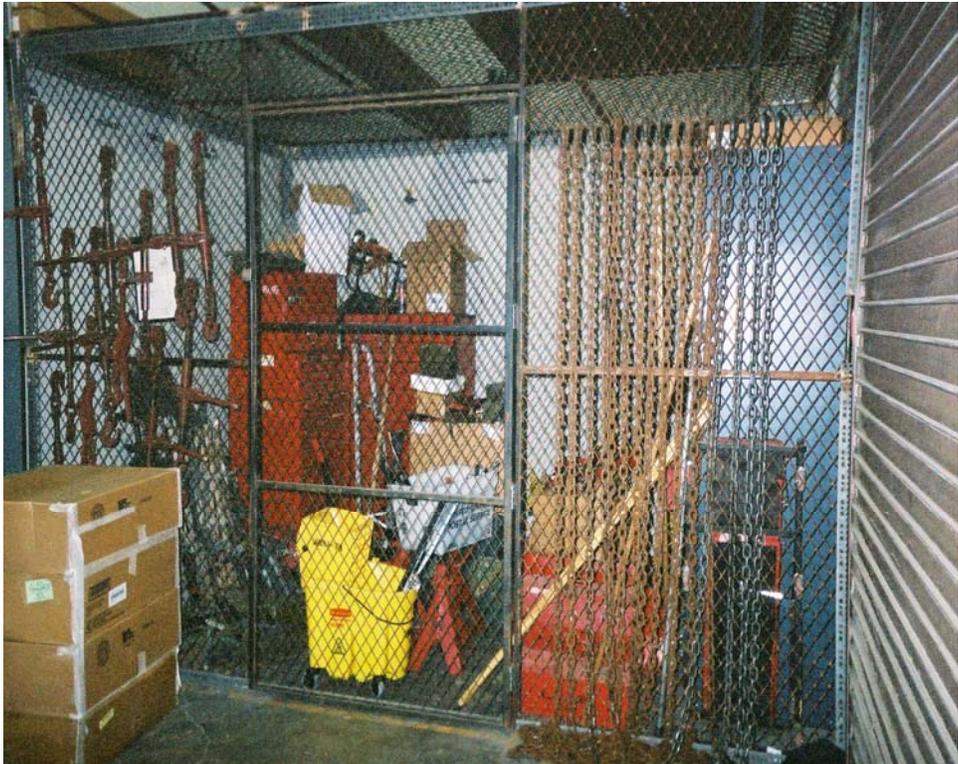
Photo 20: View of cage storage located in the cargo bay at the AMSA shop.

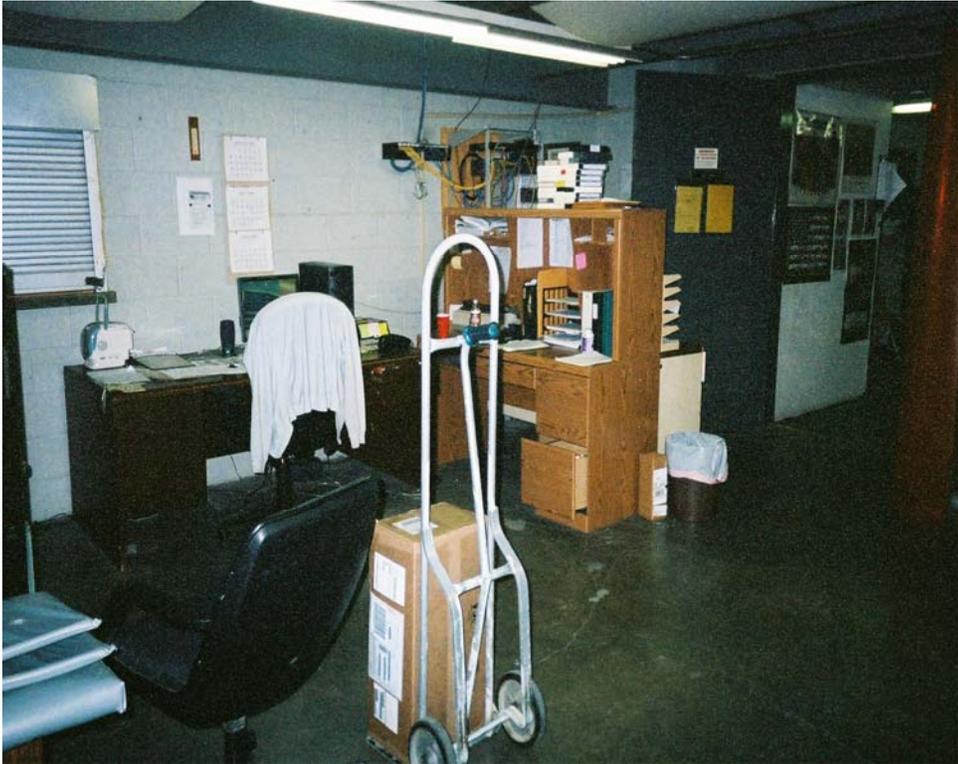
Photo 21: View of office area inside the AMSA shop.

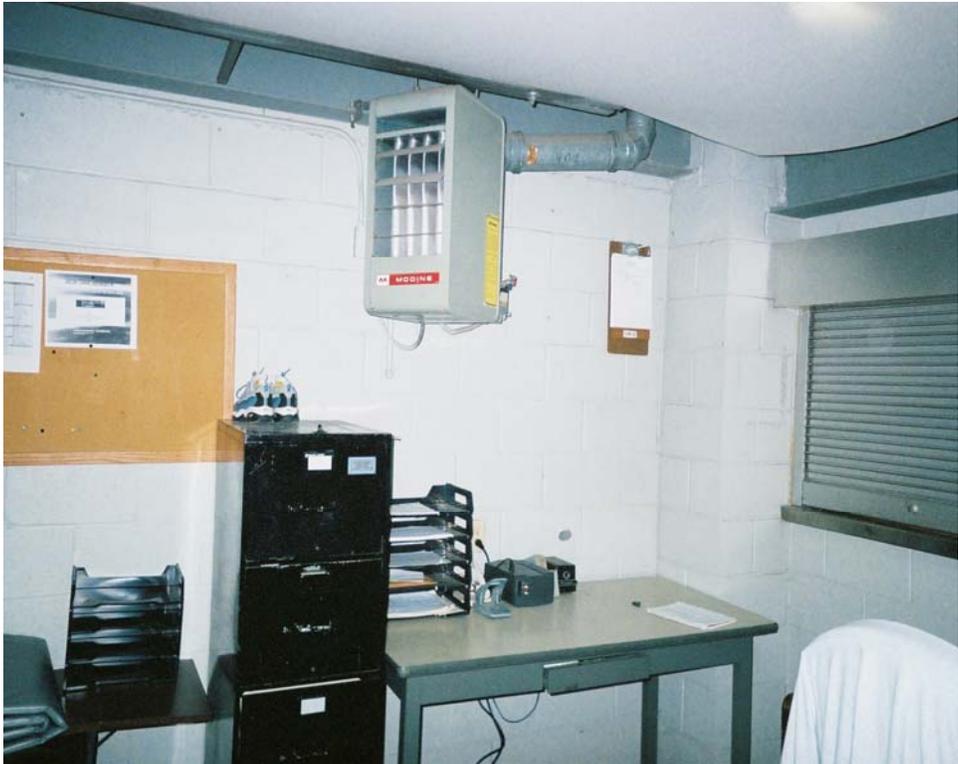
Photo 22: View of gas heater within an office in the AMSA shop.

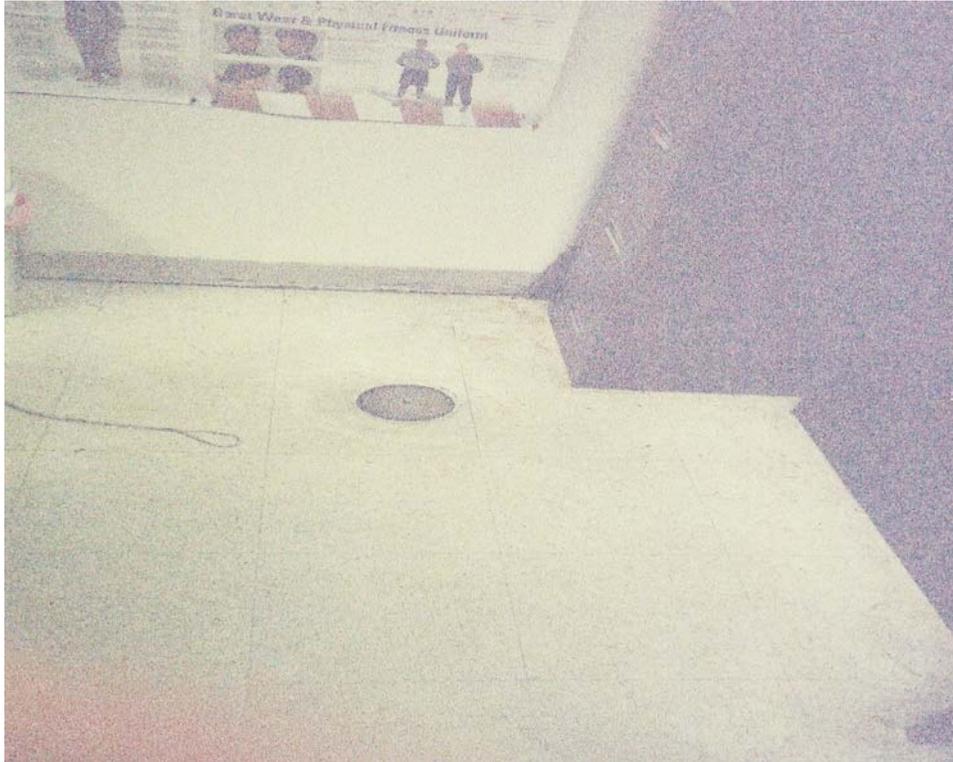
Photo 23: View of capped drain in an office in the AMSA shop.

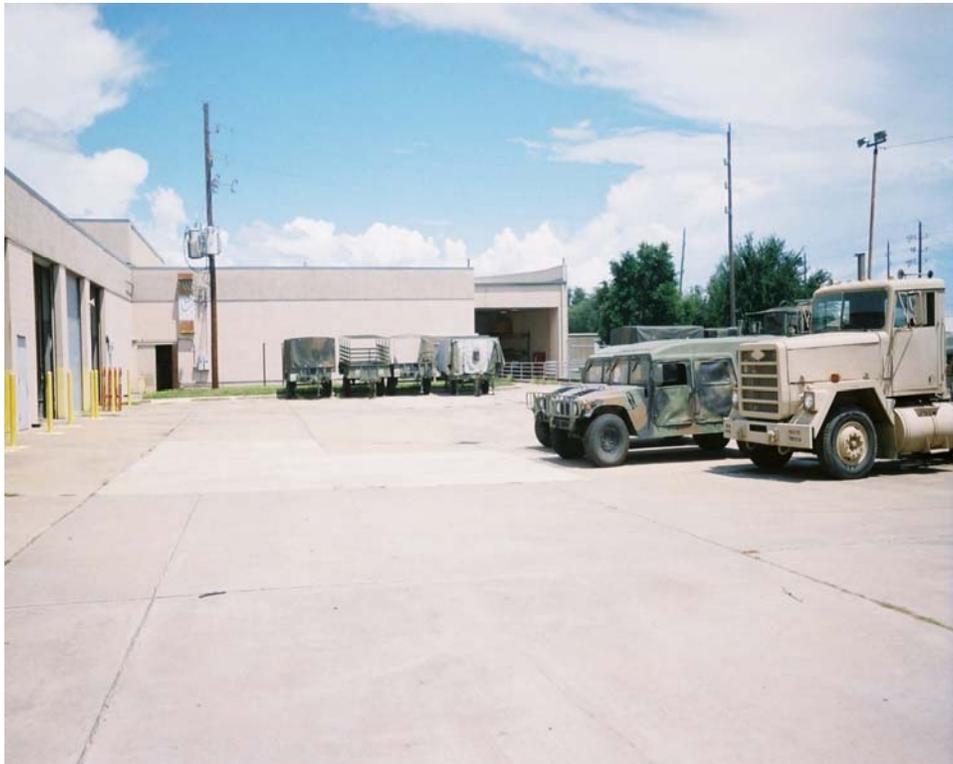
Photo 24: View of the southern MEP area located at the AMSA shop, looking to the east. Note pole-mounted transformers in the background (left) of the photograph.

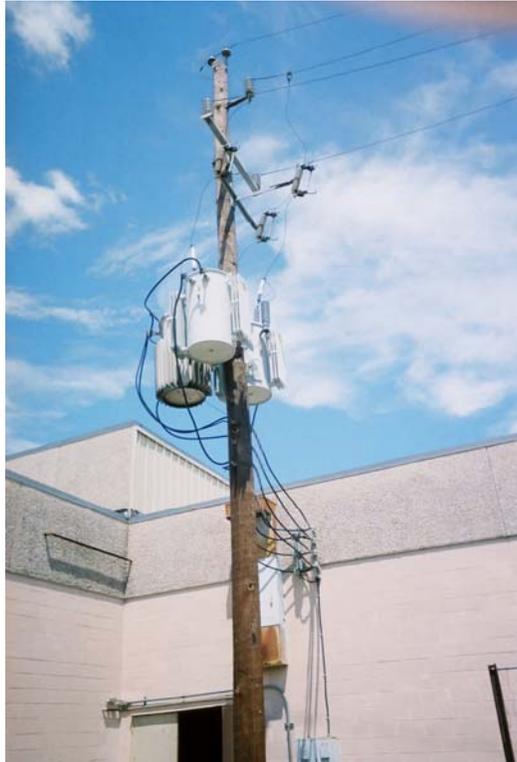
Photo 25: View of pole-mounted transformers located between the office area and AMSA shop.

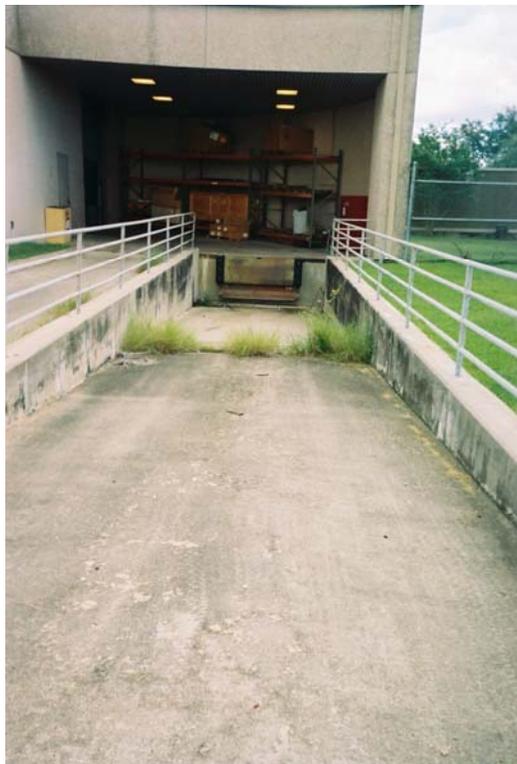
Photo 26: View of loading dock located at the southern end of the facility building.

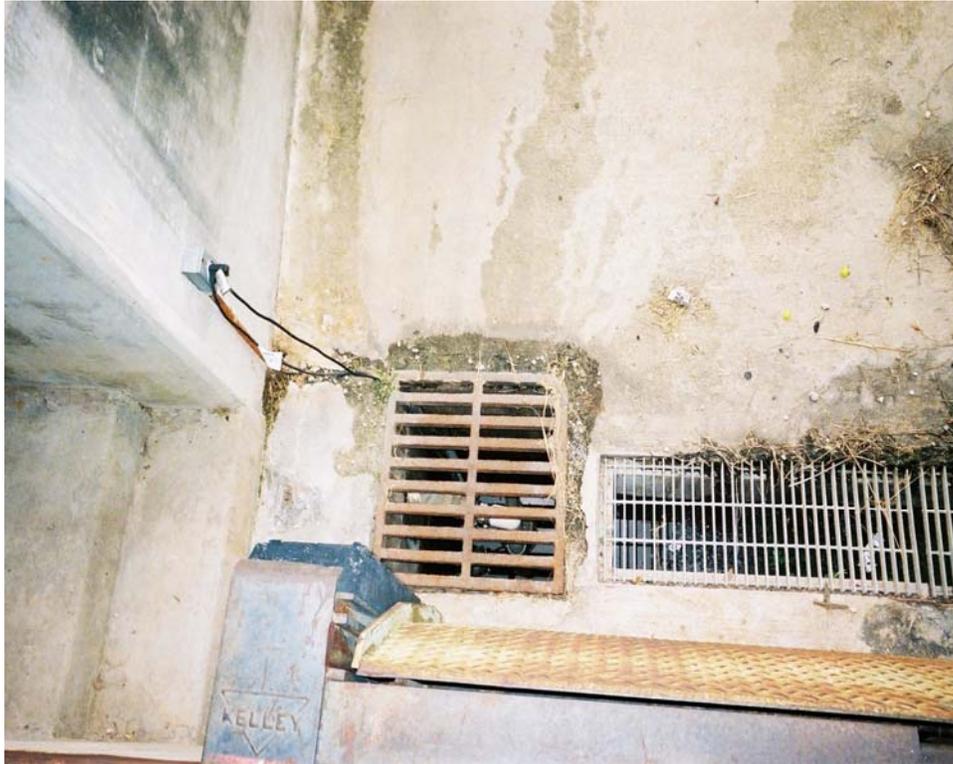
Photo 27: View of catch basin/drain located at the loading dock. Note electrical line and piping running to the drain.

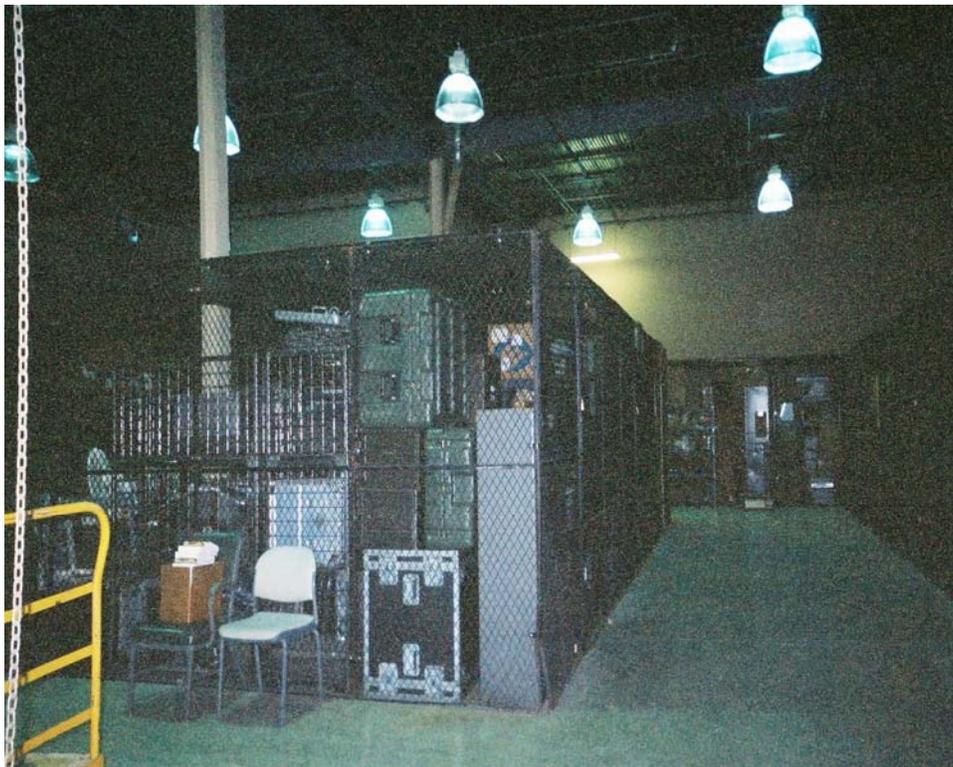
Photo 28: View of cage storage located at the southern end of the office area of the facility building.

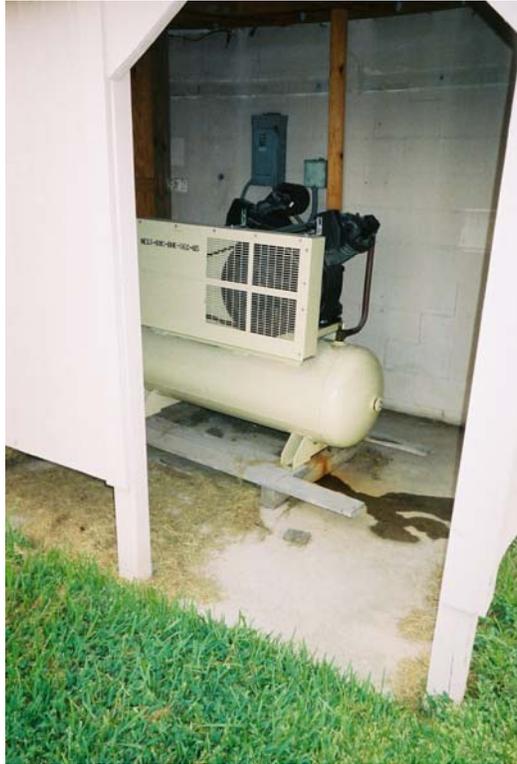
Photo 29: View of compressor located adjacent to the loading dock area on the southern end of the office area of the facility building.

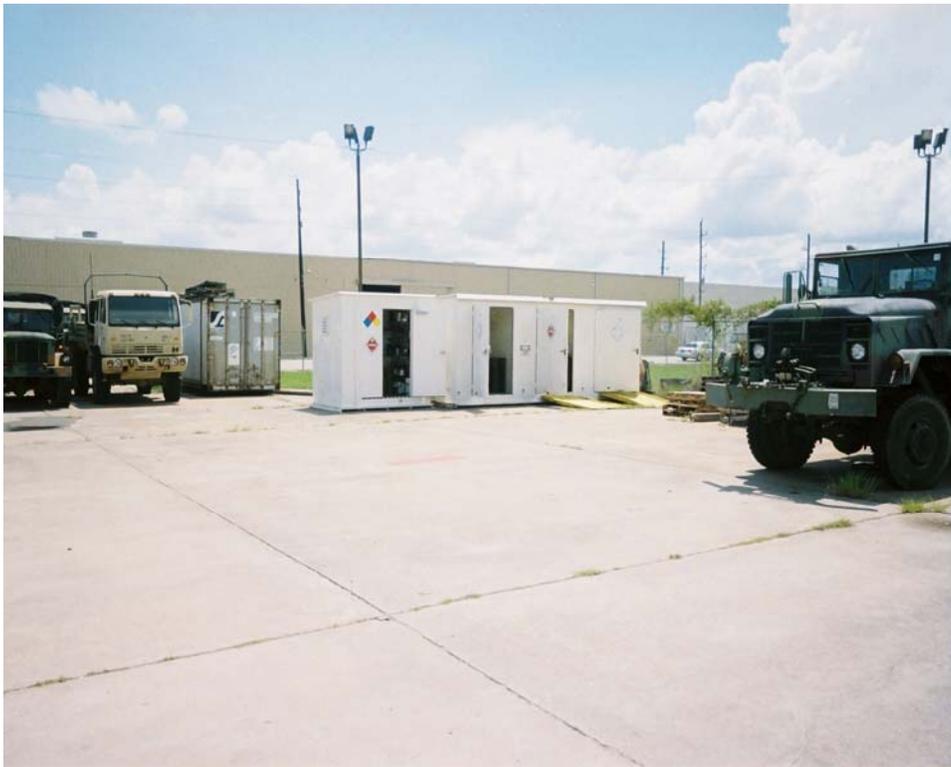
Photo 30: View of four hazardous/flammable materials storage sheds located in the paved southwest corner of the AMSA shop area, looking to the southwest.

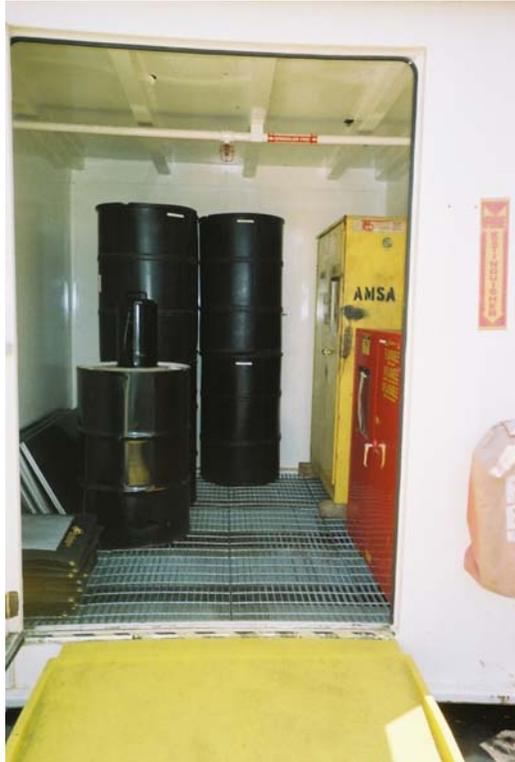
Photo 31: View inside a hazardous/flammable materials storage shed.

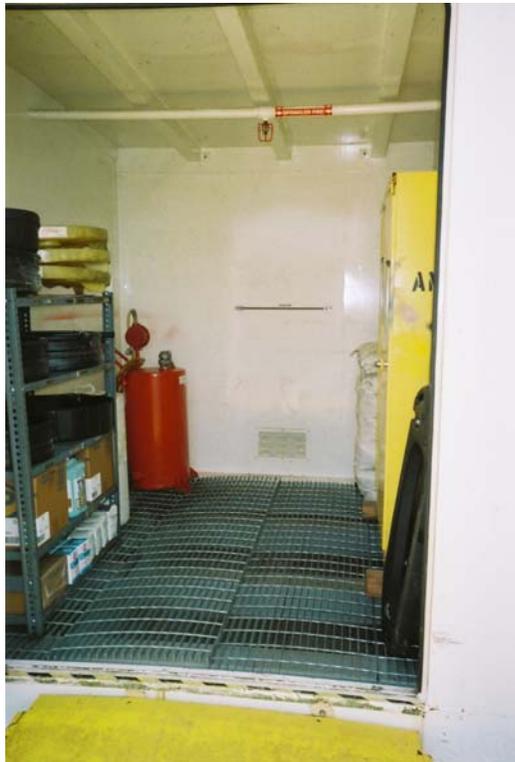
Photo 32: Another view inside a hazardous/flammable materials storage shed.

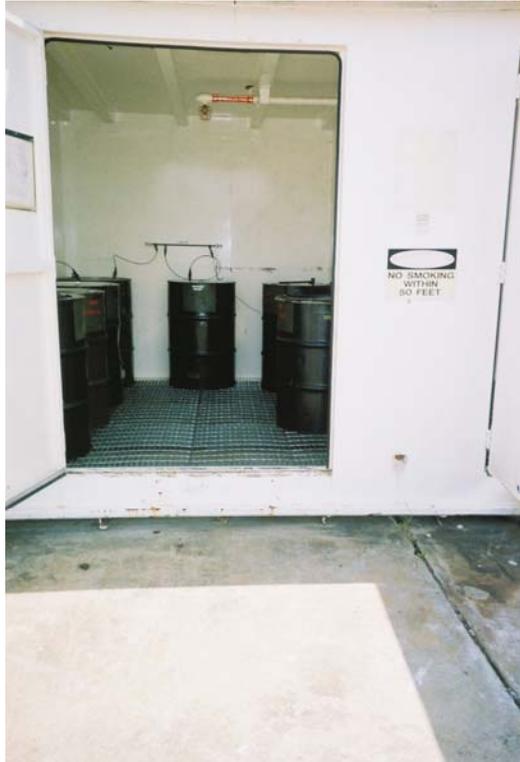
Photo 33: A hazardous/flammable materials storage shed storing drums with grounding wires.

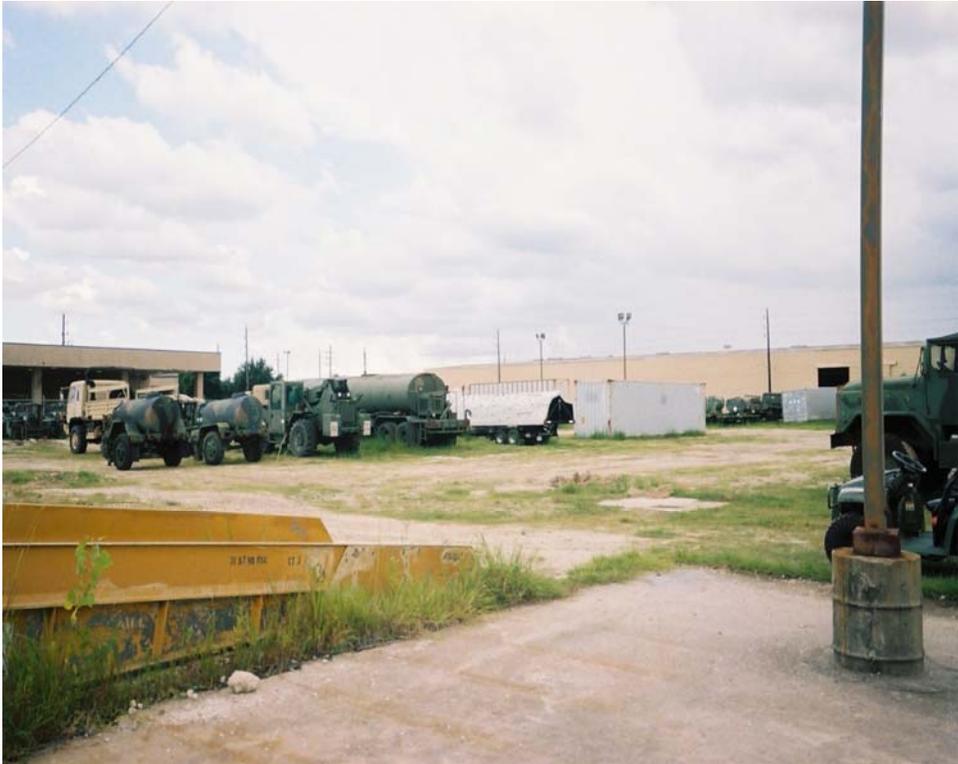
Photo 34: View of the unpaved MEP area, looking to the southeast.
