Appendix B
Site Reconnaissance Photos

Houston #3 USAR Center
6903 Perimeter Park Drive
Houston, Texas

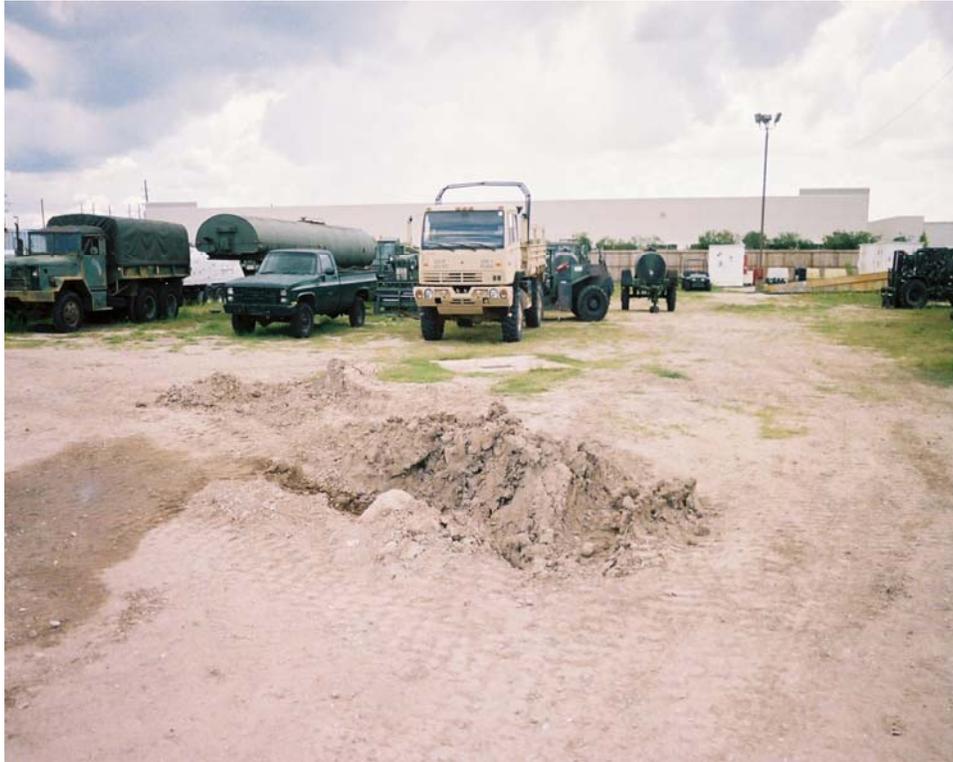
Photo 35: View of unpaved MEP area, looking west. Note large ruts caused by vehicles and wet conditions at the Site.

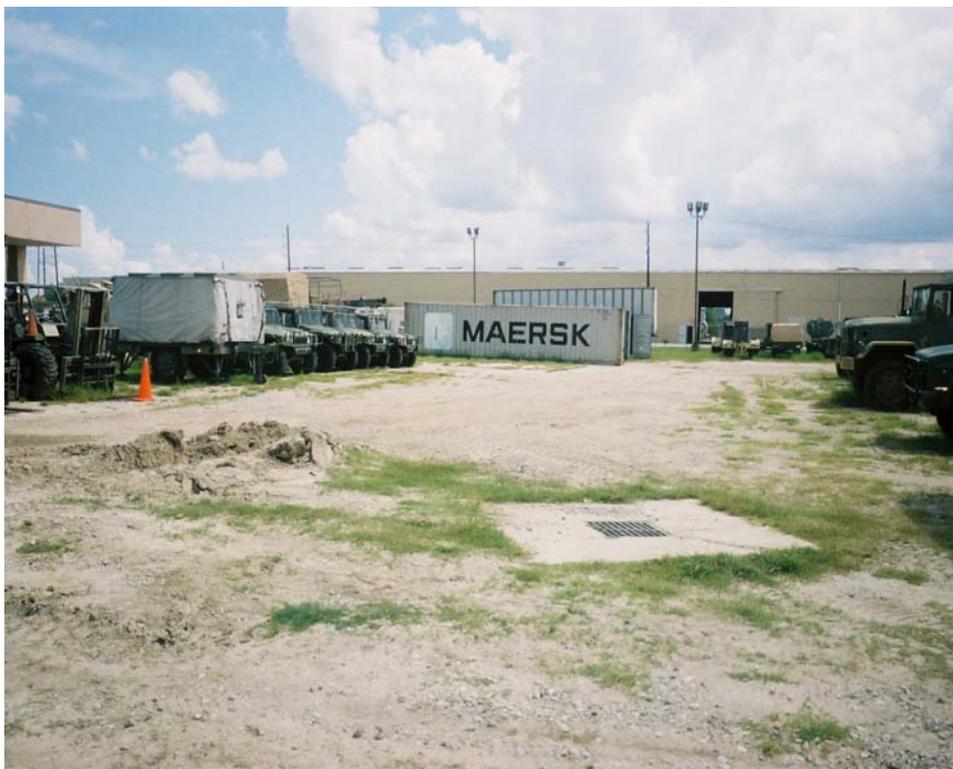
Photo 36: View of catch basin with concrete pad, located in the unpaved MEP area. There are four catch basins located in this area.

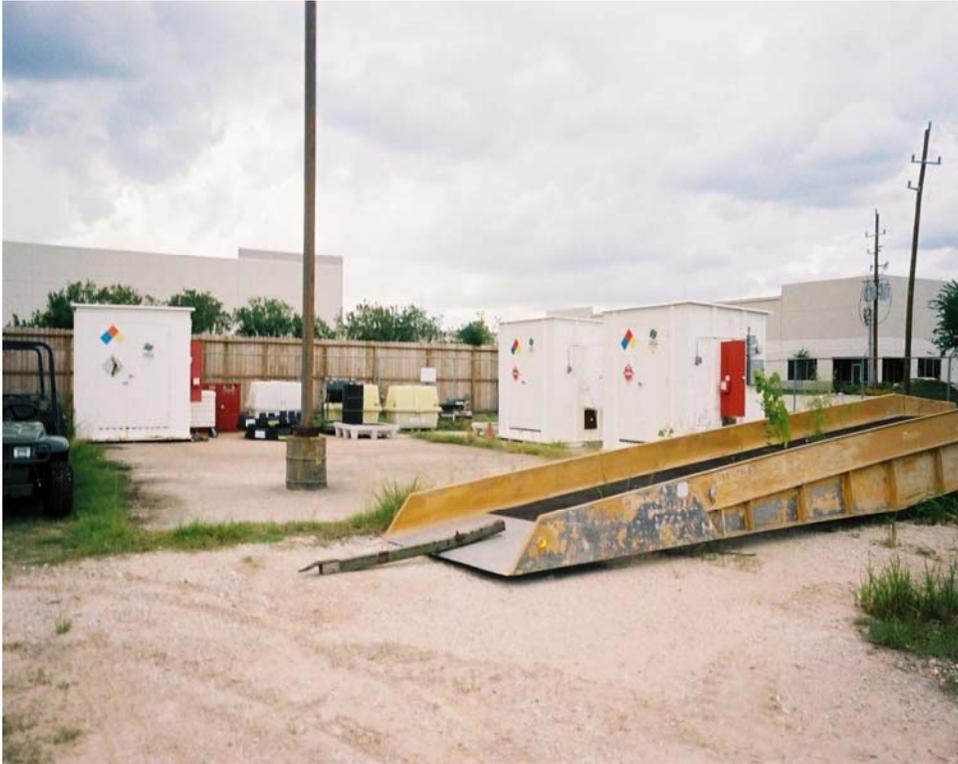
Photo 37: View of hazardous/flammable materials storage sheds and covered secondary containment pallets on a concrete pad in the MEP area.

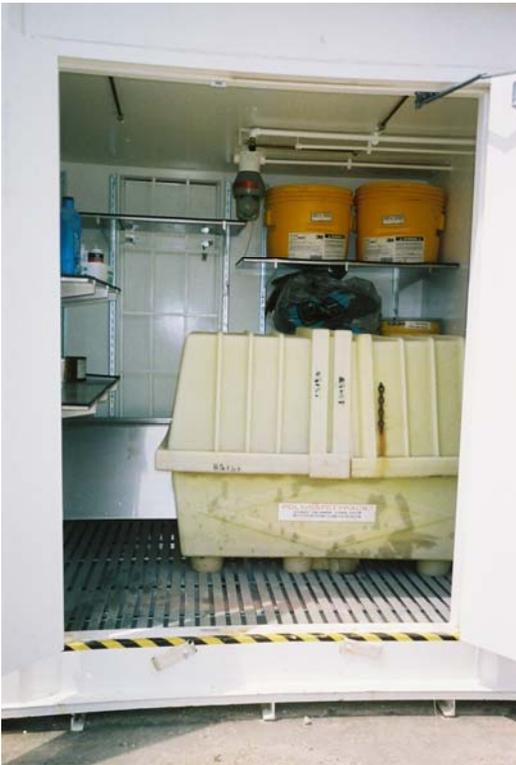
Photo 38: View inside another hazardous/flammable materials storage shed.

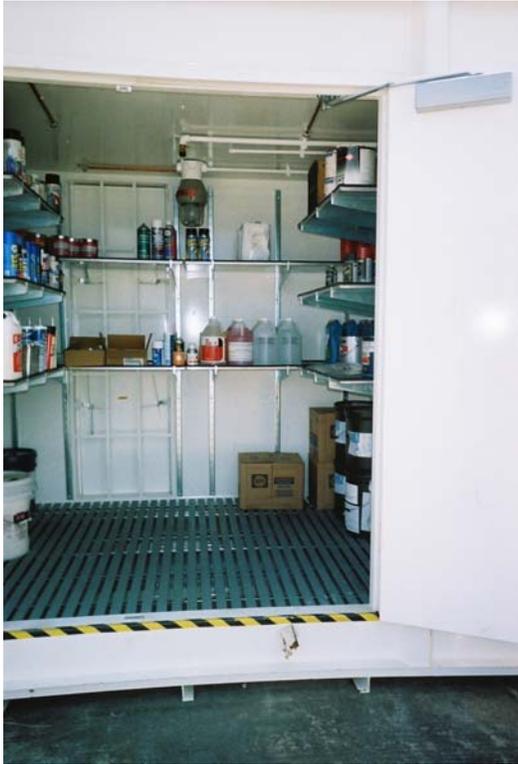
Photo 39: More containers inside a hazardous/flammable materials storage shed.

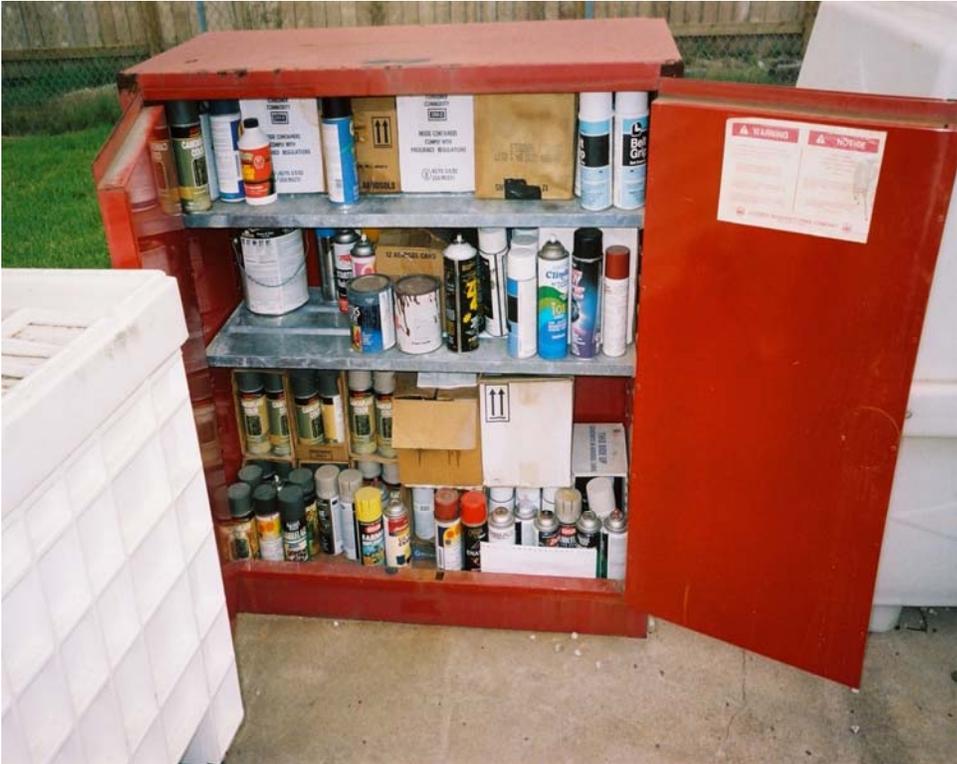
Photo 40: Containers inside a small hazardous/flammable materials storage shed.

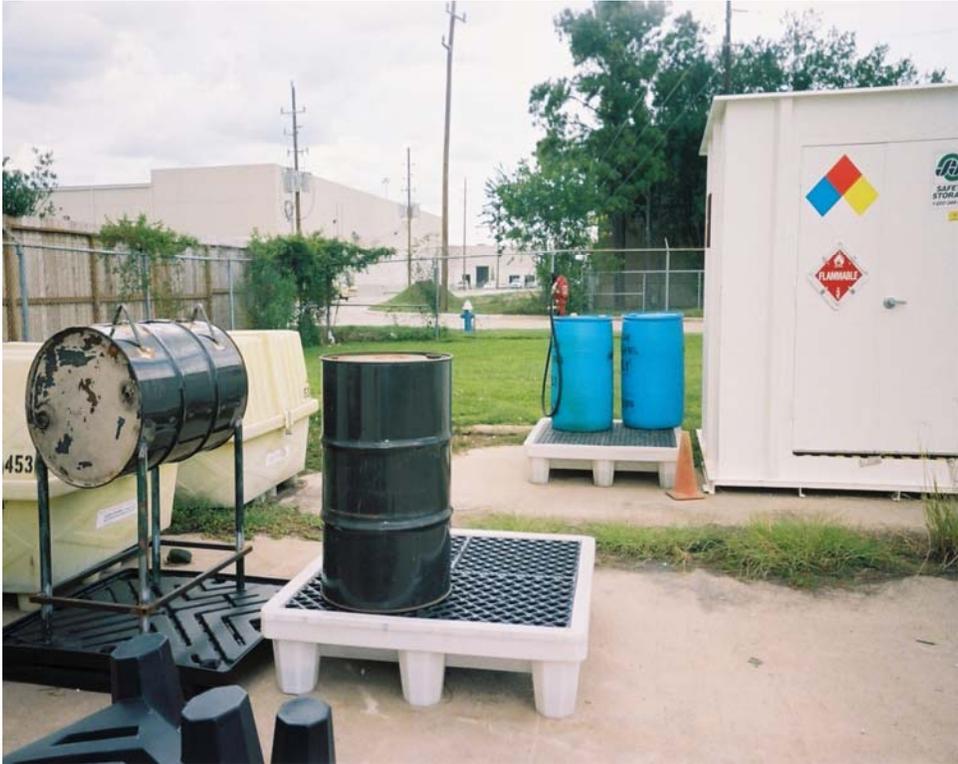
Photo 41: View of spill houses/pallets located in the MEP area.

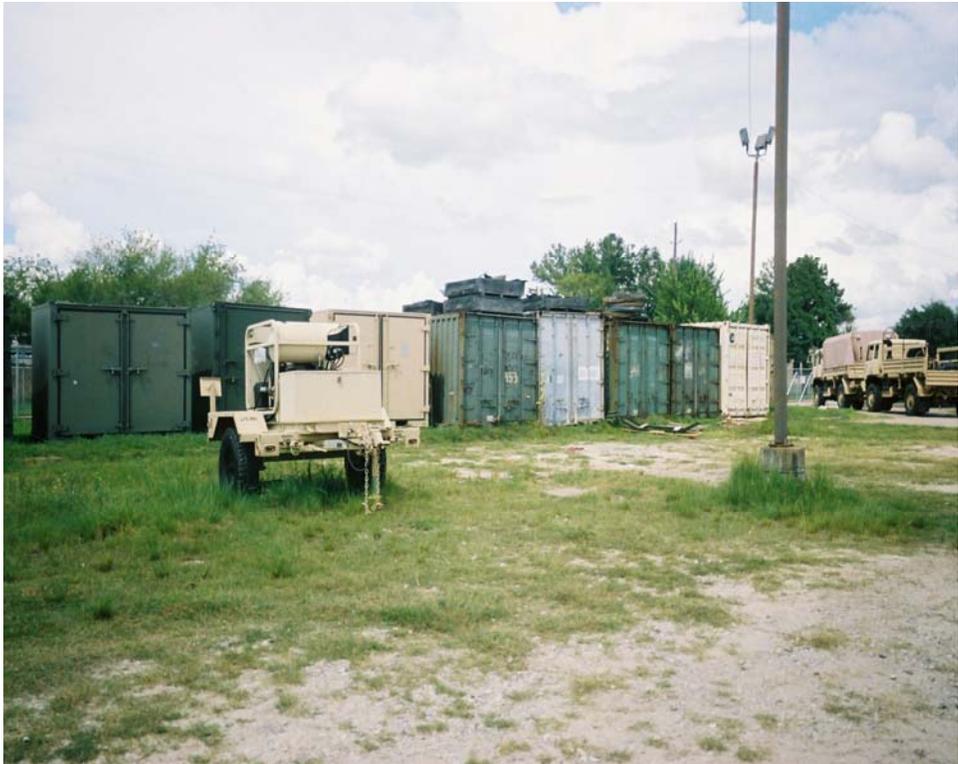
Photo 42: View of container boxes in the unpaved MEP area. These structures are used for storage and deployment.

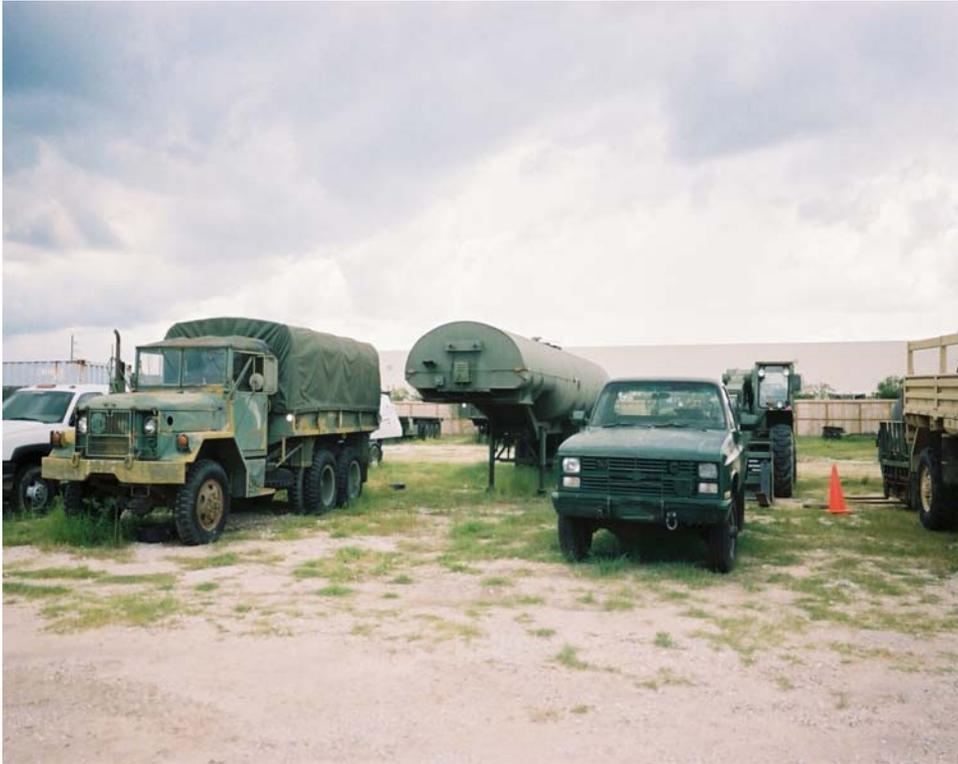
Photo 43: View of vehicles and tankers located in the unpaved MEP area.

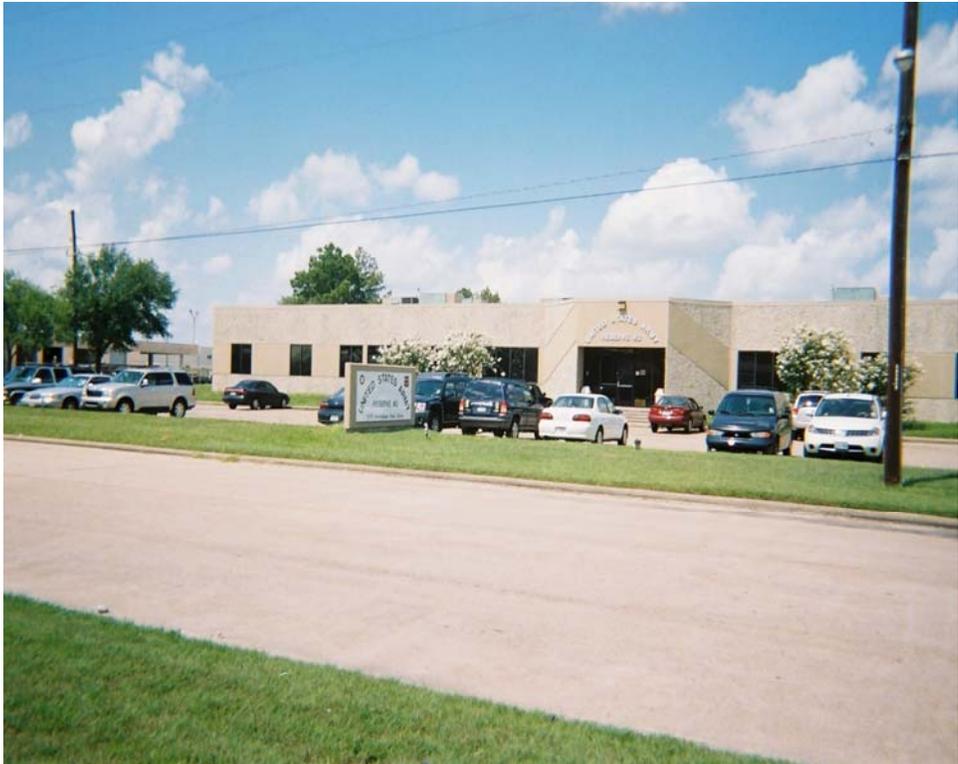
Photo 44: View of Houston #2 USAR Center located to the north of the Site.

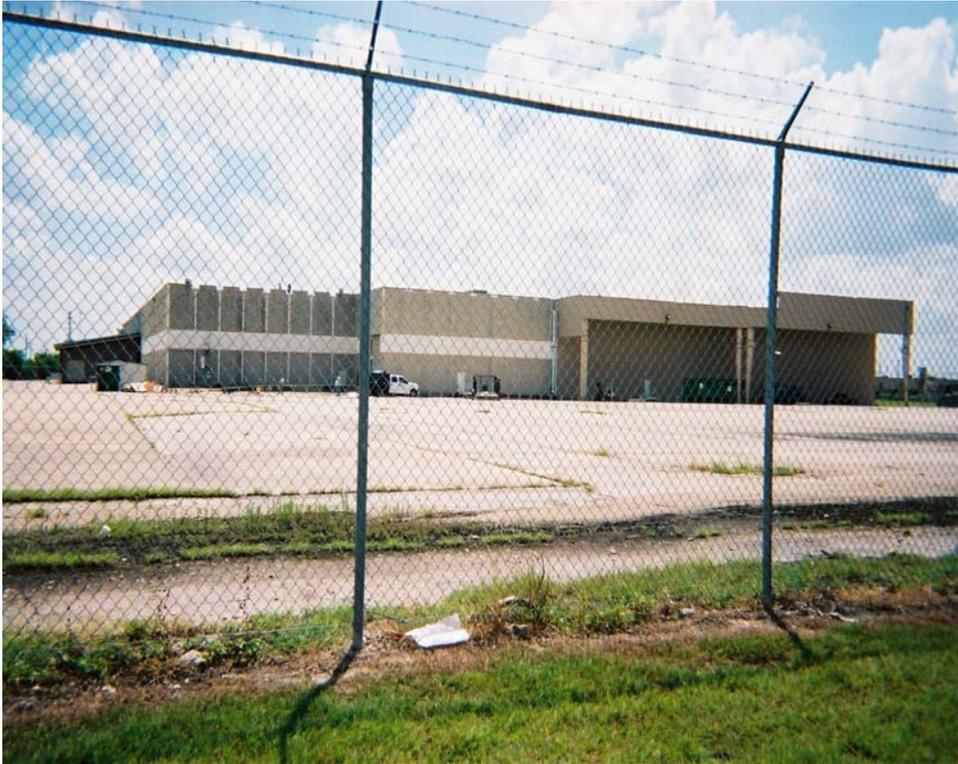
Photo 45: View of Iron Mountain (records management) located to the east of the Site.

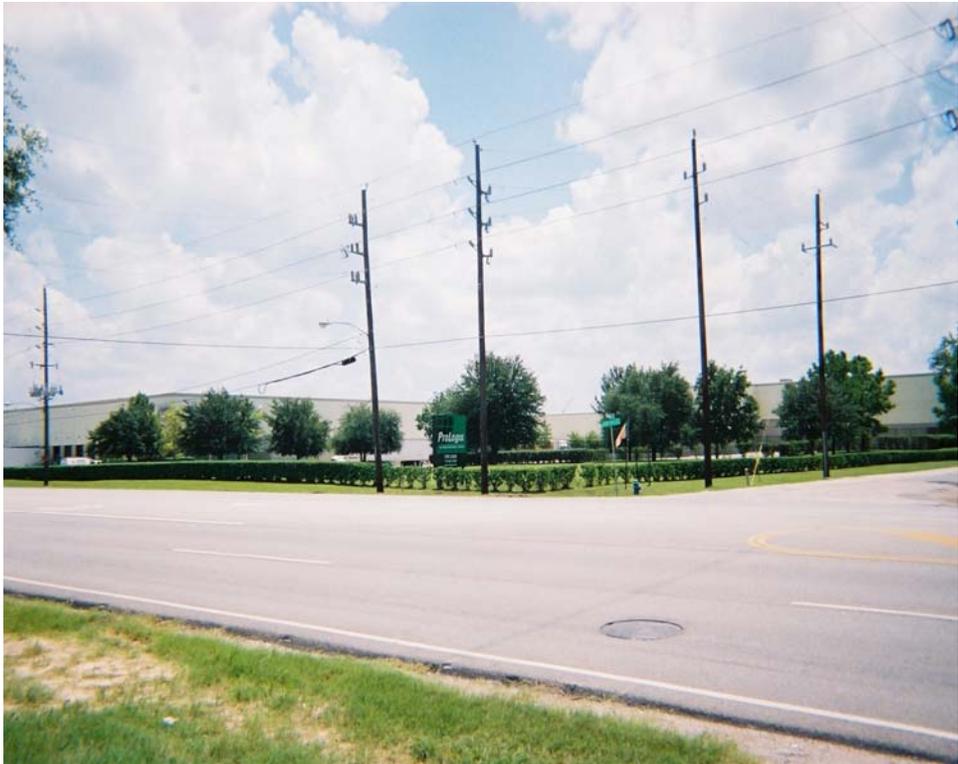
Photo 46: View of West Little York Road/Fisher Road and commercial businesses beyond, located to the south of the Site.

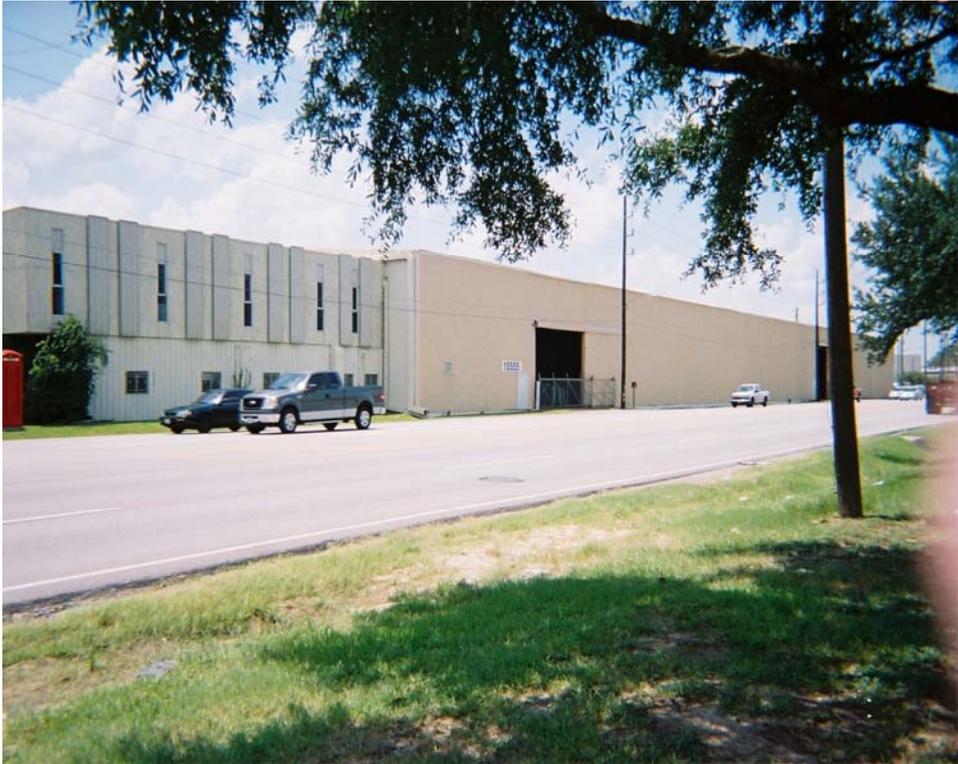
Photo 47: View of West Little York Road and commercial businesses beyond, to the south of the Site.

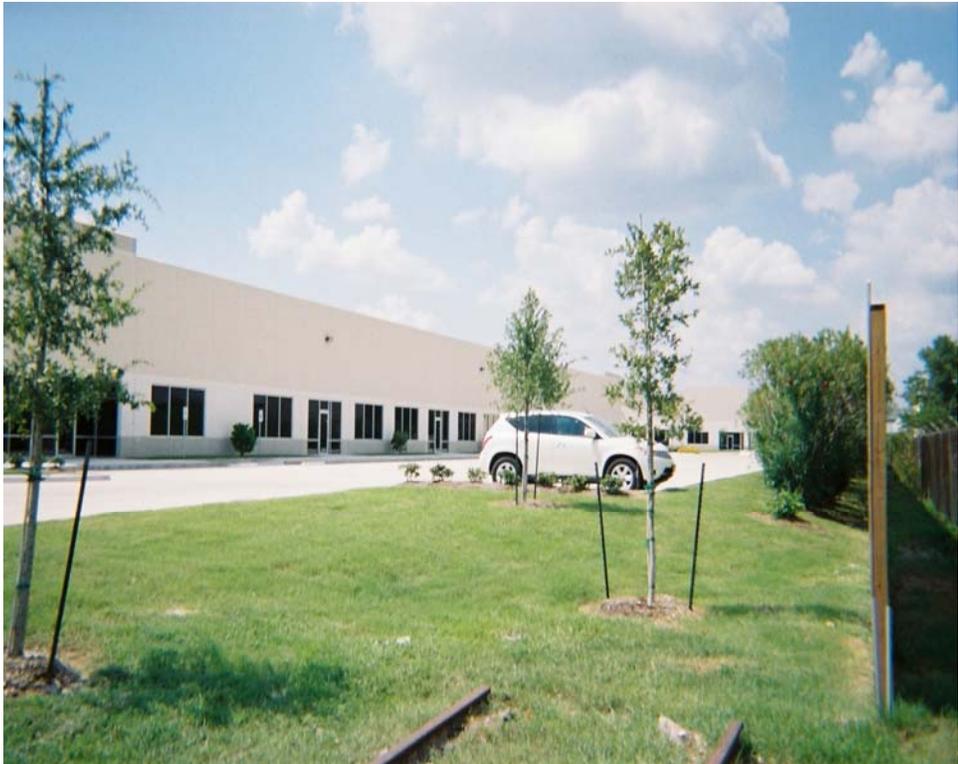
Photo 48: View of new warehouses to the west of the Site. A railroad line is visible in the foreground and the fence line between the Site and the warehouses is shown to the right.
