Appendix B
Site Reconnaissance Photographs

Wichita Falls USAR Center, TX
3315 9th Street
Wichita Falls, TX

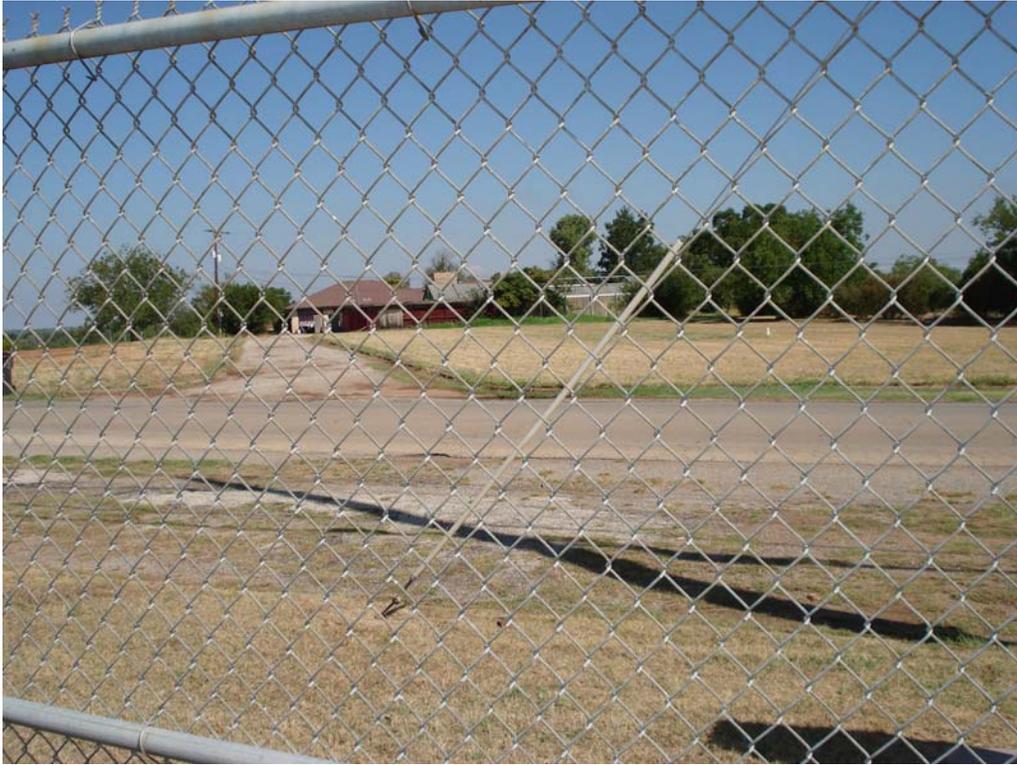
Photo 1: The property adjacent to the north side of the Site, across 9th Street, is a residence.

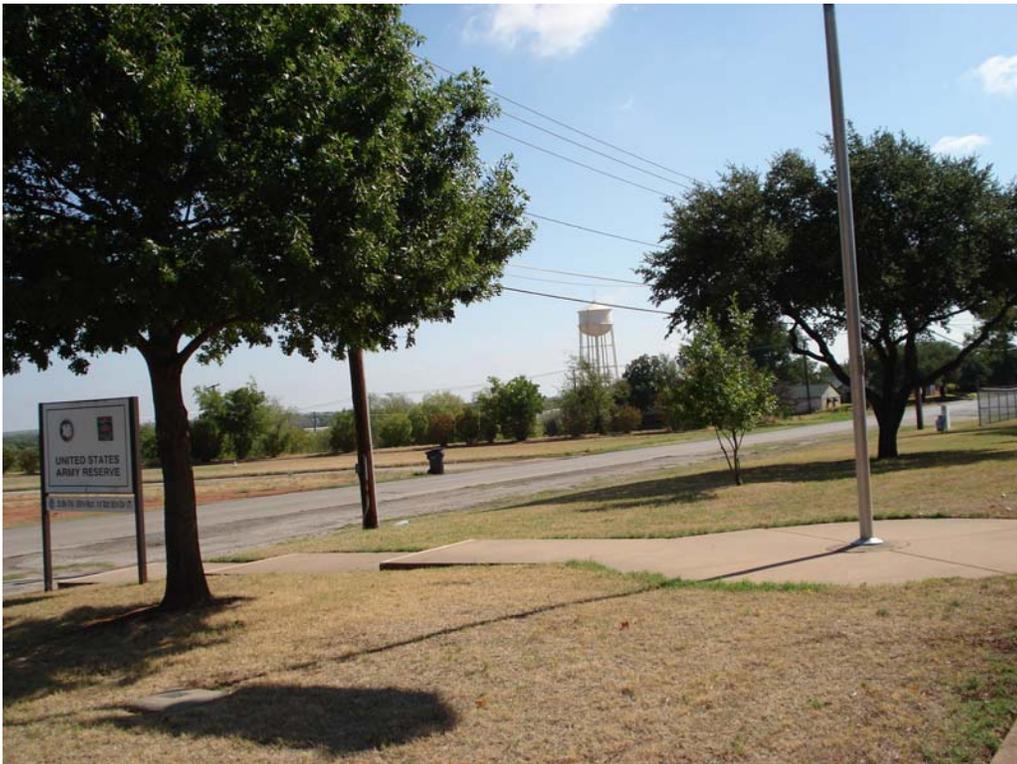
Photo 2: View from the Site to the northeast.

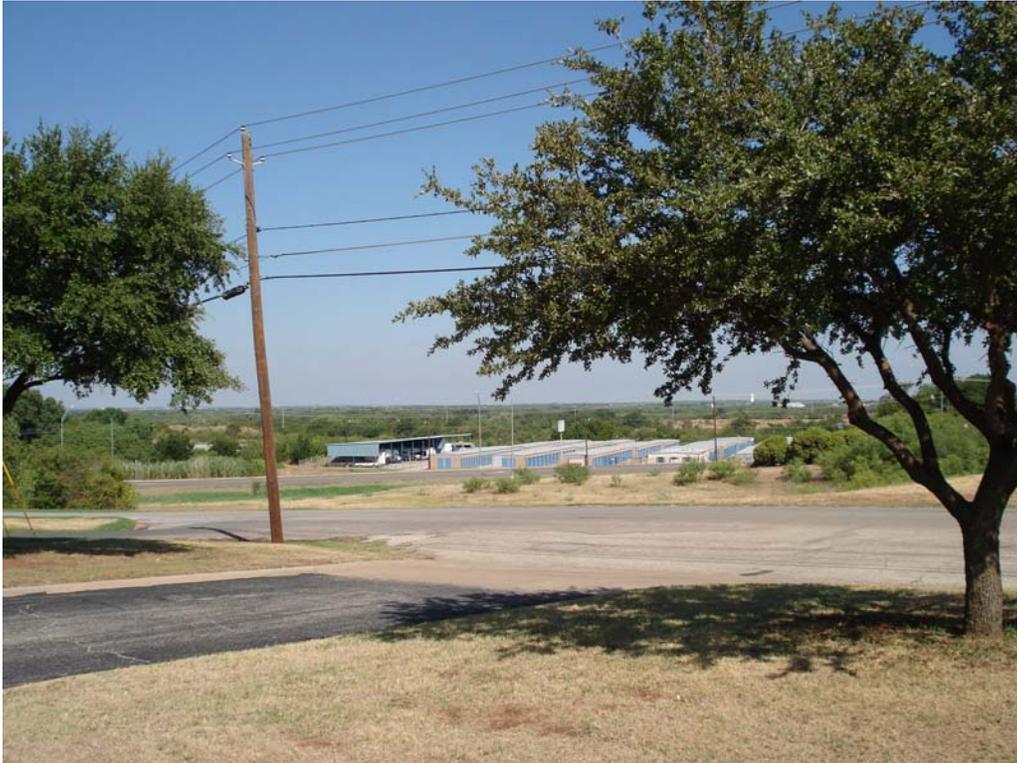
Photo 3: View from the Site to the northwest.

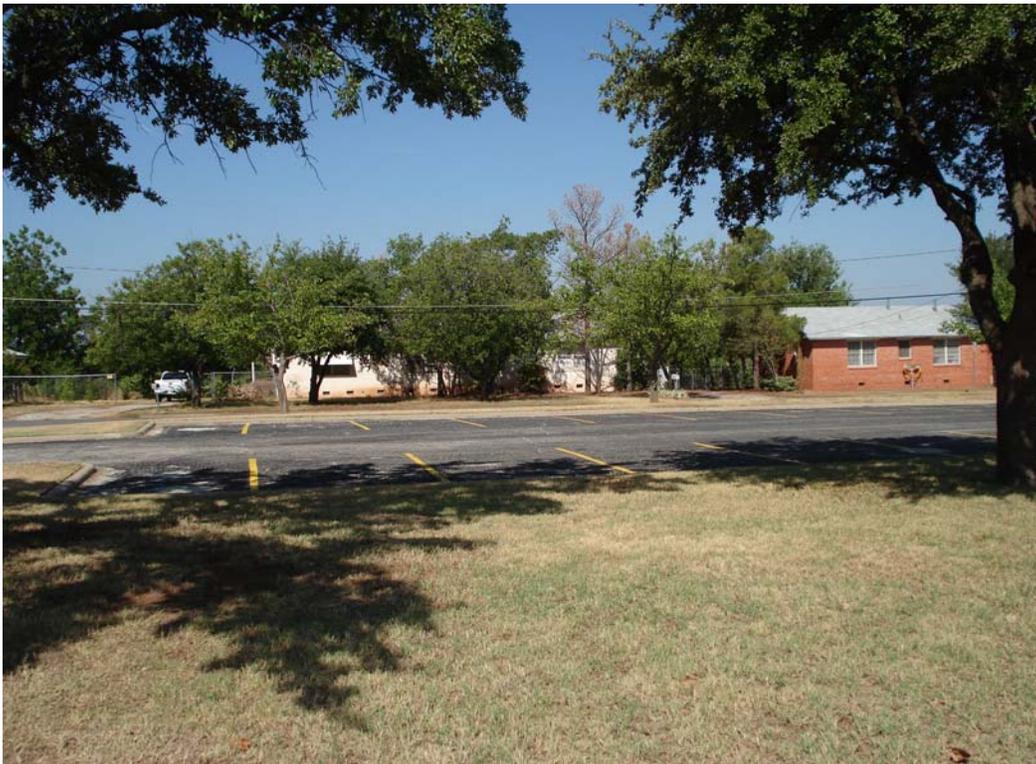
Photo 4: Adjacent properties west of the Site across West Wenonah Boulevard are residential.

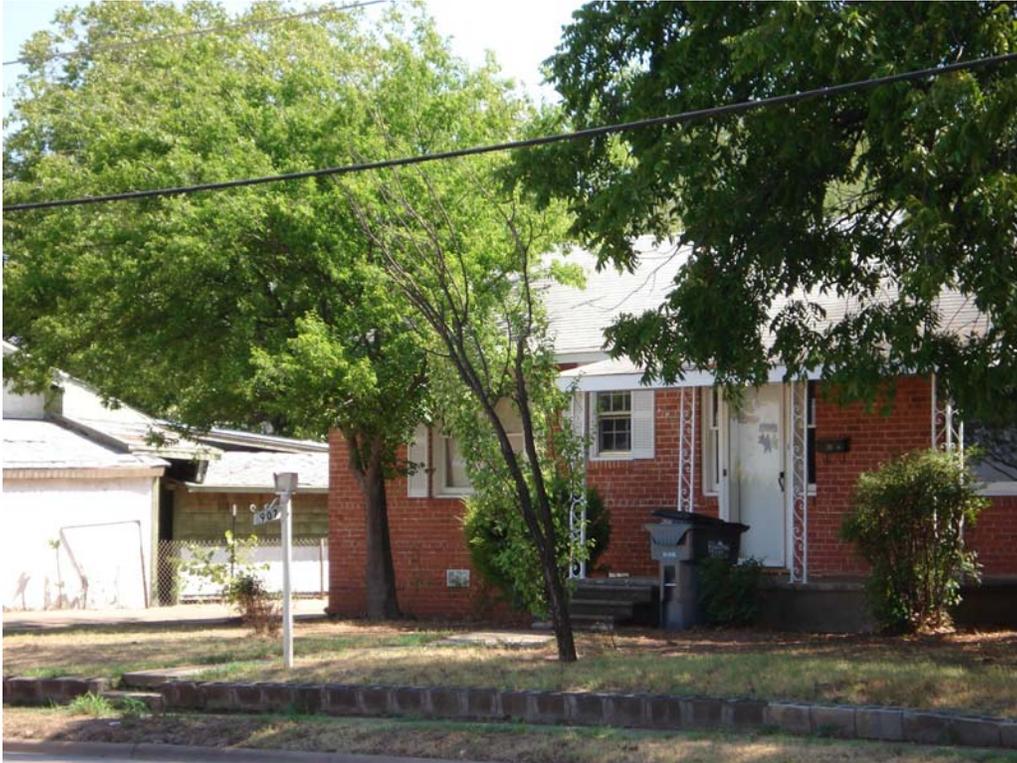
Photo 5: Adjacent properties east of the Site across East Wenonah Boulevard are residential.

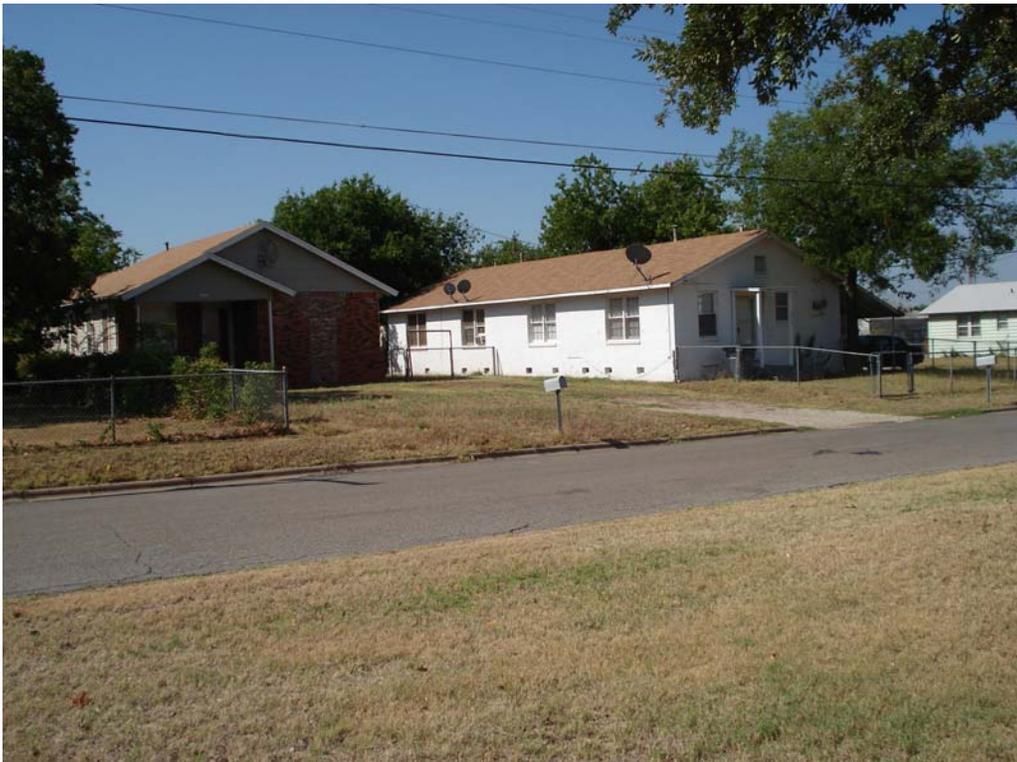
Photo 6: Adjacent properties south of the Site across 10th Street are residential.

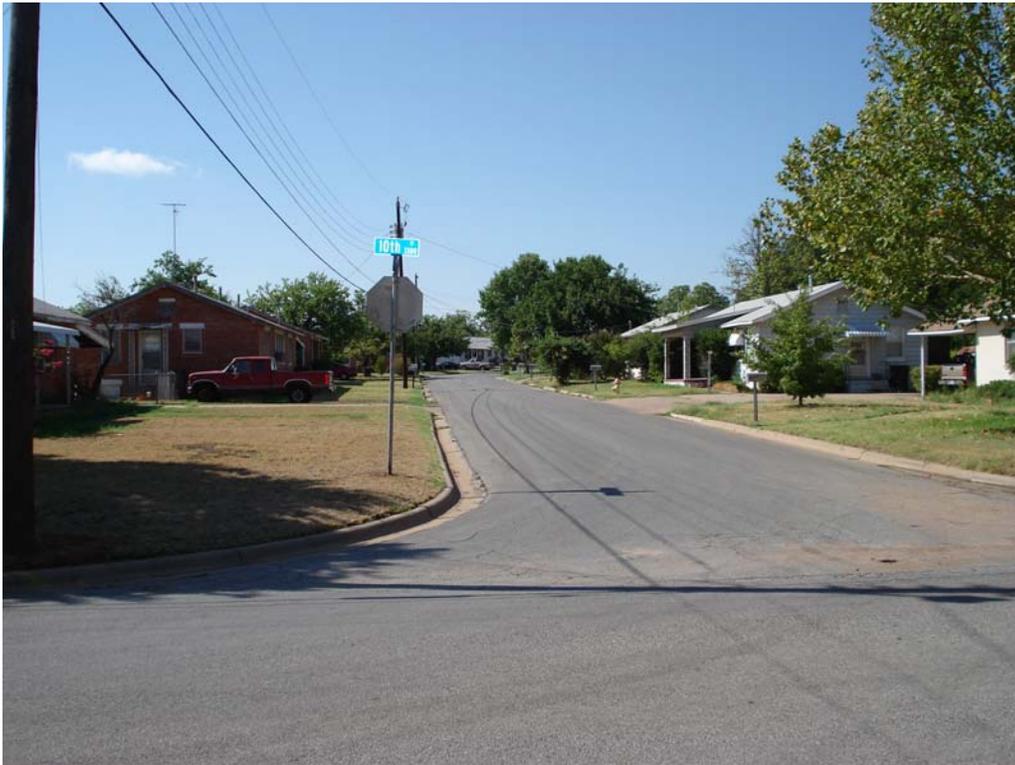
Photo 7: Westerly Drive south of the Site and south of 10th Street is a residential street.

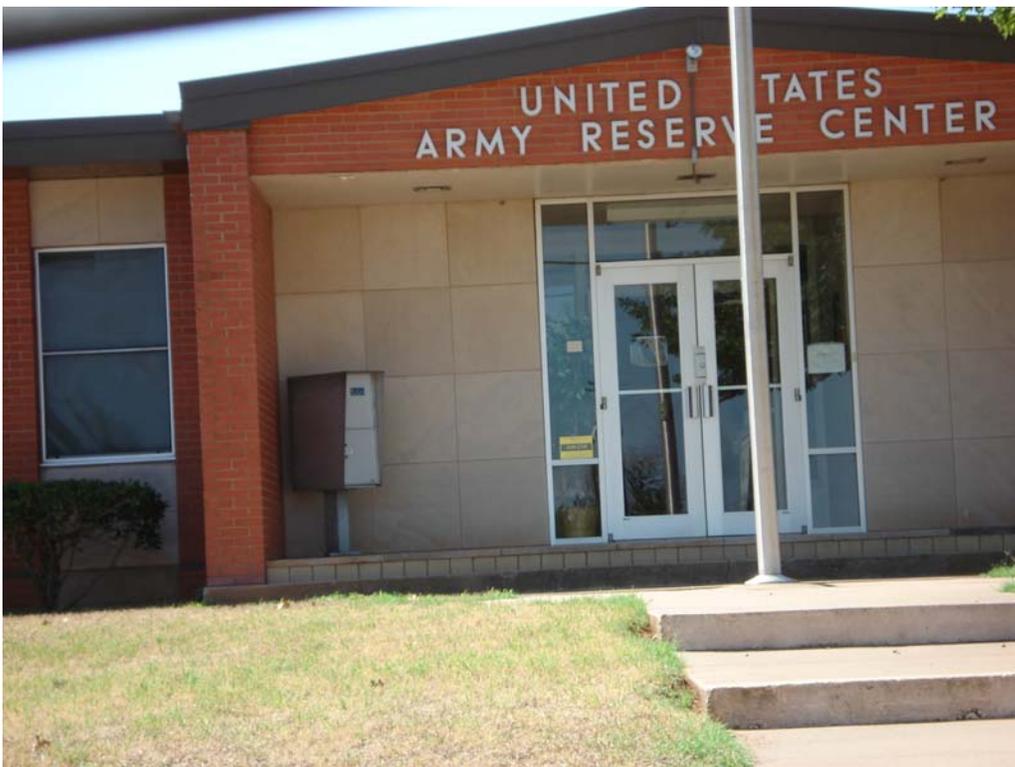
Photo 8: North side exterior of the Training Building.

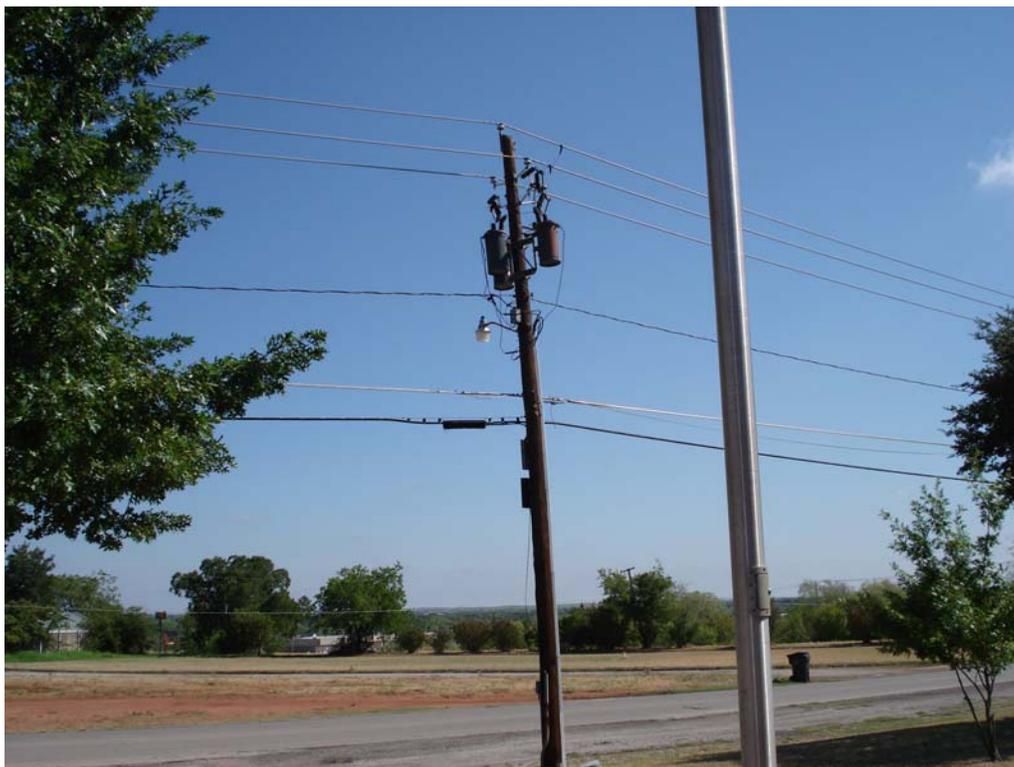
Photo 9: Three pole mounted transformers on the north side of Training Building near the property line.

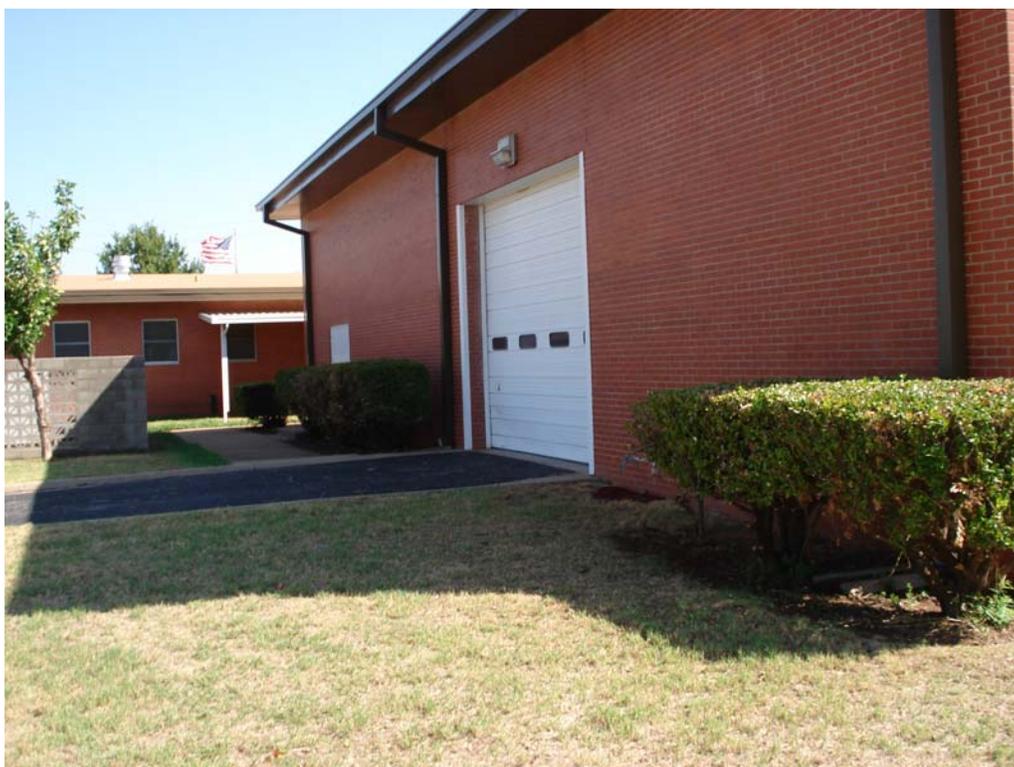
Photo 10: West side exterior of the Training Building.

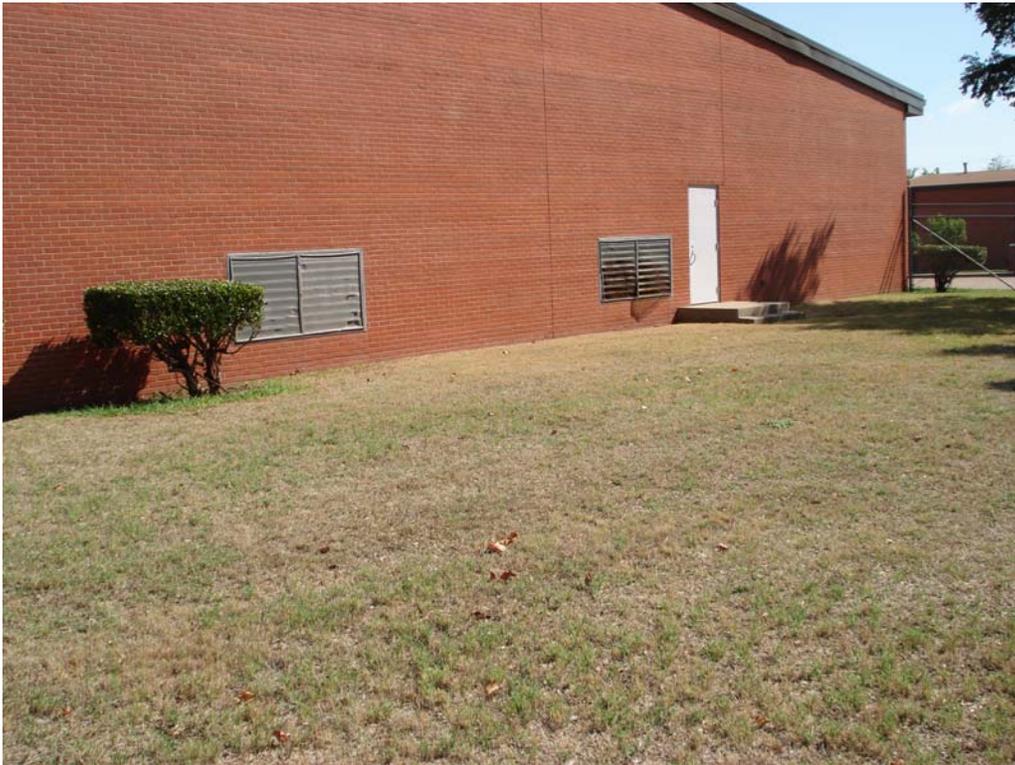
Photo 11: South side exterior of the Training Building.

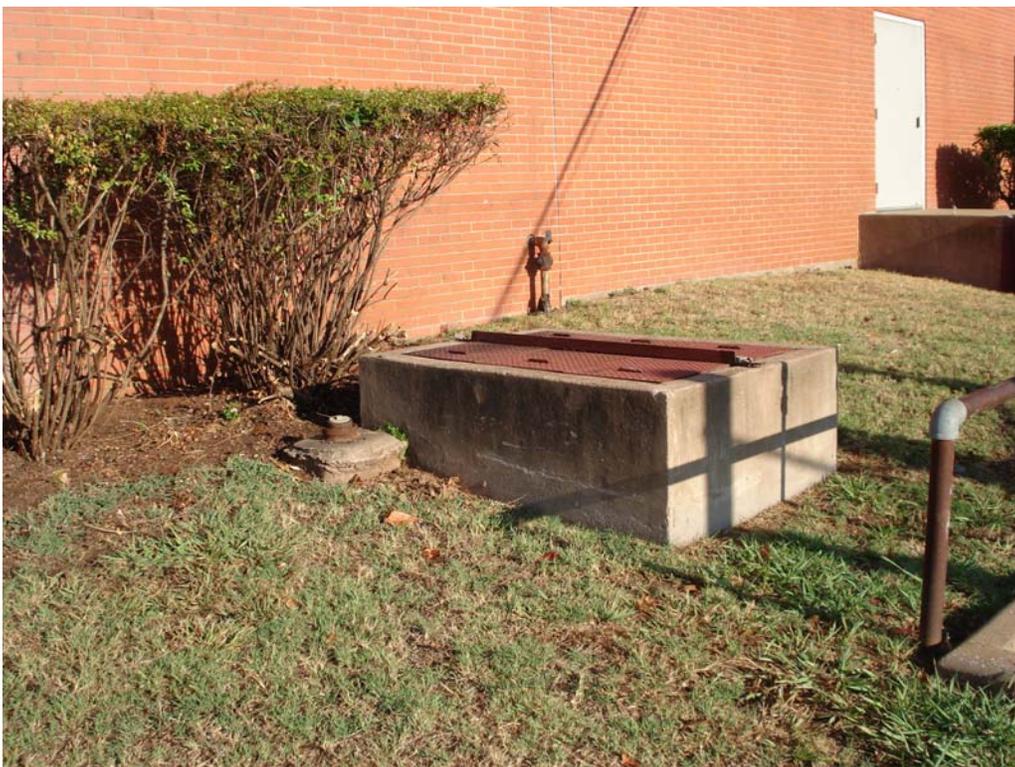
Photo 12: East side exterior of the Training Building where there is a grease trap from the former kitchen.

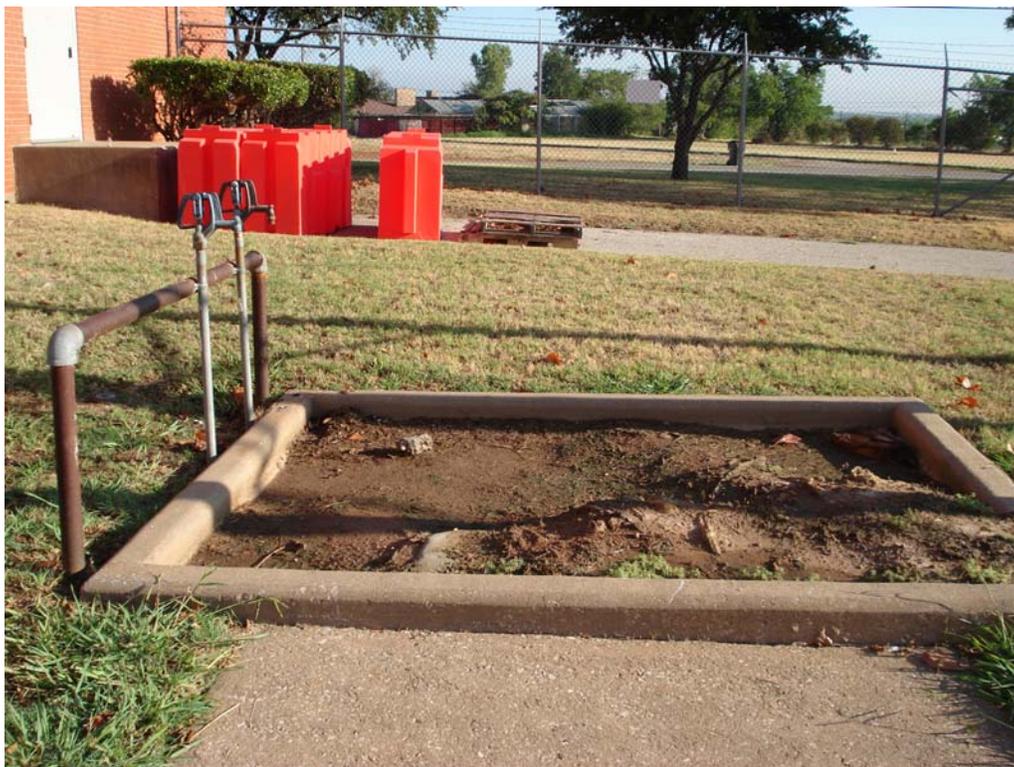
Photo 13: Wash pad on east side of the Training Building.

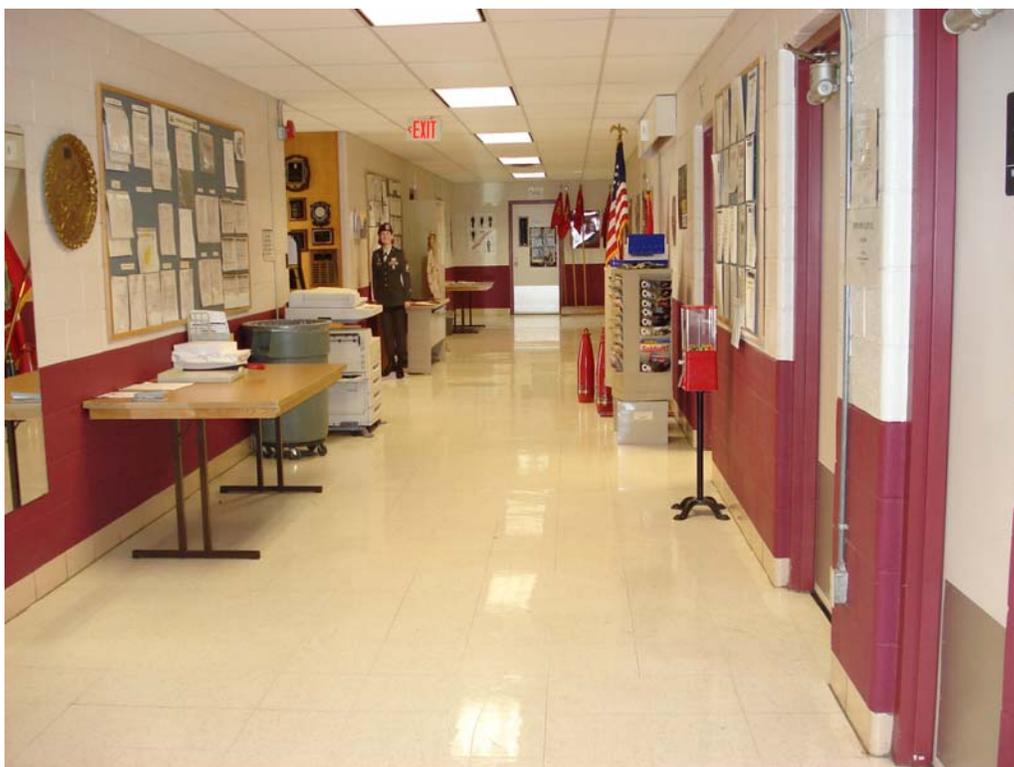
Photo 14: Training building hallway.

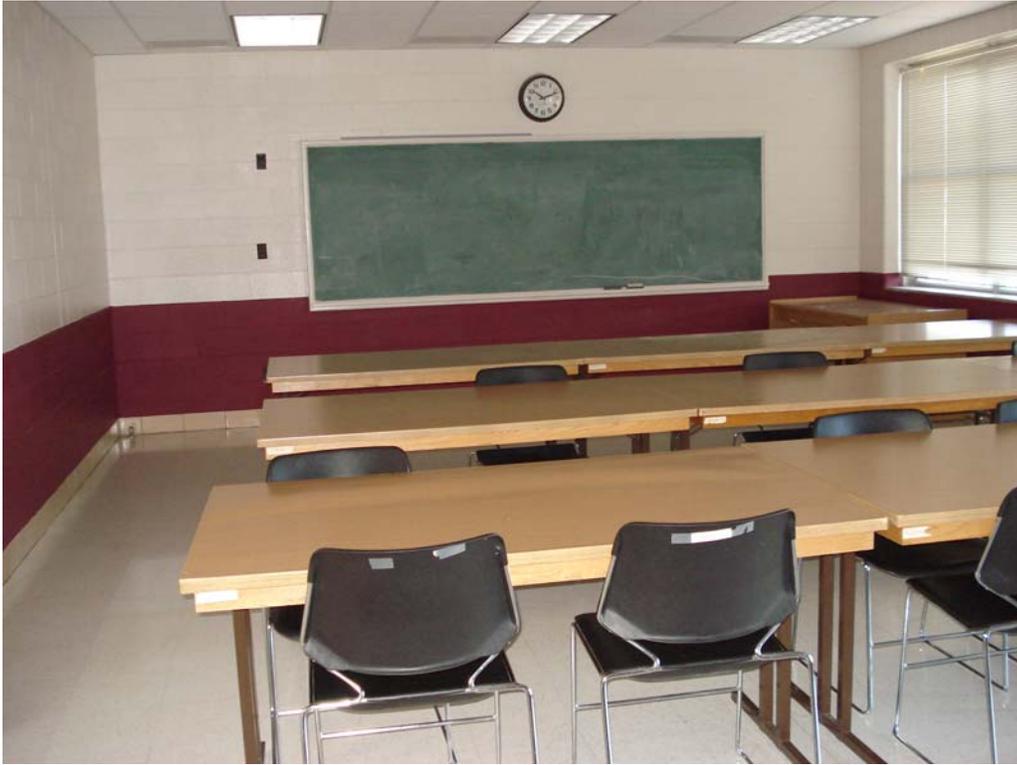
Photo 15: Training building classroom.

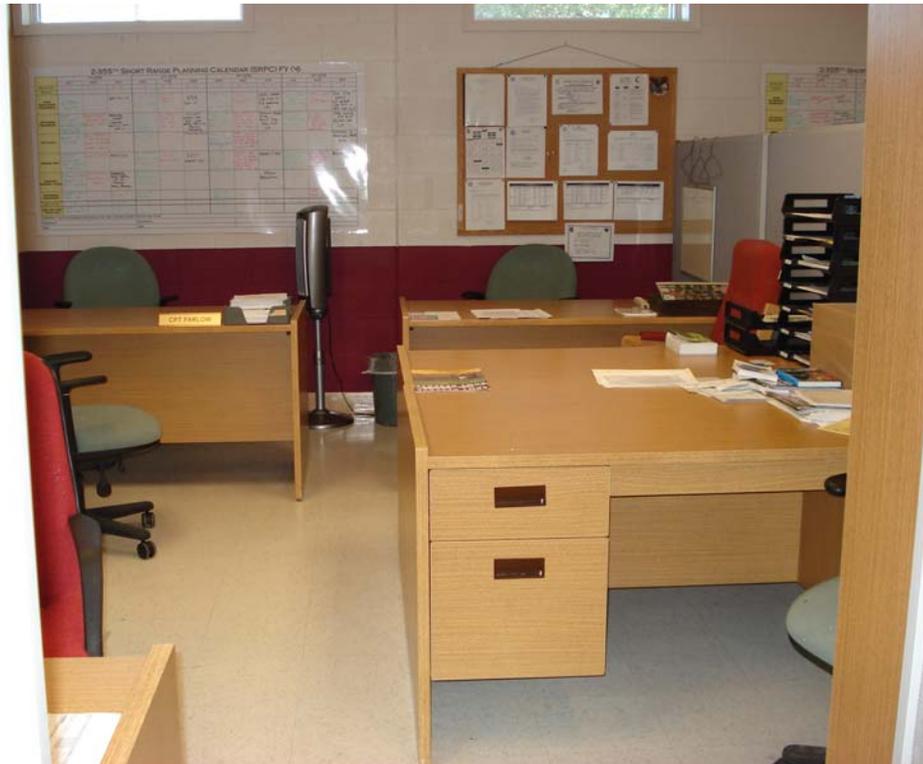
Photo 16: The Training Building has several offices.

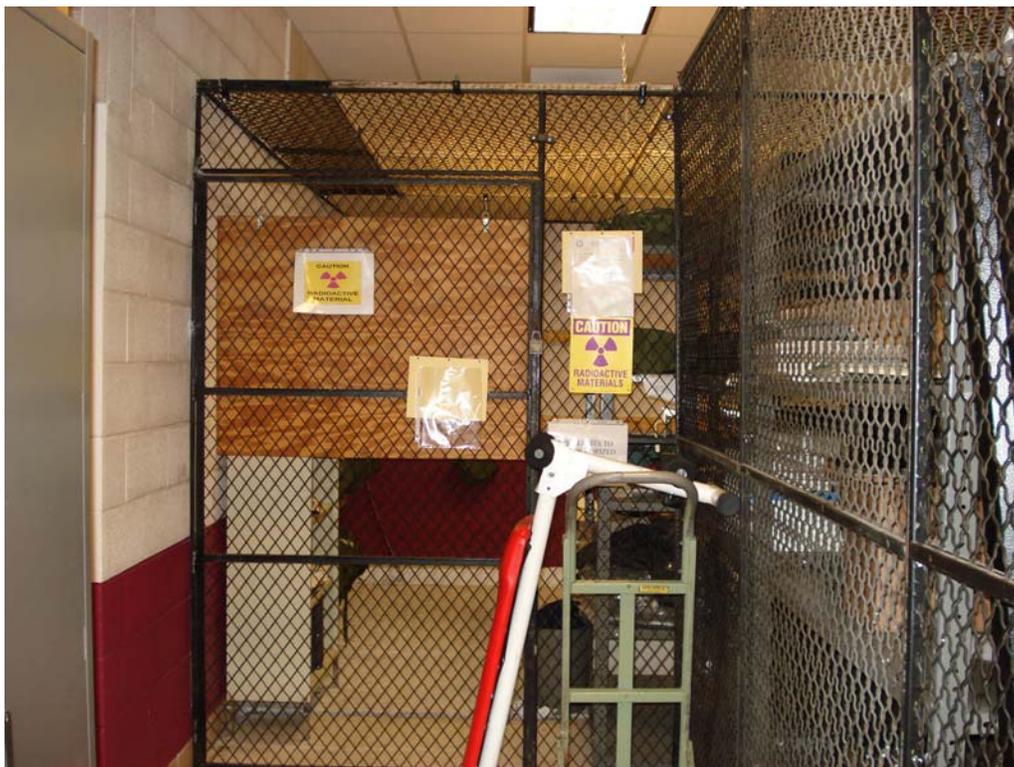
Photo 17: The supply room in the Training Building was a former firing range.

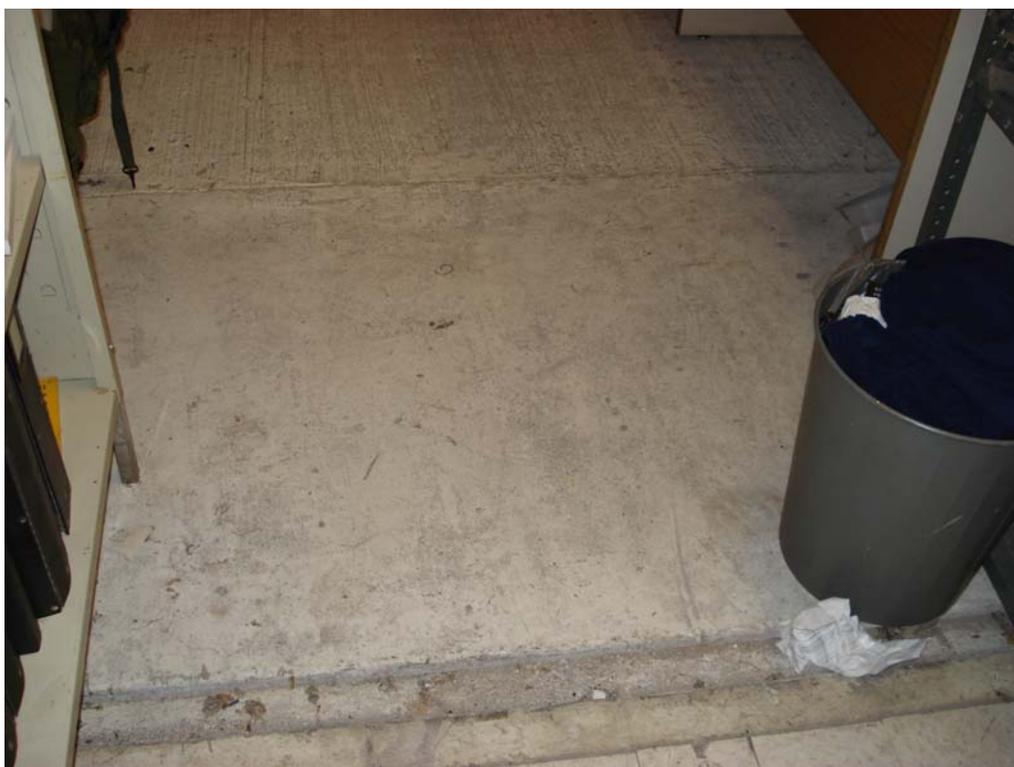
Photo 18: The lead drop from the former firing range was filled with concrete.

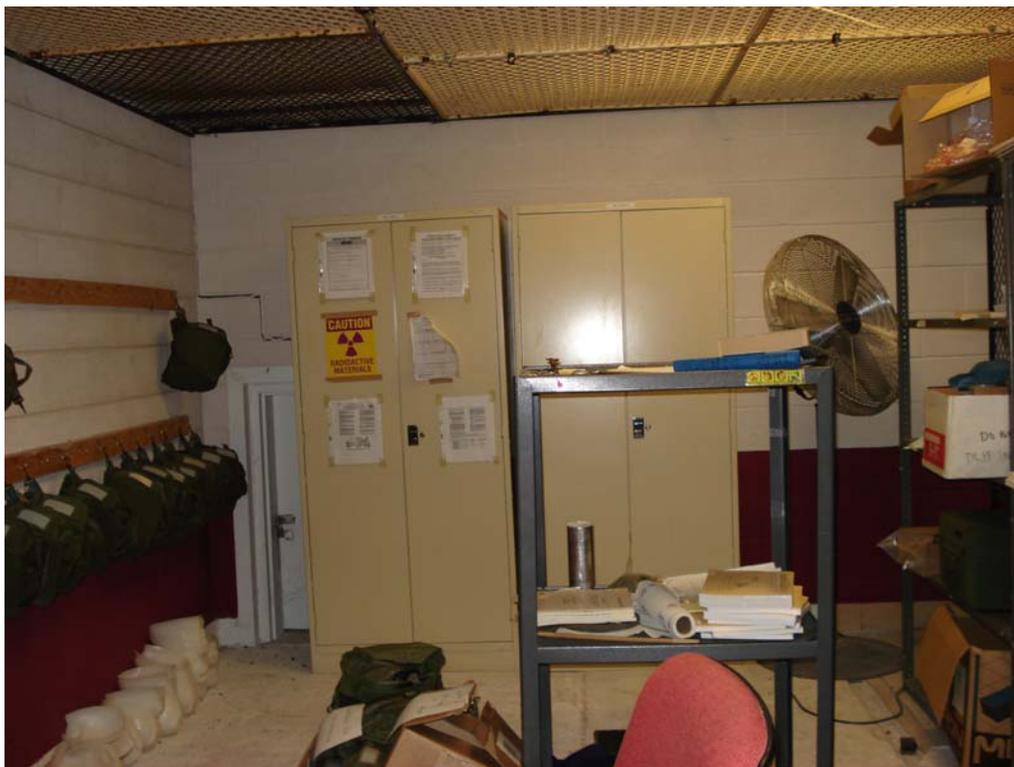
Photo 19: Supply room locker with radioactive label.

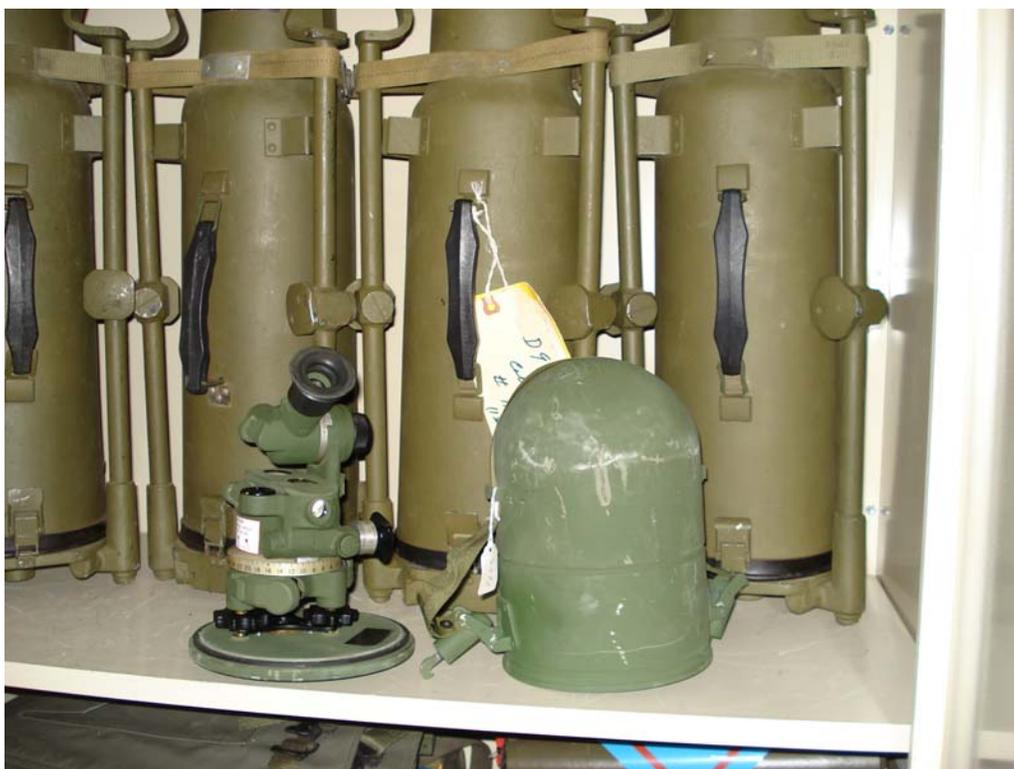
Photo 20: Equipment in the locker has a fluorescent dial with low-level radioactivity.

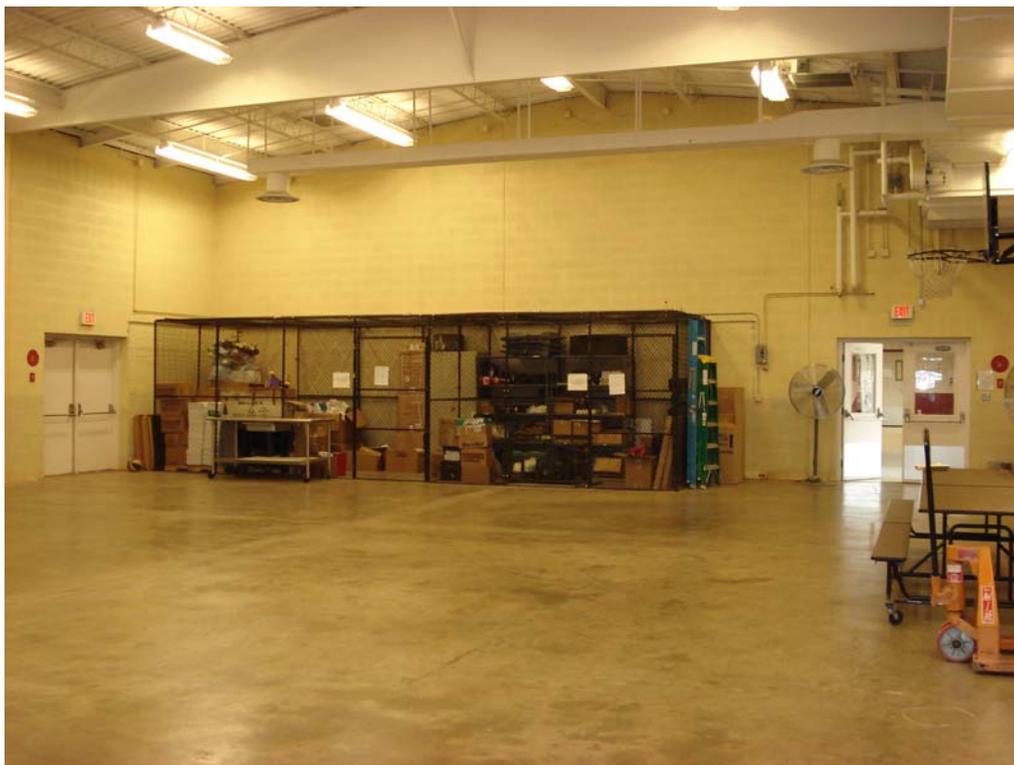
Photo 21: Drill hall in the Training Building.

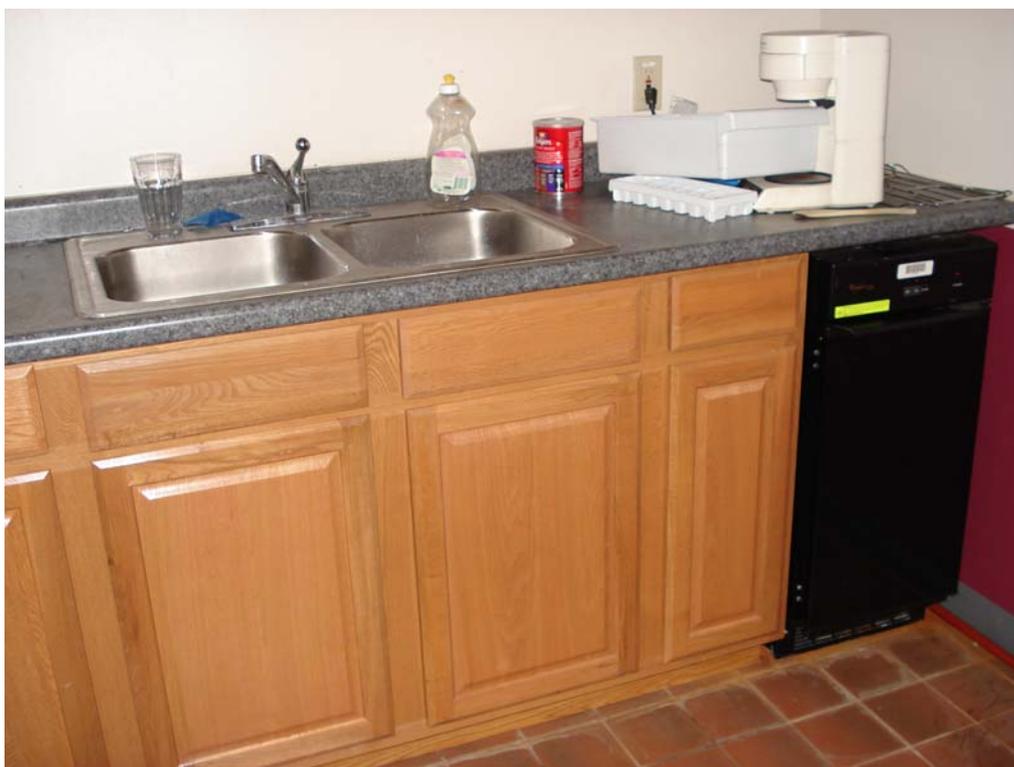
Photo 22: Breakroom within the Training Building.

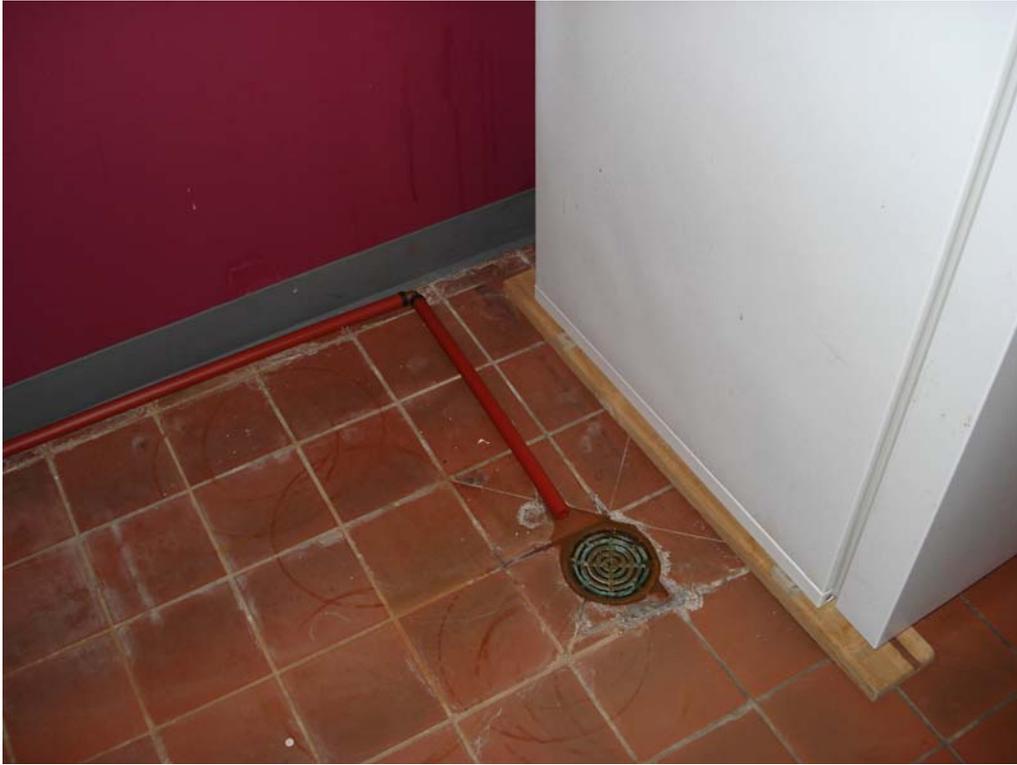
Photo 23: Drain in breakroom for condensate.

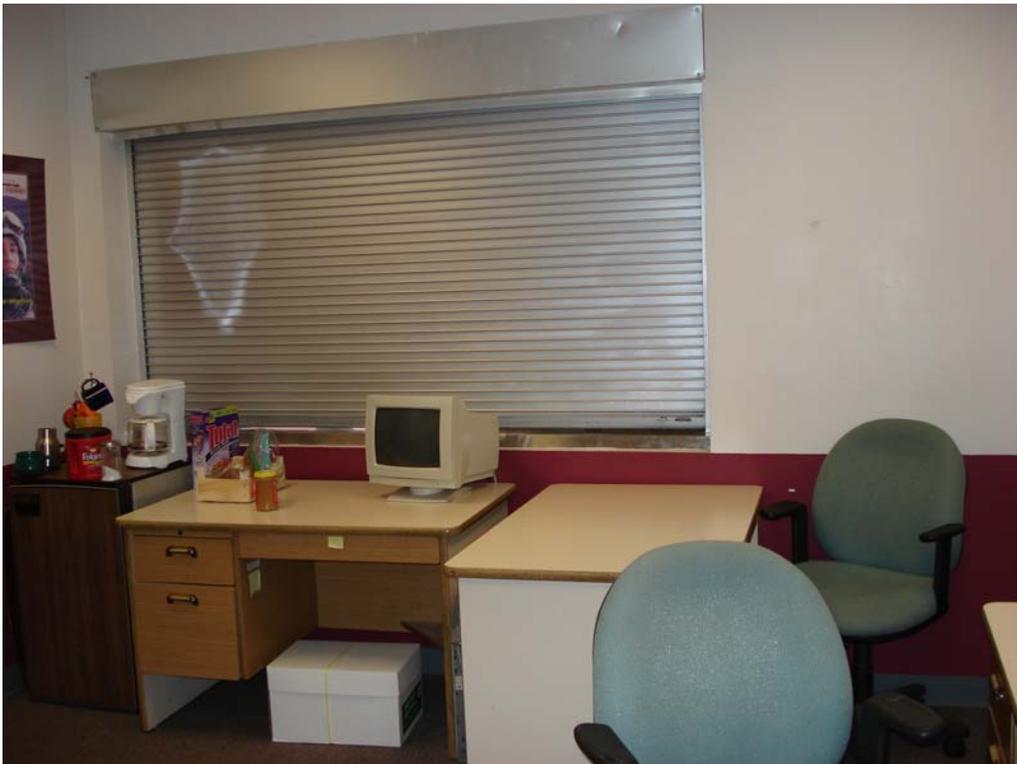
Photo 24: Former kitchen area converted into office space.

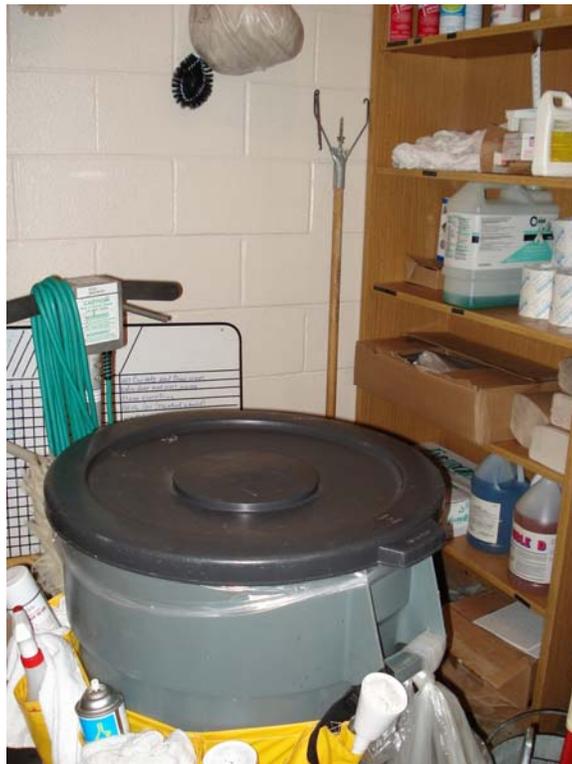
Photo 25: Chemicals were stored on wood shelving inside the janitor closet.

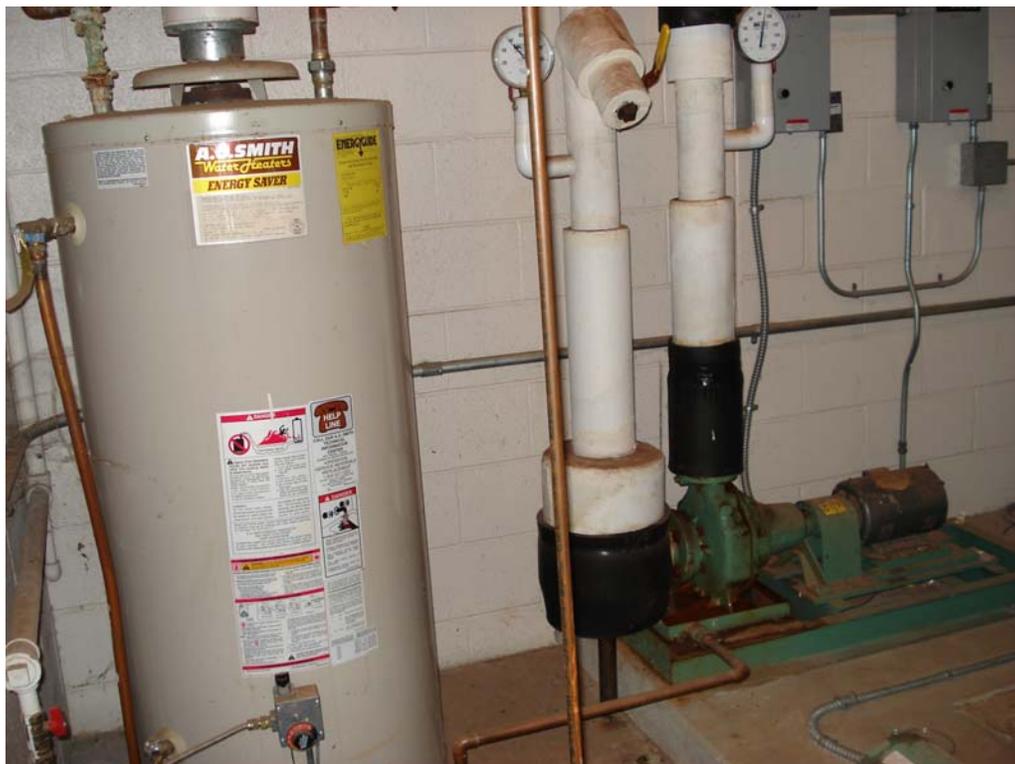
Photo 26: Boiler room equipment.

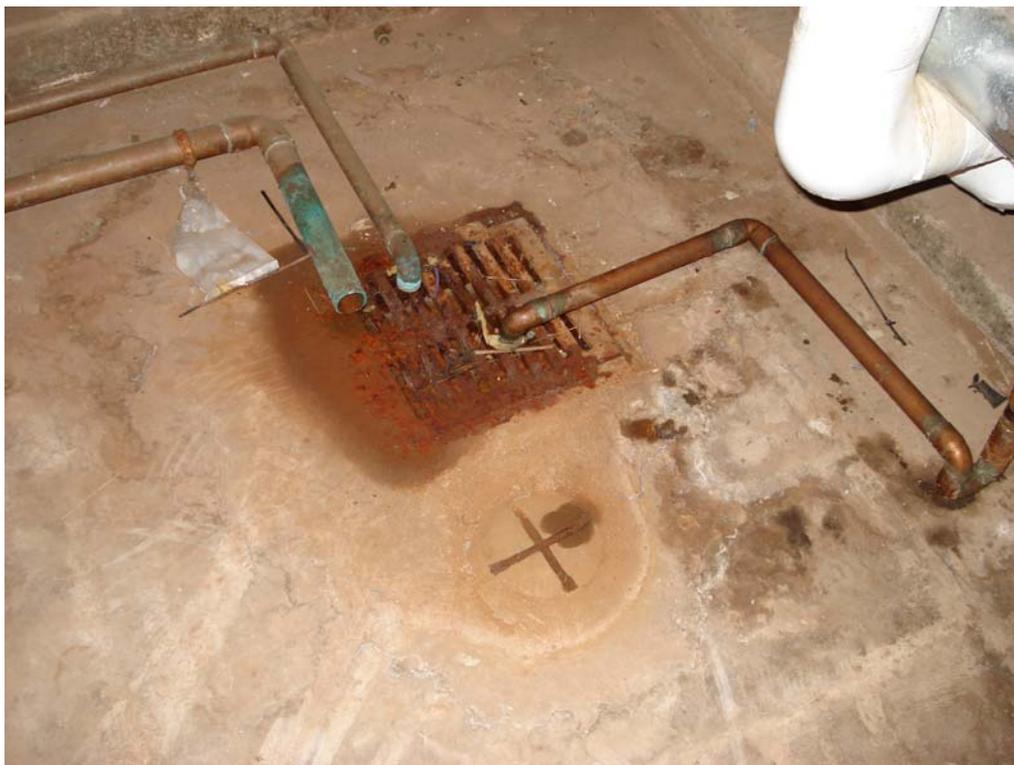
Photo 27: Boiler room drain.

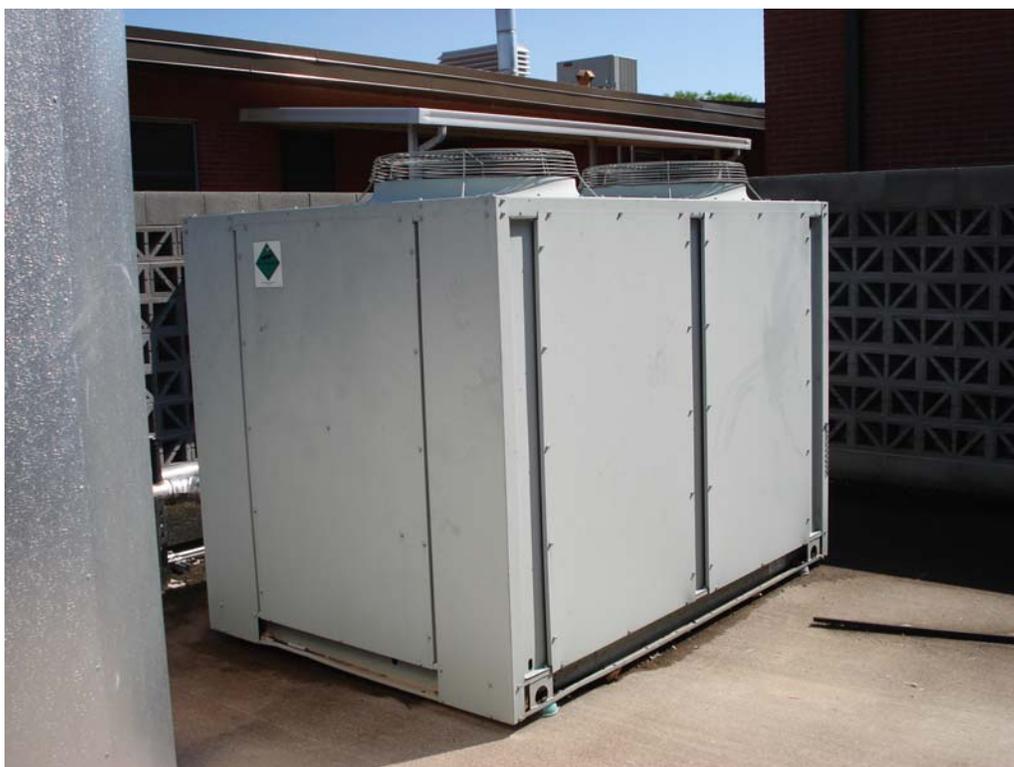
Photo 28: Chiller inside enclosure on west side of Training Building.

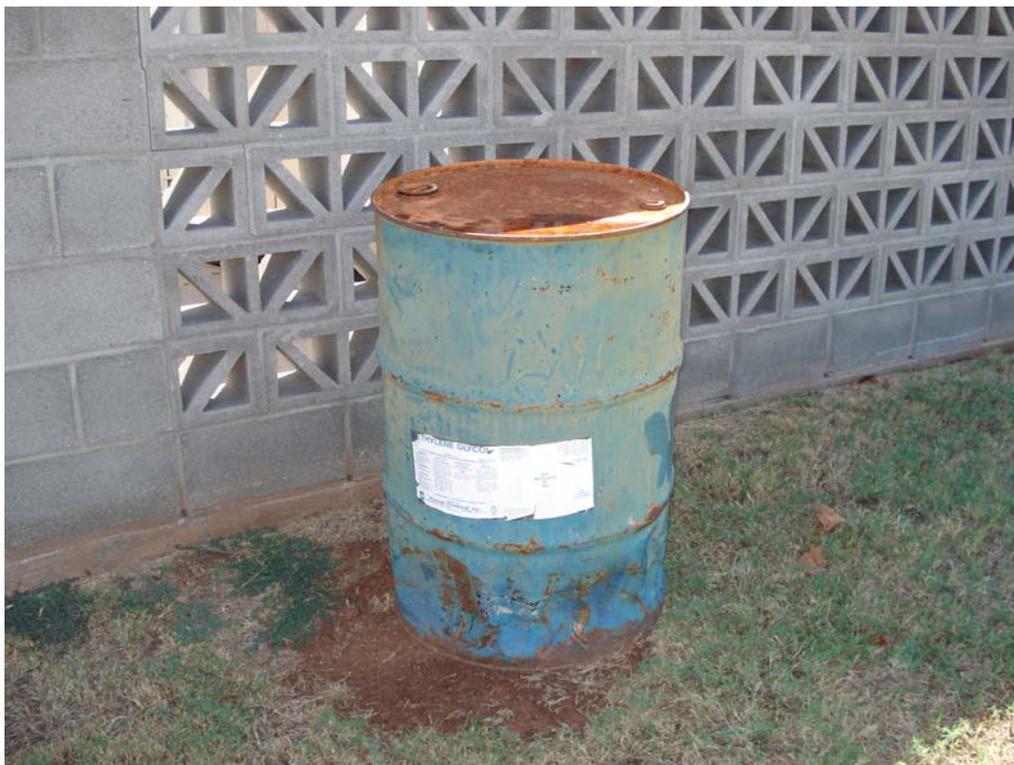
Photo 29: Drum of ethylene glycol outside of chiller enclosure.
