Appendix B
Site Reconnaissance Photographs

Wichita Falls USAR Center, TX
3315 9th Street
Wichita Falls, TX

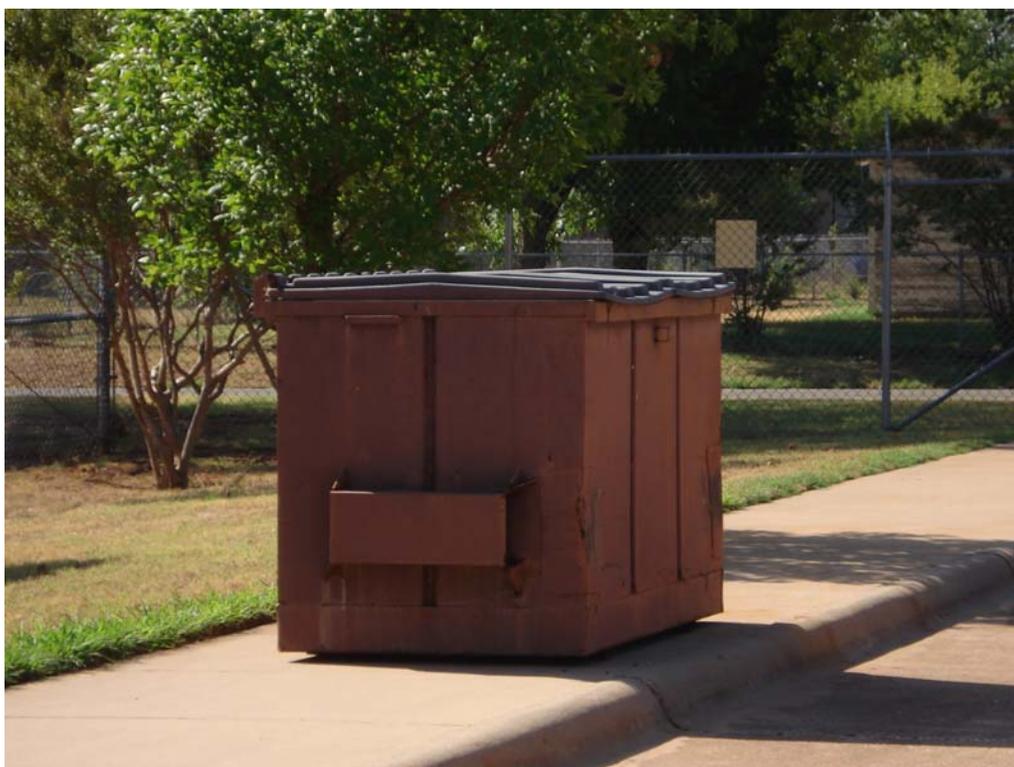
Photo 30: Dumpster between the Training and OMS buildings.

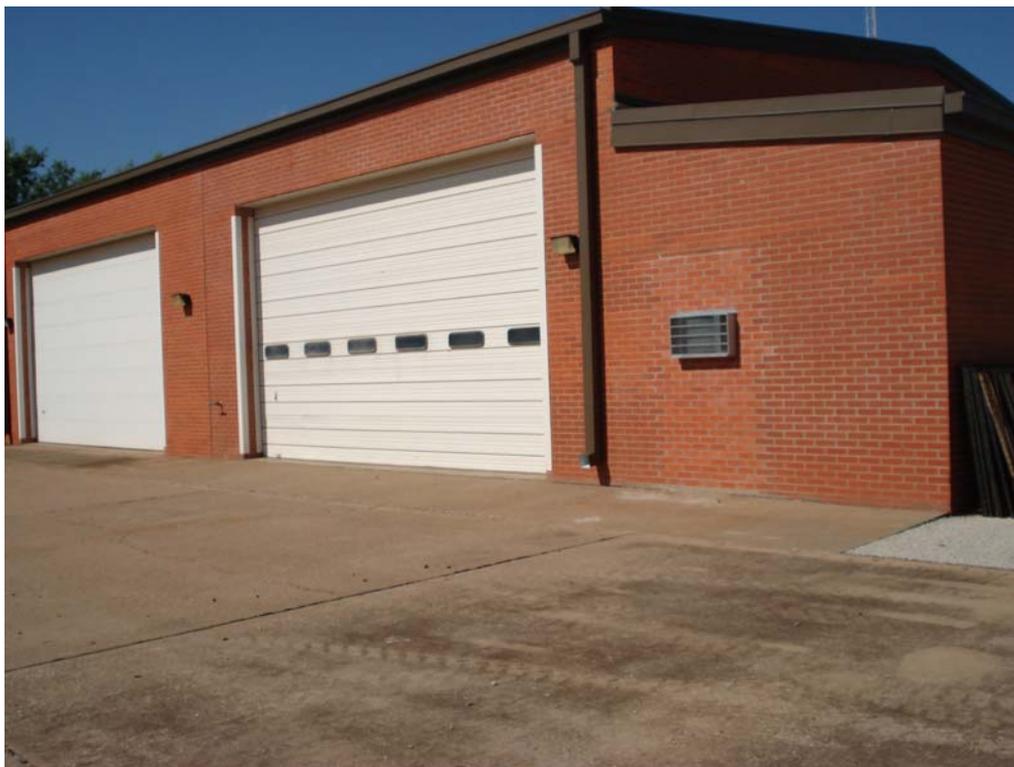
Photo 31: OMS building exterior east side.

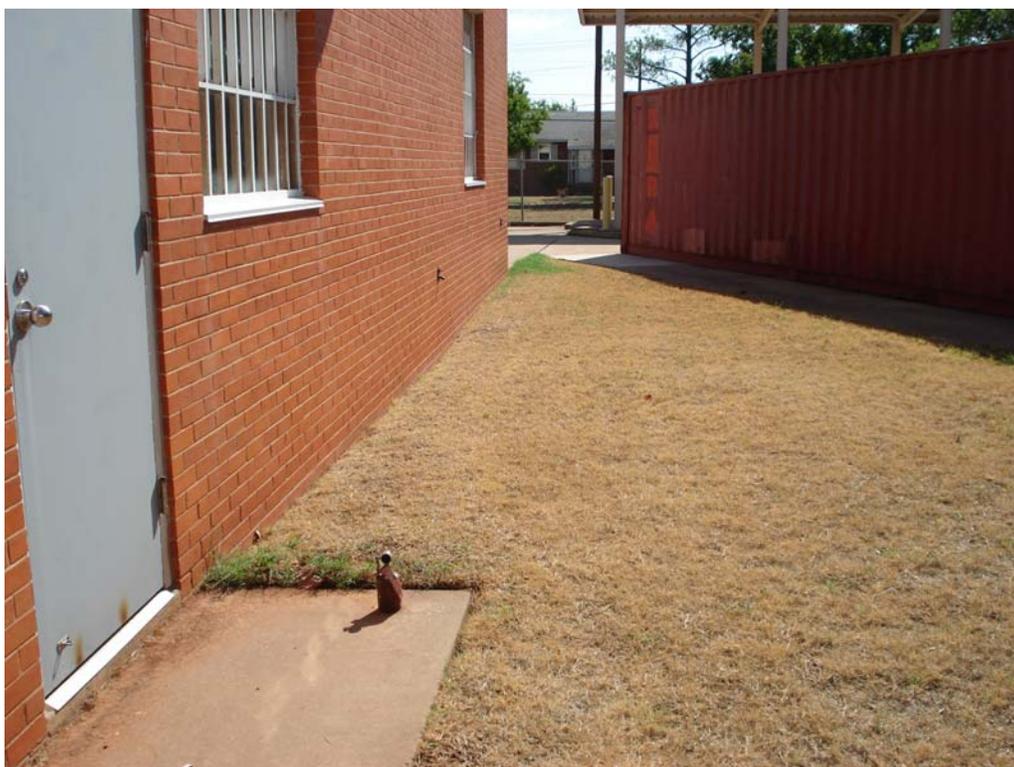
Photo 32: OMS building exterior south side.

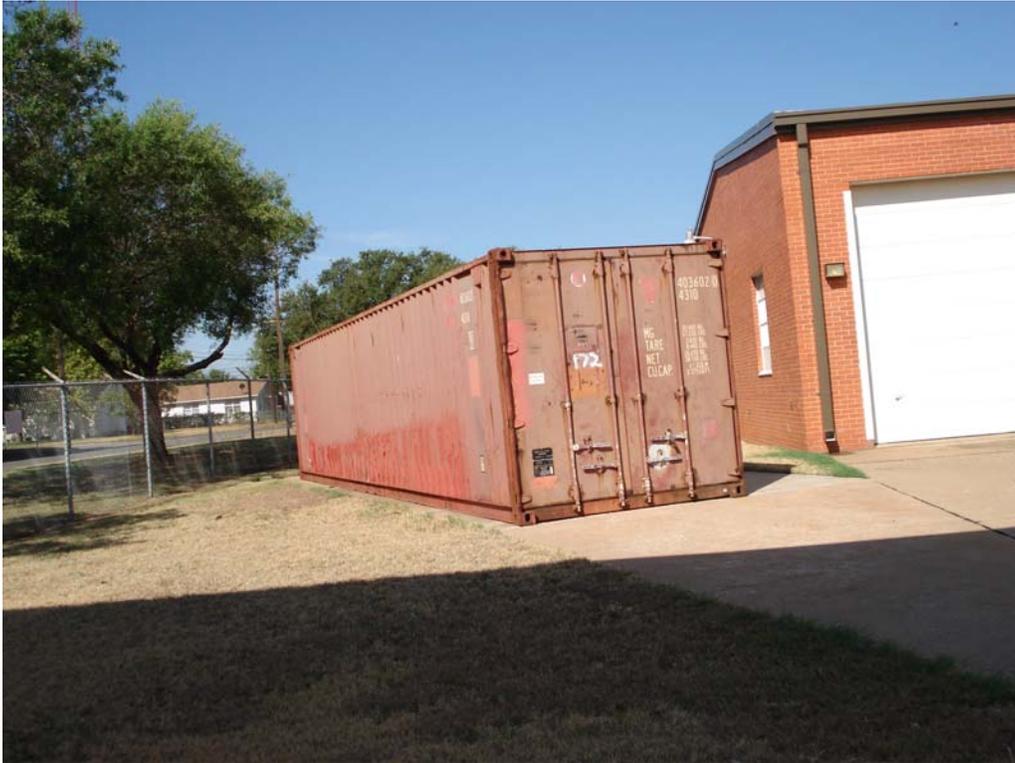
Photo 33: Storage container by the OMS building on a pad for a former grease rack.

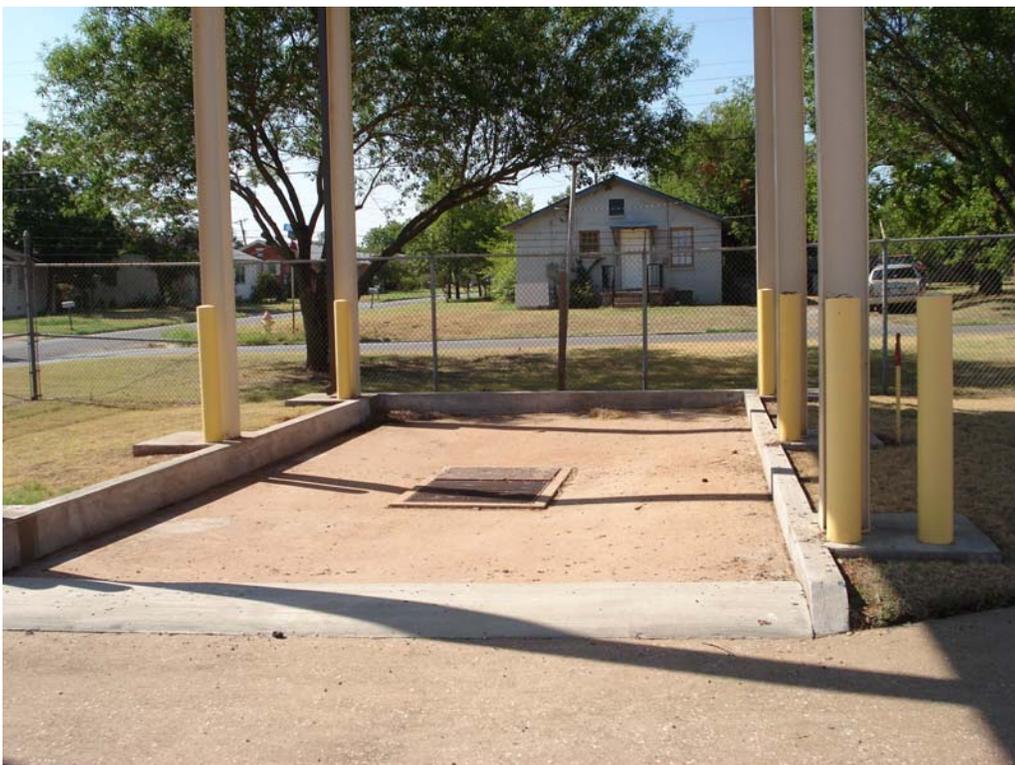
Photo 34: A vehicle wash rack on the east side of the OMS building has an oil/water separator.

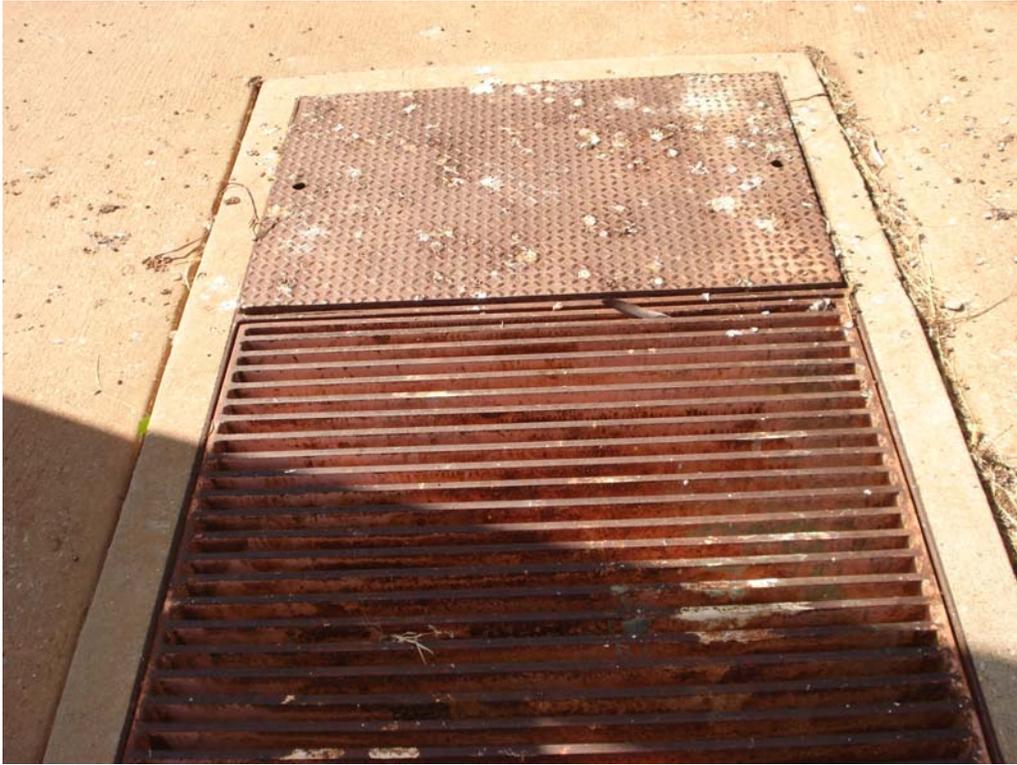
Photo 35: Close-up of the oil/water separator for the vehicle wash rack.

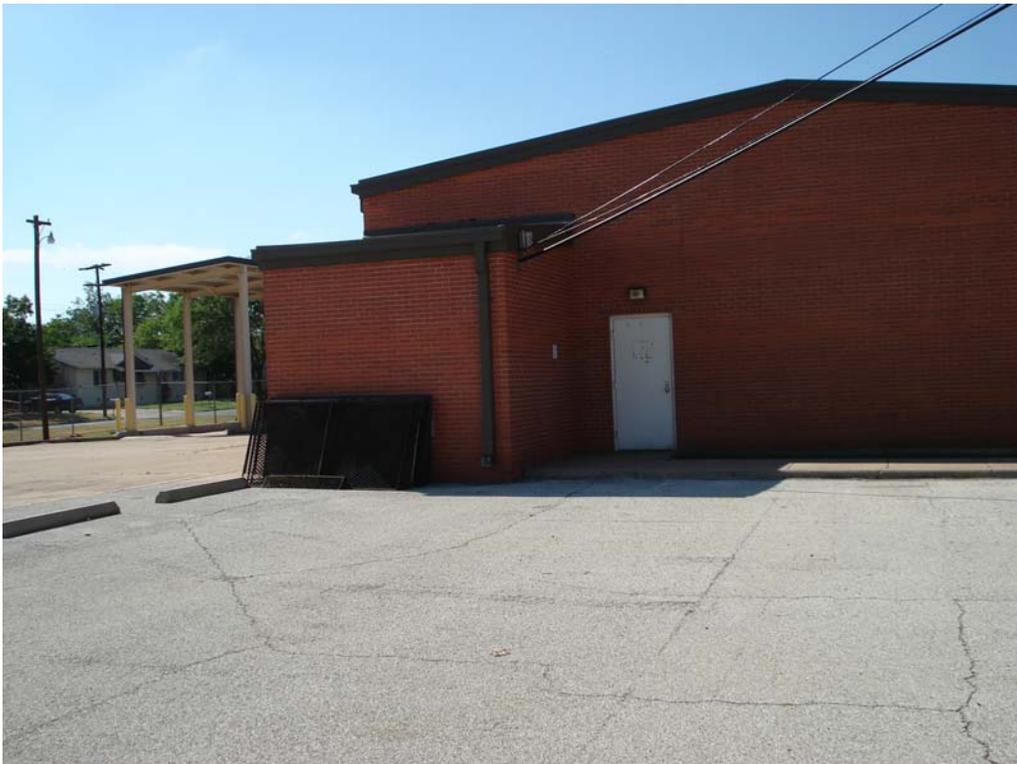
Photo 36: OMS exterior north side.

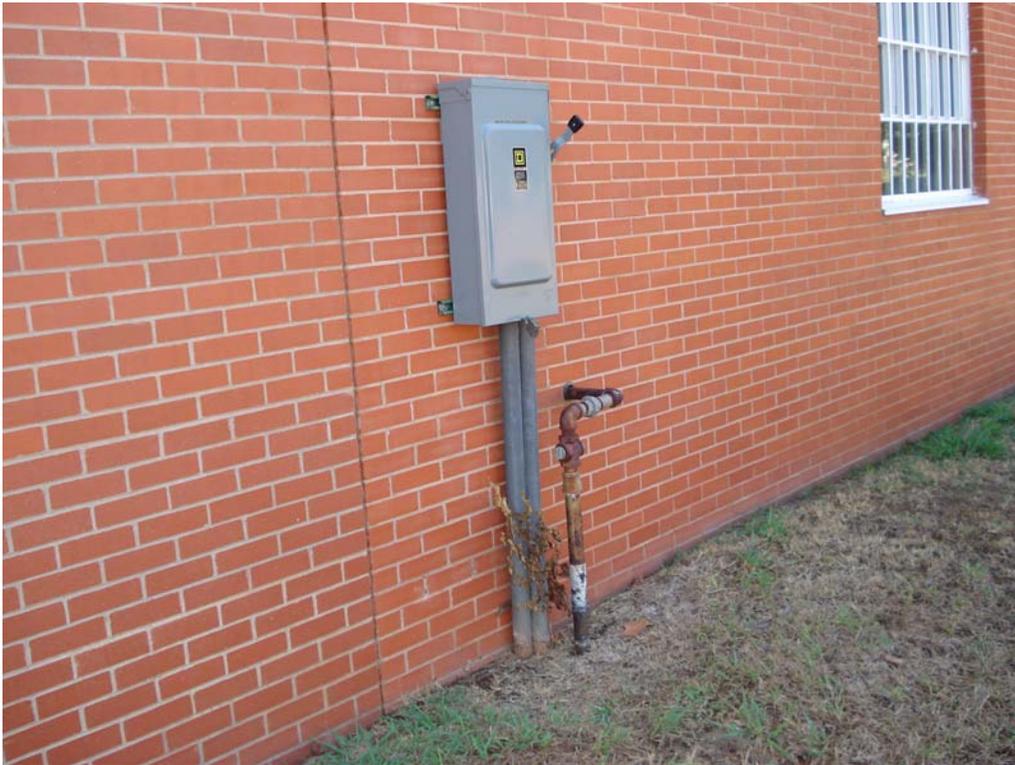
Photo 37: OMS exterior west side.

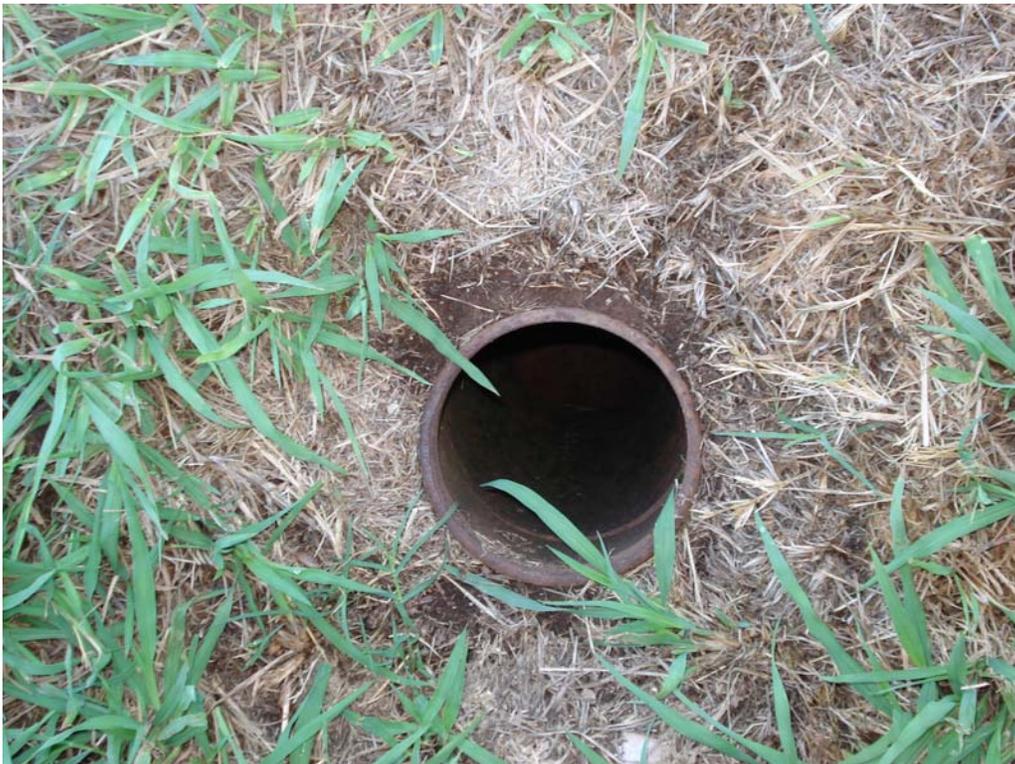
Photo 38: Pipe near northwest corner of the OMS building.

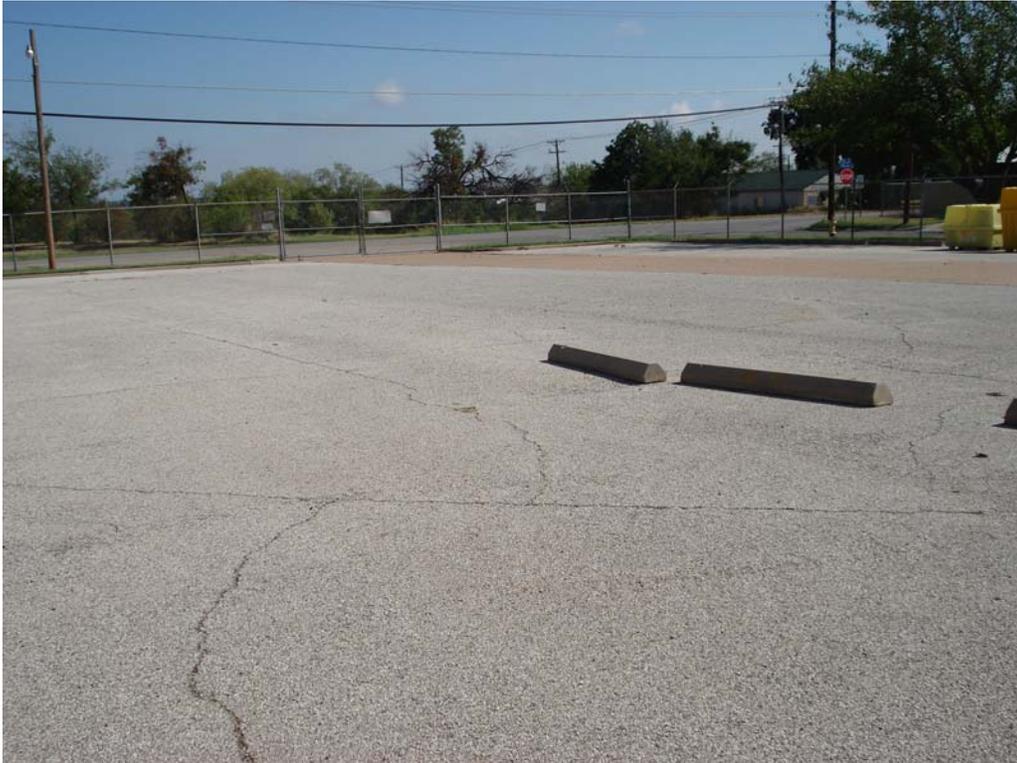
Photo 39: MEP area, north of the OMS building.

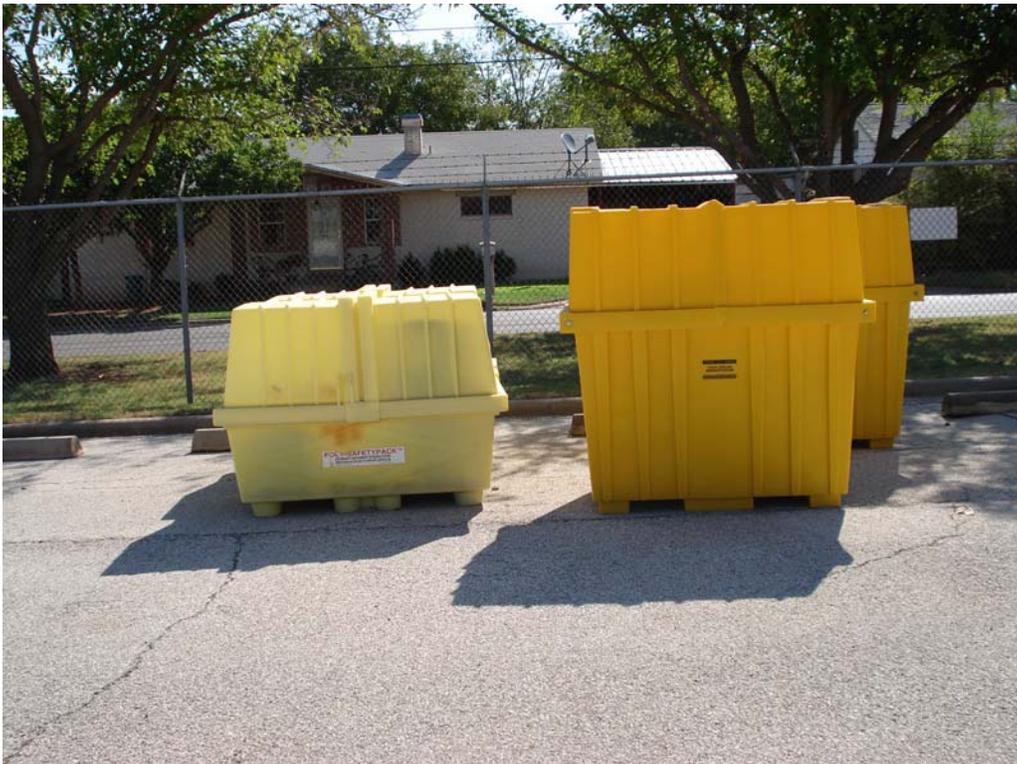
Photo 40: OMS secondary storage containers in MEP area.

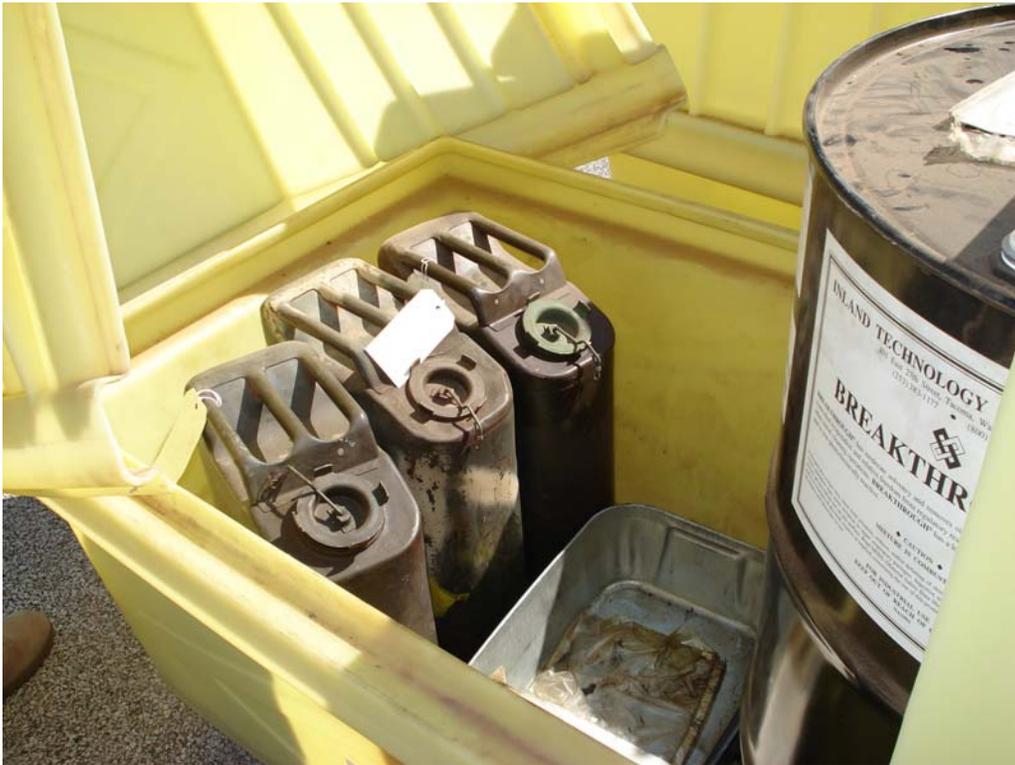
Photo 41: Fuel bowsers and parts washer fluid in secondary containment.

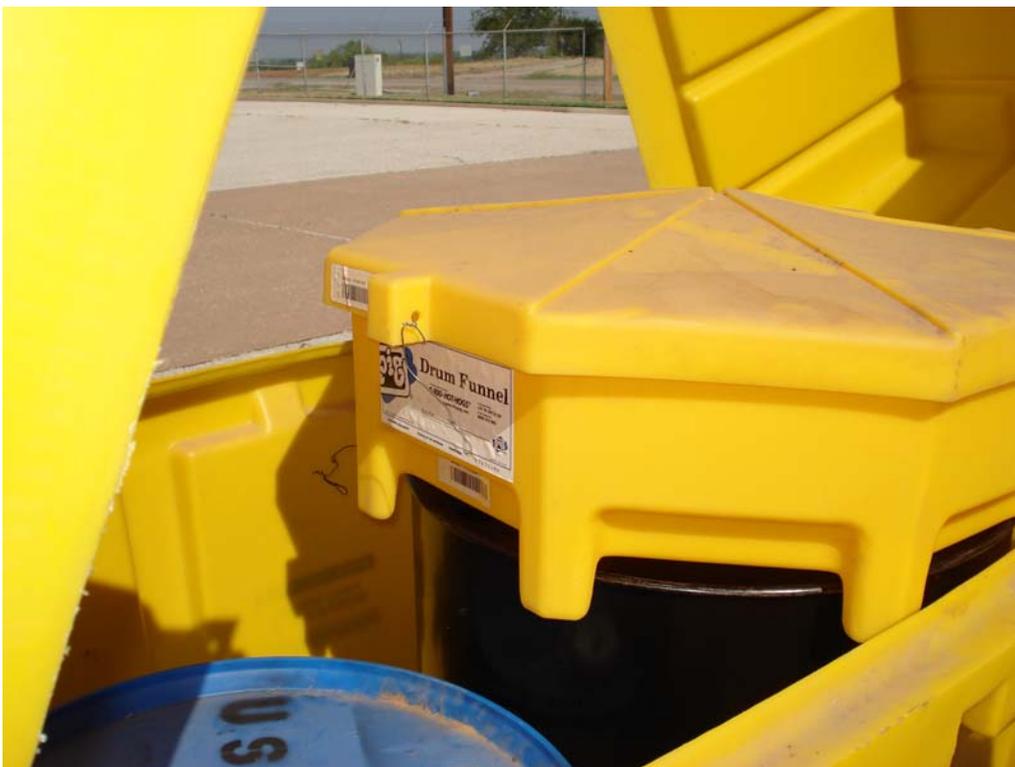
Photo 42: Used oil in drum in secondary containment.

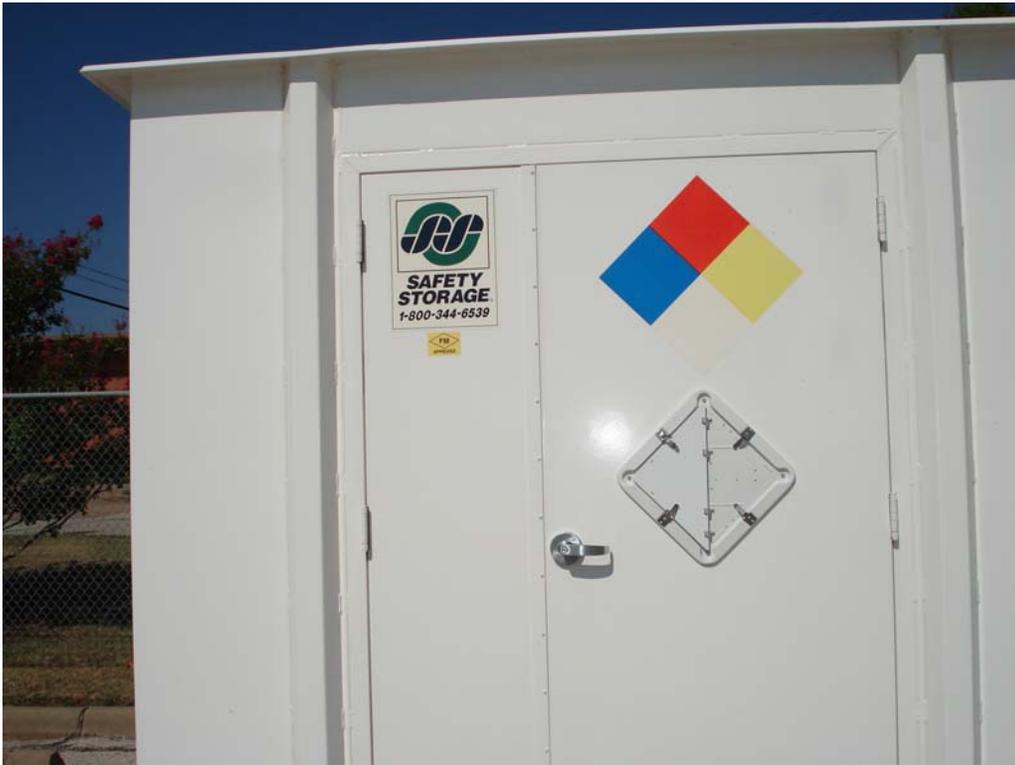
Photo 43: Flammable storage cabinet in MEP area.

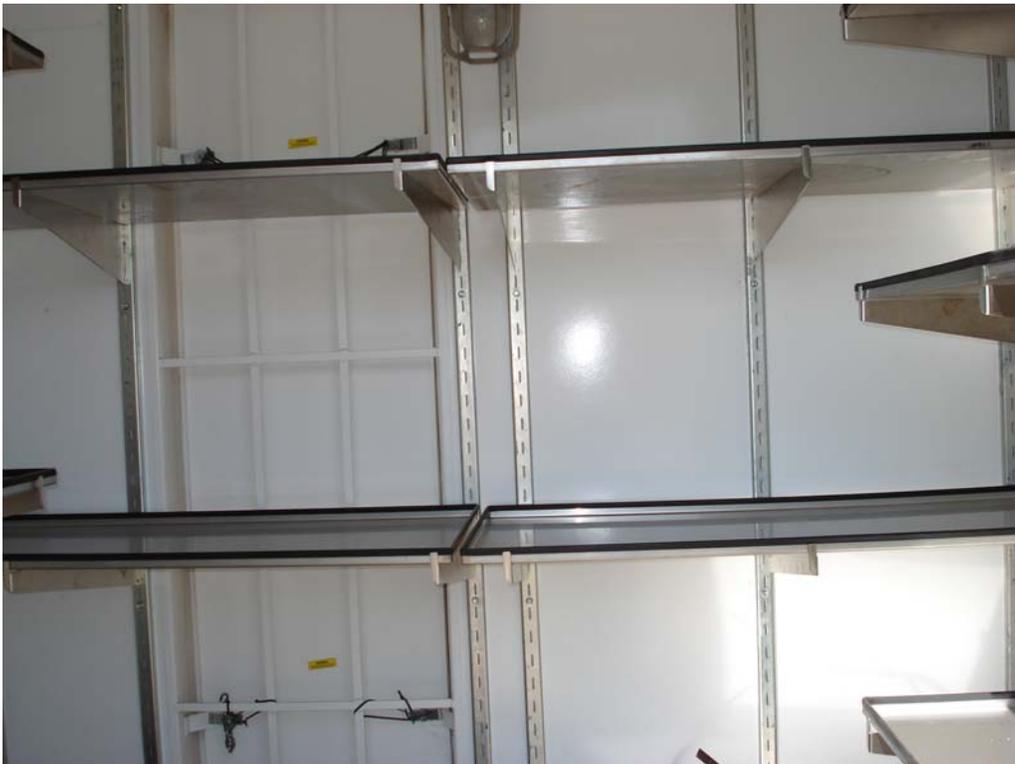
Photo 44: The interior of the flammable storage cabinet is empty and it was reportedly never used.

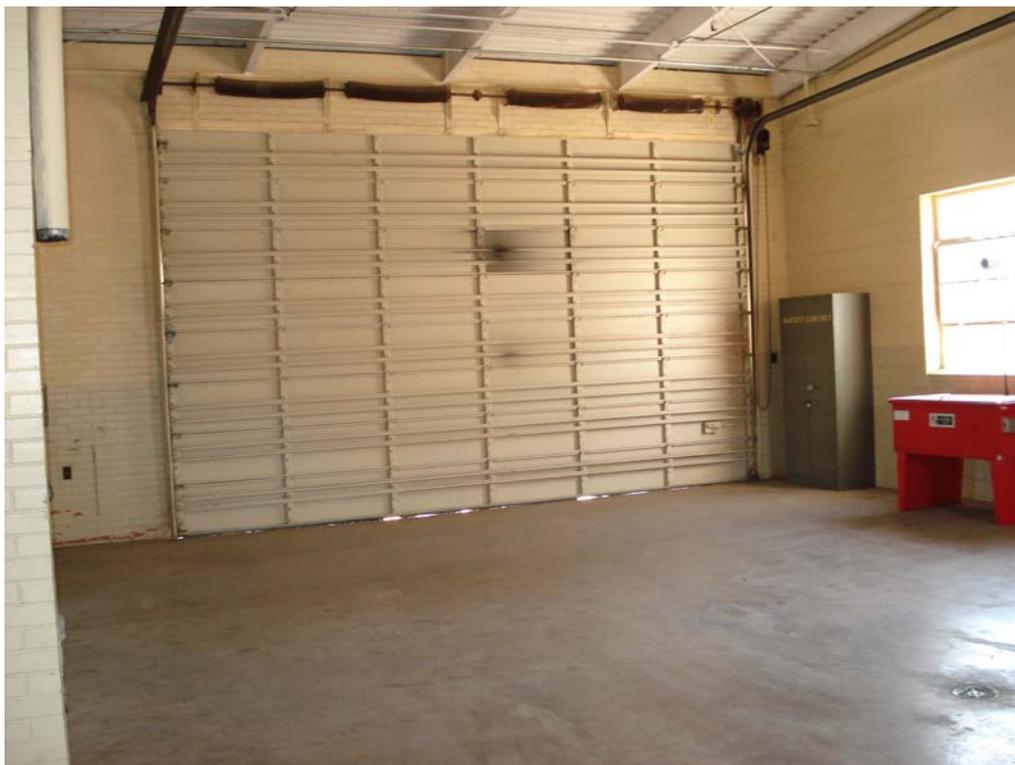
Photo 45: Bay inside the OMS building.

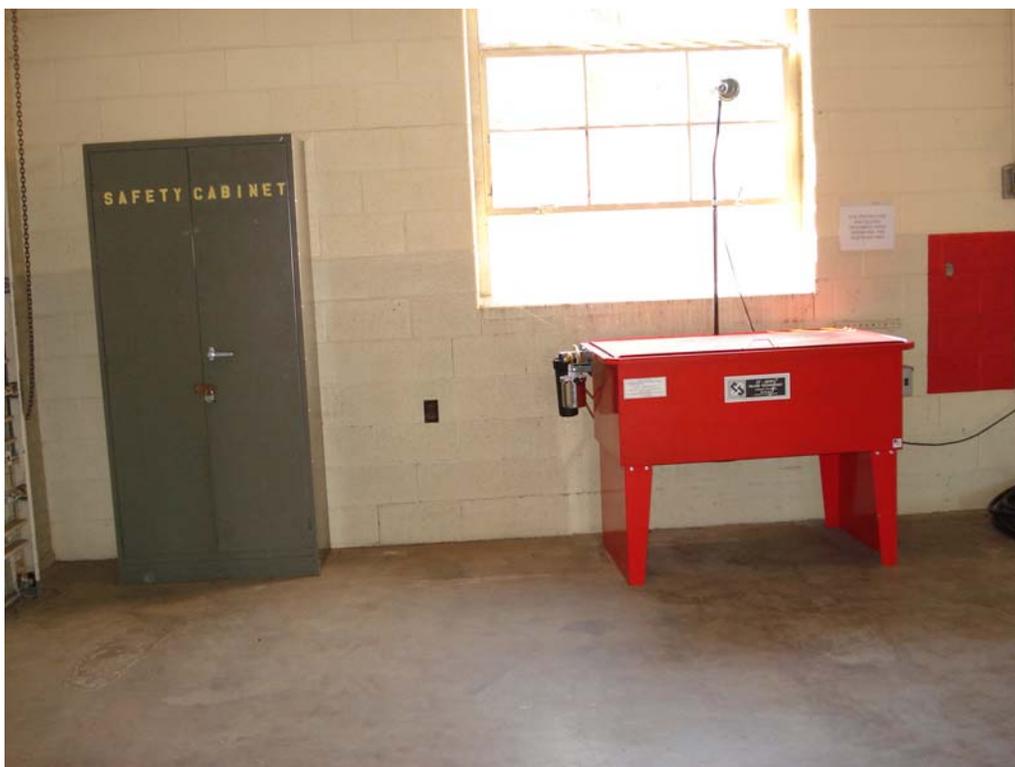
Photo 46: Parts washer inside the OMS building.

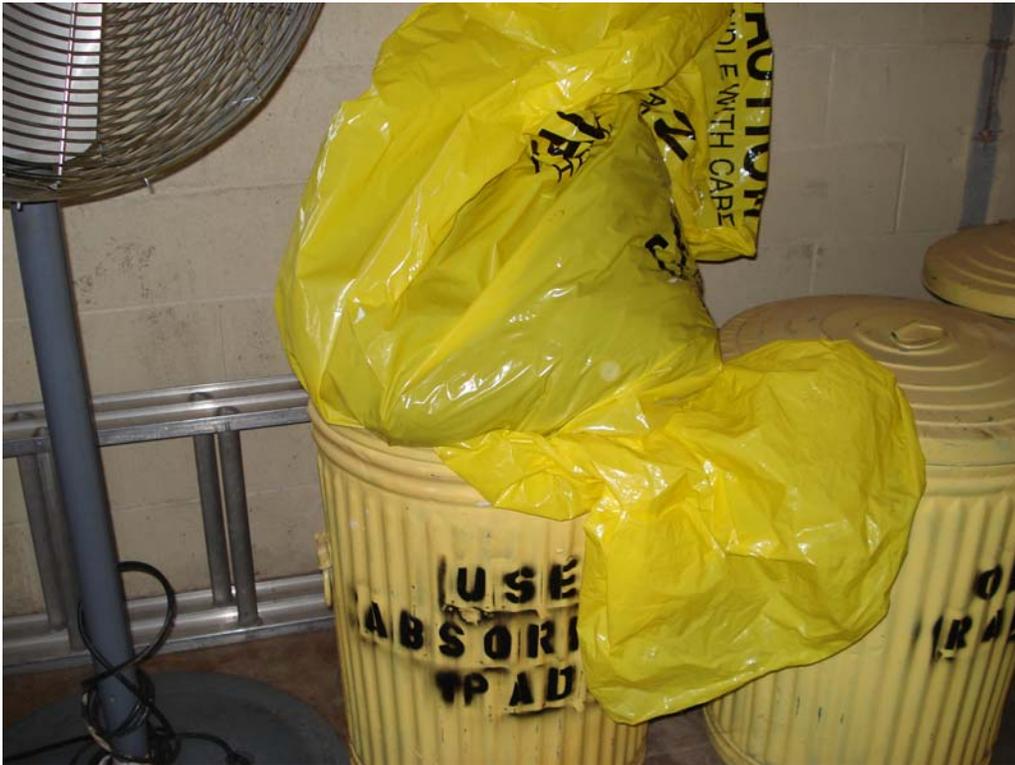
Photo 47: Spent absorbent from OMS cleanup.

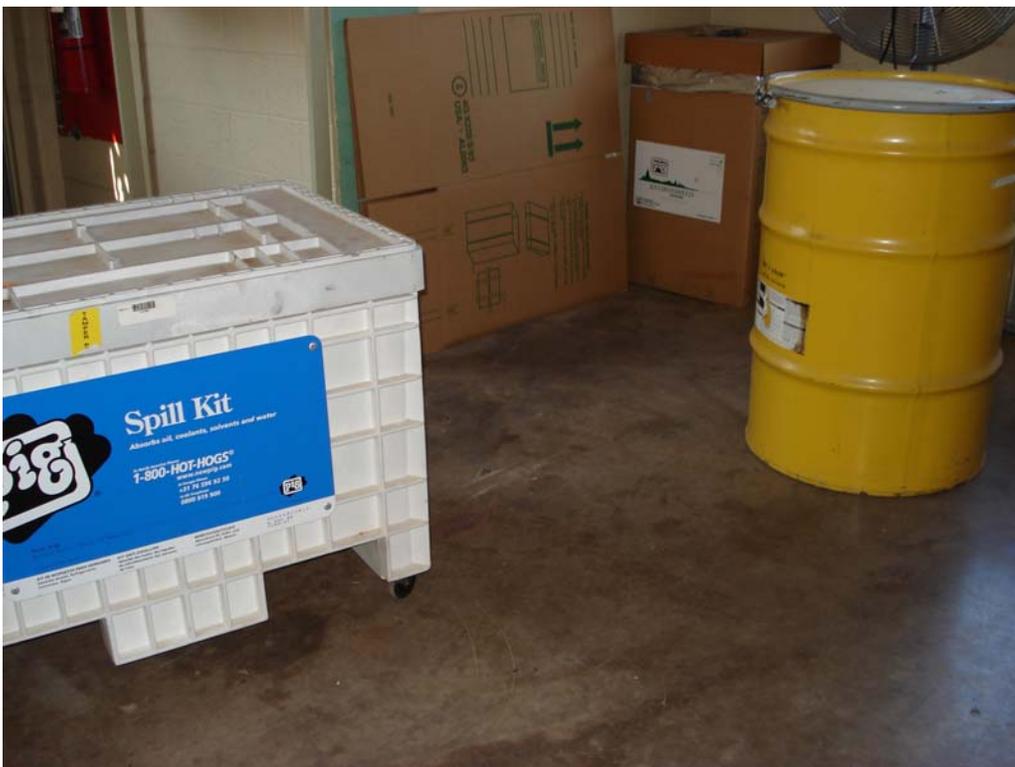
Photo 48: Spill kits inside OMS building.

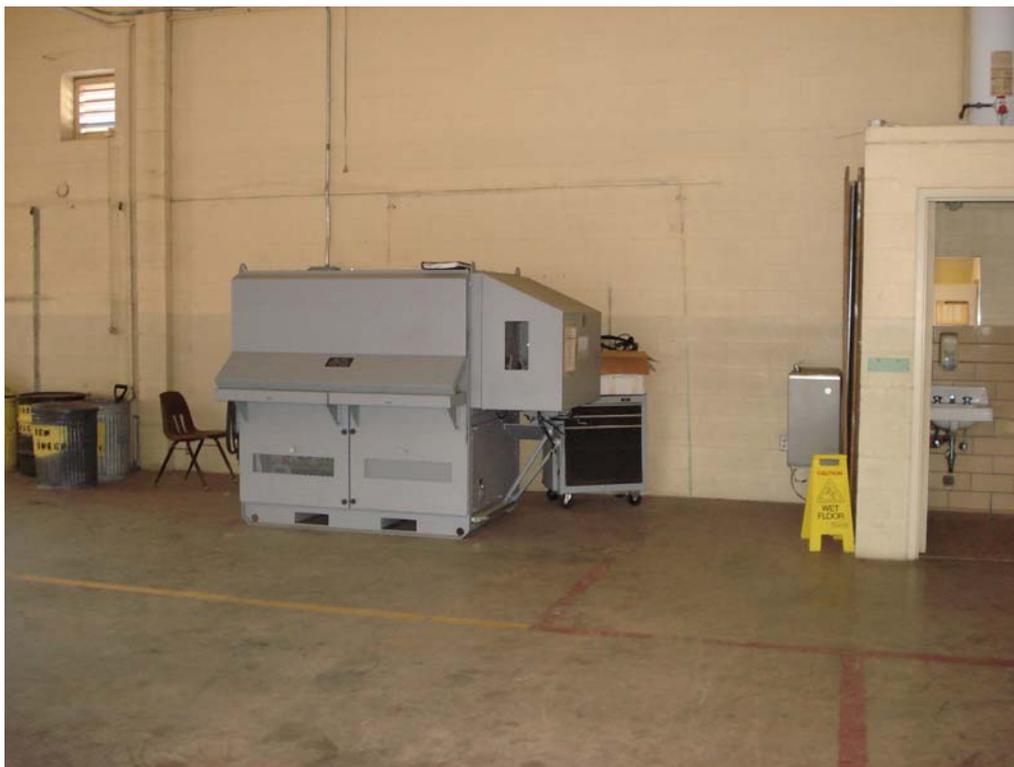
Photo 49: Test equipment inside the OMS building.

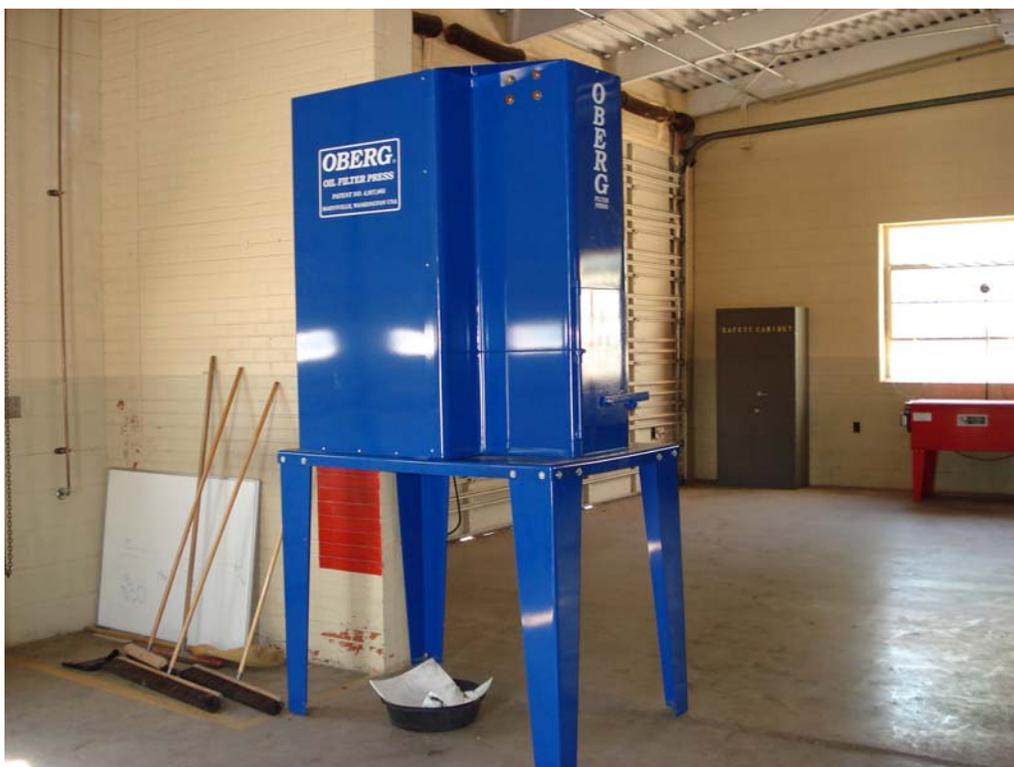
Photo 50: Oil crusher inside the OMS building.

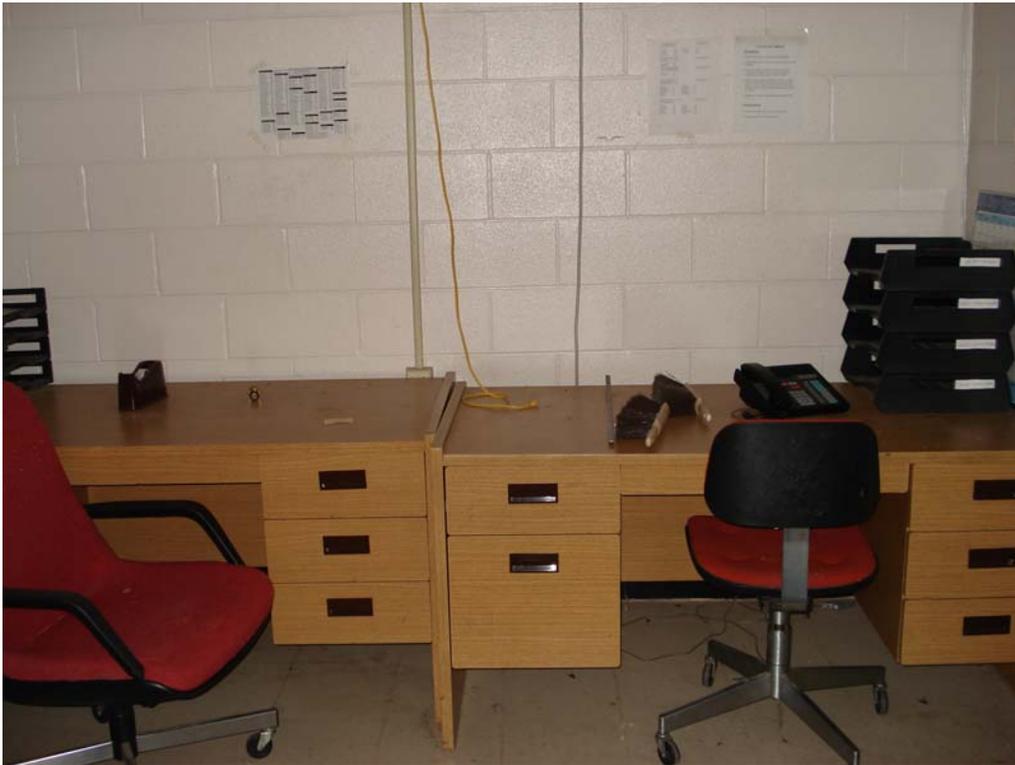
Photo 51: OMS building office.
