# **APPENDIX B**

## **SITE RECONNAISSANCE PHOTOGRAPHS**

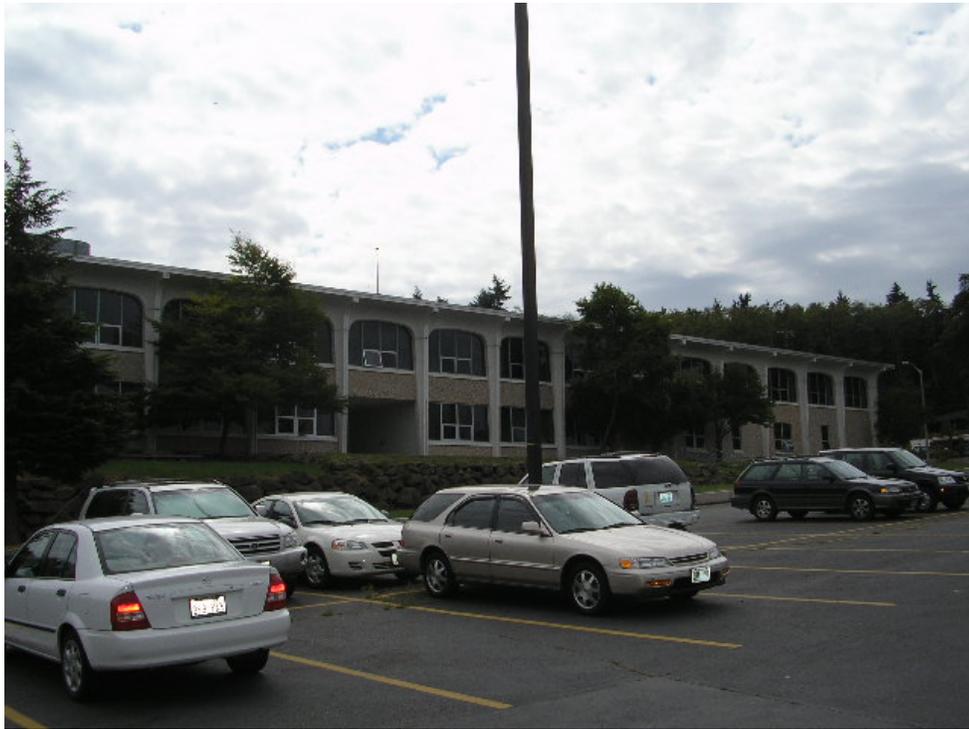
**Photograph 1. View of the main entrance to the Leisy Hall from the POV area, looking southwest**

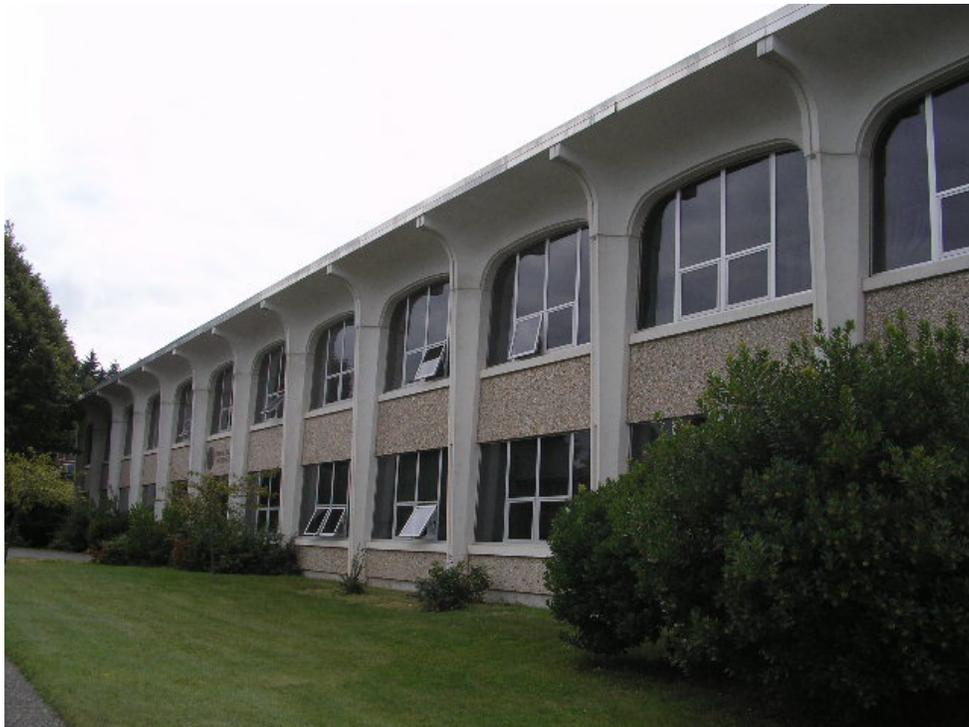
**Photograph 2. Eastern exterior of the Leisy Hall, looking southwest**

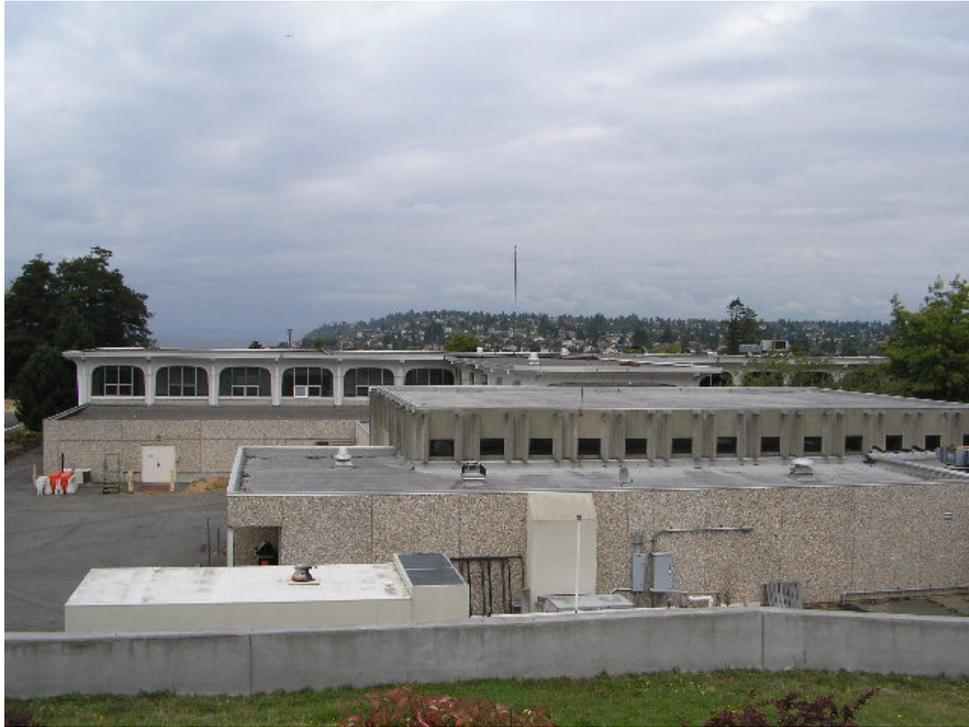
**Photograph 3. View of Leisy Hall from the south, looking north**

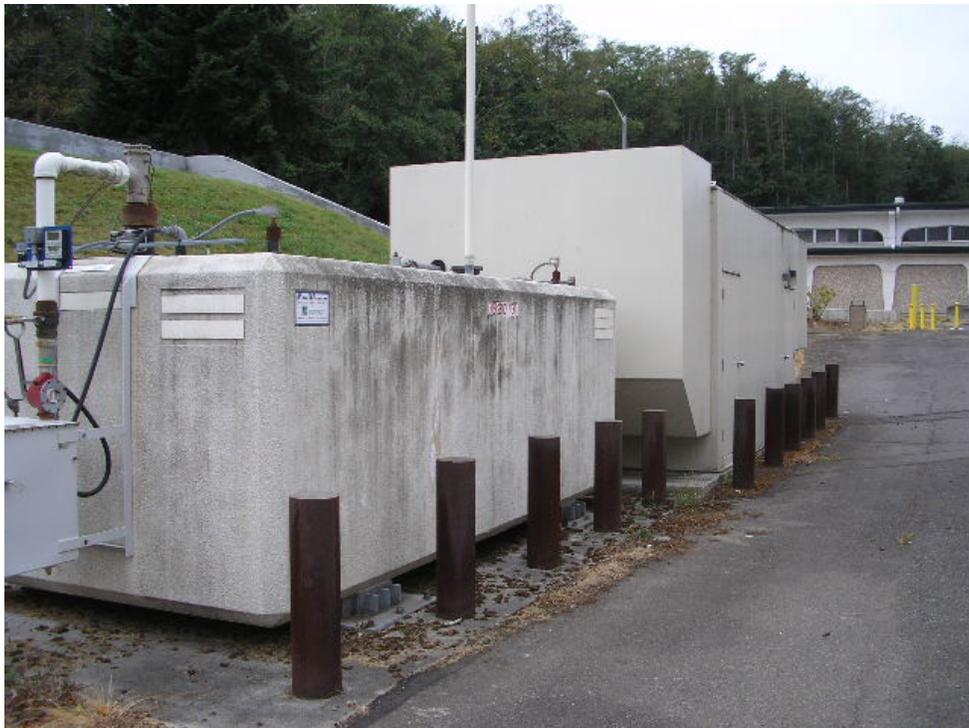
**Photograph 4. View of the 4,000 gallon capacity diesel fuel AST (pictured left) and associated diesel generator (pictured right) situated south of Leisy Hall**

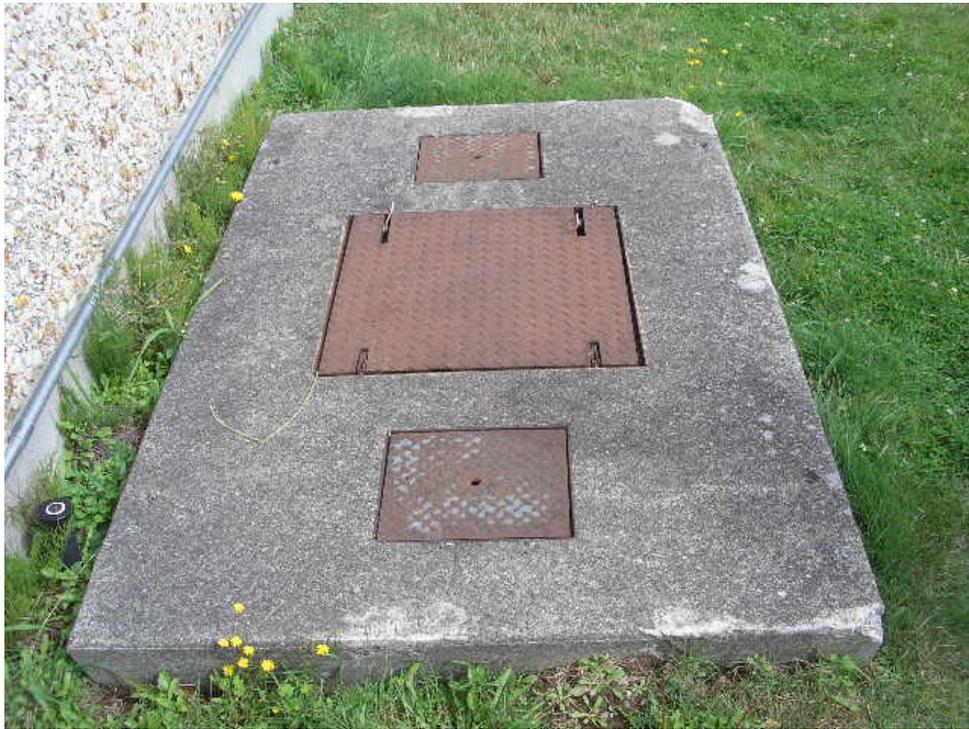
**Photograph 5. Grease trap access located south of the Leisy Hall**

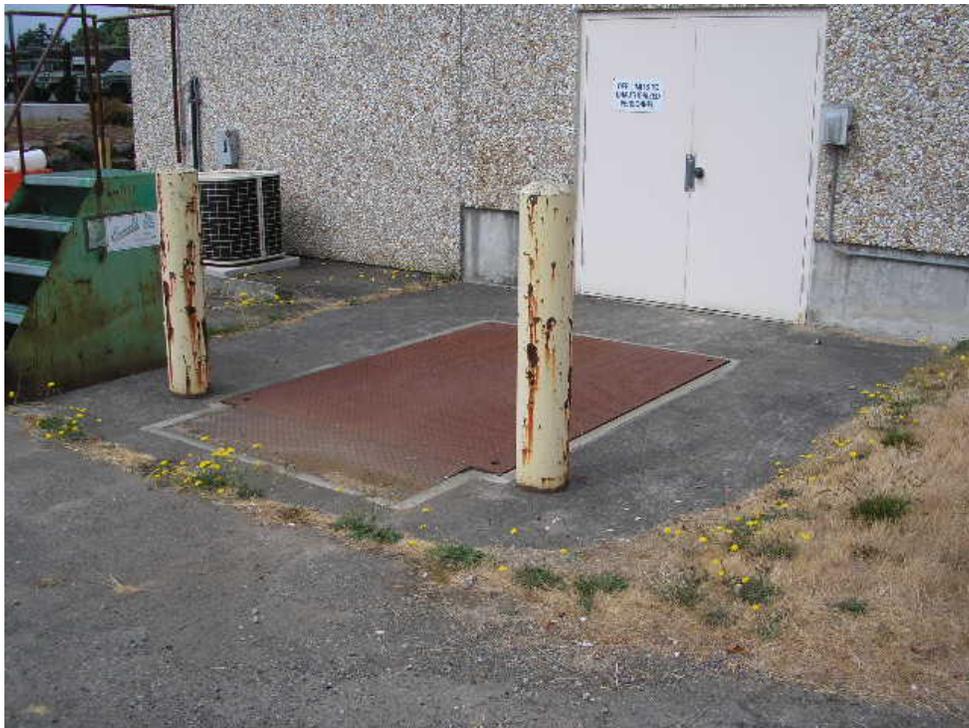
**Photograph 6. View of freight elevator access**

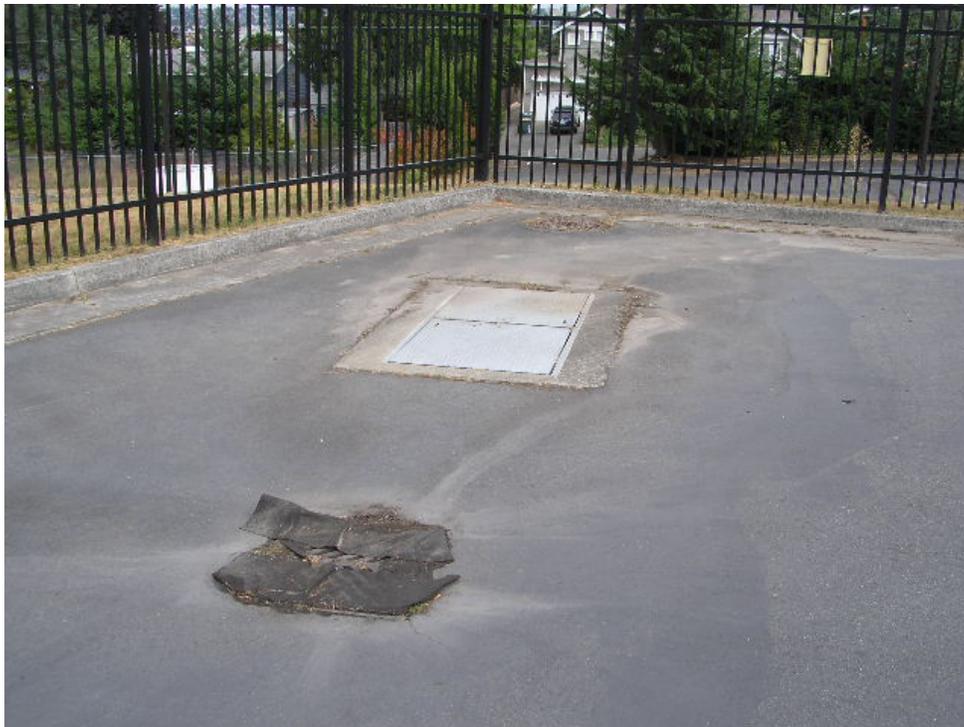
**Photograph 7. Oil/water separator situated in the POV area northeast of Leisy Hall**

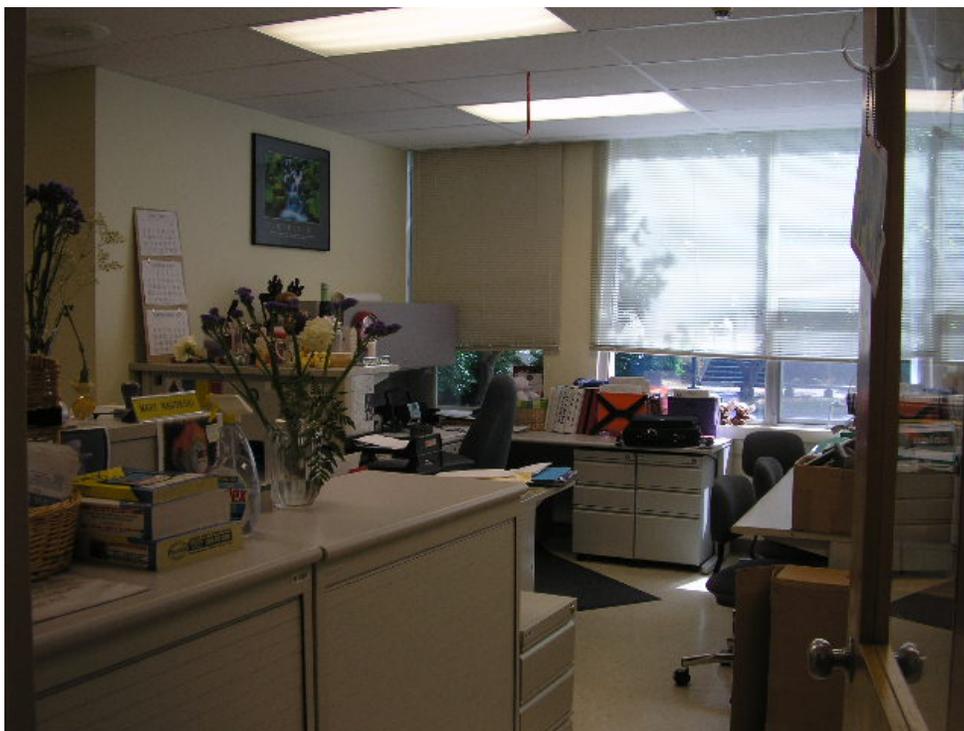
**Photograph 8. Typical office area in Leisy Hall**

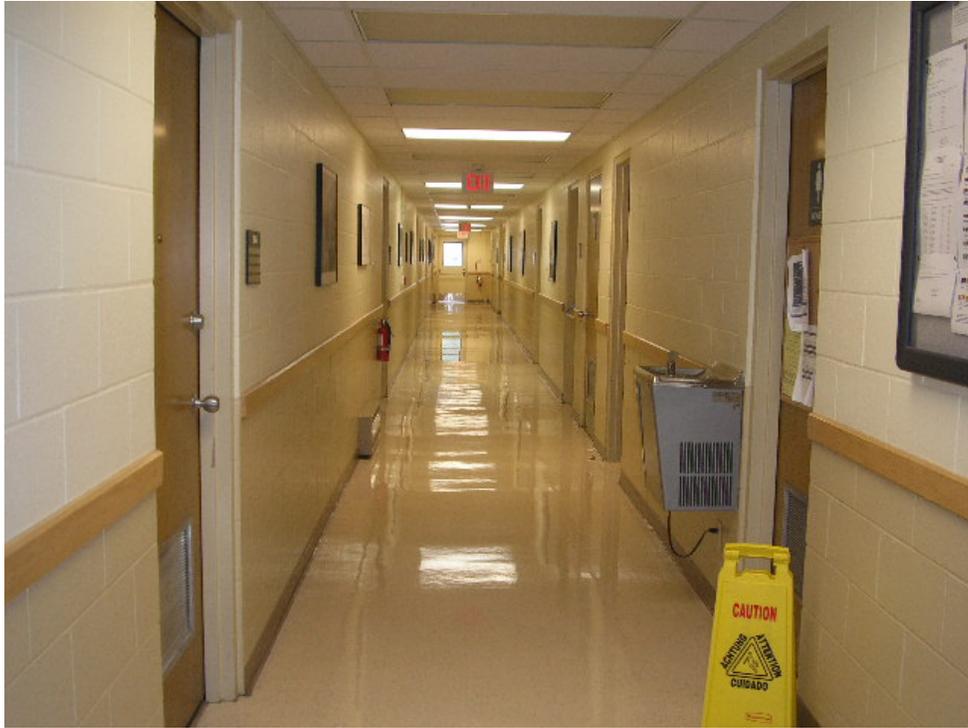
**Photograph 9. Typical hallway in Leisy Hall**

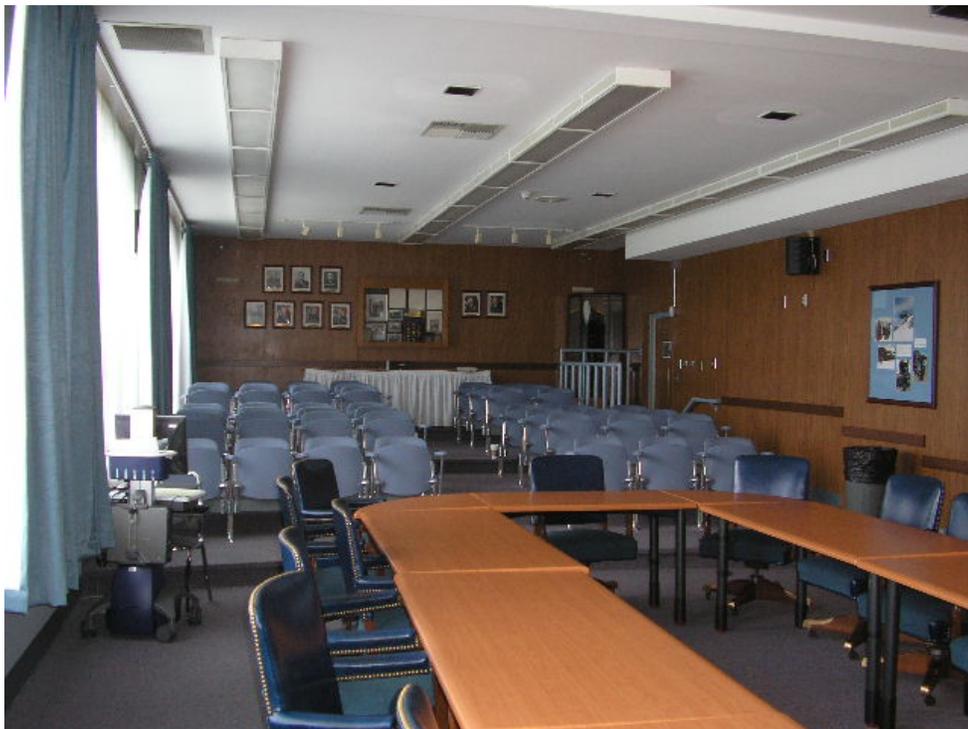
**Photograph 10. Training room interior**

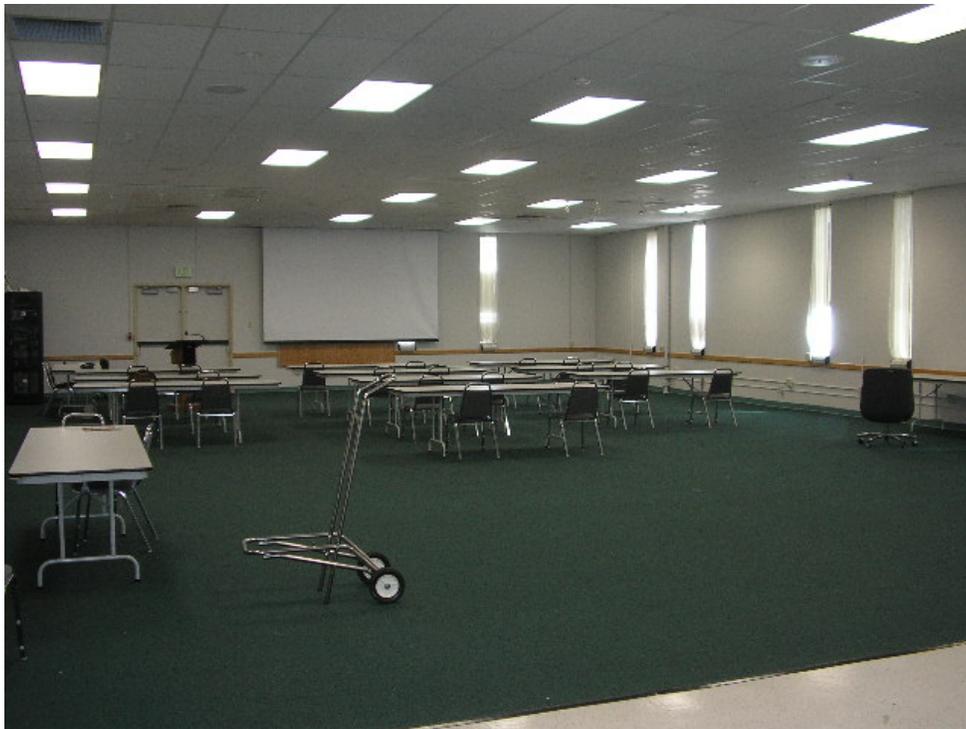
**Photograph 11. Drill hall interior**

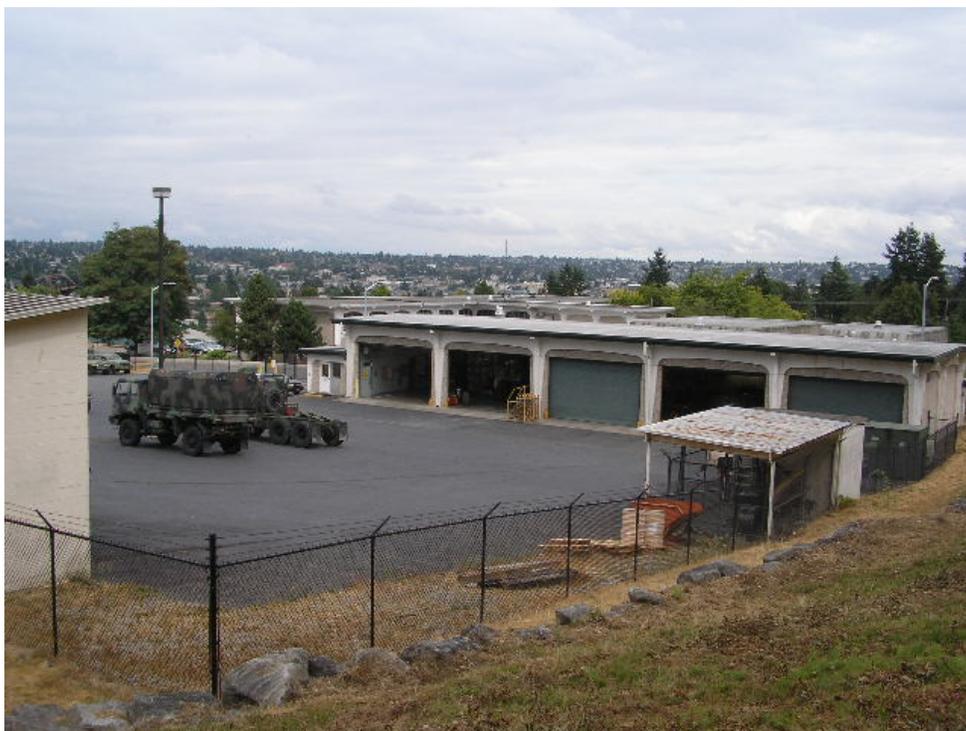
**Photograph 12. View of the AMSA 79 Building**

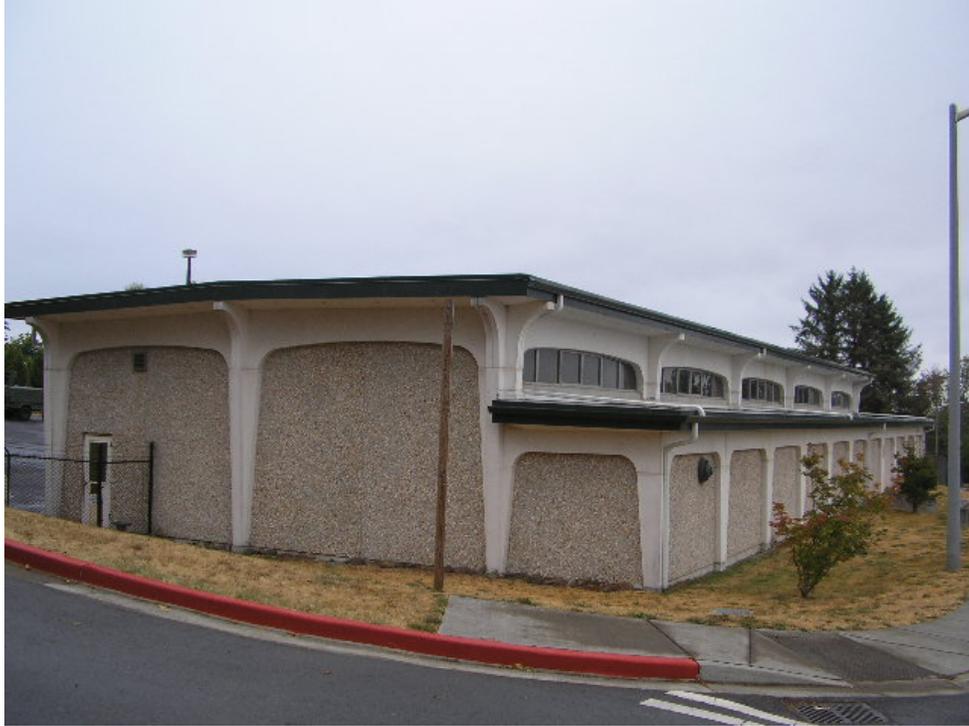
**Photograph 13. South and eastern exterior of the AMSA 79 Building**

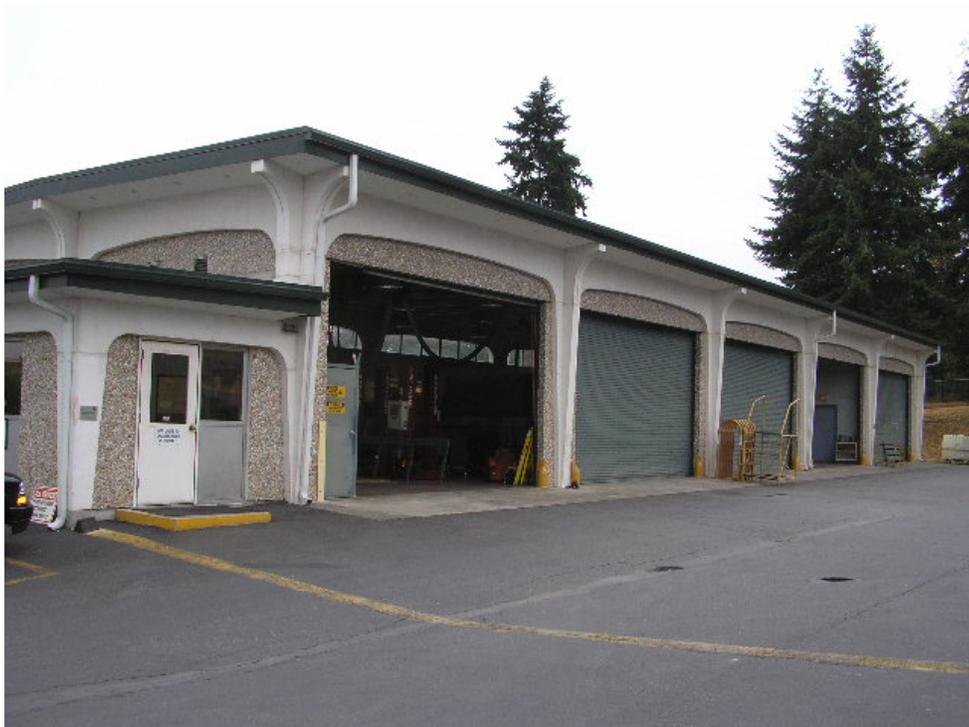
**Photograph 14. Western exterior of the AMSA 79 Building**

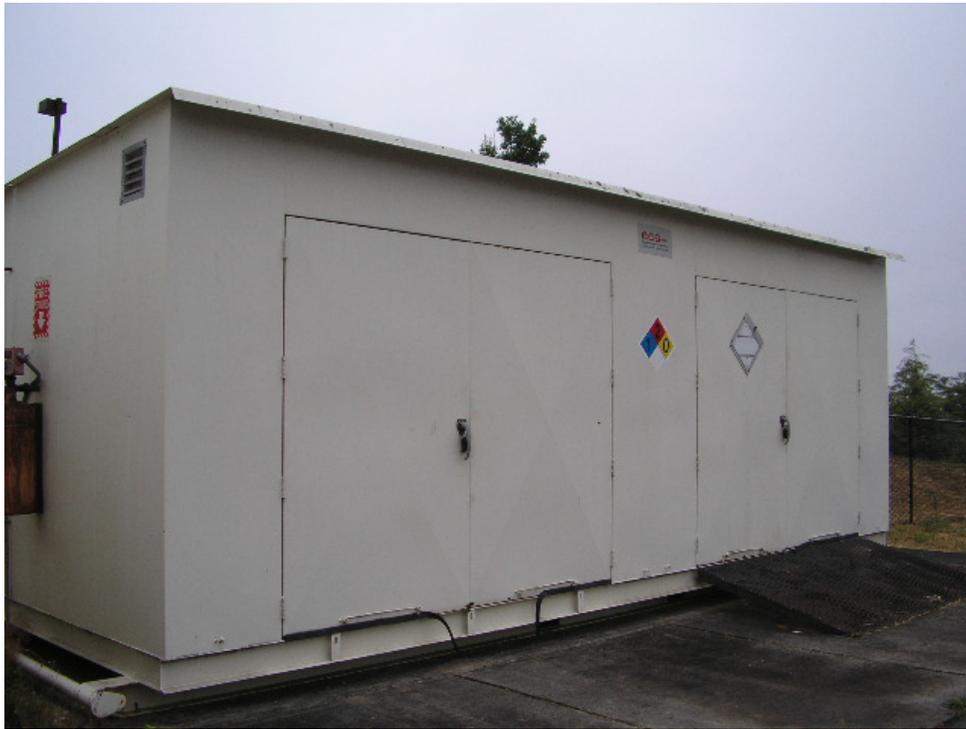
**Photograph 15. Hazmat storage shed situated on the western portion of the AMSA 79 Site**

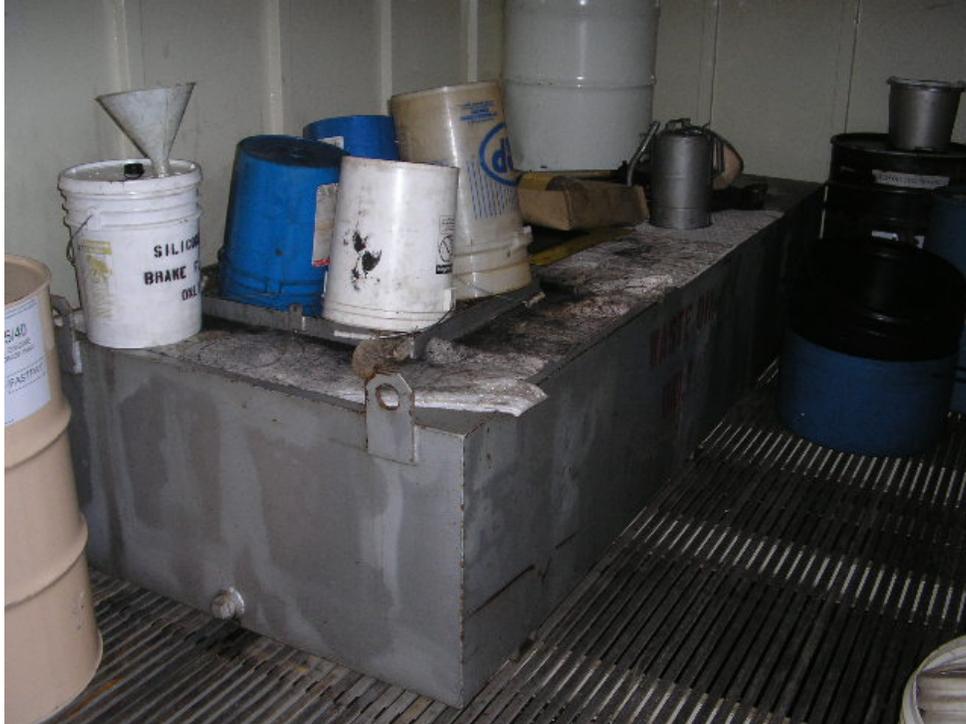
**Photograph 16. Used oil 500-gallon capacity AST located inside of the hazmat storage shed**

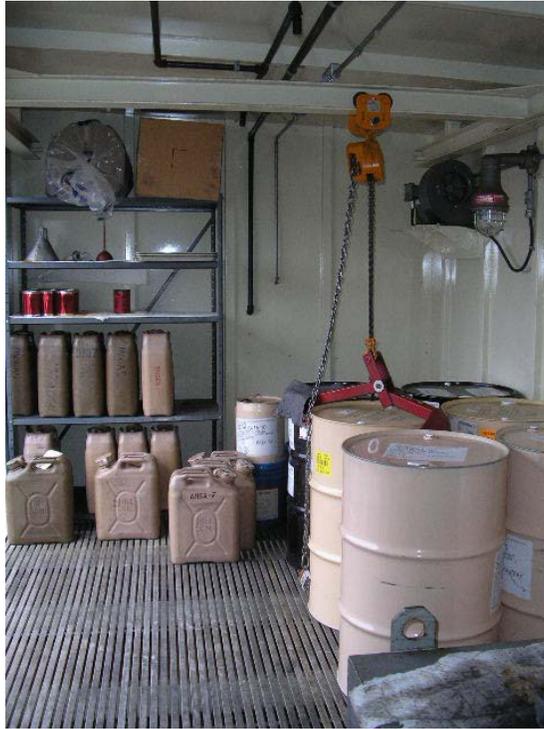
**Photograph 17. POL storage in the hazmat storage shed**

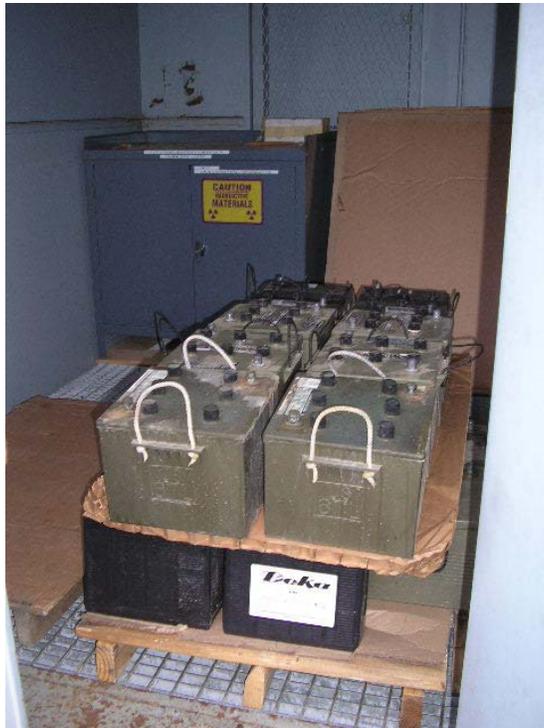
**Photograph 18. Interior view of the hazmat storage shed utilized for corrosives and a radioactive storage cabinet**

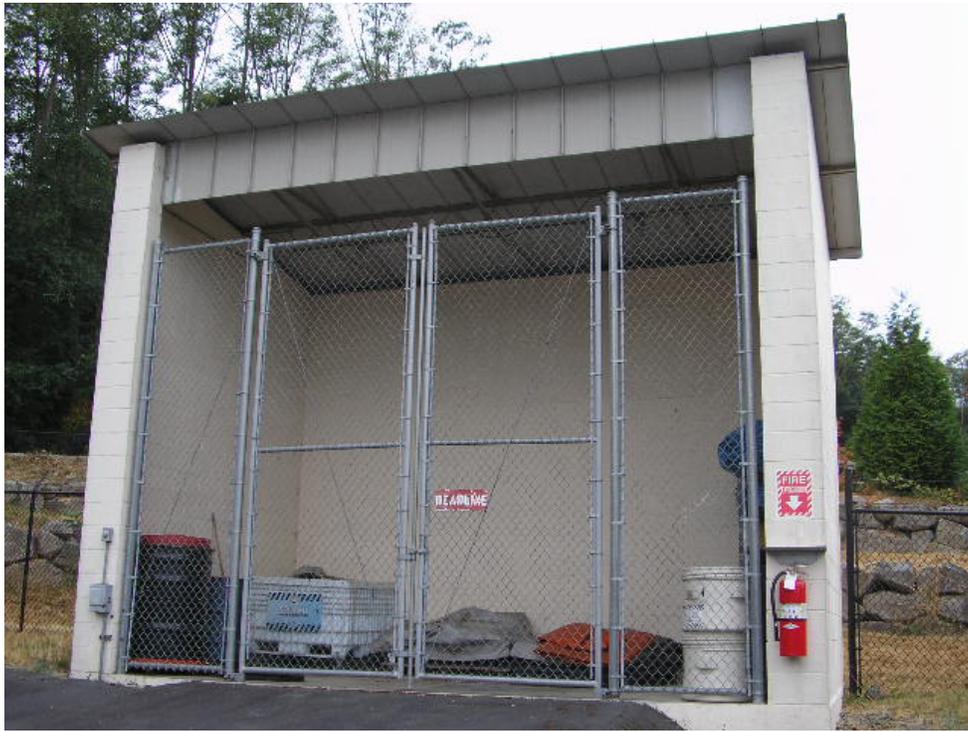
**Photograph 19. Hazardous material storage structure situated on the southeast portion of the AMSA 79 Site**

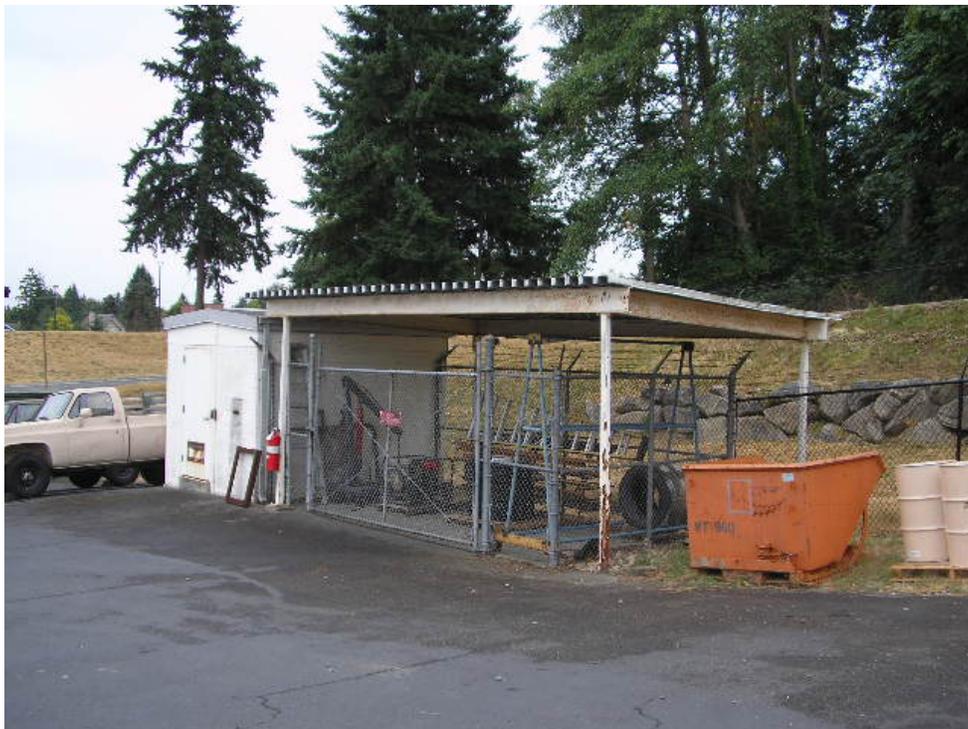
**Photograph 20. View of the former hazardous materials storage building (pictured left), overhang, and former UST location (right of overhang area)**

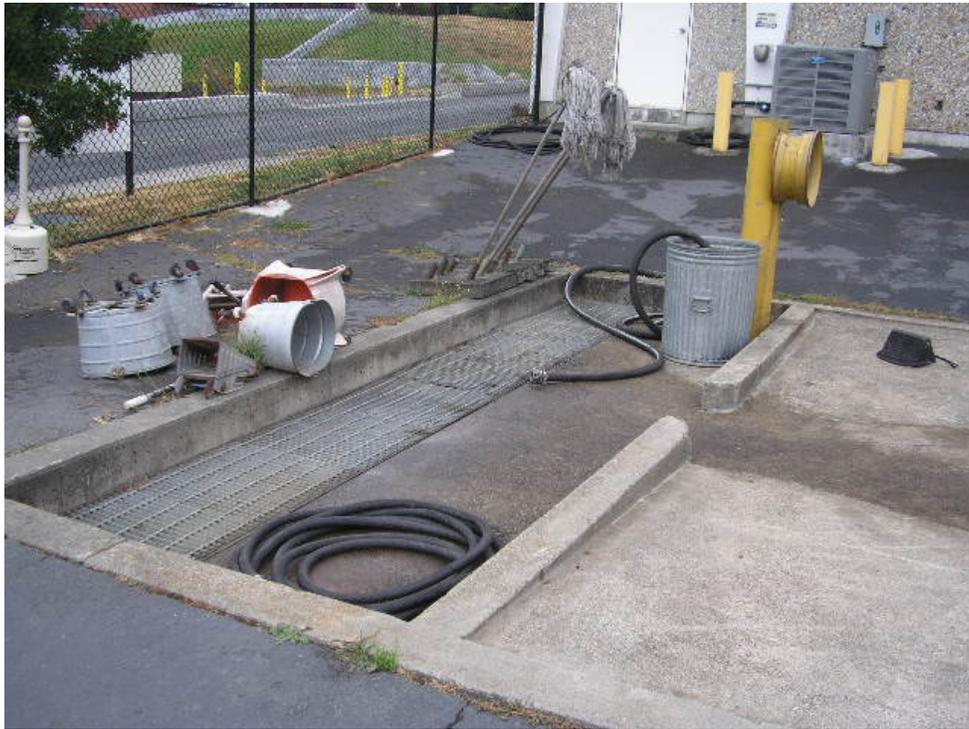
**Photograph 21. Vehicle wash rack area north of AMSA 79**

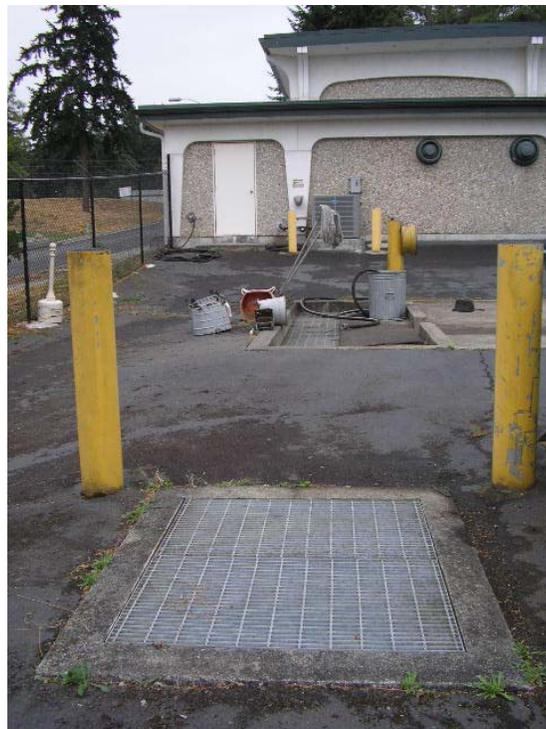
**Photograph 22. Oil/water separator situated downgradient of the AMSA 79 wash rack area**

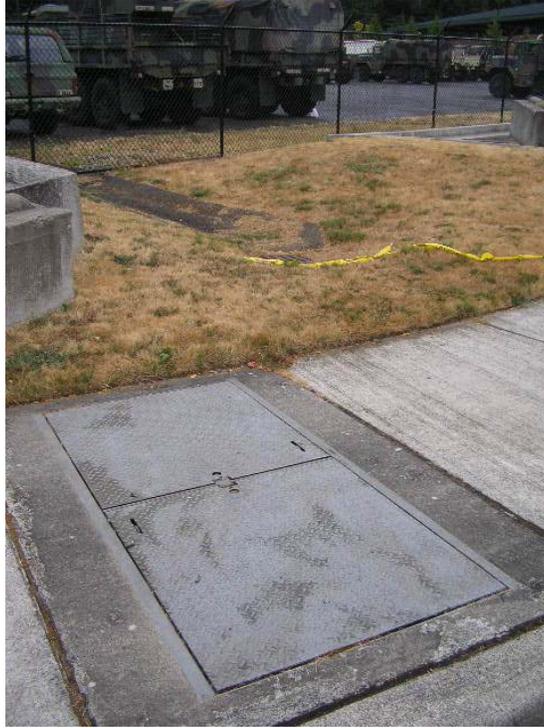
**Photograph 23. Oil/water separator situated north and outside of the AMSA 79 fence area**

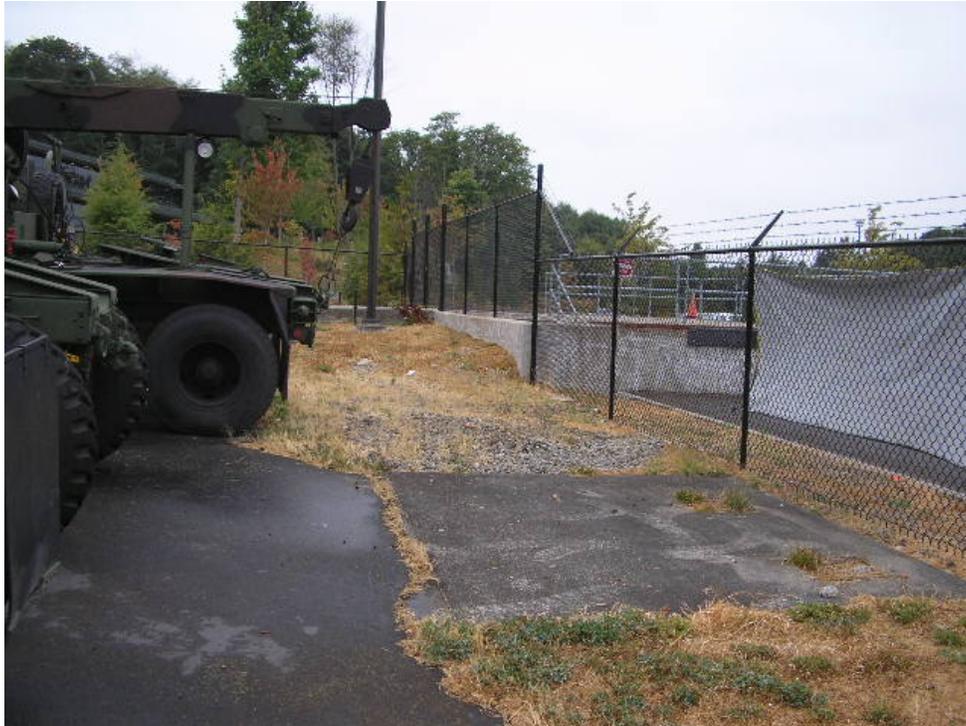
**Photograph 24. View of concrete pad associated with a former fuel island and UST area situated on the northwest portion of the AMSA 79 Site**

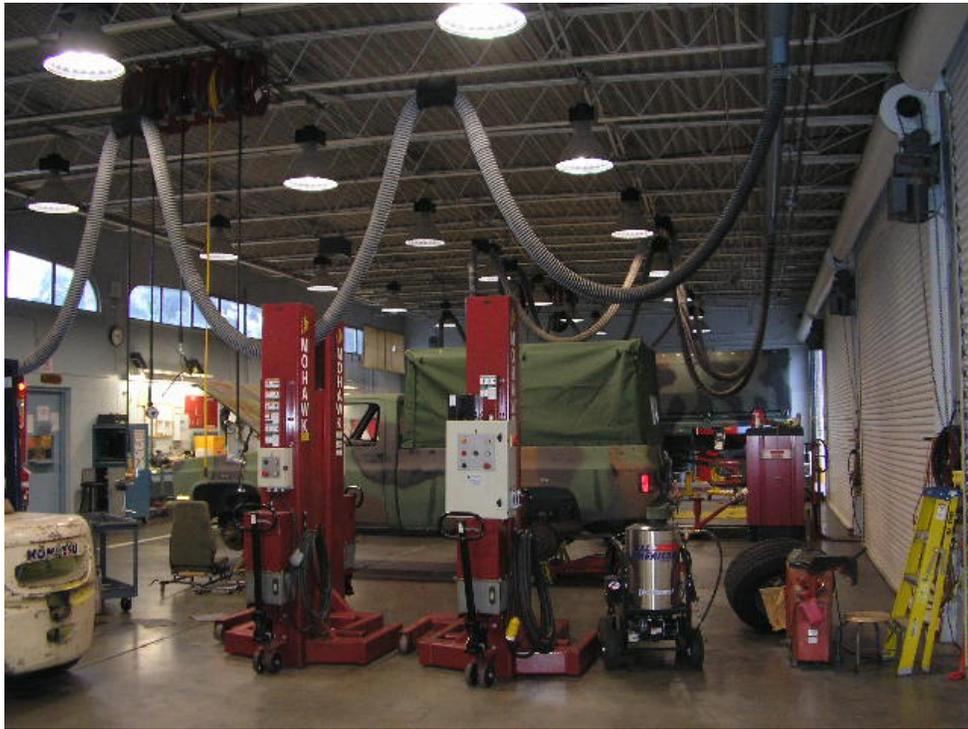
**Photograph 25. View of the interior vehicle maintenance bay areas inside of the AMSA 79**

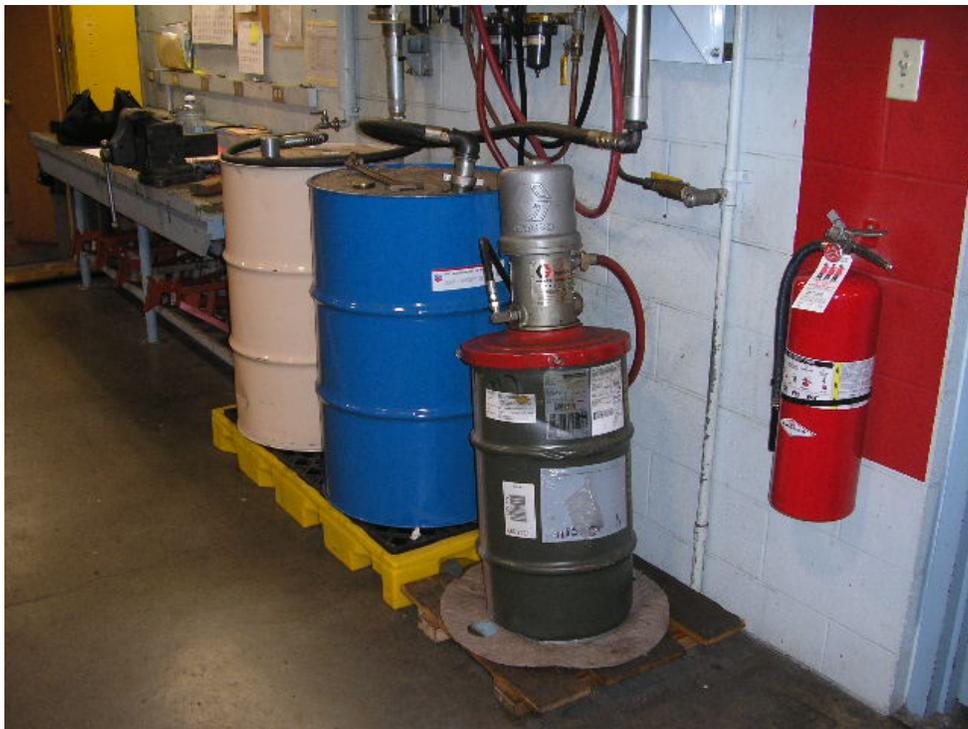
**Photograph 26. Oil and grease storage in the AMSA 79**

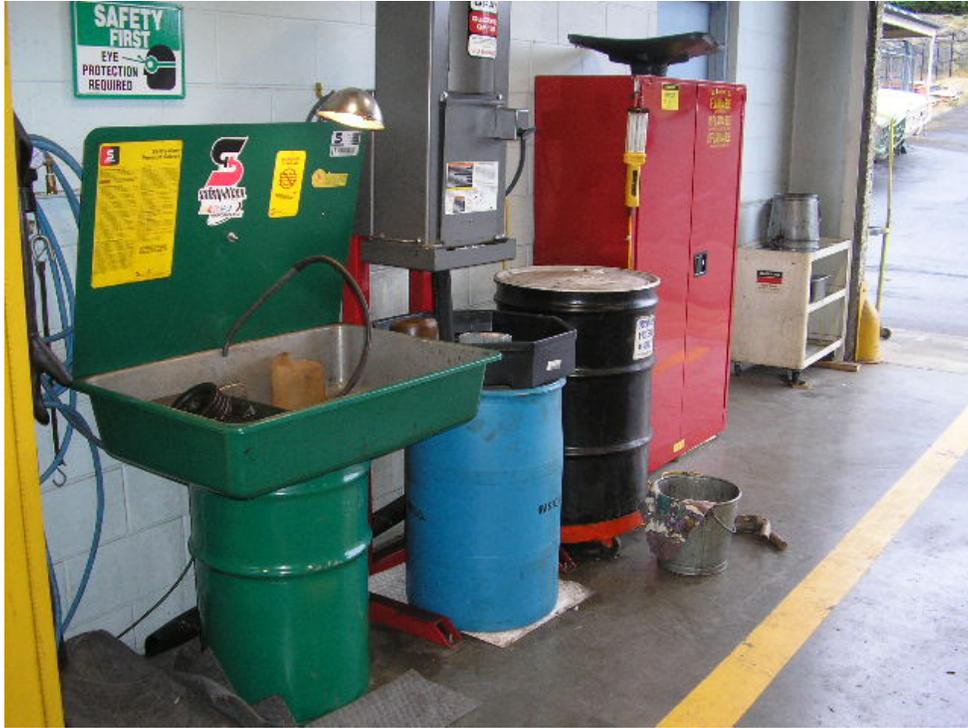
**Photograph 27. Solvent sink, filter crusher, 55-gallon drum containing crushed oil filters and a flammable storage cabinet**

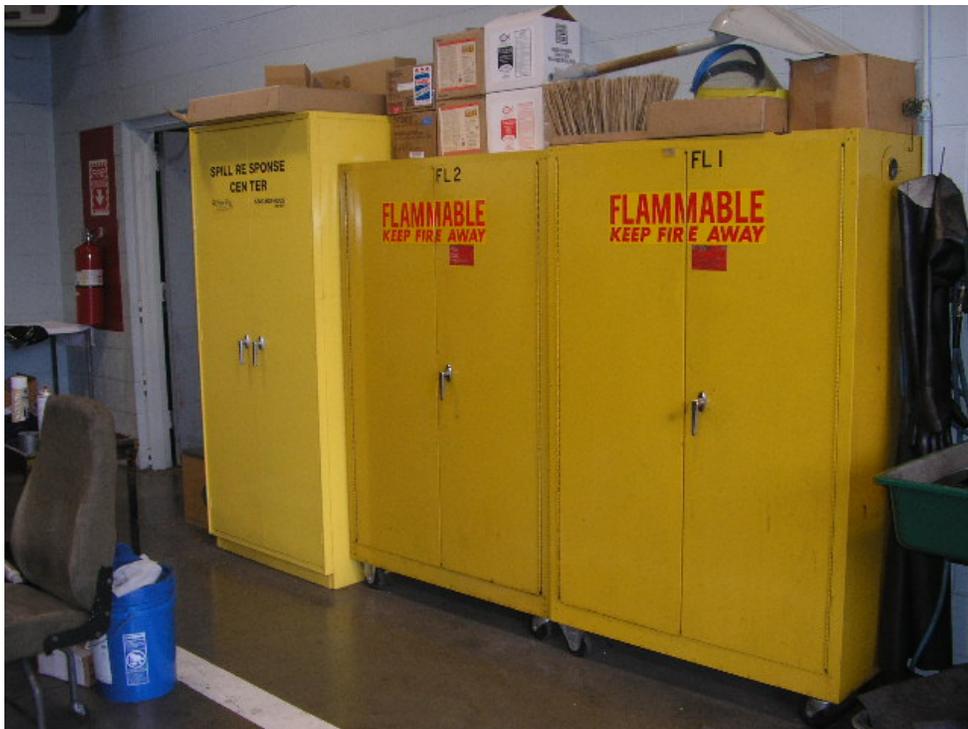
**Photograph 28. View of flammable storage cabinets**

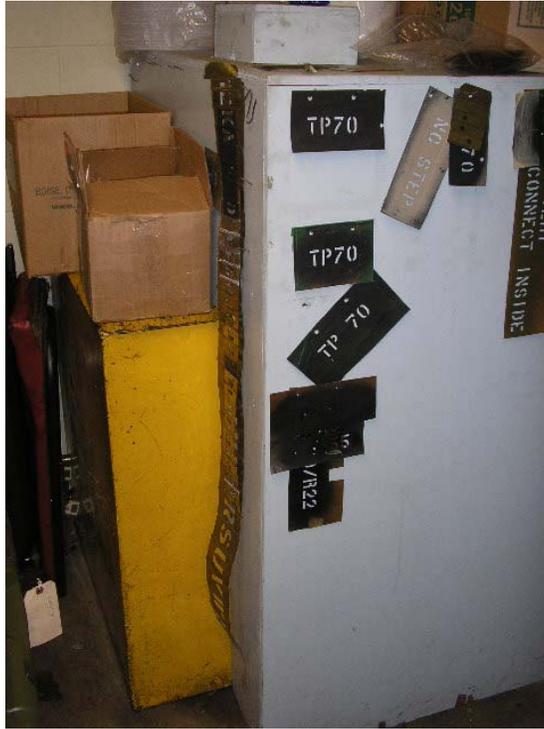
**Photograph 29. View of approximately 200-gallon capacity hydraulic oil AST utilized for the vehicle lift**

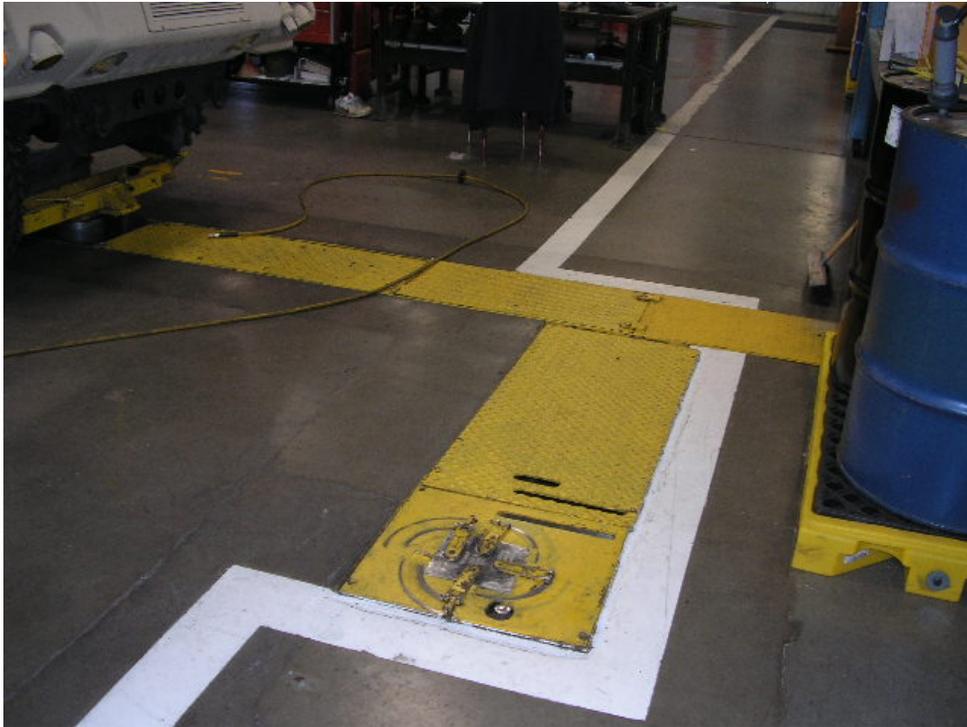
**Photograph 30. View of the vehicle lift**

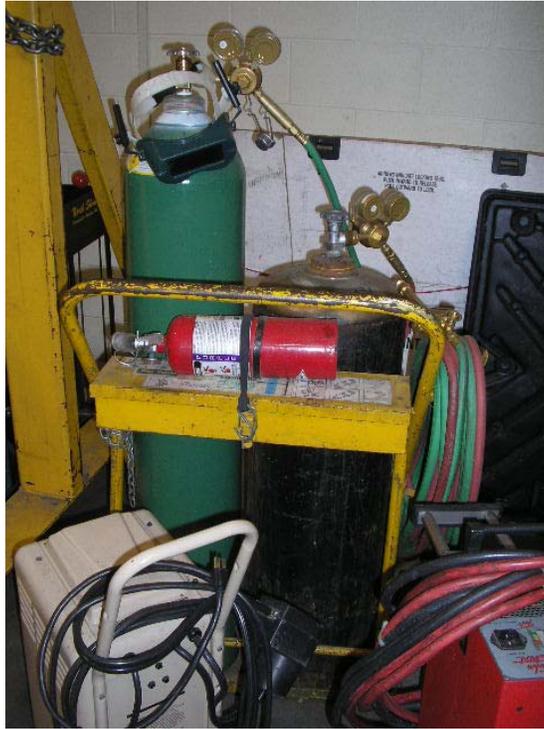
**Photograph 31. Acetylene and oxygen canister storage in the AMSA 79 Building**

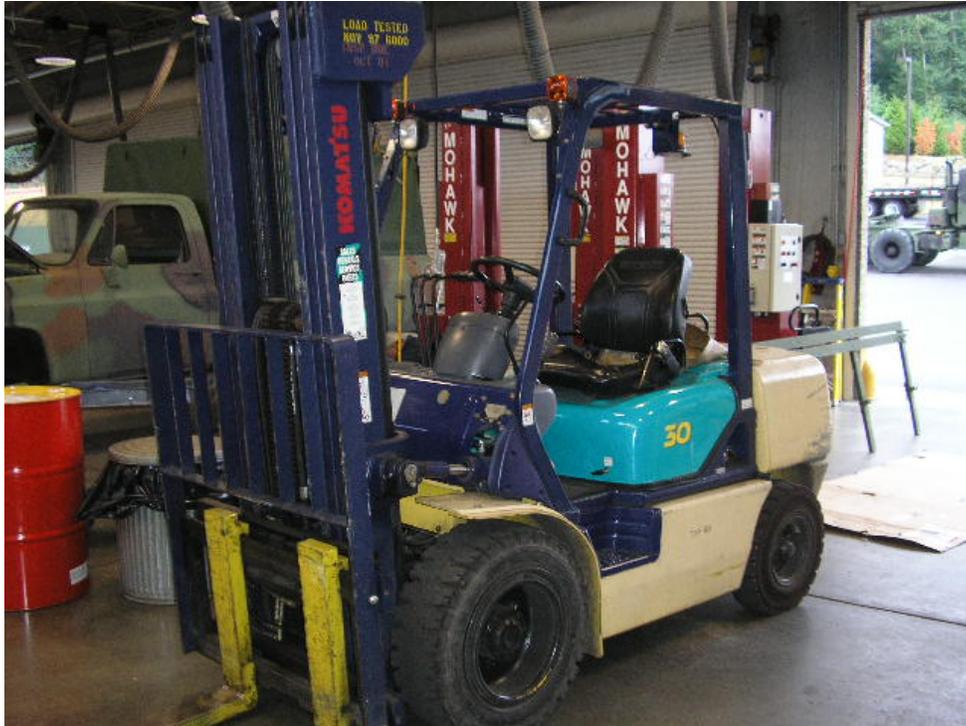
**Photograph 32. Diesel powered forklift**

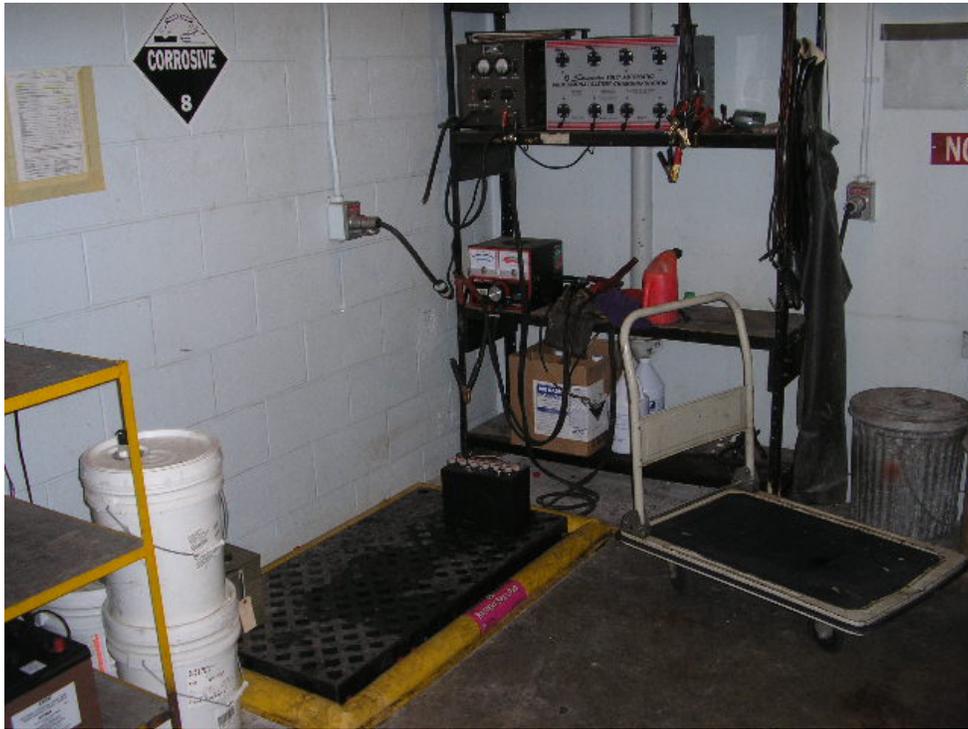
**Photograph 33. Battery charging room**

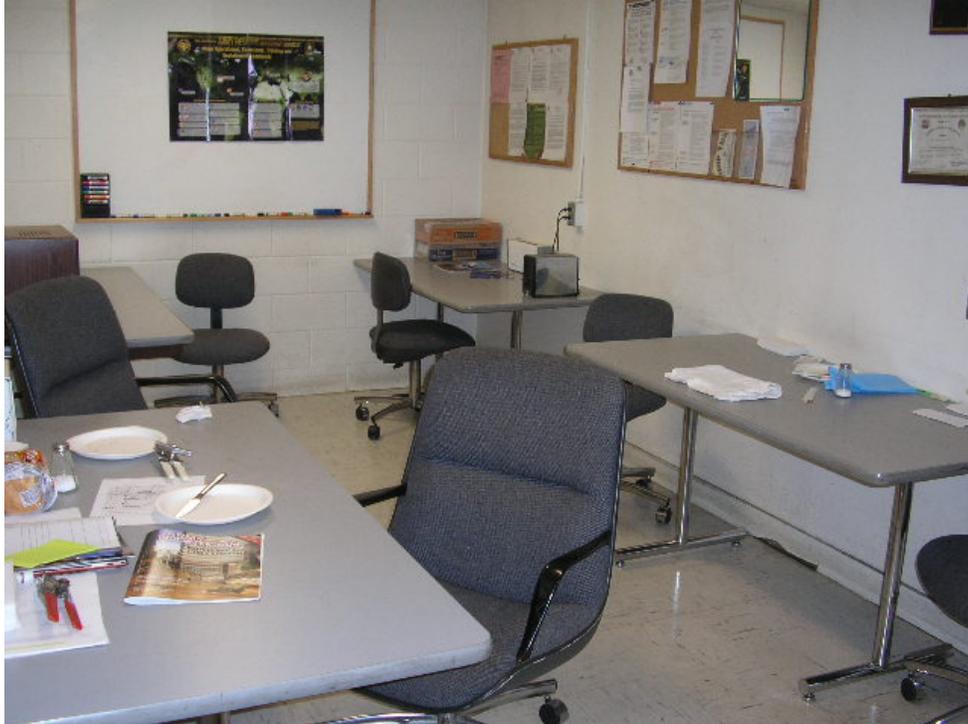
**Photograph 34. View of the break room in the AMSA 79 Building**
