# **APPENDIX B**

## **SITE RECONNAISSANCE PHOTOGRAPHS**

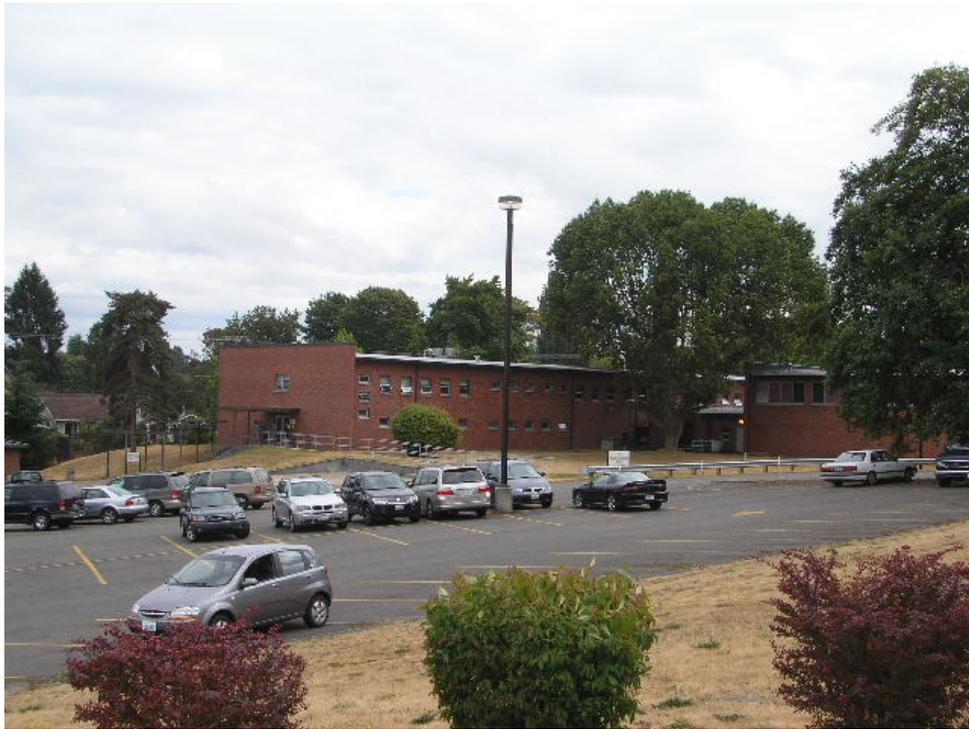
**Photograph 35. View of Harvey Hall, an adjoining USARC installation situated south of Leisy Hall and southwest of the AMSA 79**

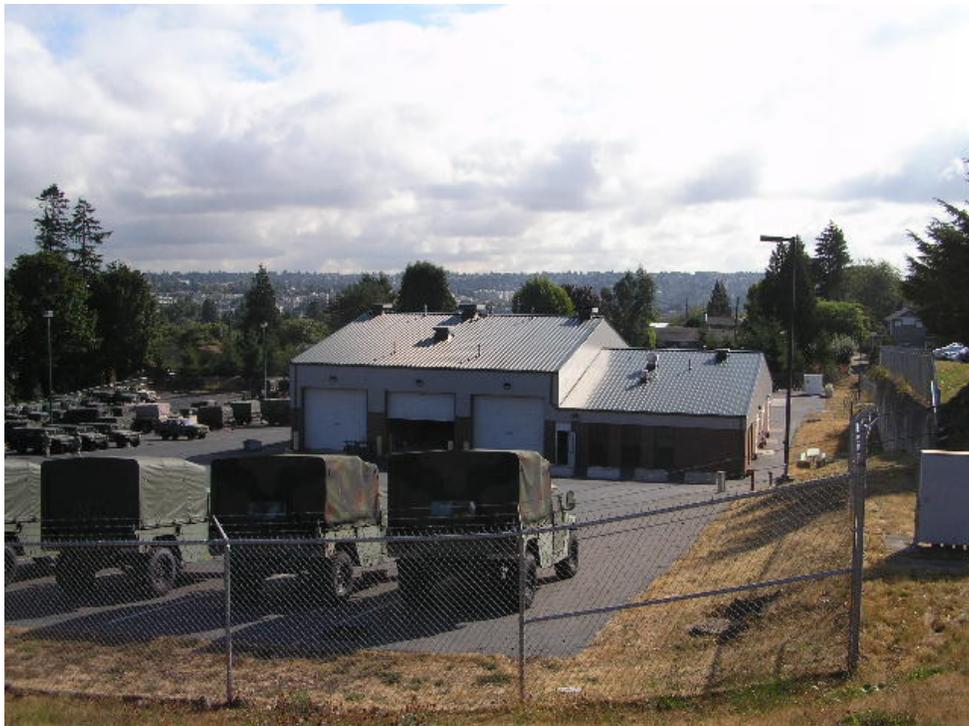
**Photograph 36. View of the Fort Lawton Army Reserve Center (FLARC) OMS Building on the adjoining property to the north of Leisy Hall and to the northeast of AMSA 79**

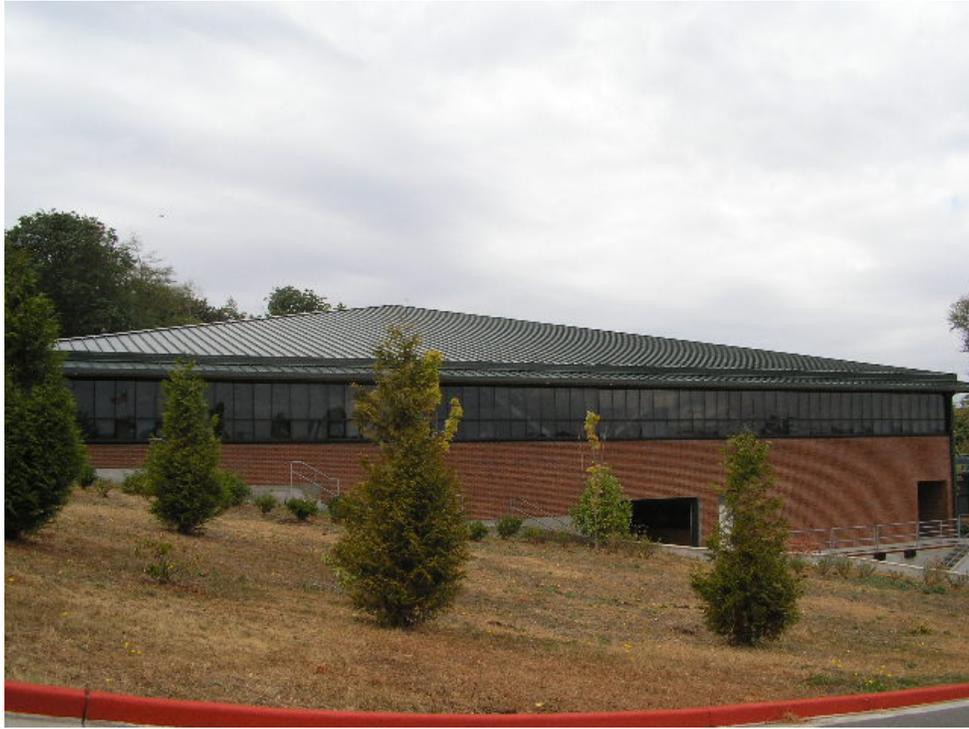
**Photograph 37. View of the FLARC administration building situated west of AMSA 79**

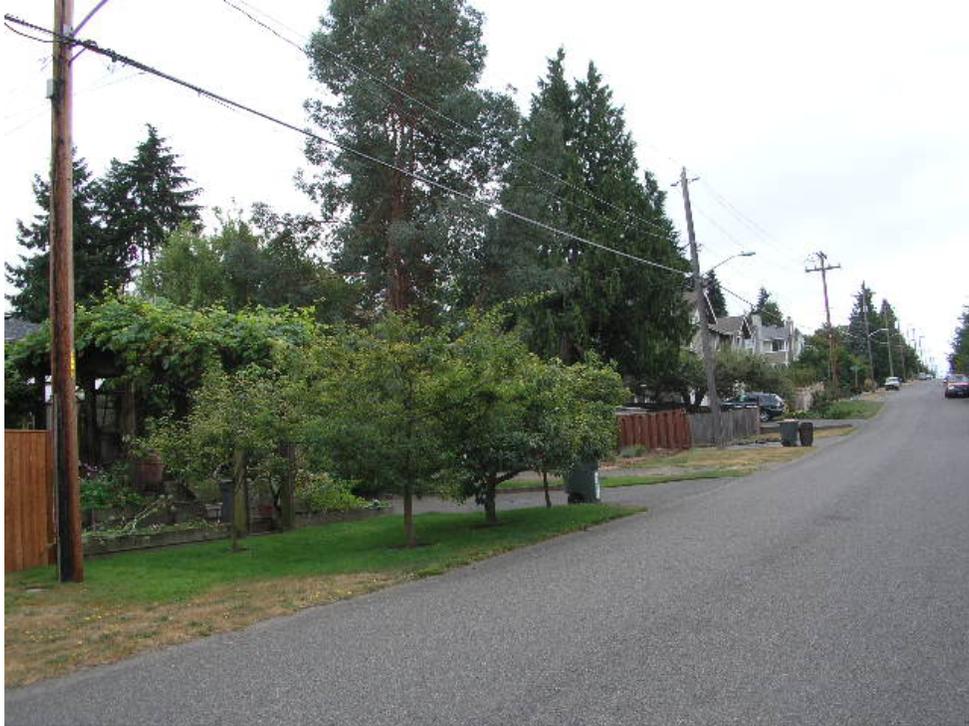
**Photograph 38. View of residential area situated east of Leisy Hall, looking south along 36<sup>th</sup> Avenue West**
