**FINDING OF SUITABILITY TO TRANSFER
(FOST)**

**Major Robert Kirkwood U.S. Army Reserve Center (DE005)
3931 Kirkwood Highway
Wilmington, Delaware 19801**

ASBESTOS INSPECTION REPORT

**KIRKWOOD US ARMY RESERVE CENTER
(DE005) - (10775)
3931 KIRKWOOD HIGHWAY
WILMINGTON, DELAWARE**

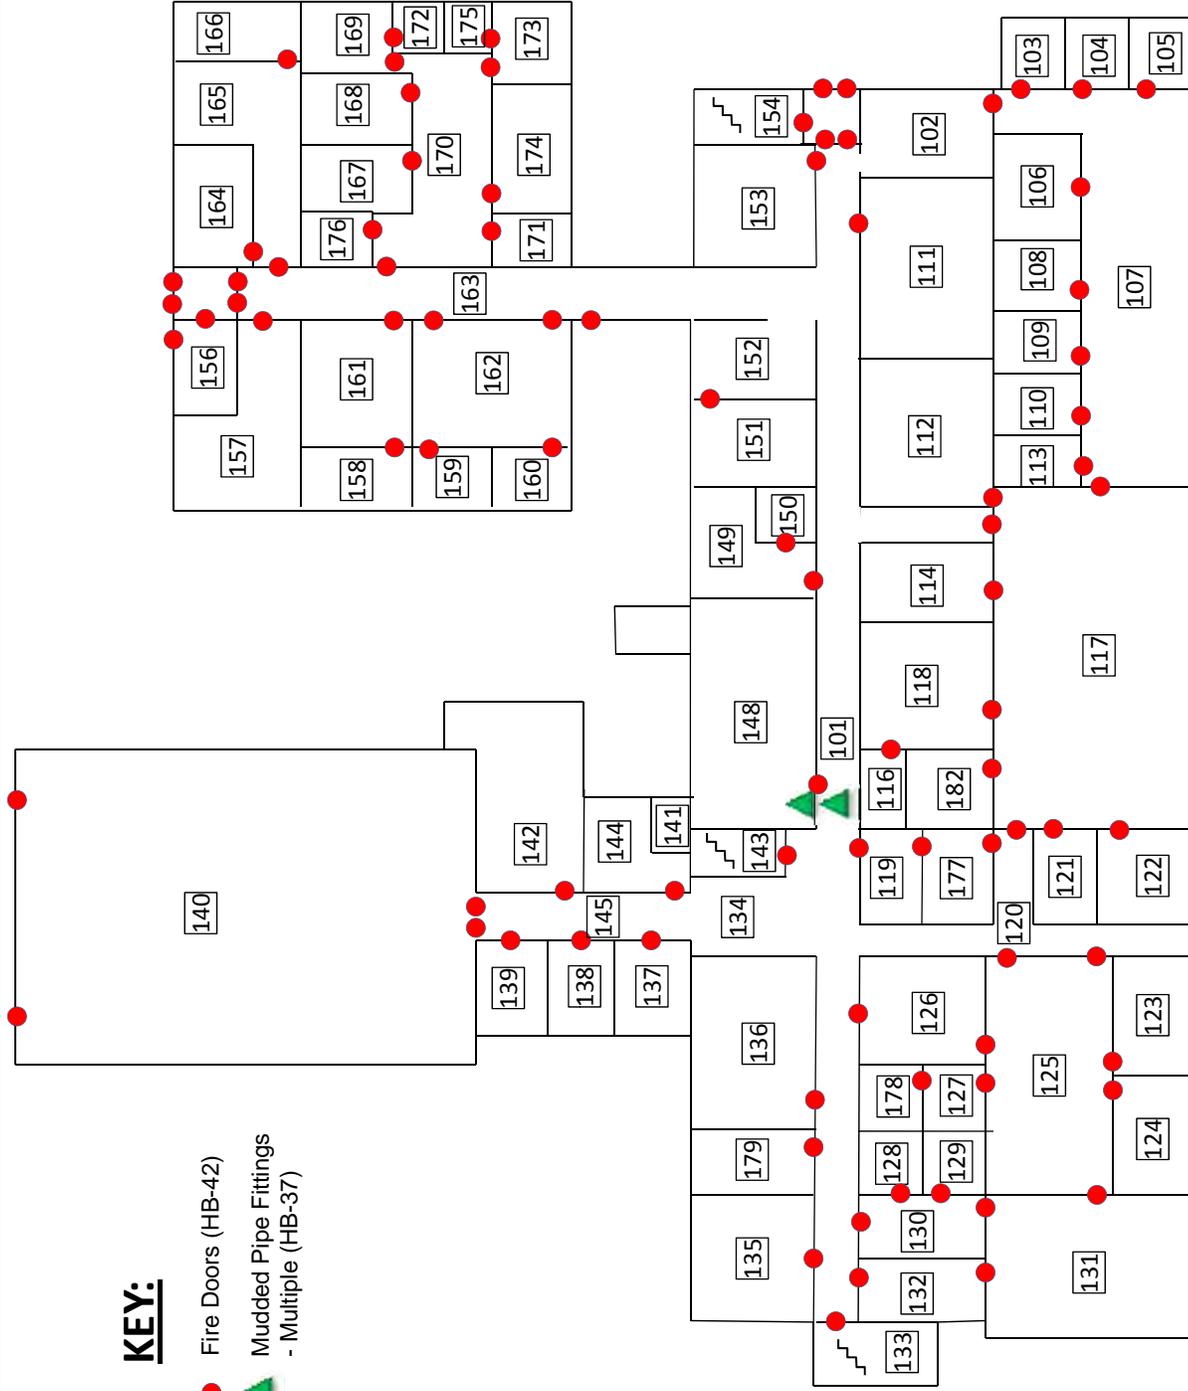
FIGURE 1:
ACBM and PACM LOCATIONS
BUILDING 1 - FIRST FLOOR

- Fire Doors (HB-42)
- ▲ Mudded Pipe Fittings - Multiple (HB-37)

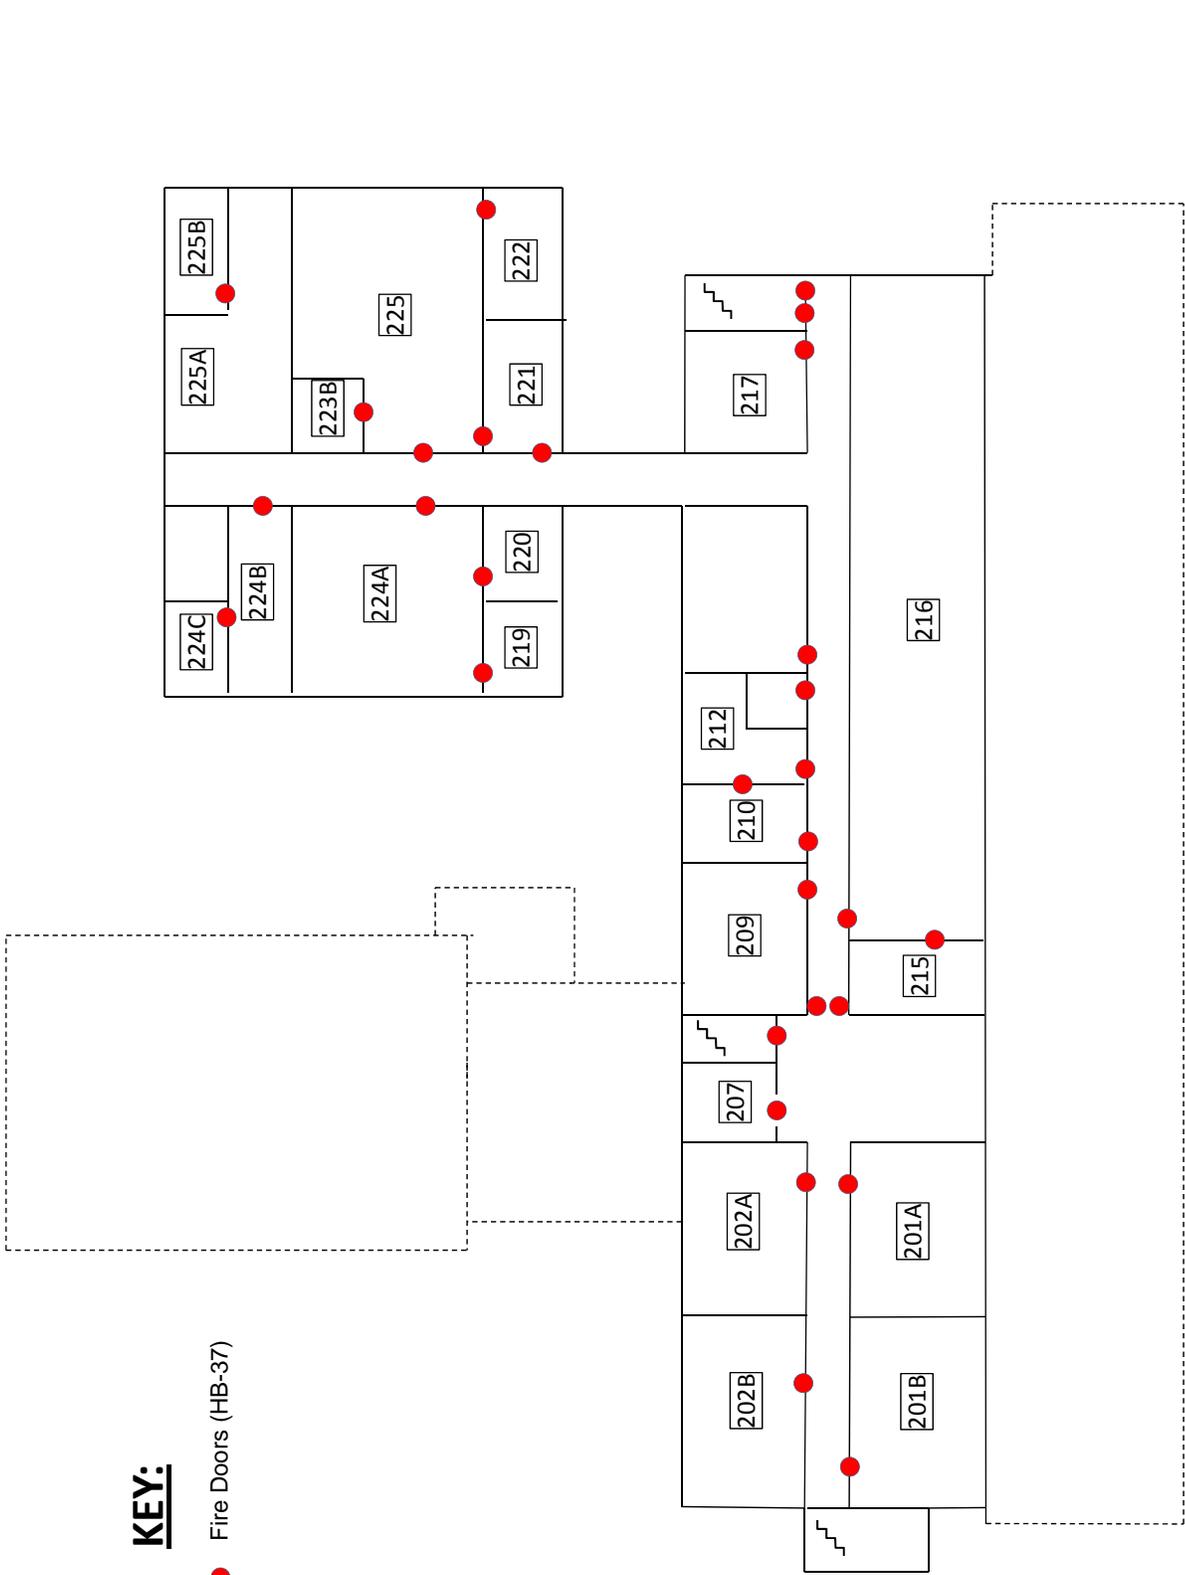
**FIGURE 2:
PACM LOCATIONS
BUILDING 1 - SECOND FLOOR**

● Fire Doors (HB-37)

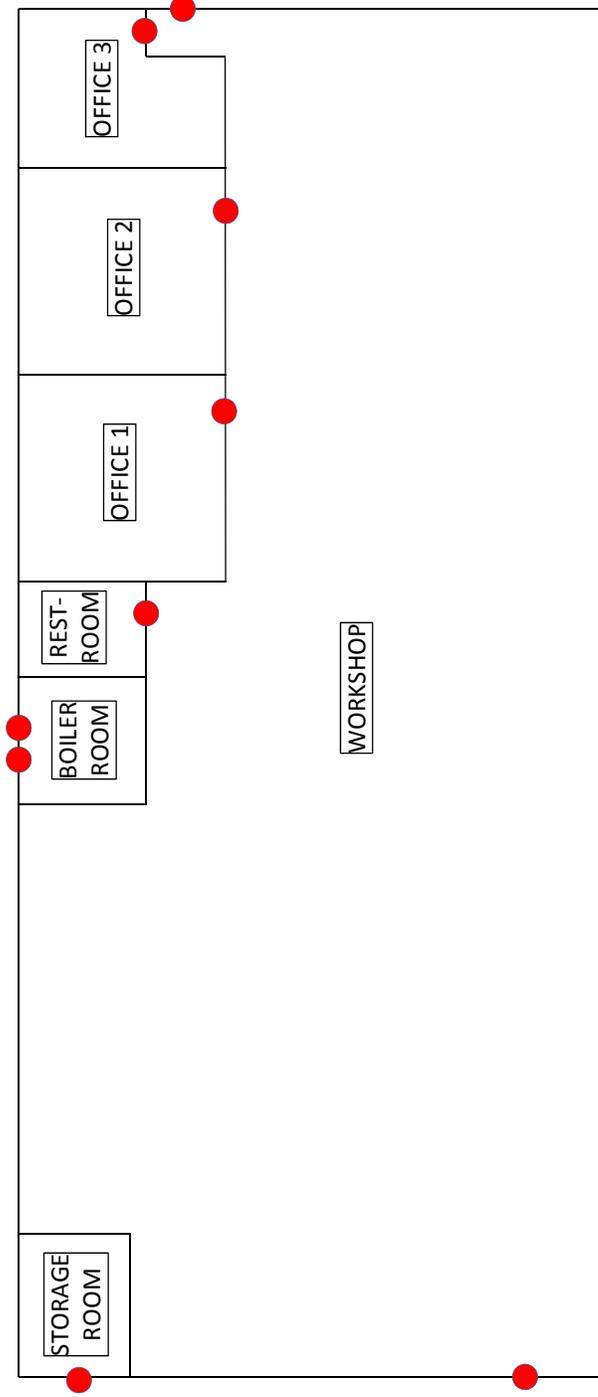
**FIGURE 3:
PACM LOCATIONS
MAINTENANCE SHOP**

● Fire Doors (HS-16)

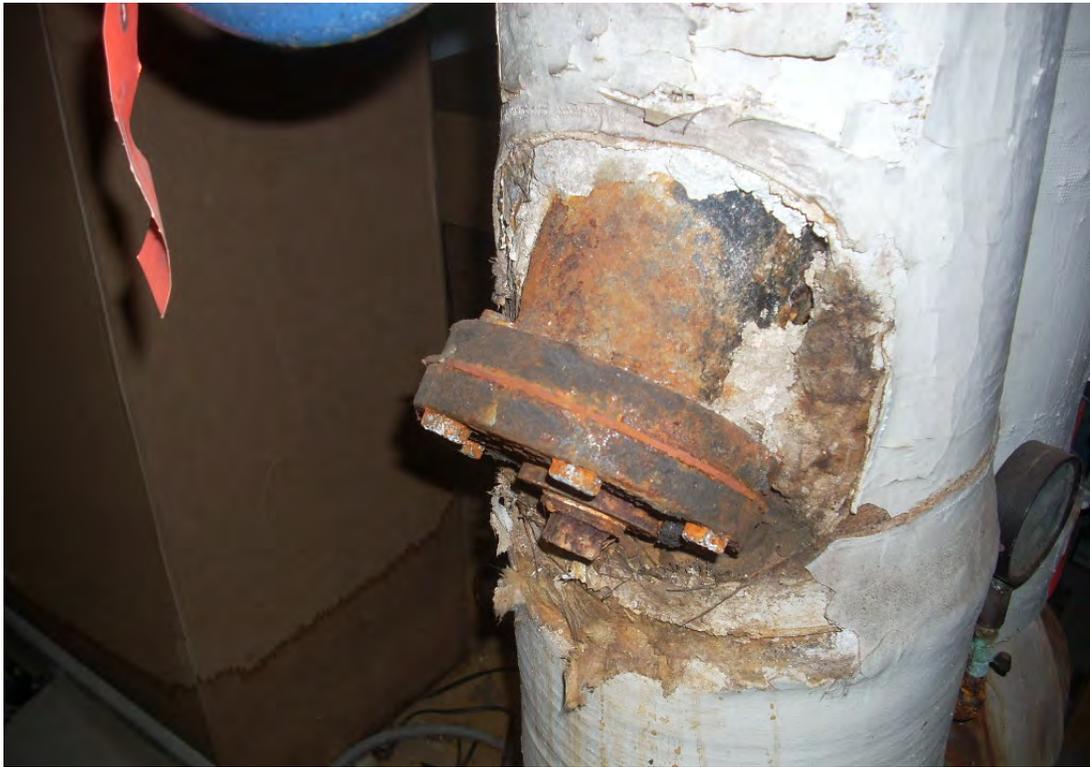
Photograph No. 25: Representative view of 18" mudded pipe fitting (HB-35) located in Building 1 boiler room

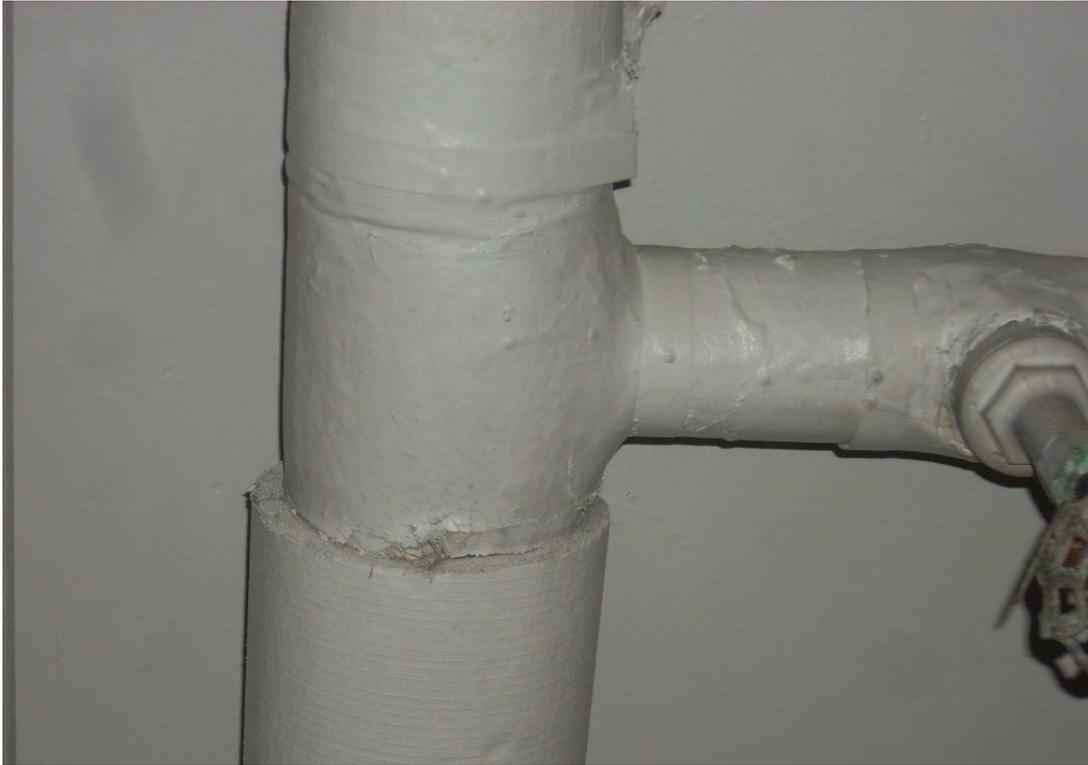
Photograph No. 27: Representative view of mudded pipe fitting (HB-37)
located in Building 1 boiler room

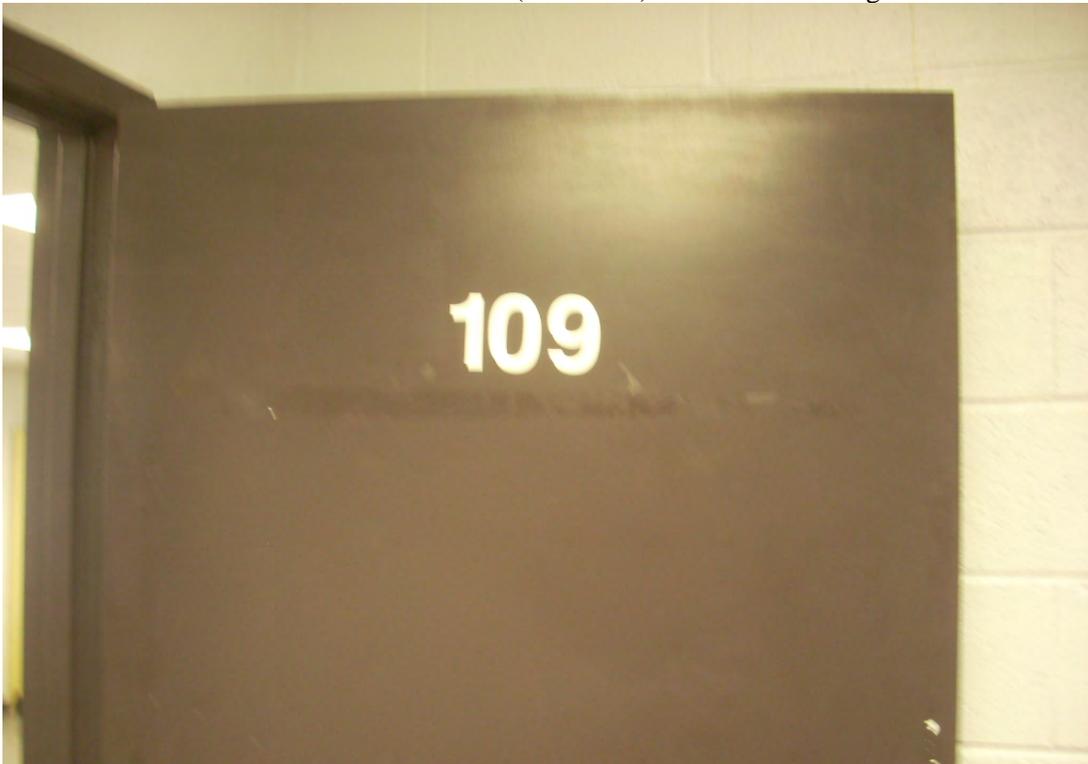
Photograph No. 30: Representative view of fire doors (HB-42) located throughout Building 1

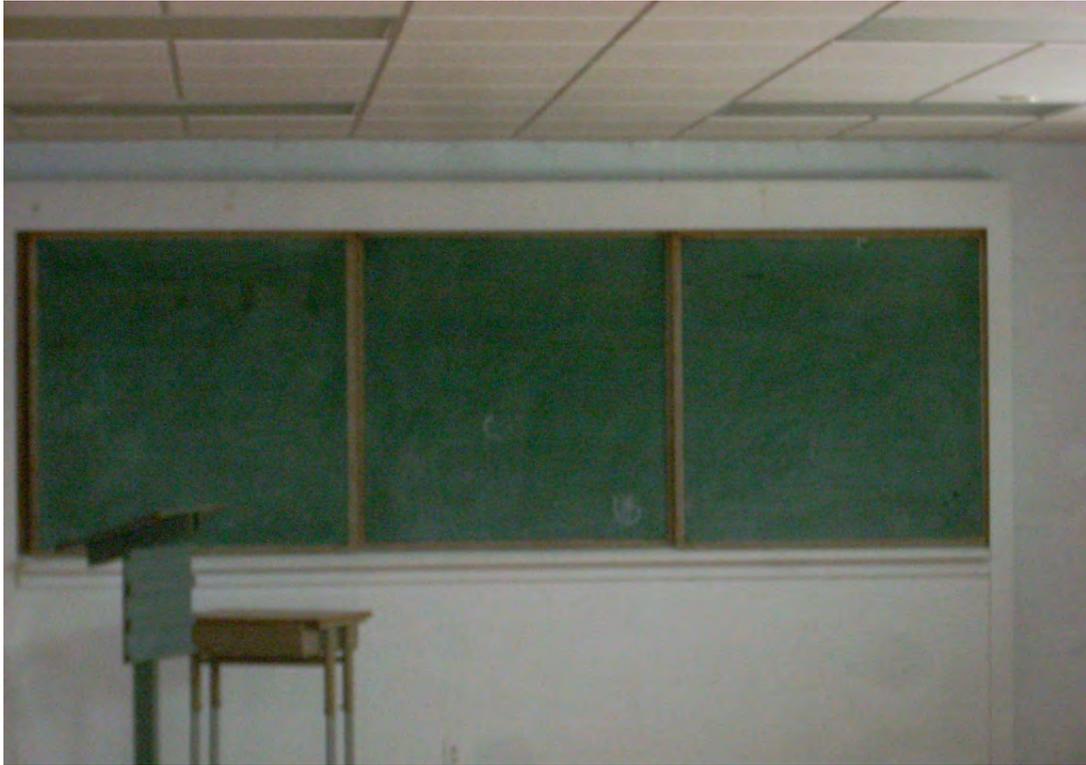
Photograph No. 31: Representative view of chalkboards (HB-44)
located in Building 1

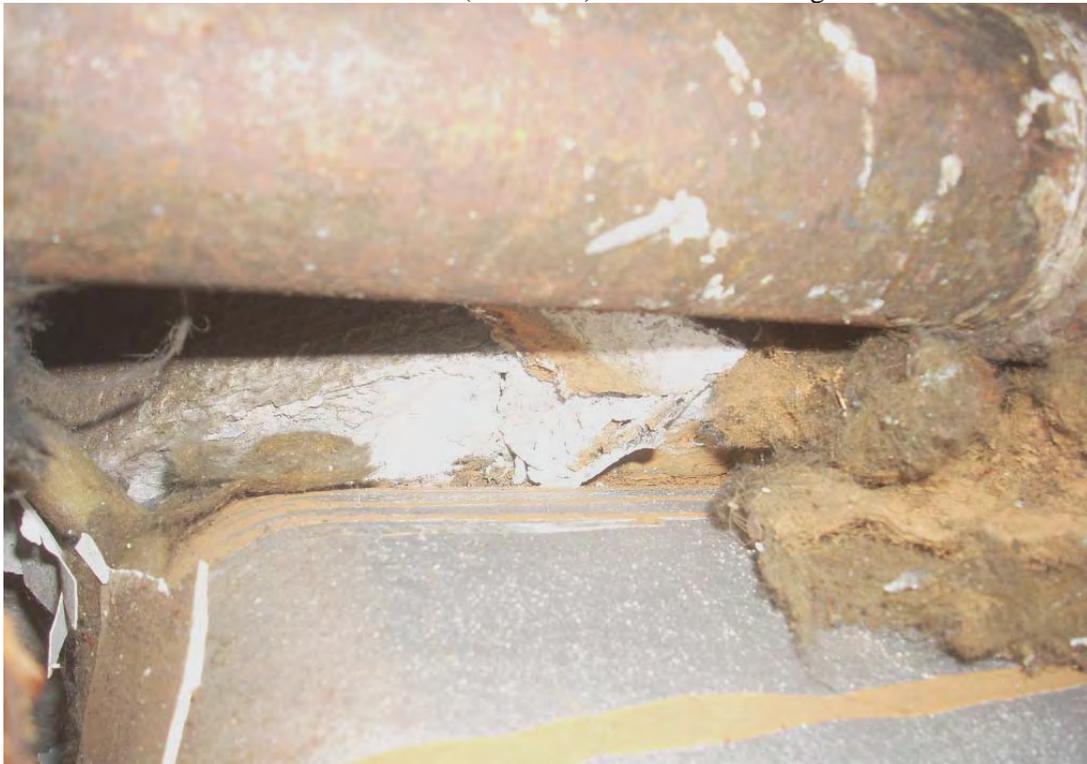
Photograph No. 44: Representative view of mudded pipe fittings (HS-14) located in Building 2 boiler room
