**FINDING OF SUITABILITY TO TRANSFER
(FOST)**

**Wilson-Kramer U.S. Army Reserve Center (PA008)
2940 Airport Road
Bethlehem, Pennsylvania 18017**

September 2015

ASBESTOS VISUAL INSPECTION REPORT

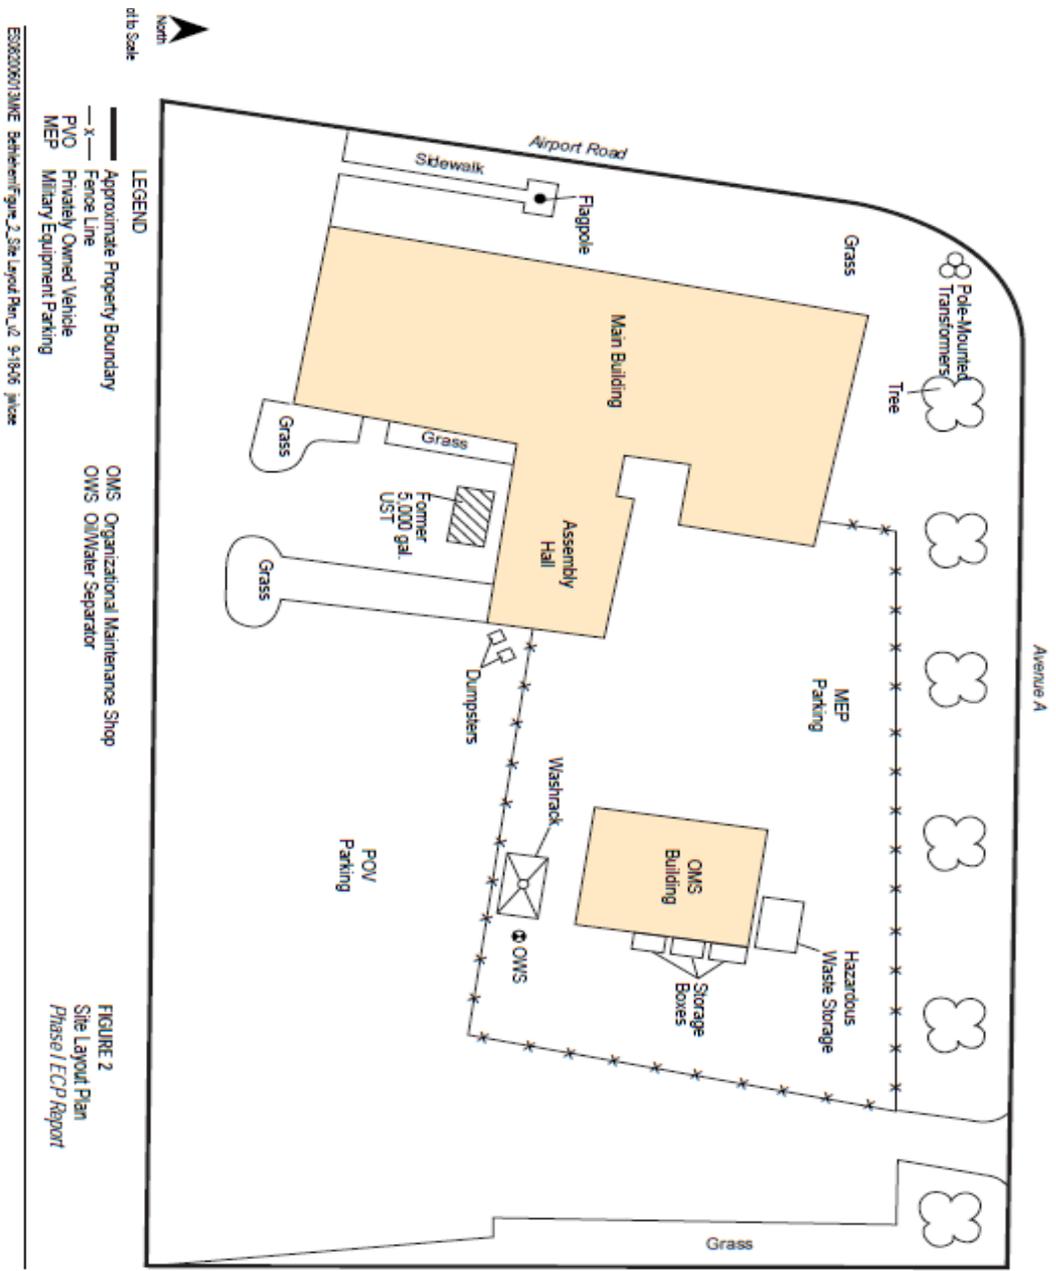
ENCLOSURE 1
SITE MAP OF PROPERTY

FIGURE 2
Site Layout Plan
Phase I ECP Report

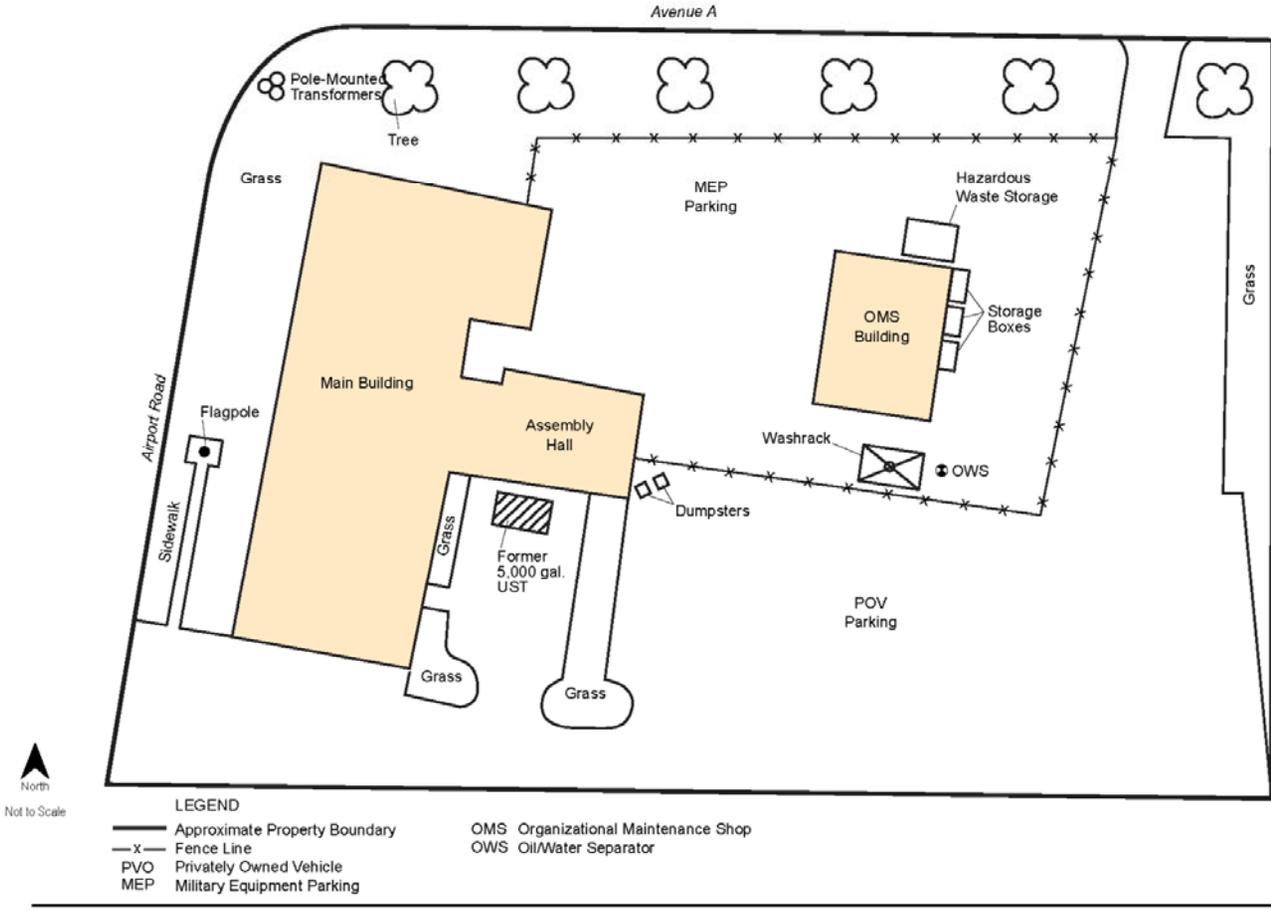
**Figure 2-2
Wilson-Kramer USARC Site Layout**

The USAR Center contains two permanent structures and two parking lots. Construction of both the 26,890-square-foot administration building and the 2,521-square-foot OMS building was completed in 1961. In 1975, additional administrative, classroom, and unit storage spaces were constructed onto the original building. Both structures are on concrete foundations and consist of concrete block walls covered with a brick veneer. A military equipment parking (MEP) area and a privately owned vehicle (POV) parking area also are contained within the Property. The land and buildings are owned by the U. S. Government. The site layout is presented in Figure 2-2.

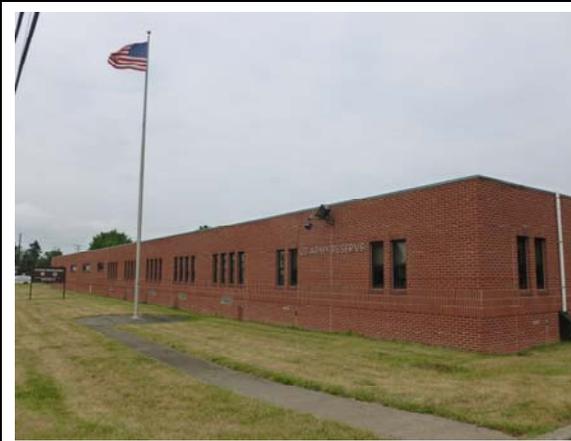
Building 1: Main Admin Building

Building 1 - Main Administrative Building							
HA#	Material Description	Friability	Total Quantity	Condition	Potential for Contact	Locations	Status
1	12" blue floor tile w/white marbling/mastic	NF	3,060 SF	Good	High	Rooms 128, Entry E-001, Halls H-100, H-101, H-102, H-105, H-106 & H-107	Assumed ACM
2	6" black coving/mastic	NF	2,000 LF	Good	Moderate	Rooms 101B, 101G, 102, 106, 110, 128, 132, Entry E-001, Halls H-100, H-101, H-102, H-103, H-105, H-106 & H-107	Assumed ACM
3	White door caulking	NF	490 LF	Good	Moderate	Rooms 124, 126, 127, 128, 129, 136, 141, Entry E-001, Halls H-100, H-102, H-103, H-104, H-105, H-107 and exterior side of building entrance doors	Assumed ACM
4	Gray caulking	NF	1,380 LF	Good	Moderate	Rooms 113, 113A, 121, 132, 138, 139, 140, 140A, 141A, 142, 146, Halls, H-100, H-106, H-107 and exterior side of windows	Assumed ACM
5	Ceiling tiles w/grooves & pinholes	F	9,450 SF	Good	High	Throughout the building	Assumed ACM

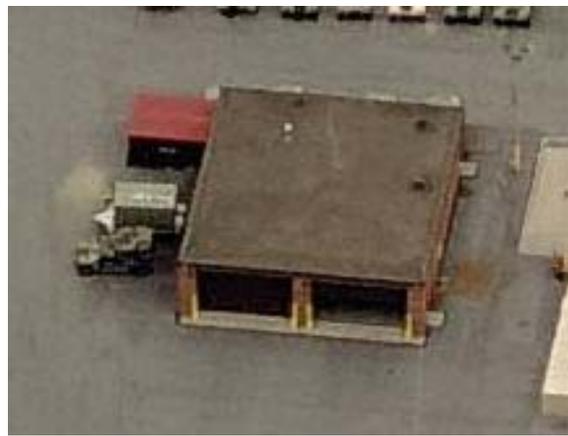
Building 2: Maintenance Shop

HA#	Material Description	Friability	Total Quantity	Condition	Potential for Contact	Locations	Status
4	Gray door caulking	NF	140 LF	Good	Moderate	Around exterior side of entry doors and bay door bollards	Assumed ACM
5	Ceiling tiles w/grooves & pinholes	F	205 SF	Good	Moderate	Rooms 101 & 102	Assumed ACM
8	4" black coving/mastic	NF	150 LF	Good	Moderate	Rooms 100, 101 & 102	Assumed ACM
11	Sheetrock/joint compound	F	725 SF	Good	High	Rooms 100, 101 & 102	Assumed ACM
13	Brown window caulking	NF	110 LF	Good	Low	Interior windows in Rooms 101 & 102, and exterior side of windows	Assumed ACM
19	Roofing tar	NF	2,525	Good	Low	Roof	Assumed ACM
20	Roofing flashing mastic	NF	12 LF	Good	Low	Around roof penetrations	Assumed ACM

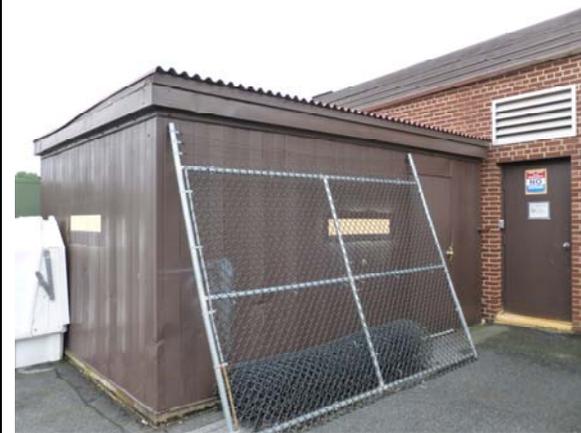
Building 3: Storage Building

HA#	Material Description	Friability	Total Quantity	Condition	Potential for Contact	Locations	Status
21	Red coorugated asphaltic roof panels	NF	195 SF	Good	Low	Roof	Assumed ACM
22	White roof caulking	NF	10 LF	Good	Low	Roof	Assumed ACM
23	Black roof caulking	NF	5 LF	Good	Low	Roof	Assumed ACM

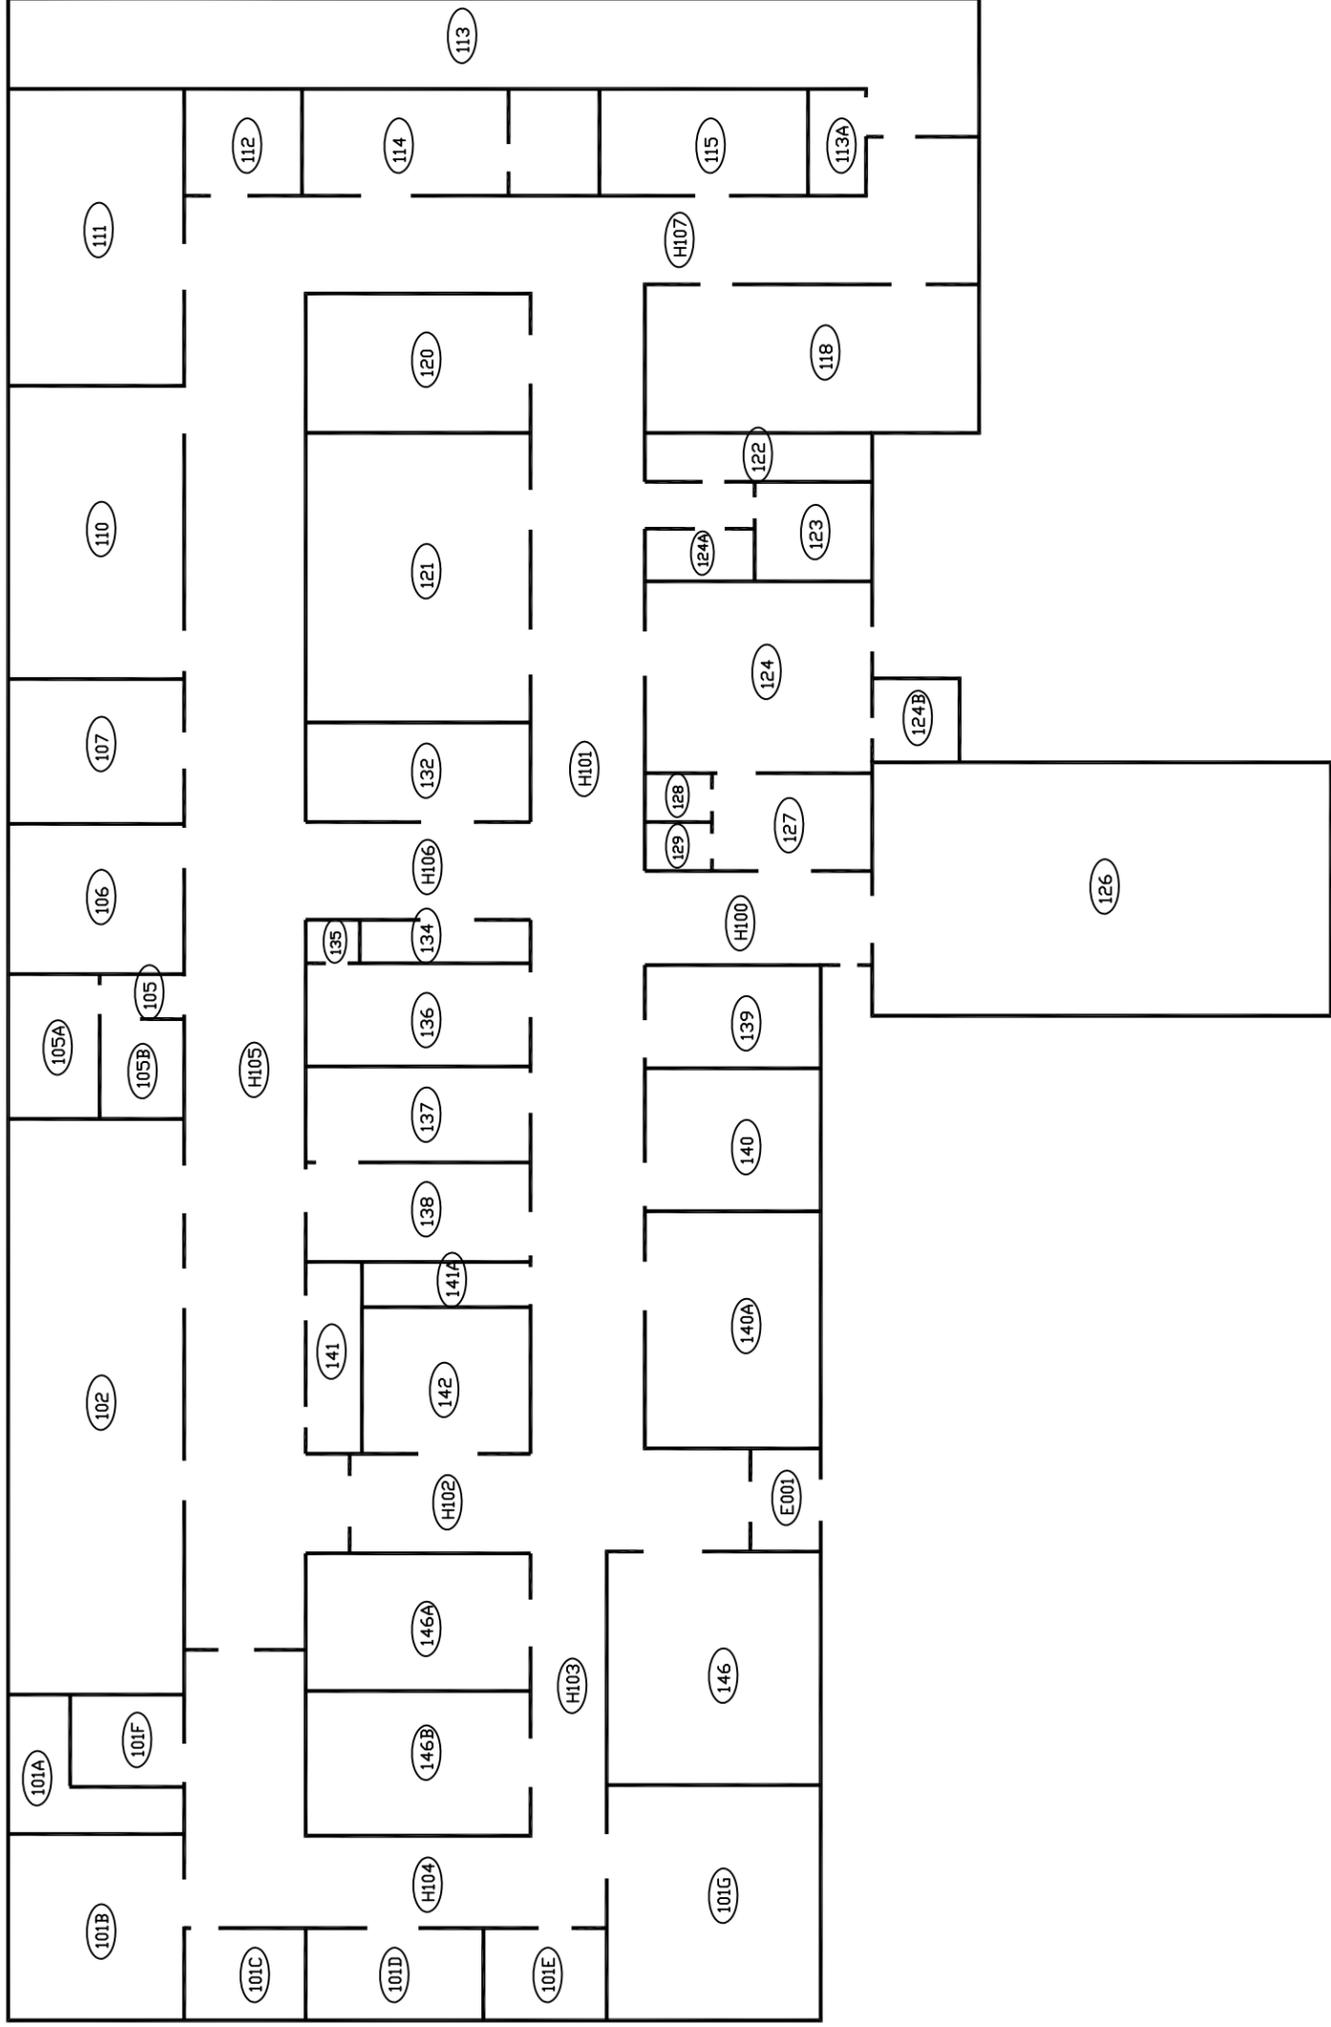
SBG-EEG		APPENDIX B ASBESTOS SAMPLE LOCATIONS BUILDING 1 ARC WILSON-KRAMER (PA008) BETHLEHAM, PENNSLVANIA	
7301 RIVERS AVE., SUITE 245 N. CHARLESTON SC 29406-4643 (843) 573-7140	DATE AUG 2012	PREPARED BY M. MOLTZEN	DRAWN BY L. C. DIASIO
SCALE NONE	DWG NUMBER SBG_PA008-B1_07-2012	SHEET 1	REV 1 OF 2
