**ENVIRONMENTAL CONDITION OF PROPERTY  
REPORT**

**AREA MAINTENANCE SUPPORT ACTIVITY (AMSA) 72G  
(CT012)  
536 SPRING STREET,  
WINDSOR LOCKS, CONNECTICUT 06096**

**APRIL 2007**

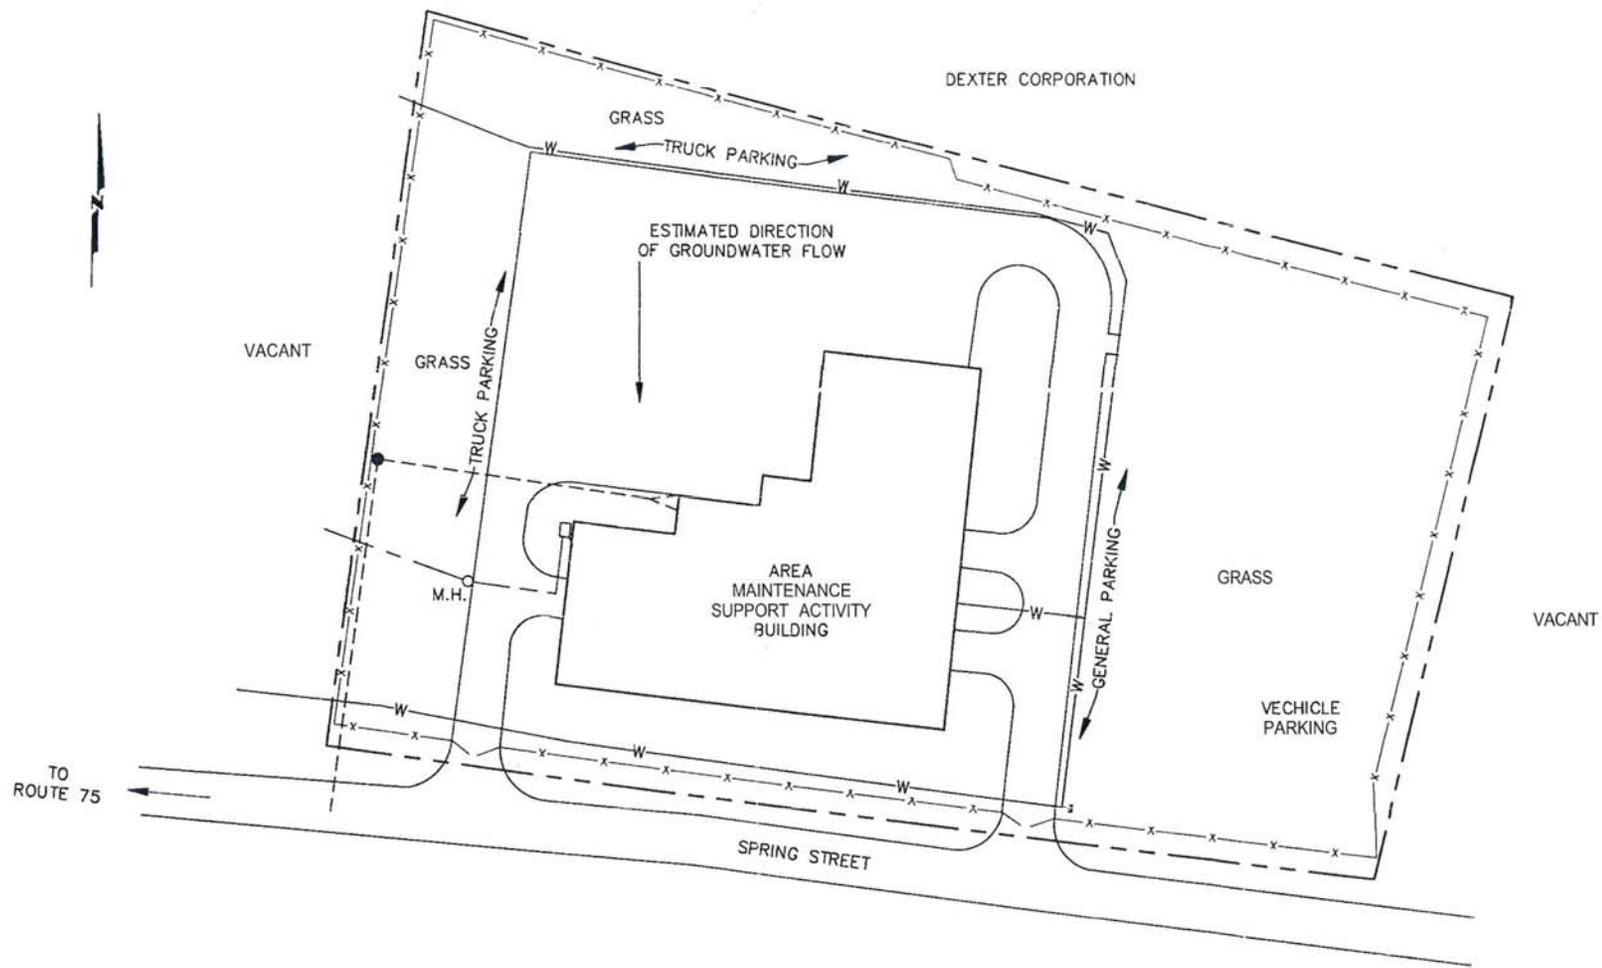
**FIGURE 2**  
 Site Layout Map  
 Area Maintenance Support Activity (AMSA)  
 Windsor Locks, Hartford County, Connecticut  
 Phase I ECP Report

Two metal hazardous material storage sheds on the north side of the building hold virgin chemical product and waste chemical and oil product. A Quonset hut that stored equipment was formerly located on the northeast side of the Property, but it was removed after 2001 (Appendix B, Photograph 5). An oil/water separator (OWS) is located on the west side of the Property.

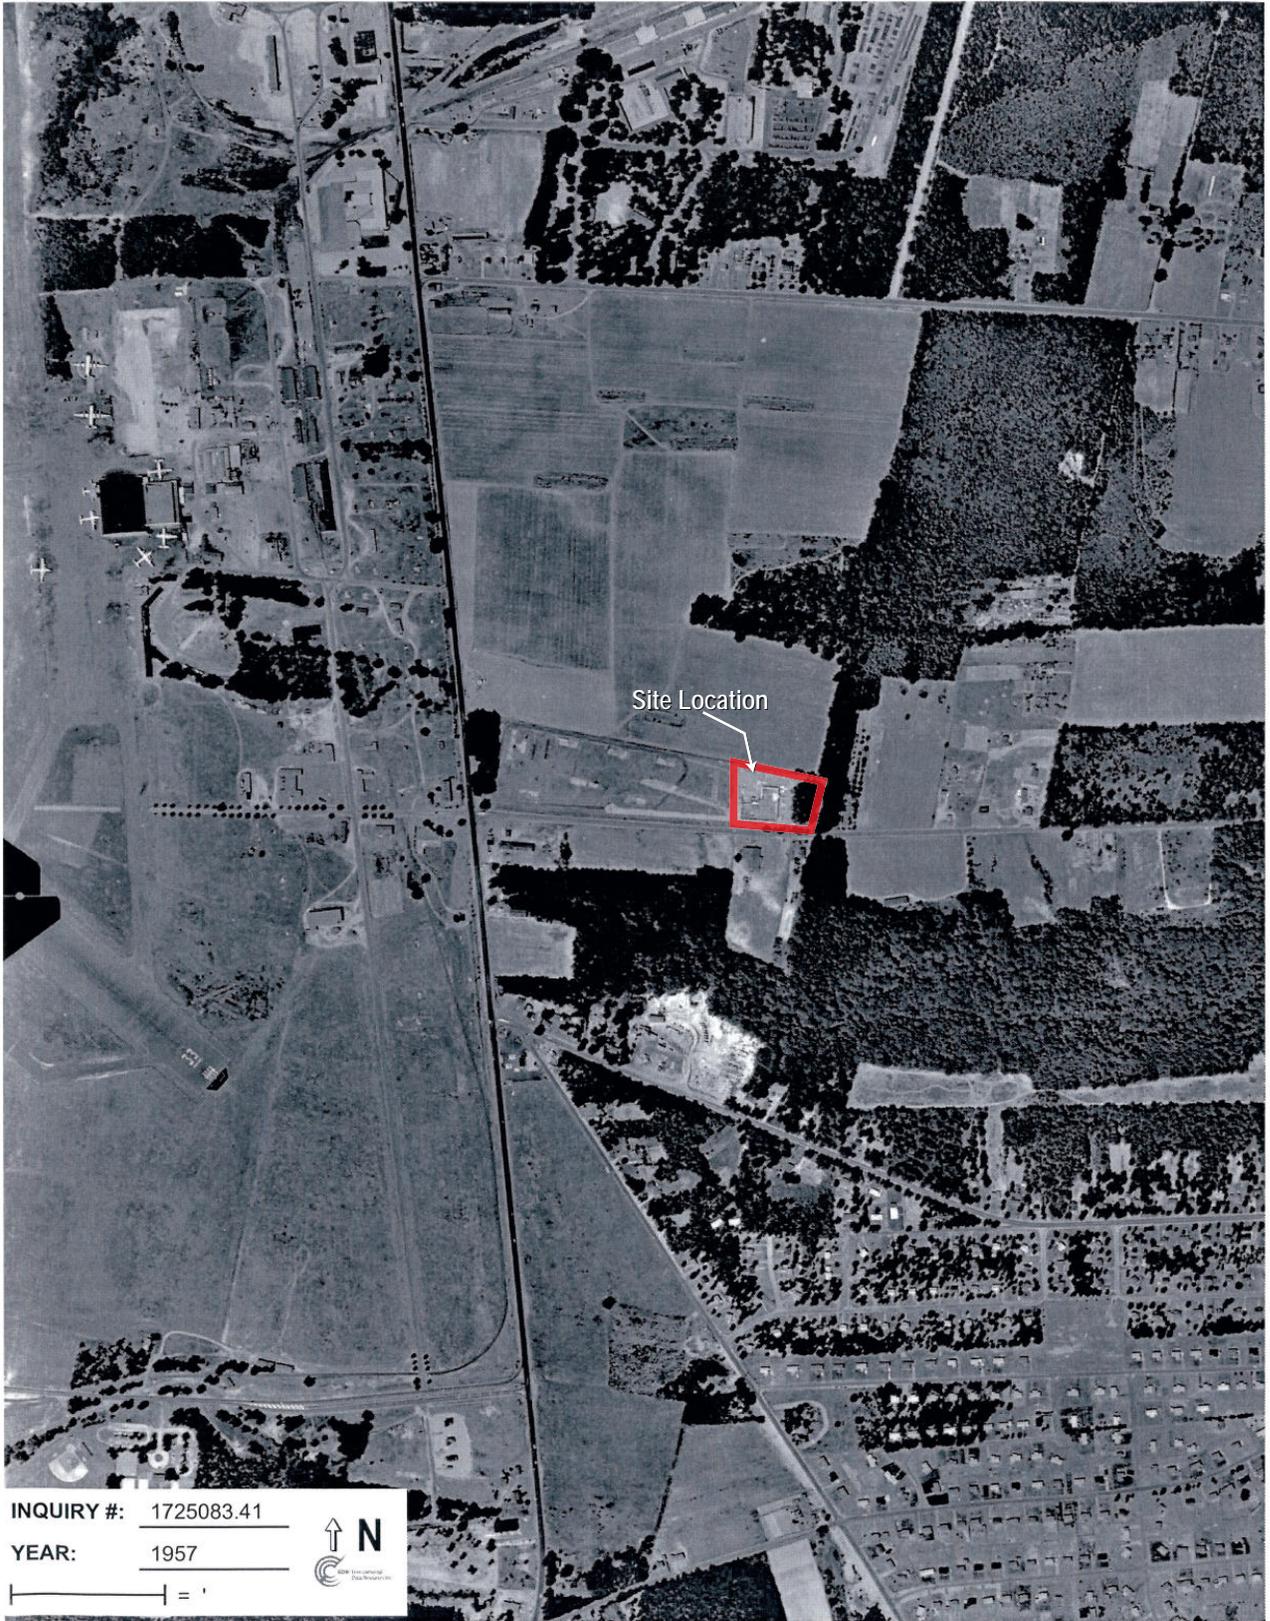
FIGURE 6  
1957 Aerial Photograph  
*Area Maintenance Support Activity (AMSA)*  
*Windsor Locks, Hartford County, Connecticut*  
*Phase I ECP Report*

The 1957 aerial photograph (Figure 6, Appendix A) shows the main building that was used for repairing Nike missiles. There is minimal development north and east of the Property, and most of that land is farmland. To the south are residential areas. To the west appears to be an airfield.

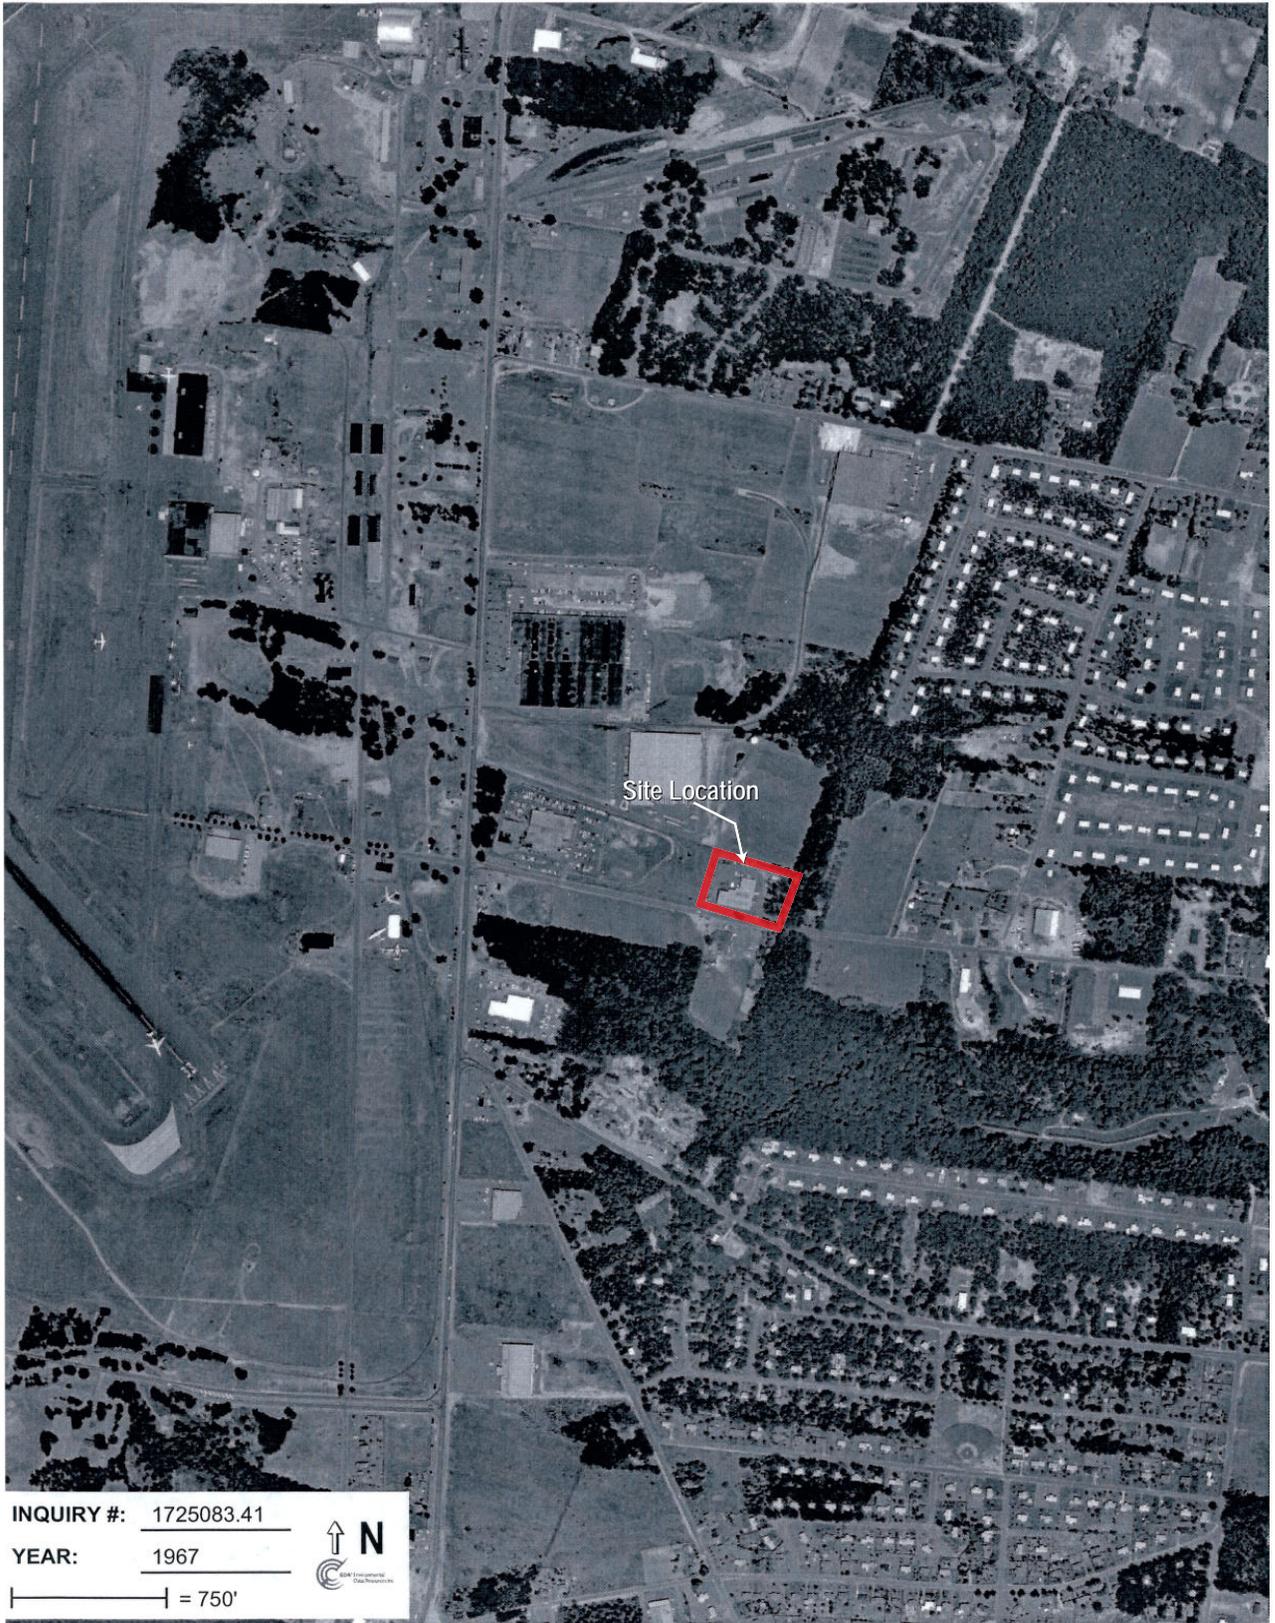
FIGURE 7  
1967 Aerial Photograph  
*Area Maintenance Support Activity (AMSA)*  
*Windsor Locks, Hartford County, Connecticut*  
*Phase I ECP Report*

west appears to be an airfield. The 1967 aerial photograph shows more development to the north and east, with some residential areas. Land use of the areas south and west of the Property are similar to those observed in the 1957 aerial photograph.

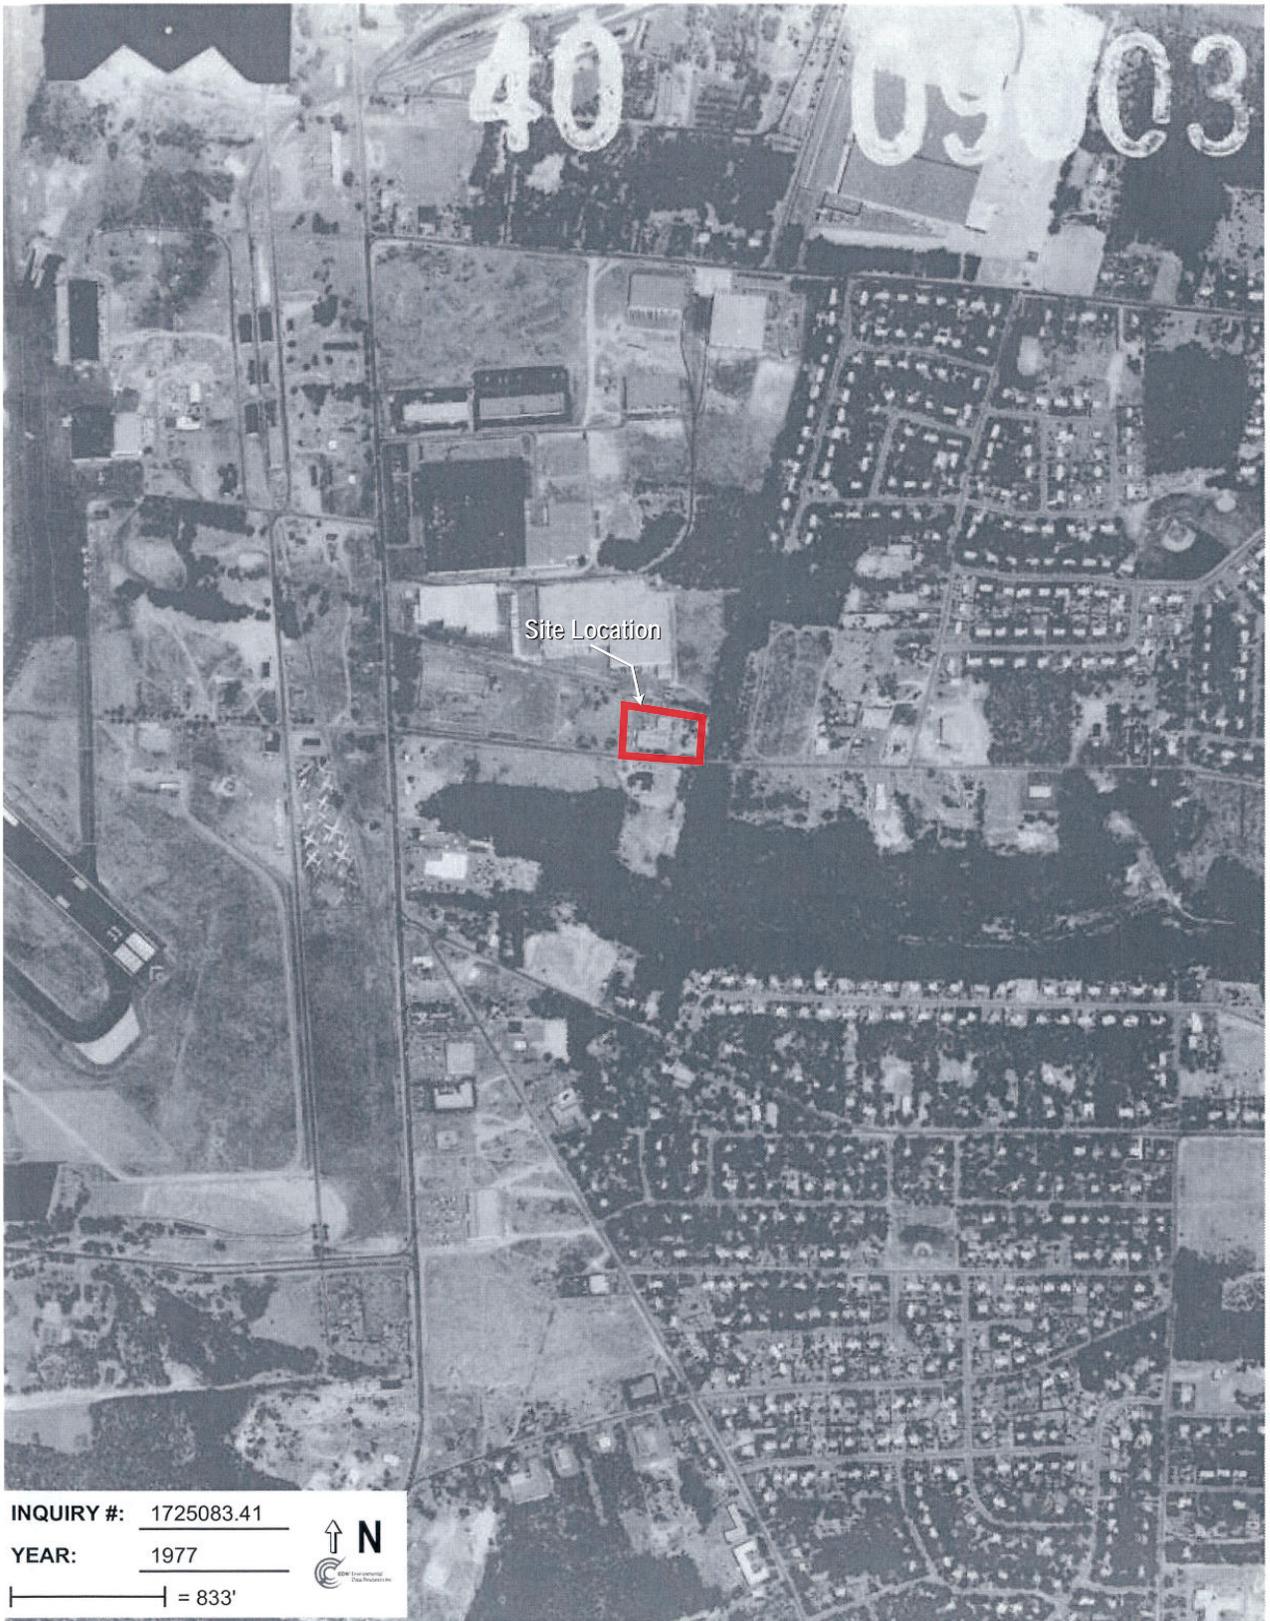
**FIGURE 8**  
1977 Aerial Photograph  
*Area Maintenance Support Activity (AMSA)*  
*Windsor Locks, Hartford County, Connecticut*  
*Phase I ECP Report*

The 1972 USGS topographic map (Figure 4, Appendix A) shows more development to the north and south. Bradley International Airport is west of the Property. The 1977 aerial photograph (Figure 8, Appendix A) shows the Property and adjacent development relatively unchanged from the 1967 aerial photograph. The 1984 USGS topographic map (Figure 5, Appendix A) shows more development north, south, and east of the Property, and Bradley International Airport is still west of the Property.

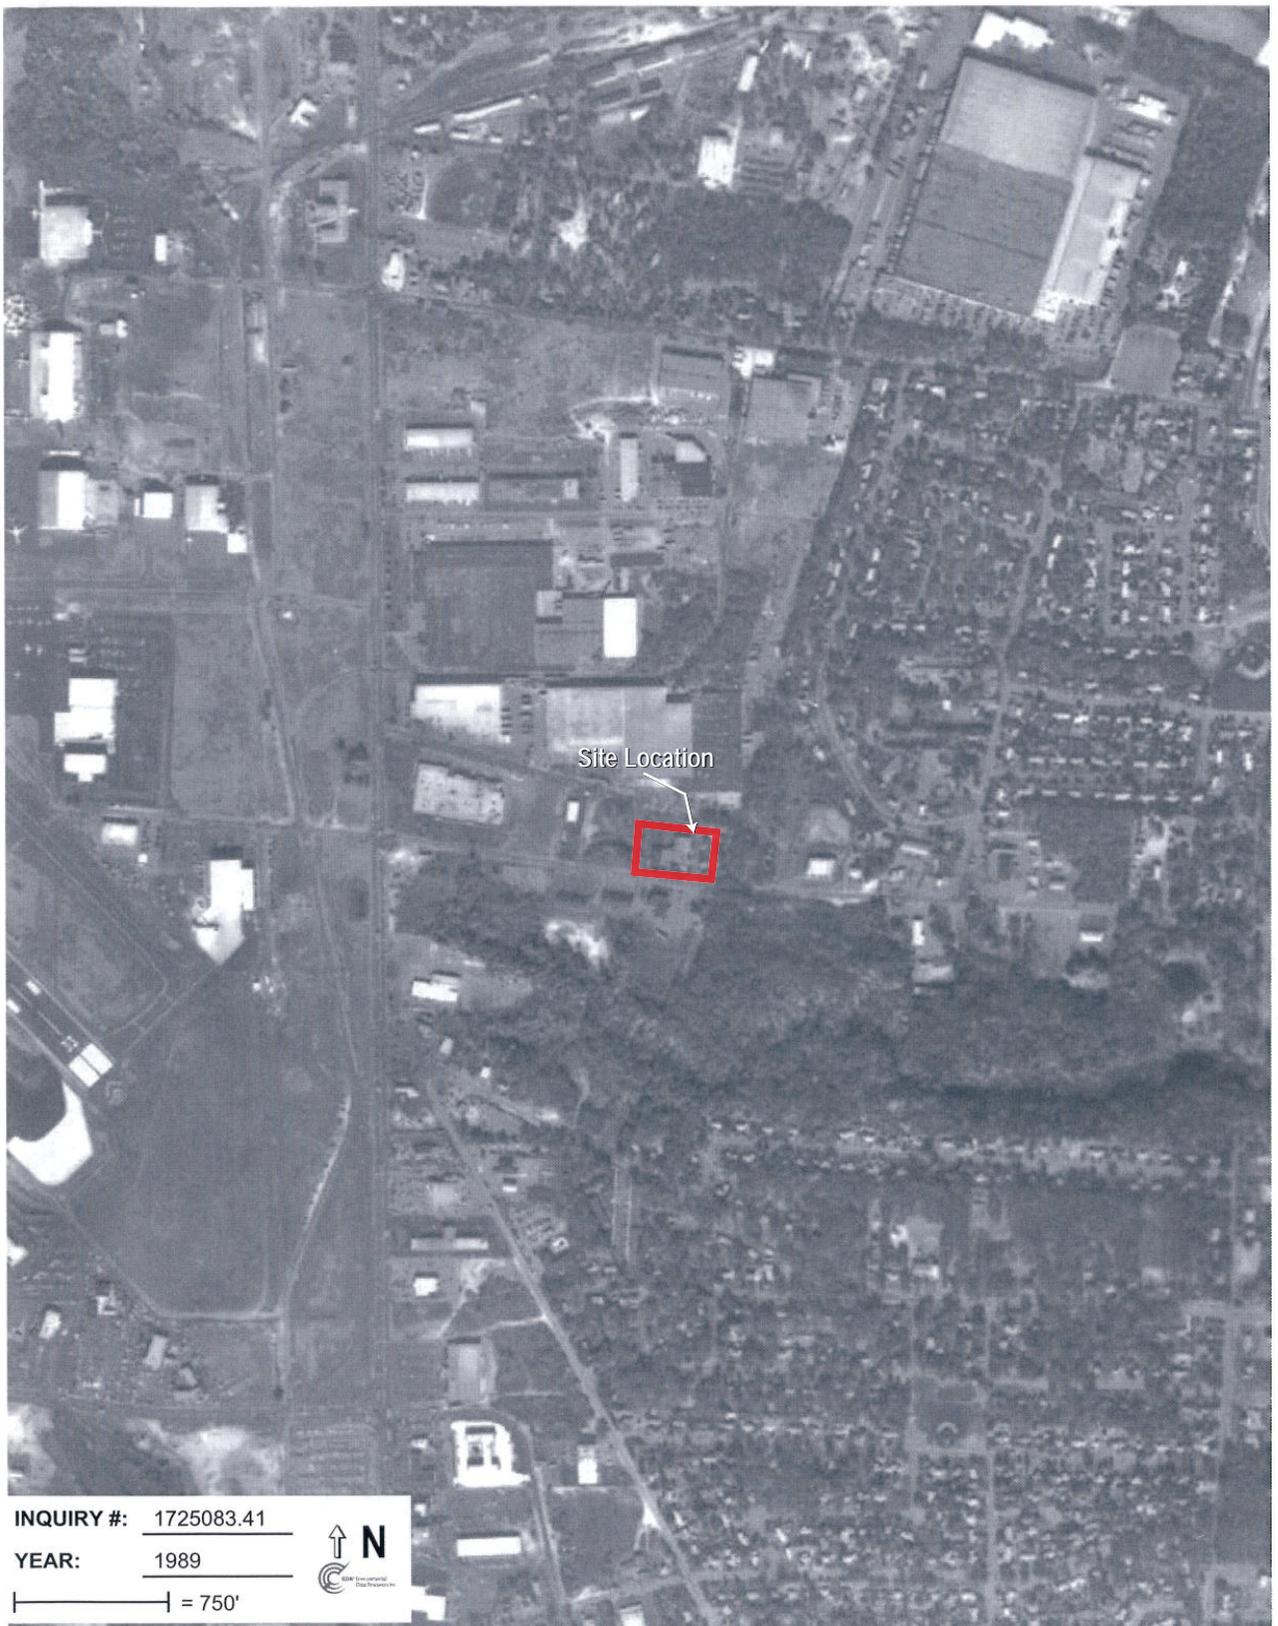
**FIGURE 9**  
1989 Aerial Photograph  
*Area Maintenance Support Activity (AMSA)*  
*Windsor Locks, Hartford County, Connecticut*  
*Phase I ECP Report*

The 1989 aerial photograph (Figure 9, Appendix A) shows construction of additional development north, south, and east of the Property. Bradley International Airport appears to be in operation west of the Property. The 1995 aerial photograph (Figure 10, Appendix A) shows additional buildings in all directions.

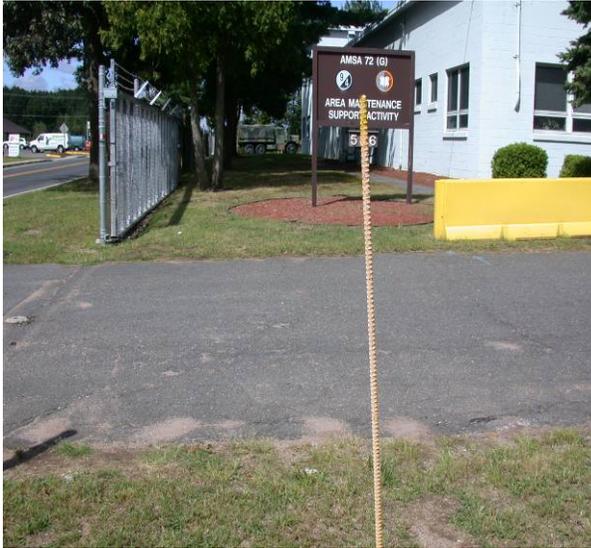
1. Entrance to the AMSA Building

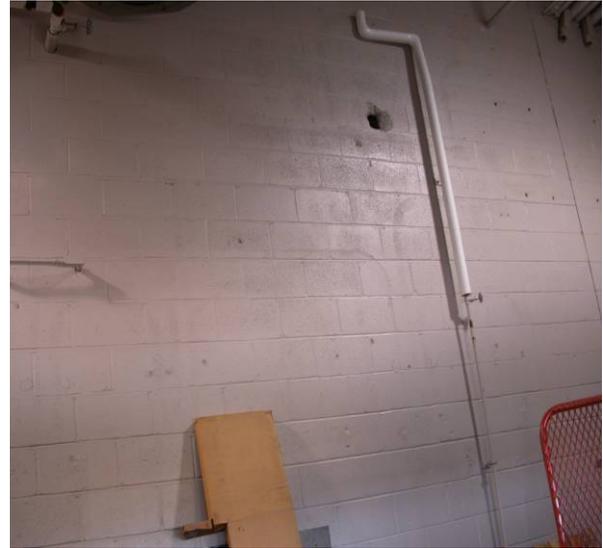
2. Location of former transformers inside AMSA Building

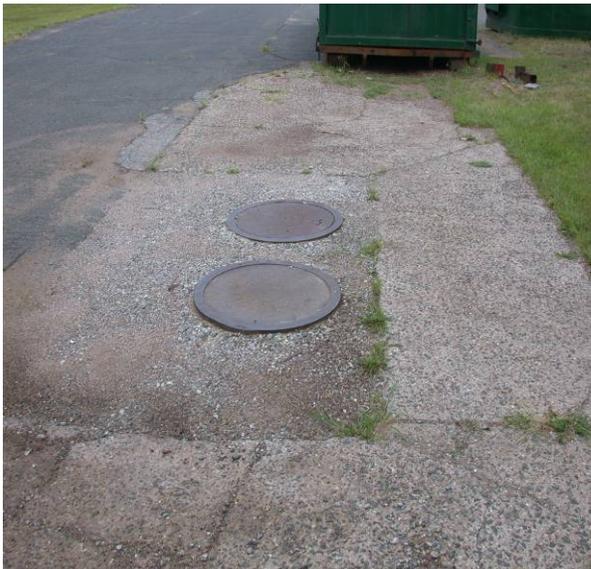
3. OWS on the west side of AMSA Building

- An additional round of groundwater sampling from MW-1 to MW-4, and EW-1 and EW-2
- Remediation of contaminated soil in the drywells
- Evacuation, cleaning, and inspection of the OWS for cracks
- One round of sampling from monitoring wells EW-5 and EW-6 to reassess the condition of groundwater in the area of the existing heating oil UST
- An additional soil boring on the south side (front) of the main facility to supplement the data obtained from borings B-9 and B-10

- No spills were noted in the last 3 years (that is, since 1998)
- Shop personnel noted that the OWS was serviced in 1998. USGS recommended the OWS be serviced annually
- Weapons were repaired and cleaned in a former bomb shelter in the AMSA building
- No POL spills or leaks were noted in the MEP area
- The waste oil AST had proper secondary containment.

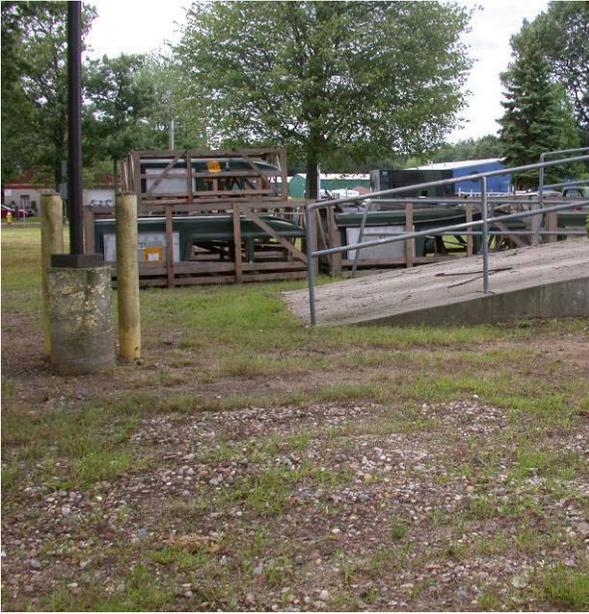
5. Location of Former Quonset

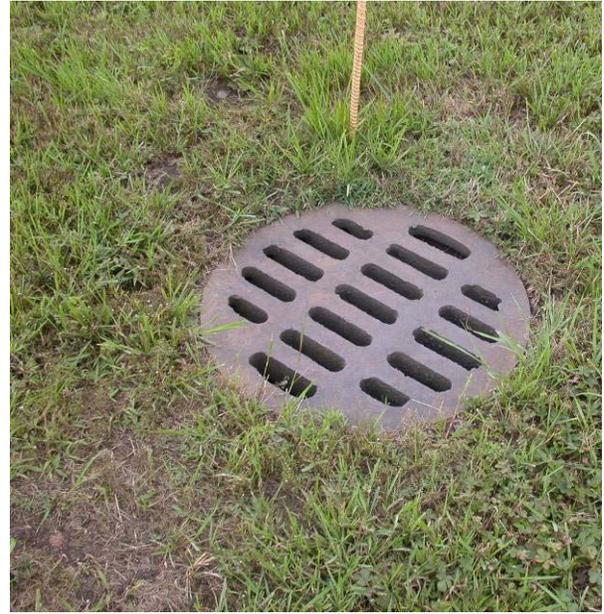
6. Dry well on Property
