**ENVIRONMENTAL CONDITION OF
PROPERTY REPORT**

**BG WILLIAM P. SCREWS
US ARMY RESERVE CENTER (AL037)
4050 ATLANTA HIGHWAY
MONTGOMERY, ALABAMA 36109**

**U.S. Army Corps of Engineers – Louisville District
600 Dr. Martin Luther King, Jr. Place
Louisville, Kentucky 40202-2232**

FEBRUARY 2007

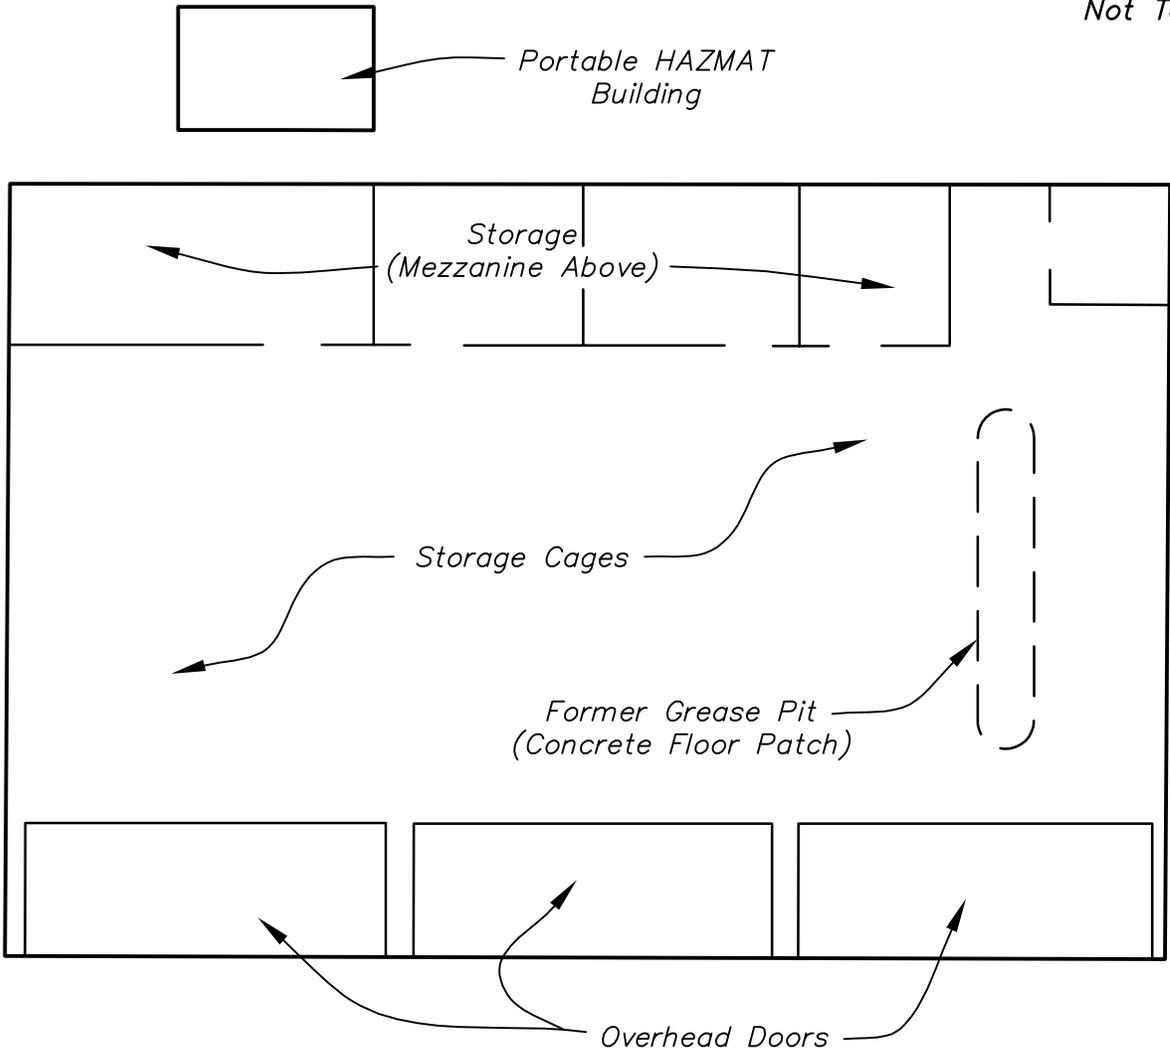
FIGURE 5
INTERIOR LAYOUT, FIRST FLOOR, FORMER AMSA BUILDING
AL037 BG WILLIAM P. SCREWS USARC
4050 Atlanta Highway
Montgomery, Montgomery County, Alabama

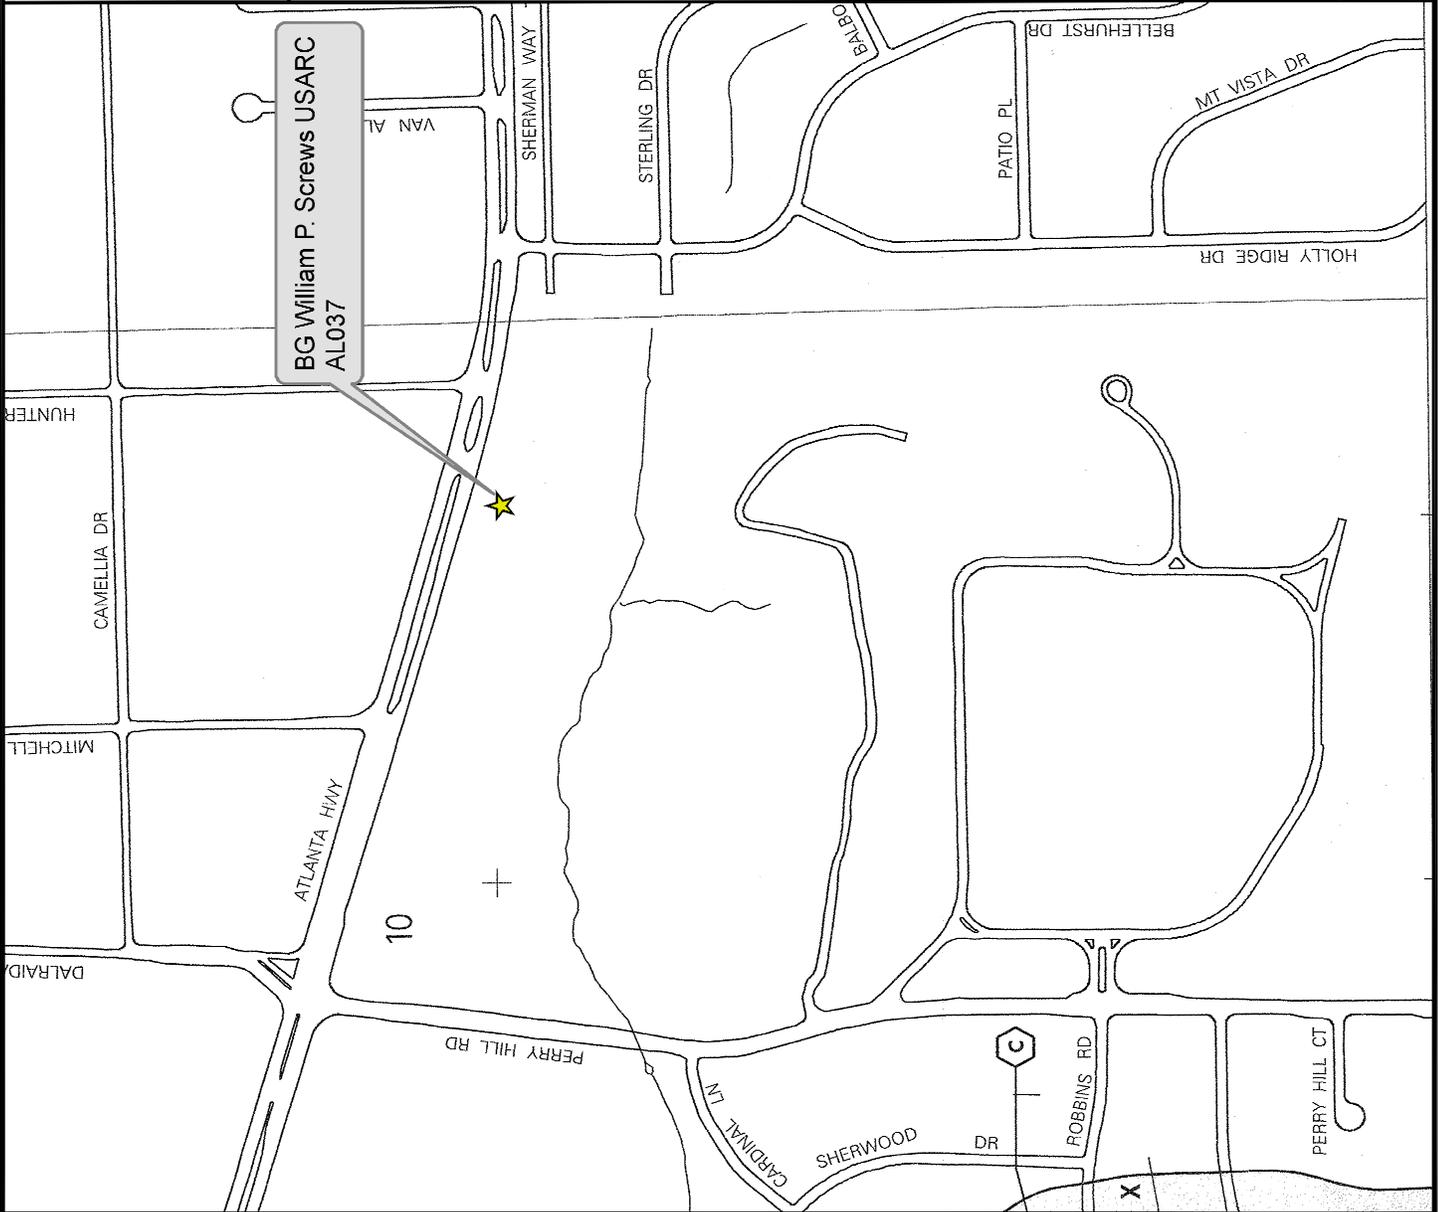
FIGURE 7
FLOOD INSURANCE RATE MAP
AL037 BG WILLIAM P. SCREWS USARC
4050 Atlanta Highway
Montgomery, Montgomery County, Alabama

A review of the FEMA digital Flood Hazard Area map indicates that the Site lies outside the 100-year floodplain. The nearest floodplain boundary is located approximately 1/2 mile to the southwest of the Site. Figure 7 in Appendix A shows the 4 August 2003, FIRM of the Site location.

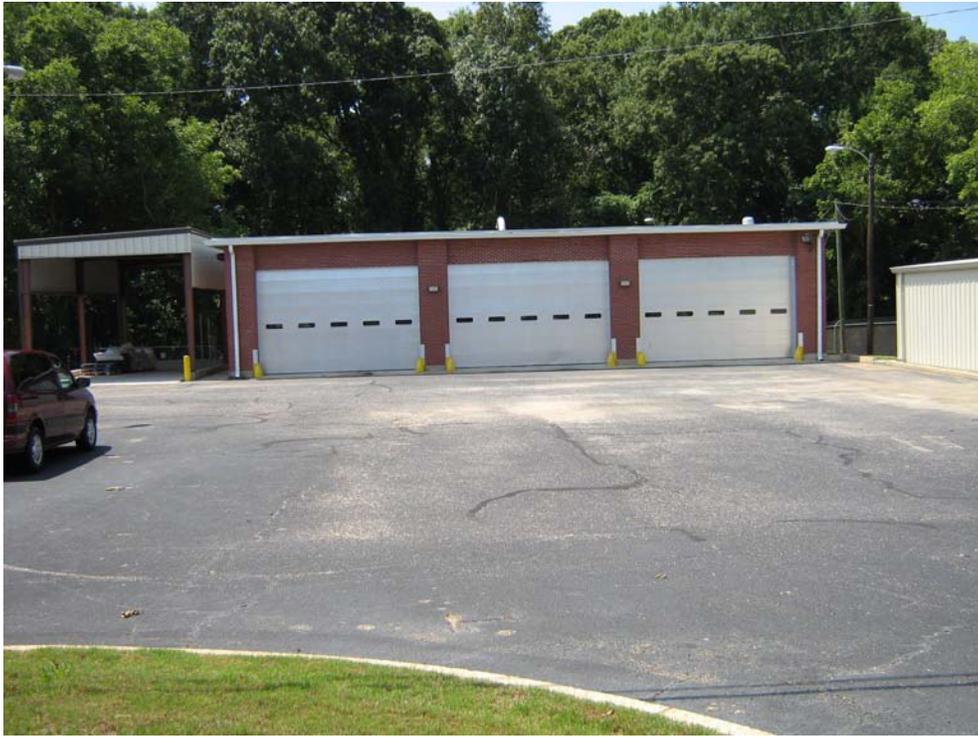
Photo 9: Front (North Side) of Former AMSA Building (circa 1959)

Vehicle washing occurred at the Wash Rack next to the former AMSA building (see Photograph 9 in Appendix B). A grated inlet was observed in the covered concrete pad of the Wash Rack. Runoff from washing activities flows to the grated inlet and is carried to an OWS located to the south of the Wash Rack. Based on discussions with site personnel and field observations, the OWS is still in place and was installed in 1997.

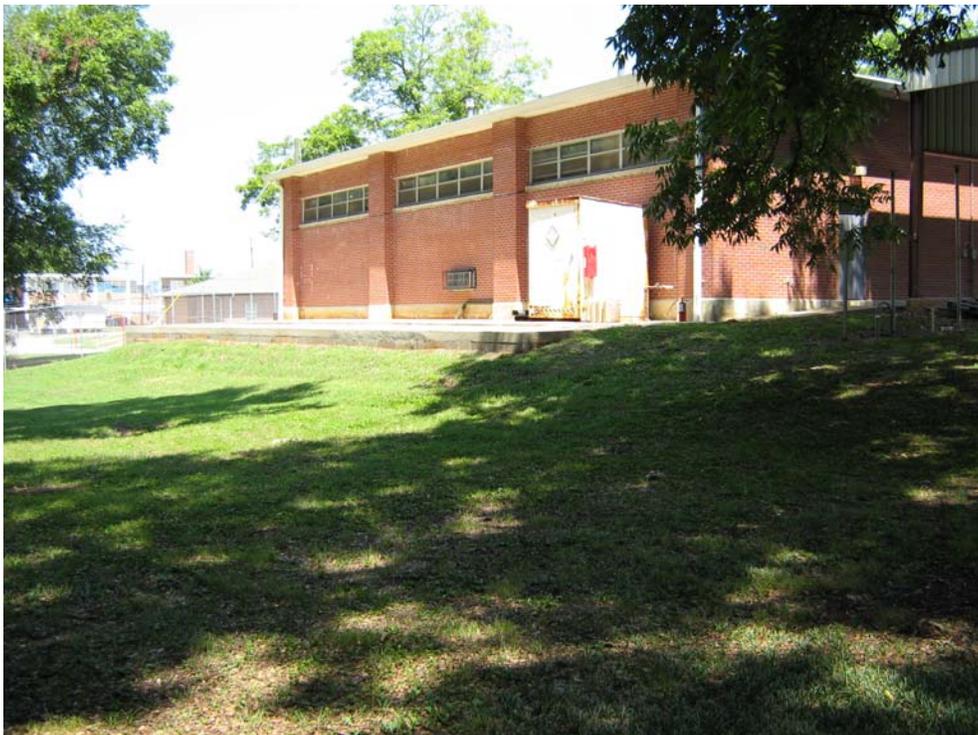
Photo 10: Rear (South Side) of Former AMSA Building (note HazMat Unit)

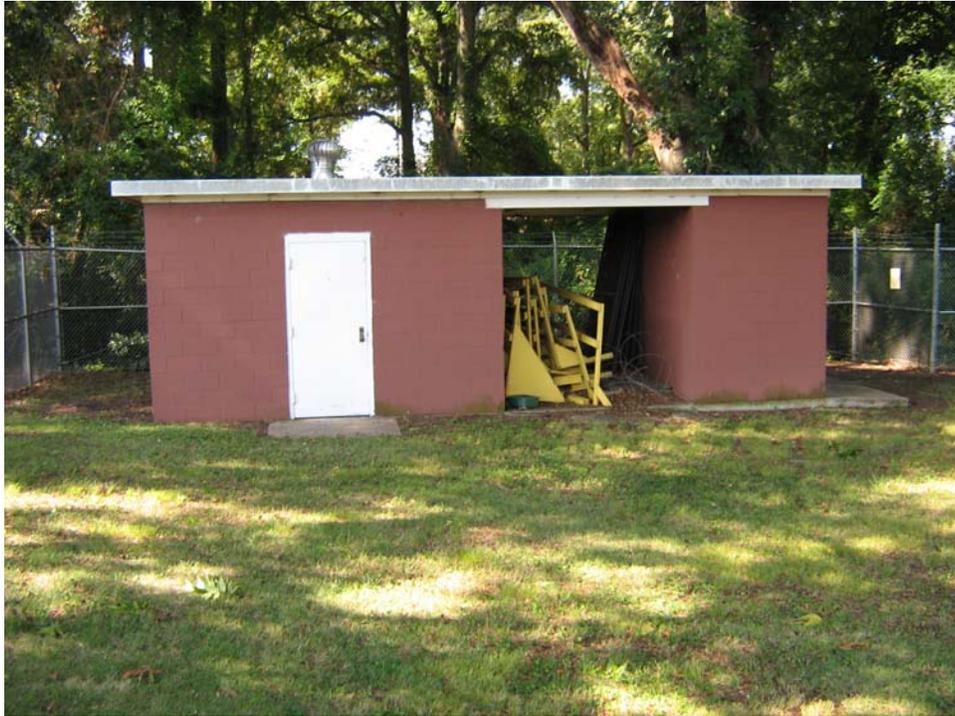
Photo 13: Former POL Building (Storage)

The 240 square-foot storage building located to the southeast of the former AMSA building was reportedly the former POL building for the facility. The building is rectangular in shape with a covered shed area on the west side. The building included signage for flammable materials, and three overpack drum container spill kits were observed inside the building. Photograph 13 in Appendix B is a general view of the storage building.

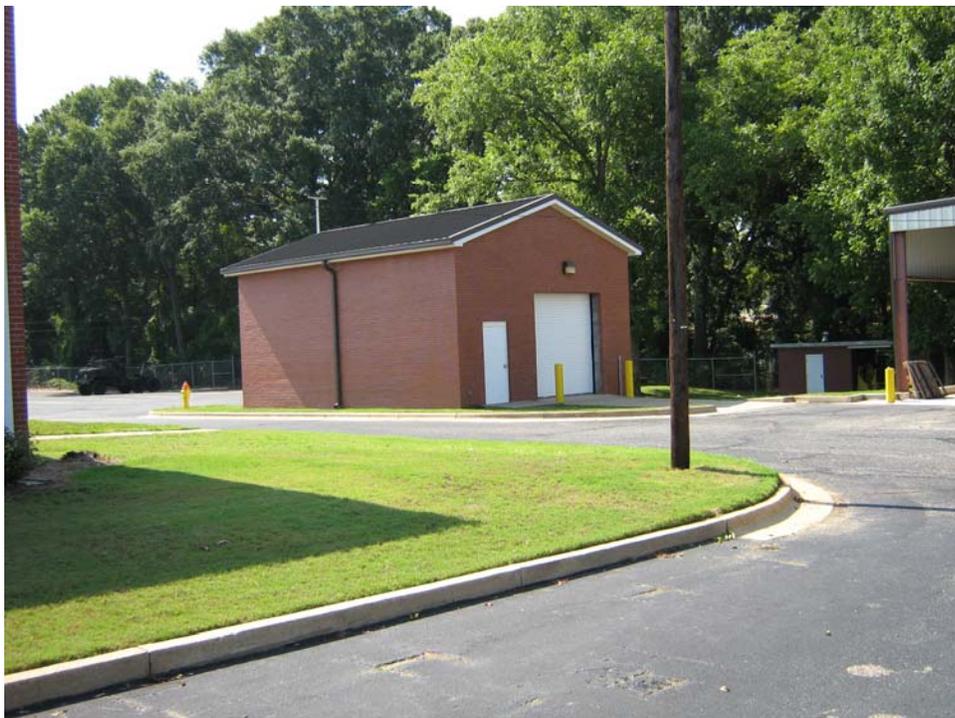
Photo 14: Brick Veneer Dry Storage Building (circa 1995)

The 720 square-foot storage building located to the northeast of the former AMSA building appeared to be used for dry storage of miscellaneous field equipment and supplies. Storage of hazardous materials was not observed in the building. Photograph 14 in Appendix B is a general view of the storage building.

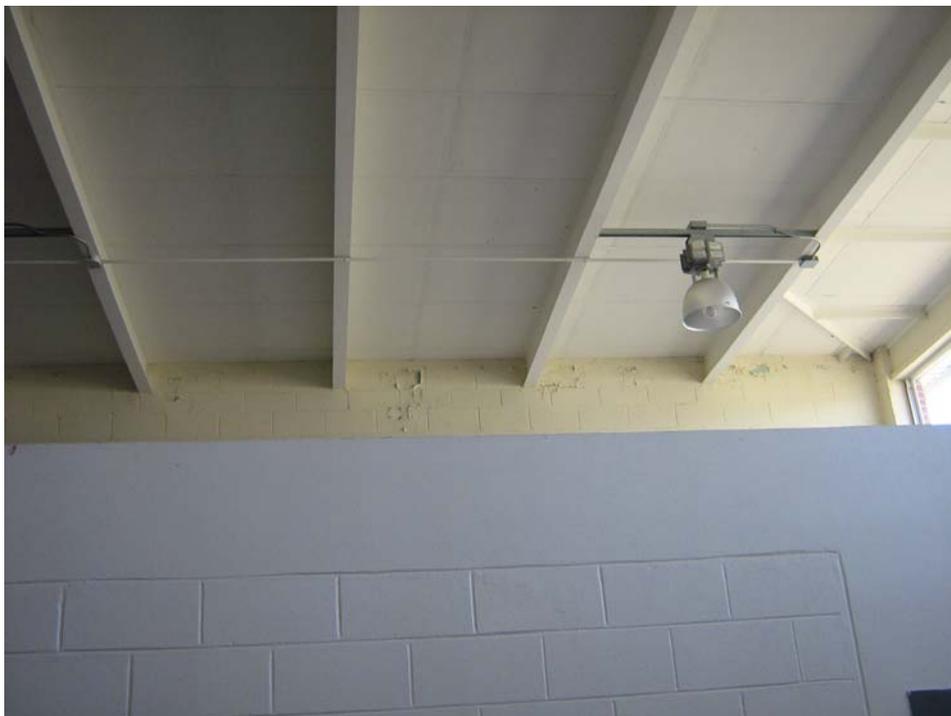
Photo 20: Peeling Paint on Wall in Drill Hall

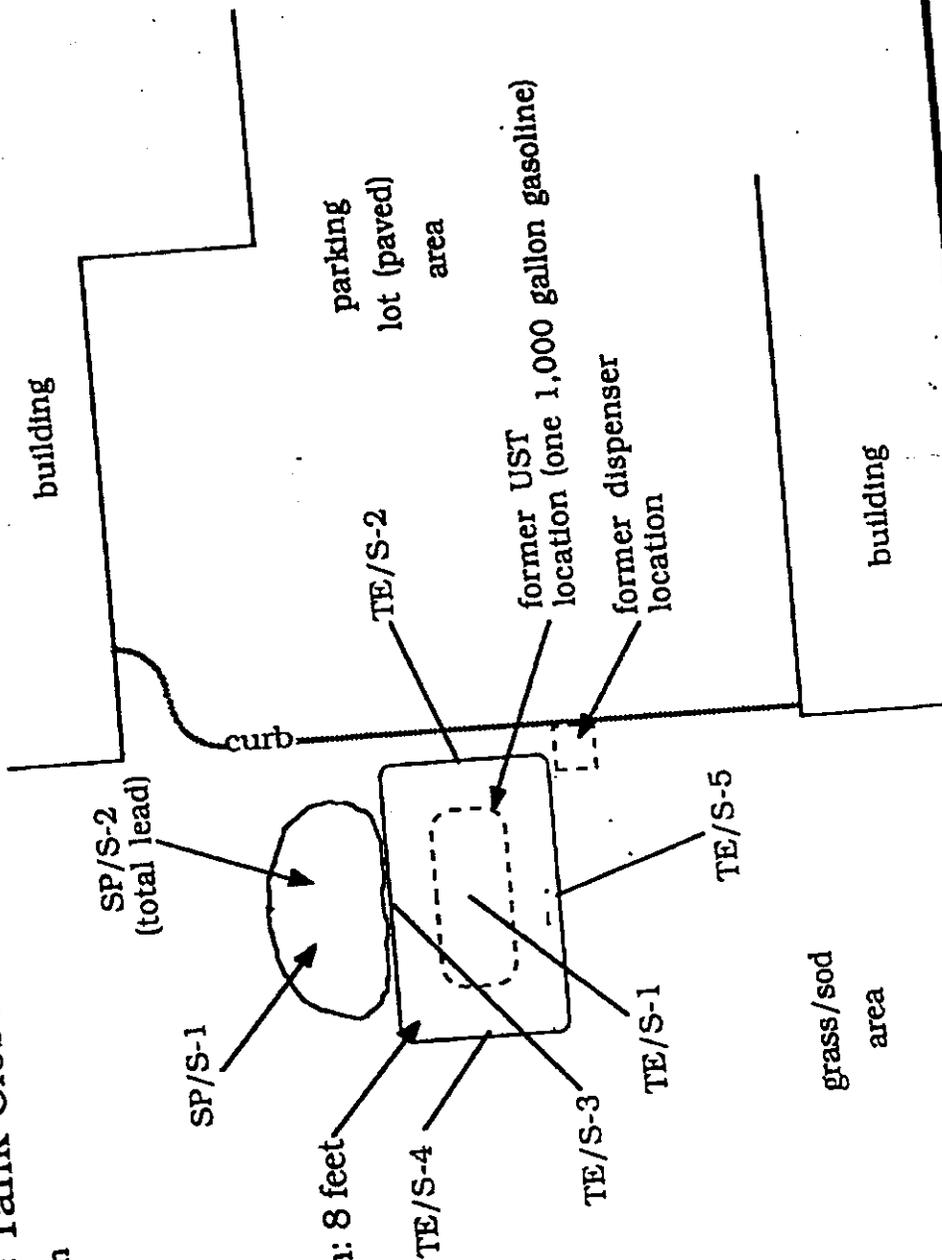
ANALYTICAL RESULTS	
TPH (PPM)	
TE/S-1	11.5
TE/S-2	<10
TE/S-3	<10
TE/S-4	<10
TE/S-5	<10
SP/S-1	<10
TOTAL LEAD (PPB)	
SP/S-2	<5

Screws USARTC Tank Excavation Cross-Sections

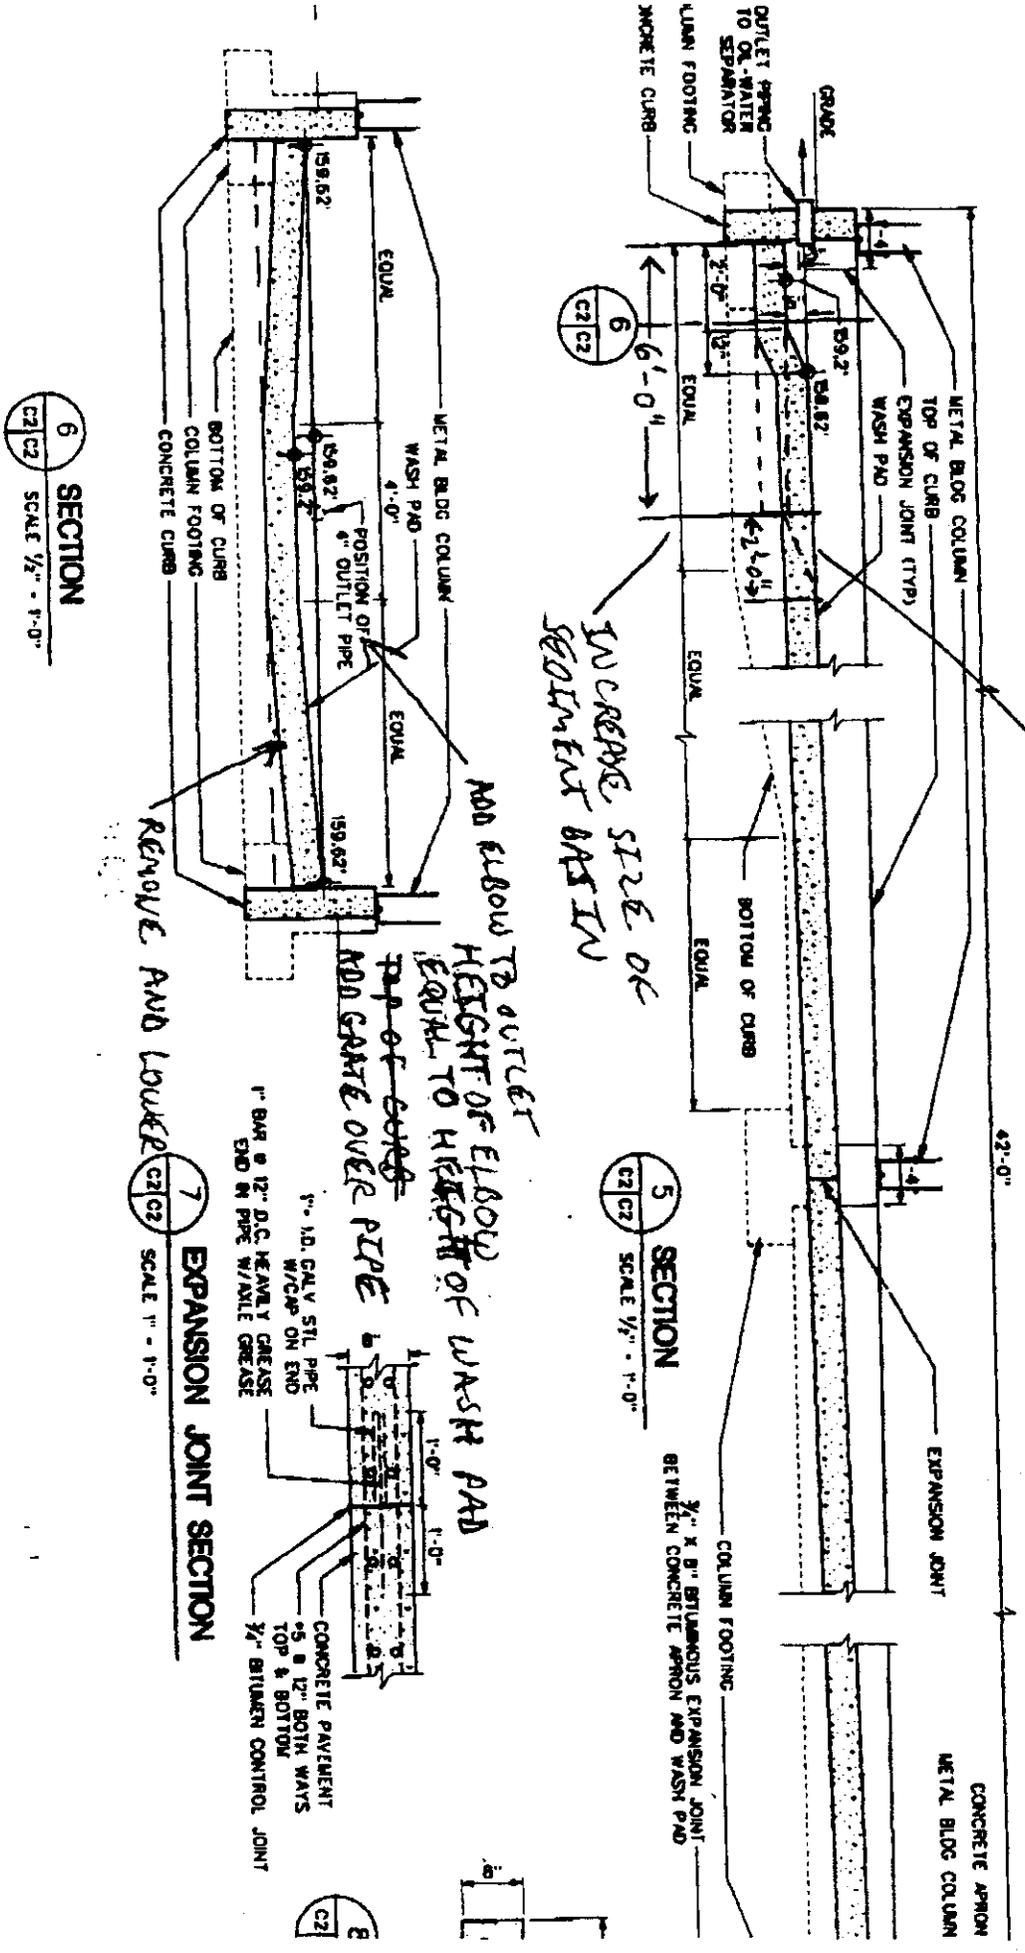
WASH RACK PLAN (DIMENSIONS)
SCALE 1/8" = 1'-0"

SECTION 6
SCALE 1/2" = 1'-0"

SECTION 5
SCALE 1/2" = 1'-0"

Design drawings dated June 1995 detail modifications to the Wash Rack to include concrete curbs, a steel structure and roof assembly, and a concrete surface sloped to drain to a center inlet discharging to a new OWS. The drawing directs that the OWS discharge to the sanitary sewer. Based on the July 2006 site reconnaissance, the improvements shown on the 1995 drawings represent the present appearance of the Wash Rack. Evidence of the current OWS, located south of the Wash Rack, was observed during the site reconnaissance.

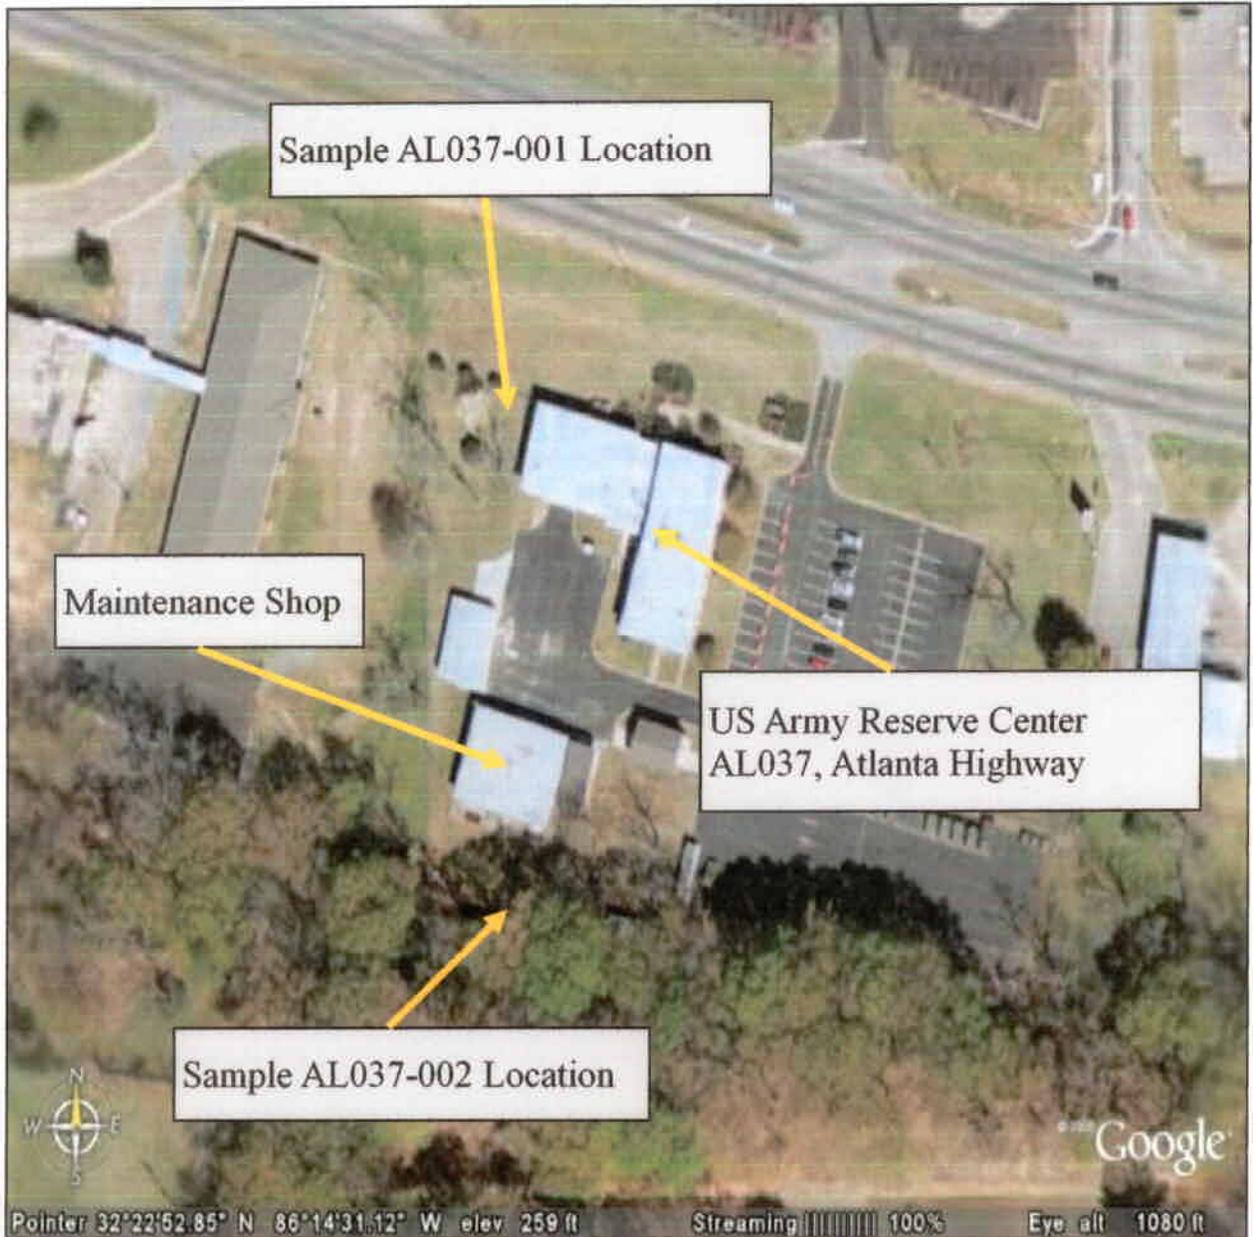
AL037 Sample Locations December 15, 2006

The weather conditions on December 15, 2006 were clear and cool with temperatures in the low to mid 60's. A stainless steel hand auger was utilized to reach sample depth. After reaching sample depth, the hand auger was cleaned with tap water and then rinsed thoroughly with deionized water.

Neither sample exhibited detectible levels of volatile or semi-volatile organic compounds (See Table 1). Specific compounds for which analysis was conducted can be found in the Laboratory Report found in Appendix B of this document.
