**ENVIRONMENTAL CONDITION OF
PROPERTY REPORT**

**FAITH WING
US ARMY RESERVE CENTER (AL079)
215 REGIMENTAL AVENUE
FORT MCCLELLAN, ALABAMA 36205**

FEBRUARY 2007

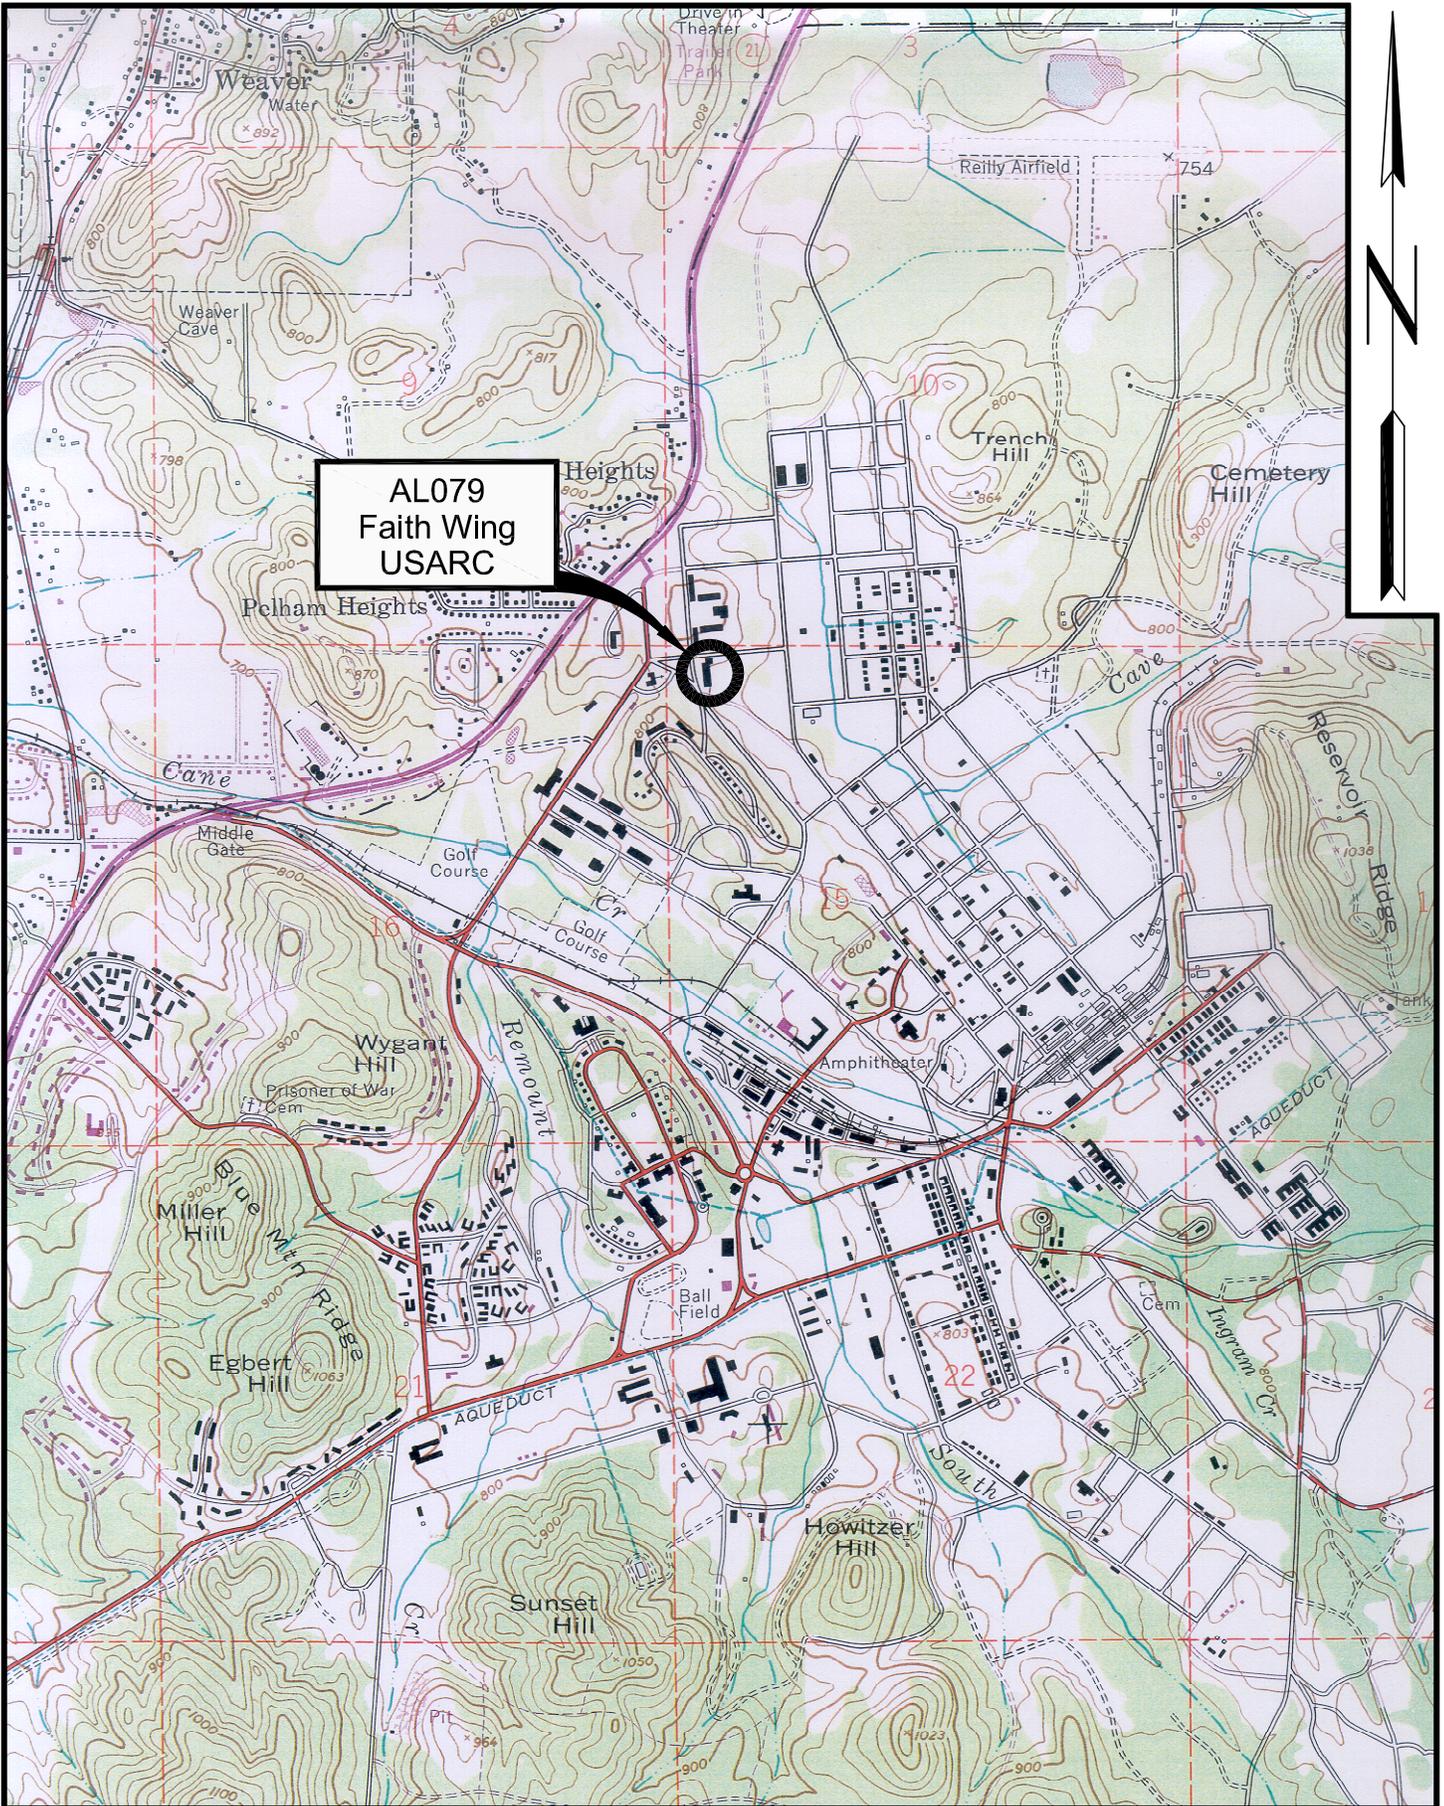
FIGURE 6
1972 USGS TOPOGRAPHIC MAP, ANNISTON, ALABAMA
AL079 FAITH WING USARC
215 Regimental Avenue
Fort McClellan, Calhoun County, Alabama

The 1972 USGS topographic map (Figure 6, in Appendix A) depicts conditions similar to those depicted in the 1956 map, except it appears that a structure located northeast of the Site location had been removed.

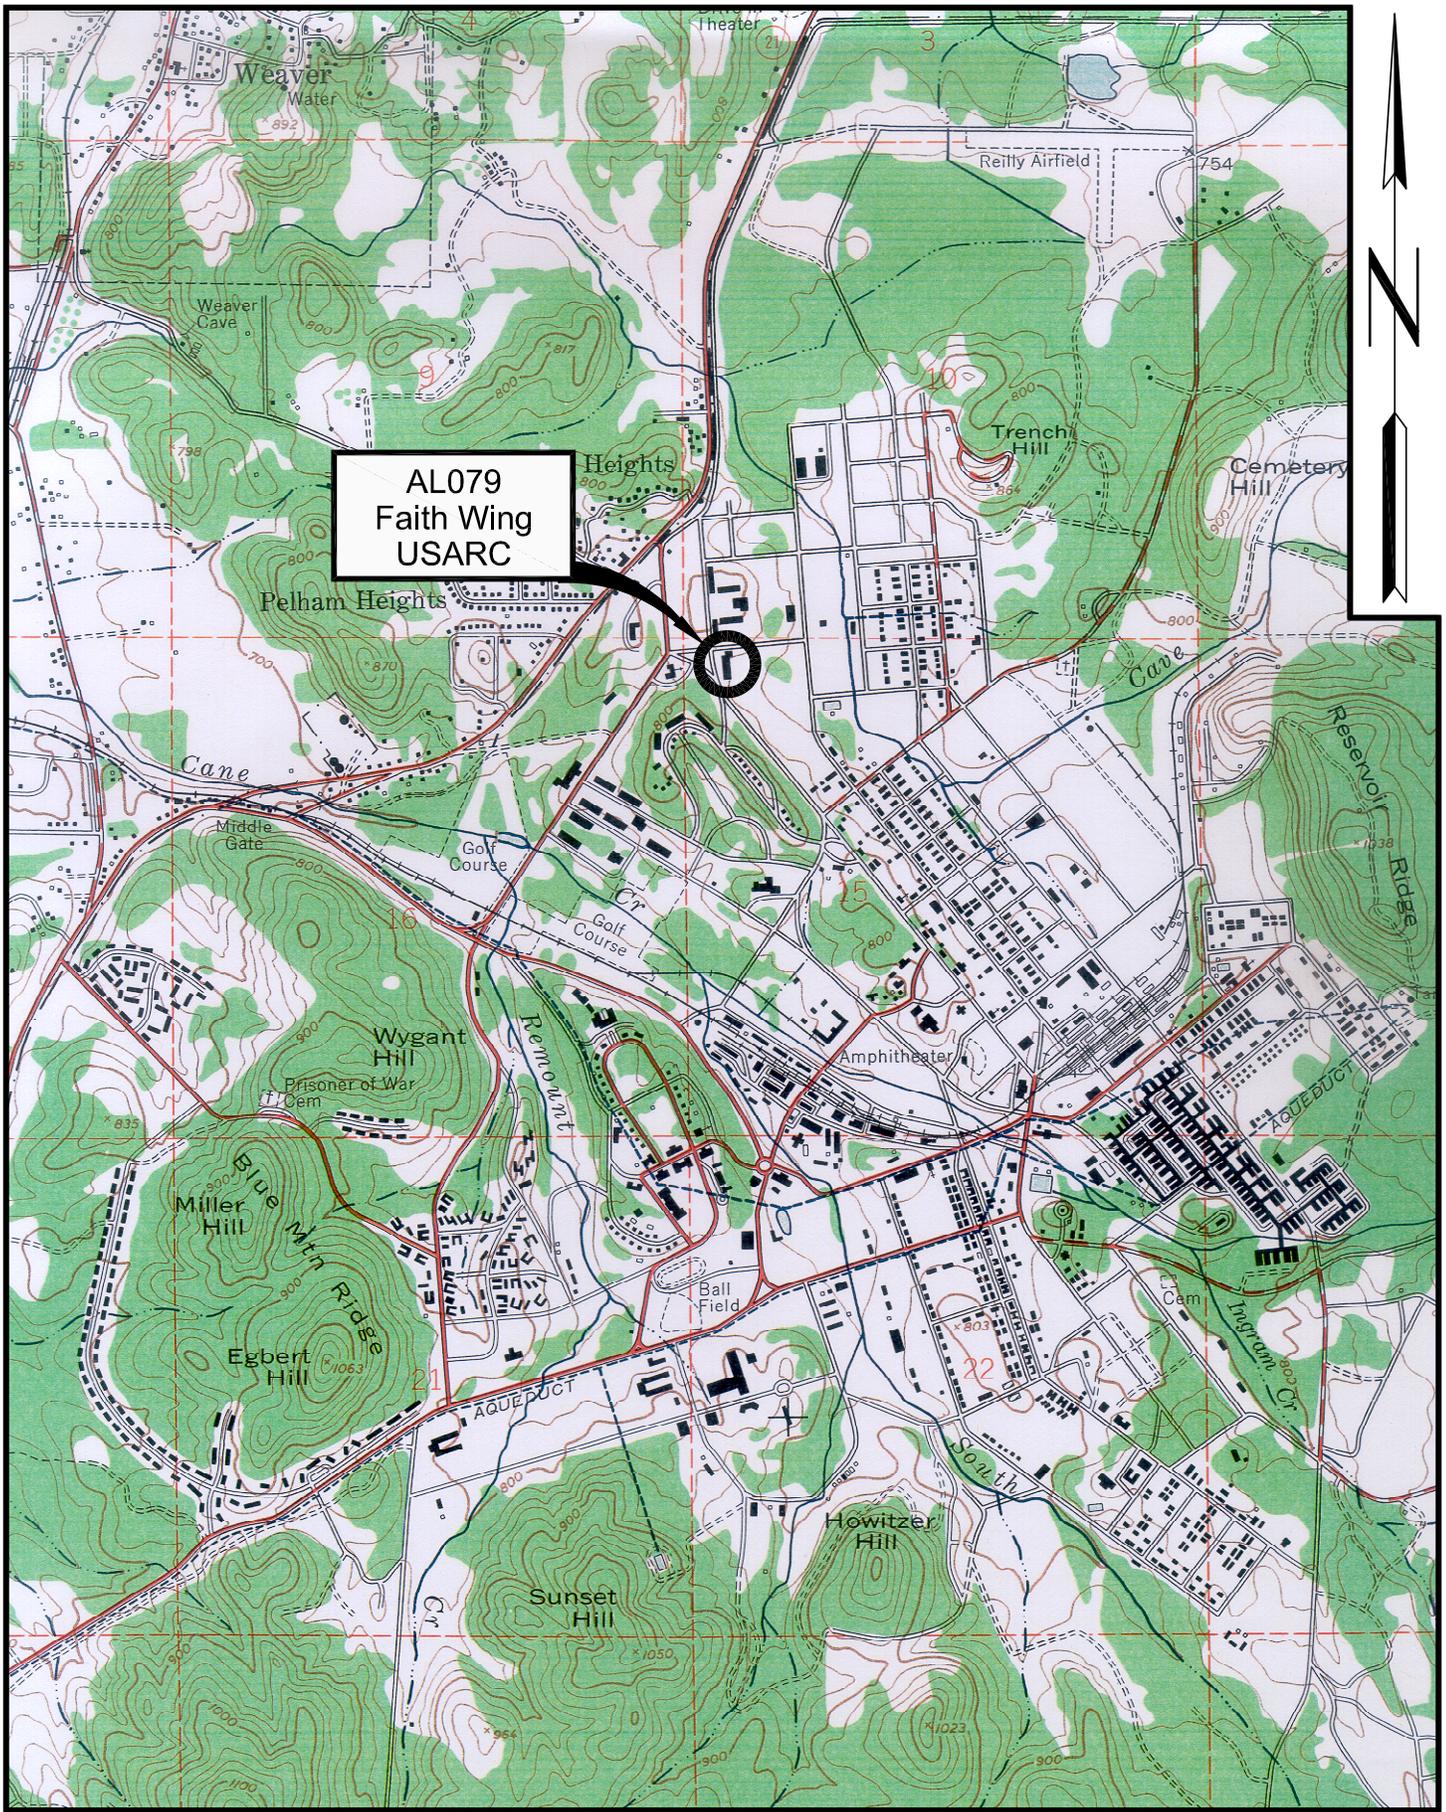
FIGURE 9
1956 USGS TOPOGRAPHIC MAP, ANNISTON, ALABAMA
AL079 FAITH WING USARC
215 Regimental Avenue
Fort McClellan, Calhoun County, Alabama

The 1956 USGS topographic map (Figure 9, in Appendix A) indicates that the structures depicted north of the Site location in the 1947 map had been removed and replaced by several structures that are similar in configuration to the present-day structures located north of Militia Avenue. Development of structures located to the southwest of the Site location is depicted. The map depicts no structures located to the east or southeast of the Site location.

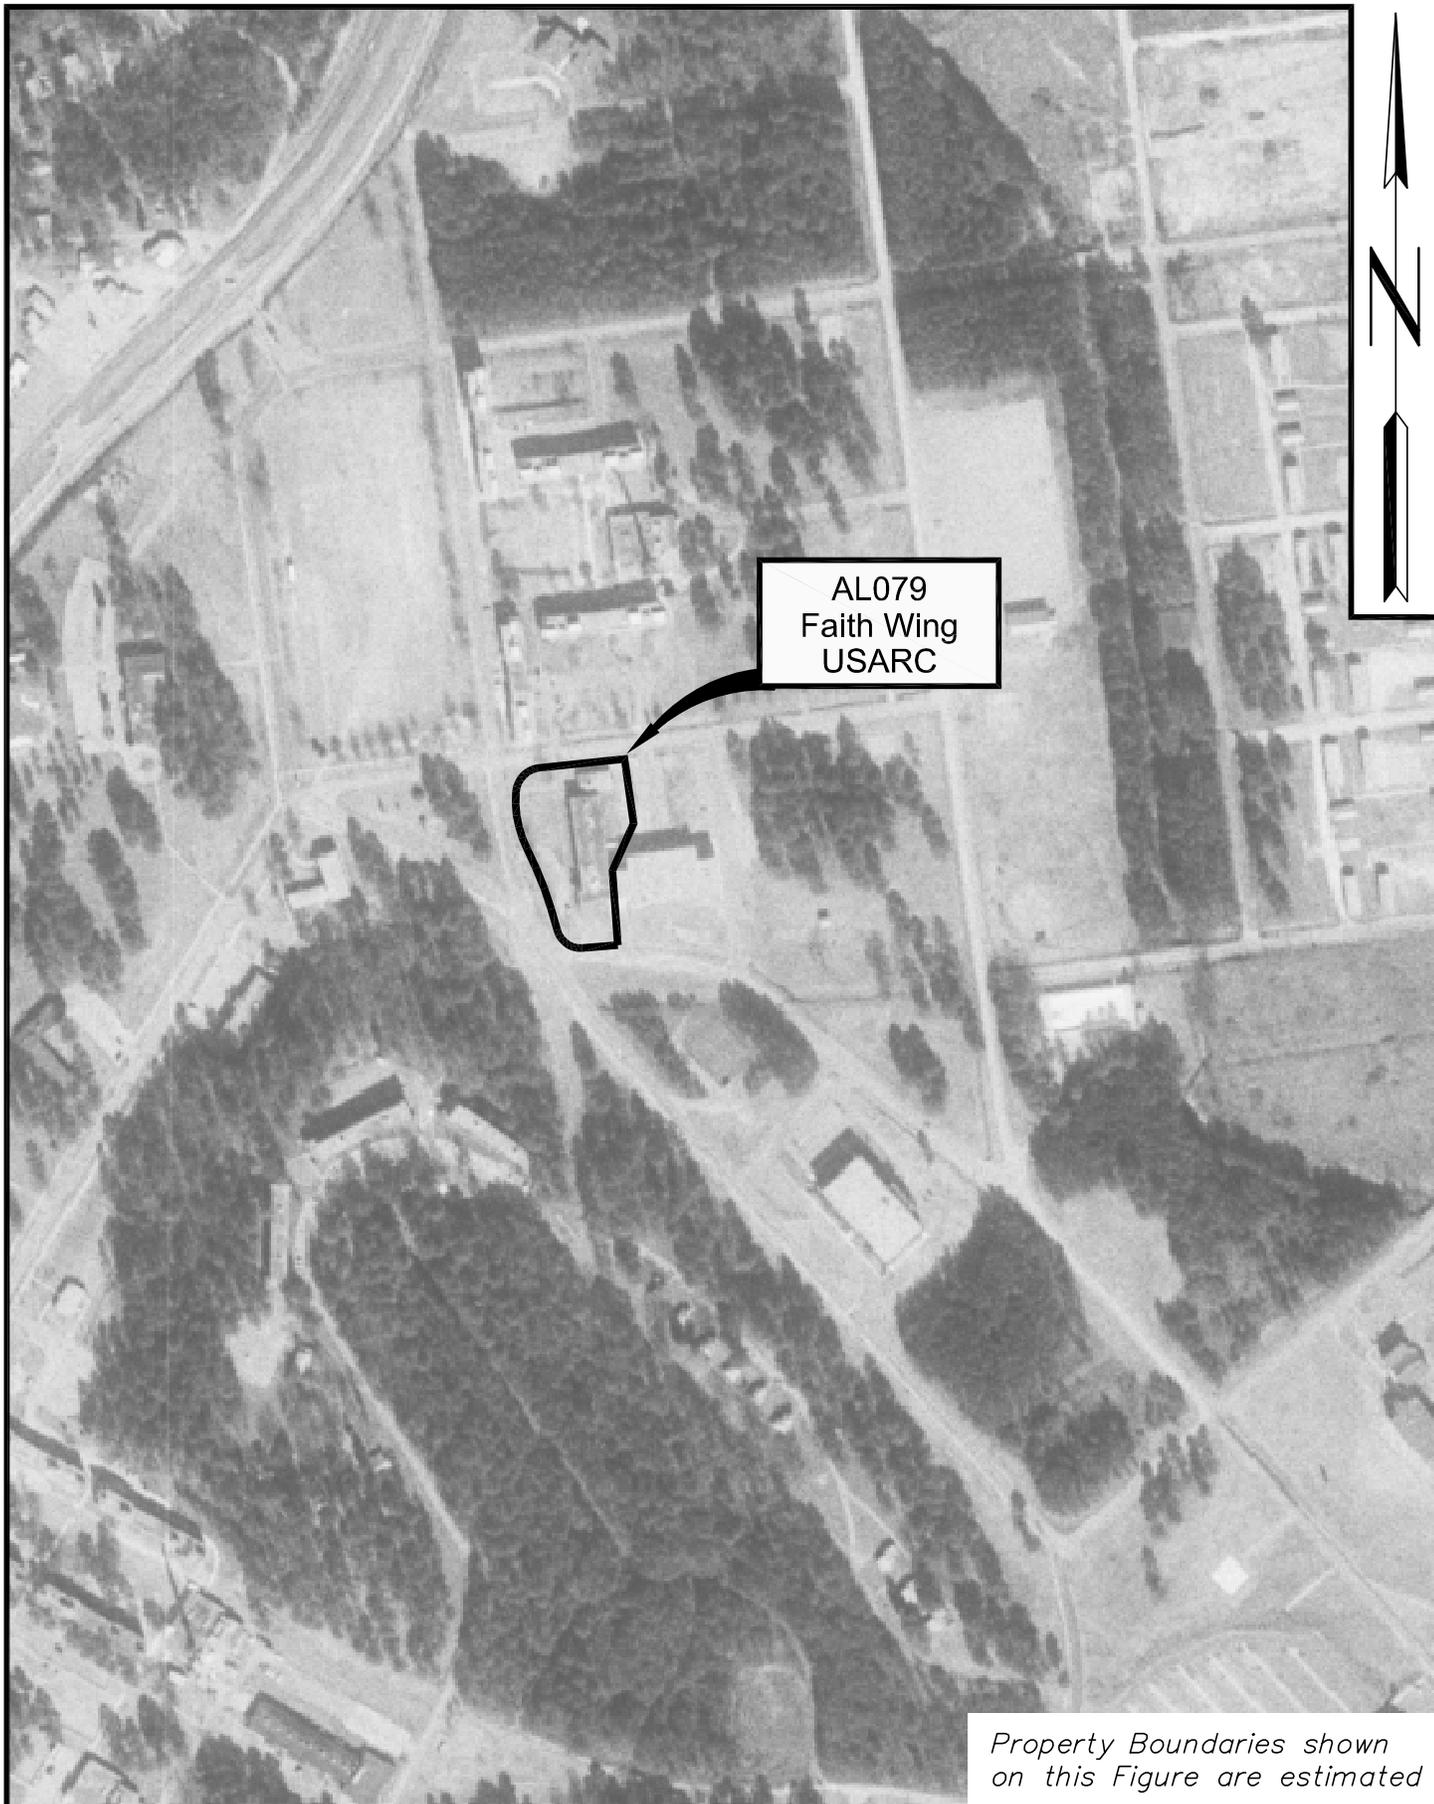
FIGURE 11
1981 AERIAL PHOTOGRAPH
AL079 FAITH WING USARC
215 Regimental Avenue
Fort McClellan, Calhoun County, Alabama

The 1981 USGS aerial photograph (Figure 11, in Appendix A) depicts conditions similar to that on the 1972 aerial photograph except that an east-west wing appears to have been added to the east side of the Faith Wing structure.

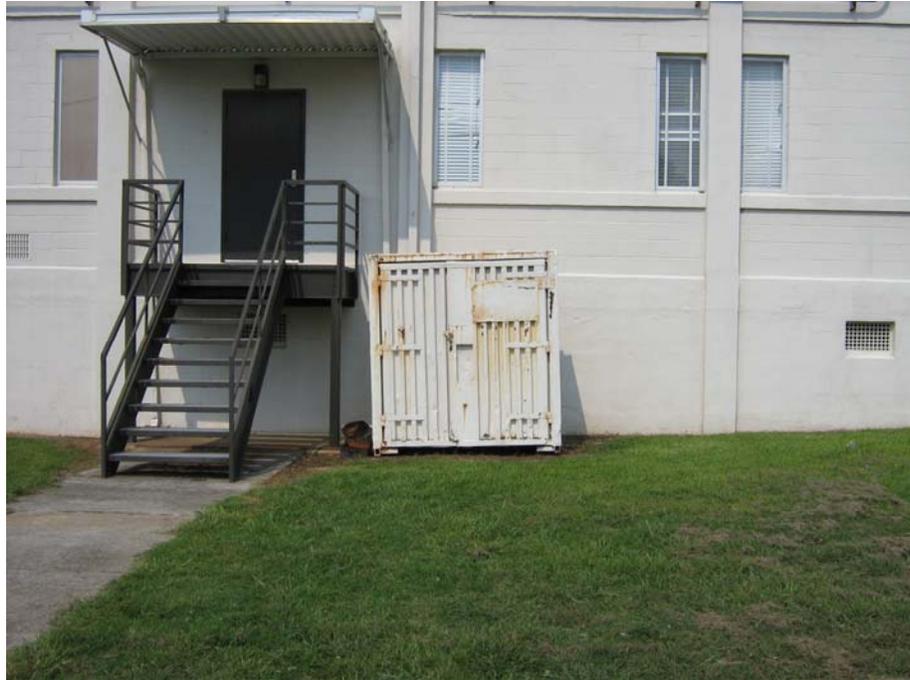
Photo 9: Hazardous Materials Storage Unit

The facility has a steel hazardous material storage shed located on the ground surface just outside the west entrance to the building, as shown in Photographs 9 and 10 in Appendix B.

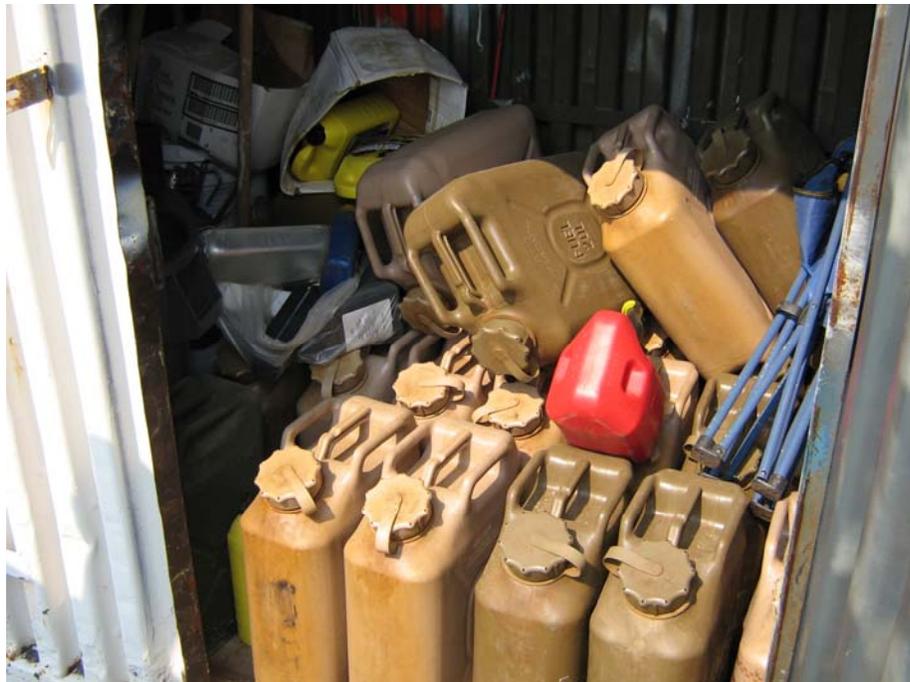
Photo 10: Materials Stored in HazMat Unit

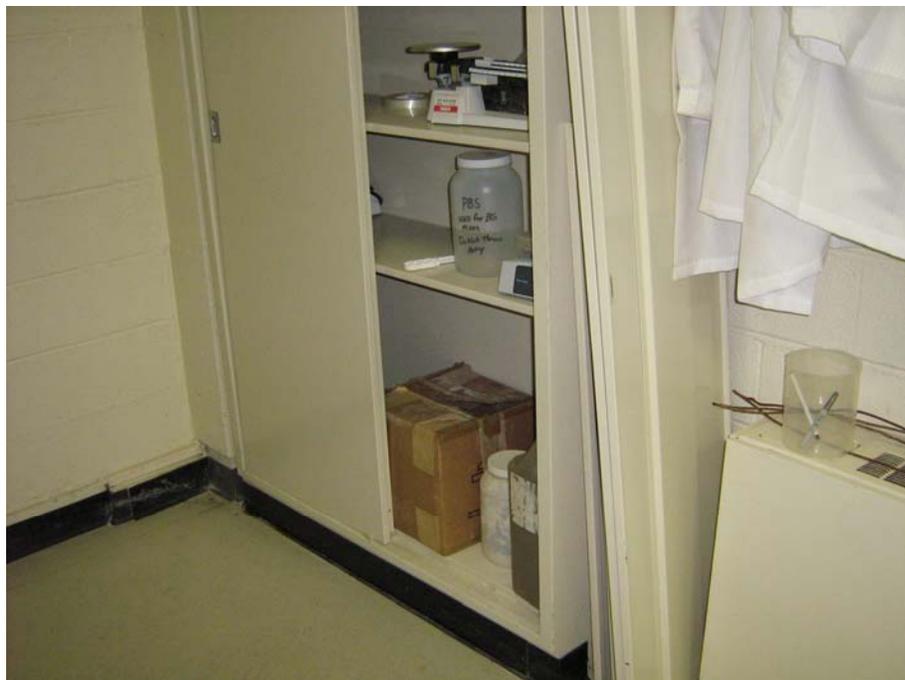
Photo 12: Mix Lab Storage of Biological Simulant, B-G

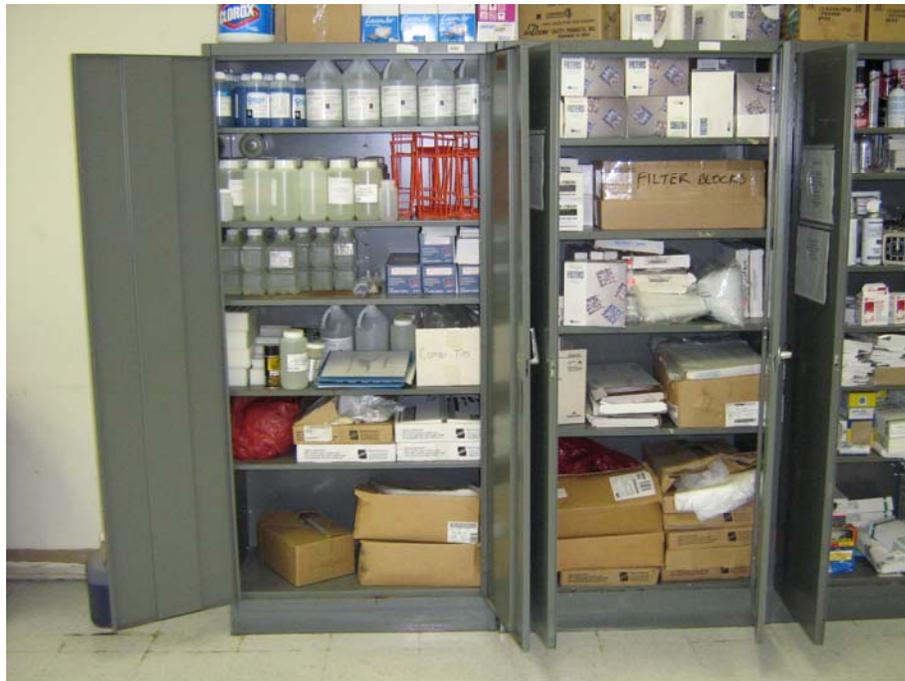
Photo 13: Storage of Various Fluids Used in Training Mission

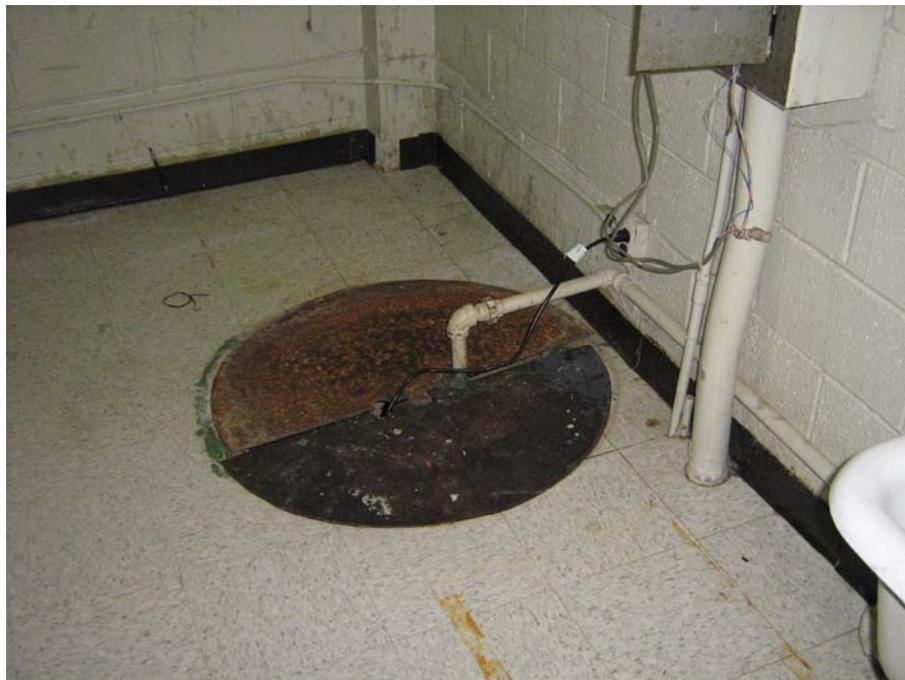
Photo 14: Sump and Pump in Basement

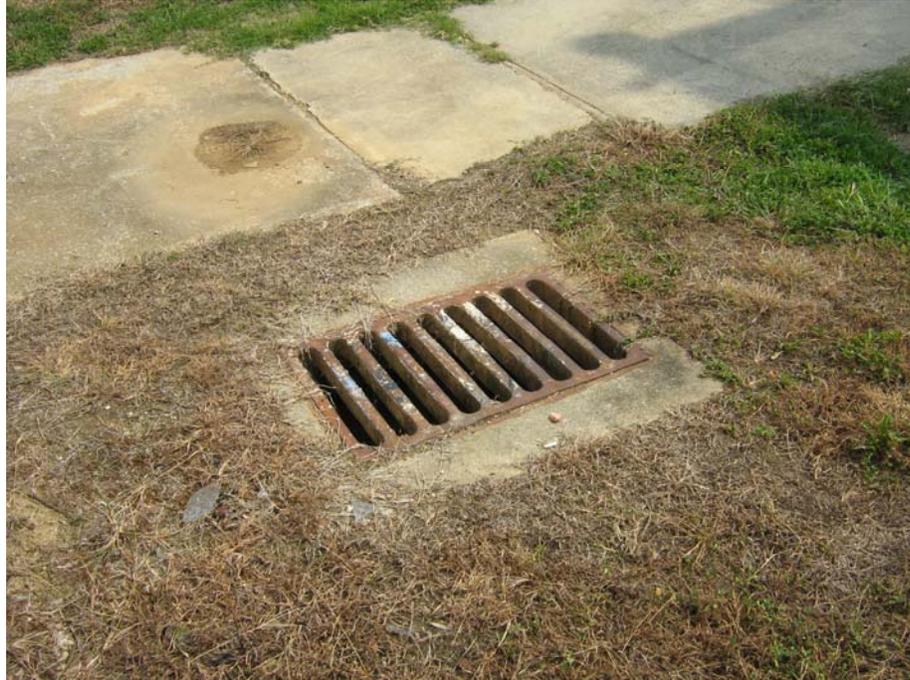
Photo 15: Yard Drain Grated Inlet with Paint Stains

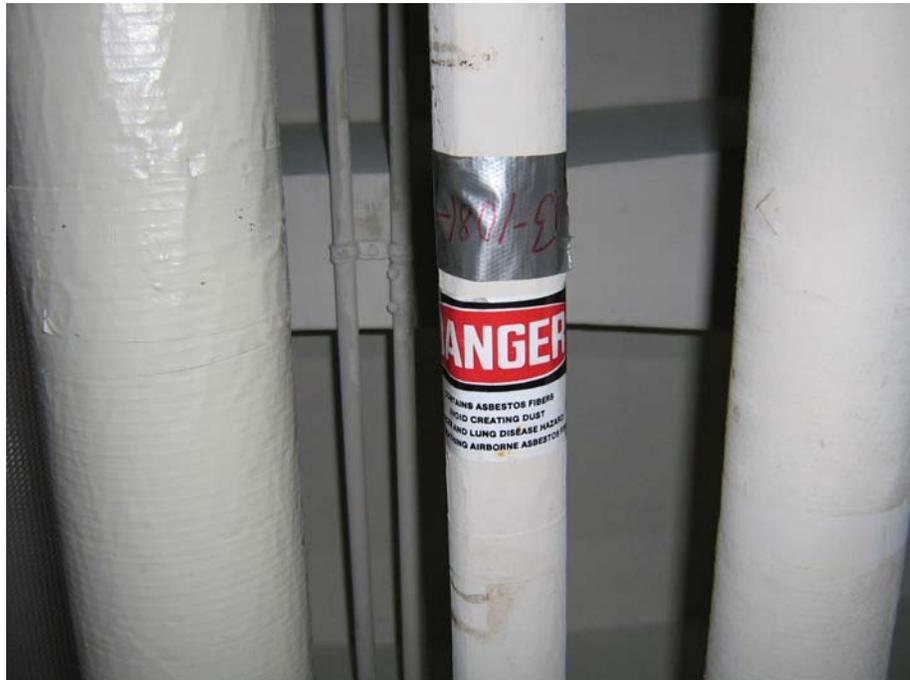
Photo 16: Asbestos-Containing Pipe Insulation in Basement

An asbestos inspection of the building was conducted in November 2006, after the site visit had been conducted for this ECP report. Asbestos sampling confirmed that pipe insulation in Room B-104 in the basement of the building was friable ACM, and was noted to be in good condition with no damage. The report also noted that ACM in the form of pipe insulation may be located in an inaccessible area above the ceiling in Room B-101 in the basement of the building.

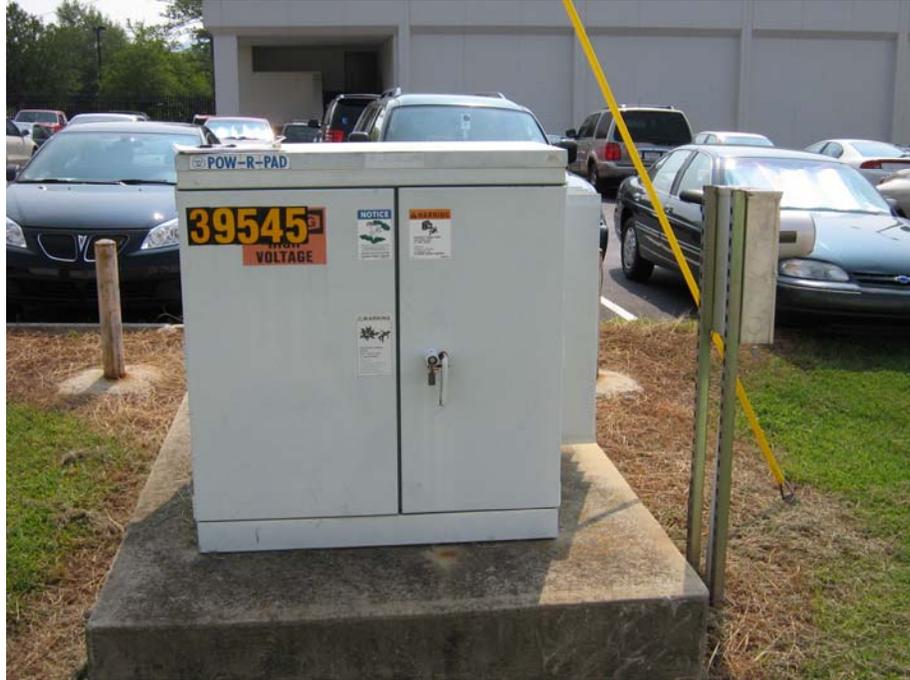
Photo 17: Pad-Mount Transformer on East Side of Building

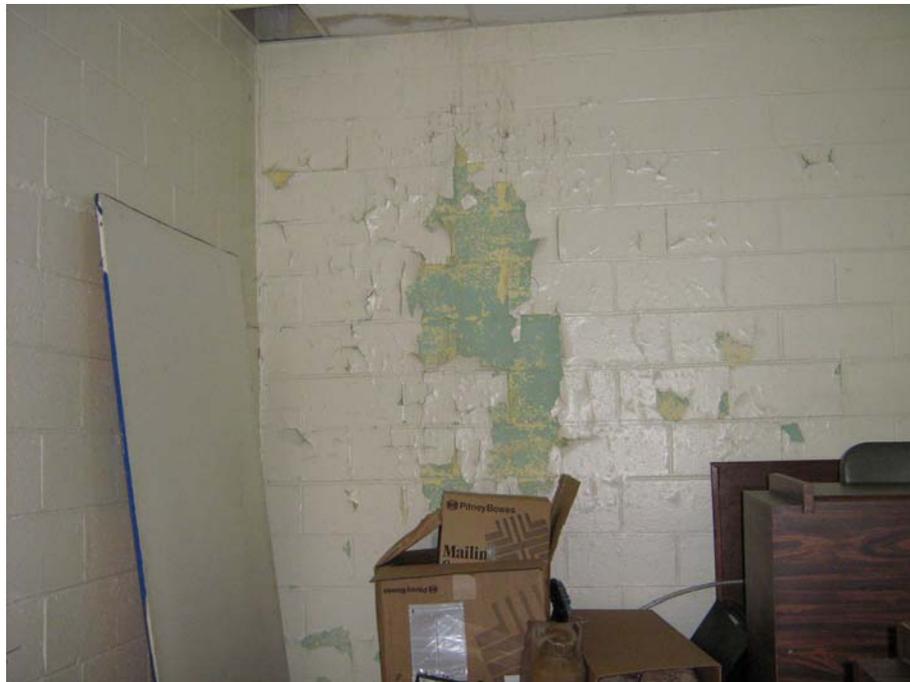
Photo 18: Severely Peeling Paint in Training Room near North Side of Building

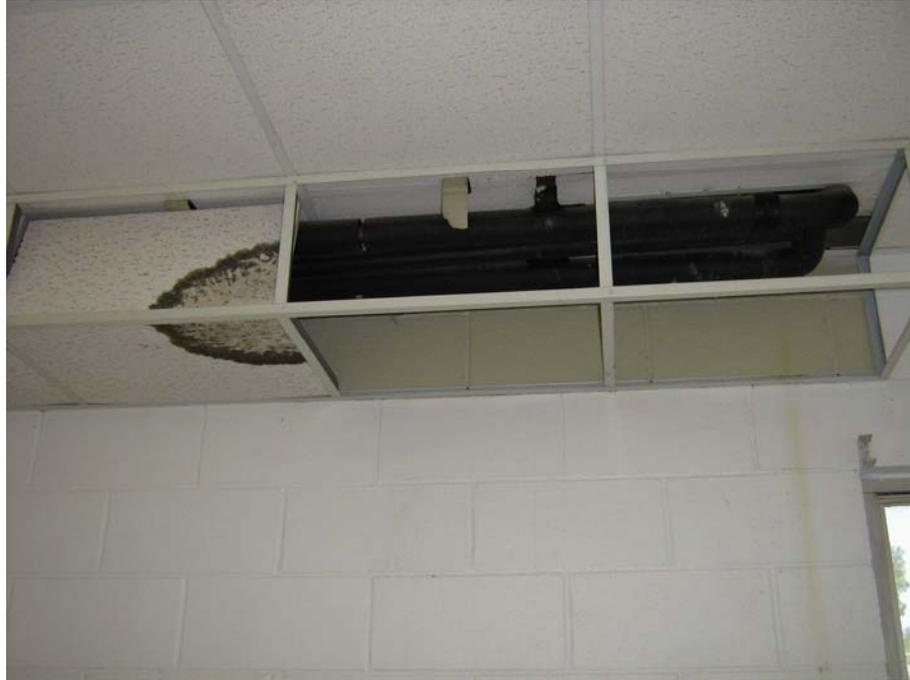
Photo 19: Mold Growth on Ceiling Tile around Leaking Pipe (1st Floor)

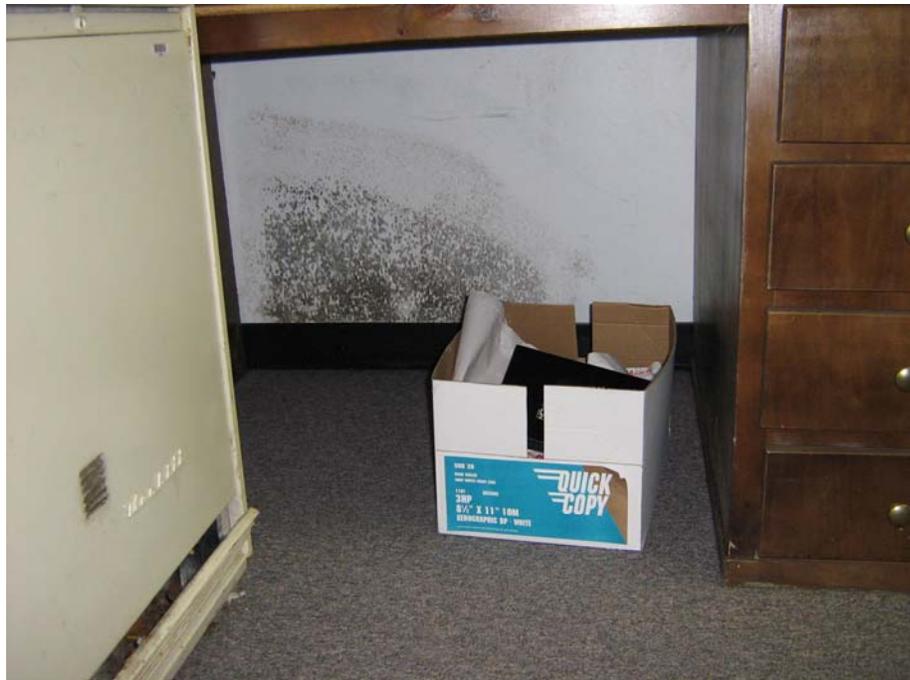
Photo 20: Mold Growth on Wall (1st Floor Storage Room)

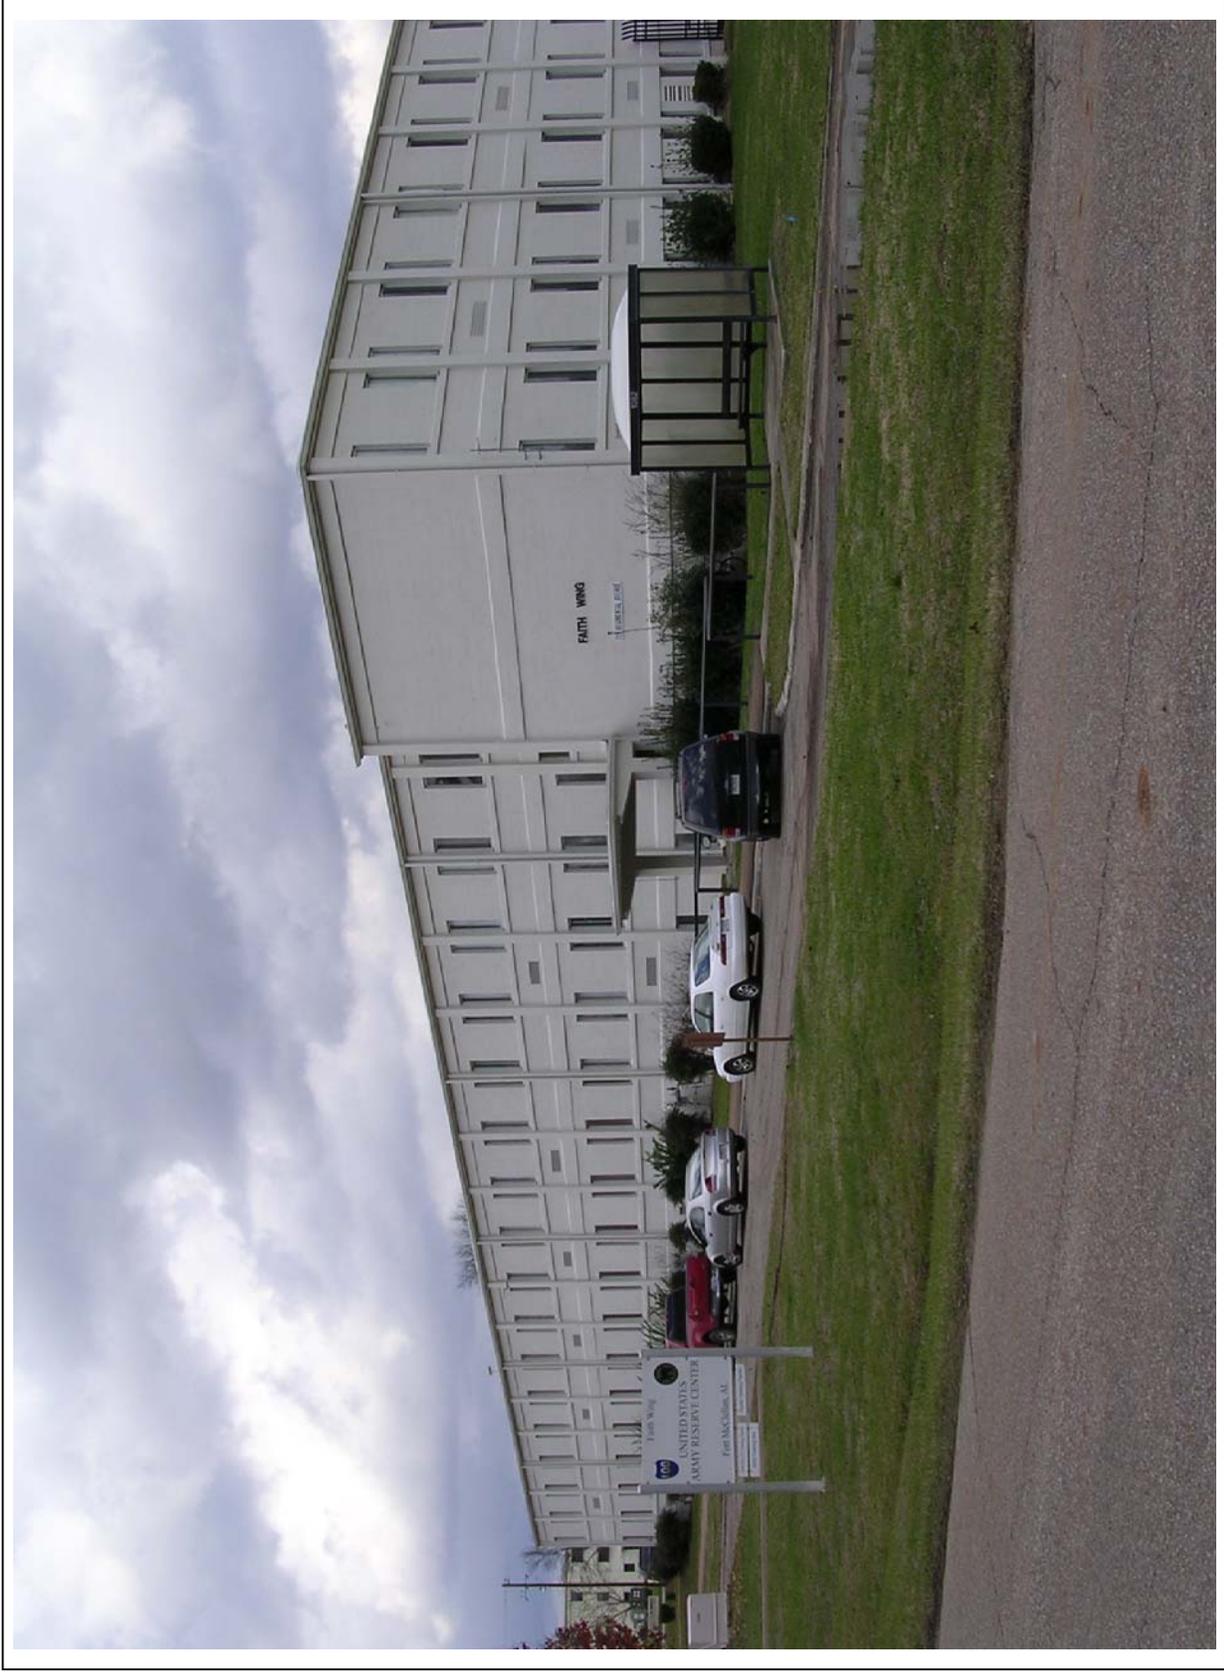
Building 1081 (Faith Wing) - Main Reserve Building
US Army Reserve Center - Ft McClellan, AL (AL079)

The room numbers shown on the CADD drawings and referenced in this report were assigned by the inspectors at the time of inspection unless previous room numbers were assigned and displayed.

Some room numbers are prefixed by a letter to indicate the type of room; **E** indicates an entry to the building, **H** indicates a hallway, **R** indicates a roof, **S** indicates a stairwell, **A** is an attic area and **B** indicates basement rooms.

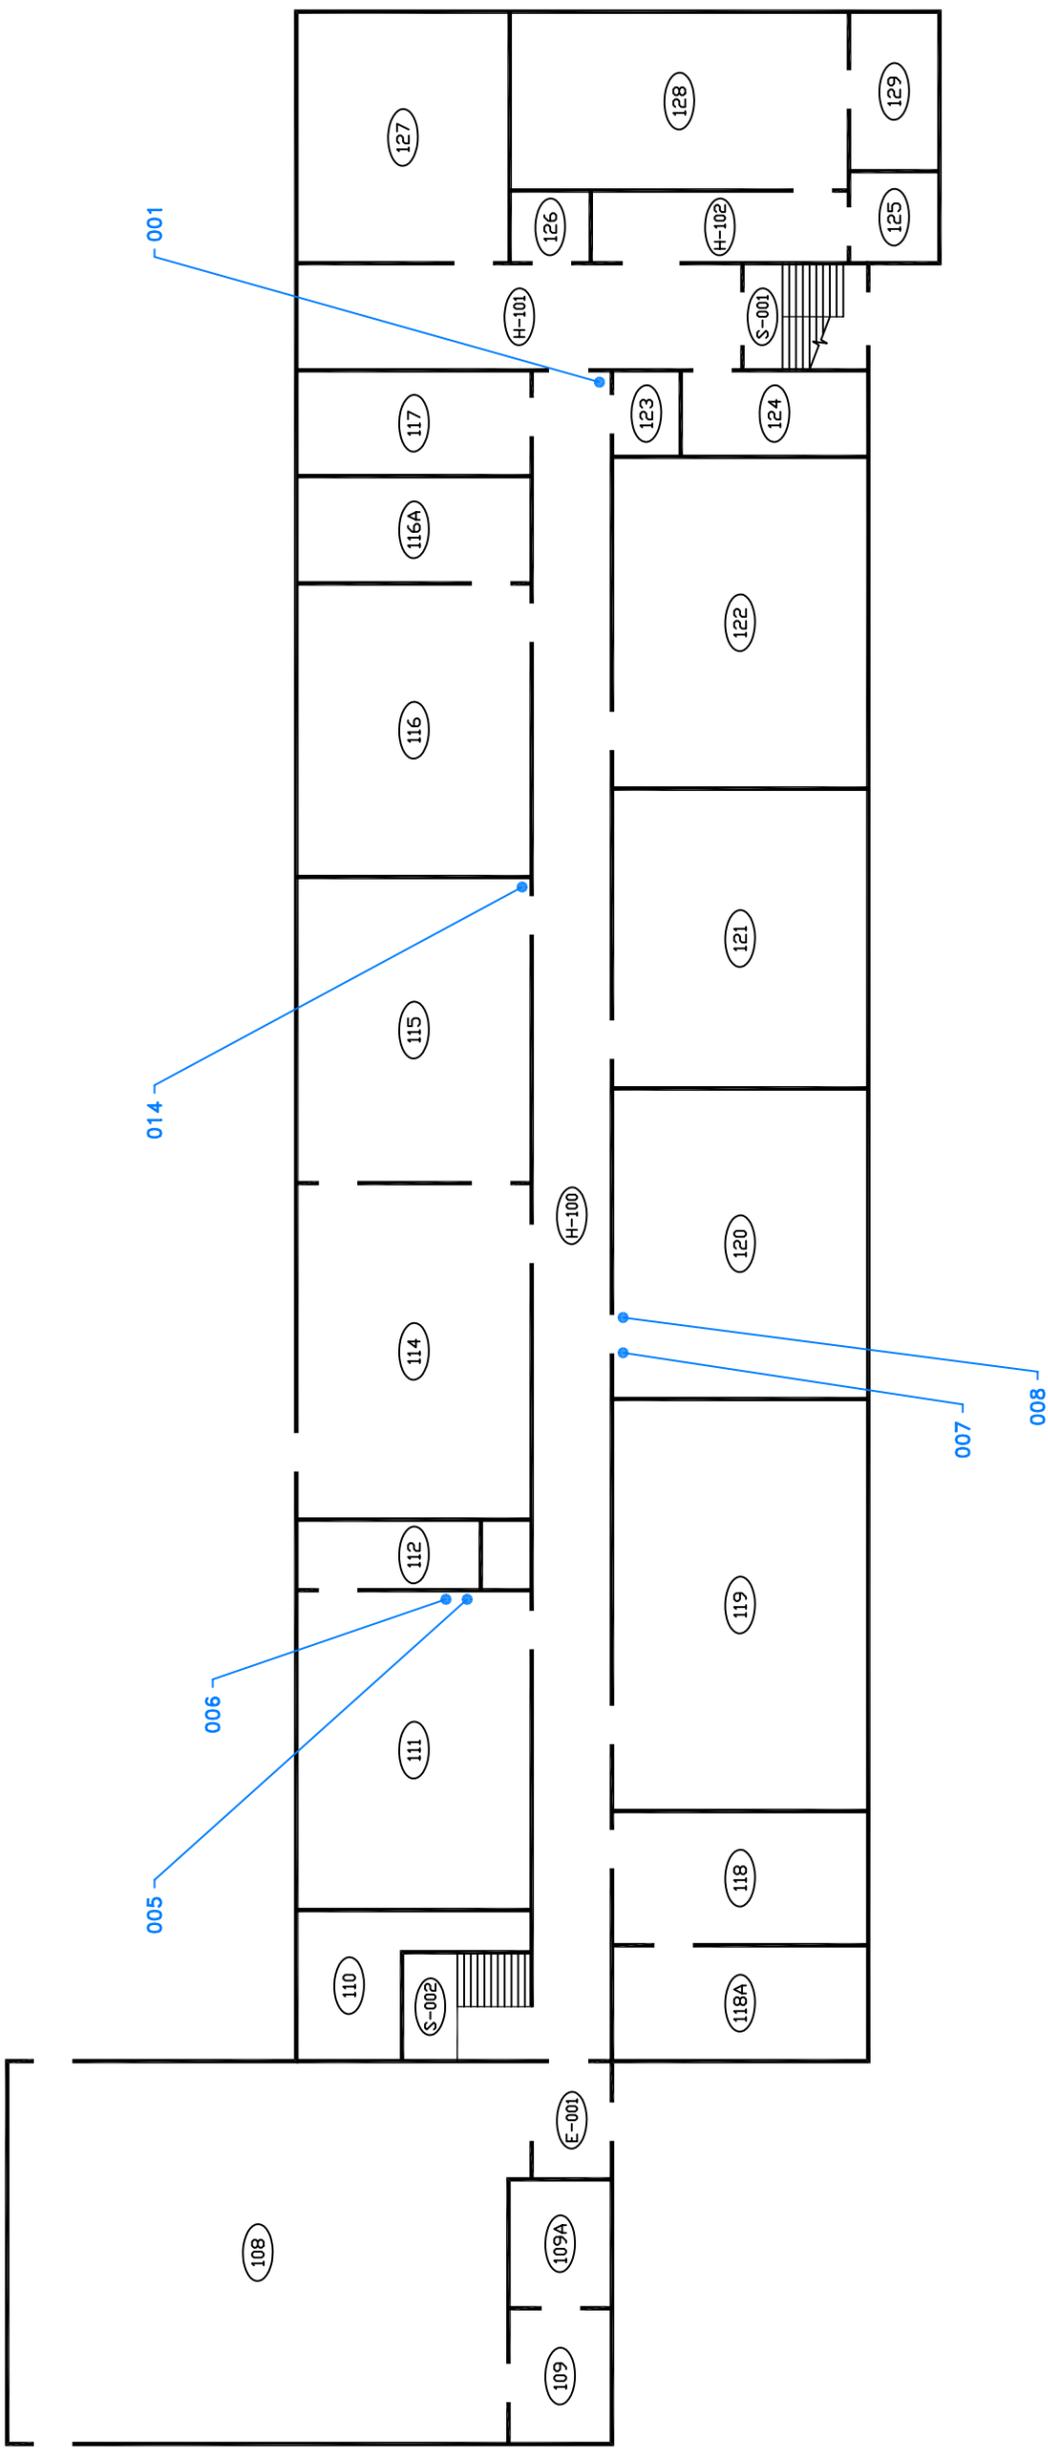
- (XXX) --- Indicates unique room number assigned by inspector
- XXX --- Indicates sample locations which tested positive for asbestos

ENVIRONMENTAL ENTERPRISE GROUP, INC. 1345 Barracks Rd. NORTH CHARLESTON, SOUTH CAROLINA 29405	
ASBESTOS SAMPLE LOCATIONS BUILDING 1081 - FIRST FLOOR ARC FT MCCLELLAN (AL079) FT MCCLELLAN, ALABAMA	
DATE 01-28-05	PREPARED BY T. LEWIS
SCALE NONE	DWG NUMBER eeeginc_AL079_Bldg1081_1st Fl
	DRAWN BY J.J. BROWNLEE
	REV -
	SHEET 1 OF 1

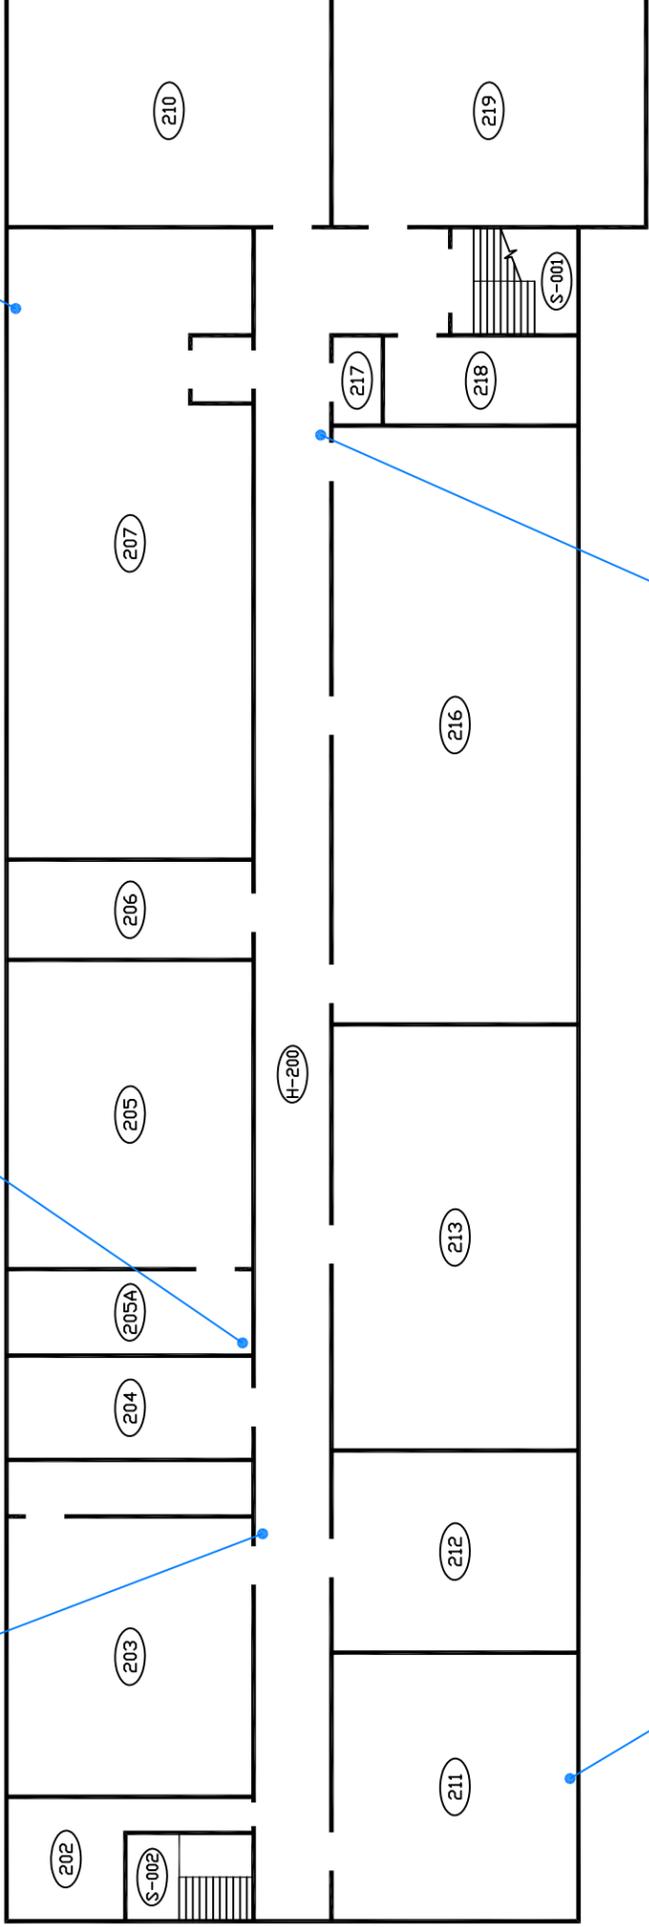
- (XXX) --- Indicates unique room number assigned by inspector
- XXX --- Indicates sample locations which tested positive for asbestos

ENVIRONMENTAL ENTERPRISE GROUP, INC. 1345 Barracks Rd. NORTH CHARLESTON, SOUTH CAROLINA 29405			
ASBESTOS SAMPLE LOCATIONS BUILDING 1081 - SECOND FLOOR ARC FT MCCLELLAN (AL079) FT MCCLELLAN, ALABAMA			
DATE	PREPARED BY	DRAWN BY	REV
01-28-05	T. LEWIS	J.J. BROWNLEE	-
SCALE	DWG NUMBER	SHEET	1 OF 1
NONE	eeeginc_AL079_Bldg1081_2nd Fl
