**ENVIRONMENTAL CONDITION OF
PROPERTY REPORT**

**FAITH WING
US ARMY RESERVE CENTER (AL079)
215 REGIMENTAL AVENUE
FORT MCCLELLAN, ALABAMA 36205**

FEBRUARY 2007

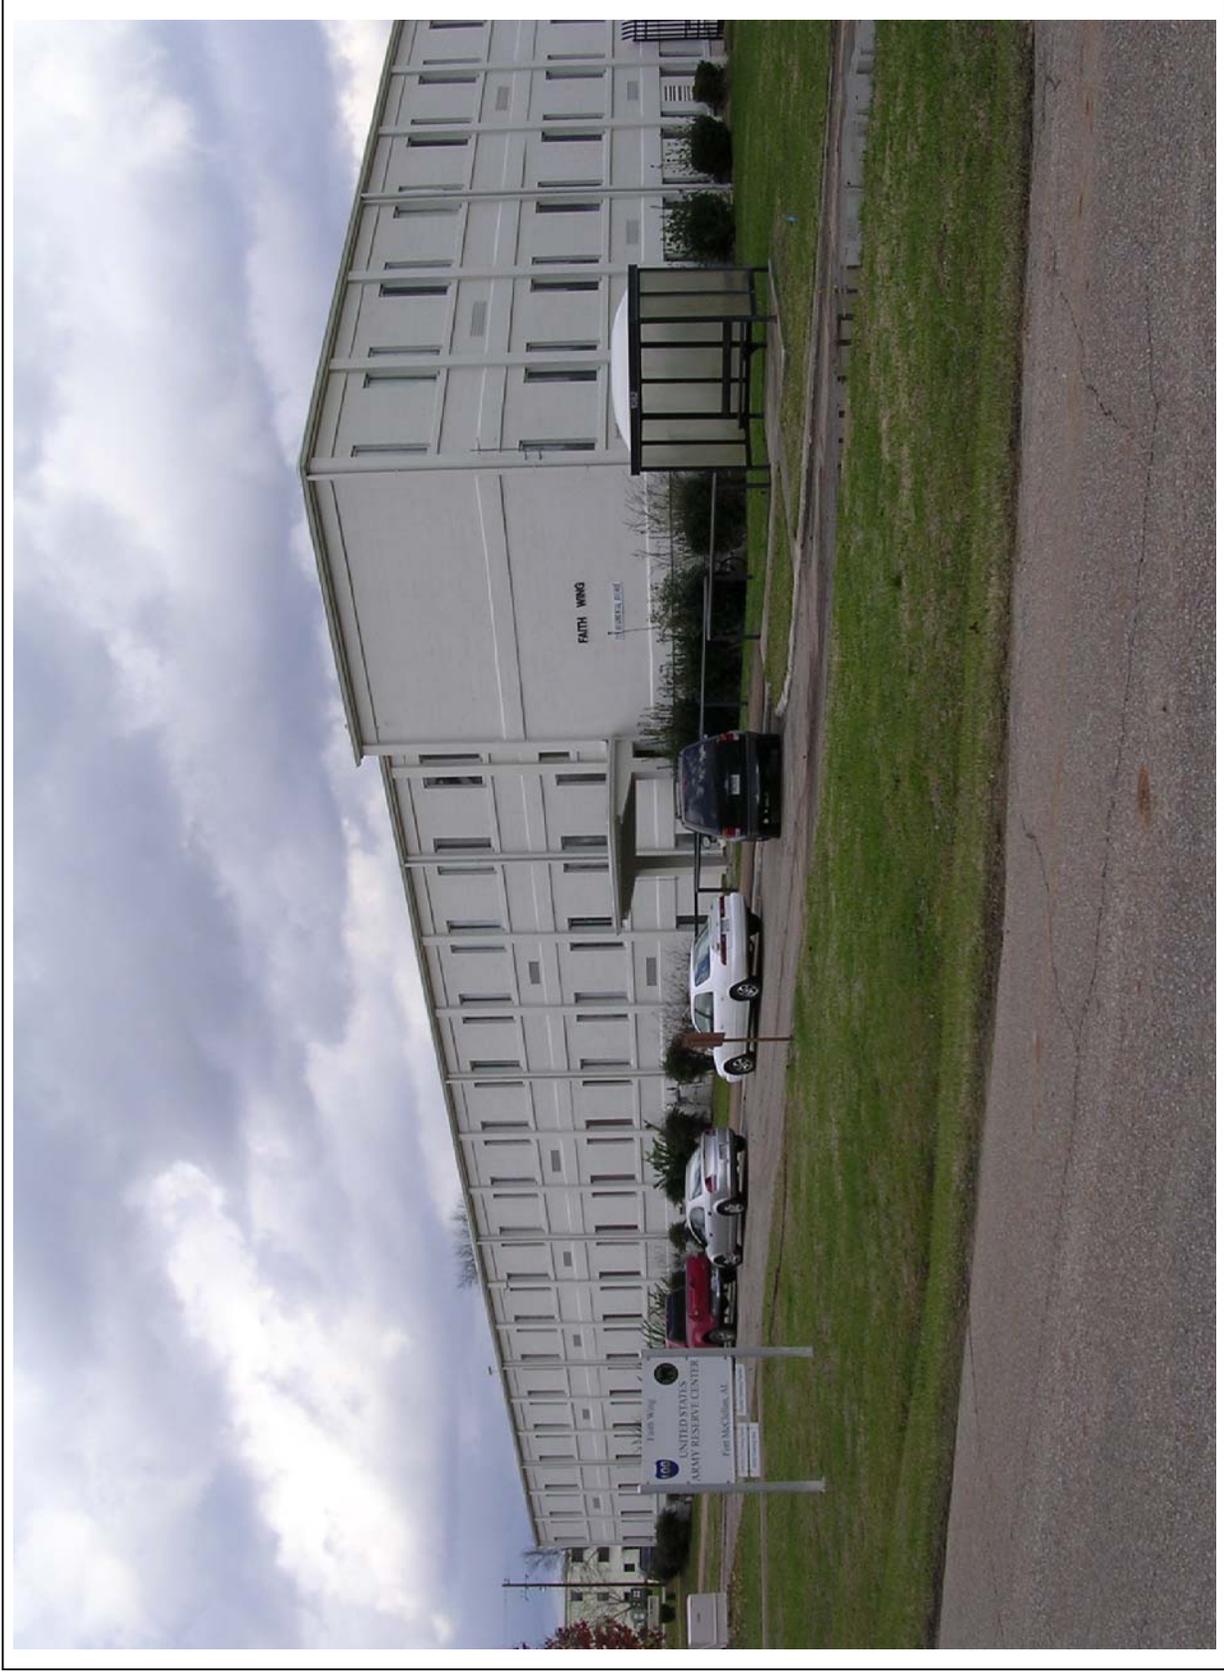
Building 1081 (Faith Wing) - Main Reserve Building
US Army Reserve Center - Ft McClellan, AL (AL079)

The room numbers shown on the CADD drawings and referenced in this report were assigned by the inspectors at the time of inspection unless previous room numbers were assigned and displayed.

Some room numbers are prefixed by a letter to indicate the type of room; **E** indicates an entry to the building, **H** indicates a hallway, **R** indicates a roof, **S** indicates a stairwell, **A** is an attic area and **B** indicates basement rooms.

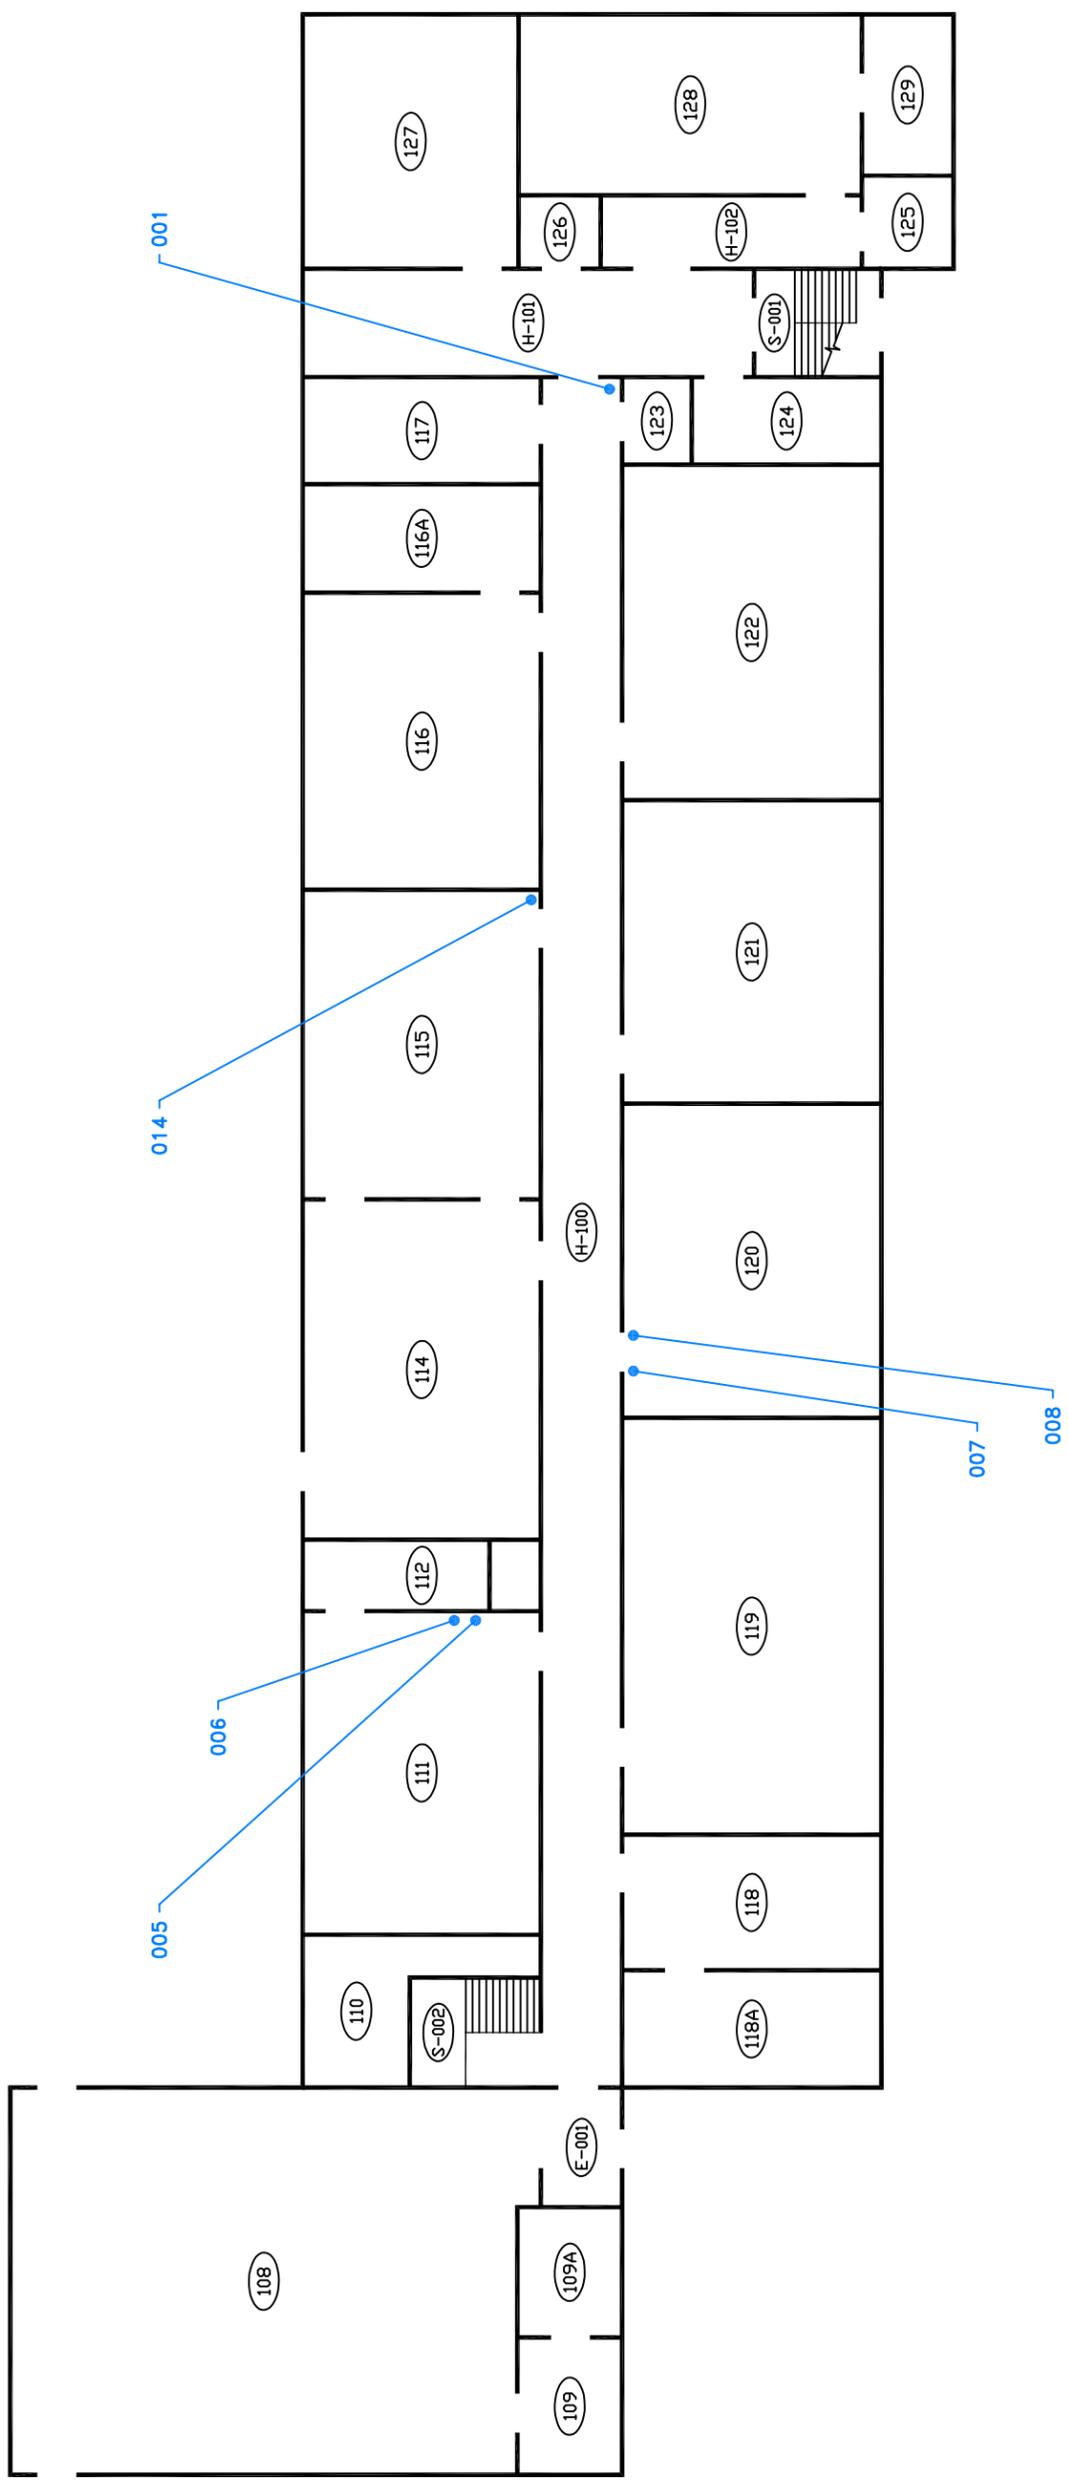
ENVIRONMENTAL ENTERPRISE GROUP, INC. 1345 Barracks Rd. NORTH CHARLESTON, SOUTH CAROLINA 29405	
ASBESTOS SAMPLE LOCATIONS BUILDING 1081 - FIRST FLOOR ARC FT MCCLELLAN (AL079) FT MCCLELLAN, ALABAMA	
DATE 01-28-05	PREPARED BY T. LEWIS
SCALE NONE	DWG NUMBER ee9inc_AL079_Bldg1081_1st Fl
REV -	DRAWN BY J.I. BROWNLEE
	SHEET 1 OF 1

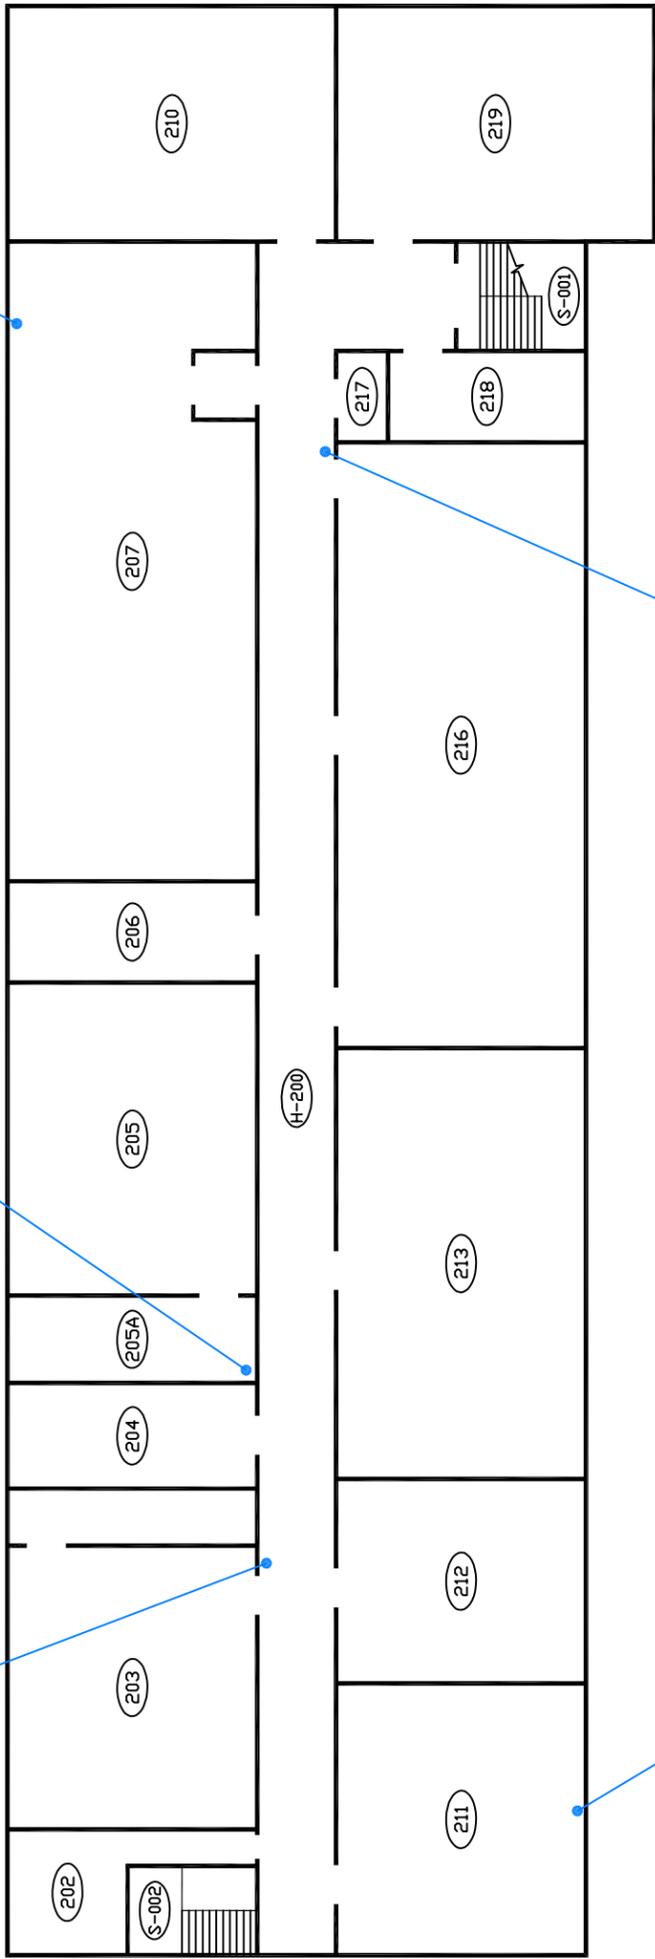
ENVIRONMENTAL ENTERPRISE GROUP, INC. 1345 Barracks Rd. NORTH CHARLESTON, SOUTH CAROLINA 29405	
ASBESTOS SAMPLE LOCATIONS BUILDING 1081 - SECOND FLOOR ARC FT MCCLELLAN (AL079) FT MCCLELLAN, ALABAMA	
DATE 01-28-05	PREPARED BY T. LEWIS
SCALE NONE	DWG NUMBER ee9inc_AL079_Bldg1081_2nd Fl
REV -	DRAWN BY J.I. BROWNLEE
	SHEET 1 OF 1
