FINAL
**ENVIRONMENTAL CONDITION OF PROPERTY
REPORT**

**WAUKEGAN ARMED FORCES RESERVE CENTER (AFRC)
(IL074)
WAUKEGAN, ILLINOIS 60085**

**U.S. Army Corps of Engineers – Louisville District
Engineering Division – Environmental Engineering Branch
600 Dr. Martin Luther King, Jr. Place
Louisville, Kentucky 40202-2232**

APRIL 2007

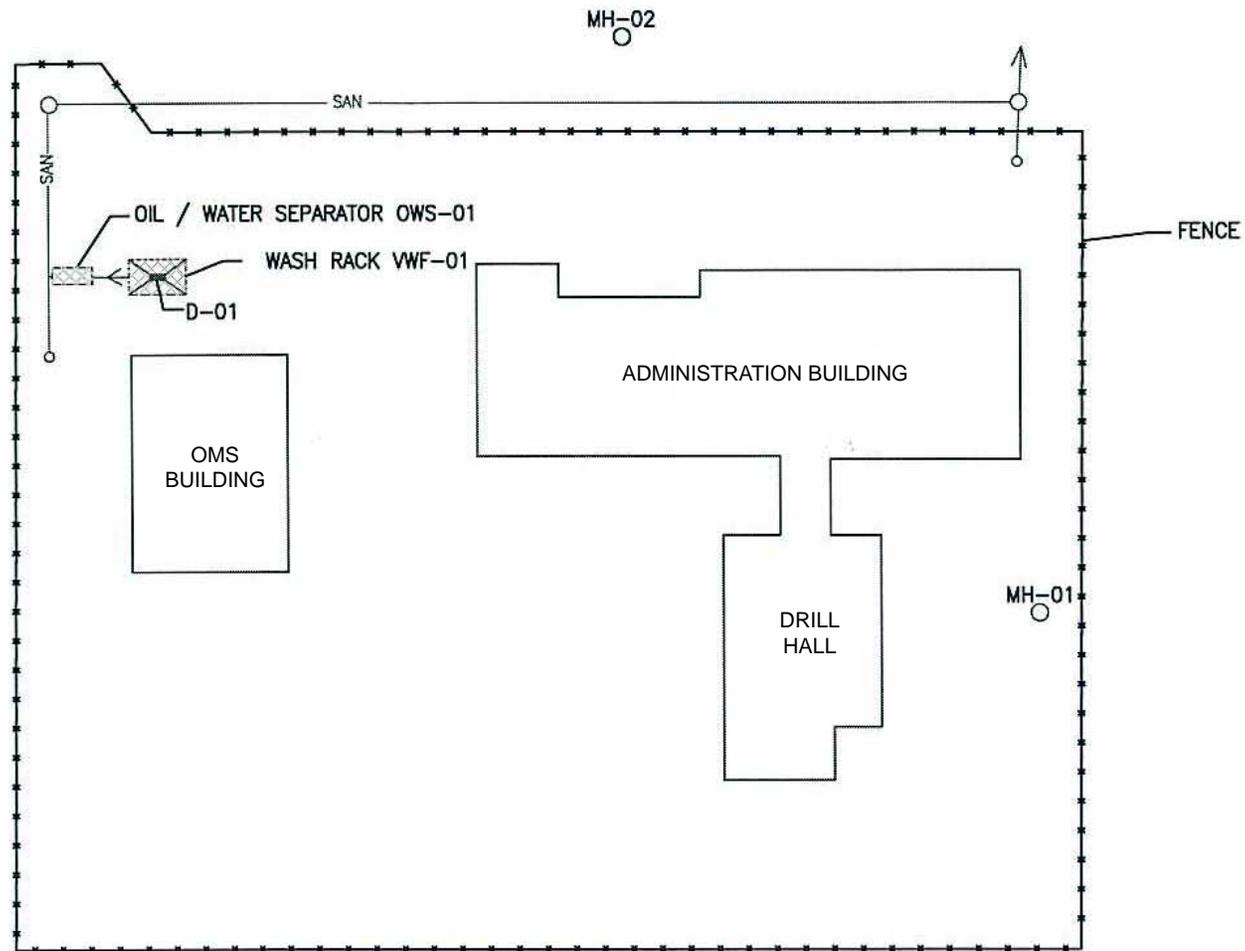
FIGURE 7
Former Location of Oil-Water
Separator (OWS) and Wash Rack (VWF)
Phase I ECP Report
Waukegan AFRC USAR Center,
Waukegan, Illinois

NOTE:
HIGHLIGHTED STRUCTURES HAVE
BEEN REMOVED OR CLOSED

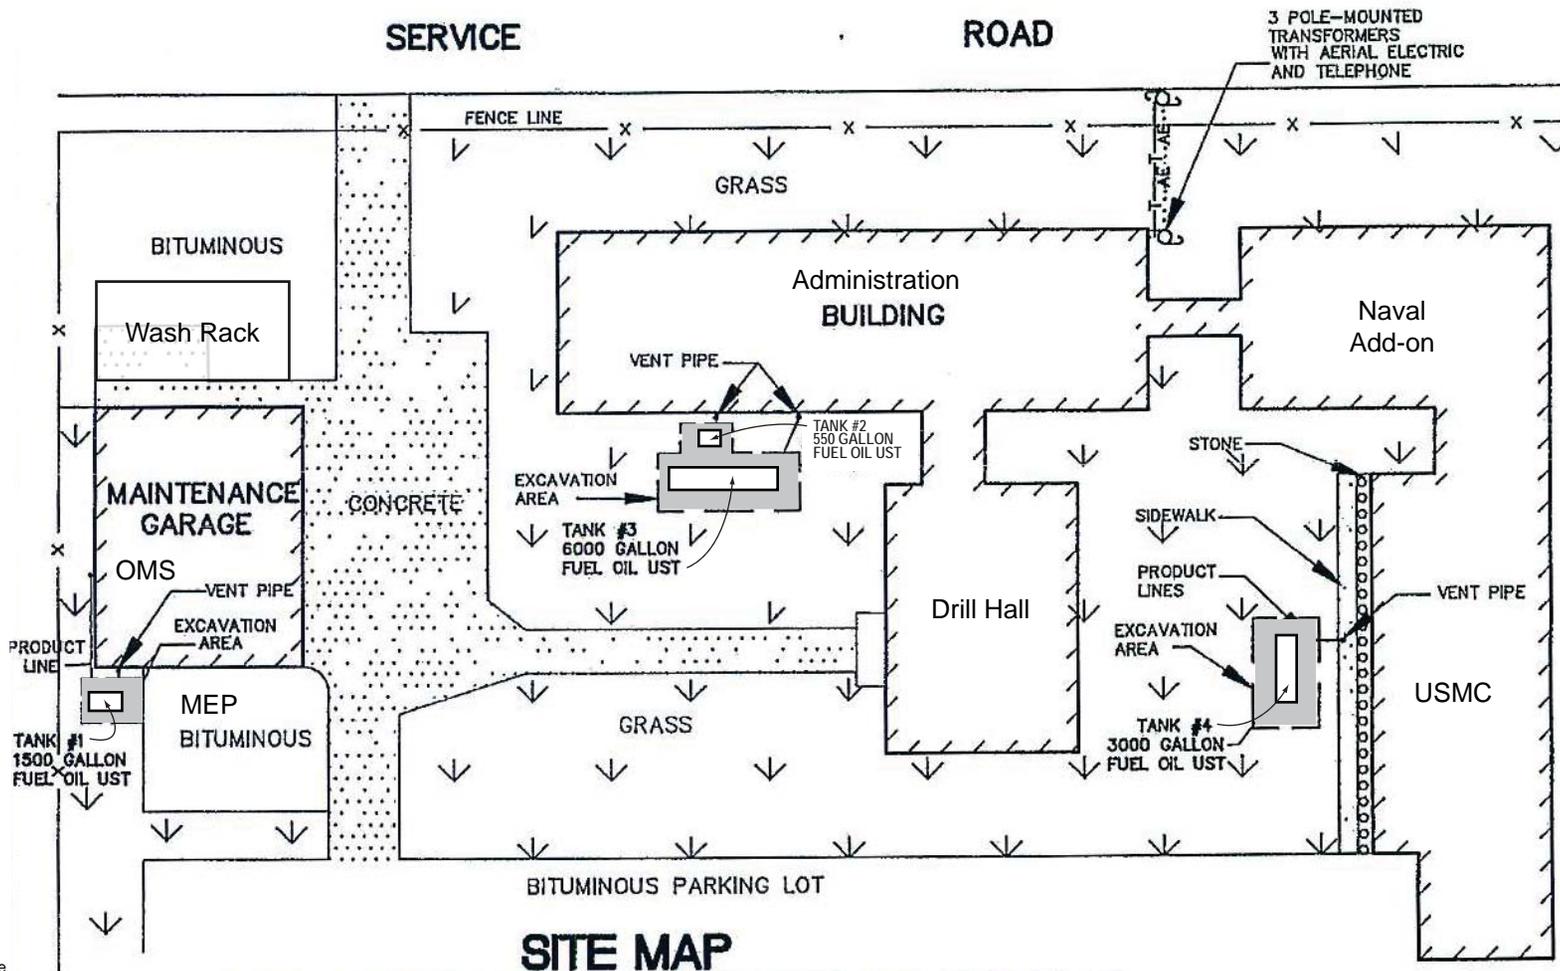
SITE MAP
U.S. ARMED FORCES RESERVE CENTER
1721 N. McAREE ROAD
WAUKEGAN, IL. 60085-1499

LEGEND
 Location of Removed Soil

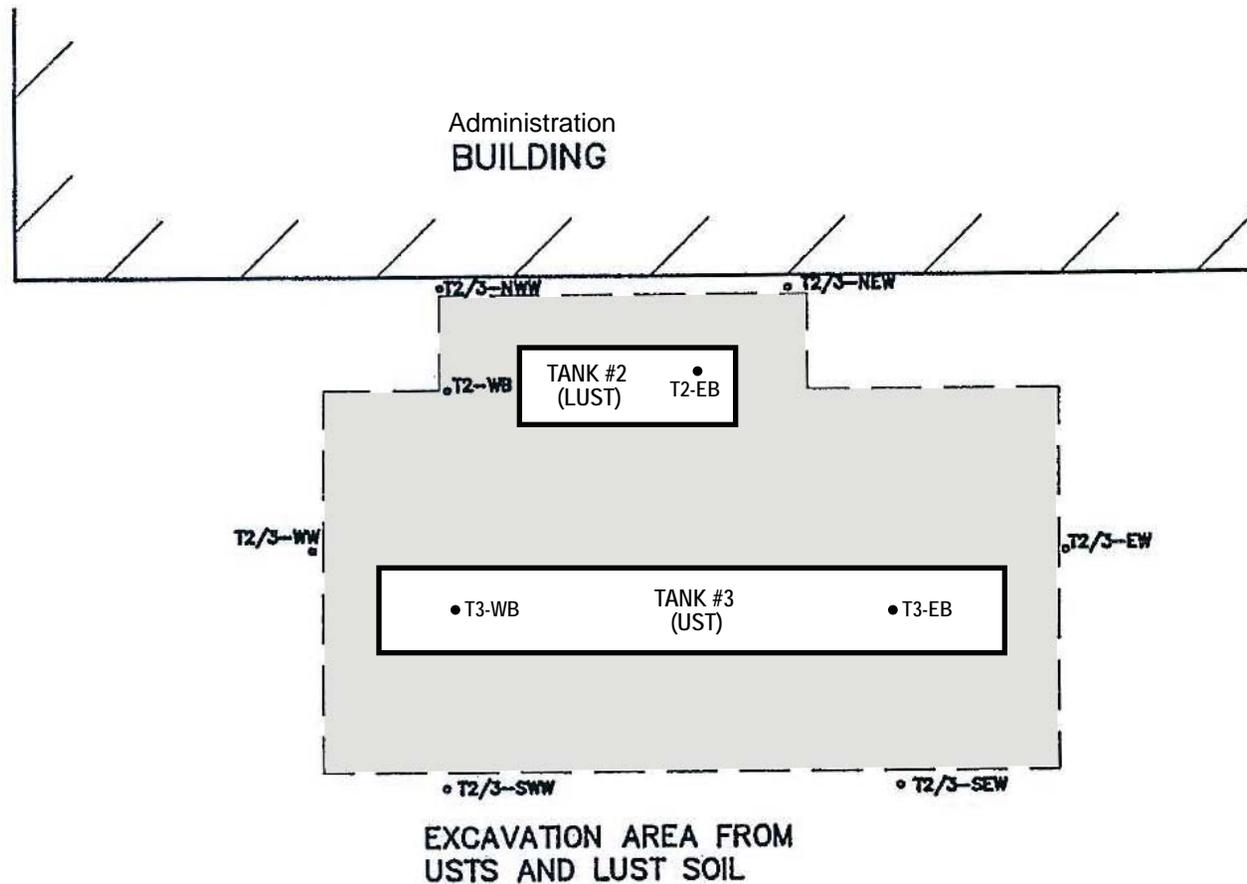
FIGURE 17
Location of Excavated Leaking
Underground Storage Tank Soil
*Phase I ECP Report
Waukegan AFRC USAR Center,
Waukegan, Illinois*

Location of removed soil

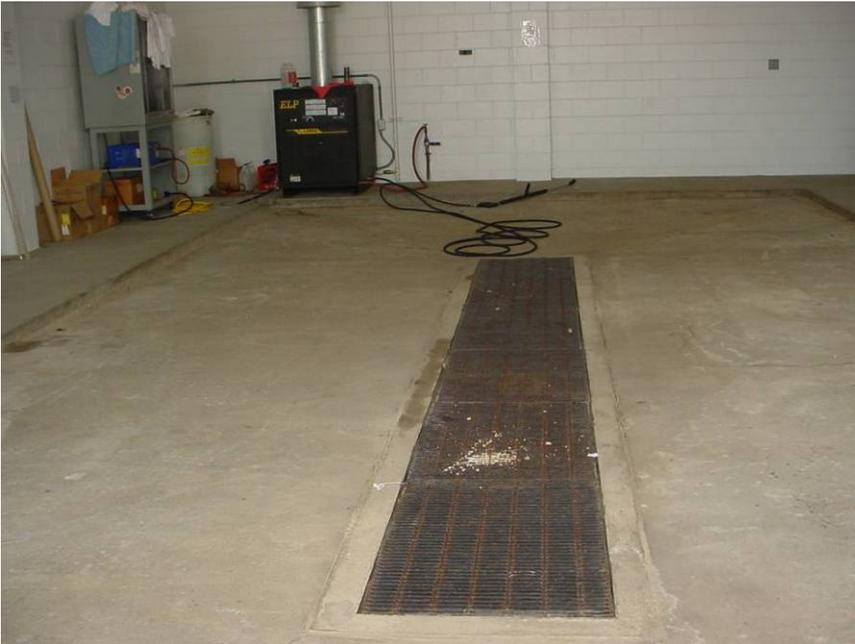
4. Wash Rack building interior. Note grit trap (center) and solvents (left). General view is to the west.

A new VWF was installed during the construction of the Wash Rack Building in 2004. The VWF included an interior trench drain and grit trap (Appendix B, Photograph 4). The grit trap was connected to an OWS that was installed on the western exterior of the Wash Rack Building, which discharges to the sanitary sewer (Appendix B, Photograph 5).

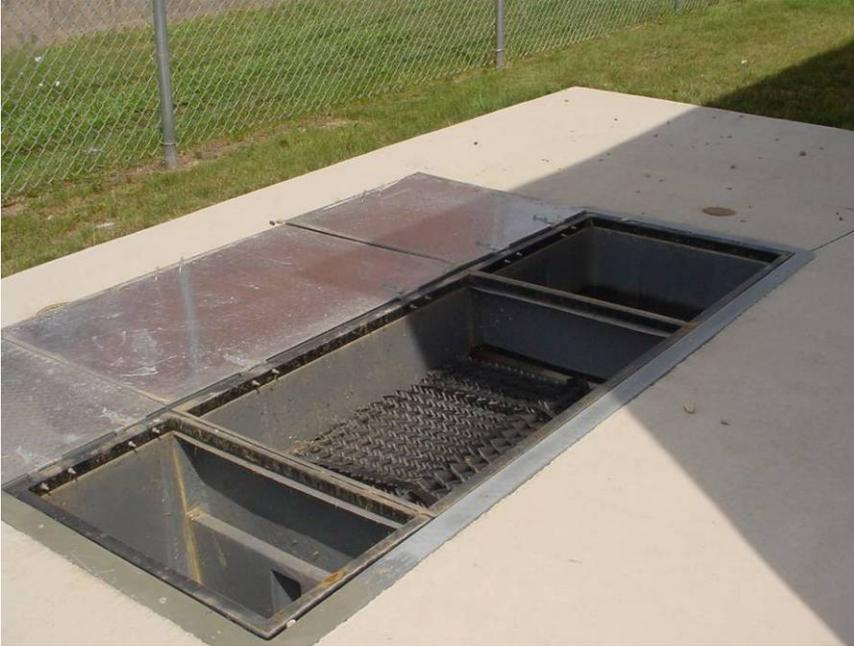
5. OWS located near the rear of the Wash Rack building exterior. General view is to the northwest.

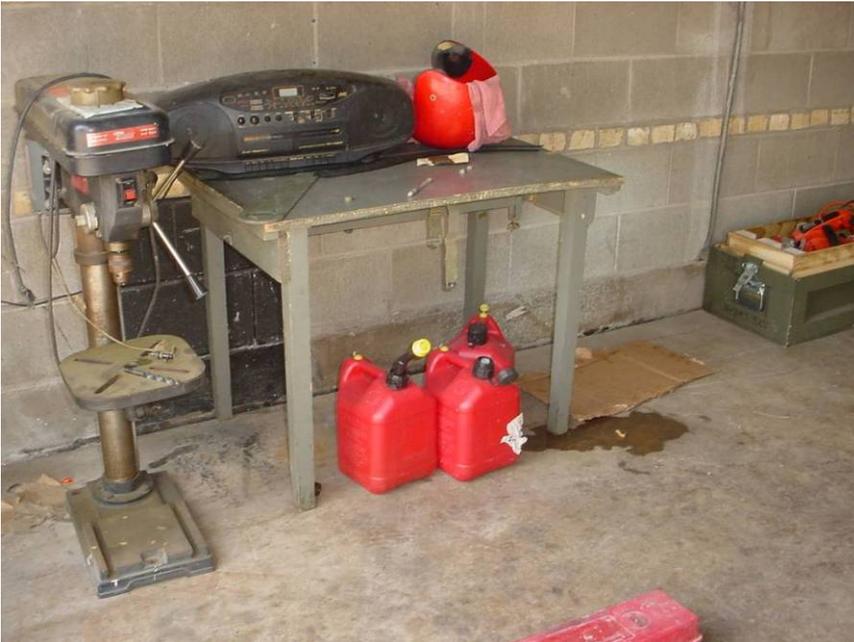
6. OMS building interior. Pooled liquid adjacent to gasoline containers. General view is to the south.

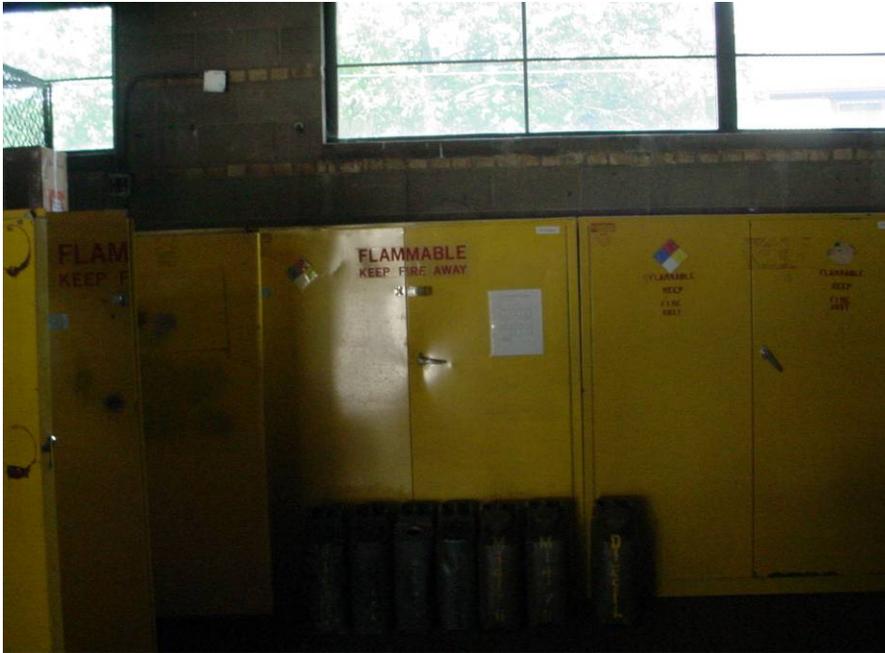
7. Located in the OMS Building are the five flammable cabinets.

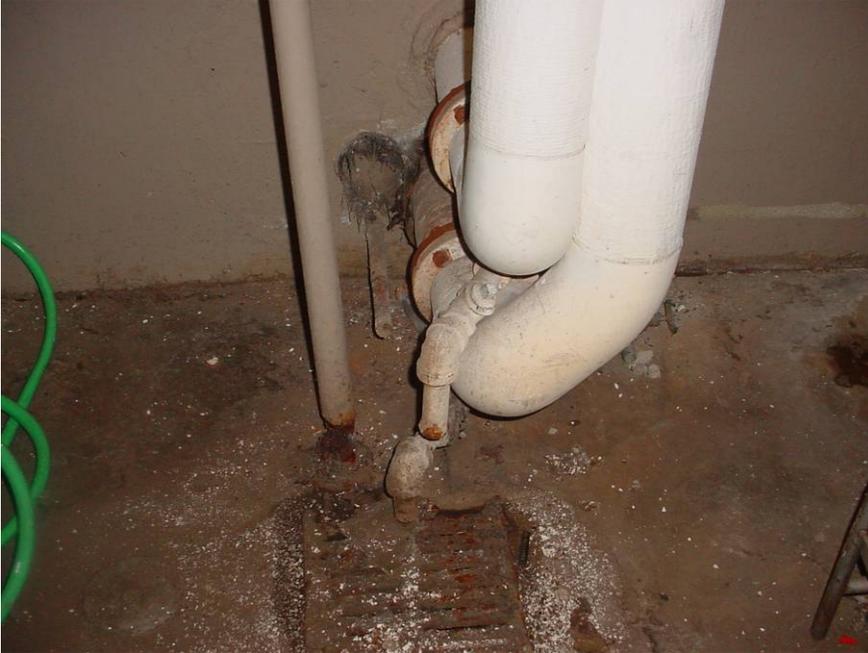
9. Drain 2. Administration building interior. Oily residue on Boiler Room floor surrounding floor drain. General view is to the south.

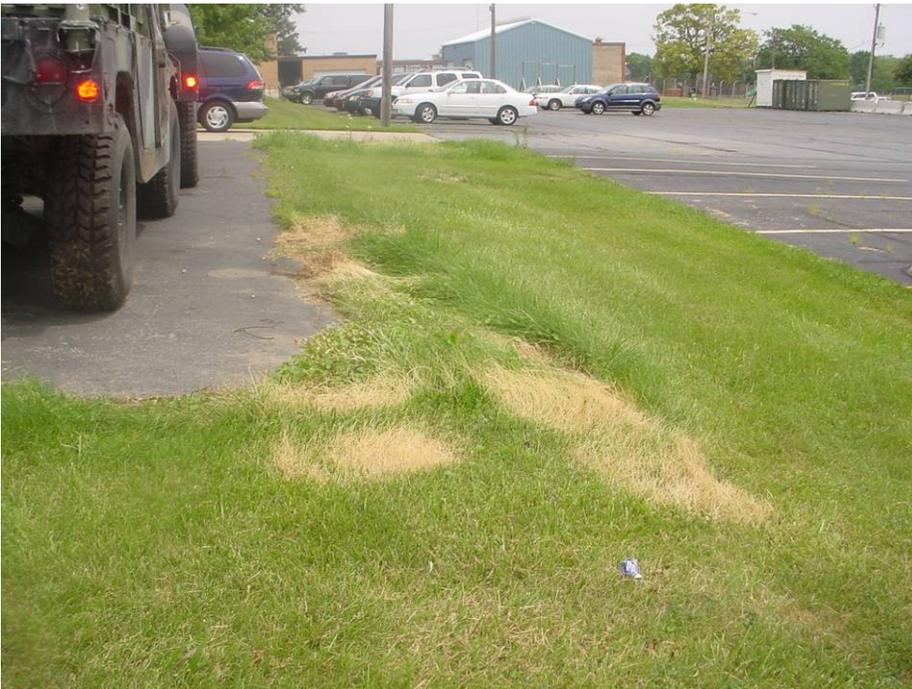
10. MEP area, mid-west side of Property. Stressed lawn. General view is to the east.

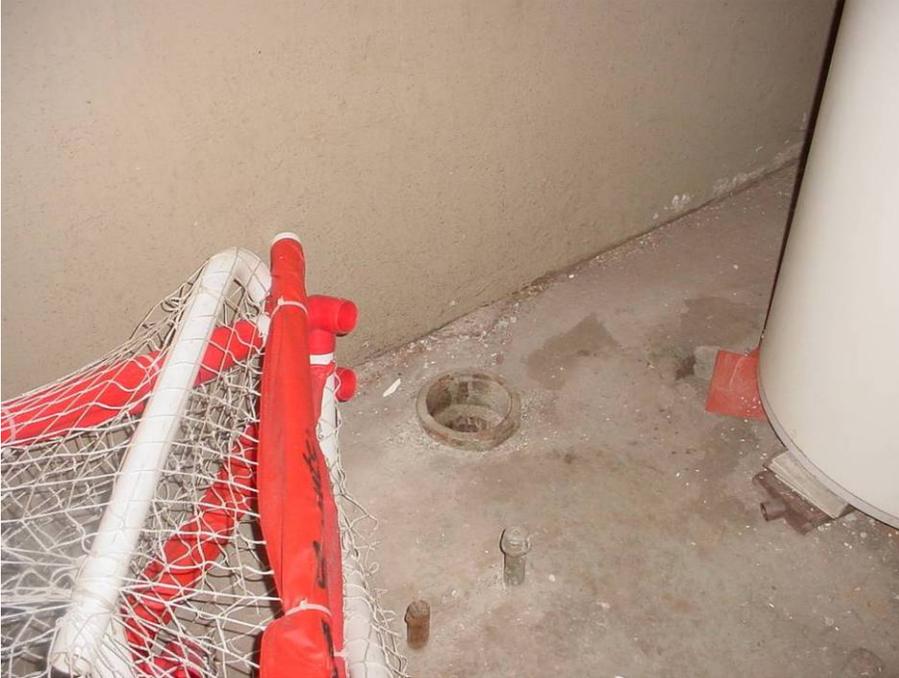
11. Administration building interior. Discontinued pipes and open drain on Boiler Room floor surrounding floor drain. General view is to the west.

Photographs 11 and 12), on an exterior rail immediately outside of the boiler room and on the Drill Hall overhead door.

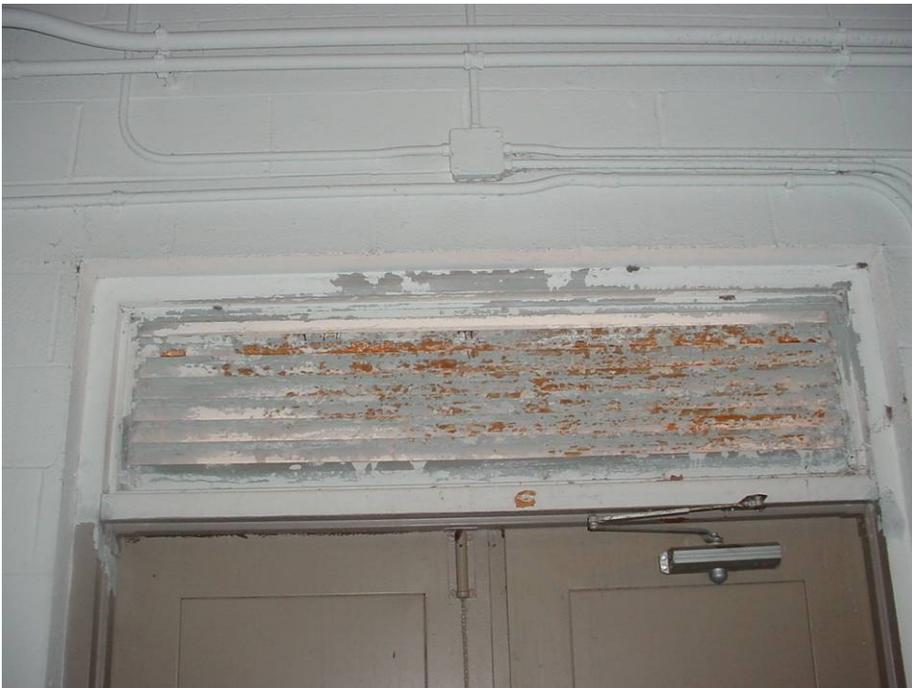
12. Administration building interior. Peeling paint above Boiler Room door leading to exterior. General view is to the south.

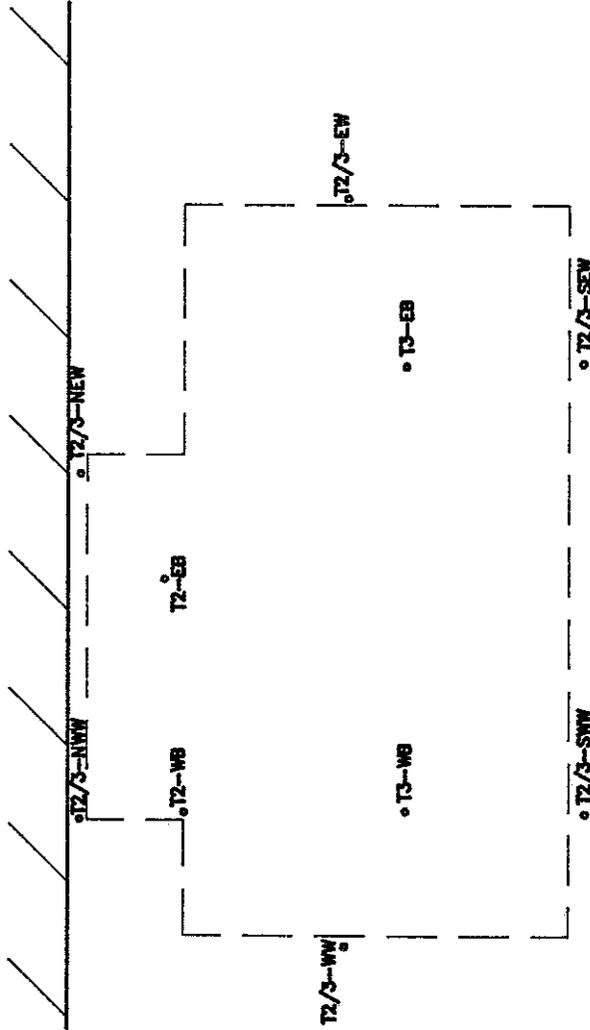
SOIL SAMPLE LOCATION MAP
U.S. ARMED FORCES RESERVE CENTER
1721 N. McAREE ROAD
WAUKEGAN, IL. 60085-1499
LUST INCIDENT #941954
CONTRACT No. DABT31-94-D-0024

EXCAVATION AREA FROM
USTS AND LUST SOIL

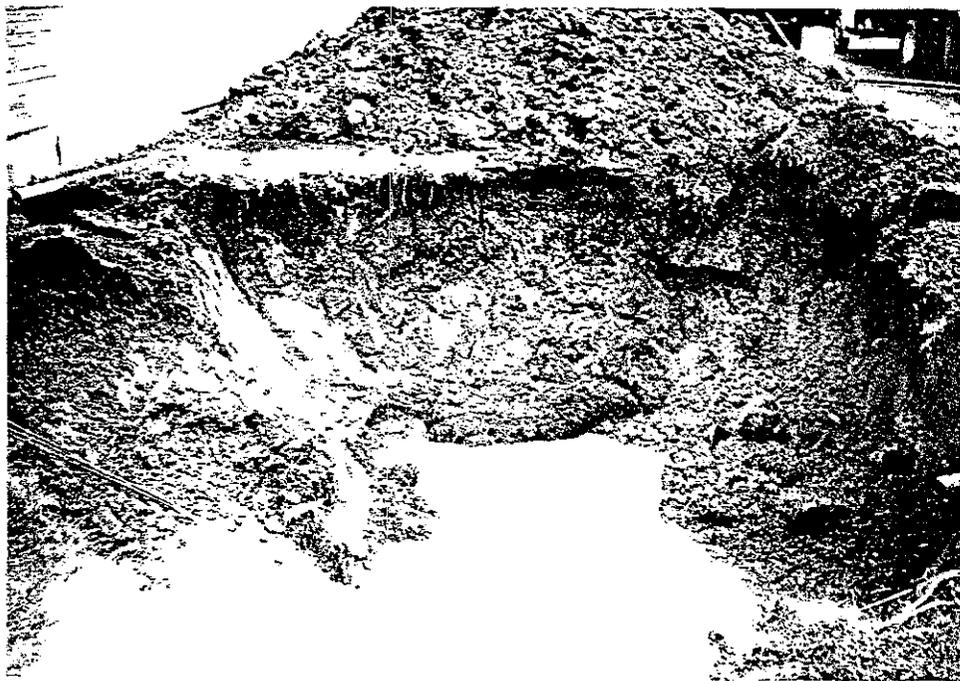
PHOTO #2. Date: April 27, 1995. Photo taken facing east.
Description: Excavation area following the removal of Tank #1 (1500 gallon #2 fuel oil UST) located at the southwest corner of the maintenance building.
Note the perched water in the excavation.

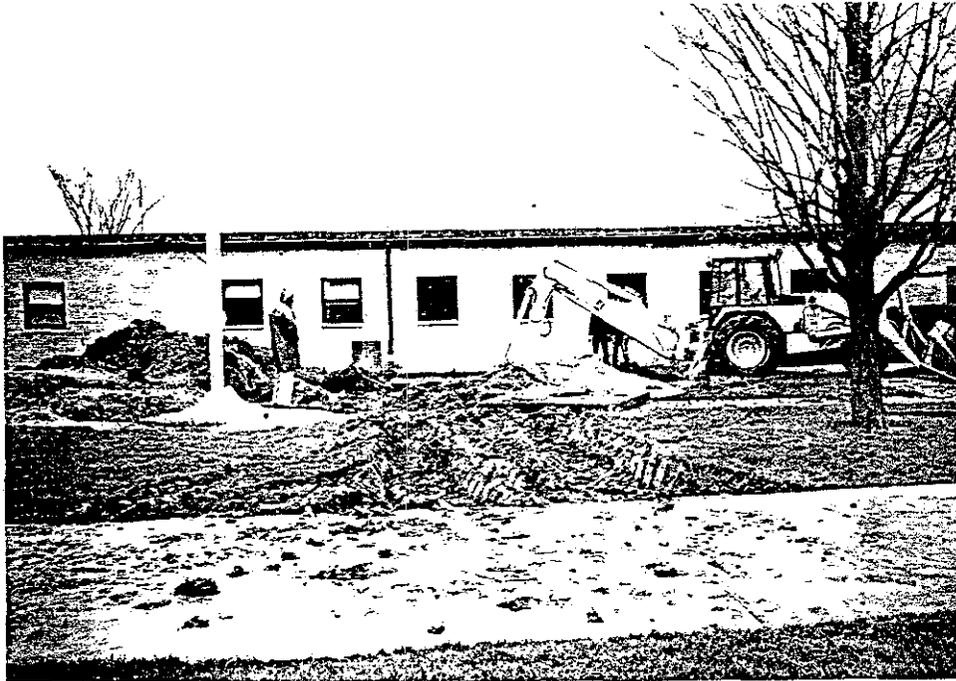
PHOTO #5. Date: April 27, 1995. Photo taken facing north.
Description: Uncovering Tank #2 (550 gallon #2 fuel oil LUST) and Tank #2 (6,000 gallon #2 fuel oil UST) located south of main building.

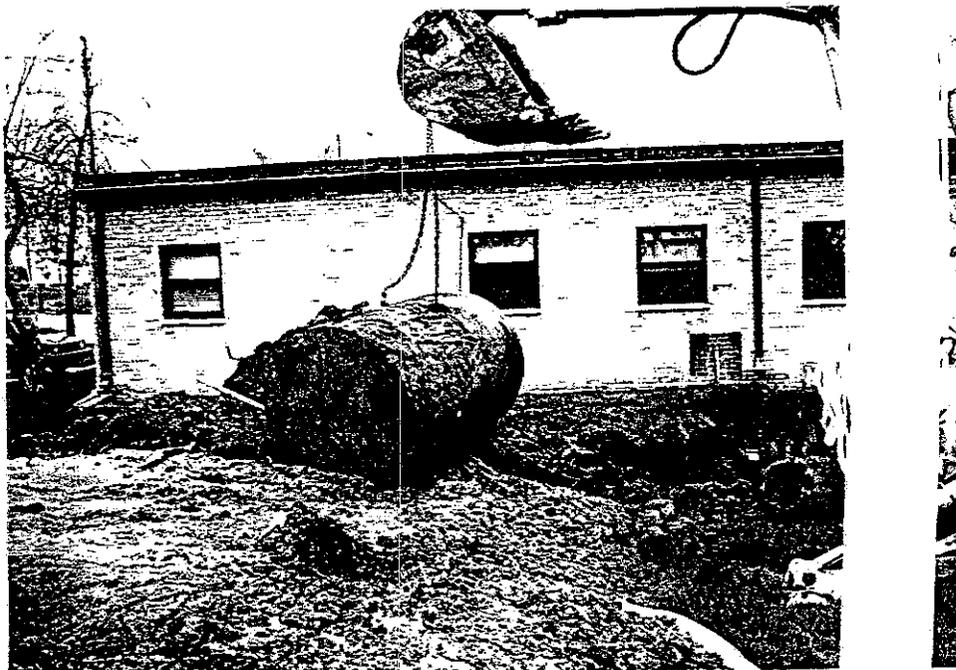
PHOTO #6. Date: April 27, 1995. Photo taken facing north.
Description: Removal of Tank #2 from excavation. Tank had several holes in the bottom and sides. Contaminated soil was evident surrounding LUST.

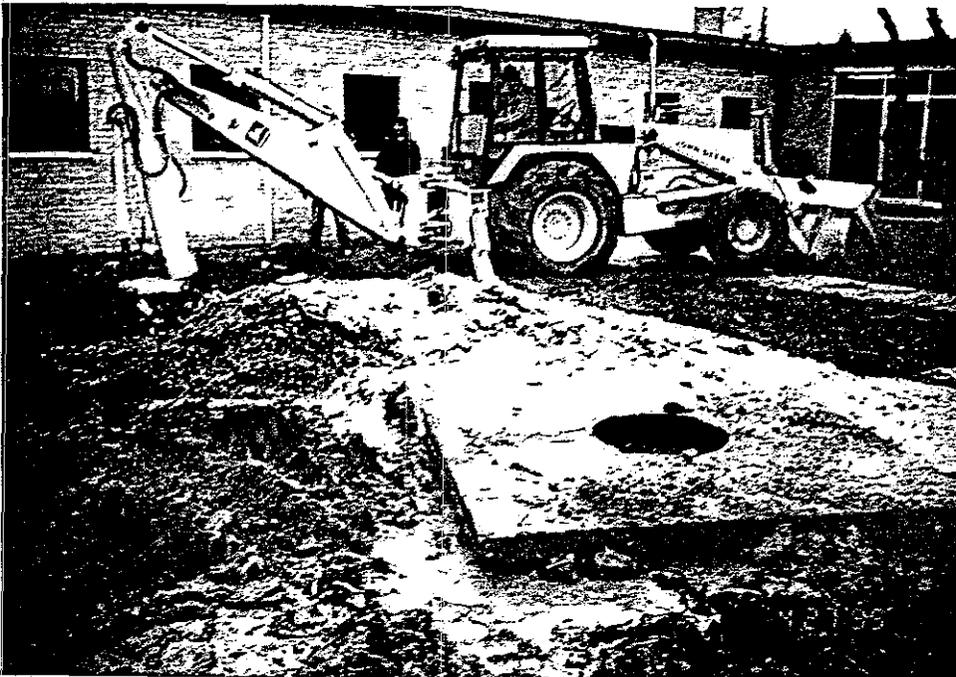
PHOTO #8. Date: April 27, 1995. Photo taken facing north/northeast.
Description. Uncovering Tank #3 (6,000 gallon UST).
Note the 7' x 7' concrete pad which surrounded the UST manhole.

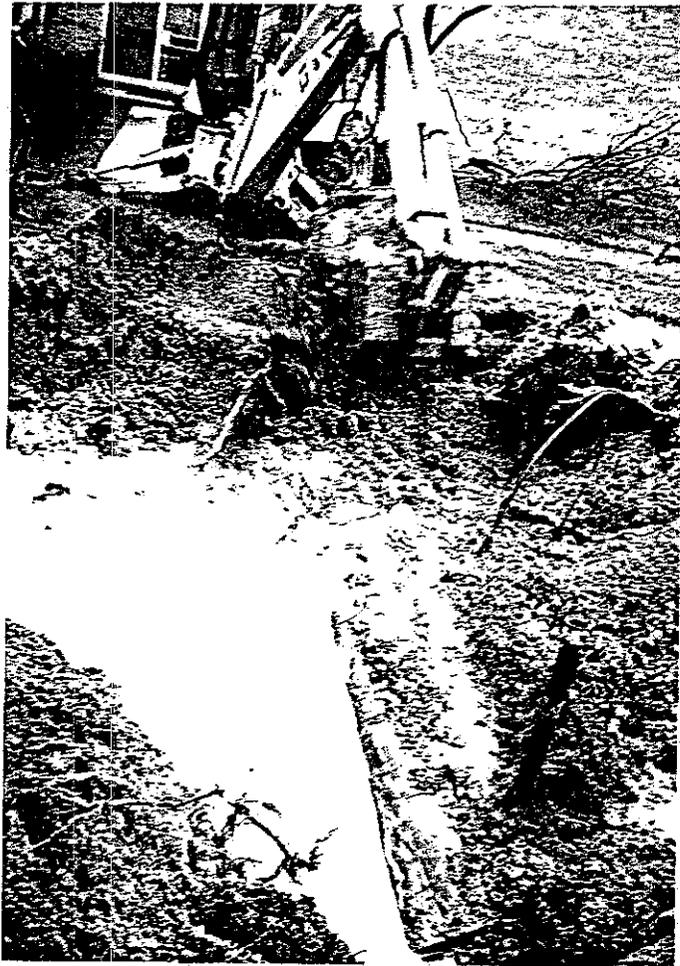
PHOTO #11. Date: April 27, 1995. Photo taken facing west.

Description: Tank #3 exposed.

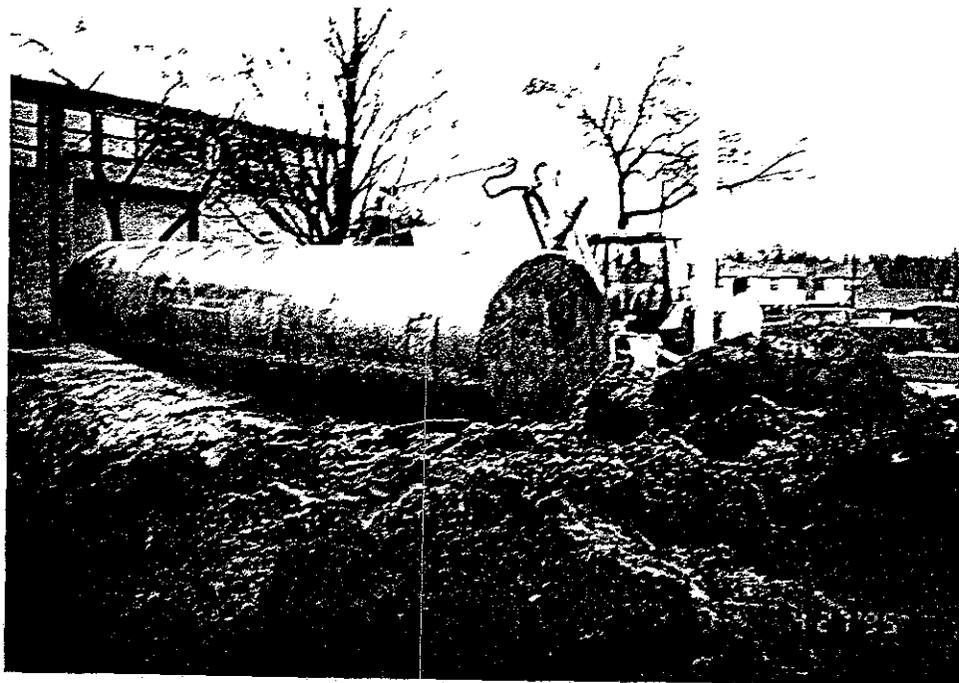
PHOTO #13. Date: April 27, 1995. Photo taken facing southeast.
Description: Removal of Tank #3.

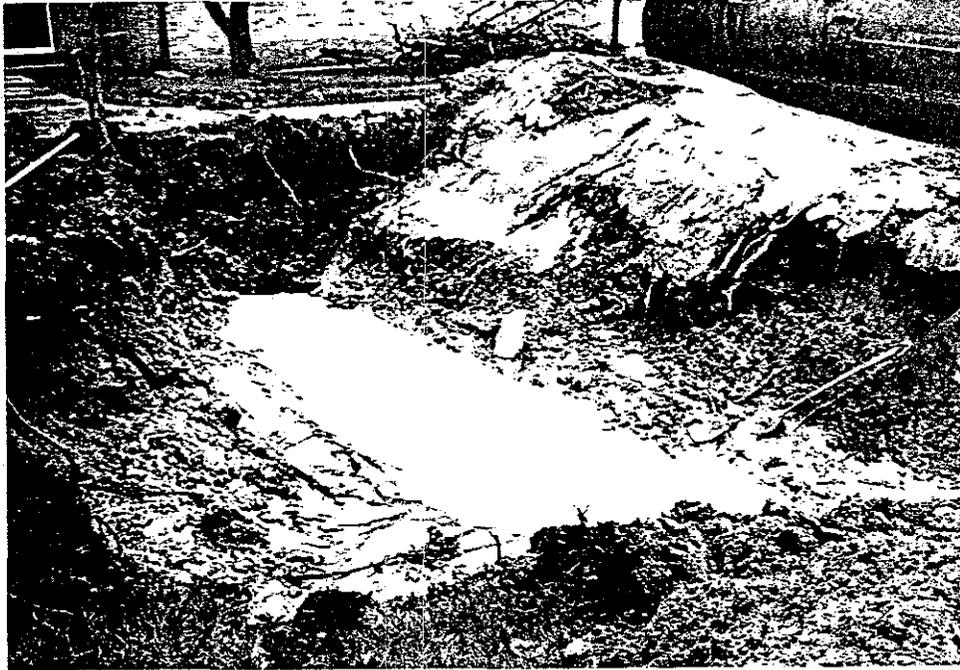
PHOTO #14. Date: April 27, 1995. Photo taken facing east.
Description: Excavation area following the removal of Tank #2 and #3.
Note the perched water from heavy precipitation.

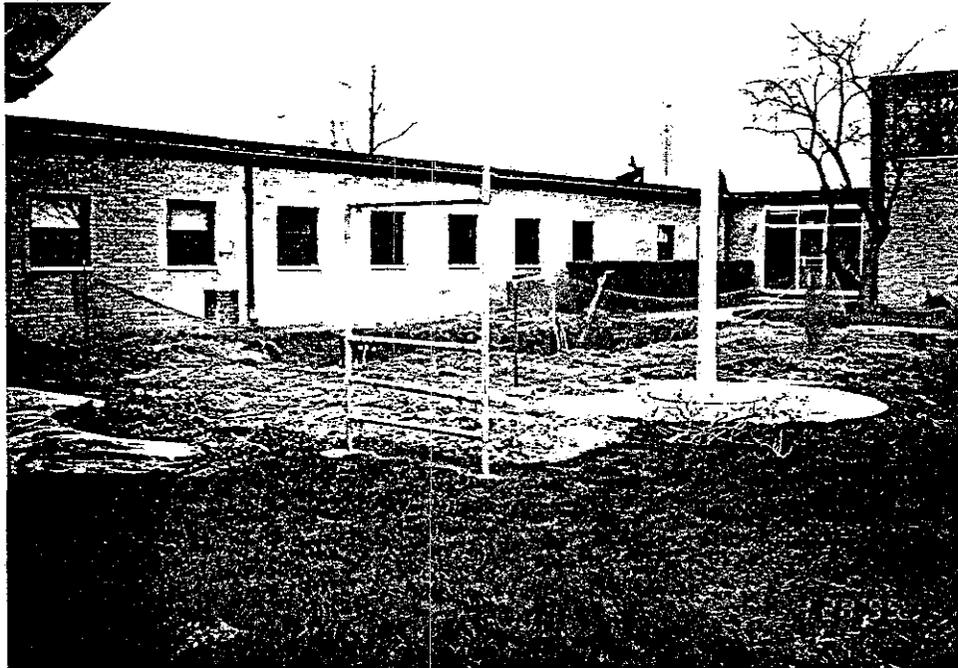
PHOTO #15. Date: April 28, 1995. Photo taken facing northeast.
Description: Tank #2 and #3 excavation area partially backfilled and
fenced off until LUST soil disposal is scheduled.

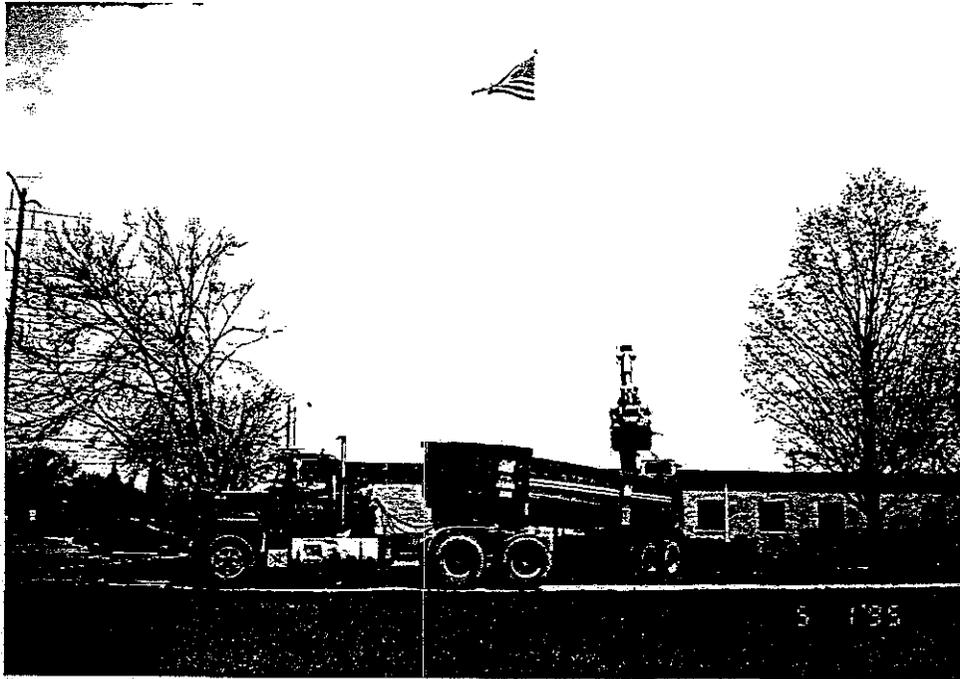
PHOTO #27. Date: May 1, 1995. Photo taken facing north.
Description: ECI loading LUST soil onto a licensed special waste hauler semi truck/trailer (Bass Trucking).

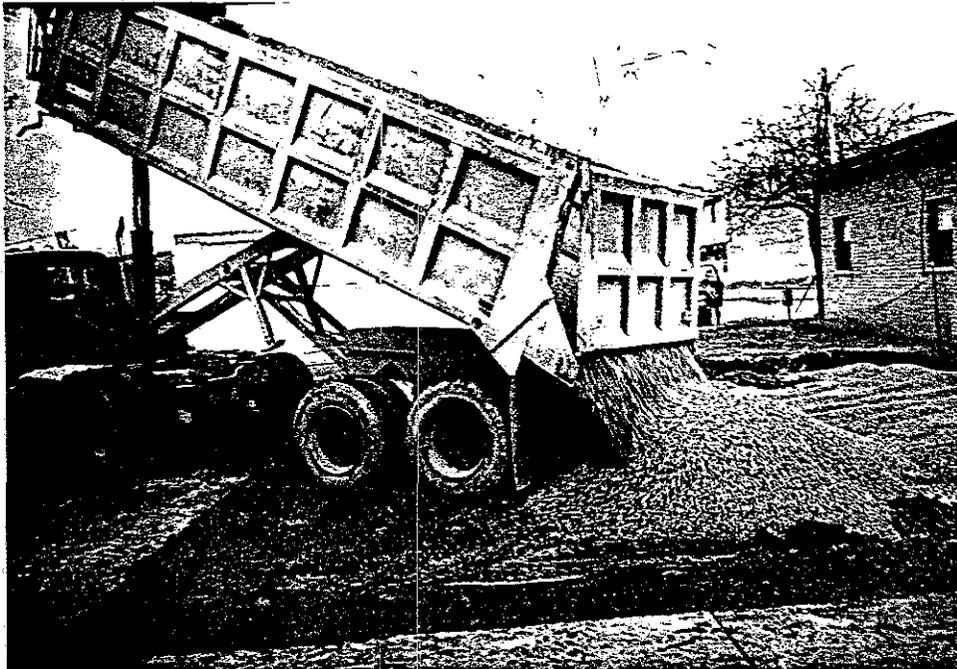
PHOTO #28. Date: May 2, 1995. Photo taken facing west.
Description: Backfilling the LUST excavation with pea gravel.

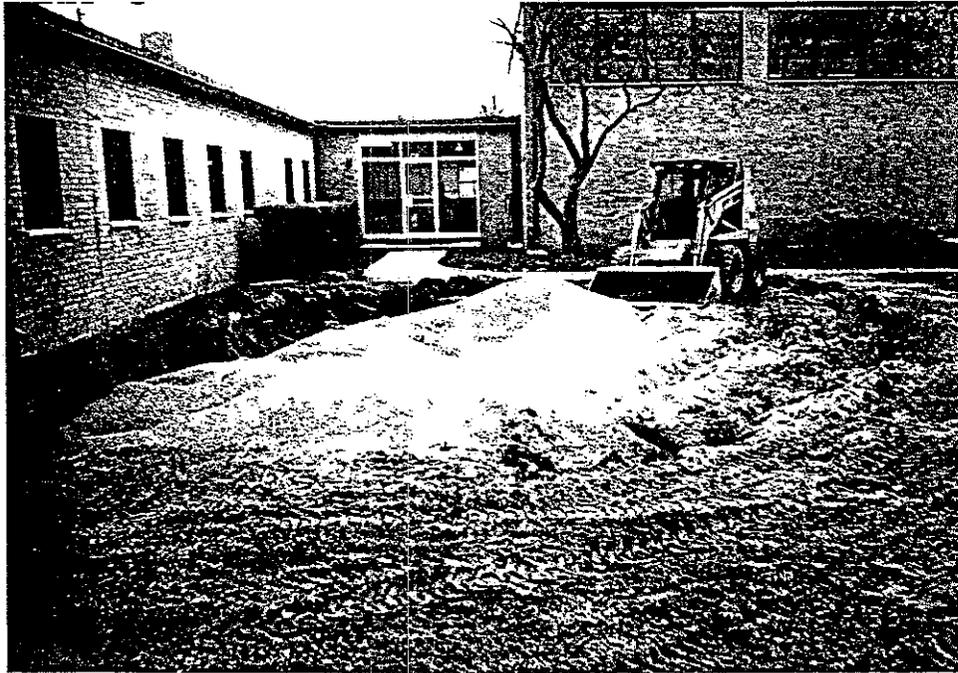
PHOTO #29. Date: May 2, 1995. Photo taken facing east.
Description: Excavation backfilled with pea gravel.

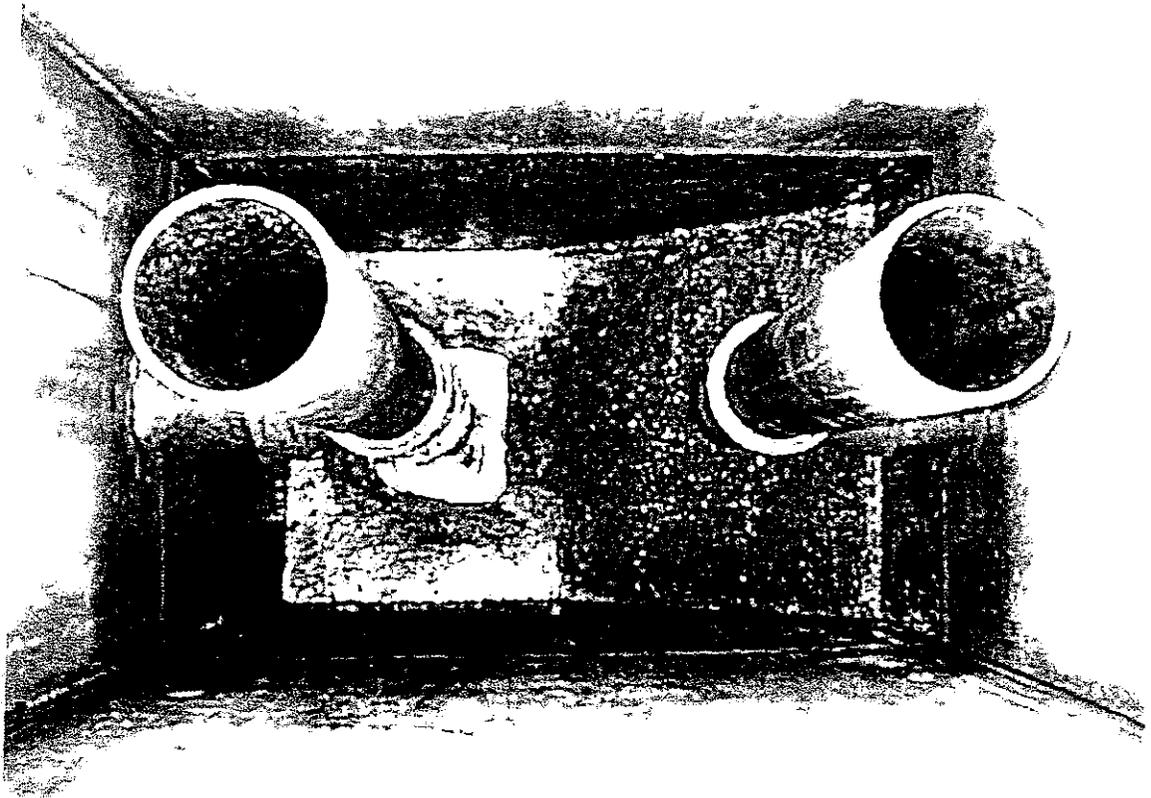
Oil / Water Separator Interior, Inlet End (Right) and Outlet End (Left)
(Looking North)

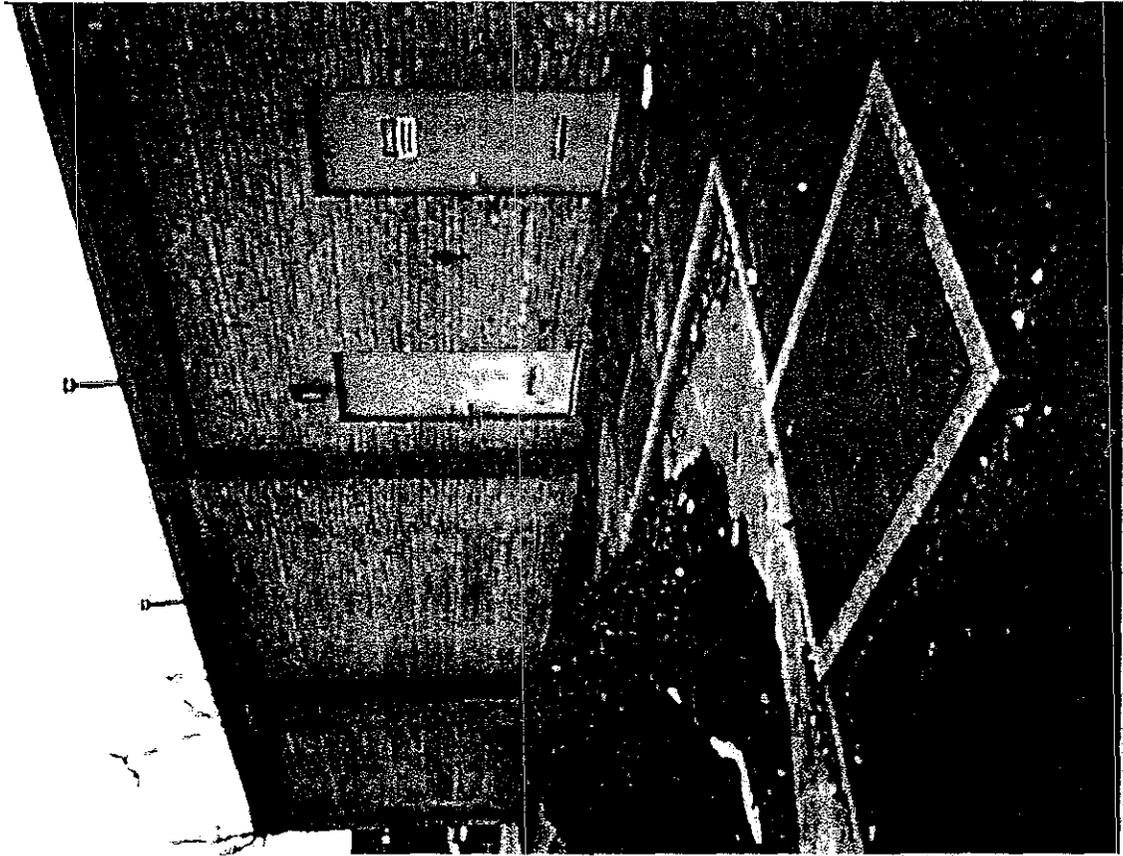
Oil / Water Separator Location, OMS Building
in Background (Looking Southeast)

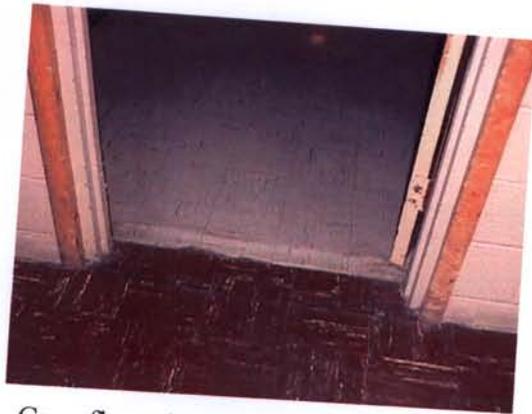
Grey floor tiles; yellow mastic (VFT-5) Non asbestos

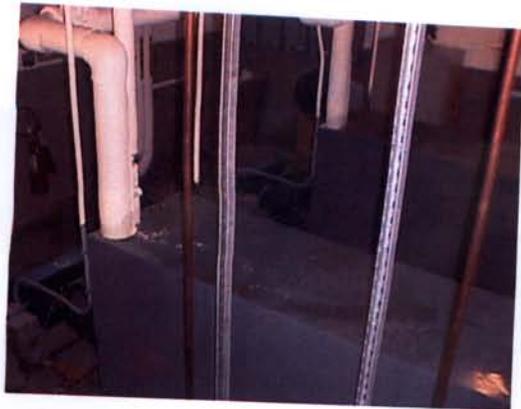
Thermal system insulation on pipes
Non asbestos

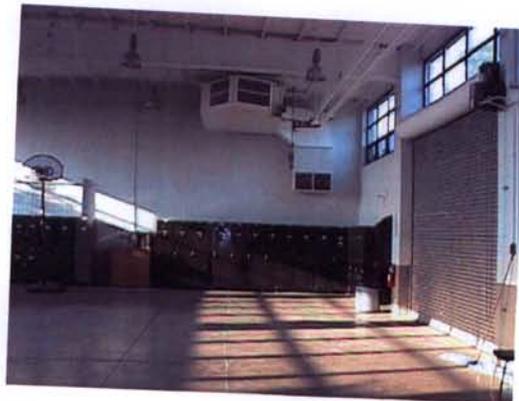
Vibration damping cloths on HVAC
Presumed to contain asbestos
