**ENVIRONMENTAL CONDITION OF PROPERTY
REPORT**

**SFC MORGAN L. DOWNS
U.S. ARMY RESERVE CENTER (OH059)
1515 W. HIGH STREET
SPRINGFIELD, OH 43215**

February 2007

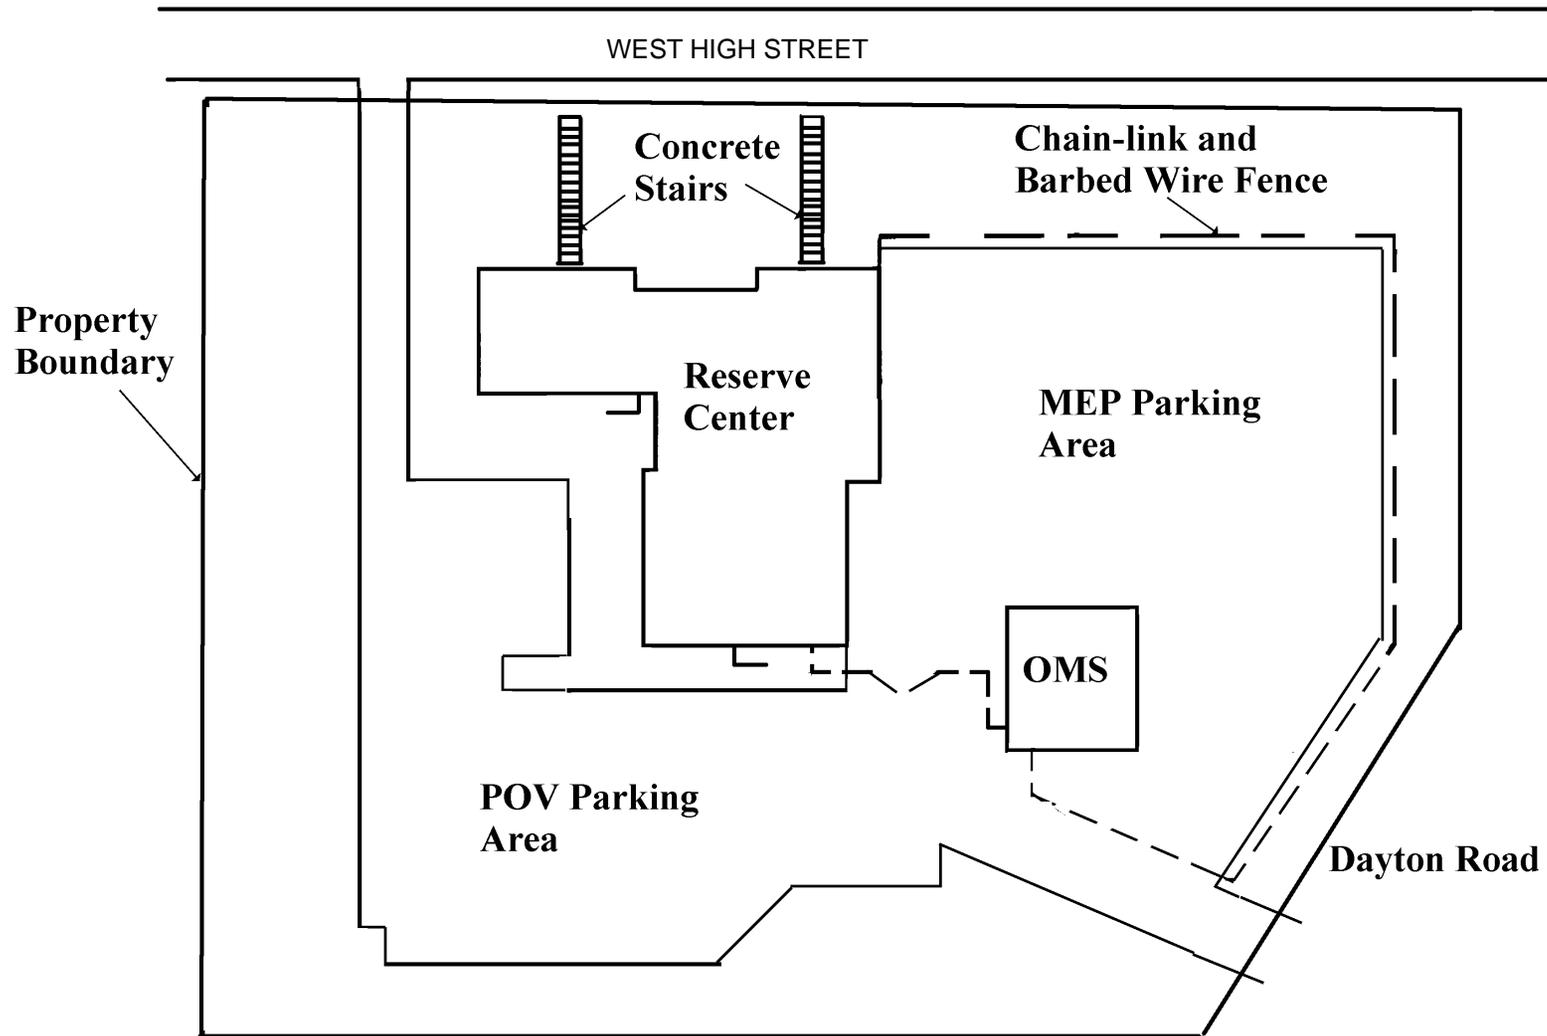
FIGURE 2
 Site Layout Plan
 Phase I ECP Report

The USAR Center is located on a 3-acre parcel in Springfield, Ohio, and contains two permanent structures, a personally owned vehicle (POV) parking lot, and one military equipment parking (MEP) area. A site map is included as Figure 2 in Appendix A. The two structures are brick buildings that include a USARC Building and an Area Maintenance Support Activity (AMSA) Number 58 Building, which provides maintenance and major repairs for military vehicles stationed at multiple USAR Centers around the state.

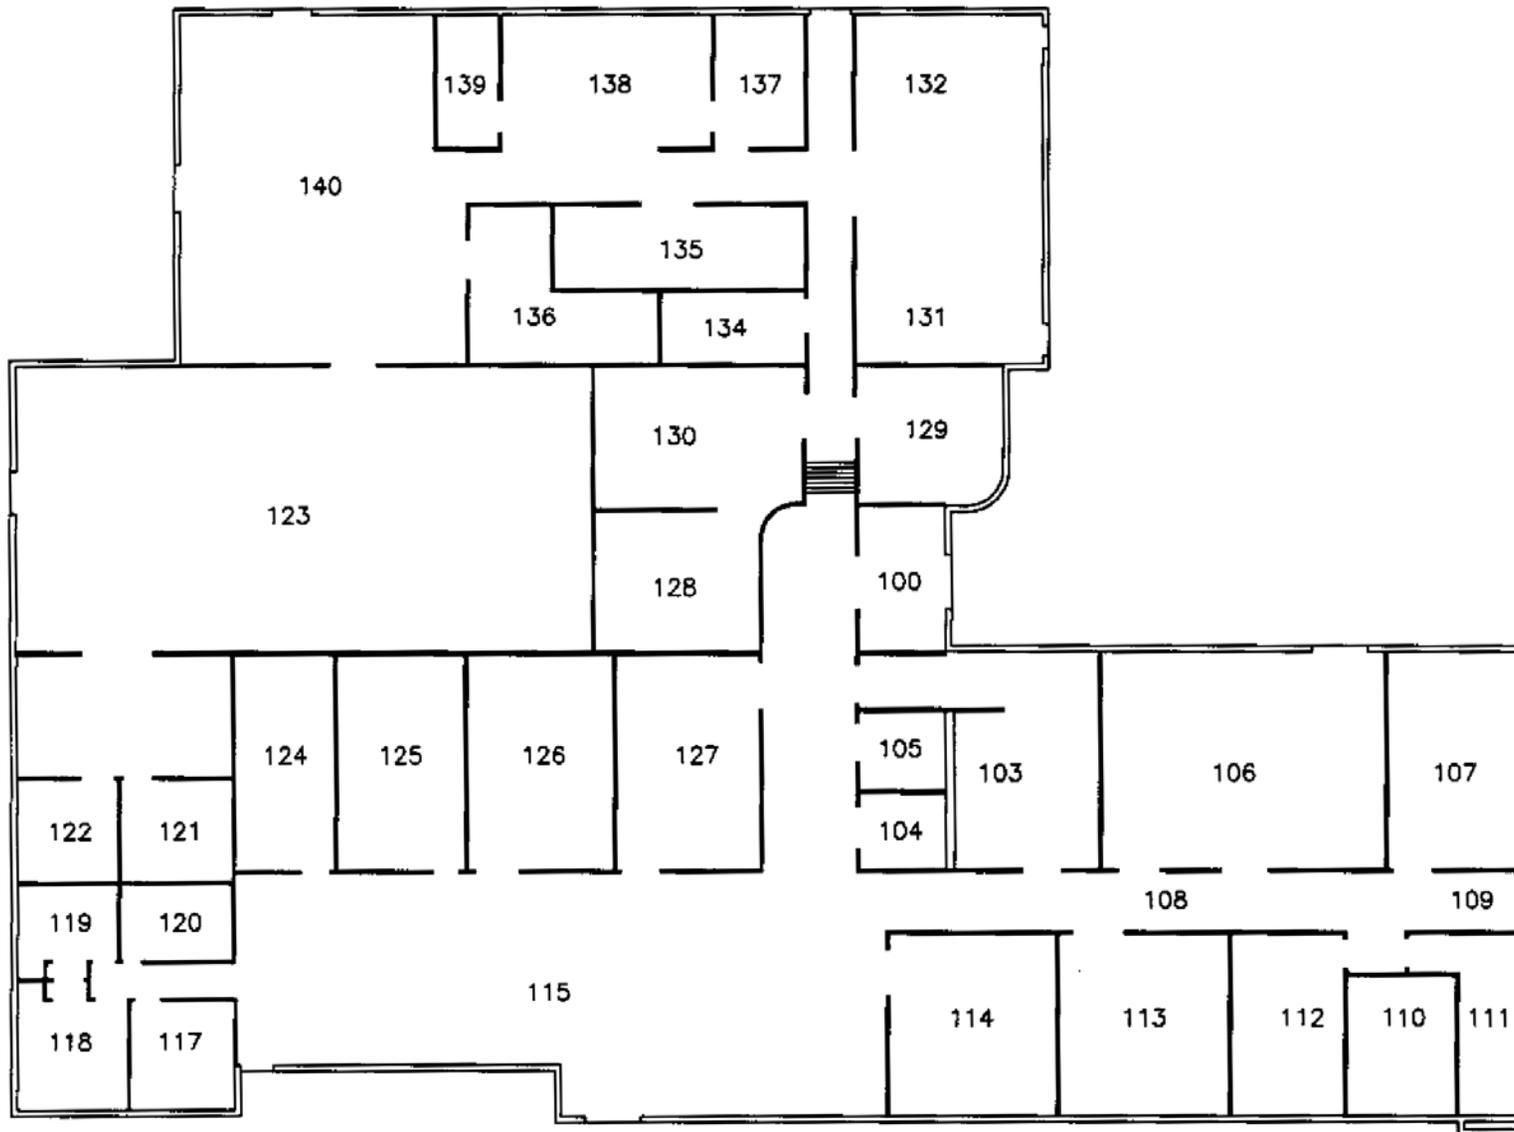
FIGURE 3
Interior Layout, Reserve Center
Phase I ECP Report

The USARC Building functions as an administrative and drill facility for the USAR Center (Figure 3, Appendix A). The structure was constructed in 1957 as a rectangular building that rested on a concrete foundation with concrete block walls and a brick veneer. The USARC Building underwent an extensive renovation in 1986, when additional space was added to the south and east sections of the building, modifying it into a multiple-level irregular-shaped structure. A gray stucco façade was also installed on the exterior at that time. A recessed entrance containing a pair of glass pedestrian doors is located on the west side of the building. A tiled walkway leads from a POV parking area to the western entrance. Two sets of concrete stairs are located between the public sidewalk and the USARC Building on the west side of the building. Additional entrances include single and paired metal pedestrian doors located on the north, south, east, and west walls. A flat roof covers the structure.

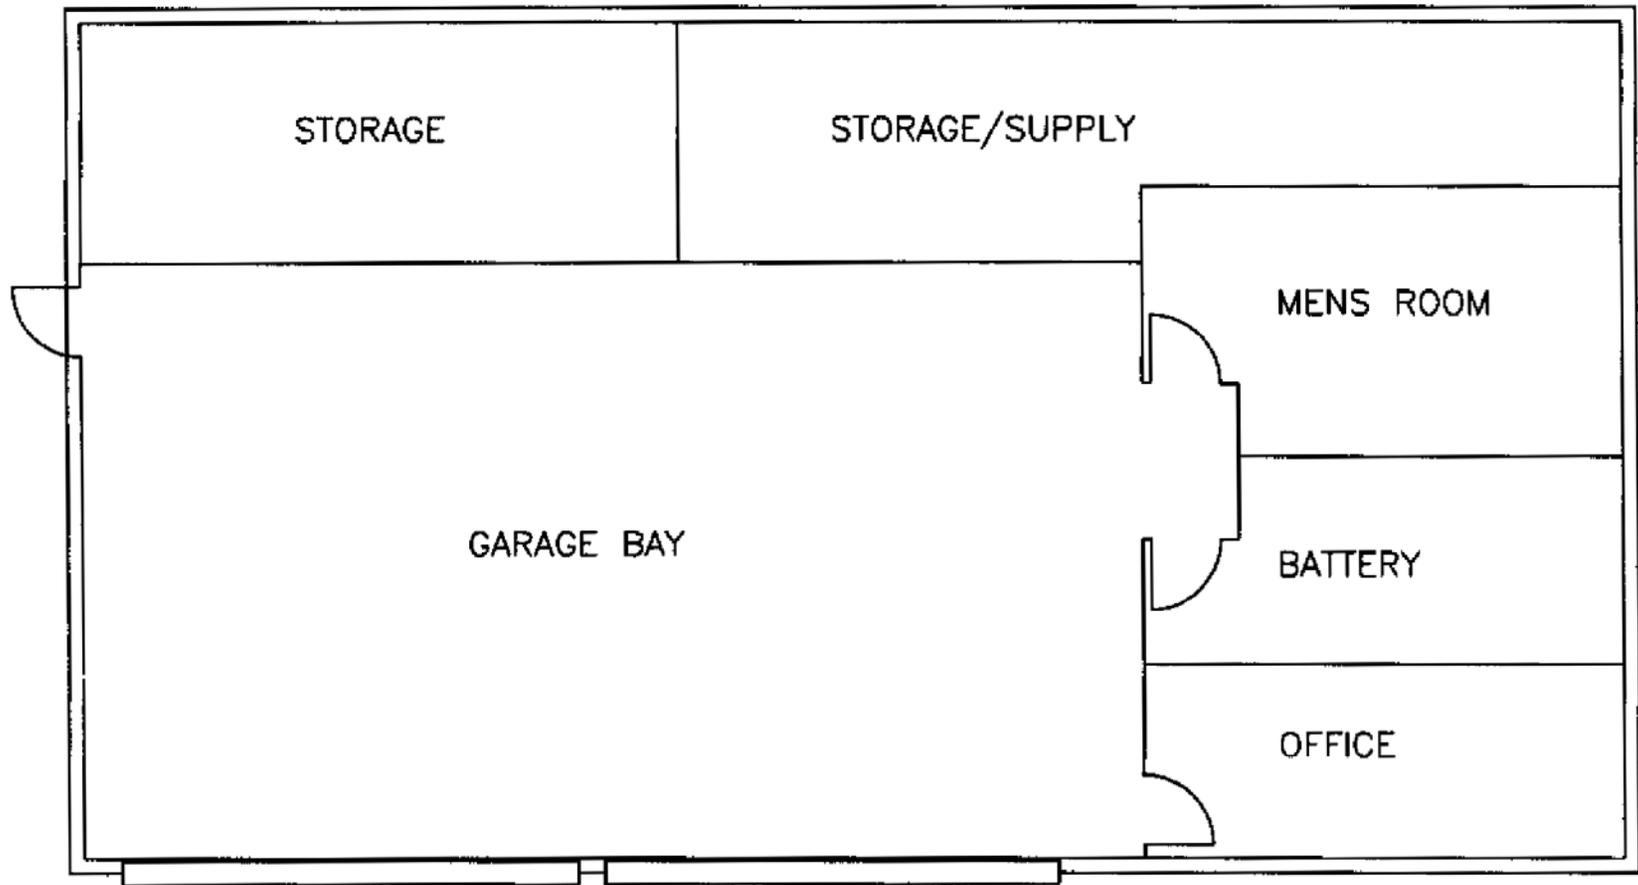
FIGURE 4
Interior Layout, AMSA Building
Phase I ECP Report

The AMSA Building functions as a full-service vehicle maintenance facility for the USAR Center (Figure 4, Appendix A) that supports many of the USAR Centers located in the State of Ohio. The structure was constructed in 1957 as a rectangular building that rested on a concrete foundation with concrete block walls and a brick veneer. The AMSA Building underwent an extensive renovation in 1986 when additional space was added, modifying it into a multiple-level rectangular structure. A gray stucco façade was also installed on the exterior at that time. Two metal overhead retractable bay doors are located on the north wall of the building. Additional entrances include single and paired metal pedestrian doors along the east and west walls. A flat roof covers the one-and-one-half-story maintenance bay, and a low-pitch shed roof covers the administration area.

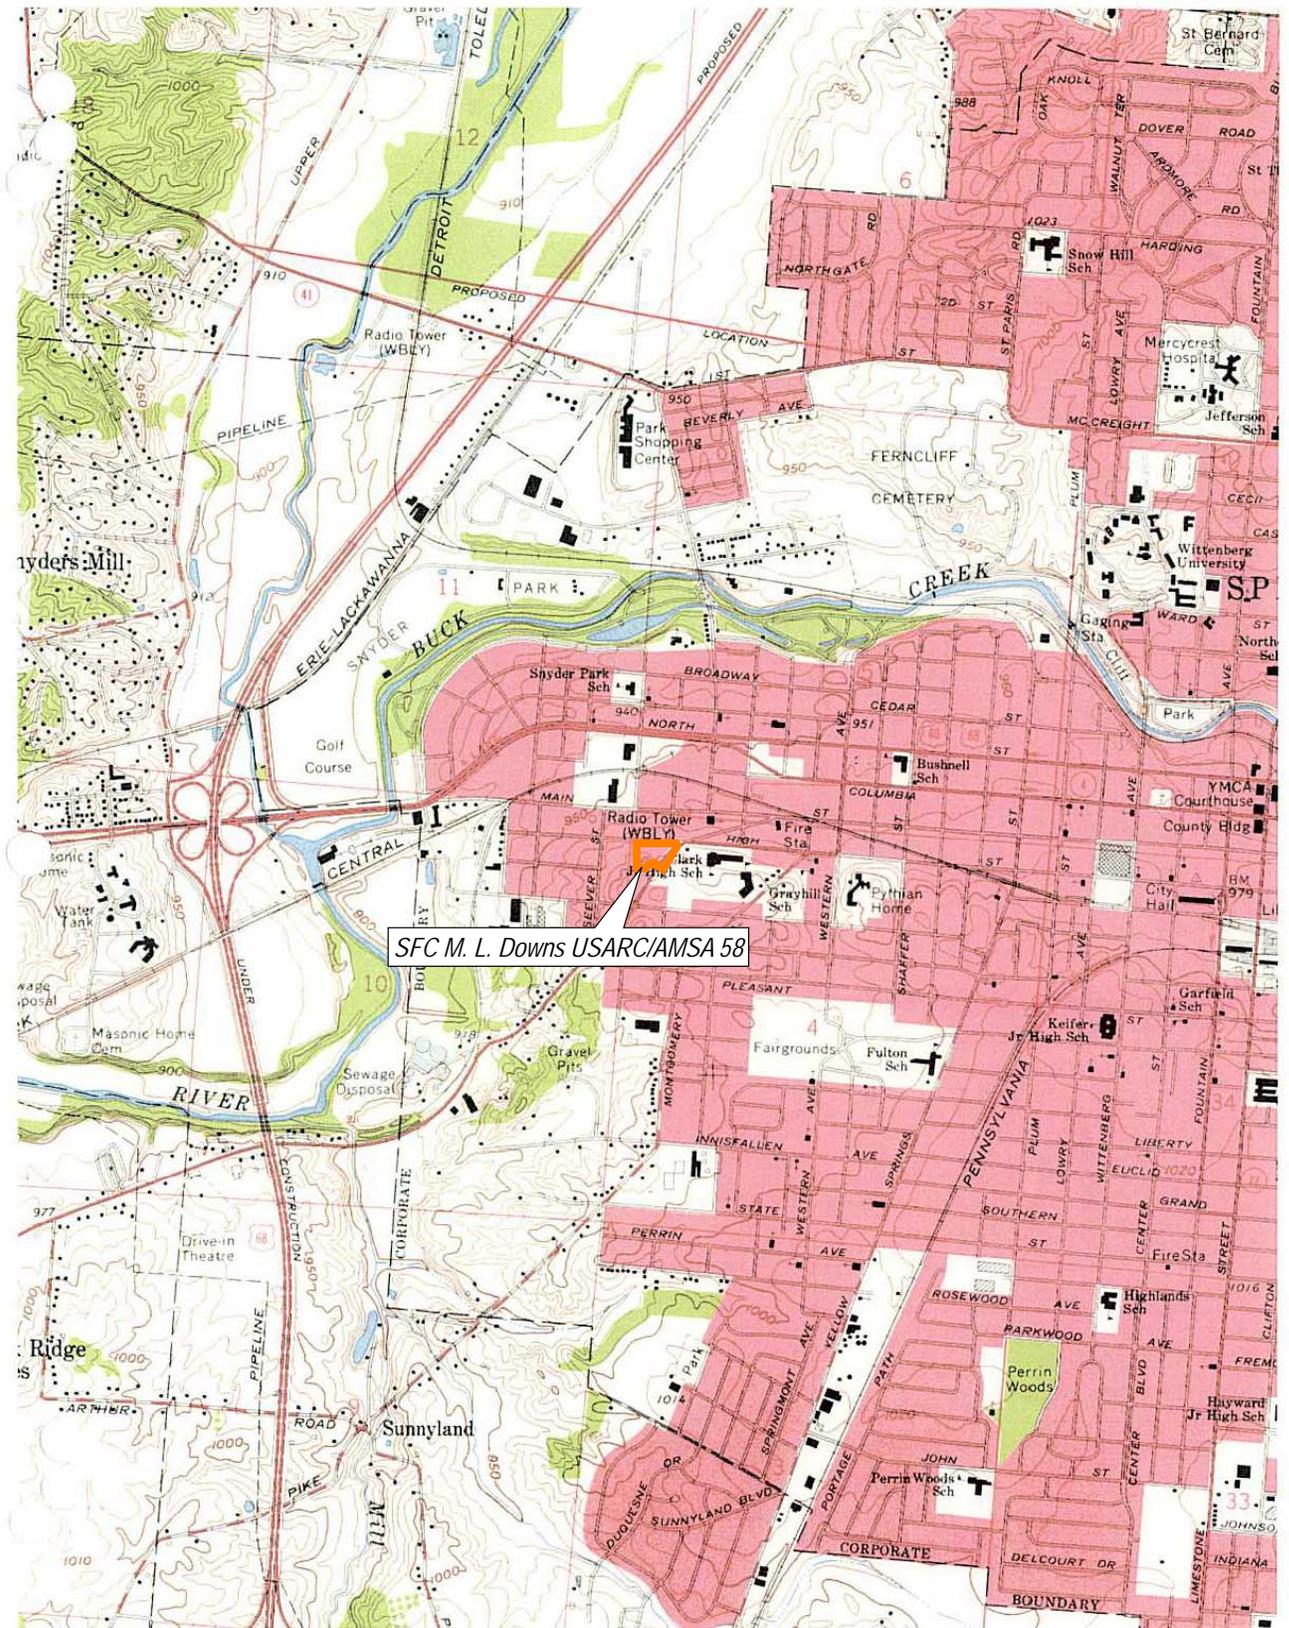
FIGURE 7
1966 USGS 7.5-Minute Topography Map
Phase I ECP Report

Figure 7 in Appendix A provides the 1966–1981 Springfield, Ohio, USGS topographic map, which includes the Property. As shown, the Property is situated at an elevation of approximately 979 feet above mean sea level and is relatively flat. The topography is somewhat flat on the northern part of the Property and has a steep slope on the southern part of the Property. Surface water flows to the west. Stormwater at the Property that does not infiltrate into the underlying soil generally flows via overland flow toward the west area of the property. Surface water eventually flows into the City of Springfield stormwater system. Additionally, a natural resources survey was performed at the USAR Center in 2005. Although a copy of the document was not supplied for review for this ECP report, USAR representatives state that the report documents that no wetlands are located on the Property.

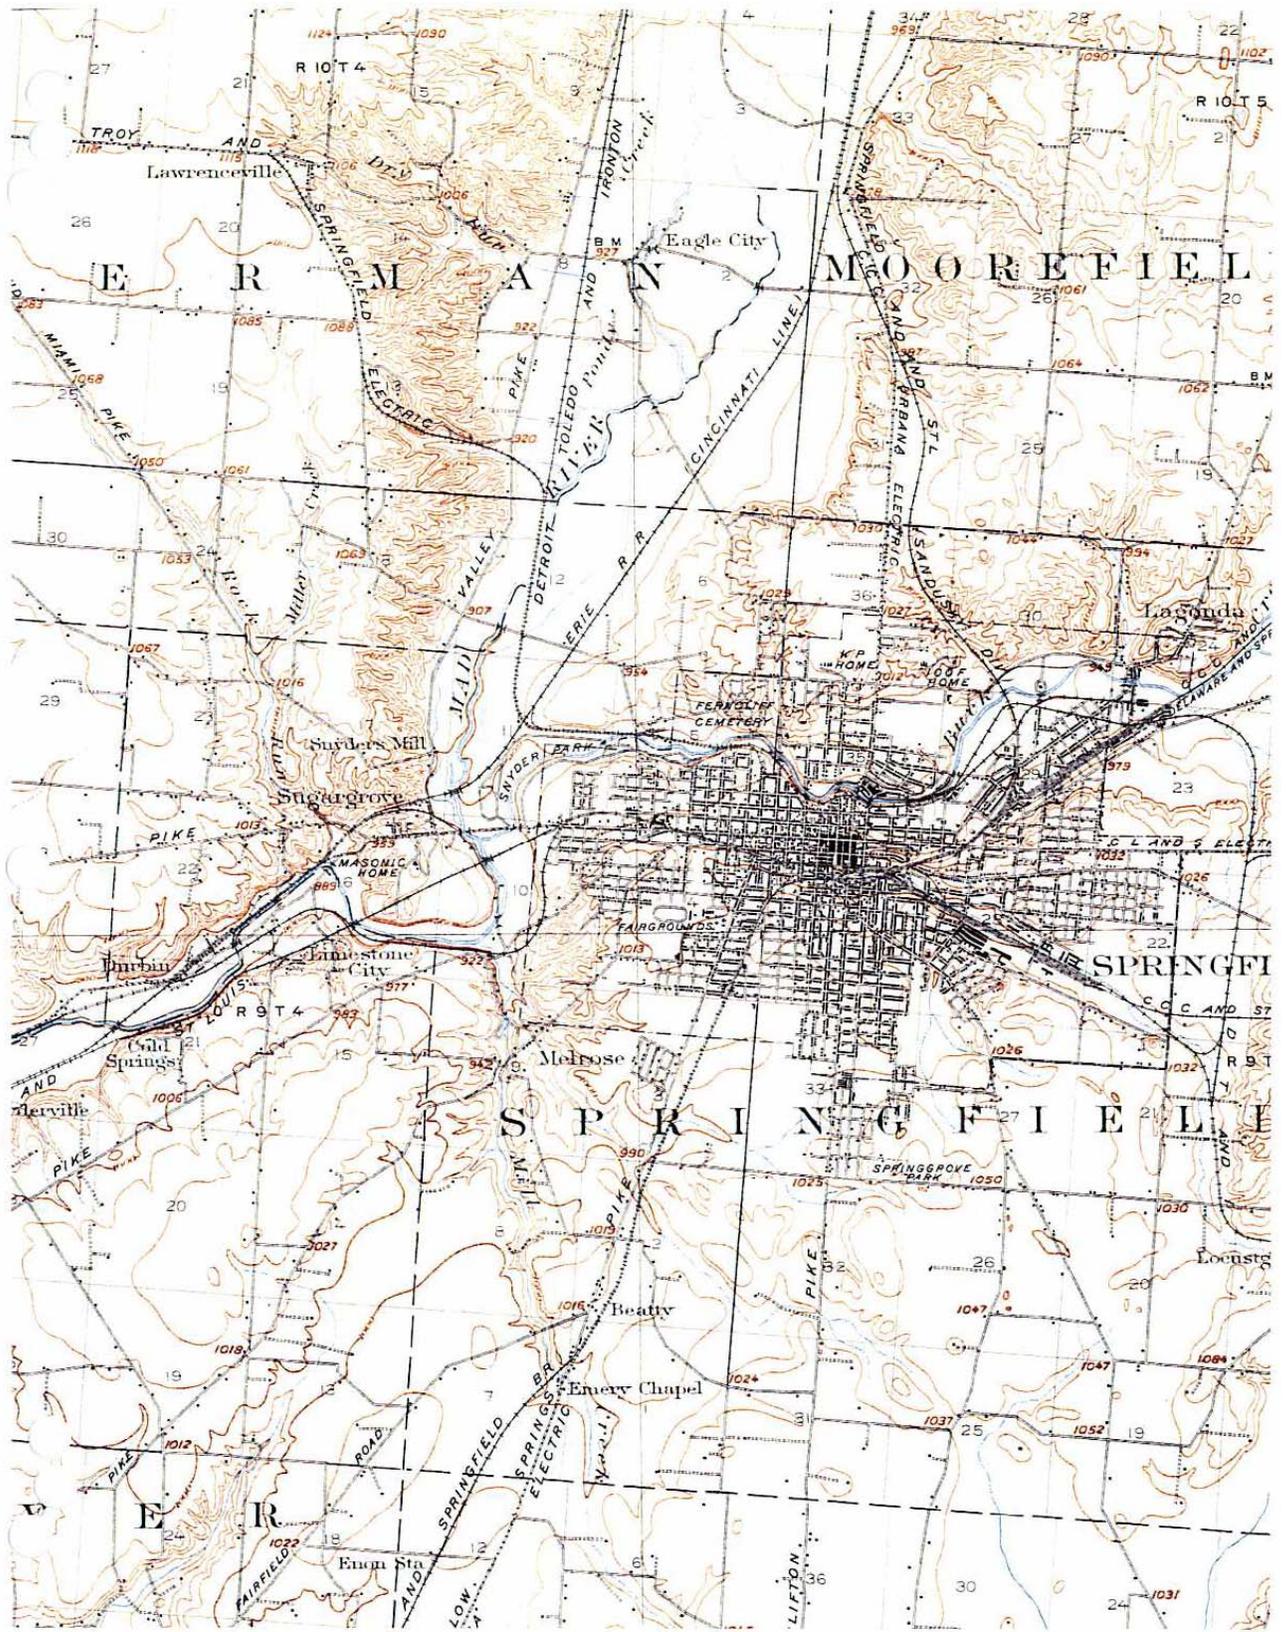
FIGURE 9
1906 USGS Series 15' Topography Map
Phase I ECP Report

The 1906 USGS topographic map (Figure 9 of Appendix A) shows the City of Springfield to be established and that the future location of the USAR Center is in the western area of the city. The 1955, 1966, 1970, and 1984 USGS topographic maps (Figures 5 through 8, in Appendix A) show the Property is in a well developed area, but little change is noted over time.

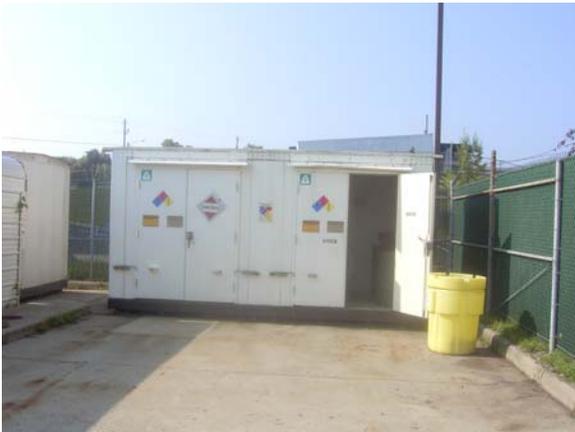
3. Hazardous Materials Storage Shed located between the Reserve Center and the OMS.

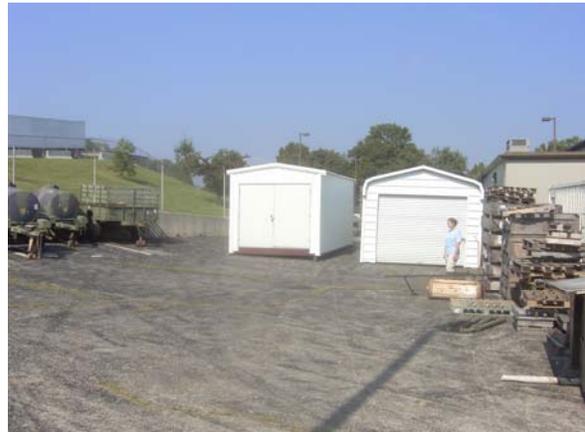
4. Equipment Storage Sheds located on the South east corner of the OMS.

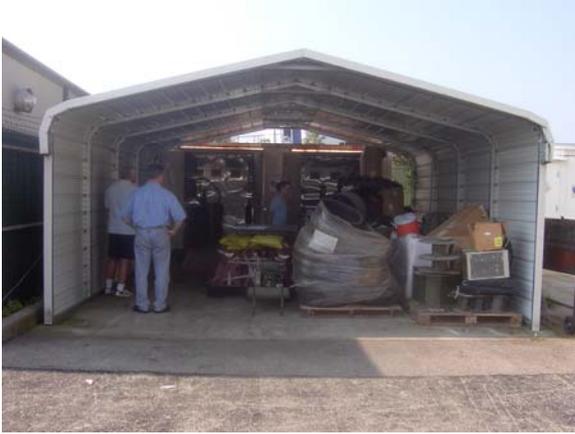
3. Cover area containing the Hazardous Waste Storage Containers. Located between the Reserve Center and OMS.

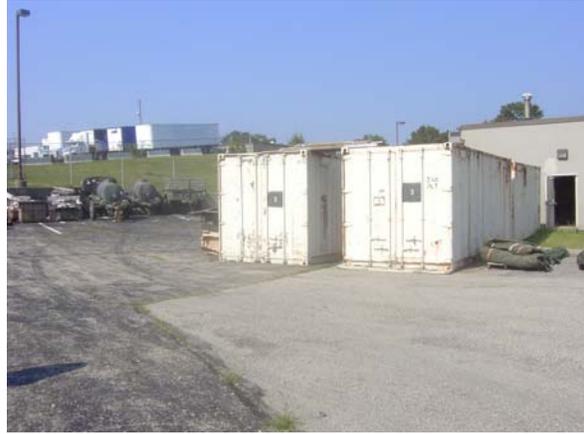
4. Conex Storage Boxes used Several are to store equipment that is sent with Deployed Units. Located throughout the MEP Area.

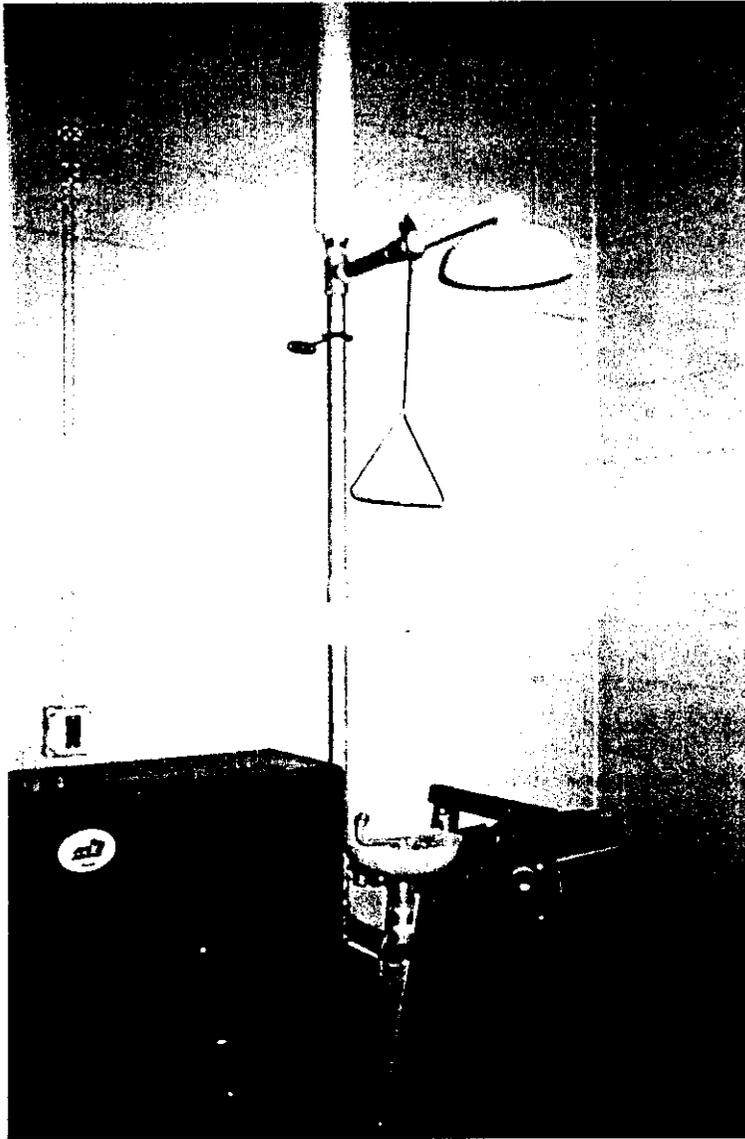
Photograph P: Emergency shower and eye wash in battery room are satisfactory by design, no BFP devices required.

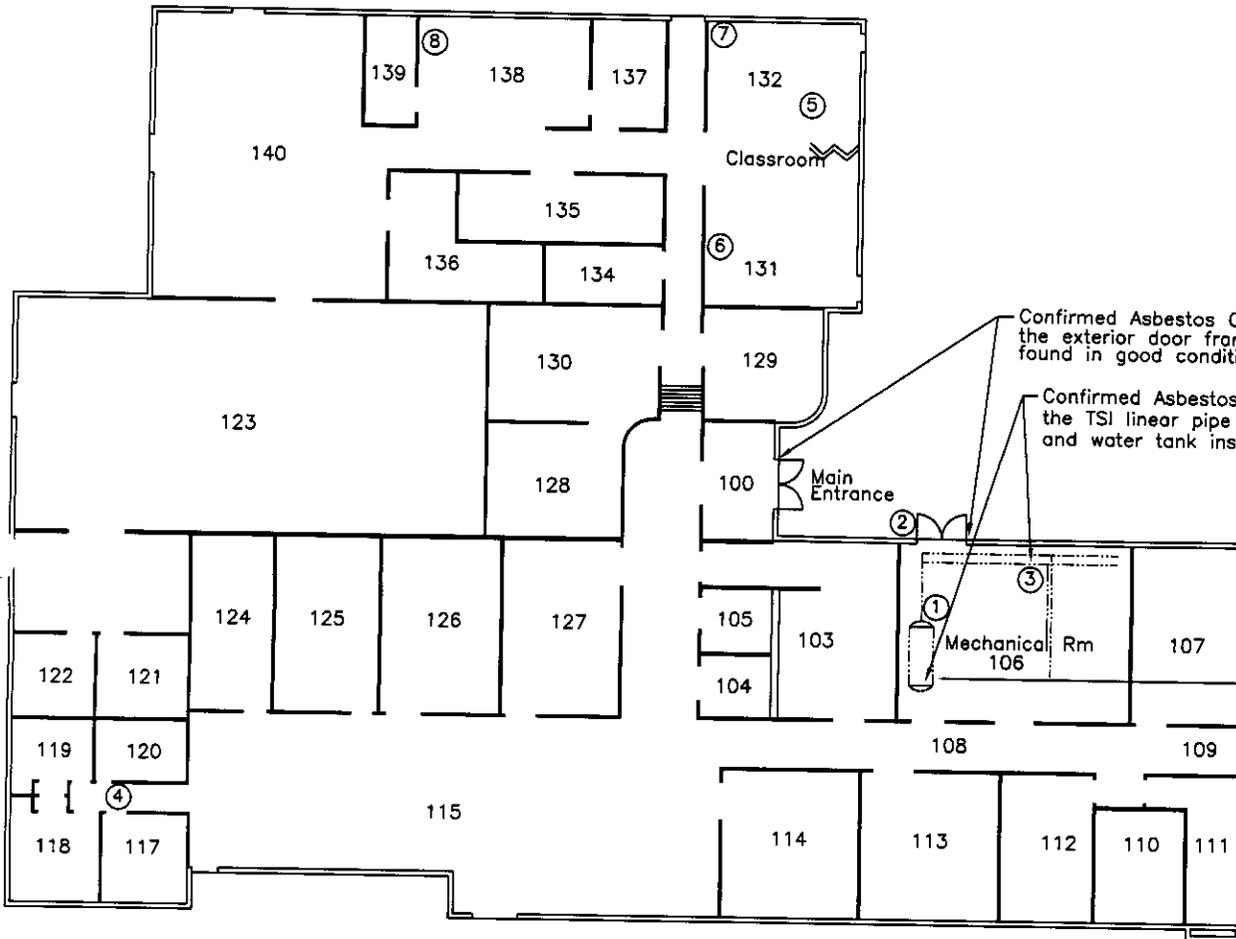
Confirmed Asbestos Containing Material in the exterior door frame caulking (White) found in good condition (CK)

Confirmed Asbestos Containing Material in the TSI linear pipe insulation, fitting and water tank insulation. (TSI)
