FINAL
**ENVIRONMENTAL CONDITION OF PROPERTY
REPORT**

**MIDDLETOWN
U.S. ARMY RESERVE CENTER (CT005)
499 MILE LANE
MIDDLETOWN, CT 06457**

MARCH 2007

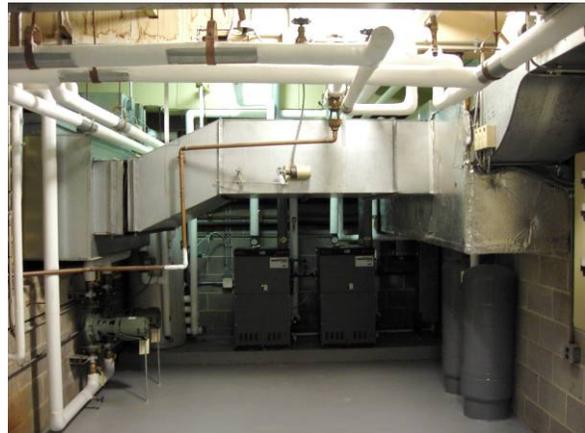
10. Boiler Room

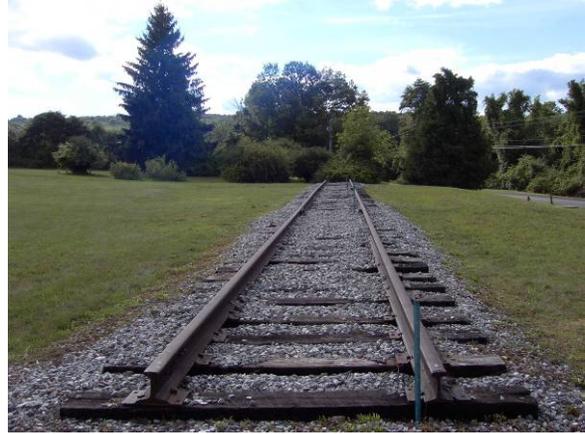
12. *Railroad Section*

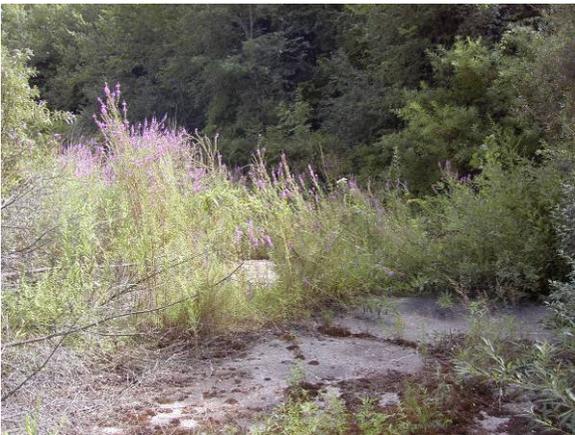
13. *Acid Neutralization Building Foundation—East Side*

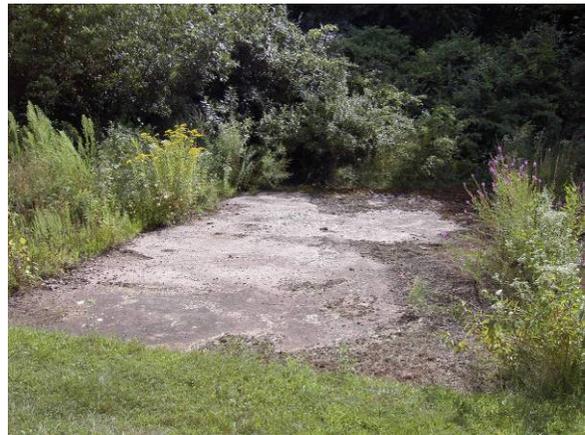
14. *Acid Neutralization Building Foundation—West Side*

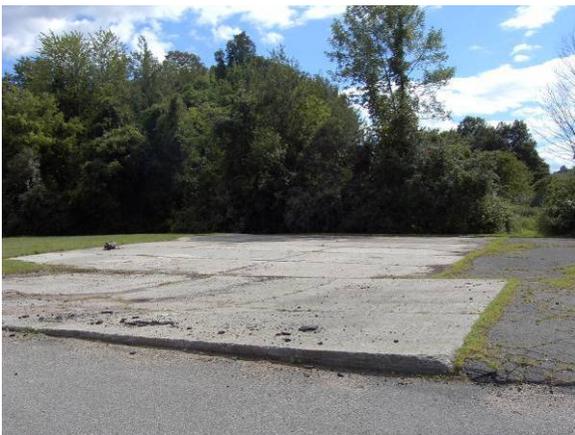
15. *General Maintenance Building Foundation*

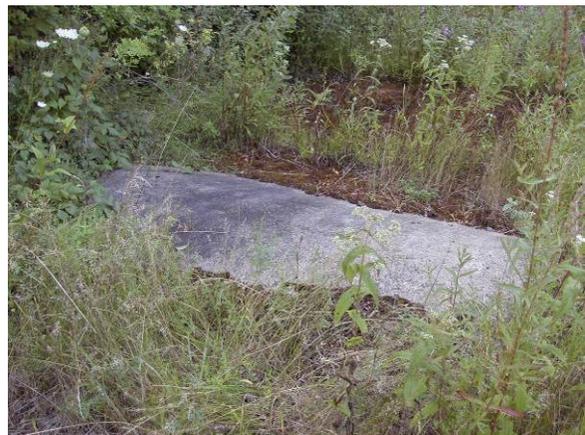
16. *Possible Acid Neutralization Pit*

⁸ References to an “acid neutralization pit” near the acid fueling station on drawings for Nike Ajax sites, however, no drawings or references to this pit have been located.

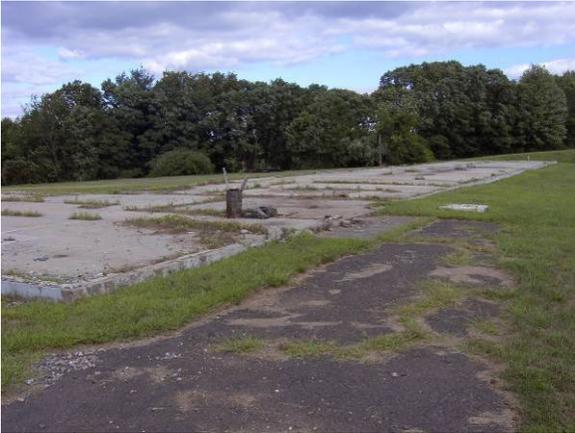
17. Barracks/Reserve Center Foundation

The third foundation, formerly the barracks for personnel that supported the Nike missile operations, is located centrally on the property, just north of the Reserve Center. The building was converted for use as a Reserve Center until the current building was constructed in 1987. An undated aerial photo (Figure 3, Appendix A) found at the Property shows the Nike missile site when it was in operation.

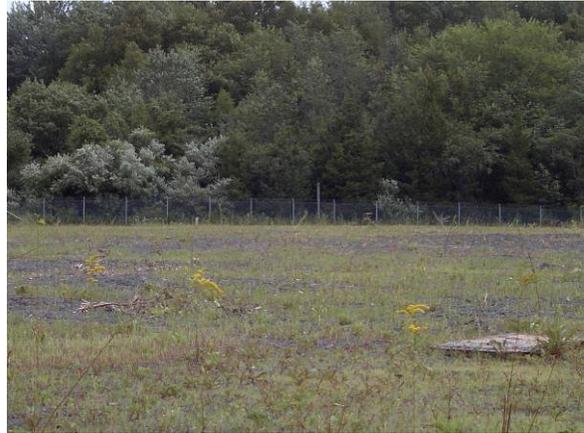
18. Former Nike Missile Launch Pad Site

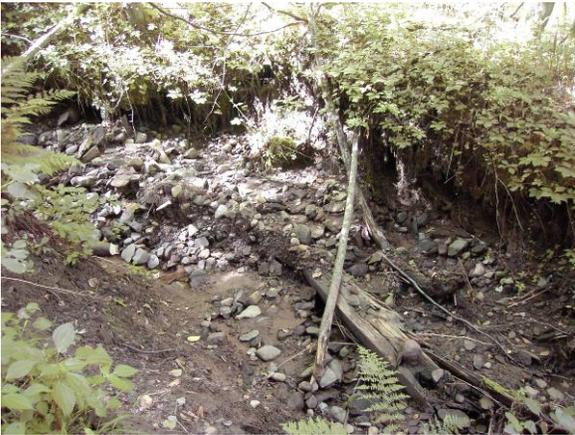
19. Rail Timbers Disposed of in South Portion of the Property.

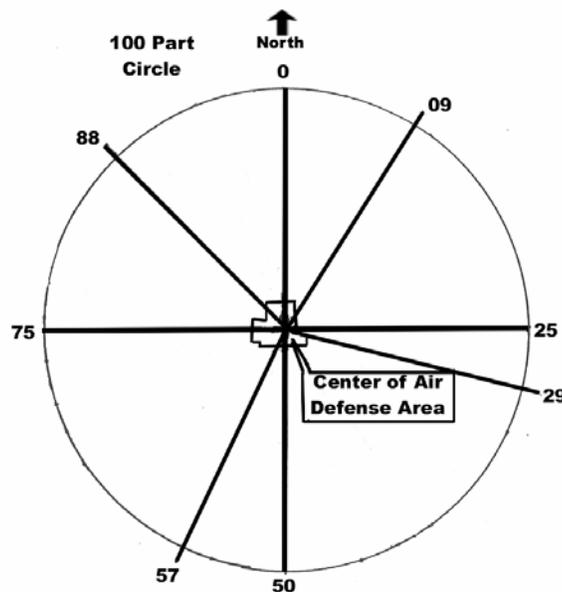
Figure 2-1: Nike Site Designation System

The Nike-Ajax fixed sites were staggered between out-skirts and close-in locations to provide for greater defense capability. The battery control area for each site was located in an inner ring towards the vital area with the launcher areas located farther out away from the vital area. Battery site designations were based on a 100-segment circle. See Figure 2-1 for an example of battery site designation.

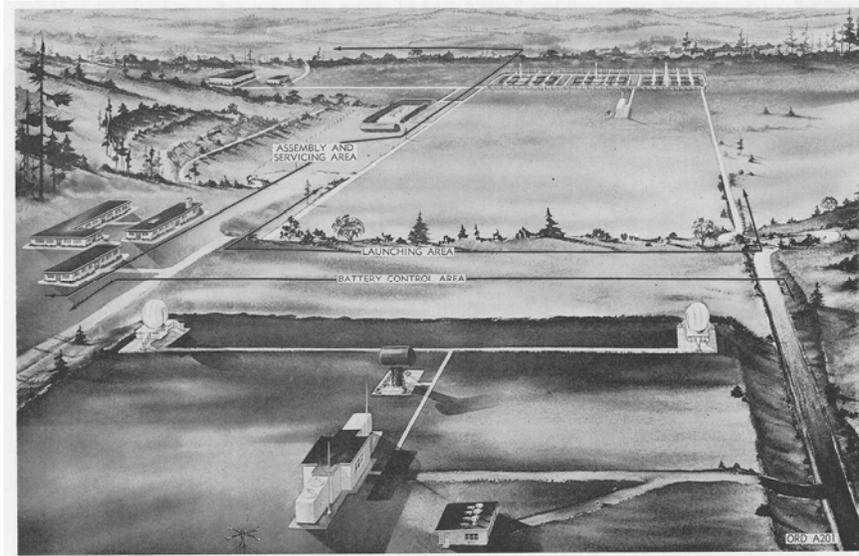
Figure 2-2: Typical Permanent Missile Battery

Nike-Ajax and Nike-Hercules missile batteries were very similar. Each battery consisted of two principal operational areas: the battery control area, (also called Integrated Fire Control (IFC)) and the launch area with launchers and adjacent assembly/service area. Figure 2-2 shows a typical permanent Nike-Hercules battery. The Nike Ajax batteries also included missile fueling facilities not required by the Nike Hercules. An administrative area provided housing and office functions. These facilities could be collocated with one of the two principle areas or as a separate area. Utilities such as water, sewer, and electrical power were required as well as the storage of fuels. In general, the battery control area was located on relatively level and well-drained terrain and higher than the launch area. This area had to be free of any visual obstructions to allow a direct line of sight between the radar equipment, missiles and targets. The physical layout of the facilities on a site was adapted to site-specific topography, land availability and other site-specific conditions while using standardized "modified emergency" design structures. There were slight variations in these standard designs. An overview of the Nike battery facilities and operations are provided in the Section 3 and 4. While launch sites generally stored missiles in the underground magazines, most of the sites protecting SAC bases stored missiles on the surface with earthen berms around the launchers. Also, some of the early Ajax launch sites were temporarily above ground until underground magazines were constructed.

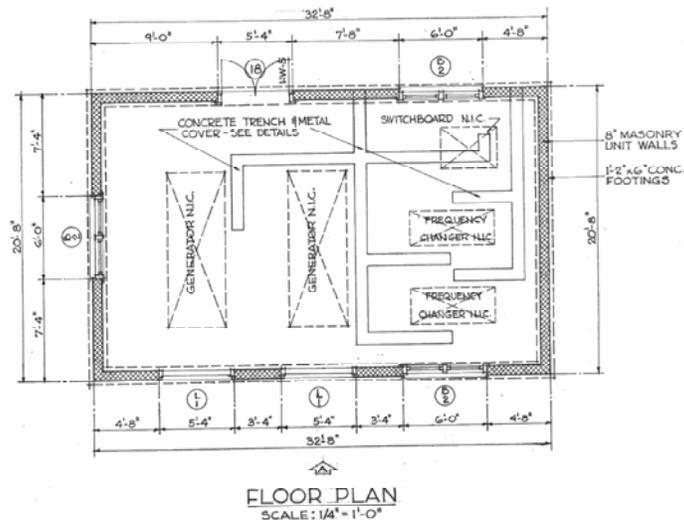
Figure 3-2: Battery Control Generator Building

Standard drawing ME 26-03-34 for the generator building in the control area show a floor trench to the generators and frequency converters. No detail drawing was available for this trench. Details of the trench for the generator building in the launch area may provide information relevant to this trench. The trenches were sloped to drain. See Figure 3-2. Drawings ME 26-03-34. It should be noted that some buildings may also have been renovated when Nike Ajax sites were upgraded for Nike Hercules.

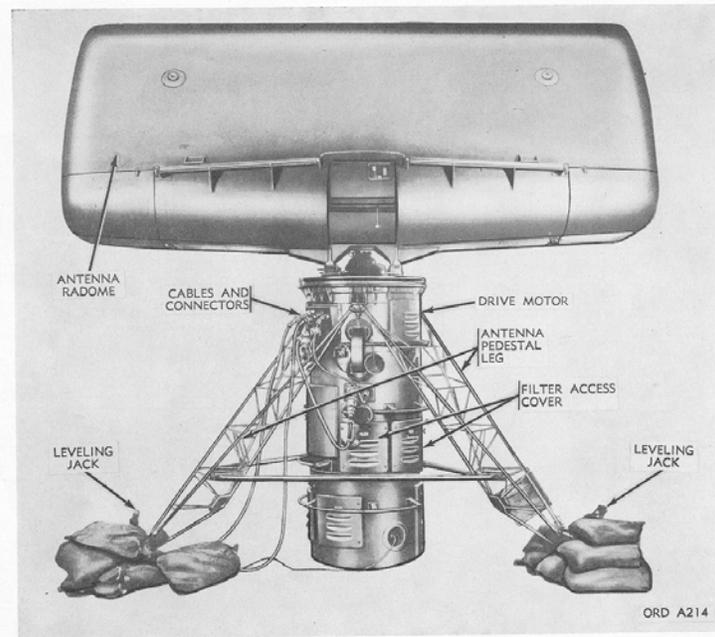
Figure 3-3: Acquisition Radar

Acquisition Radar/LOPAR⁵. The Acquisition Antenna-Receiver-Transmitter Group, also known as LOPAR, contained a receiver-transmitter that generated and radiated into space, a radio frequency energy necessary to detect and acquire a target. In addition, this receiver-transmitter received target echoes and converted them into a usable intermediate frequency. A listing of major components of which this group is comprised is presented below. See Figure 3-3. PAM 750-1-2 at 9.

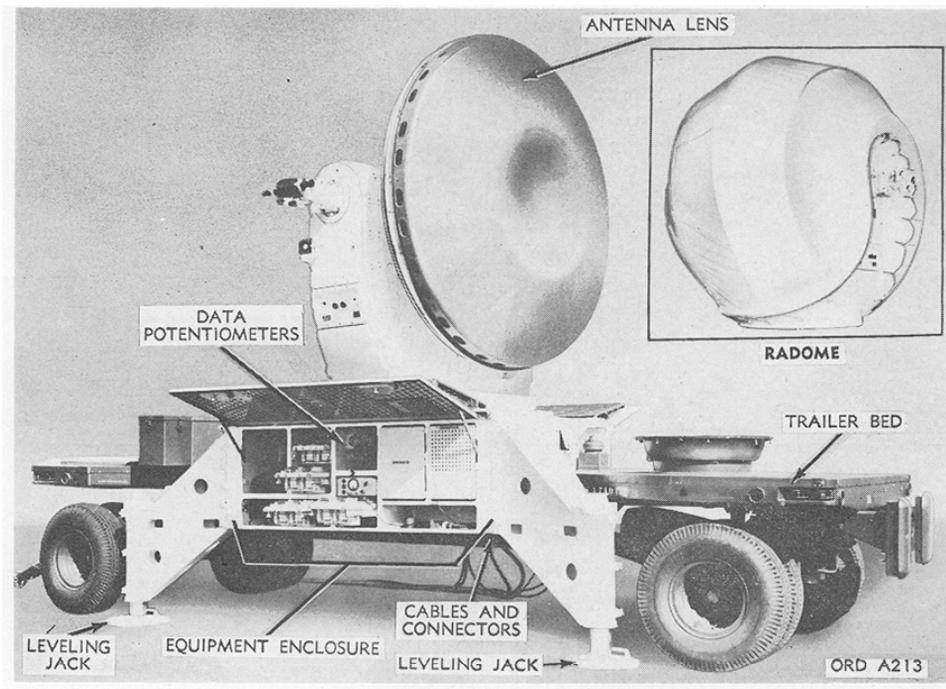
Figure 3-4: Tracking Radar

Trailer Mounted Target-Track Antenna-Receiver-Transmitter Group (TTR). This group contained the transmitting and receiving equipment necessary to supply continuous target position information to the computer. Once locked on target, it automatically tracked the target as long as it was within range. PAM 750-1-2 at 14.

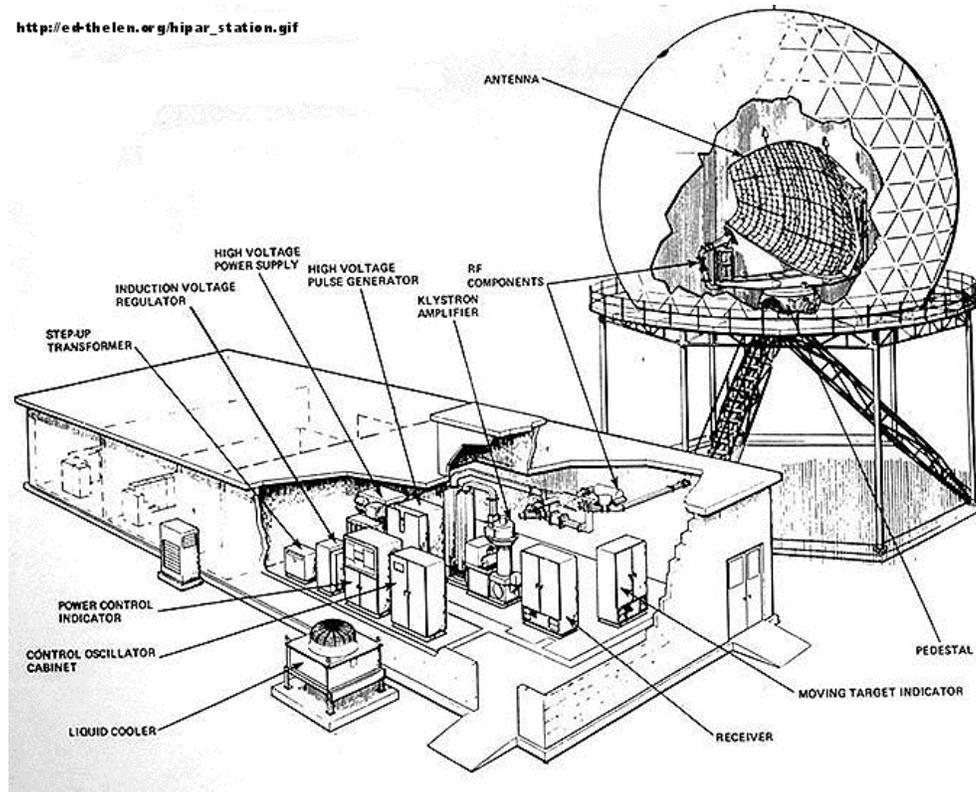
Figure 3-5: HIPAR and Support Building

High-Power Acquisition Radar (HIPAR). HIPAR increased the detection range, altitude coverage and improved the system's capability to detect small, high-speed targets at long range. The HIPAR was often located on a support and tripod structure, often as high as 50 feet. A radome covered the radar and various antennas. There were usually three types of antennas: the main, omni, and auxiliary antennas. The HIPAR building housed the transmitter and receiver systems and non-tactical operational controls. During conversion selected sites received the Improved Hercules package of new radars. However, HIPAR radars were not installed at some sites due to geographical constraints and/or to avoid duplication of radars located at adjacent sites. ABAR radar was used in place of HIPAR on certain locations. See Figure 3-5. Lonquest, 1996 at 182; Whitacre, 1996 at 58-59; FM 44-82 at 10-11.

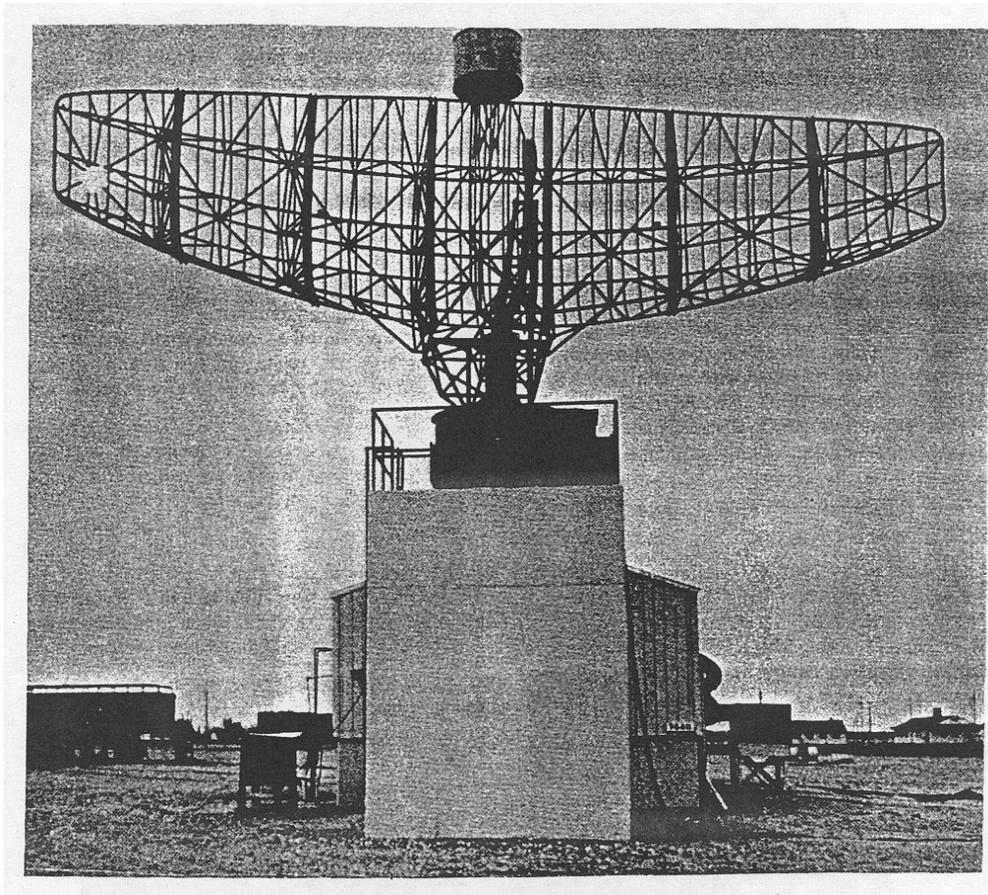
Figure 3-6: ABAR

Alternate Battery Acquisition Radar (ABAR). In lieu of the HIPAR, Some Improved Hercules systems were equipped with ABAR (radar set AN/FPS-69, AN/FPS-71, or AN/FPS-75) to improve target detection range and electronic counter-counter measures. The ABAR equipment less the antenna assembly was sheltered in a building. The antenna assembly was mounted on a concrete tower. See Figure 3-6. FM 44-82 at 11.

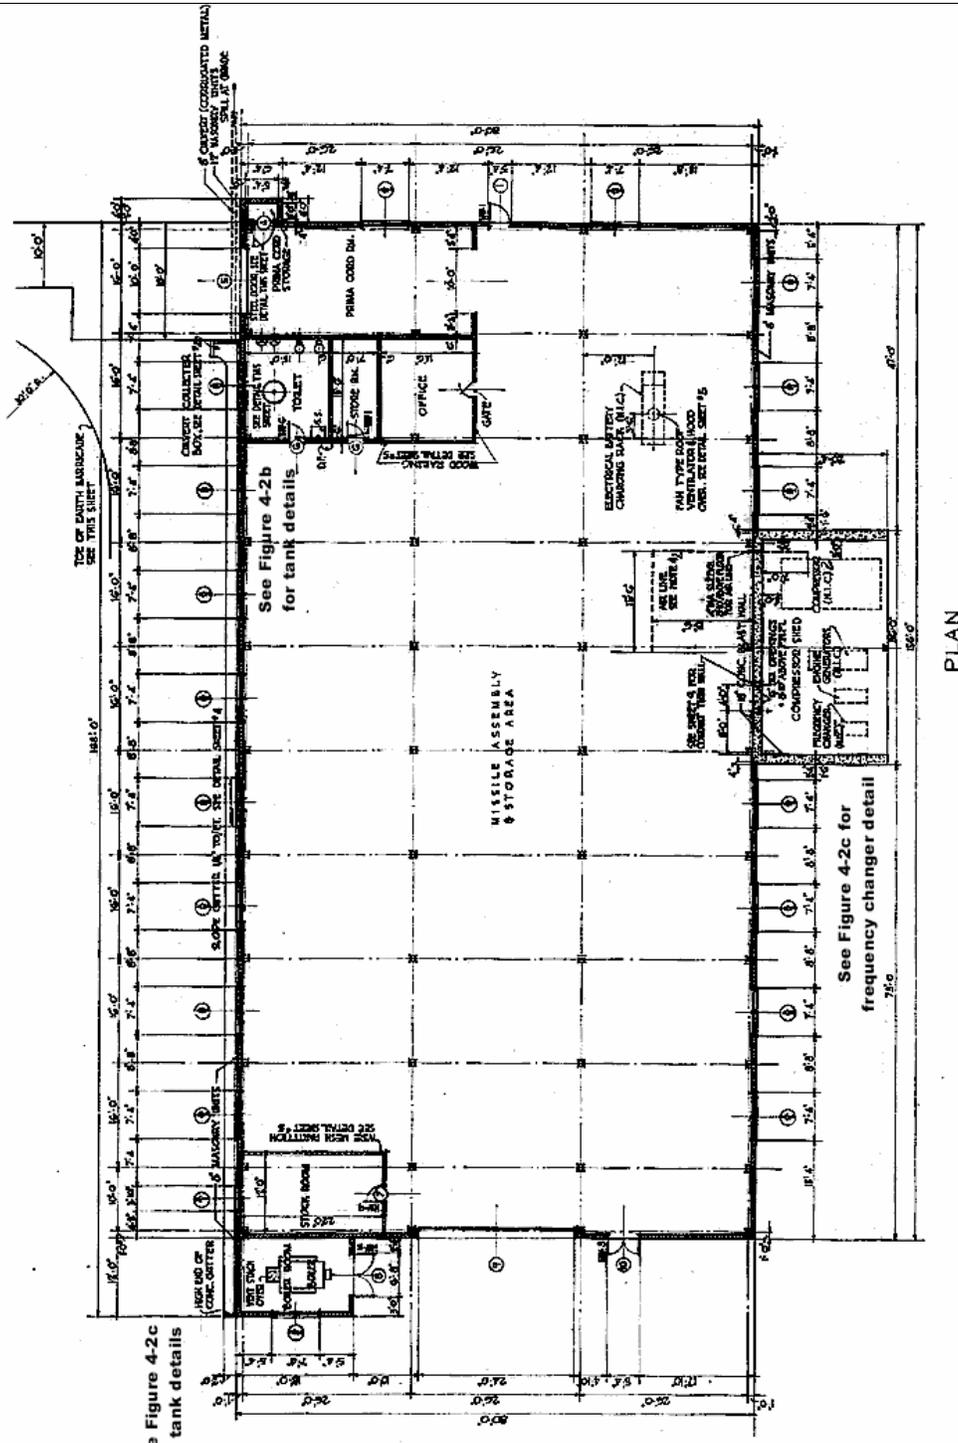
Figure 4-2a: Nike Ajax Assembly and Test Building

Initial missile assembly and test operations were conducted in the assembly and test building. Adjacent hardstand received, uncrated, and stored missile components. Missiles arrived in major assembly components unassembled and unarmed. The assembly consisted of the installation of the missile fins, ailerons or elevons, and missile body sections and system tests. Two large overhead doors at either end allowed the missiles to be rolled in and out of the main test and assembly room. Other rooms included a stock room, first aid room, restroom, and boiler room. A concrete walkway was provided for moving the missile from this building to the service area. ME 35-60-04 and 35-60-29. See Figures 4-2a and 4-2c for configuration assembly and test buildings.

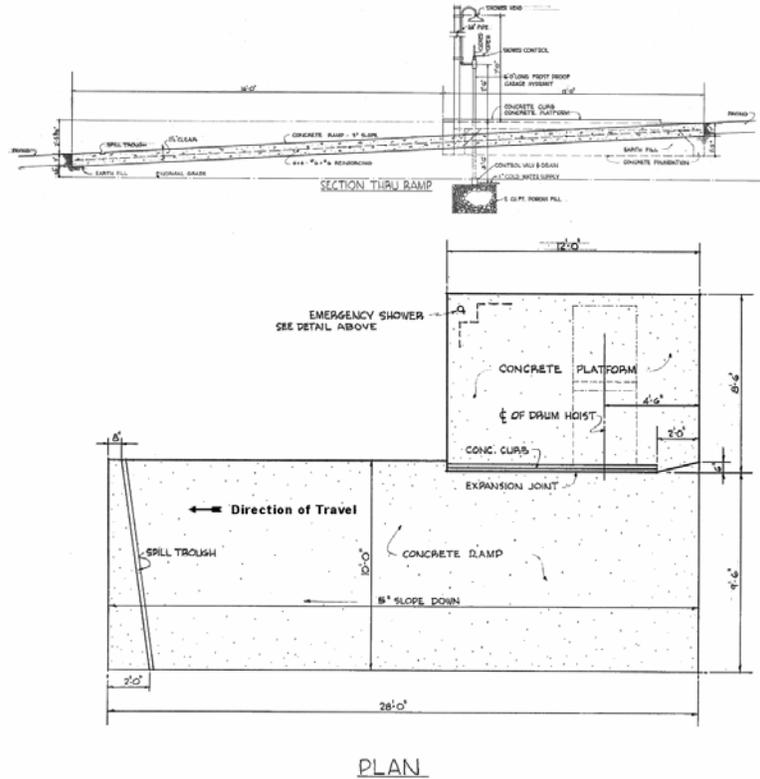
Fueling of the Nike Ajax was performed at two fueling stations arranged in series. The missile was tilted by a 3° to 5° ramp/bump built into the acid fueling station. The M2 acid platform hoist assembly automatically inverted the barrel as it was raised to provide a 60-inch head between the acid drum and acid port on the missile body. As protection against the caustic acid, crewmen wore disposable protective clothing and breathing apparatus during the fueling process. An emergency shower was provided at the acid platform.⁸ See Figures 4-3a and 4-3b. Propellant fueling followed the acid fueling. The M3 fuel hoist was a crank-operated lift approximately 12 feet high. The fuel was hoisted onto this platform, allowing the fuel to flow into the missile by gravity. The propellant fueling ramp and platform were similar but no shower was provided or acid neutralization pit was provided at the propellant station. Both ramps were constructed with a built-in spill trough. TM 9-1450-250-12 at 6; TM 9-5012-1 at 197-199, 202, 208; MS-70 Drwg.

Fueling
Figure 4-3b: Typical Acid Fueling Ramp and Platform
(Note: Propellant Ramp and Platform was similar)

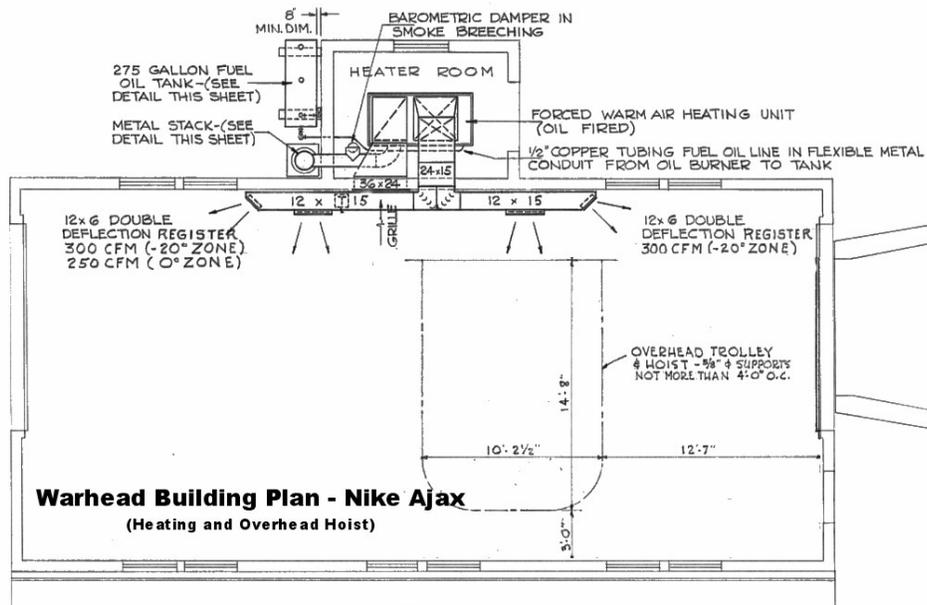
Figure 4-3c: Warheading Building

The joining and/or warheading building provided a protective shelter during the uncrating and installation of the warhead body section and for the installation of the missile rocket motor subassembly. A separate heater room with an exterior above ground fuel oil tank is shown on the standard drawings. TM 9-1450-250-12 at 6; ME 33-38-10 Sheet 1 & 4; ME 35-60-05 Sheet 1.

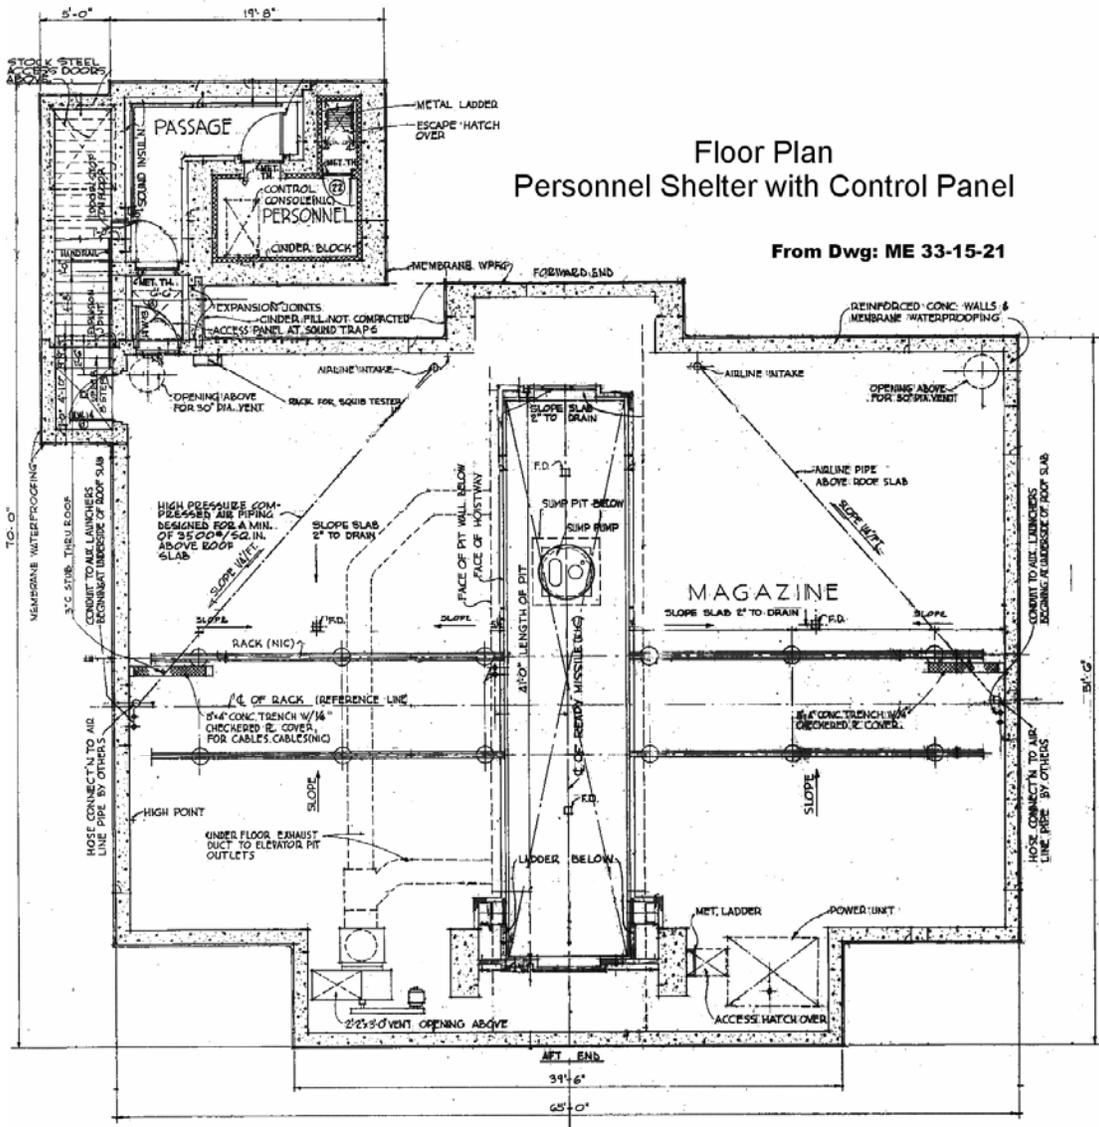
Figure 4-4b: Typical Magazine Underground Configuration

The Section Control Indicator Group consisted of an indicator with the necessary switches, indicator lights, meters, and communication equipment required for preparing the missile fire and launch order circuits for coordinating activities of the launchers with the launching control group. The Section Simulator Group received the 208-volt AC and 24-volt DC power from the launching section generator. It then supplied power to each launcher in the section, to the launcher control-indicators, and to the launching section control-indicator. PAM 750-1-2 at 30. Pipe drains that could daylight to meet ditch grade or empty to a French drain system drained the magazine sump and access doors.

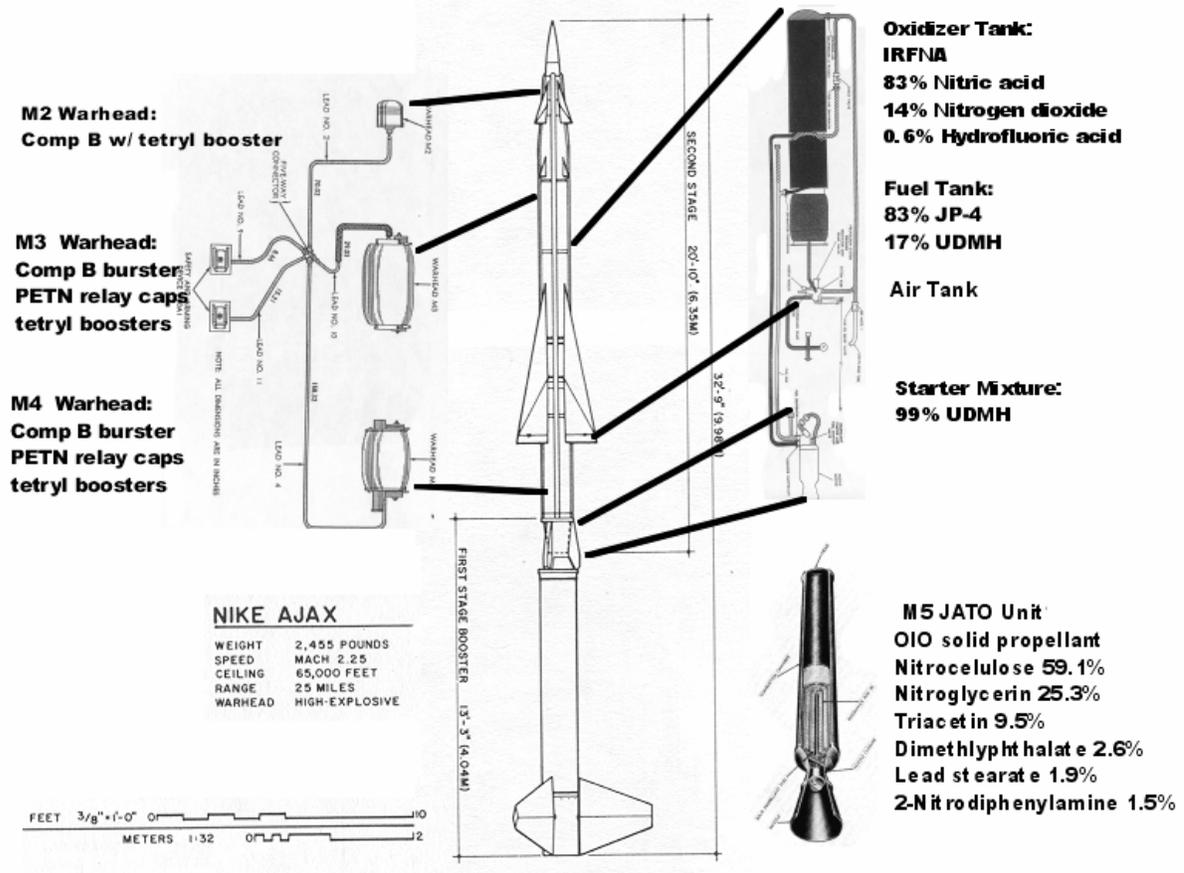
Figure 4-6a: Nike Ajax Missile and Booster

Figures 4-6a and 4-6b illustrate the explosive and fuel components of the Nike Ajax and Nike Hercules.

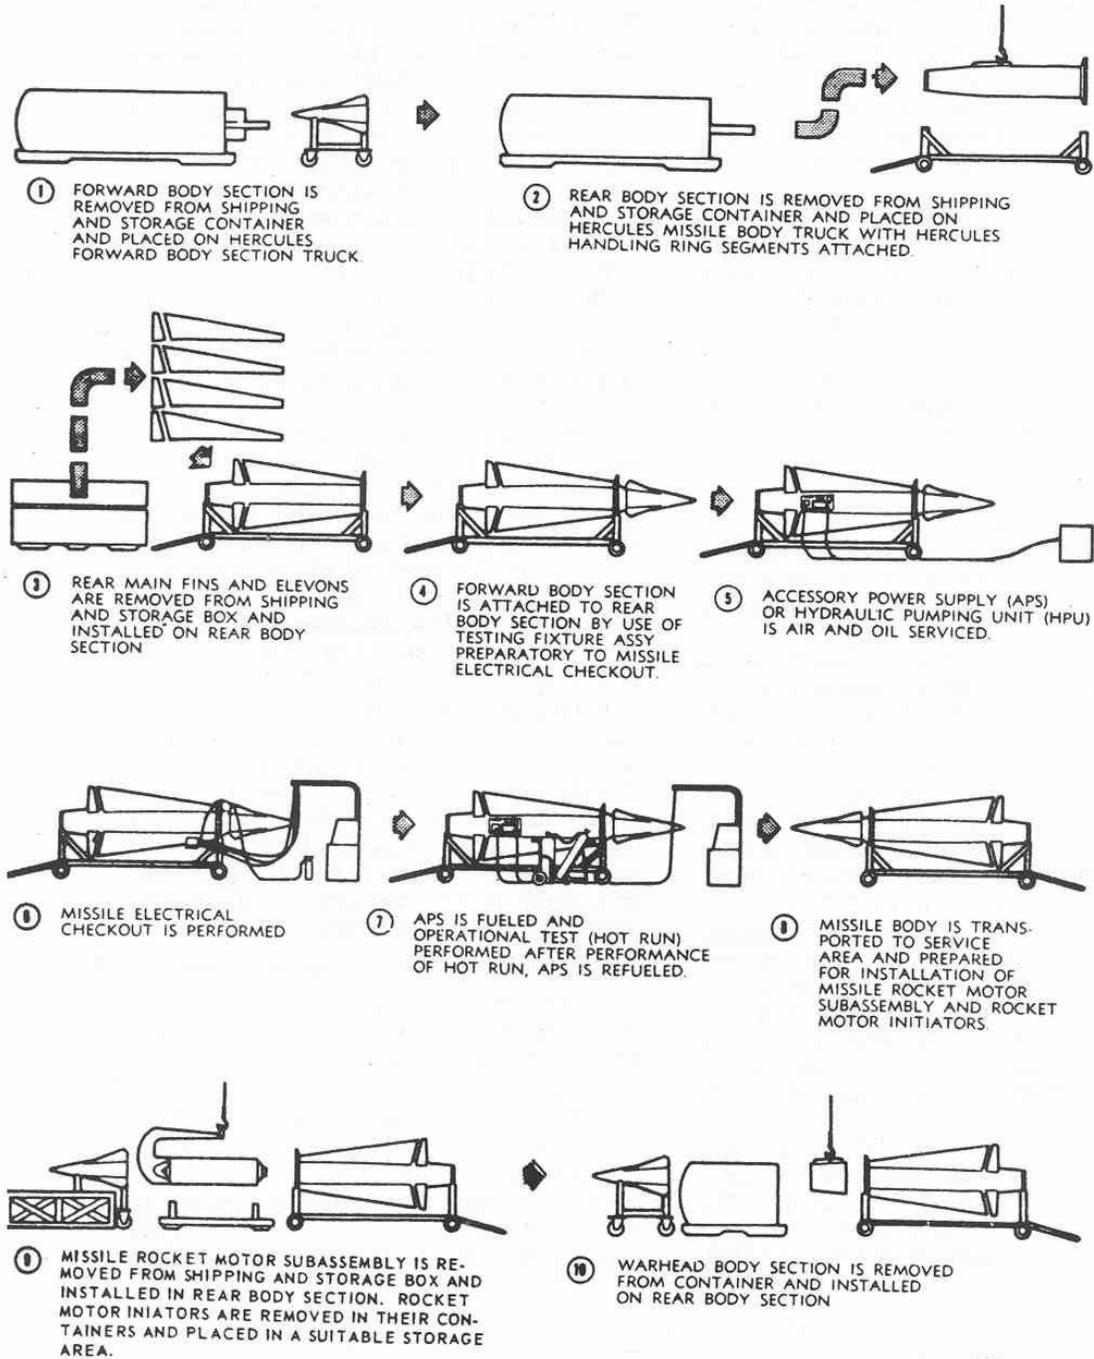
Figure 4-6e: Nike Hercules Assembly Process

Uncrating and assembling the missile was similar to the Nike Ajax, however, the Nike Hercules manual specified the use of a cleaning solvent to remove all corrosion-preventive compound from the fin spar sockets and unpainted surfaces of all main fins, elevons, and attaching hardware. The cleaning was followed by a light application of general-purpose lubrication-grade oil. TM 9-1410-250-12/1 at 3-23.
