**ENVIRONMENTAL CONDITION OF
PROPERTY REPORT**

**CAMBRIDGE MEMORIAL
U.S. ARMY RESERVE CENTER (MN006)
540 FIFTH AVENUE NORTHWEST
CAMBRIDGE, MINNESOTA 55008**

MARCH 2007

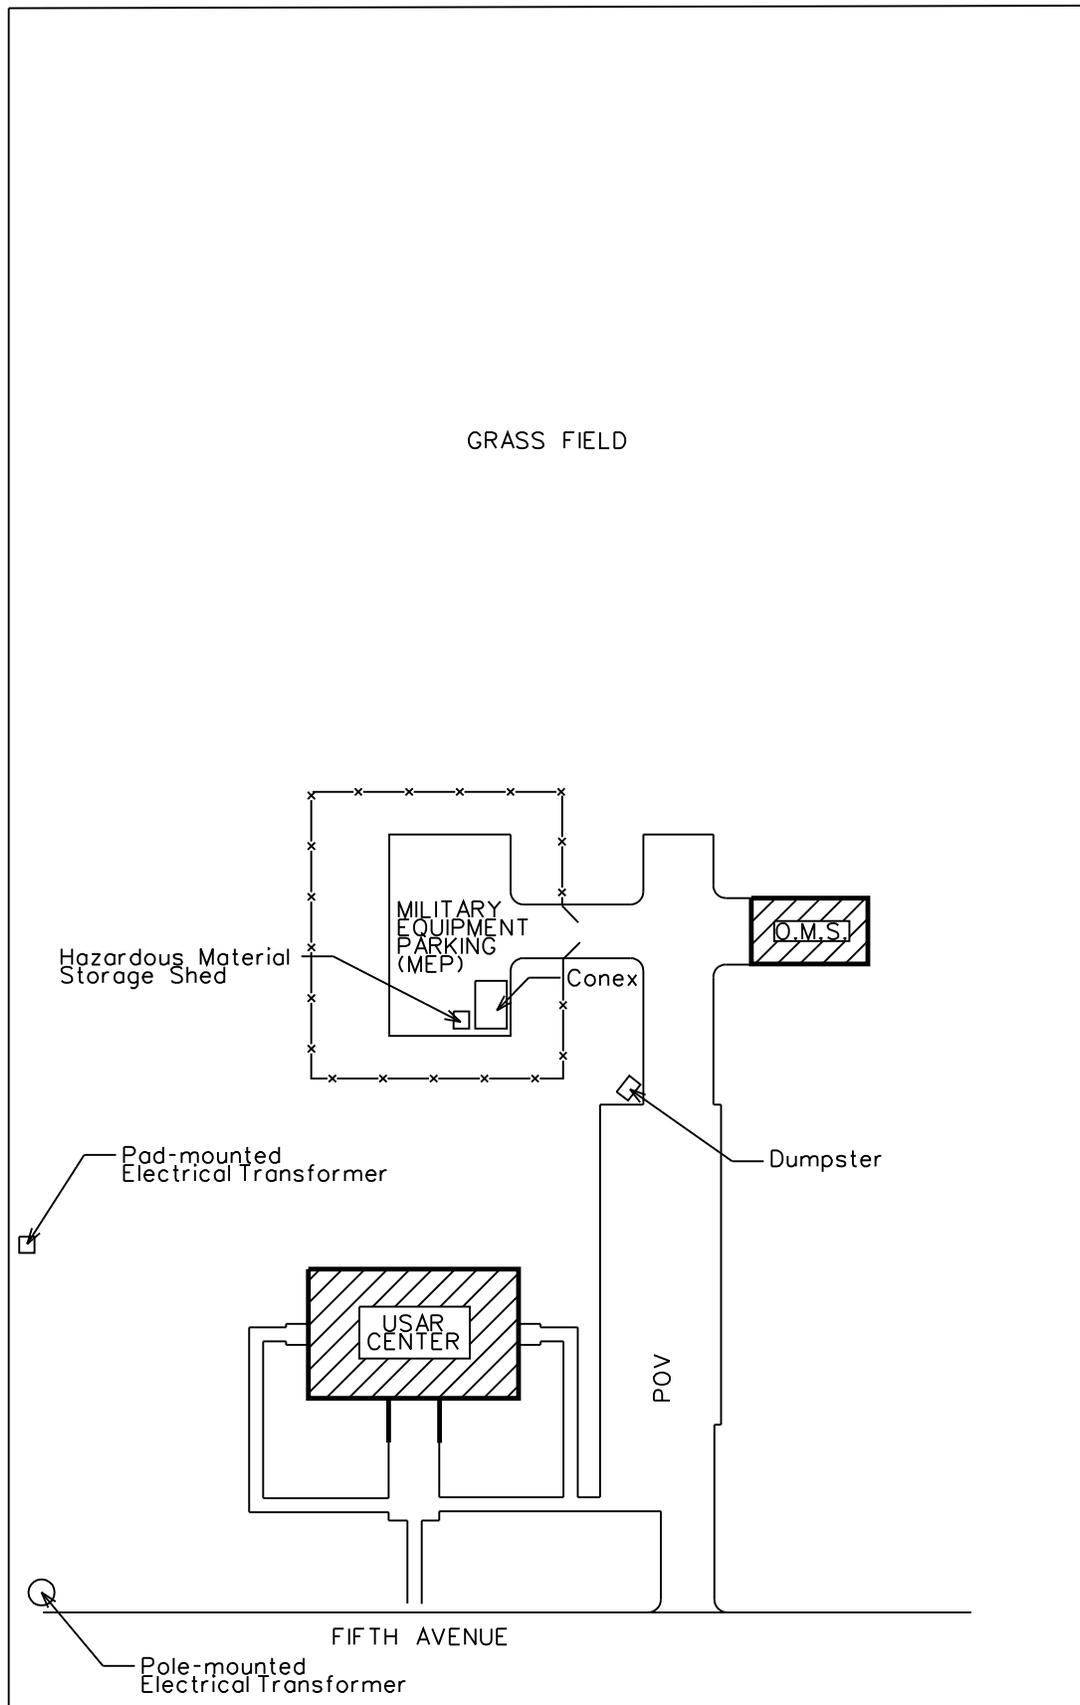
FIGURE 2
SITE LAYOUT PLAN
CAMBRIDGE USARC CENTER ECP REPORT
CAMBRIDGE, MINNESOTA

The USAR Center contains two permanent structures and two parking lots. Construction of the 4,316 square-foot administration building and the 1,313 square-foot organizational maintenance shop (OMS) building was completed in 1960 and 1961, respectively (Fort McCoy Archaeological Laboratory, 2001; ITI, 2002). Both structures are on concrete foundations, and consist of concrete block walls covered with a brick veneer. A military equipment parking (MEP) area and a privately owned vehicle (POV) parking area are also contained within the Property. Chain-link security fencing topped with barbed wire encloses the MEP area. Figure 2, in Appendix A shows the site layout.

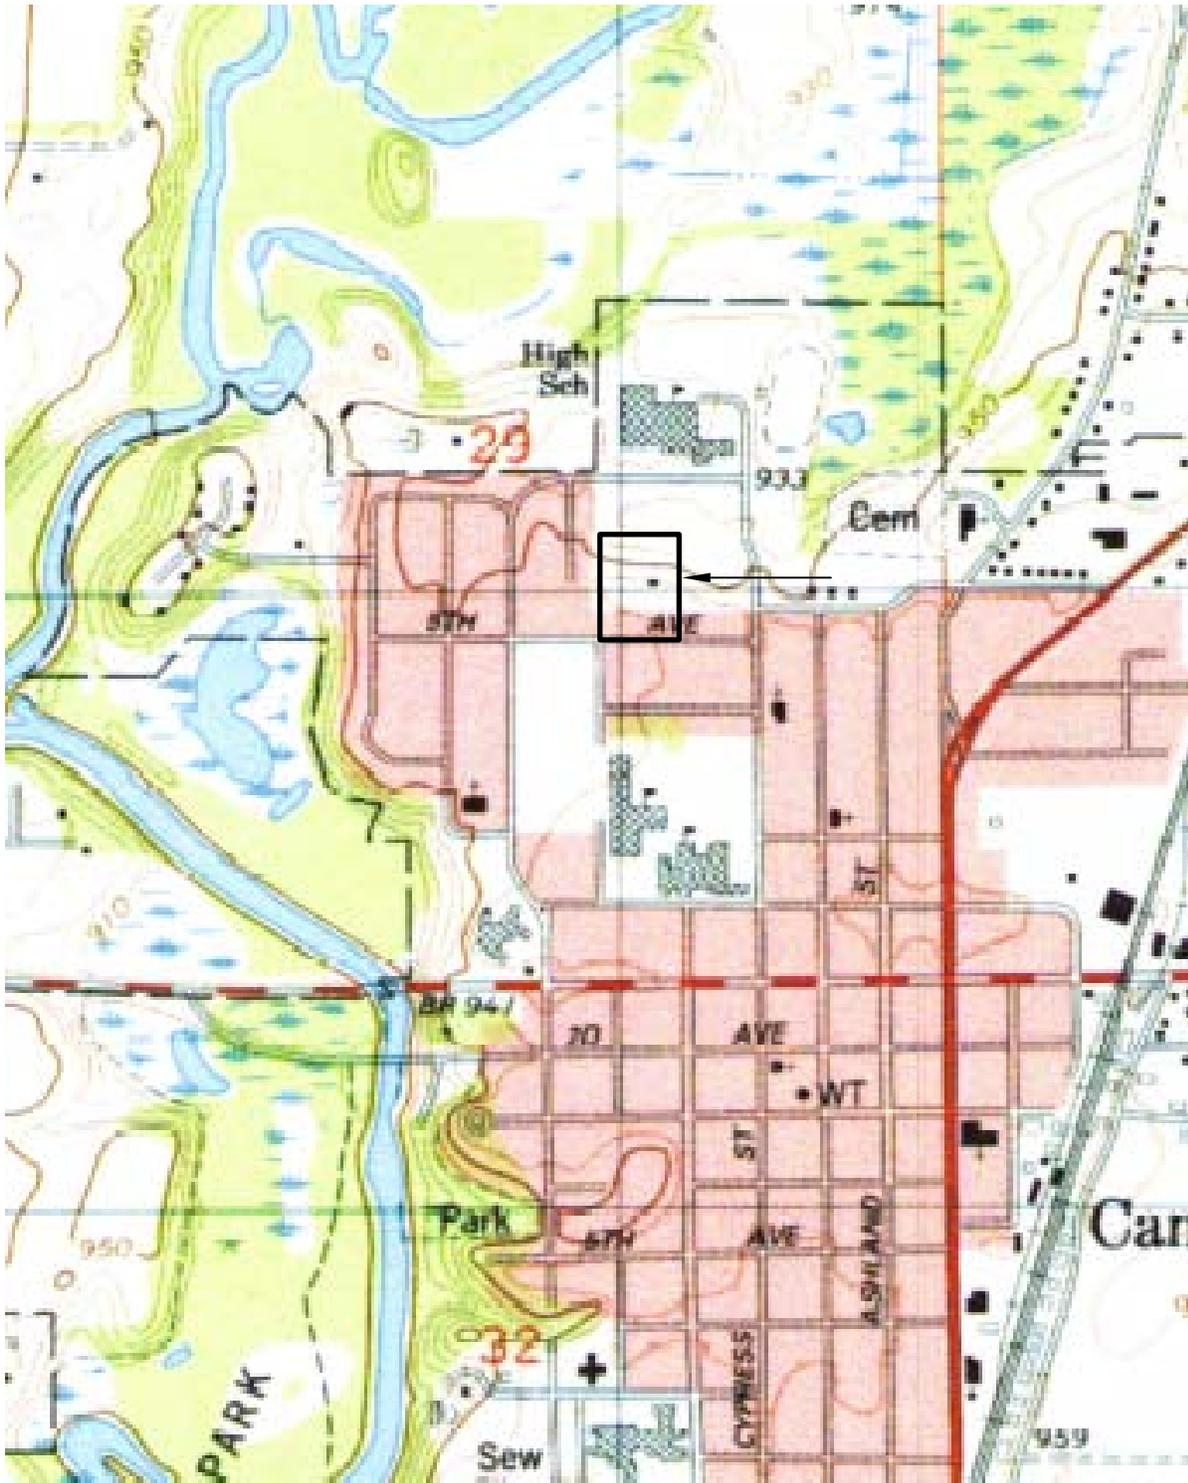
FIGURE 3

Both Cambridge and the Cambridge Memorial USAR Center are found on the USGS 7.5 minute Cambridge quadrangle map (Figure 3). As shown on this map, ground surface elevations at the center average 960 feet msl.

1983 USGS 7.5 Minute, Topographic Map, Cambridge, Minnesota
Cambridge USAR Center ECP Report
Cambridge, Minnesota

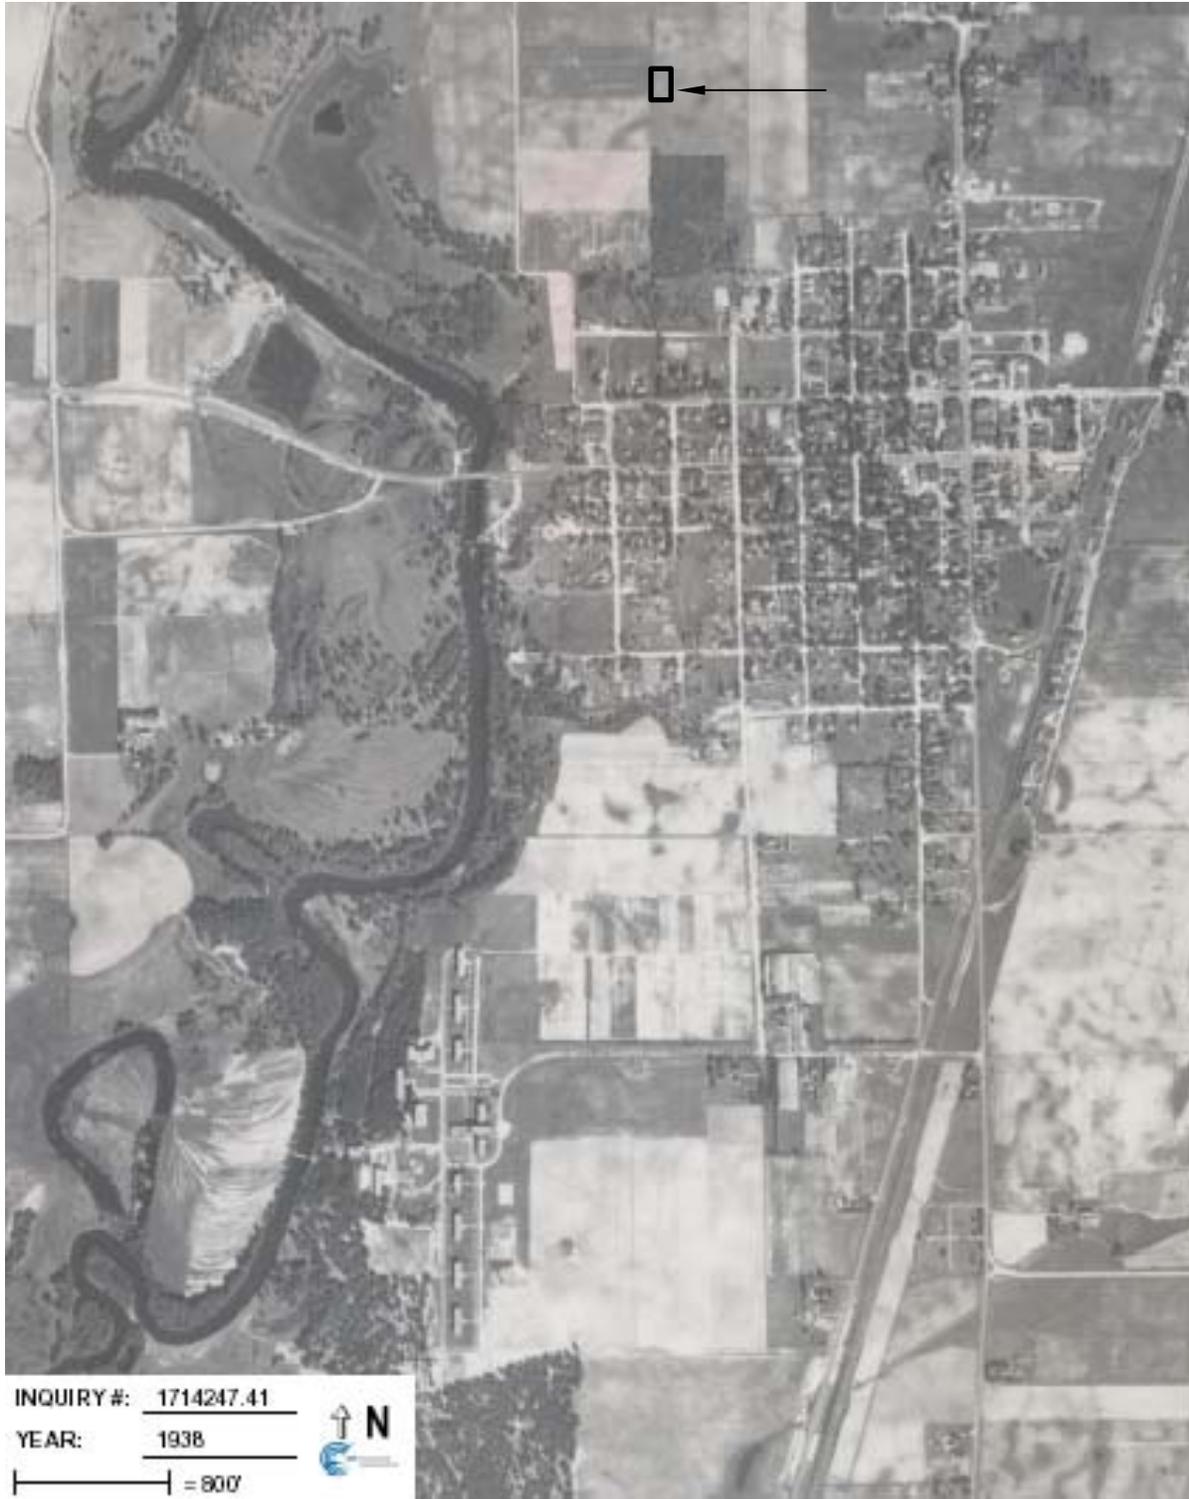
FIGURE 4
1938 Aerial Photograph
Cambridge USAR Center ECP Report
Cambridge, Minnesota

The 1938 aerial photograph (Figure 4, Appendix A) shows the Property and adjacent properties as undeveloped and used for agricultural purposes. The 1957 aerial photograph (Figure 5, Appendix A) still shows the Property and adjacent properties as undeveloped;

Land use at adjacent properties does not appear to have changed significantly over the years, based on a review of available aerial photographs. Based on the 1938 aerial photograph (Figure 4), the property was open fields used for agricultural purposes in 1938. Development in the surrounding areas further to the south and southeast began prior to 1938. Development of single-family residences on the properties to the west, east, south began between 1957 and 1965 (Figures 5 and 7, respectively). The Cambridge-Isanti High School to the north was constructed between 1965 and 1973 (Figures 7 and 8, respectively). With the exception of additional single-family residences, the 1973 and 1991 aerial photographs (Figures 8 and 9, respectively) indicated little change in the adjacent property land use.

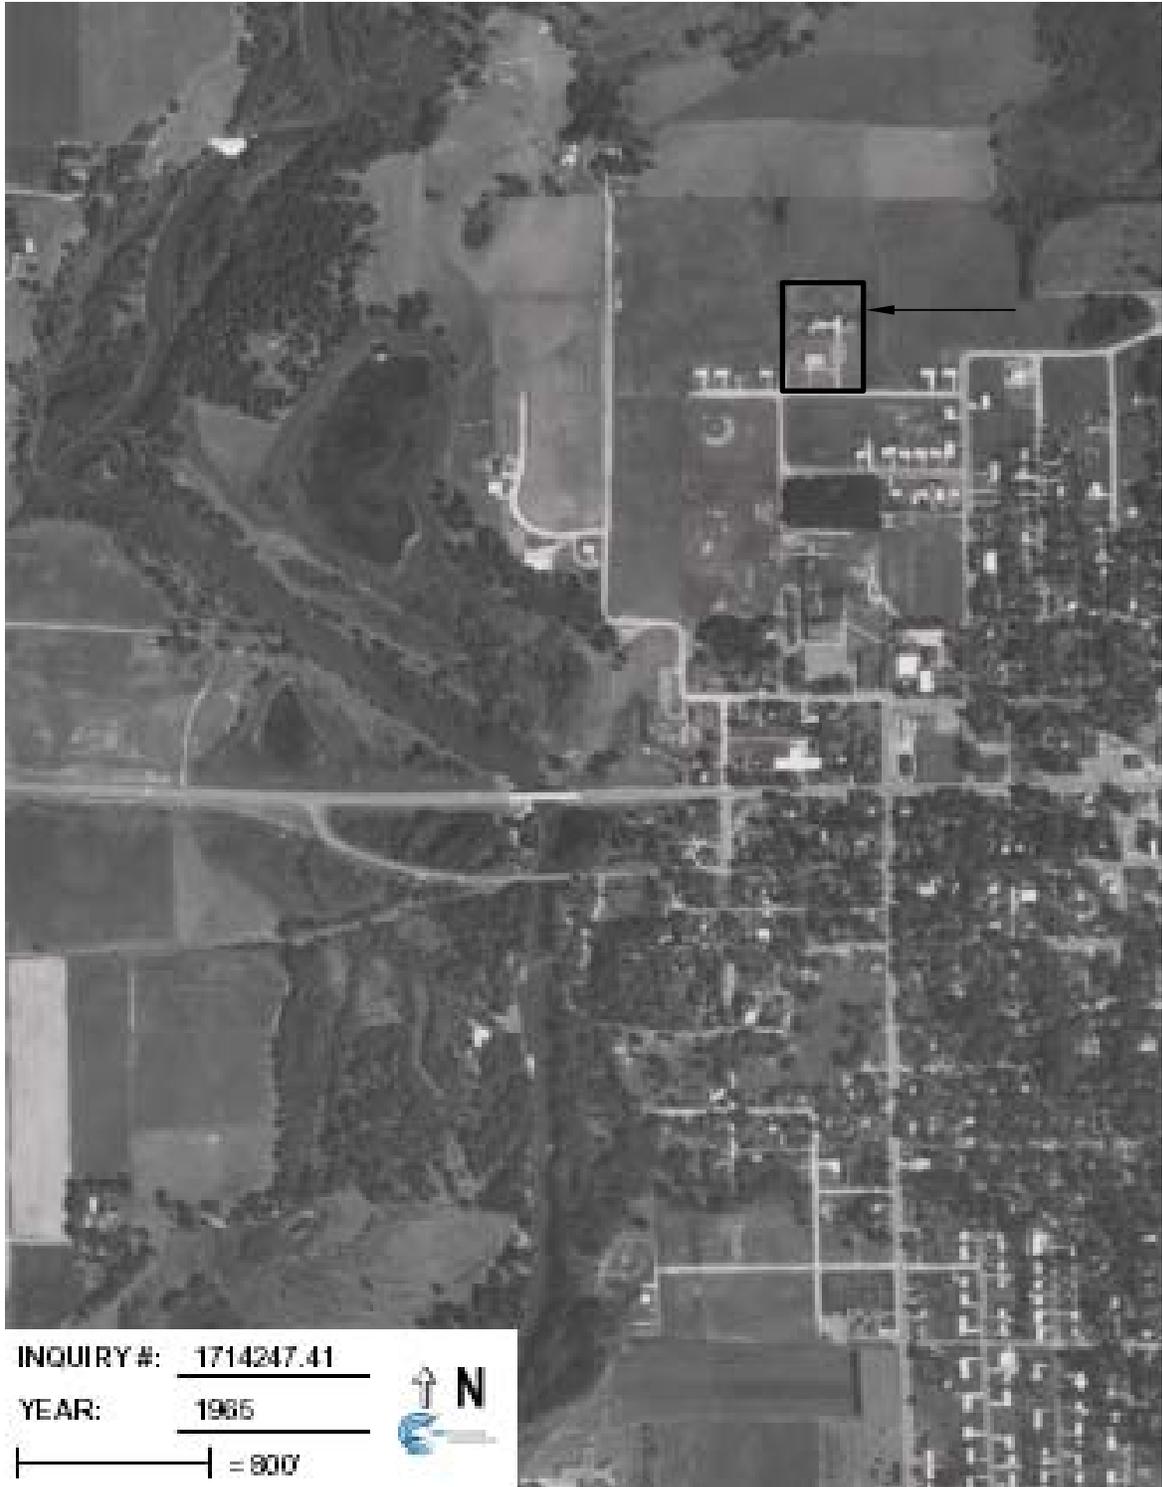
FIGURE 7
1965 Aerial Photograph
Cambridge USAR Center ECP Report
Cambridge, Minnesota

The 1965 aerial photograph (Figure 7, Appendix A) shows the Property as it presently exists with the exception of present day trees and brush. The adjacent properties to the east, north, and south are undeveloped and appear to be grassed fields. A small unpaved vehicular path (oriented in a north-south direction) is evident on the adjacent property to the east. This road appears to provide access from Fifth Avenue Northwest to the agricultural field further to the north of the Property. Four single-family residences are located to the west (including the western adjacent property) of the Property. Additional single-family residences are present further to the east and southeast of the Property.

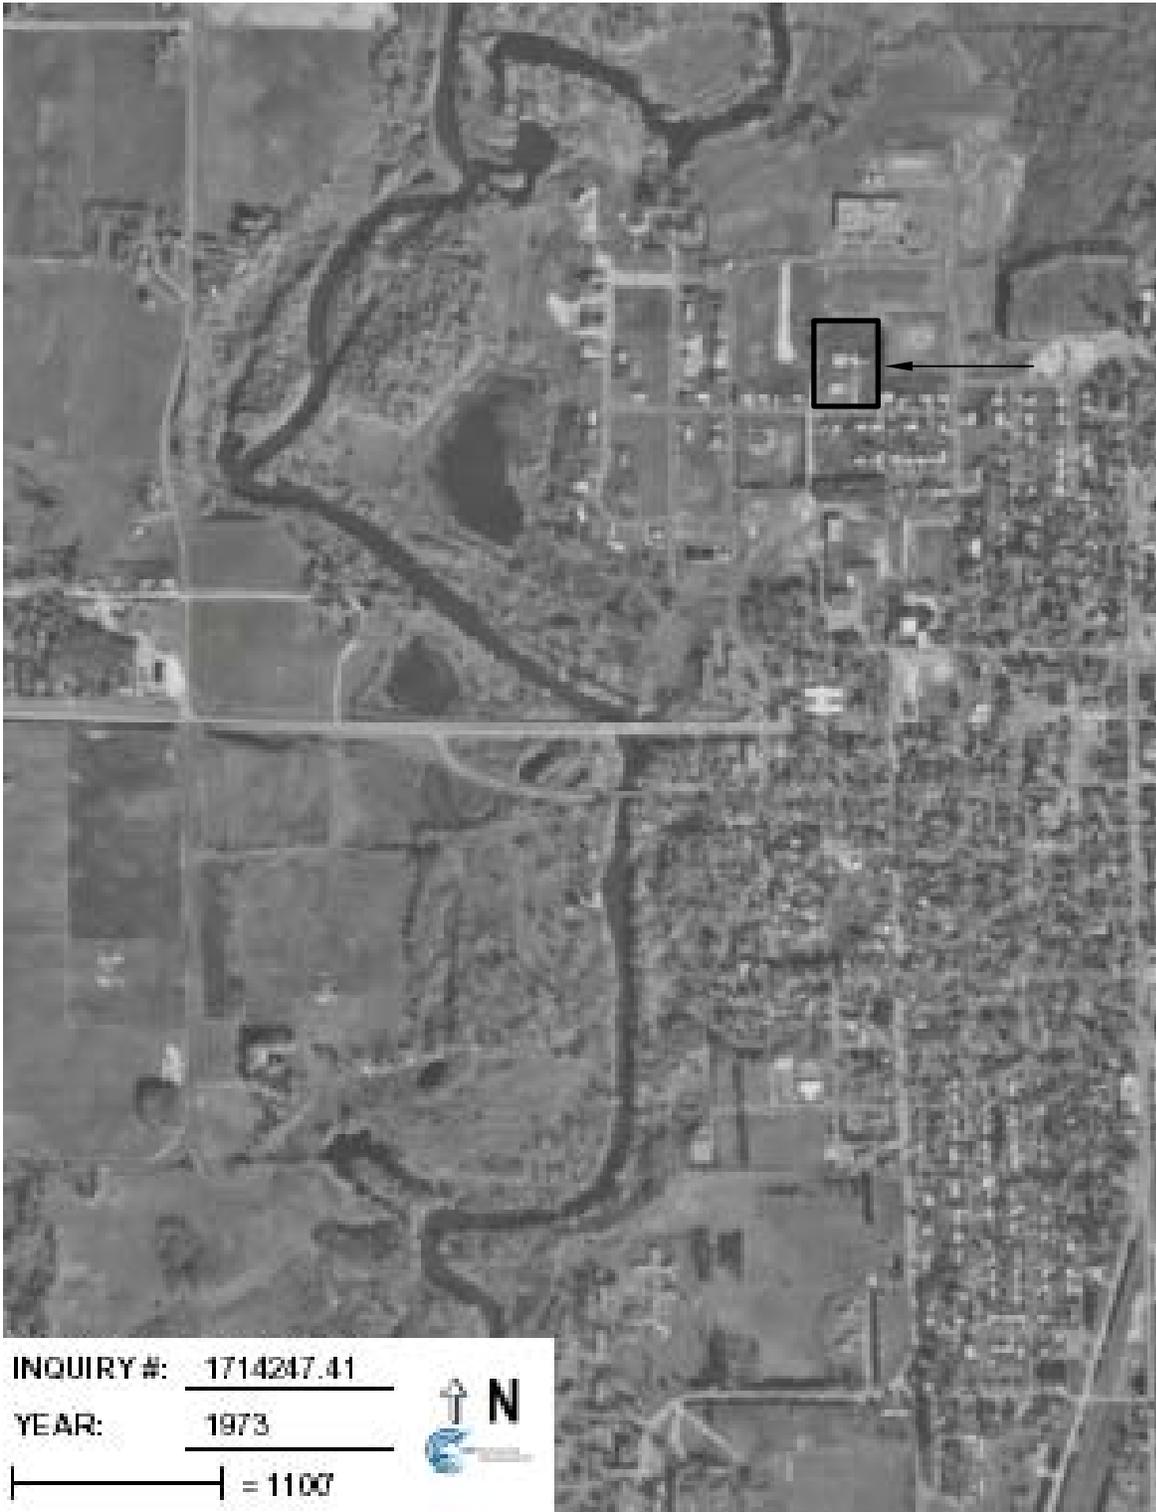
FIGURE 8
1973 Aerial Photograph
Cambridge USAR Center ECP Report
Cambridge, Minnesota

The 1973 aerial photograph (Figure 8, Appendix A) shows the Property and western adjacent property relatively unchanged from the 1965 aerial photograph. A tree line is located along the northern portion of the eastern property boundary. Single-family residences have been constructed on the adjacent properties to the east and south. The high school is present on the adjacent property to the north; however, the abutting property still appears mostly grassed and undeveloped. A baseball diamond is present on the northern portion of the eastern adjacent property. Three additional residences have been constructed on the adjacent property to the west (northern portion).

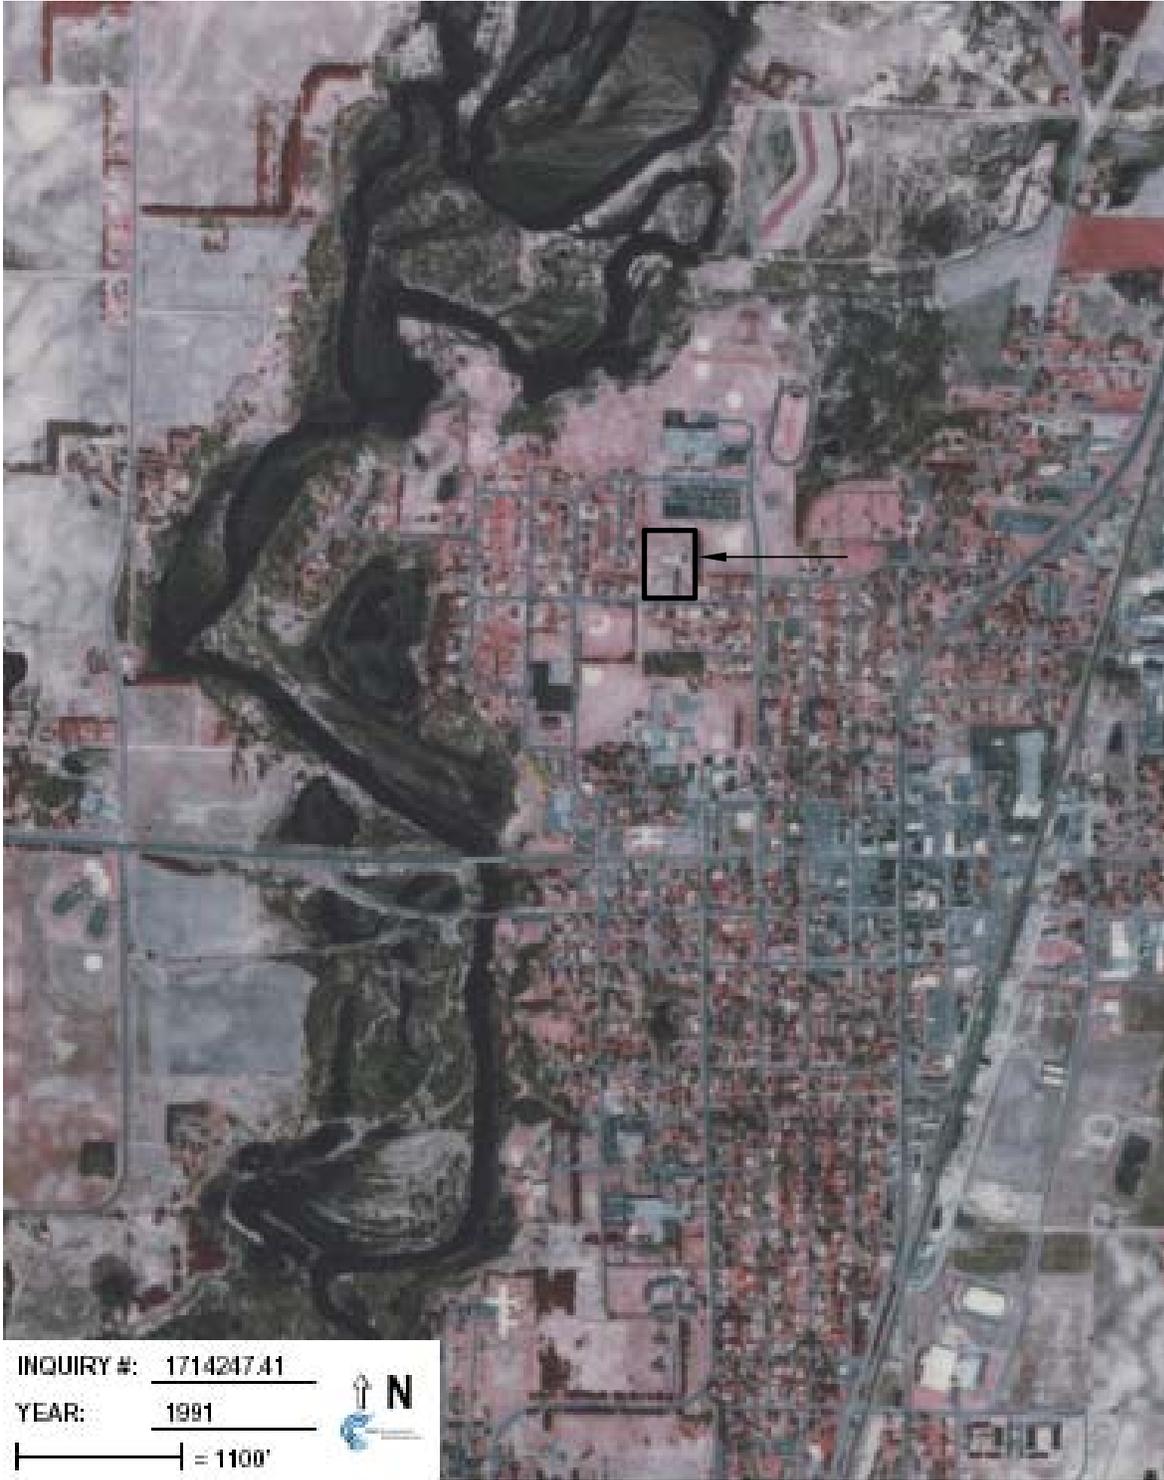
FIGURE 9

The 1991 aerial photograph (Figure 9, Appendix A) shows the Property and adjacent properties to the west, east, and south relatively unchanged from the 1965 aerial photograph. Numerous vehicles are parked in the MEP and POV areas. A paved parking area and tennis courts appear to have been constructed on the high school property adjacent to the north of the Property. Additional single-family residences have been constructed to the west and northwest of the Property.

1991 Aerial Photograph
Cambridge USAR Center ECP Report
Cambridge, Minnesota

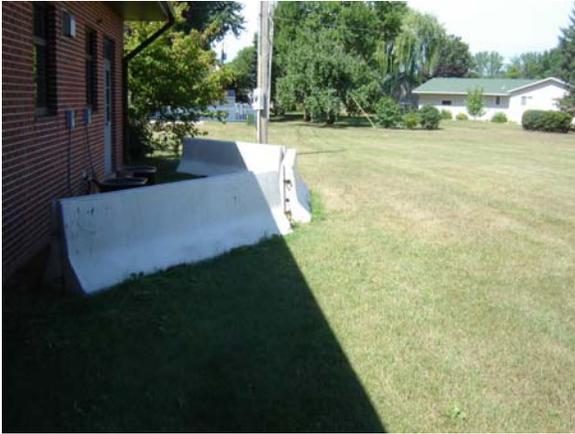
5. View to west of former UST location near northwest corner of administration building.

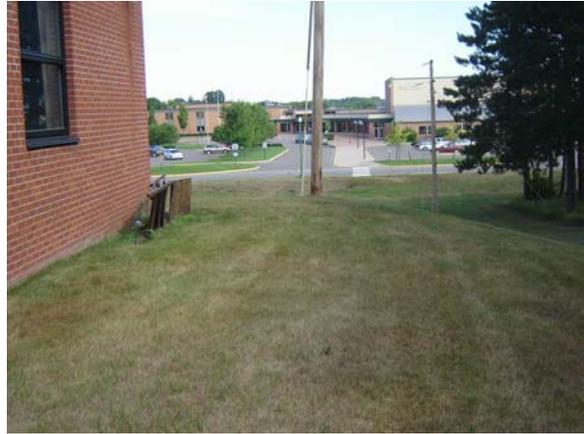
6. View to north of former UST location near northeast corner of OMS building.

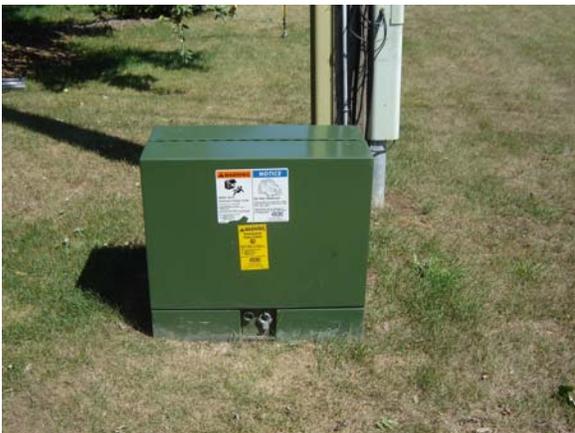
One pad-mounted transformer is located along the western edge of Property, approximately 75 feet west of the exterior west wall of the administration building (see Photograph 7 in Appendix B). A label on the transformer indicated that the unit is owned by East Central Energy. No labels indicating the presence or absence of PCBs was present on the transformer during the August 2006 site reconnaissance, and the unit appeared to be in

7. Pad-mounted electrical transformer located along western edge of property and east of administration building.

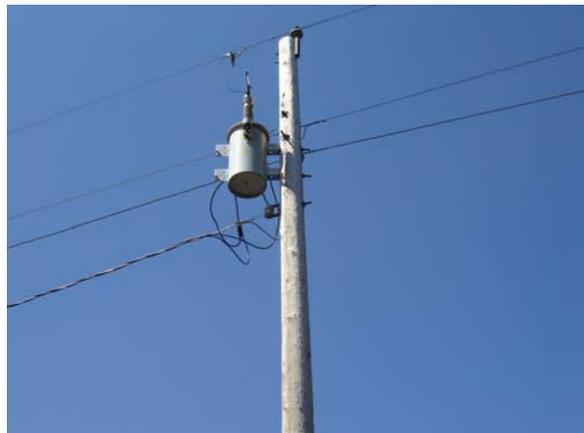
One pole-mounted electrical transformer was located within the right-of-way of Fifth Avenue Northwest and near the southwestern corner of the Property (see Photograph 8 in Appendix B). No labels indicating the presence or absence of PCBs were visible on the transformer during the August 2006 site reconnaissance, and the unit appeared to be in good condition and no evidence of leakage was observed.

8. Pole-mounted electrical transformer located within city right-of-way along Fifth Avenue Northwest.

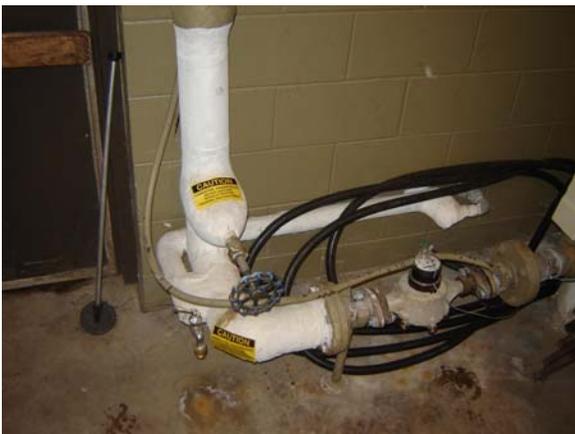
9. TSI elbow containing ACM in mechanical room located in northwest corner of administration building.

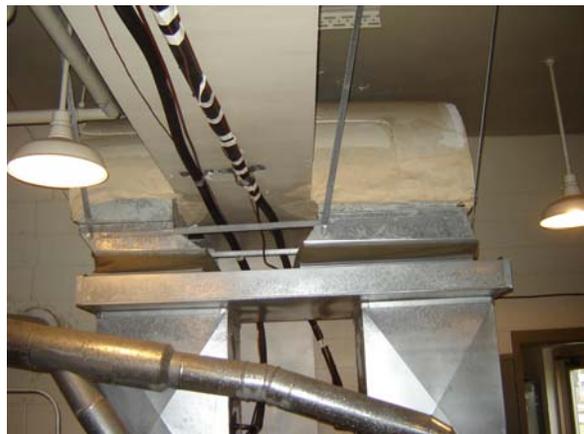
10. TSI insulation on air handling equipment containing ACM in mechanical room located in northwest corner of administration building.

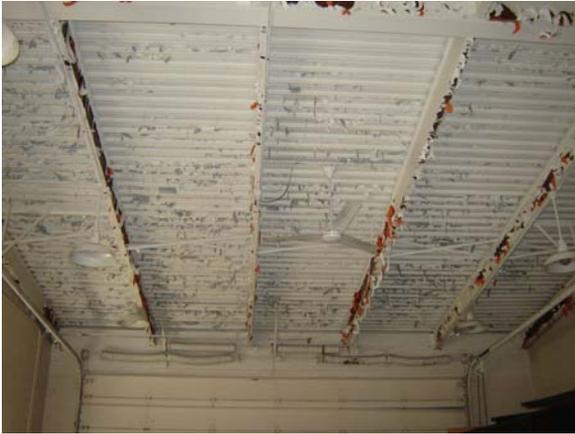
11. View to west of peeling lead-based paint inside OMS building.

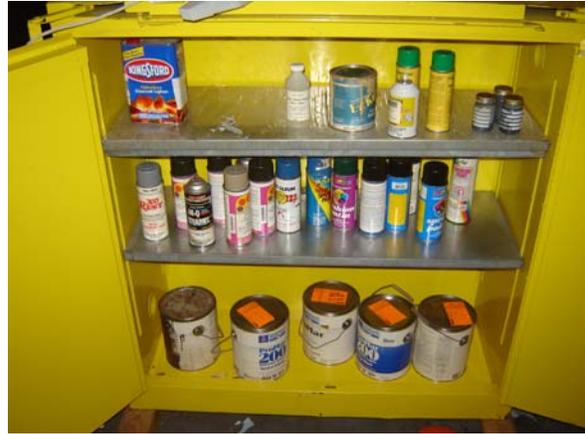
12. Flammable materials storage cabinet in OMS building.

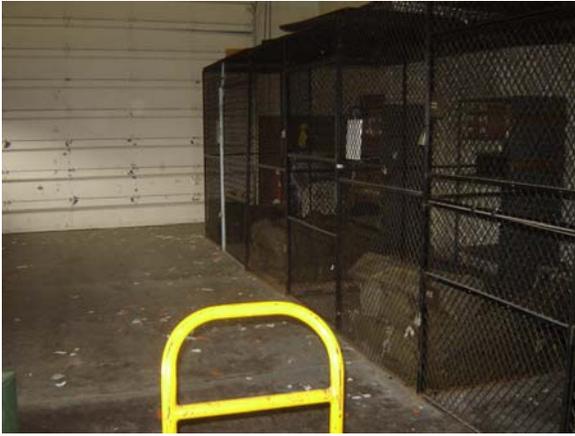
17. Storage and fallen lead-based paint on ground inside OMS building.

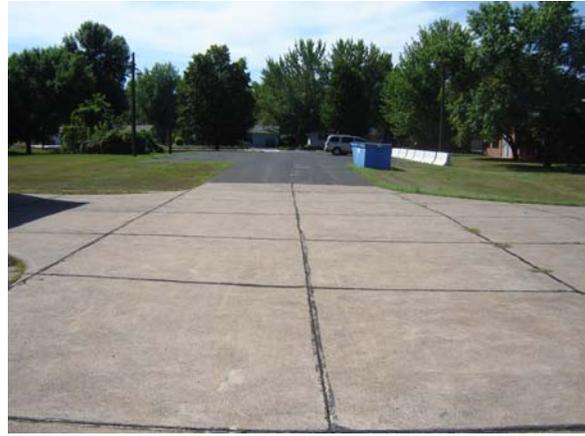
18. View to the south of the suspected vehicle wash area (foreground) and POV area (background).

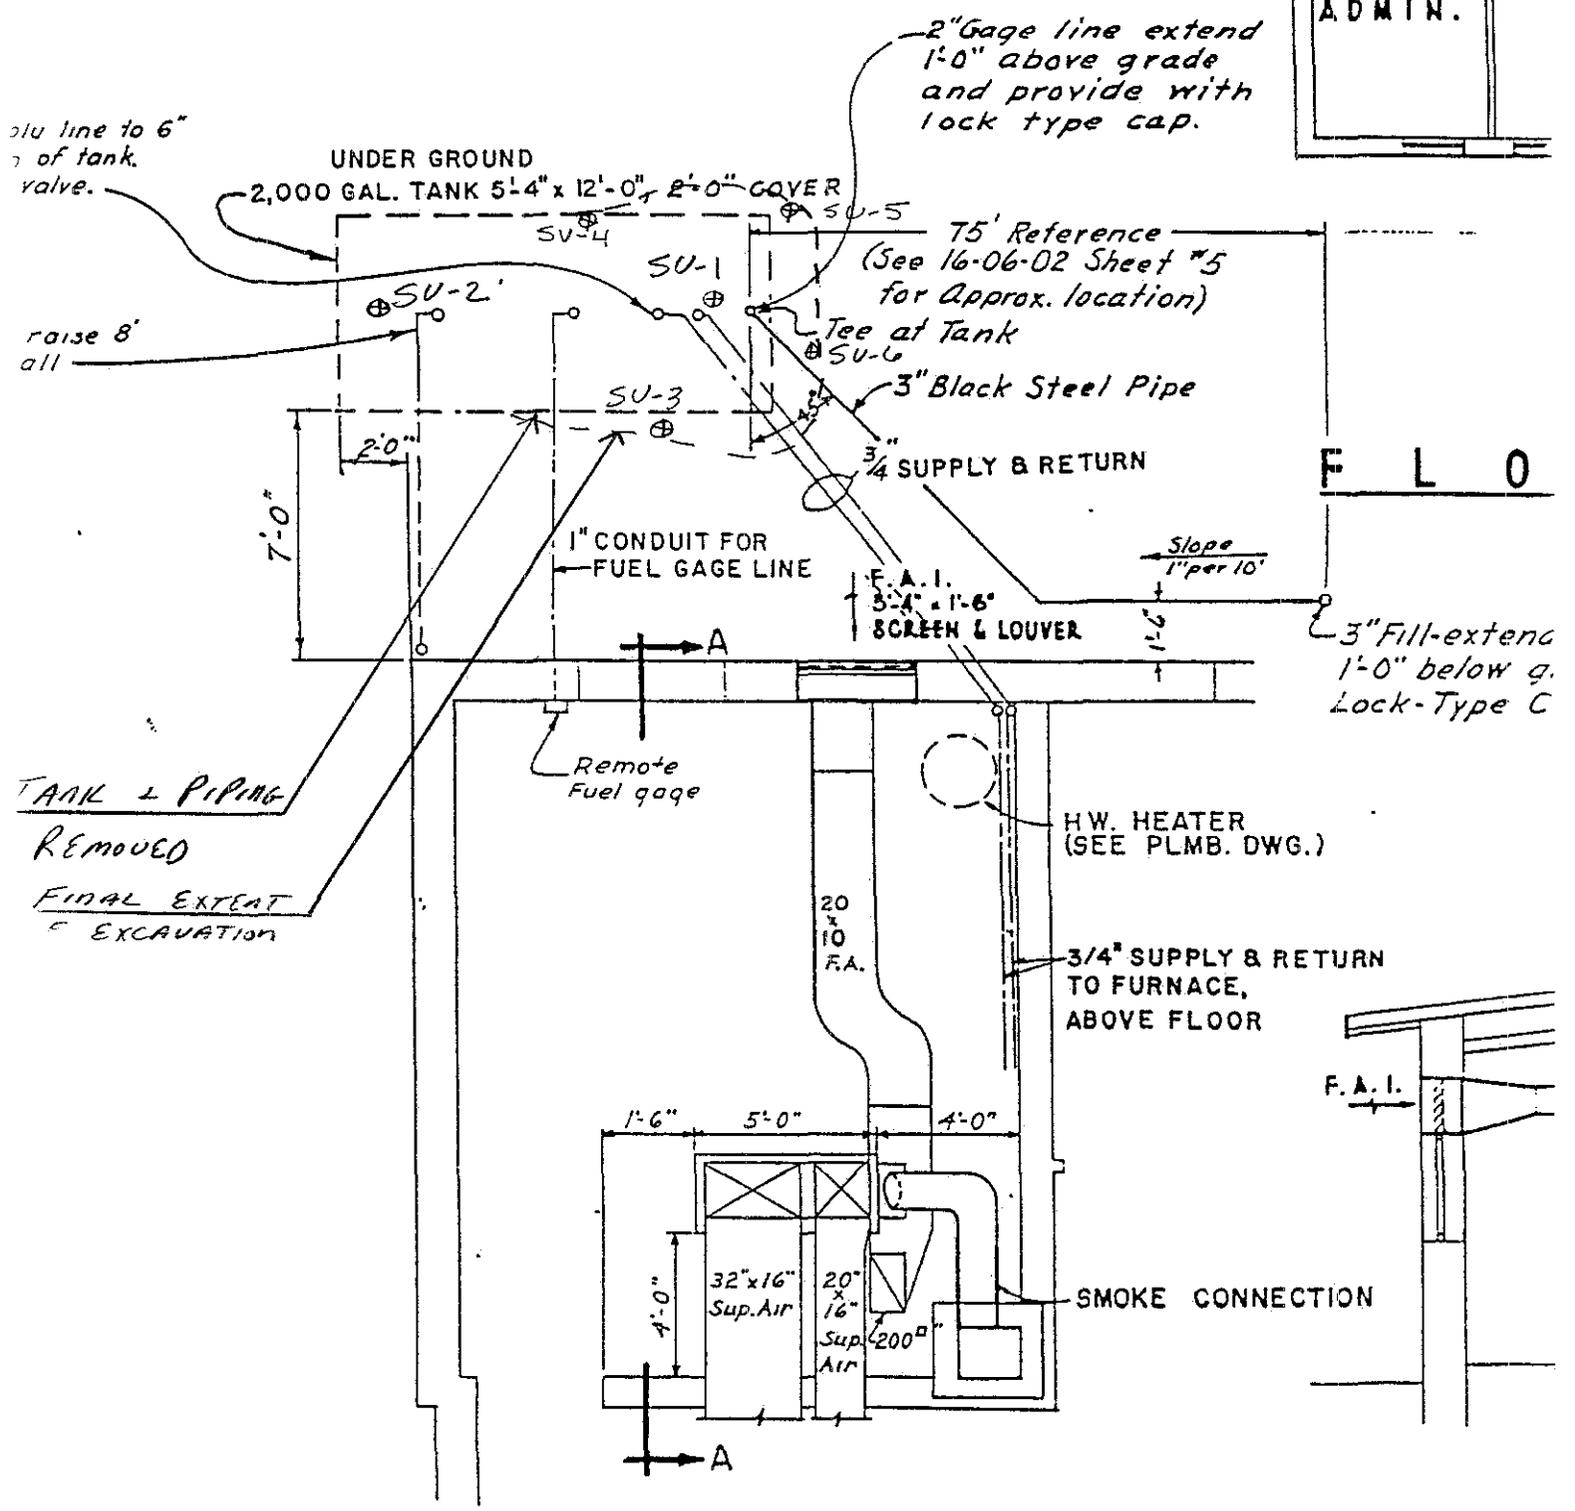
H E A T E R R O O M

Depth to Ground Water NONE Boring Abandonment Method N/A
 Comments FILL PIPE BROKEN, CONTAMINATION VERY LIMITED
SOUTH END OF TANK ONLY SU-1 THRU SU-6 FOR 2000 GAL

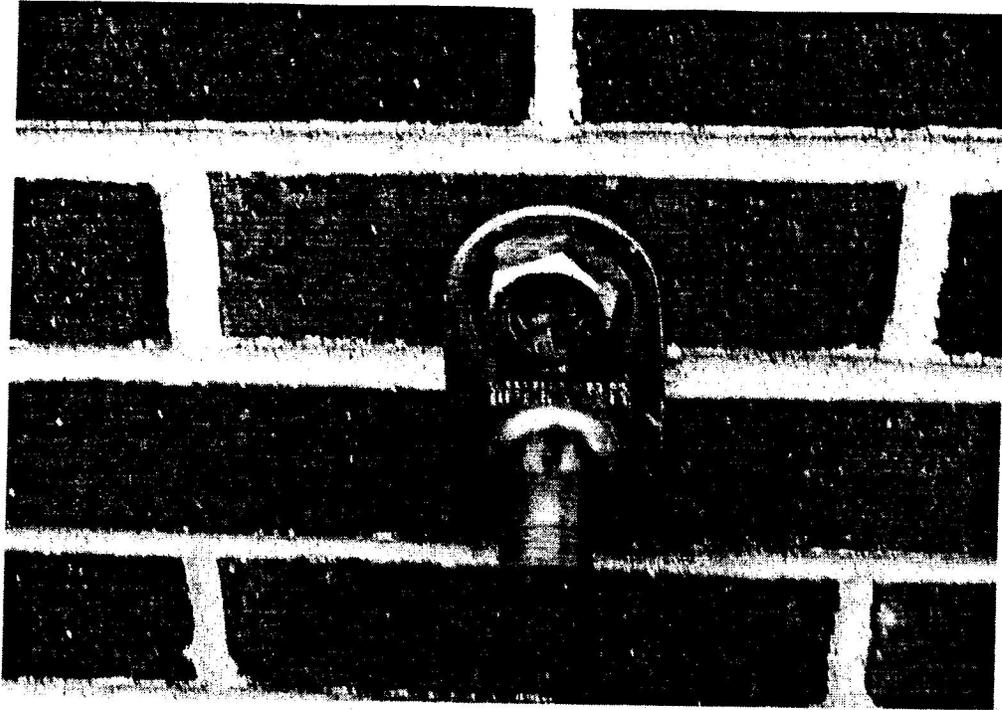
Photo 1. Wall Hydrant Requires Atmospheric Vacuum Breaker (ASSE Type 1011). Typical of 3 (One on Garage).

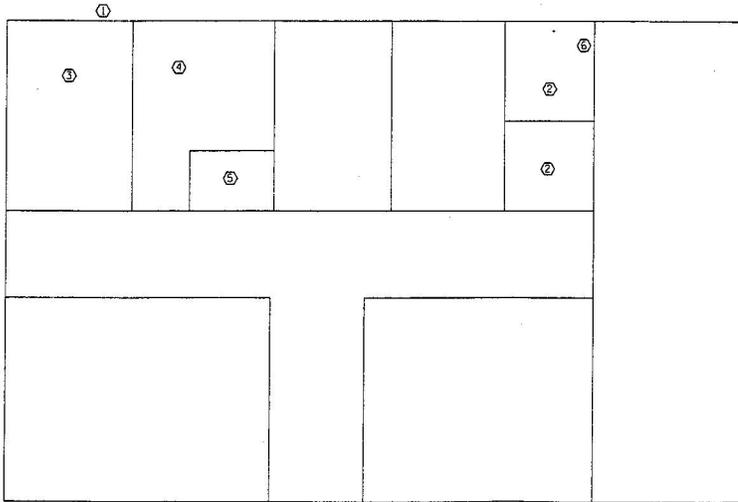
FLOOR PLAN
NO SCALE

- ① WALL HYDRANT REQUIRES ATMOSPHERIC VACUUM BREAKER (ASSE TYPE 1011).
- ② RESTROOM FIXTURES, FLUSH VALVES AND FAUCETS ARE SATISFACTORY BY DESIGN. NO FURTHER BACKFLOW PROTECTION REQUIRED.
- ③ MECHANICAL ROOM - SEE SHEET MNO602.
- ④ KITCHEN - FIXTURES ARE SATISFACTORY BY DESIGN. NO FURTHER BACKFLOW PROTECTION IS REQUIRED.
- ⑤ JANITOR'S SINK WITH ATMOSPHERIC VACUUM BREAKER (ASSE TYPE 1011) REQUIRES NO FURTHER BACKFLOW PROTECTION.
- ⑥ HOSE BIBB INSIDE BUILDING REQUIRES ATMOSPHERIC VACUUM BREAKER (ASSE TYPE 1011).

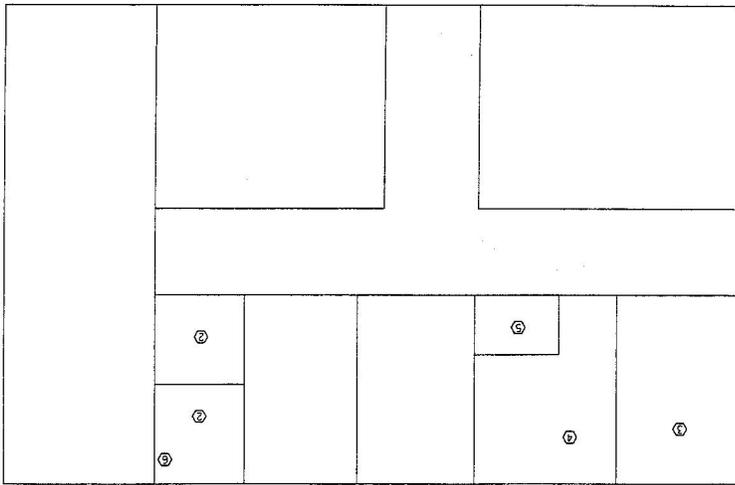
FLOOR PLAN
NO SCALE

- ① WALL HYDRANT REQUIRES ATMOSPHERIC VACUUM BREAKER (ASSE TYPE 1011).
- ② RESTROOM FIXTURES, FLUSH VALVES AND FAUCETS ARE SATISFACTORY BY DESIGN. NO FURTHER BACKFLOW PROTECTION REQUIRED.
- ③ MECHANICAL ROOM - SEE SHEET MNO602.
- ④ KITCHEN - FIXTURES ARE SATISFACTORY BY DESIGN. NO FURTHER BACKFLOW PROTECTION IS REQUIRED.
- ⑤ JANITOR'S SINK WITH ATMOSPHERIC VACUUM BREAKER (ASSE TYPE 1011) REQUIRES NO FURTHER BACKFLOW PROTECTION.
- ⑥ HOSE BIBB INSIDE BUILDING REQUIRES ATMOSPHERIC VACUUM BREAKER (ASSE TYPE 1011).

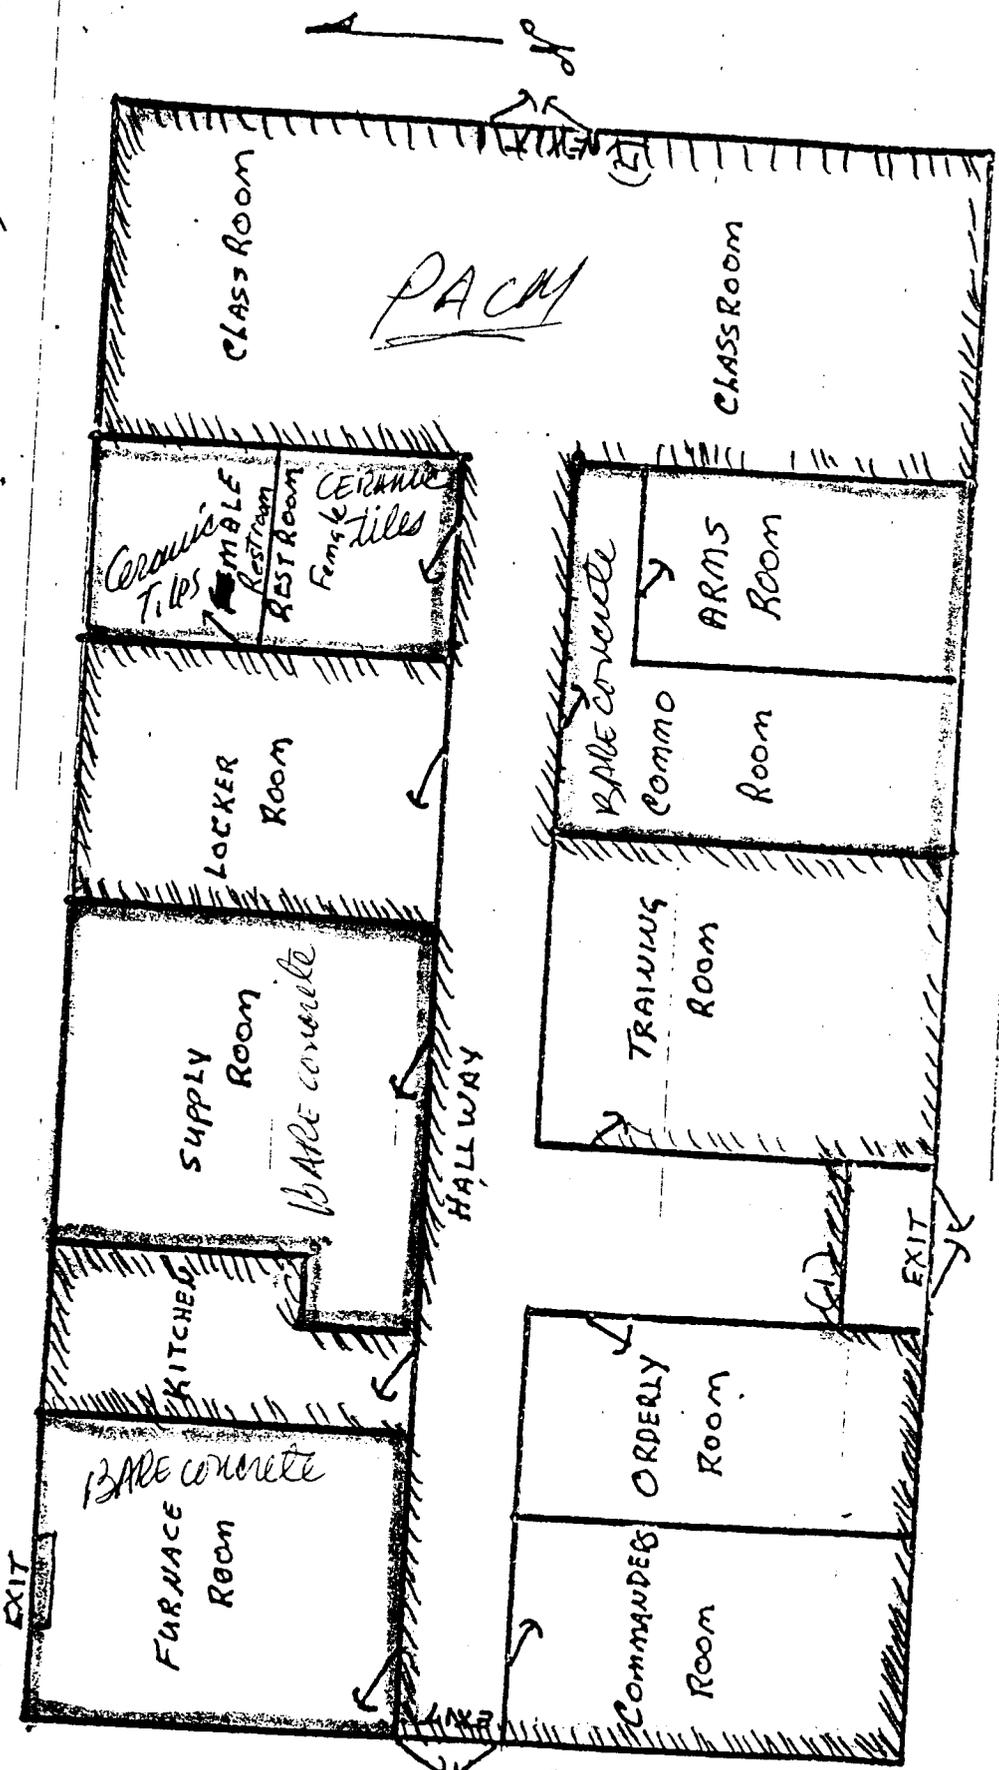
Floor level

There is approximately 3,190 SF of vinyl floor tile VFT - 1 within this facility. This material is a presumed asbestos-containing material (PACM). This material is nonfriable and in good condition.

Notes: All floor area is of vinyl floor tile VFT - a presumed asbestos containing material. Except where noted.

PT-1 = Fibers - This material contains
 around 2 percent and is a composite
 material is made and in good condition
 TT-1 = Duct Insulation @ furnace. This material
 contains 40 percent chrysotile asbestos
 fibers and in poor condition.

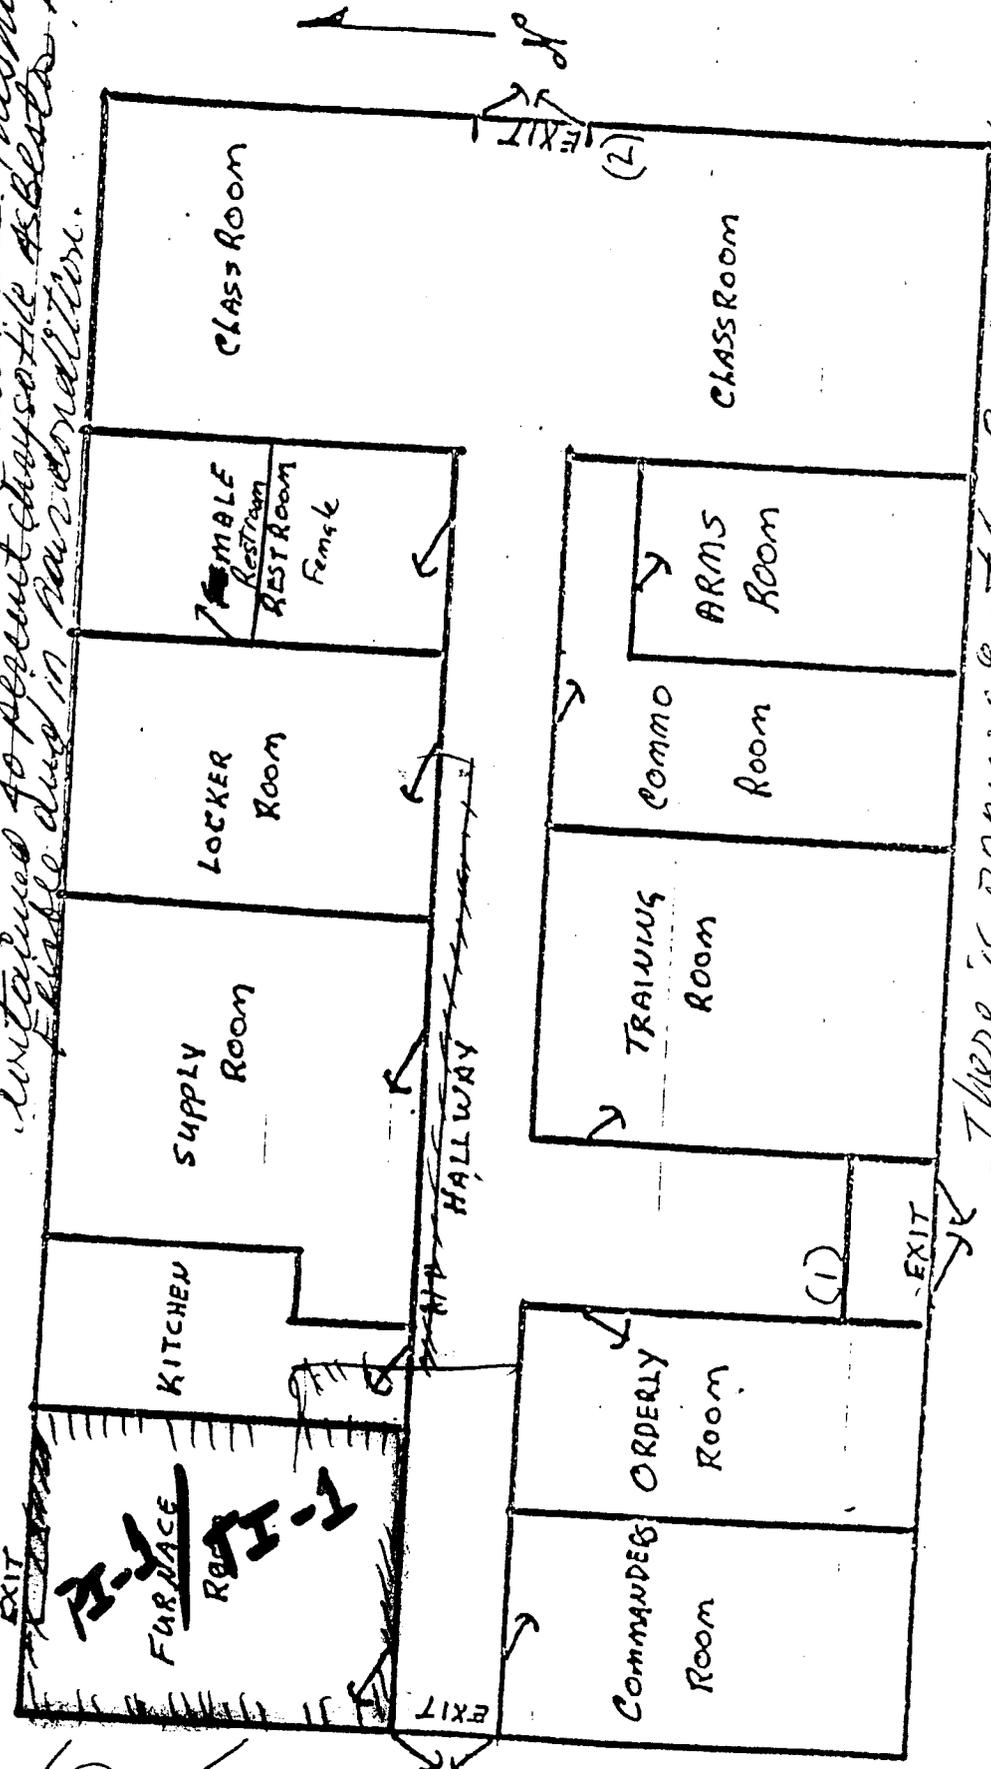
There is approximately 28 elbows/fittings
 that contained asbestos (PT-1) and
 approximately 250sf of furnace duct
 insulation (TI-1). The vibration damp-
 ster in the air duct are PACM, no sample
 were collected from the ductwork in order
