**ENVIRONMENTAL CONDITION OF
PROPERTY REPORT**

**CAMBRIDGE MEMORIAL
U.S. ARMY RESERVE CENTER (MN006)
540 FIFTH AVENUE NORTHWEST
CAMBRIDGE, MINNESOTA 55008**

MARCH 2007

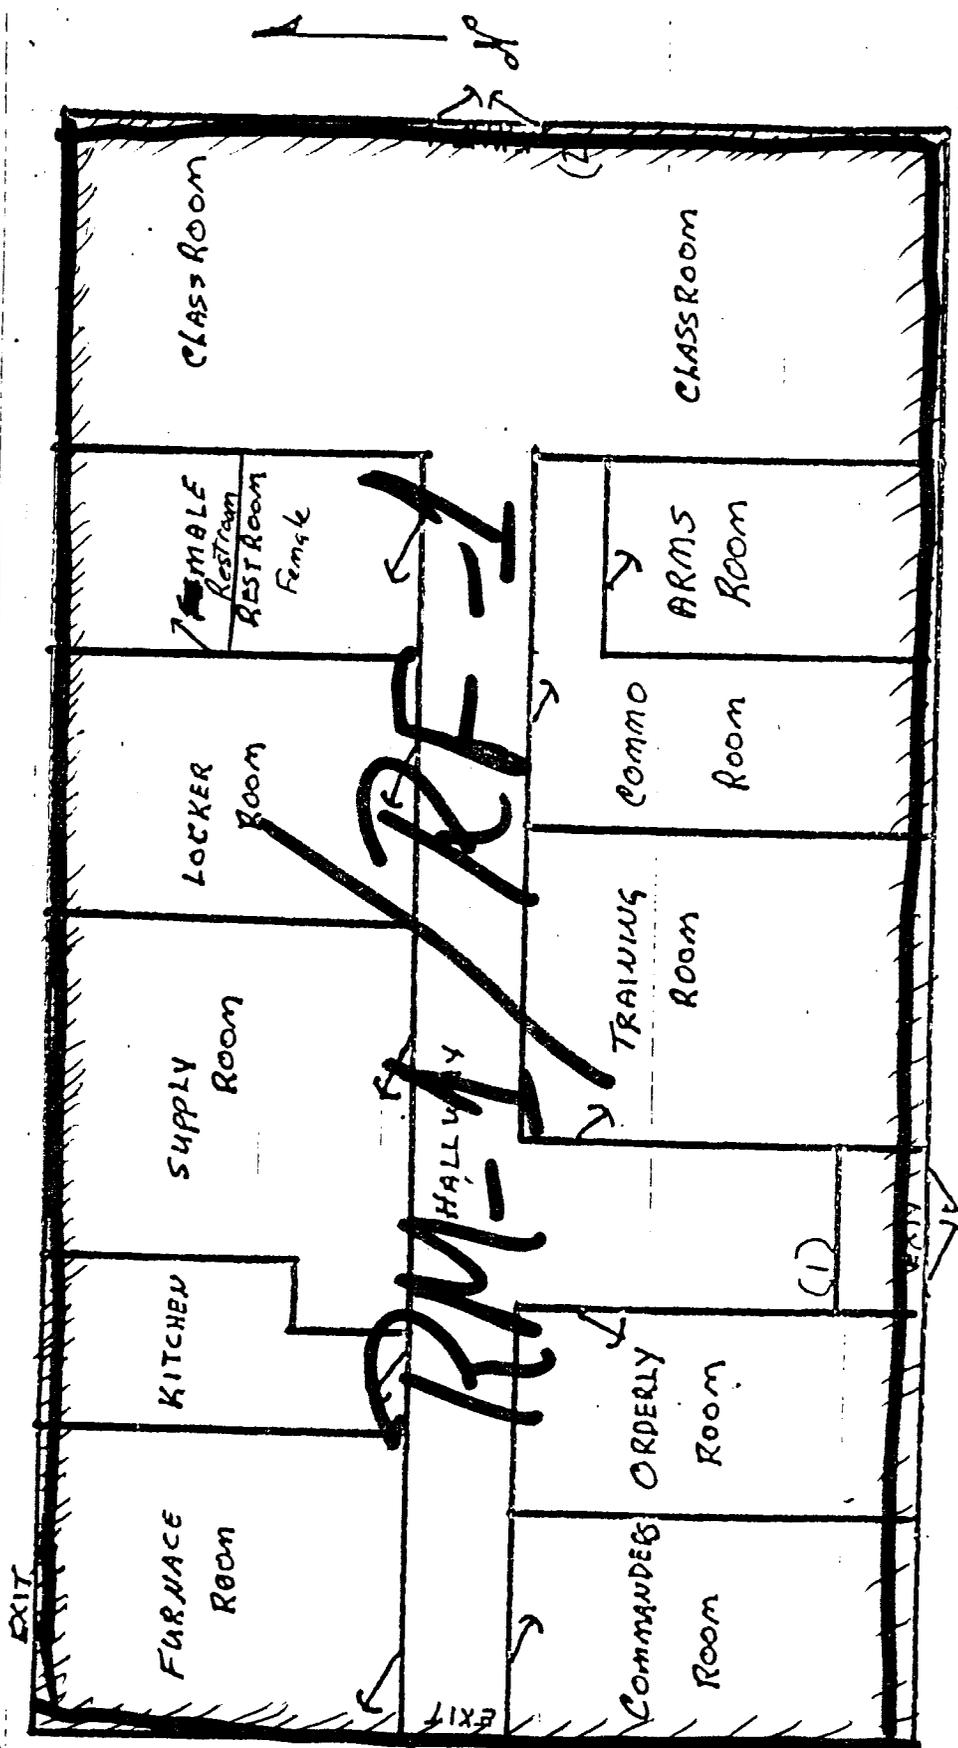
Roof level:

Notes: The roofing flashings RF-1 provided Chrysotile Asbestos ranging in the 2 percent. This material is non friable and in good condition.
