**ENVIRONMENTAL CONDITION OF PROPERTY  
REPORT**

**SSG ROY CLIFTON SCOUTEN  
U.S. ARMY RESERVE CENTER (OH037)  
MANSFIELD, OH 44902**

**FEBRUARY 2007**

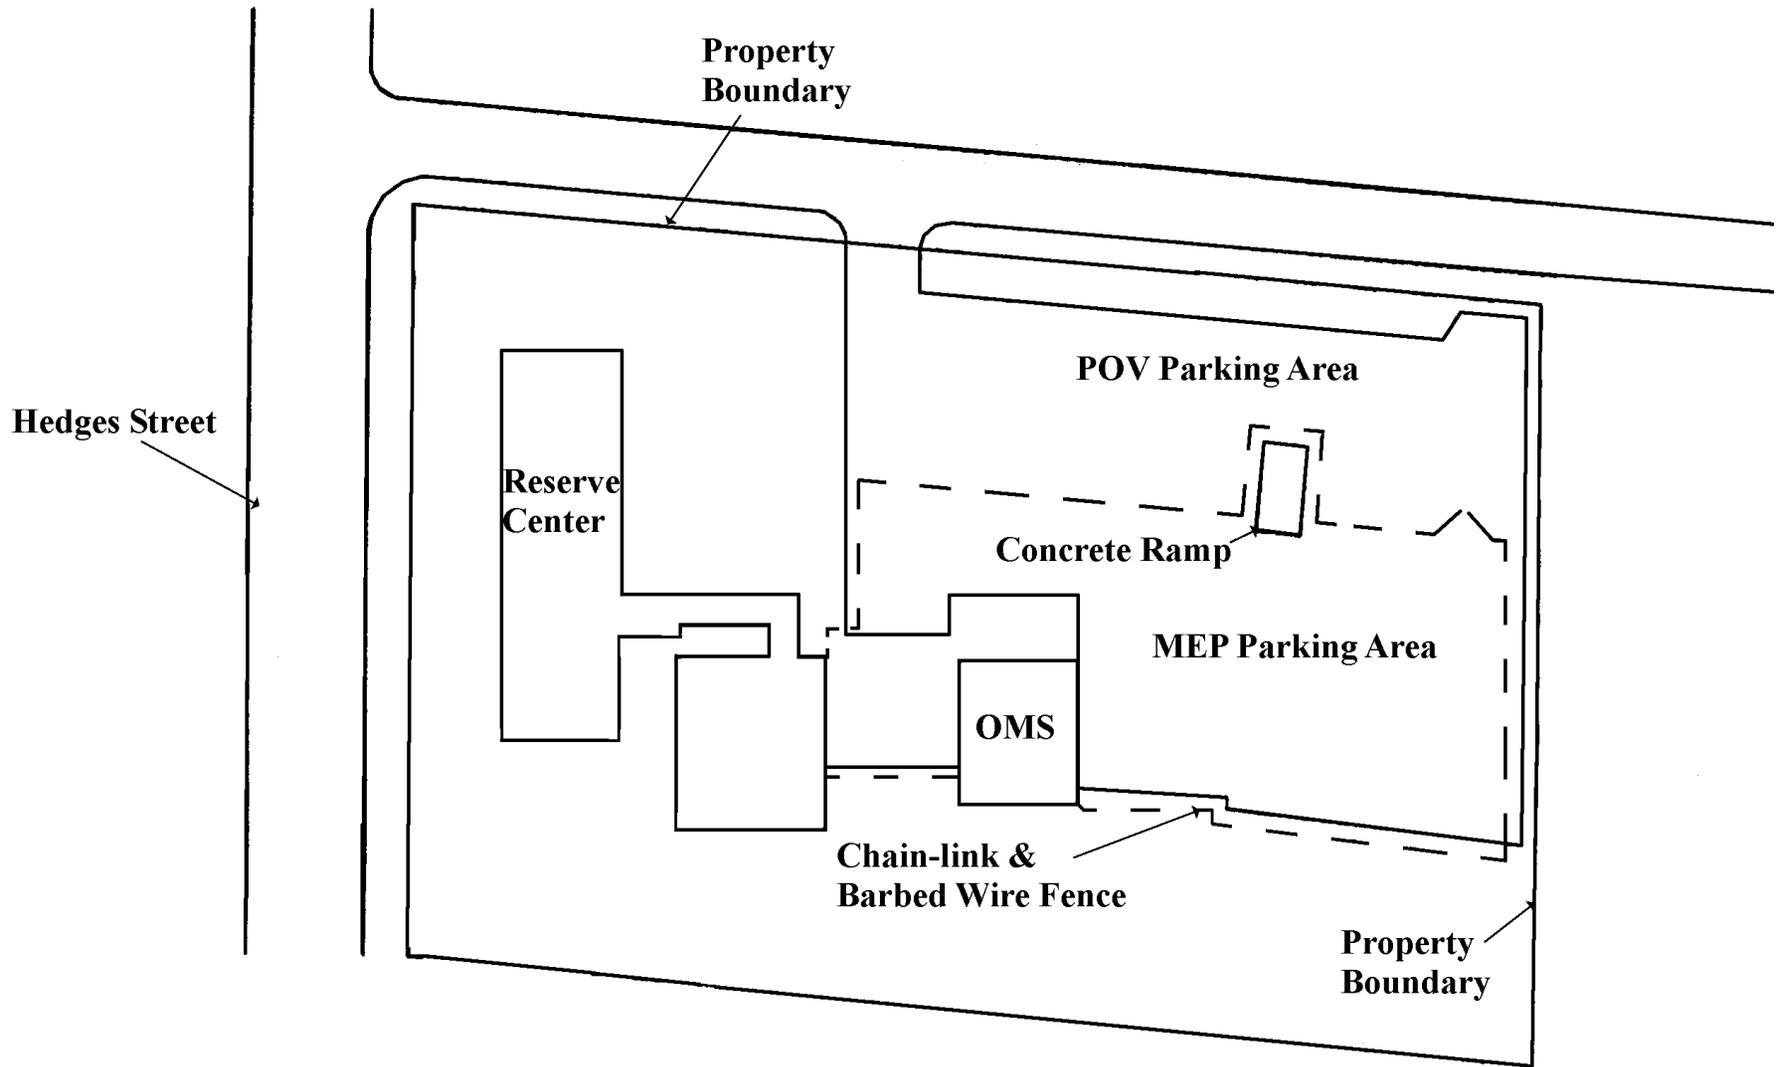
FIGURE 2  
Site Layout Plan  
Phase I ECP Report

The USAR Center is located on a 4-acre parcel in Mansfield, Ohio, and contains two permanent structures and two parking lots. A site map is included as Figure 2 in Appendix A. Construction of both the main building and the Organizational Maintenance Shop (OMS) were completed in 1958. Both structures are on concrete foundations and consist of concrete block walls covered with a brick veneer. A military equipment parking (MEP) area and a privately owned vehicle (POV) parking area also are contained within the Property. Chain-link security fencing encloses the MEP area and OMS building.

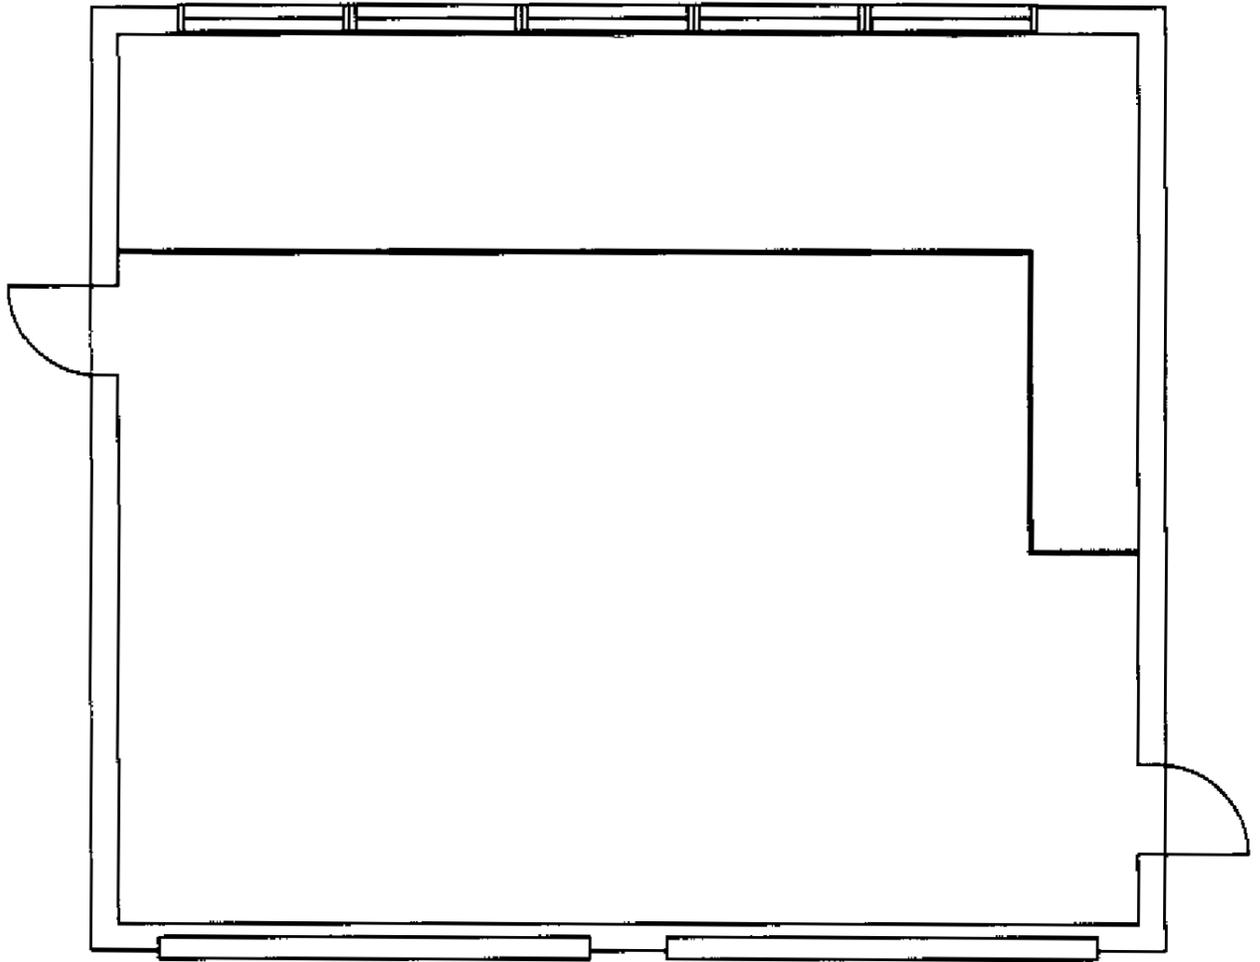
FIGURE 4  
Interior Layout, OMS Building  
*Phase I ECP Report*

The OMS functions as a vehicle maintenance facility for the USAR Center (Figure 4, Appendix A). It is a one-story, rectangular building that rests on a concrete foundation with concrete block walls and a brick veneer. Two metal overhead retractable bay doors are located on north side of the building. Additional entrances include metal pedestrian doors with concrete steps located on the east and west walls. A flat roof covers the structure.

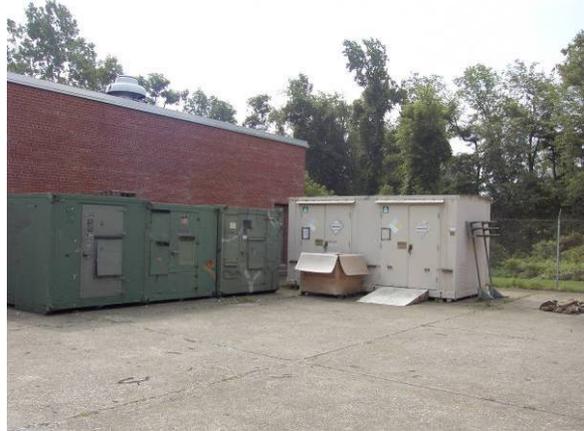
2. Hazardous Materials Storage Shed

Information related to the past use and storage of hazardous substances at the Property was compiled through review of available site records, search of federal and state environmental databases, and interviews with USAR personnel. Chemicals formerly used and stored at the Property were associated with vehicle and facility maintenance activities, and janitorial services. Janitorial chemicals and building maintenance-related products were stored in the designated storage area within the janitorial closet located in the main building. Vehicle maintenance products and small amounts of POL products also were stored within designated areas in the OMS building. Other potentially hazardous materials and POL products would have been stored in the outdoor hazardous material storage shed located north of the OMS building within the MEP area (Photograph 2, Appendix B).

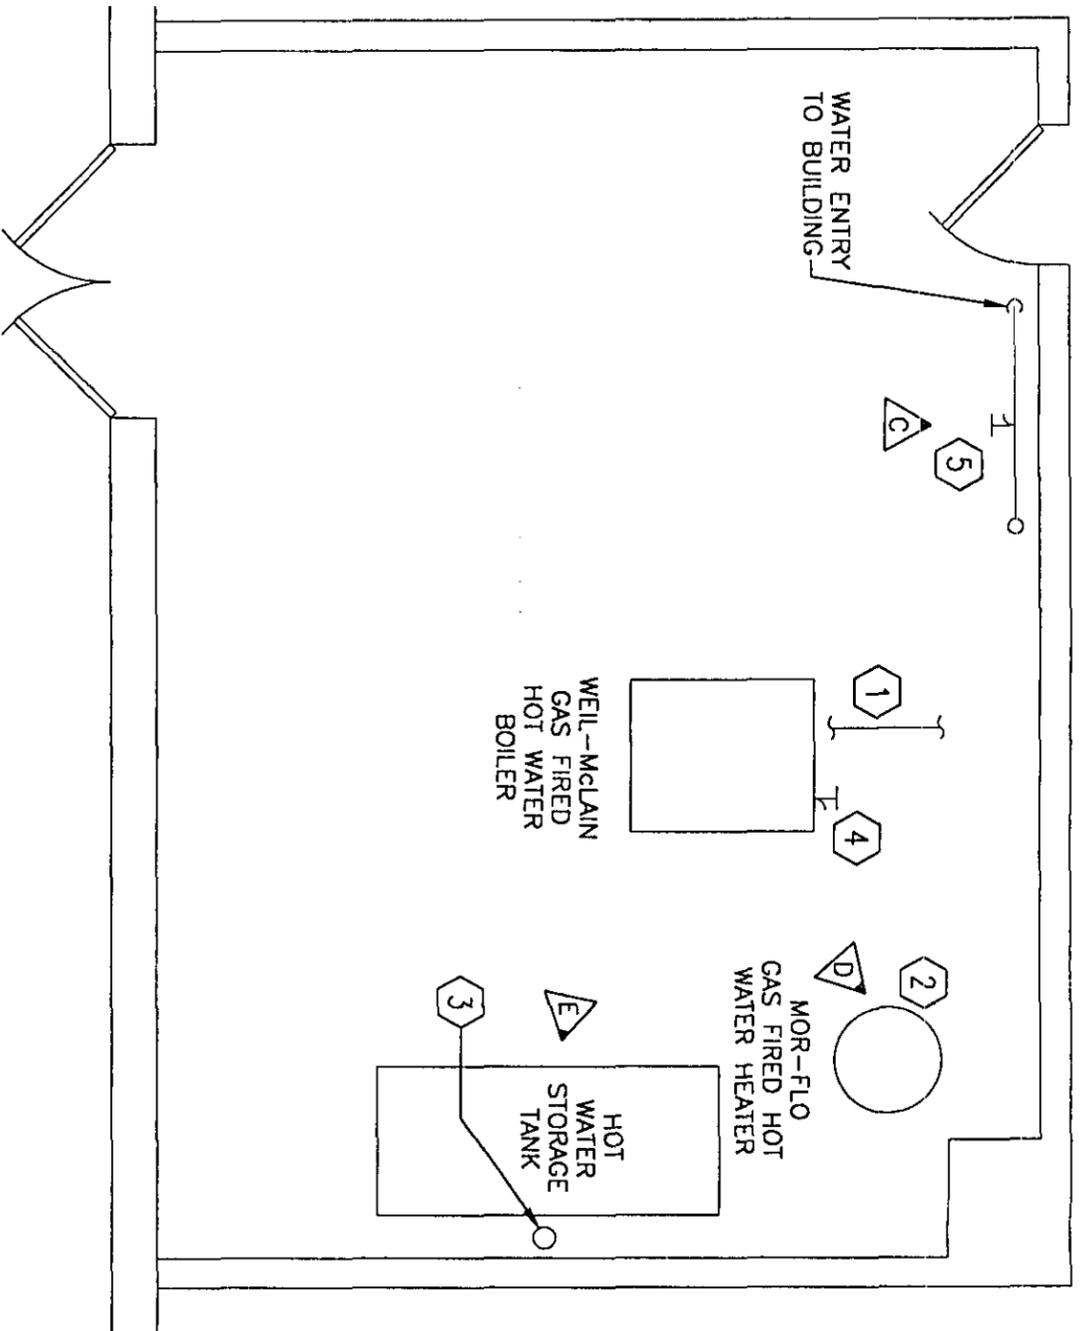
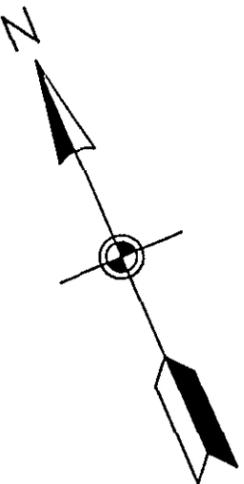
**BOILER ROOM PLAN**  
 APPROXIMATE SCALE: 1/4" = 1'

- ① UNPROTECTED 3/4" COLD WATER MAKE-UP TO BOILER REQUIRES BACKFLOW PREVENTION DEVICE TYPE 2 TO PROTECT FROM POSSIBLE HEALTH HAZARD.
- ② GAS FIRED WATER HEATER WITH UNPROTECTED DRAIN ON BOTTOM OF TANK REQUIRES BACKFLOW PREVENTION DEVICE TYPE 4 PER OEPA 3745-95-04-(B2) AND OBBC 4101:2-61-05.
- ③ 2" DRAIN PIPE FROM WATER STORAGE TANK EXTENDS BELOW RIM OF HUB DRAIN. REWORK PIPE SO THAT 2" AIR GAP IS PROVIDED PER OEPA 3745-95-04-(B2) AND OBBC 4101:2-61-05.
- ④ UNPROTECTED HOSE BIBB REQUIRES BACKFLOW PREVENTER TYPE 4 PER OEPA 3745-95-04-(B2) AND OBBC 4101:2-61-05.
- ⑤ UNPROTECTED HOSE BIBB ON INCOMING COLD WATER PIPE REQUIRES BACKFLOW PREVENTER TYPE 4 PER OEPA 3745-95-04-(B2) AND OBBC 4101:2-61-05.

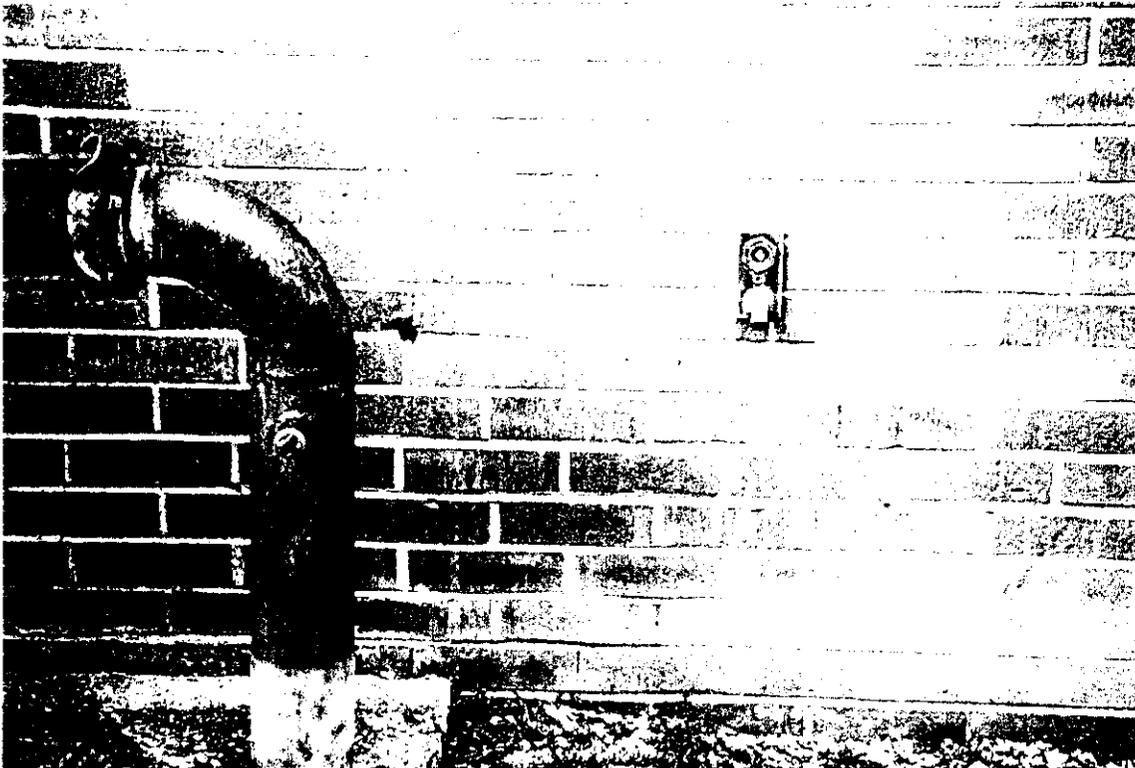
Photograph A: Unprotected frost proof wall hydrant.

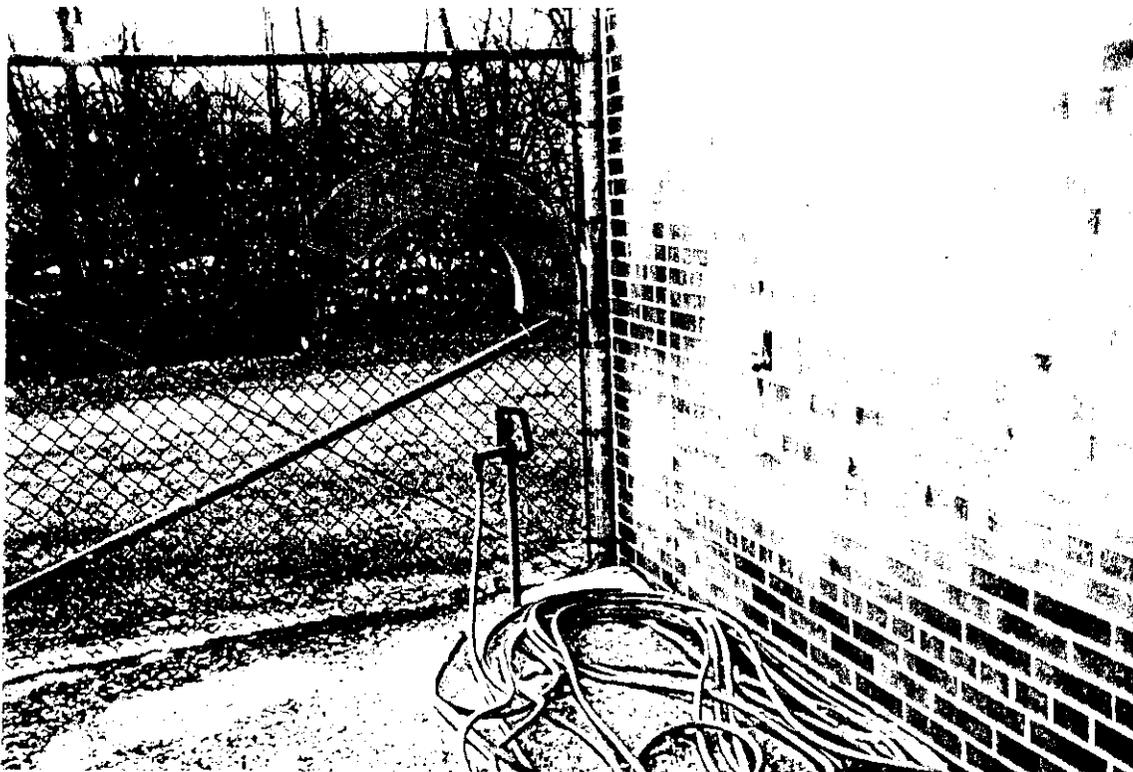
Photograph B: Unprotected frost proof wall hydrant and unprotected frost proof yard hydrant.

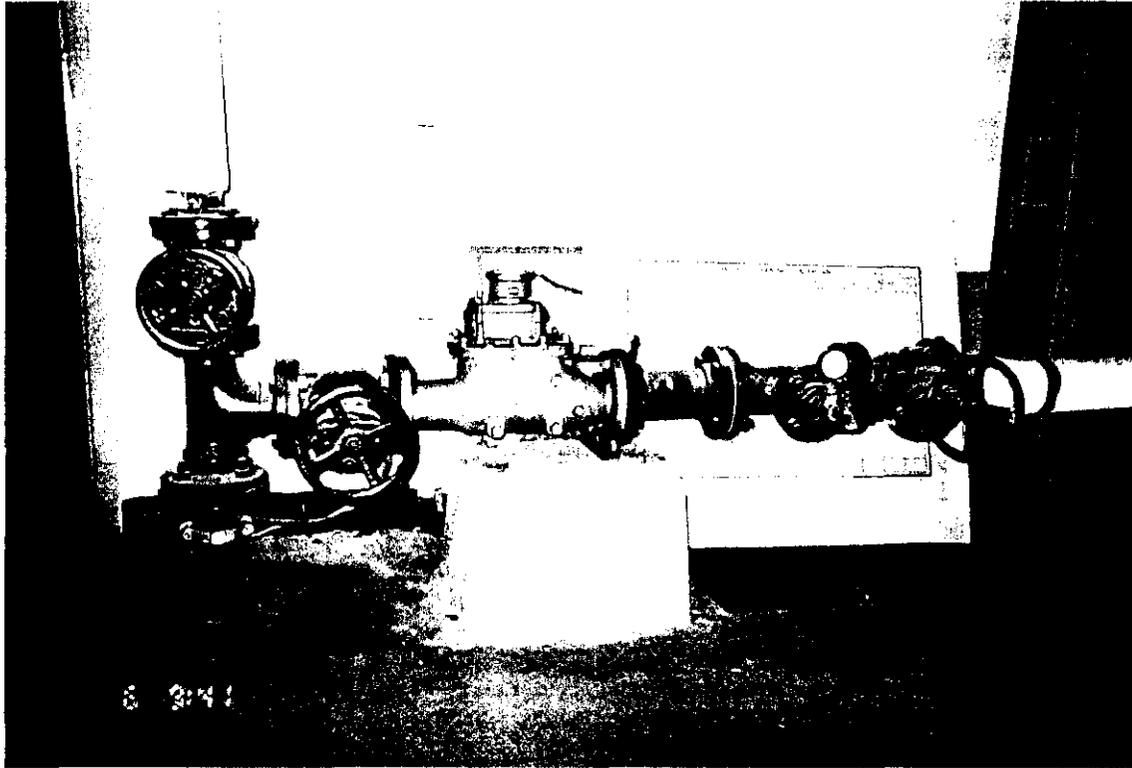
Photograph C: Unprotected hose bibb.

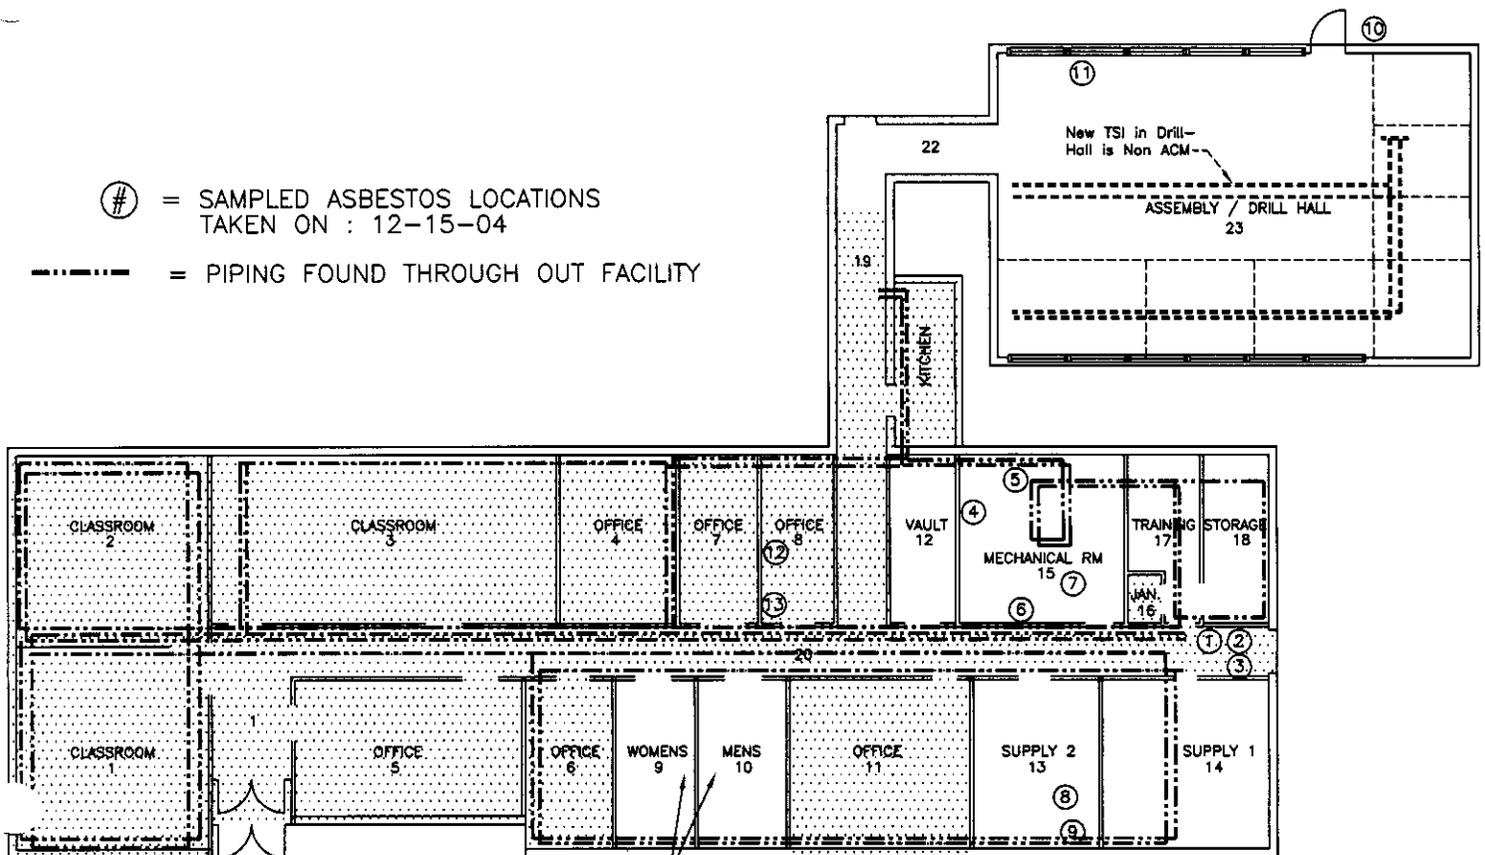
CONFIRMED ASBESTOS CONTAINING MATERIAL

Transite wall panels found in restrooms is a confirmed ACM.
