**ENVIRONMENTAL CONDITION OF PROPERTY
REPORT**

**GERMANTOWN VETERANS MEMORIAL
U.S. ARMY RESERVE CENTER (PA076)
5200 WISSAHICKON AVENUE
PHILADELPHIA, PA 19144**

FEBRUARY 2007

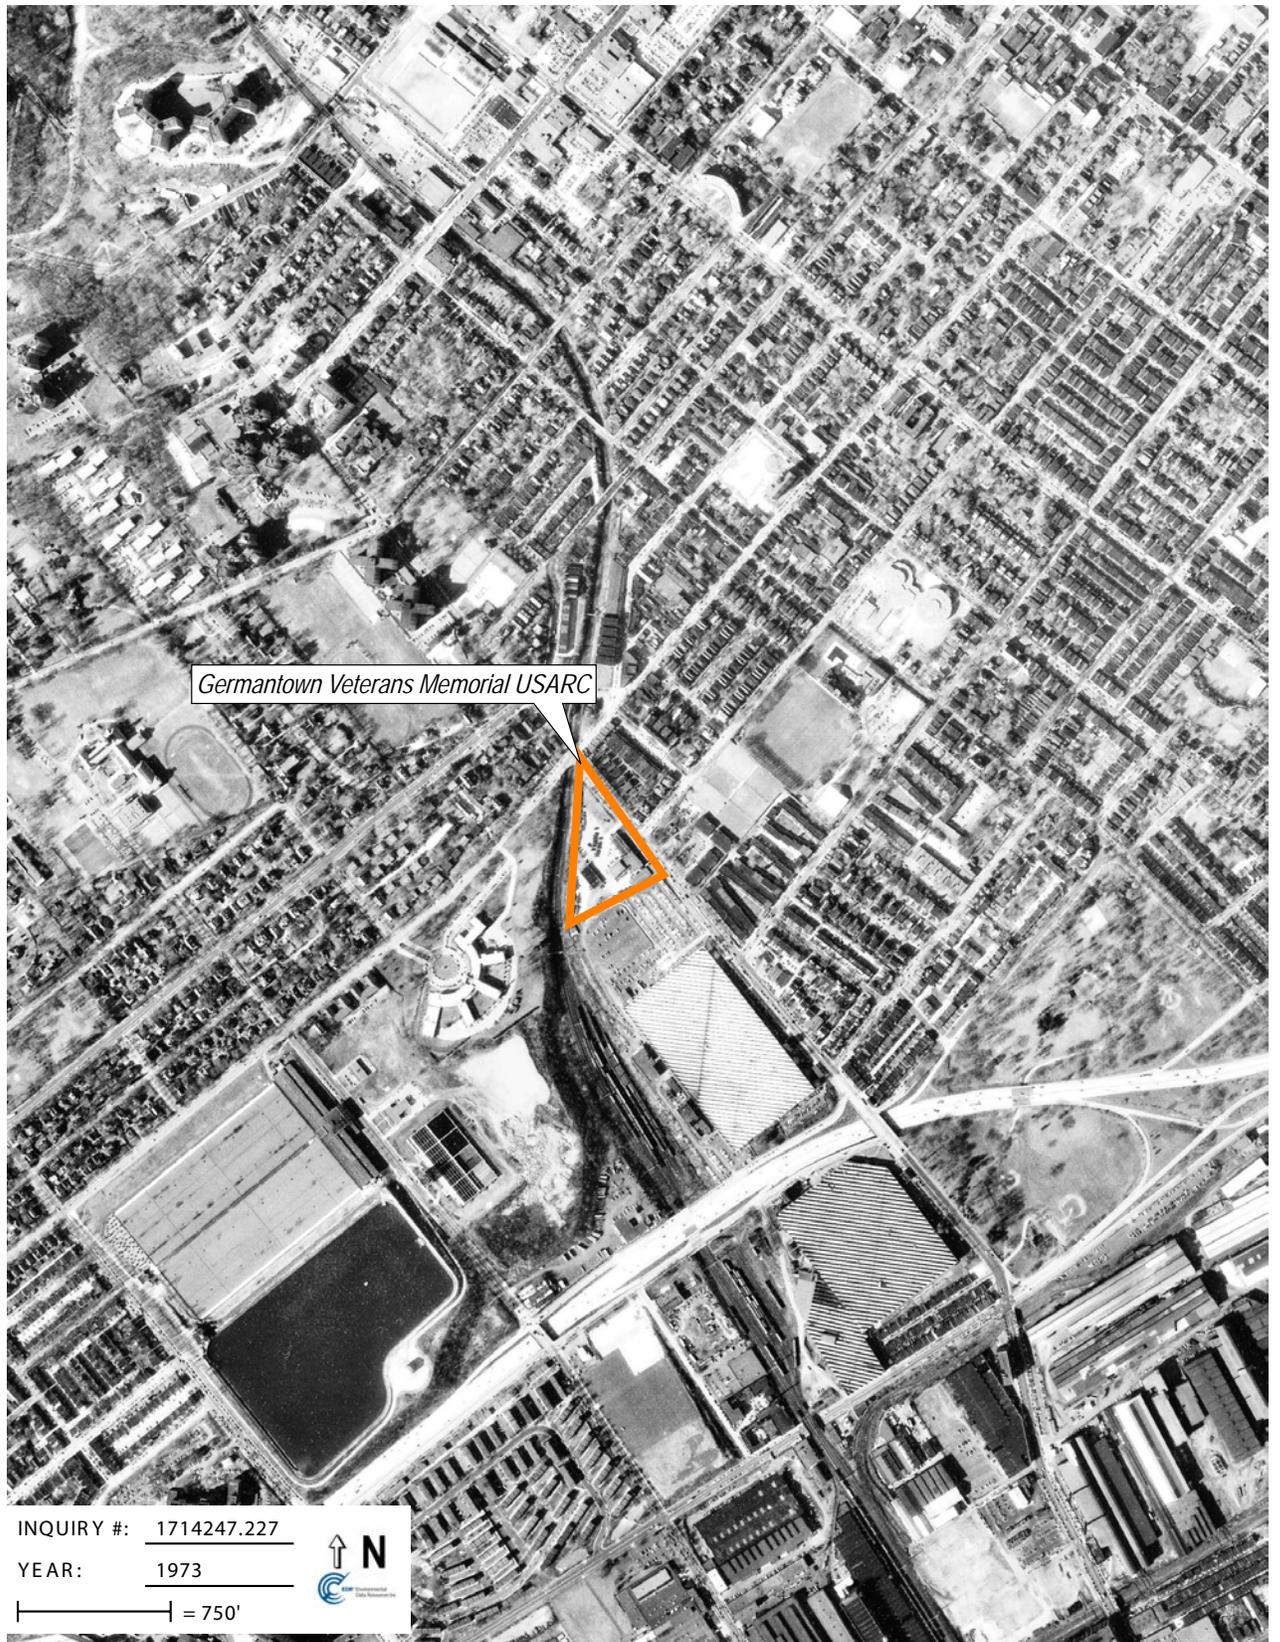
FIGURE 6
1965 Aerial Photograph
Phase I ECP Report

The 1965 historical aerial photograph (Figure 6, Appendix A) shows the developed USAR Center. Note that in the current location of the POV parking lot, the pavement appears as two separate colors, indicating that this area may have been unpaved at this time. Directly south of the Property is a parking lot followed by the former Federal Building. Interviews with 99th RRC personnel noted that the Federal Building was renovated about 10 years before the August 8, 2006, site reconnaissance. This is confirmed in recent aerial photographs (Figures 7 through 10, Appendix A), as the location of the Federal Building and parking lot have switched places (that is, the building is now on the northwest side of the lot). Little change has occurred at the Property since the 1965 aerial photograph. Figure 10 (Google Earth Image) in Appendix A shows a sink hole at the southwestern corner of the Property and some stains on the asphalt in the MEP area. The visible sink hole is reportedly common in the area based on the regional geology. Similar sink holes have been reported elsewhere in the area. The stains that appear in the aerial photograph are confined to the MEP area and do not run off the asphalt pavement onto the adjacent grassed areas.

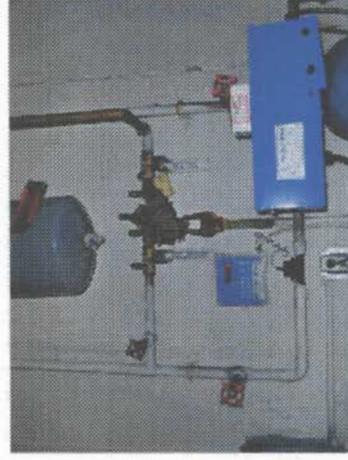
ROOM: MECHANICAL EQUIPMENT ROOM **TYPE:** REDUCE PRESSURE PRINCIPLE

SYSTEM: HEAT MAKE UP **INSTALLED:** YES
SIZE: 1" **MAKE:** WATTS
HAZARD: HEALTH **MODEL:** 909
TEST FREQ: SEMI-ANNUAL **SERIAL #:** 318459
STATUS: FAILED **DATE:** 8/15/00

REMARKS: RP FUNCTIONS BUT FAILS FOR HEIGHT Y=7'. REBUILD RP FOR 5 YEAR CYCLE
AND RELOCATE NO MORE THAN 4' OFF FLOOR.

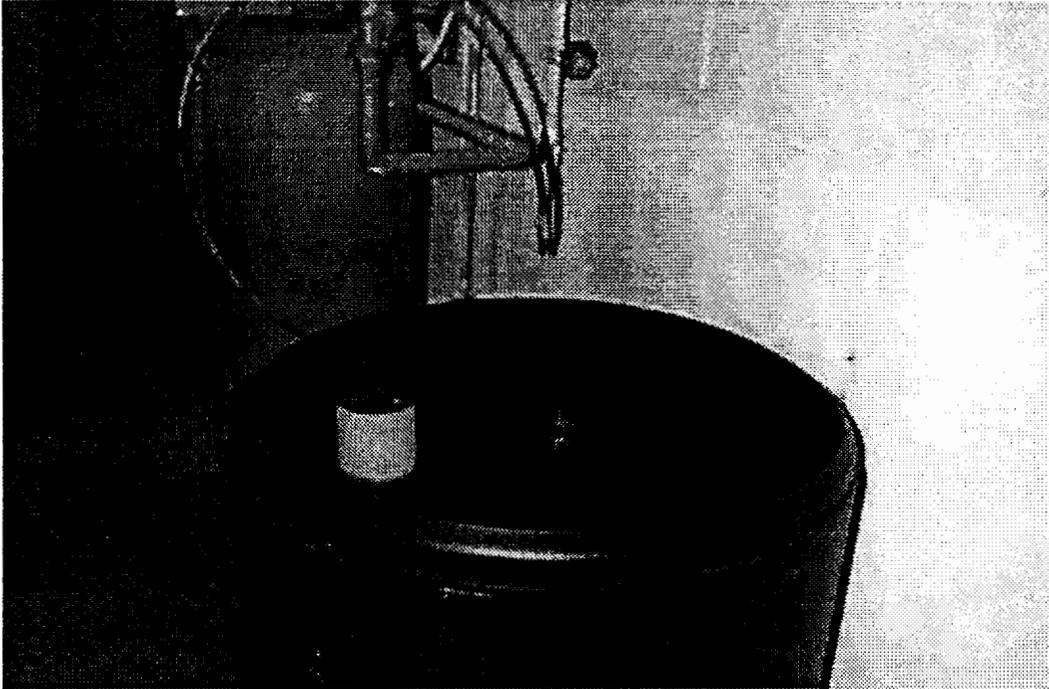
Photo 16: Improperly stored lithium batteries in room 124.
