**ENVIRONMENTAL CONDITION OF  
PROPERTY REPORT**

**MAJ ELBERT LESLIE BIAS  
U.S. ARMY RESERVE CENTER (WV017)  
1550 SPRING VALLEY DRIVE  
HUNTINGTON, WEST VIRGINIA 25704**

**FEBRUARY 2007**

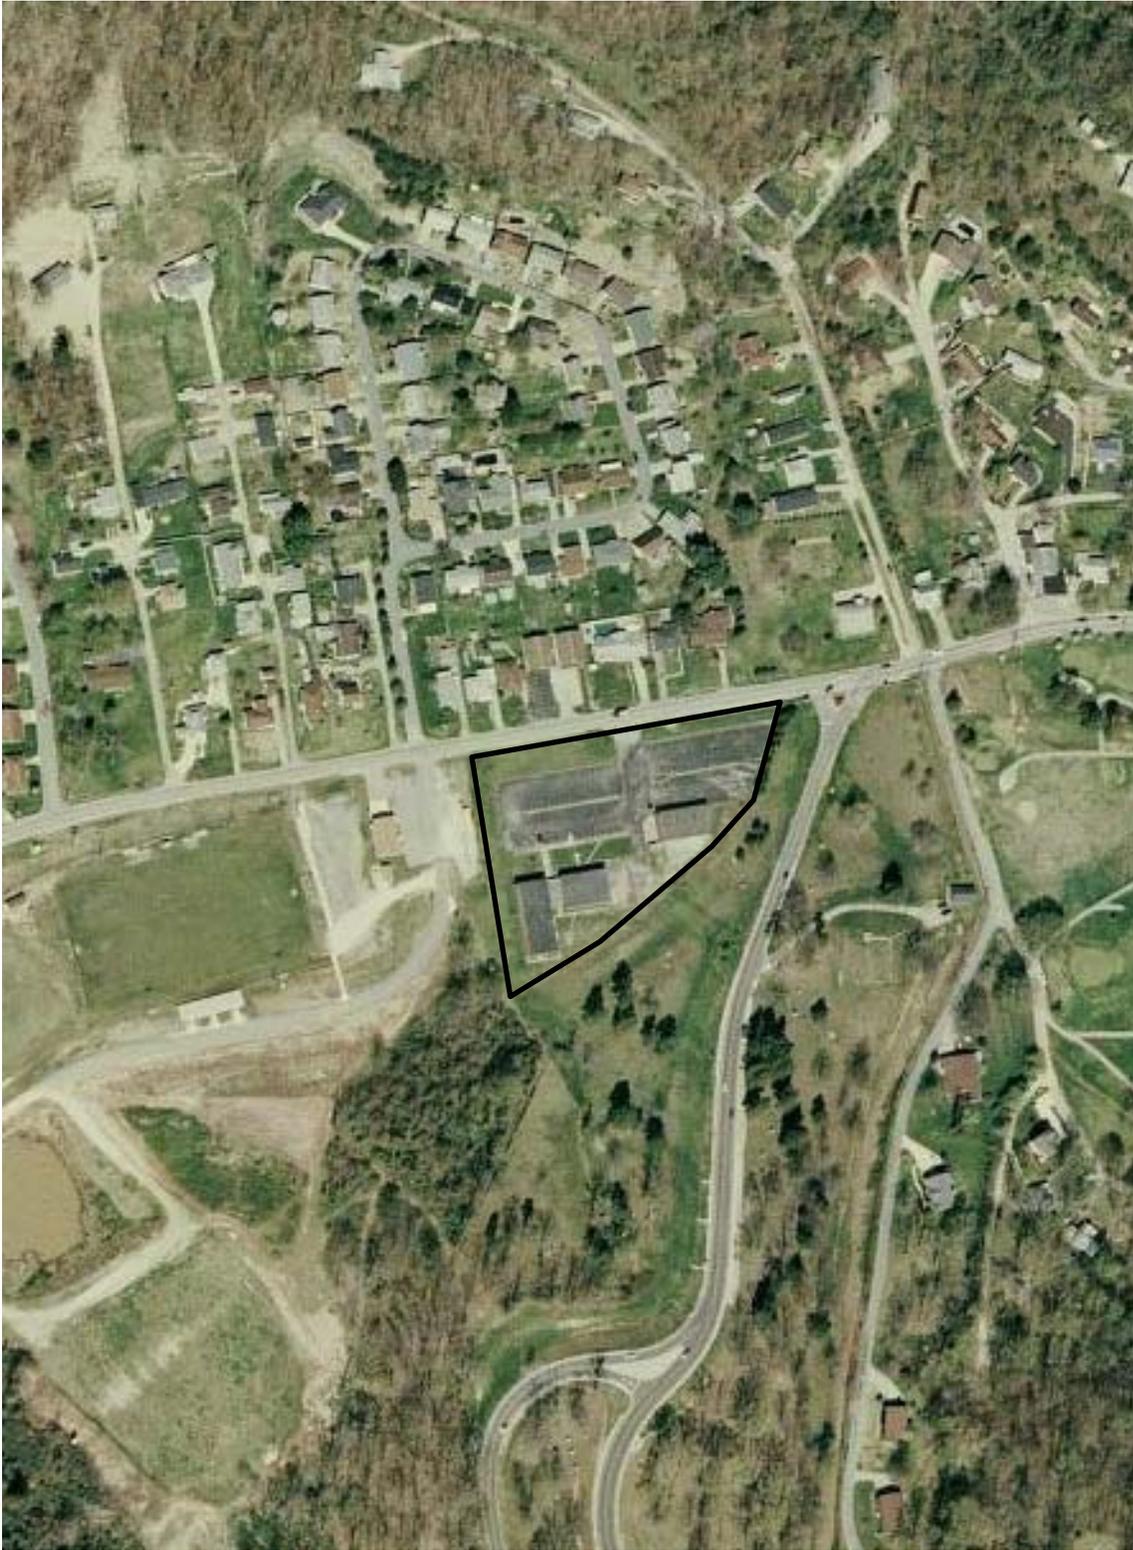
**FIGURE 12**  
2003 Aerial Photograph  
MAJ Bias USAR Center ECP Report  
Huntington, West Virginia

The 2003 aerial photograph (Figure 12, Appendix A) shows the Property as it currently exists. Residential properties are visible to the north of the Property. The Spring Valley Public Safety Center is visible to the west and the access to the VA Hospital is visible east of the Property. No stained or distressed areas are visible on the Property.

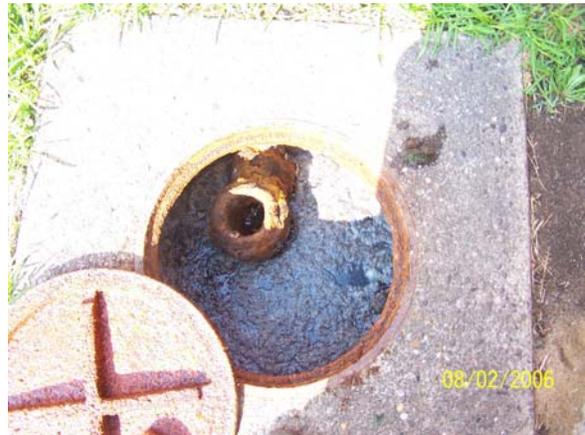
4. Grease trap outside of kitchen.

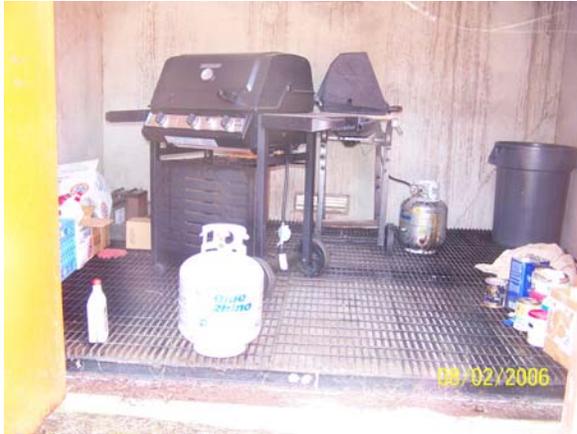
5. Interior of hazardous materials storage shed.

At the time of the site reconnaissance, the OMS building was empty. The outdoor hazardous material storage shed contained small containers (1 gallon or less) of motor oil and paints and two propane grills.

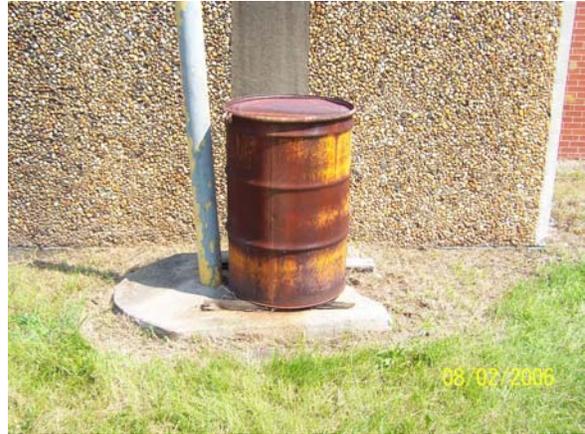
6. Drum south of hazardous materials storage shed.

The OMS building contains an open bay area with some storage cages and a pit area. This facility formerly functioned as limited vehicle maintenance in the past, although not for the last 15 to 20 years. Presently it is mostly empty and occasionally used for storage. West of the OMS building is an outdoor hazardous material storage shed where hazardous materials and petroleum, oil, and lubricant (POL) products are stored (see Photograph 5 in Appendix B). At the time of the site reconnaissance, a drum of unknown contents was identified behind the storage shed (see Photograph 6 in Appendix B). There was no evidence of any release from the drum (e.g., no stains on pad or adjacent soil). According to 99th RRC personnel, the drum has since been removed from site; sampling and analysis revealed that the drum contained water, sand and trace amounts of antifreeze.

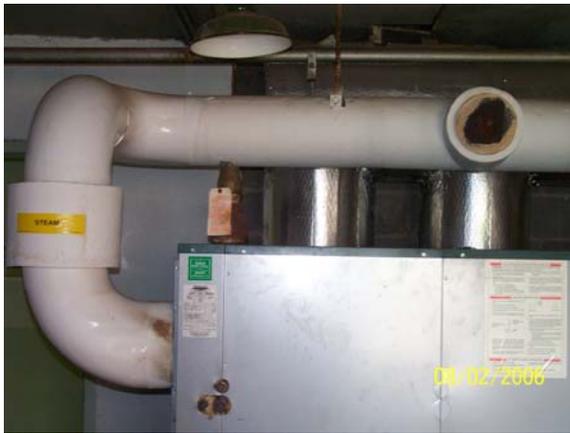
7. Pipes in boiler room of training building.

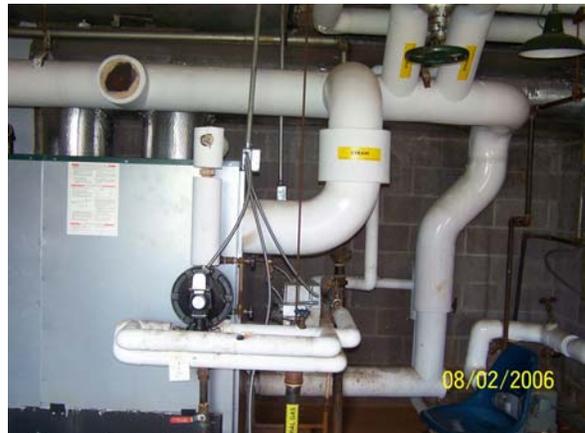
8. Pipes in boiler room of training building.

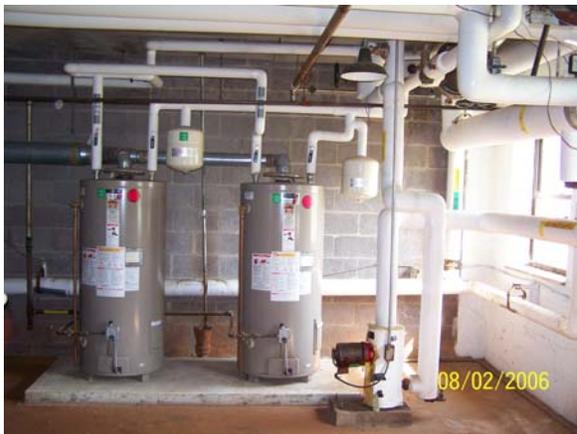
9. Pipes in boiler room of training building.

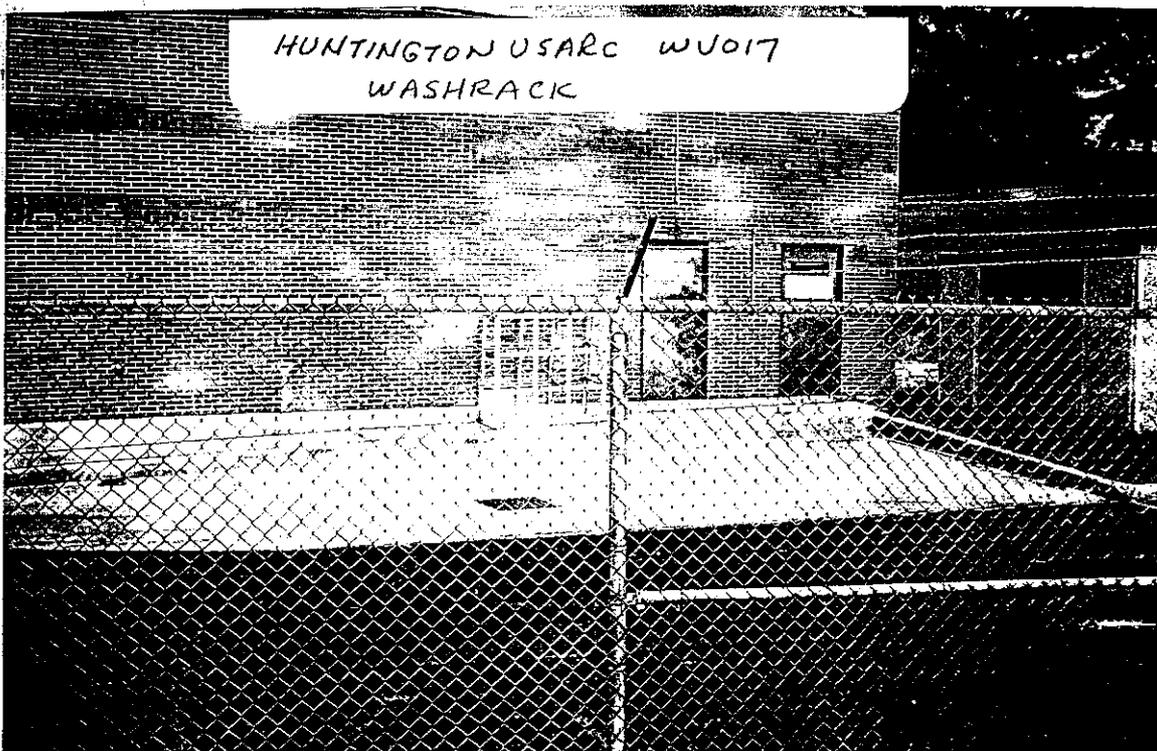
HUNTINGTON USARC WJ017  
WASHRACK

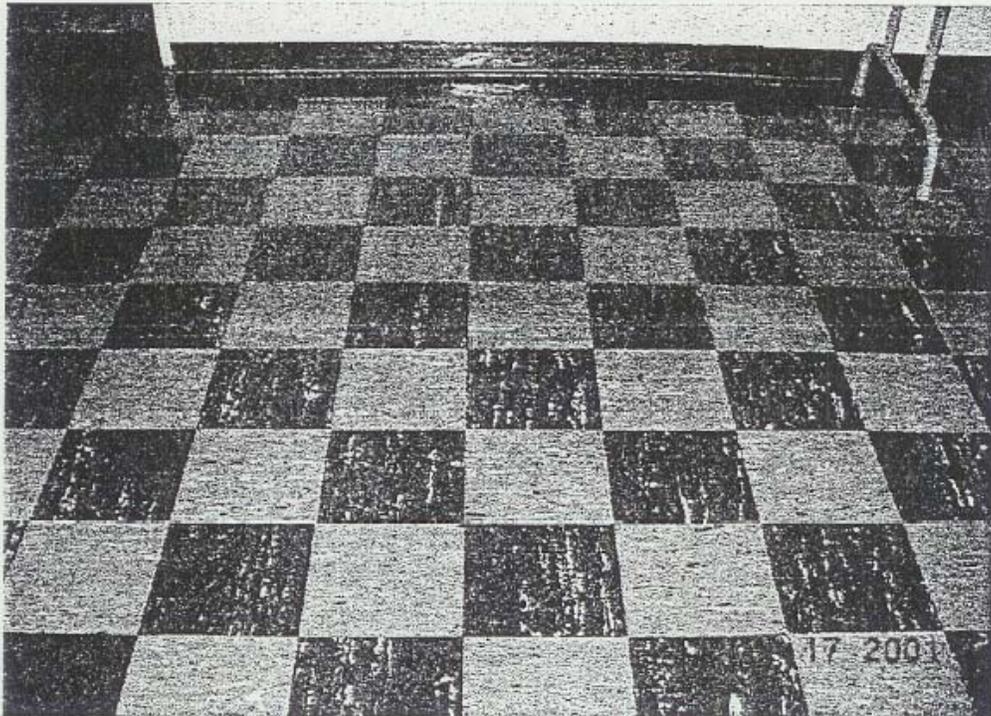
ASBESTOS TILE, BIAS USAR CENTER (WV017)

HUB Testing Laboratories prepared Asbestos Survey Reports for both the training building and OMS building for the MAJ Elbert Leslie Bias USAR Center following a survey conducted November 1995. Potential types, quantities, locations, and conditions of asbestos were examined in the report. Friable asbestos was confirmed in several areas of the training building: first floor offices and hallways, second floor classrooms, drill hall and boiler room, some of which was damaged. In addition, non-friable floor tile and mastic was observed throughout the training building. The roof on the OMS building could not be sampled due to snow, but was assumed to contain asbestos (HUB Testing Laboratories, 1995).

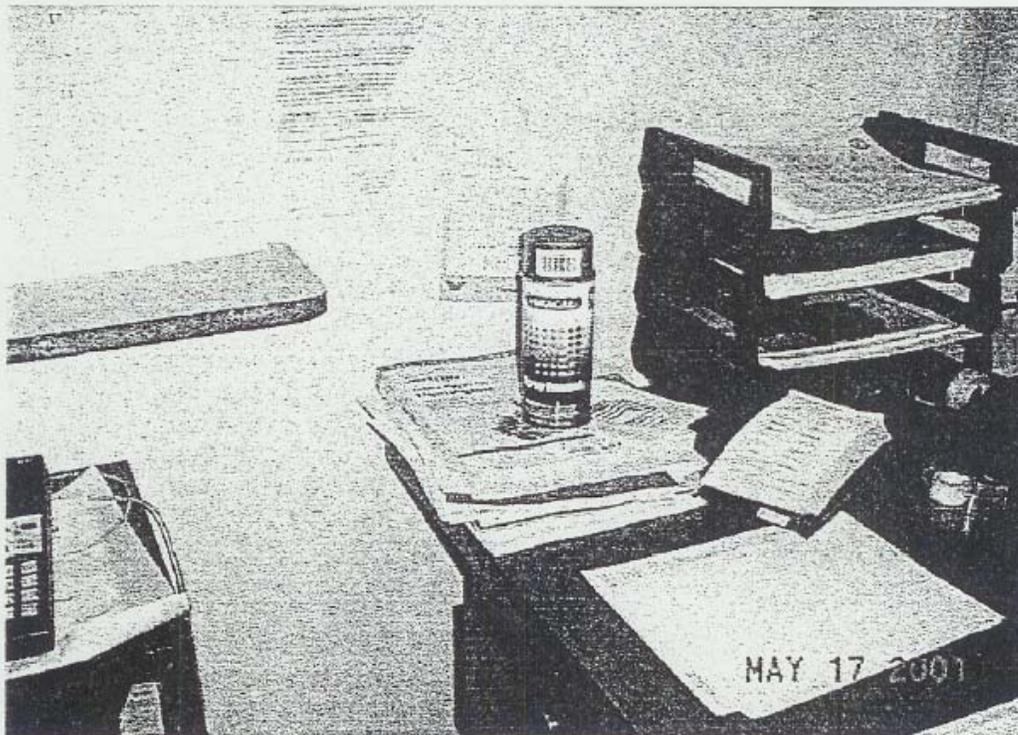
IMPROPER STORAGE, BIAS USAR CENTER (WV017)

The 416<sup>th</sup> ENCOM, Oakdale Facility Engineer Team performed a facility assessment on May 17, 2001 for the MAJ Elbert Leslie Bias USAR Center. This assessment included an external environmental compliance assessment for the facility. The assessment identified several findings that were related to improper storage of hazardous materials (416<sup>th</sup> ENCOM, 2001).

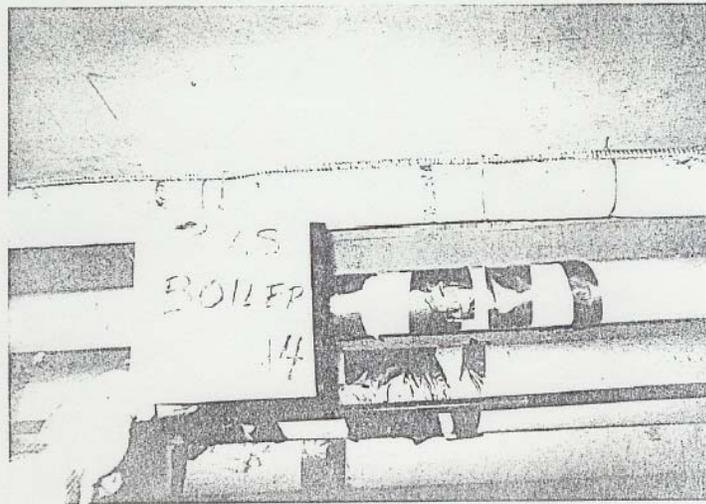
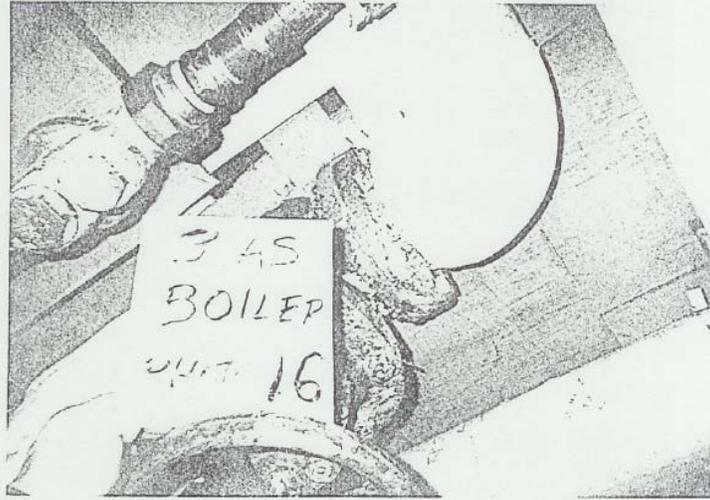
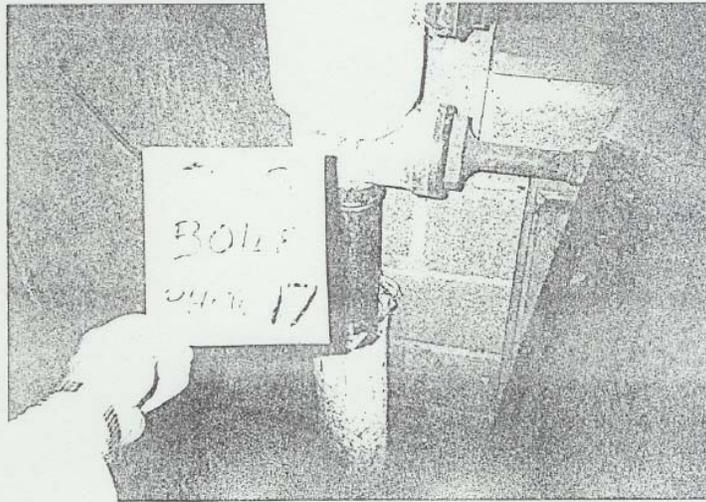
Boiler room photos #13, #14, #16 and #17 show the significantly damaged condition of the pipe insulation throughout the boiler room. Because of the highly friable nature of this asbestos containing material it is highly recommended that this material in the boiler room be removed or repaired with re-wettable fiberglass cloth.

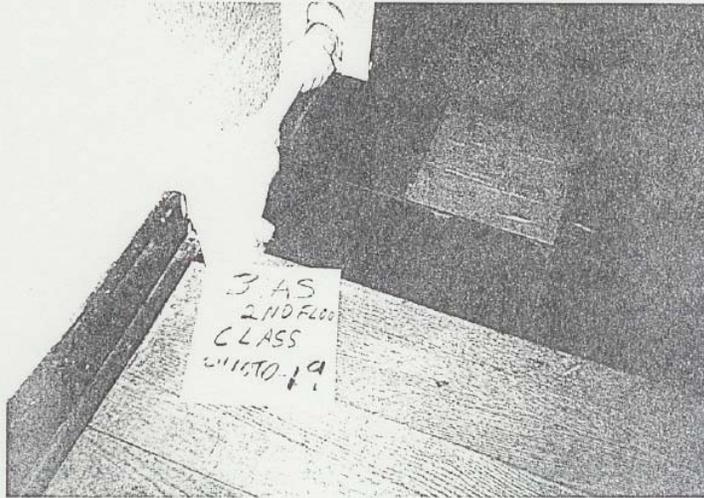
Photo #19 showing the damaged condition of the pipe insulation located at the radiators in the second floor classroom areas. Because of the highly friable nature of this asbestos containing material and the probability of further impact and damage by chairs and desks, it is highly recommended that this material be removed or repaired with re-wettable fiberglass cloth. If this material is repaired it is also recommended that a hard impact resistant jacket be placed over the material where further impact is likely to occur.

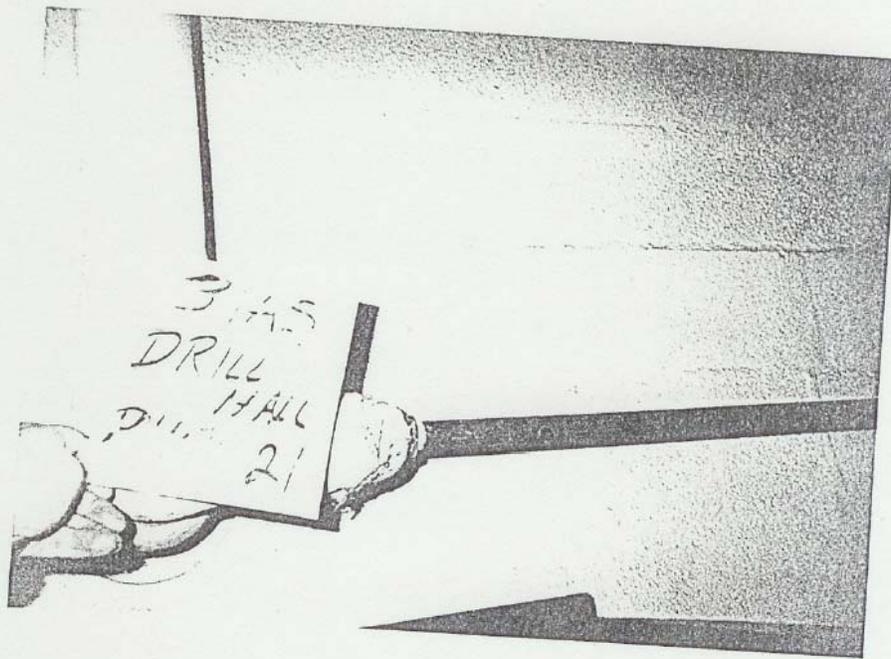
Photo #21 showing the damaged end on the 4.5" diameter pipe insulation in the drill hall near the entrance to the main building. This damage is located well above the floor level, however the highly friable nature of this asbestos containing material necessitates the repair of this material with re-wettable fiberglass cloth.

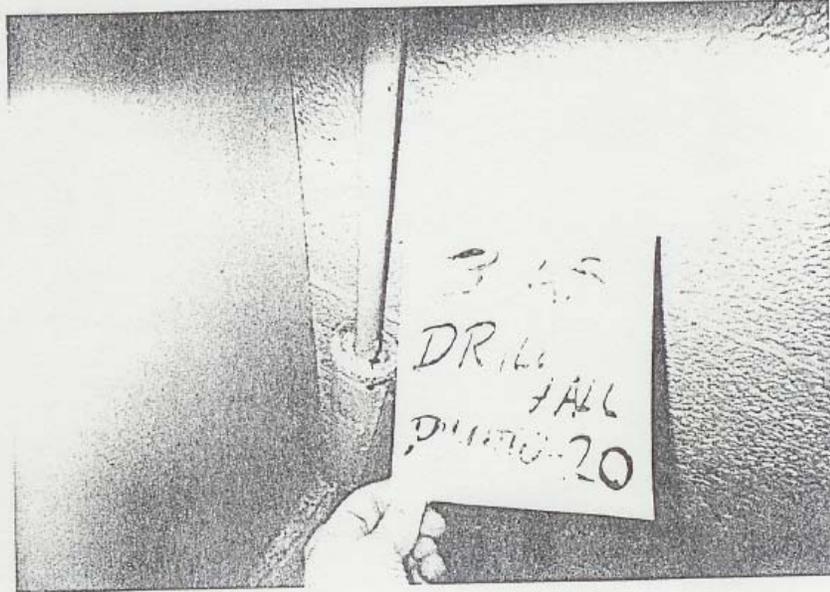
Photo #20 showing the damaged condition of the pipe insulation located at the floor level in the drill hall. This material has missing portions of insulation and the remaining insulation is damaged with exposed ends. The probability of further impact and damage by drill hall activity is high. Therefore it is highly recommended that this material be removed or repaired with re-wettable fiberglass cloth. If this material is repaired it is also recommended that a hard impact resistant jacket be placed over the material where further impact is likely to occur.

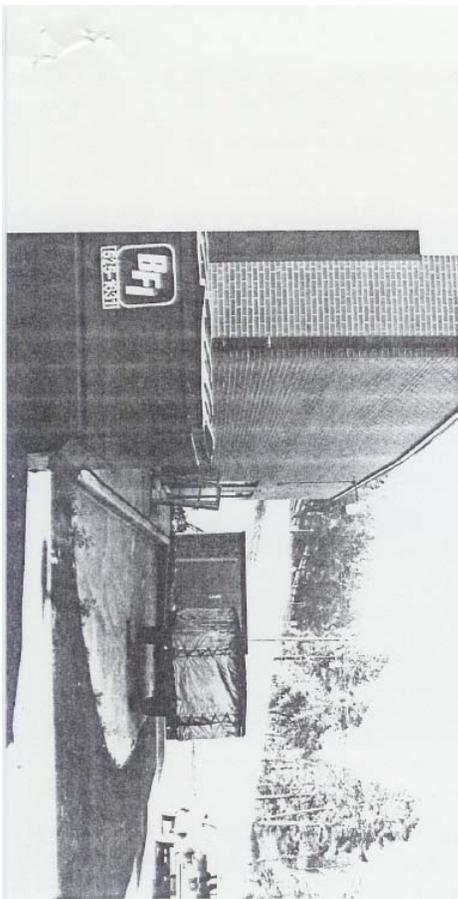
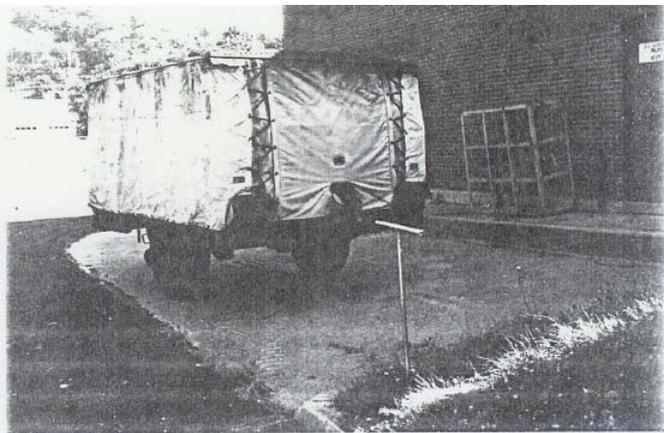
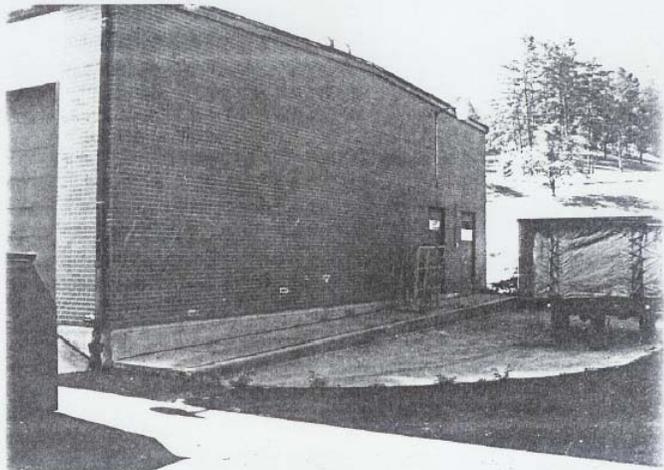
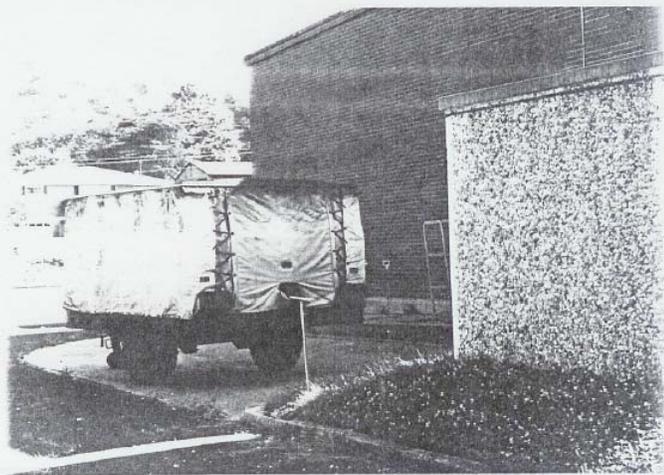
Huntington, WV  
washrack  
Hunt-02

The sample was taken about 1-1/2 feet off the edge of the concrete washrack.

The sketch shows the layout of the washrack and the sample location.
