**ENVIRONMENTAL CONDITION OF
PROPERTY REPORT**

**1LT HARRY B. COLBORN
U.S. ARMY RESERVE CENTER (WV013)
MARY LOU RETTON DRIVE & BIG TREE DRIVE
FAIRMONT, WV 26554**

FEBRUARY 2007

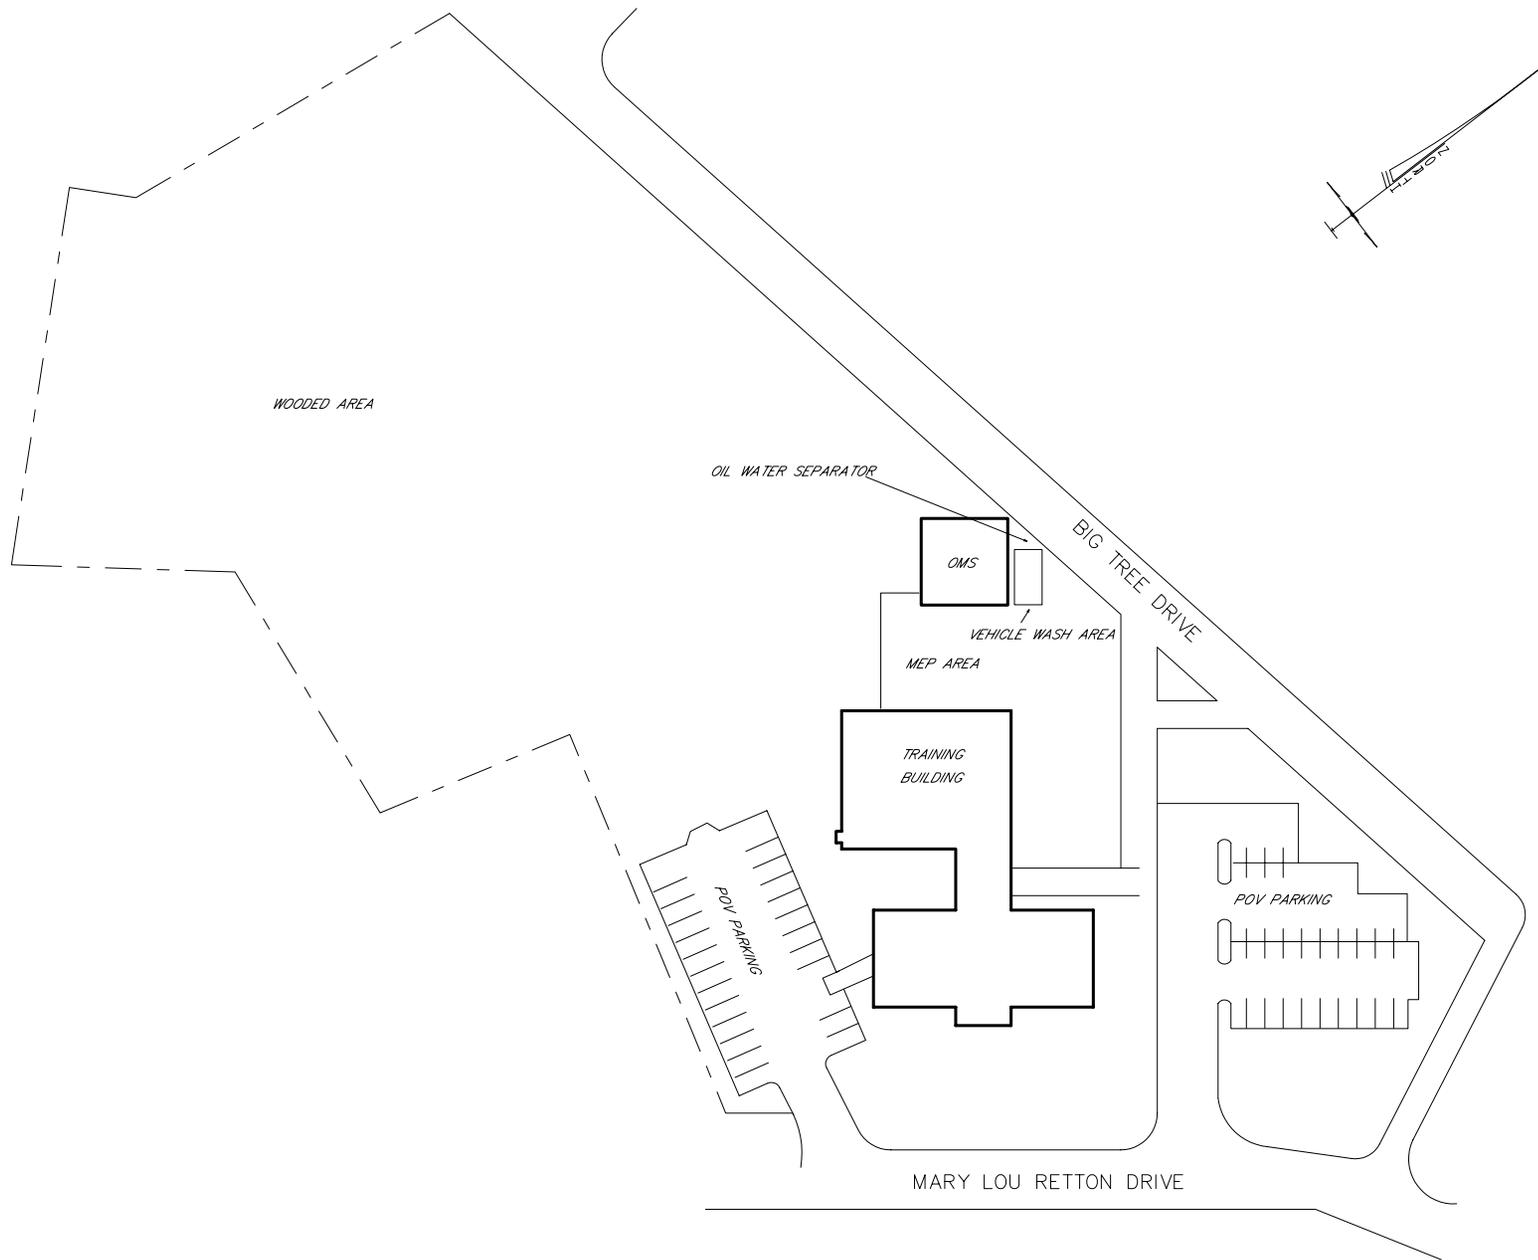
FIGURE 2
 SITE LAYOUT PLAN
1LT Colburn USAR Center ECP Report
Fairmont, West Virginia

The USAR Center contains two permanent structures and three parking lots (Figure 2, Appendix A). Construction of both the 13,595 square-foot training building and the 2,316 square-foot organizational maintenance shop (OMS) building was completed in 1958. The footprint of both buildings was expanded and major renovations were completed in 1981. Both structures are on concrete foundations, and consist of concrete block walls covered with a stucco veneer. A military equipment parking (MEP) area and two privately owned vehicle (POV) parking areas are also contained within the Property. Chain-link security fencing topped with barbed wire encloses the MEP area and OMS building.

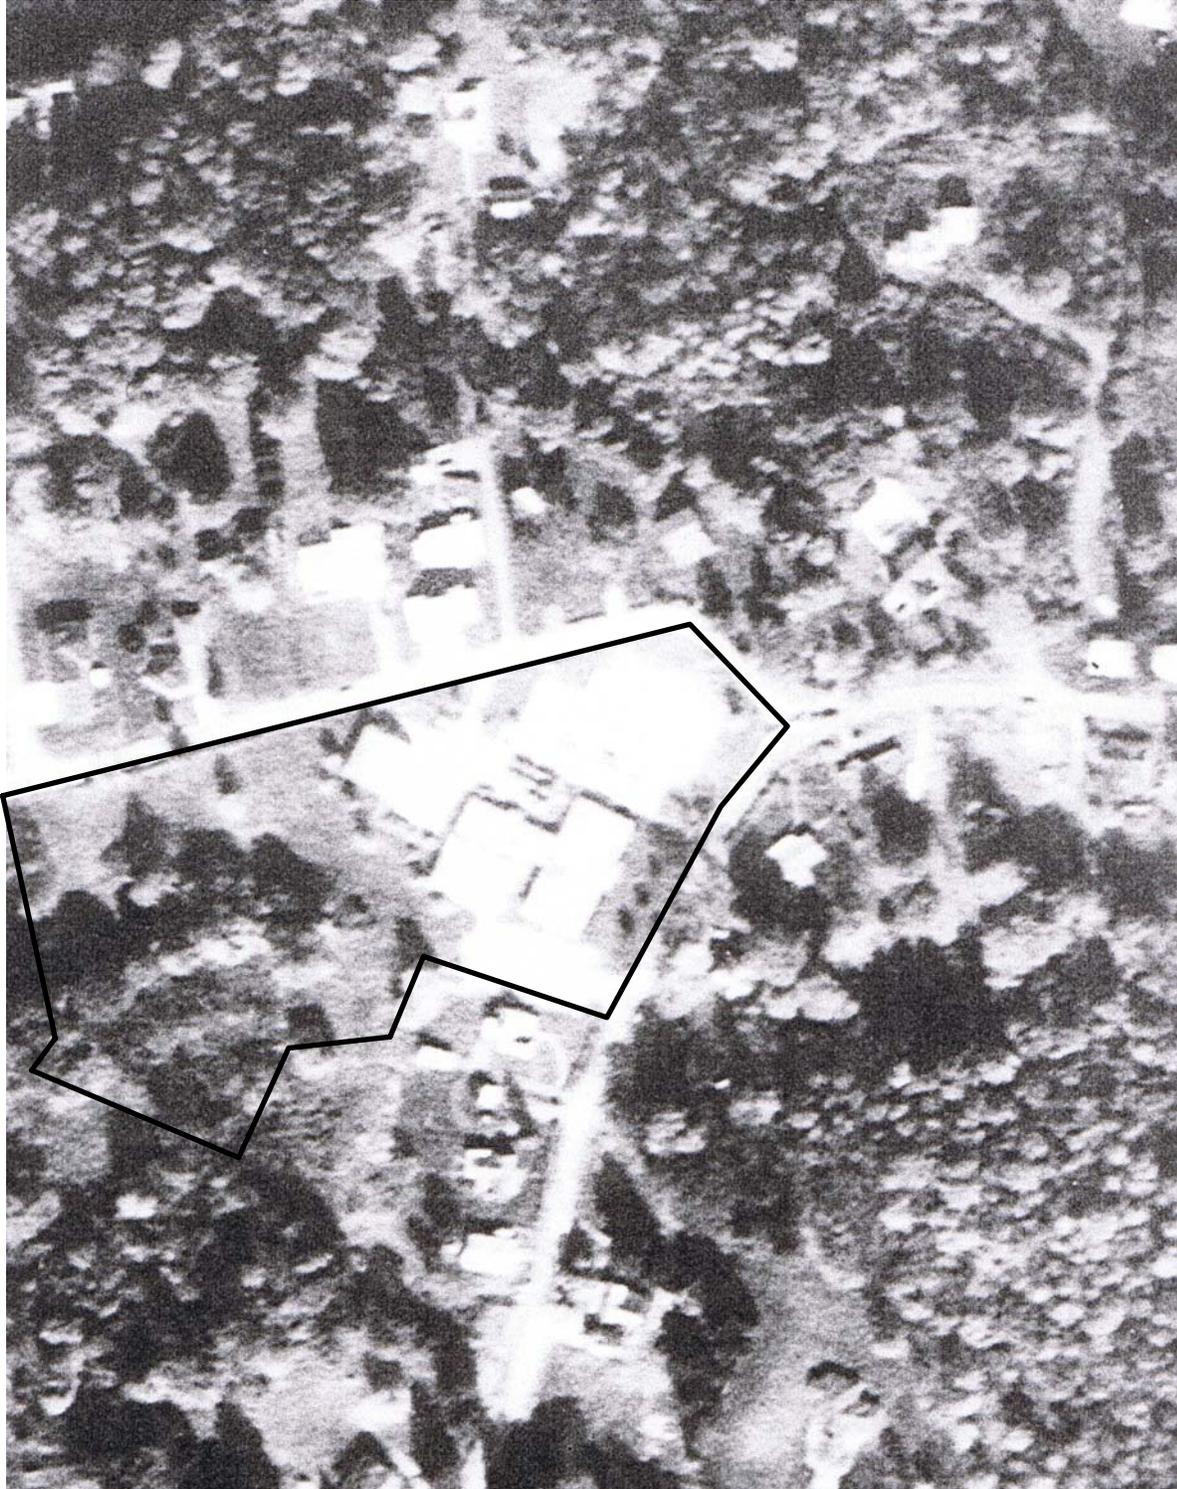
FIGURE 9
1990 Aerial Photograph
1LT Colborn USAR Center ECP Report
Fairmont, West Virginia

The 1990 aerial photograph (Figure 9, Appendix A) shows the expanded training and OMS buildings and the additional POV area. Adjacent properties appear relatively unchanged from the 1967 and 1981 aerial photographs. The 1996 and 2003 aerial photographs (Figures 10 and 11, Appendix A) show the Property and adjacent properties relatively unchanged from the 1990 aerial photograph. Vehicles are visible in the MEP and POV areas in both photographs. No stained or distressed areas are visible on the Property.

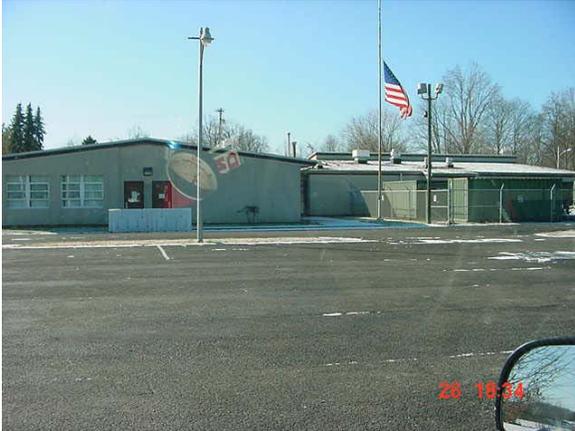
1. Exterior of training building.

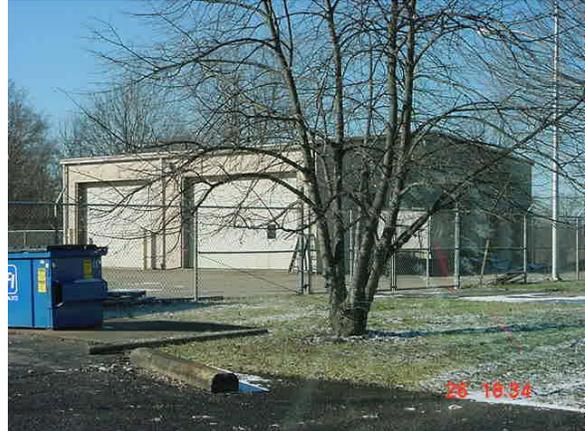
The OMS building contains two open bay areas, a battery room, and an office. The southern bay was added in 1981. This facility functions as limited vehicle maintenance and storage. The contents stored in the battery room and a flammable storage cabinet are shown in Photographs 4 and 5 in Appendix B, respectively. Floor drains in the facility are connected to the Oil Water Separator (OWS) servicing the vehicle wash area.

2. Exterior of OMS building.

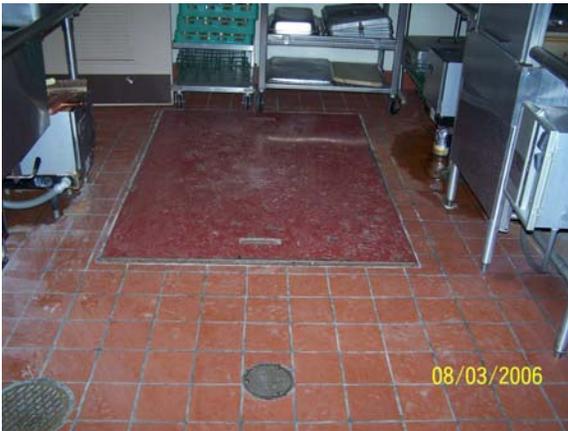
3. Grease trap in kitchen of training building.

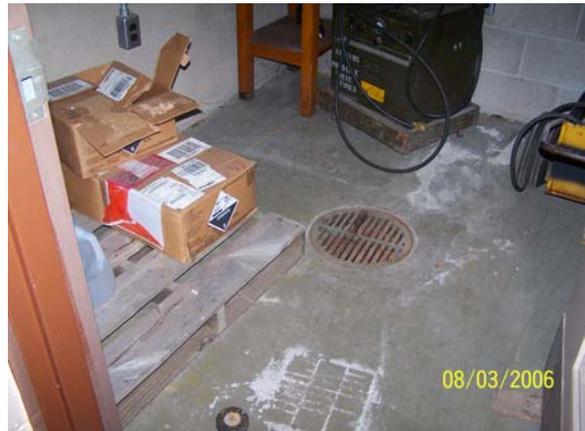
A catch basin is located in the battery room of the OMS building, near the storage of battery acid fluid (see Photograph 4 in Appendix B). This catch basin does not drain anywhere; it is simply a floor drain with a bucket underneath. At the time of the August 2006 site visit, it was empty and in good condition.

4. Battery room in OMS building showing battery acid fluid and catch basin.

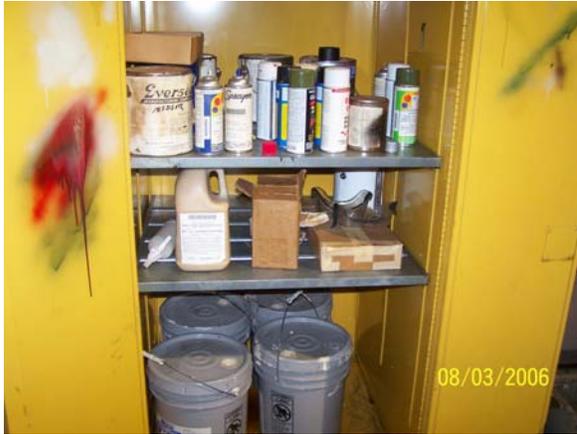
5. Flammables locker in OMS building.

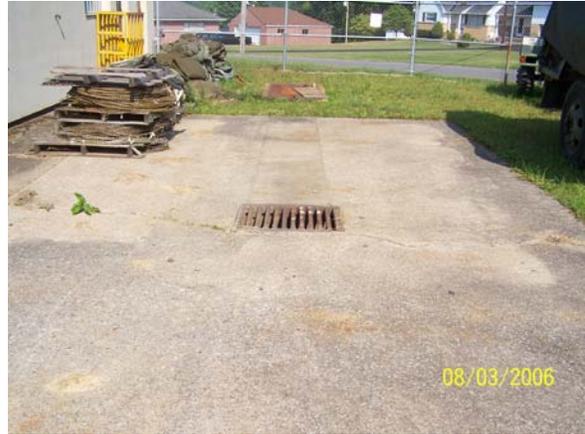
The wash area, which is located outside, along the north side of the OMS building, contains a floor drain connected to an OWS, which is connected to the sanitary sewer. According to site personnel, the wash area has not been used in at least 12 years. There is a patched area of concrete between the OWS and wash area, which appears to be related to a repair to the pipe connecting the OWS and wash area, although 99th Regional Readiness Command personnel was not aware of when this patch occurred. The wash area and OWS are shown in Photographs 6 and 7 in Appendix B, respectively.

6. Wash area north of OMS building.

An OWS is present north of the OMS building. The OWS was connected to the wash area drain and the OMS building's floor drains. The piping between wash area and OWS was replaced, as evidenced by the concrete patch above the piping between the wash area and the OWS (see Photograph 6 in Appendix B). Information on the date of installation of the OWS or whether the pipe replacement was done to increase pipe size or to correct defective piping was not available. The OWS is connected to the sanitary sewer. According to site personnel, the wash area has not been used in at least 12 years.

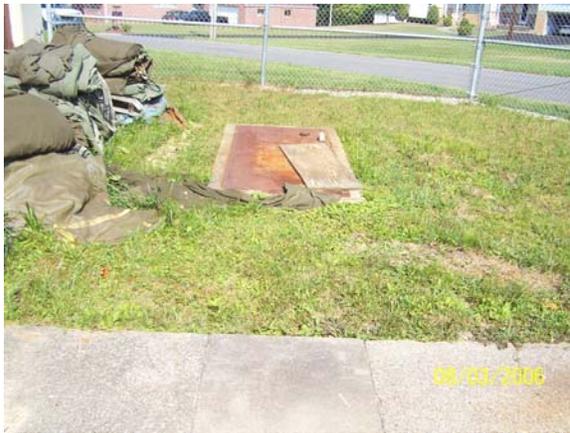
7. Oil Water Separator west of wash area.

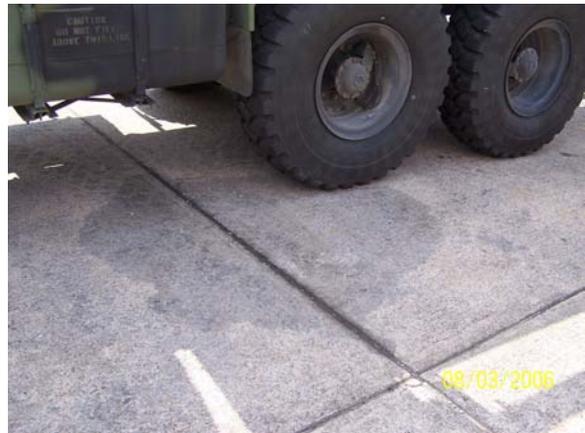
Photographs 8 and 9 show crank case oil releases from a military vehicle. The 4-foot diameter stain is situated on a concrete joint, while the 1-foot diameter stain is situated where there are no cracks or joints in the concrete. Photograph 10 shows some orange stains that encompass a total of approximately 15 square feet and appear to be rust stains. None of these stains appear to have resulted in a release to the soil under the pavement.

8. Four foot diameter oil stain in MEP area.

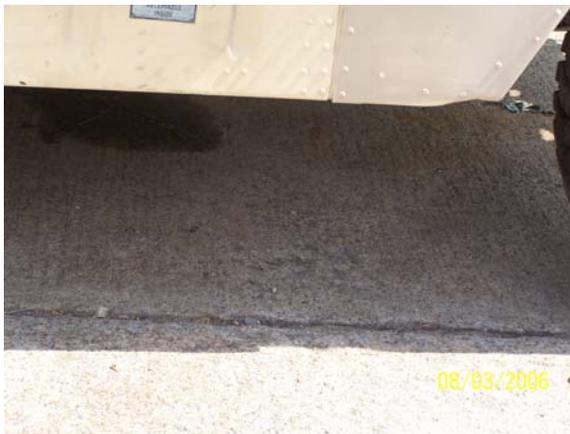
9. One foot diameter oil stain in MEP area.

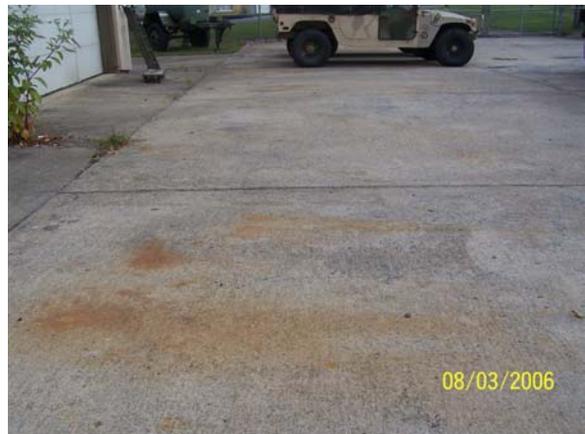
10. Orange stains in MEP area.
