**ENVIRONMENTAL CONDITION OF PROPERTY
REPORT**

**1st LT PAUL LAVERGNE
U.S. ARMY RESERVE CENTER (PR003)
STATE ROAD 167
KM 5.0 HIGHWAY 8
BAYAMÓN, PR 00936-0350**

**U.S. Army Corps of Engineers – Louisville District
Engineering Division – Environmental Engineering Branch
600 Dr. Martin Luther King, Jr. Place
Louisville, Kentucky 40202-2232**

AUGUST 2007

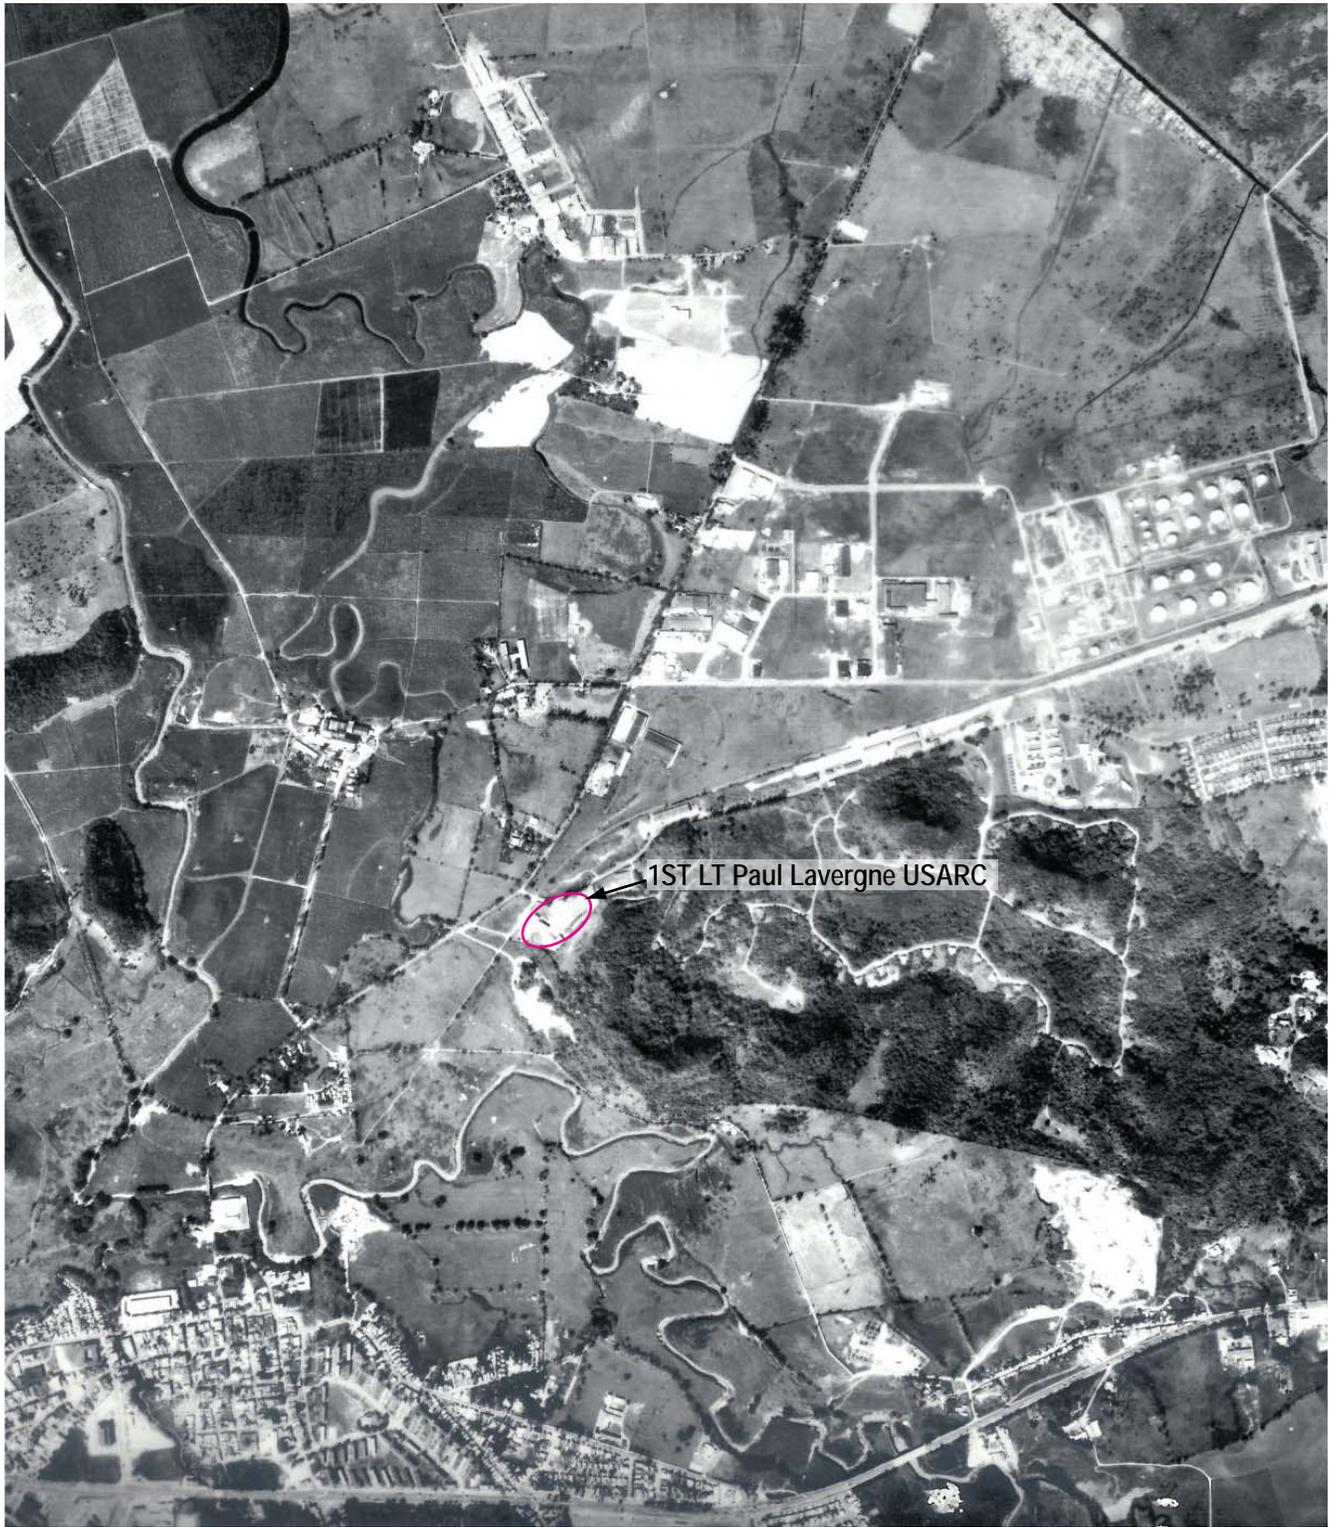
FIGURE 3
 1982 USGS 7.5-Minute Topographic Map
 Bayamón, Puerto Rico
 Phase I ECP Report

Figure 3 in Appendix A provides a portion of the 1982 Bayamón, Puerto Rico, USGS topographic map that includes the Property. As shown, the Property is situated at an elevation of approximately 33 feet above msl and is relatively flat with increasing site elevation towards the south-southeast.

The 1982 USGS topographical map (Figure 3, Appendix A) shows the area surrounding the Property as undeveloped. Commercial Residential development is visible north-northeast of the Property.

Historical aerial photographs and 1982 topographic map were the primary source of information on the past use and operations at the Property. Figures 3–6 in Appendix A provide a USGS topographical map and aerial views of the Property and surrounding areas in 1962, 1981, 1982, and 2005.

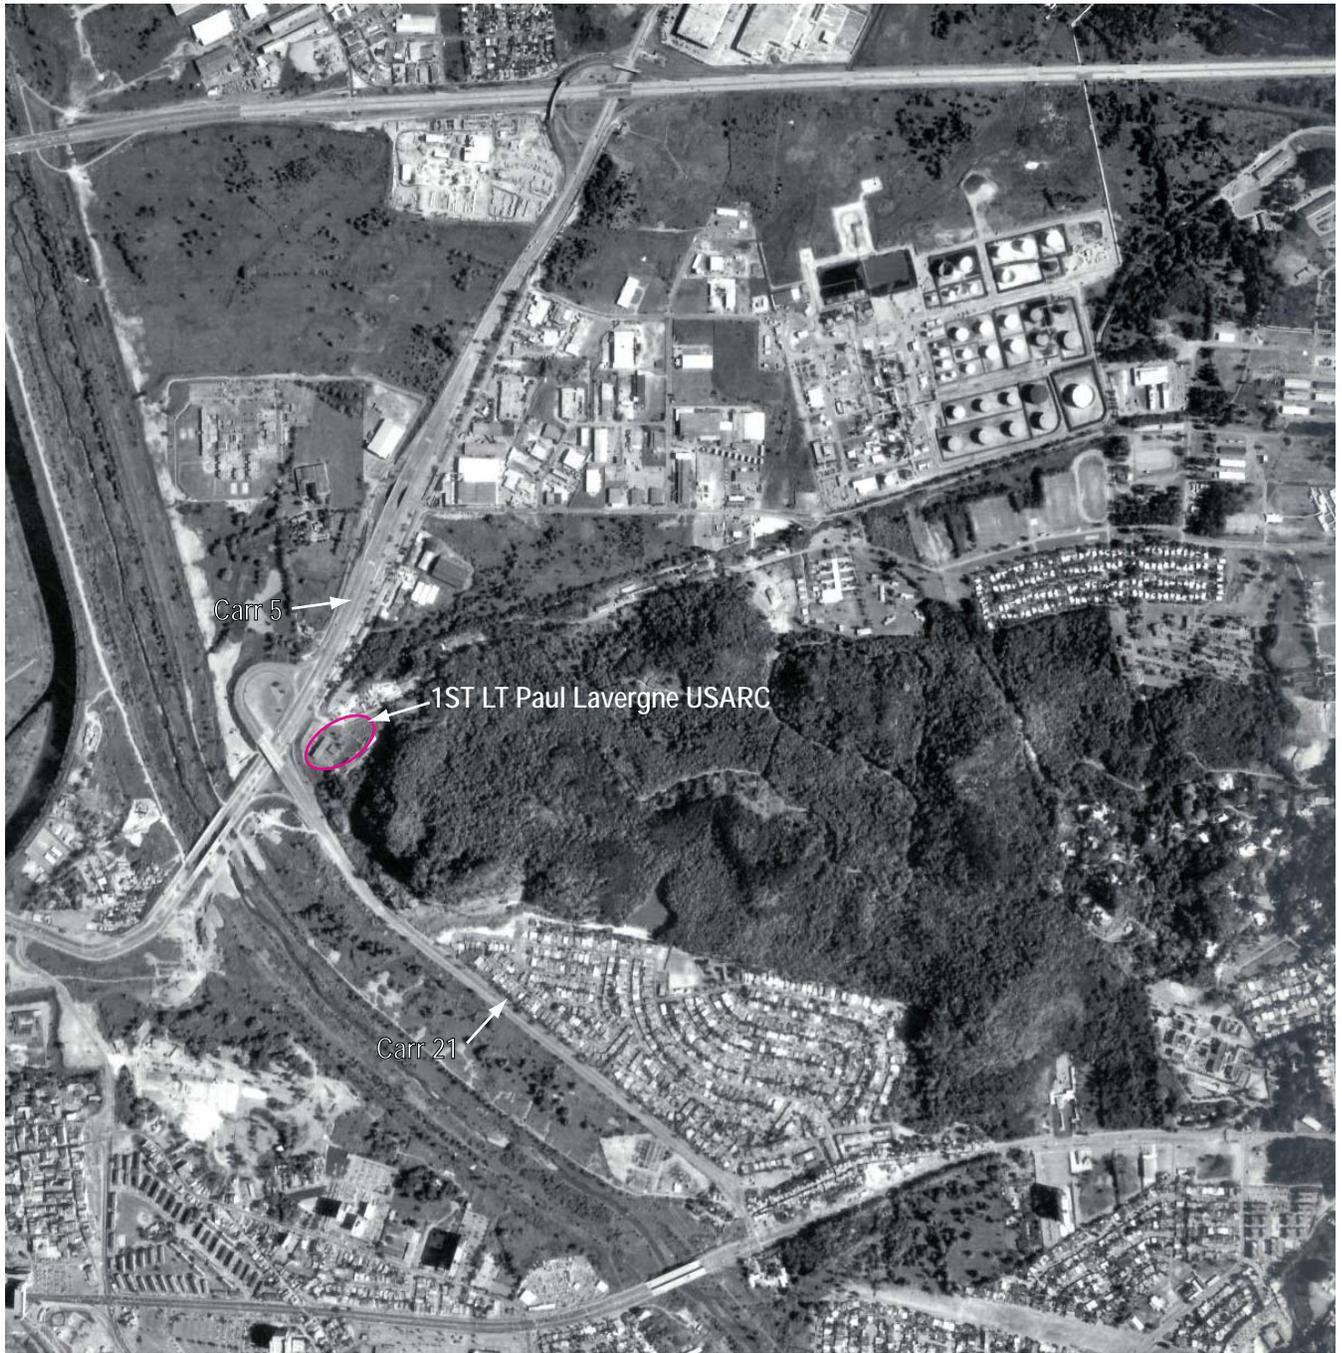
FIGURE 4
1962 Aerial Photograph
Phase I ECP Report

The 1962 aerial photograph (Figure 4, Appendix A) shows what appears to be the administration building, the OMS, and military vehicles or CONEX structures in the MEP area. The area immediately surrounding the property appeared vacant and undisturbed. Building structures are located northwest and northeast of the Property. The Rio De Bayamón River, which is located within 0.5 mile of the Property, is not visible to the west-southwest.

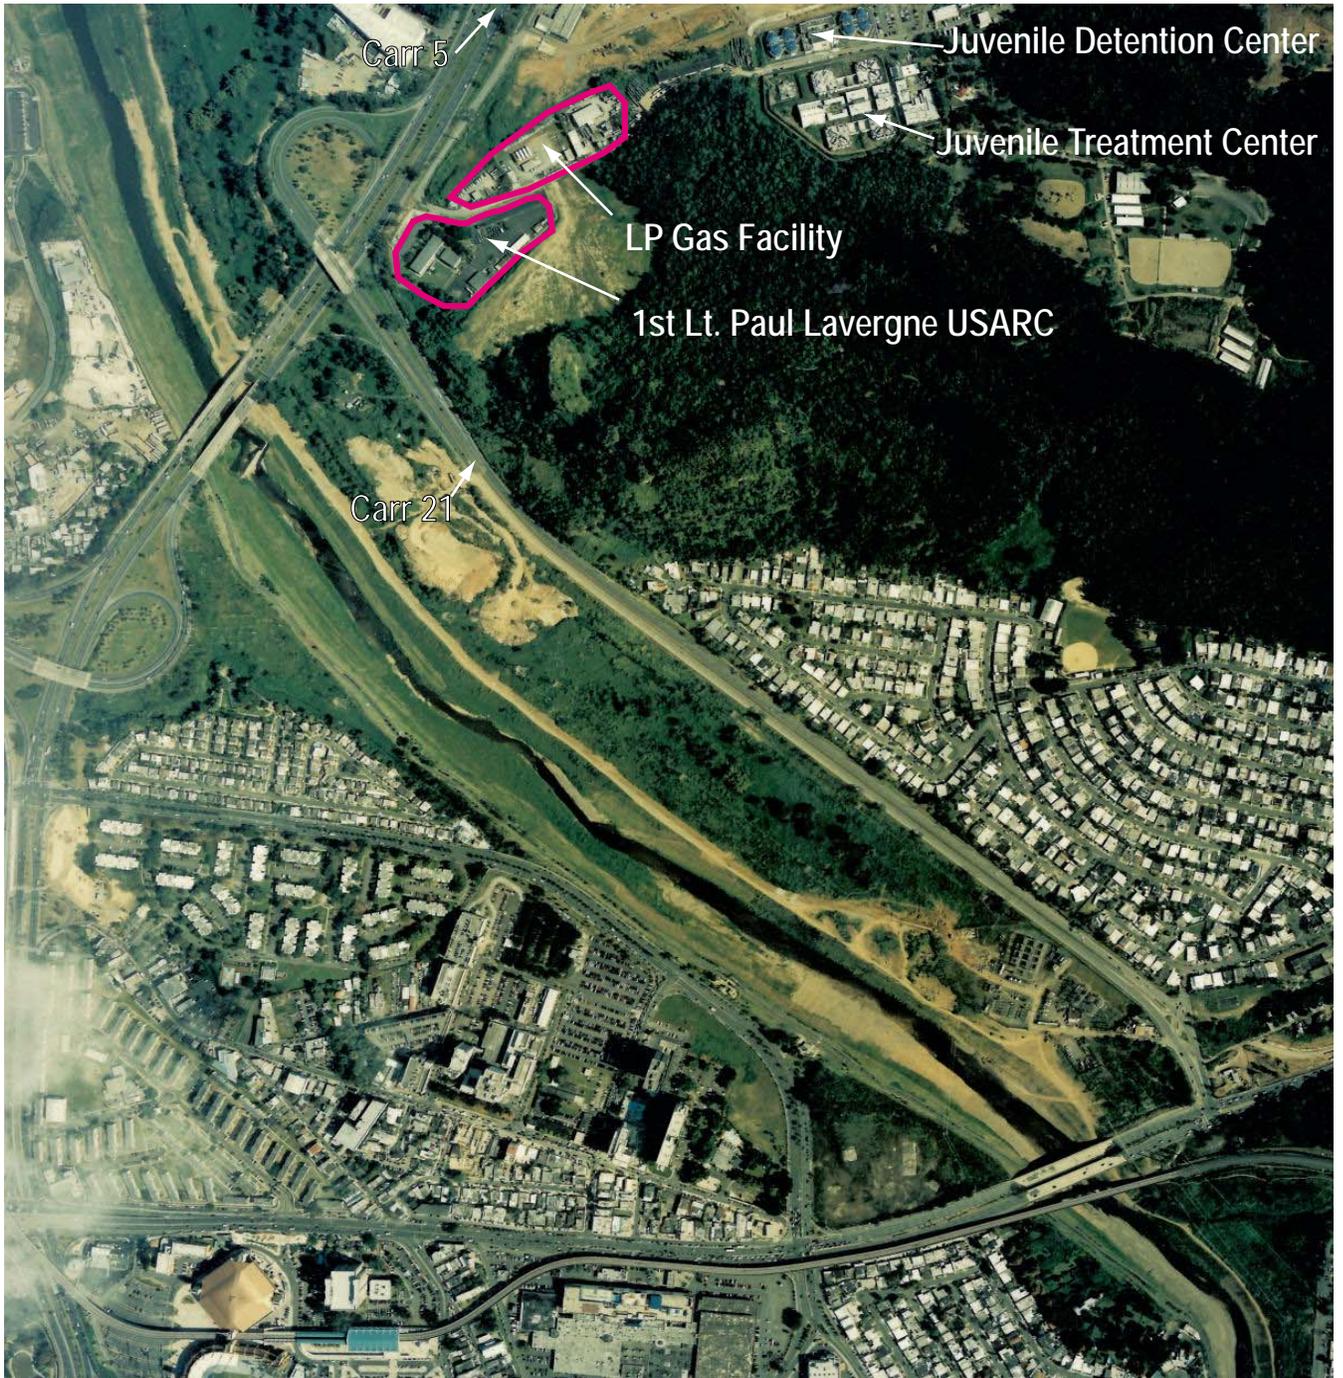
FIGURE 5
1981 Aerial Photograph
Phase I ECP Report

The 1981 aerial photograph (Figure 5, Appendix A) shows increased development of the Property and adjacent properties relative to the 1962 aerial photograph. The 1981 aerial photograph shows what appears to be the mess hall and development of the neighboring facility to the north. The Rio De Bayamón River appears in the 1981 photograph, indicating it was constructed between February 1962 and March, 1981

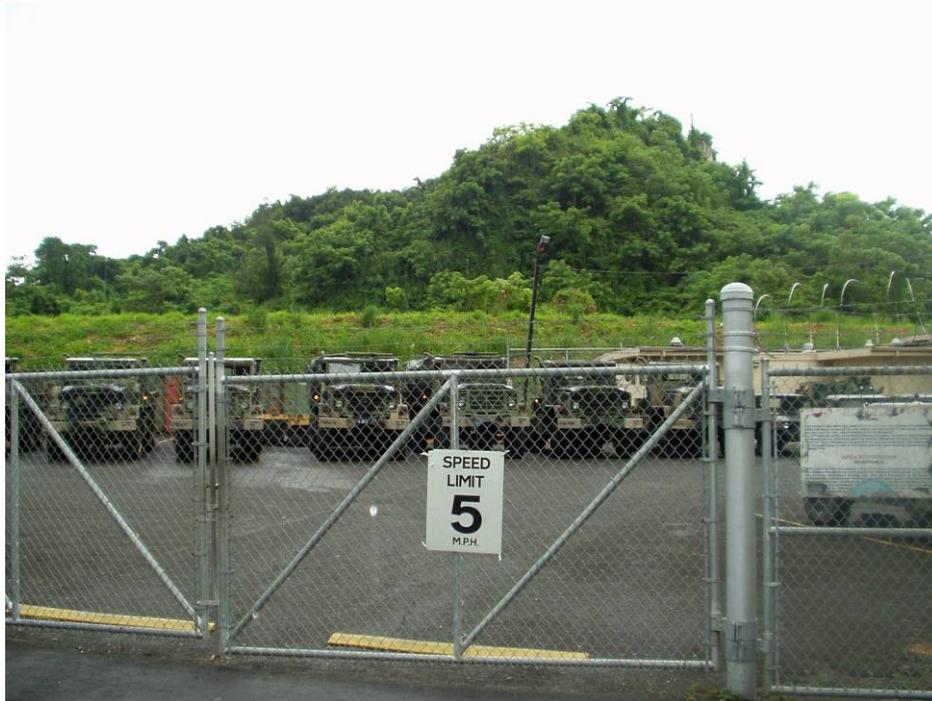
Exhibit B-1: Entrance to MEP Area from the asphalt access road. Rolling limestone hills (haystacks) and heavy forested vegetation located east of Property. Standing north of the Property on asphalt access road and facing east.

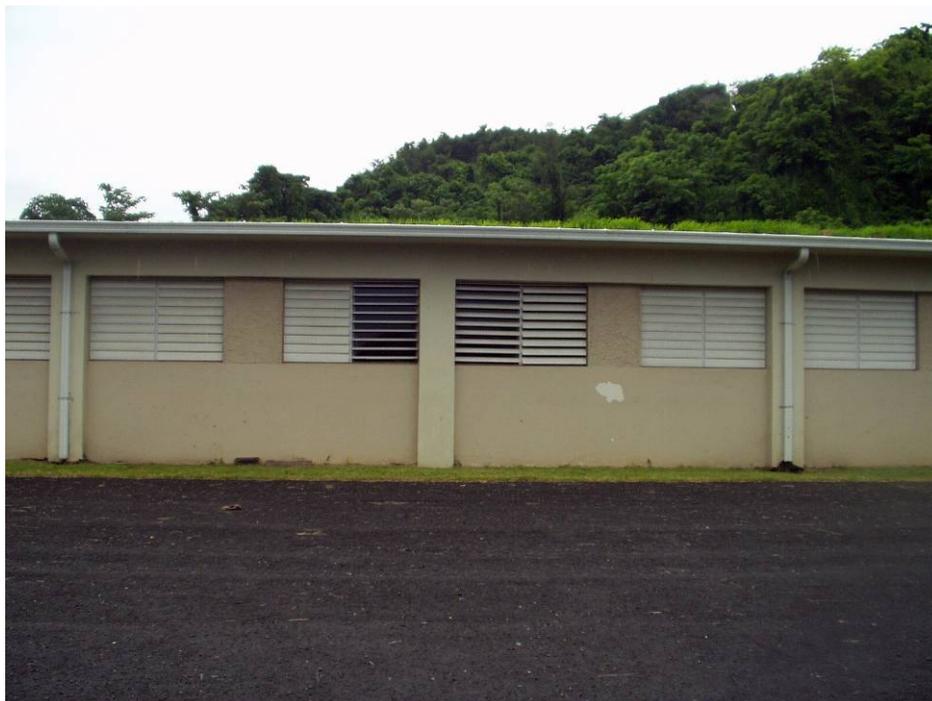
Exhibit B-2: Single-story Mess Hall Building. Building was locked and some doors blocked by tables or other objects. Note location of peeling paint. Standing centrally, north of the Mess Hall and facing east.

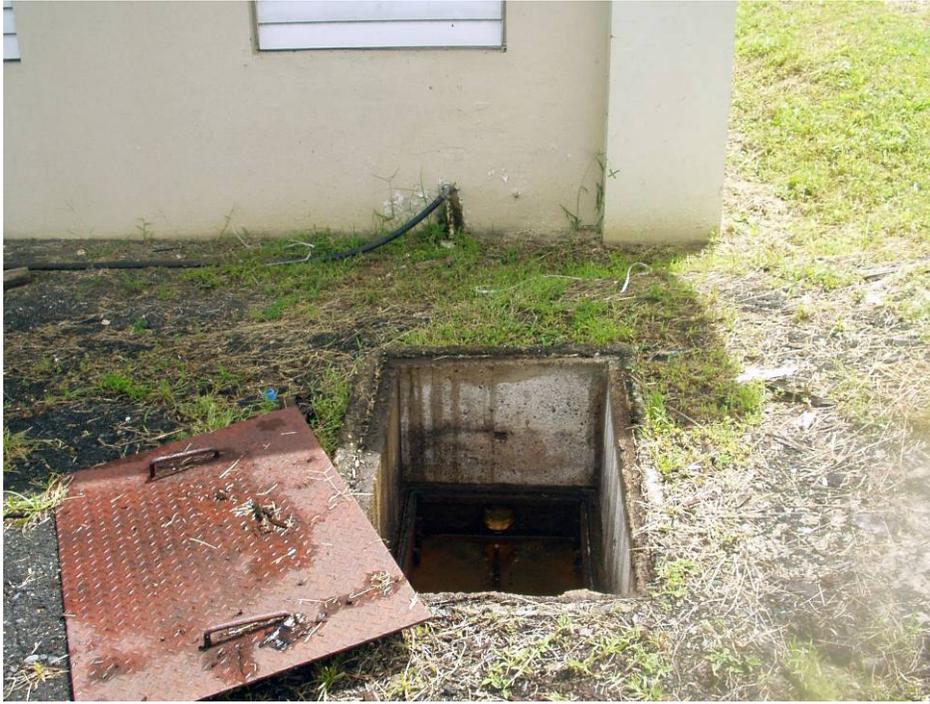
Exhibit B-3: Unknown pit/sump/grease trap located southwest of the Mess Hall. Sump has influent and effluent lines. Standing near southwest wall of Mess Hall and facing northeast.

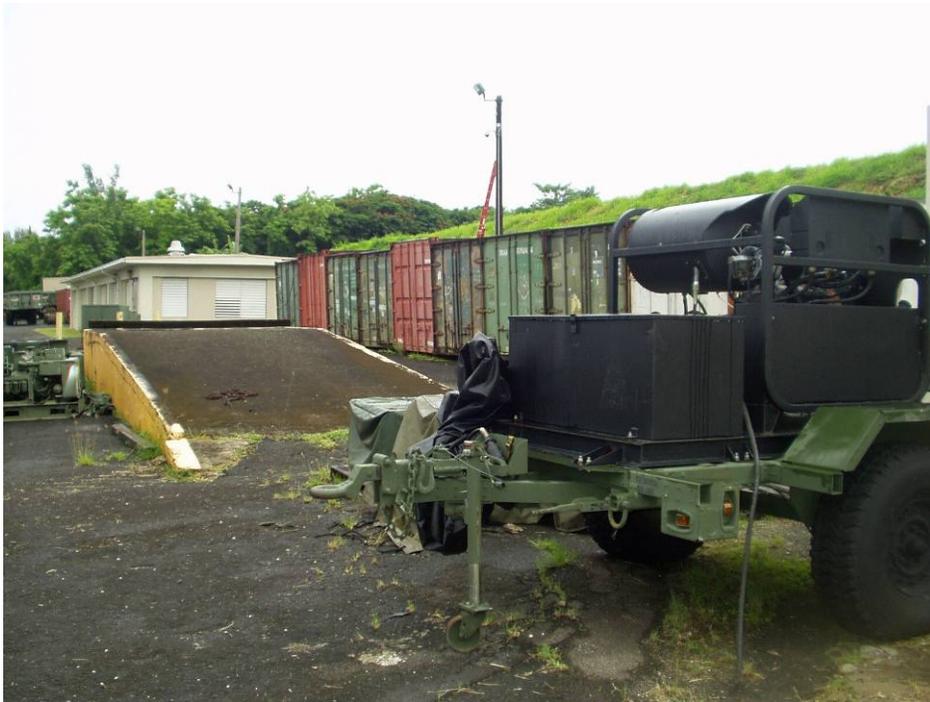
Exhibit B-4: MEP Area between Mess Hall (in the background) and OMS Building. Note location of loading/unloading platform, conex boxes (total 10 boxes, 6 of them locked), and miscellaneous military equipment. Standing southwest of loading platform and facing northeast.

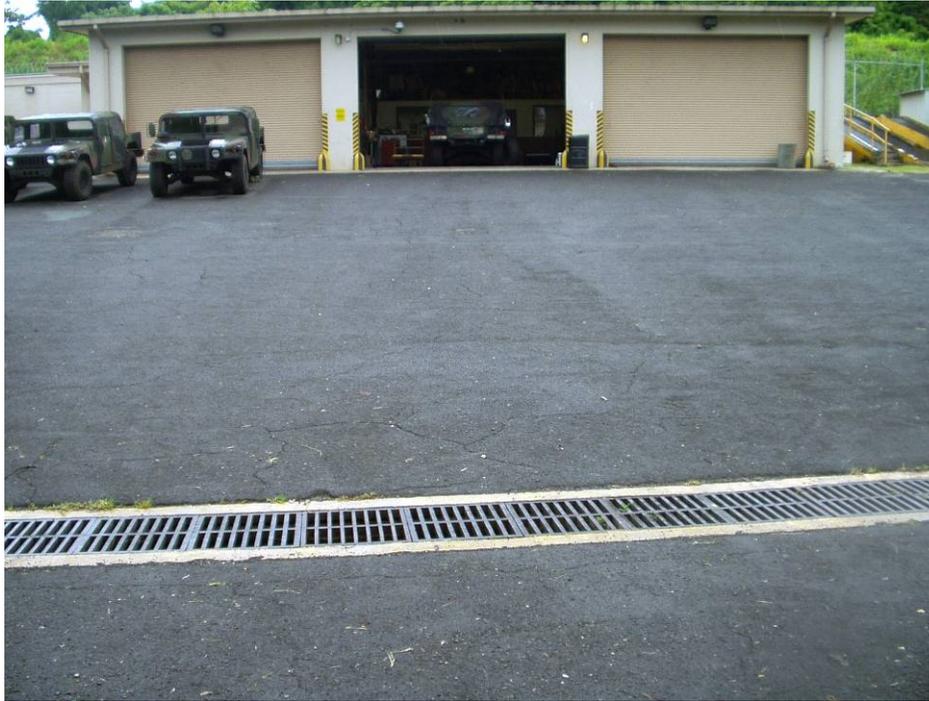
Exhibit B-5: OMS Building. Showing the 3-bay light maintenance facility, storm water drain, and miscellaneous military vehicles . Standing west-northwest of the OMS Building and facing east-southeast.

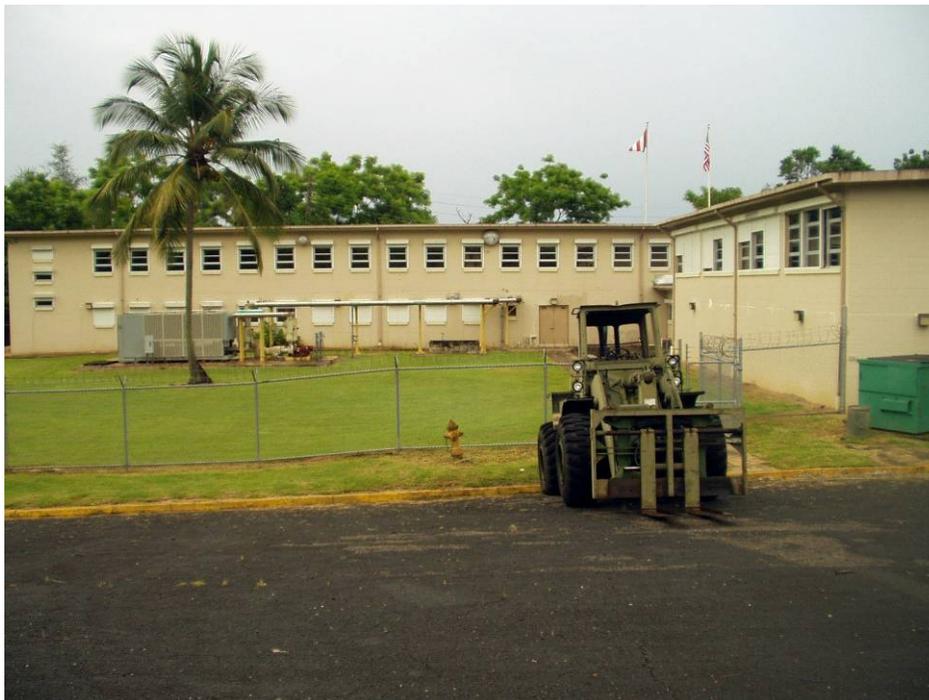
Exhibit B-6: MEP Area between rear of the Administration Building (in the background) and OMS Building. Standing west-northwest of the OMS Building and facing west-northwest .

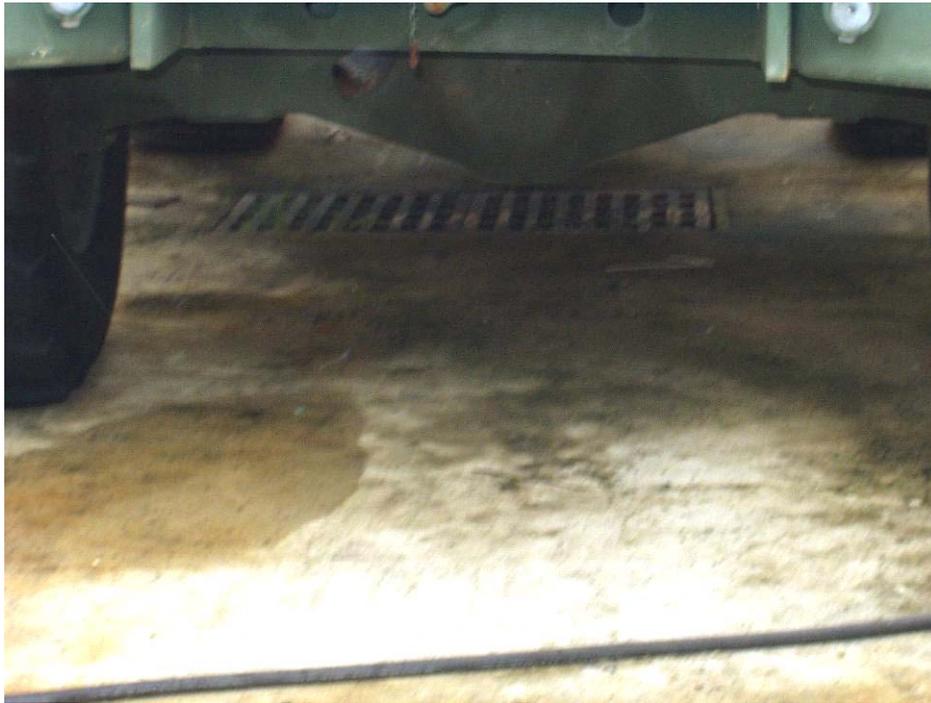
Exhibit B-7: Vehicle Washrack Area located northeast of the OMS Building. Showing sloped platform of the wash pad and central drain that is connected an oil/water separator via gravity line. Standing northwest of washrack platform and facing southeast.

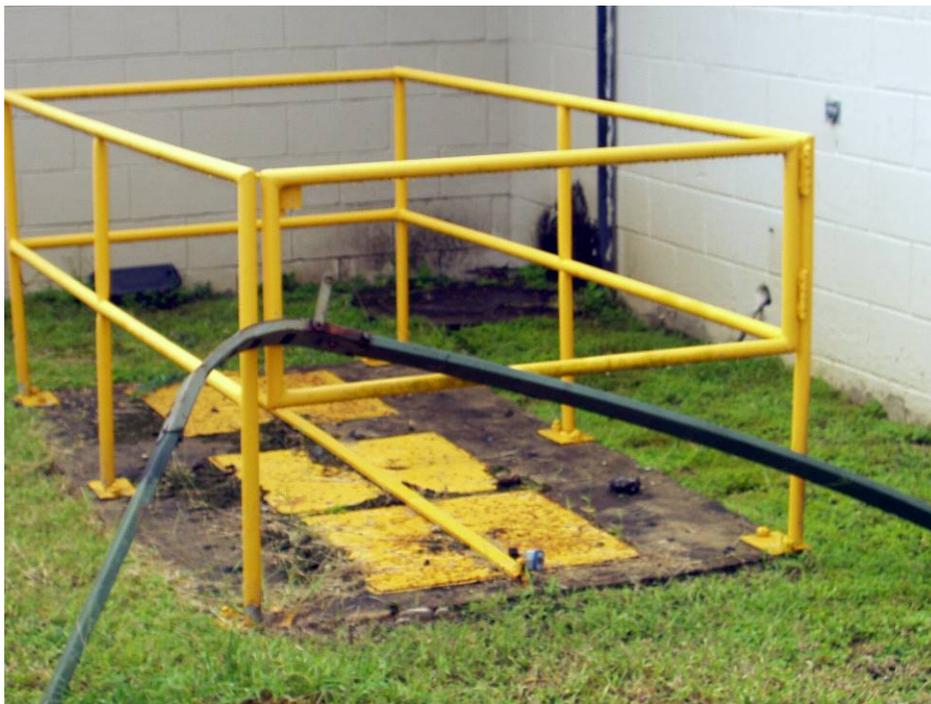
Exhibit B-8: Oil/water separator located east of the OMS Building. The oil/water separator discharges to the sanitary sewer system. Standing northwest of OMS Building and facing southeast.

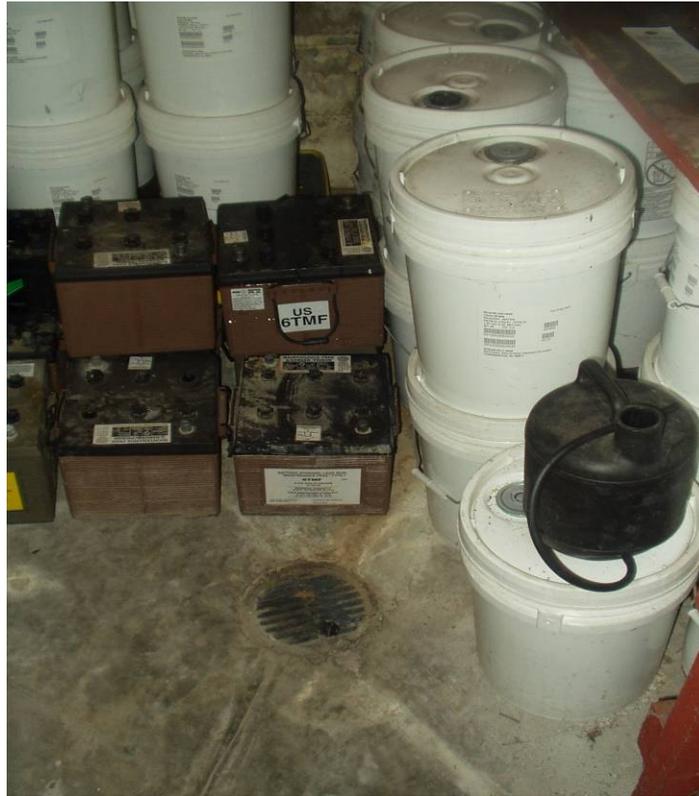
Exhibit B-9: Battery Storage Room. Room located inside OMS near the northeast corner of main section of the building. Room contained vehicle batteries and battery maintenance supplies (battery acids, reagent water, etc). Floor drains connects to the OWS which ultimately discharges to the sanitary sewer system.

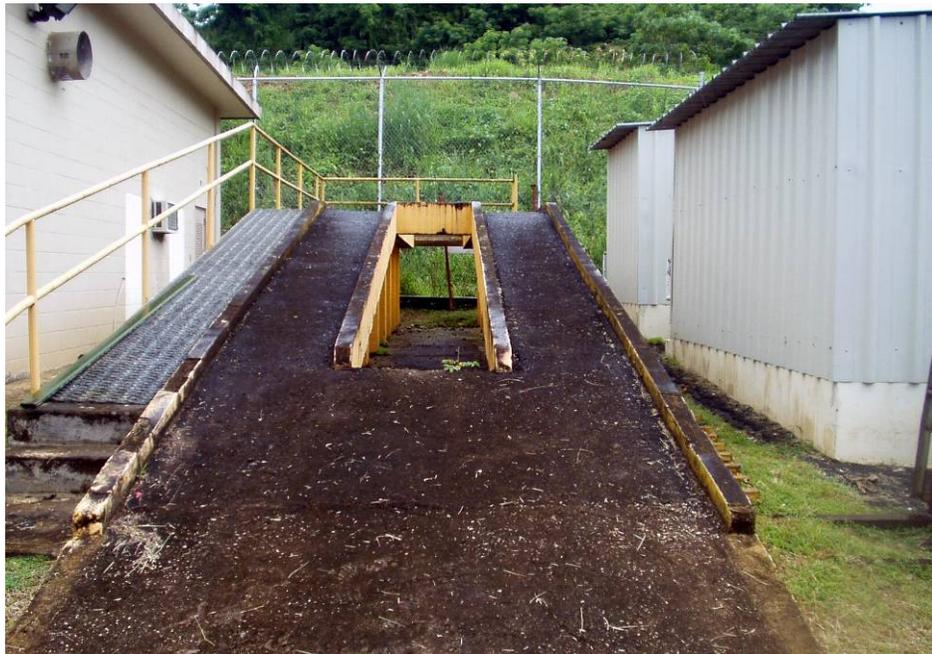
Exhibit B-10: Elevated Vehicle Maintenance Structure. Structure is located southwest of the OMS Building, between the Hazardous Waste Storage Sheds. Standing northwest of the structure and facing southeast.

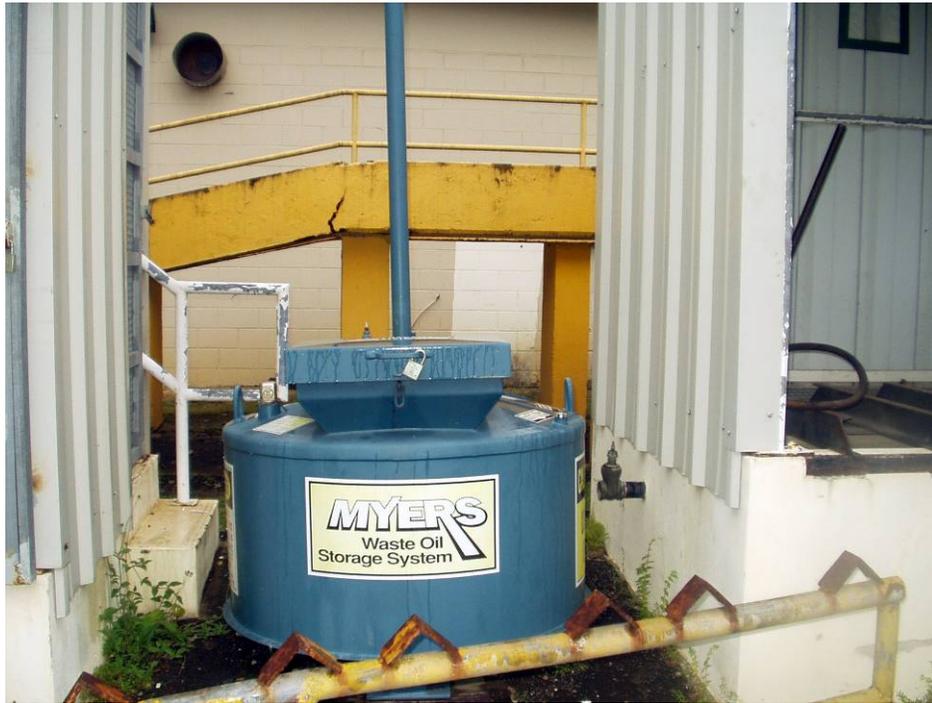
Based upon a review of available site records, a search of federal and state environmental databases, and interviews with USAR personnel, the Property maintains one active aboveground storage tank (AST). The vaulted 132-gallon, used-oil AST, located west-southwest of the OMS near the hazardous material storage sheds, appeared in good condition. No spill or leaks were noted near the vaulted used-oil AST.

Exhibit B-11: 132-gallon vaulted AST containing used oil. The vaulted AST is southwest of the OMS Building, adjacent to the elevated maintenance structure. The 132-gallon AST was locked and the vent pipe was appropriately secured to prevent rain from entering the tank. Standing southwest of the OMS Building, maintenance structure, and hazardous waste sheds and facing northeast.

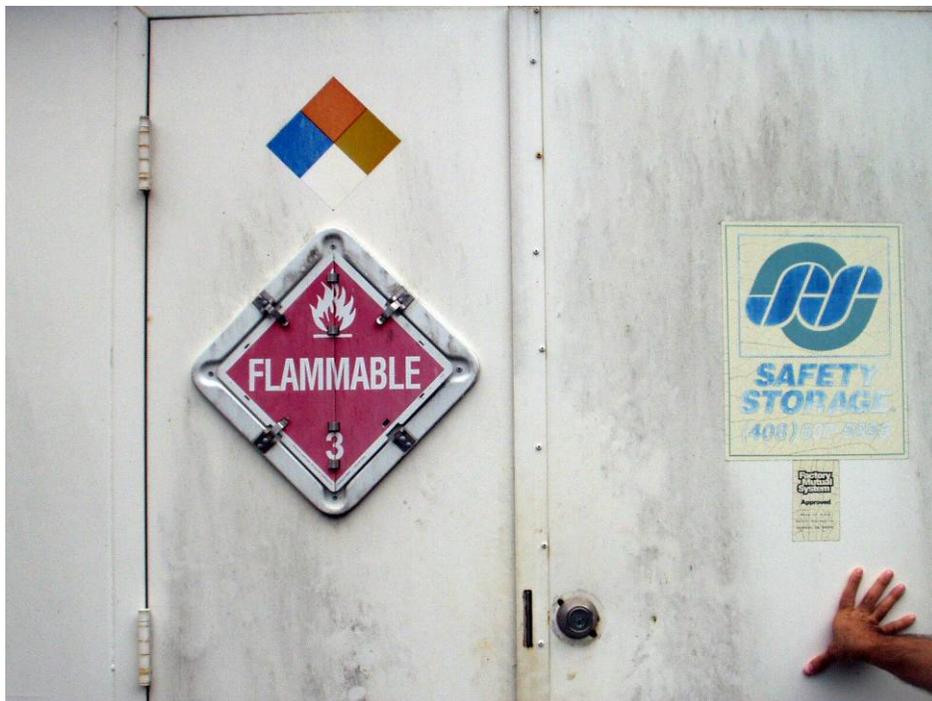
A flammable liquids storage cabinet (equipped with a spill containment platform) and two roofed sheds (equipped with secondary concrete containment) are currently used to store hazardous and non-hazardous regulated wastes. Wastes generated at the OMS are stored at these structures and eventually collected and disposed of off-site by a regulated waste refuse contractor. The storage cabinet is located south of the main building. Materials stored in the structures include used oil, used paint and solvents, used antifreeze, used transmission fluids, used dry-absorbent, and used rags.

Exhibit B-12: Hazardous Material Storage Shed containing flammable materials and/or hazardous waste. Shed is located southwest of the OMS Building and the AST and Hazardous Waste Storage Sheds. Standing northwest of the shed and facing southeast.

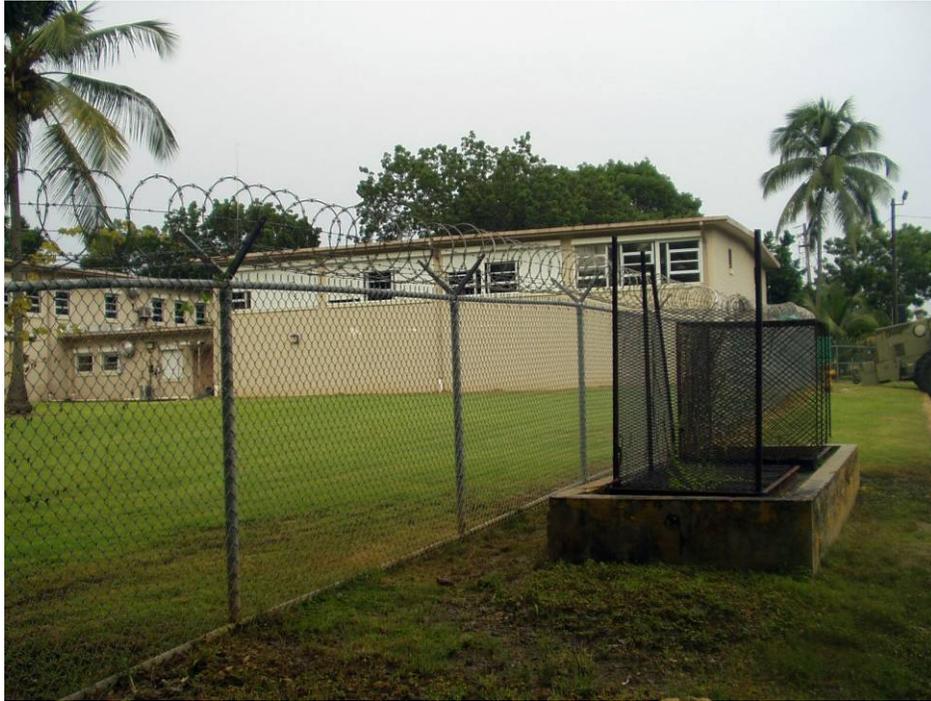
As previously noted, a May 15, 2003, report prepared by On-Site Environmental, Inc., documented the removal of approximately 40 cubic yards of petroleum hydrocarbon-affected soil from the grassy area located southwest of the administrative building and adjacent to the former flammable materials storage area (see Appendix B, Photo B-13). According to information provided in the report, strong hydrocarbon odors were noted in November 2002 during the installation of a new fence line. As a result, On-Site Environmental, Inc. was subsequently hired by the 65th RRC to perform site investigation of the flammable materials storage area. According to the May 2003 report, results of the investigation were documented in On-Site Environmental, Inc.'s February 3, 2003, Site Investigation for Hydrocarbon Affected Soil. At the time of this draft final ECP report, the February 3, 2003, report was not reasonably available for review. Based on the results of the site investigation, approximately 40 cubic yards of petroleum hydrocarbon-affected soil were excavated and transported as nonhazardous waste to Browning Ferris Industries' Ponce Sanitary Landfill for disposal. The May 2003 remediation report concluded that all petroleum hydrocarbon-affected soil had been removed from the flammable material storage area and recommended no further work at the flammable material storage area. There was no regulatory review or approval of this work noted in the documents reviewed for this ECP.

Exhibit B-13: Former Flammable Materials Storage Point located in a grassy area in the southwest corner of the MEP Area (southwest of OMS). Approximately 40 cubic yards of petroleum hydrocarbon affected soils were removed from the former storage area in April 2003. Standing southwest of the abandoned used oil storage area and facing northeast towards the Administration Building.

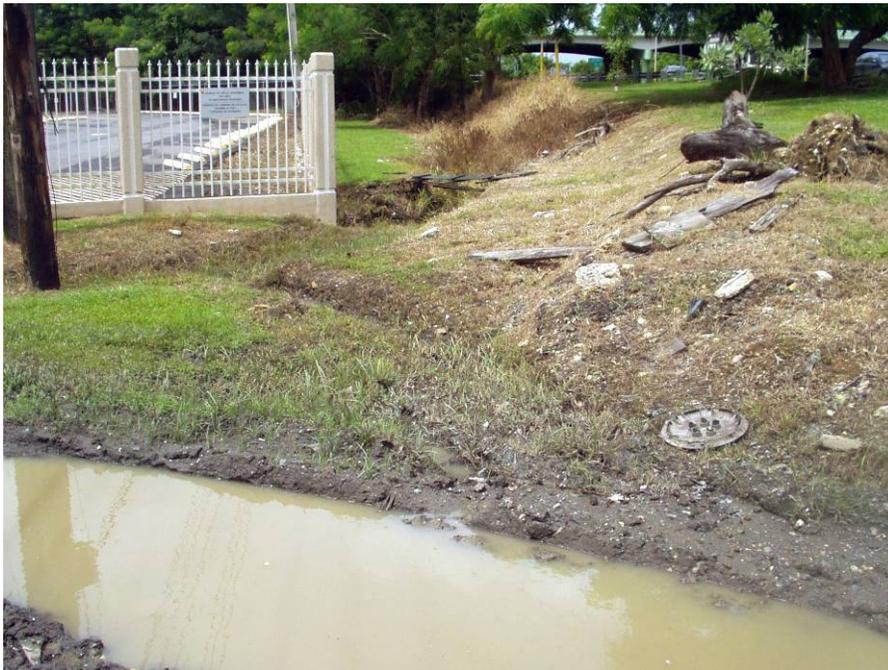
Exhibit B-14: Storm water Drainage Ditch/Swale with north-south orientation. Ditch/swale located along northern border of the Property. Channels surface water runoff from asphalt access road, Carr (Interstate) 5, and areas located northwest of the Mess Hall and northeast of the OMS (in the MEP area) and from the northern section of the POV towards the southwest corner of the Property and eventually discharges into the Rio De Bayamon River. Standing northwest of security booth and facing south-southeast west towards Carr (Interstate) 21.
