ENVIRONMENTAL CONDITION OF PROPERTY REPORT

PAUL J. SUTCOVOY
U.S. ARMY RESERVE CENTER (CT010)
LYDIA STREET EXTENSION
WATERBURY, CT 06705

MARCH 2007

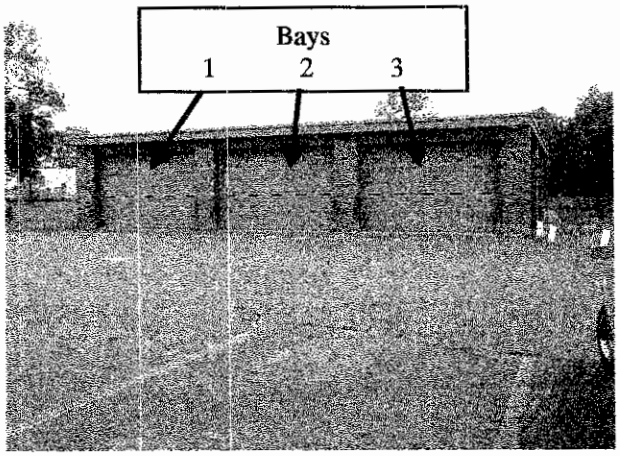
PLATE 2: OMS, locking east

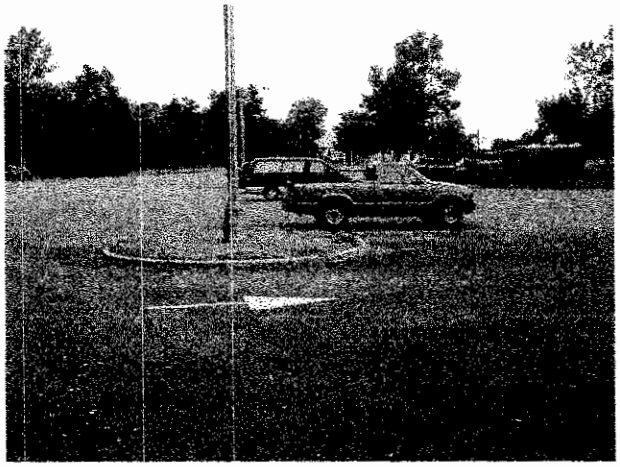
PLATE 4: POV/MEP, looking north

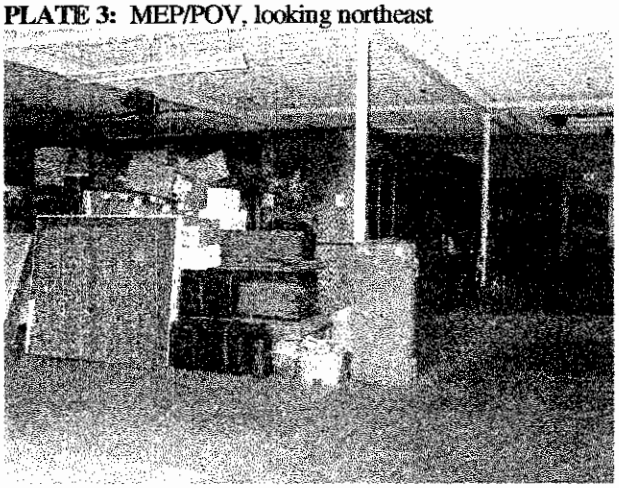
PLATE 5: Interior of OMS, bay two

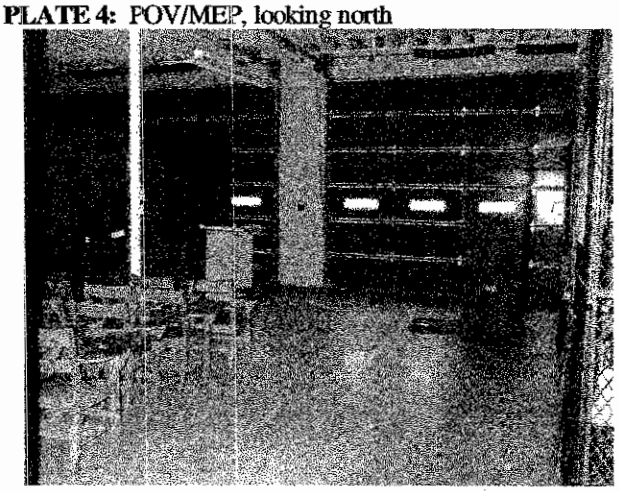
PLATE 6: Interior of OMS, bay one

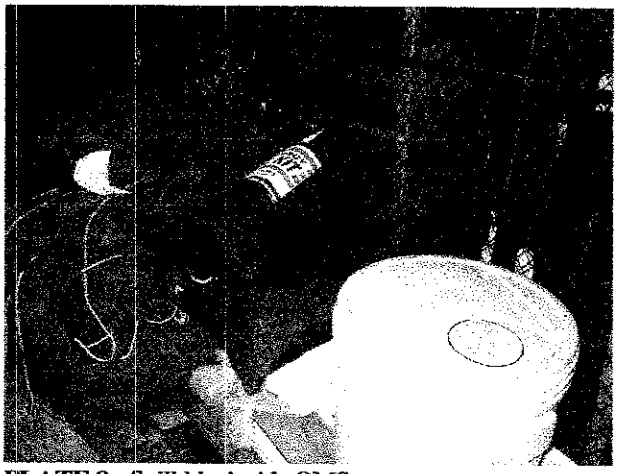
PLATE 8: Spill kits inside OMS

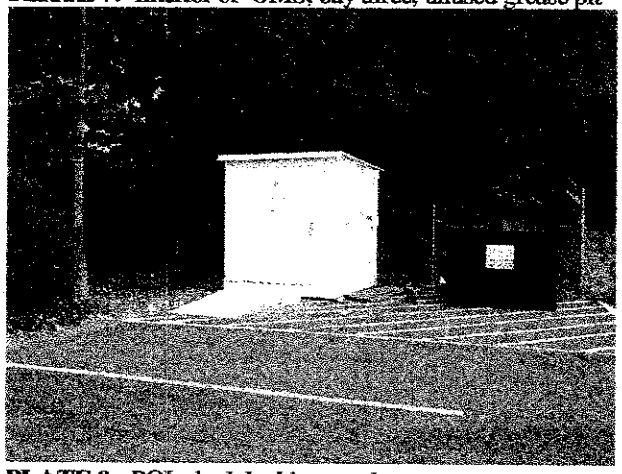
Most new PPMs previously used for maintenance operations at the facility are stored in the outdoor double-floored Petroleum Oil Lubricant (POL) shed on the paved POV and MEP parking area (**site 9**, *PLATES 9 & 10*). Materials stored at this location are fully protected from precipitation and stormwater runoff during storage.

PLATE 9: POL shed, looking northwest

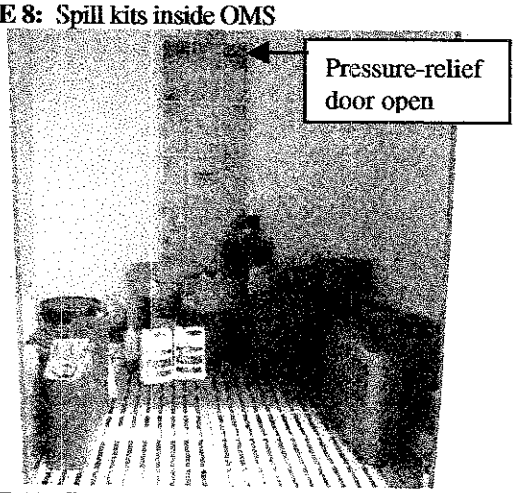
PLATE 10: Contents of POL shed

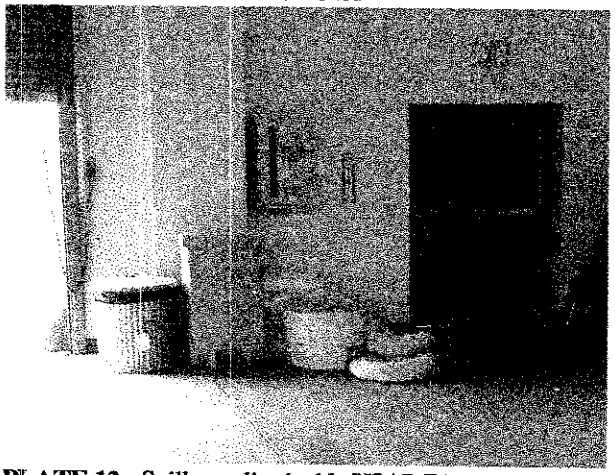
PLATE 12: Spill supplies inside USARC building

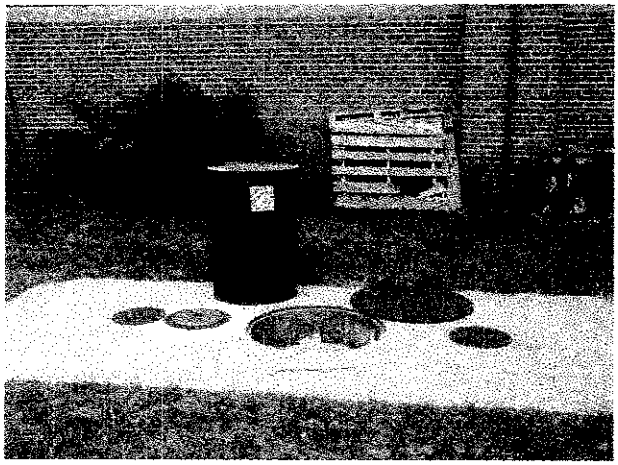
PLATE 13: 55-gallon drum marked hazardous waste, UST concrete pad behind OMS

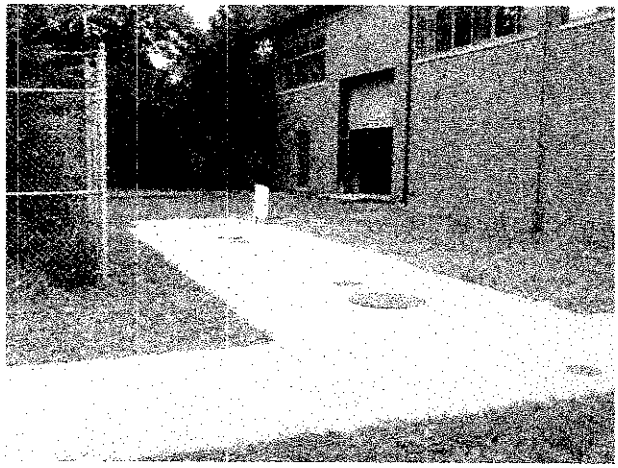
Paul J. Sutcovoy USARC is considered to be a conditionally exempt, small-quantity hazardous waste generator by the Connecticut DEP and has been issued the generation number (CVS024248900). The OMS is currently not used for vehicle maintenance so hazardous wastes related to such activities are not generated at this facility at the present time. One 1,000-gallon and one 10,000-gallon Underground-Storage Tanks (USTs) are used for storage of number 2 fuel oil, which is used to heat the OMS and USARC buildings (**sites 3 & 2**, *PLATES 13 & 14 respectively*).

PLATE 14: Other UST concrete pad,behind USARC building

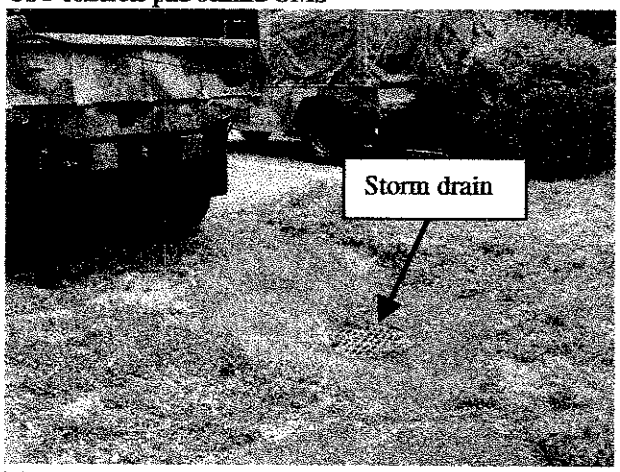
Outfall **OF-1** (figure 3.1, *PLATE 17*) is located in the southeast corner of the site. Six storm drains (one shown in *PLATE 15*), direct storm water to this outfall. This outfall drains the MEP parking area (**site 7**, *PLATE 3*) and the front of the OMS, a potential hazardous materials loading/unloading area. One of the storm drains leading to **OF-1**, (**site 6**, *PLATE 15*) is located in very close proximity to the MEP.

PLATE 15: Storm drain near MEP

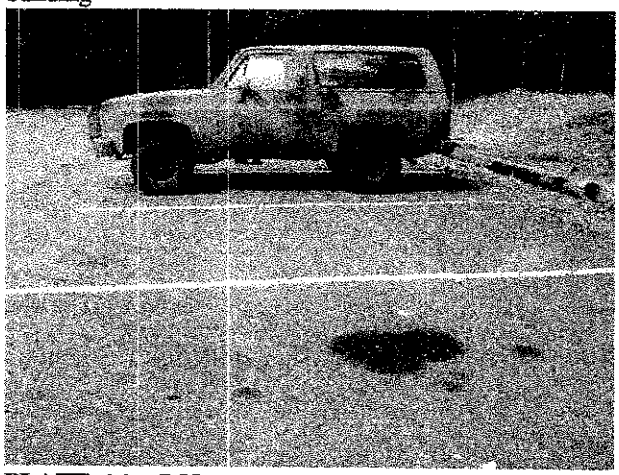
PLATE 16: POL stain in MEP/POV, isolated military vehicle

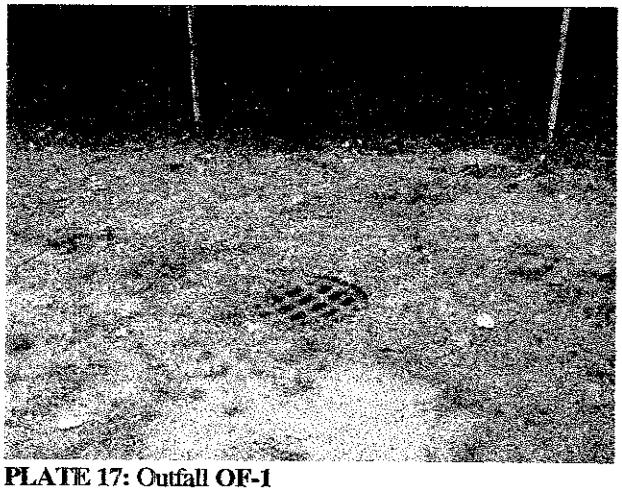
PLATE 17: Outfall OF-1

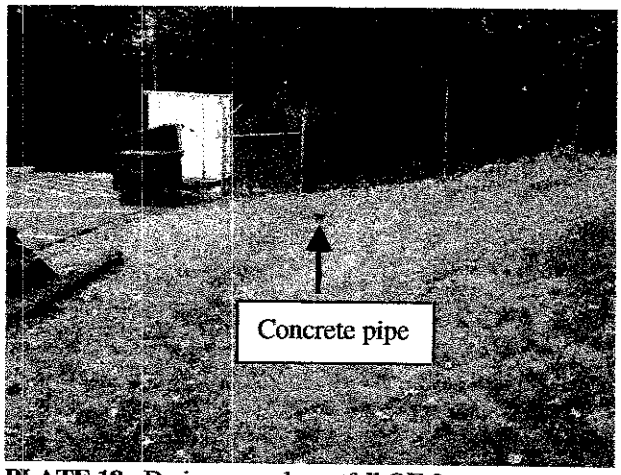
Outfall **OF-2** is located at the northwest corner of the site at the end of a grass drainage swale (figure 3.1, *PLATE 18*).

Stormwater runoff from the Paul J. Sutcovoy USARC flows into six storm drains (*one shown in PLATE 15*), which direct flow into the storm-sewer system within the facility leading to outfall **OF-1**. A twelve-inch concrete pipe (**OF-2,** *PLATE 18*) directs flow under a security fence, discharging onto USARC owned shrub-covered land where it infiltrates the ground or exits the site as overland flow during heavy rainfall events. Floor drains in the furnace room direct flow to the sanitary-sewer system.

PLATE 18: Drainage swale, outfall OF-2
