**U.S. Army BRAC 2005
Environmental Condition of Property Report
Charles E. Kelly Support Facility, Oakdale, Pennsylvania**

November 2006

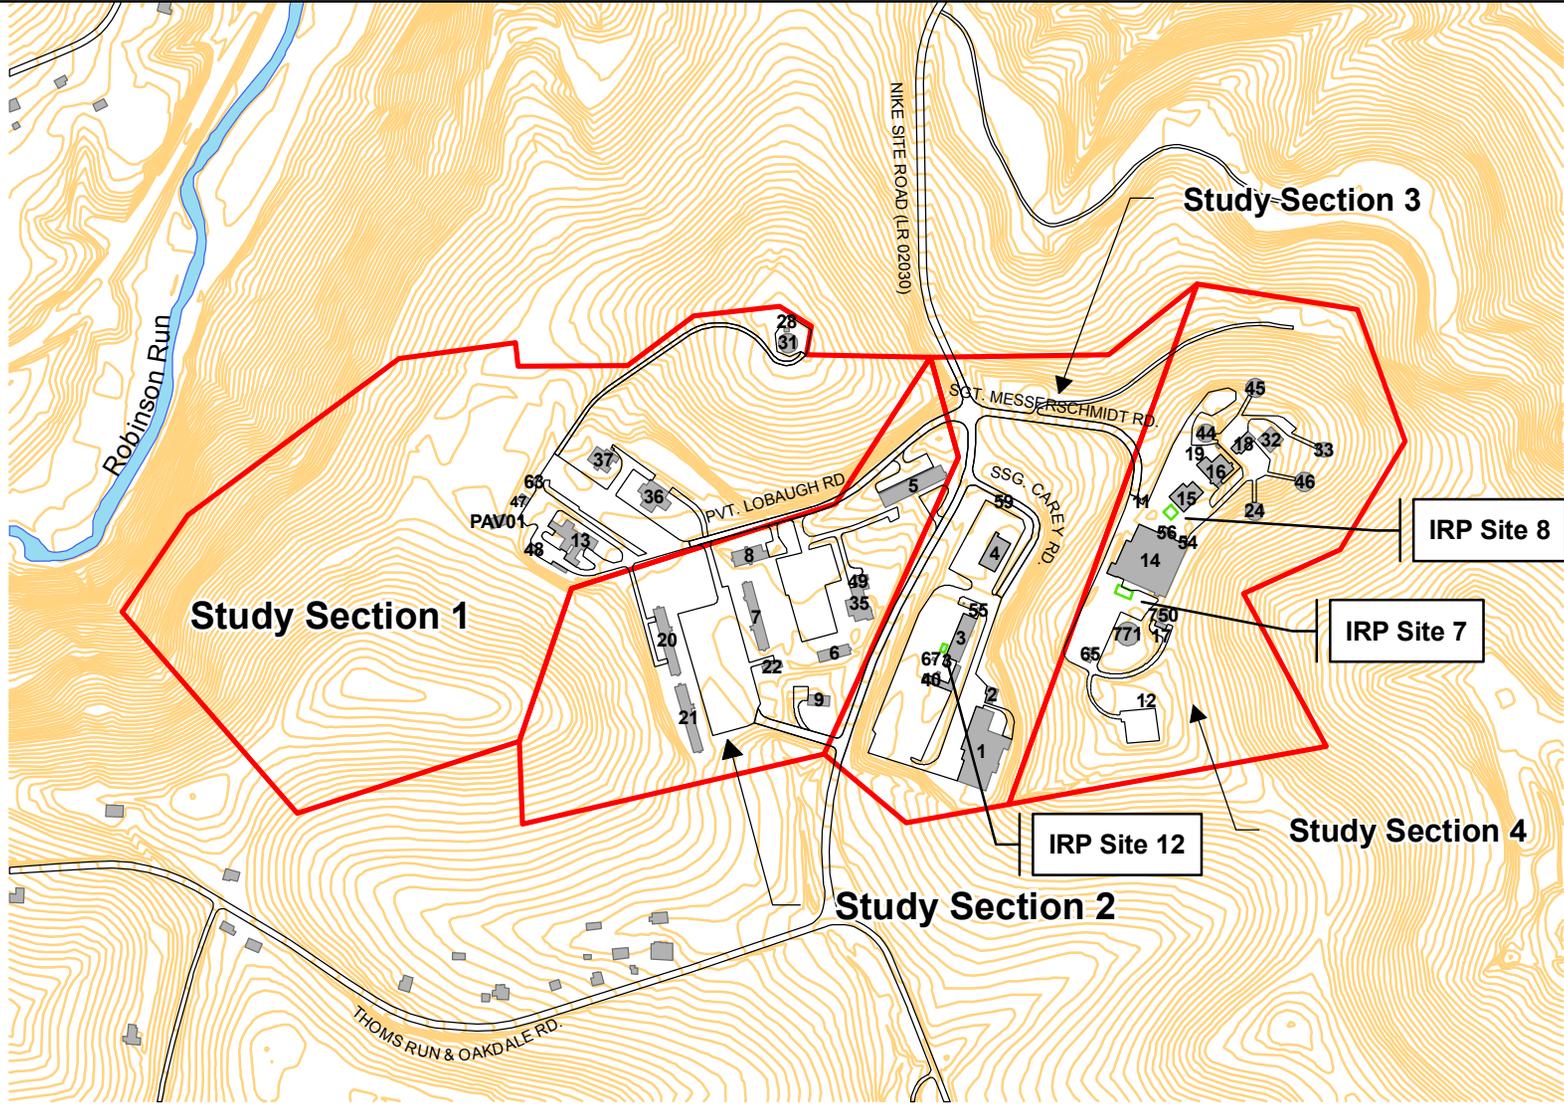
**FIGURE 3-1
MAIN POST LAYOUT**

Study Sections

Accordingly, section boundaries were generally designated at the center of roads or streams, along fences, and along township section lines. Therefore, the Main Post is divided into Study Sections 1 through 4, Site 62 is defined as Study Section 5, and Neville Island is divided into Study Sections 6 and 7. Study section boundaries are shown in Figures 3-1 through 3-3.

Main Post and Site 62—The Main Post is approximately 12 miles southwest of Pittsburgh, Pennsylvania, and comprises roughly 118 acres. There are a total of 48 buildings enclosing a combined 228,504 square feet. These buildings are shown in Figure 3-1 and described in Table 4-1. Developed land within the Main Post accounts for more than 45 acres, or approximately 38 percent, of the site. Developed land contains roads, paved areas, buildings, material and fuel storage areas, parking lots, lawns, landscaped areas, and a helicopter landing area. Forested land and open area together comprise the predominant land uses of the Main Post and total more than 70 acres (nearly 60 percent) surrounding the developed portions of the facility. A small recreation area to the northwest contains a baseball field and comprises approximately 4 percent of the land area of the Main Post (CEKSF 2005).

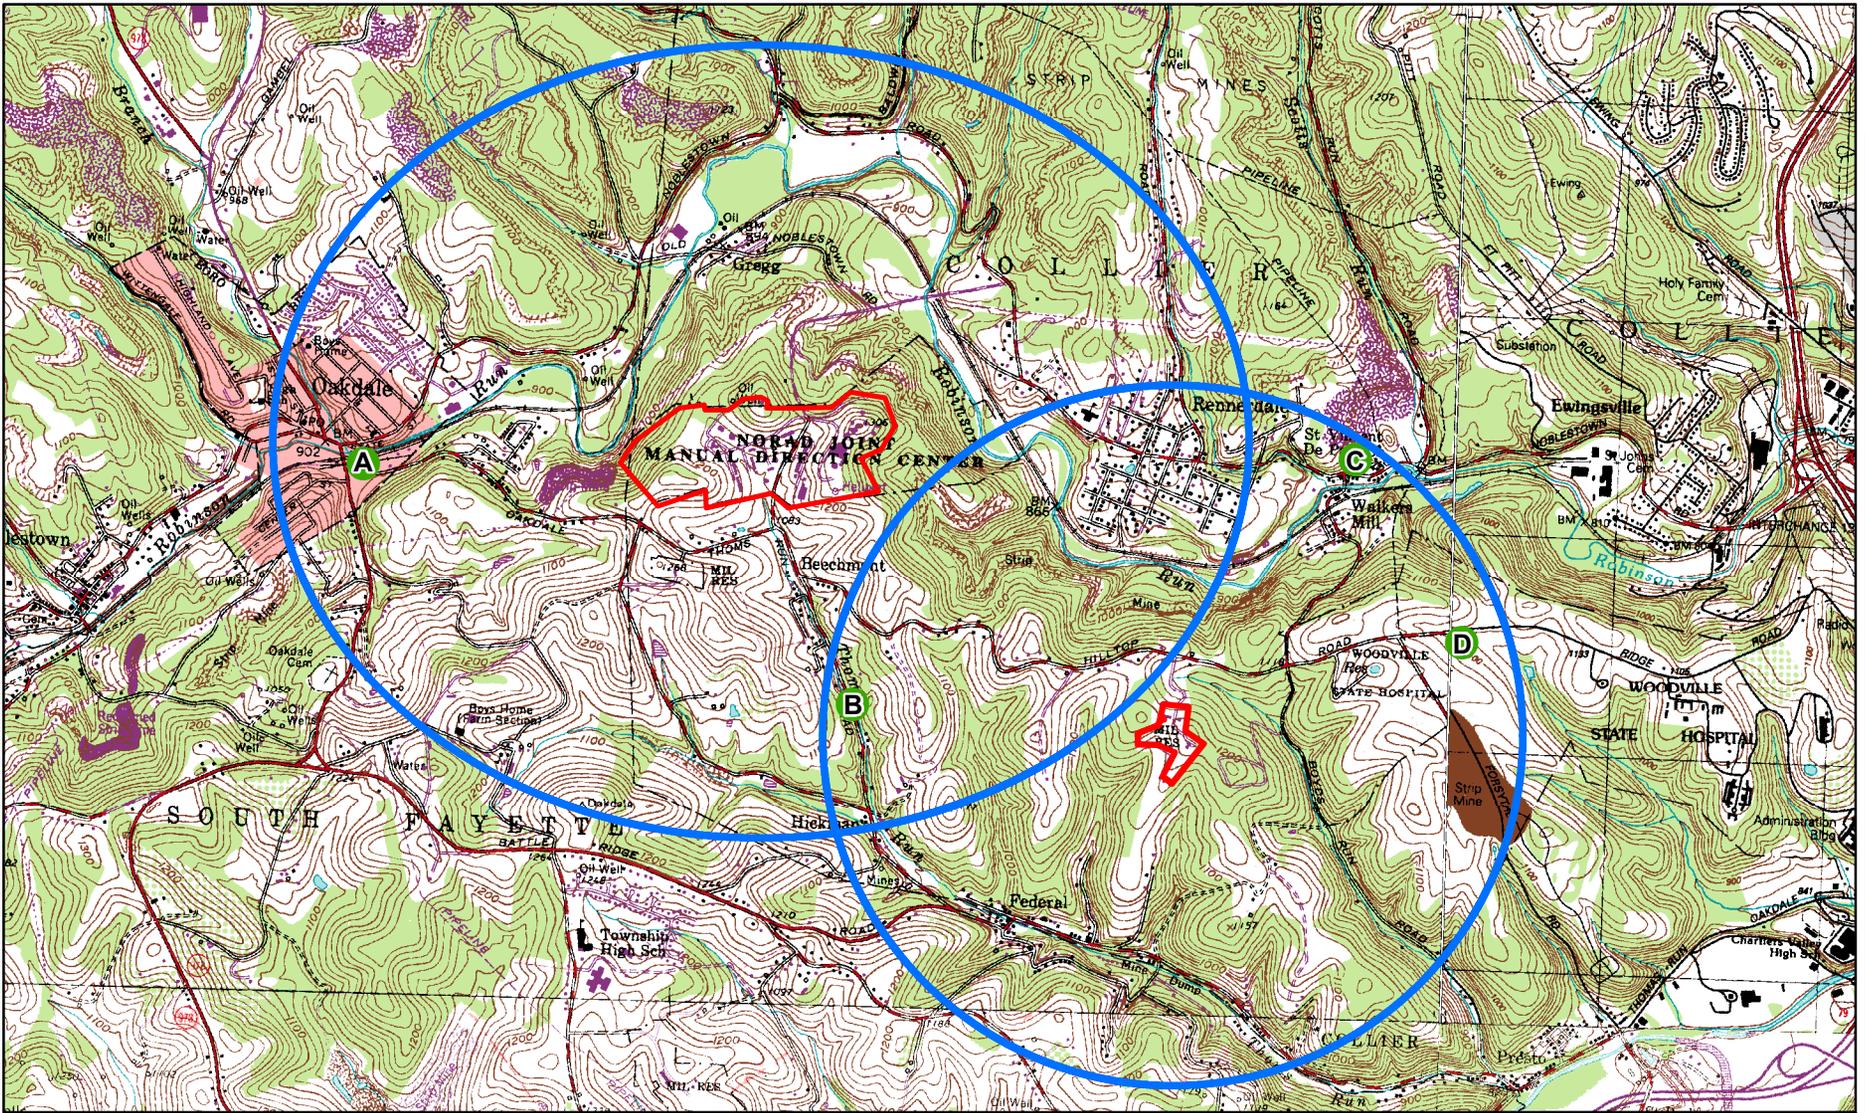
**FIGURE 5-1
ADJACENT PROPERTY SURVEY MAP –
MAIN POST AND SITE 62**

- Main Post and Site 62 Boundaries
- 1-mile radius
- A Adjacent Properties

A database search of adjacent properties was conducted as described in Section 3.4.1. The results of the search are provided in Table 5-8. Adjacent property locations are shown in Figure 5-1.

Site 62—The area surrounding Site 62 is primarily forested and residential. The database search did not identify any adjacent properties that were potential sources of contamination at Site 62. Site 62 is located on a topographic high. Due to this topographic layout, no sources of potential contamination from adjacent or surrounding properties are likely (see Table 5-8). Adjacent property locations are shown in Figure 5-1.

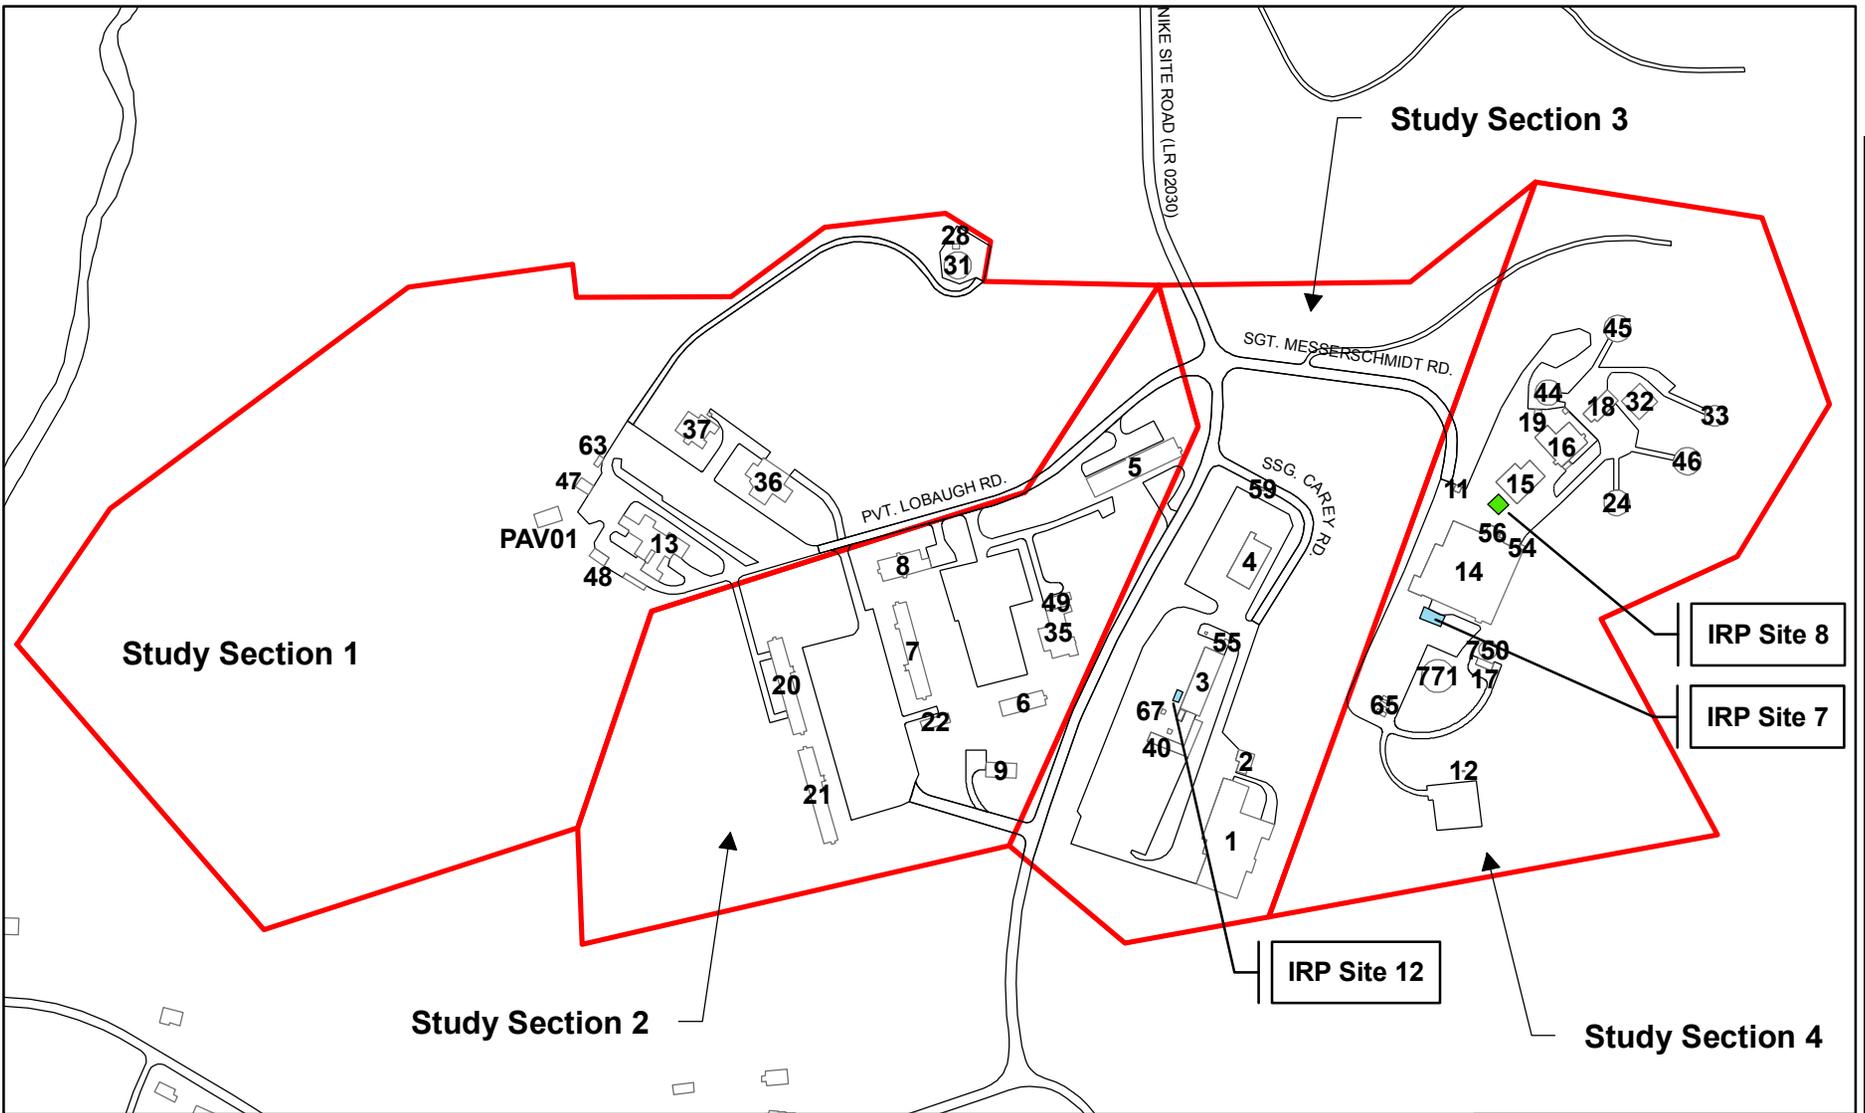
**FIGURE 6-2
PROPERTY CATEGORIZATION
MAP FOR THE MAIN POST**

- Roads
- Buildings
- Study Sections
- Category 1
- Category 2
- Category 4

The following property is classified as Category 1, areas in which no release or disposal of hazardous substances or petroleum products has occurred, and to which there has been no migration of such substances from adjacent areas:

- **Study Section 1 – Lower Main Post**—Entire property
- **Study Section 2 – Mid Lower Main Post**—Entire property
- **Study Section 3 – Mid Upper Main Post**—Entire property with the exception of IRP Site 12
- **Study Section 4 – Upper Main Post**—Entire property with the exception of IRP Sites 7 and 8
- **Study Section 5 – Site 62**—Entire property with the exception of IRP Site 9, the fenceline, and building perimeters
- **Study Section 7 – Neville Island Facility South of Grand Avenue**—Entire property.
