U.S. Army BRAC 2005 Environmental Condition of Property Phase I Report Vancouver Barracks, Vancouver, Washington

November 10, 2006

The United States Army Corps of Engineers (USACE) Louisville District has prepared this Environmental Condition of Property (ECP) report for the Vancouver Barracks, hereafter referred to as the "Property." The Property is situated approximately 0.25 mile north of the Columbia River immediately east of Interstate 5 (I-5) in Vancouver, Washington. The parcel is approximately 47.46 acres.

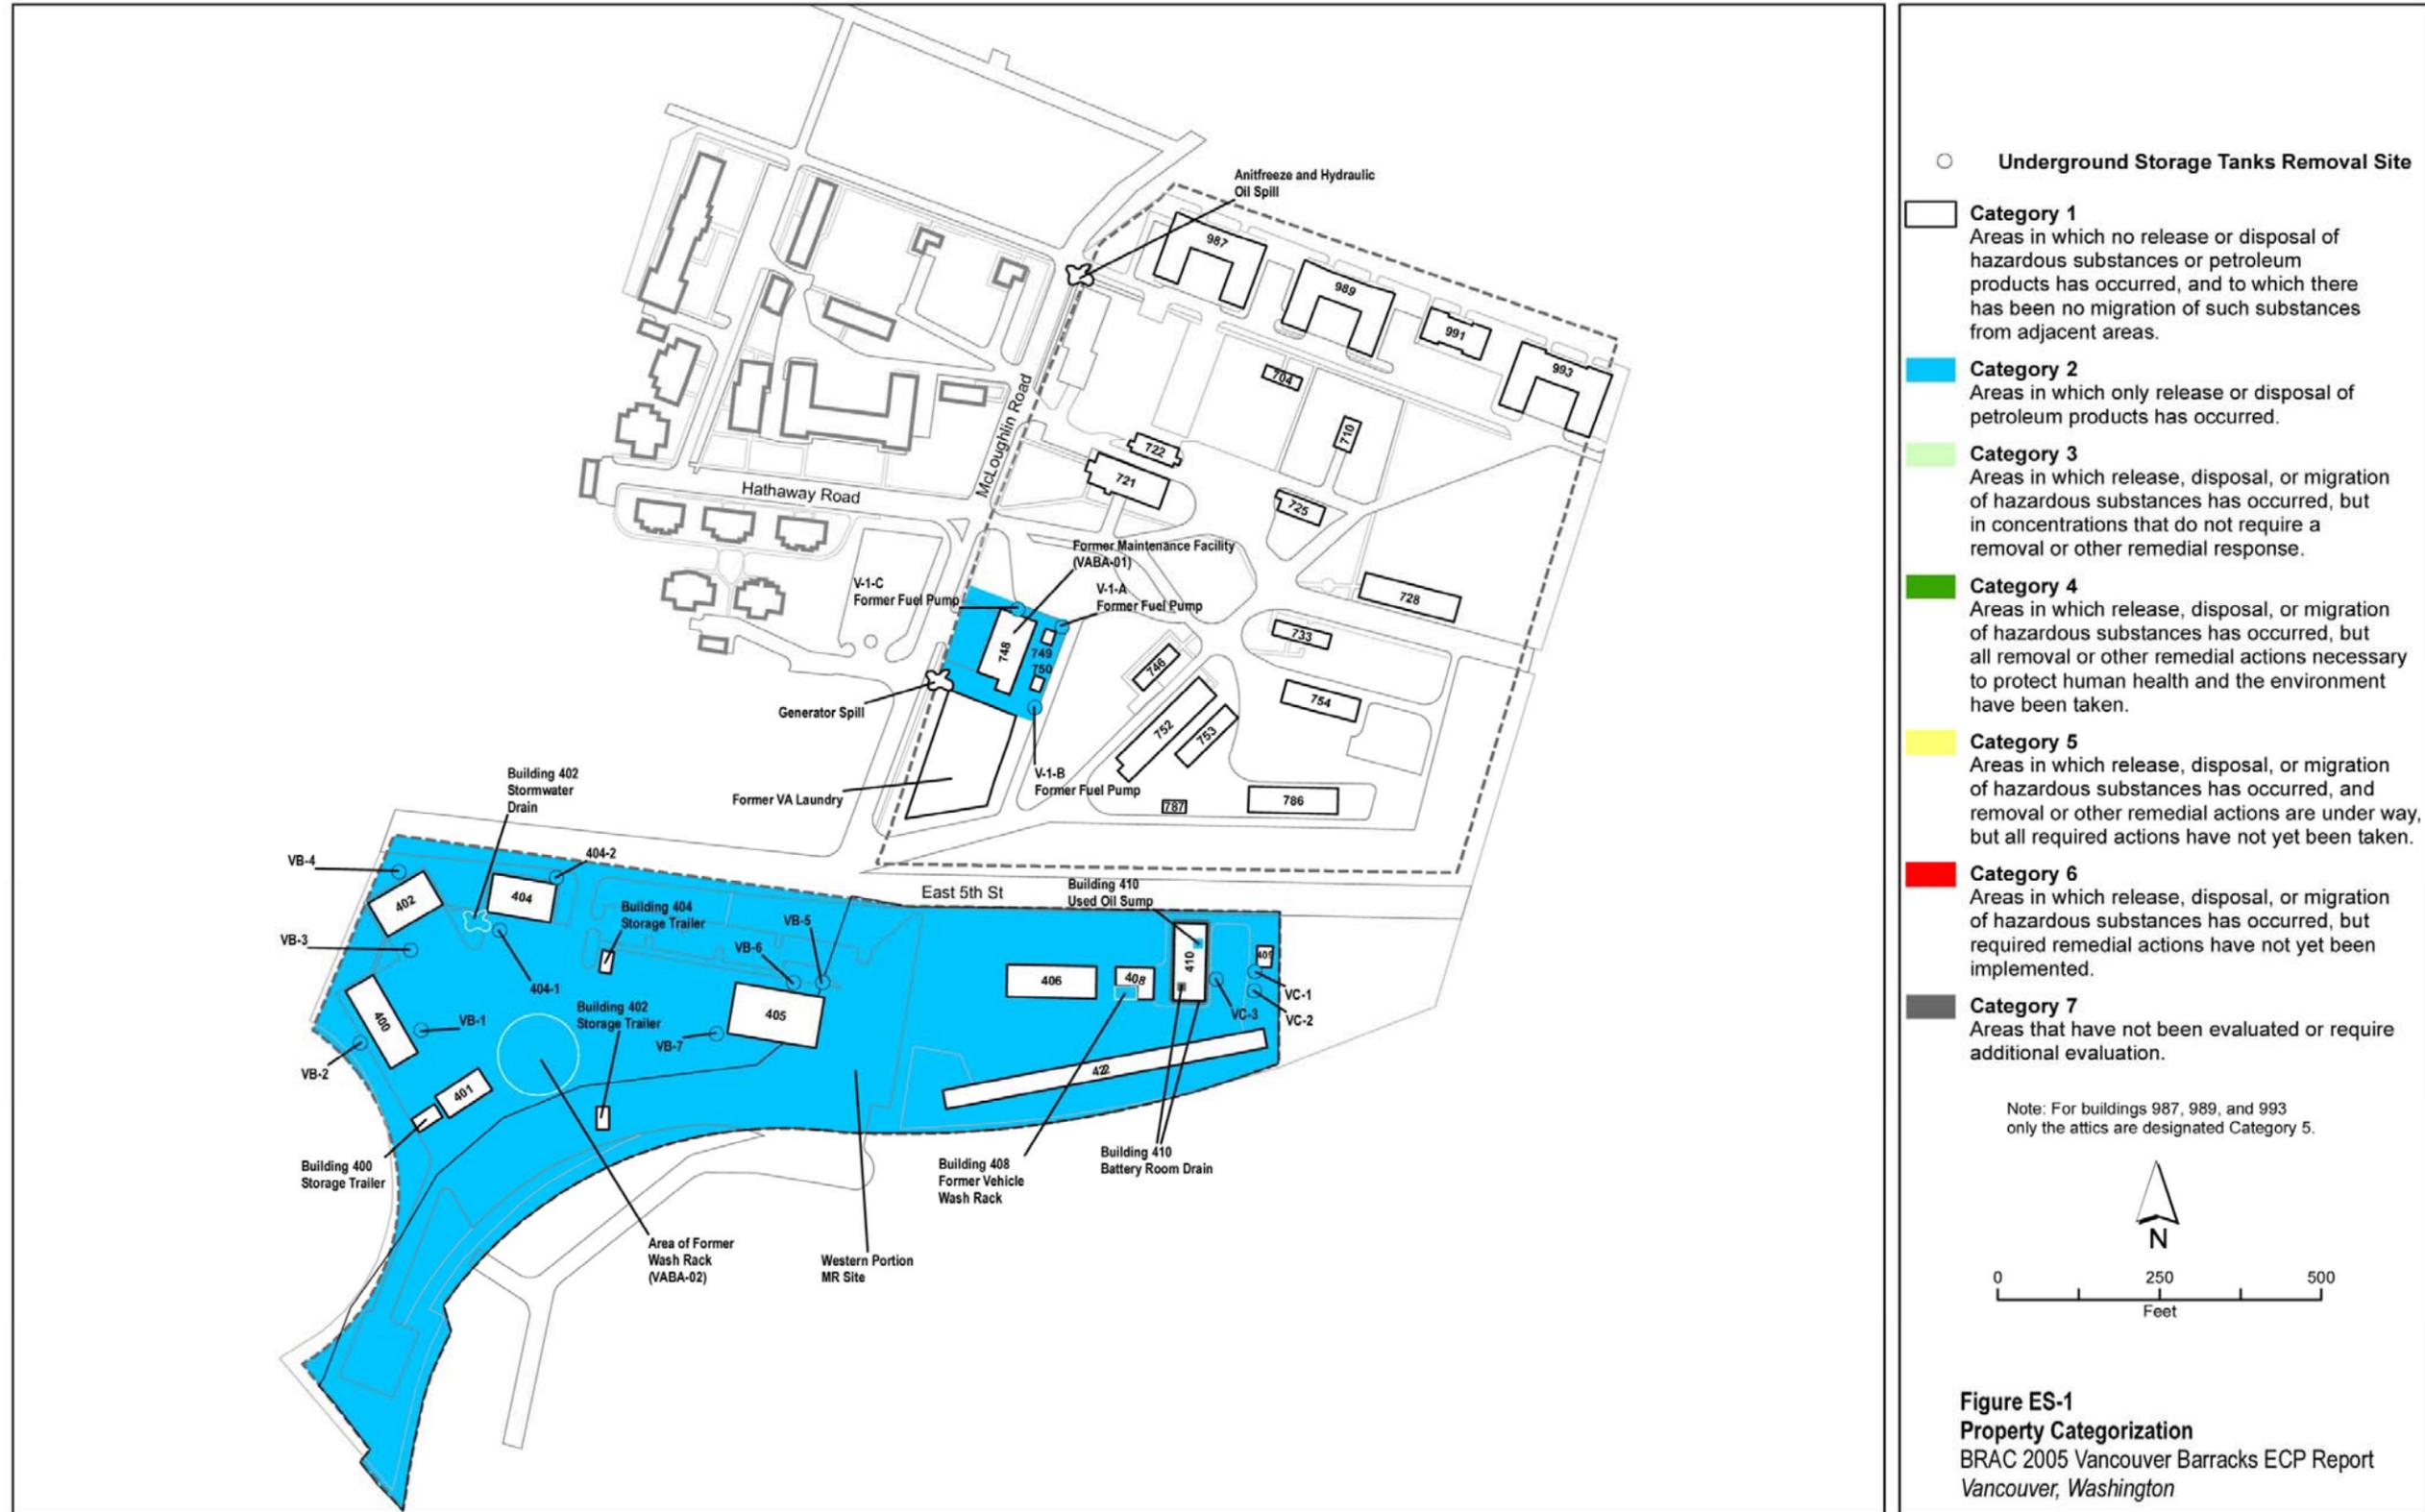
File Path: \\Rosatproj\USACE\Louisville\Dist\343346\Vancouver_Barracks\Phase I\GIS\mxds\ES-1_PropertyCategorization.mxd, Date: October 31, 2006 2:29:27 PM

All parcels listed as a Category 1 are considered “uncontaminated property” (as amended by the Fiscal Year 1997 Defense Authorization Act) where no release or disposal of hazardous substances or petroleum products has occurred (including no migration of these substances from adjacent areas). The Community Environmental Response Facilitation Act Sections 120(h)(4)(iii) and (iv), an amendment to the Comprehensive Environmental Response, Compensation, and Liability Act of 1980 (CERCLA, Section 120[h]), was enacted to facilitate the rapid return of uncontaminated properties identified during the BRAC process to the local communities. The following parcels have been classified as Category 1 properties:

The following areas are considered Category 7 Properties. These are areas that have not been evaluated or that require additional evaluation:

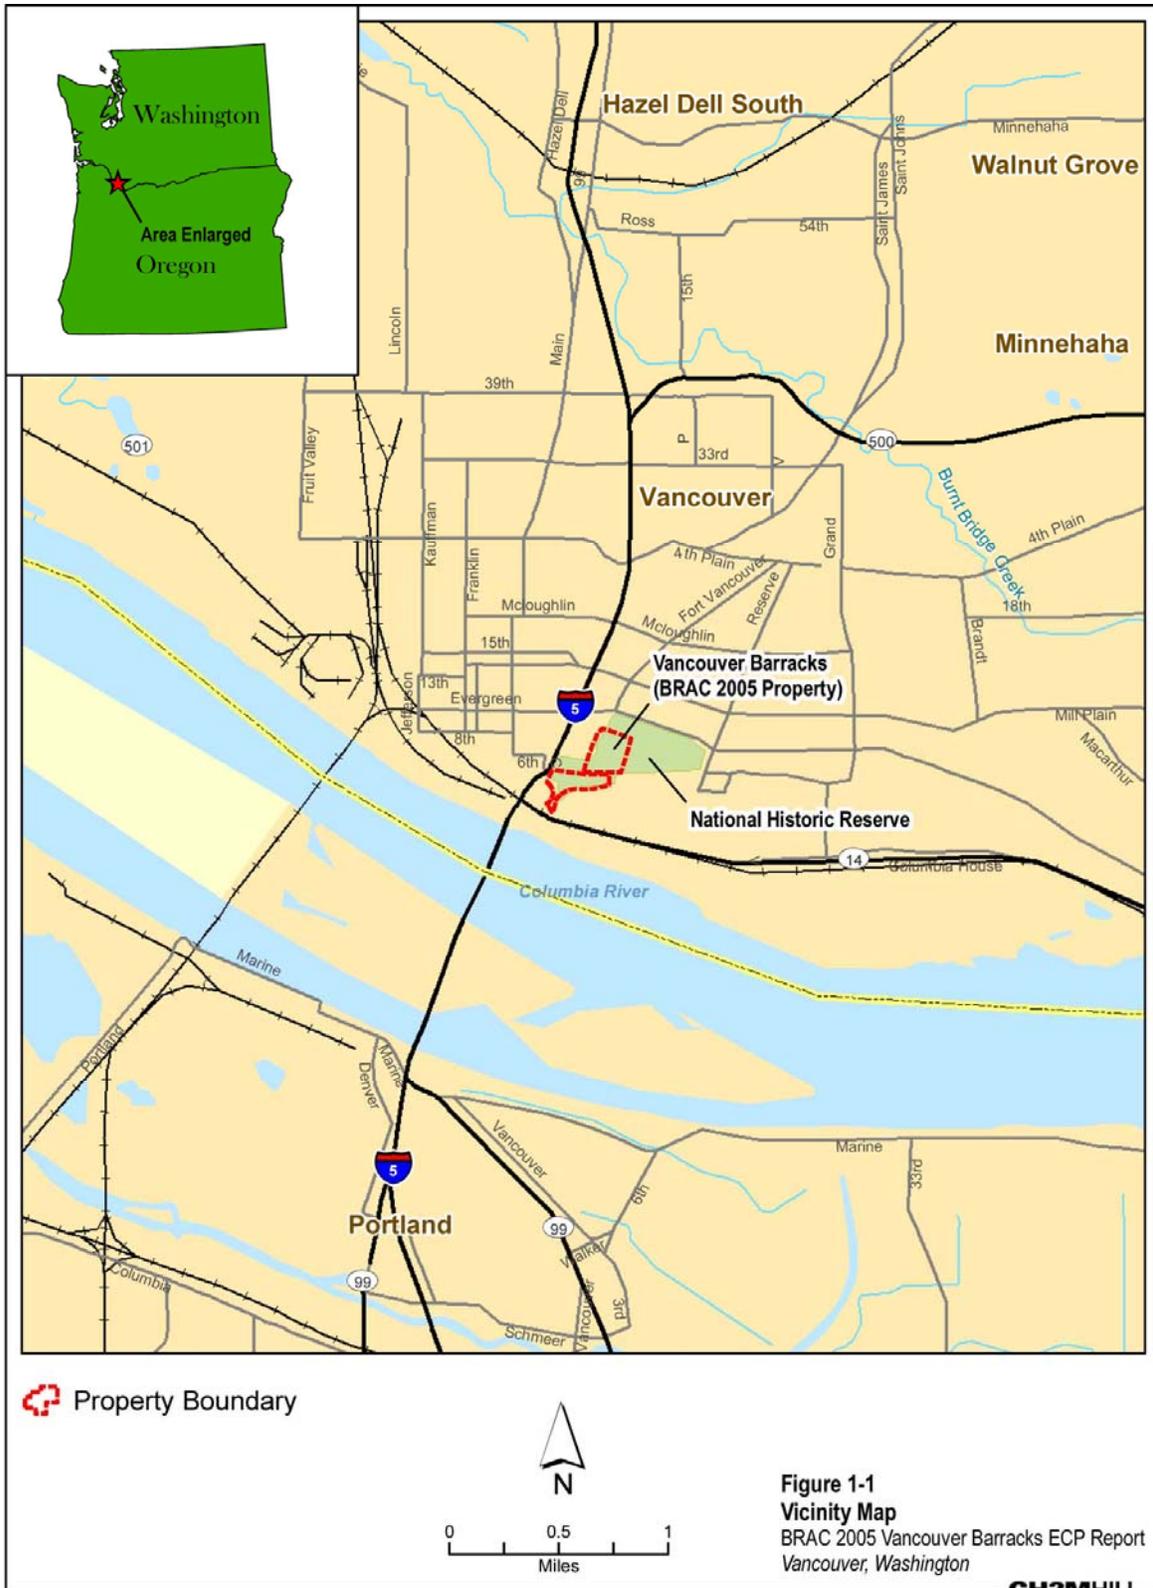
File Path: \\Rosa\proj\USACE\Louisville\Distr\343346\Vancouver_Barracks\GIS\mxds\Figure1-1_VicinityMap.mxd, Date: August 9, 2006 11:09:51 AM

This ECP covers the 47.46 acres of the eastern and southern portions of Vancouver Barracks. Vancouver Barracks are located in Vancouver Washington. The site is approximately 0.25 mile north of the Columbia River, immediately east of Interstate 5 (I-5) in Vancouver, Washington. The Property is bounded by the West Barracks to the west and the Vancouver Barracks National Historic Reserve on all other sides. A vicinity map showing the general location of the Property is presented in Figure 1-1; a Property layout map is presented in Figure 1-2. A legal description of the Property is provided in Section 3.1.

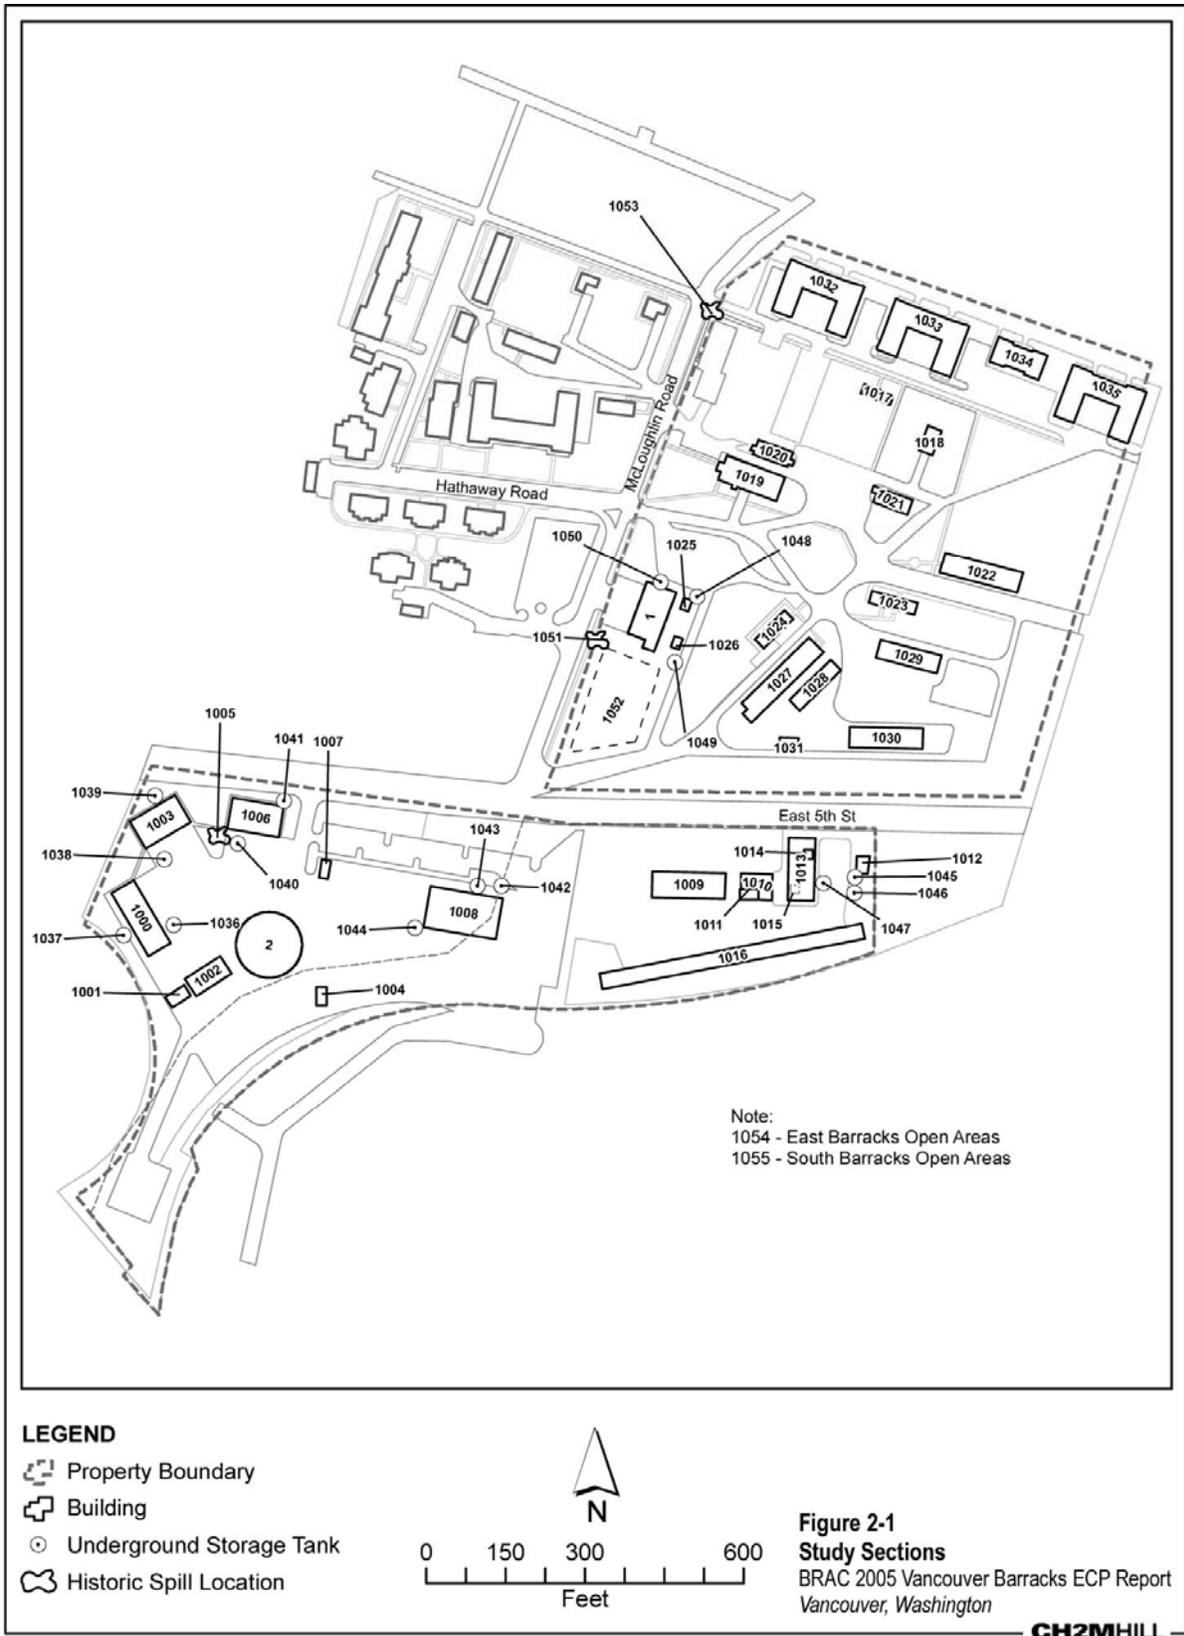
File Path: \vrosa\proj\USACELouisvilleDistr\343346\Vancouver_Barracks\GIS\mxds\Figure2-1_Study_Sections_Letter.mxd, Date: September 22, 2006 2:41:06 PM

There are three series of buildings on the Property, including the 400 Series, 700 Series, and 900 Series. Most of the buildings in the 400 Series are used for vehicle maintenance and storage; most of the buildings in the 700 and 900 Series buildings are used for administrative offices. Because the functions of most buildings in a series are similar, this report will refer to building series when appropriate, rather than to specific buildings. Open areas that are not associated with a building or other environmental feature have been assigned a study section. Table 2-1 lists the study section associated with each building series. Figure 2-1 shows the study section associated with each building series.

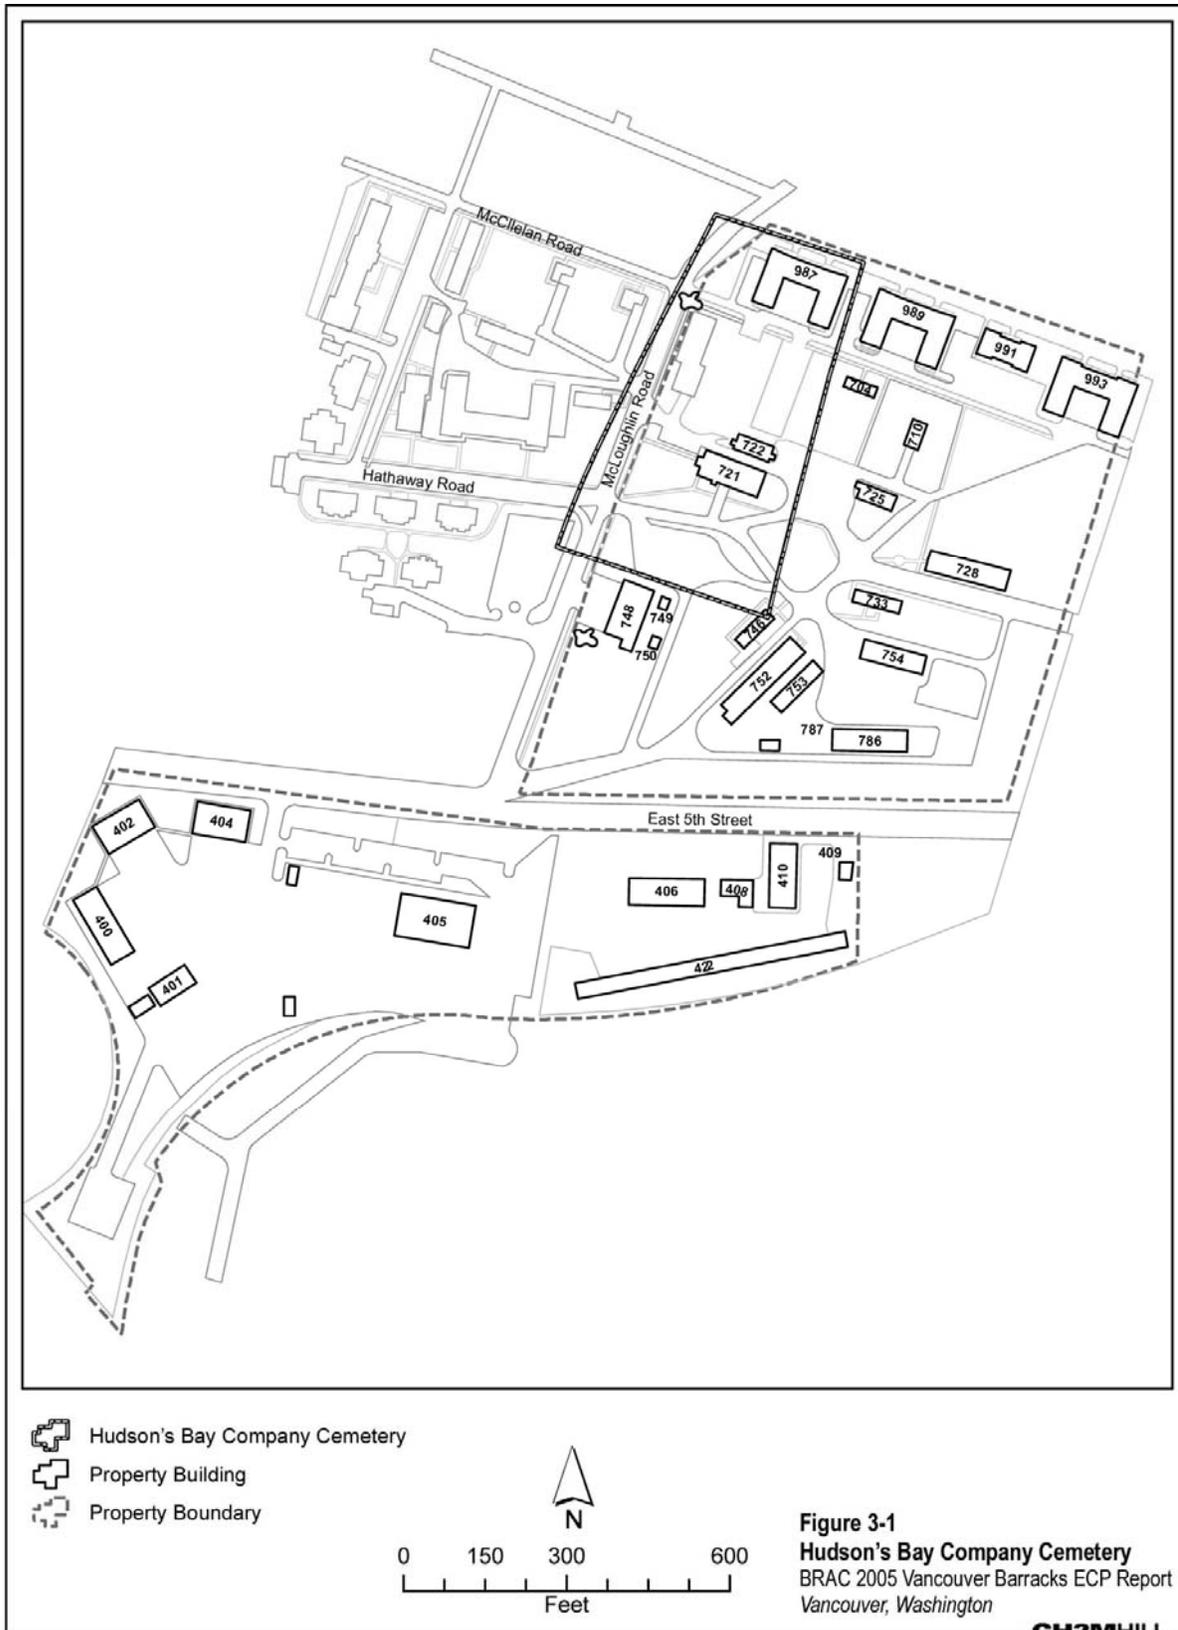
Figure 3-1
Hudson's Bay Company Cemetery
 BRAC 2005 Vancouver Barracks ECP Report
 Vancouver, Washington

During HBC presence at Fort Vancouver between 1824 and 1860, officers, servants, their families, and other inhabitants of varied ethnicities were buried at the HBC Cemetery established on the Fort. The boundaries of the cemetery are shown in Figure 3-1. Catholic priests from St. James Mission recorded over 200 burials at the cemetery during the 17-year period between 1839 and 1856, but prior burials predate church records (ENSR, 2002).

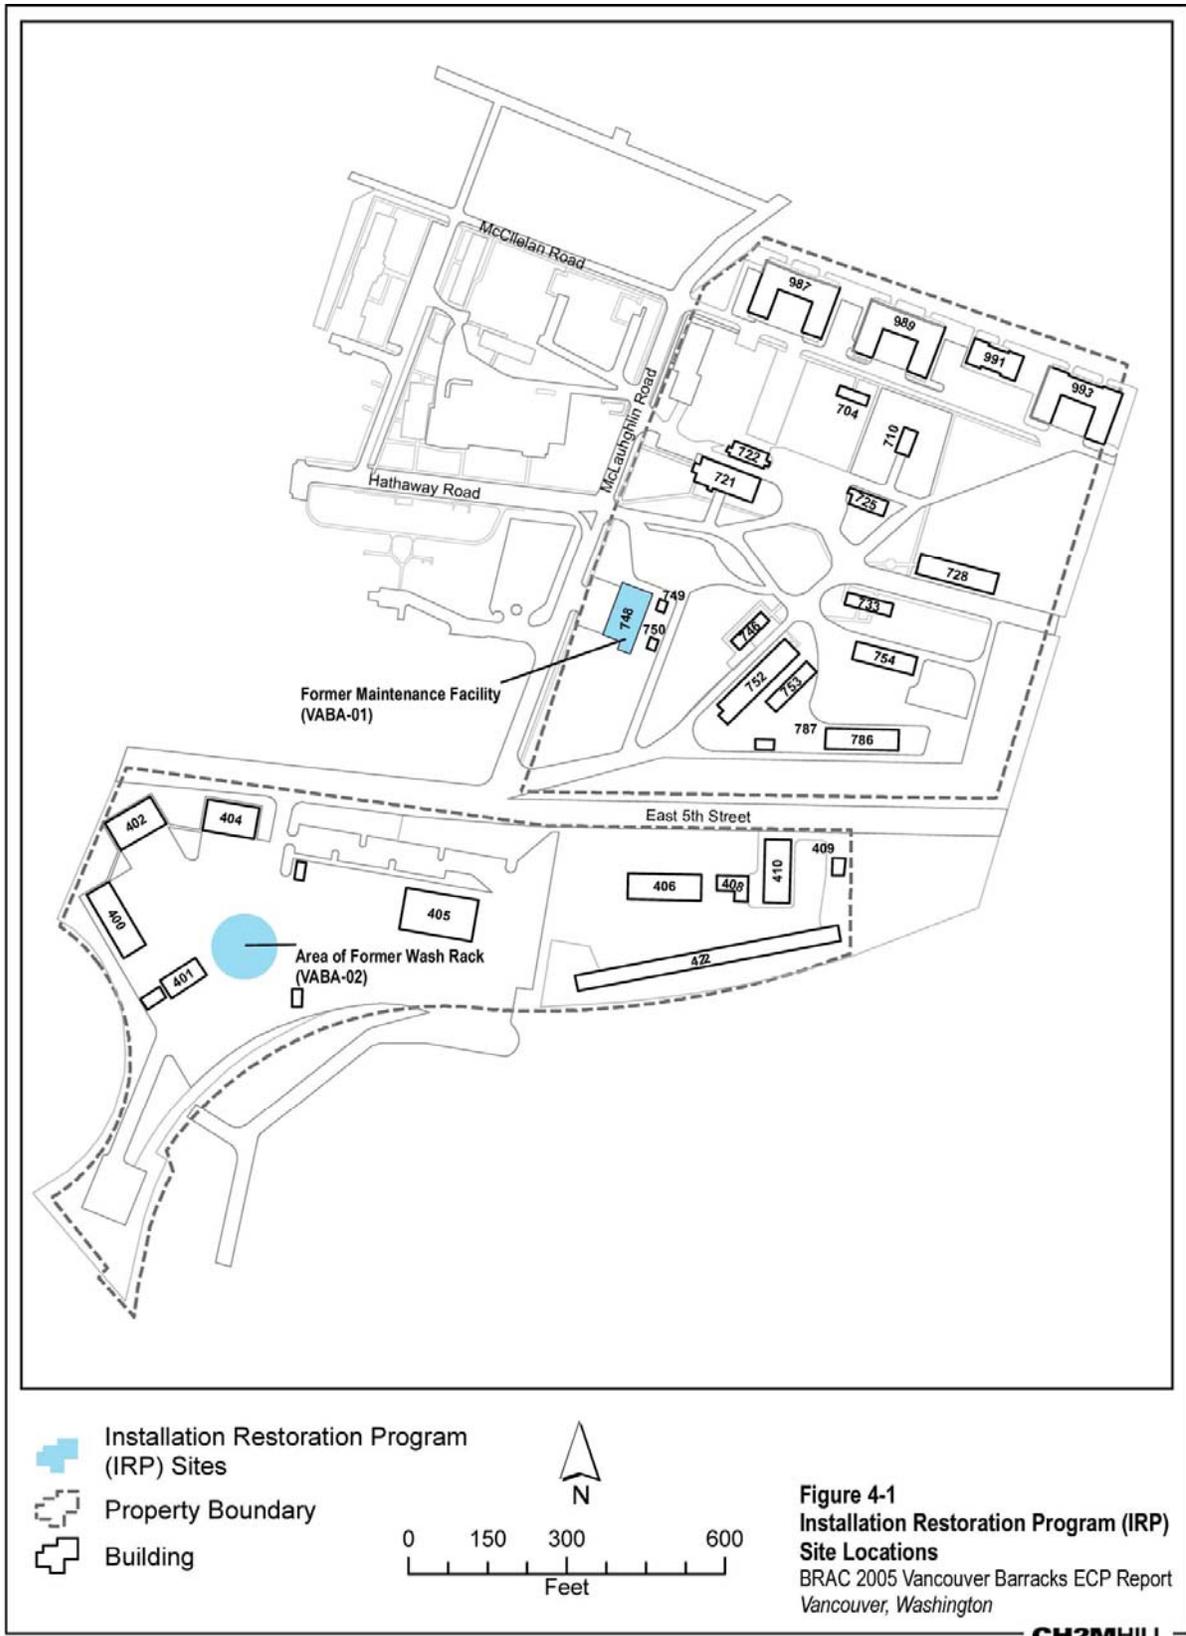
File Path: \\Rosa\proj\USACE\LouisvilleDistr\343346\Vancouver_Barracks\GIS\mxds\Figure4-1_IRP_Sites.mxd, Date: September 5, 2006 10:21:00 AM

There are two sites listed in the Army Environmental Database Restoration (AEDB-R) that are included in the U.S. Army DOD IRP. These include the former maintenance support Building 748 (site VABA-01) and the former wash rack (site VABA-02) at Building 400 (Figure 4-1).

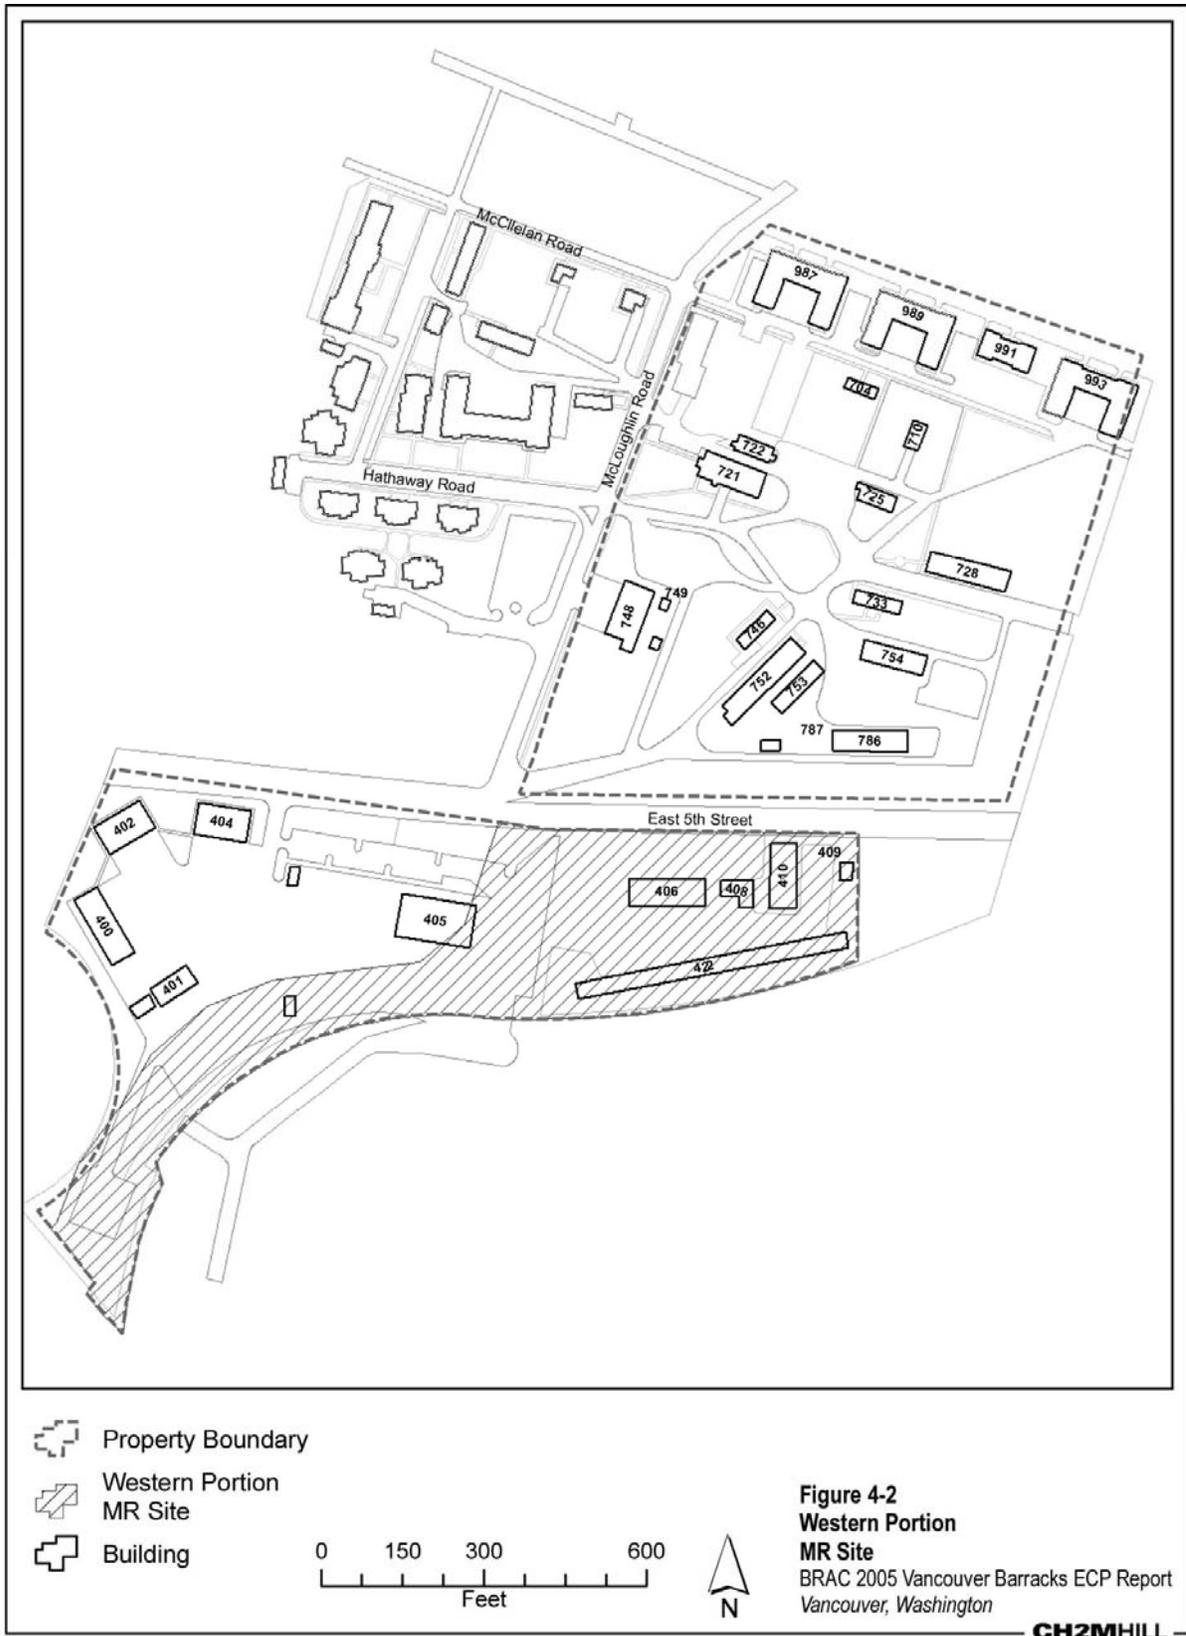
File Path: \\Rosa\proj\USACE\Louisville\Dist1\343346\Vancouver_Barracks\GIS\mxds\Figure4-2_MEC_site-West.mxd, Date: September 5, 2006 10:28:03 AM

One area on the Property has the potential for munitions and explosives of concern (MEC) to be present. This area of 8.15 acres is located south of East 5th Street and currently is included in the MMRP (see Figure 4-2). Known historic uses of the MEC site (sometimes referred to as the Western Portion Site) include powder storage, ordnance depot, ammunition storage buildings, and firing ranges. This site had various ordnance and munition use on it from 1849 to 1960 (TechLaw, 2006). Section 4.12 describes this site in further detail.

There is one potential MEC site within the Property. This potential MEC site is located south of East 5th Street and involves 8.15 acres. The location of the potential MEC site (sometimes referred to as the Western Portion MR site) is shown in Figure 4-2.
