Base Realignment and Closure (BRAC) Walter Reed Field Activity Caretaker Staff, has prepared this Environmental Condition of Property (ECP) Update Report for the Assistant Chief of Staff Installation Management, Office of Base Realignment and Closure. This report updates a previous ECP that was completed for Walter Reed Army Medical Center (WRAMC) in December 2006. The facility is located at Walter Reed Field Activity, 6900 Georgia Ave NW, Washington District of Columbia (DC), 20307, hereafter referred to as the “Site” or “Property”. In support of the ECP Update Report, a visual reconnaissance of the Site was conducted on October 17, 2014. The purpose of the visit was to visually obtain information indicating the environmental condition of the Property.

### **1.1 PURPOSE OF ENVIRONMENTAL CONDITION OF PROPERTY (ECP) UPDATE REPORT**

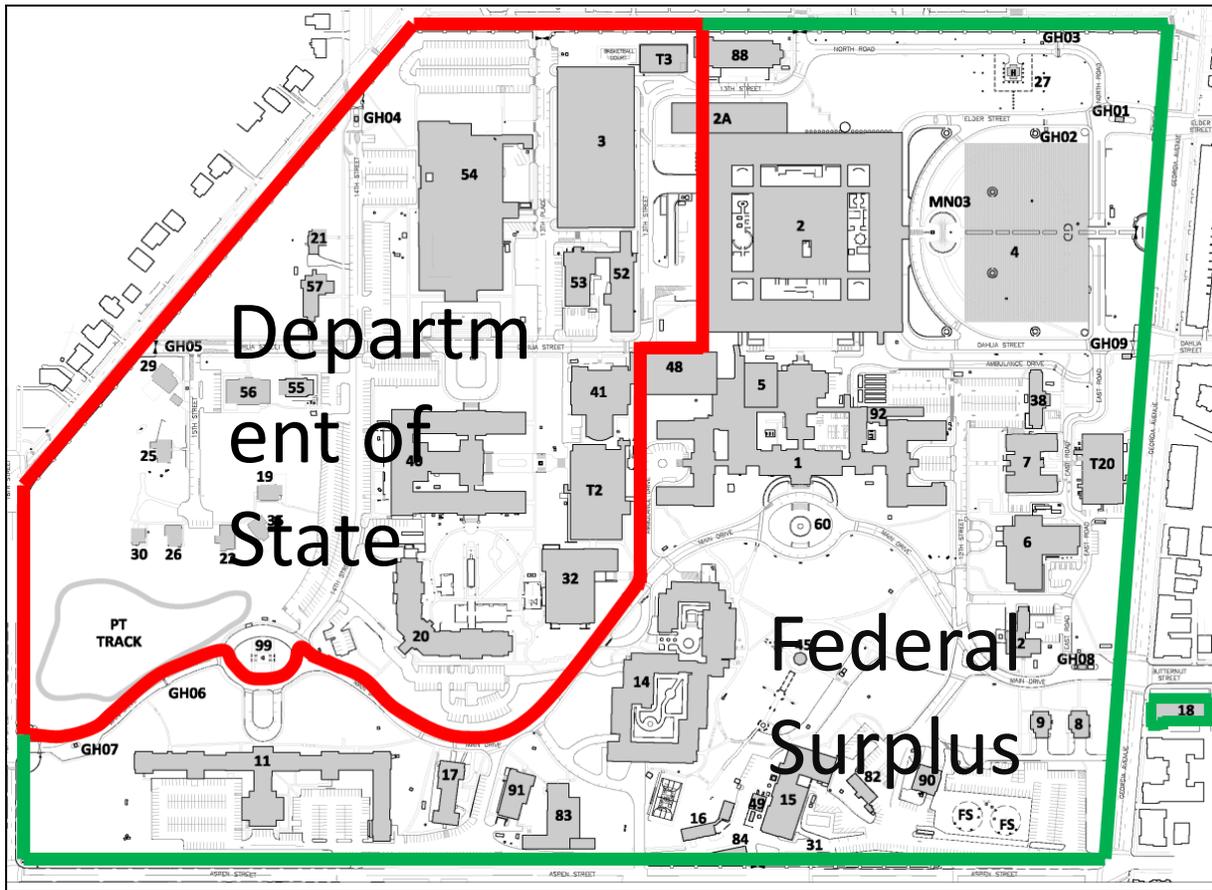
The property is located at 6900 Georgia Ave NW, Washington, DC, 2030, and is approximately 1 mile south of the DC and Maryland state line. The property is roughly rectangular in shape and encompasses approximately 110.3 acres (in 2006 ECP was 113 acres). It is bordered by Rock Creek Park to the west, and bordered mainly residential on the south, east and west. The property has 47 buildings (not including guard shacks, gazebos, fountains, landmarks and pergolas.). Of the 47 buildings, 28 buildings are contributing resources to the historic district, and 12 of which are individually eligible historic structures. Included in the property is Building 18, formerly known as the Walter Reed Inn. In accordance with 2005 BRAC law, WRAMC ceased all operations on September 15, 2011. Prior to closure, WRAMC's primary activity was medical care and treatment. Some of the operations on the property included: hospital functions, housing, administrative functions, medical research and heating/cooling operations. Most research operations ceased in early 2011, while all other operations ceased in September 2011. Since closure, the property has been in a caretaker status. Some buildings have been decommissioned, while others are maintained at a minimal level (due to historical status). The boiler plant is operational 24 hours a day, 7 days a week. The chiller plant is operational 12 hours a day, 7 days a week. Figure 1 shows the proposed parcel division for property conveyance.

Figure 1. Proposed Parcel Division After BRAC 2005 Closure.

Effective March 1, 2010, DC WASA revised the discharge permit to require WRAMC to conduct monthly mercury monitoring at the compliance manhole (MH), MH40. The location of the compliance manhole is on the parcel labeled as "Surplus Federal Property" on Figure 1; however, the sanitary lines discharging into that point are largely north of Dalia Street, extending from Buildings 2 and 54.
