**ENVIRONMENTAL CONDITION OF
PROPERTY REPORT**

**JONESBORO
U.S. ARMY RESERVE CENTER (AR022)
1001 SOUTH CARAWAY ROAD
JONESBORO, ARKANSAS 72401**

February 12, 2007

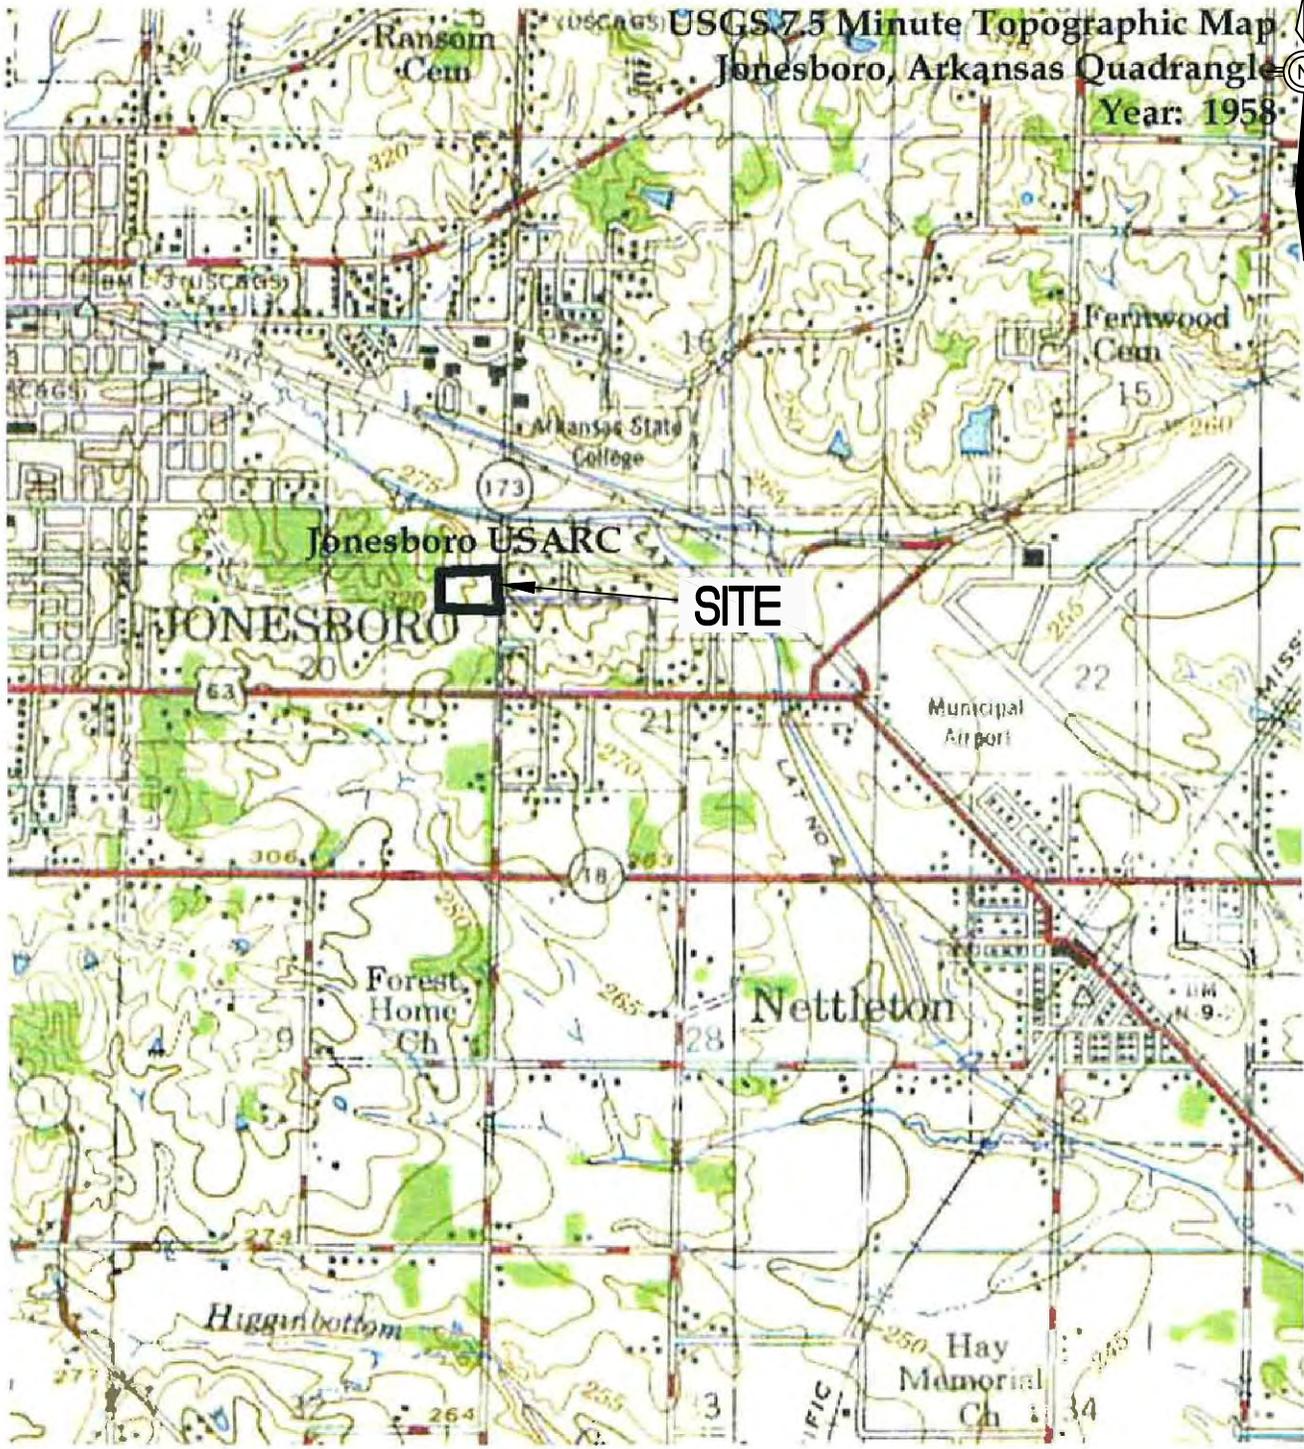
FIGURE 3
 1958 TOPOGRAPHIC MAP
 ENVIRONMENTAL CONDITION OF PROPERTY
 JONESBORO USARC
 JONESBORO, ARKANSAS

- **1958 (Figure 3).** No buildings are shown on the Site. The area immediately east of South Caraway Road is shown as developed. The areas to the north, south, and west are either agricultural land or undeveloped. The developed area of the City of Jonesboro is shown to the west/northwest of the Site.
- **1983 (Figure 4).** The Site is shown as part of the developed area east of Jonesboro; the Administration Building and OMS are specifically plotted on the map. The area east and south of the Site is shown as developed. More development is shown west of the Site in the City of Jonesboro.

USGS 7.5 Minute Topographic Map
 Jonesboro, Arkansas Quadrangle
 Year: 1958

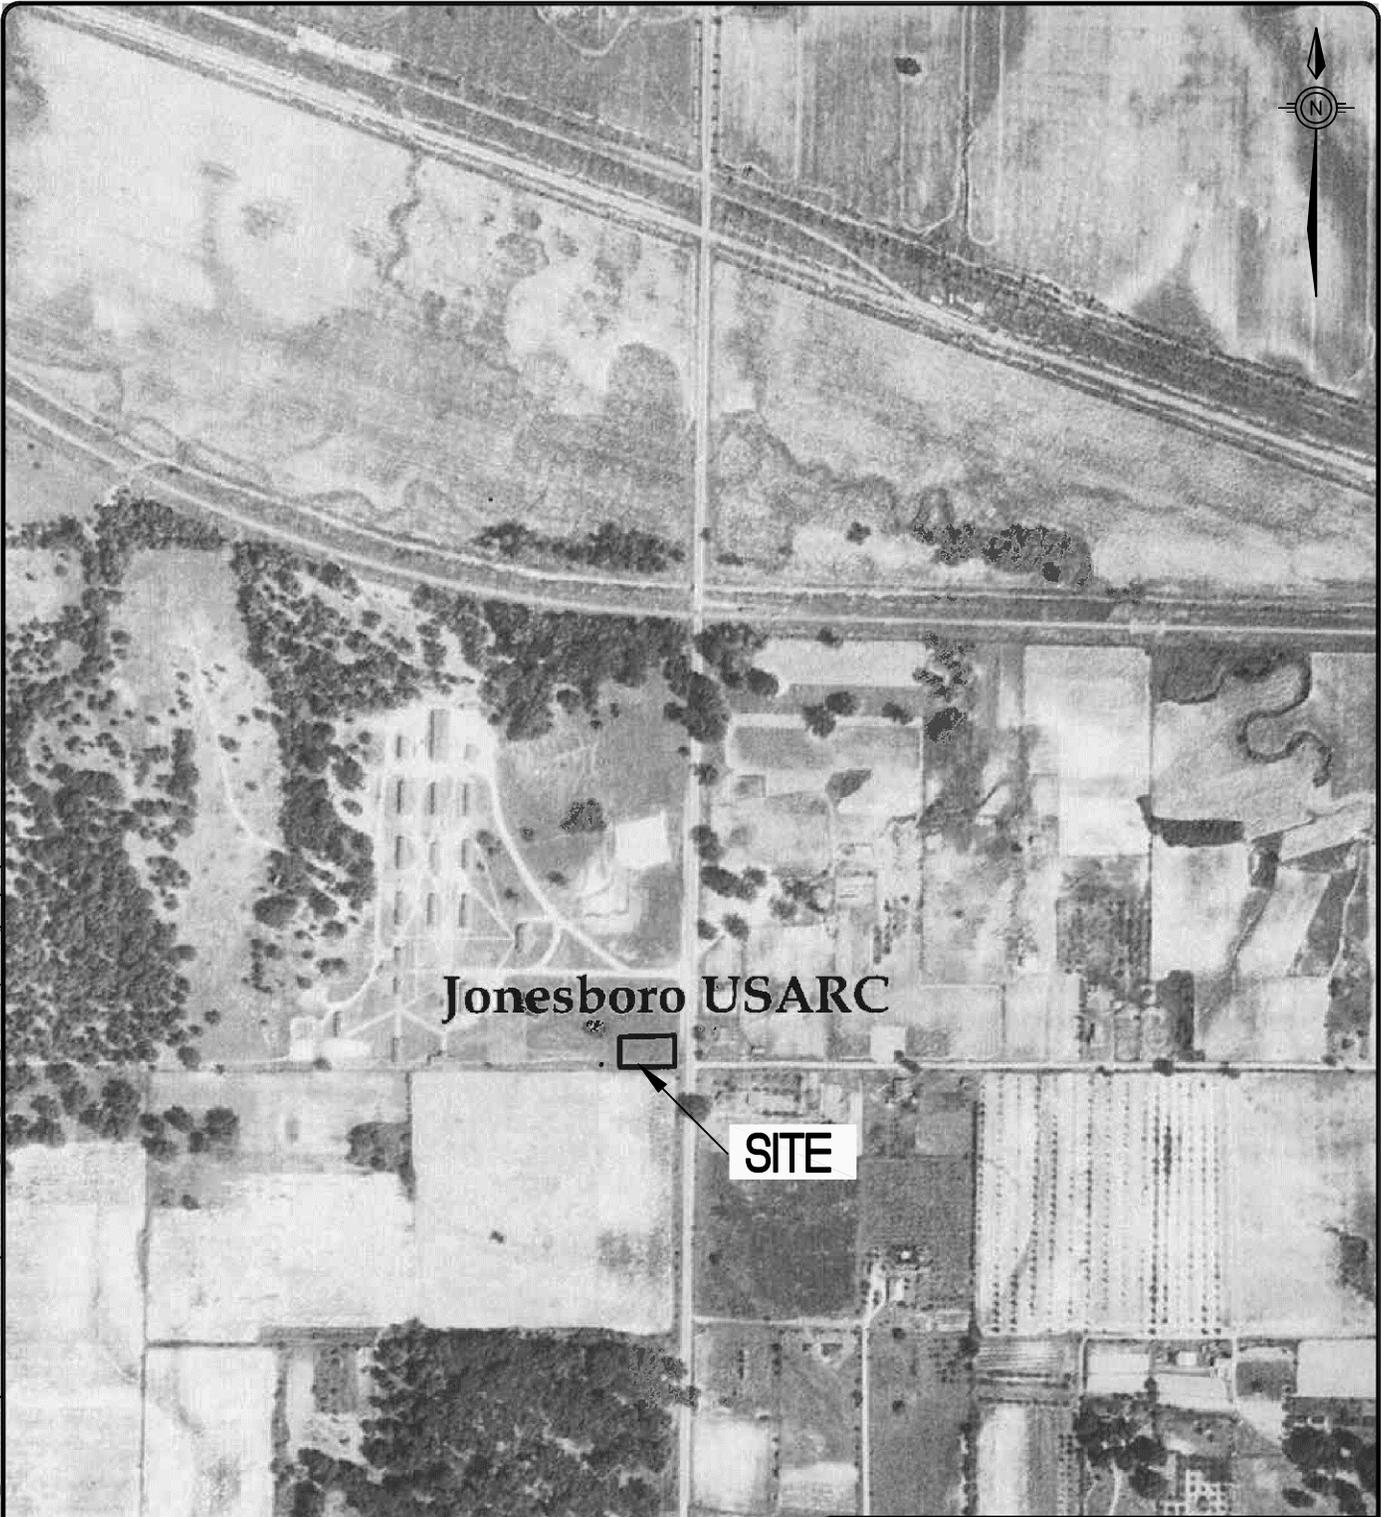
FIGURE 5
1937 AERIAL PHOTOGRAPH
ENVIRONMENTAL CONDITION OF PROPERTY
JONESBORO USARC
JONESBORO, ARKANSAS

- **1937 (Figure 5).** No buildings are shown on the Site. The Site appears to be in a farmed/cleared area on the southeast side of Jonesboro. The areas north and west of the Site appear to have several structures and roads. East across South Caraway Road are agricultural fields and residential homes. South of the Site is an agricultural field.

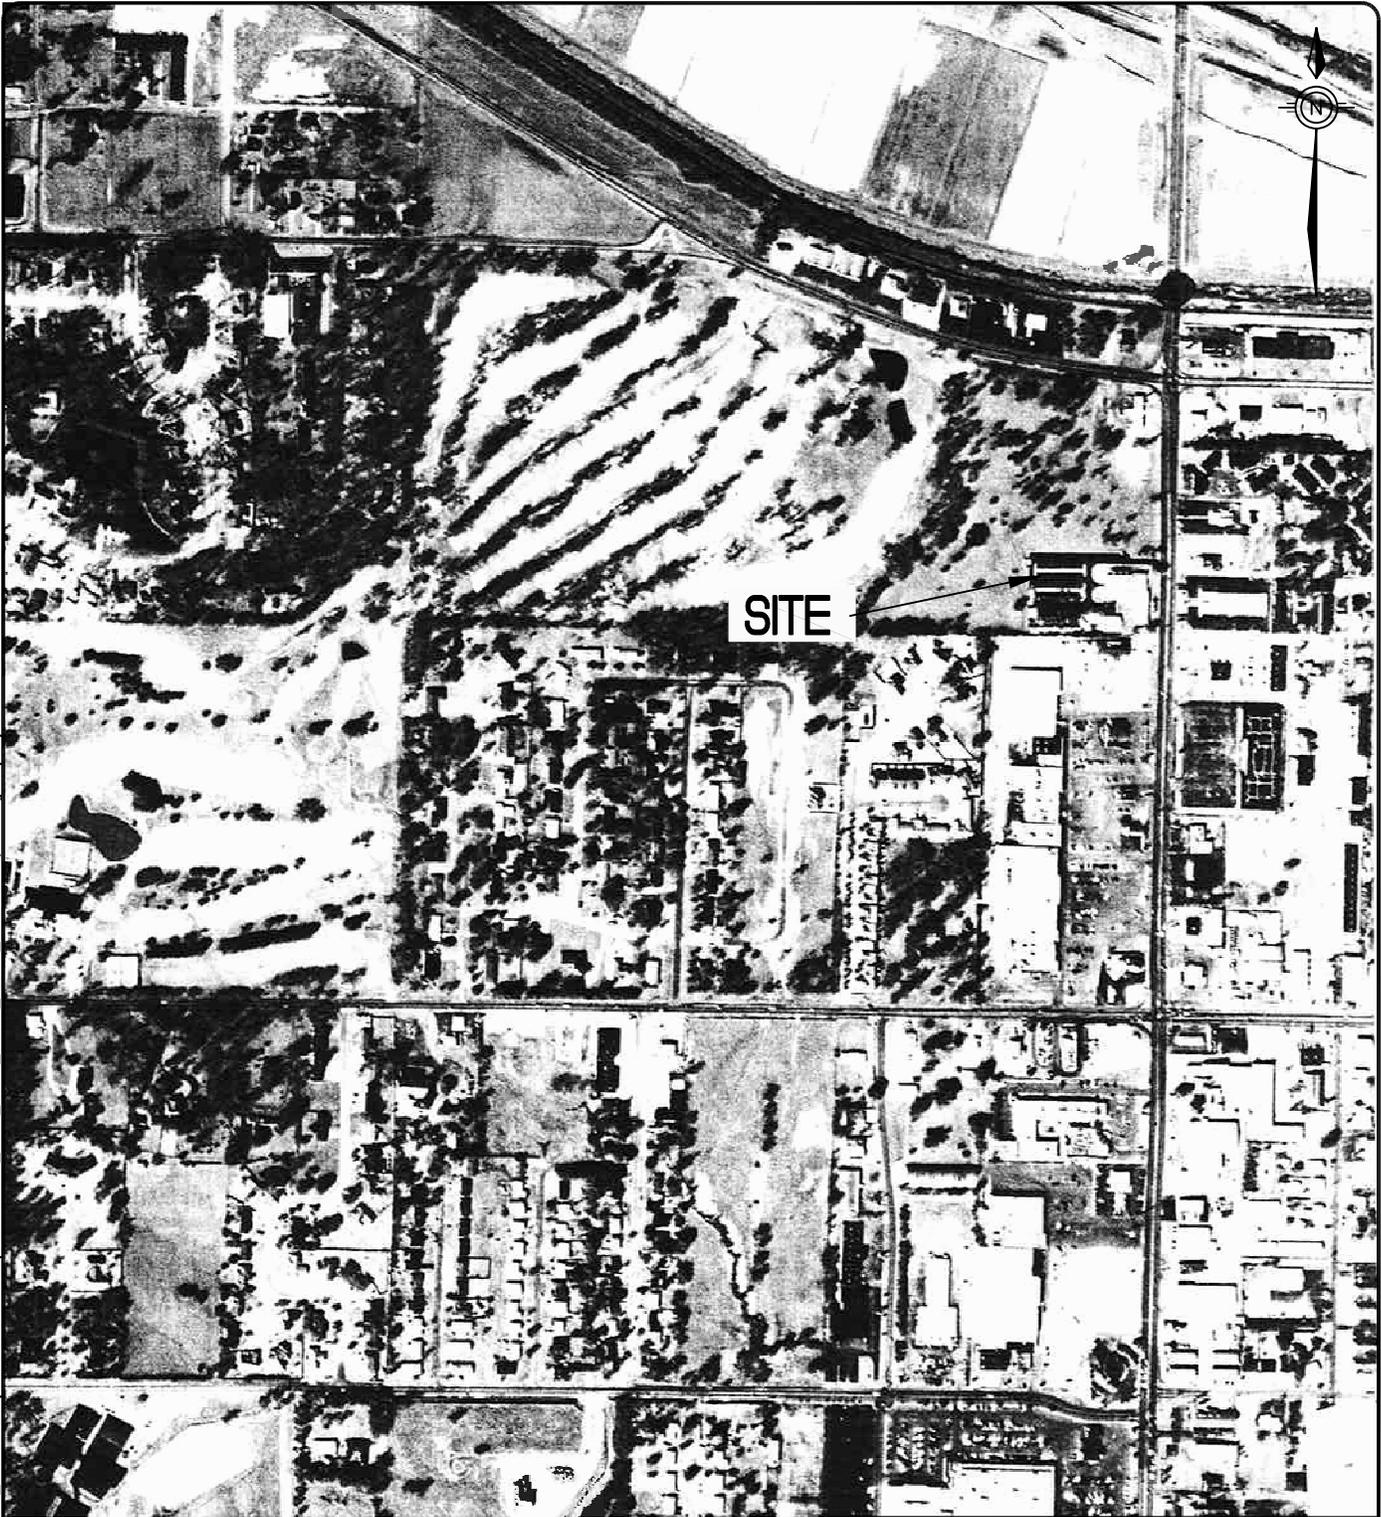
FIGURE 7
1991 AERIAL PHOTOGRAPH
ENVIRONMENTAL CONDITION OF PROPERTY
JONESBORO USARC
JONESBORO, ARKANSAS

- **1991 (Figure 7).** The USAR Center shown on the Site appears similar to the 1972 to 1979 conditions. Additional development has occurred in the area. What is now a BP gas station is shown north of the Site.

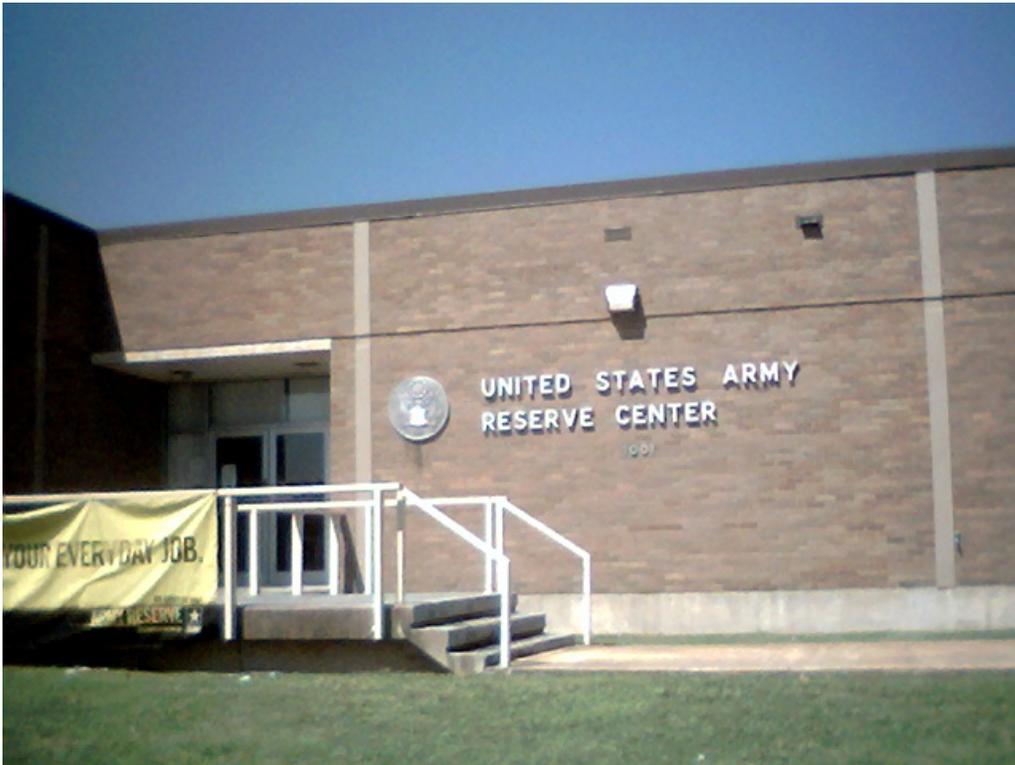
Photo 1: The Administration Building entrance looking west at the Jonesboro USAR Center (AR022).

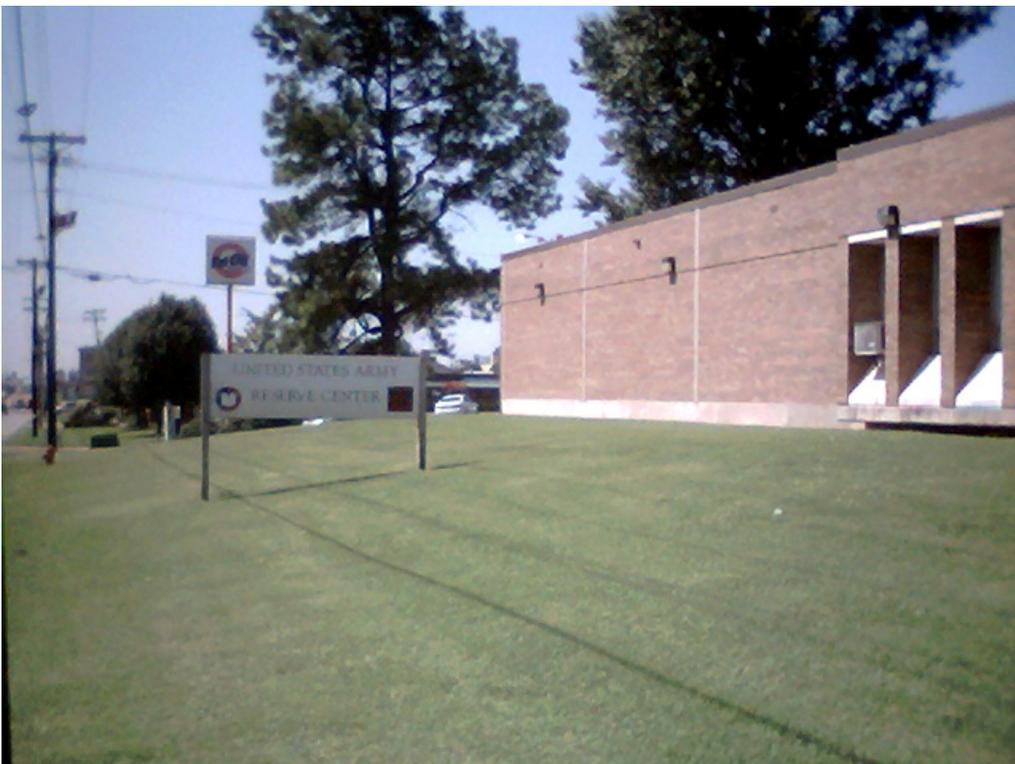
Photo 2: The front of the Administration Building looking south at the Jonesboro USAR Center. Also, shown is the adjacent retail property to the south.

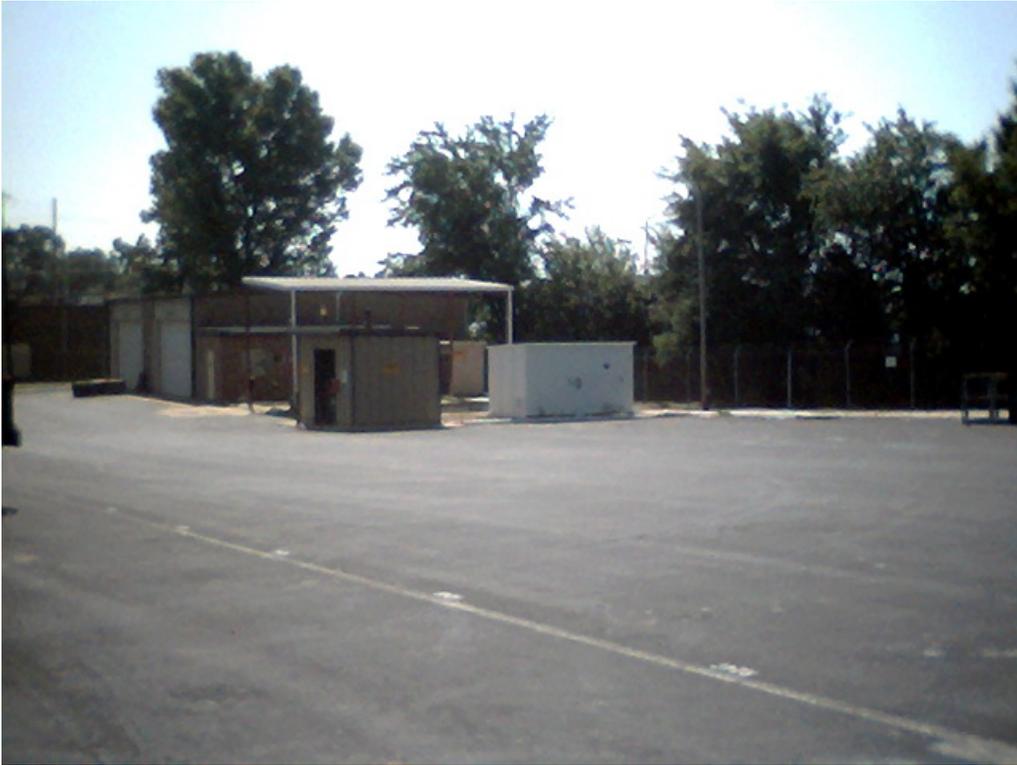
Photo 3: Military equipment parking (MEP) as viewed from the southwest corner of the MEP looking southeast at the OMS and vehicle wash rack.

The USAR Center is on 3.45 acres of land with two permanent structures: a 14,192-square-foot Administration Building and the 3,235-square-foot OMS. Both structures were built in 1972. The Administration Building walls are concrete block with brick veneer, while the OMS walls are concrete block. Both buildings have concrete foundations. The general layout of the Site relative to the Administration Building is shown in Photographs 1 and 2 in Appendix B. The general layout of the Site relative to the OMS is shown in Photographs 3 and 4 in Appendix B.

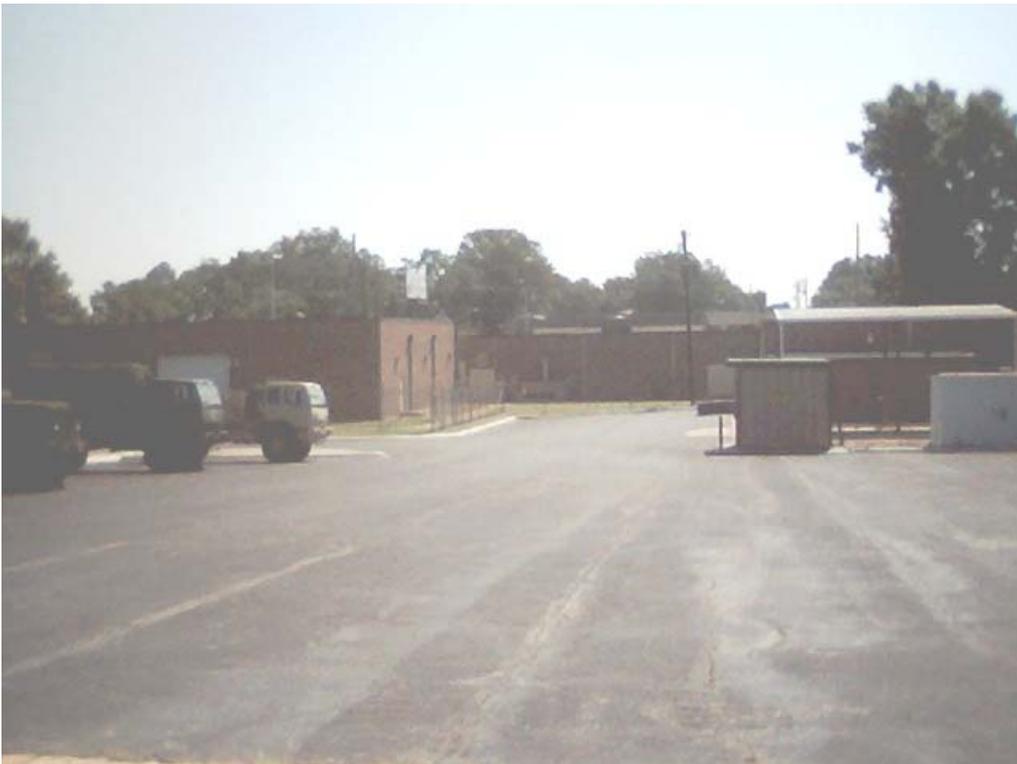
Photo 4: MEP as viewed from the southwest corner of the MEP and looking east at the Administration Building and vehicle wash rack.

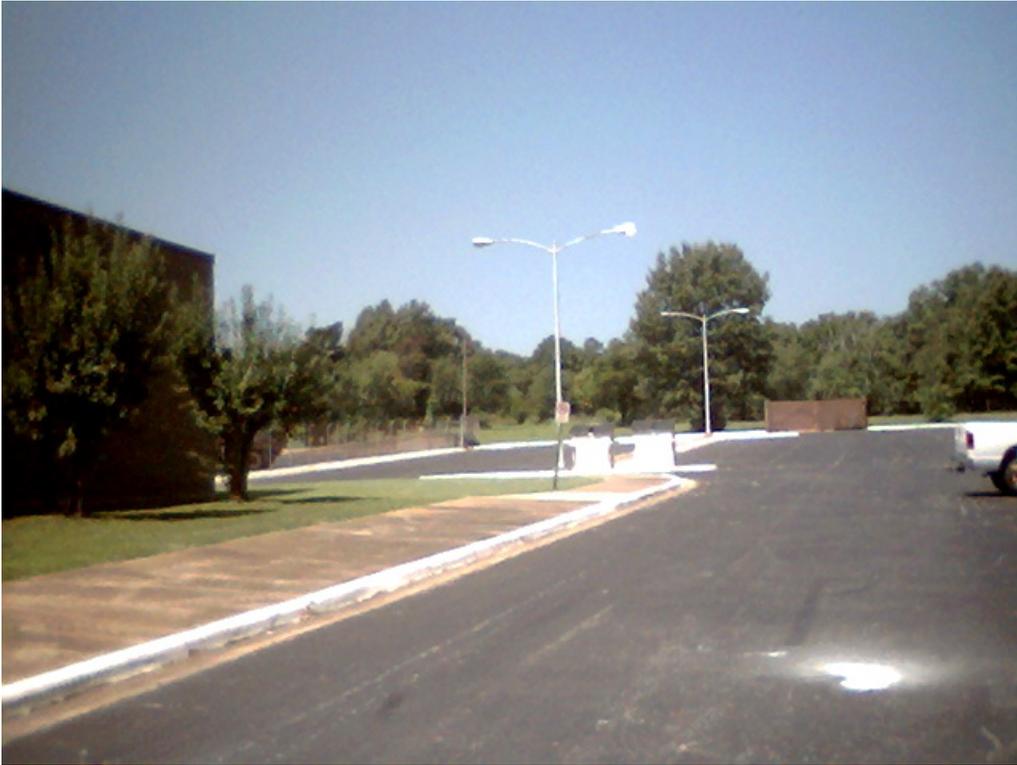
Photo 5: Privately owned vehicle parking, viewed from the north side of the Administration Building looking west. Also, the undeveloped lot to the west of the Site is visible.

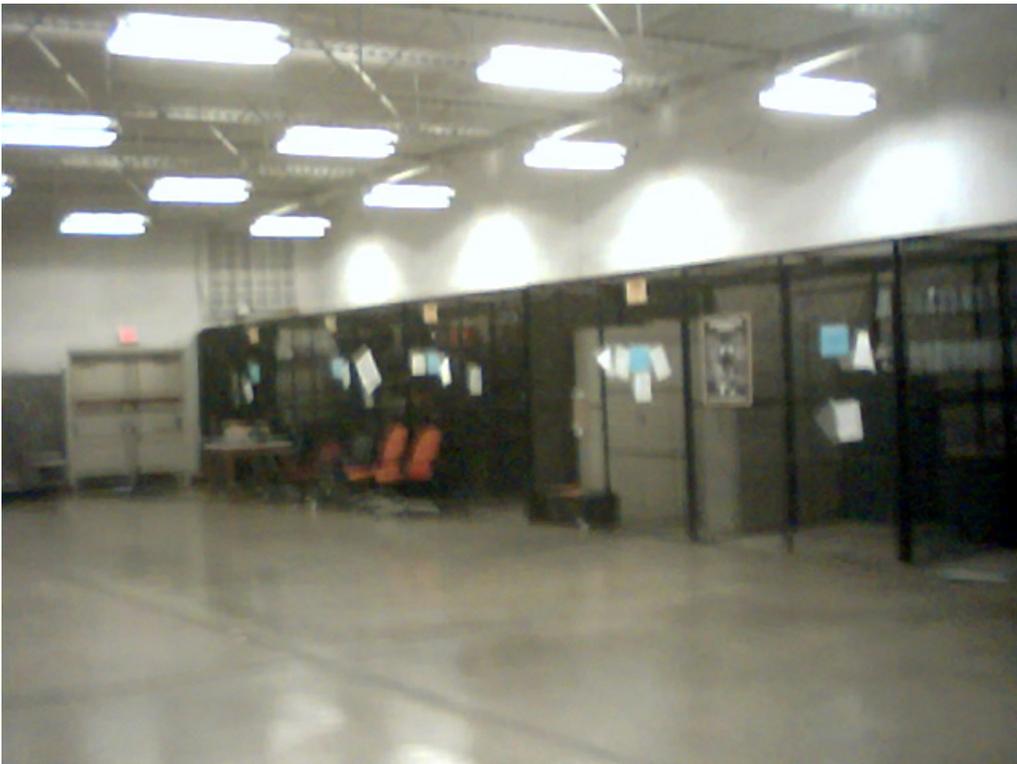
Photo 6: Drill hall in the northeast corner of the Administration Building.

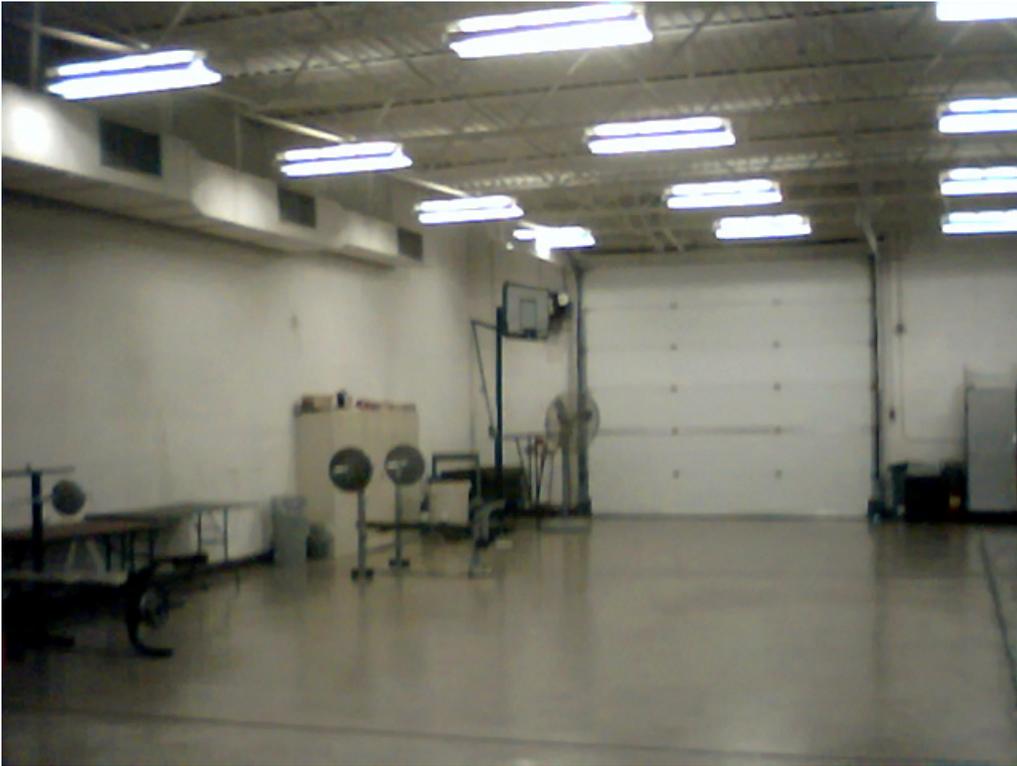
Photo 7: Another view of the drill hall in the northeast corner of the Administration Building.

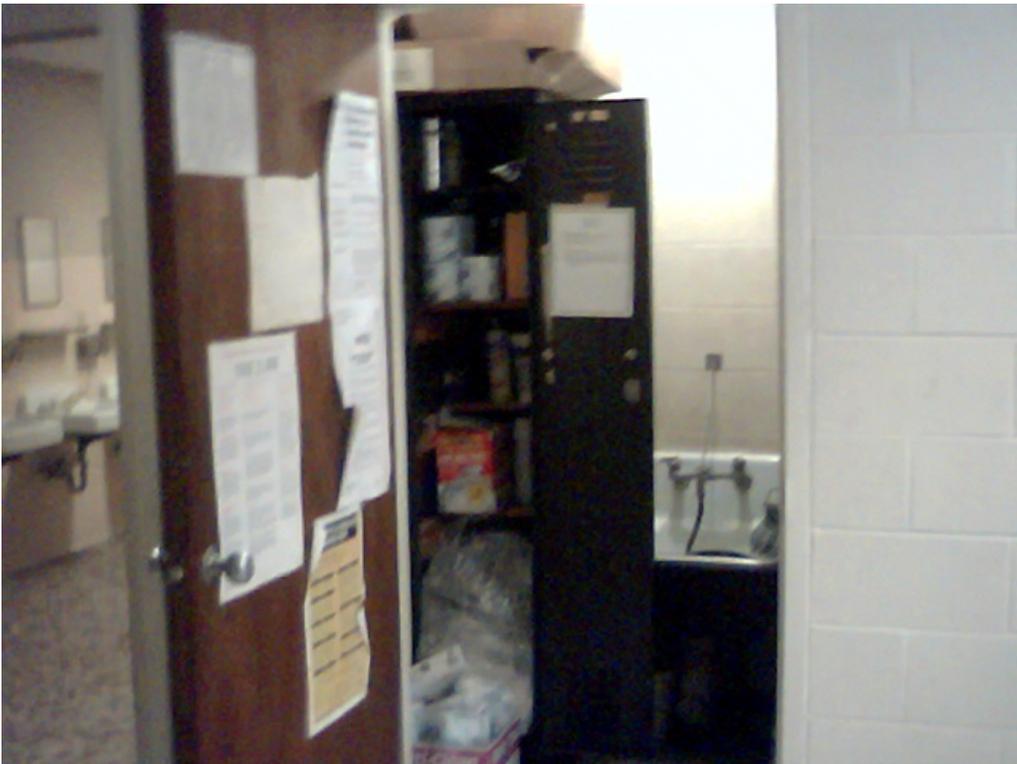
Photo 8: Storage cabinet with cleaning supplies in a janitor's closet in the Administration Building.

Chemicals formerly used and stored at the Site were associated with vehicle and facility maintenance activities and janitorial services. Janitorial chemicals and building maintenance-related products were stored in the designated storage area within the janitorial closet in the Administration Building. Vehicle maintenance chemicals and small amounts of petroleum, oil, and lubricant products were stored in hazardous materials storage sheds or in designated areas within the maintenance bay area of the OMS building. No visual evidence of staining or stressed vegetation was observed around the OMS building.

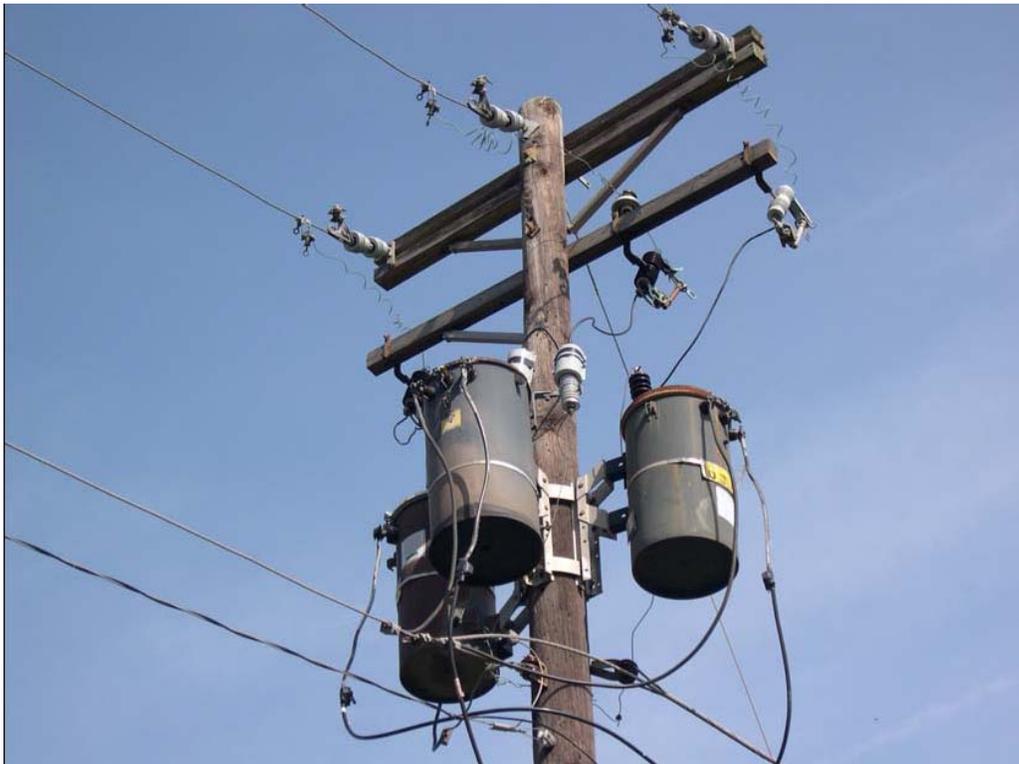
Photo 10: Electrical transformers on a utility pole on the west side of the Administration Building. (Photo from the 2005 EBS report.)

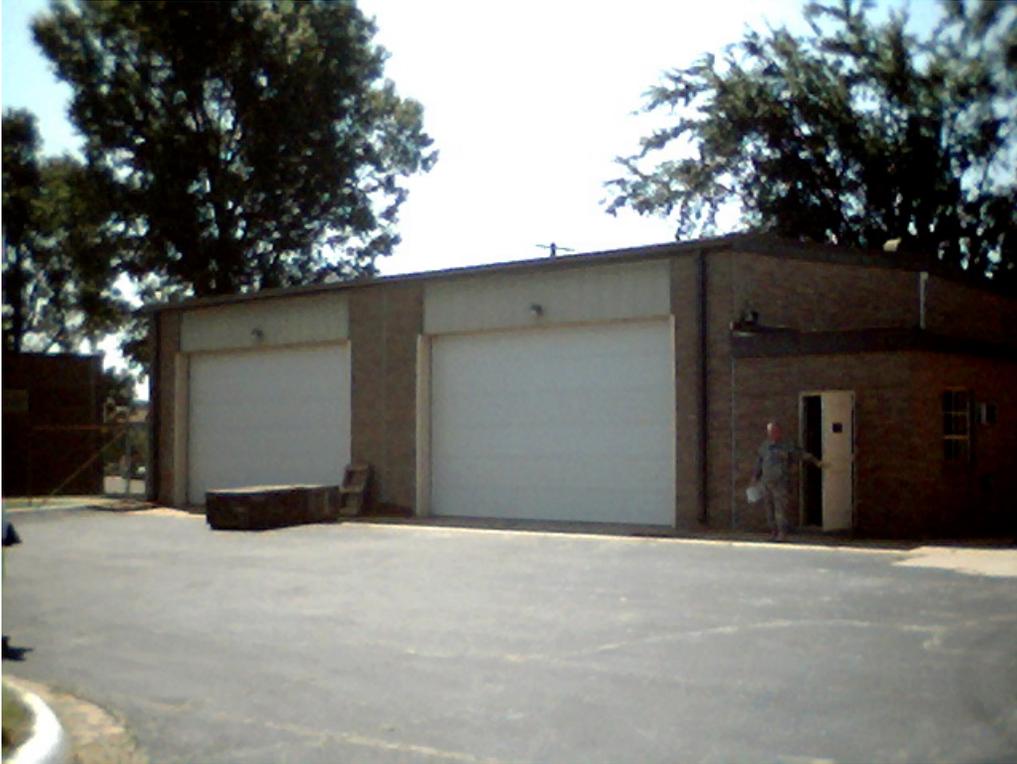
Photo 11: OMS maintenance bay, viewed looking to the southeast.

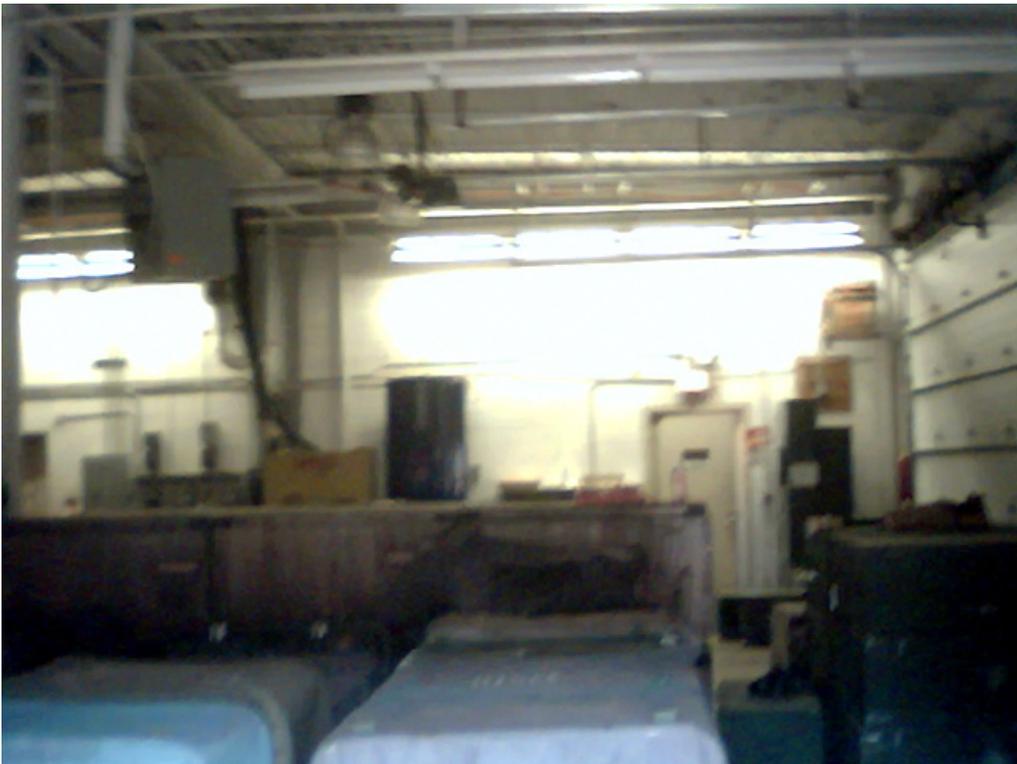
Photo 12: Storage inside the OMS maintenance bay.

The Administration Building contained tables, chairs, desks, cabinets, and exercise and kitchen equipment from USAR activities. The OMS was full of stored equipment, but no vehicles. A vehicle wash platform discharging to an OWS is located west of the OMS, within the fenced area. Several military vehicles were observed within the MEP area or on the Site during the Site reconnaissance.

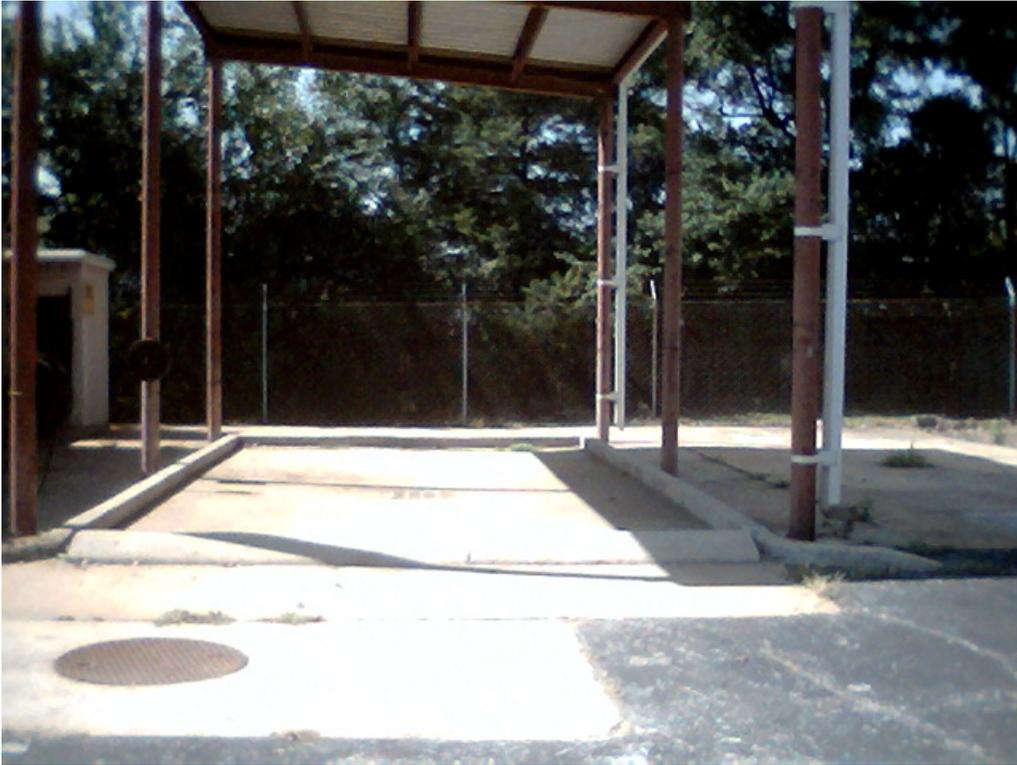
Photo 13: Vehicle wash rack and an oil/water separator in the south central portion of the property, viewed looking south.

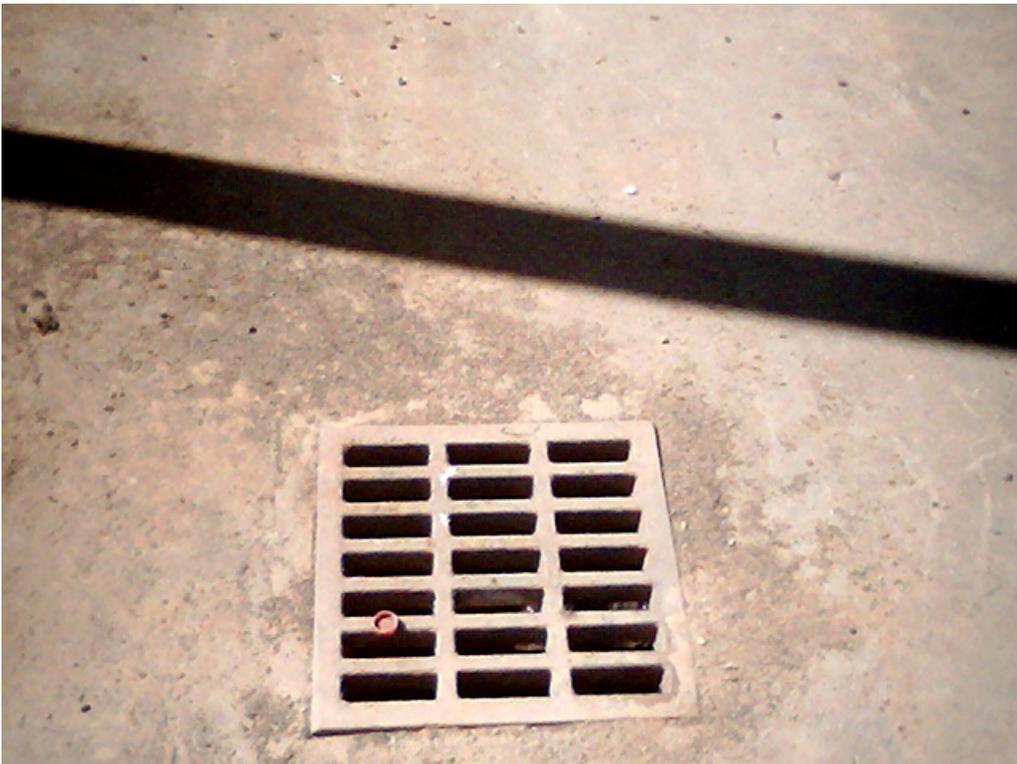
Photo 14: Vehicle wash rack drain which connects to an oil/water separator.

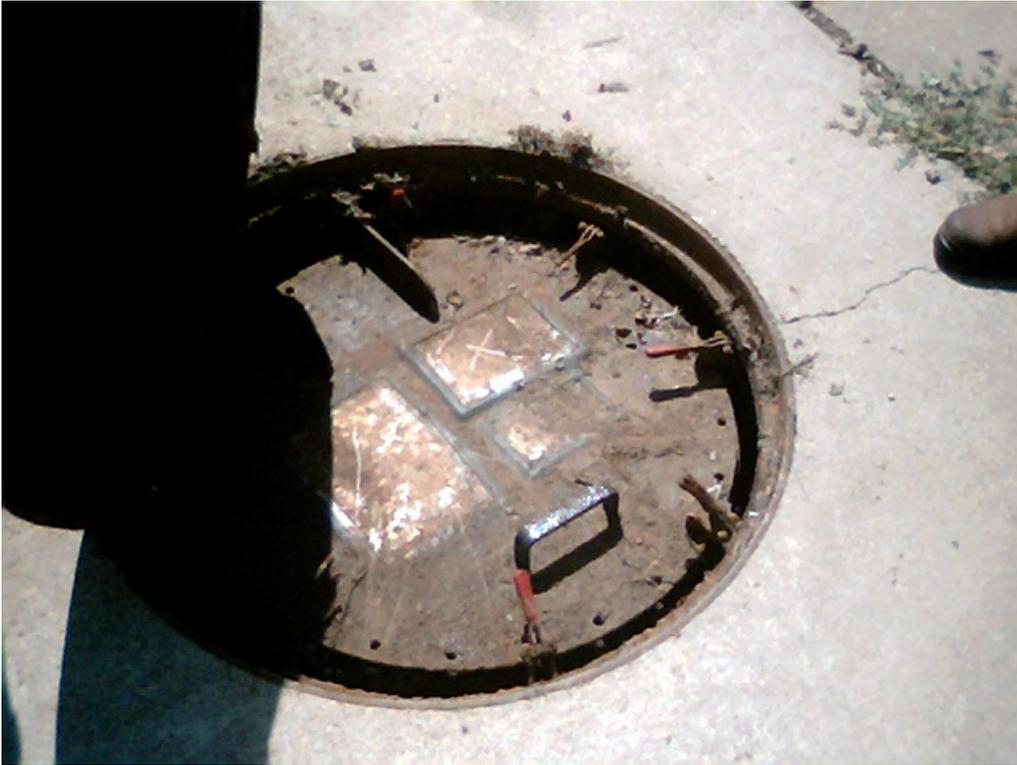
Photo 15: The top of the oil/water separator for the vehicle wash rack.

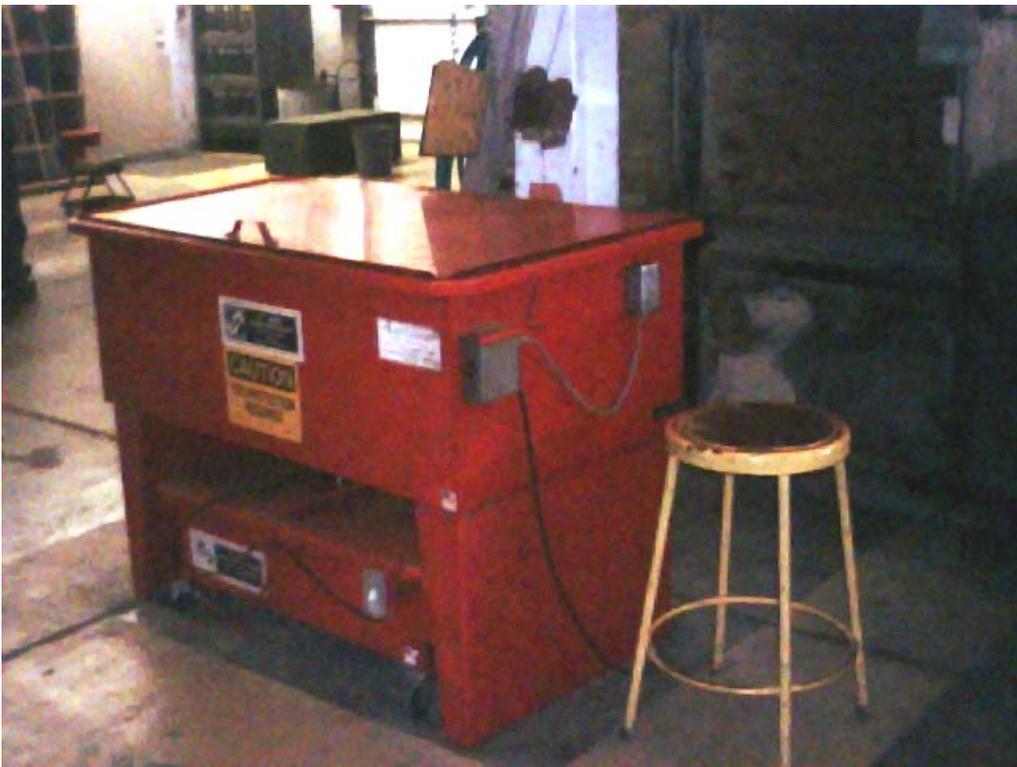
Photo 16: A parts washer was stored inside the OMS maintenance bay.

A sink-type vehicle parts washer inside the OMS was used during historical vehicle maintenance operations (Photographs 16 and 17 in Appendix B). The washer contained residual solvent-based cleaning solution and appeared to be in good condition. According to USAR personnel, cleaning solutions are used sparingly and allowed to evaporate.

A vehicle parts washer inside the OMS was used during past vehicle maintenance operations. At the time of the Site reconnaissance, the parts washer appeared to be in good condition and contained residual solvent-based cleaning solution (Appendix B, Photographs 16 and 17). USAR personnel reported that an outside vendor (Safety-Kleen) serviced the unit as needed. Documentation was not available to determine the time frame that Safety-Kleen serviced the parts washer.

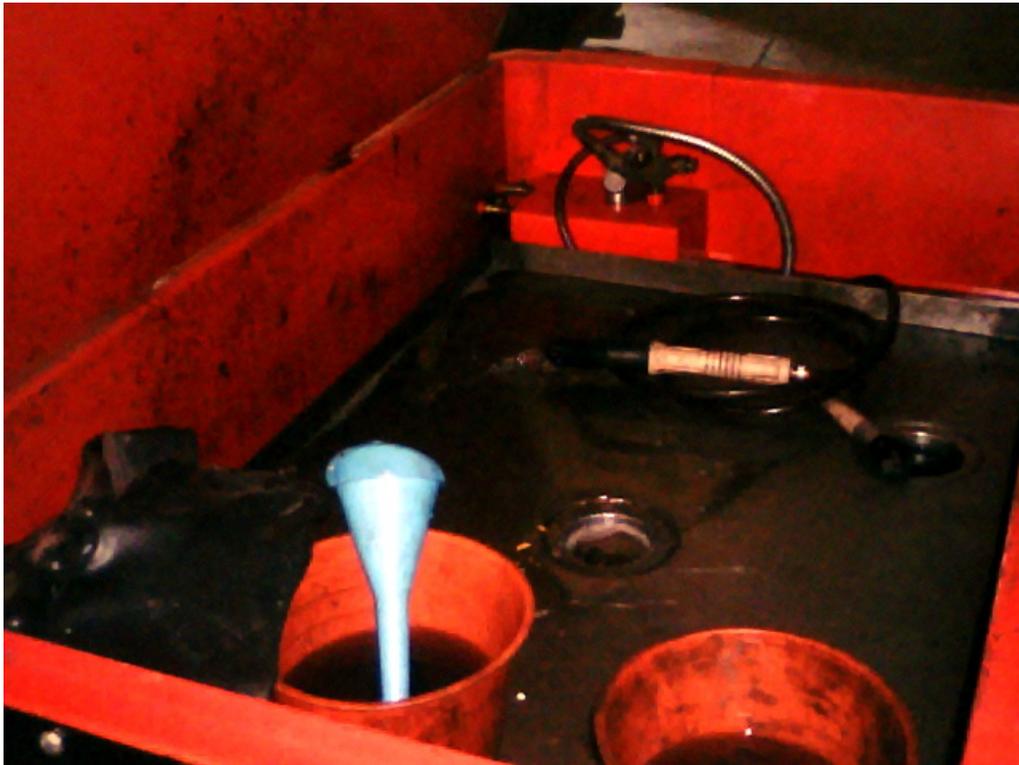
Photo 17: Parts washer with spent solvents in the OMS maintenance bay.

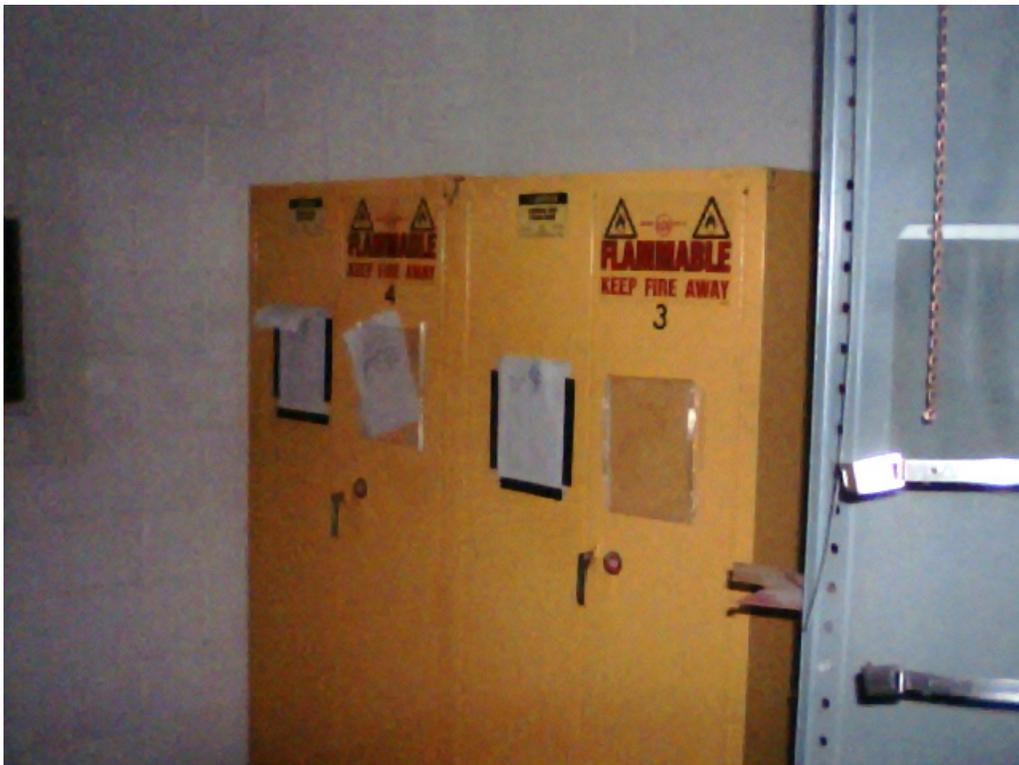
Photo 18: Hazardous material flammable storage cabinets in the OMS maintenance building.

Chemicals were stored in two hazardous/flammable materials storage sheds inside the OMS or in three hazardous materials storage sheds, one on the west side of the OMS and two in the southeast corner of the MEP, within the OMS fenced area (Photographs 18, 19, and 20 in Appendix B). Several military vehicles were located within the MEP area or on the Site during the Site reconnaissance.

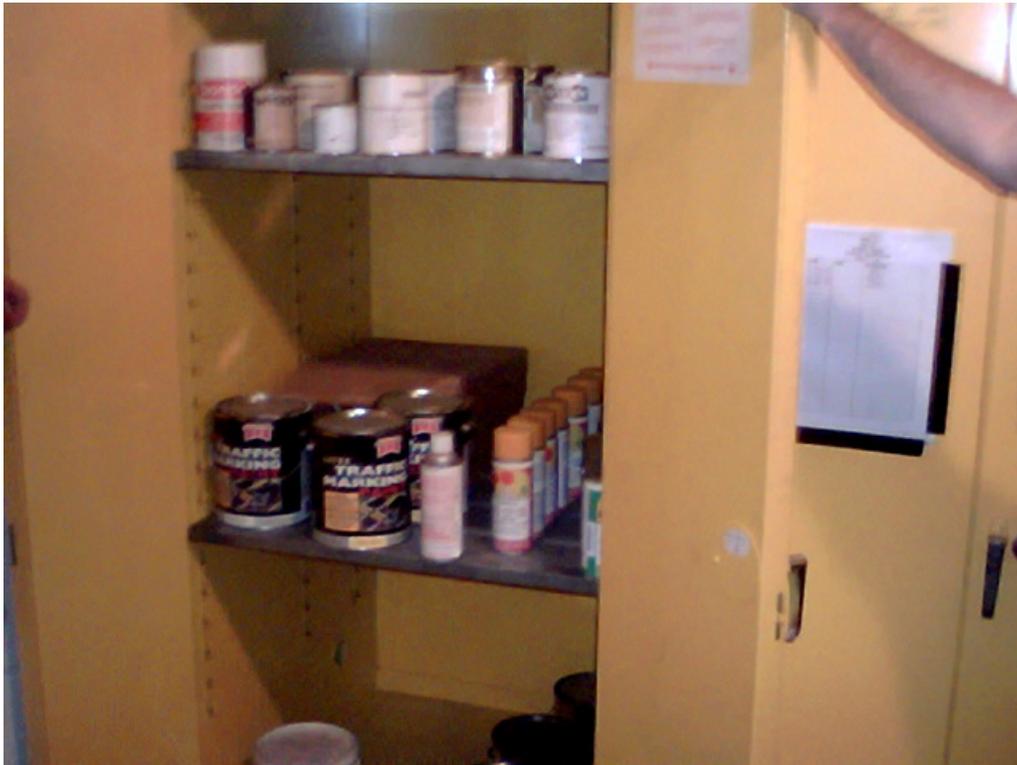
Photo 19: Materials within the hazardous material flammable storage cabinets in OMS maintenance building.

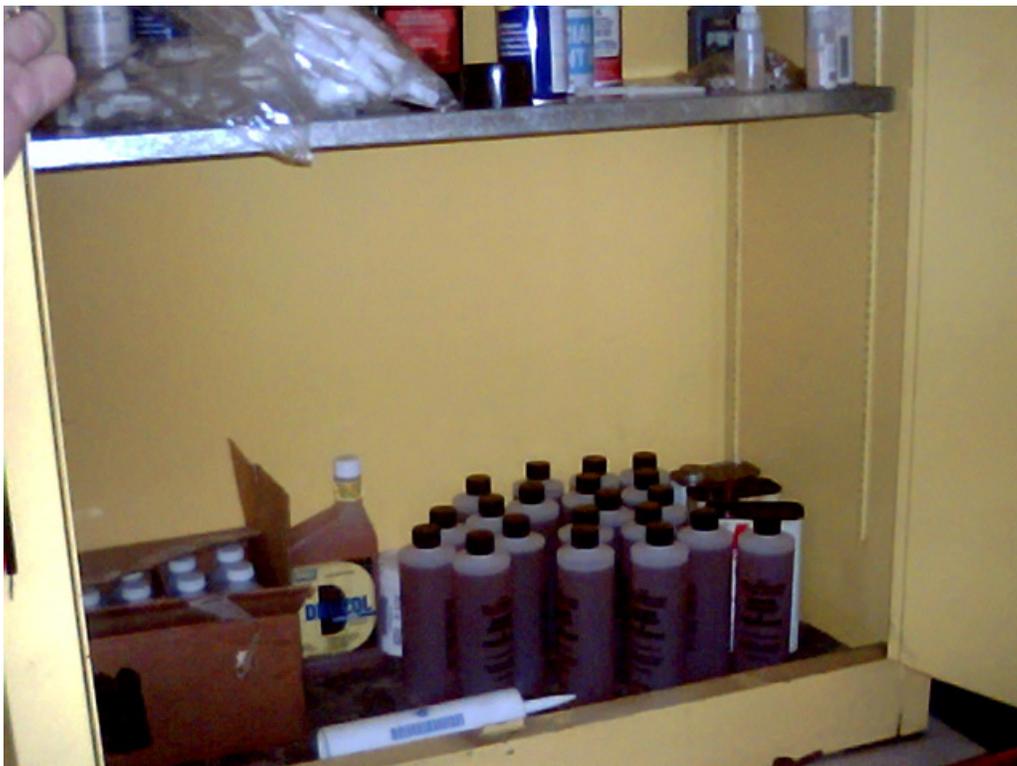
Photo 20: Another view of materials within the hazardous material flammable storage cabinet in the OMS maintenance building.
