**ENVIRONMENTAL CONDITION OF
PROPERTY REPORT**

**JONESBORO
U.S. ARMY RESERVE CENTER (AR022)
1001 SOUTH CARAWAY ROAD
JONESBORO, ARKANSAS 72401**

February 12, 2007

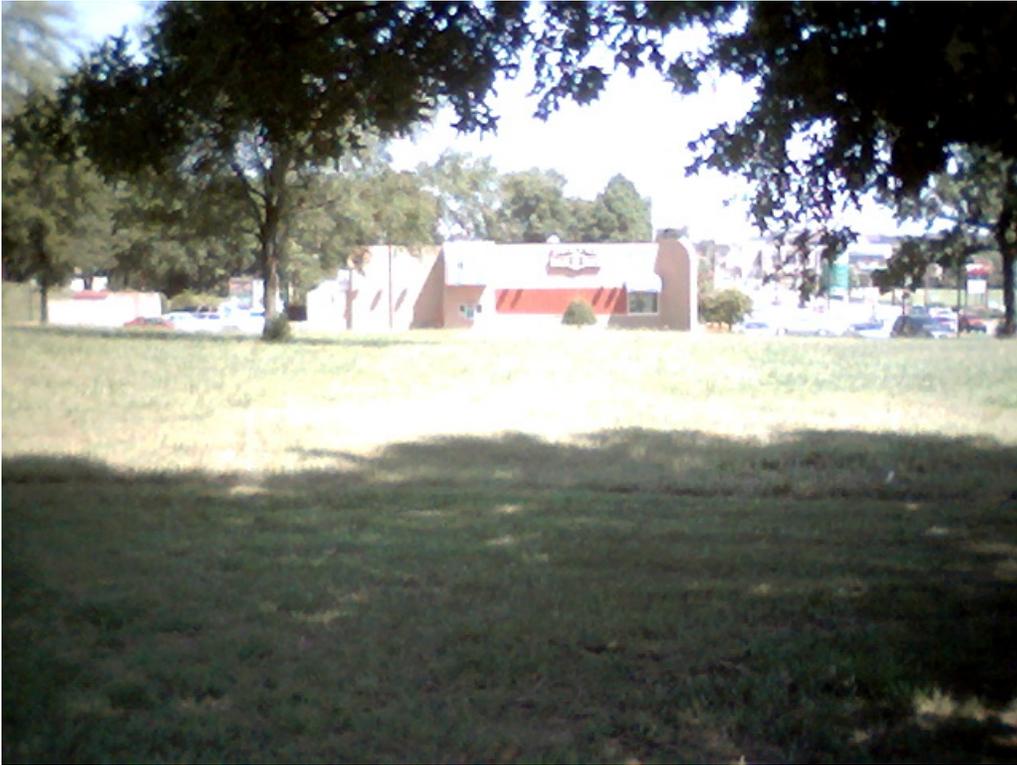
Photo 21: Looking north from the privately owned vehicle parking area on the north end of the Site is a vacant lot and a restaurant on the northern adjacent property.

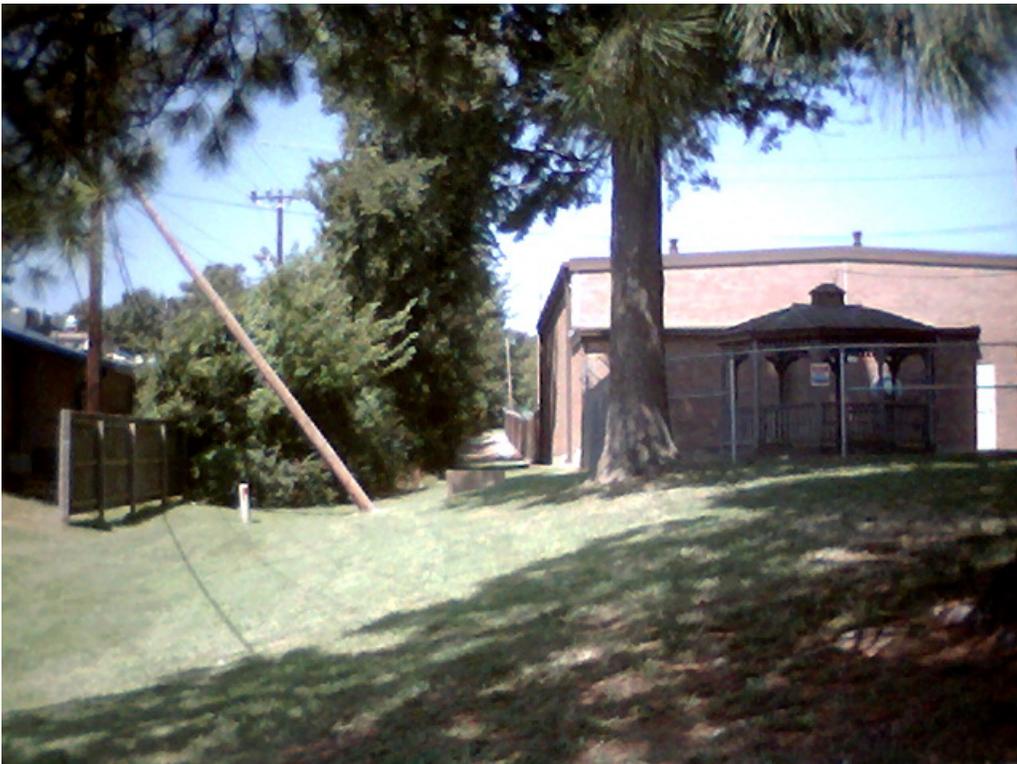
Photo 22: Looking west from the southeast corner of the Site, a grass covered drainage way borders the southern portion of the facility.

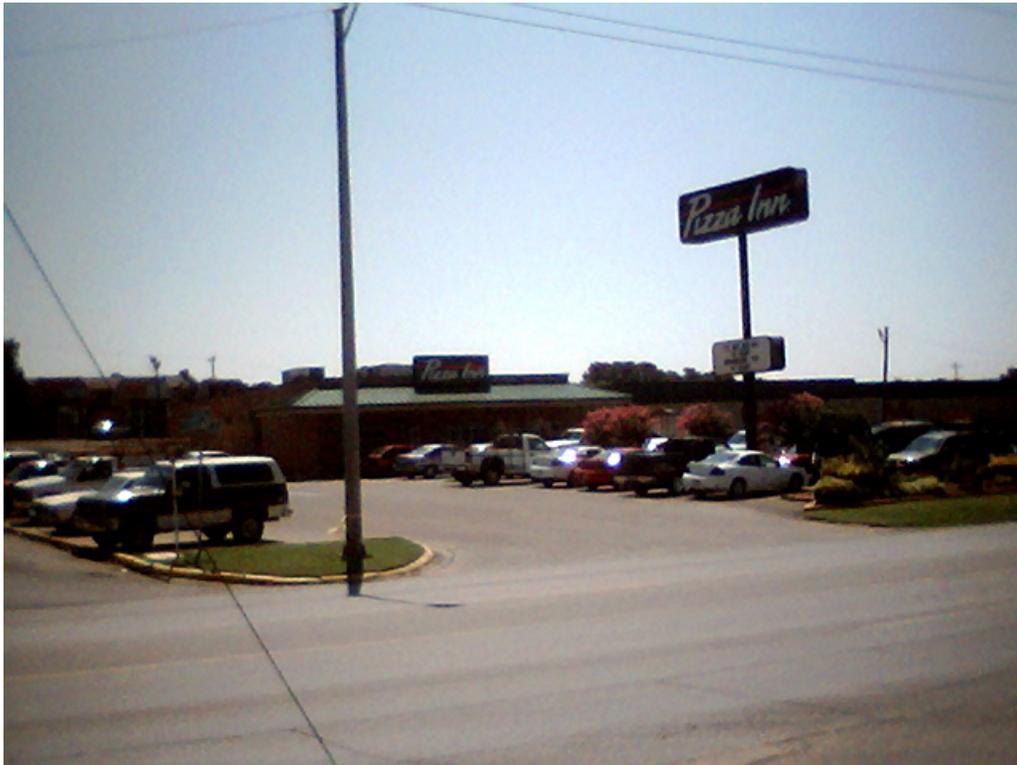
Photo 23: Looking southeast from the east boundary of the Site are retail businesses on the adjoining property.

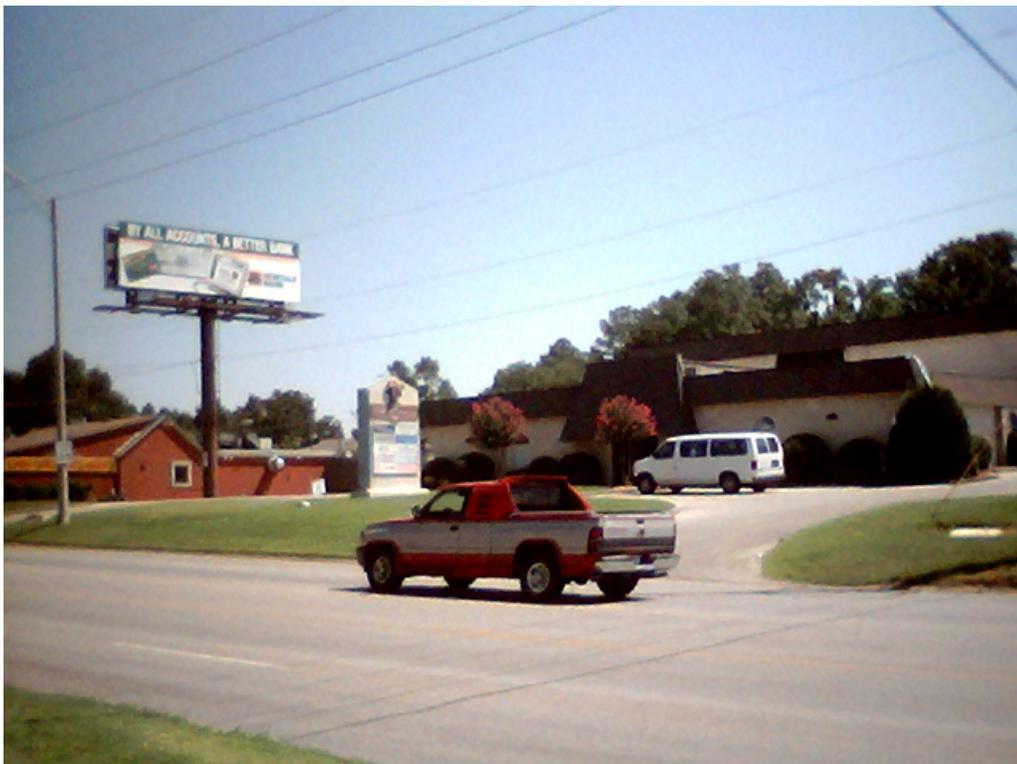
Photo 24: Looking northeast from the east boundary of the Site are retail businesses on the adjoining property.
