**ENVIRONMENTAL CONDITION OF  
PROPERTY REPORT**

**ALICE U.S. ARMY RESERVE CENTER (TX002)  
100 SOUTH STADIUM ROAD  
ALICE, TEXAS 78332**

**U.S. Army Corps of Engineers — Louisville District  
Engineering Division — Environmental Engineering Branch  
600 Dr. Martin Luther King, Jr. Place  
Louisville, Kentucky 40202-2232**

**February 13, 2007**

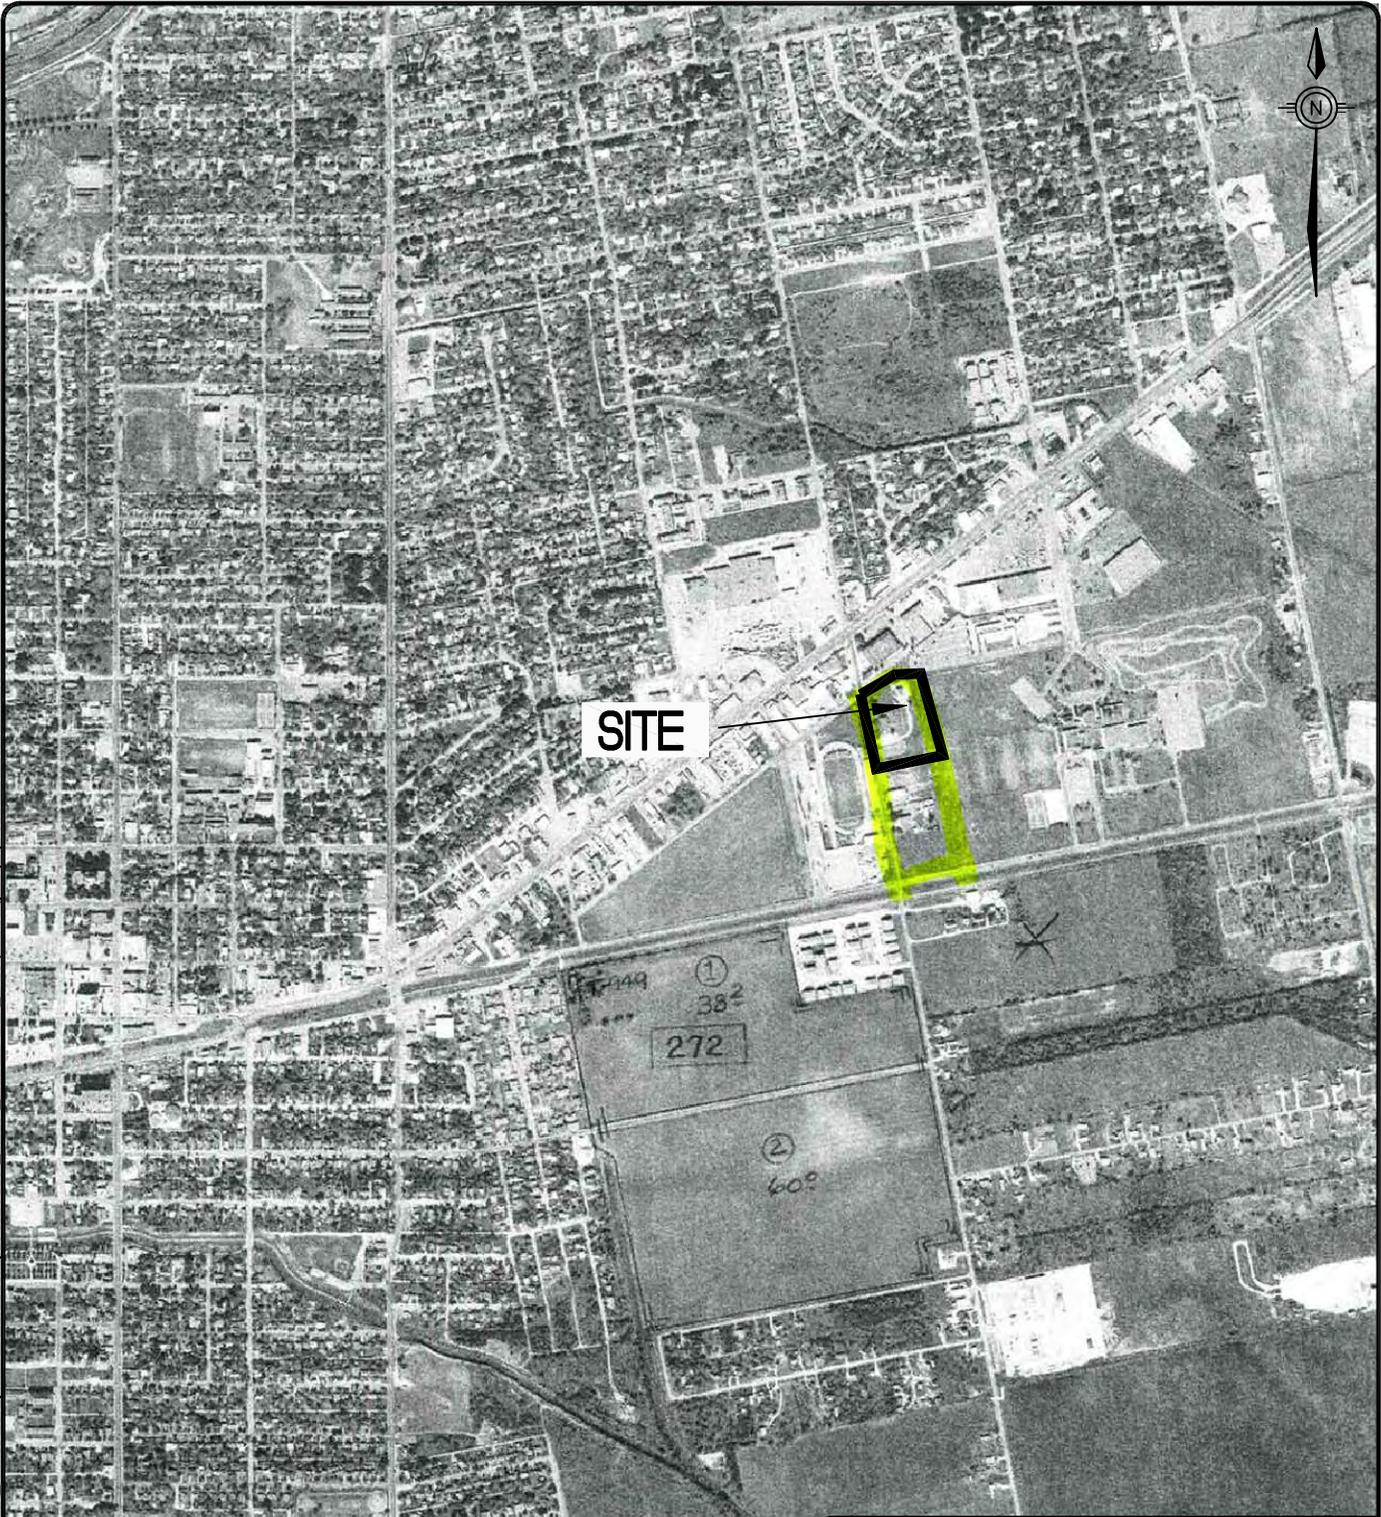
FIGURE 8  
1979 AERIAL PHOTOGRAPH  
ENVIRONMENTAL CONDITION OF PROPERTY  
ALICE USARC  
ALICE, TEXAS

- **1979 through 2006 (Figures 8 through 15).** These aerial photographs show the Site, adjacent properties (including the First Community Bank north of the Site), and the surrounding area in the same configuration as observed during the August 10, 2006 Site reconnaissance.

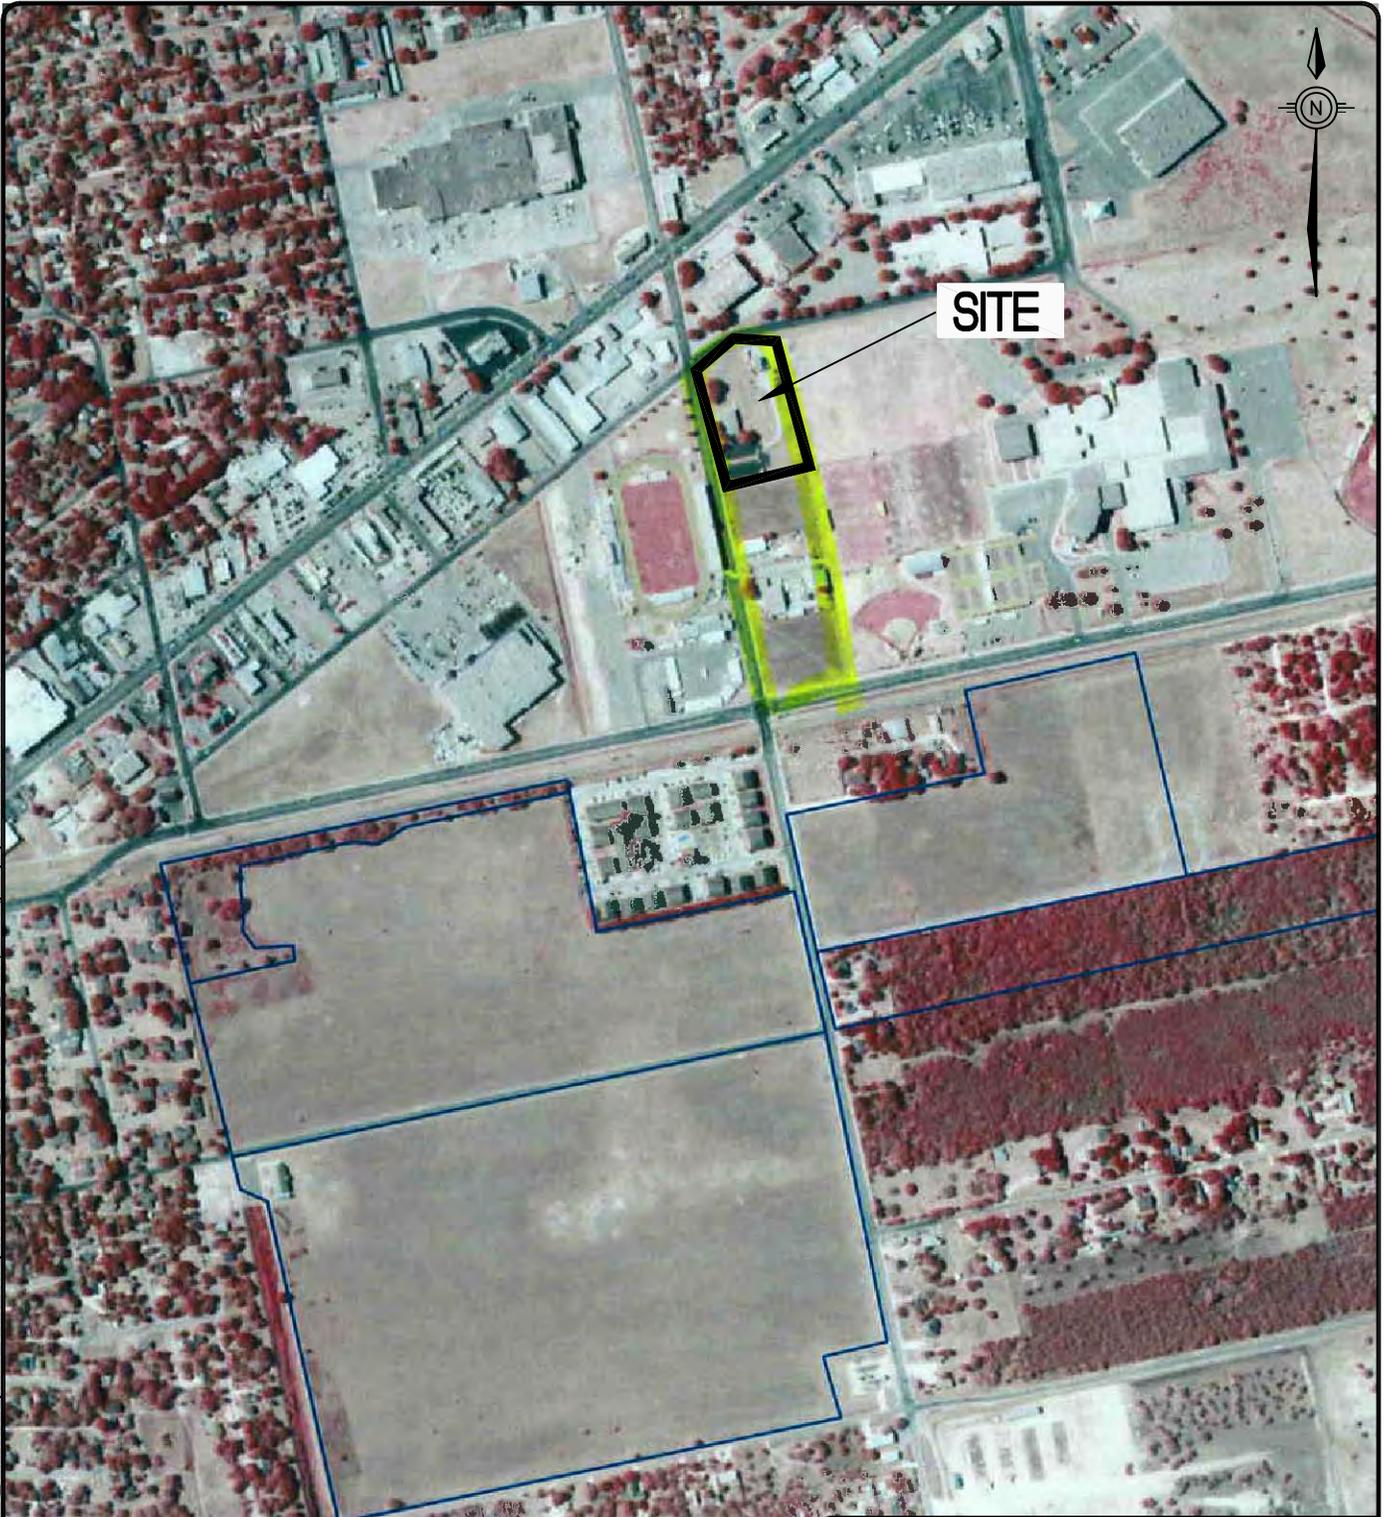
FIGURE 15  
2006 AERIAL PHOTOGRAPH  
ENVIRONMENTAL CONDITION OF PROPERTY  
ALICE USARC  
ALICE, TEXAS

Figure 15 in Appendix A provides a 2006 aerial view of the Site and adjacent properties. The property is bounded by Houston Street and the First Community Bank to the north; South Stadium Road, then the Alice High School Stadium to the west; a vacant undeveloped lot, then the Alice High School Maintenance Department to the south; and an Alice High School athletic field to the east. Table 2 provides a list of adjacent properties with their directional location from the Site and zoning.

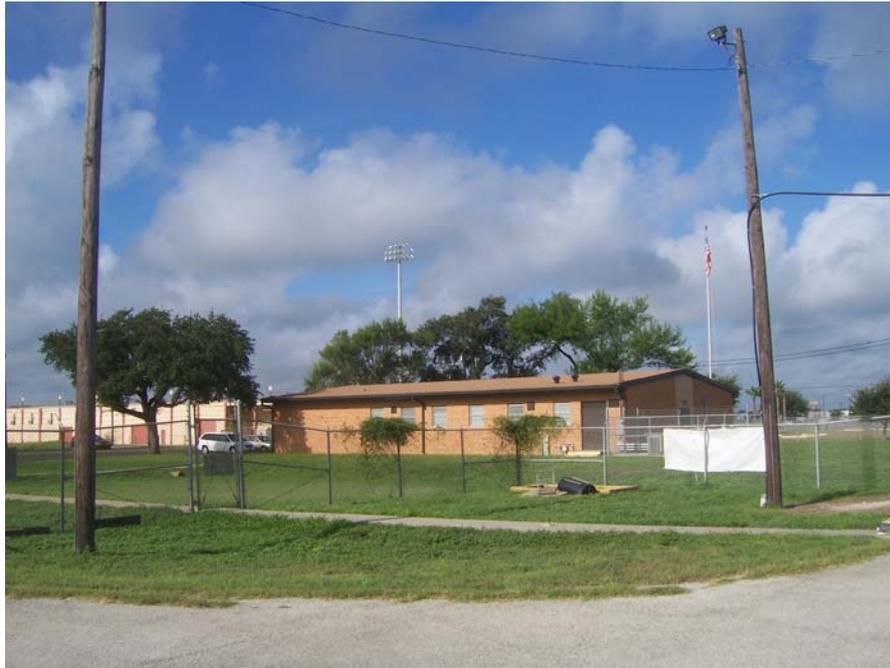
**Photo 9:** View of the back (east side) of the Administration Building, looking southwest from the fenced OMS Building area. The fence in the foreground surrounds the OMS building, container boxes, flammable materials storage sheds, vehicle washing station, and MEP area. The Alice High School Stadium adjacent to the property (west) can be seen in the background left.

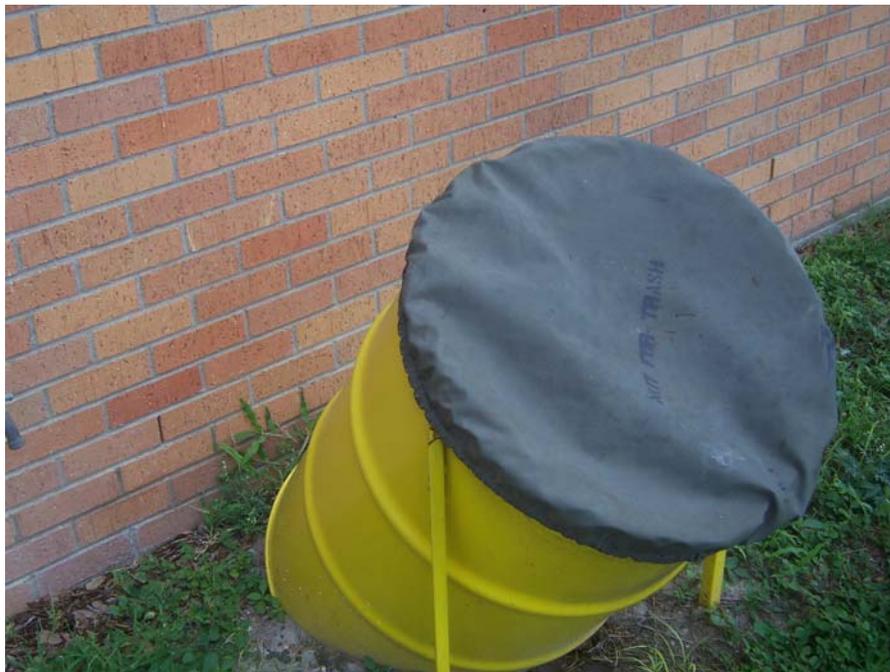
**Photo 10:** This sand filled drum outside the side door to the Administration Building is designed to be used by soldiers returning from the rifle range. Before a soldier enters the building with a rifle, the muzzle is pointed at the sand in the drum and the trigger pulled to ensure there are no weapons with live rounds in the building. According to USAR personnel, the drum has not been used.

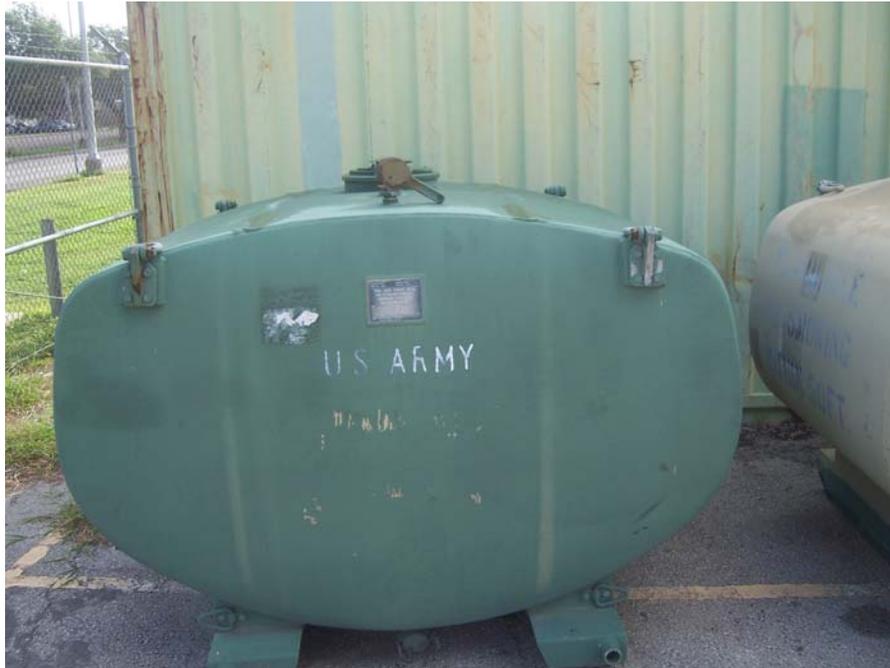
Also located in the northeast part of the fenced-in area were two empty 600-gallon, single-walled steel mobile diesel tanks (Photographs 22 through 24). Both tanks appeared in good condition during the Site reconnaissance. According to USAR personnel familiar with the Site, the tanks have not been used since 2003 when the unit mobilized to Kuwait. Fuel for military vehicles is purchased at a local gas station and is not stored in bulk on the Site.

**Photo 25:** One of two empty 600-gallon, single-walled, steel, mobile diesel tanks. Part of the second tank can be seen to the right. These tanks are set on a flatbed trailer when in use. According to USAR personnel, the tanks have not been used since 2003 when the unit mobilized to Kuwait. Fuel for military vehicles is purchased at a local gas station and is not stored on the Site.
